1	PROJECT NO. <u>I-5892</u> <u>BUNCOMBE</u> COUNTY BRIDGE NO. <u>429</u> SHEET 2 OF 3				
John Andrew Carolina Con -780 CERREC AND SEAL 32492 YANNA YANNA 1/2017	DEPARTMENT OF TRANSPORTATION RALEIGH BENT 1 SPAN B FACE REVISIONS				
DOCUMENT NOT CONSIDERED	NO. BY:	DATE:	NO. BY:	DATE:	S-49
FINAL UNLESS ALL SIGNATURES COMPLETED	1 2		3 4		TOTAL SHEETS 68

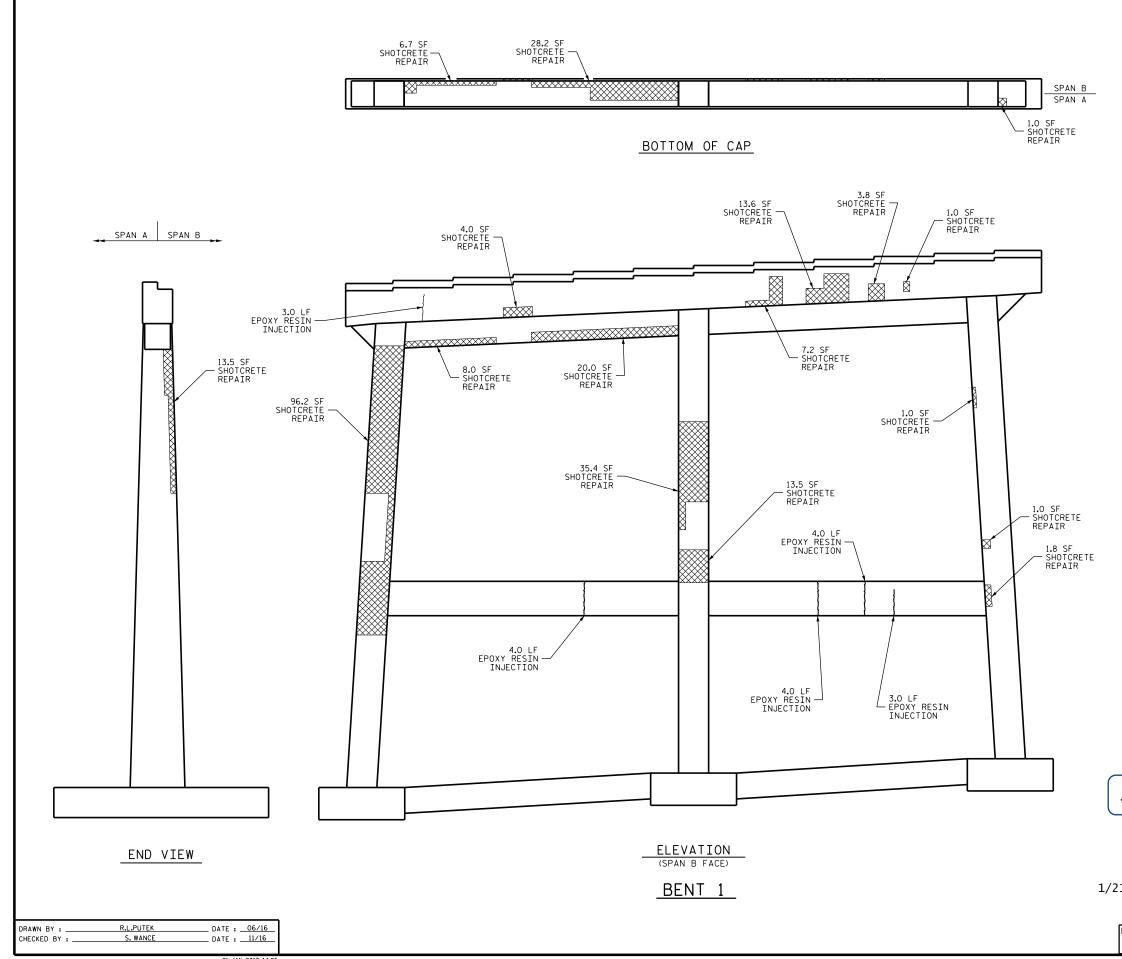
DAMAGED AREA

CLEAN AND REMOVE DEBRIS FROM THE TOP OF THE CAP AND APPLY EPOXY PROTECTIVE COATING. EPOXY COATING SHALL BE APPLIED TO THE TOP FACE OF THE CAP. THE CONTRACTOR SHALL NOT COAT THE THE AREA OF THE CAP BENEATH THE MASONRY PLATES.

----- EPOXY RESIN INJECTION
