AS-BUILT REPAIR QUANTITY TABLE				
REPAIRS BENT 2	QUANTITIES			
	ESTIMATE		ACTUAL	
SHOTCRETE REPAIRS	AREA SF	VOLUME CF	AREA SF	VOLUME CF
CAP	102.5	64.1 *		
COLUMNS AND STRUTS	45.9	28.7 *		
CONCRETE REPAIRS	AREA SF	VOLUME CF	AREA SF	VOLUME CF
CAP	4.3	2.7 *		
COLUMNS AND STRUTS	0.0	0.0		
EPOXY RESIN INJECTION		LN. FT		LN. FT
CAP		4.0		
COLUMNS AND STRUTS		0.0		
EPOXY COATING		SO. FT		SO. FT
TOP OF BENT CAP		283

PROJECT NO. I-5892
BUNCOMBE COUNTY
 BRIDGE NO. 429

**BENT 2
 SPAN B FACE**

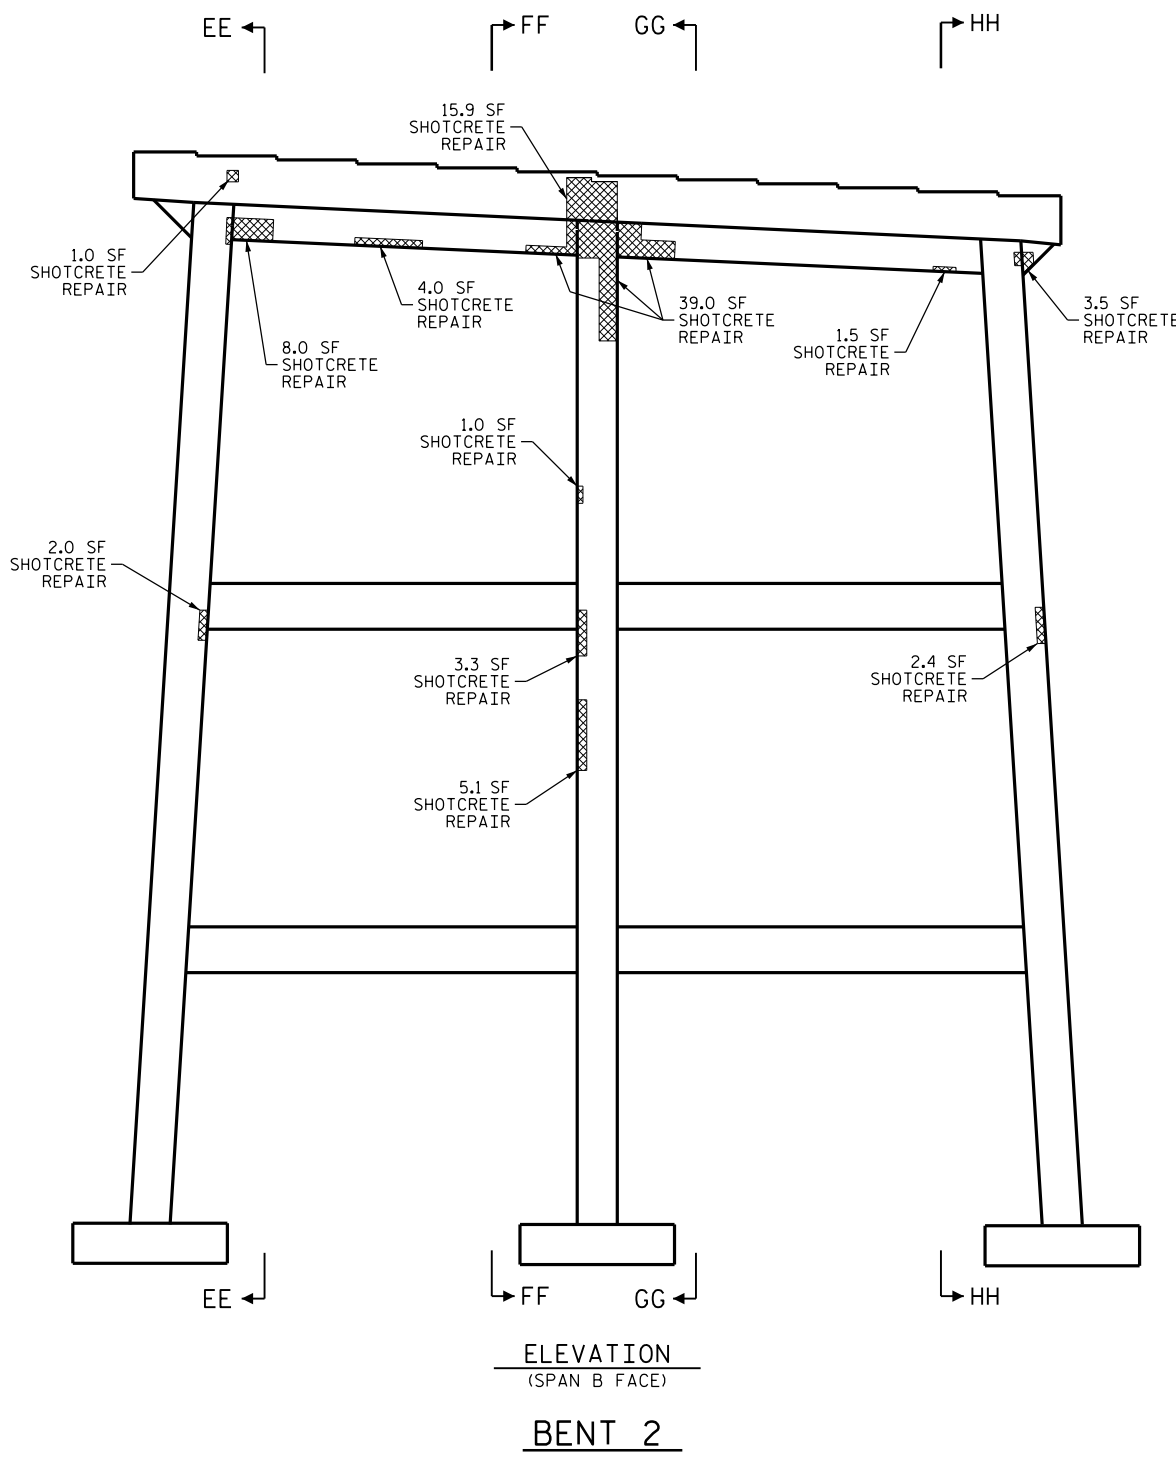
DAMAGED AREA

EPOXY RESIN INJECTION

VALUES IN CHART REPRESENT ESTIMATED REPAIR TOTALS AFTER REMOVAL OF UNSOUND CONCRETE, MINIMUM OF 1" BEHIND REBAR AND MINIMUM 2" CLEARANCE TO SAWCUT. SEE REPAIR DETAILS.
