MBE		2 UNTY
JOLUN AMARAMACCONE STATE OF NORTH CAROLINA DEPARTMENT OF TRANSPORTATION 78CAEROCEEXAPECTING					
21/2017	BENT 2 COLUMN SIDE VIEWS				
	REVISIONS SHEET NO.				
DOCUMENT NOT CONSIDERED	NO. BY:		NO. BY:	DATE:	S-53
FINAL UNLESS ALL SIGNATURES COMPLETED	1 2		3 4		TOTAL SHEETS 68

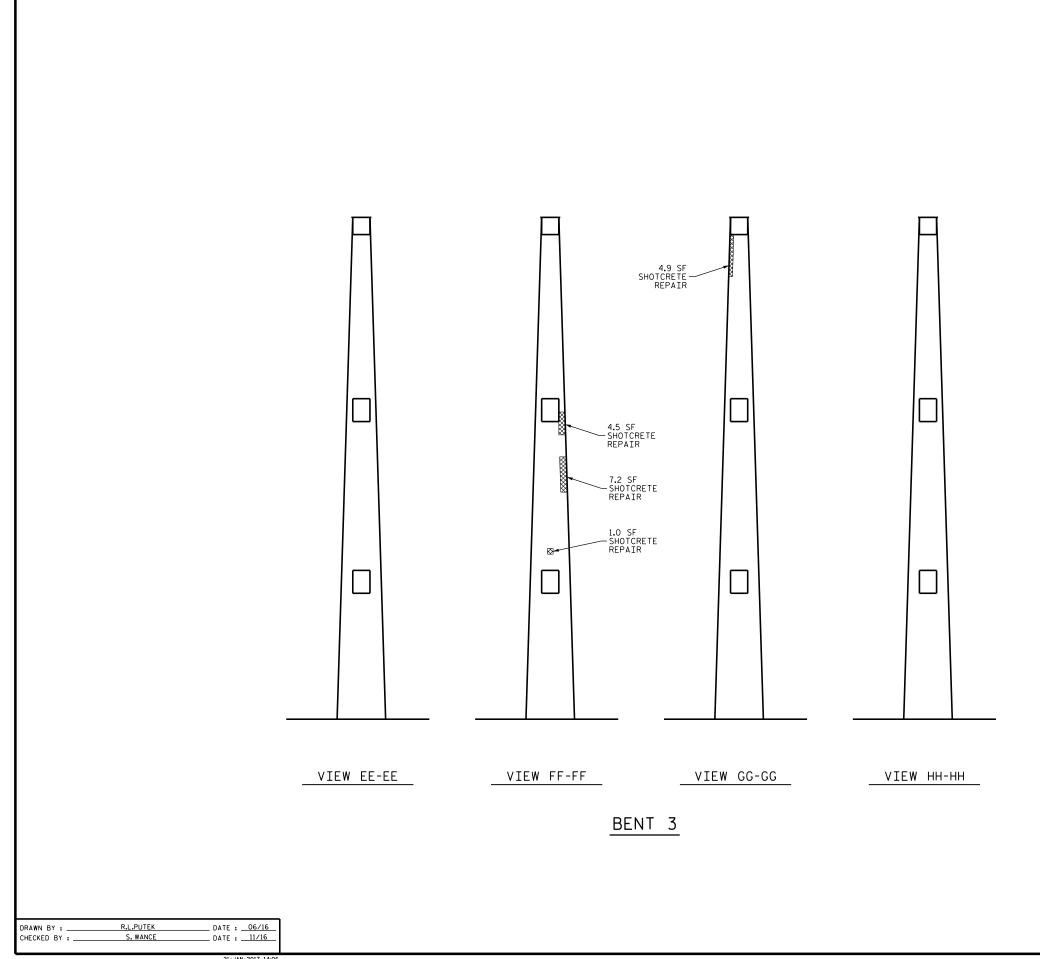
DAMAGED AREA

----- EPOXY RESIN INJECTION

FOR REPAIRS, SEE "TYPICAL CAP AND COLUMN REPAIR DETAILS" SHEET.

CLEAN AND REMOVE DEBRIS FROM THE TOP OF THE CAP AND APPLY EPOXY PROTECTIVE COATING. EPOXY COATING SHALL BE APPLIED TO THE TOP FACE OF THE CAP. THE CONTRACTOR SHALL NOT COAT THE THE AREA OF THE CAP BENEATH THE MASONRY PLATES.
