PROJECT NO. I-5892
BUNCOMBE COUNTY
 BRIDGE NO. 429

SHEET 2 OF 3

BENT 3
SPAN D FACE

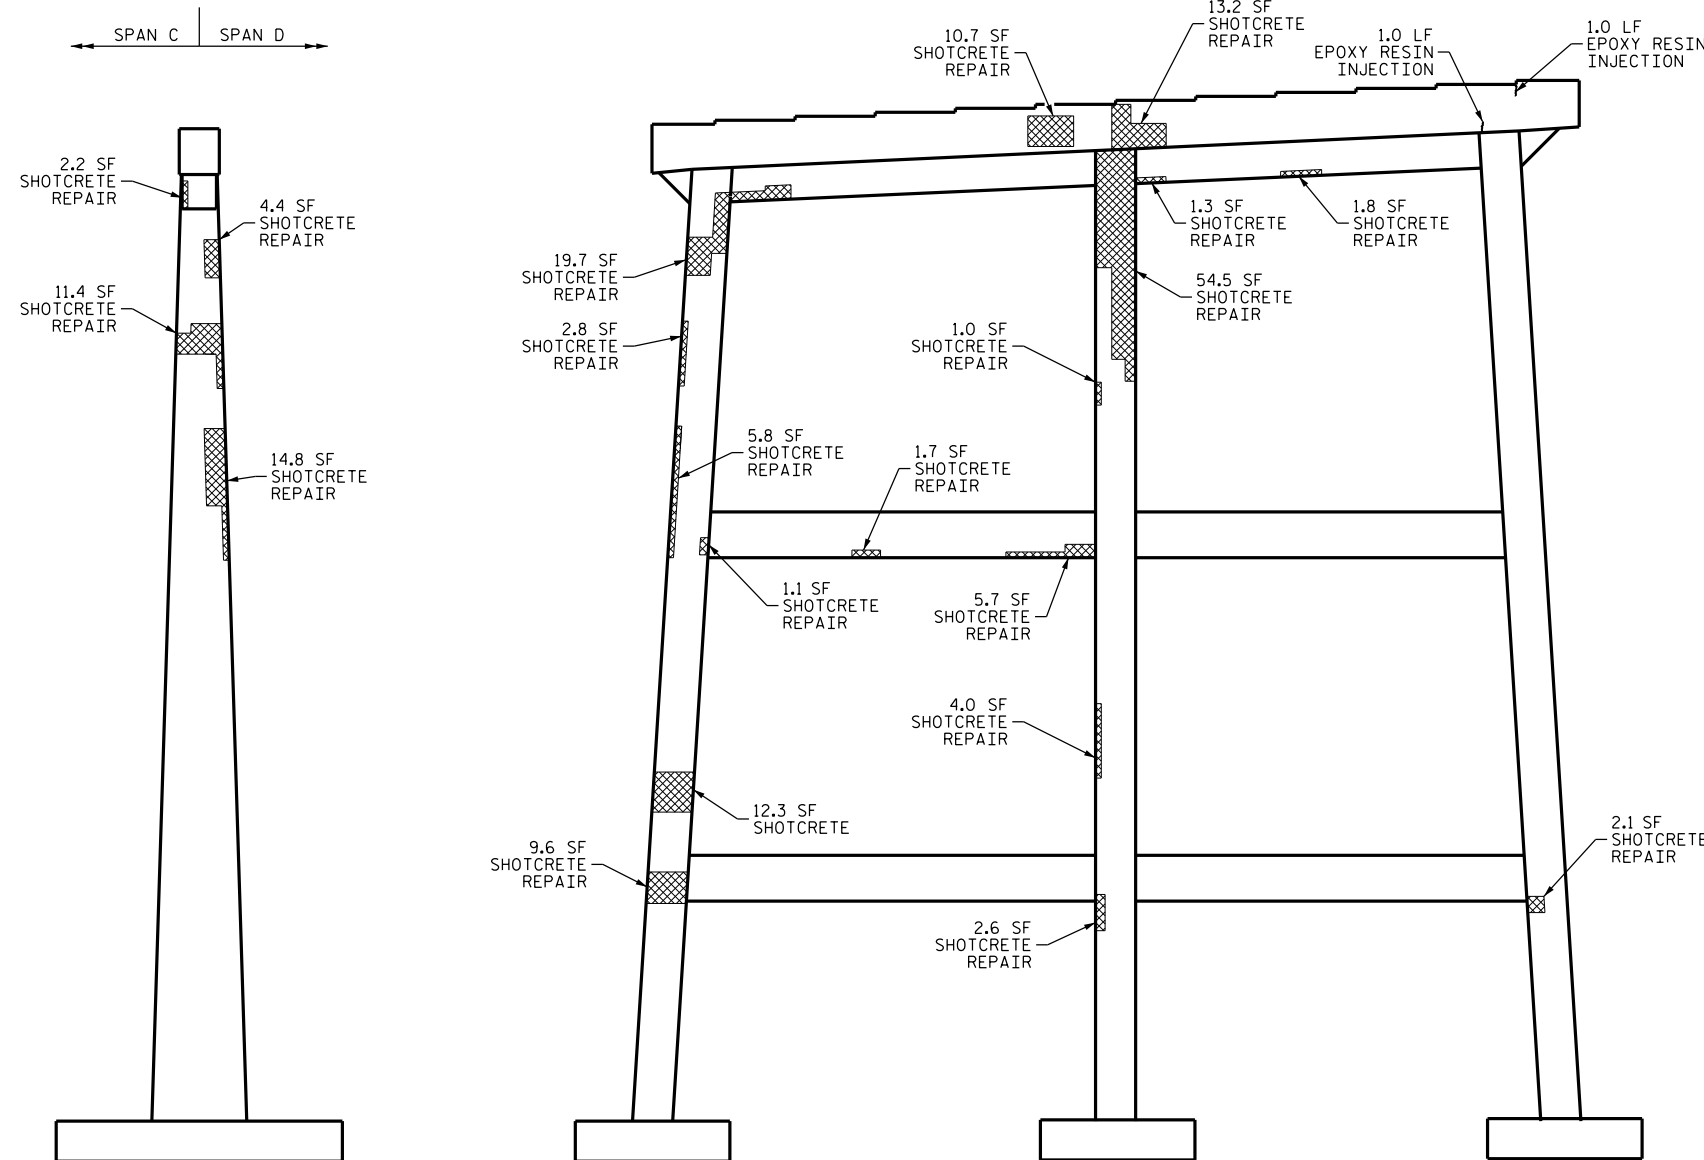
BENT 3
(SPAN D VIEW)

DAMAGED AREA

EPOXY RESIN INJECTION

CLEAN AND REMOVE DEBRIS FROM THE TOP OF THE CAP AND APPLY EPOXY PROTECTIVE COATING. EPOXY COATING SHALL BE APPLIED TO THE TOP FACE OF THE CAP. THE CONTRACTOR SHALL NOT COAT THE AREA OF THE CAP BENEATH THE MASONRY PLATES.
