PROJECT NO. I-5892  
BUNCOMBE COUNTY  
 BRIDGE NO. 429

SHEET 2 OF 3

STATE OF NORTH CAROLINA  
 DEPARTMENT OF TRANSPORTATION  
 RALEIGH

**BENT 4**  
**SPAN E FACE**

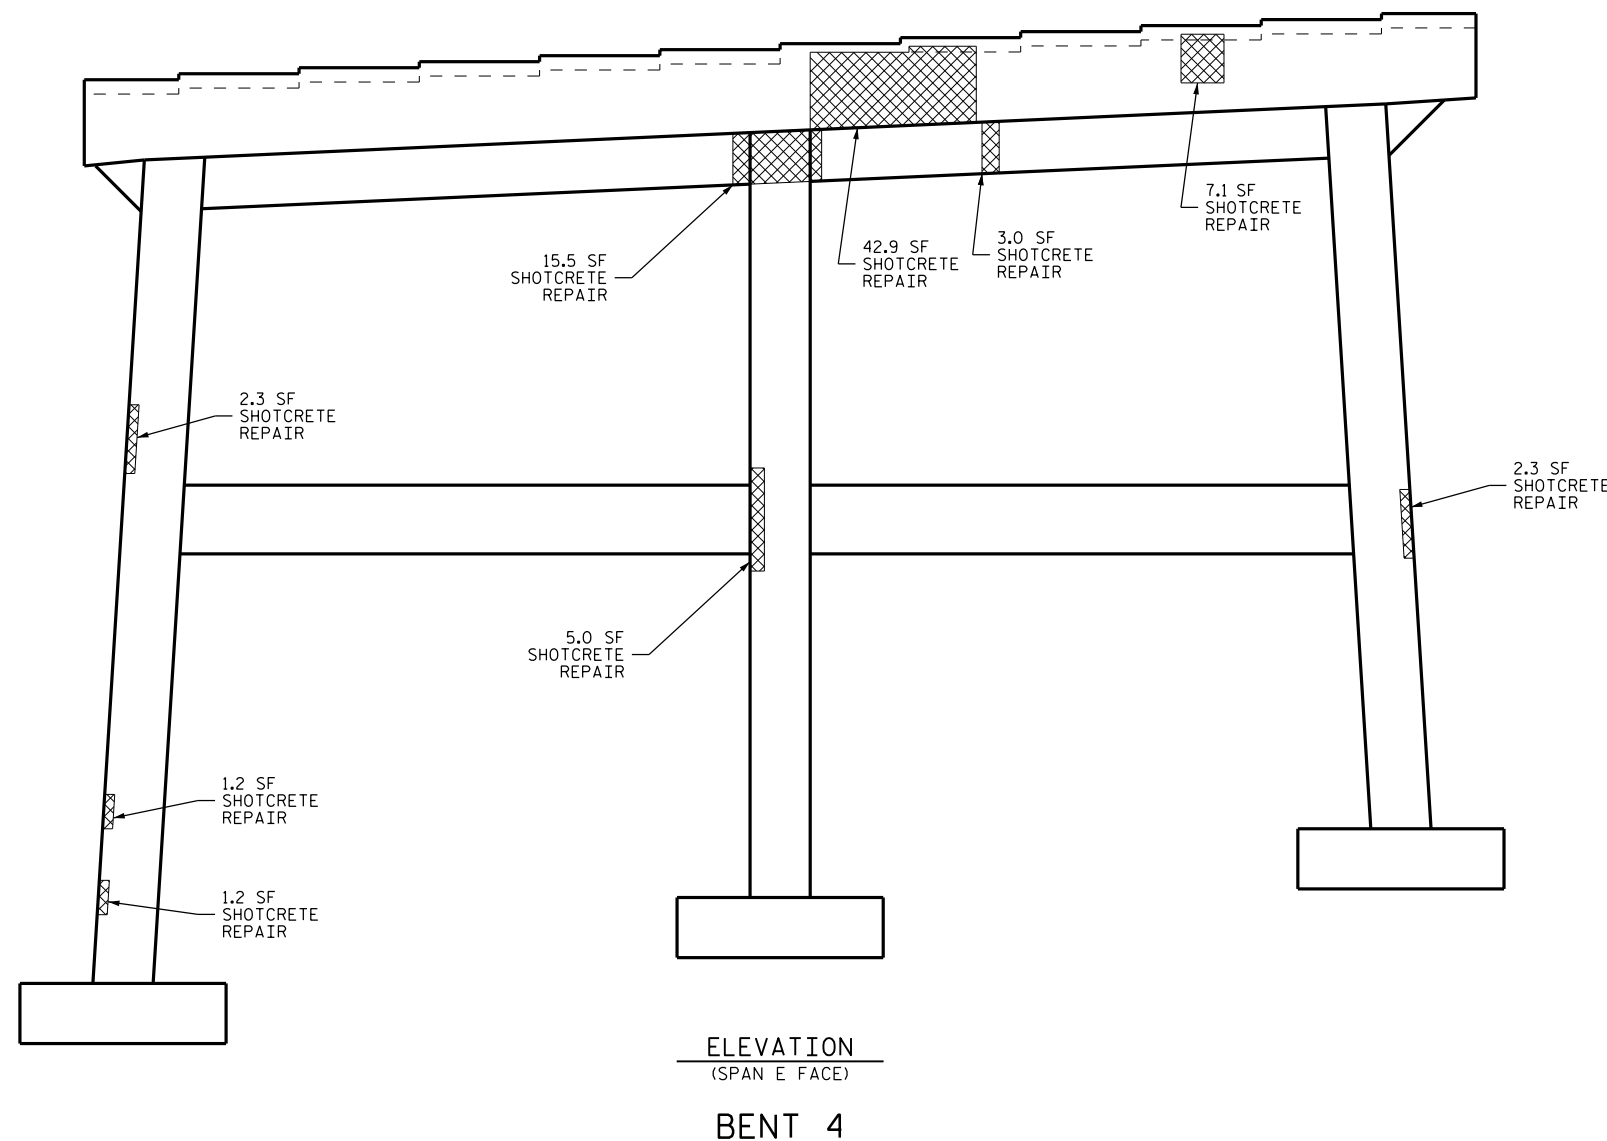
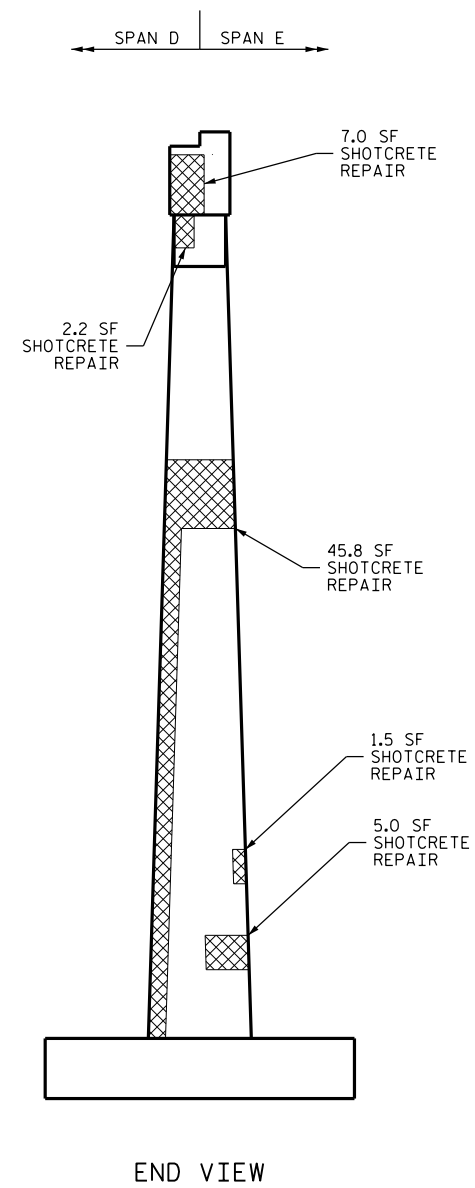
ELEVATION  
(SPAN E FACE)

DAMAGED AREA

CLEAN AND REMOVE DEBRIS FROM THE TOP OF THE CAP AND APPLY EPOXY PROTECTIVE COATING. EPOXY COATING SHALL BE APPLIED TO THE TOP FACE OF THE CAP. THE CONTRACTOR SHALL NOT COAT THE AREA OF THE CAP BENEATH THE MASONRY PLATES.

EPOXY RESIN INJECTION
