B-5939 PROJECT NO._ CARTERET COUNTY BRIDGE NO.

STATE OF NORTH CAROLINA DEPARTMENT OF TRANSPORTATION

SUBSTRUCTURE END BENT 1

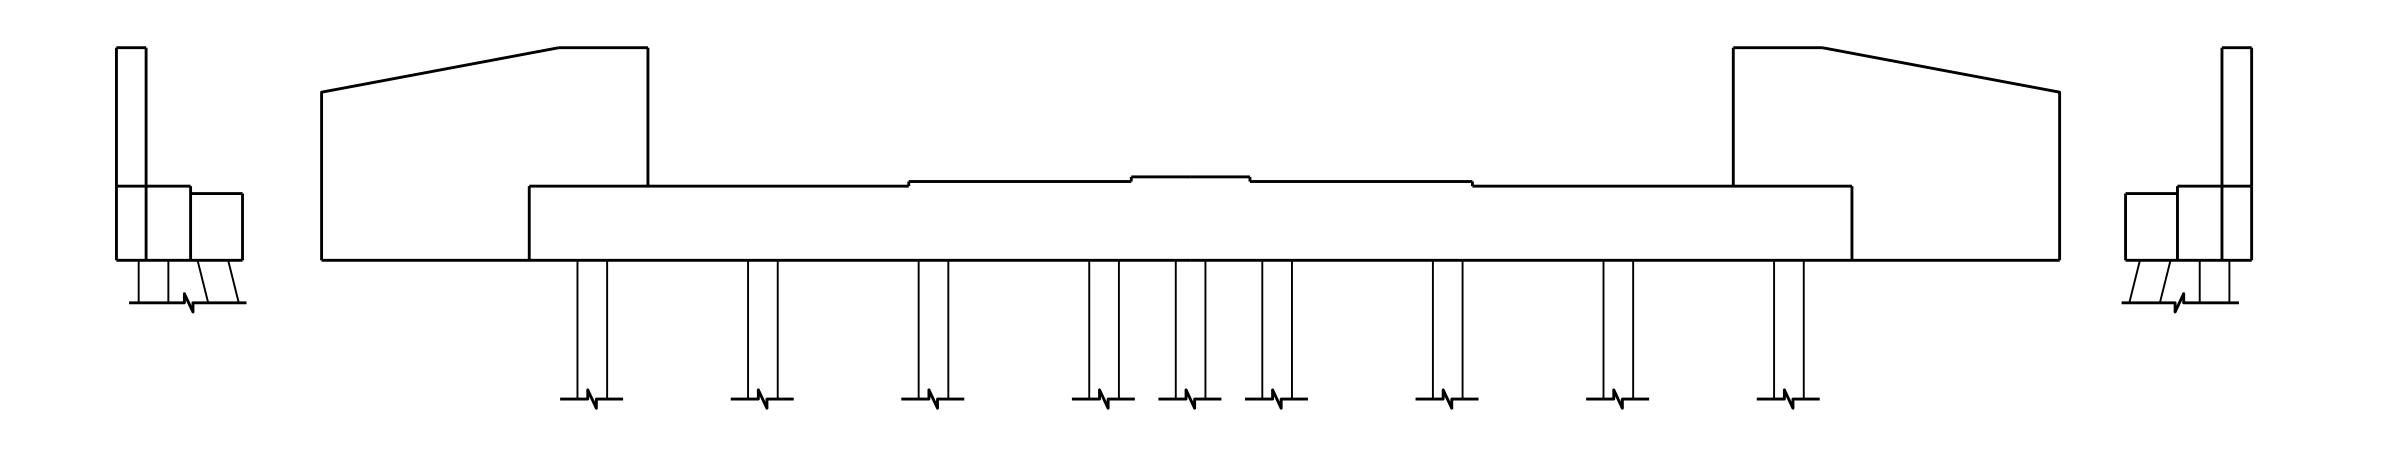
ELEVATION

NO REPAIRS NOTED DURING INSPECTION BY STRUCTURES MANAGEMENT UNIT. THE CONTRACTOR AND ENGINEER SHALL INSPECT THE BENT PRIOR TO BEGINNING WORK.
