ELEVATION SOUTH SIDE

PLAN BOTTOM OF CAP

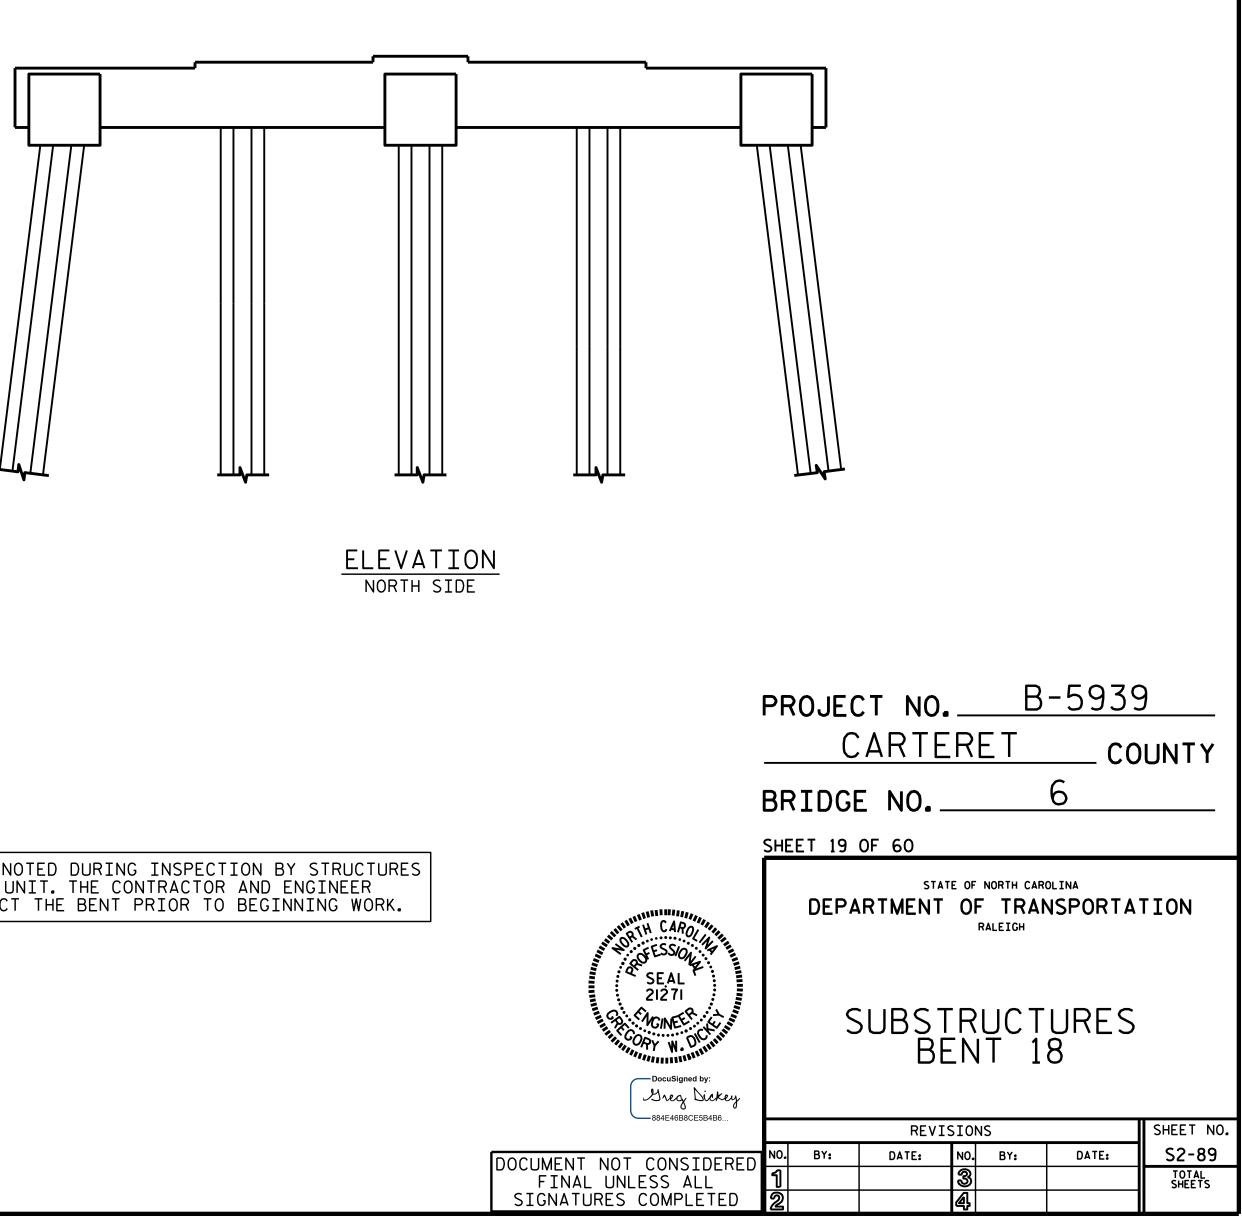
NO REPAIRS NOTED DURING INSPECTION BY STRUCTURES MANAGEMENT UNIT. THE CONTRACTOR AND ENGINEER SHALL INSPECT THE BENT PRIOR TO BEGINNING WORK.
