PROJECT NO. I-5000
GASTON COUNTY
 BRIDGE NO. 120

SHEET 1 OF 3

STATE OF NORTH CAROLINA
 DEPARTMENT OF TRANSPORTATION
 RALEIGH

BENT 1
 (LEFT SECTION)

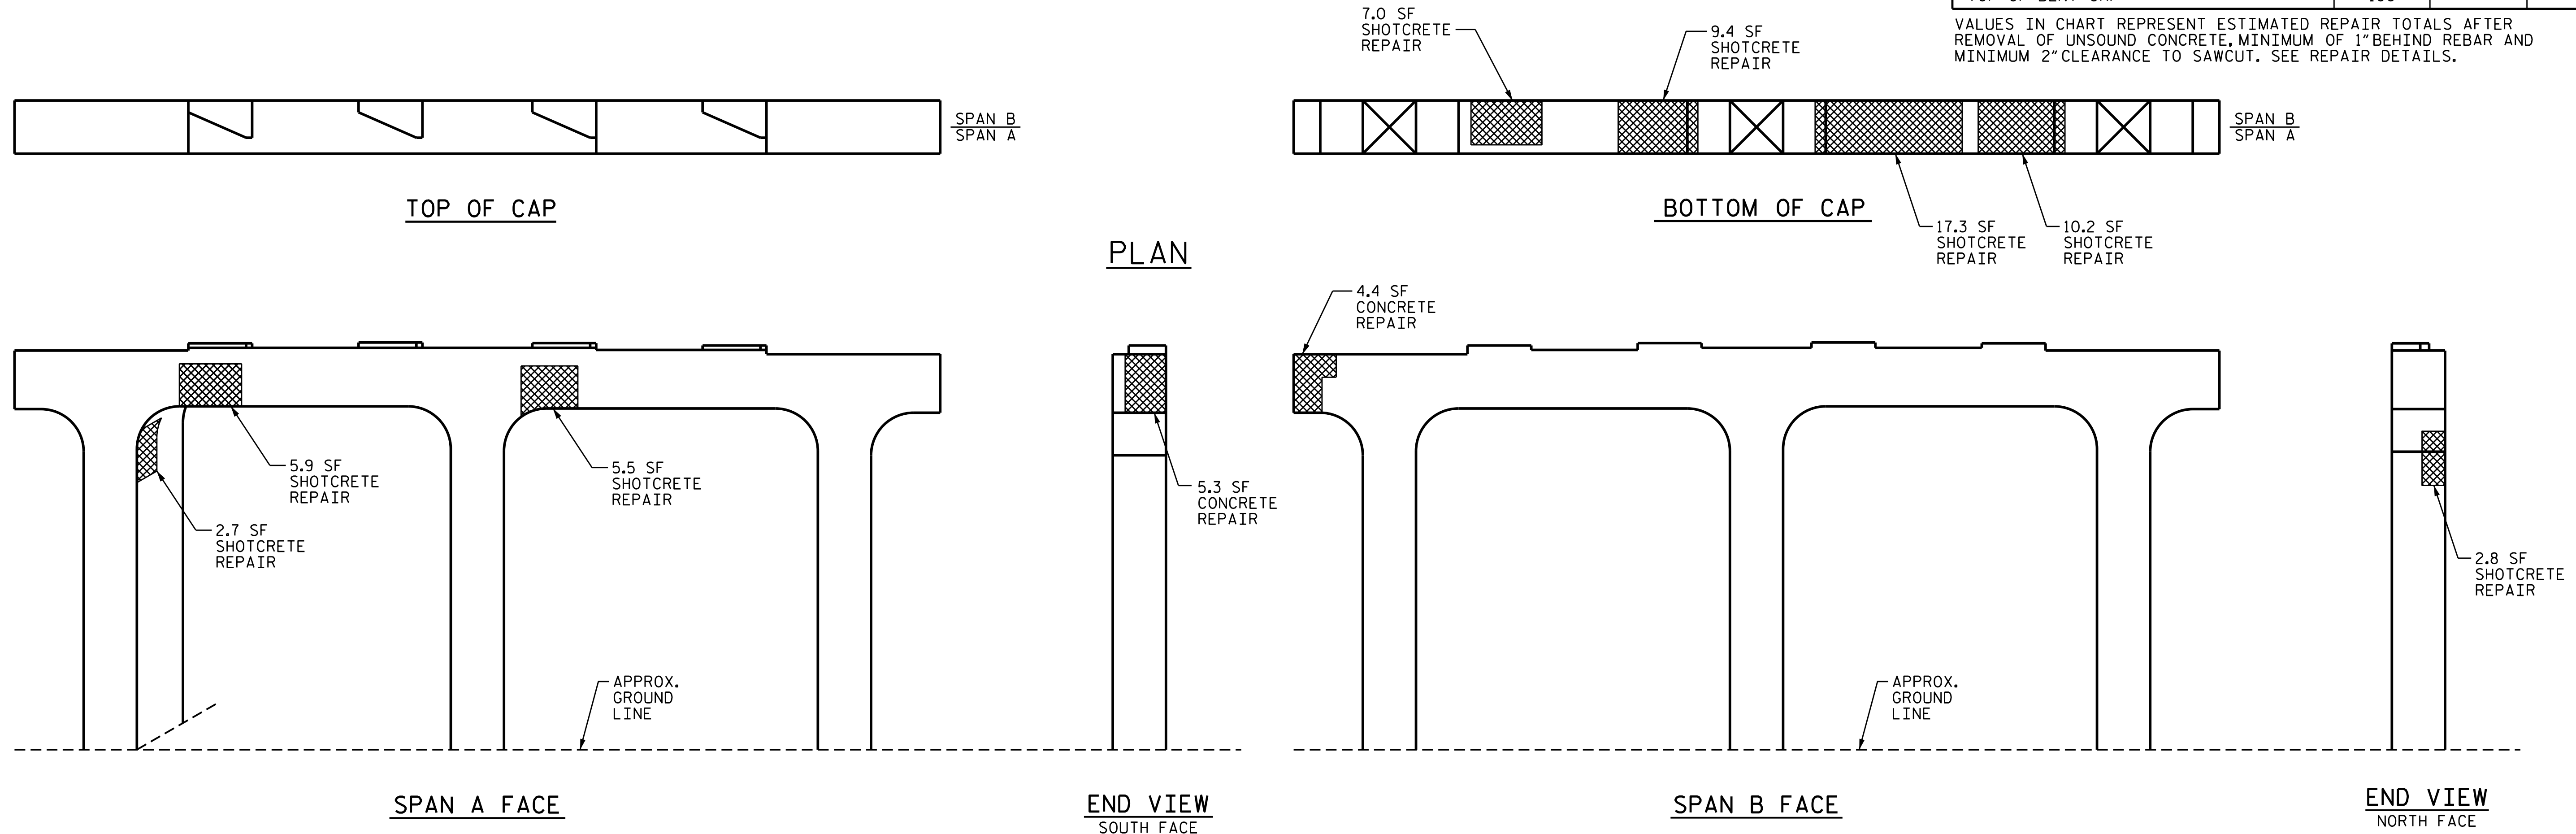
ELEVATION

DAMAGED AREA
 EPOXY RESIN INJECTION

EPOXY COATING SHALL BE APPLIED TO THE TOP FACE OF THE CAP. THE CONTRACTOR SHALL NOT COAT THE AREA OF THE CAP BENEATH THE MASONRY PLATES. FOR EPOXY COATING, SEE SPECIAL PROVISIONS.

CONCRETE REPAIRS TO THE BENT CAP MAY REQUIRE BRIDGE JACKING. FOR BRIDGE JACKING DETAILS, SEE "JACKING DETAILS" SHEET.
