PROJECT NO. I-5000
GASTON COUNTY
BRIDGE NO. 120
SHEET 1 OF 3

STATE OF NORTH CAROLINA
DEPARTMENT OF TRANSPORTATION
RALEIGH

BENT 3
(LEFT SECTION)

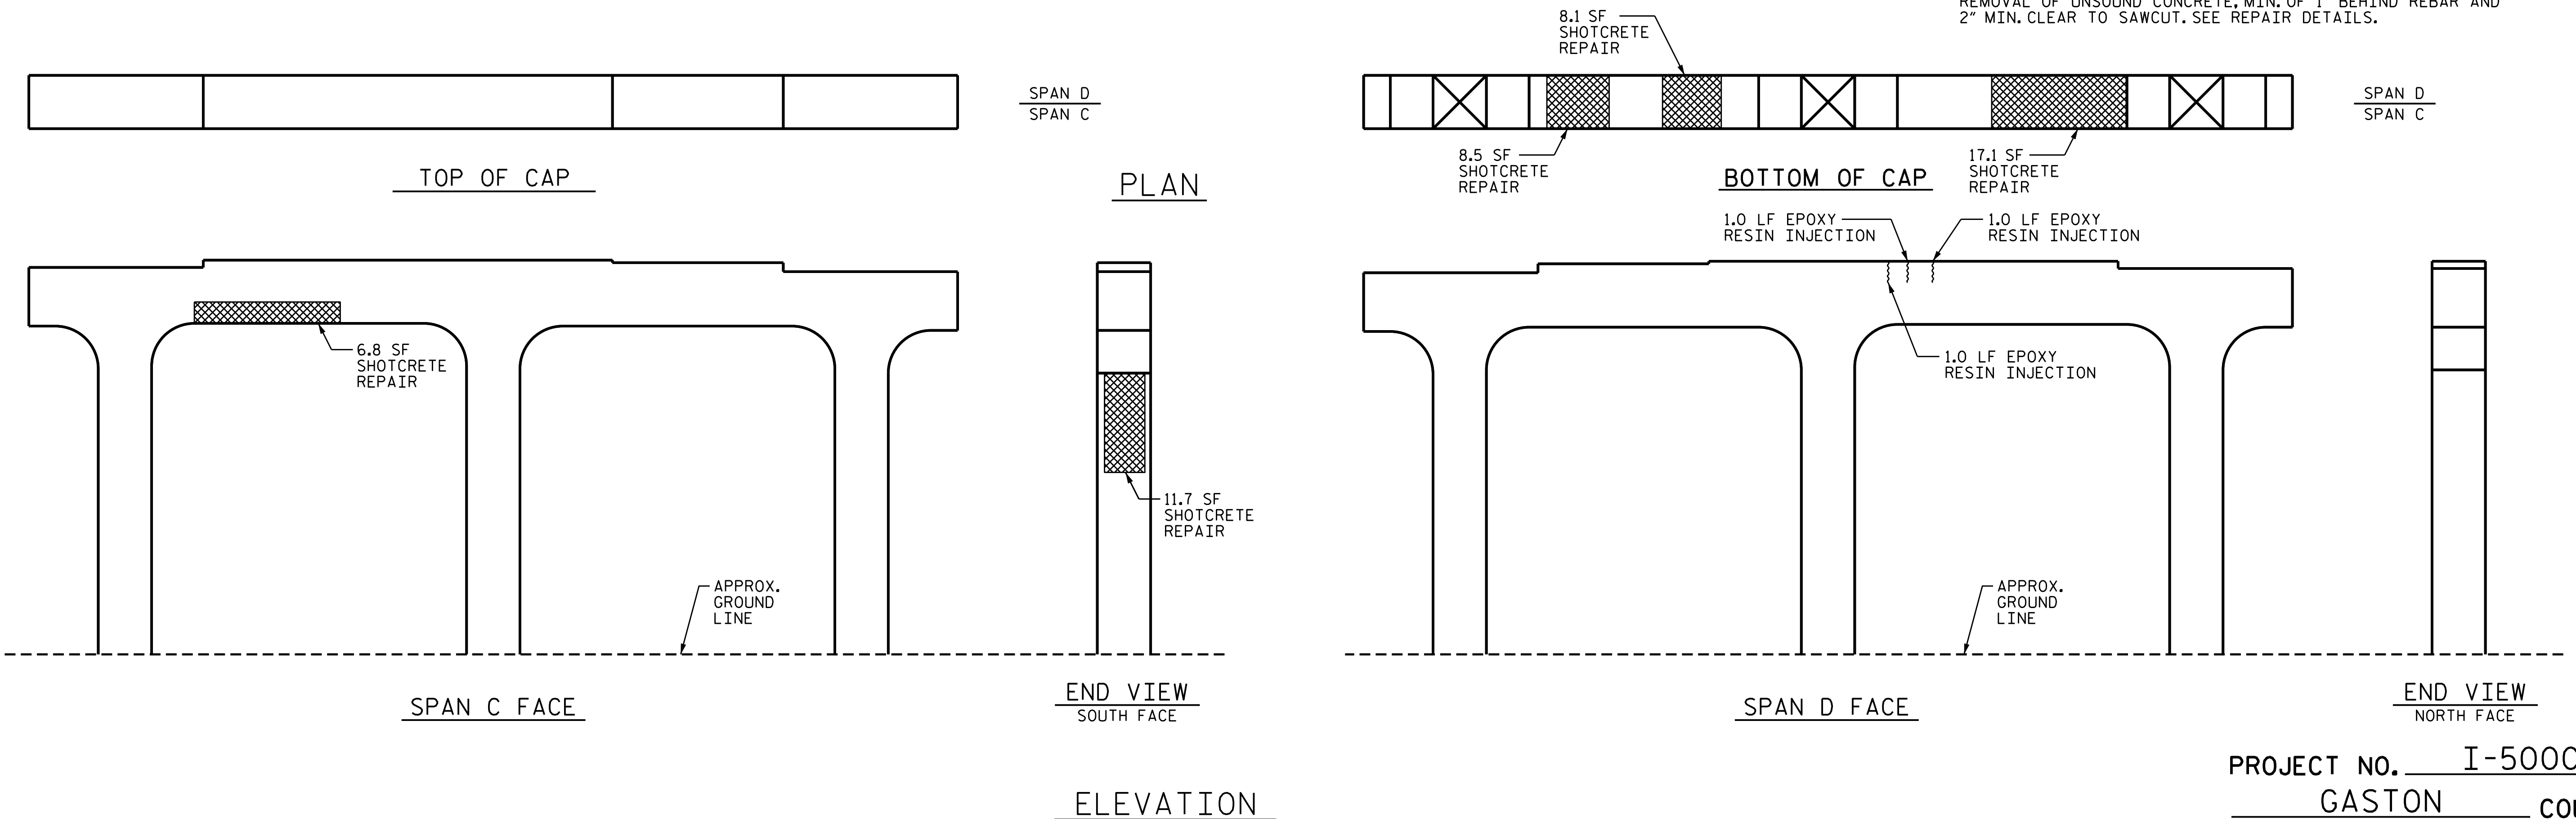
REPAIRS BENT 3 (LEFT)	QUANTITIES			
	ESTIMATE		ACTUAL	
SHOTCRETE REPAIRS	AREA SF	VOLUME CF	AREA SF	VOLUME CF
CAP	40.5	16.9 *		
COLUMN	11.7	4.9 *		
CONCRETE REPAIRS	AREA SF	VOLUME CF	AREA SF	VOLUME CF
CAP	0.0	0.0		
COLUMN	0.0	0.0		
EPOXY RESIN INJECTION	LN. FT.		LN. FT.	
CAP	3.0			
COLUMN	0.0			
EPOXY COATING	SQ. FT.		SQ. FT.	
TOP OF BENT CAP	109

DAMAGED AREA
 EPOXY RESIN INJECTION

EPOXY COATING SHALL BE APPLIED TO THE TOP FACE OF THE CAP. THE CONTRACTOR SHALL NOT COAT THE AREA OF THE CAP BENEATH THE MASONRY PLATES. FOR EPOXY COATING, SEE SPECIAL PROVISIONS.
