GASTON 120 BRIDGE NO._

SHEET 2 OF 3

STATE OF NORTH CAROLINA DEPARTMENT OF TRANSPORTATION

BENT 3 (CENTER SECTION)

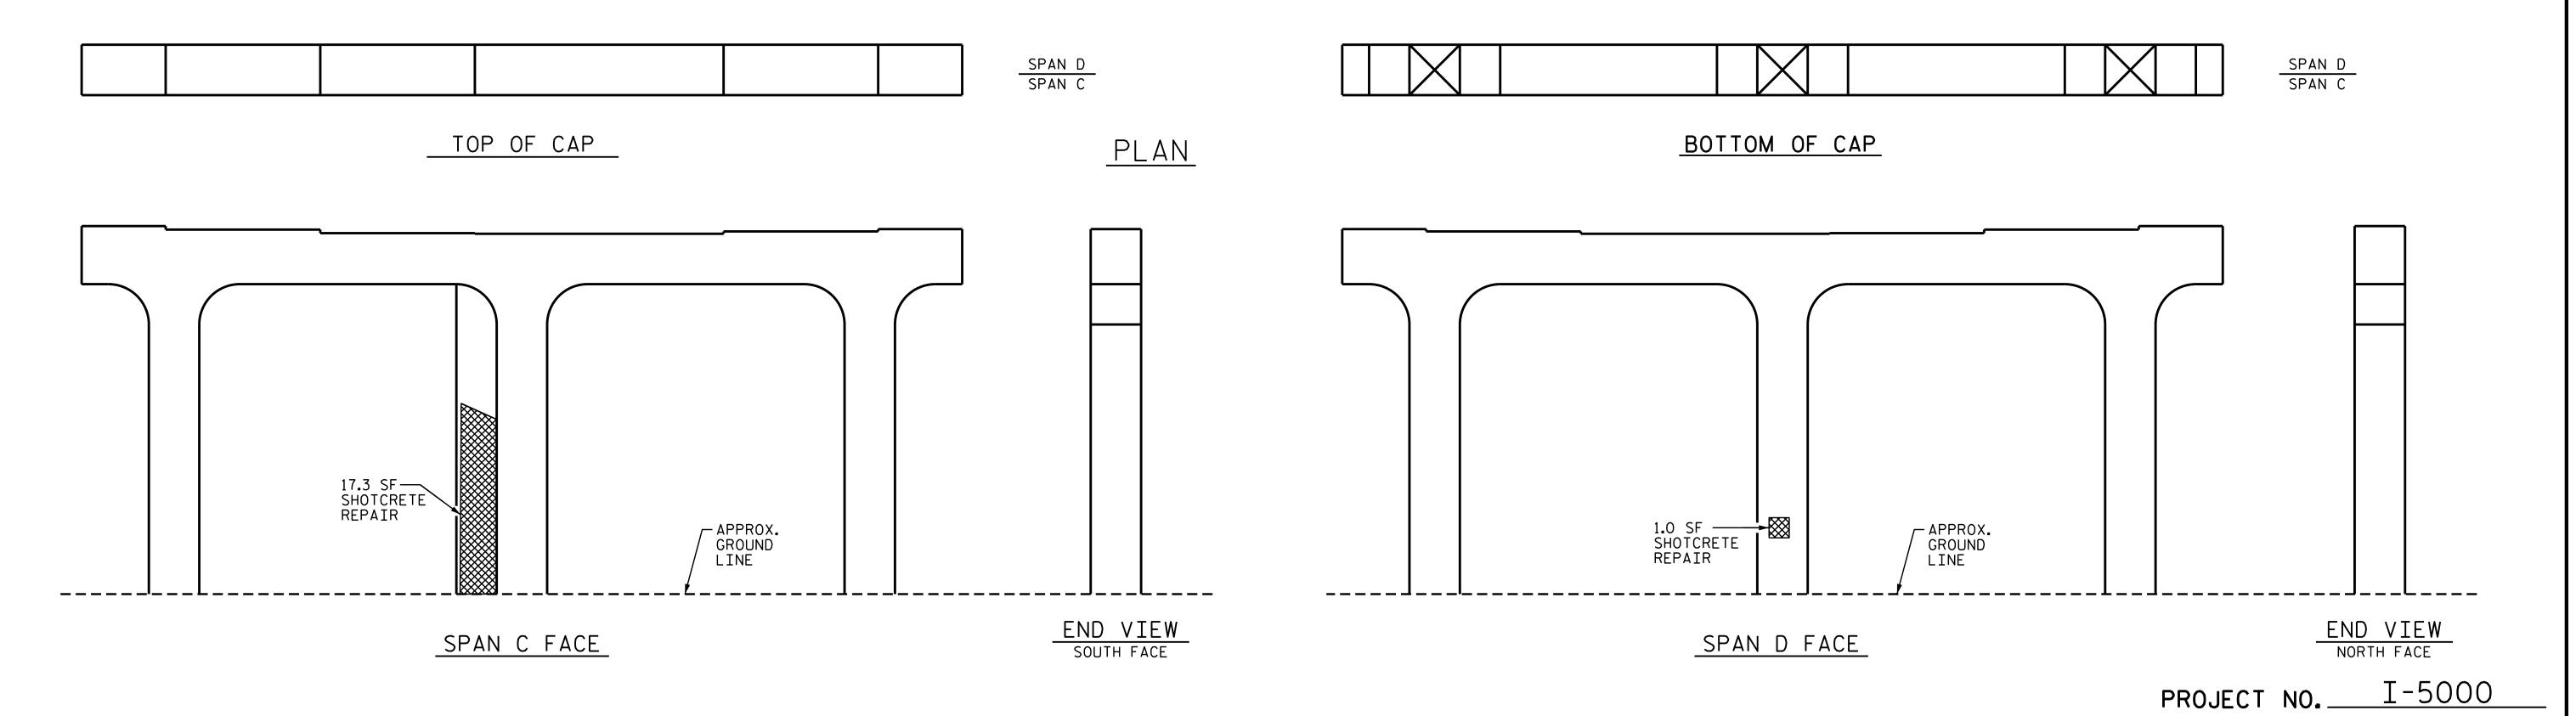
ELEVATION

* QUANTITY HAS BEEN INCREASED DUE TO THE POTENTIAL FOR FURTHER DETERIORATION SINCE THE FIELD INSPECTION BY STRUCTURES MANAGEMENT UNIT.

AS-BUILT REPAIR QUANTITY TABLE				
REPAIRS BENT 3 (CENTER)	QUANTITIES			
	ESTIMATE		ACTUAL	
SHOTCRETE REPAIRS	AREA SF	VOLUME CF	AREA SF	VOLUME CF
CAP	0.0	0.0		
COLUMN	18.3	7 . 6 *		
CONCRETE REPAIRS	AREA SF	VOLUME CF	AREA SF	VOLUME CF
CAP	0.0	0.0		
COLUMN	0.0	0.0		
EPOXY RESIN INJECTION		LN. FT		LN. FT
CAP		0.0		
COLUMN		0.0		
EPOXY COATING		SQ. FT.		SQ. FT.
TOP OF BENT CAP		109

EPOXY COATING SHALL BE APPLIED TO THE TOP FACE OF THE CAP. THE CONTRACTOR SHALL NOT COAT THE AREA OF THE CAP BENEATH THE MASONRY PLATES. FOR EPOXY COATING, SEE SPECIAL PROVISIONS.
