PROJECT NO. I-5000  
GASTON COUNTY  
 BRIDGE NO. 120

SHEET 3 OF 3

**BENT 3**  
 (RIGHT SECTION)

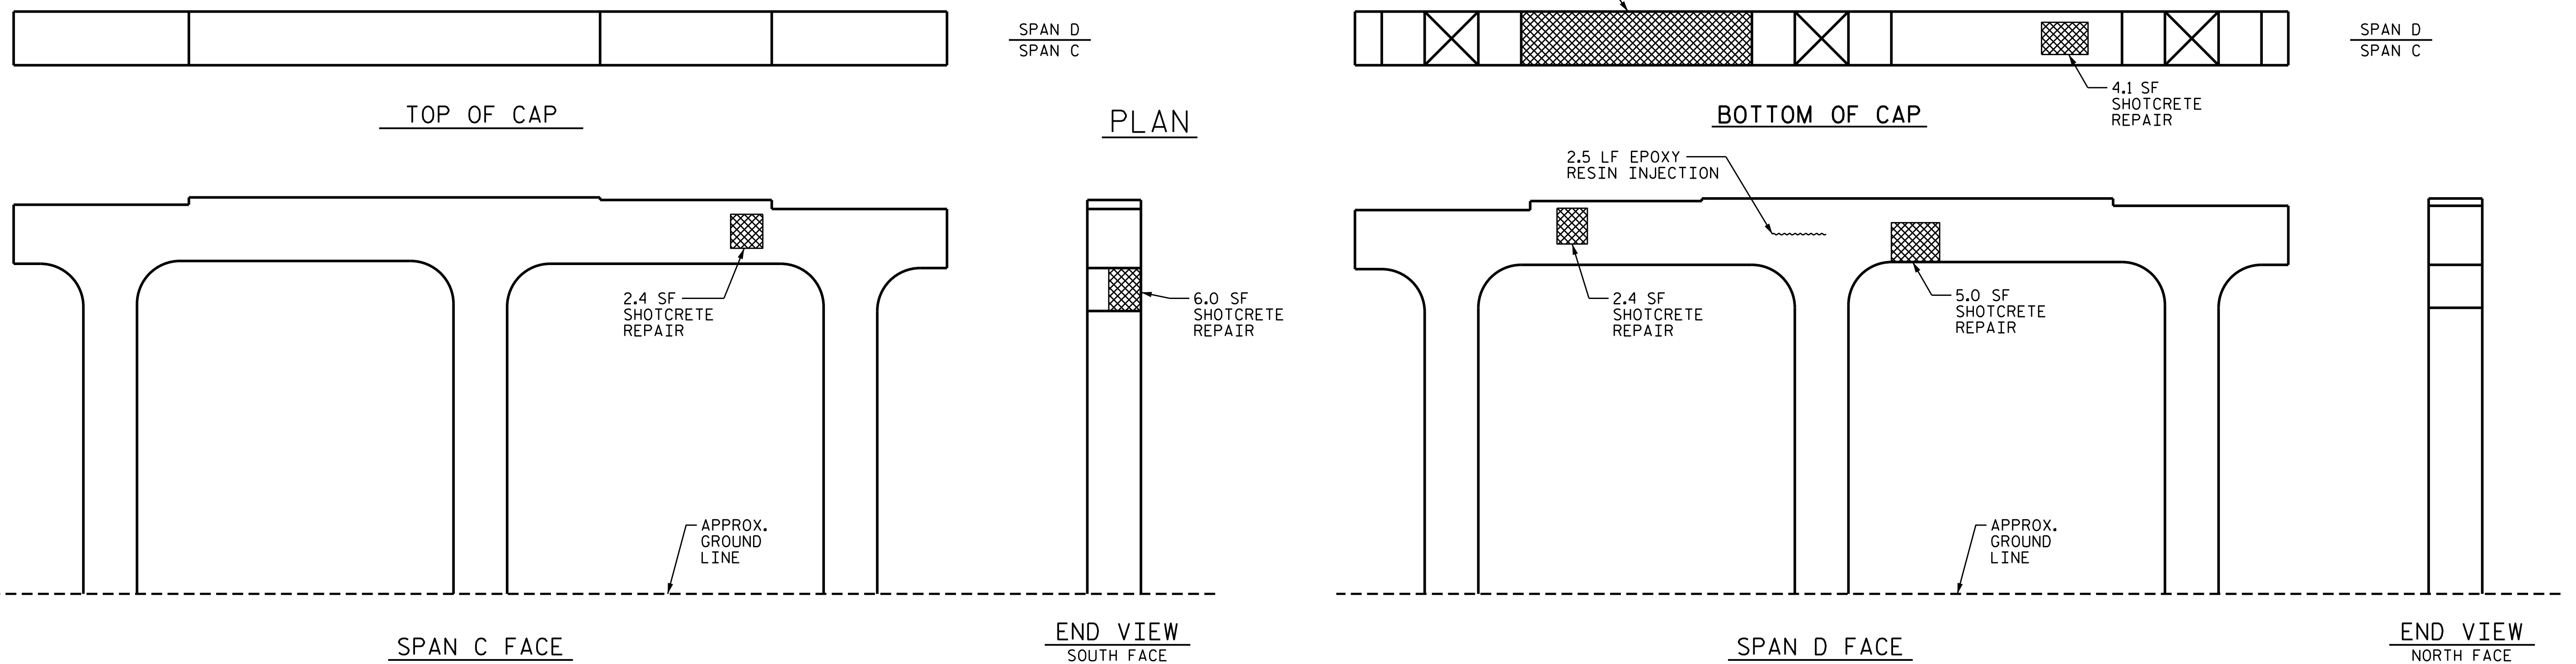
\* QUANTITY HAS BEEN INCREASED DUE TO THE POTENTIAL FOR FURTHER DETERIORATION SINCE THE FIELD INSPECTION BY STRUCTURES MANAGEMENT UNIT.

DAMAGED AREA  
 EPOXY RESIN INJECTION

EPOXY COATING SHALL BE APPLIED TO THE TOP FACE OF THE CAP. THE CONTRACTOR SHALL NOT COAT THE AREA OF THE CAP BENEATH THE MASONRY PLATES. FOR EPOXY COATING, SEE SPECIAL PROVISIONS.
