PROJECT NO. I-5000 GASTON _ COUNTY 120

STATE OF NORTH CAROLINA DEPARTMENT OF TRANSPORTATION

> BENT 4 SPAN D FACE (LEFT SECTION)

> > SHEET NO S-16

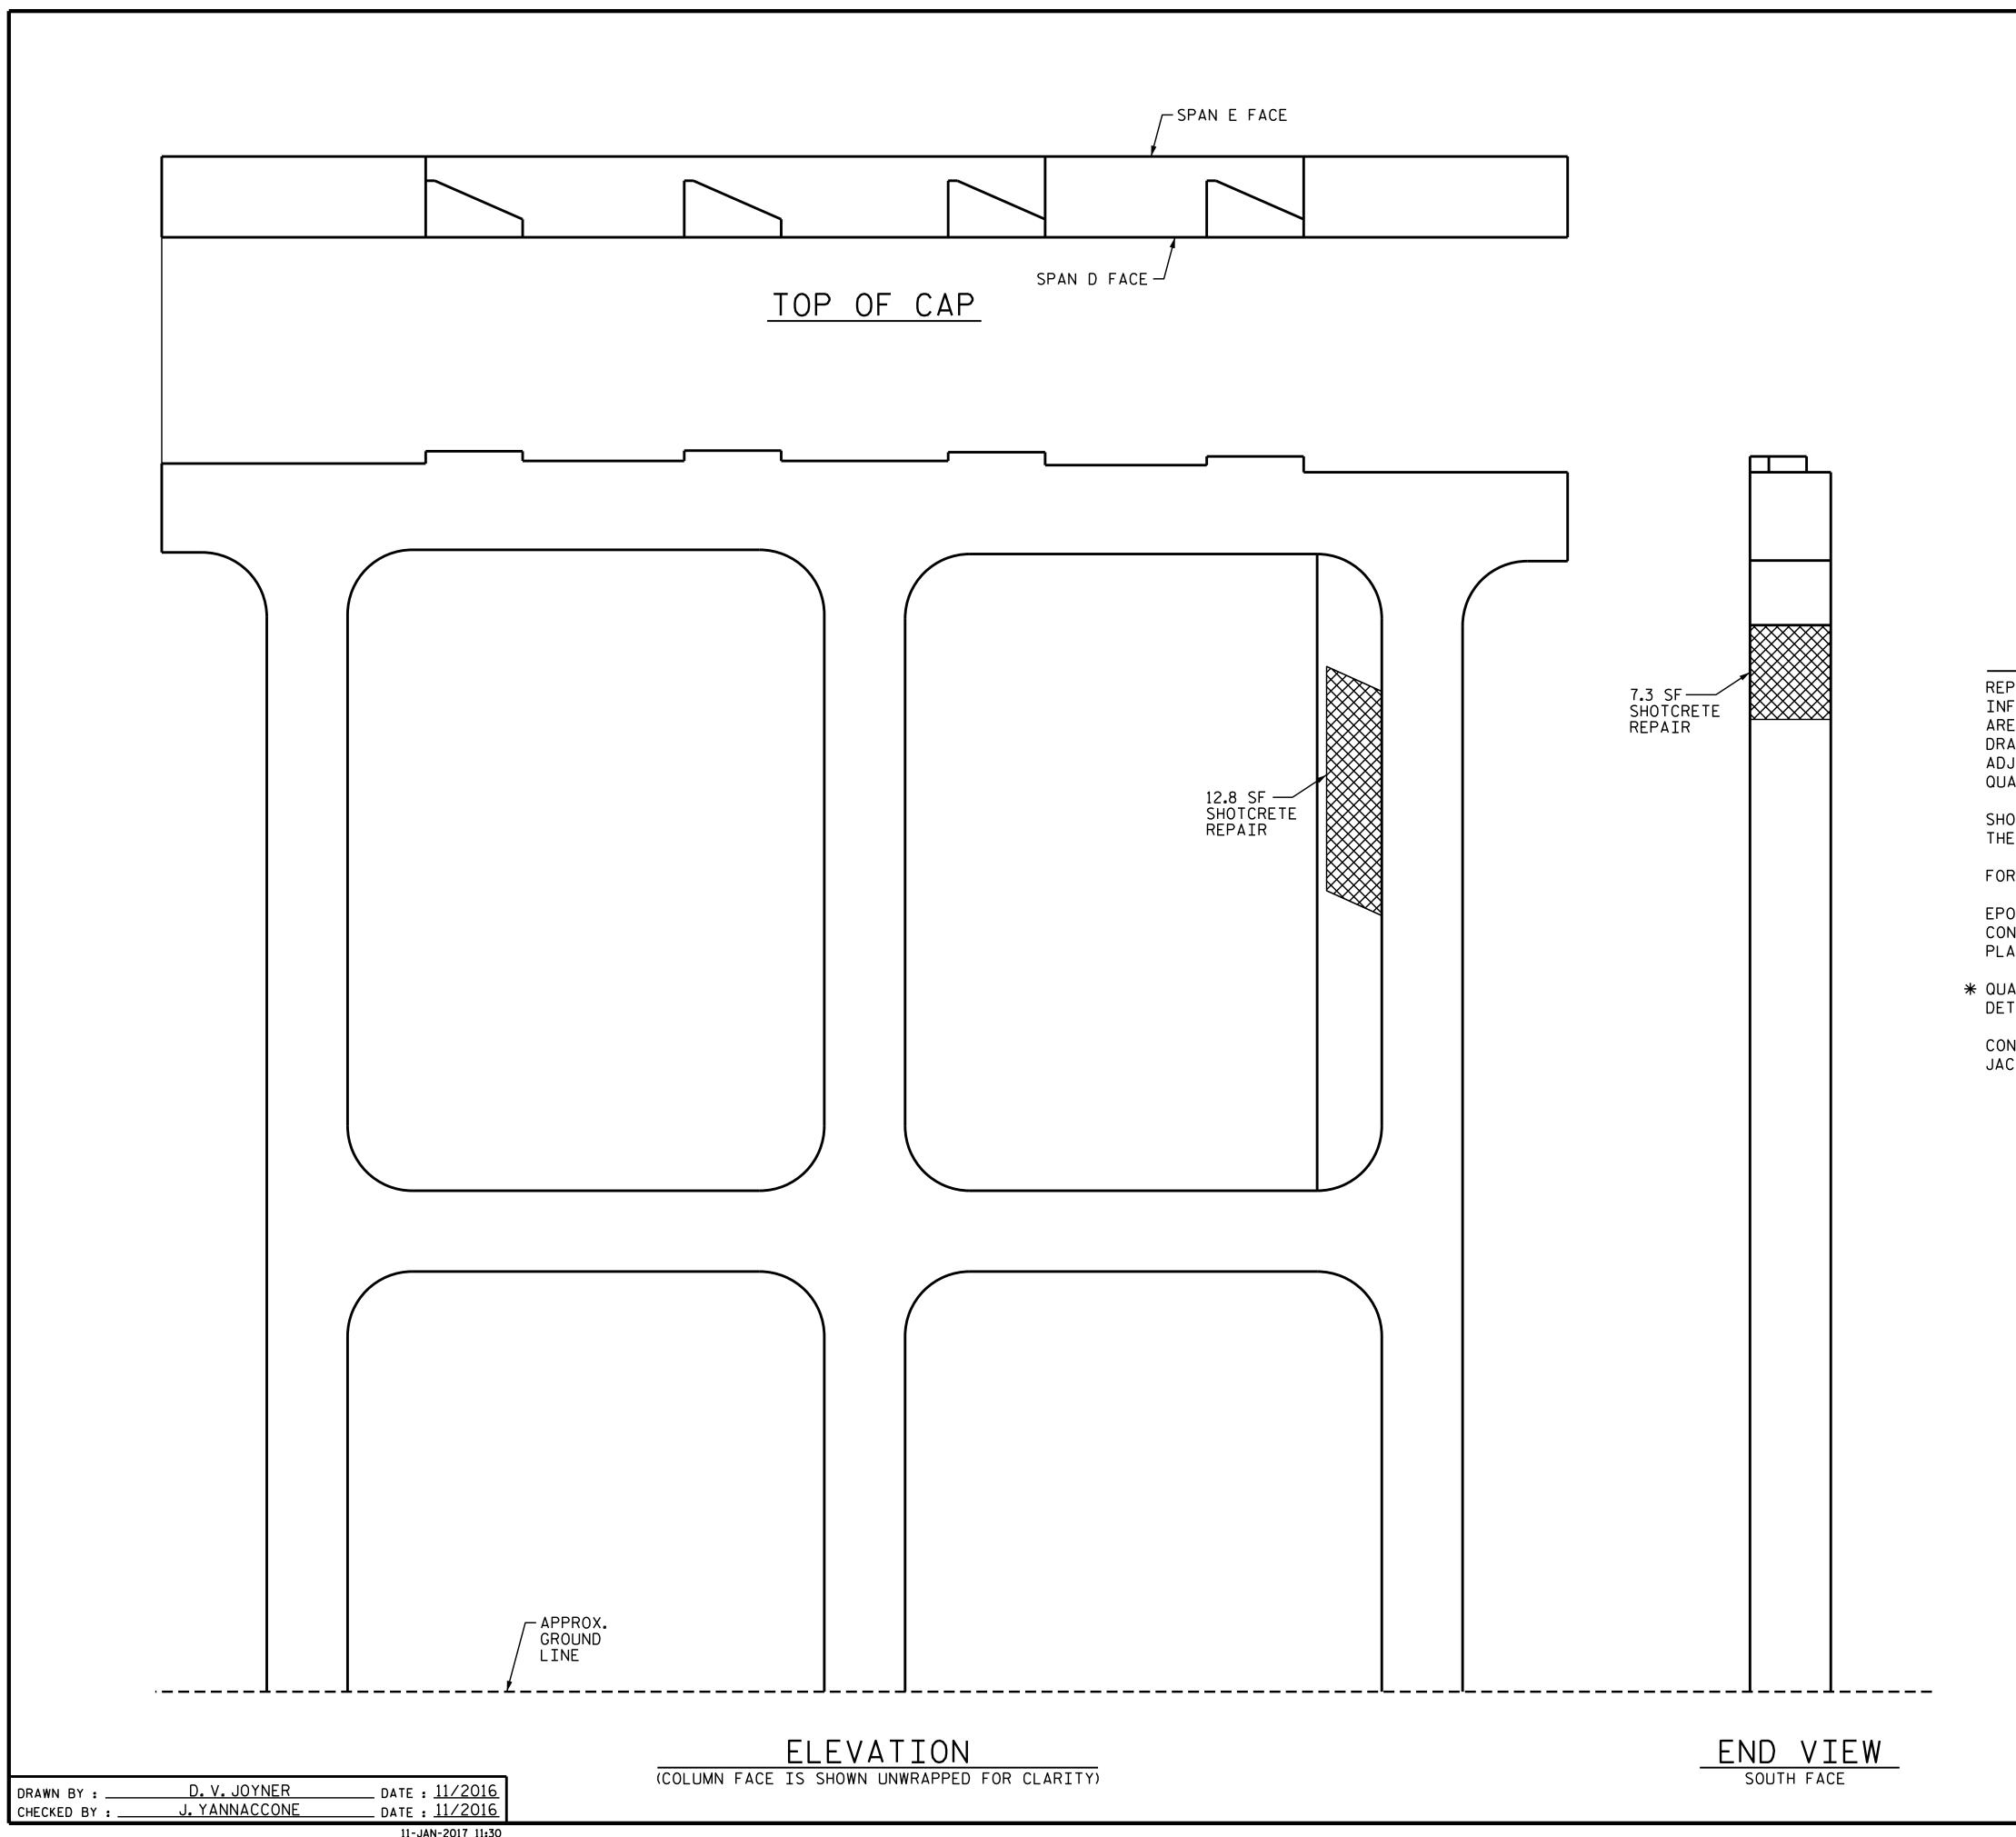
AS-BUILT REPAIR QUANTITY TABLE REPAIRS QUANTITIES BENT 4 (LEFT) ESTIMATE ACTUAL AREA SF AREA VOLUME VOLUME SHOTCRETE REPAIRS CF 36.6 15.3 * COLUMNS & STRUTS 20.1 8.4 * VOLUME AREA VOLUME CONCRETE REPAIRS SF CF CF CAP 2.8 ***** 6.6 COLUMNS & STRUTS 10.5 4.4 * LN. FT EPOXY RESIN INJECTION 0.0 COLUMNS & STRUTS 0.0 SQ. FT. SQ. FT. EPOXY COATING TOP OF BENT CAP 109

* QUANTITY HAS BEEN INCREASED DUE TO THE POTENTIAL FOR FURTHER DETERIORATION SINCE THE FIELD INSPECTION BY STRUCTURES MANAGEMENT UNIT.

EPOXY COATING SHALL BE APPLIED TO THE TOP FACE OF THE CAP. THE CONTRACTOR SHALL NOT COAT THE AREA OF THE CAP BENEATH THE MASONRY PLATES. FOR EPOXY COATING, SEE SPECIAL PROVISIONS.

CONCRETE REPAIRS TO THE BENT CAP MAY REQUIRE BRIDGE JACKING. FOR BRIDGE JACKING, SEE "JACKING DETAILS" SHEET.
