PROJECT NO. I-5000

GASTON COUNTY

BRIDGE NO. 120

BENT 5 SPAN E FACE (LEFT SECTION)

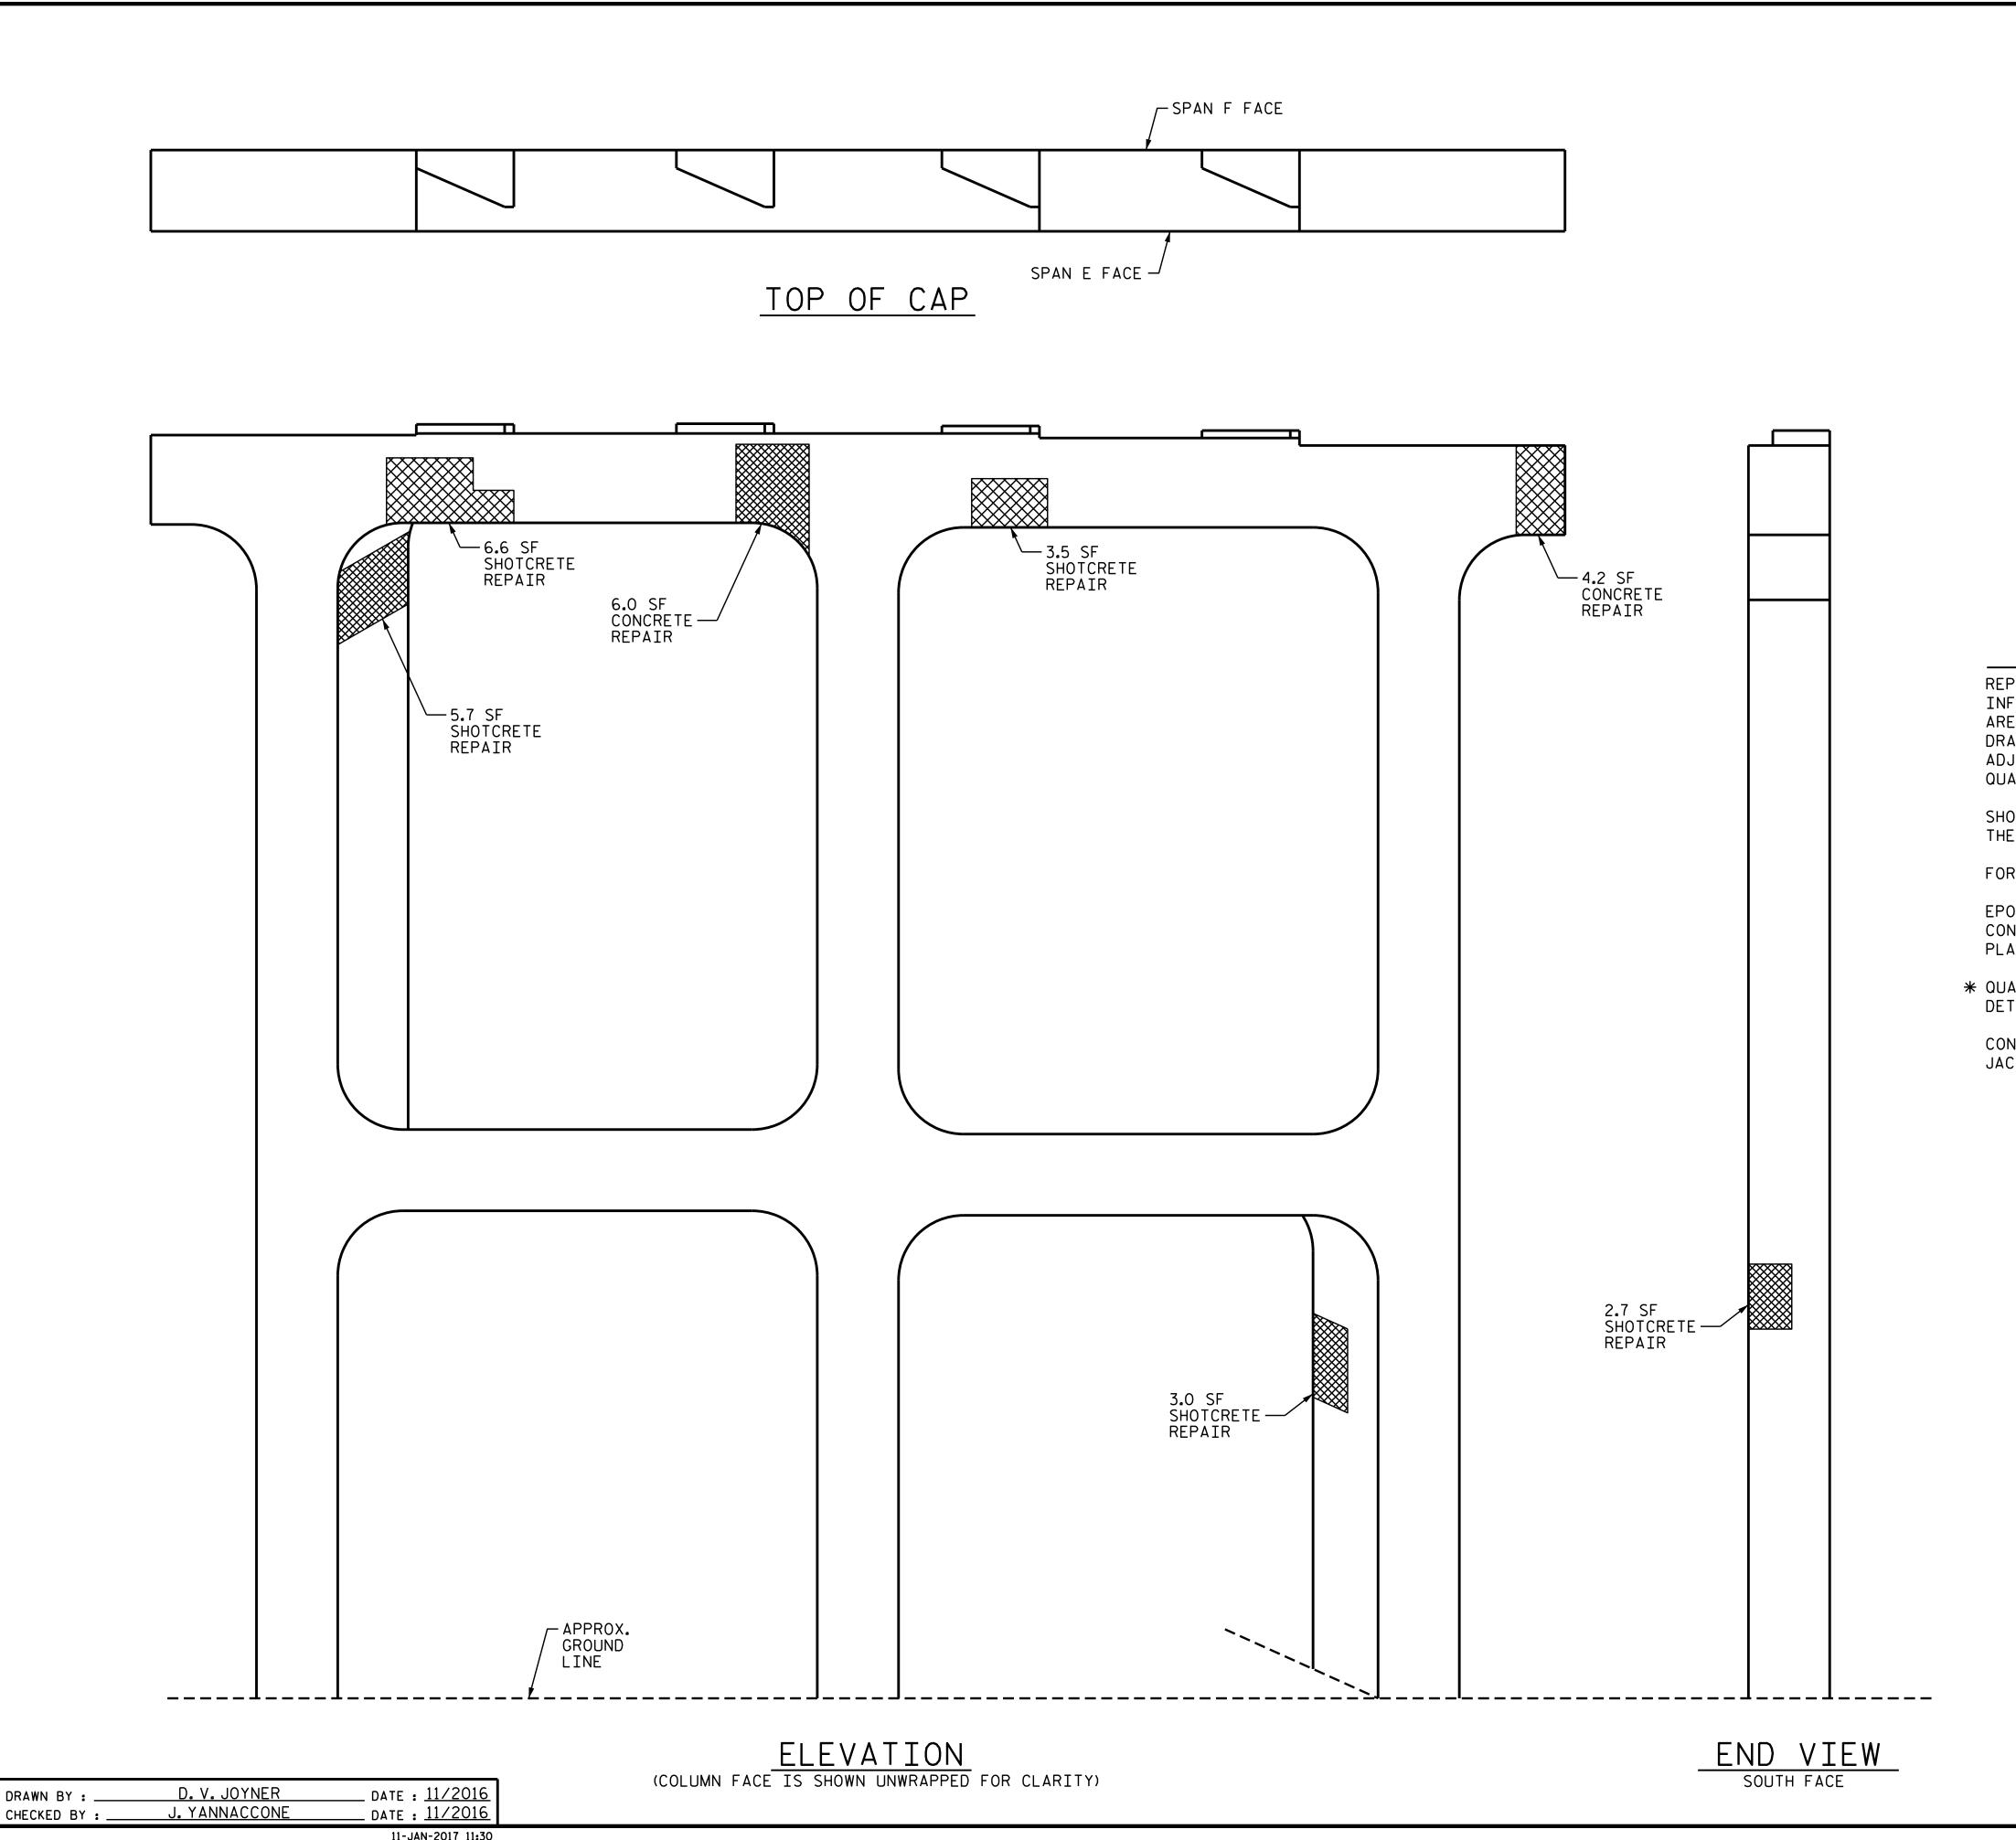
\* QUANTITY HAS BEEN INCREASED DUE TO THE POTENTIAL FOR FURTHER DETERIORATION SINCE THE FIELD INSPECTION BY STRUCTURES MANAGEMENT UNIT.

DAMAGED AREA

VALUES IN CHART REPRESENT ESTIMATED REPAIR TOTALS AFTER REMOVAL OF UNSOUND CONCRETE, MIN. OF 1" BEHIND REBAR AND 2" MIN. CLEAR TO SAWCUT. SEE REPAIR DETAILS.

SHOTCRETE REPAIRS MAY BE SUBSTITUTED IN LIEU OF CONCRETE REPAIRS WITH THE APPROVAL OF THE ENGINEER.

FOR REPAIR DETAILS, SEE "TYPICAL CAP AND COLUMN REPAIR DETAILS" SHEET.

EPOXY COATING SHALL BE APPLIED TO THE TOP FACE OF THE CAP. THE CONTRACTOR SHALL NOT COAT THE AREA OF THE CAP BENEATH THE MASONRY PLATES. FOR EPOXY COATING, SEE SPECIAL PROVISIONS.

CONCRETE REPAIRS TO THE BENT CAP MAY REQUIRE BRIDGE JACKING. FOR BRIDGE JACKING, SEE "JACKING DETAILS" SHEET.
