PROJECT NO. I-5000
GASTON COUNTY
BRIDGE NO. 120

SHEET 2 OF 6

BENT 5
SPAN F FACE
(LEFT SECTION)

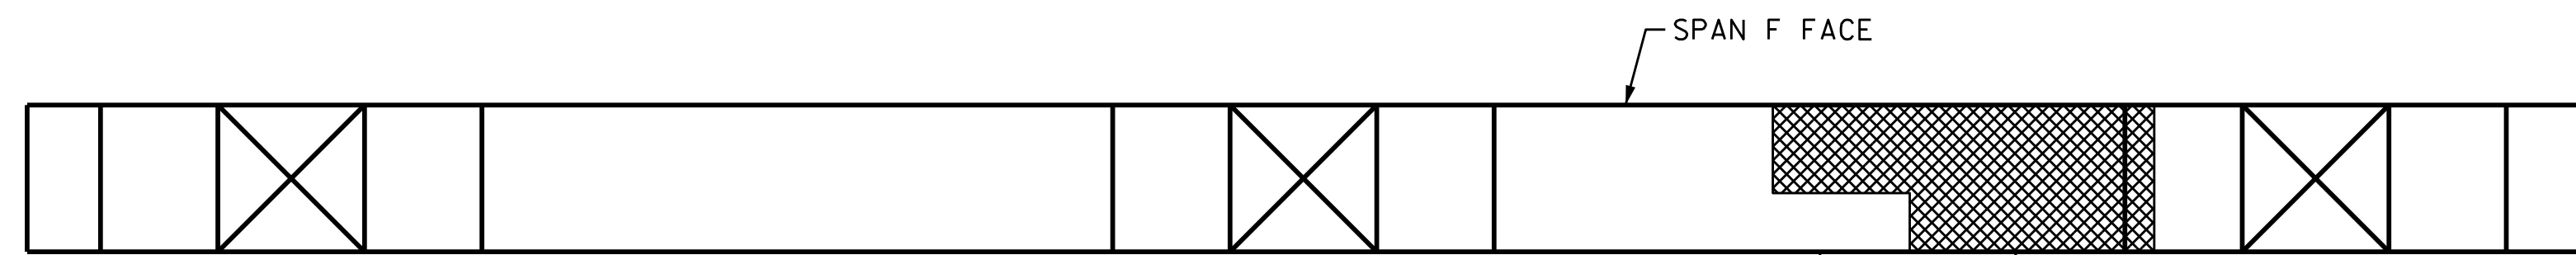
1.8 SF CONCRETE REPAIR

12.2 SF SHOTCRETE REPAIR

10.9 SF SHOTCRETE REPAIR

2.6 SF SHOTCRETE REPAIR

* QUANTITY HAS BEEN INCREASED DUE TO THE POTENTIAL FOR FURTHER DETERIORATION SINCE THE FIELD INSPECTION BY STRUCTURES MANAGEMENT UNIT.

DAMAGED AREA

EPOXY COATING SHALL BE APPLIED TO THE TOP FACE OF THE CAP. THE CONTRACTOR SHALL NOT COAT THE AREA OF THE CAP BENEATH THE MASONRY PLATES. FOR EPOXY COATING, SEE SPECIAL PROVISIONS.

CONCRETE REPAIRS TO THE BENT CAP MAY REQUIRE BRIDGE JACKING. FOR BRIDGE JACKING, SEE "JACKING DETAILS" SHEET.

EPOXY RESIN INJECTION
