PROJECT NO. I-5000

GASTON COUNTY

BRIDGE NO. 120

BENT 5 SPAN E FACE (CENTER SECTION)

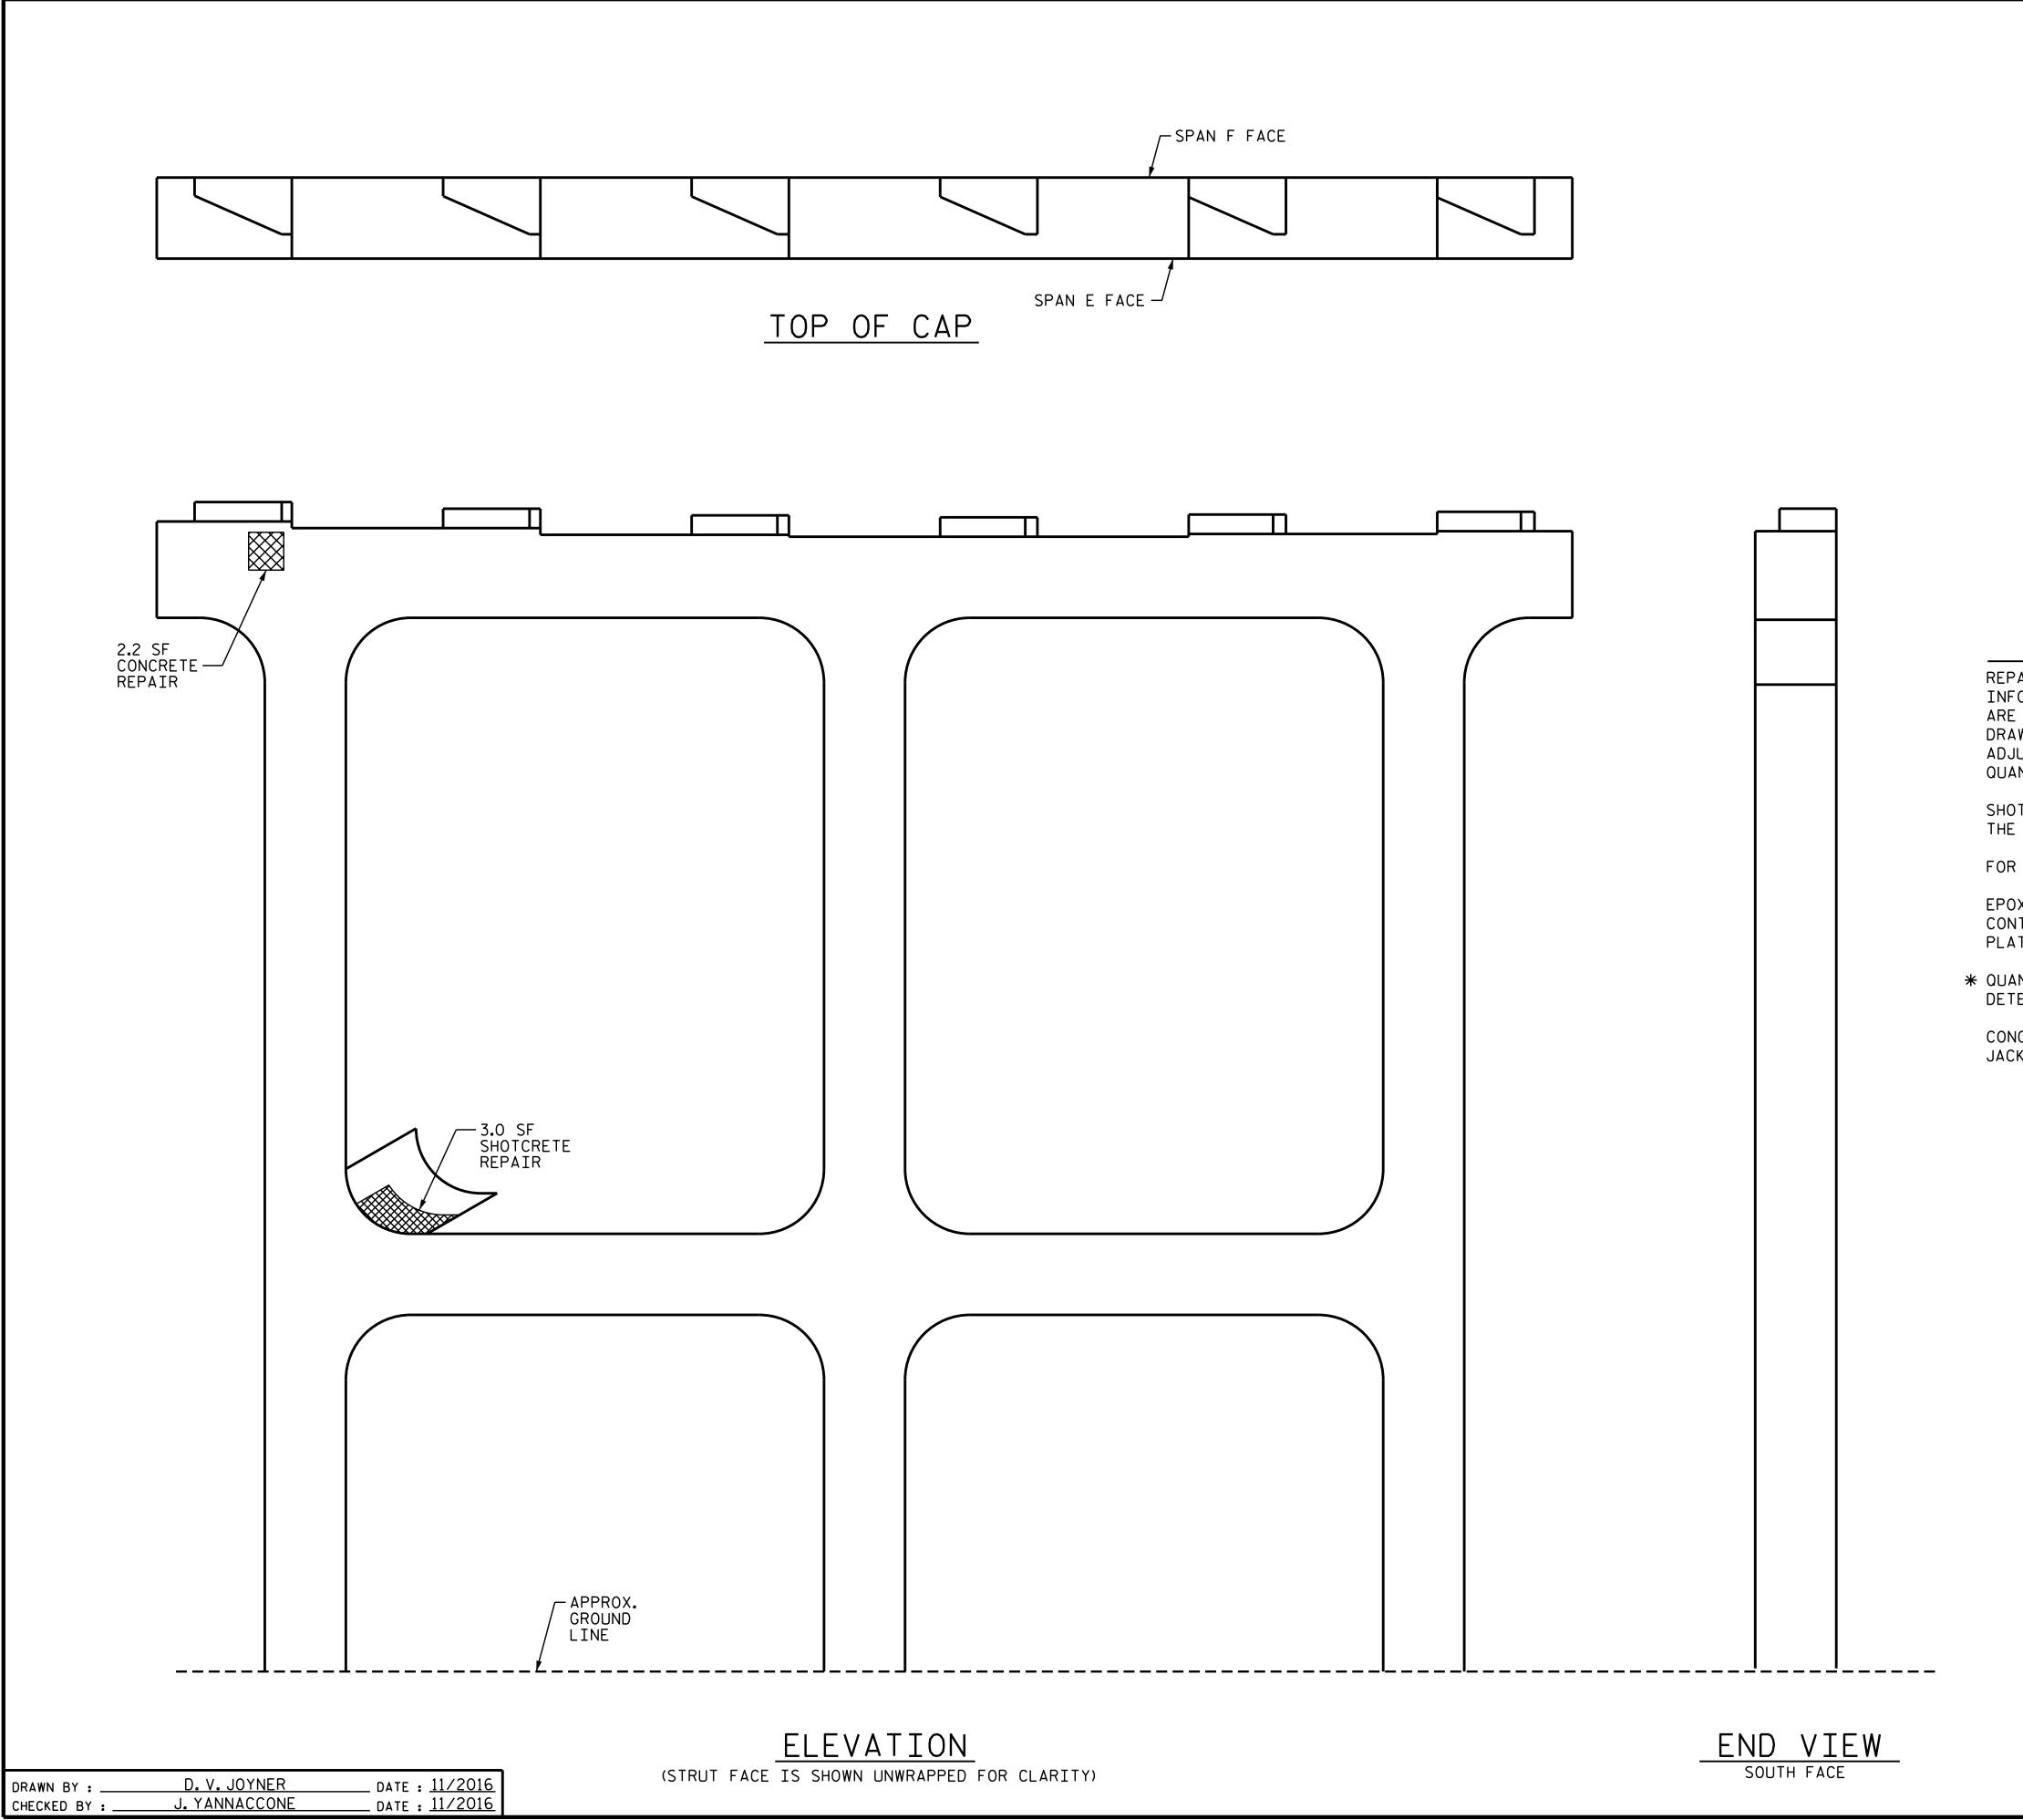
AS-BUILT REPAIR QUANTITY TABLE REPAIRS QUANTITIES BENT 5 (CENTER) ESTIMATE ACTUAL AREA VOLUME AREA VOLUME SHOTCRETE REPAIRS CAP 0.0 0.0 COLUMNS & STRUTS 3.0 1.3 * CONCRETE REPAIRS AREA VOLUME **VOLUME** 6.5 2**.**7 * COLUMNS & STRUTS 0.0 0.0 EPOXY RESIN INJECTION FΤ FΤ CAP 0.0 COLUMNS & STRUTS 0.0 SQ. FT. SQ. FT. EPOXY COATING TOP OF BENT CAP

VALUES IN CHART REPRESENT ESTIMATED REPAIR TOTALS AFTER REMOVAL OF UNSOUND CONCRETE, MIN. OF 1" BEHIND REBAR AND 2" MIN. CLEAR TO SAWCUT. SEE REPAIR DETAILS.

* QUANTITY HAS BEEN INCREASED DUE TO THE POTENTIAL FOR FURTHER DETERIORATION SINCE THE FIELD INSPECTION BY STRUCTURES MANAGEMENT UNIT.

SHOTCRETE REPAIRS MAY BE SUBSTITUTED IN LIEU OF CONCRETE REPAIRS WITH THE APPROVAL OF THE ENGINEER.

EPOXY COATING SHALL BE APPLIED TO THE TOP FACE OF THE CAP. THE CONTRACTOR SHALL NOT COAT THE AREA OF THE CAP BENEATH THE MASONRY PLATES. FOR EPOXY COATING, SEE SPECIAL PROVISIONS.

CONCRETE REPAIRS TO THE BENT CAP MAY REQUIRE BRIDGE JACKING. FOR BRIDGE JACKING, SEE "JACKING DETAILS" SHEET.
