PROJECT NO. I-5000
GASTON COUNTY
BRIDGE NO. 120

SHEET 4 OF 6

BENT 5
SPAN F FACE
(CENTER SECTION)

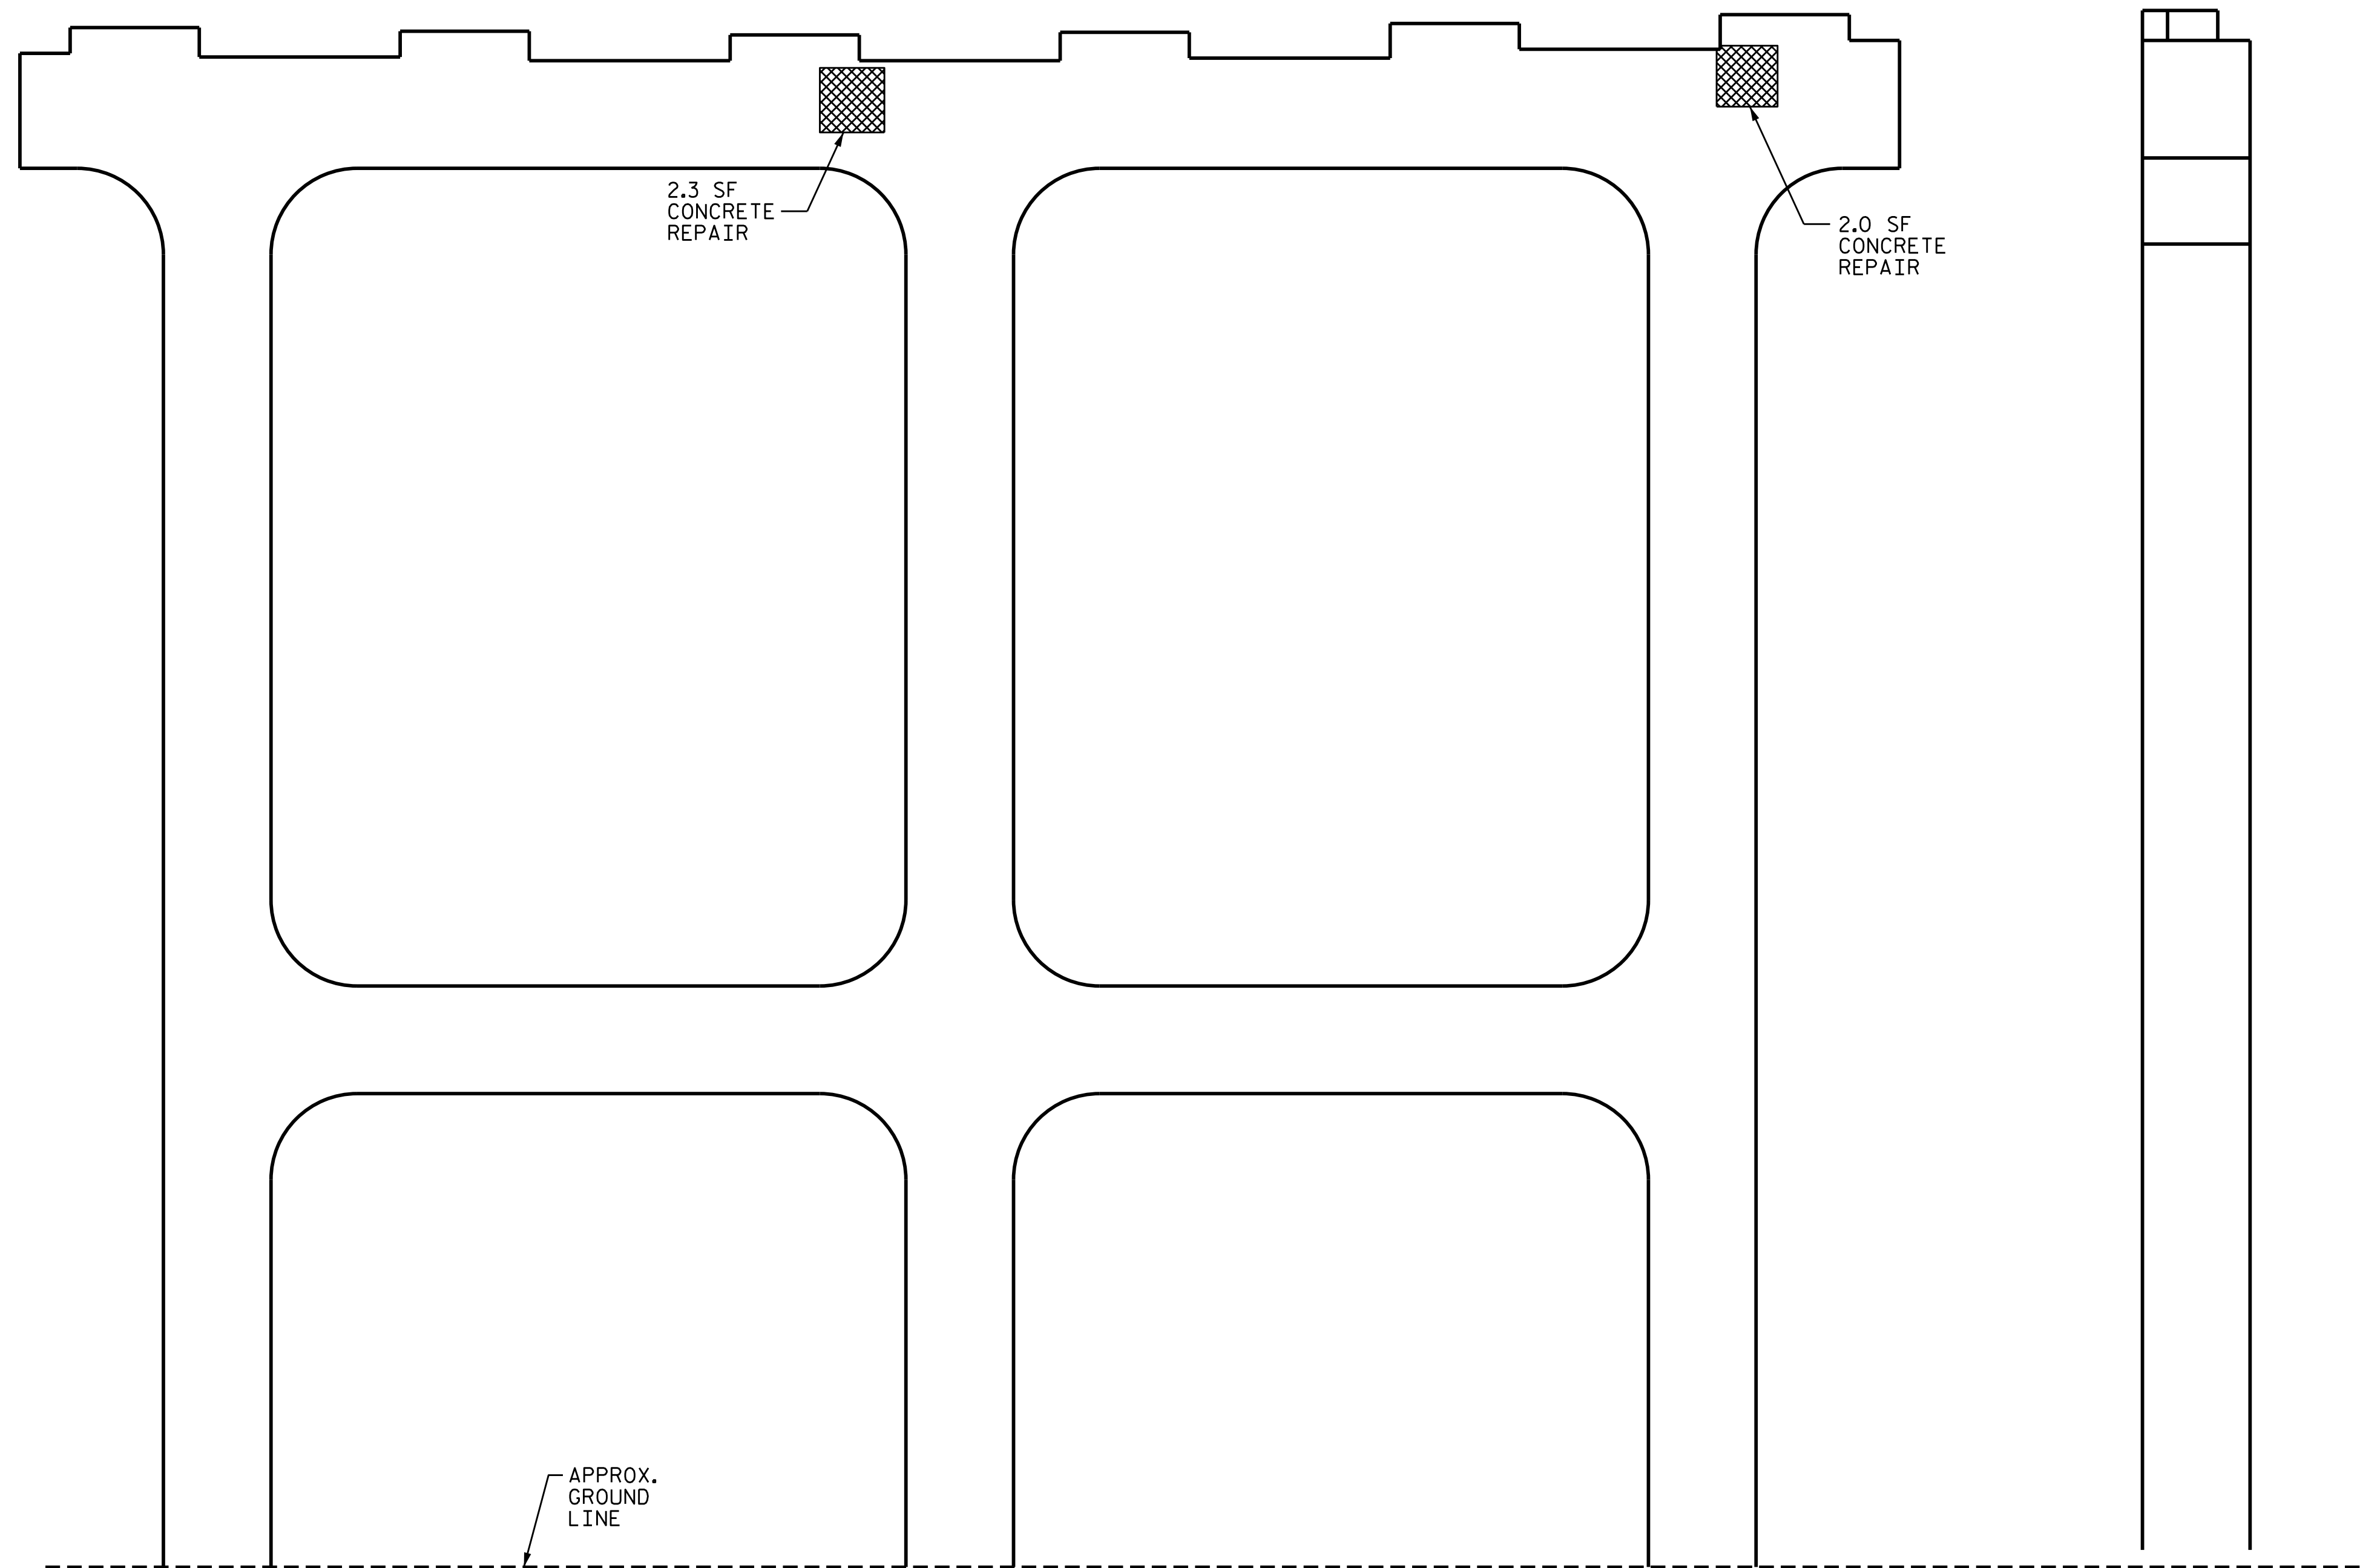
ELEVATION

DAMAGED AREA

EPOXY RESIN INJECTION

FOR REPAIR DETAILS, SEE "TYPICAL CAP AND COLUMN REPAIR DETAILS" SHEET.

EPOXY COATING SHALL BE APPLIED TO THE TOP FACE OF THE CAP. THE CONTRACTOR SHALL NOT COAT THE AREA OF THE CAP BENEATH THE MASONRY PLATES. FOR EPOXY COATING, SEE SPECIAL PROVISIONS.

CONCRETE REPAIRS TO THE BENT CAP MAY REQUIRE BRIDGE JACKING. FOR BRIDGE JACKING, SEE "JACKING DETAILS" SHEET.
