PROJECT NO. I-5000 GASTON _ COUNTY 120

BRIDGE NO._

STATE OF NORTH CAROLINA DEPARTMENT OF TRANSPORTATION

> BENT 5 SPAN E FACE (RIGHT SECTION)

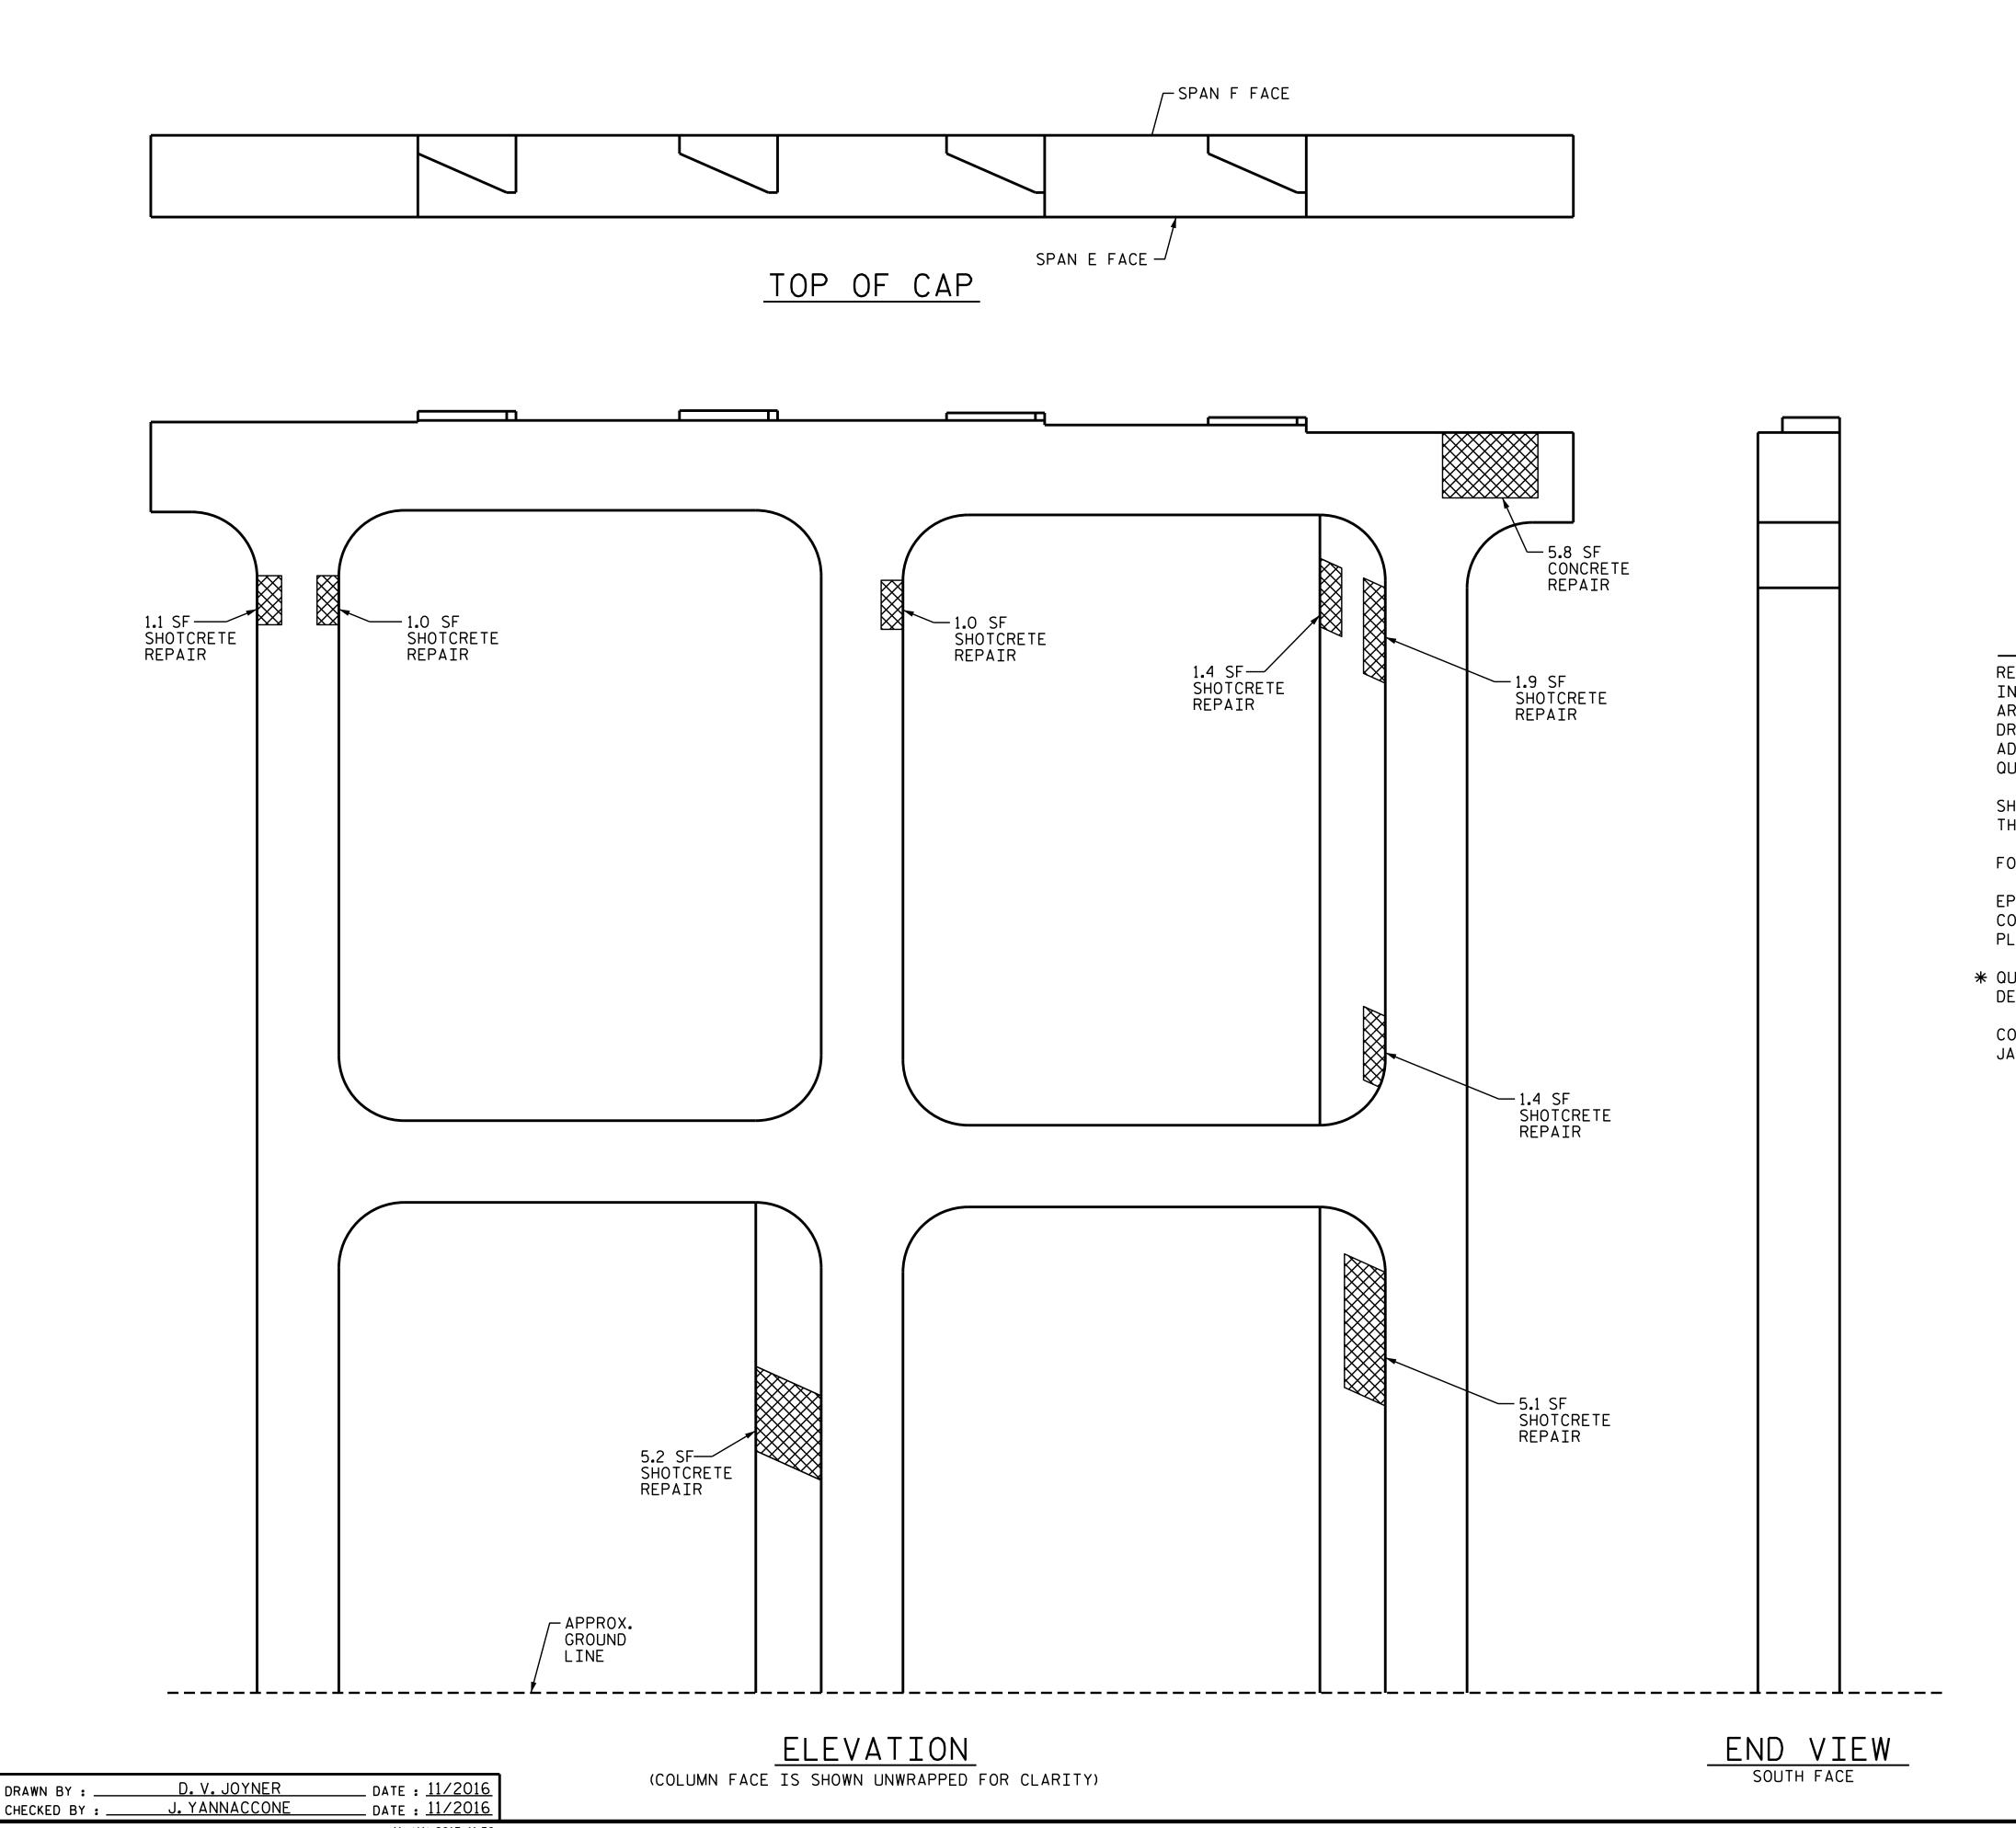
* QUANTITY HAS BEEN INCREASED DUE TO THE POTENTIAL FOR FURTHER DETERIORATION SINCE THE FIELD INSPECTION BY STRUCTURES MANAGEMENT UNIT.

DAMAGED AREA

VALUES IN CHART REPRESENT ESTIMATED REPAIR TOTALS AFTER REMOVAL OF UNSOUND CONCRETE, MIN. OF 1" BEHIND REBAR AND 2" MIN. CLEAR TO SAWCUT. SEE REPAIR DETAILS.

EPOXY COATING SHALL BE APPLIED TO THE TOP FACE OF THE CAP. THE CONTRACTOR SHALL NOT COAT THE AREA OF THE CAP BENEATH THE MASONRY PLATES. FOR EPOXY COATING, SEE SPECIAL PROVISIONS.

CONCRETE REPAIRS TO THE BENT CAP MAY REQUIRE BRIDGE JACKING. FOR BRIDGE JACKING, SEE "JACKING DETAILS" SHEET.
