NC DEPARTMENT OF TRANSPORTATION
 DIVISION OF HIGHWAYS
 STRUCTURE MANAGEMENT UNIT

ATTENTION: PRIORITY MAINTENANCE, SNOOPER, DATA CHANGES

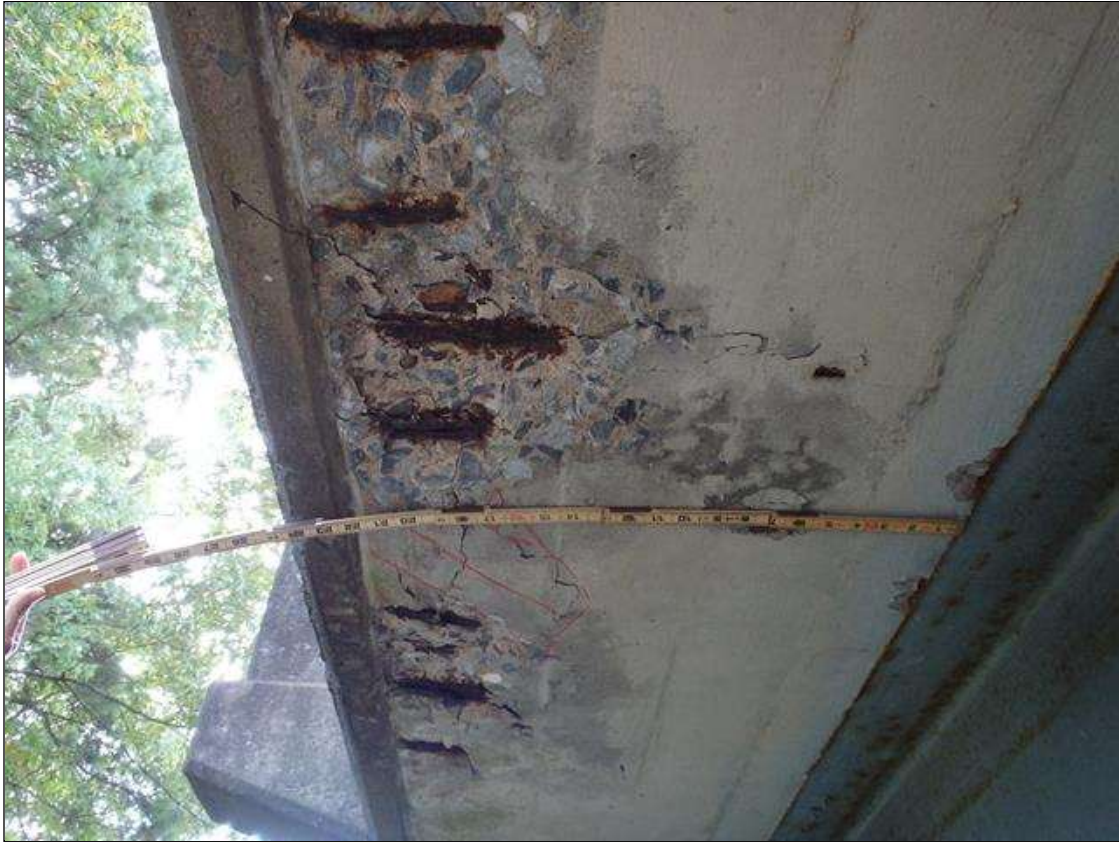
Span 1 Deck: UP TO 21" X 12" X 1 3/4" DEEP SPALLS WITH EXPOSED REBAR AND UP TO 9" X 9" AREAS OF DELAMINATION THROUGHOUT BOTTOM OF BOTH OVERHANGS, CONDITION IN BOTTOM OF RIGHT OVERHANG NEAR MIDSPAN SHOWN

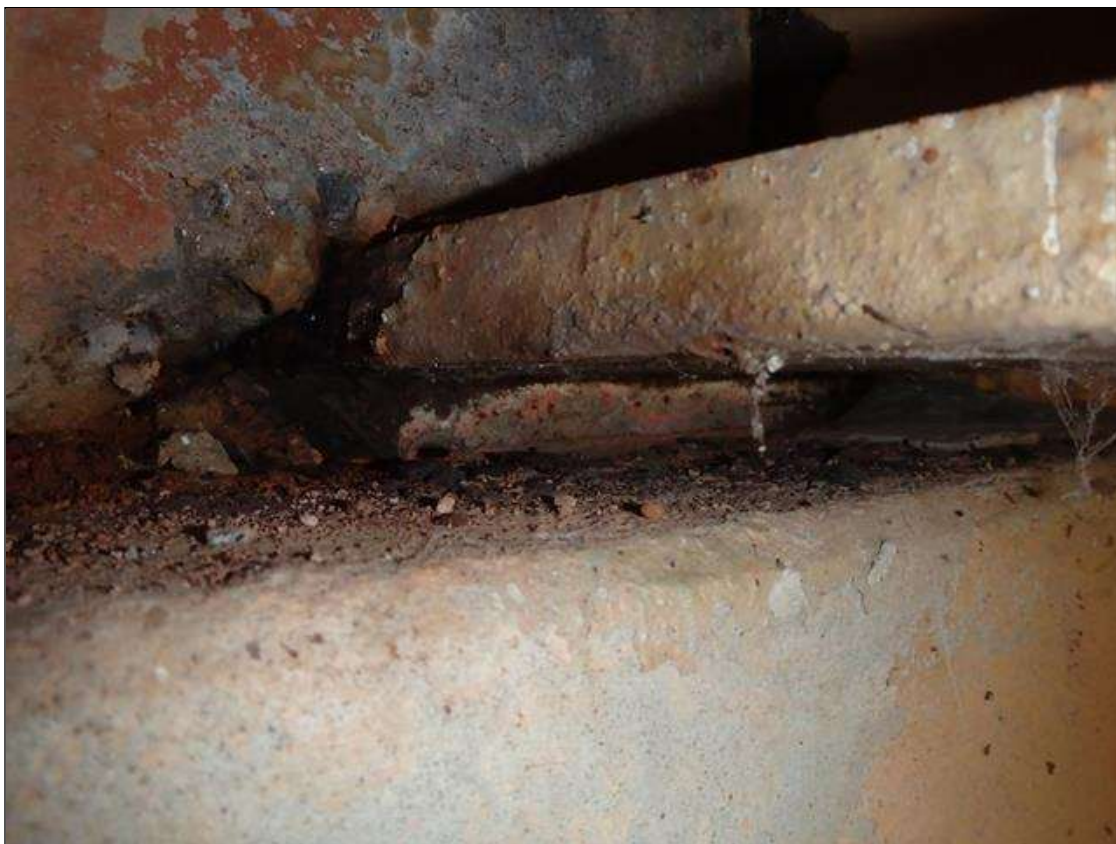
Span 1 Beam 3 Near Bearing: SURFACE CORROSION THROUGHOUT EXPOSED FACE OF BEAM 3 BEARING AT END BENT 1

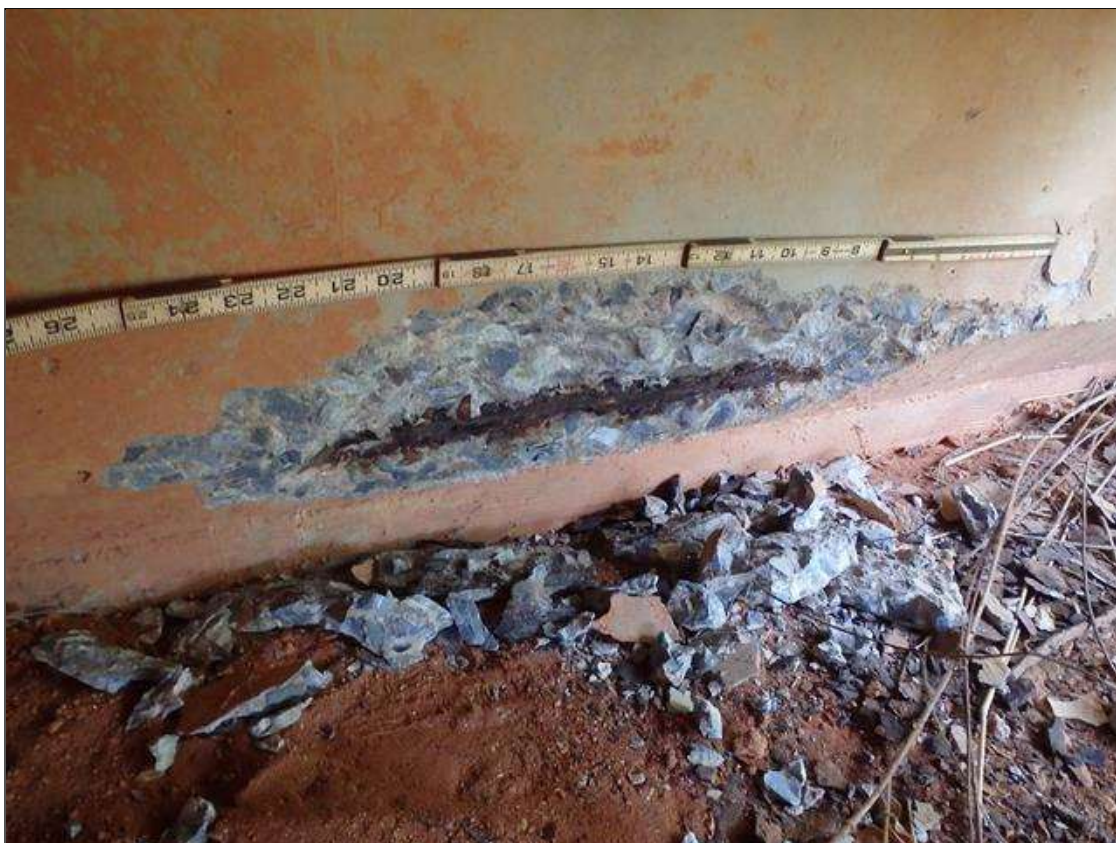
End Bent 1 Cap 1: 28" X 8" X 1 1/2" DEEP SPALL WITH EXPOSED REBAR IN FACE OF CAP TO RIGHT OF BEAM 1, PRIORITY MAINTENANCE

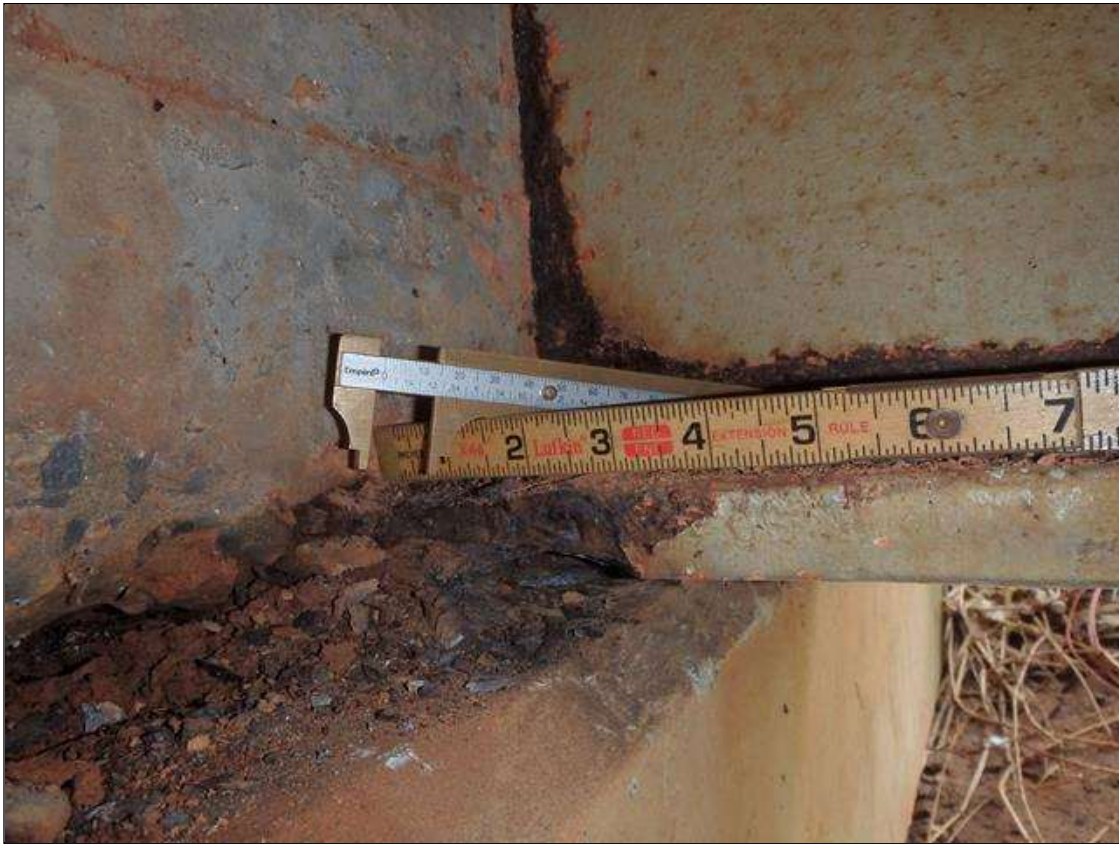
Span 1 Beam 1: SCALING AND PACK RUST ALONG BOTTOM FLANGE UP TO 6" LONG X FULL WIDTH DOWN TO 5/8" RESIDUAL FLANGE AT FACE OF END BENT 1 BEARING, CONDITION ON RIGHT SIDE SHOWN, PRIORITY MAINTENANCE

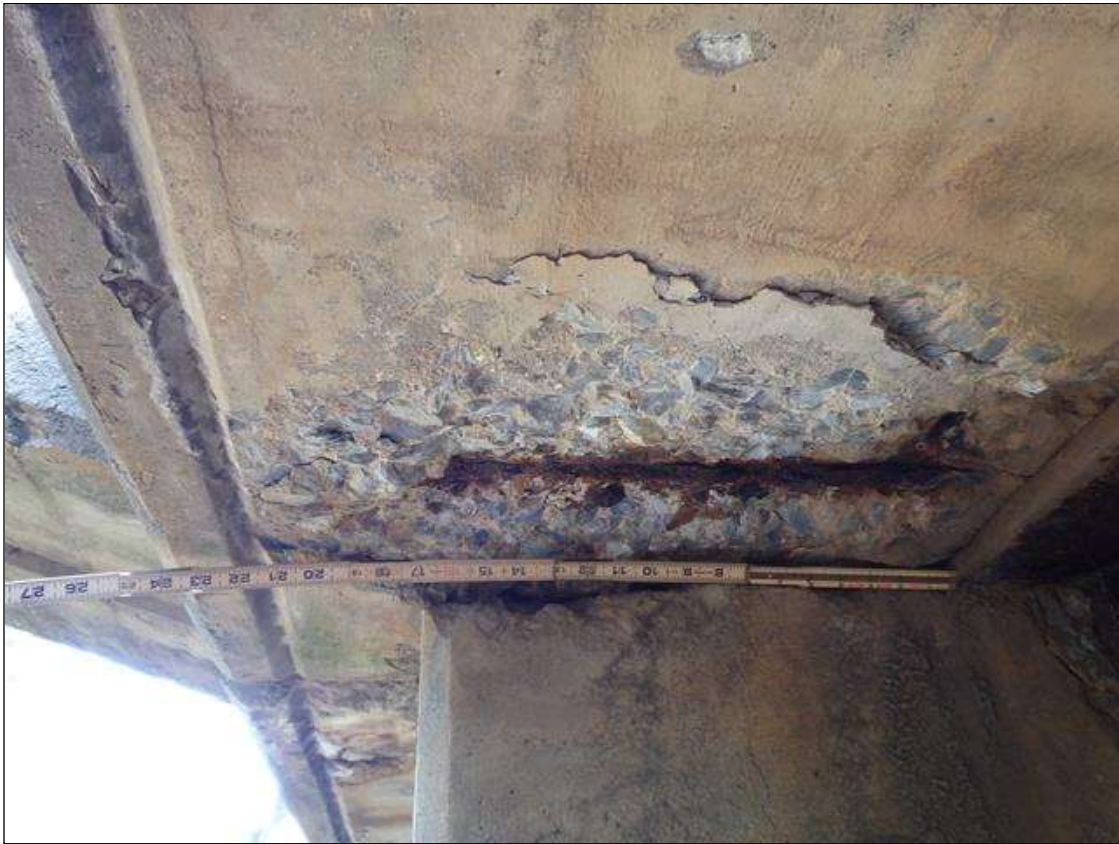
Span 1 Deck: UP TO 22" X 16" X 1 1/2" DEEP SPALLS WITH EXPOSED REBAR IN BOTTOM OF BOTH OVERHANGS ABOVE BENT, SPALL IN BOTTOM OF LEFT OVERHANG SHOWN

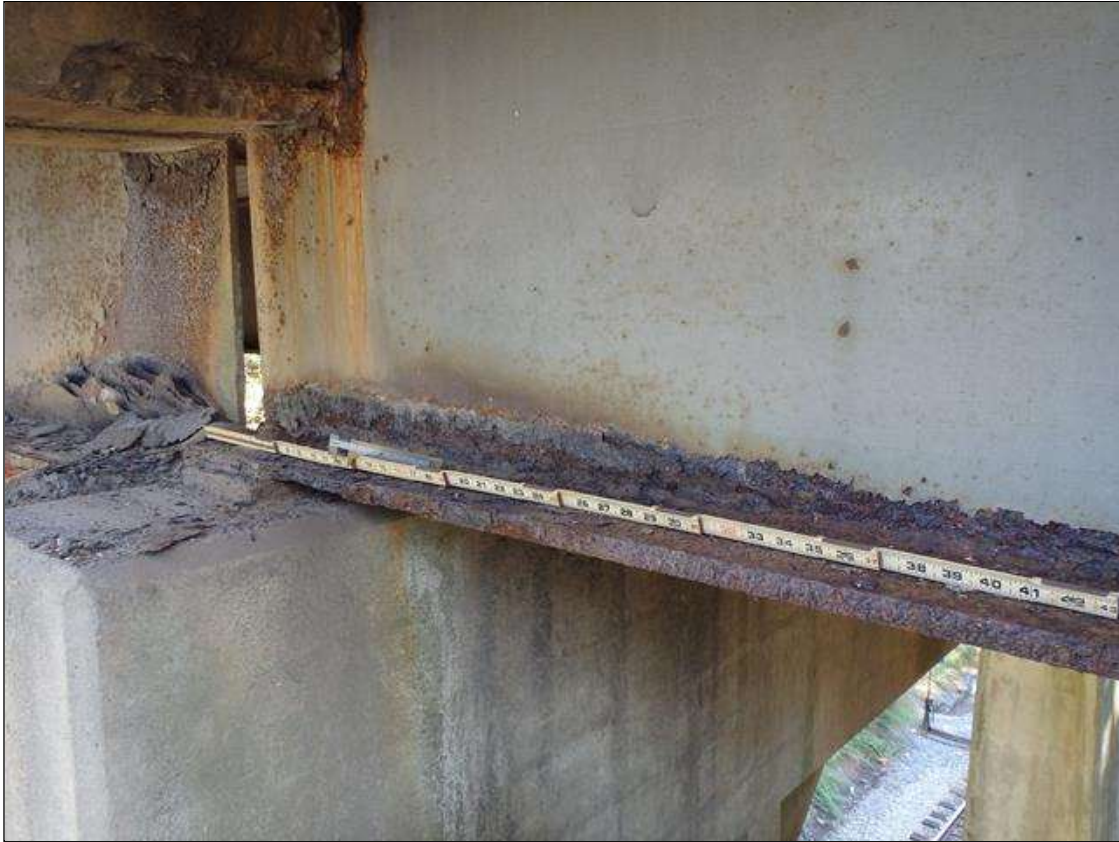
Span 1 Beam 1: SCALING AND PACK RUST ALONG BOTH FACES OF WEB AND BOTTOM FLANGE UP TO 102" LONG X 3" HIGH WITH UP TO 1/16" LOSS OF SECTION IN WEB AND 13" LONG X 3" WIDE DOWN TO 1/2" RESIDUAL FLANGE ALONG EDGES OF BOTTOM FLANGE AT FACE OF BENT BEARING, CONDITION ON LEFT SIDE SHOWN, PRIORITY MAINTENANCE

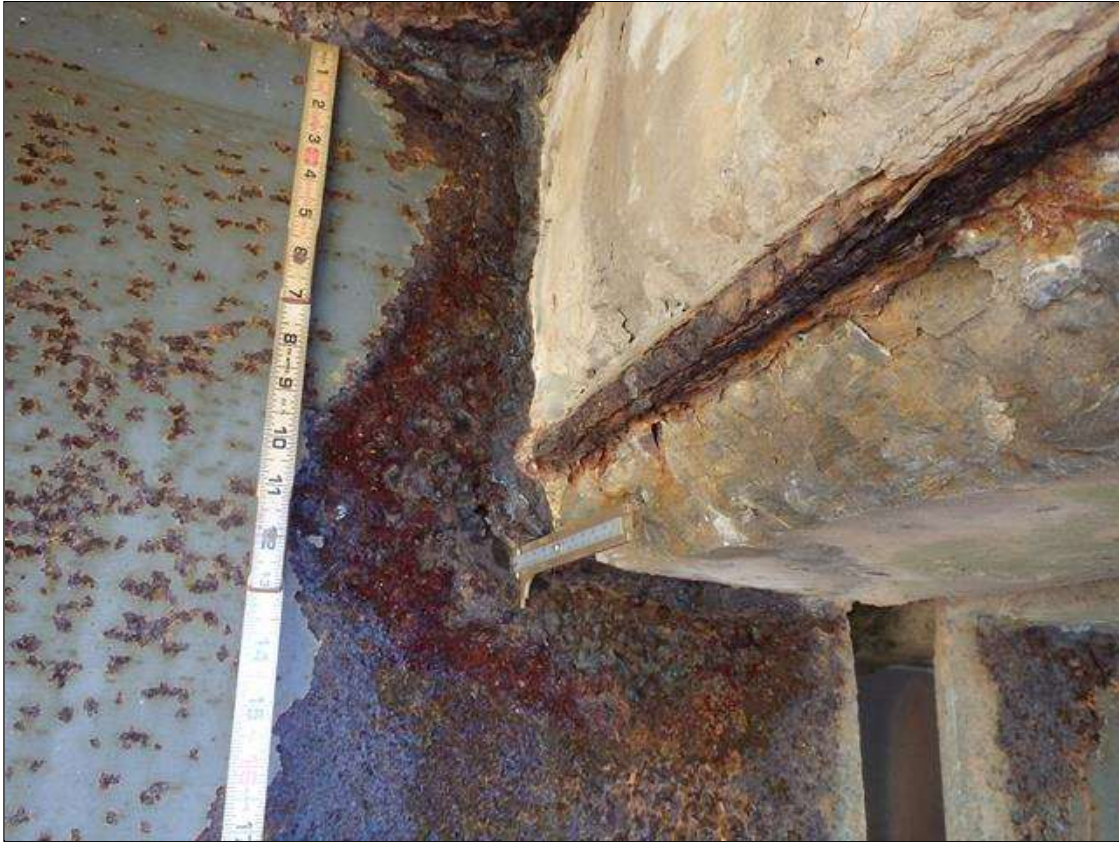
Span 2 Beam 1: SCALING AND PACK RUST IN BOTH FACES OF WEB UP TO 15" HIGH X 12" WIDE WITH 4" X 1/4" HOLE AROUND BENT DIAPHRAGM, CONDITION ON LEFT SIDE SHOWN, PRIORITY MAINTENANCE

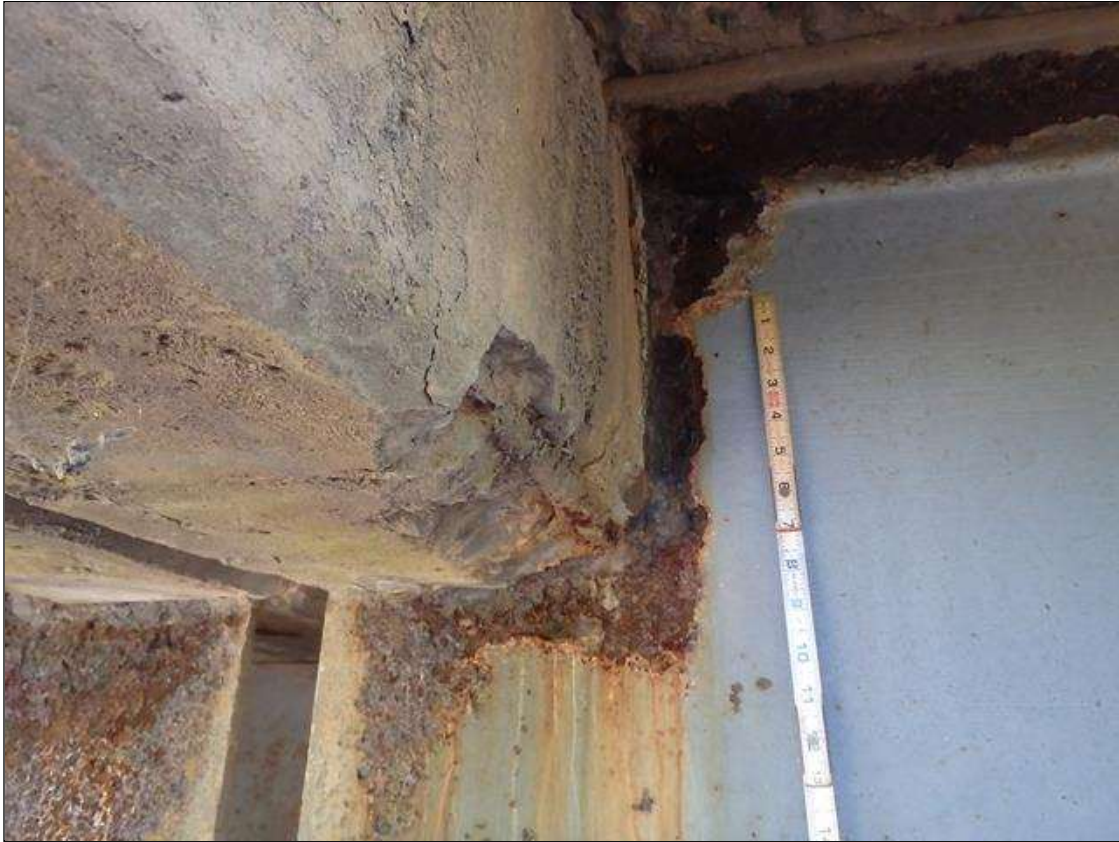
Span 1 Beam 1: SCALING AND PACK RUST IN BOTH FACES OF WEB UP TO 14" HIGH X 10" WIDE WITH UP TO 1/16" LOSS OF SECTION AROUND BENT DIAPHRAGM, CONDITION ON LEFT SIDE SHOWN, PRIORITY MAINTENANCE

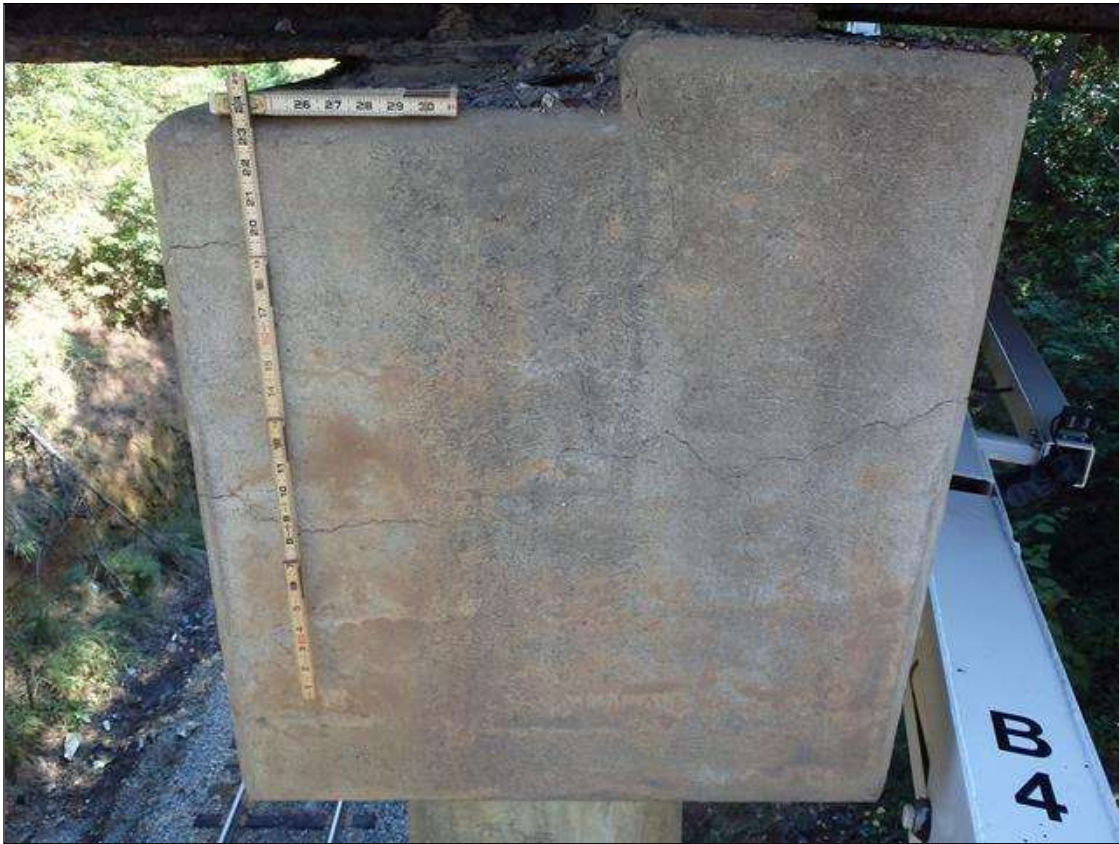
Bent 1 Cap 1: UP TO 0.04" MAP CRACKS IN BOTH ENDS OF CAP EXTENDING INTO ALL FACES, CRACKS IN LEFT END SHOWN

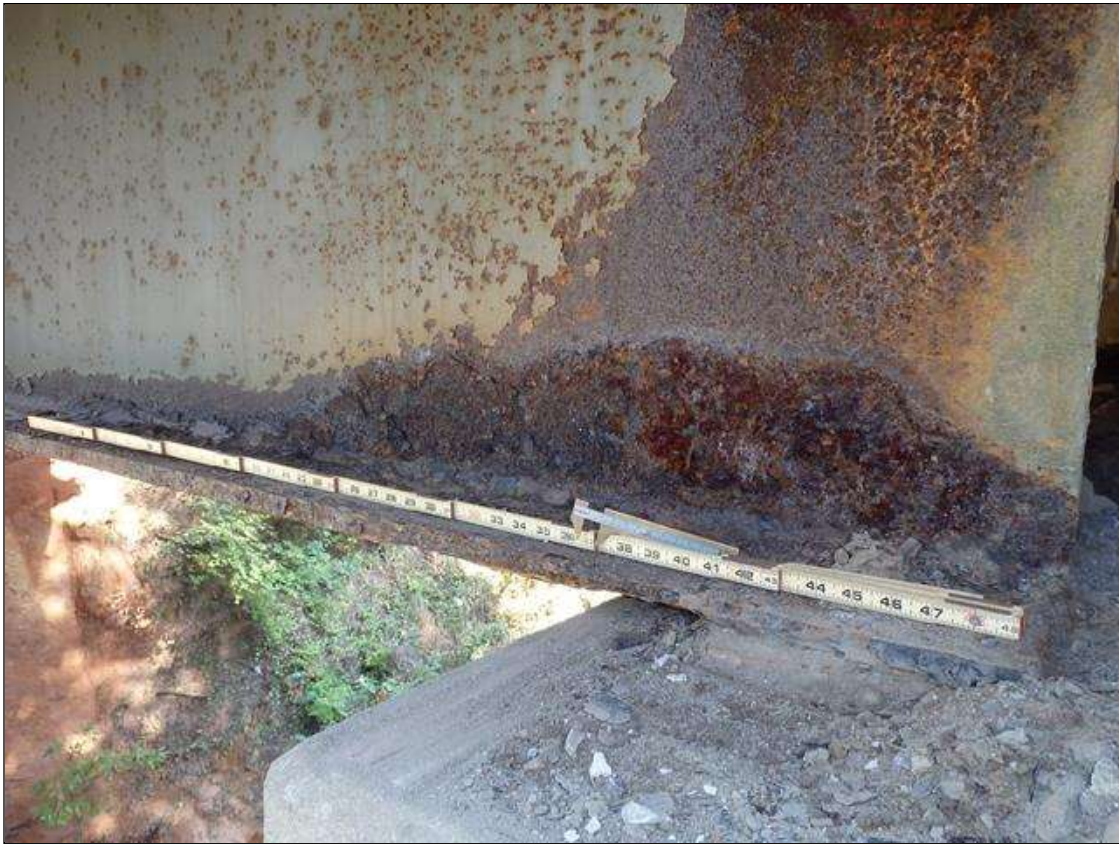
Span 2 Beam 1: SCALING AND PACK RUST ALONG BOTH FACES OF WEB AND BOTTOM FLANGE UP TO 55" LONG X 6" HIGH WITH UP TO 1/16" LOSS OF SECTION IN WEB AND 30" LONG X FULL WIDTH DOWN TO 1/2" RESIDUAL FLANGE AT FACE OF BENT BEARING, CONDITION ON LEFT SIDE SHOWN, PRIORITY MAINTENANCE

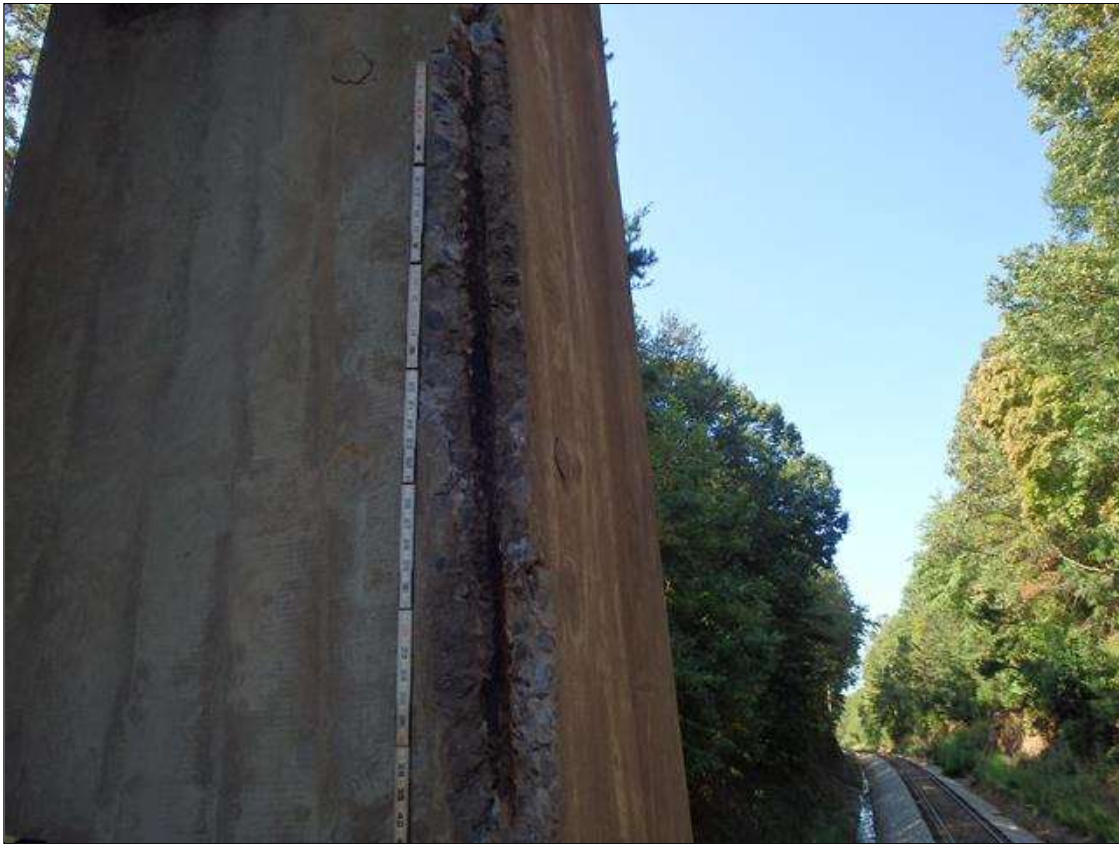
Bent 1 Pile 1: 55" X 6" X 2" DEEP SPALL WITH EXPOSED REBAR IN NORTHEAST CORNER OF COLUMN, APPROXIMATELY 16' FROM BOTTOM OF CAP, PRIORITY MAINTENANCE

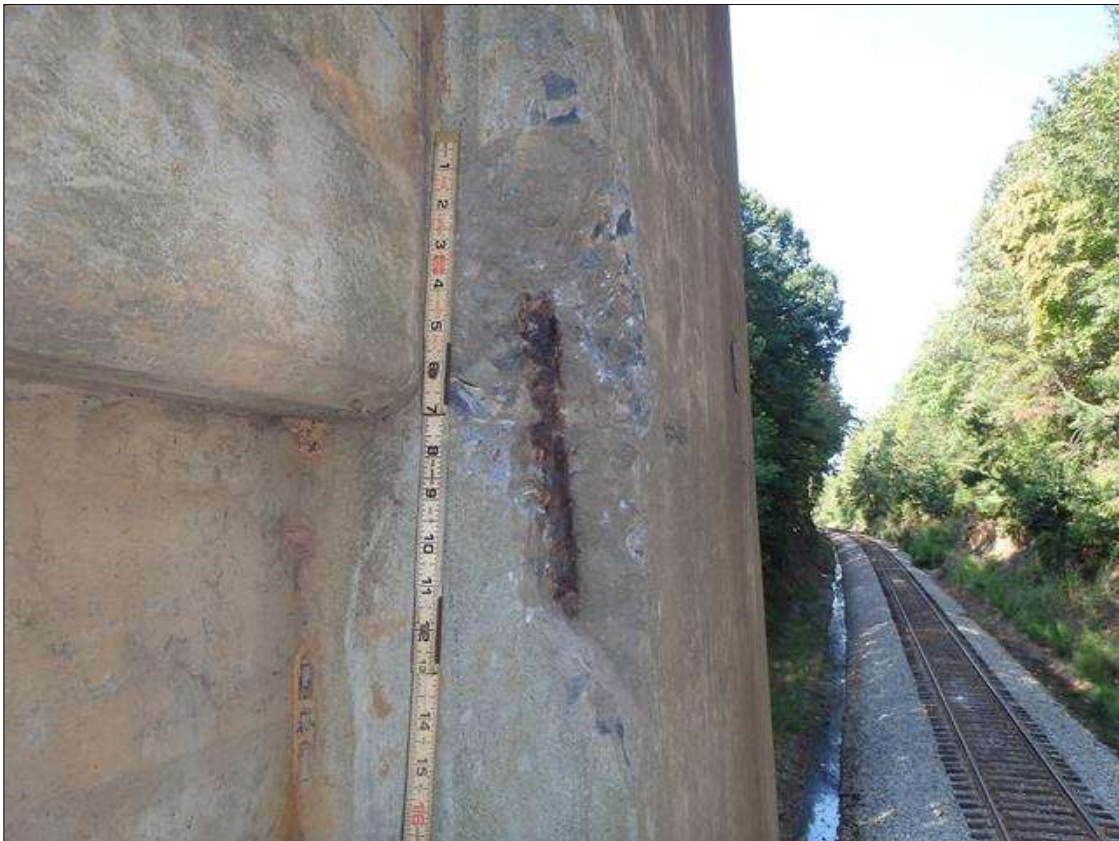
Bent 1 Pile 1: 18" X 7" X 2" DEEP SPALL WITH EXPOSED REBAR IN NORTHEAST CORNER OF COLUMN, APPROXIMATELY 13' FROM BOTTOM OF CAP, PRIORITY MAINTENANCE

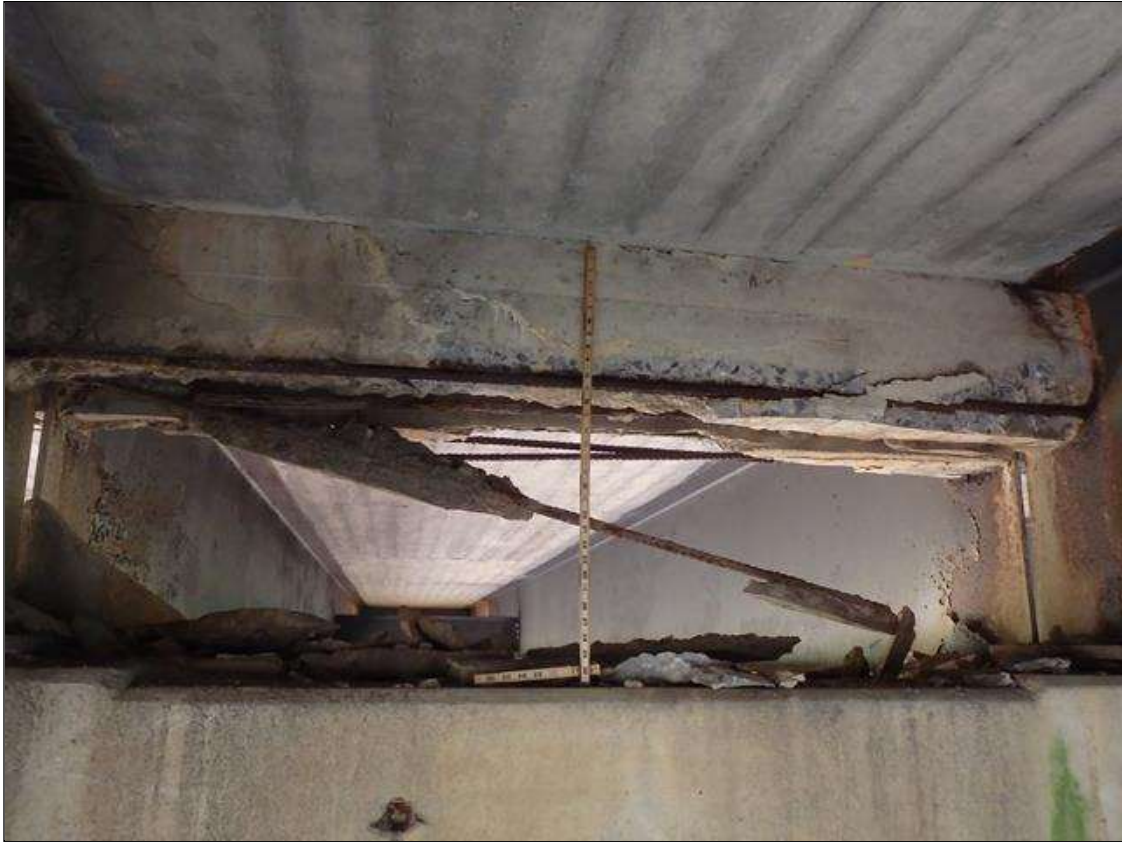
BENT DIAPHRAGMS: UP TO FULL LENGTH X FULL WIDTH X UP TO 6" DEEP SPALLS WITH EXPOSED REBAR IN DIAPHRAGMS, CONDITION IN BAY 2 OF SPAN 1 SHOWN

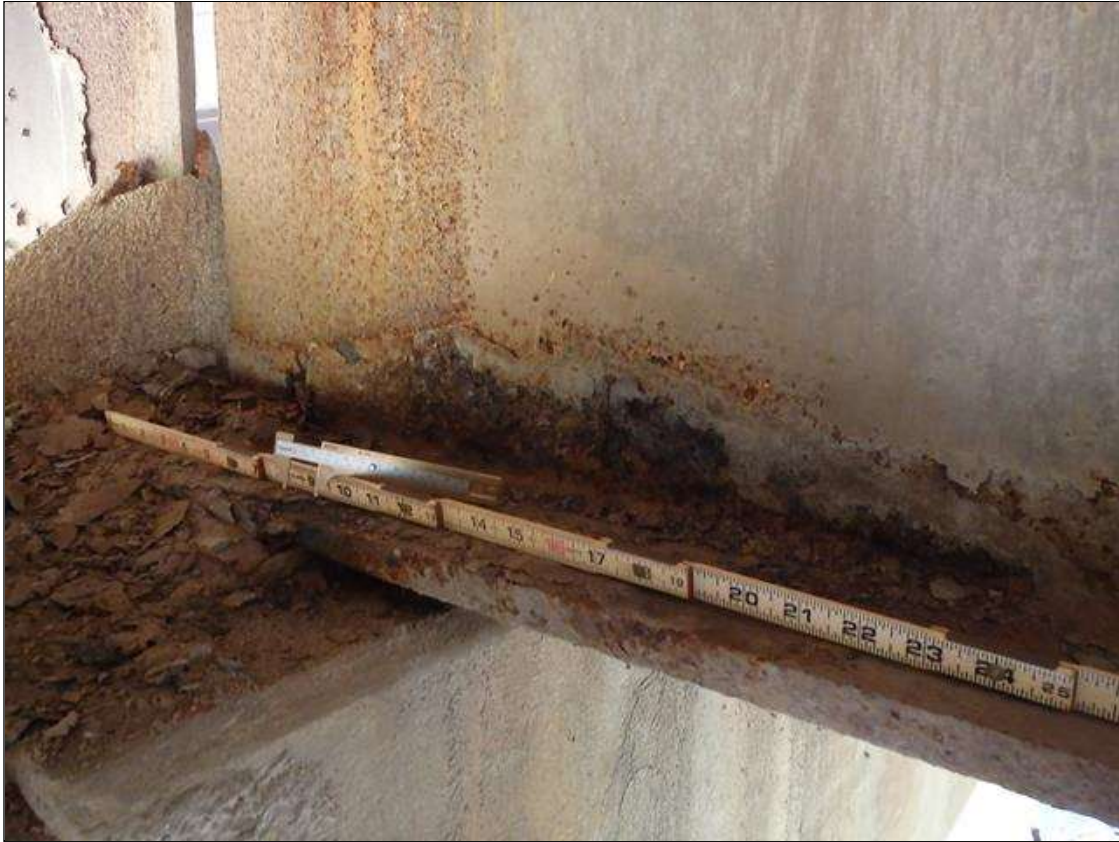
Span 1 Beam 2: SCALING AND PACK RUST ALONG BOTH FACES OF WEB AND BOTTOM FLANGE UP TO 20" LONG X 4" HIGH WITH NO MEASURABLE LOSS OF SECTION IN WEB AND 8" LONG X 2 1/2" WIDE DOWN TO 11/16" RESIDUAL FLANGE ALONG EDGES OF BOTTOM FLANGE AT FACE OF BENT BEARING, CONDITION ON LEFT SIDE SHOWN, PRIORITY MAINTENANCE

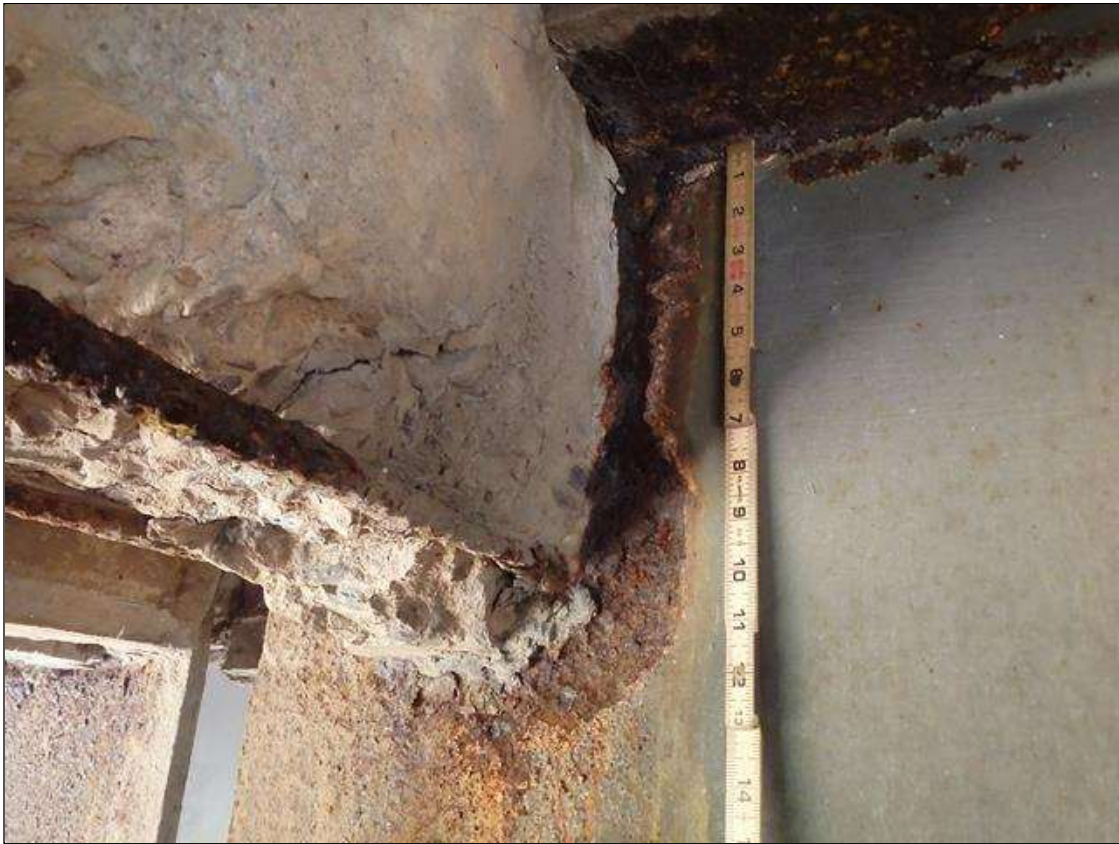
Span 1 Beam 2: SCALING AND PACK RUST IN BOTH FACES OF WEB UP TO 13" HIGH X 7" WIDE WITH UP TO 1/8" LOSS OF SECTION AROUND BENT DIAPHRAGM, CONDITION ON LEFT SIDE SHOWN, PRIORITY MAINTENANCE

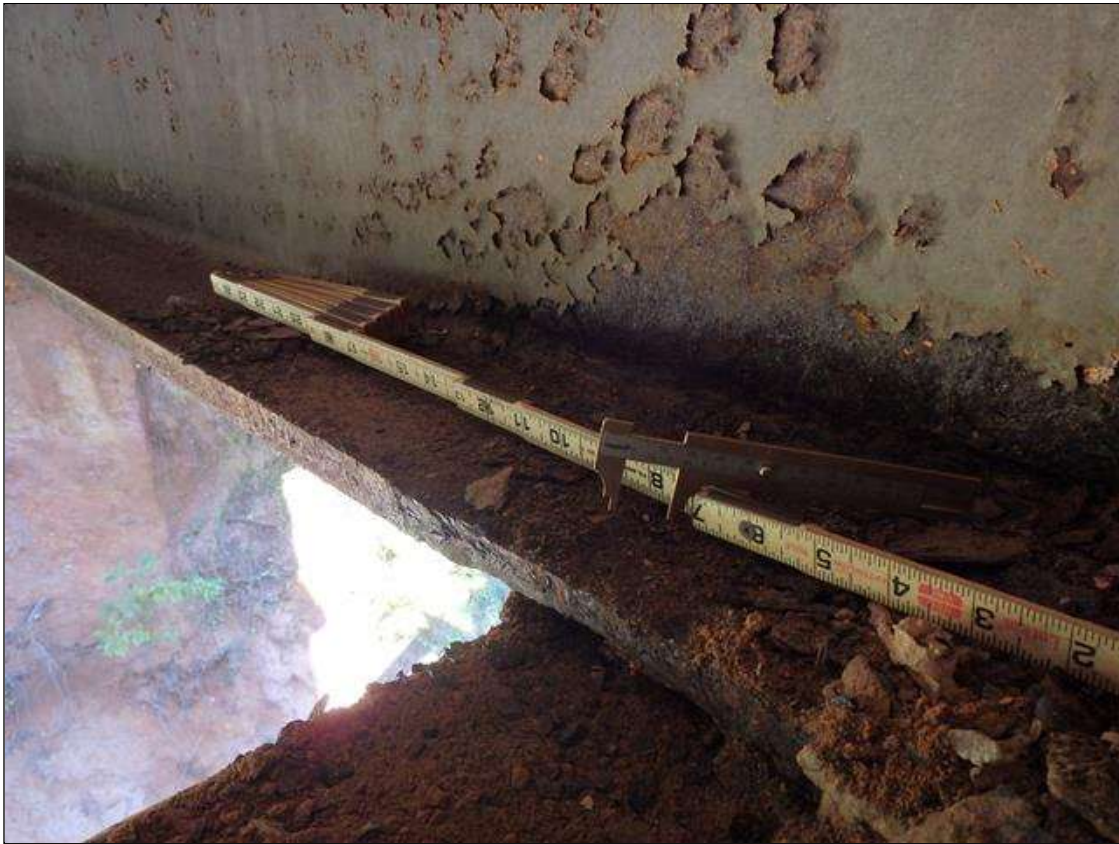
Span 2 Beam 2: SCALING AND PACK RUST ALONG BOTH FACES OF WEB AND BOTTOM FLANGE UP TO 18" LONG X 2" HIGH WITH NO MEASURABLE LOSS OF SECTION IN WEB AND 9" LONG X 2" WIDE DOWN TO 3/4" RESIDUAL FLANGE ALONG EDGES OF BOTTOM FLANGE AT FACE OF BENT BEARING, CONDITION ON LEFT SIDE SHOWN, PRIORITY MAINTENANCE

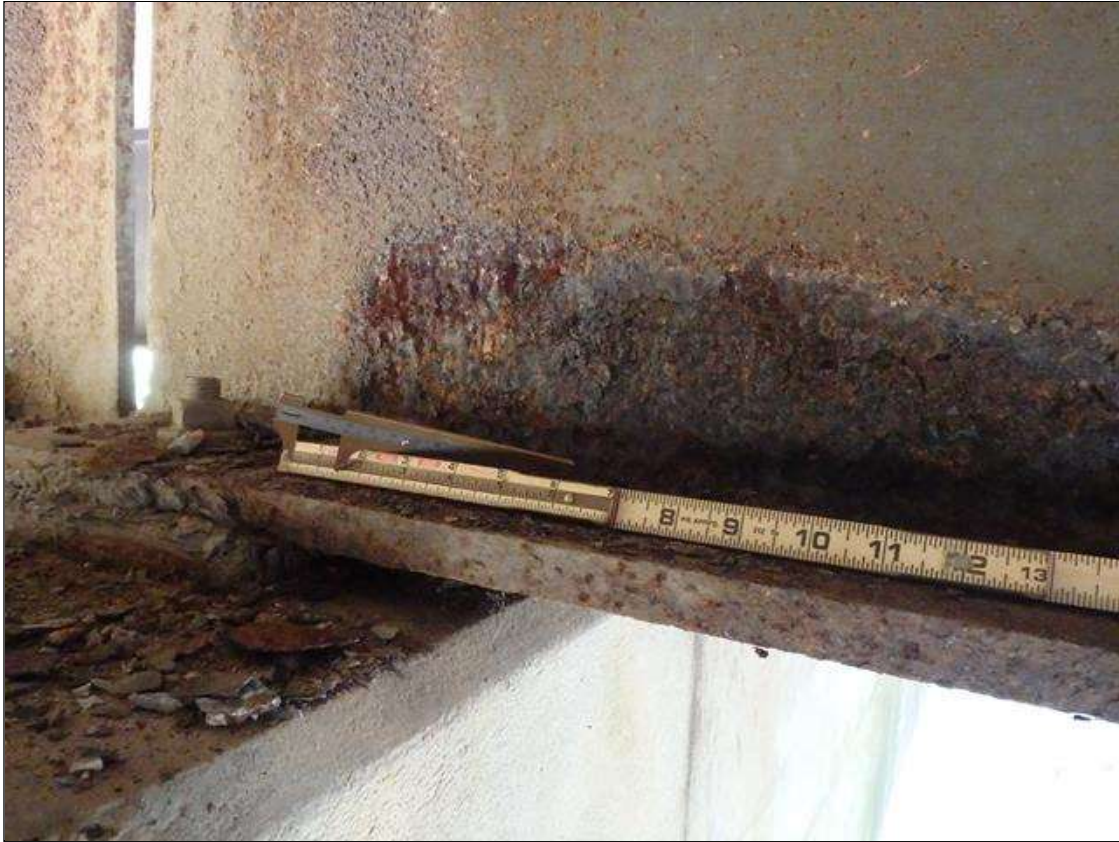
Span 1 Beam 3: SCALING AND PACK RUST ALONG BOTH FACES OF WEB AND BOTTOM FLANGE UP TO 48" LONG X 4" HIGH WITH NO MEASURABLE LOSS OF SECTION IN WEB AND 3" LONG X 2" WIDE DOWN TO 3/4" RESIDUAL FLANGE ALONG EDGES OF BOTTOM FLANGE AT FACE OF BENT BEARING, CONDITION ON LEFT SIDE SHOWN, PRIORITY MAINTENANCE

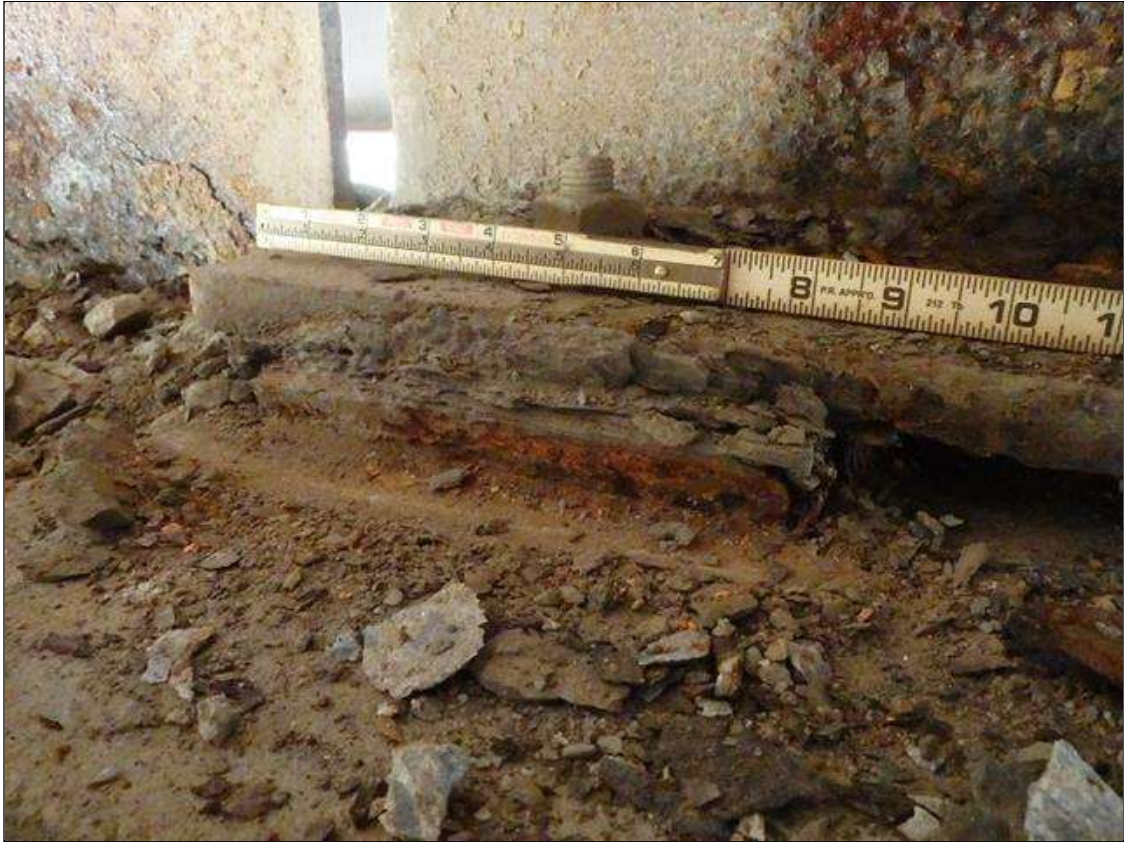
Span 1 Beam 3 Far Bearing: SCALING AND PACK RUST THROUGHOUT BEAM 3 BEARING AT BENT

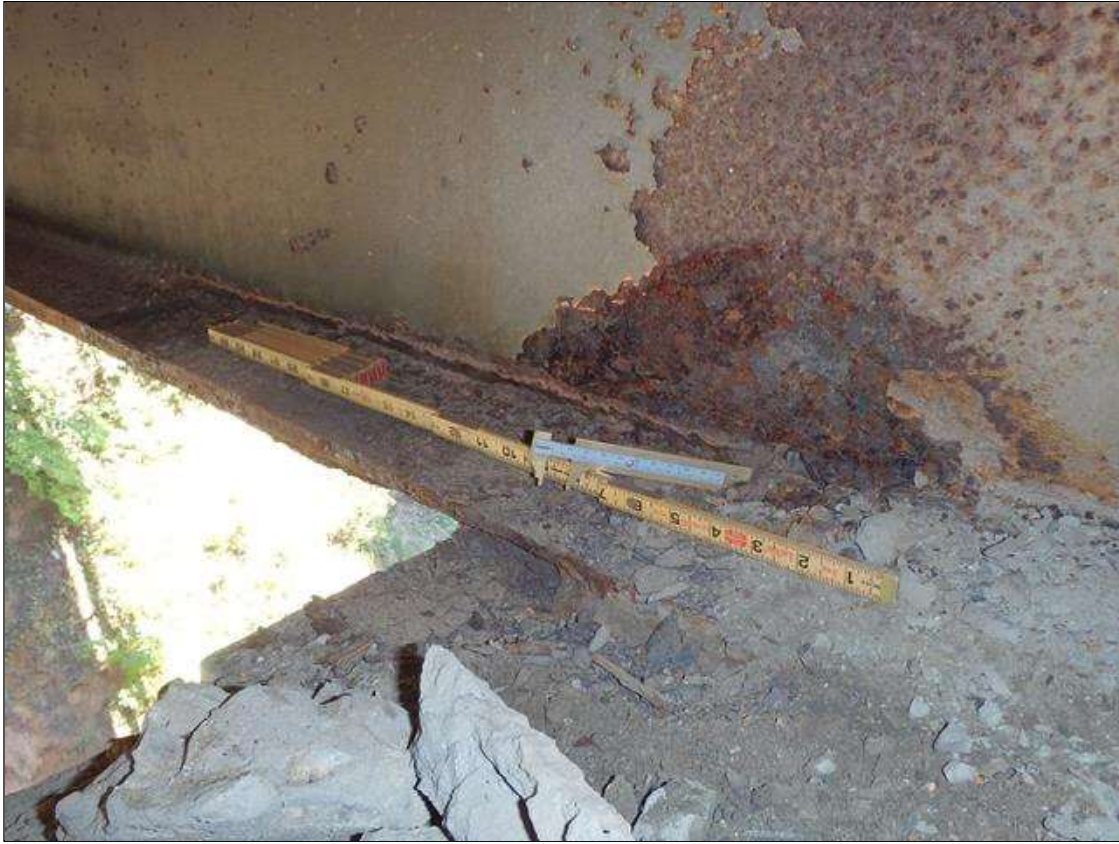
Span 2 Beam 3: SCALING AND PACK RUST ALONG BOTH FACES OF WEB AND BOTTOM FLANGE UP TO 34" LONG X 6" HIGH WITH UP TO 1/16" LOSS OF SECTION IN WEB AND 20" LONG X 3" WIDE DOWN TO 9/16" RESIDUAL FLANGE ALONG EDGES OF BOTTOM FLANGE AT FACE OF BENT BEARING, CONDITION ON LEFT SIDE SHOWN, PRIORITY MAINTENANCE

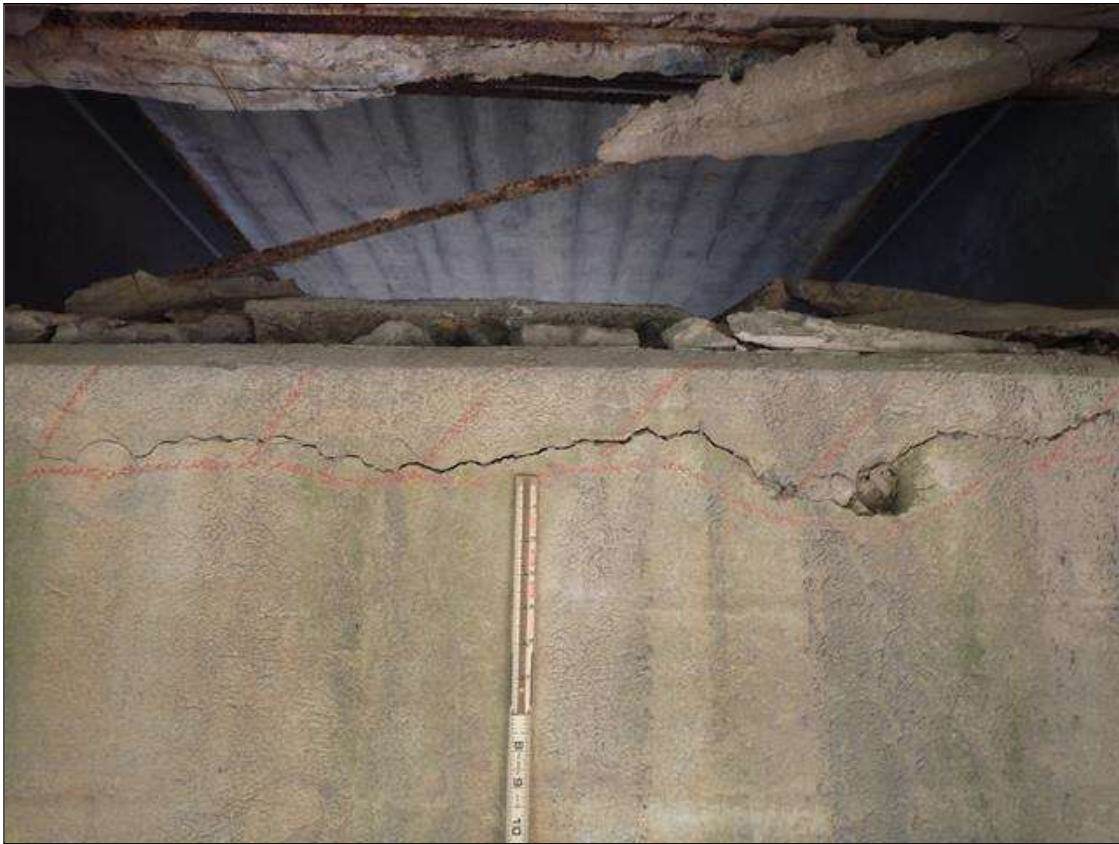
Bent 1 Cap 1: 56" X 6" X 3" AREA OF DELAMINATION AND UP TO 1/8" LONGITUDINAL AND HORIZONTAL CRACKS AND HAIRLINE MAP CRACKS THROUGHOUT TOP, BOTTOM AND SPAN 2 FACE OF CAP, CONDITION BENEATH BAY 2 SHOWN

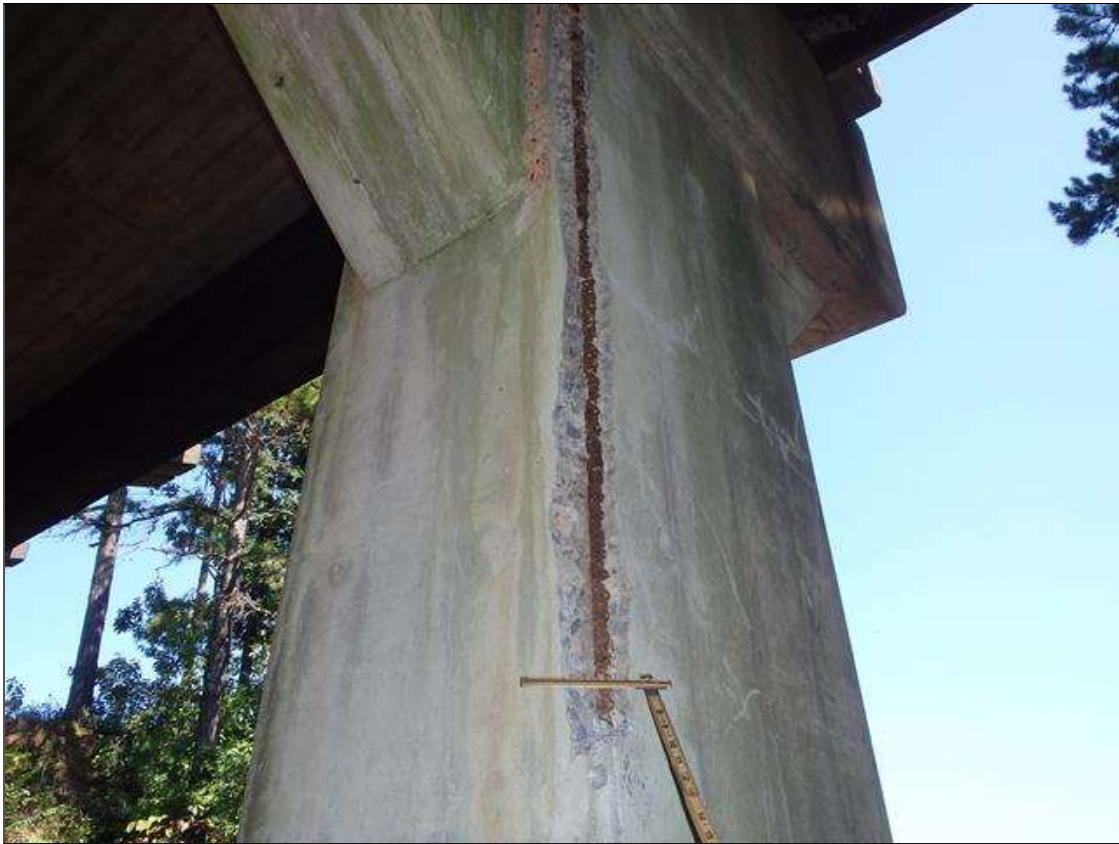
Bent 1 Pile 2: 66" X 4" X 2" DEEP SPALL WITH EXPOSED REBAR IN SOUTHWEST CORNER OF COLUMN AT BOTTOM OF CAP, PRIORITY MAINTENANCE

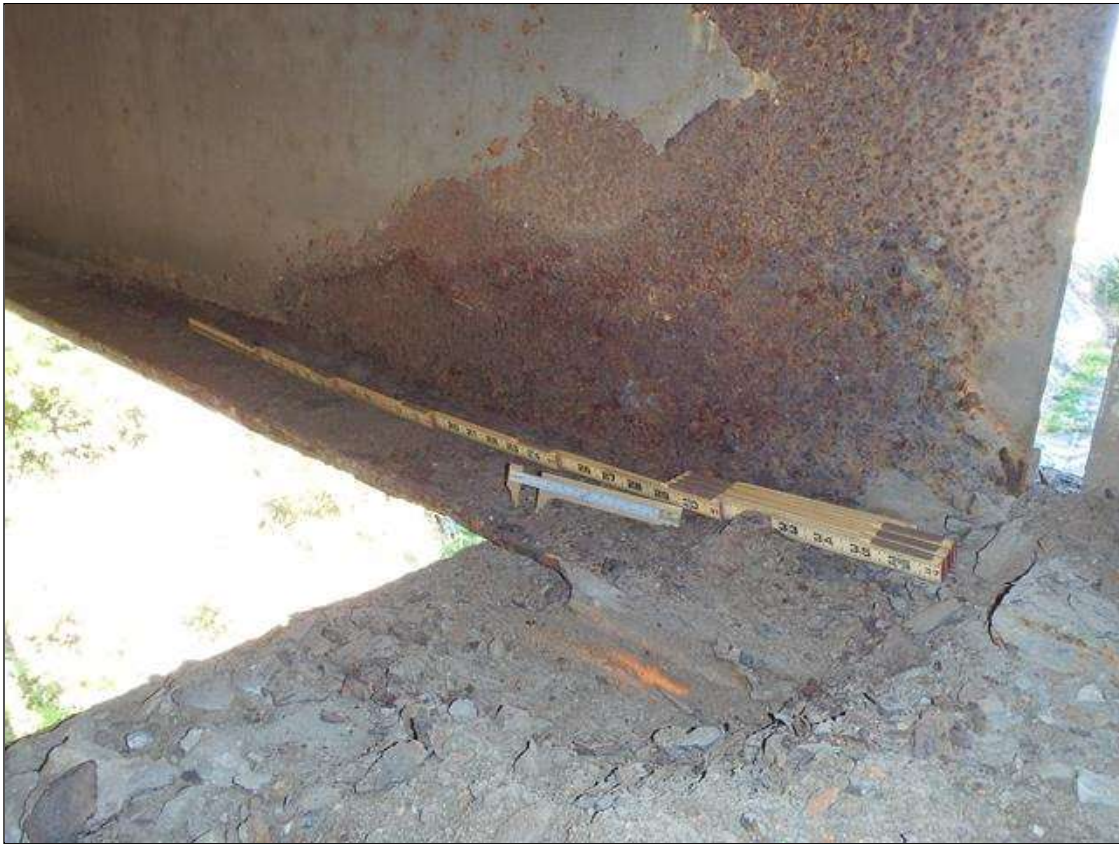
Span 2 Beam 4: SCALING AND PACK RUST ALONG BOTH FACES OF WEB AND BOTTOM FLANGE UP TO 58" LONG X 8" HIGH WITH UP TO 1/16" LOSS OF SECTION IN WEB AND 28" LONG X 3" WIDE DOWN TO 9/16" RESIDUAL FLANGE ALONG EDGES OF BOTTOM FLANGE AT FACE OF BENT BEARING, CONDITION ON LEFT SIDE SHOWN, PRIORITY MAINTENANCE

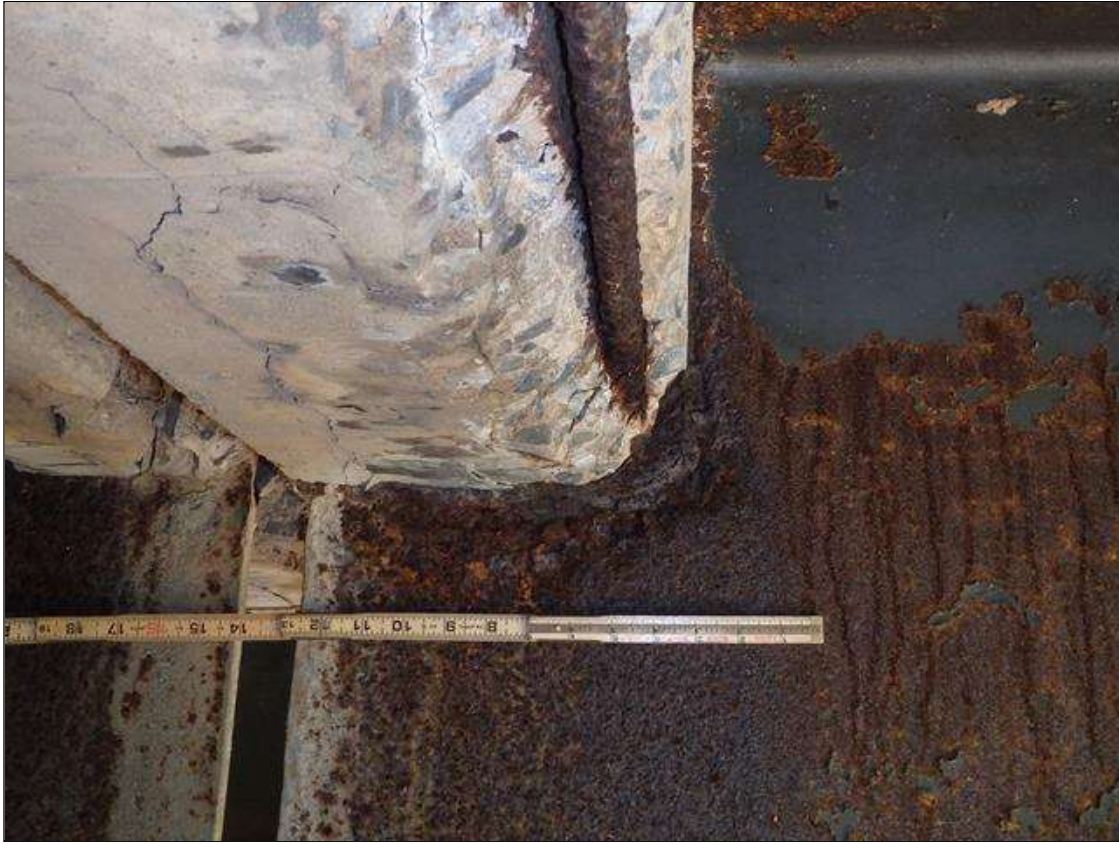
Span 2 Beam 3: SCALING AND PACK RUST IN BOTH FACES OF WEB UP TO 6" HIGH X 11" WIDE WITH UP TO 1/8" LOSS OF SECTION AROUND BENT DIAPHRAGM, CONDITION ON RIGHT SIDE SHOWN, PRIORITY MAINTENANCE
