NC DEPARTMENT OF TRANSPORTATION
 DIVISION OF HIGHWAYS
 STRUCTURE MANAGEMENT UNIT

ATTENTION: PRIORITY MAINTENANCE, SNOOPER, DATA CHANGES

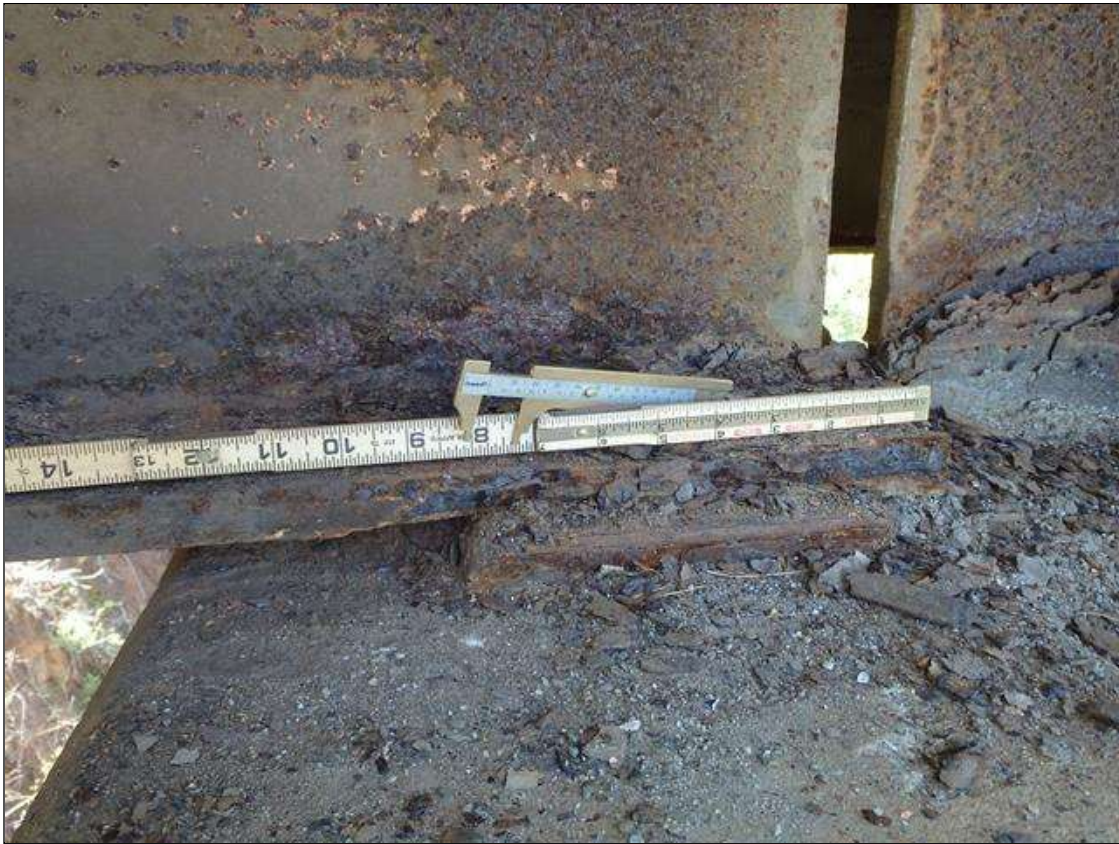
Span 1 Beam 4: SCALING AND PACK RUST ALONG BOTH FACES OF WEB AND BOTTOM FLANGE UP TO 12" LONG X 2" HIGH WITH NO MEASURABLE LOSS OF SECTION IN WEB AND 10" LONG X 2" WIDE DOWN TO 3/4" RESIDUAL FLANGE ALONG EDGES OF BOTTOM FLANGE AT BENT BEARING, CONDITION ON RIGHT SIDE SHOWN, PRIORITY MAINTENANCE

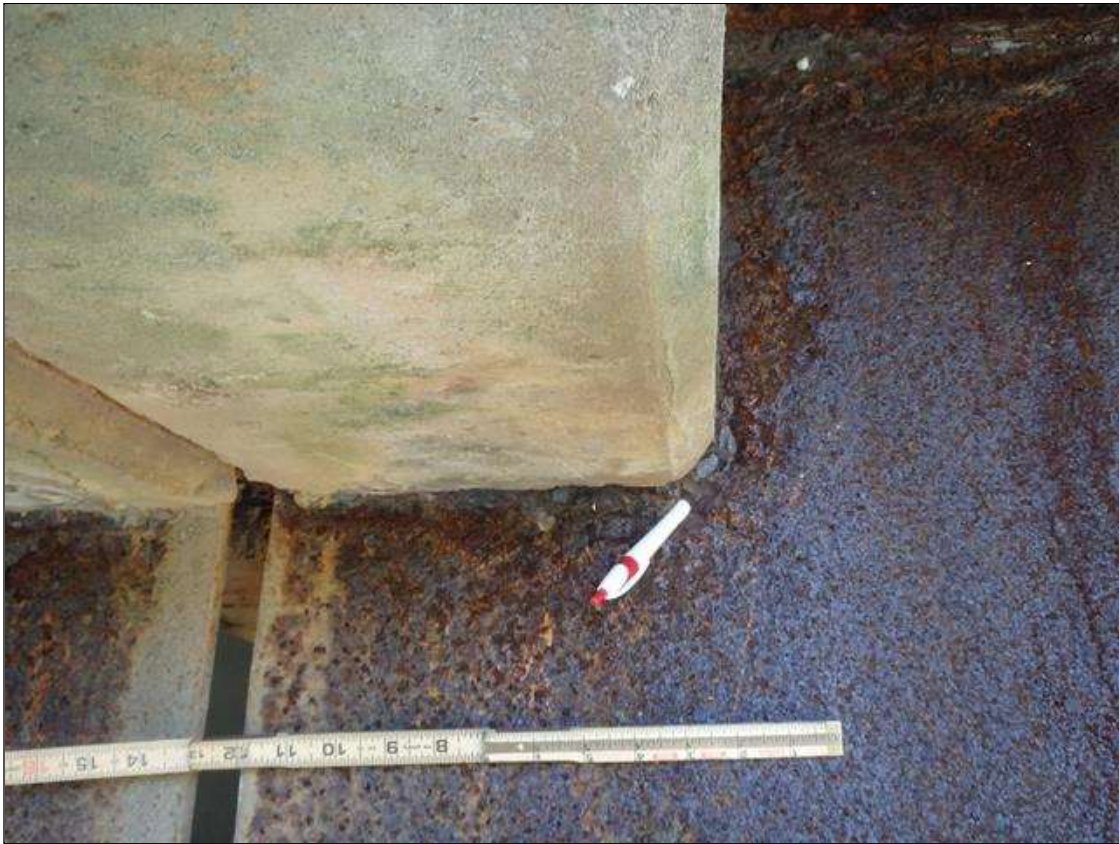
Span 2 Beam 4: SCALING AND PACK RUST IN BOTH FACES OF WEB UP TO 14" HIGH X 12" WIDE WITH UP TO 1/2" DIAMETER HOLES AROUND BENT DIAPHRAGM, CONDITION ON RIGHT SIDE SHOWN, PRIORITY MAINTENANCE

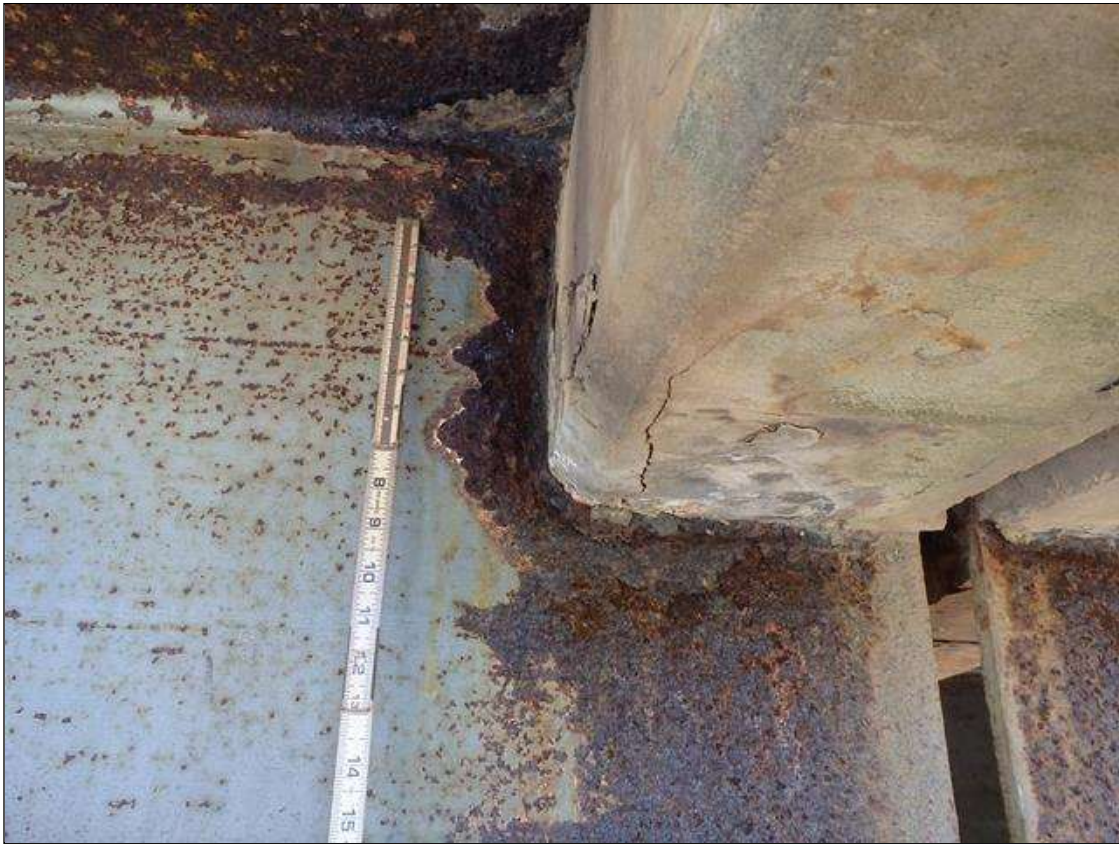
Span 1 Beam 4: SCALING AND PACK RUST IN BOTH FACES OF WEB UP TO 13" HIGH X 11" WIDE WITH UP TO 1/16" LOSS OF SECTION AROUND BENT DIAPHRAGM, CONDITION ON RIGHT SIDE SHOWN, PRIORITY MAINTENANCE

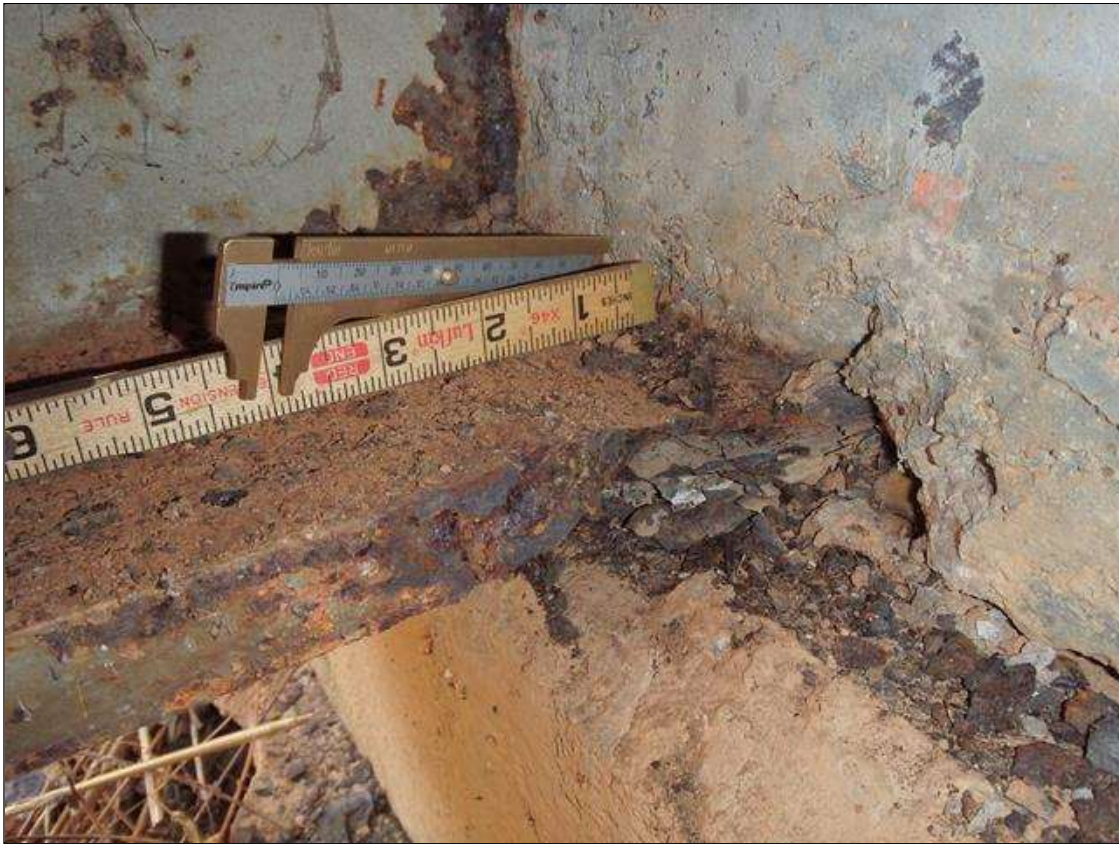
Span 2 Beam 1: SCALING AND PACK RUST ALONG BOTH EDGES OF BOTTOM FLANGE UP TO 4" LONG X 5" WIDE DOWN TO 1/4" RESIDUAL FLANGE AT FACE OF END BENT 2 BEARING, CONDITION ON RIGHT SIDE SHOWN, PRIORITY MAINTENANCE

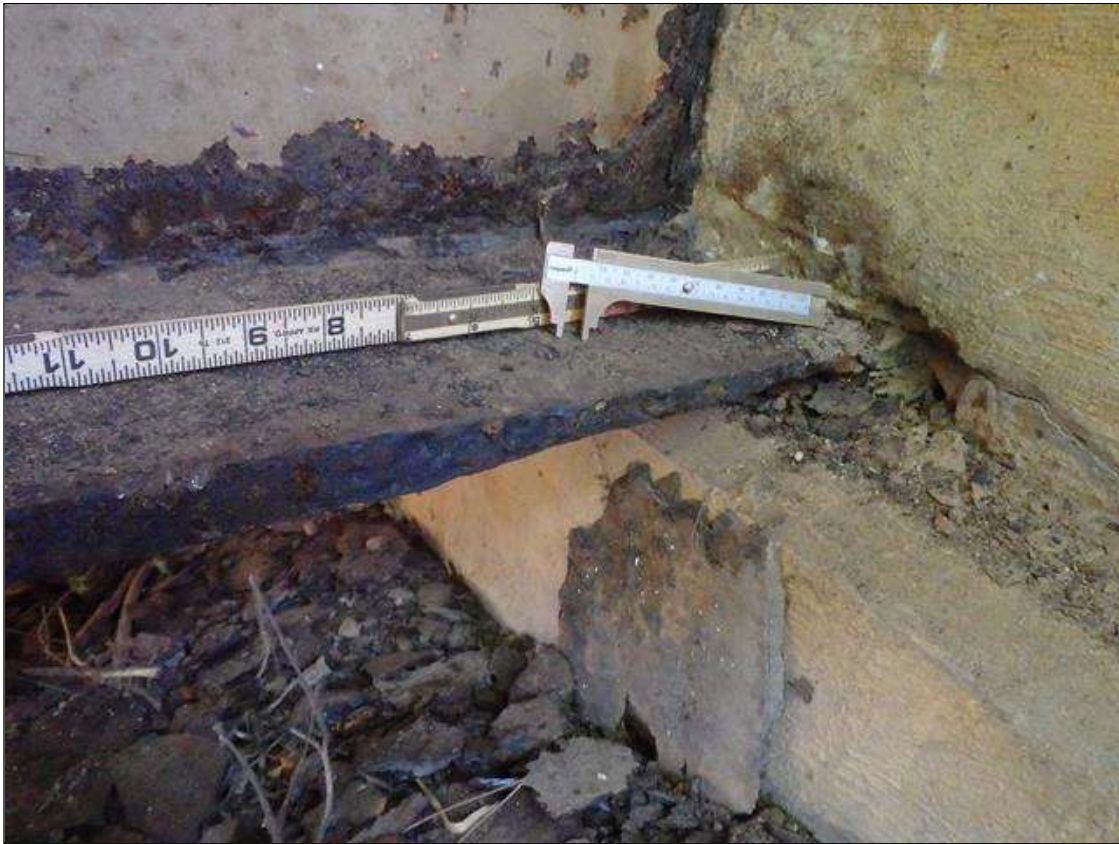
Span 2 Beam 4: SCALING AND PACK RUST ALONG BOTH EDGES OF BOTTOM FLANGE UP TO 9" LONG X 2" WIDE DOWN TO 5/16" RESIDUAL FLANGE AT FACE OF END BENT 2 BEARING, CONDITION ON RIGHT SIDE SHOWN, PRIORITY MAINTENANCE

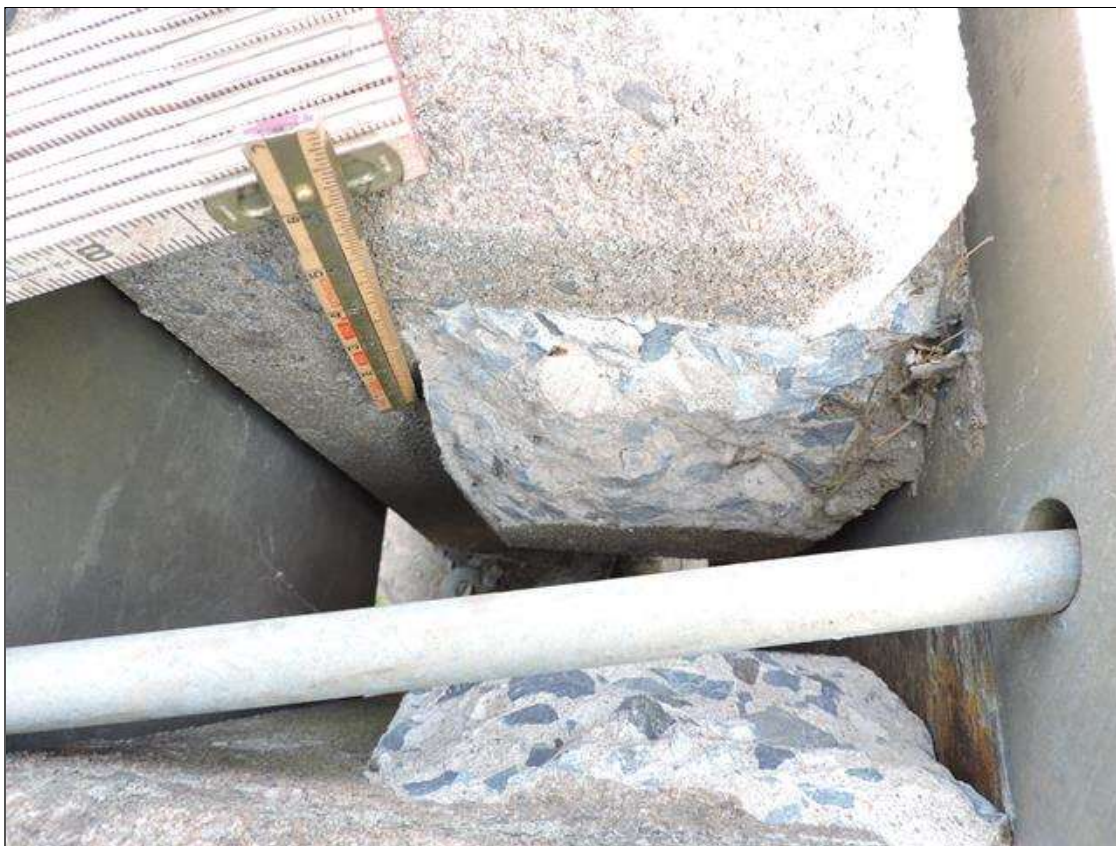
Span 1 Left Bridge Rail: TWO (2) SPALLS UP TO 7" X 5" X 2" DEEP IN ENDS OF RAIL, APPROXIMATELY 16' FROM END BENT 1

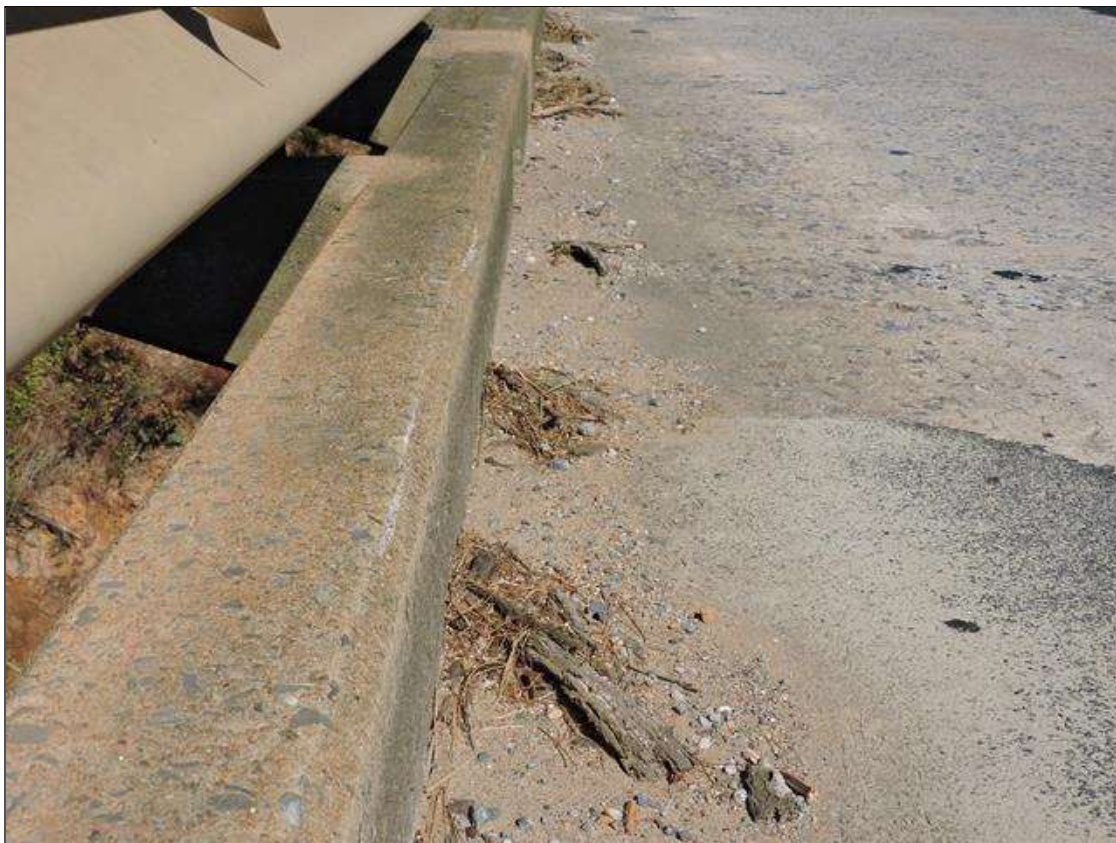
DIRT AND DEBRIS ACCUMULATION IN BOTH SHOULDERS, ACCUMULATION IN LEFT SHOULDER SHOWN

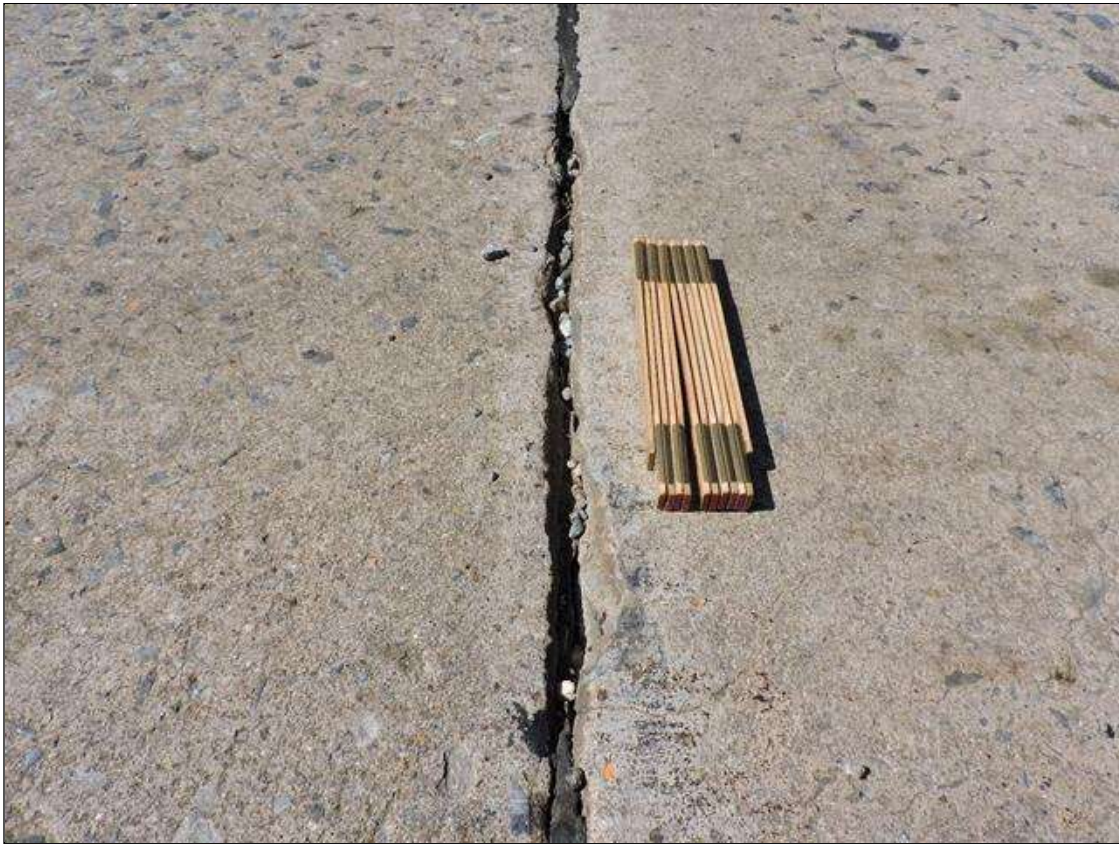
Expansion Joint 2: DETERIORATED JOINT MATERIAL ALONG BENT JOINT IN VARIOUS LOCATIONS THROUGHOUT, CONDITION IN SOUTHBOUND LANE SHOWN

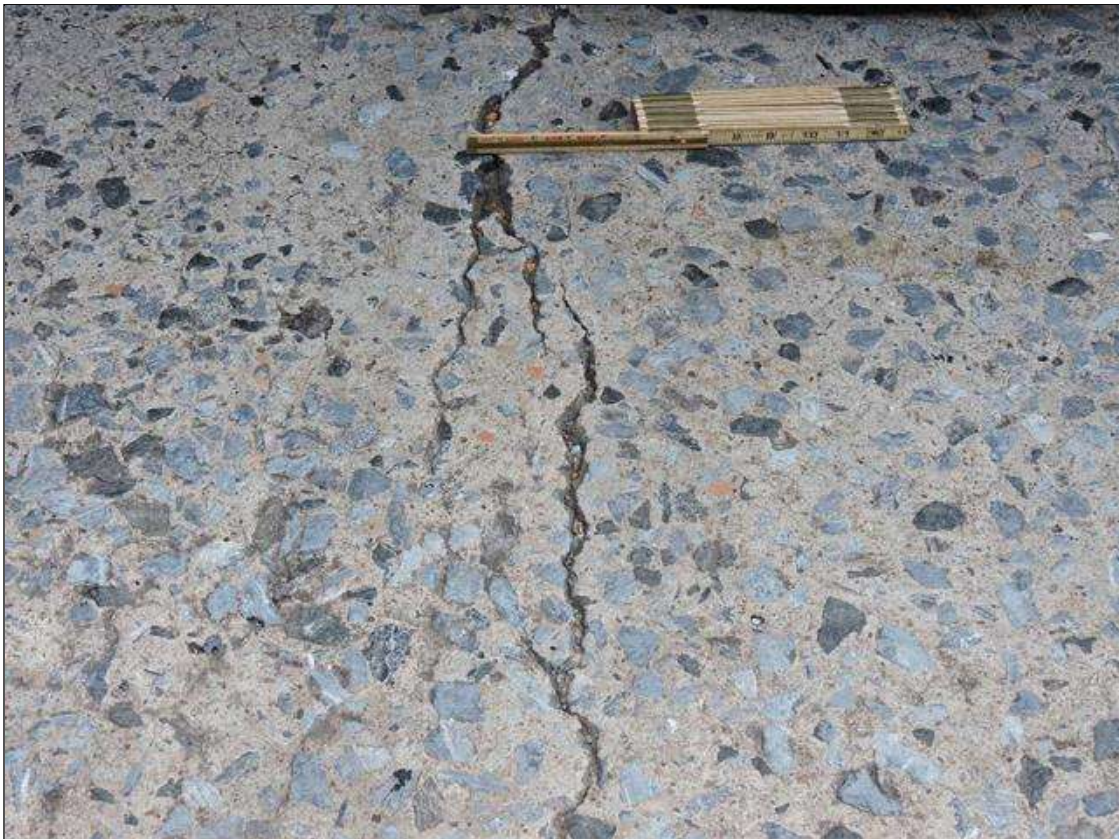
Span 1 Deck: UP TO 1/2" TRANSVERSE CRACKS AND UP TO 1/16" MAP CRACKS IN TOP OF DECK IN VARIOUS LOCATIONS THROUGHOUT, CRACKS NEAR MIDSPAN SHOWN

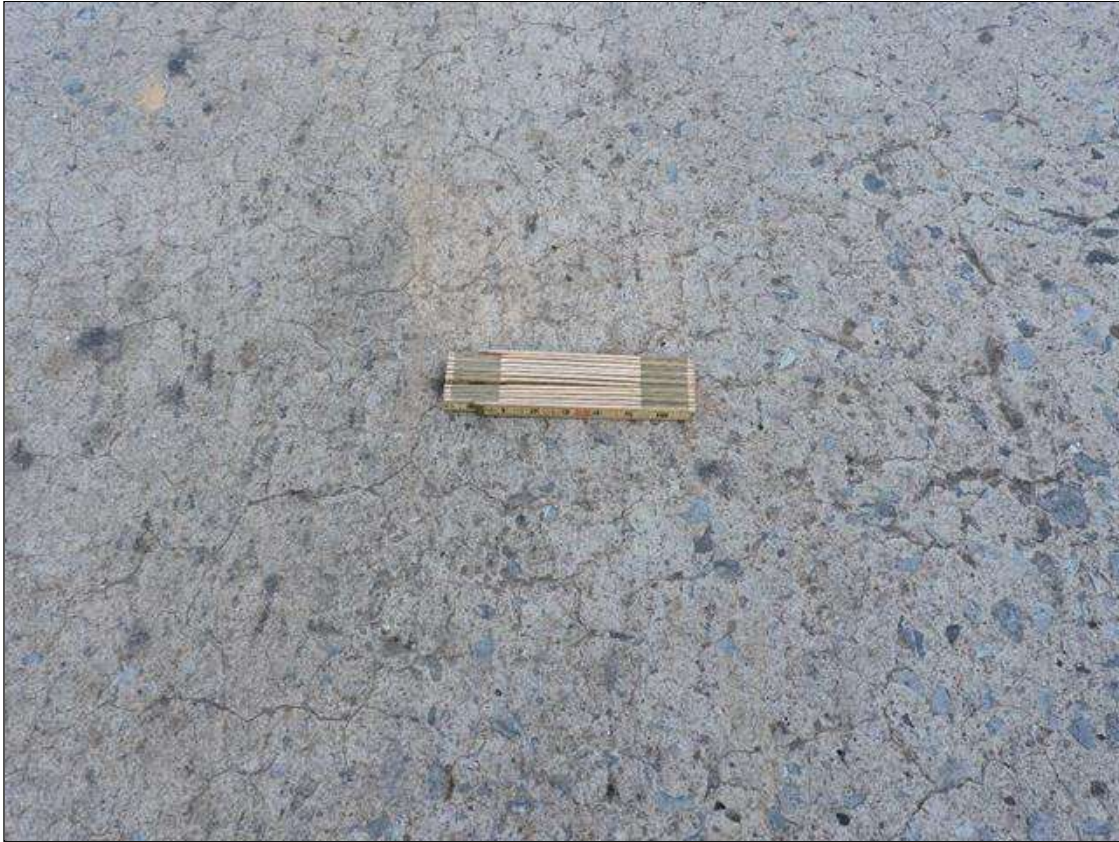
Span 2 Deck: UP TO 0.03" MAP CRACKS THROUGHOUT TOP OF DECK, CRACKS IN NORTHBOUND LANE APPROXIMATELY 8' FROM BENT SHOWN

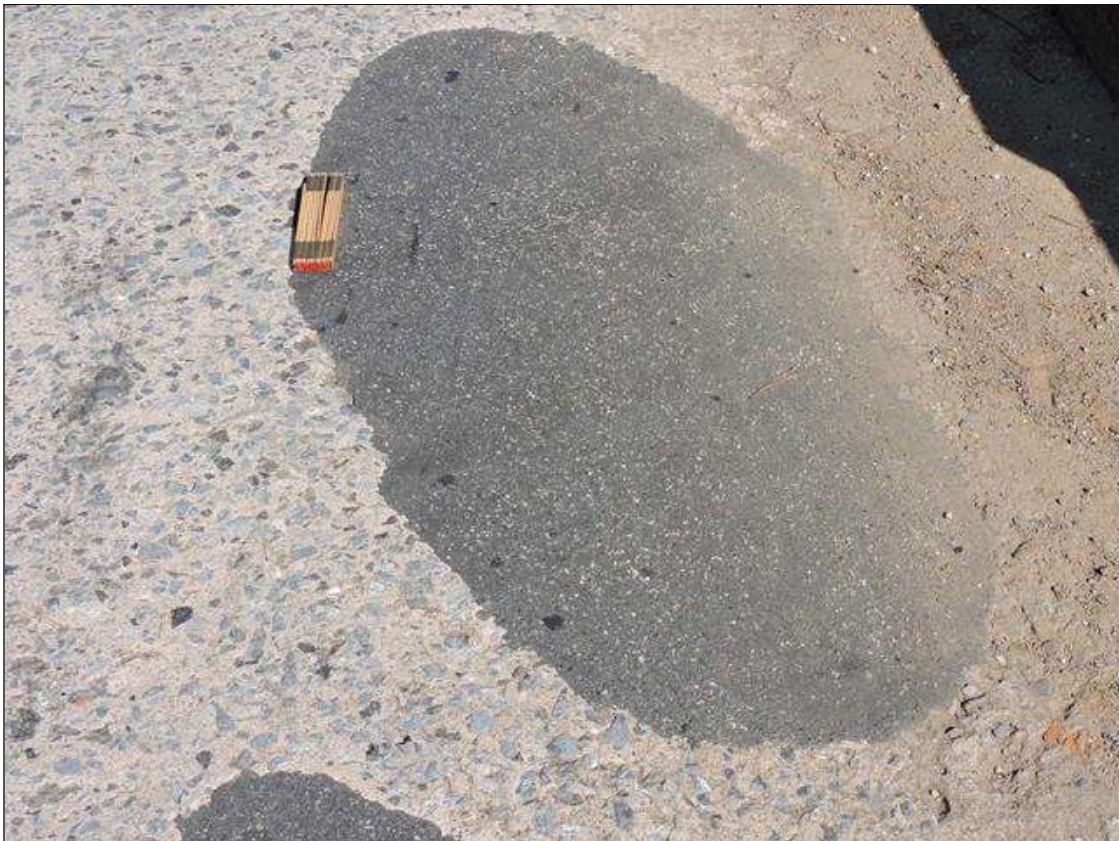
Span 2 Deck: 13 PATCHED AREAS UP TO 15' X 67" IN TOP OF DECK IN VARIOUS LOCATIONS THROUGHOUT, CONDITION IN NORTHBOUND LANE APPROXIMATELY 16' FROM END BENT 2 FILL FACE SHOWN

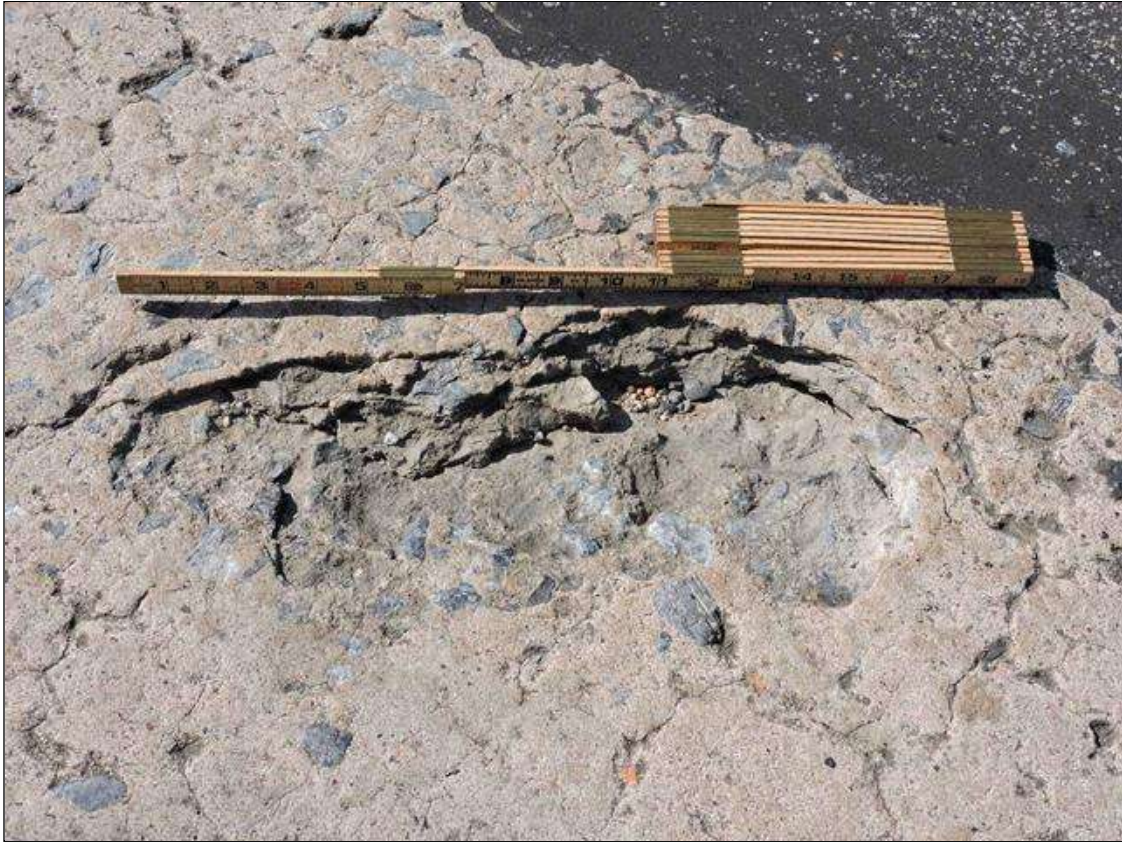
Span 2 Deck: 16" X 7" X 1" DEEP SPALL IN TOP OF DECK IN WHEEL LINE OF SOUTHBOUND LANE,
APPROXIMATELY 8' FROM END BENT 2 FILL FACE

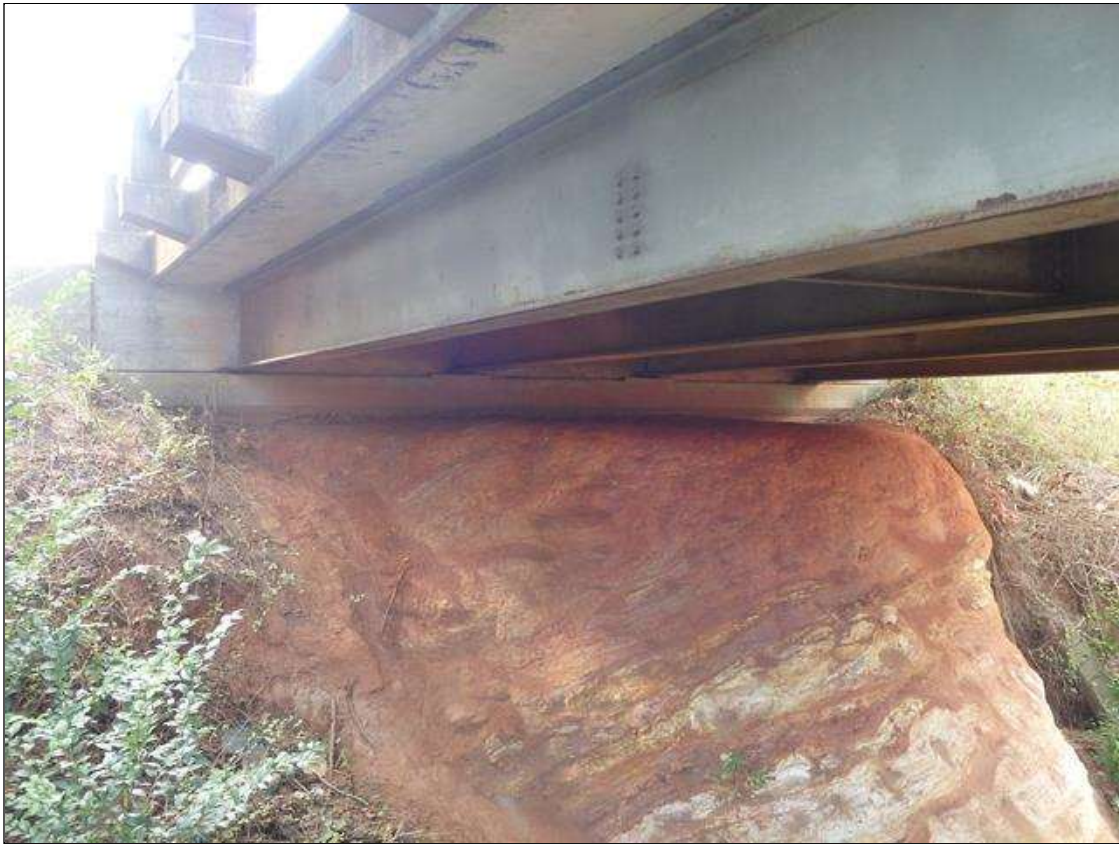
END BENT 1, END BENT 2 SIMILAR

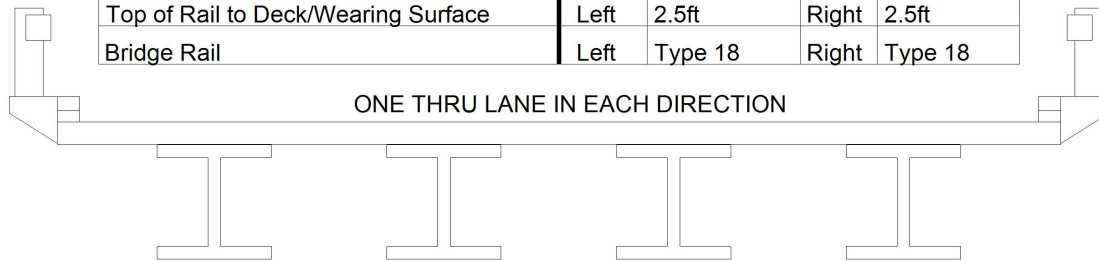
Measurements for Spans	1 and 2		
Deck Thickness	0.563	Left Overhang	3.958*
Top of Rail to Bottom of Beam	5.417	Right Overhang	3.958*

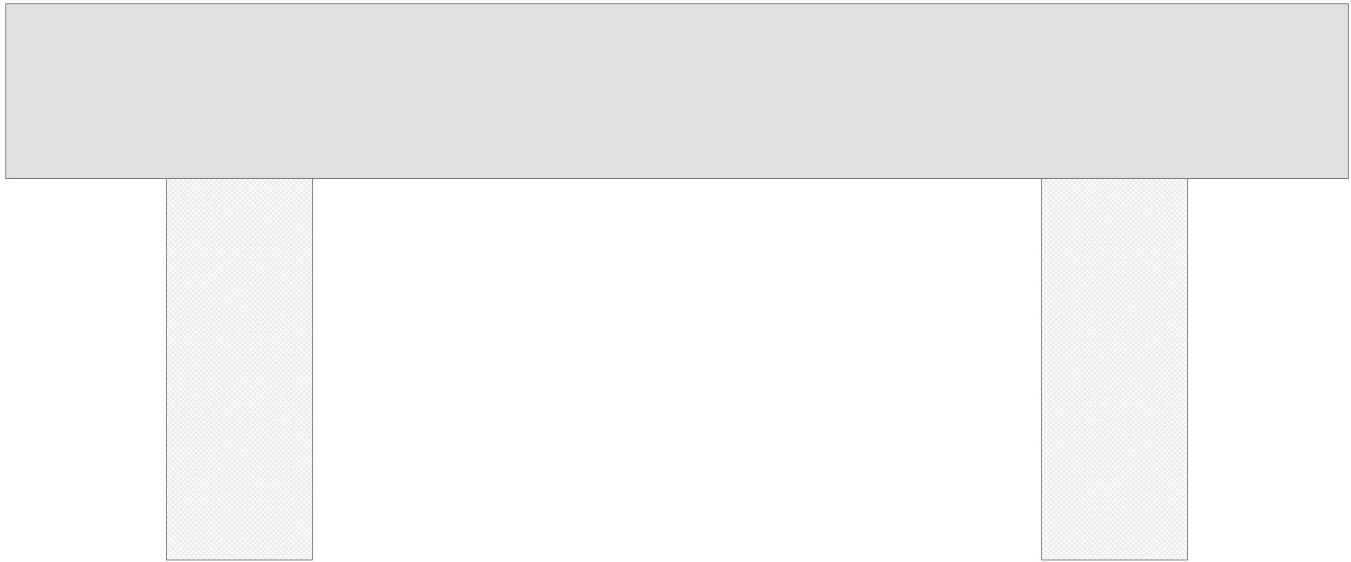
Cap Information			Material Cast-in-Place Concrete							
Length	Width	Height	Left Overhang	Right Overhang	Left Beam to End of Cap.	Right Beam to End of Cap.				
23.0 ft.	2.5 ft.	2.5 ft.	4.0 ft.	4.0 ft.	1.375 ft.	1.375 ft.				
Subcap Information			Material							
Length	Width	Height	Left Overhang	Right Overhang	Left Pile to Splice.					
Sill Information			Material							
Length	Width	Height								
Pile	Material	Spacing	Width/Dia.	Height	Length	Orientation	Driven?	Replacement?	Removed?	Collar?
1	Concrete	15.0 ft.	2.5 ft.	2.0 ft.		Vertical	No	No	No	No
2	Concrete		2.5 ft.	2.0 ft.		Vertical	No	No	No	No
Bent
