N.C. DEPARTMENT OF TRANSPORTATION
 DIVISION OF HIGHWAYS
 BRIDGE MAINTENANCE UNIT

BRIDGE INSPECTION REPORT

COUNTY CLEVELAND BRIDGE NUMBER 220015 INSPECTION CYCLE 2 YRS

ROUTE NC180 ACROSS SEABOARD COAST LINE R.R. M.P. 0

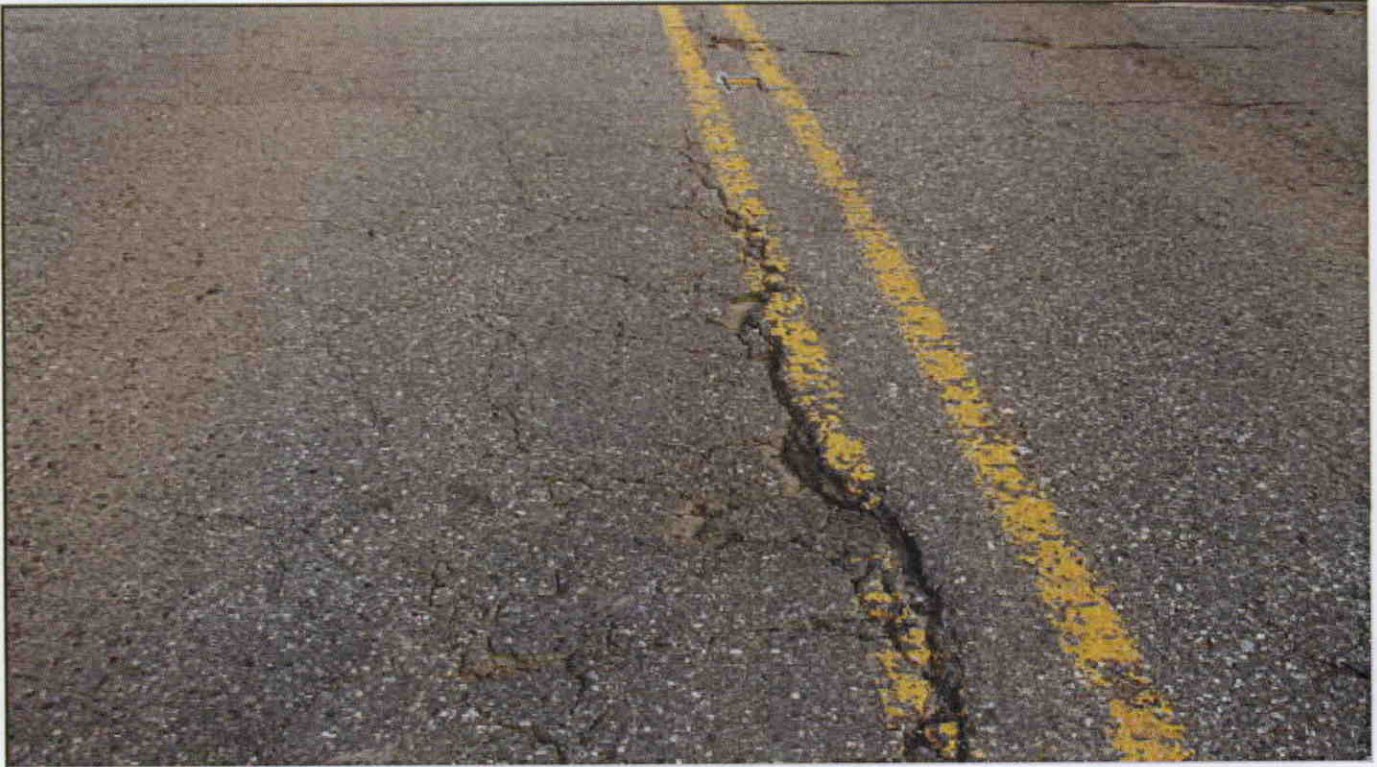
SETTLEMENT CRACKING IN SOUTH APPROACH

Function Code	Description of Function	Unit	Quantity	Remarks	Est. Cost
552	Complete Cleaning and painting of structural steel	Sq-ft	3380	RUST AND SECTION LOSS ON BEAMS	
556	Bridge approaches, surfacing or pavement replacement or repair	Man-Hours	60	CRACKING AND POTHOLES IN APPROACHES	
560	Maintenance and repairs to concrete bridge floors	Sq-ft	2520	CRACKING, POPOUTS, DELAMINATION, AND EXPOSED REINFORCEMENT IN DECK	
576	Maintenance of standard deck expansion joints	Lin-ft	26	DETERIORATED AND LEAKING JOINT	
578	General Maintenance of superstructure	Man-Hours	200	SPALLING WITH EXPOSED REINFORCEMENT IN BENT 1 END DIAPHRAGMS

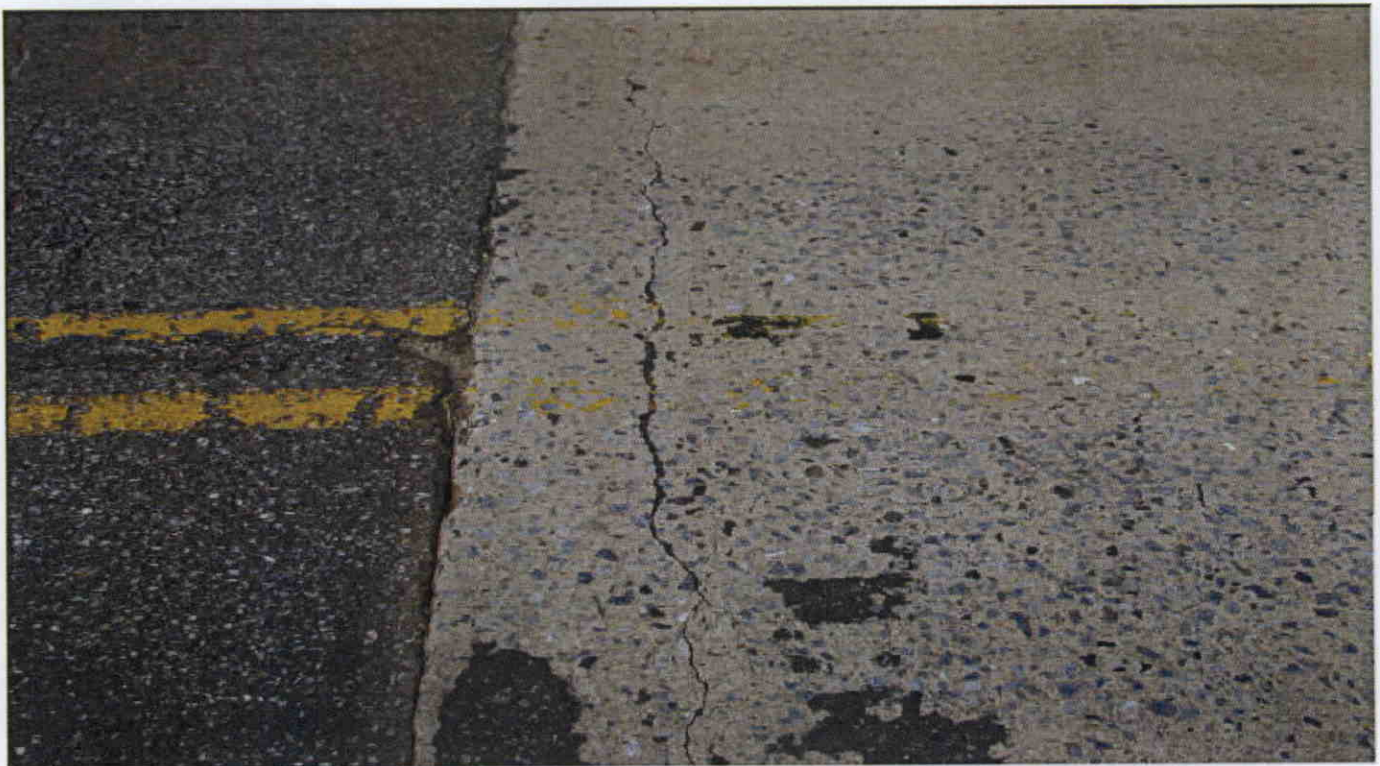
Item No	Grade	
2a	5	HORIZONTAL CRACKS UP TO 1/16 INCH ARE PRESENT 1 FOOT FROM EACH FILL FACE AND 1 FOOT ON EITHER SIDE OF THE INTERIOR BENT JOINT. HAIRLINE TRANSVERSE CRACKS ARE PRESENT ELSEWHERE IN RANDOM LOCATIONS AT APPROXIMATELY 7 TO 10 FOOT SPACING AND FULL WIDTH ACROSS THE DECK. A 5 FOOT LONG BY 3 FOOT WIDE DECK PATCH WITH EXPOSED COARSE AGGREGATE AND EXPOSED REINFORCEMENT EXISTS AT THE NORTHEAST CORNER. RANDOM POPOUTS WITH EXPOSED COARSE AGGREGATE AND DECK SCALE ARE PRESENT THROUGHOUT. A 3.5 FOOT LONG BY 2 FOOT WIDE AREA OF DELAMINATION IS PRESENT IN THE WEST SIDE OF SPAN 2. DECK SCALE AND DELAMINATION ARE MAXIMIZED ALONG THE PARAPETS. THE DECK OVERHANGS EXHIBIT MINOR SPALLING WITH EXPOSED REINFORCEMENT ON THE UNDERSIDE. NO VISIBLE CRACKING OR EFFLORESCENCE IS NOTED IN THE SPAN 1 OR SPAN 2 BAYS.
3a	7	THE CONCRETE RAILS SHOW MINOR CHIPPING AND SPALLING THROUGHOUT. SPALLS EXIST PRIMARILY AT THE GUARDRAIL TERMINATION CONNECTIONS.

TRANSVERSE DECK CRACK AT SOUTH END OF BRIDGE

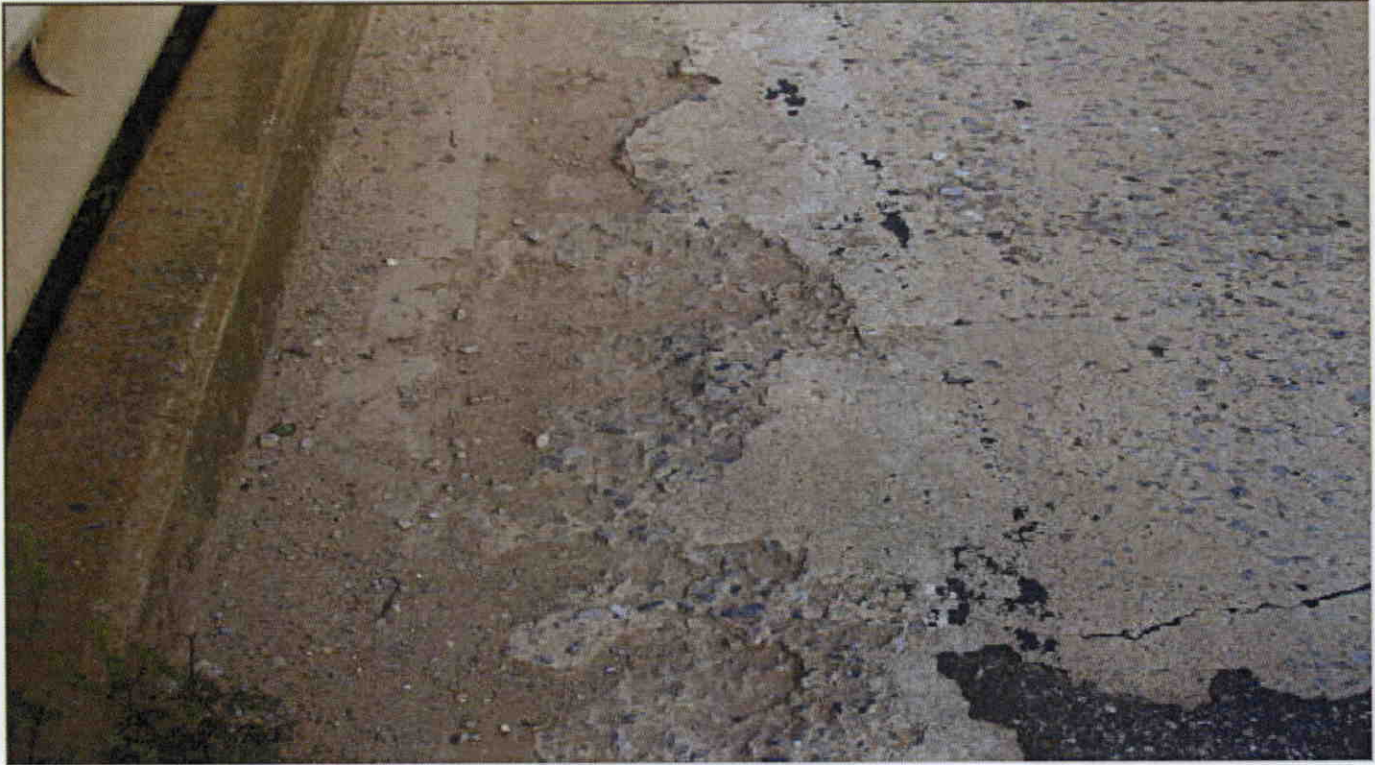
DECK DELAMINATION AT SOUTHWEST CORNER

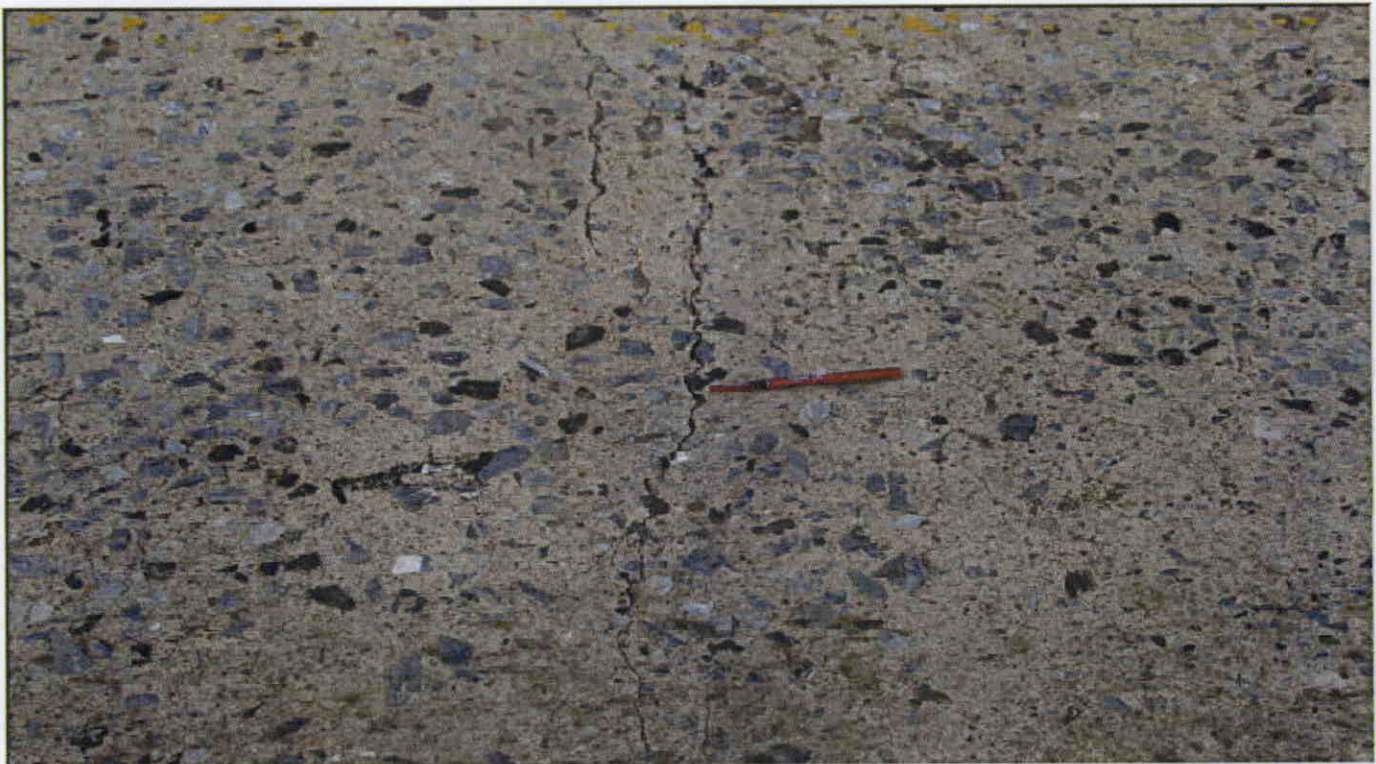
TRANSVERSE DECK CRACK AT MIDSPAN OF SPAN 1

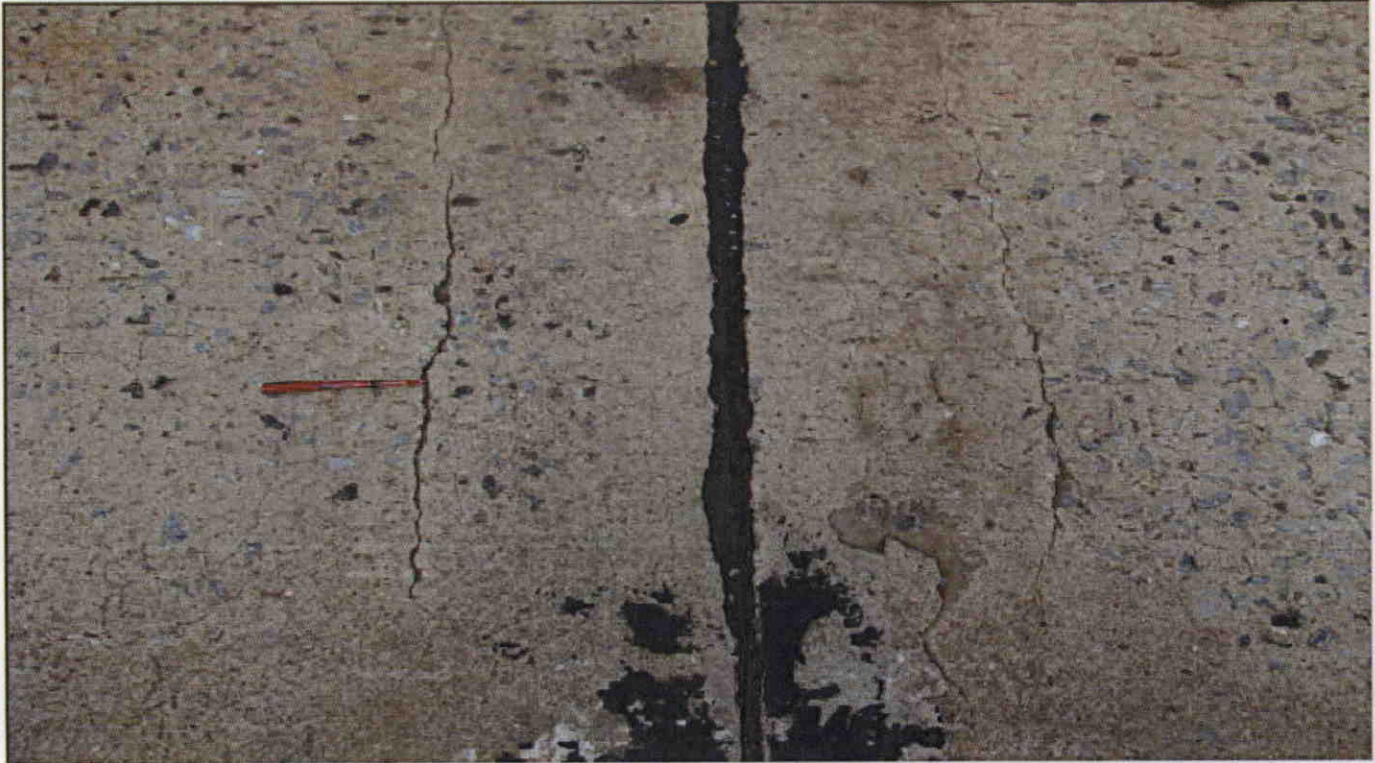
TRANSVERSE DECK CRACKS ALONG INTERIOR BENT JOINT

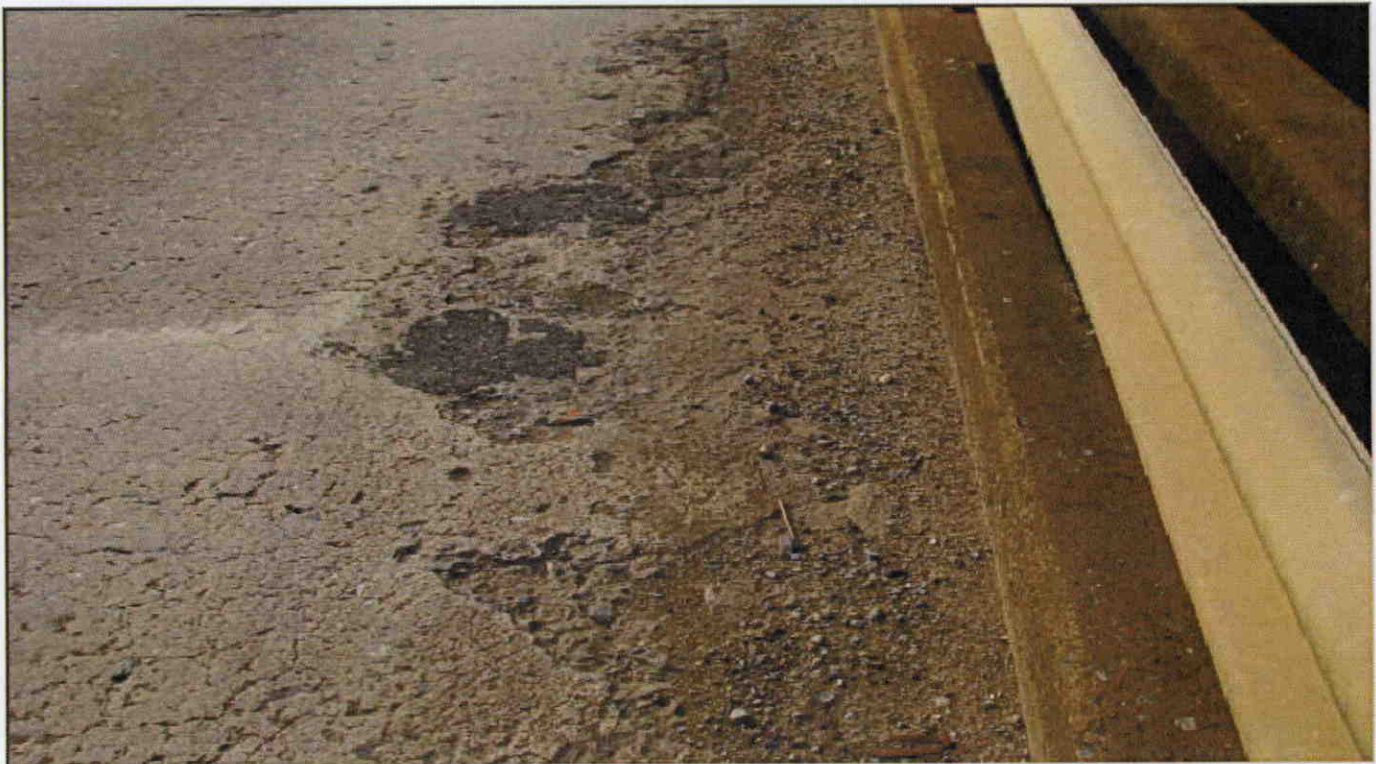
DECK DELAMINATION AT NORTHWEST CORNER

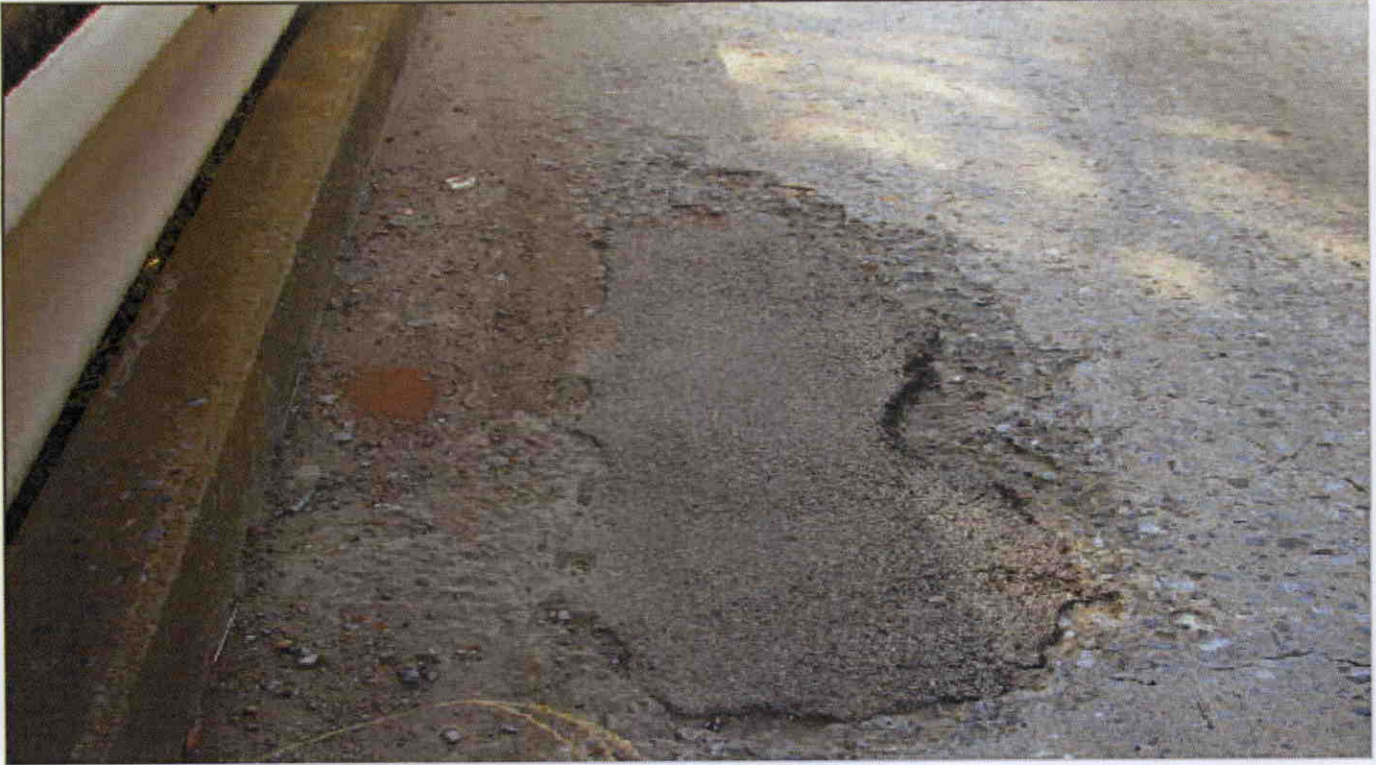
DECK DELAMINATION AT NORTHEAST CORNER

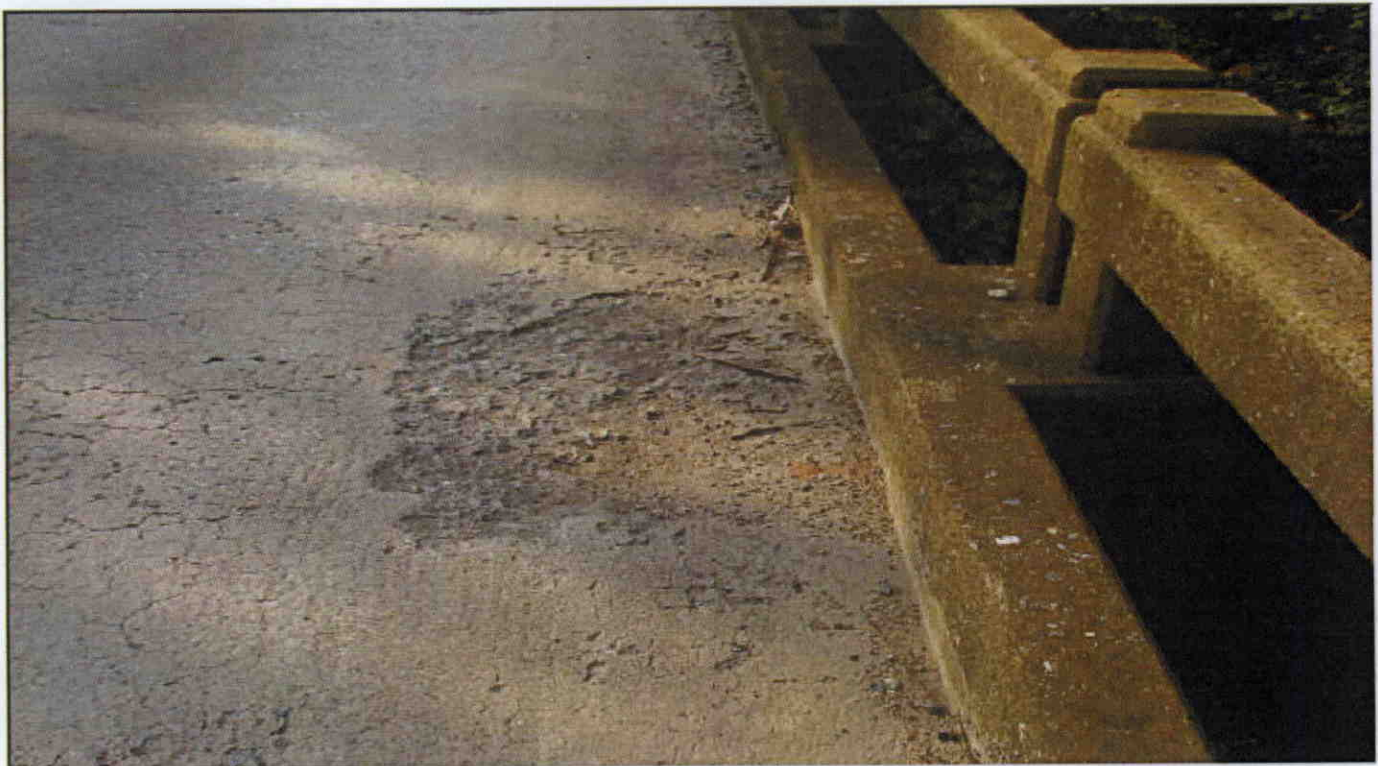
DECK DELAMINATION ALONG WEST CURB IN SPAN 2

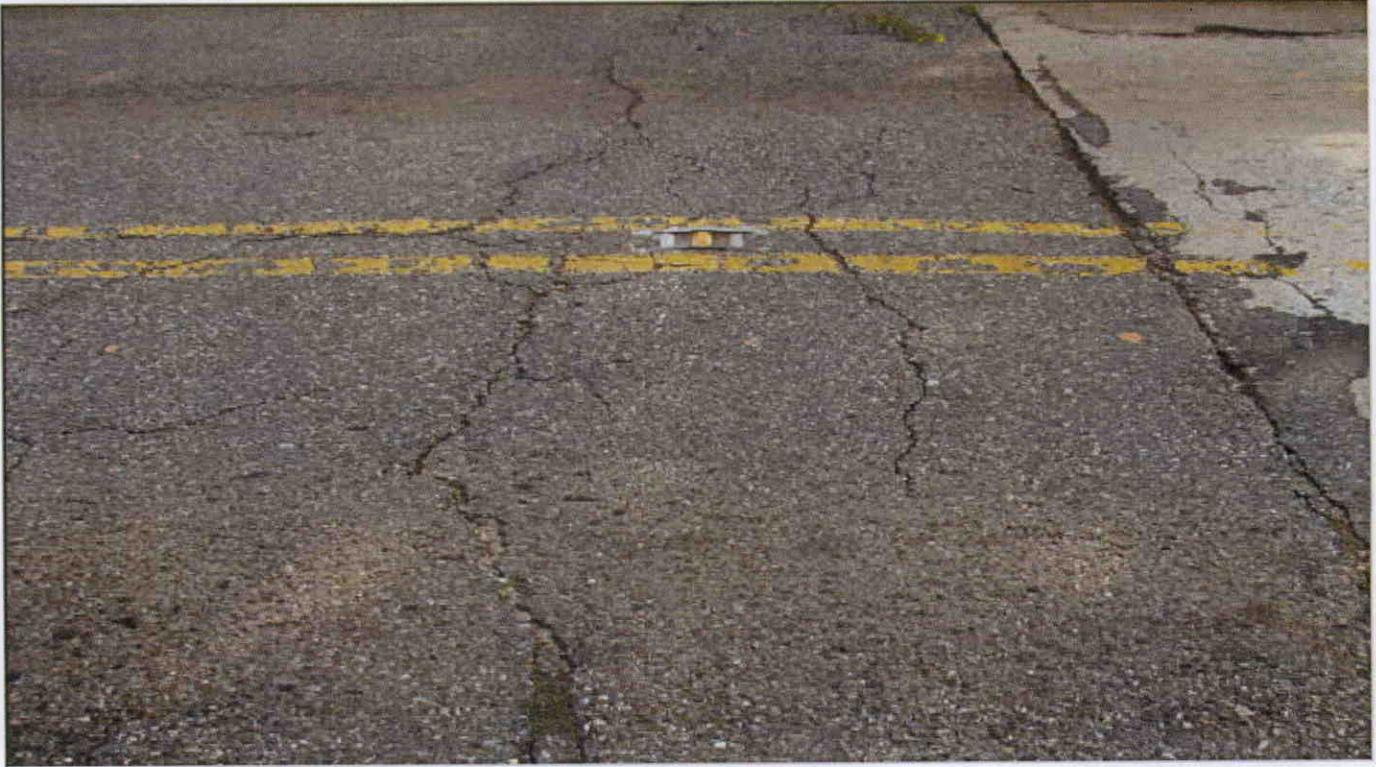
15	6	THE BEARINGS SHOW MODERATE RUSTING WITH NEGLIGIBLE SECTION LOSS PARTICULARLY OVER BENT 1.
16	7	DECK DRAINAGE FLOWS UNDER THE PARAPETS AND APPEARS ADEQUATE WITH NO OBSTRUCTIONS.
36a	7	HAIRLINE TO 1/16 INCH VERTICAL CRACKS ARE PRESENT ON THE ABUTMENT AND INTERIOR BENT CAPS IN RANDOM LOCATIONS. STAINING DUE TO JOINT LEAKAGE EXISTS ON THE CAPS. OTHERWISE, THE CAPS ARE SOUND WITH NO DISTRESS NOTED.
50	6	SEVERAL TRANSVERSE CRACKS UP TO 1/8 INCH ARE PRESENT AT THE SOUTH FILL FACE. A POTHOLE 1 FOOT IN DIAMETER IS PRESENT AT THE CENTERLINE IN THE SOUTH APPROACH. A SIMILAR CONDITION IS EVIDENT IN THE NORTH APPROACH. THE ASPHALT WEARING SURFACE IS BREAKING AWAY FROM THE DECK EDGE.

CRACKING ALONG NORTH APPROACH

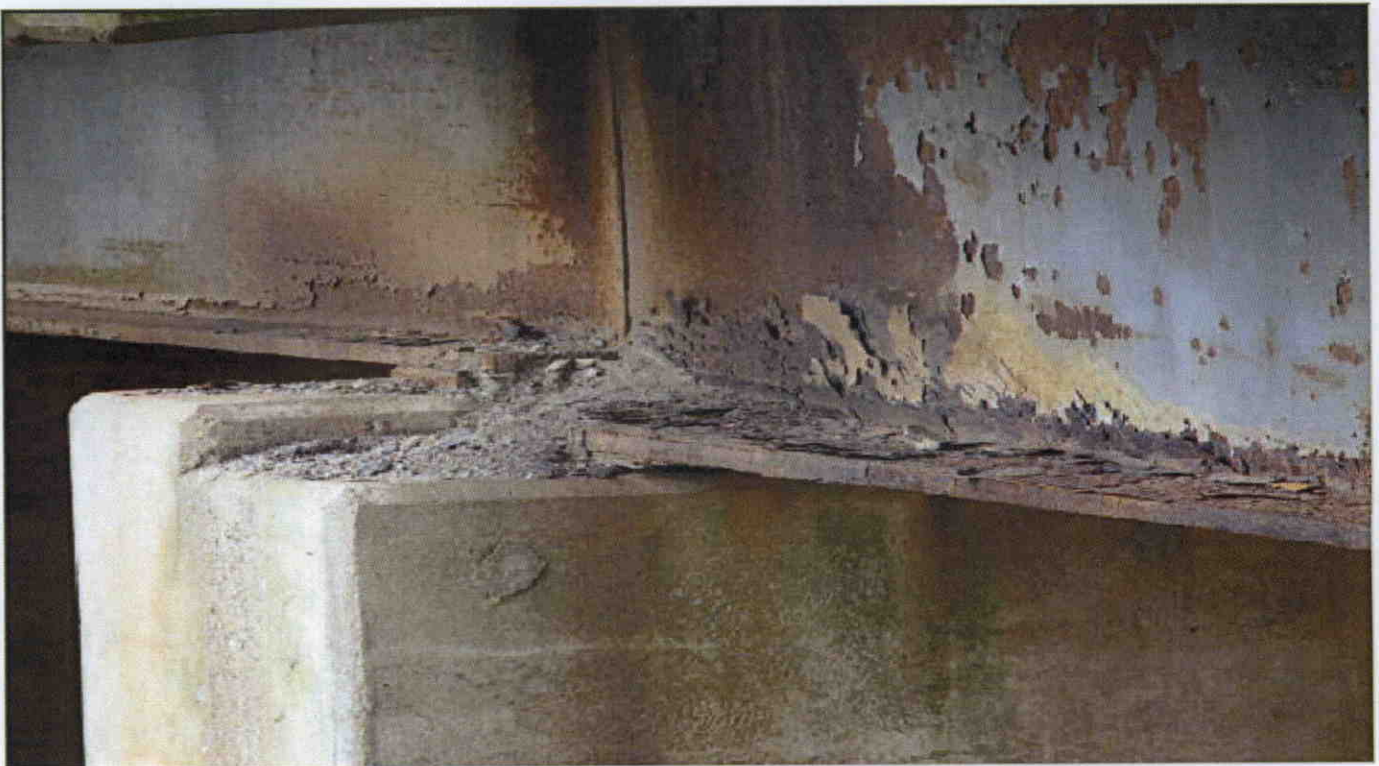
4	6	MINOR HAIRLINE VERTICAL CRACKING IS PRESENT IN THE PARAPETS WITH RANDOM CHIPS AND SPALLS ALONG THE FACES. NO DISTRESS IS NOTED OTHERWISE.
6d	6	THE JOINT IS SEALED WITH TAR ON THE TOPSIDE. BEAM END RUST, BEARING RUST, AND STAINING ON THE CAP INDICATE THE JOINT IS LEAKING. MOST OF THE JOINT MATERIAL HAS FALLEN OUT AND IS ON THE INTERIOR BENT CAP.
7	7	SEDIMENT IS PRESENT ALONG BOTH PARAPETS
10	5	RUSTING AND MINOR PAINT FAILURE IS PRESENT THROUGHOUT BEAM SPANS. RUSTING AND SECTION LOSS ARE MAXIMIZED AT THE BEAM ENDS AND BEARING AREAS. SEE TABLE FOR AMOUNT OF SECTION LOSS IN EACH BEAM.
12	7	THE INTERMEDIATE DIAPHRAGMS SHOW MINOR PAINT FAILURE BUT NO SECTION LOSS IS NOTED.
13	5	THE END DIAPHRAGMS OVER BENT 1 SHOW HORIZONTAL CRACKING UP TO 1/8 INCH AND SPALLING WITH EXPOSED REINFORCEMENT THROUGHOUT. IMMINENT SPALLS ARE PRESENT IN OTHER LOCATIONS. THE CURTAIN WALLS HAVE MINOR POPOFFS AND SPALLS AT THE BEAM CONNECTIONS.

BEAM END RUST AT BENT 1 ON GIRDER 4

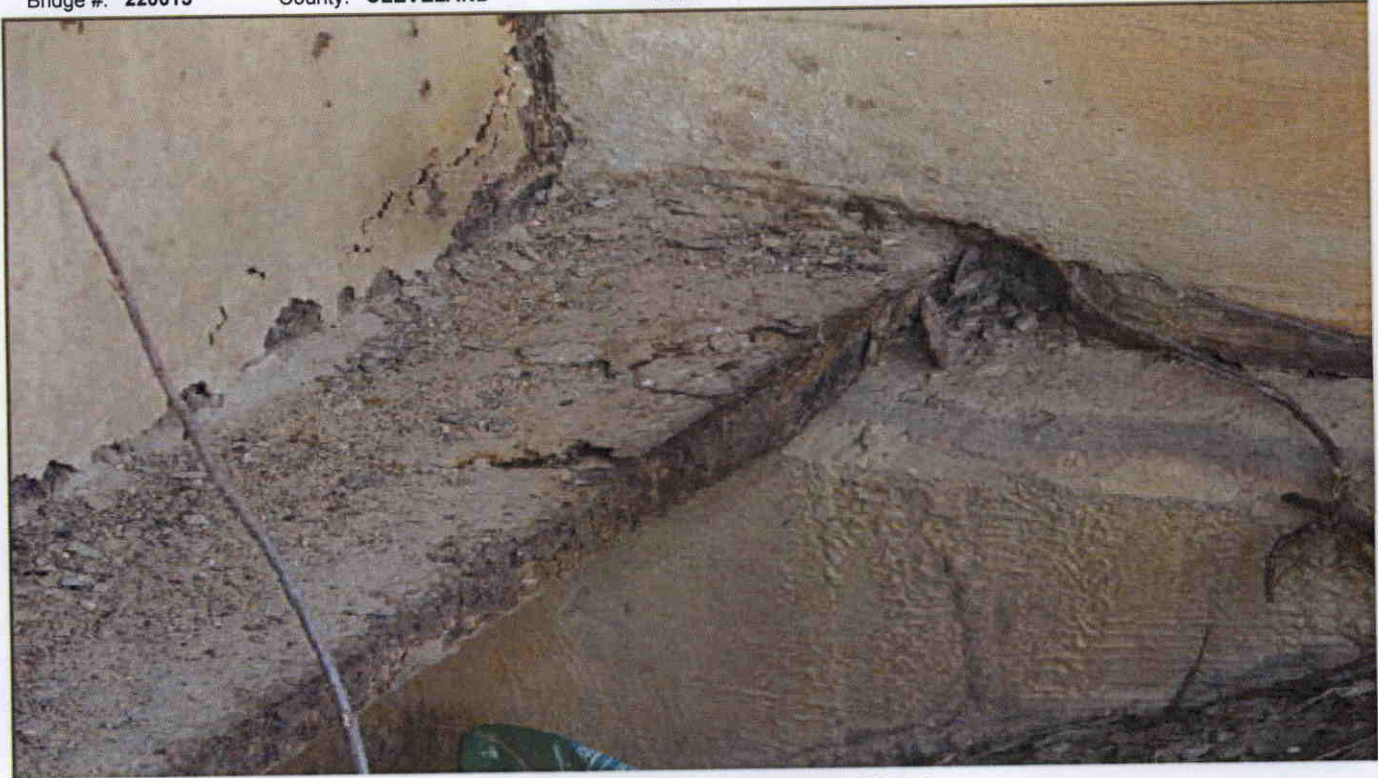
BEAM END RUST ON GIRDER 4 AT END BENT 2

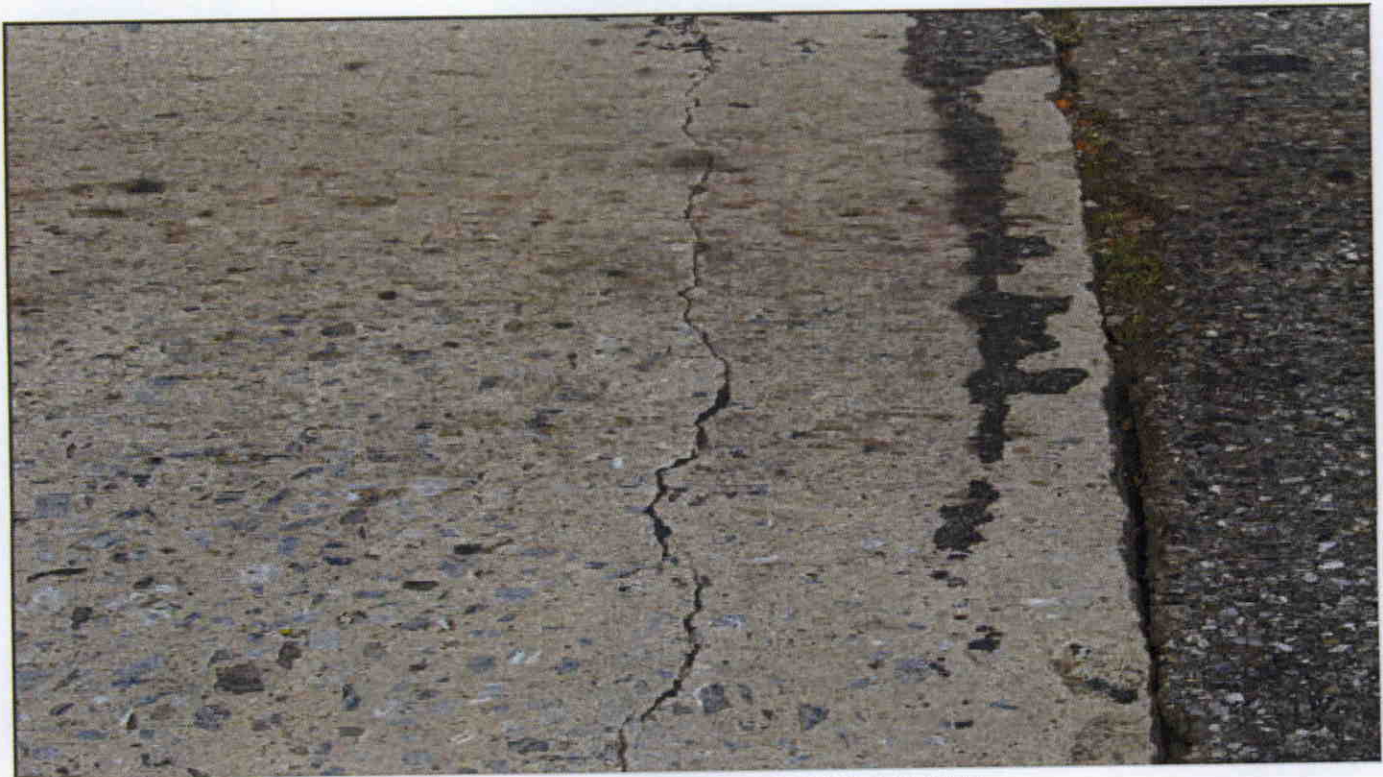
TRANSVERSE DECK CRACK AT NORTH END OF BRIDGE

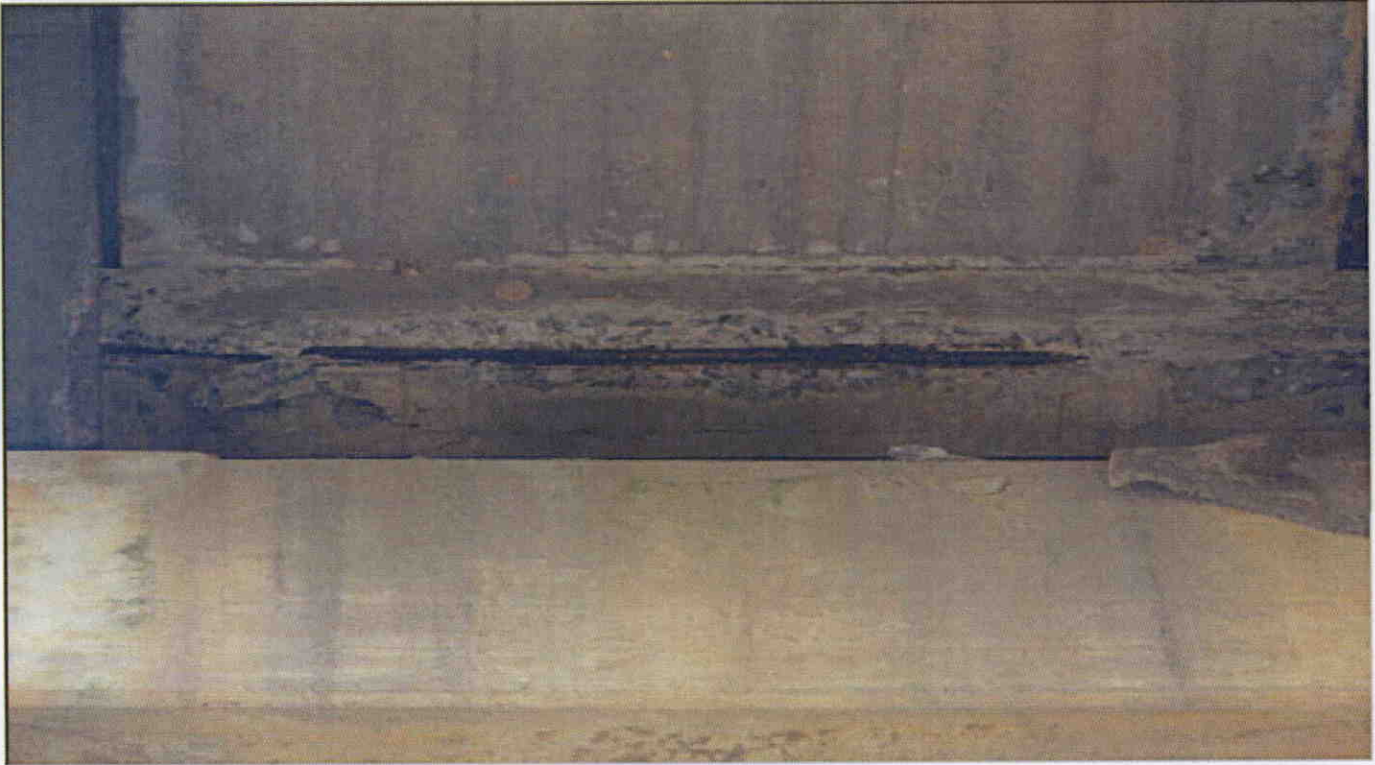
SPALLED END DIAPHRAGM IN BAY 2 OVER BENT 1

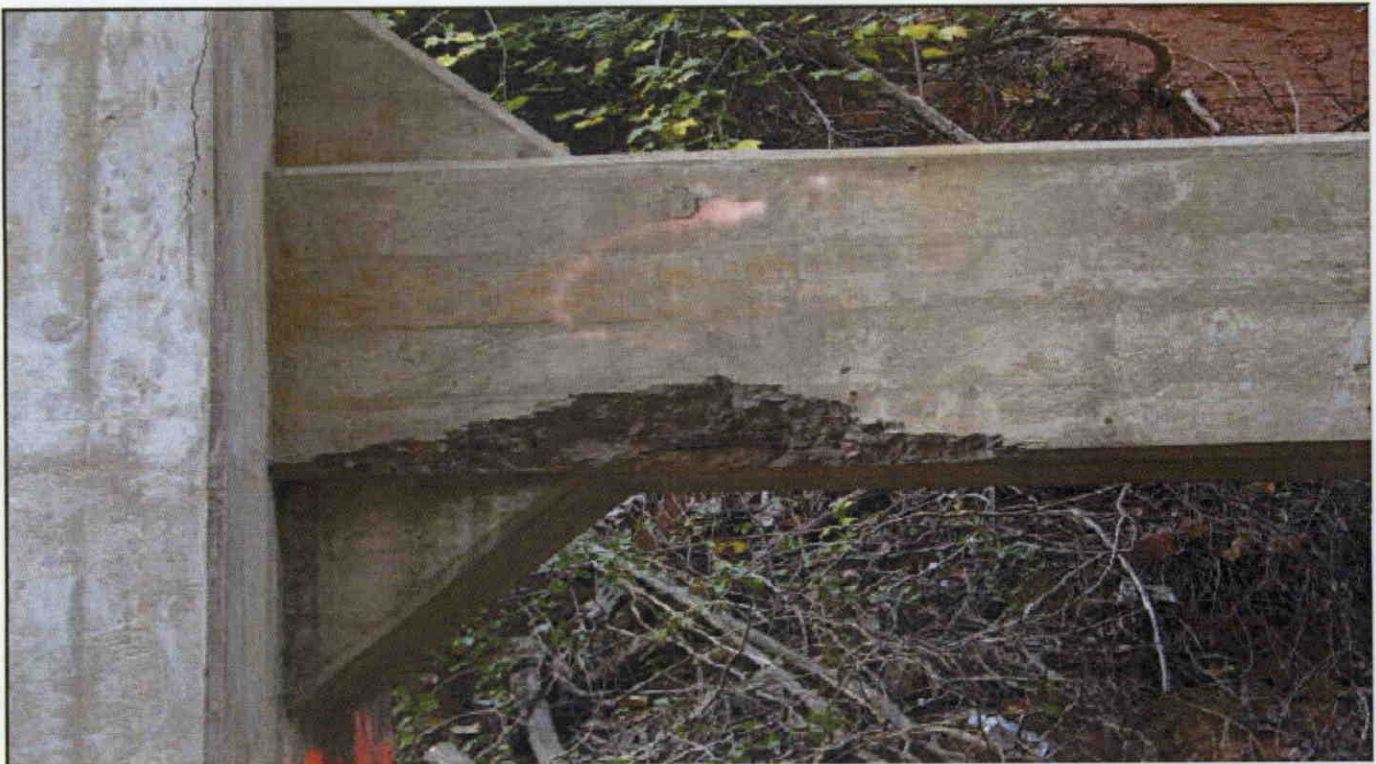
SPALLED NORTH FACE OF INTERIOR BENT LOWER STRUT

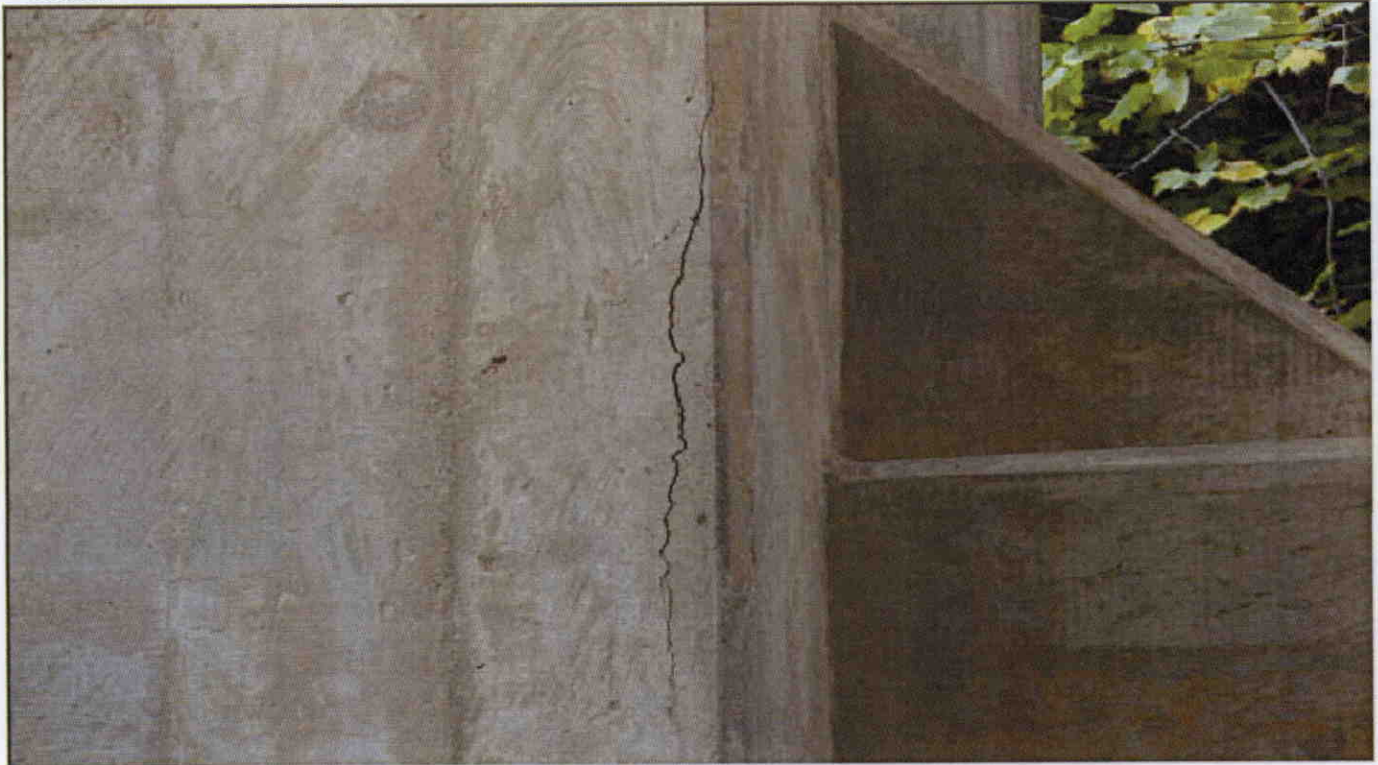
VERTICAL CRACK ON NORTH FACE OF INTERIOR BENT COLUMN 2

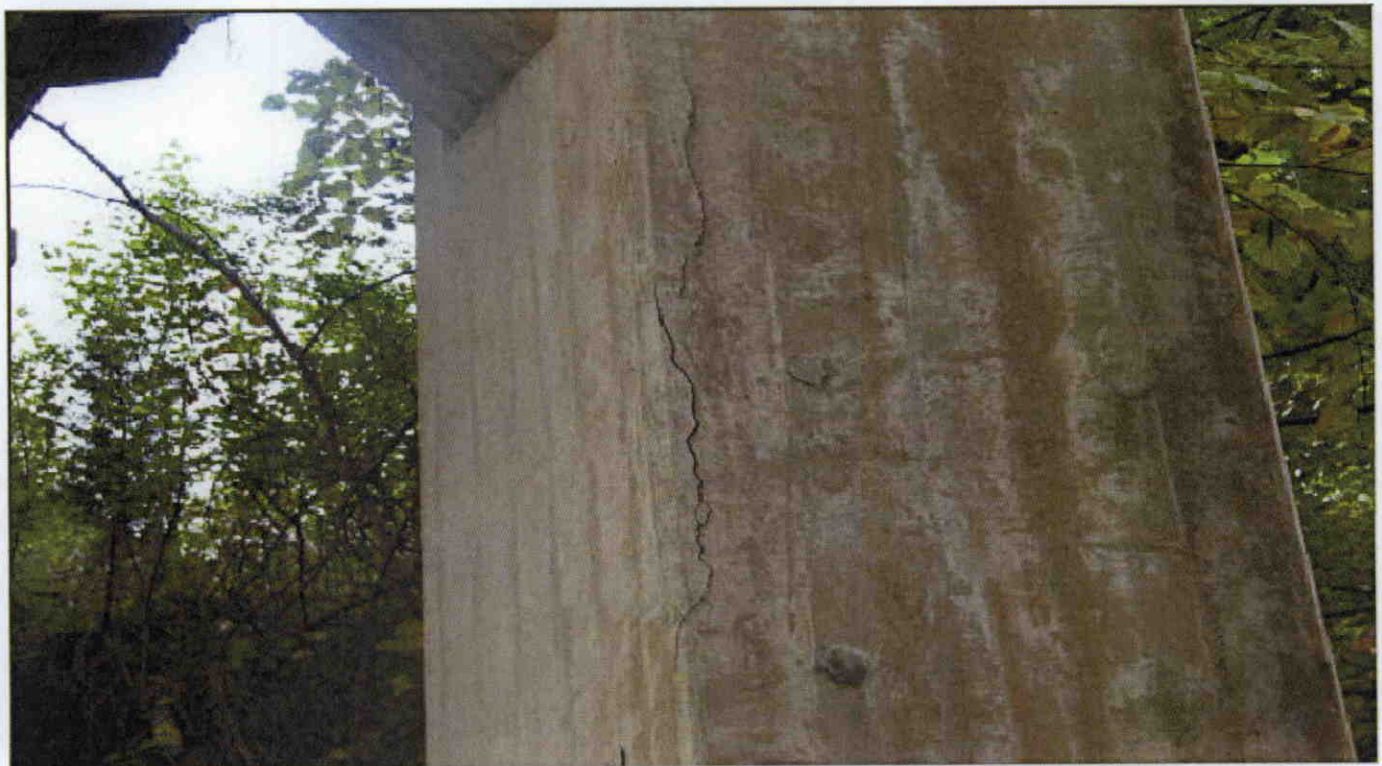
VERTICAL CRACK ON NORTH FACE OF INTERIOR BENT COLUMN 1

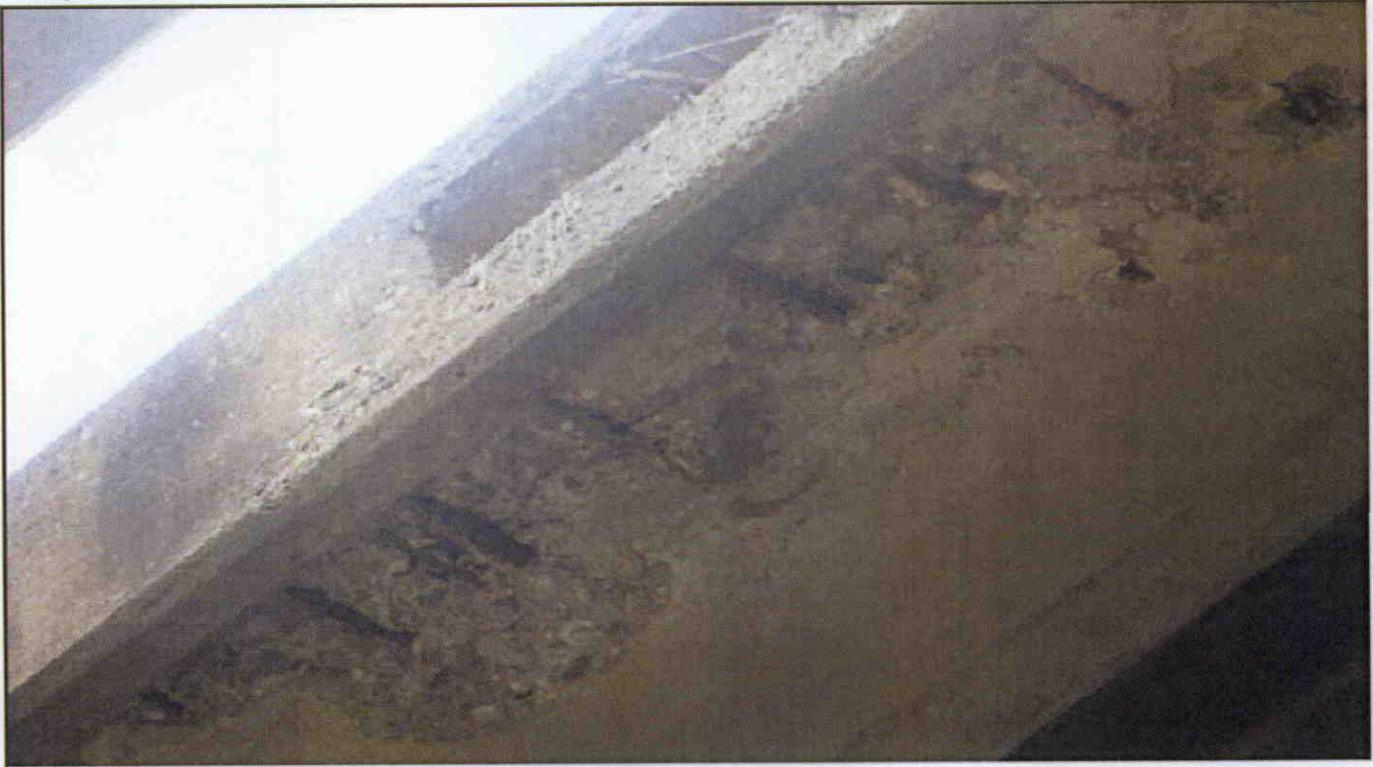
SPALLING ALONG WEST OVERHANG IN SPAN 2

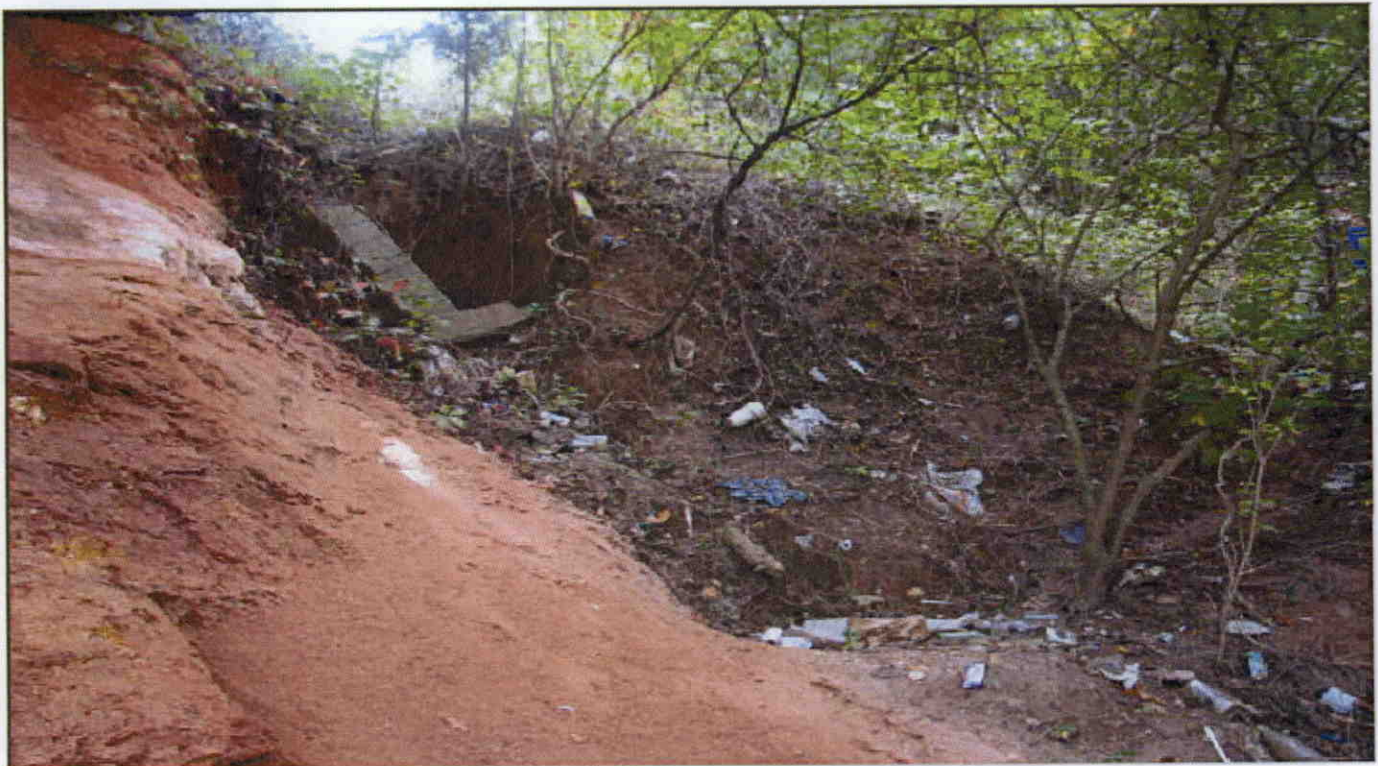
SLOPE EROSION AT SOUTHWEST CORNER UNDER SPAN 1

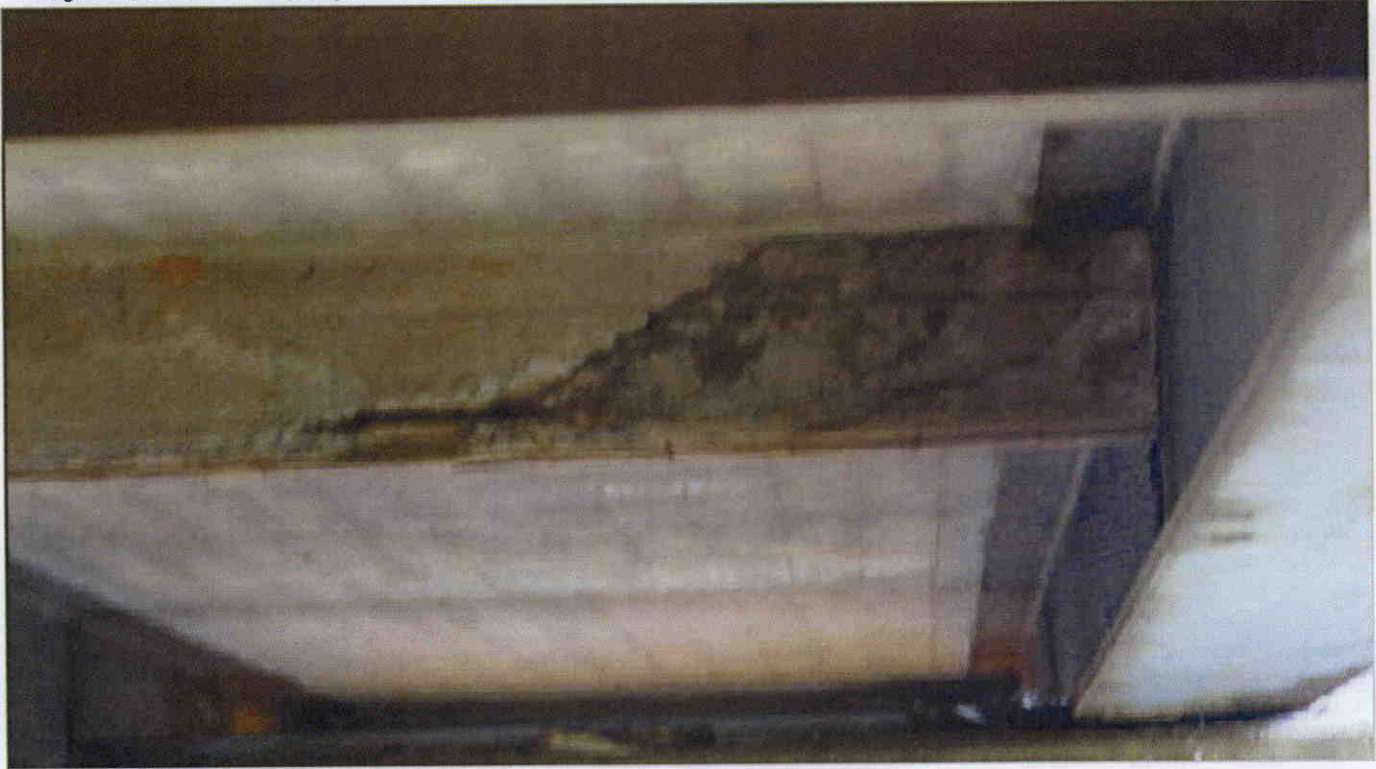
CRACKED END DIAPHRAGM IN BAY 3 OF SPAN 1 OVER BENT 1

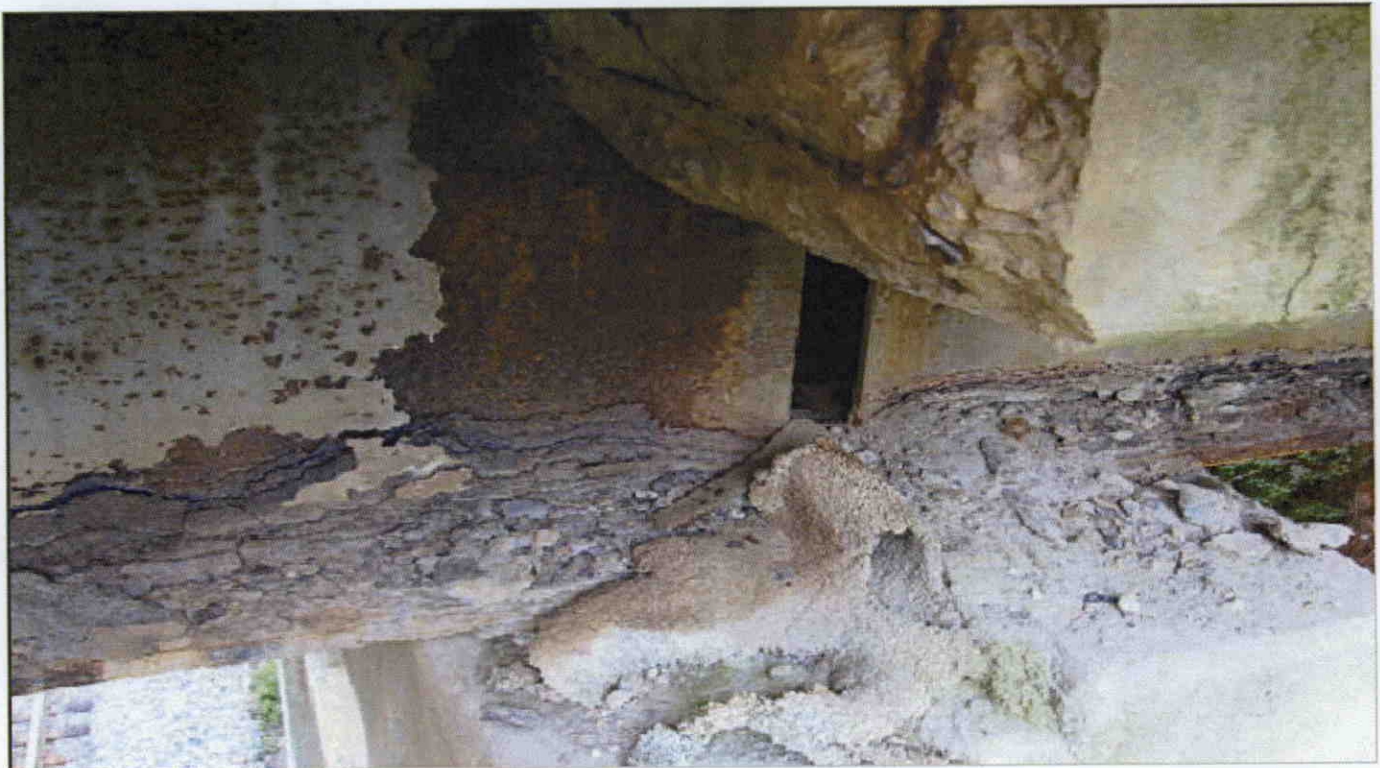
SECTION LOSS AT GIRDER 1 BEAM ENDS OVER BENT 1

GIRDER	LOCATION	SPAN	REMAINING FLANGE SECTION	FLANGE SECTION LOSS
1	END BENT 1	1	13/16	1/16
2	END BENT 1	1	7/8	0
3	END BENT 1	1	7/8	0
4	END BENT 1	1	7/8	0
1	BENT 1	1	3/4	1/8
2	BENT 1	1	13/16	1/16
3	BENT 1	1	13/16	1/16
4	BENT 1	1	3/4	1/8
1	BENT 1	2	7/8	1/8
2	BENT 1	2	15/16	1/16
3	BENT 1	2	15/16	1/16
4	BENT 1	2	7/8	1/8
1	END BENT 2	2	7/8	1/8
2	END BENT 2	2	15/16	1/16
3	END BENT 2	2	1	0
4	END BENT 2	2	1/2	1/2
