N.C. DEPARTMENT OF TRANSPORTATION
 DIVISION OF HIGHWAYS
 BRIDGE MAINTENANCE UNIT

BRIDGE INSPECTION REPORT

COUNTY CLEVELAND BRIDGE NUMBER 220015 INSPECTION CYCLE 2 YRS

ROUTE NC180 ACROSS SEABOARD COAST LINE R.R. M.P. 0

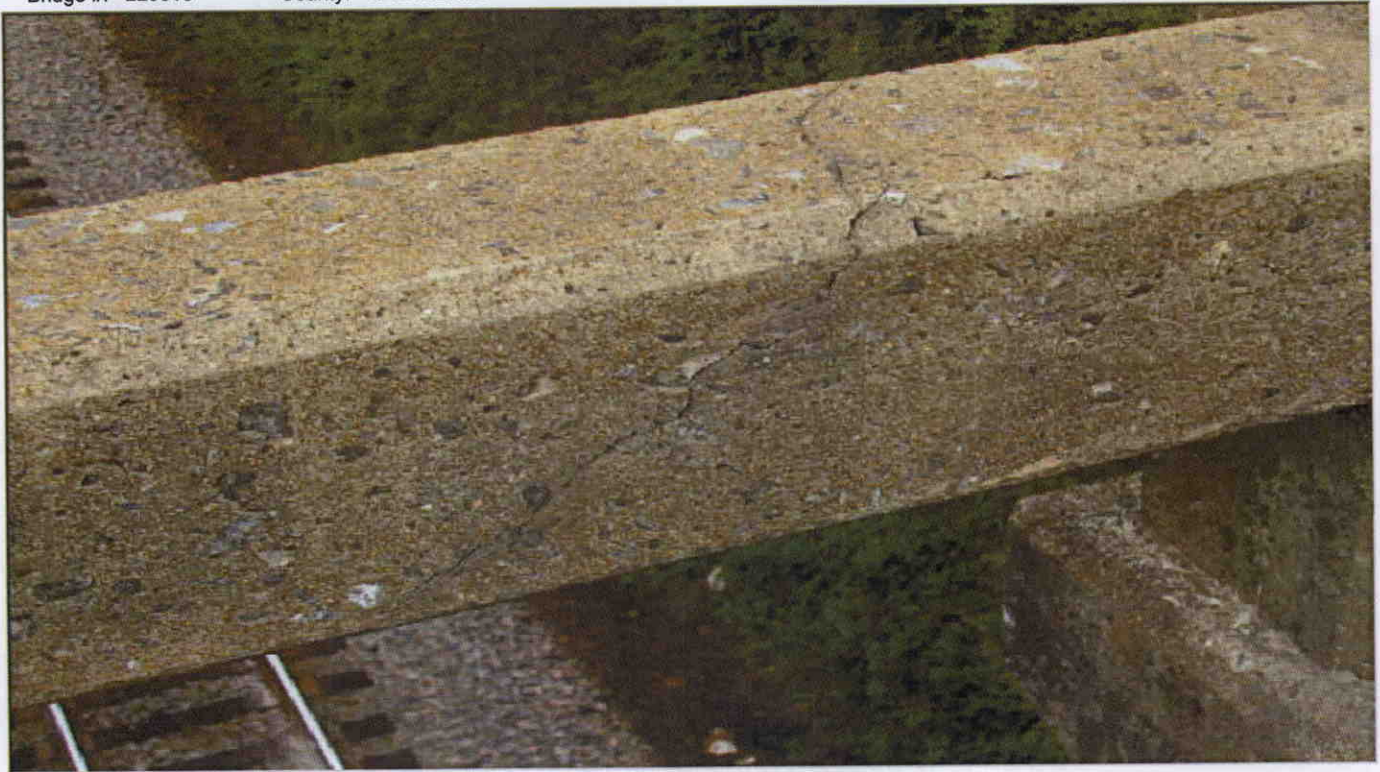
DIAGONAL CRACK ALONG WEST RAIL IN SPAN 2

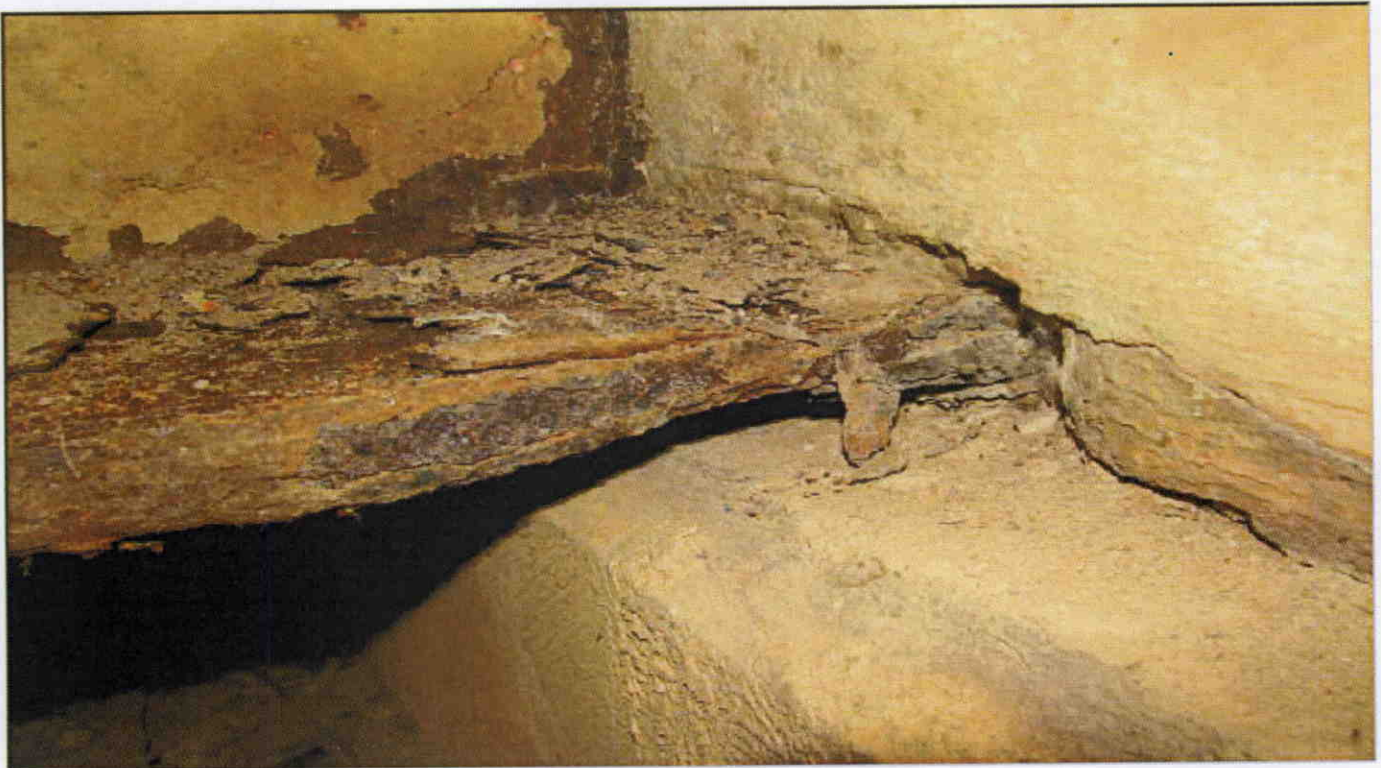
GIRDER 4 SECTION LOSS AT END BENT 2 CURTAIN WALL

GIRDER	LOCATION	SPAN	REMAINING FLANGE SECTION	FLANGE SECTION LOSS
1	END BENT 1	1	13/16	1/16
2	END BENT 1	1	7/8	0
3	END BENT 1	1	7/8	0
4	END BENT 1	1	7/8	0
1	BENT 1	1	3/4	1/8
2	BENT 1	1	13/16	1/16
3	BENT 1	1	13/16	1/16
4	BENT 1	1	3/4	1/8
1	BENT 1	2	7/8	1/8
2	BENT 1	2	15/16	1/16
3	BENT 1	2	15/16	1/16
4	BENT 1	2	7/8	1/8
1	END BENT 2	2	7/8	1/8
2	END BENT 2	2	15/16	1/16
3	END BENT 2	2	1	0
4	END BENT 2	2	1/2	1/2

Function Code	Description of Function	Unit	Quantity	Remarks	Est. Cost
552	Complete Cleaning and painting of structural steel	Sq-ft	3380	RUST AND SECTION LOSS ON BEAMS	
556	Bridge approaches, surfacing or pavement replacement or repair	Man-Hours	60	CRACKING AND POTHOLES IN APPROACHES	
560	Maintenance and repairs to concrete bridge floors	Sq-ft	2520	CRACKING, POPOUTS, DELAMINATION, AND EXPOSED REINFORCEMENT IN DECK	
576	Maintenance of standard deck expansion joints	Lin-ft	26	DETERIORATED AND LEAKING JOINT	
578	General Maintenance of superstructure	Man-Hours	200	SPALLING WITH EXPOSED REINFORCEMENT IN BENT 1 END DIAPHRAGMS

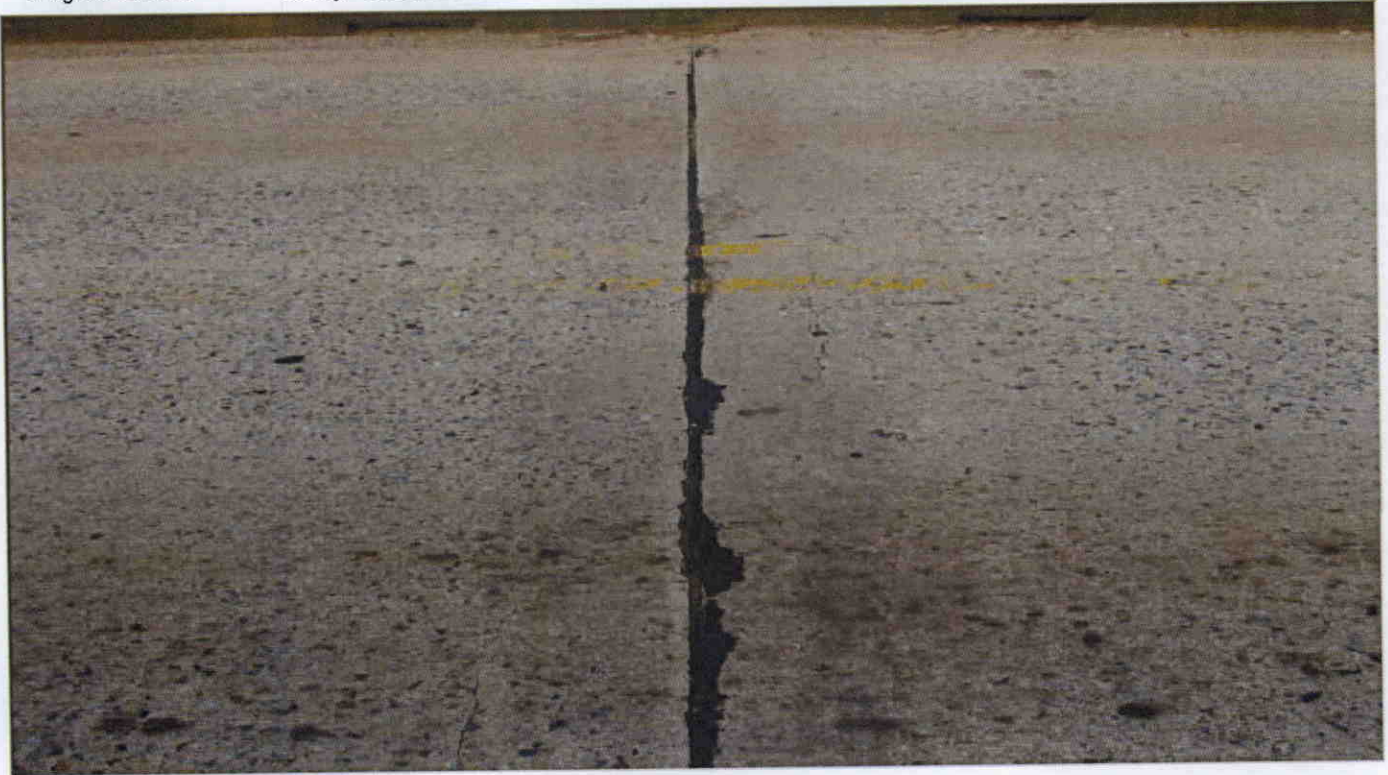
4	6	MINOR HAIRLINE VERTICAL CRACKING IS PRESENT IN THE PARAPETS WITH RANDOM CHIPS AND SPALLS ALONG THE FACES. NO DISTRESS IS NOTED OTHERWISE.
6d	6	THE JOINT IS SEALED WITH TAR ON THE TOPSIDE. BEAM END RUST, BEARING RUST, AND STAINING ON THE CAP INDICATE THE JOINT IS LEAKING. MOST OF THE JOINT MATERIAL HAS FALLEN OUT AND IS ON THE INTERIOR BENT CAP.
7	7	SEDIMENT IS PRESENT ALONG BOTH PARAPETS
10	5	RUSTING AND MINOR PAINT FAILURE IS PRESENT THROUGHOUT BEAM SPANS. RUSTING AND SECTION LOSS ARE MAXIMIZED AT THE BEAM ENDS AND BEARING AREAS. SEE TABLE FOR AMOUNT OF SECTION LOSS IN EACH BEAM.
12	7	THE INTERMEDIATE DIAPHRAGMS SHOW MINOR PAINT FAILURE BUT NO SECTION LOSS IS NOTED.
13	5	THE END DIAPHRAGMS OVER BENT 1 SHOW HORIZONTAL CRACKING UP TO 1/8 INCH AND SPALLING WITH EXPOSED REINFORCEMENT THROUGHOUT. IMMINENT SPALLS ARE PRESENT IN OTHER LOCATIONS. THE CURTAIN WALLS HAVE MINOR POPOFFS AND SPALLS AT THE BEAM CONNECTIONS.

JOINT OVER INTERIOR BENT
