PROJECT NO. I-5781
JOHNSTON COUNTY
 BRIDGE NO. 497

SUBSTRUCTURE

REPAIR
 BENT 2

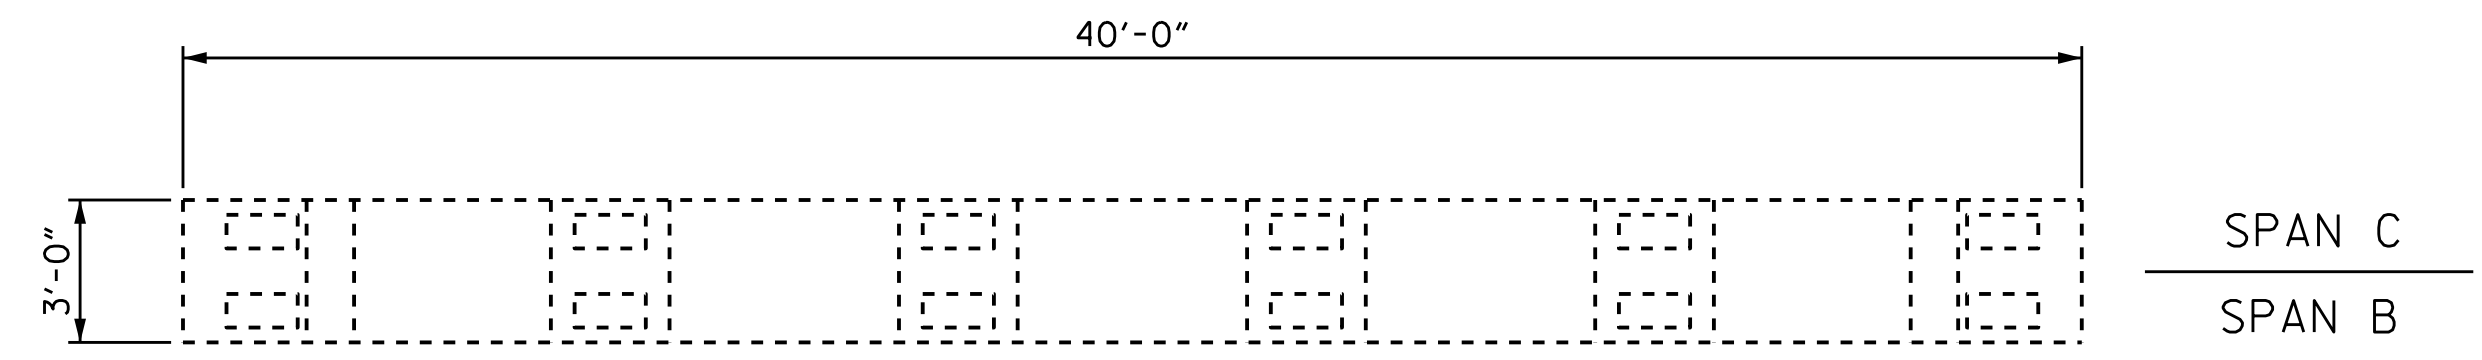
PLAN
TOP OF CAP

NO REPAIRS NOTED DURING INSPECTION BY STRUCTURES MANAGEMENT UNIT. THE CONTRACTOR AND ENGINEER SHALL REINSPECT THE SUBSTRUCTURE FOR POTENTIAL REPAIRS.
