PROJECT NO. I-5781 JOHNSTON \_ COUNTY

STATE OF NORTH CAROLINA DEPARTMENT OF TRANSPORTATION
RALEIGH

SUBSTRUCTURE

REPAIR BENT 4

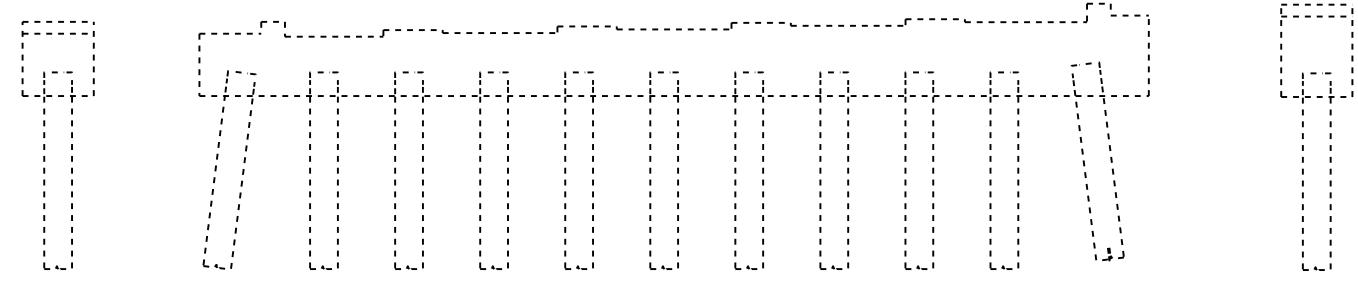
END VIEW
LEFT SIDE END VIEW
RIGHT SIDE ELEVATION (SPAN D SIDE)

NO REPAIRS NOTED DURING INSPECTION BY STRUCTURES MANAGEMENT UNIT. THE CONTRACTOR AND ENGINEER SHALL REINSPECT THE SUBSTRUCTURE FOR POTENTIAL REPAIRS. 40'-0" SPAN E i ---i SPAN D \_ - - - - - . **⊢** - - - - - 1
