UNCO	-		A UNTY		
TH CAROLINE	STATE OF NORTH CAROLINA DEPARTMENT OF TRANSPORTATION RALEIGH						
SEAL 020208	BENT 2 SPAN B SIDE						
Ein Bhil fr 11/16/2017 BA9F91762D7044A							
Poad			SHEET NO.				
607-3073 DOCUMENT NOT CONSIDERED	NO. BY:	DATE:	NO. BY:	DATE:	S-56		
0 FINAL UNLESS ALL 0270 SIGNATURES COMPLETED	1		영 4		TOTAL SHEETS		
STONATONES COMILETED	ß		[		208

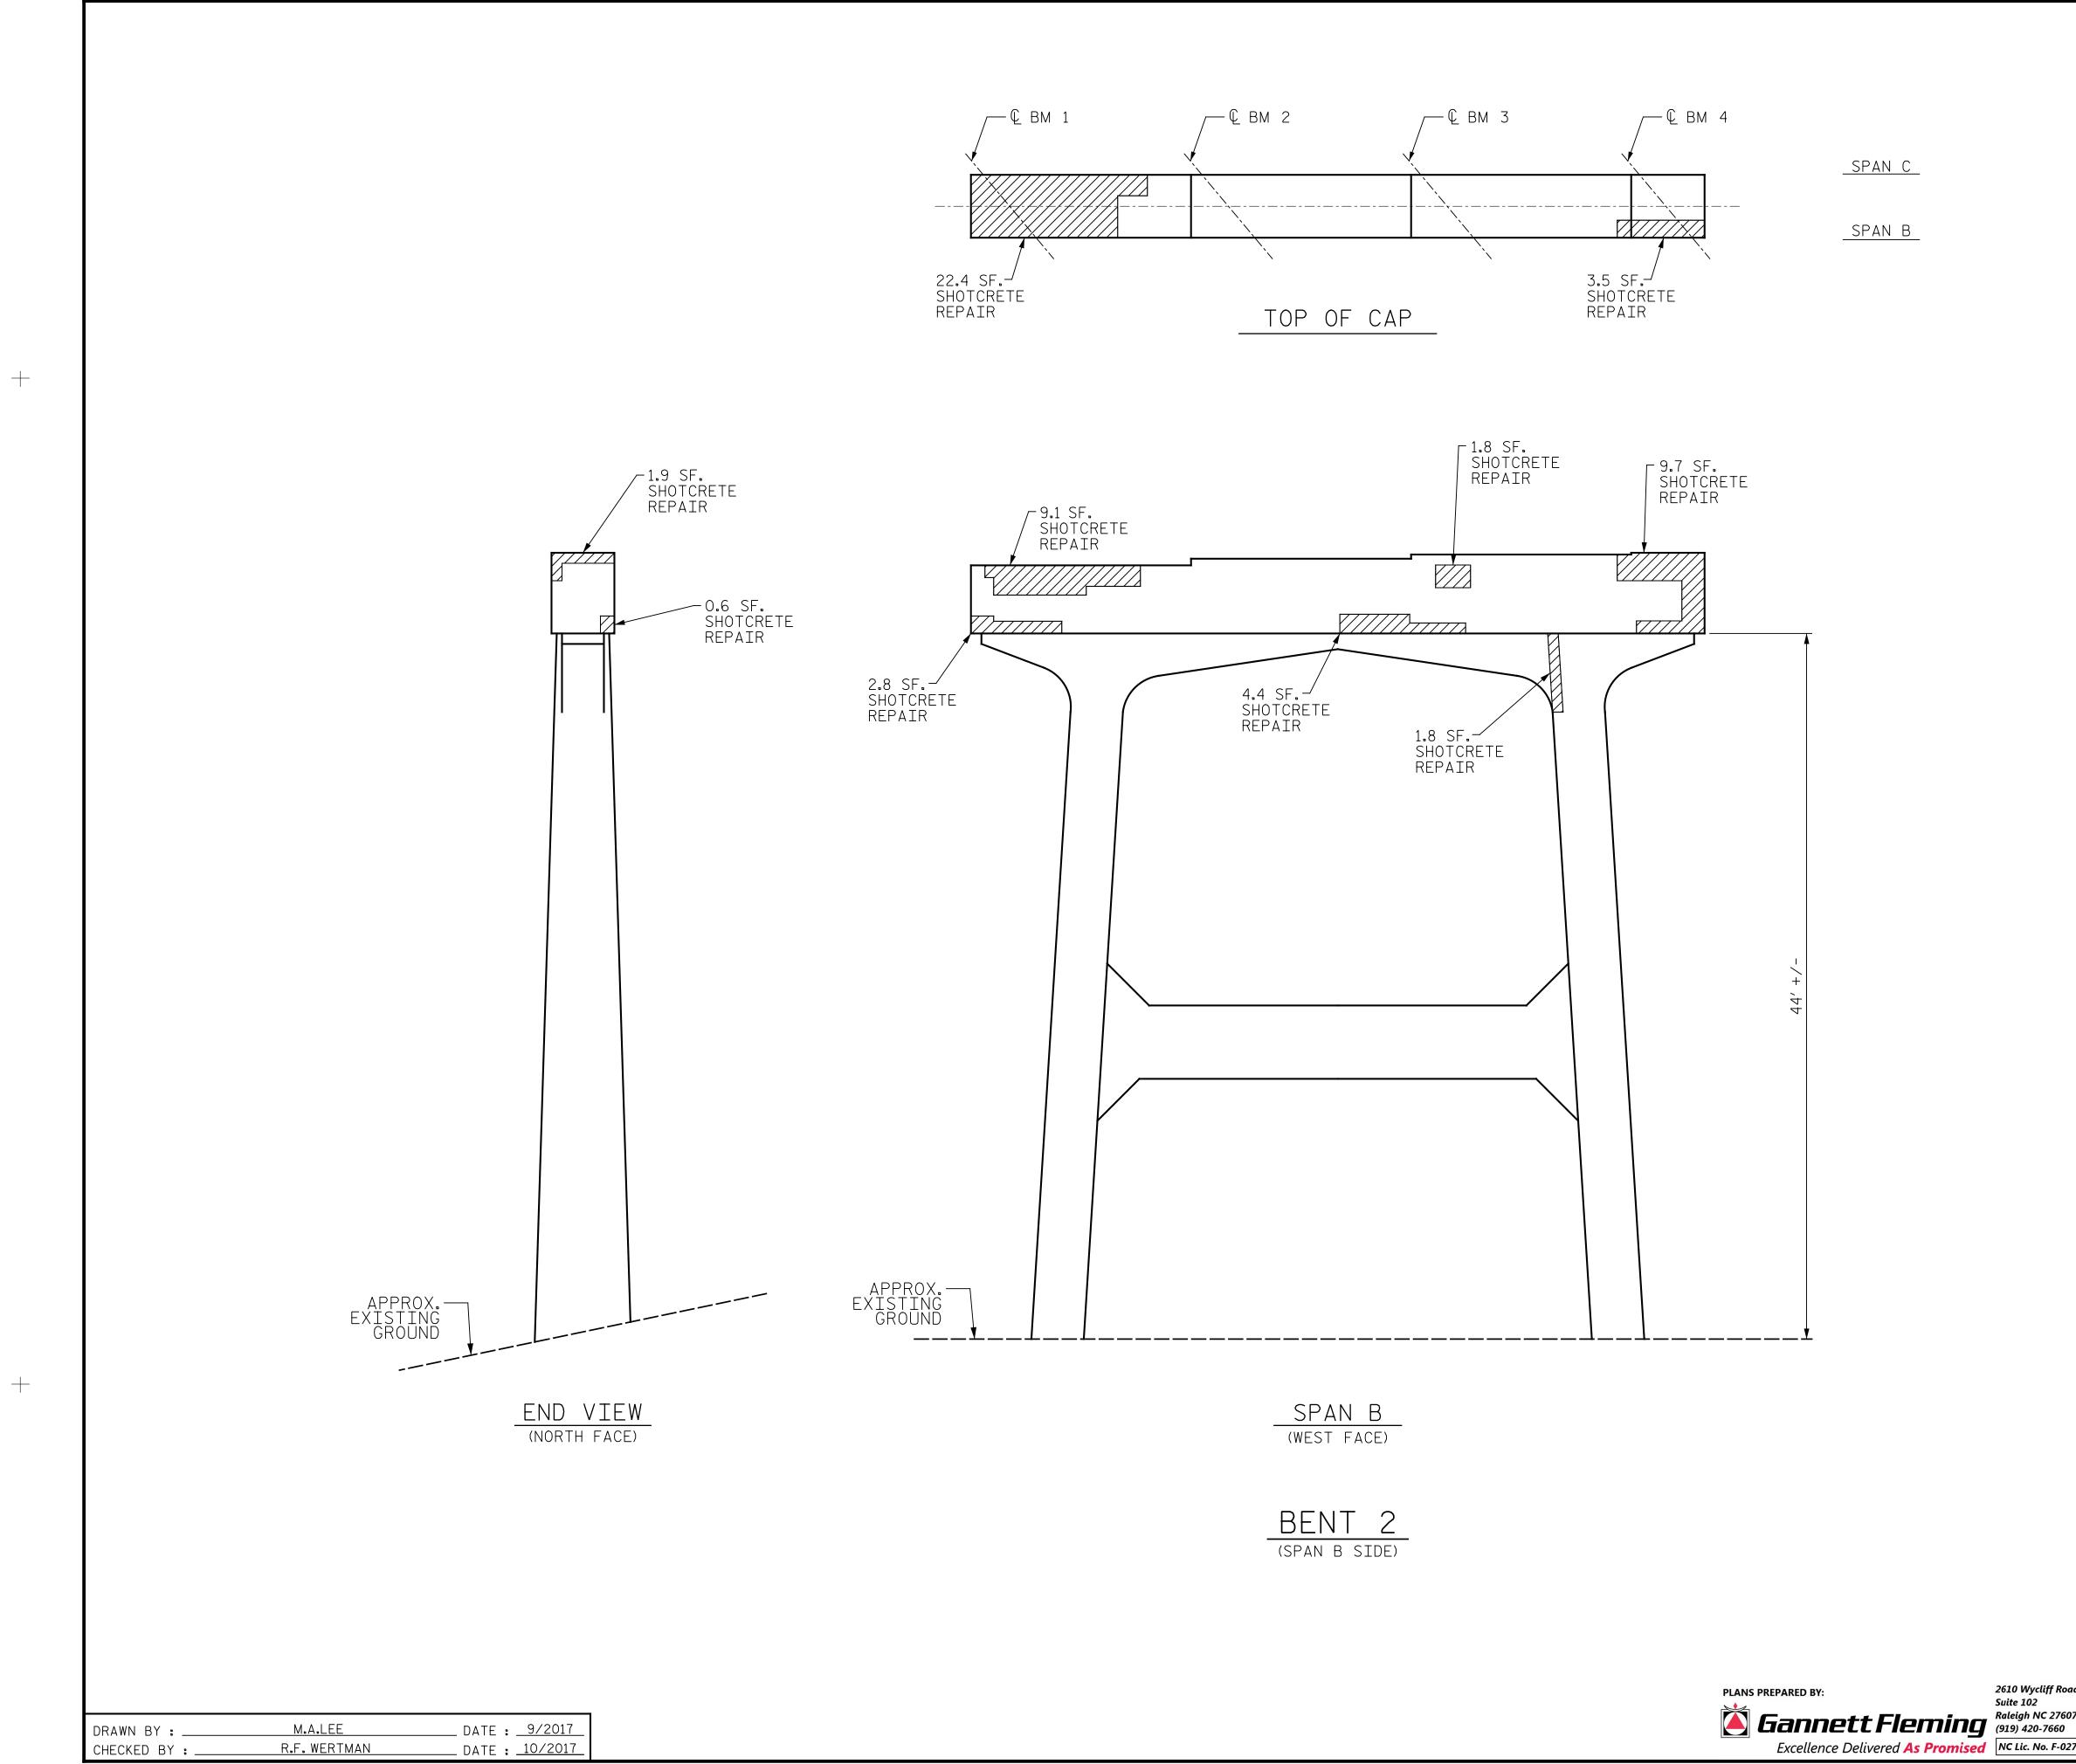
AS-BUILT REPAIR QUANTITY TABLE									
BENT 2 REPAIRS	QUANTITIES								
DENT Z REFAIRS	ESTI	ACTUAL							
SHOTCRETE REPAIRS	AREA SF	VOLUME CF	AREA SF	DEPTH FT	VOLUME CF				
CAP (VERTICAL FACE)	66.7	33.4							
CAP (HORIZONTAL, CORNER)	25.9	13.0							
COLUMN	0	0

VALUES IN CHART REPRESENT ESTIMATED REPAIR TOTALS AFTER REMOVAL OF UNSOUND CONCRETE, MIN. OF 1"BEHIND REBAR AND MIN. 2"CL TO SAWCUT. SEE REPAIR DETAILS.
