PROJECT NO. <u>I-5889A</u> <u>BUNCOMBE</u> county BRIDGE NO. <u>352</u>				
THE CAROLINE	STATE OF NORTH CAROLINA DEPARTMENT OF TRANSPORTATION RALEIGH				
DocuSigned by:	BENT 7 Span g side				
Ei Bruch (h 11/16/2017 BA9F91762D7044A					
Road	REVISIONS SHEET NO.				
7607-3073 DOCUMENT NOT CONSIDERE	NO. BY: DATE: NO. BY: DATE: S-66				
FINAL UNLESS ALL SIGNATURES COMPLETED	1 3 TOTAL 2 4 208				
JIONATONES COMPLETED	任 208

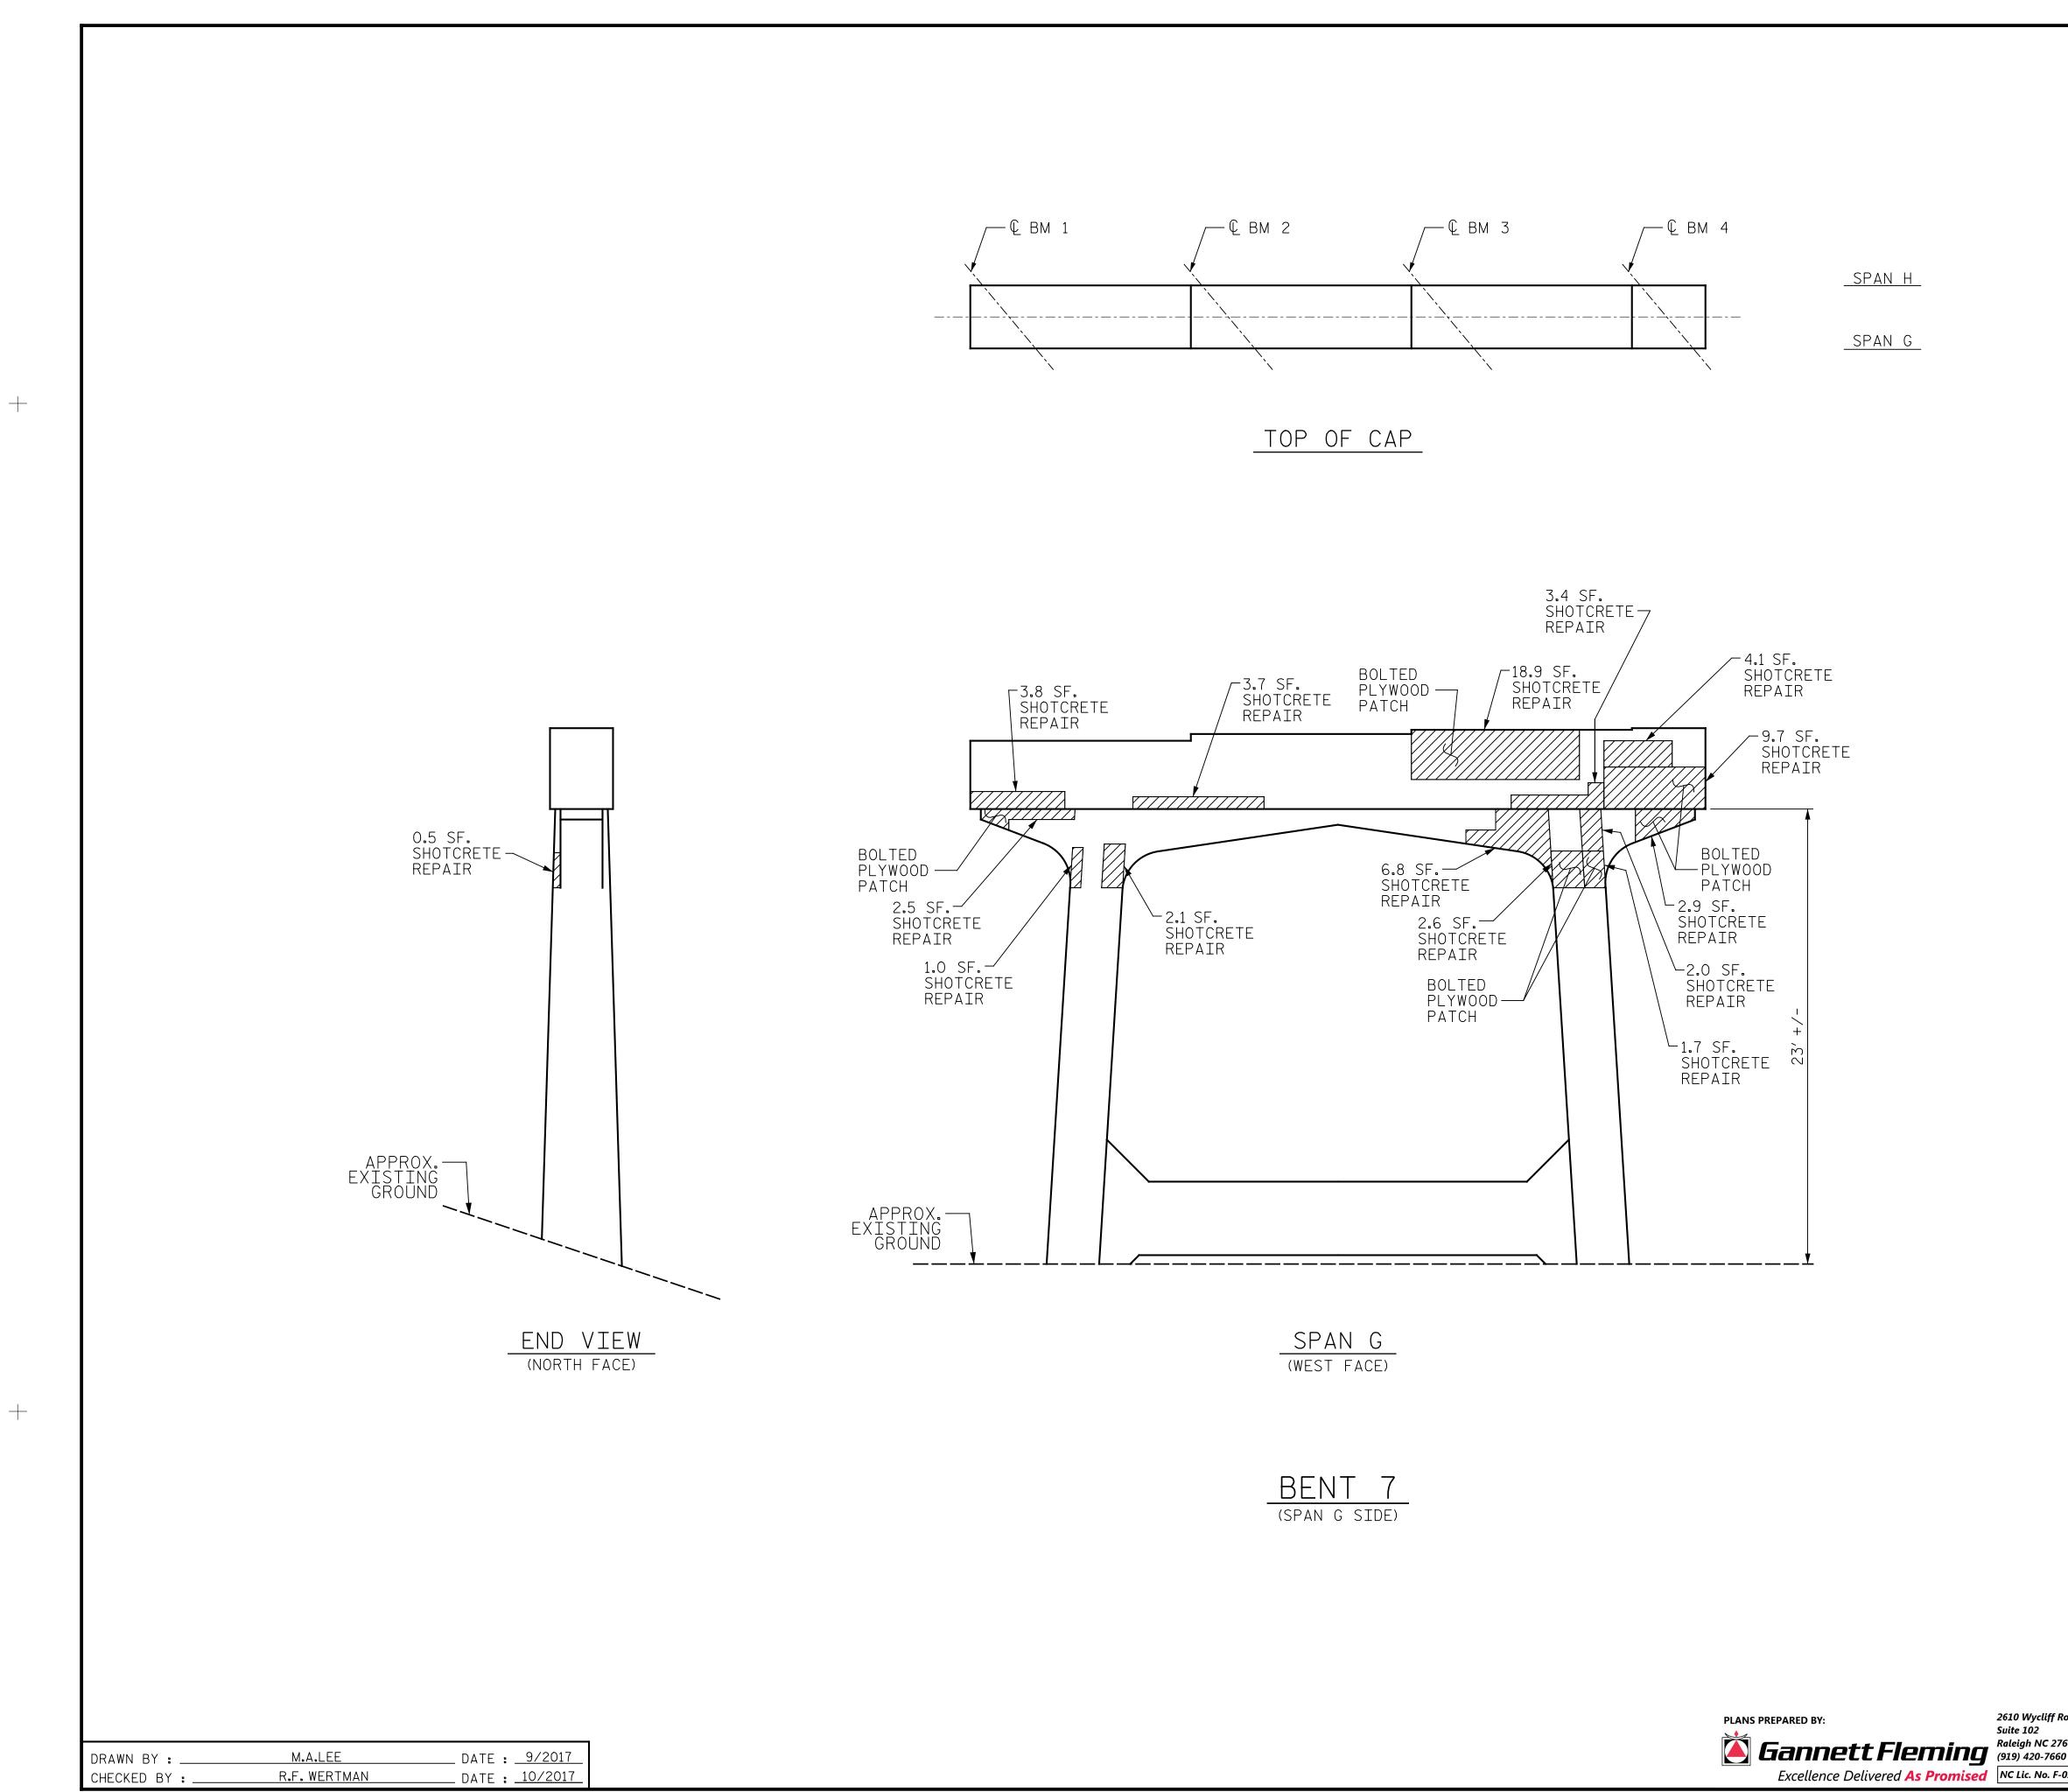
AS-BUILT REPAIR QUANTITY TABLE						
BENT 7 REPAIRS	QUANTITIES					
	ESTIMATE		ACTUAL			
SHOTCRETE REPAIRS	AREA SF	VOLUME CF	AREA SF	DEPTH FT	VOLUME CF	
CAP (VERTICAL FACE)	106.0	53.0				
CAP (HORIZONTAL, CORNER)	0	0				
COLUMN	0	0

VALUES IN CHART REPRESENT ESTIMATED REPAIR TOTALS AFTER REMOVAL OF UNSOUND CONCRETE, MIN. OF 1"BEHIND REBAR AND MIN. 2"CL TO SAWCUT. SEE REPÁIR DETAILS.
