AS-BUILT REPAIR QUANTITY TABLE									
BENT 1 REPAIRS	QUANTITIES								
	ESTI	ACTUAL							
SHOTCRETE REPAIRS	AREA SF	VOLUME CF	AREA SF	DEPTH FT	VOLUME CF				
CAP (VERTICAL FACE)	20.5	10.2							
CAP (HORIZONTAL, CORNER)	17.3	8.6							
COLUMN	78.6	39.3							
EPOXY COATING		AREA SF			AREA SF				
TOP OF CAP		80

UNCO	I- MBE					
TH CAROL	STATE OF NORTH CAROLINA DEPARTMENT OF TRANSPORTATION RALEIGH							
SEAL 020208	BENT 1 Span a face							
Ein Bruch h 11/20/2017 BA9F91762D7044A			SIONS					
I	NO. BY:		SHEET NO. S-160					
-3073 DOCUMENT NOT CONSIDERED	NO. Вт. 1	DATE:	NO. ВҮ:	DATE:	TOTAL SHEETS			
<pre>FINAL UNLESS ALL SIGNATURES COMPLETED</pre>	2		③ 4〕		SHEETS 208

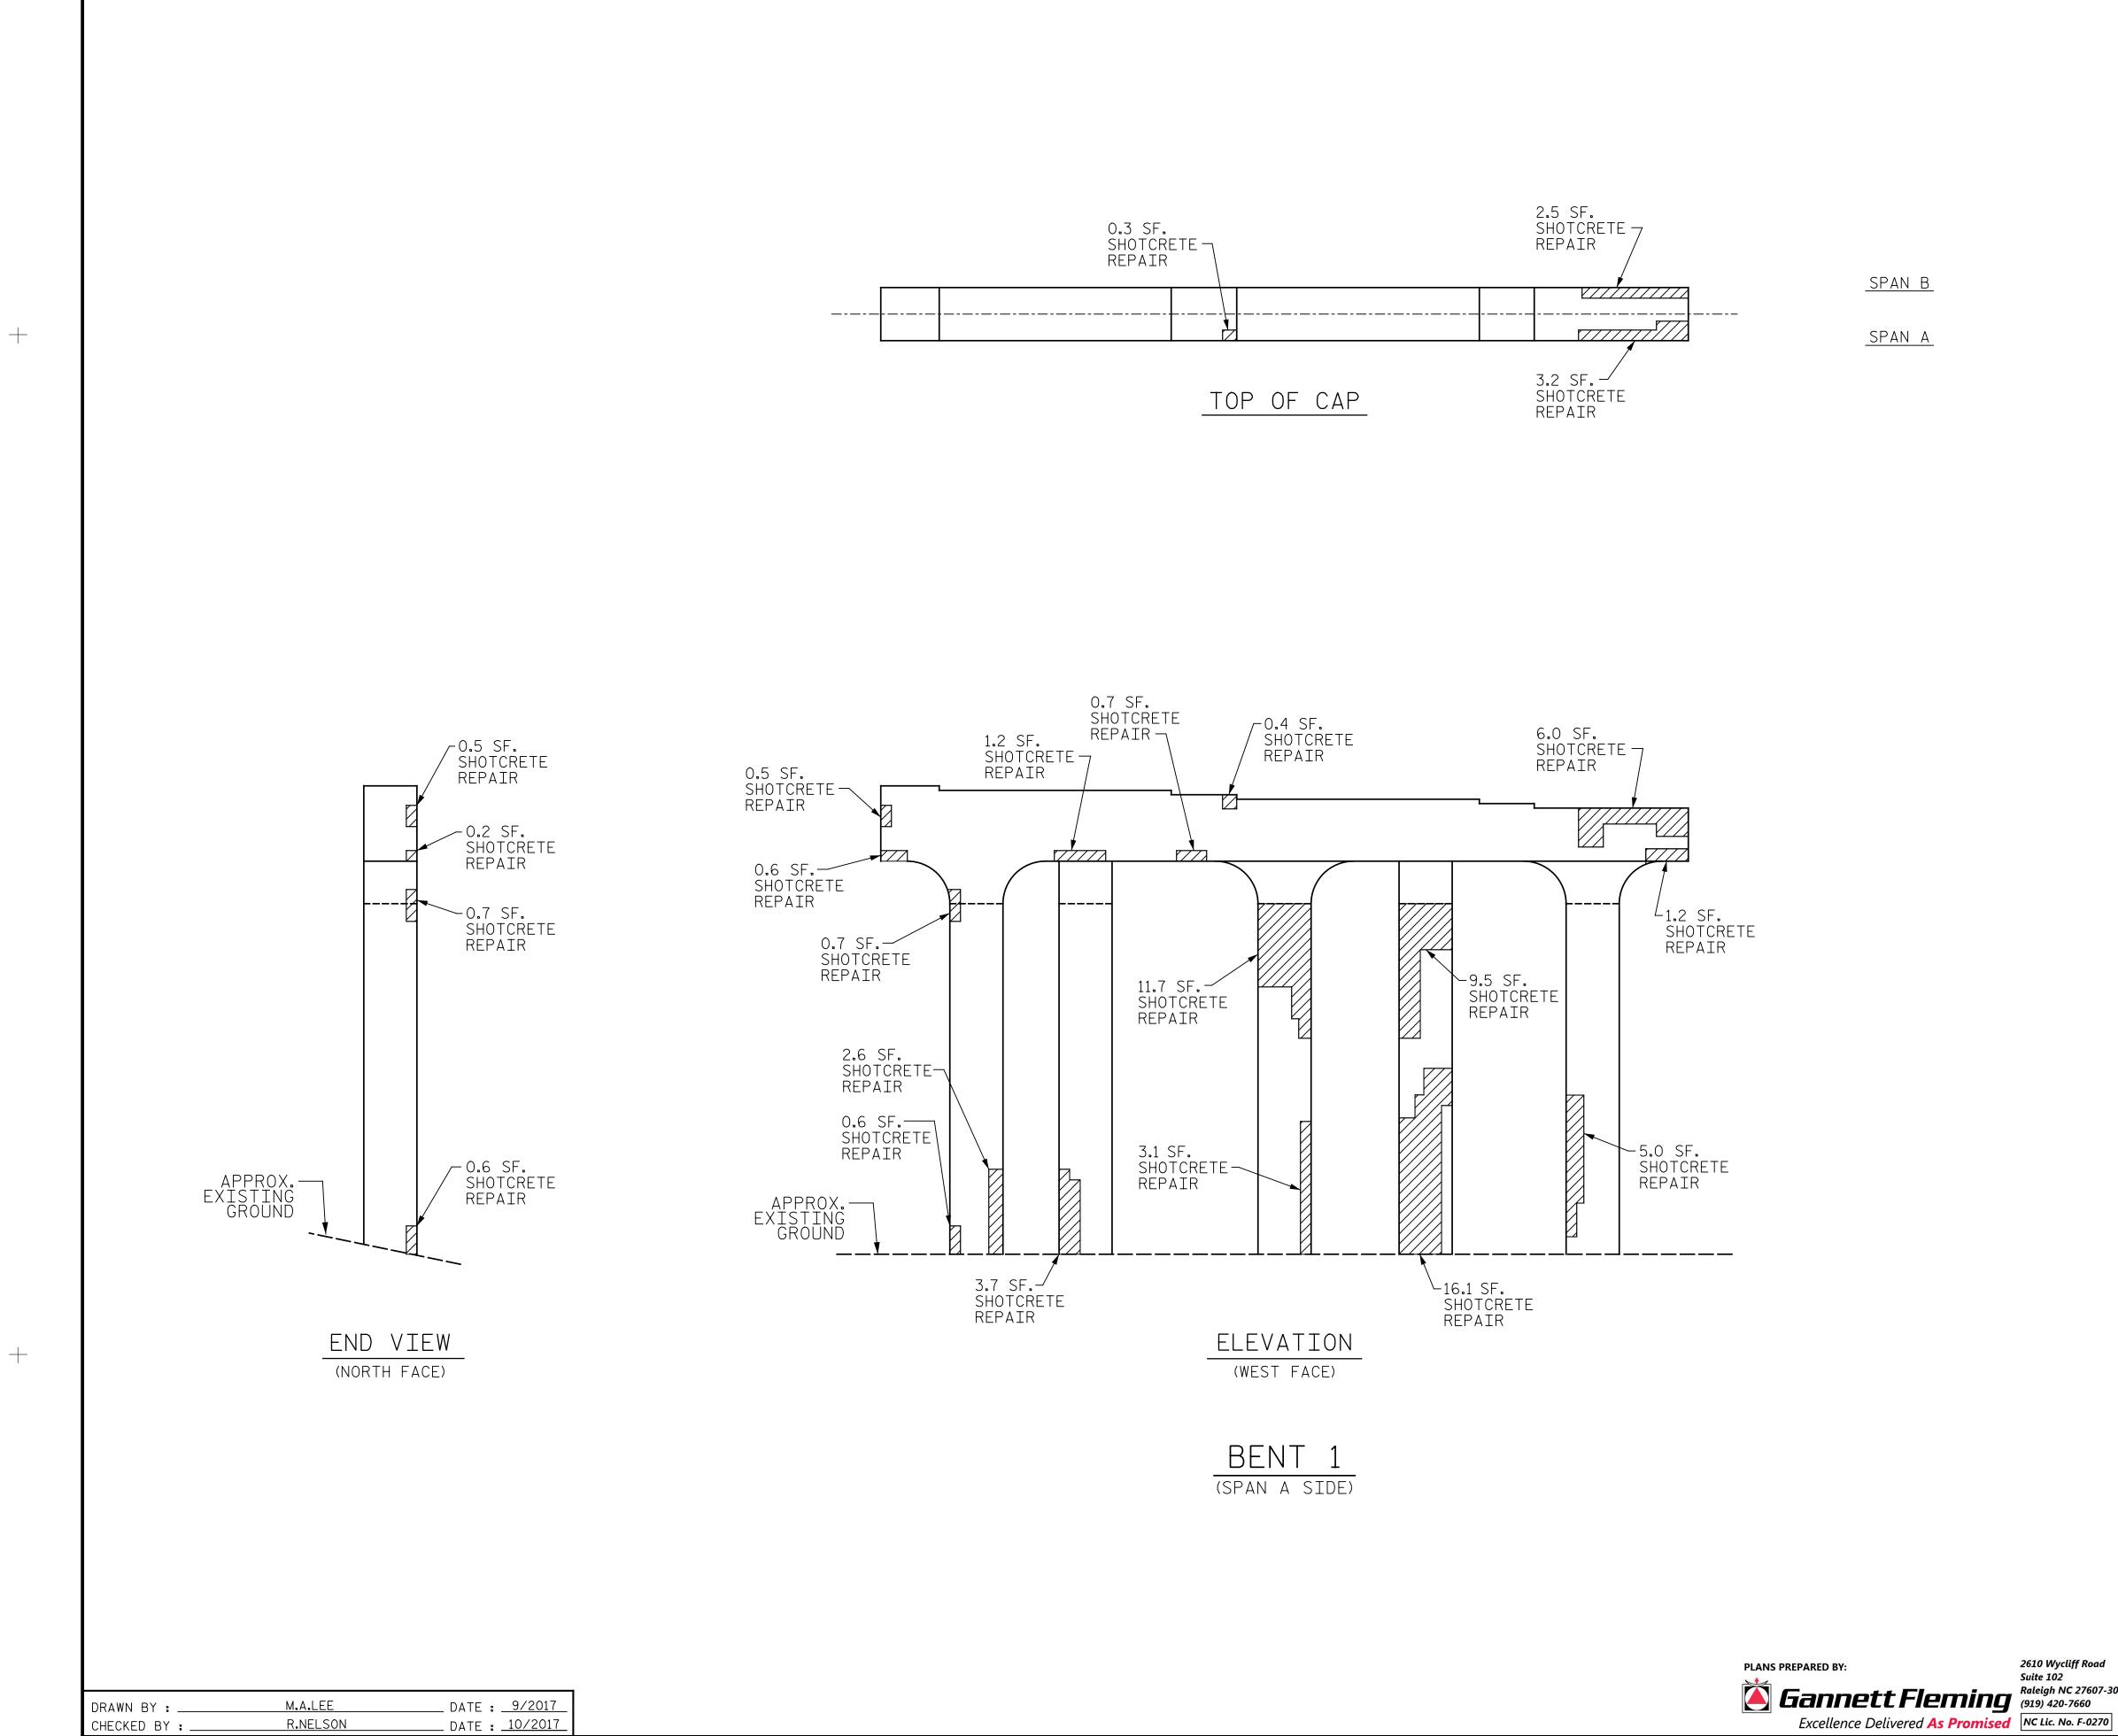
VALUES IN CHART REPRESENT ESTIMATED REPAIR TOTALS AFTER REMOVAL OF UNSOUND CONCRETE, MIN. OF 1"BEHIND REBAR AND MIN. 2"CL TO SAWCUT. SEE REPAIR DETAILS.

SHOTCRETE REPAIRS MAY BE REPLACED WITH CONCRETE REPAIRS WITH THE APPROVAL OF THE ENGINEER.

FOR SHOTCRETE REPAIRS, SEE SPECIAL PROVISIONS.

FOR CONCRETE REPAIR DETAILS, SEE "TYPICAL CAP & COLUMN REPAIR DETAILS" SHEET.
