NC DEPARTMENT OF TRANSPORTATION
 DIVISION OF HIGHWAYS
 STRUCTURE MANAGEMENT UNIT

Structure Safety Report

Routine Element Inspection - Contract

COUNTY: AVERY STRUCTURE NUMBER: 050031 FREQUENCY: 24 MONTHS

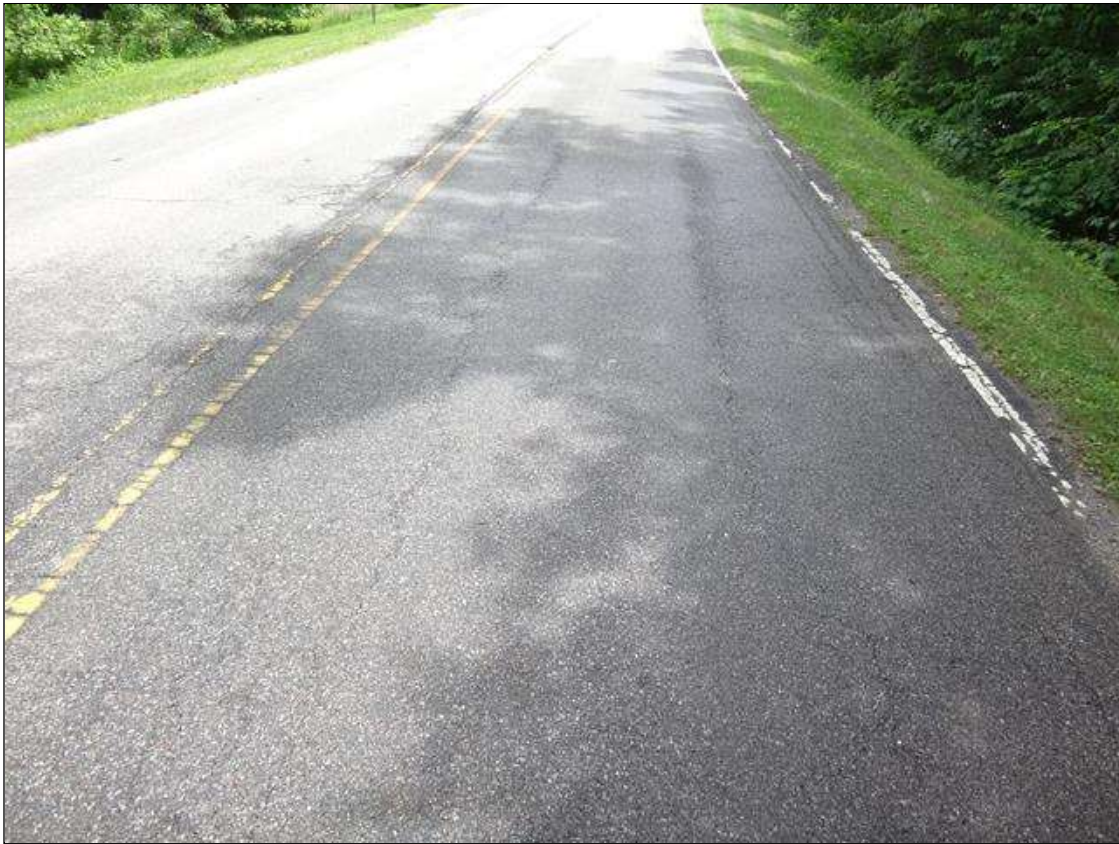
Item	Approach Roadway Alignment - Item 72	Grade	8	Maint Code		Qty.	0
Details	northbound lane over culvert, (2) longitudinal cracks (full length x up to 1/8in) southbound lane over culvert, (5) transverse cracks (12ft x up to 1/8in)

northbound lane over culvert, (2) longitudinal cracks (full length x up to 1/8in)

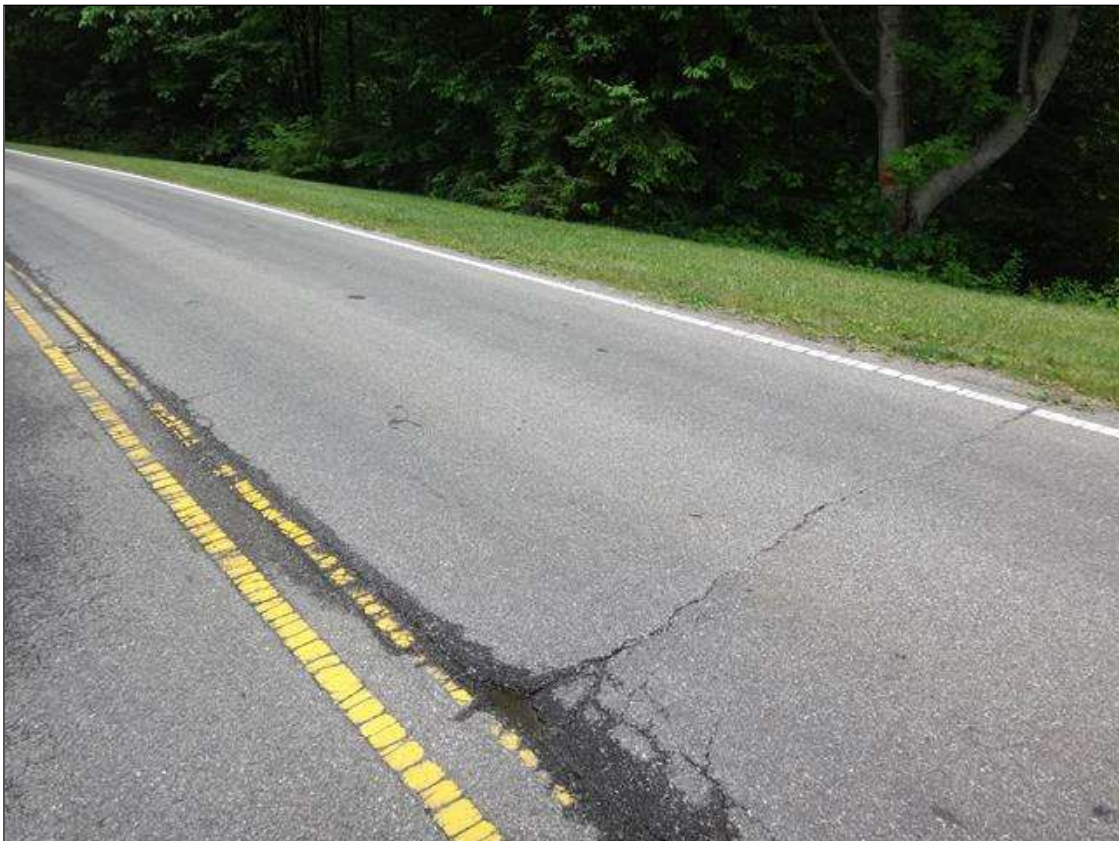
southbound lane over culvert, (5) transverse cracks (12ft x up to 1/8in)

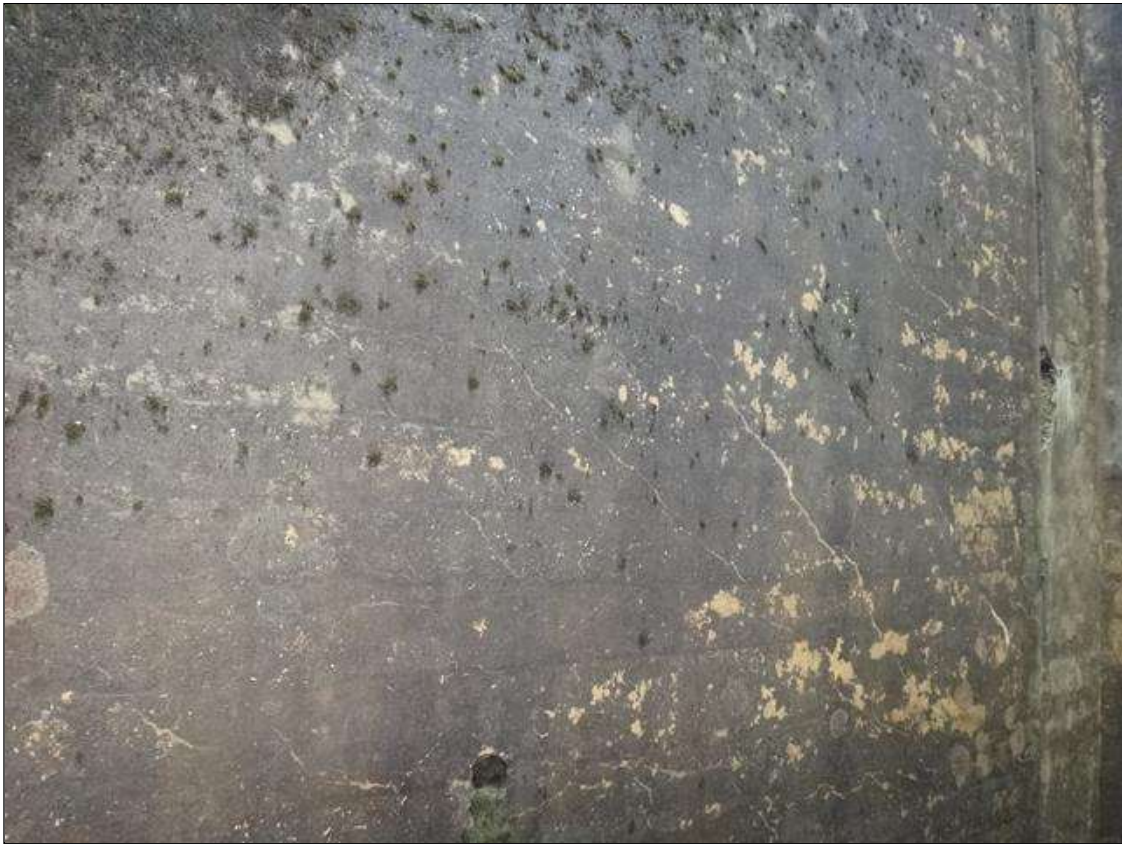
southeast wingwall, multiple diagonal cracks (up to 6ft x hairline)

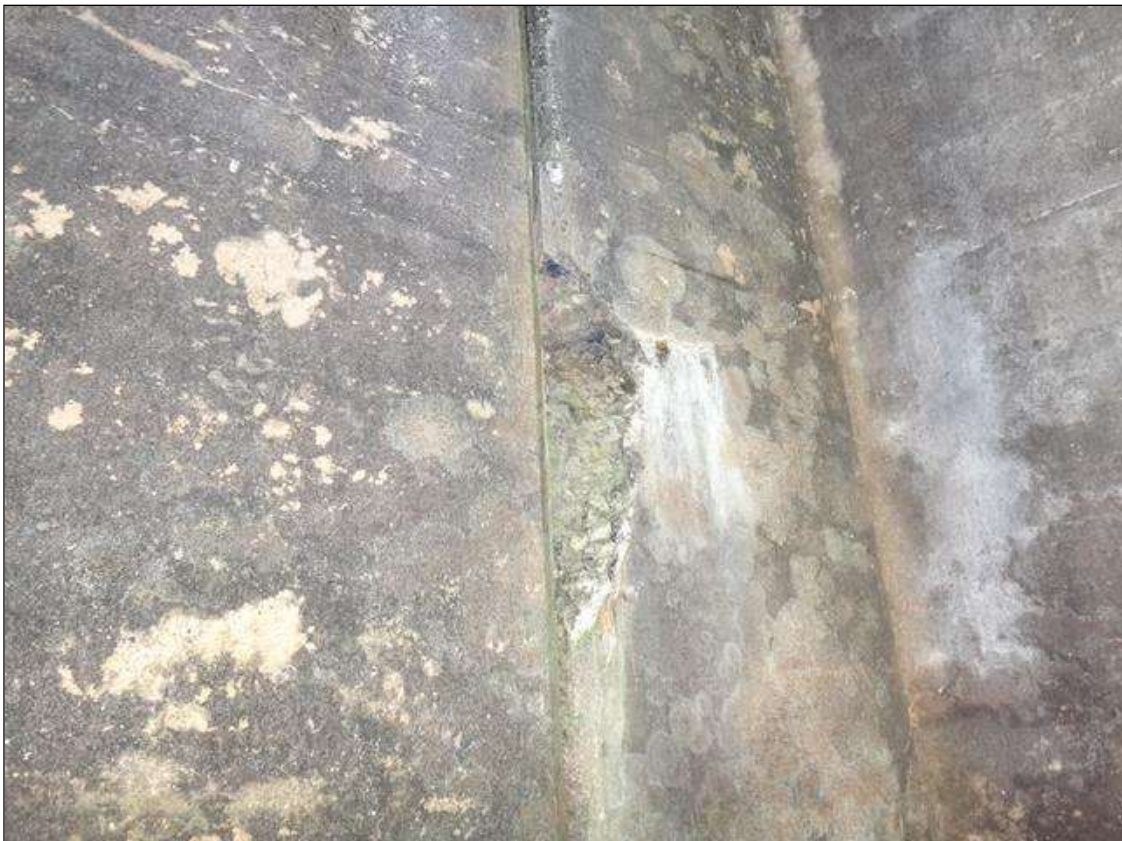
southeast wingwall, spall (4in x 1ft x up to 2in)

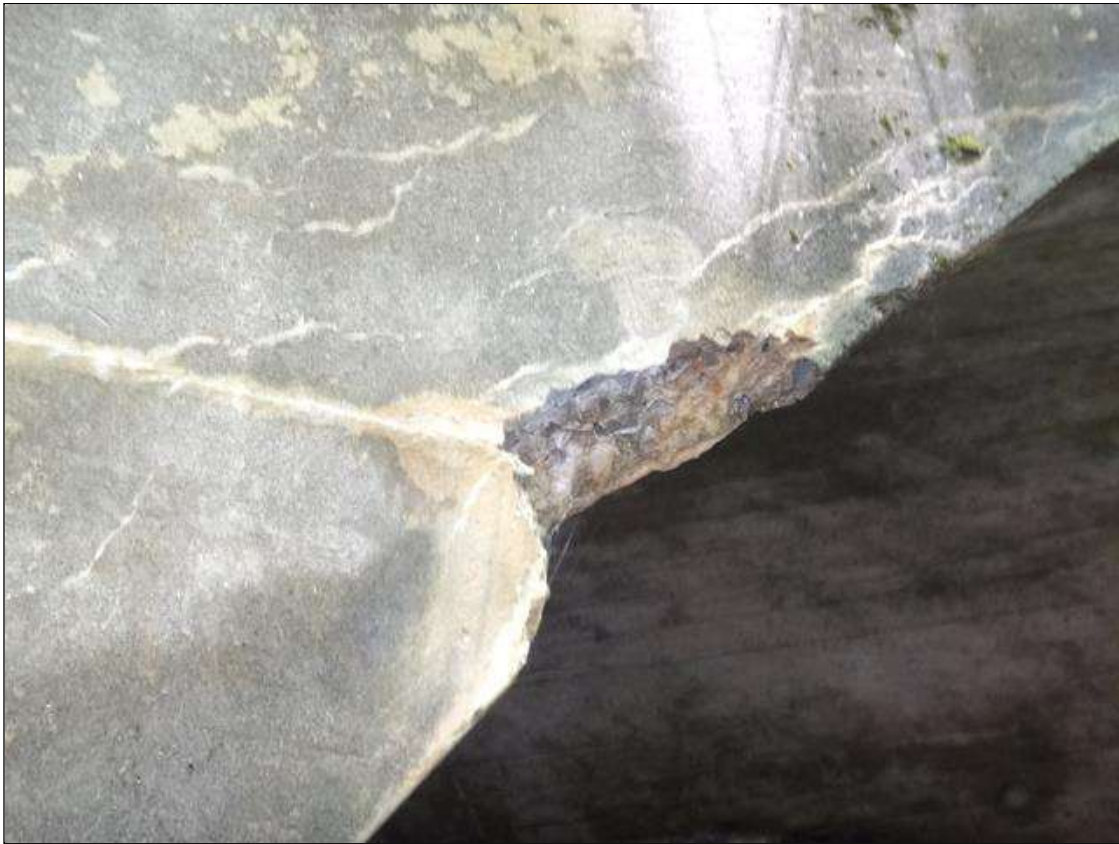
east headwall at south end, spall (10in x 5in x up to 4in)

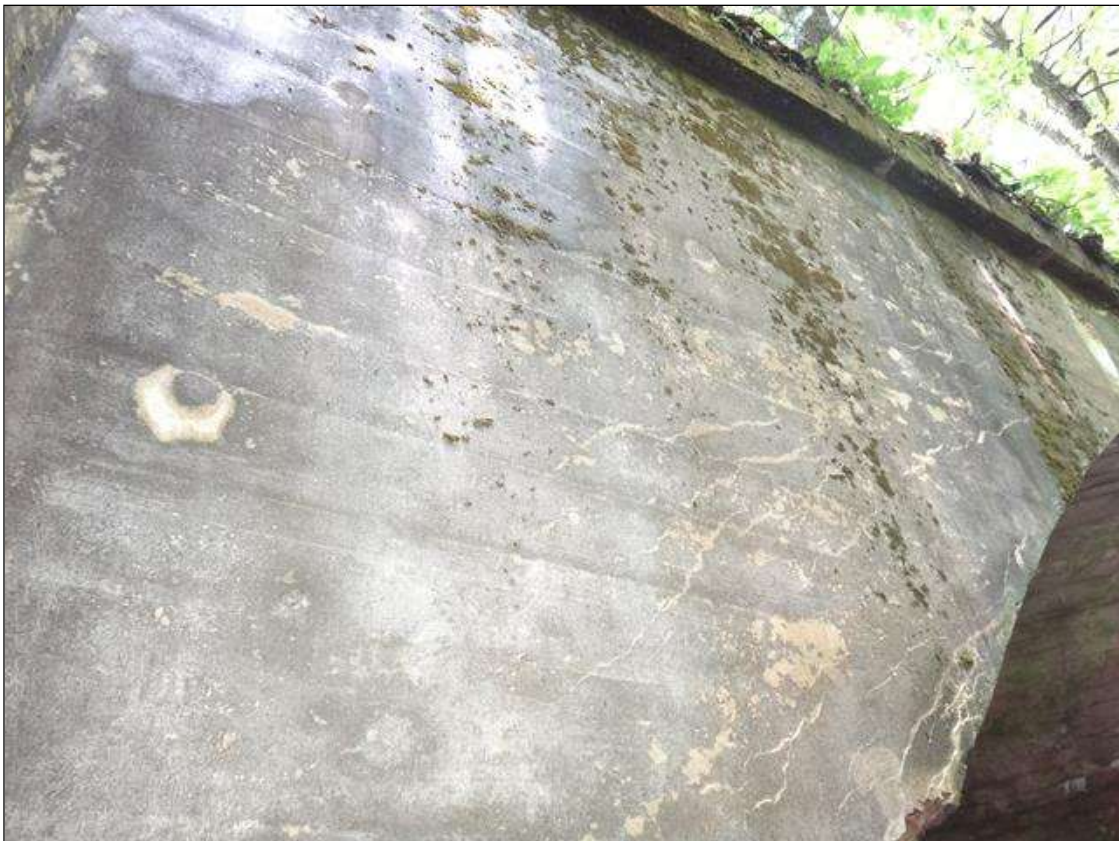
east headwall at south end, multiple diagonal cracks (up to 10ft x hairline)

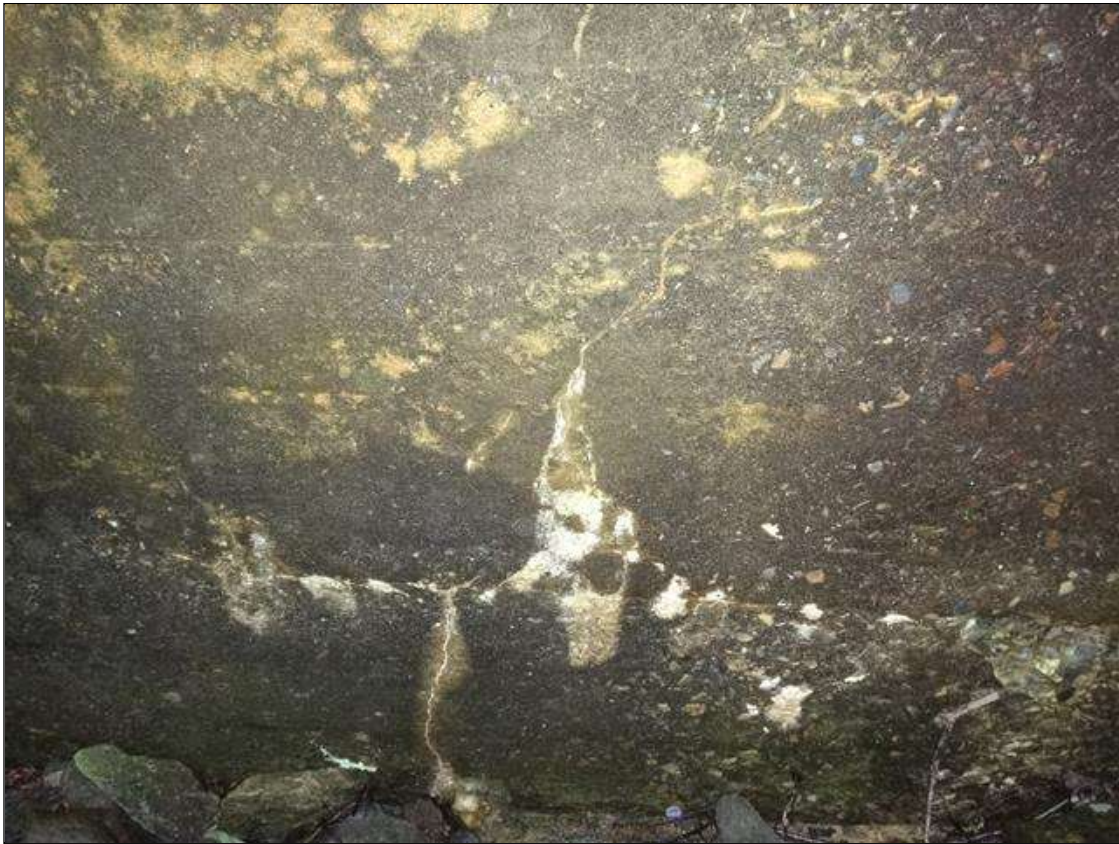
northeast wingwall at midpoint, vertical crack (5ft x hairline) with efflorescence

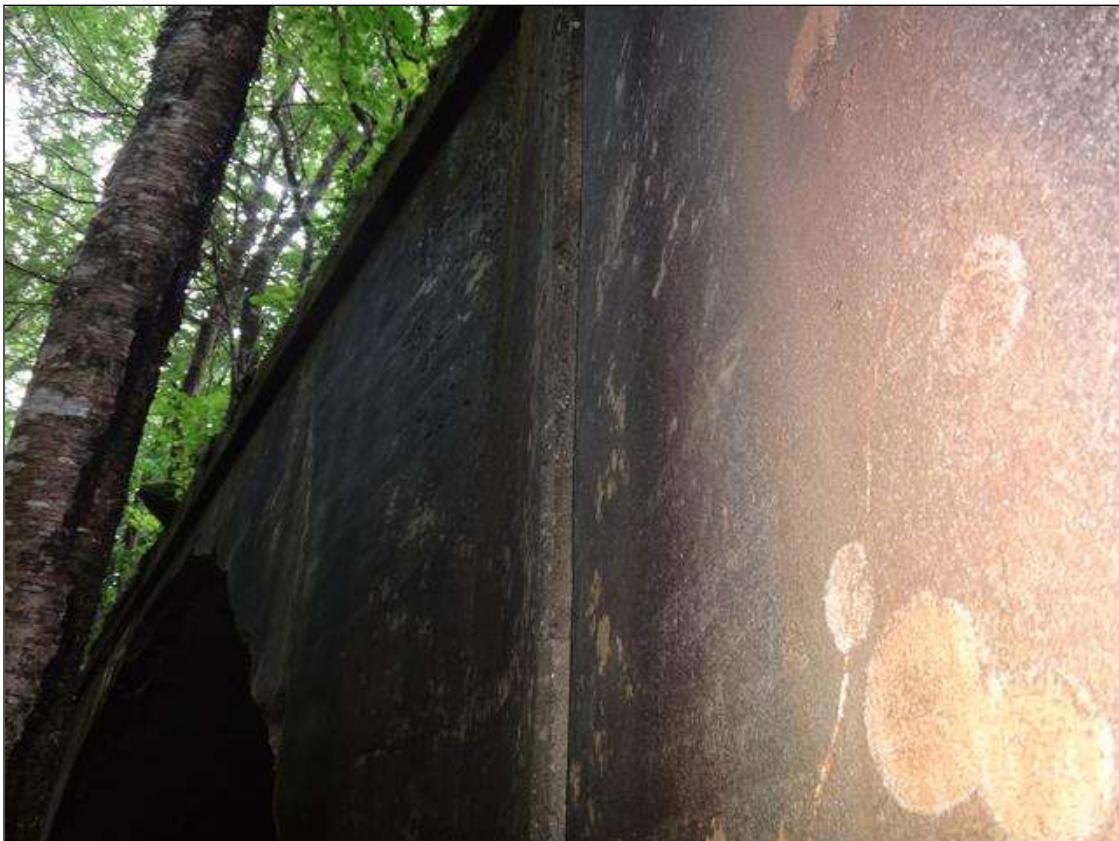
northeast wingwall, rotated west (up to 1-1/2in)

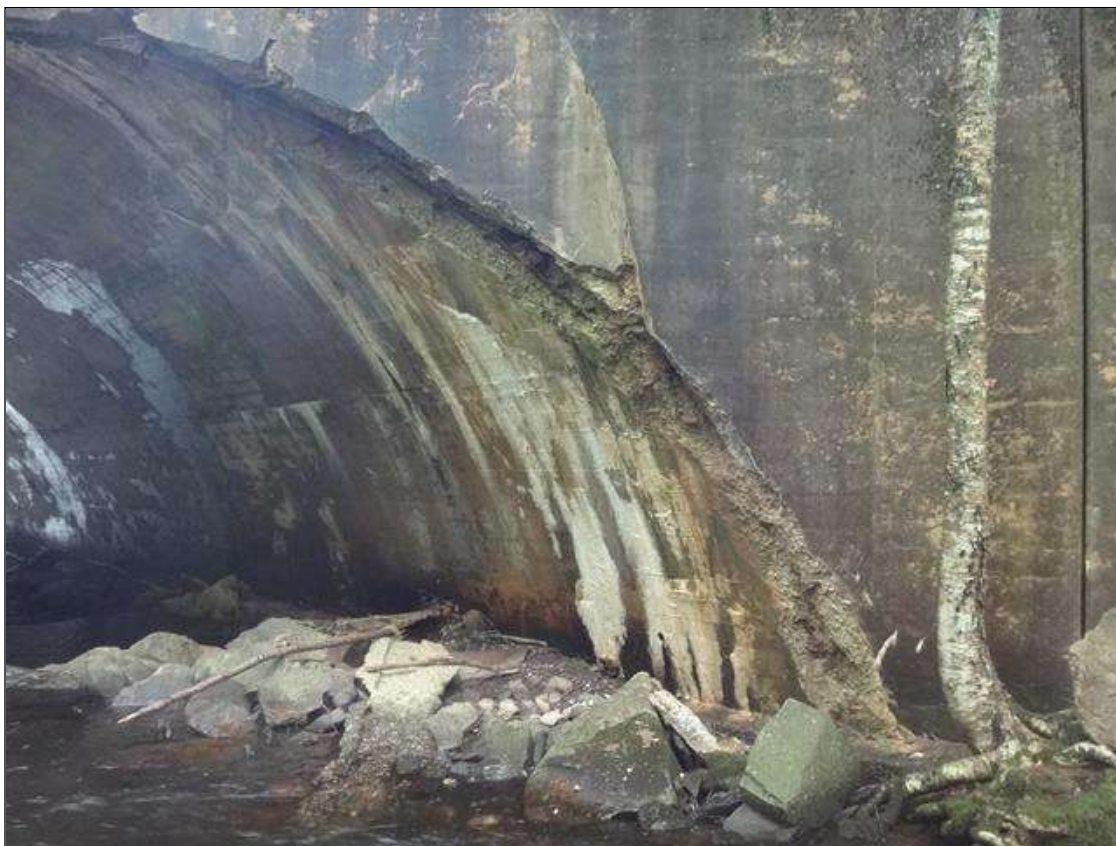
east headwall along northside, spall (16ft x 18in x up to 1ft) with exposed rusted rebar

3370	Maintenance and Repair of NBIS Pipes and Culverts	LF	16	EAST HEADWALL ALONG NORTHERN HALF OF SPANDREL, SPALL (16FT X 18IN X UP TO 1FT) WITH EXPOSED RUSTED REBAR

MMS Code	MMS Description	Quantity
3370	Maintenance and Repair of NBIS Pipes and Culverts	16 LF
Location:		
Pipe	Bent/Span No. 1	HEADWALL
Priority Level	Status	
Priority Maintenance	Division Maintenance Work In Process	
Submitted Date:	Submitted By:	Assisted By:
06/05/2017	WILLIAM MITCHELL	PARKER GUFFEY
Details		
EAST HEADWALL ALONG NORTHERN HALF OF SPANDREL, SPALL (16FT X 18IN X UP TO 1FT) WITH EXPOSED RUSTED REBAR

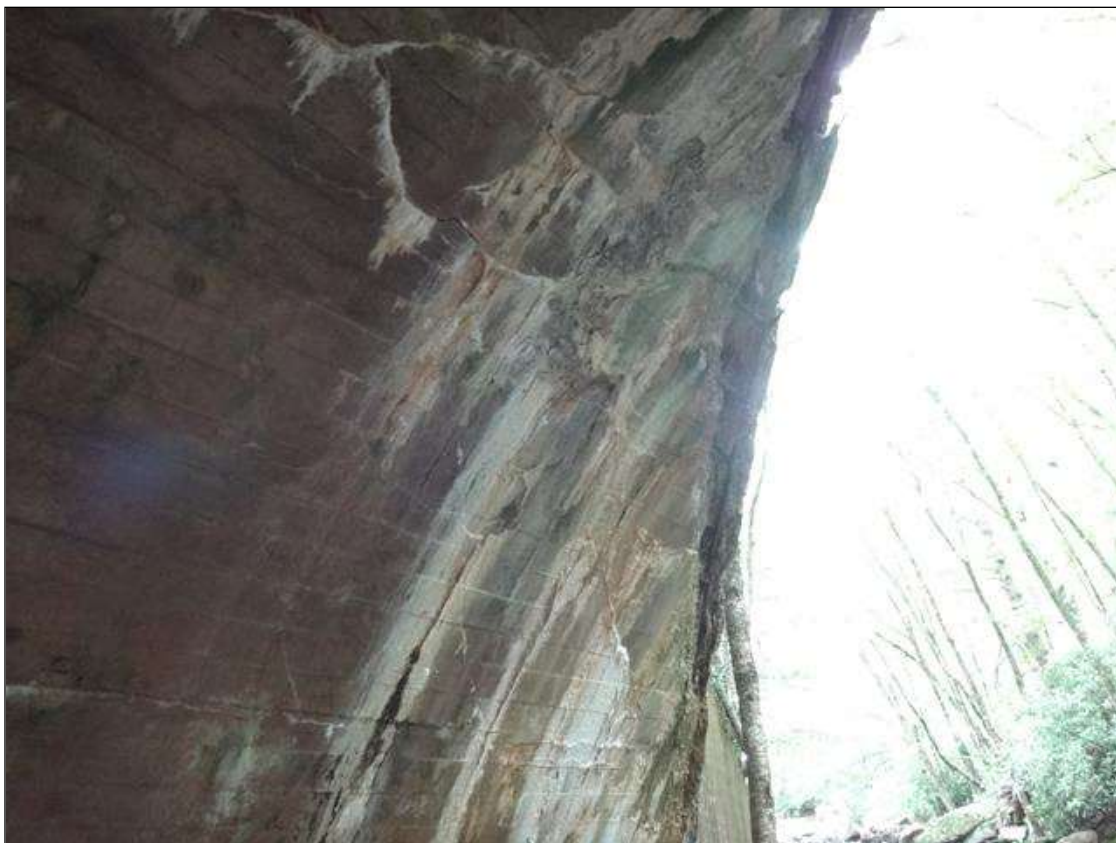
Barrel 1 Section 1: north wall at east end of barrel 1, cracking (12ft x up to 1/8in) with efflorescence

MMS Code	MMS Description	Quantity
3370	Maintenance and Repair of NBIS Pipes and Culverts	12 LF
Location:		
Bent/Span No.		
Priority Level	Status	
Recommended	Routine Maintenance	
Submitted Date:	Submitted By:	Assisted By:
06/05/2017	WILLIAM MITCHELL	
Details		
Barrel 1 Section 1: north wall at east end of barrel 1, cracking (12ft x up to 1/8in) with efflorescence

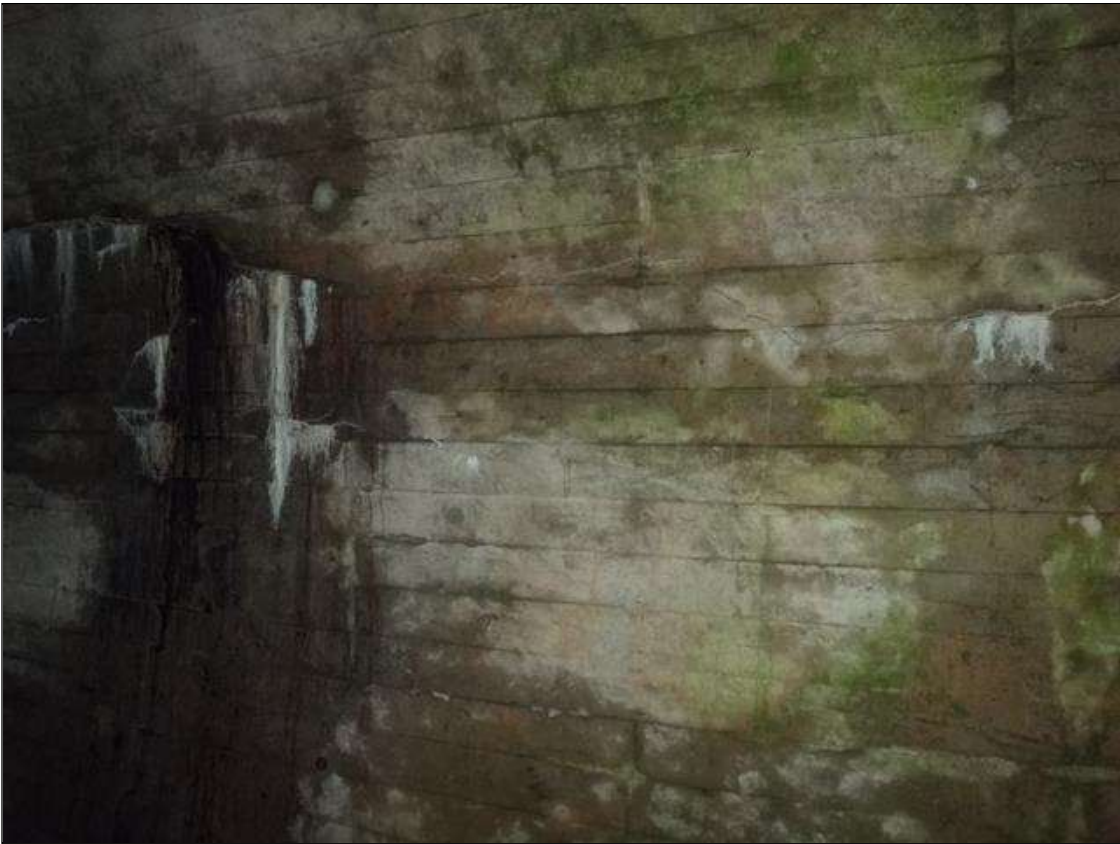
Barrel 1 Section 1: near top of north wall, (2) longitudinal cracks (24ft x up to 1/4in) at east end

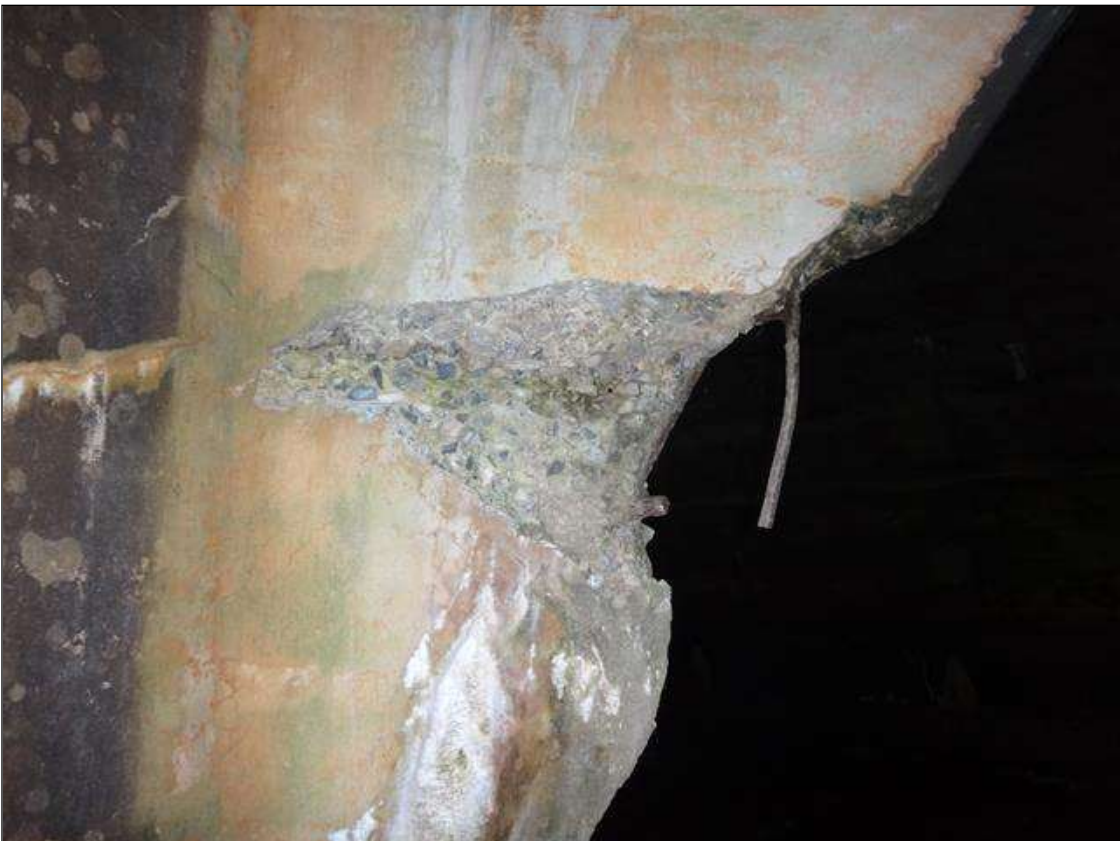
west headwall at north side, spall (20in x 14in x 4-1/2in) with exposed rusted rebar

3370	Maintenance and Repair of NBIS Pipes and Culverts	LF	2	WEST HEADWALL AT NORTH WALL, SPALL (20IN X 14IN X 4-1/2IN) WITH EXPOSED RUSTED REBAR

MMS Code	MMS Description	Quantity
3370	Maintenance and Repair of NBIS Pipes and Culverts	2 LF
Location:		
Pipe	Bent/Span No. 1	HEADWALL
Priority Level	Status	
Priority Maintenance	Division Maintenance Work In Process	
Submitted Date:	Submitted By:	Assisted By:
06/05/2017	WILLIAM MITCHELL	PARKER GUFFEY
Details		
WEST HEADWALL AT NORTH WALL, SPALL (20IN X 14IN X 4-1/2IN) WITH EXPOSED RUSTED REBAR

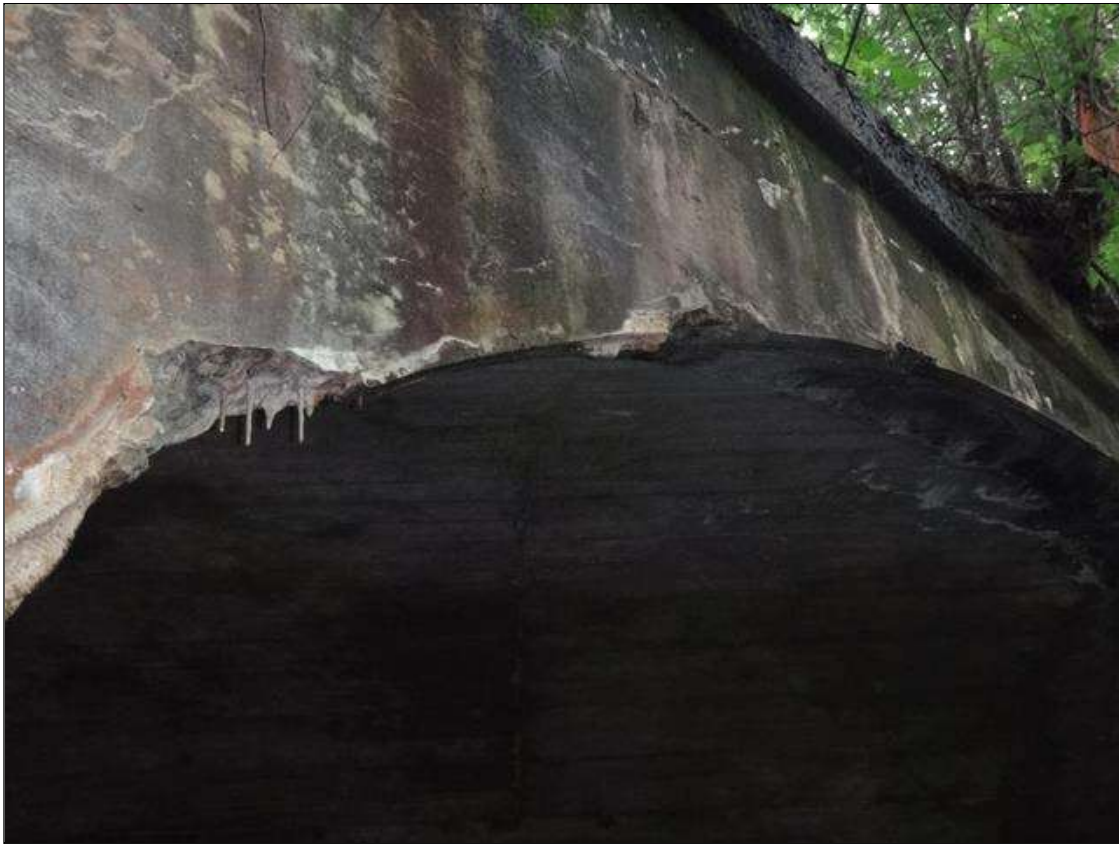
west headwall, (3) spalls (up to 24in x 6in x up to 5in)

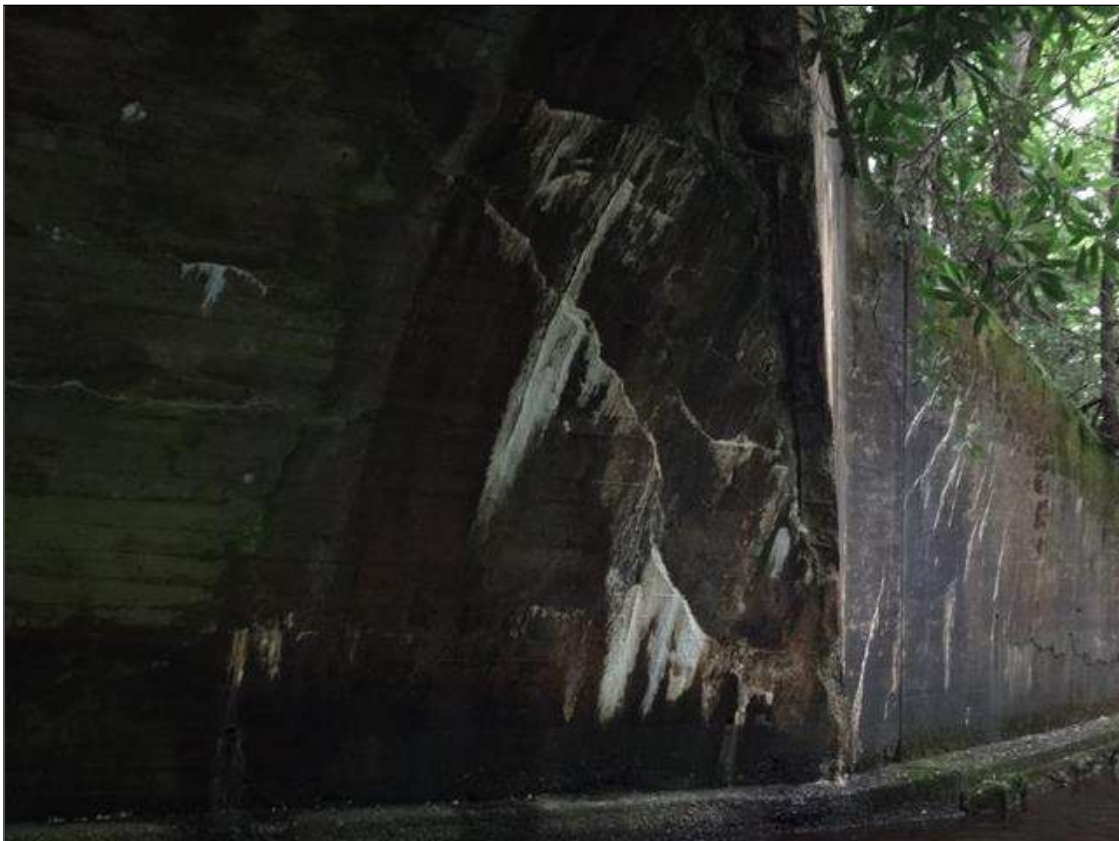
Barrel 1 Section 1: south wall at west end of barrel 1, cracking (12ft x up to 1/8in) with efflorescence

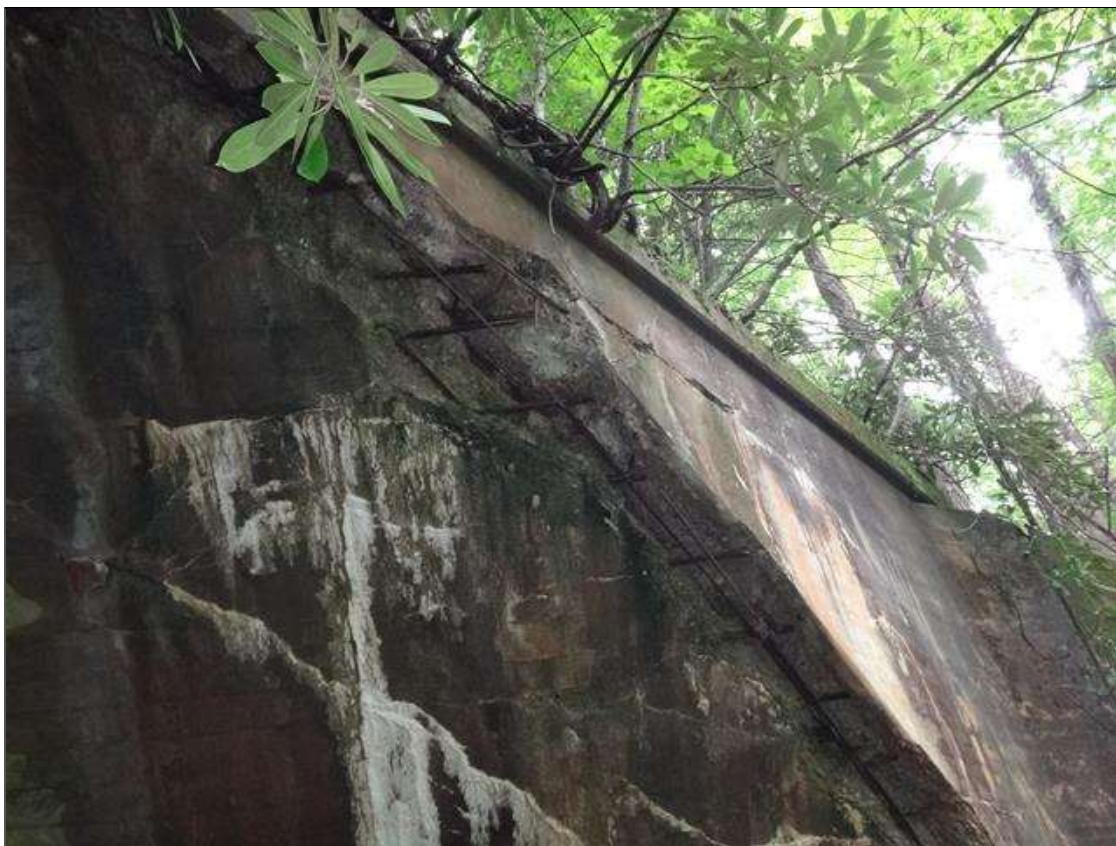
west headwall along southside, spall (18ft x 30in x up to 16in) with exposed rusted rebar

3370	Maintenance and Repair of NBIS Pipes and Culverts	LF	18	WEST HEADWALL ALONG SOUTHERN HALF OF SPANDREL, SPALL (18FT X 30IN X UP TO 16IN) WITH EXPOSED RUSTED REBAR	
3370	Maintenance and Repair of NBIS Pipes and Culverts	LF	12	Barrel 1 Section 1: north wall at east end of barrel 1, cracking (12ft x up to 1/8in) with efflorescence

MMS Code	MMS Description	Quantity
3370	Maintenance and Repair of NBIS Pipes and Culverts	18 LF
Location:		
Pipe	Bent/Span No. 1	HEADWALL
Priority Level	Status	
Priority Maintenance	Division Maintenance Work In Process	
Submitted Date:	Submitted By:	Assisted By:
06/05/2017	WILLIAM MITCHELL	PARKER GUFFEY
Details		
WEST HEADWALL ALONG SOUTHERN HALF OF SPANDREL, SPALL (18FT X 30IN X UP TO 16IN) WITH EXPOSED RUSTED REBAR

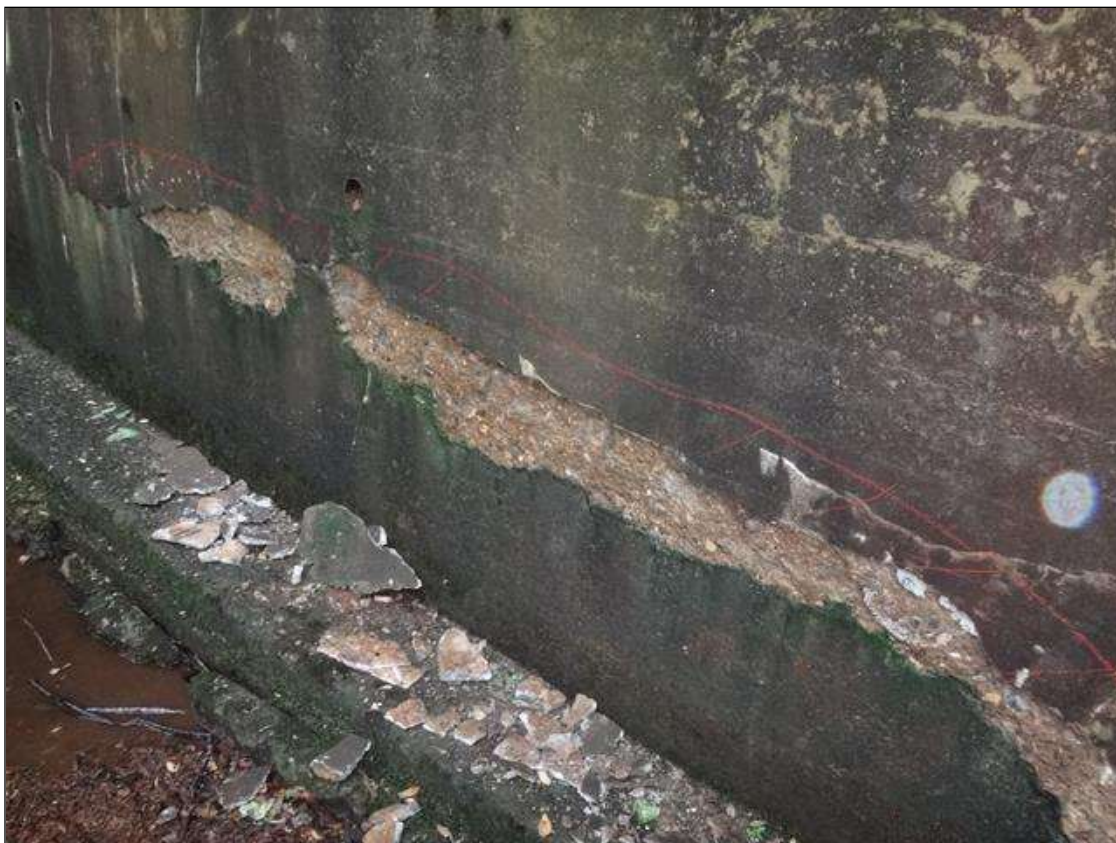
southwest wingwall, spall (13ft x up to 1ft x up to 1in) with adjacent delamination (13ft x up to 1ft)

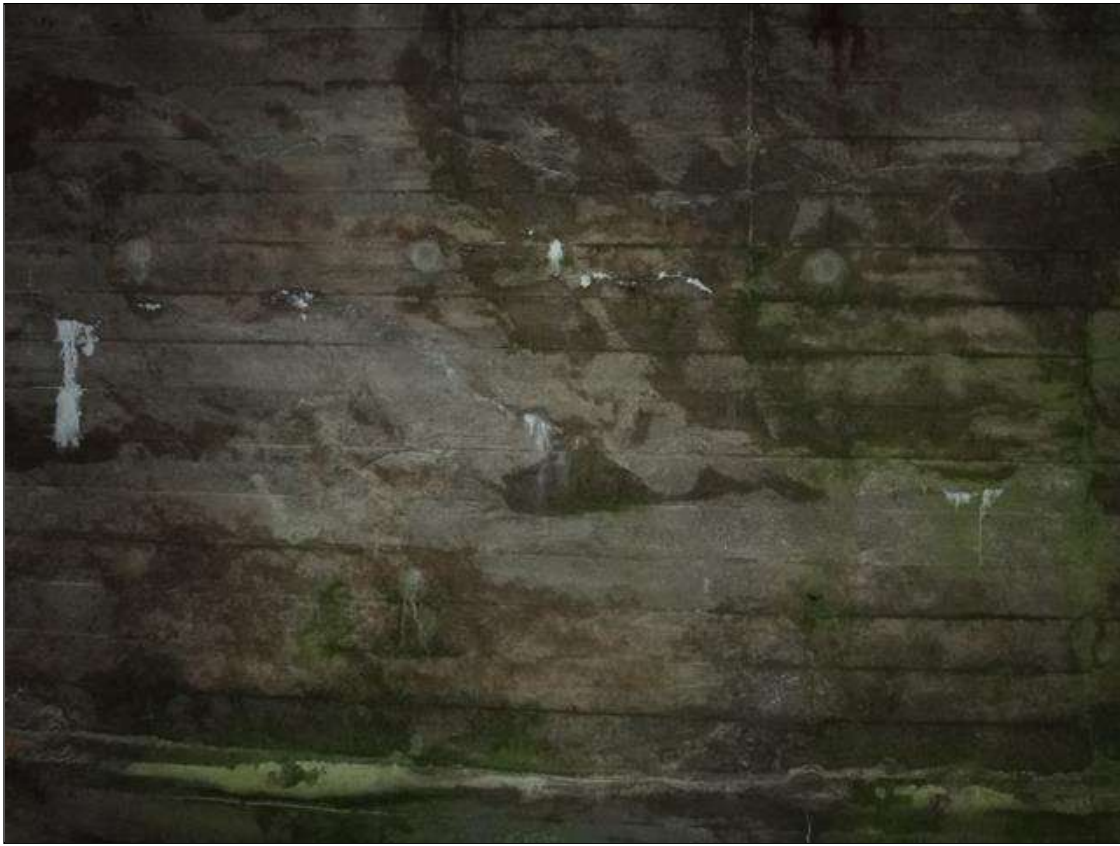
Barrel 1 Section 1: south wall near top at west end, (2) horizontal cracks (up to 30ft x up to 1/4in)

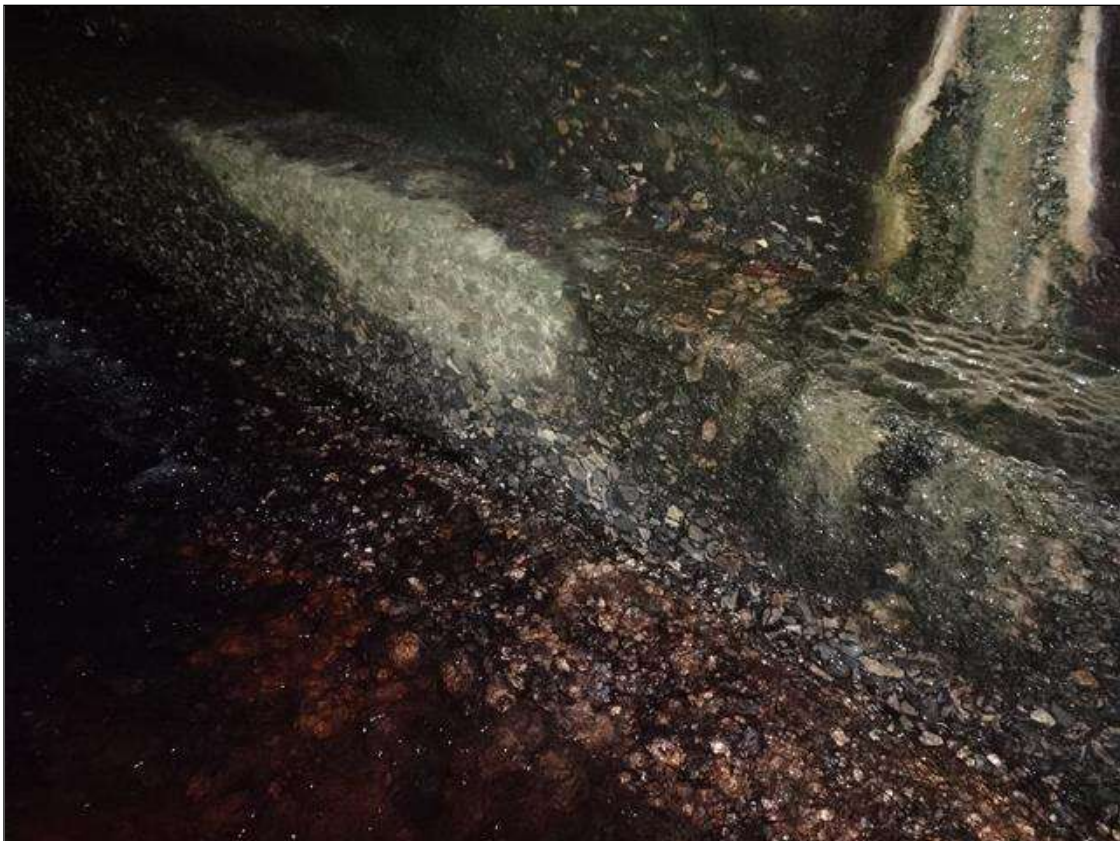
south footing at waterline, abrasion (full length) with exposed aggregate

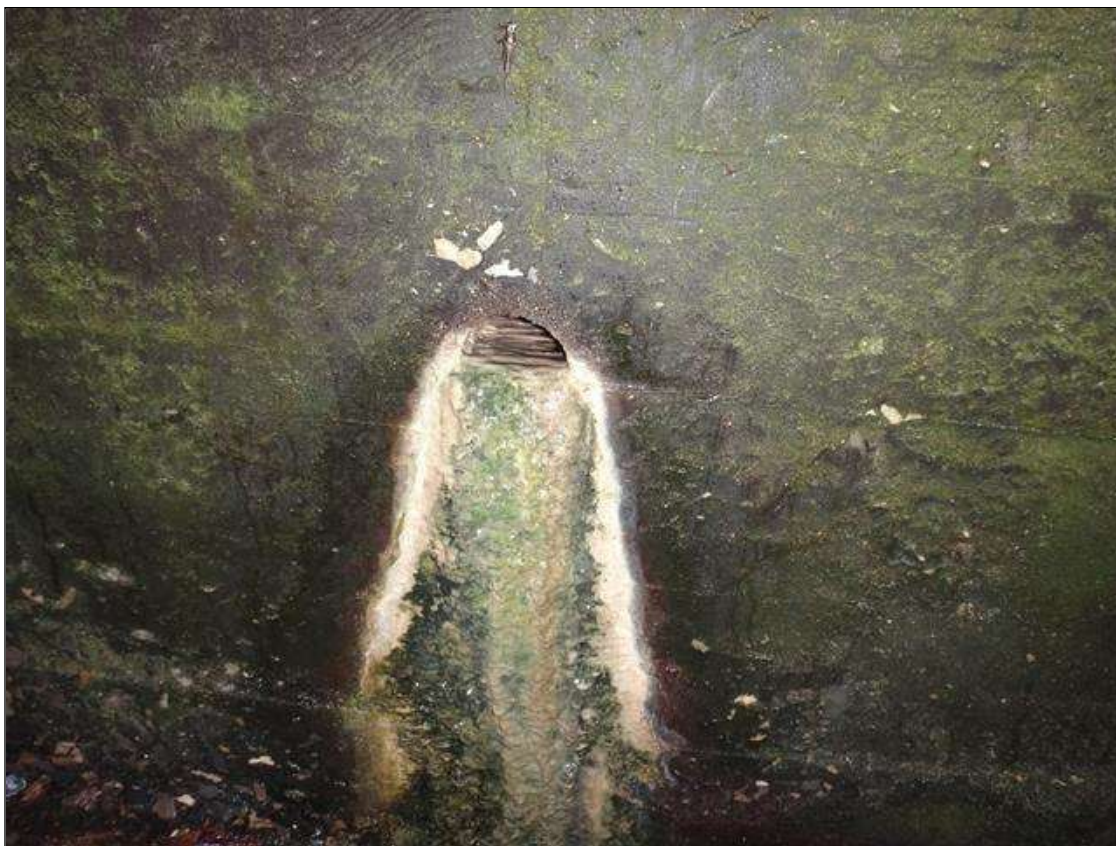
Item	Drainage System	Grade	F	Maint Code	3332	Qty.	8
Details	south wall at west end, partially clogged weep drains (all weep drains on south wall similar)

south wall at west end, partially clogged weep drain

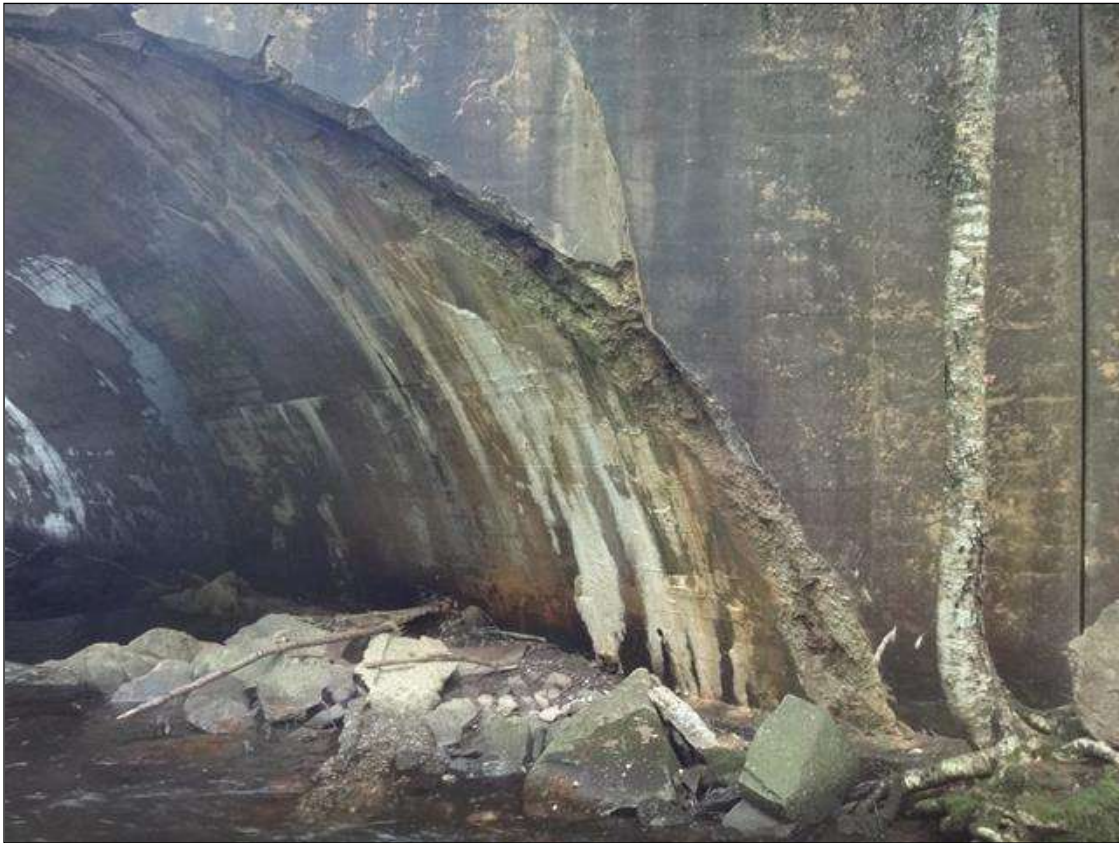
EAST HEADWALL ALONG NORTHERN HALF OF SPANDREL, SPALL (16FT X 18IN X UP TO 1FT) WITH EXPOSED RUSTED REBAR

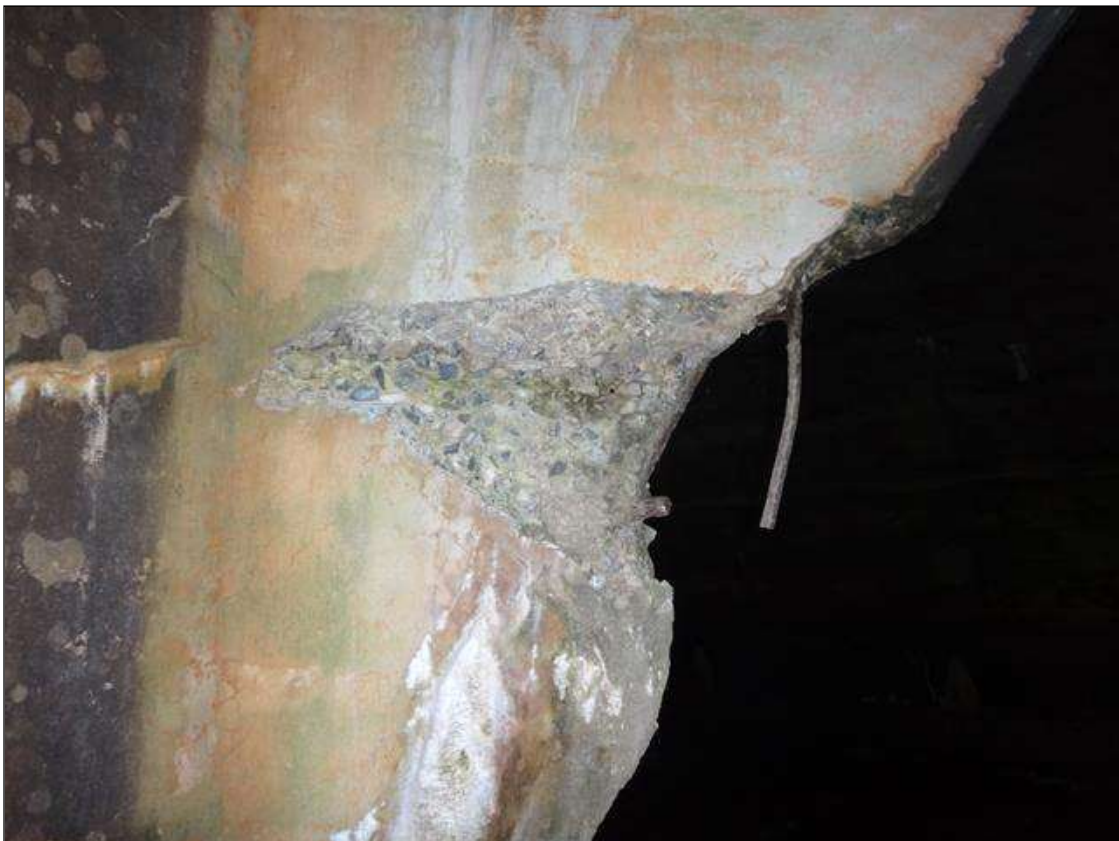
WEST HEADWALL AT NORTH WALL, SPALL (20IN X 14IN X 4-1/2IN) WITH EXPOSED RUSTED REBAR

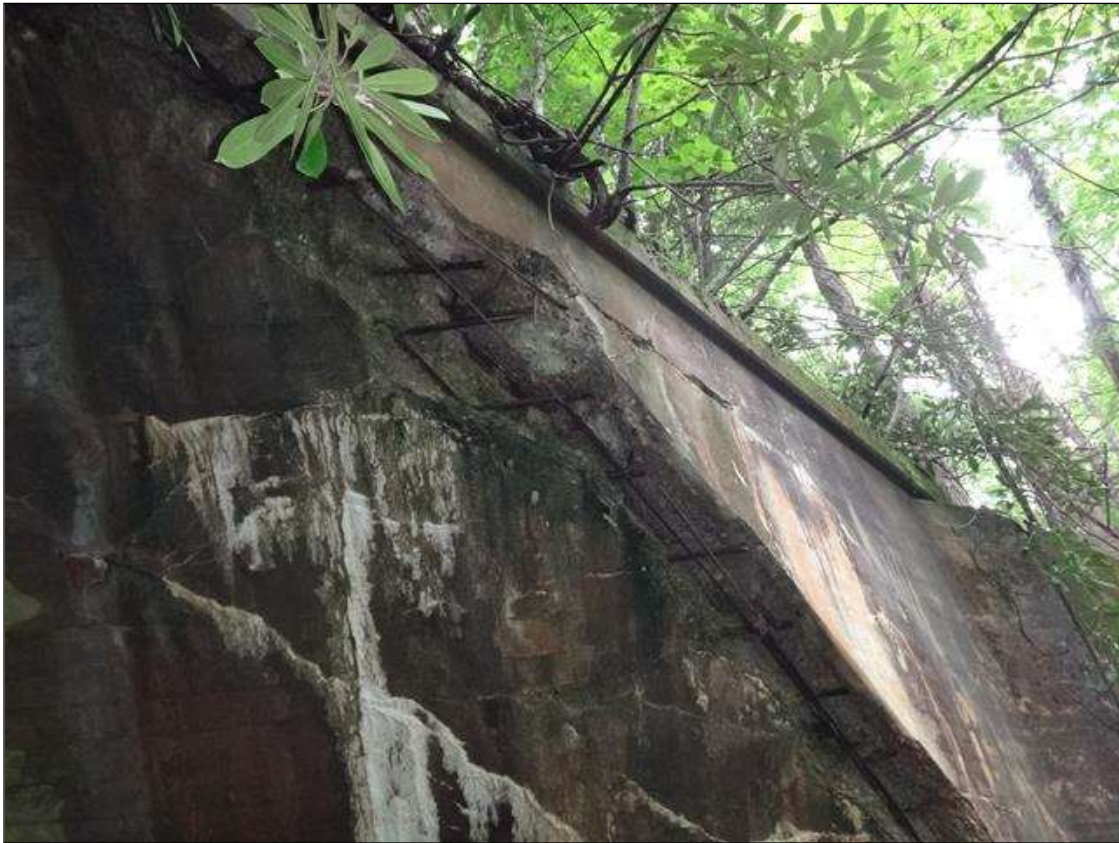
WEST HEADWALL ALONG SOUTHERN HALF OF SPANDREL, SPALL (18FT X 30IN X UP TO 16IN) WITH EXPOSED RUSTED REBAR
