NC DEPARTMENT OF TRANSPORTATION
 DIVISION OF HIGHWAYS
 STRUCTURE MANAGEMENT UNIT

Structure Safety Report

COUNTY: WATAUGA STRUCTURE NUMBER: 940066 FREQUENCY: 24 MONTHS

SUPERSTRUCTURE: SINGLE 30'X19'RC ARCH CULVERT;65'ALONG CENTERLINE CULVERT

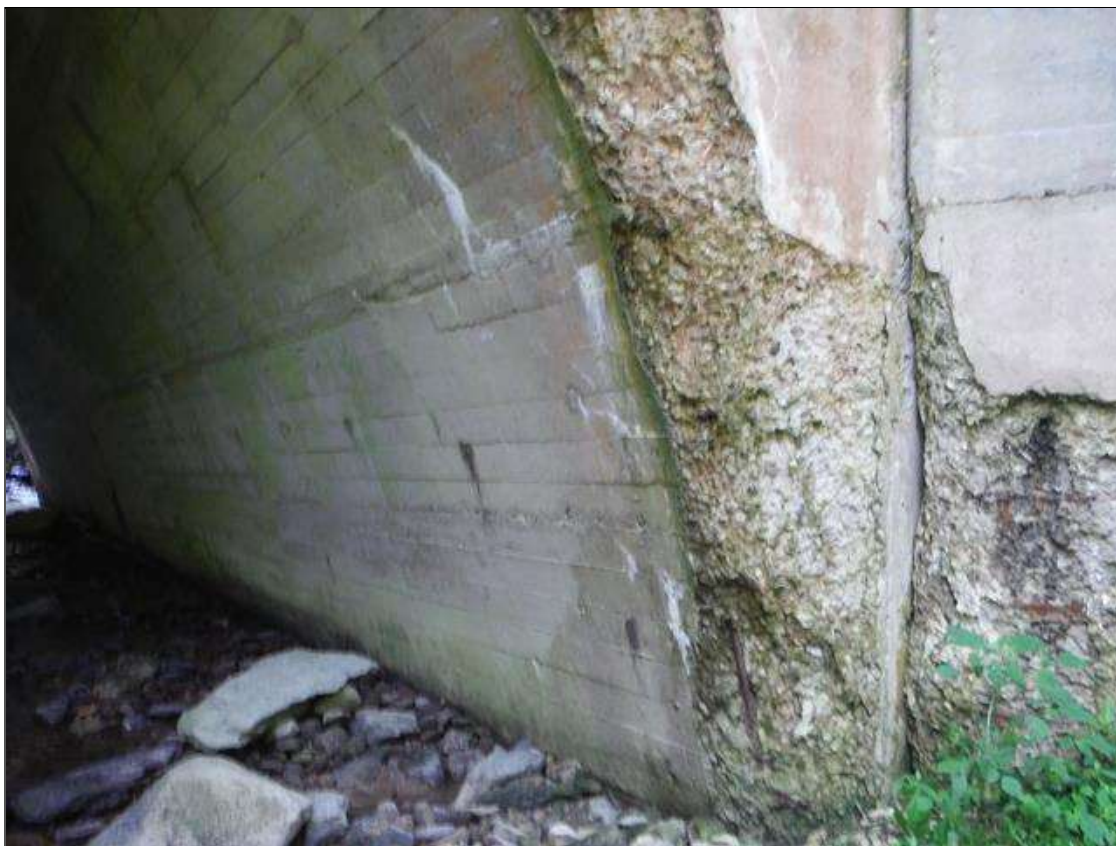
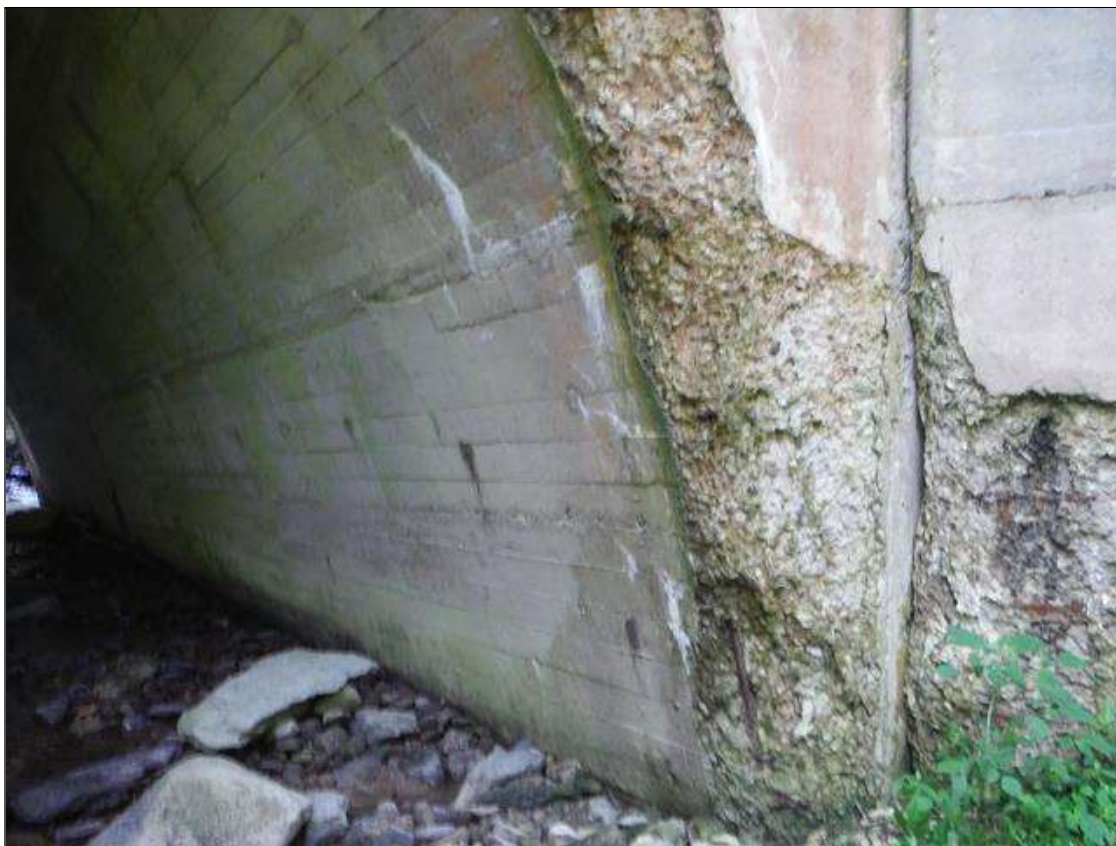
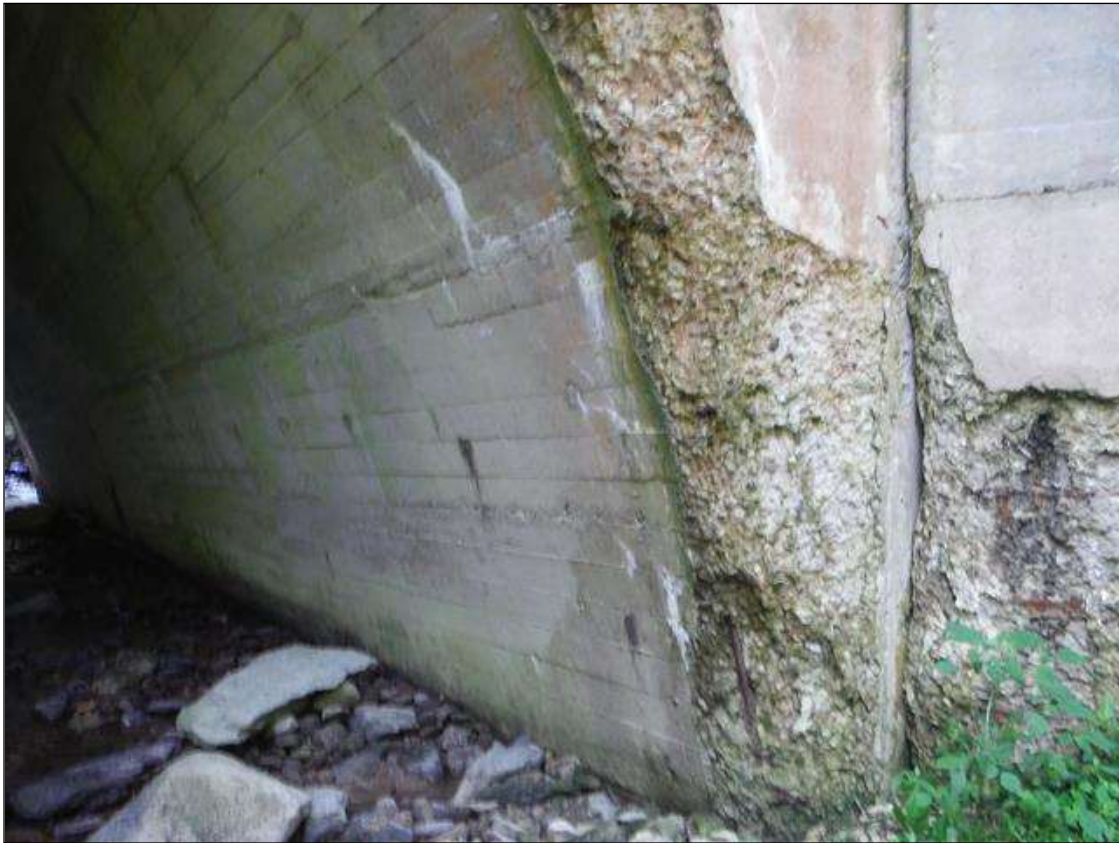
Item	Headwalls	Grade P	Maint Code 4675	Qty. 294
Details	150 SF. X UP TO 4" DEEP SPALL WITH EXPOSED REBAR IN DOWNSTREAM HEADWALL (PM) 5 FT. X 1 FT. X 4" DEEP SPALL WITH EXPOSED REBAR IN UPSTREAM HEADWALL (PM) 36 FT. X 1 FT. X 2" DEEP SPALL IN UPSTREAM HEADWALL 36" X 7" DELAMINATION AND 12" X 3" X 1" DEEP SPALL IN UPSTREAM HEADWALL 100 SF. OF VERTICAL AND LONGITUDINAL CRACKING WITH EFFLORESCENCE IN UPSTREAM HEADWALL

150 SF. X UP TO 4" DEEP SPALL WITH EXPOSED REBAR IN DOWNSTREAM HEADWALL (PM)

3370	Maintenance and Repair of NBIS Pipes and Culverts	LF	30	150 SF. X UP TO 4" DEEP SPALL WITH EXPOSED REBAR IN DOWNSTREAM HEADWALL (PM)

MMS Code	MMS Description	Quantity
3370	Maintenance and Repair of NBIS Pipes and Culverts	30 LF
Location:		
Pipe	Bent/Span No. 1	DOWNSTREAM HEADWALL
Priority Level	Status	
Priority Maintenance	Division Maintenance Work In Process	
Submitted Date:	Submitted By:	Assisted By:
07/25/2017	MATTHEW MOYER	DAVID WAGNER
Details		
150 SF. X UP TO 4" DEEP SPALL WITH EXPOSED REBAR IN DOWNSTREAM HEADWALL (PM)

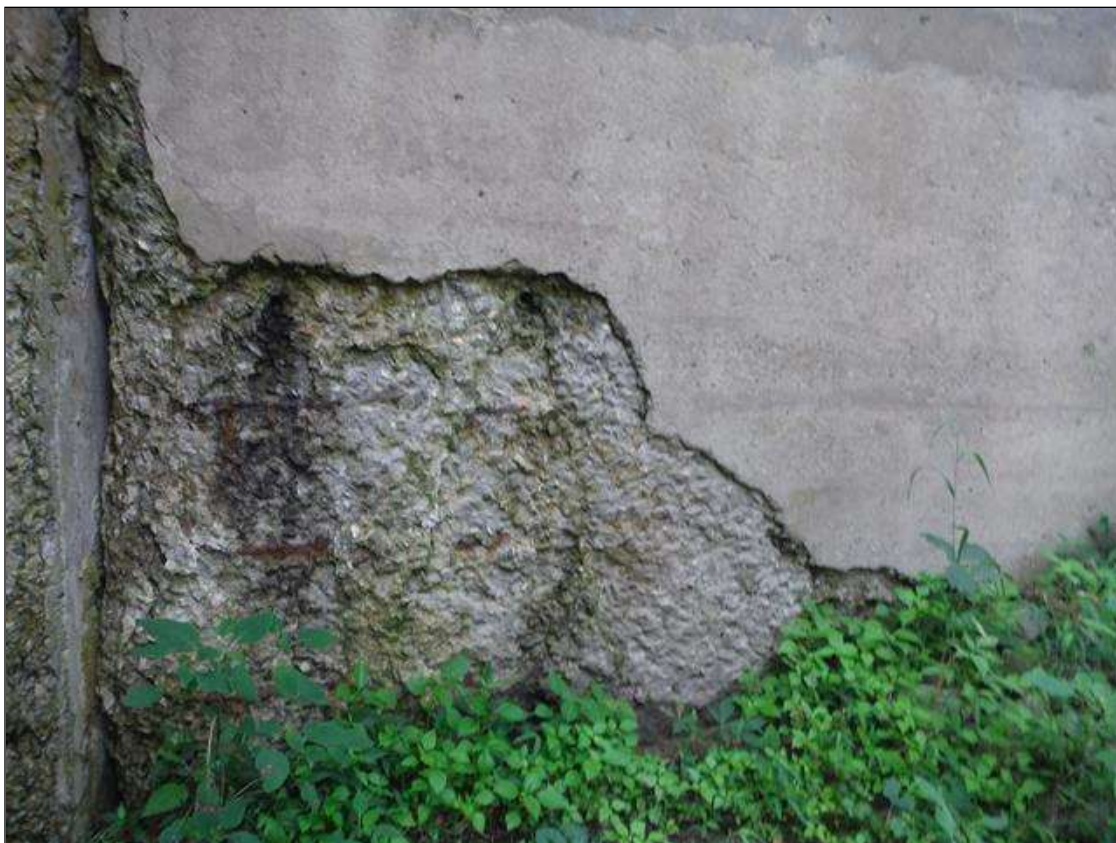
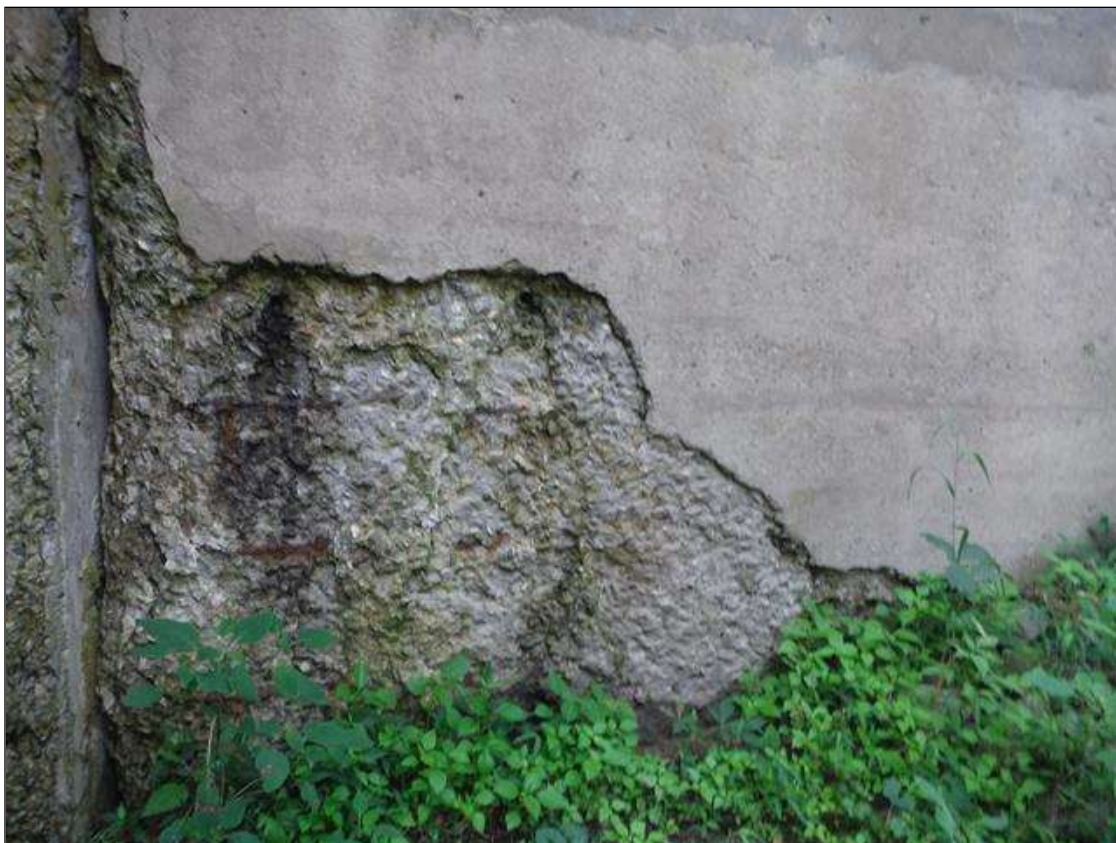
Item	Wingwalls	Grade P	Maint Code 3350	Qty. 36
Details	5 FT. X 4 FT. X 2" DEEP SPALL WITH EXPOSED REBAR IN NORTHEAST WINGWALL 6 FT. X 1 FT. X 2" DEEP SPALL WITH EXPOSED REBAR IN NORTHEAST WINGWALL 10 FT. OF ABRASION WITH EXPOSED COARSE AGGREGATE 6" ABOVE WATERLINE IN NORTHWEST WINGWALL

5 FT. X 4 FT. X 2" DEEP SPALL WITH EXPOSED REBAR IN NORTHEAST WINGWALL

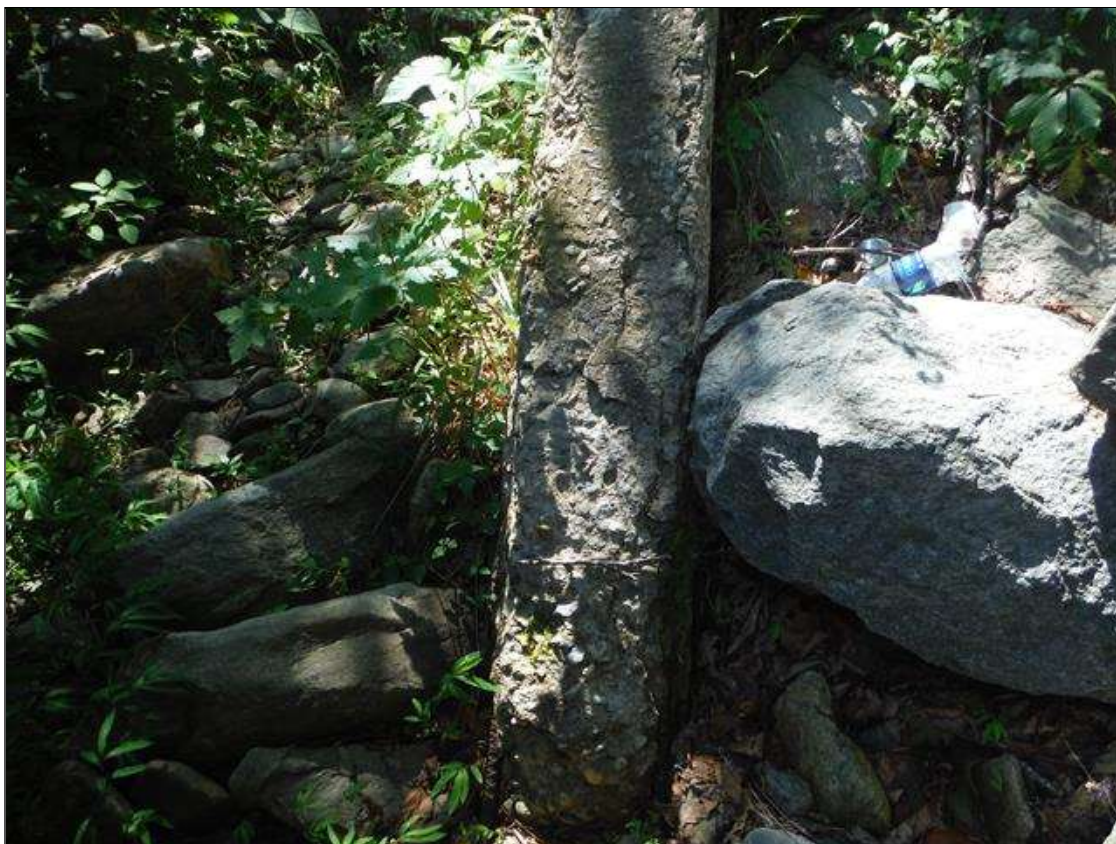
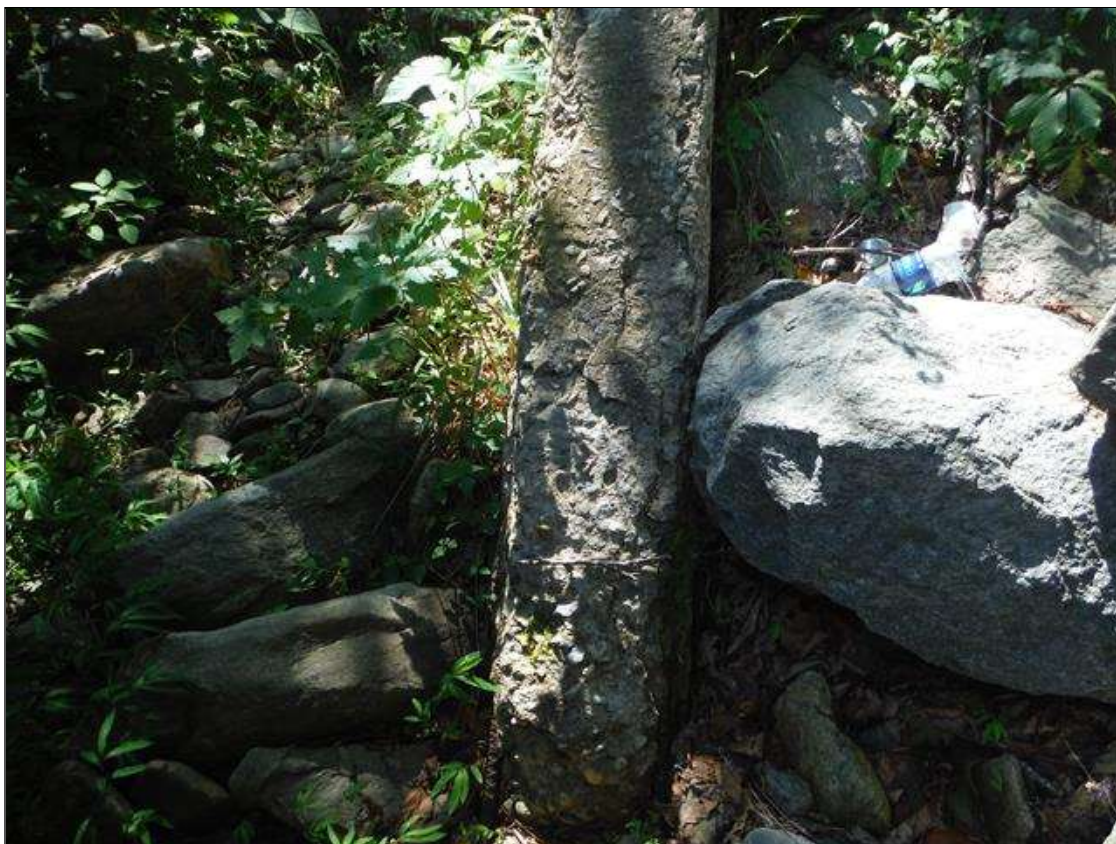
6 FT. X 1 FT. X 2" DEEP SPALL WITH EXPOSED REBAR IN NORTHEAST WINGWALL

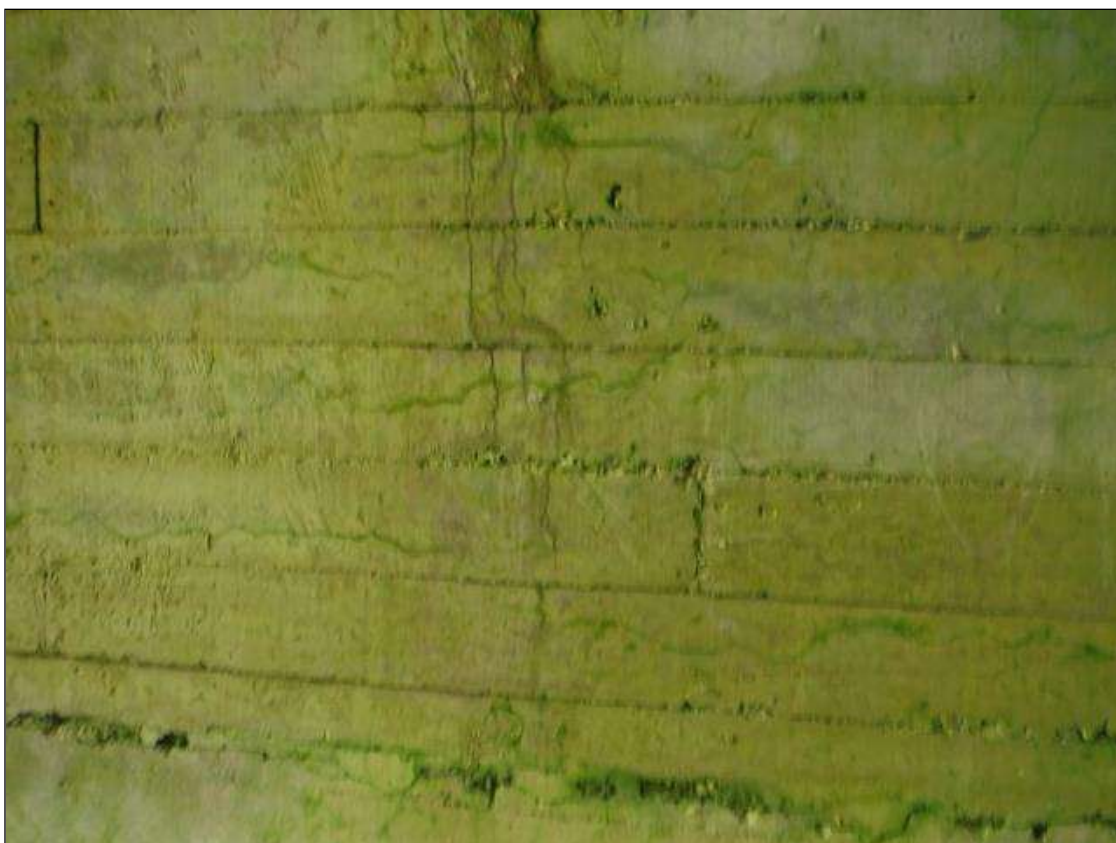
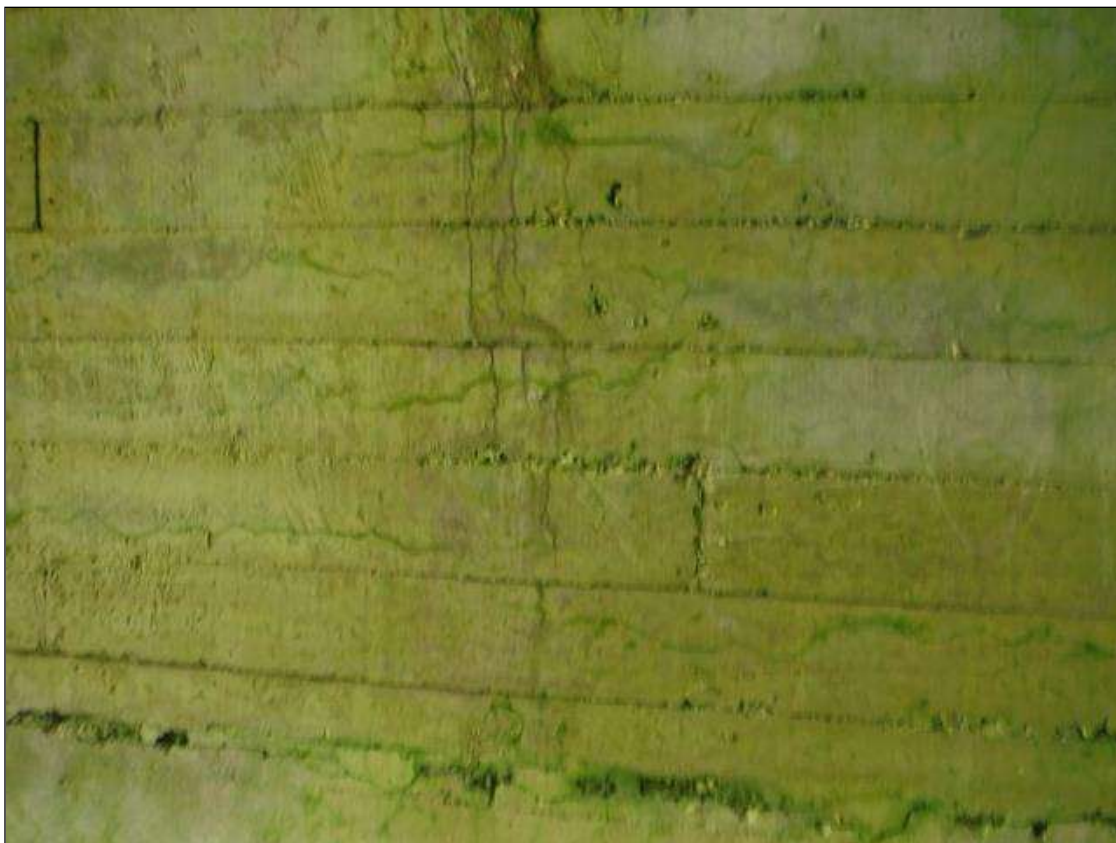
Element Number	Defect Type	Defect Description	CS	CS Qty	Maint Qty
241	Cracking (RC and Other)	2300 SF. OF LONGITUDINAL CRACKING AND MAP CRACKING UP TO 1/32" WIDE	3	64	2,300 Feet
241	Efflorescence/Rust Staining	25 SF. OF LONGITUDINAL AND VERTICAL CRACKING WITH EFFLORESCENCE	2		25 Feet
241	Exposed Rebar	6" X 1" X 4" DEEP SPALL WITH EXPOSED REBAR IN TOP OF PIPE 25 FT. FROM DOWNSTREAM END	2	1	1 Feet

2300 SF. OF LONGITUDINAL CRACKING AND MAP CRACKING UP TO 1/32" WIDE

Barrel 1 Section 1: 2300 SF. OF LONGITUDINAL CRACKING AND MAP CRACKING UP TO 1/32" WIDE

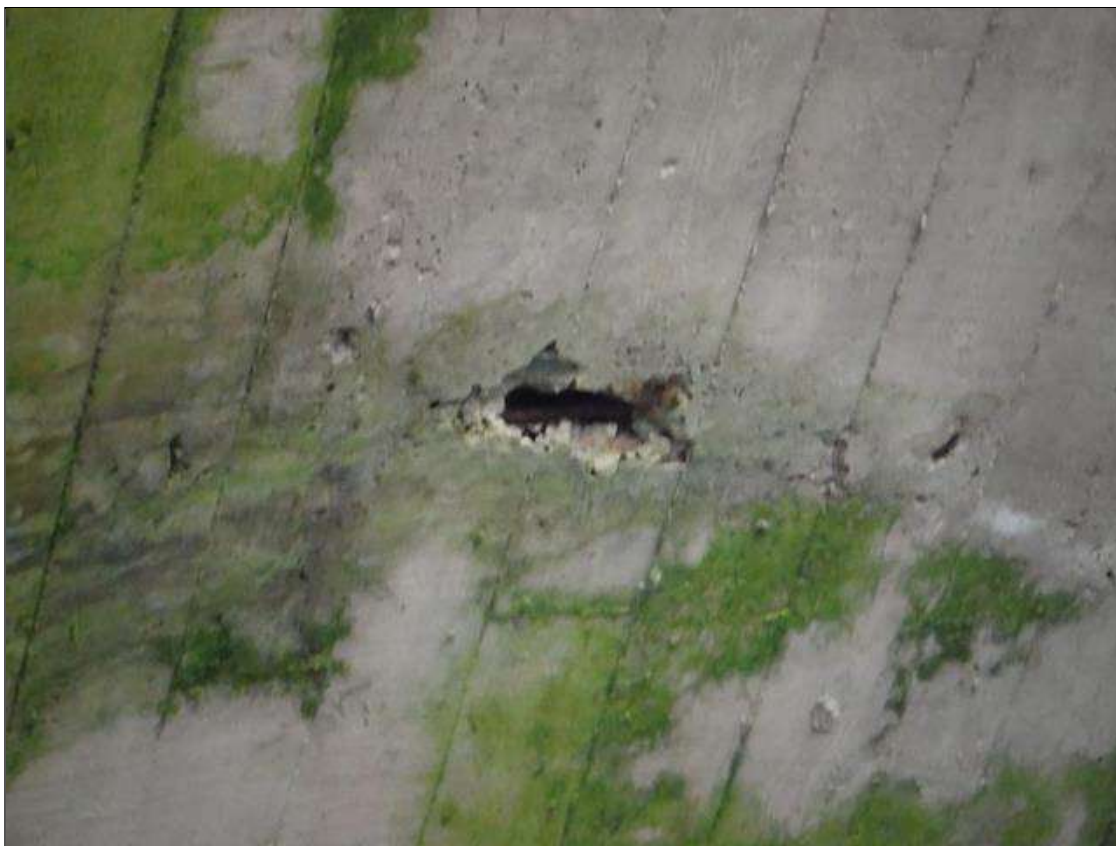
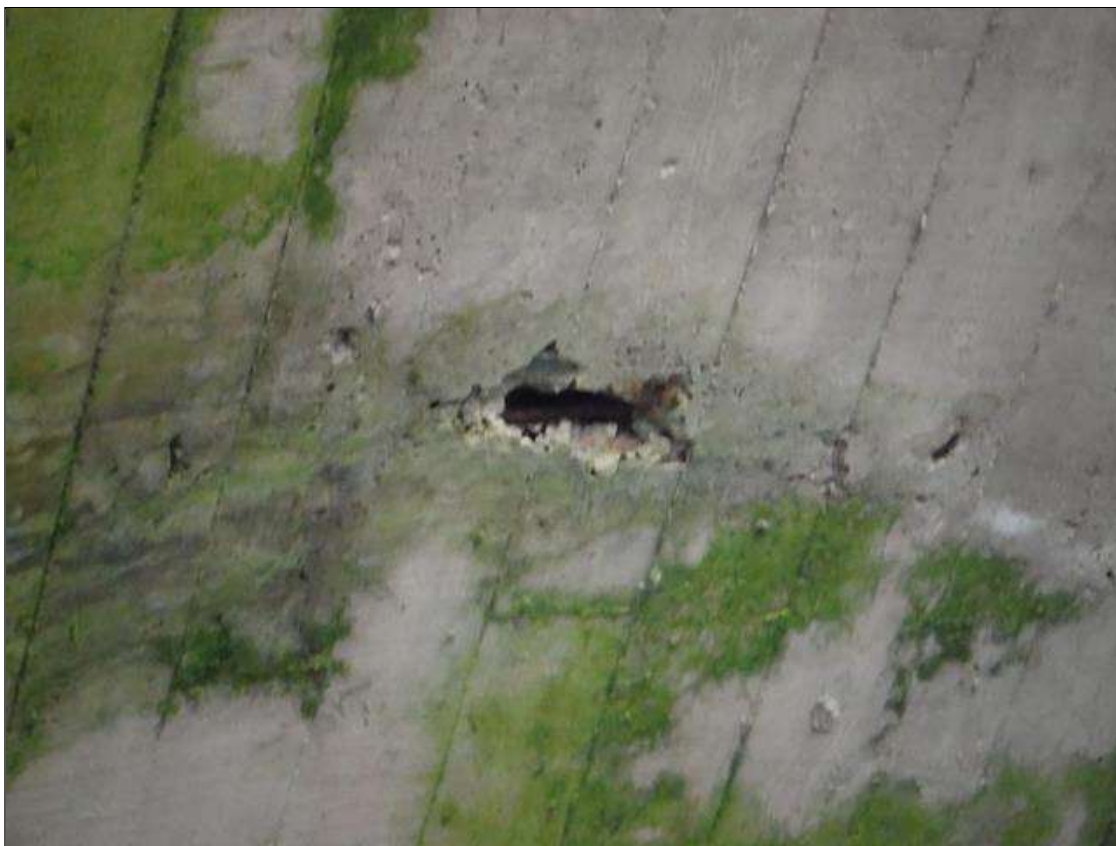
Barrel 1 Section 1: 6" X 1" X 4" DEEP SPALL WITH EXPOSED REBAR IN TOP OF PIPE 25 FT. FROM DOWNSTREAM END

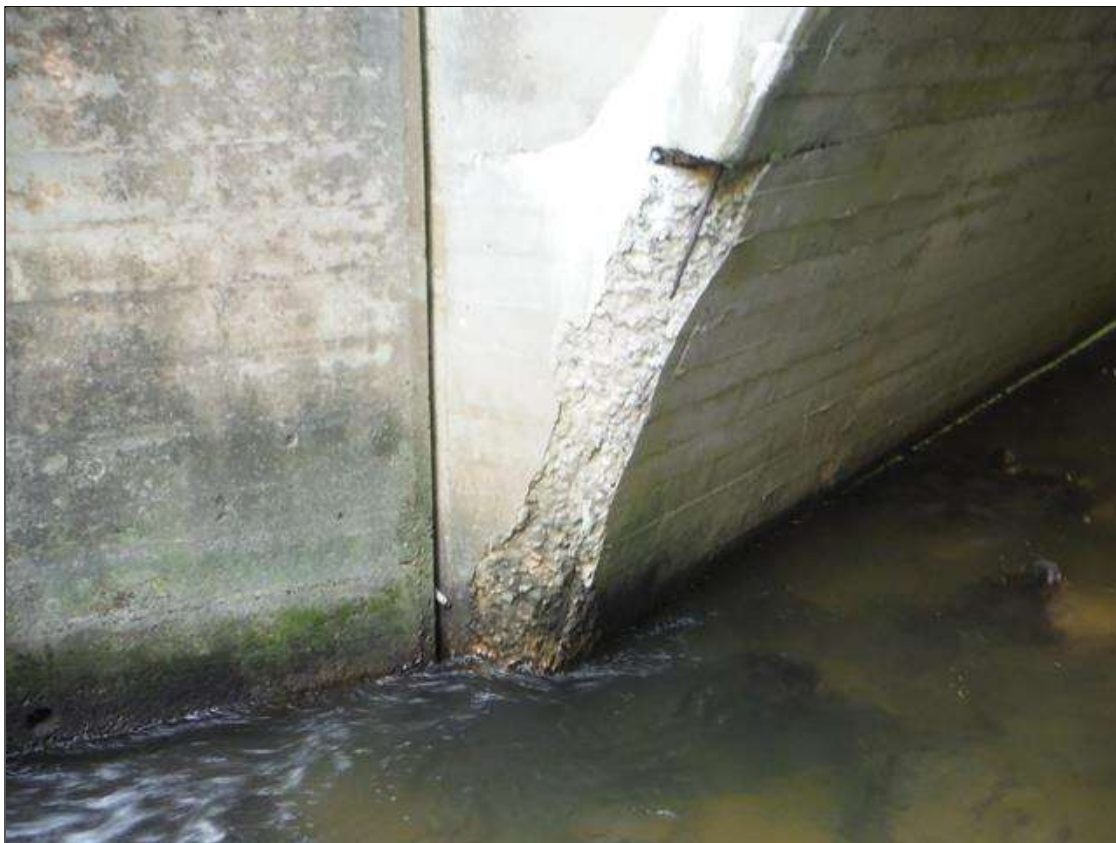
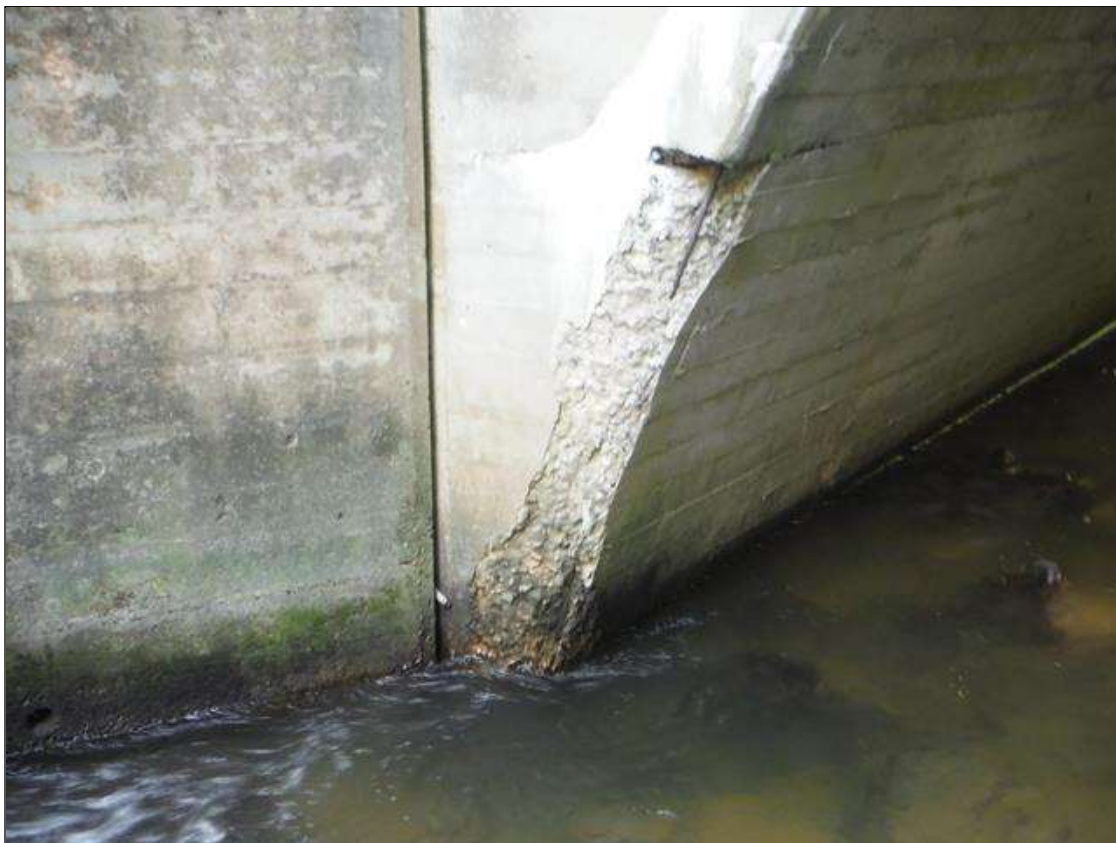
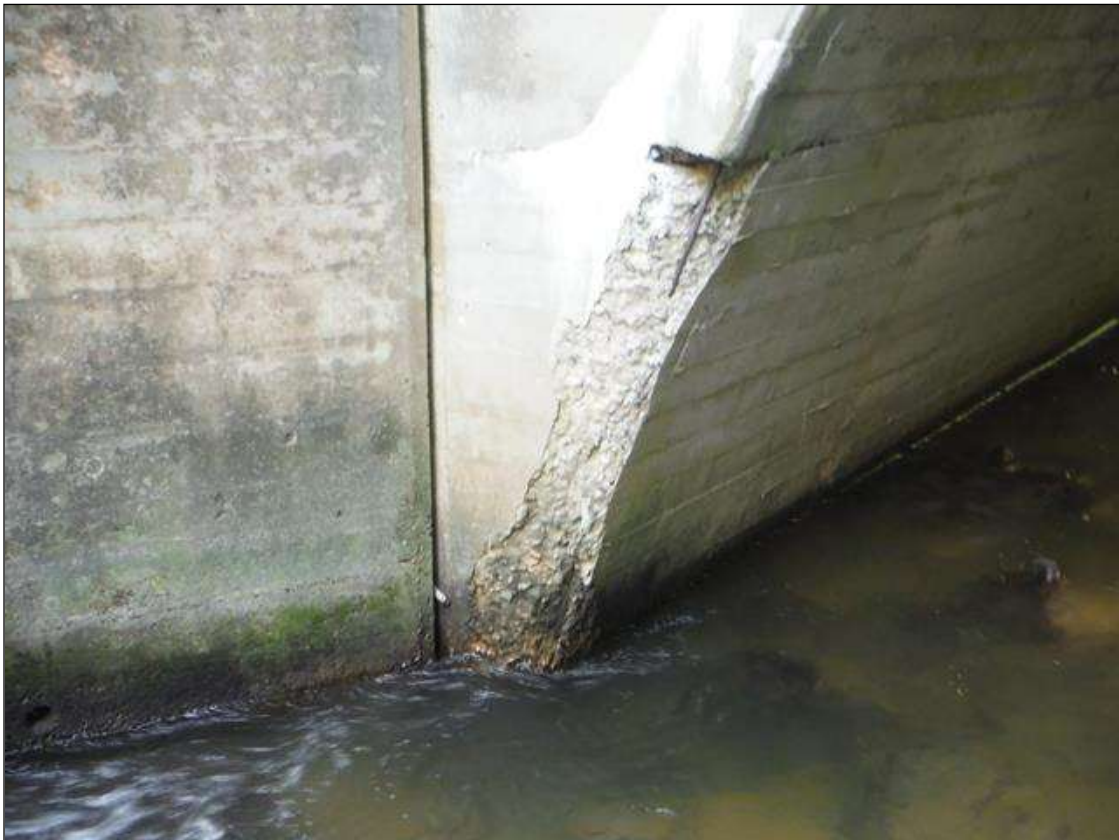
5 FT. X 1 FT. X 4" DEEP SPALL WITH EXPOSED REBAR IN UPSTREAM HEADWALL (PM)

3370	Maintenance and Repair of NBIS Pipes and Culverts	LF	5	5 FT. X 1 FT. X 4" DEEP SPALL WITH EXPOSED REBAR IN UPSTREAM HEADWALL (PM)

MMS Code	MMS Description	Quantity
3370	Maintenance and Repair of NBIS Pipes and Culverts	5 LF
Location:		
Pipe	Bent/Span No. 1	UPSTREAM HEADWALL
Priority Level	Status	
Priority Maintenance	Division Maintenance Work In Process	
Submitted Date:	Submitted By:	Assisted By:
07/25/2017	MATTHEW MOYER	DAVID WAGNER
Details		
5 FT. X 1 FT. X 4" DEEP SPALL WITH EXPOSED REBAR IN UPSTREAM HEADWALL (PM)

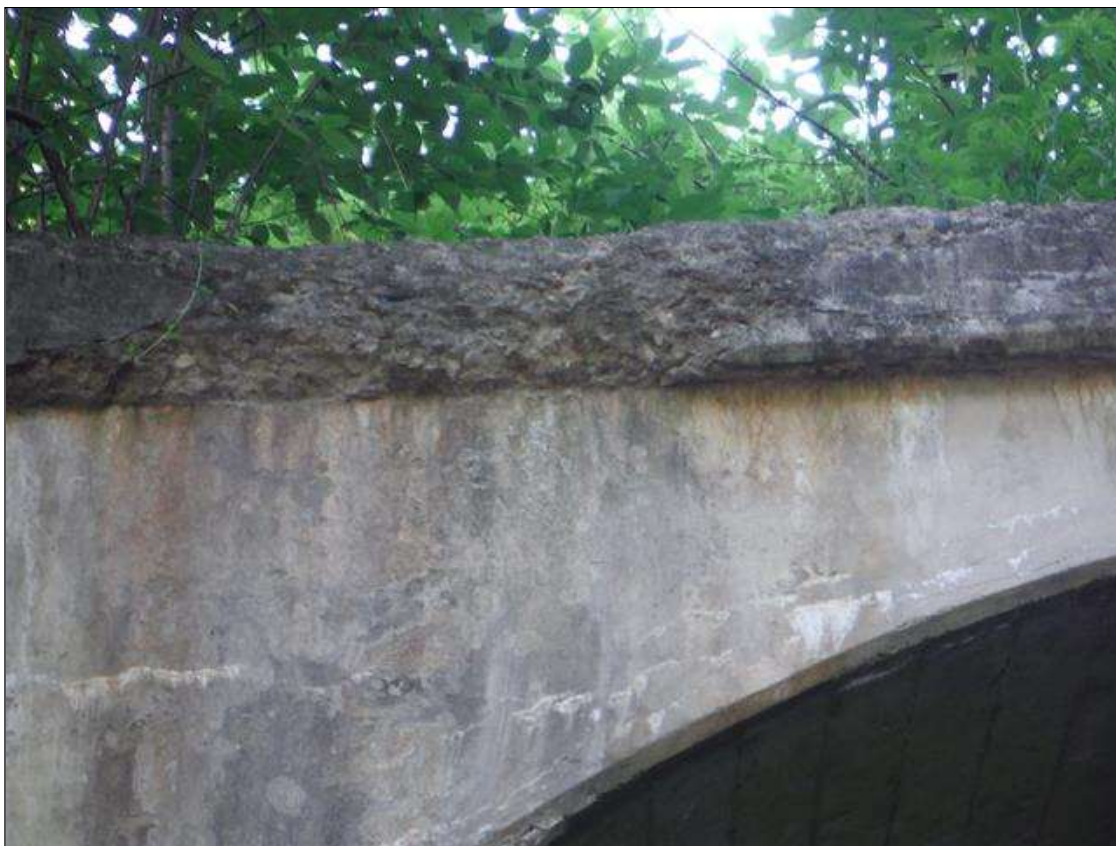
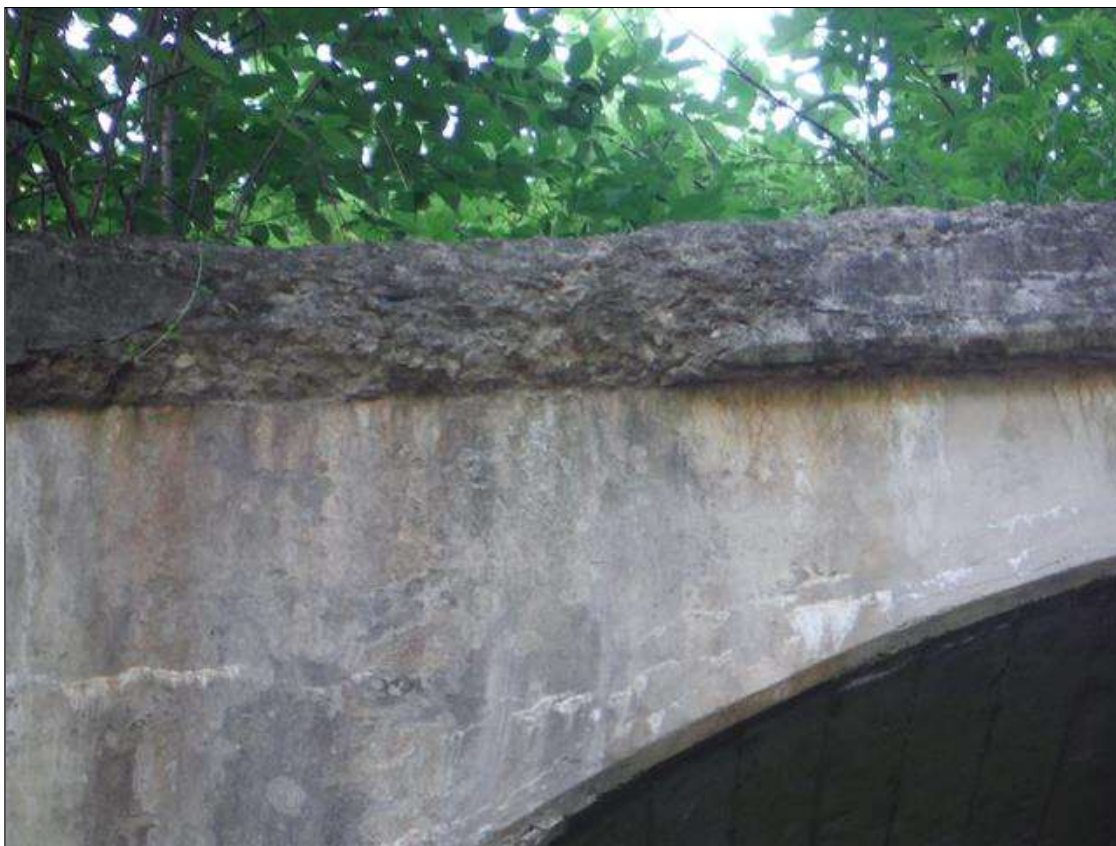
36 FT. X 1 FT. X 2" DEEP SPALL IN UPSTREAM HEADWALL

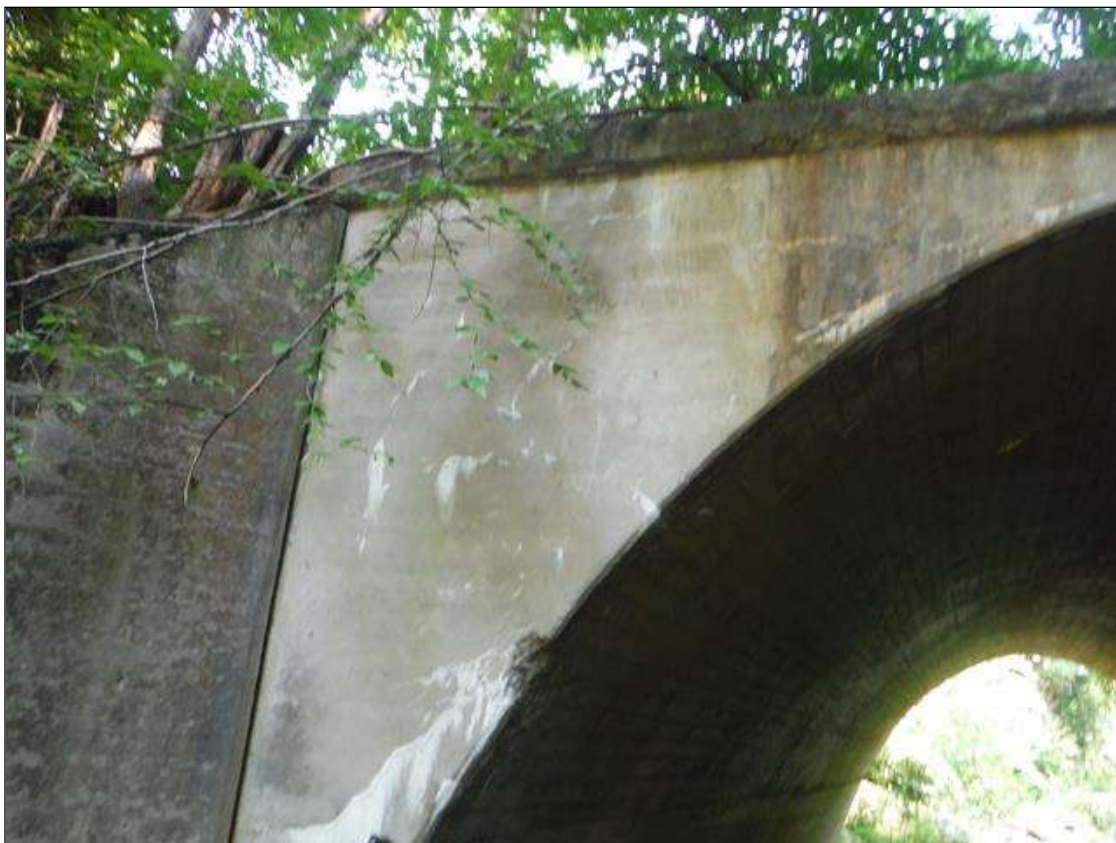
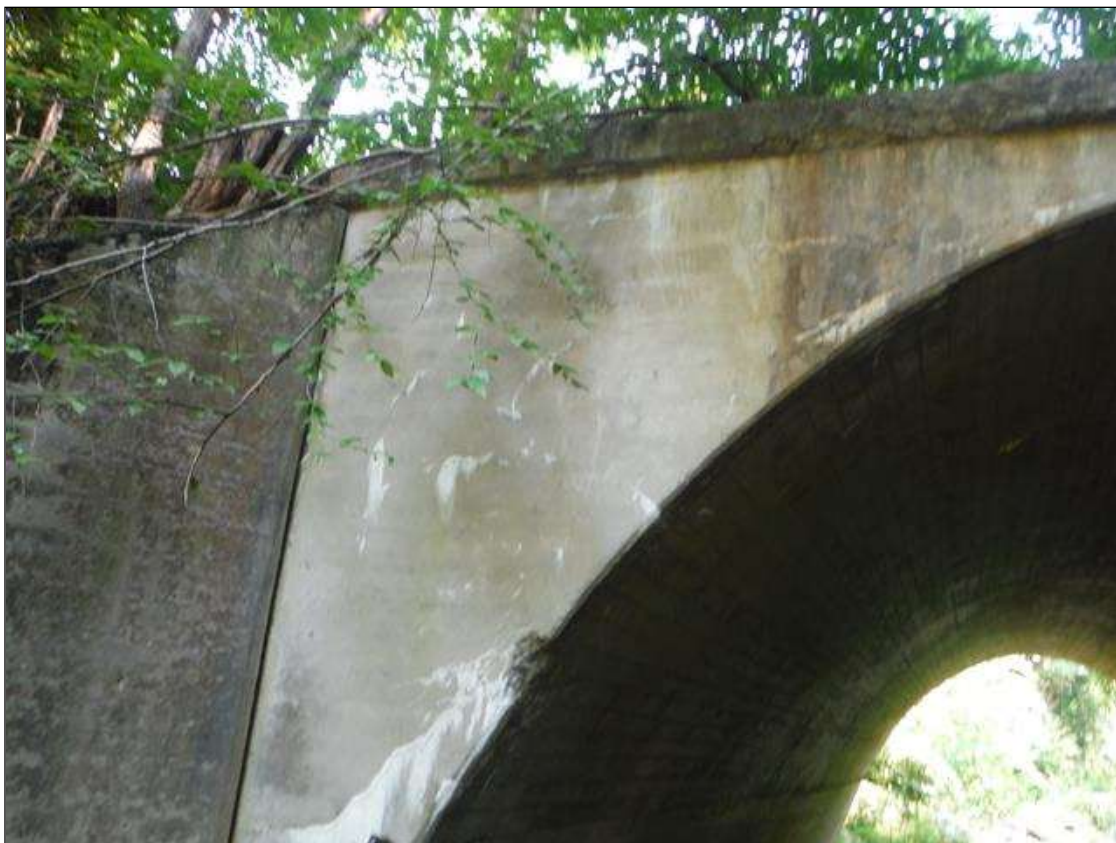
100 SF. OF VERTICAL AND LONGITUDINAL CRACKING WITH EFFLORESCENCE IN UPSTREAM HEADWALL
