PROJECT NO. 15BPR.32 WATAUGA \_ COUNTY

940066 STRUCTURE: \_

> DOWNSTREAM WING FACES

REVISIONS SHEET NO S-21 1223 Jones Franklin Rd. Raleigh, N.C. 27606 Bus: 919 851 8077 Fax: 919 851 8107 LICENSE NO. F-0377 NO. BY: TOTAL SHEETS

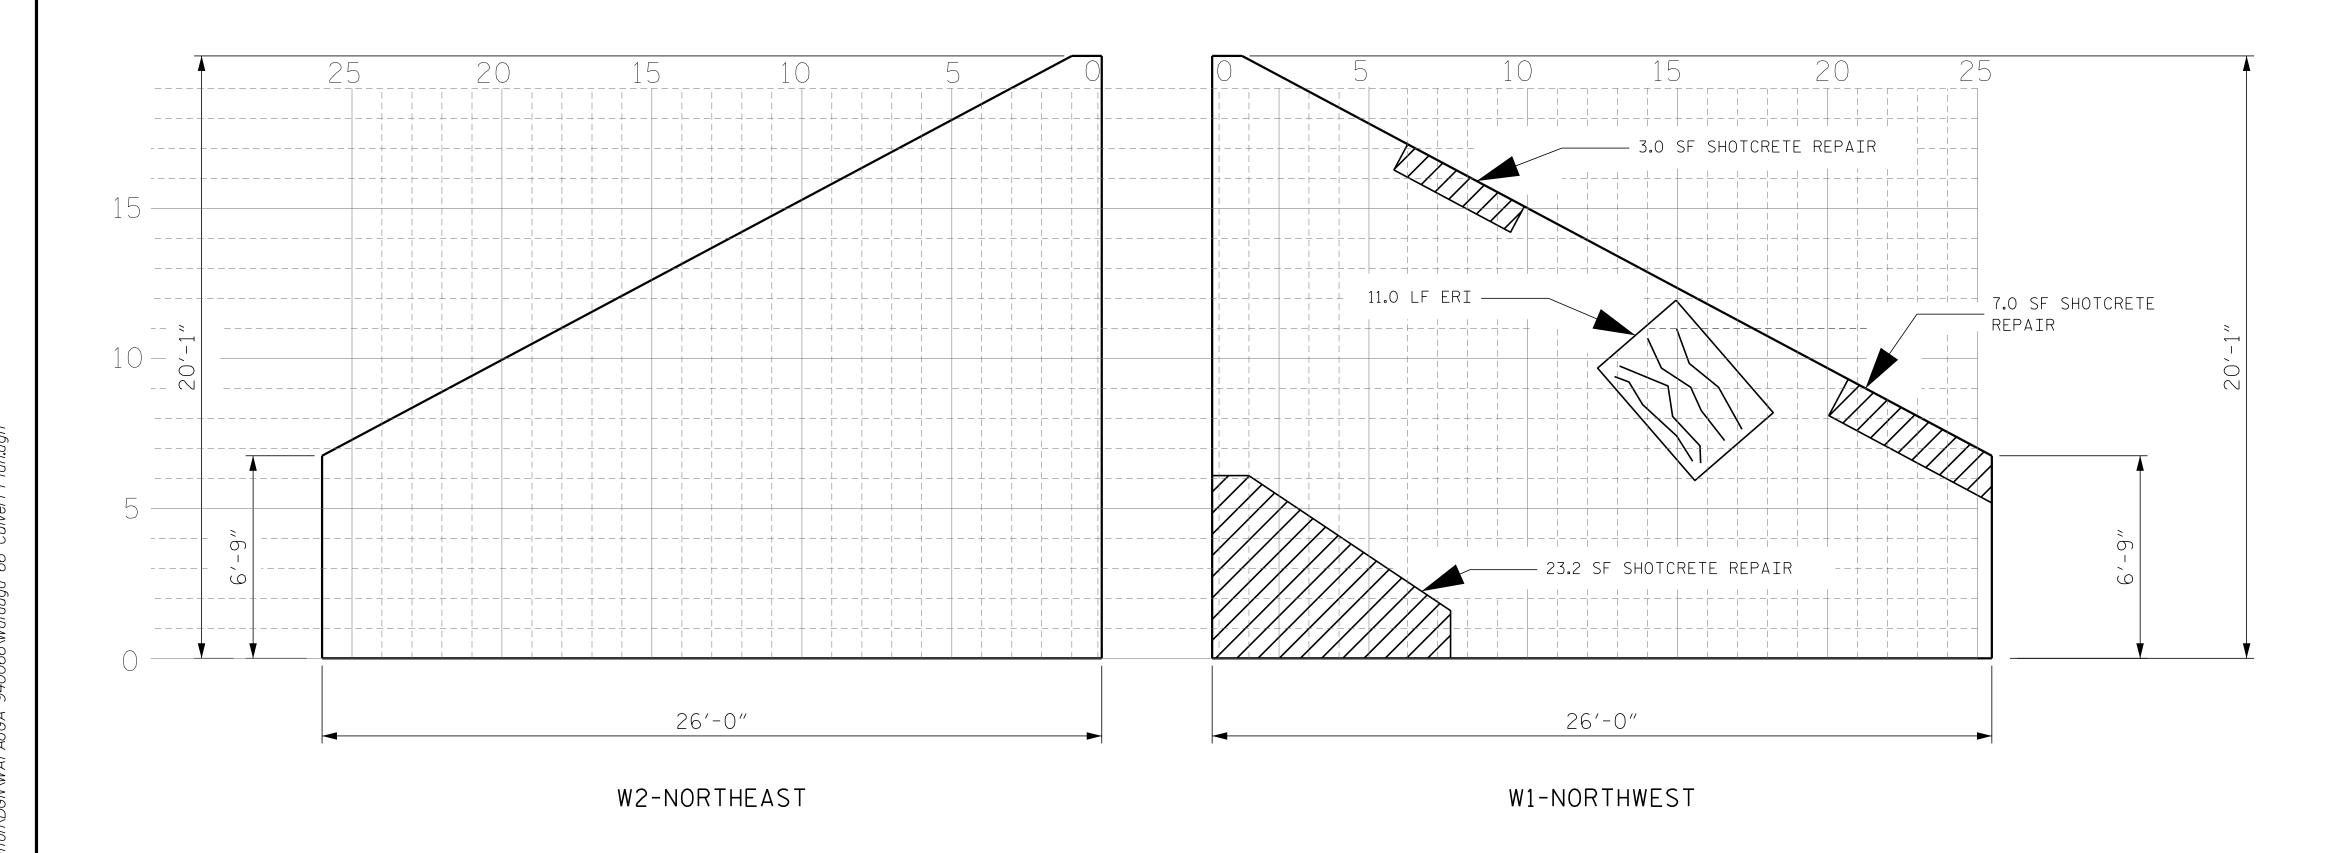
DOWNSTREAM WINGS

AS-BUILT REPAIR QUANTITY TABLE QUANTITIES ESTIMATE ACTUAL AREA | VOLUME | AREA | VOLUME SHOTCRETE REPAIRS SQ.FT. CU.FT. SQ.FT. CU.FT. 33.2 16.6 DOWNSTREAM FACE VOLUME VOLUME CONCRETE REPAIRS CU.FT. CU.FT. DOWNSTREAM FACE 0.0 EPOXY RESIN INJECTION LIN.FT. LIN.FT DOWNSTREAM FACE 11.0

- 1. NO DAMAGE WAS FOUND ON WINGWALL W2 DURING STRUCTURAL INSPECTION.
- 2. VALUES IN CHART REPRESENT ESTIMATED REPAIR TOTALS AFTER REMOVAL OF UNSOUND CONCRETE, MINIMUM OF 1"BEHIND REBAR AND MINIMUM 2"CLEARANCE TO SAWCUT. FOR REPAIR DETAILS, SEE "TYPICAL REPAIR DETAILS" SHEET
- 3. REPAIR LOCATIONS AND ESTIMATE OF QUANTITIES ARE BASED ON THE BEST INFORMATION AVAILABLE. IF ADDITIONAL REPAIRS NOT SHOWN ON THE DRAWINGS ARE DEEMED NECESSARY BY THE ENGINEER, THE ENGINEER WILL NOTE ON THE DRAWINGS THE APPROXIMATE LOCATION AND DESCRIPTION OF THE REPAIRS AND ENTER THE ACTUAL QUANTITIES INTO THE AS-BUILT REPAIR QUANTITY TABLE.
- 4. CONCRETE REPAIRS MAY BE SUBSTITUTED IN LIEU OF SHOTCRETE REPAIRS WITH THE APPROVAL OF THE ENGINEER.
- 5. SEE SHEET S-22 FOR CONCRETE REPAIR DETAILS.
