PROJECT NO. 15BPR.32

WATAUGA COUNTY

STRUCTURE: 940066

UPSTREAM WING FACES

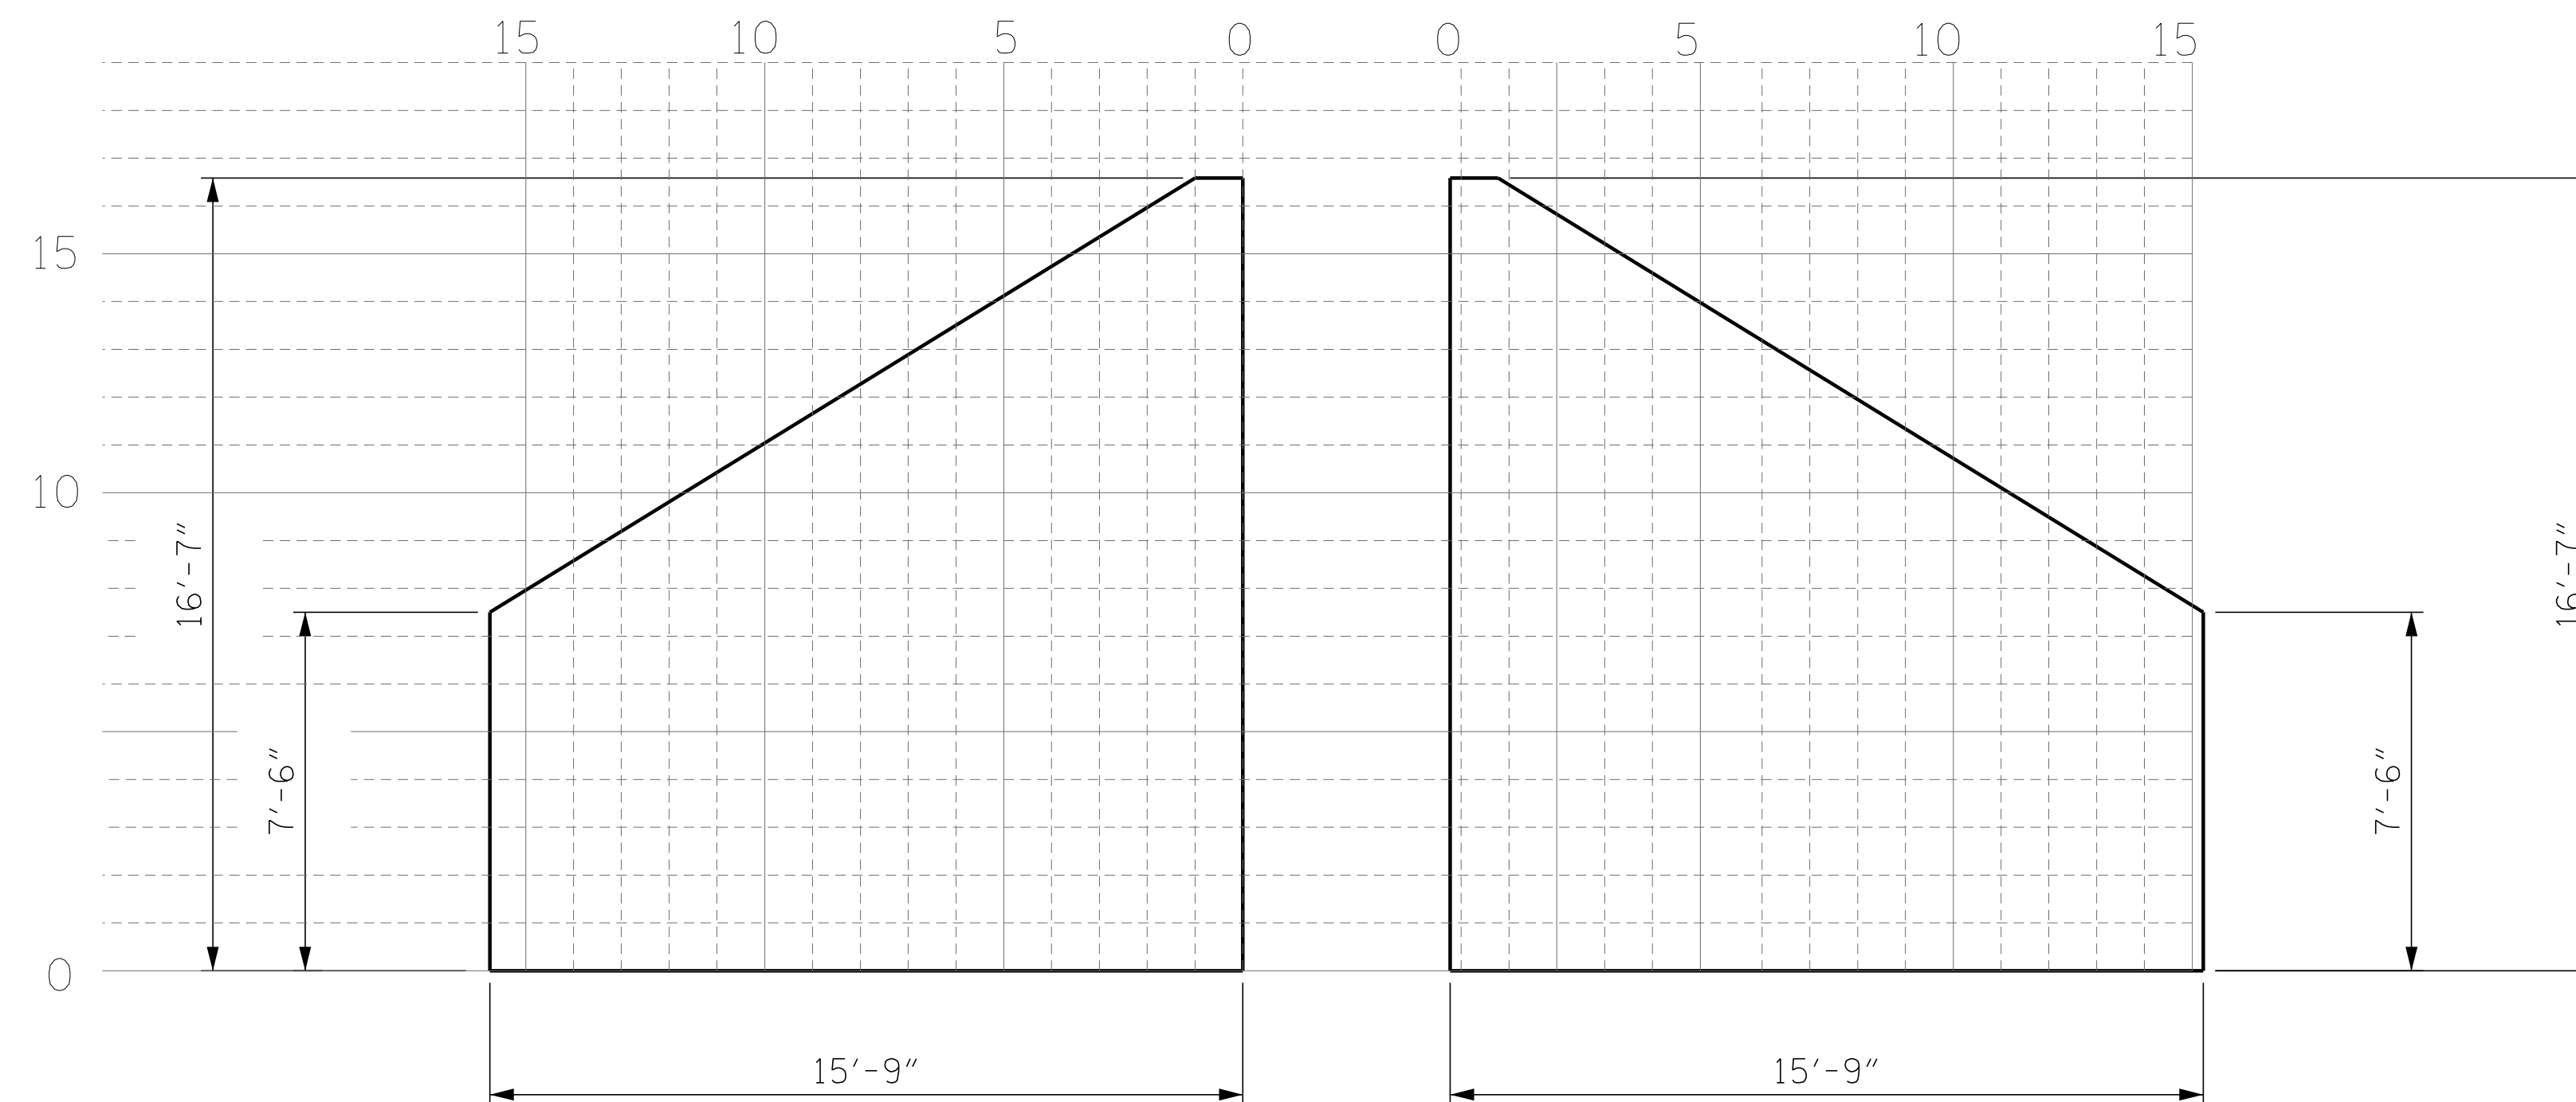
UPSTREAM WINGS

- NO DAMAGE WAS FOUND ON WINGWALLS W3 AND W4 DURING STRUCTURAL INSPECTION.
- VALUES IN CHART REPRESENT ESTIMATED REPAIR TOTALS AFTER REMOVAL OF UNSOUND CONCRETE, MINIMUM OF 1" BEHIND REBAR AND MINIMUM 2" CLEARANCE TO SAWCUT. FOR REPAIR DETAILS, SEE "TYPICAL REPAIR DETAILS" SHEET
- REPAIR LOCATIONS AND ESTIMATE OF QUANTITIES ARE BASED ON THE BEST INFORMATION AVAILABLE. IF ADDITIONAL REPAIRS NOT SHOWN ON THE DRAWINGS ARE DEEMED NECESSARY BY THE ENGINEER, THE ENGINEER WILL NOTE ON THE DRAWINGS THE APPROXIMATE LOCATION AND DESCRIPTION OF THE REPAIRS AND ENTER THE ACTUAL QUANTITIES INTO THE AS-BUILT REPAIR QUANTITY TABLE.
- CONCRETE REPAIRS MAY BE SUBSTITUTED IN LIEU OF SHOTCRETE REPAIRS WITH THE APPROVAL OF THE ENGINEER.
- SEE SHEET S-22 FOR CONCRETE REPAIR DETAILS.
