PROJECT NO. 15BPR.32
AVERY COUNTY
 STRUCTURE: 050002
 SHEET 6 OF 6

STATE OF NORTH CAROLINA
 DEPARTMENT OF TRANSPORTATION
 RALEIGH

DOWNSTREAM HEADWALL
 AND WINGS

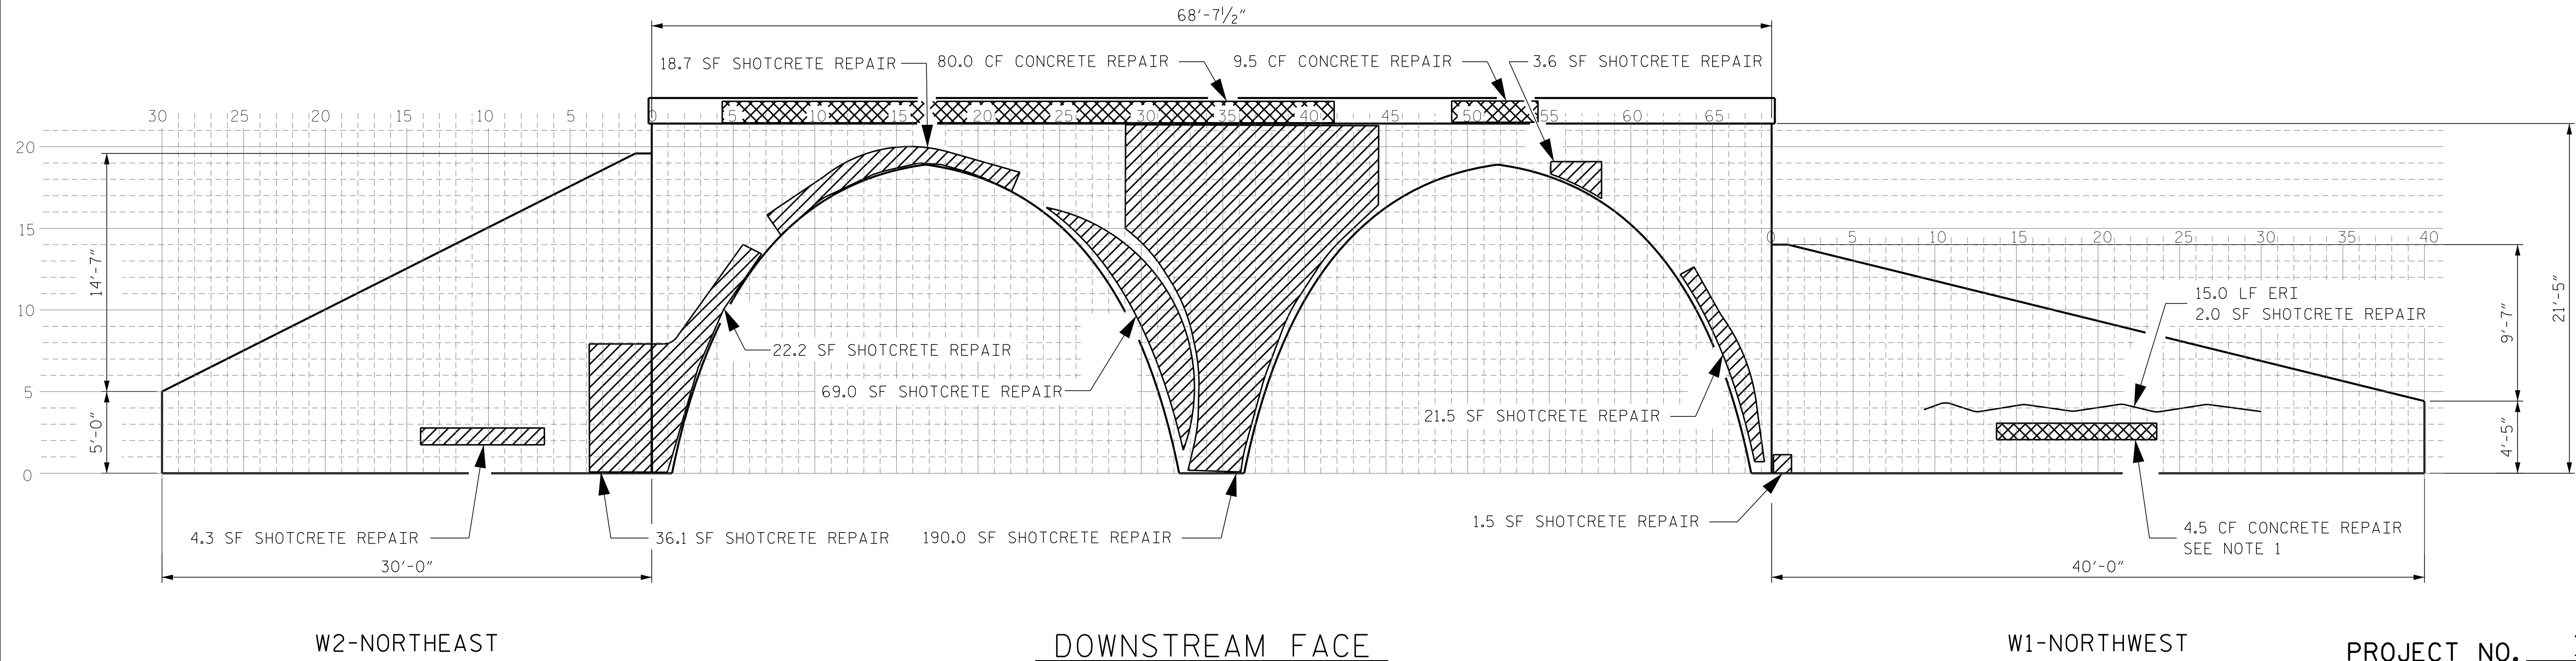
1. SPALL IN CONCRETE BUILD-UP IN FRONT OF WING.
2. VALUES IN CHART REPRESENT ESTIMATED REPAIR TOTALS AFTER REMOVAL OF UNSOUND CONCRETE, MINIMUM OF 1" BEHIND REBAR AND MINIMUM 2" CLEARANCE TO SAWCUT. FOR REPAIR DETAILS, SEE "TYPICAL REPAIR DETAILS" SHEET
3. REPAIR LOCATIONS AND ESTIMATE OF QUANTITIES ARE BASED ON THE BEST INFORMATION AVAILABLE. IF ADDITIONAL REPAIRS NOT SHOWN ON THE DRAWINGS ARE DEEMED NECESSARY BY THE ENGINEER, THE ENGINEER WILL NOTE ON THE DRAWINGS THE APPROXIMATE LOCATION AND DESCRIPTION OF THE REPAIRS AND ENTER THE ACTUAL QUANTITIES INTO THE AS-BUILT REPAIR QUANTITY TABLE.
4. CONCRETE REPAIRS MAY BE SUBSTITUTED IN LIEU OF SHOTCRETE REPAIRS WITH THE APPROVAL OF THE ENGINEER.
5. SEE SHEET S-22 FOR CONCRETE REPAIR DETAILS.
