NC DEPARTMENT OF TRANSPORTATION
 DIVISION OF HIGHWAYS
 STRUCTURE MANAGEMENT UNIT

ATTENTION: **PRIORITY MAINTENANCE ISSUED; SNOOPER USED**

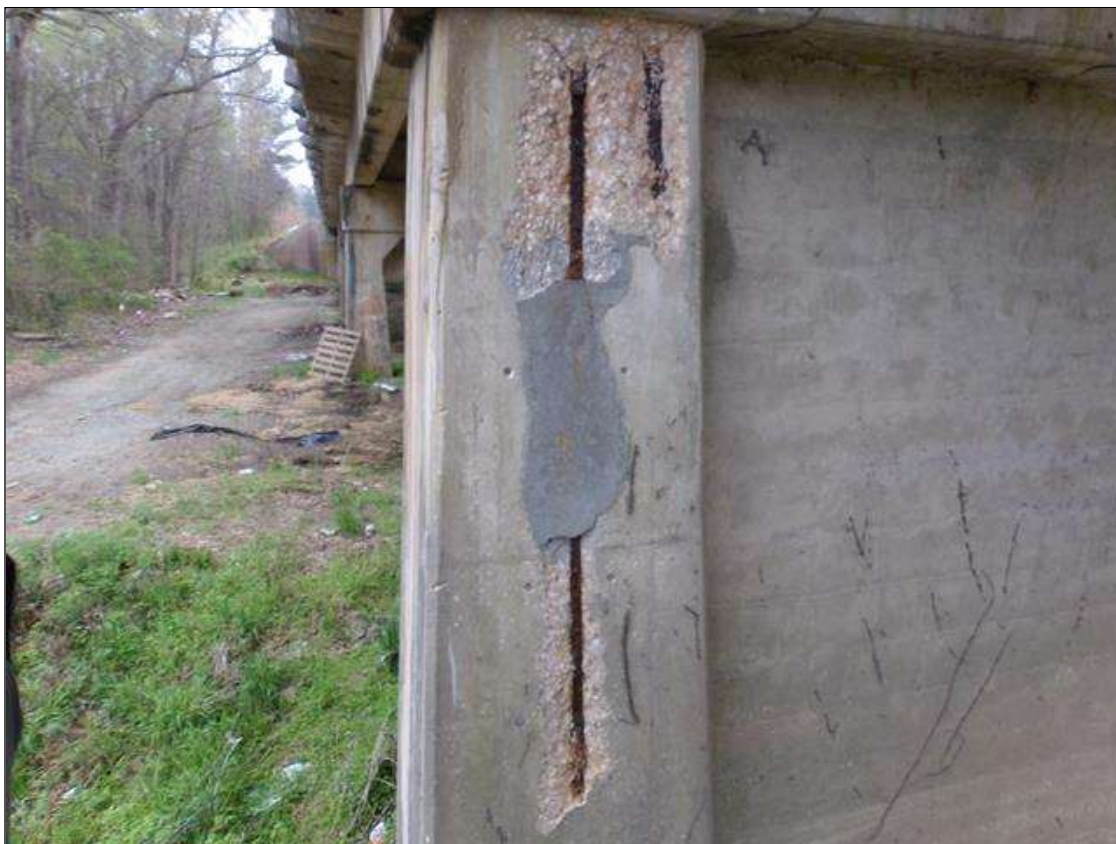
Bent 4 Pile 1: PM-- Patch that has failed, Spall 8' long x up to 21" wide x 2" deep with exposed rebar with section loss on north face of column starting under cap.

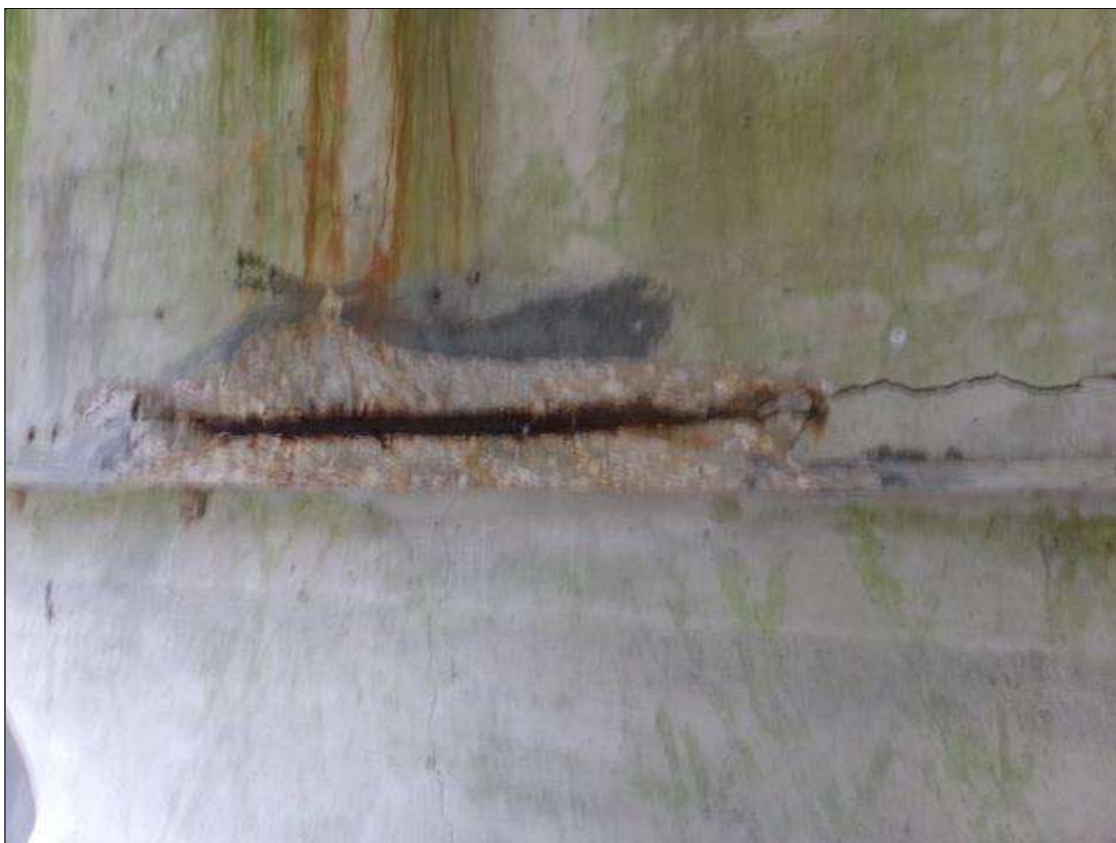
Bent 4 Cap 1: PM--3' long x up to 1' high x up to 5" deep spall on bottom corner of cap with exposed rebar with section loss on north face with a 5' long x 5" high area of delamination.

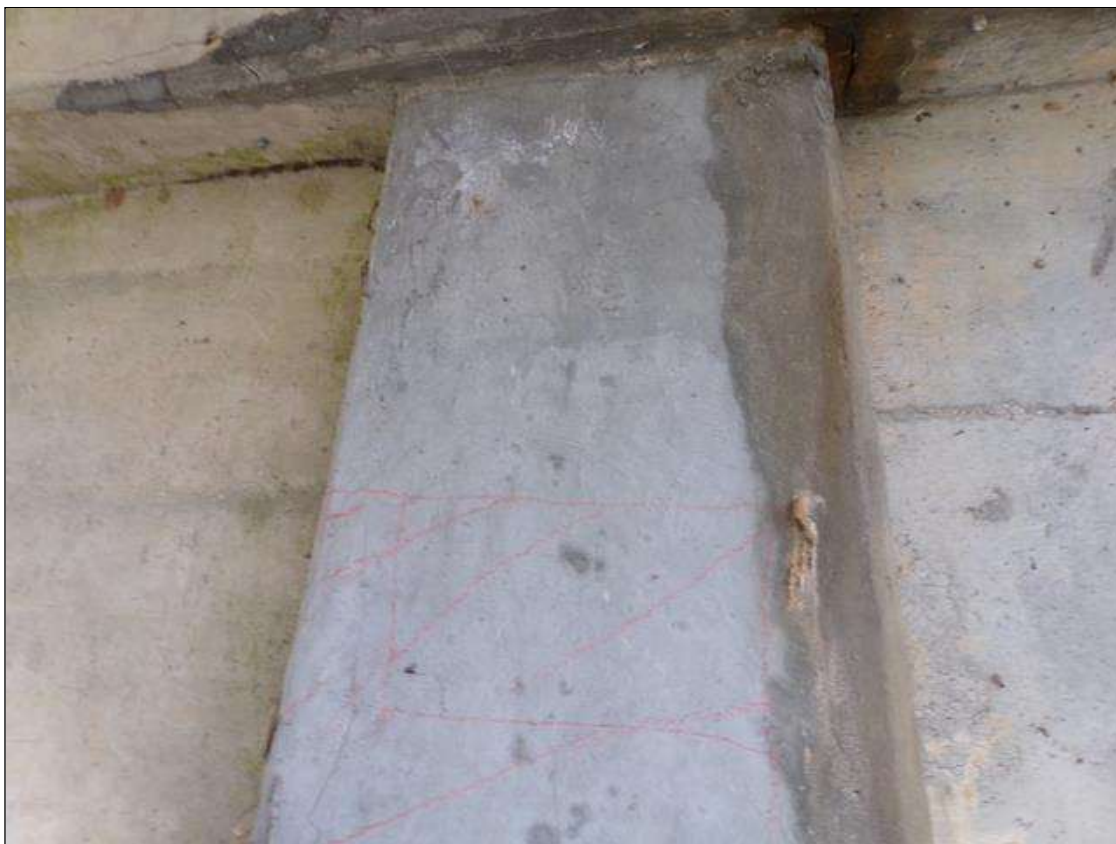
Bent 4 Pile 2: 3' square sound patched area with a 1/32" vertical crack north face starting at bottom of cap

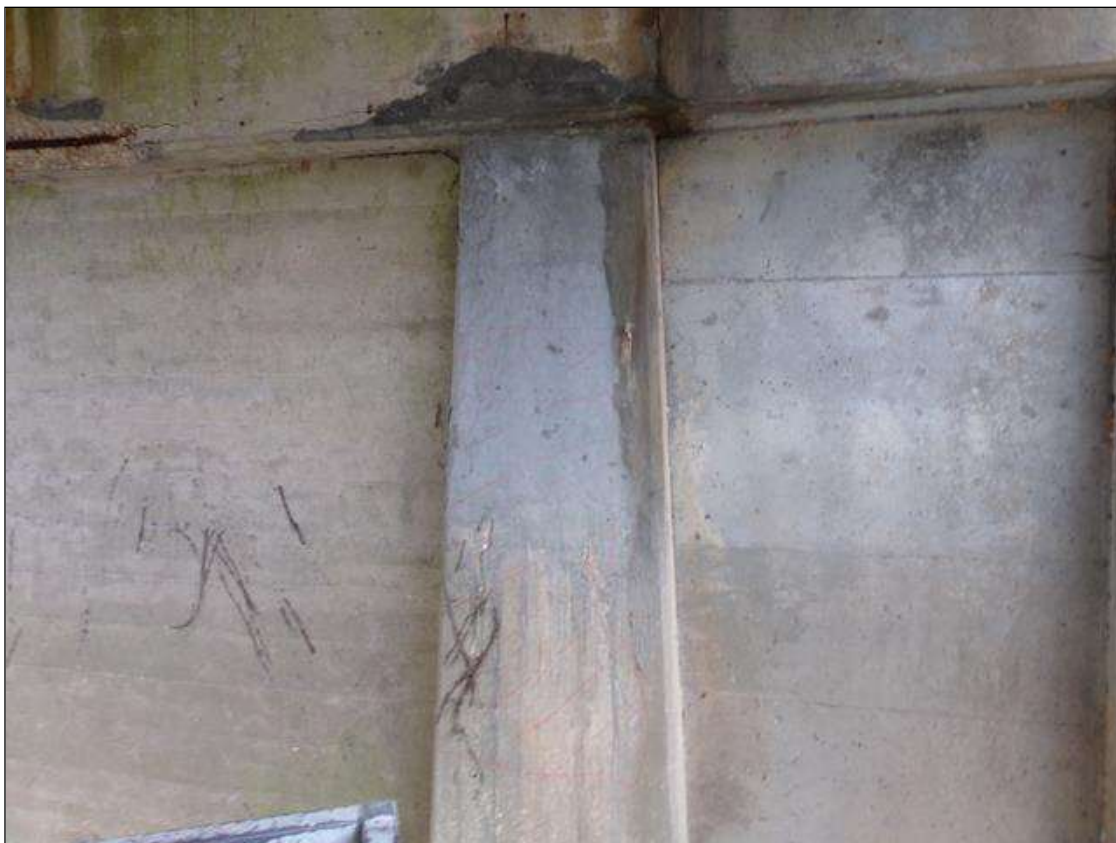
Bent 4 Pile 2: 5' high x 3' wide area of delamination on north face of column starting 3' from bottom of cap.

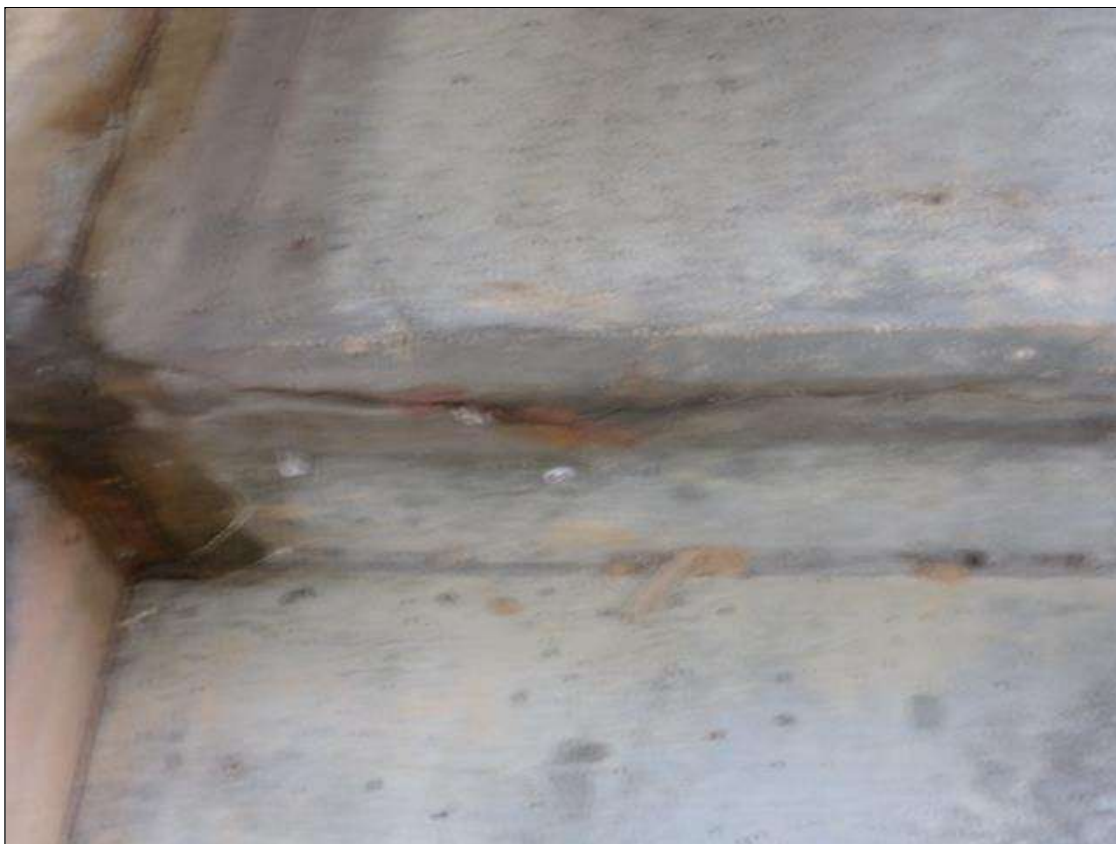
Bent 4 Cap 1: 3' long x 1/8" wide horizontal crack on bottom of cap between columns 1 and 2 starting at construction joint north side.

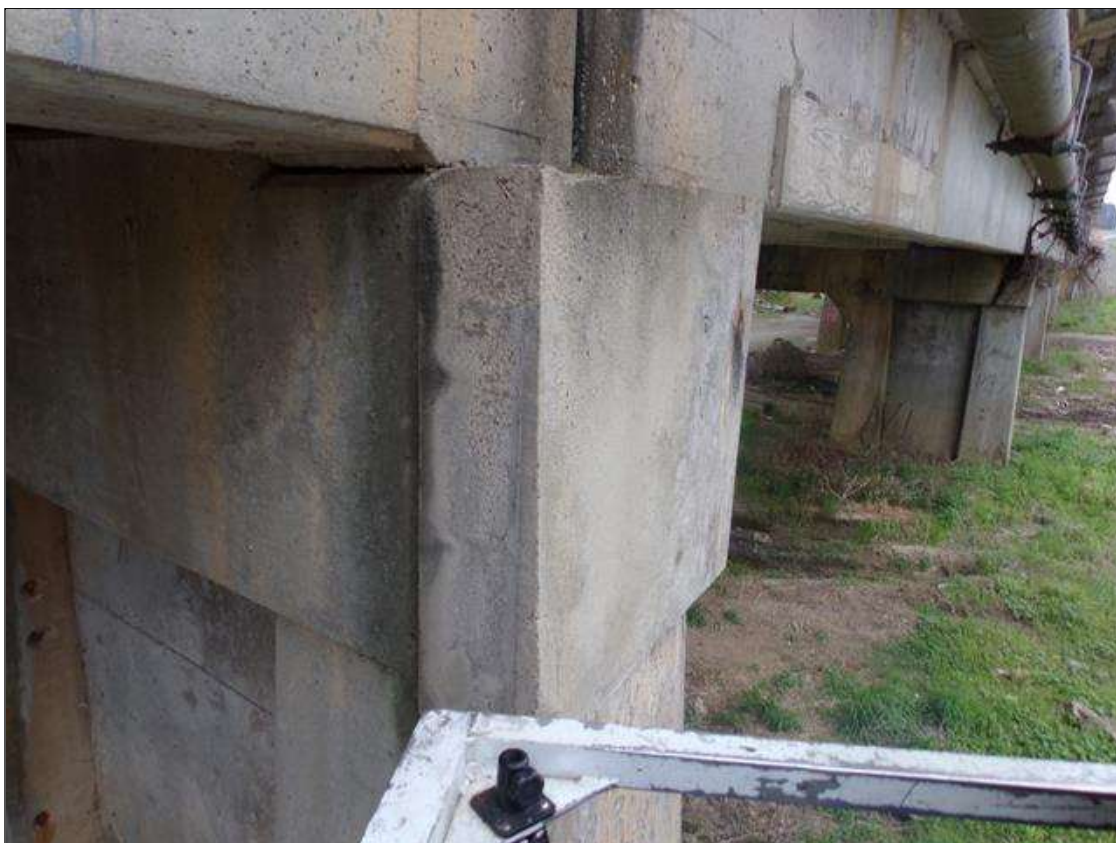
Bent 4 Cap 1: 6" deep x full height/width sound patched area on west end of cap.

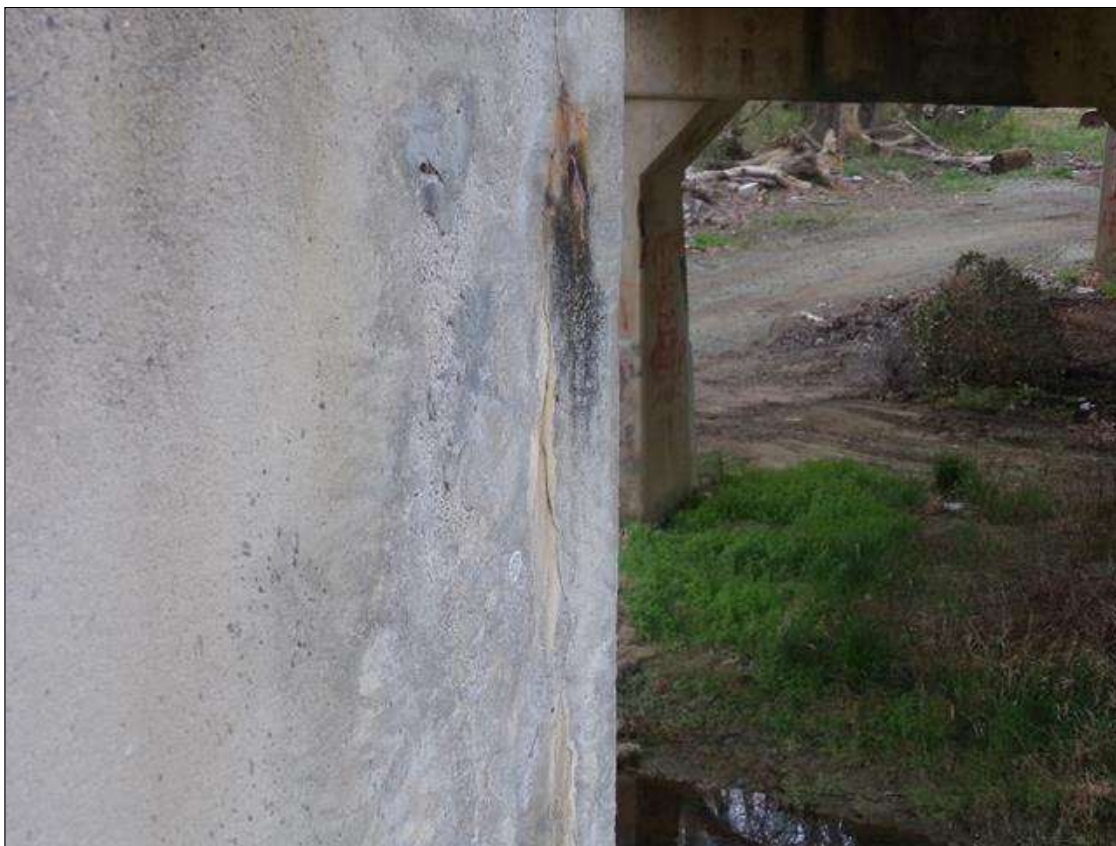
Bent 4 Cap 1: Full height vertical crack up to 1/16" wide on west face of cap.

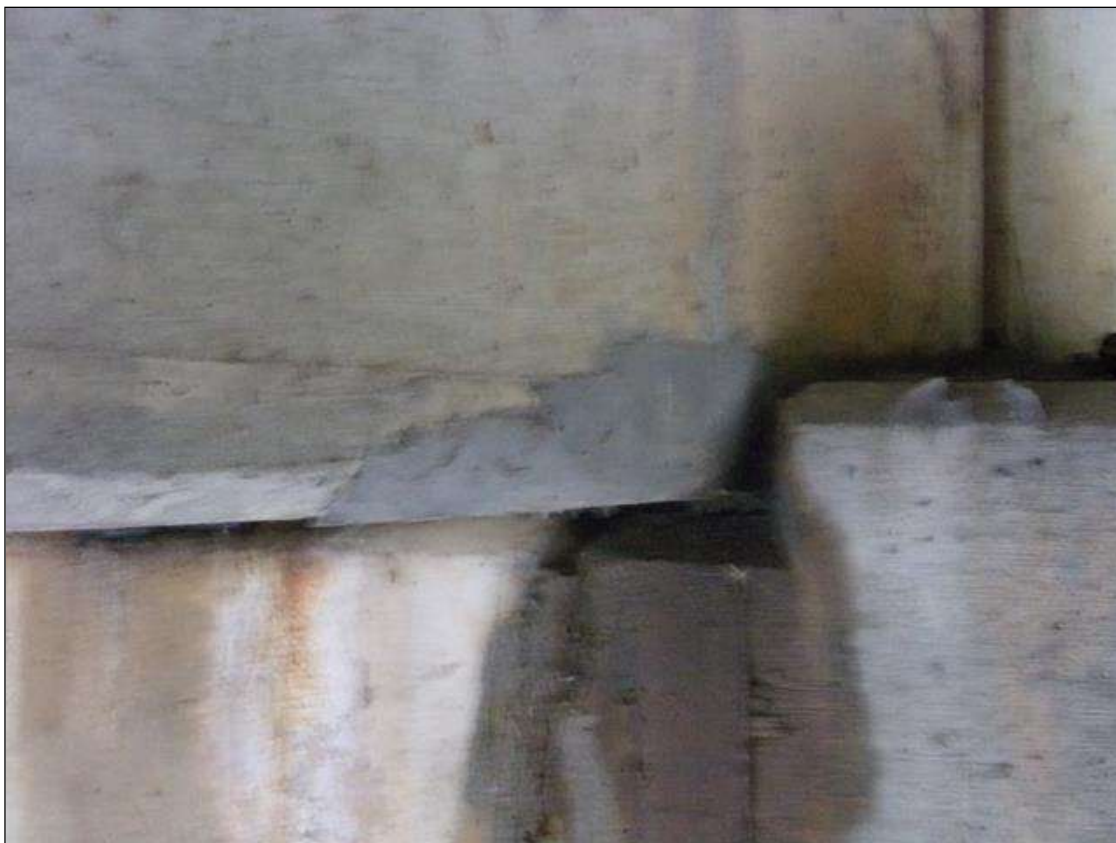
Span 5 Beam 2: 18" long x 4" high on west face x 4" wide on bottom of beam sound patched area starting at pier 4.

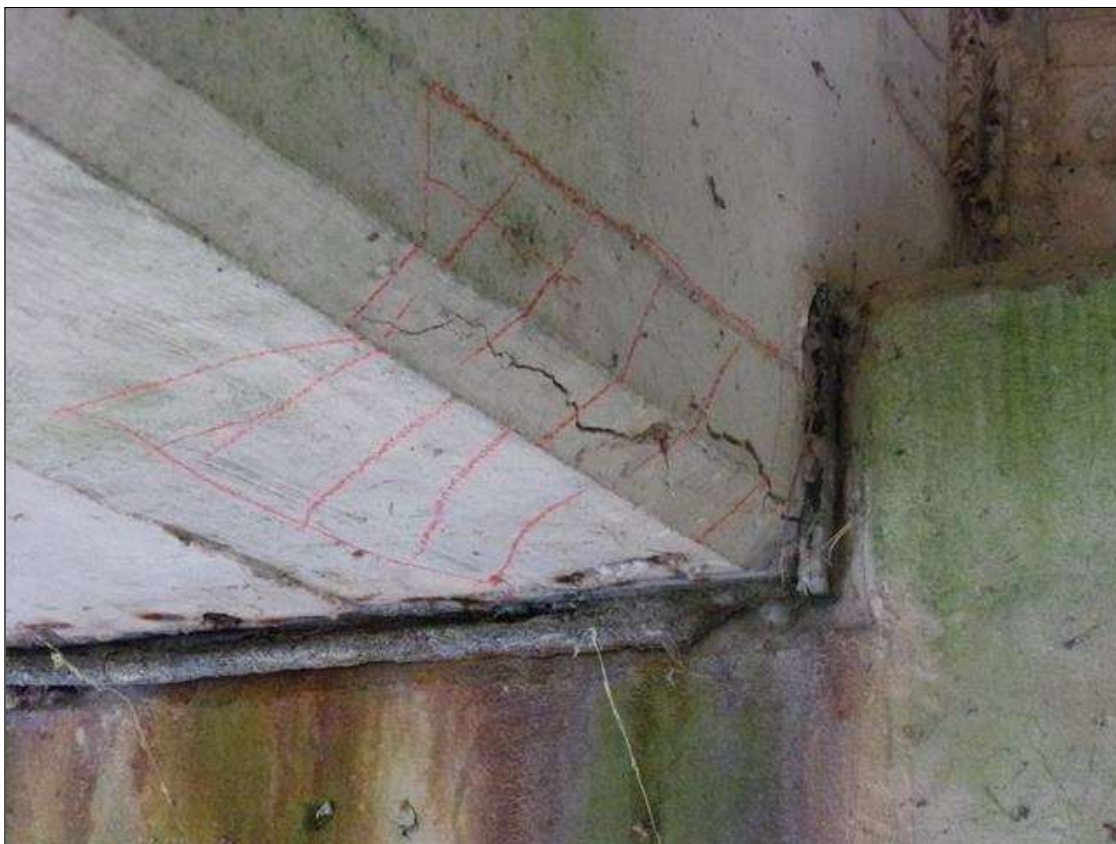
Span 5 Beam 4: 1" long x 4" high on west face x 6" wide on bottom of beam delamination with a crack up to 1/8" wide full width of delamination starting at pier 4.

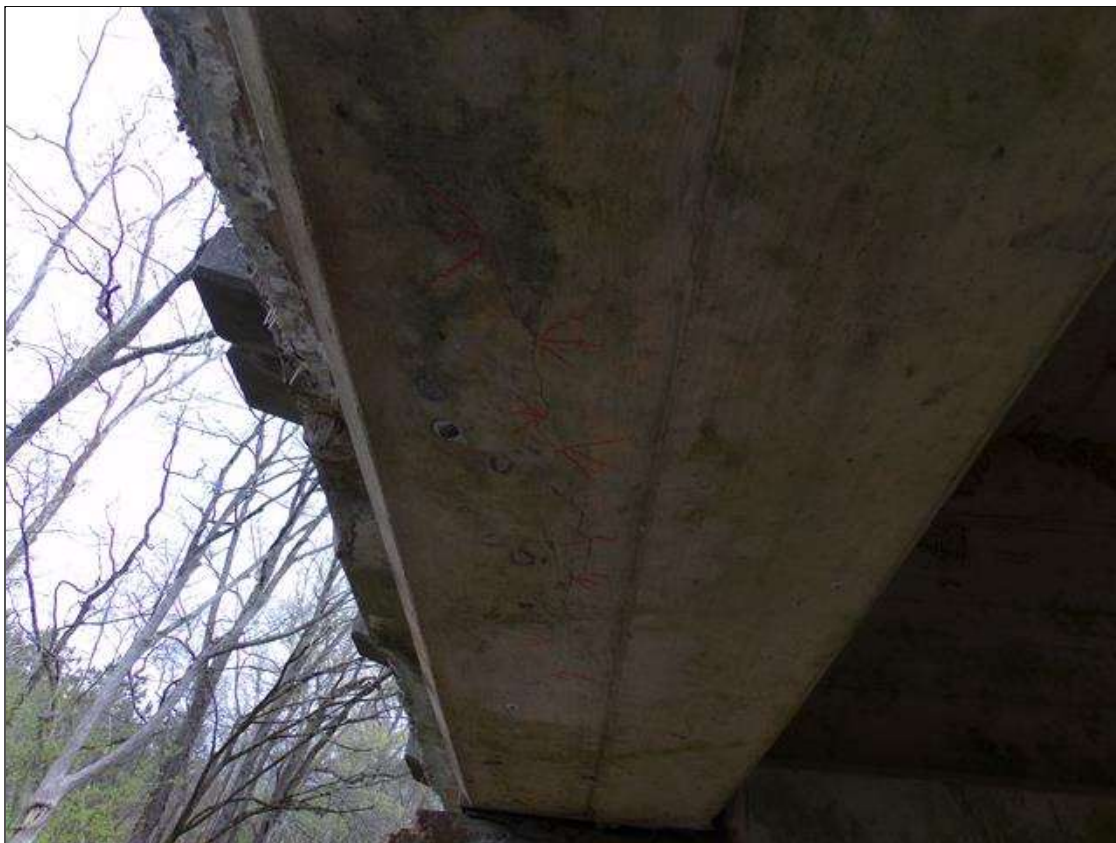
Span 5 Beam 5: 2' long x 1/32" wide longitudinal crack on bottom of beam starting 2' from pier 4.

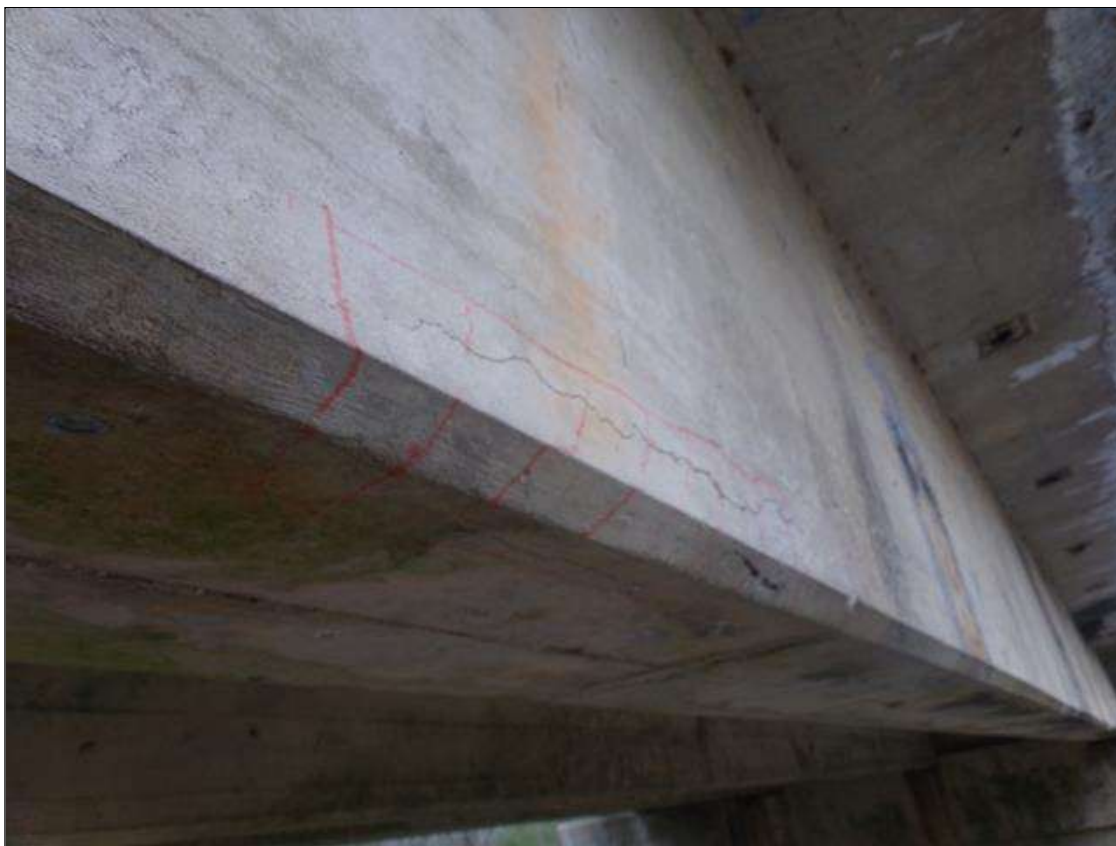
Span 5 Beam 5: 18" long x 3" high on east face x 2" wide on bottom of beam starting 7' from pier 4.

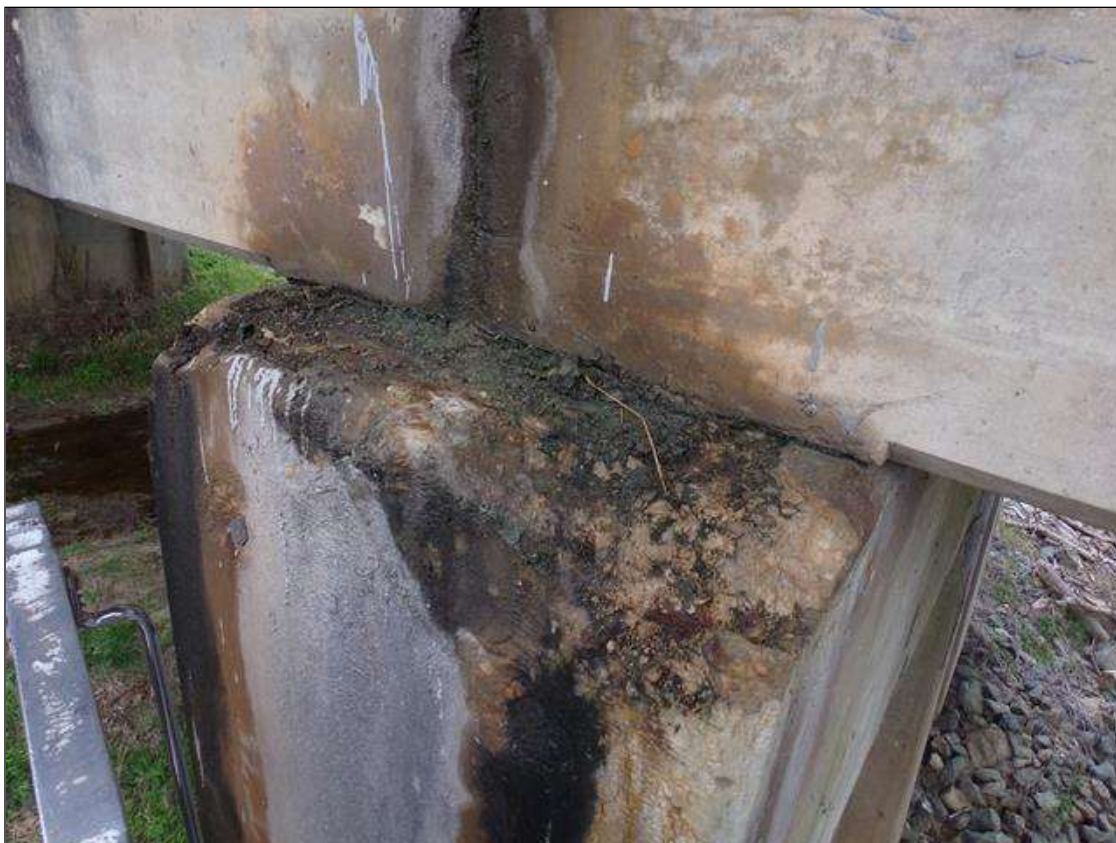
Bent 4 Cap 1: 14" wide x 8" long x 3" deep and 11" wide x 8" long x 2" deep corner spalls on top of cap east end both corners.

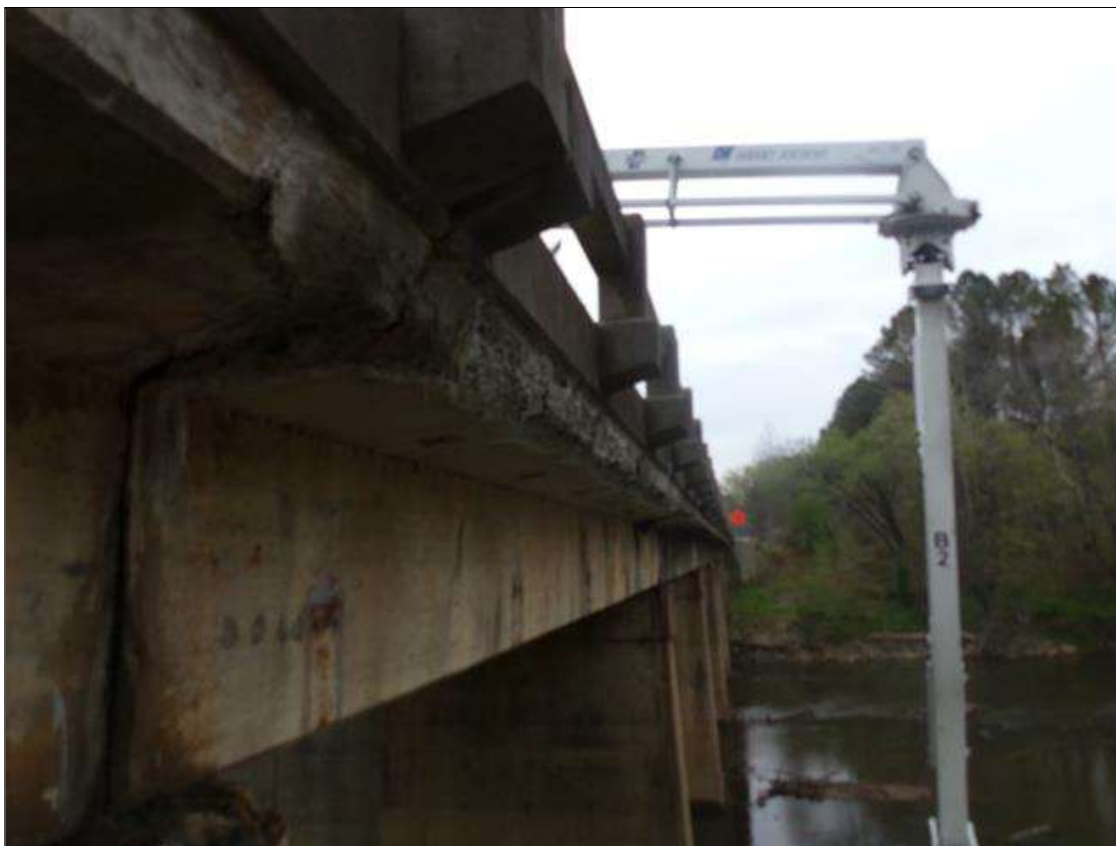
Span 5 Deck: Patched area 1' high x full length of east overhang that is distressed with efflorescence/stalactites/staining and cracking throughout

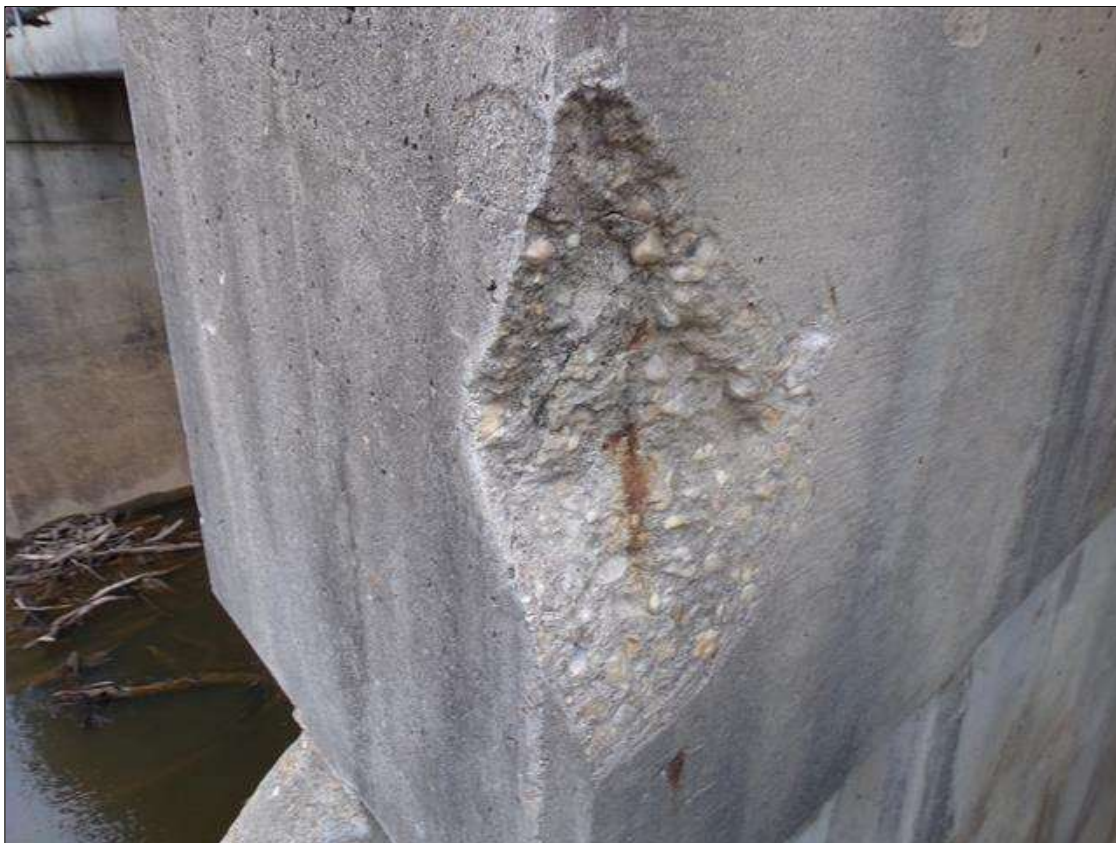
Bent 5 Cap 1: 18" high x 11" wide x 3" deep spall on south face of cap at west end.

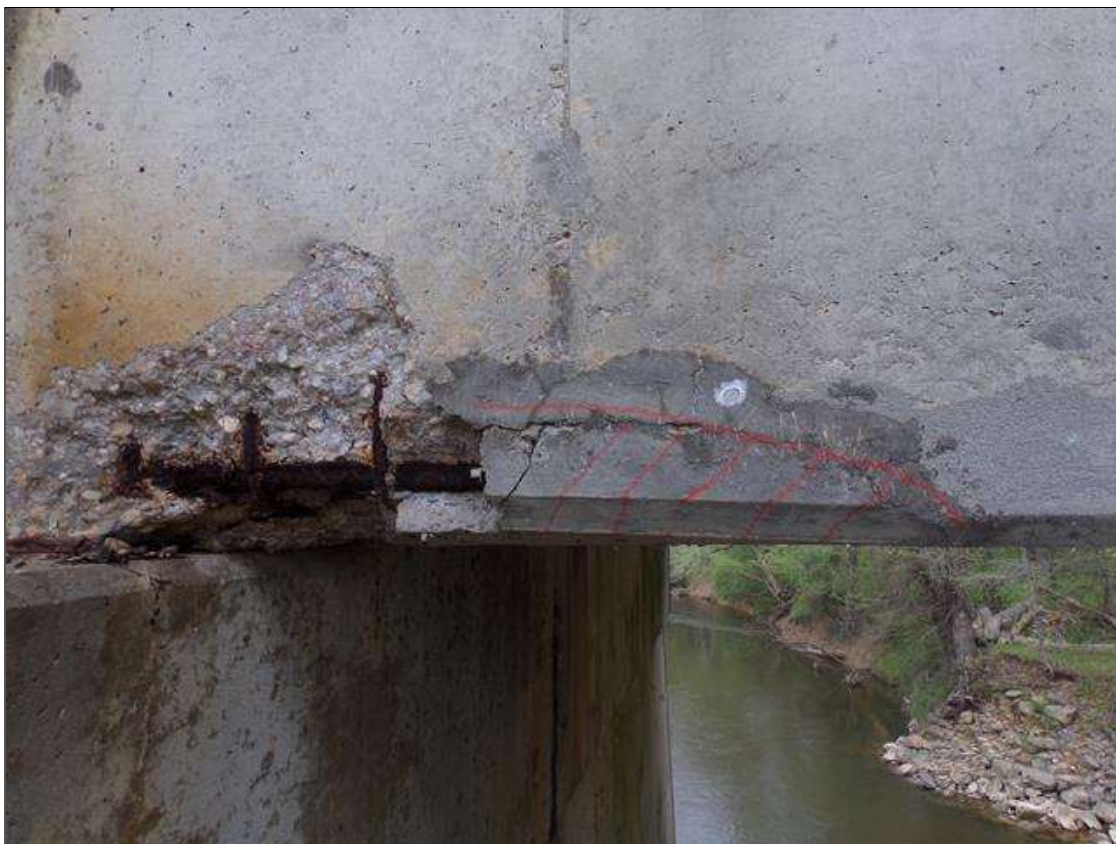
Span 5 Beam 1: Spall 18" long x 1' high on west face x 10" wide on bottom of beam with exposed rebar with no measurable section loss and an area of delamination 16" long x 5" high x 5" wide starting at pier 5.

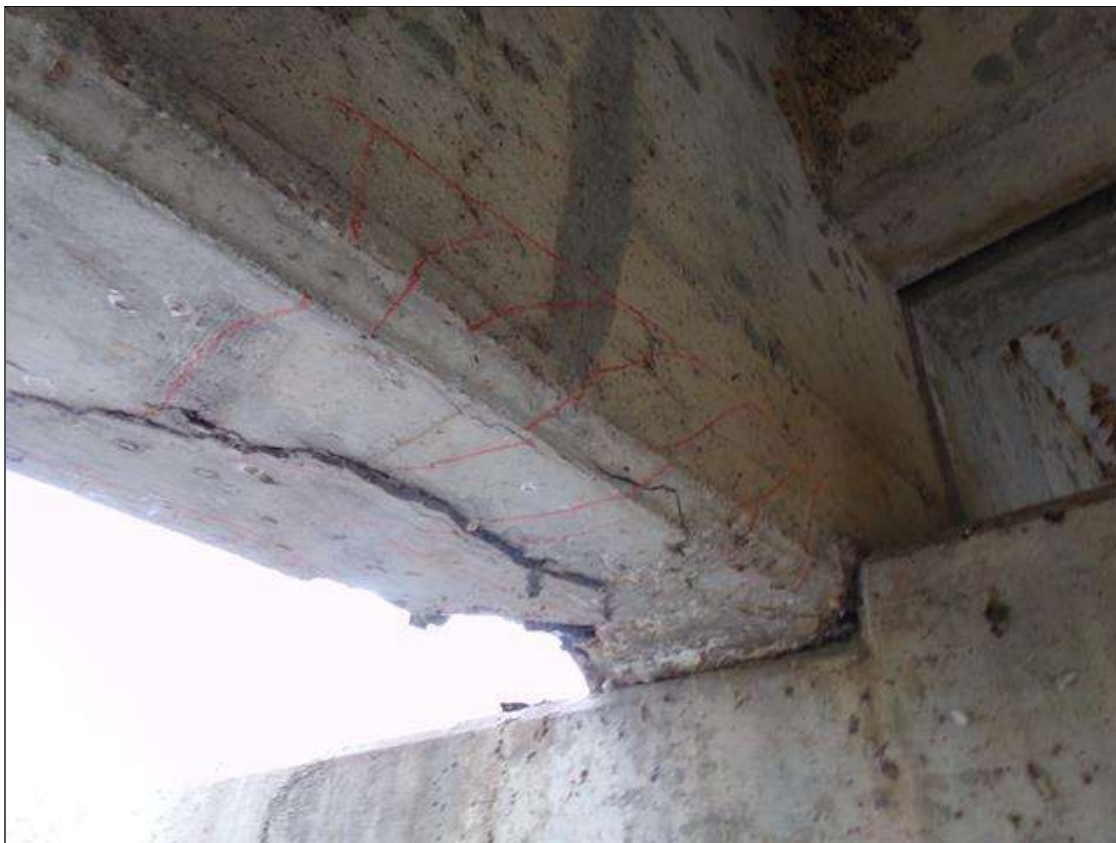
Span 5 Beam 1: 2' long x 14" wide on bottom of beam x 6" high on east face area of delamination starting at pier 5

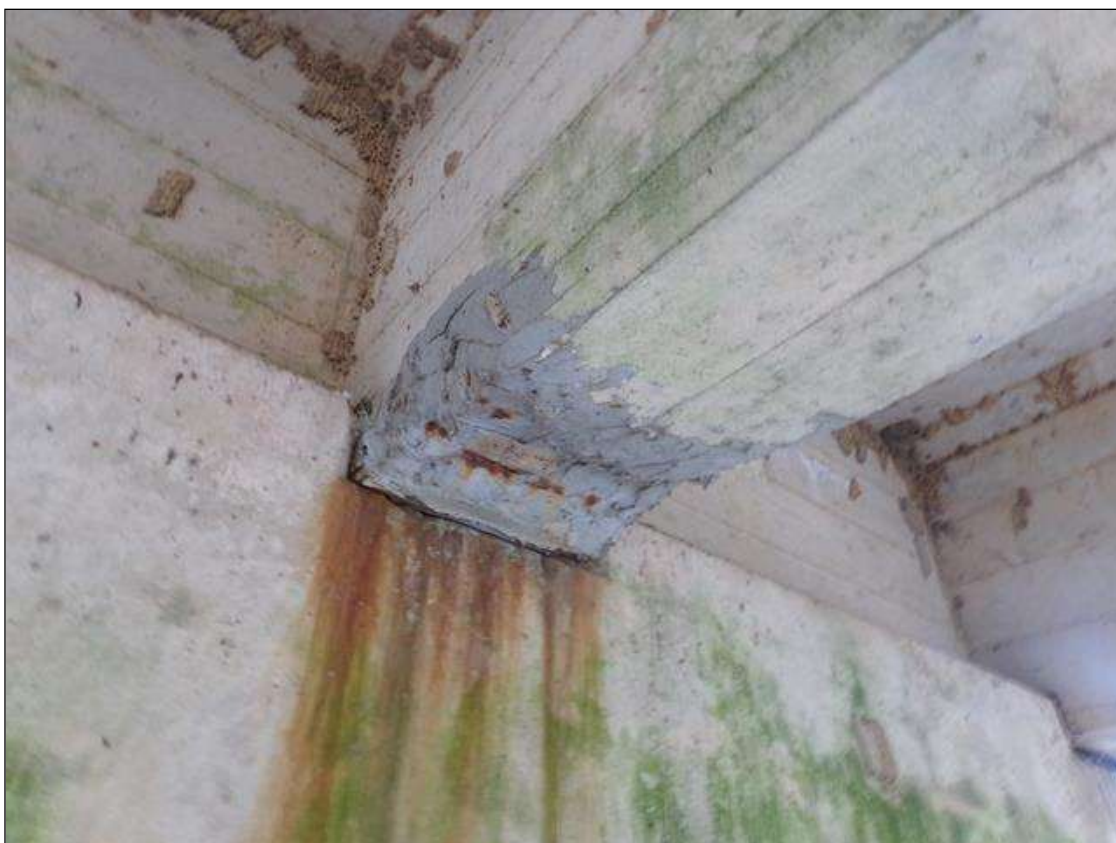
Span 5 Beam 4: 1' long x full width of bottom of beam sound patched area with staining at pier 5.

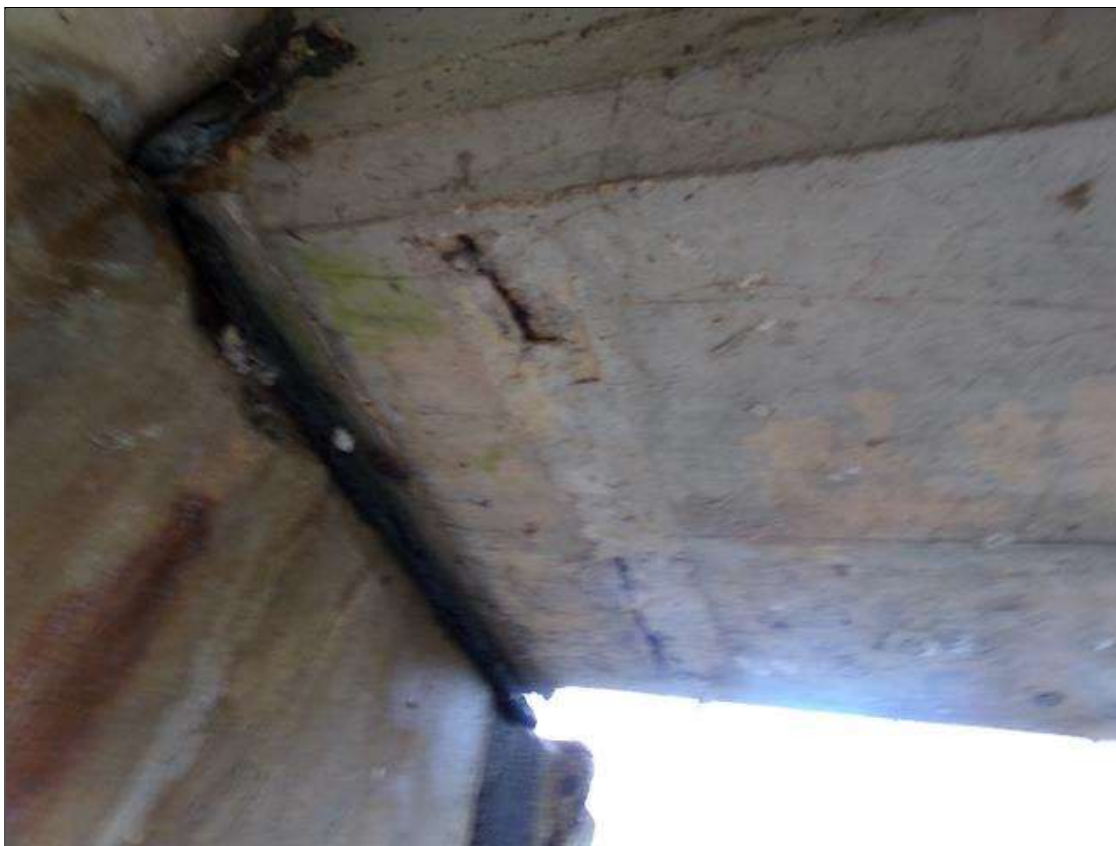
Span 5 Beam 5: Spall 1" wide x full width of bottom of beam x 1/4" deep at pier 5.

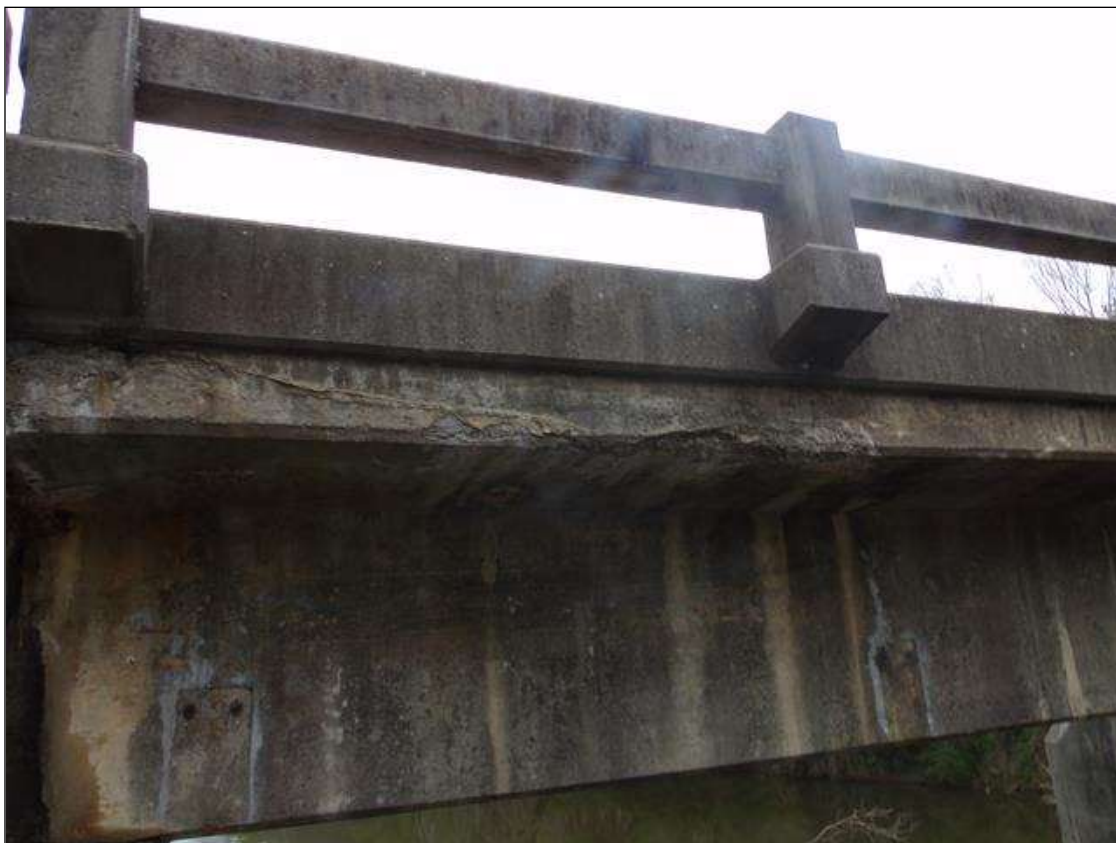
Span 6 Deck: 15' long x full height of front face east overhang area of concrete deterioration with a spall 2' long x 7" wide x up to 2" deep starting at pier 5.

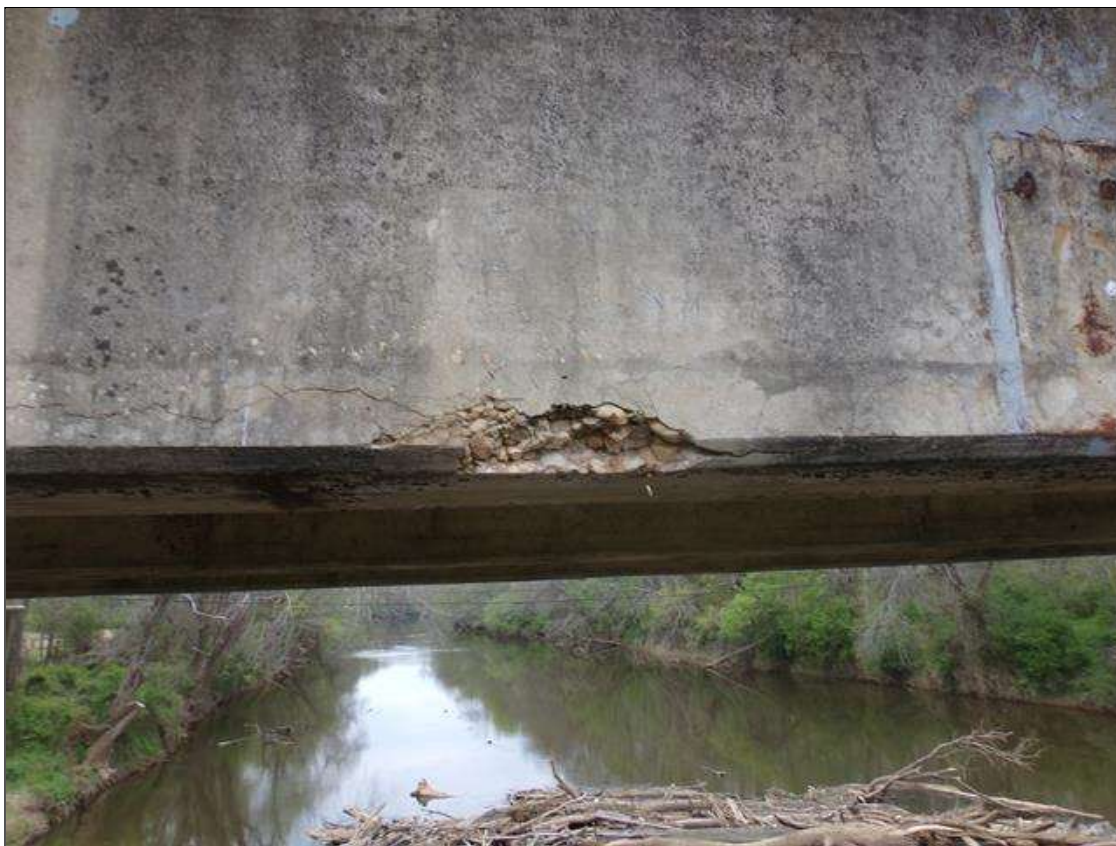
Span 6 Beam 5: 1' long x 4" high x 2" deep spall on east face of beam with cracking up to 3' long x up to 3/16" wide on both sides of spall.

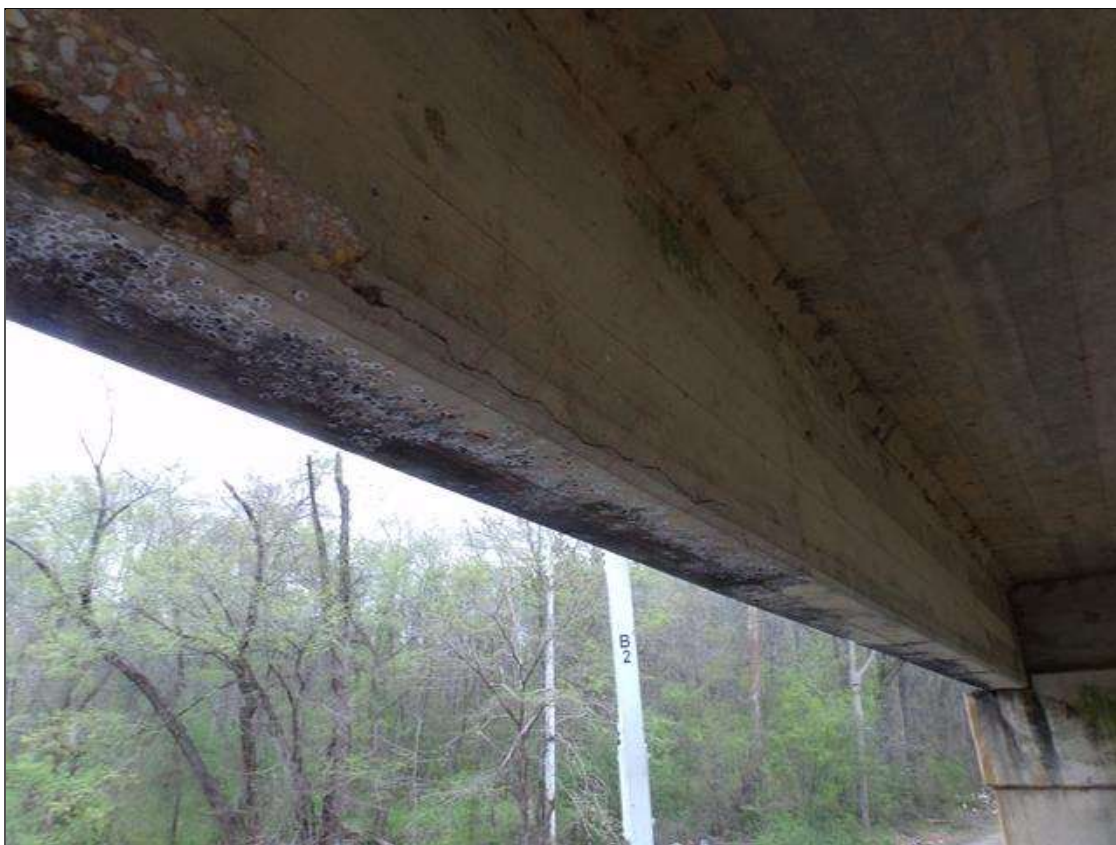
Span 6 Beam 5: Area of delamination 6' long x up to 1' high on west face x up to 10" wide on bottom of beam 16' from pier 6

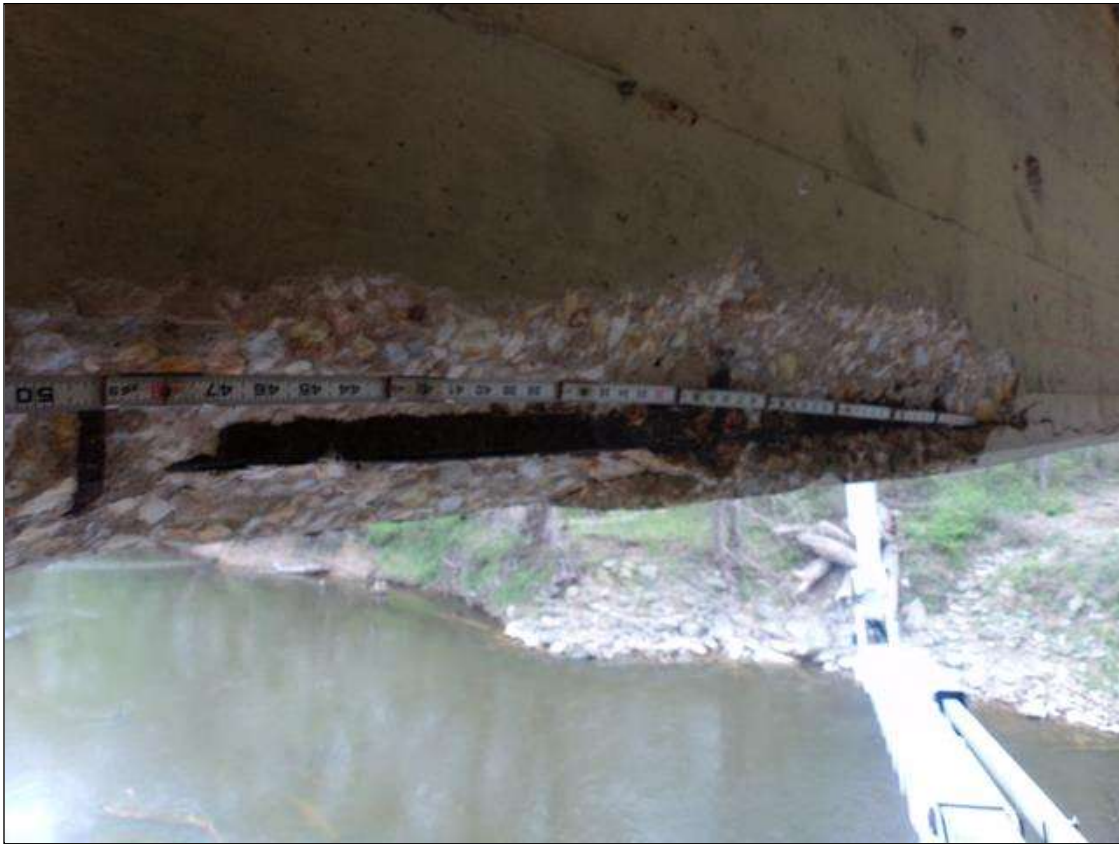
Span 6 Beam 5: PM--Spall 4' long x 10" high on west face x 8" wide on bottom of beam with exposed rebar with section loss 14' from pier 6.

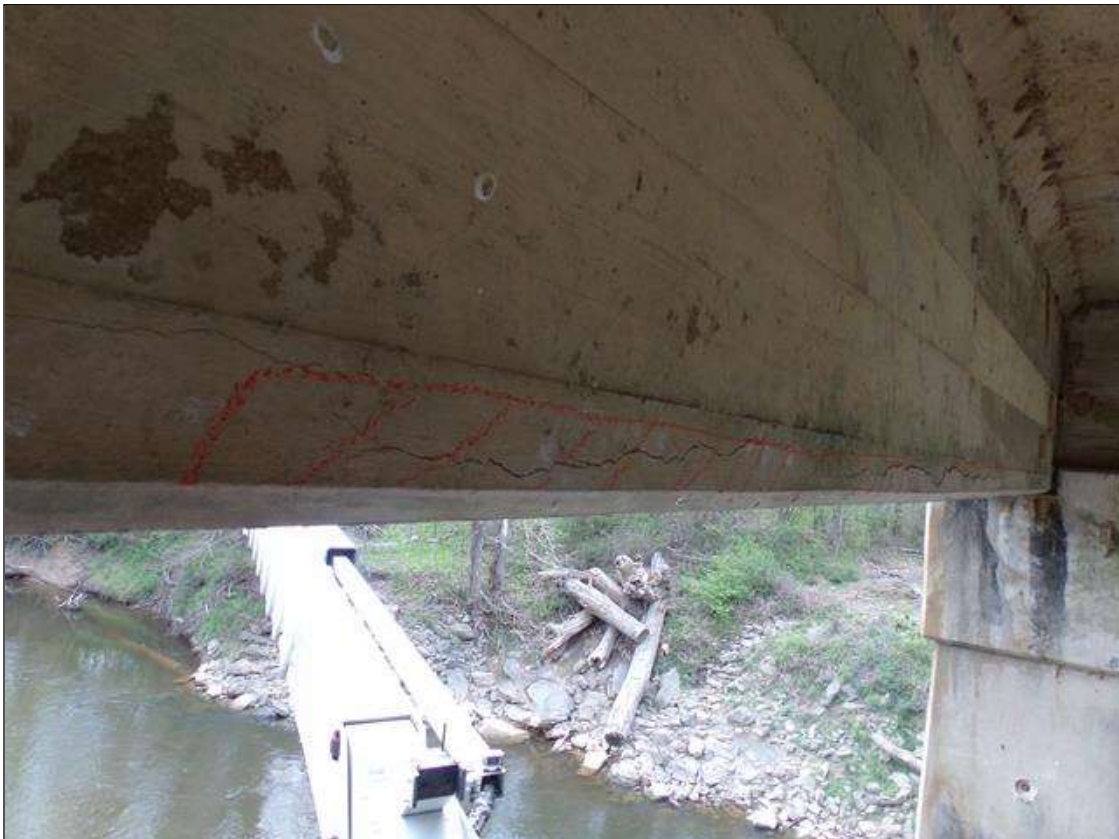
Span 6 Beam 5: 10' long x 4" high area of delamination with a full length cracks up to 1/4" wide on west face of bottom of beam starting 10' from pier 5.
