NC DEPARTMENT OF TRANSPORTATION
 DIVISION OF HIGHWAYS
 STRUCTURE MANAGEMENT UNIT

ATTENTION: **PRIORITY MAINTENANCE ISSUED; SNOOPER USED**

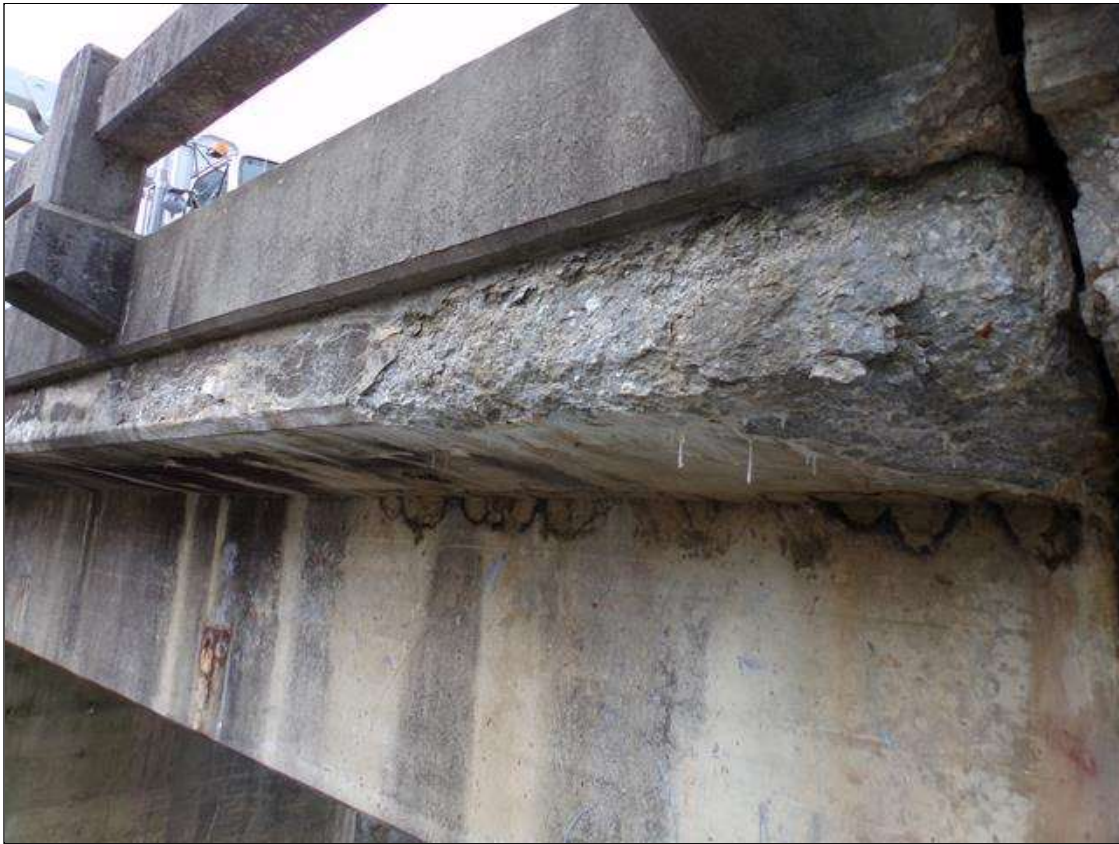
Span 6 Deck: 15' long x full height of front face east overhang area of concrete deterioration with a spall 2' long x 7" wide x up to 2" deep starting at pier 6.

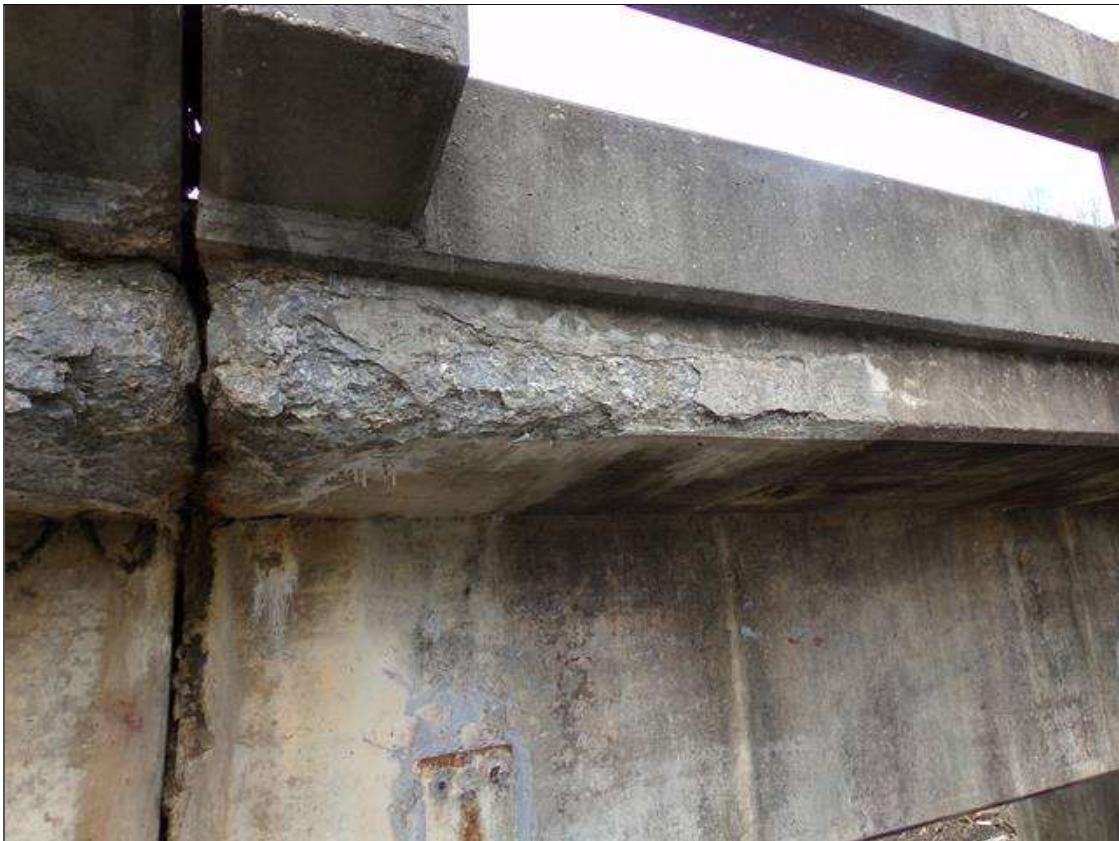
Span 7 Deck: 6' long x full height of front face east overhang area of concrete deterioration with a spall 2' long x 7" wide x up to 2" deep starting at pier 6.

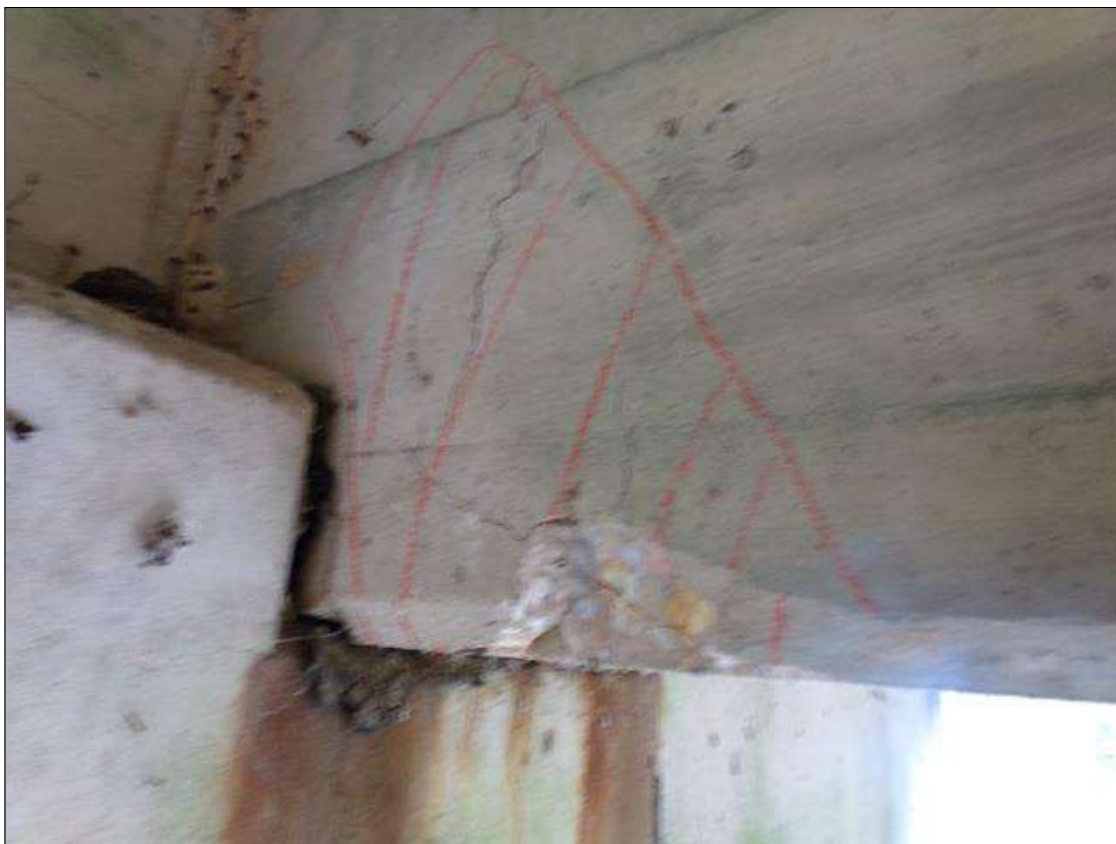
Span 6 Beam 4: Delamination 16" high x 1' long x 9" wide on bottom of beam with a 7" wide x 4" long x 3" deep corner spall at bottom of beam on west face at pier 6.

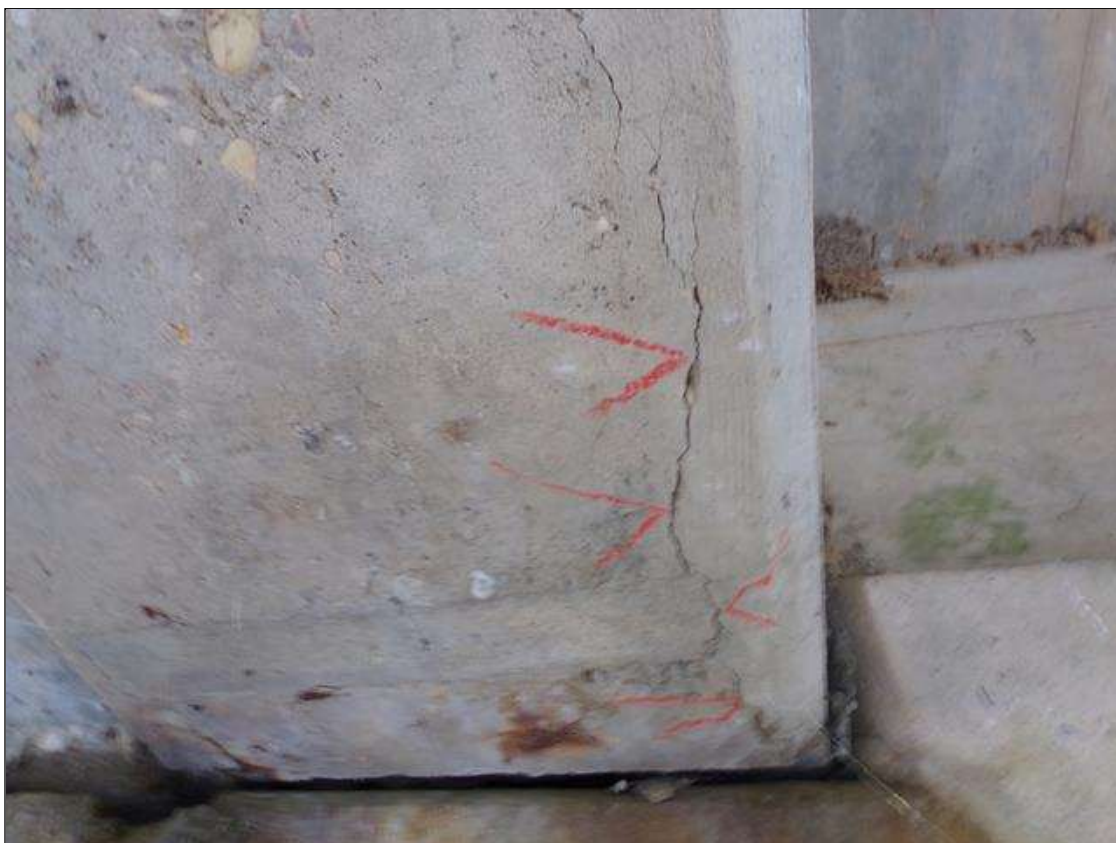
Span 6 Beam 3: 2' long crack 1/16" wide on bottom of beam starting at pier 6.

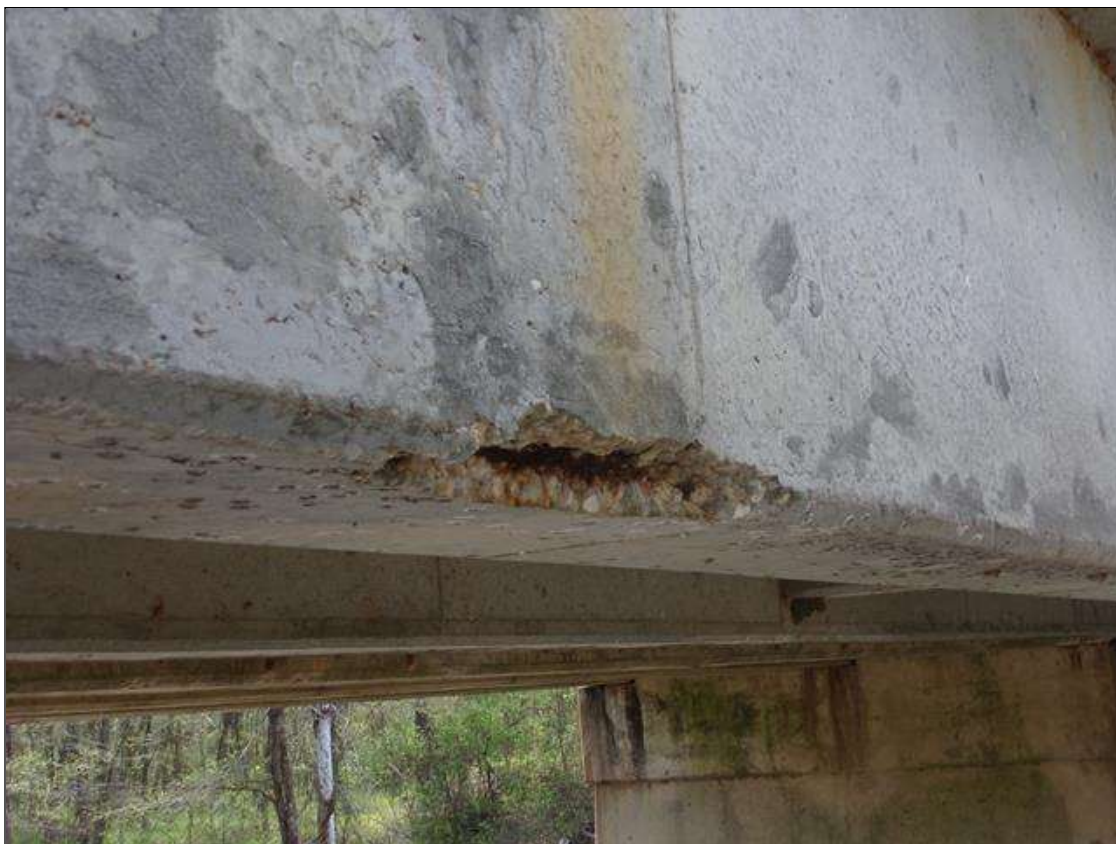
Span 6 Beam 1: 1' long x 4" wide x 1 1/2" deep corner spall with exposed rebar with no measurable section loss on bottom of beam west face 7' from pier 6.

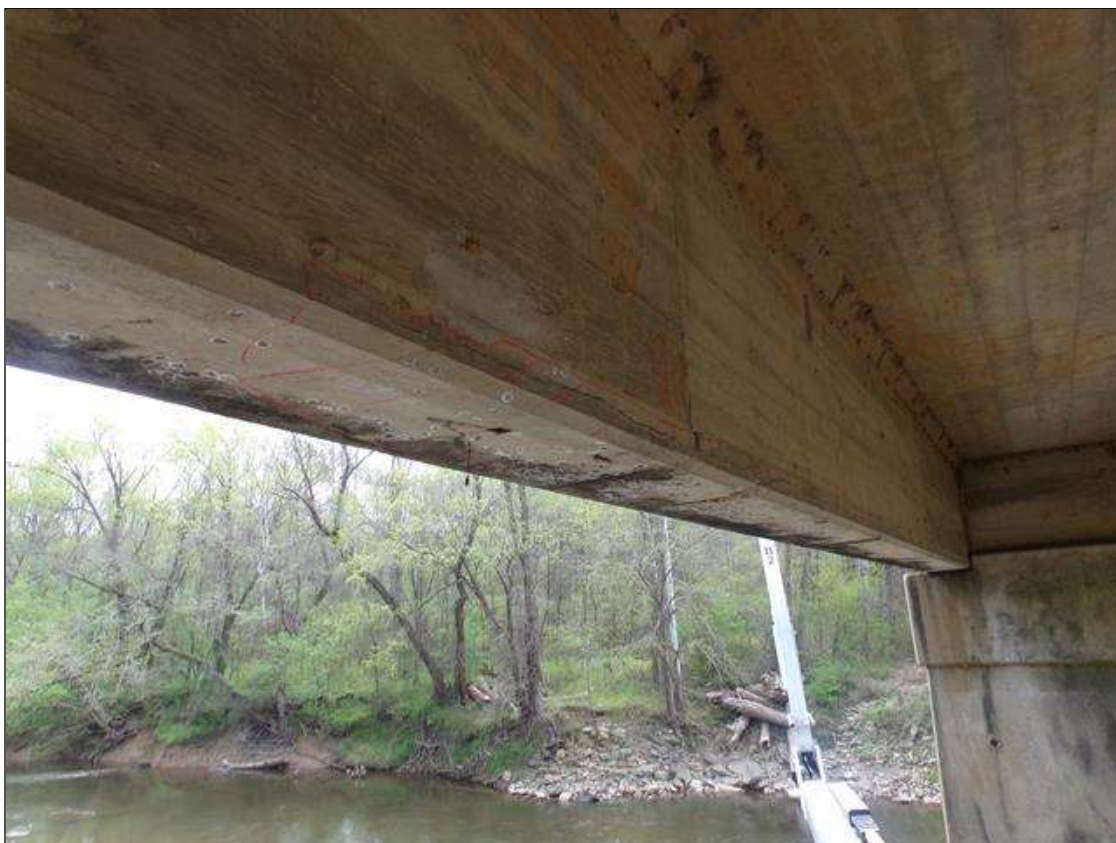
Span 7 Beam 5: Delamination 20' long x up to full width on bottom of beam x 4" high on west face at mid span.

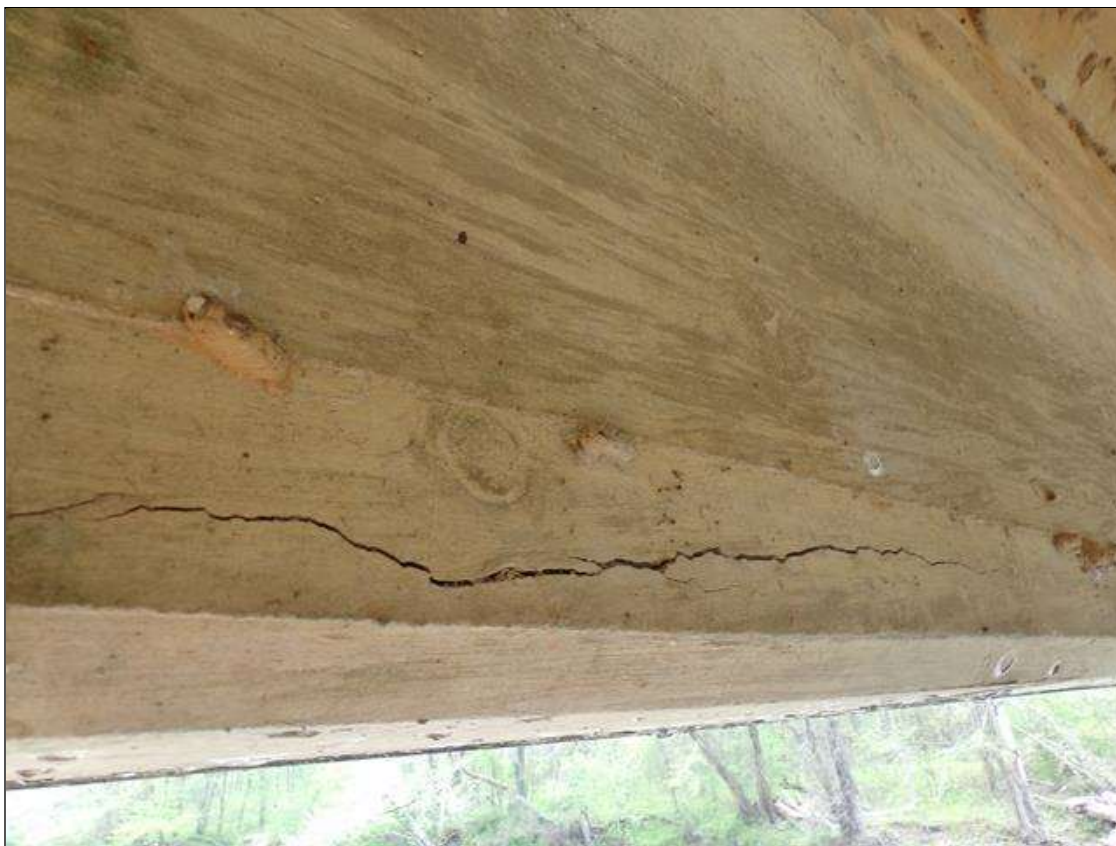
Span 7 Beam 5: 2' long horizontal crack 1/8" wide on west face of beam 16' from pier 7.

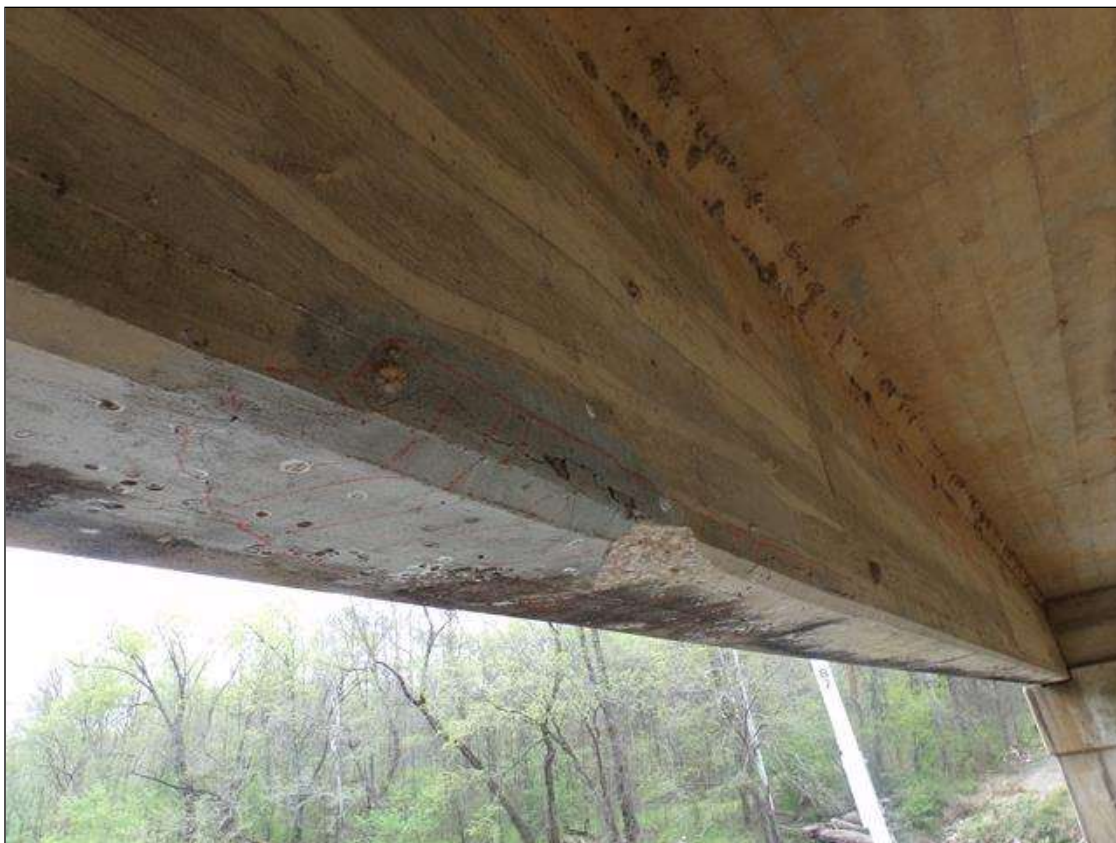
Span 7 Beam 5: Delamination 8' long x up to full width on bottom of beam x 4" high on west face with a 10" diameter spall x 2" deep on bottom of beam starting 3' from pier 7.

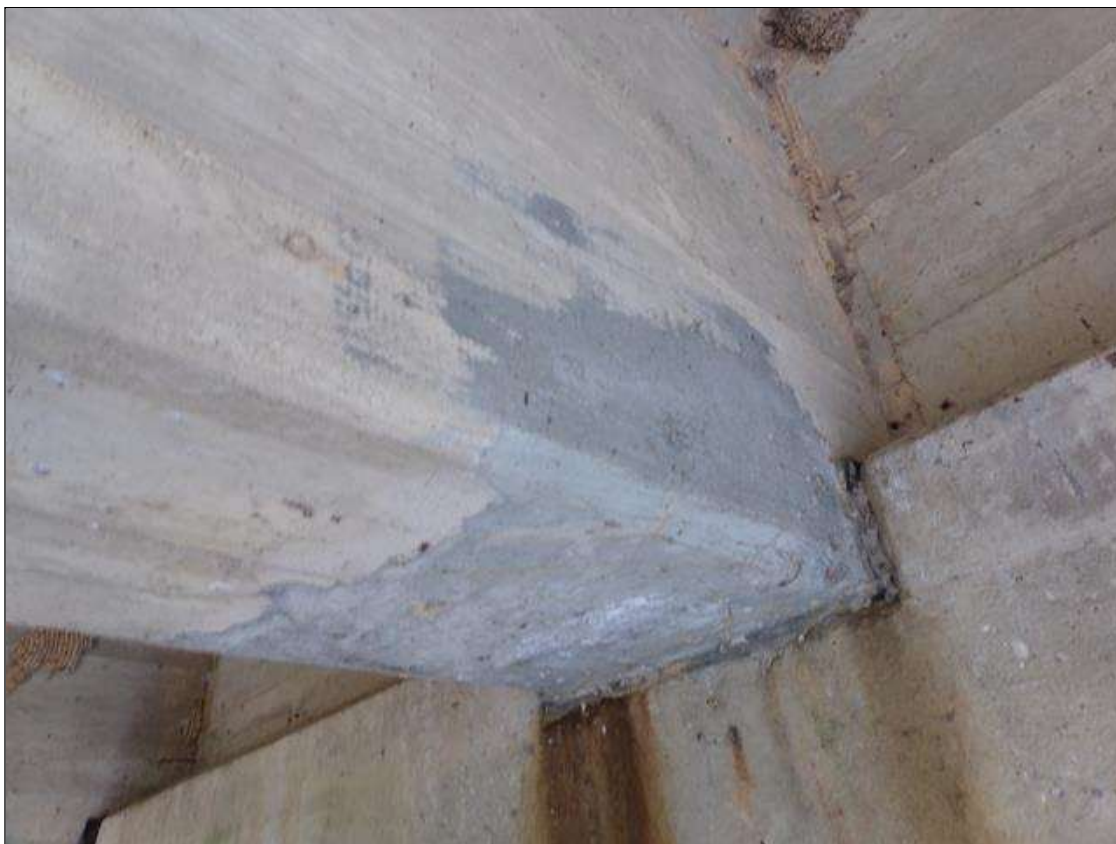
Span 7 Beam 4: Sound patched area 18" long x 1' high on east and west faces of beam at pier 7.

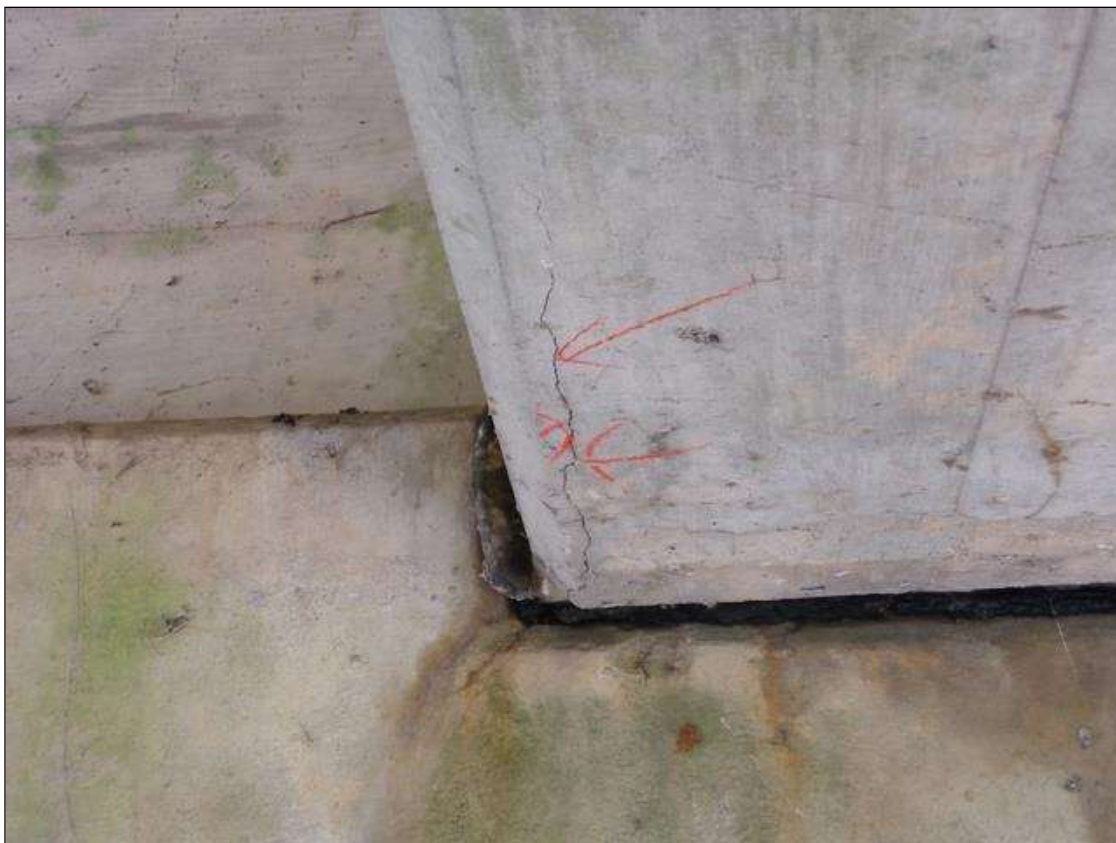
Span 7 Beam 3: 1' long longitudinal crack 1/8" wide on bottom of beam starting at pier 6.

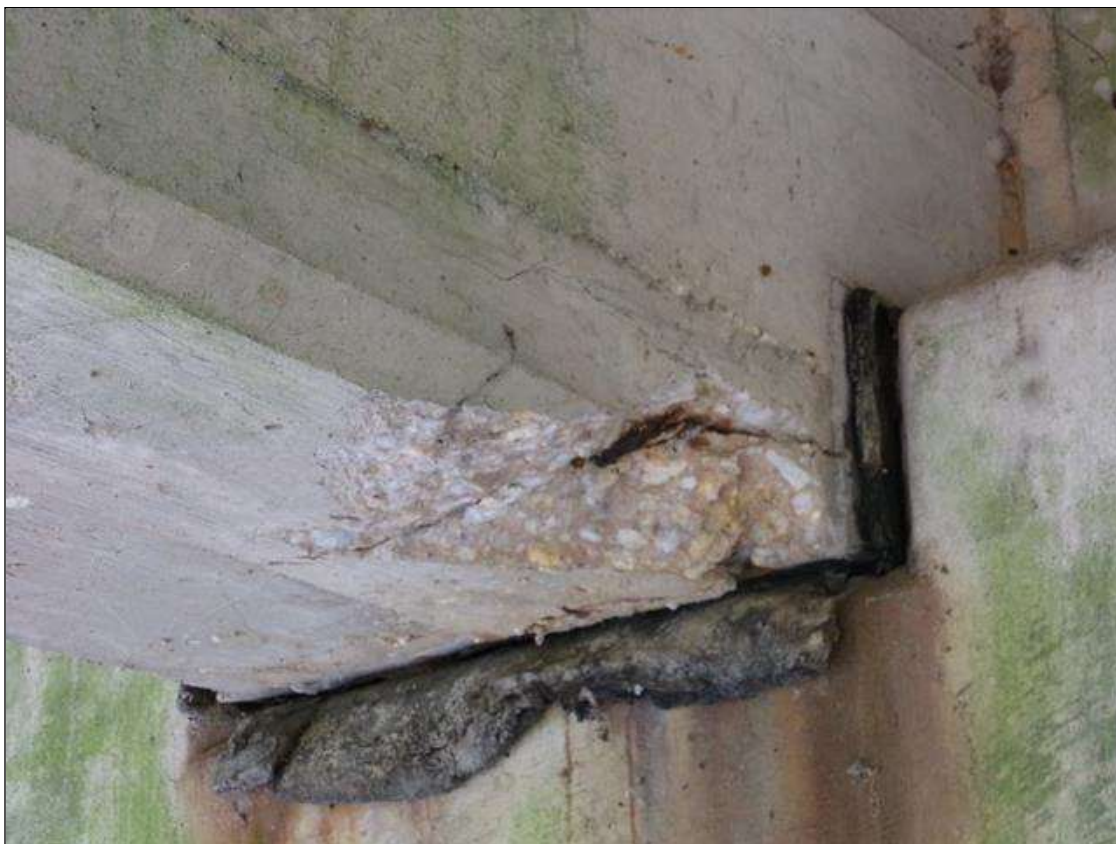
Span 7 Beam 4: 10" long x 6" wide x 1" deep spall with exposed rebar with no measurable section loss on bottom of beam at pier 6

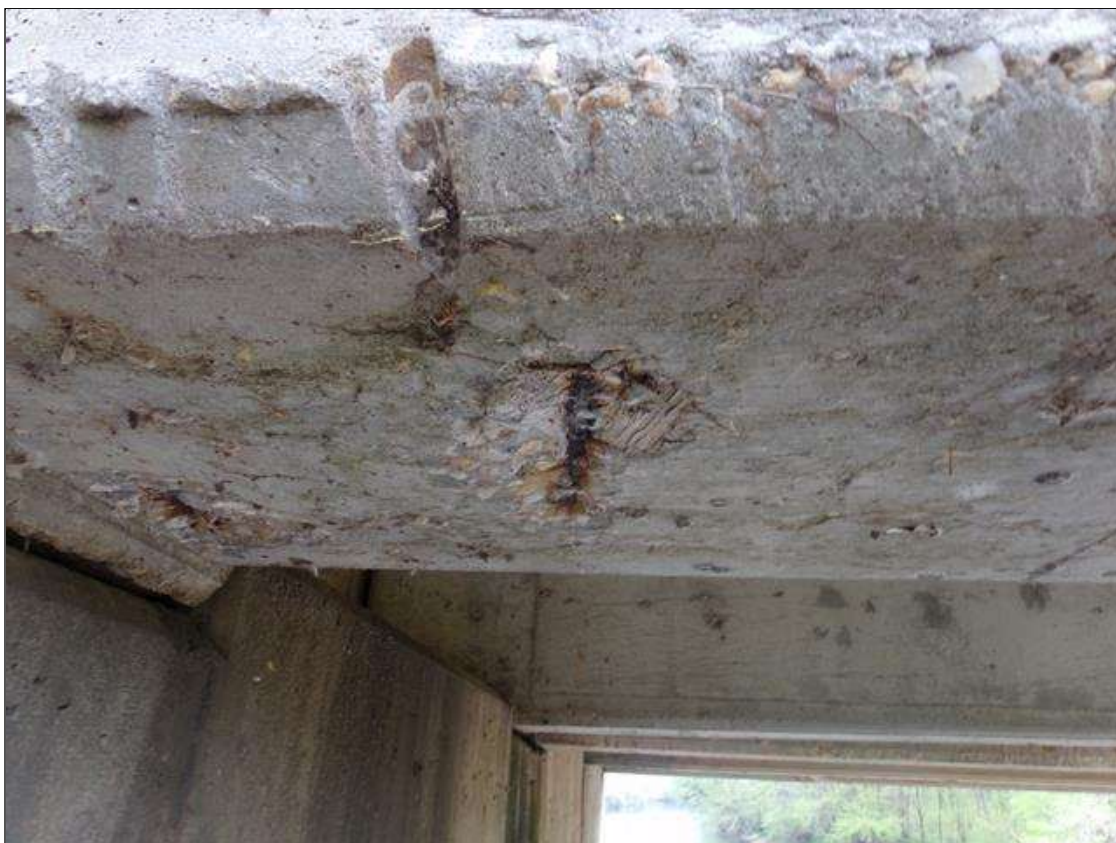
Span 7 Beam 1: 9" long x 6" wide x 1/2" deep spall with exposed rebar with no measurable section loss on bottom of beam 1' from pier 7.

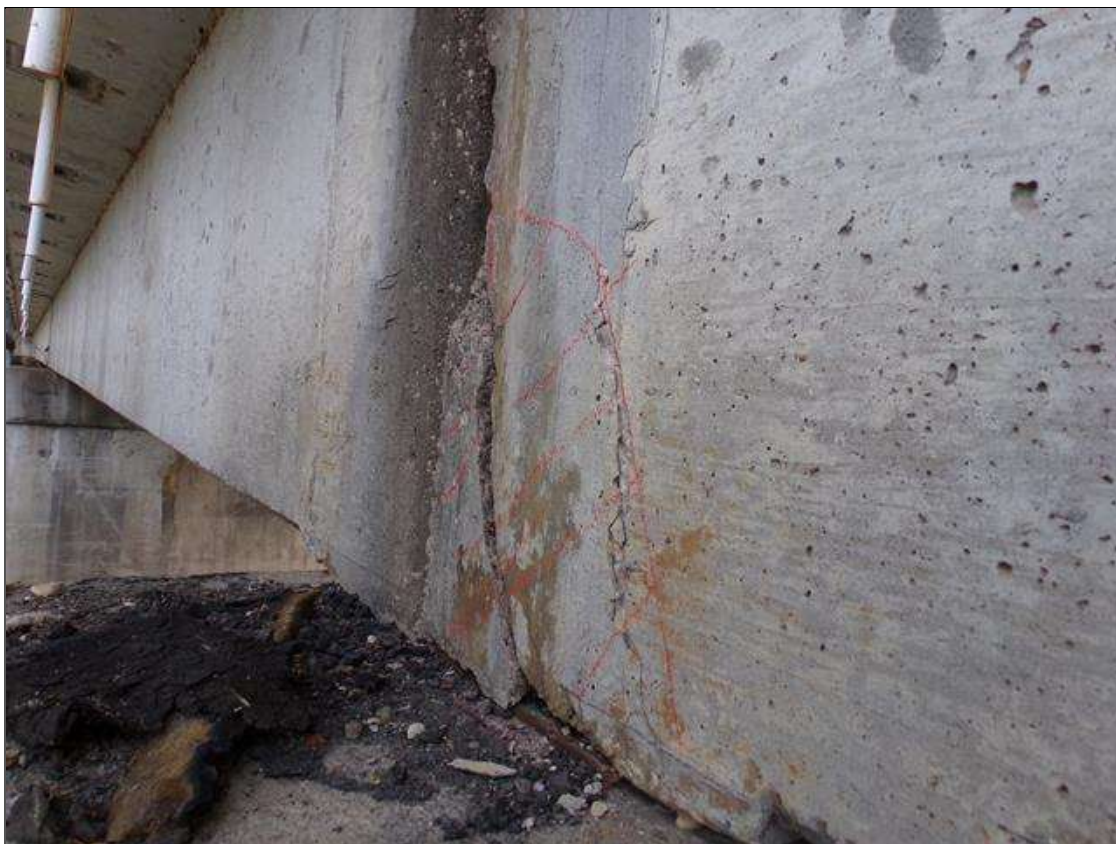
Span 7 Beam 1: Delamination 25" high x 16" wide on west face of beam over pier 7

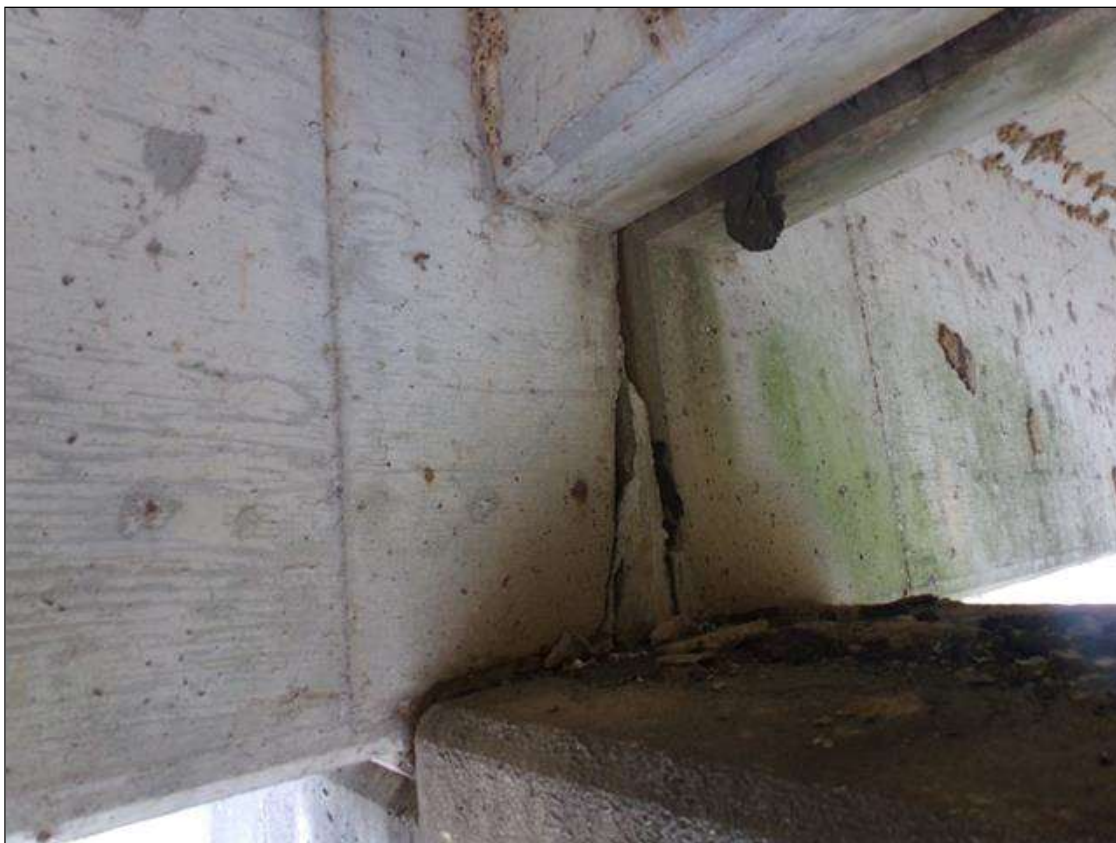
Span 7 Beam 1: End of beam has spalled off 18" high x full width x up to 3" deep over pier 7.

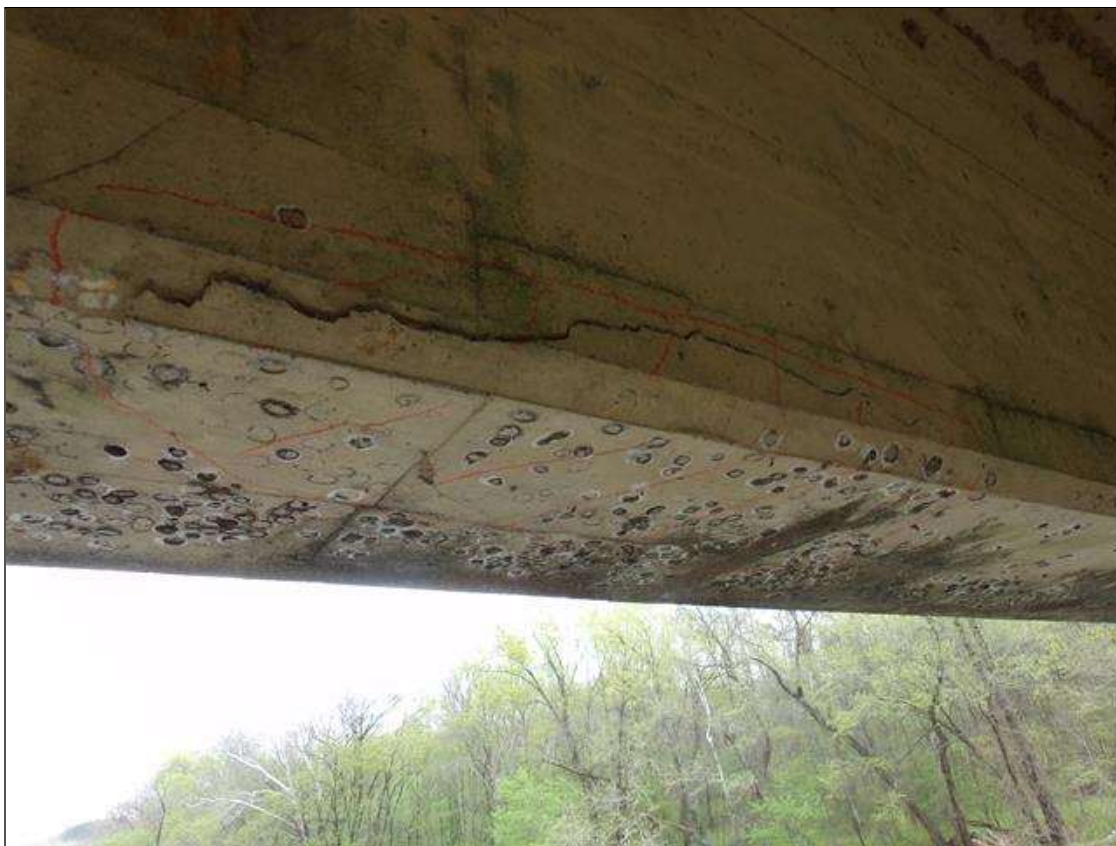
Span 8 Beam 5: Delamination 2' long x 10" wide on bottom of beam x 4" high on west face 10' from pier 7

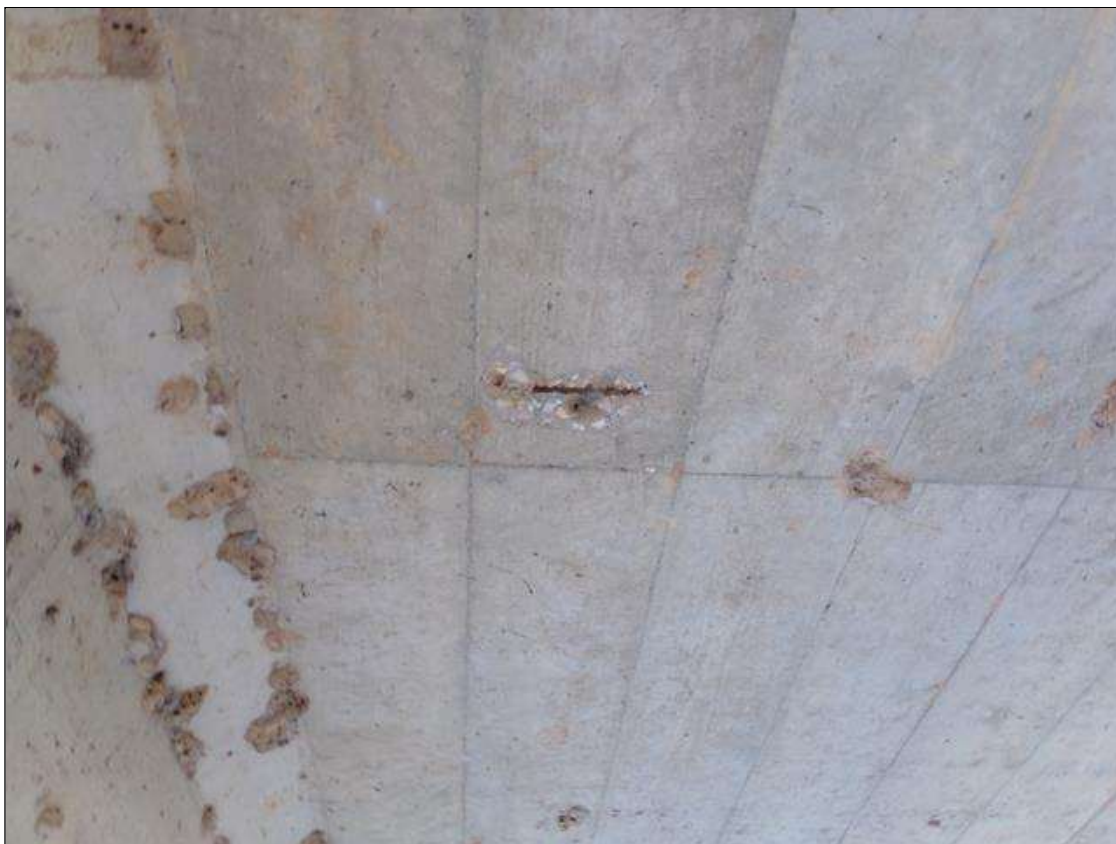
Span 8 Deck: Spall 6" wide x 3" long x 1/4" deep with exposed rebar with no measurable section loss on underside of deck near mid span in bay 3.

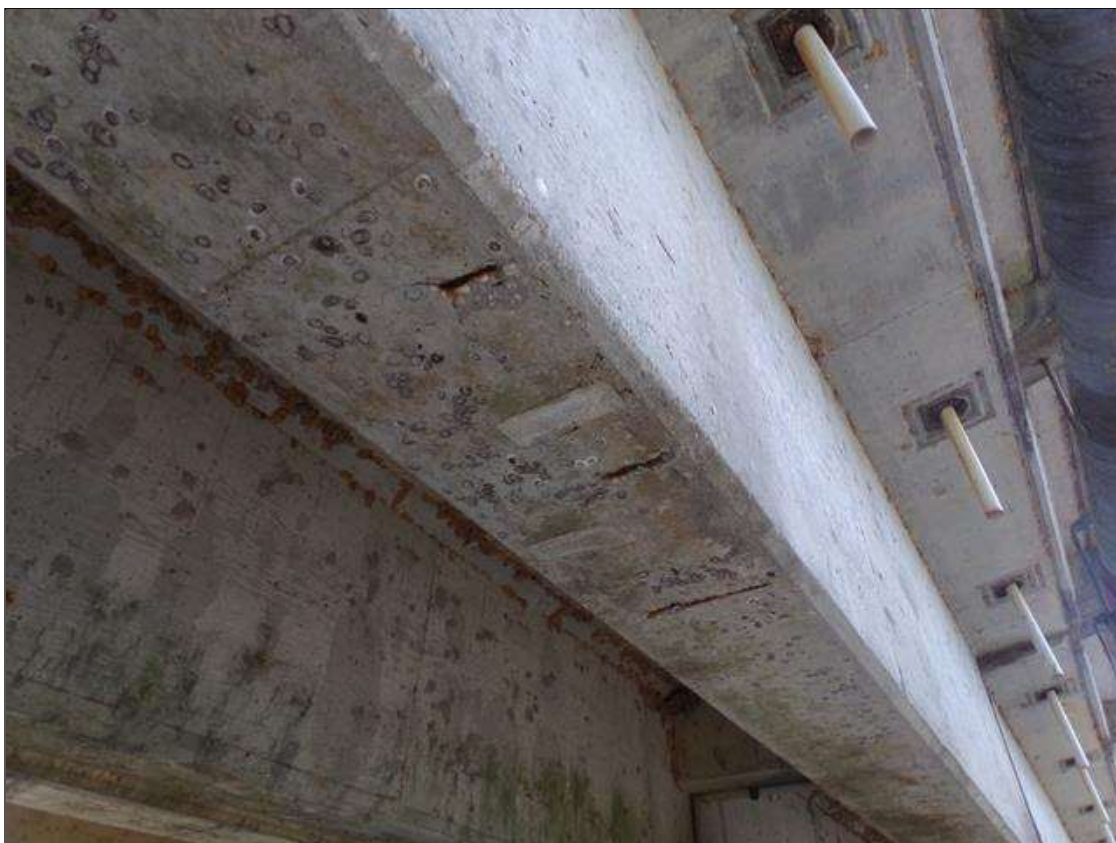
Span 8 Beam 1: Three spalls spaced 1' apart up to 10" long x 1" wide x 1/4" deep with exposed rebar with no measurable section loss on bottom of beam 14' from pier 7

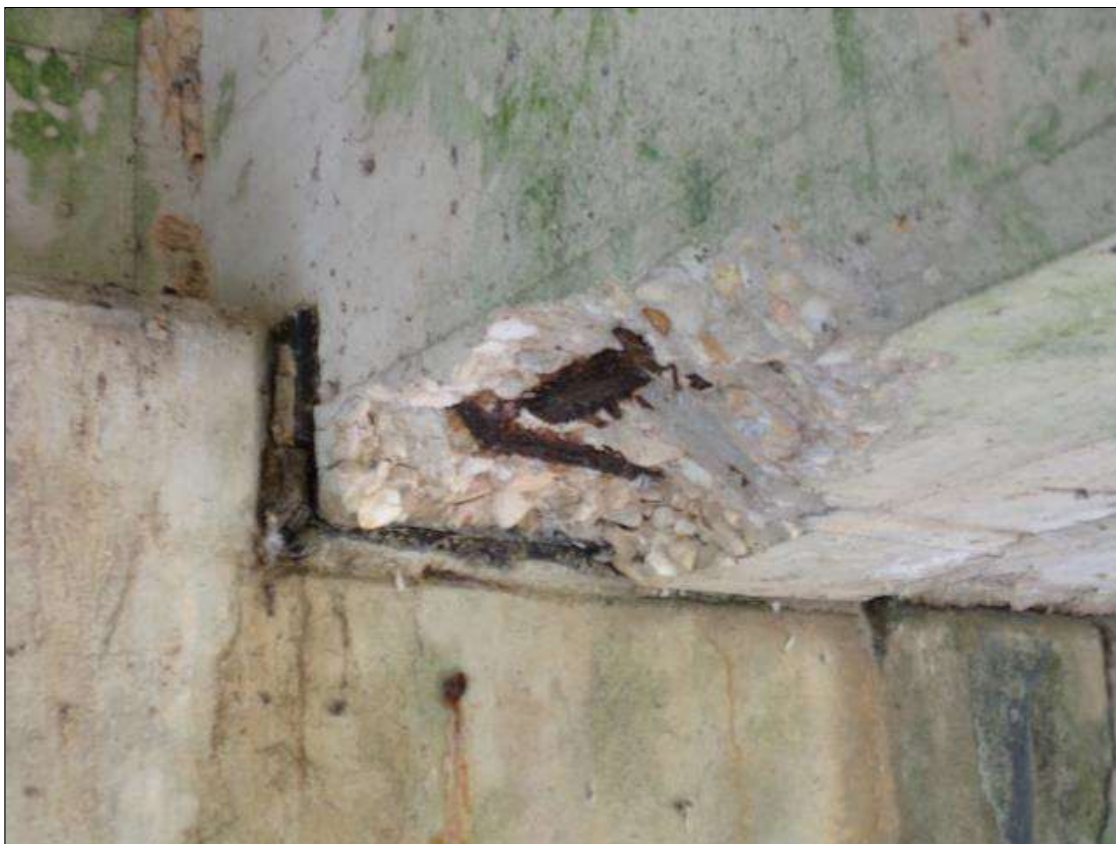
Span 8 Beam 3: Spall 1' square x 3" deep on bottom of beam with exposed rebar with no measurable section loss at pier 7.

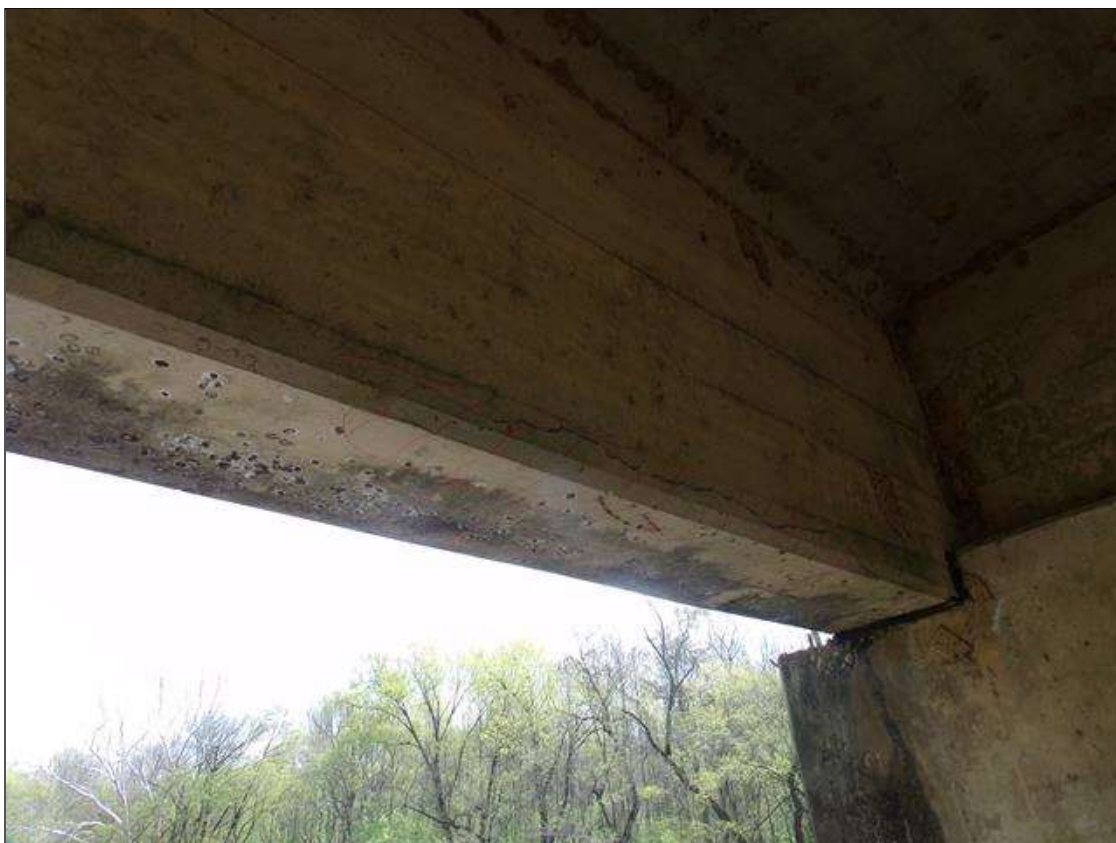
Span 8 Beam 5: Delamination 4' long x up to full width of bottom of beam x 4" high on west face starting 1' from pier 7

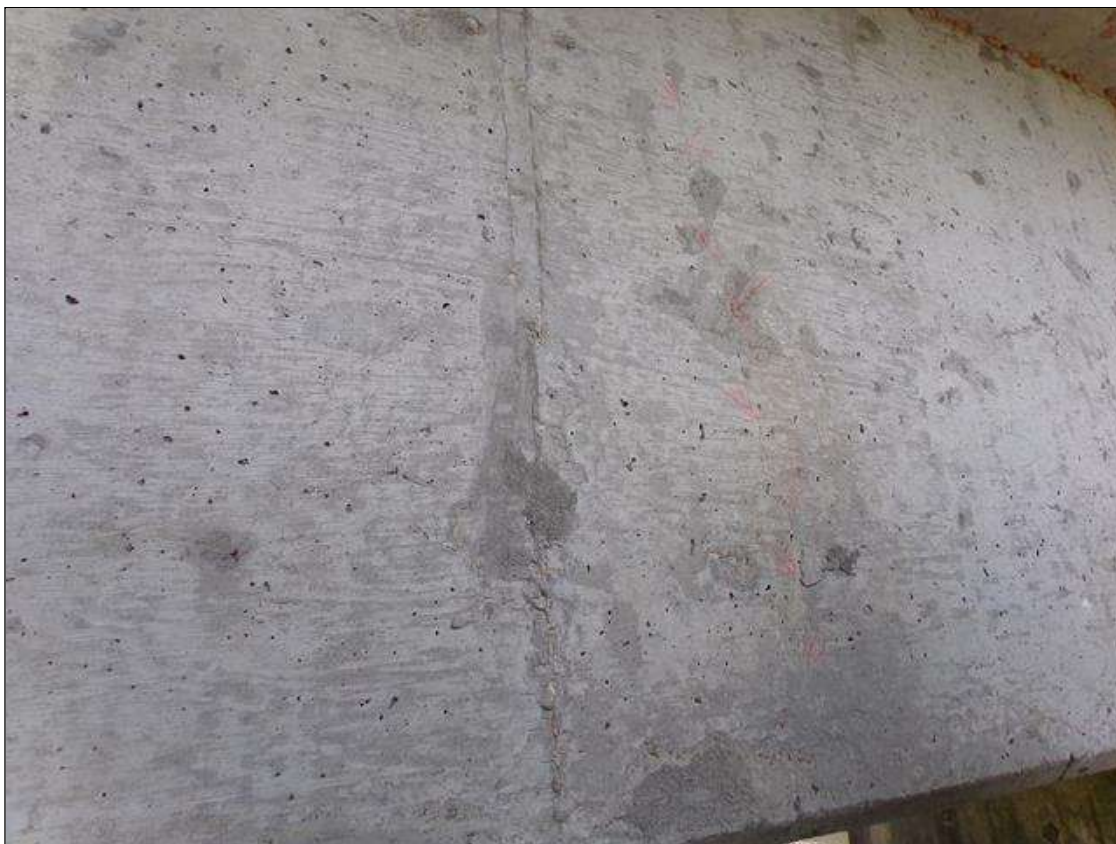
Span 8 Beam 1: Full height vertical hairline to 1/32" crack on west face of beam at mid span.

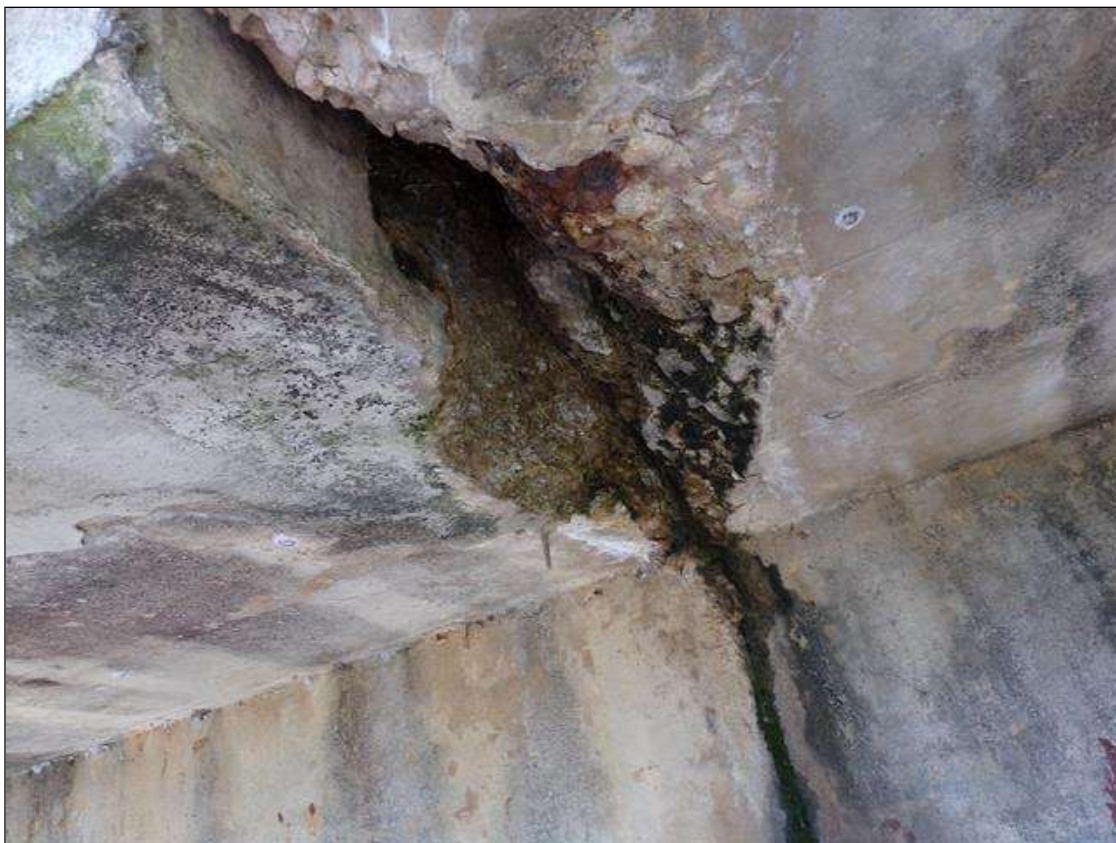
Span 8 Deck: Spall in east overhang 2' wide x 4" long x 5" deep at end of span over pier 8.

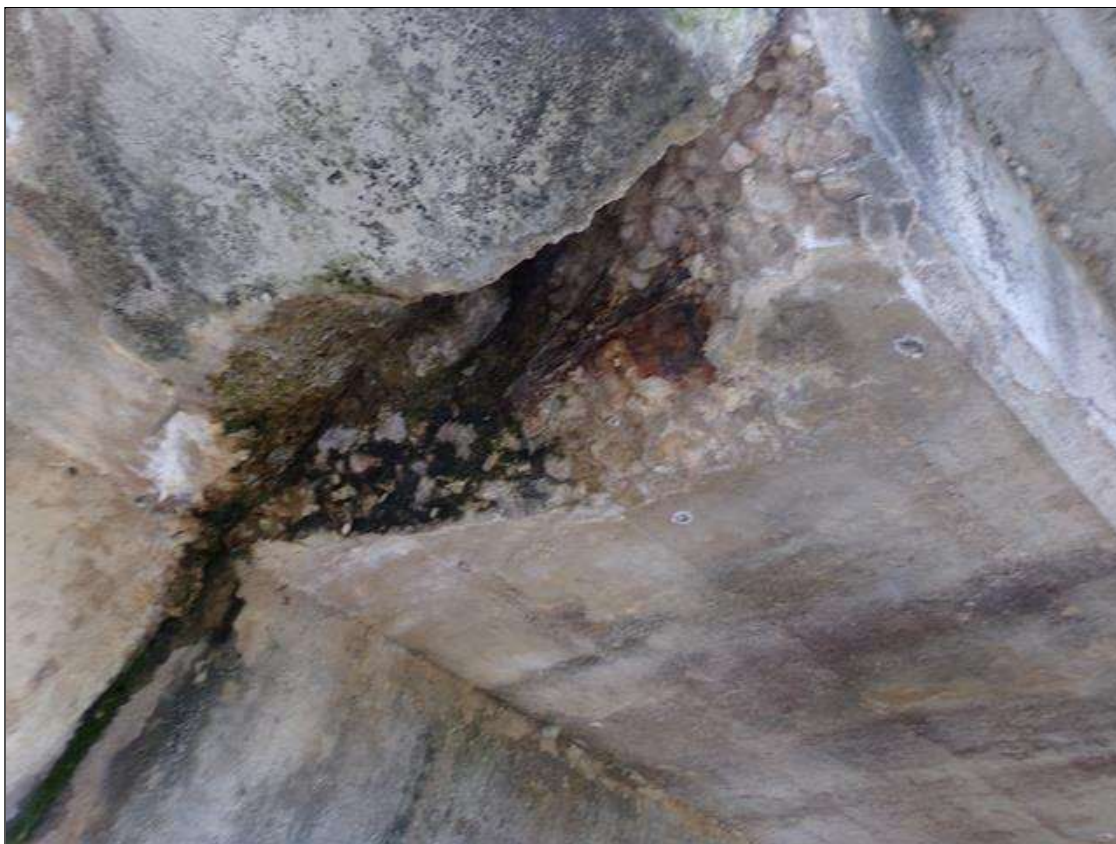
Span 9 Deck: Spall in east overhang 2' wide x 9" long x 5" deep with exposed rebar with no measurable section loss at end of span over pier 8.

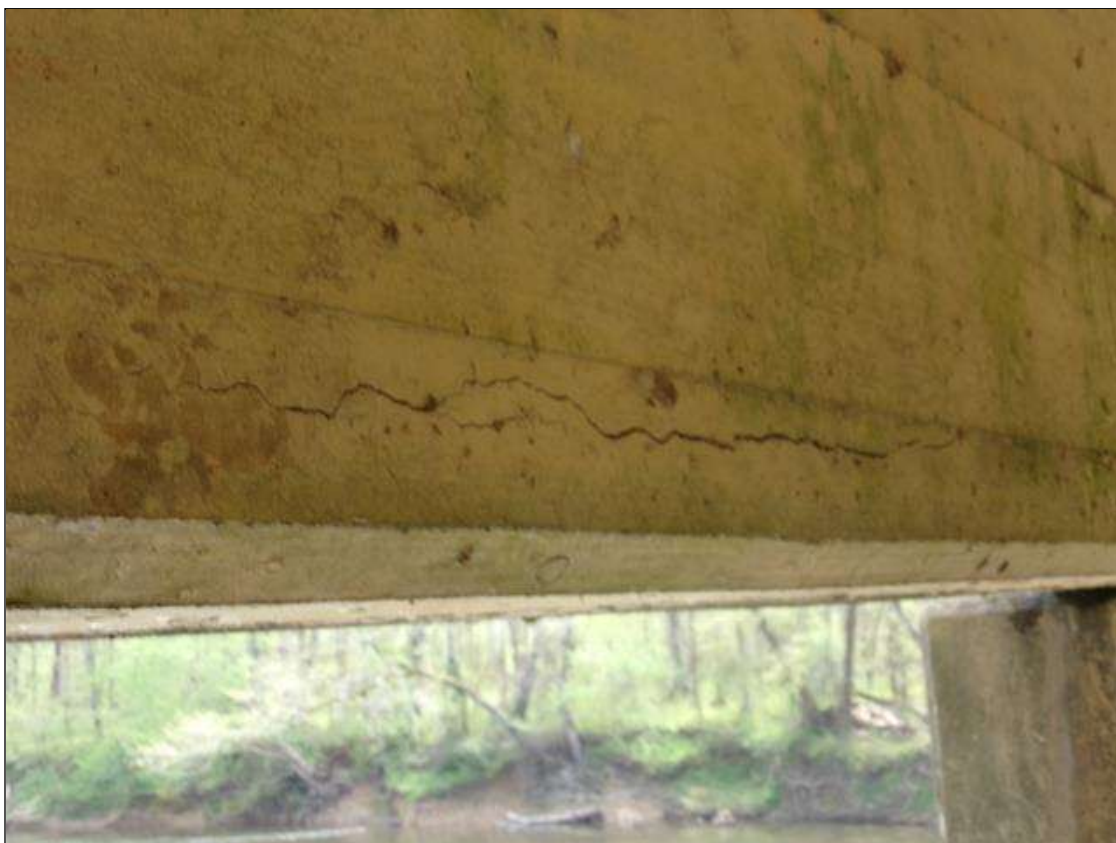
Span 9 Beam 5: 3' long horizontal crack 3/16" wide on west face of beam starting 5' from pier 8
