NC DEPARTMENT OF TRANSPORTATION
 DIVISION OF HIGHWAYS
 STRUCTURE MANAGEMENT UNIT

ATTENTION: **PRIORITY MAINTENANCE ISSUED; SNOOPER USED**

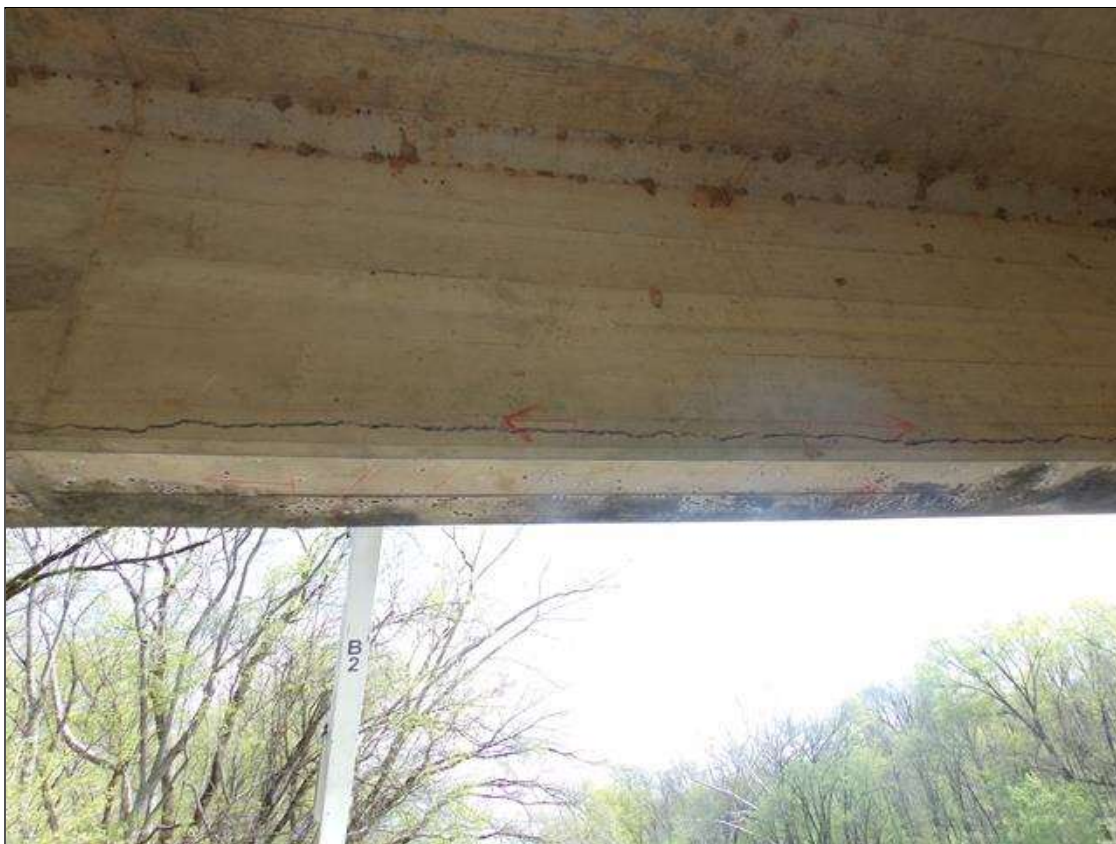
Span 9 Beam 5: Delamination 30' long x up to full width of bottom of beam x up to 1' on west face starting approximately 10' from pier 9.

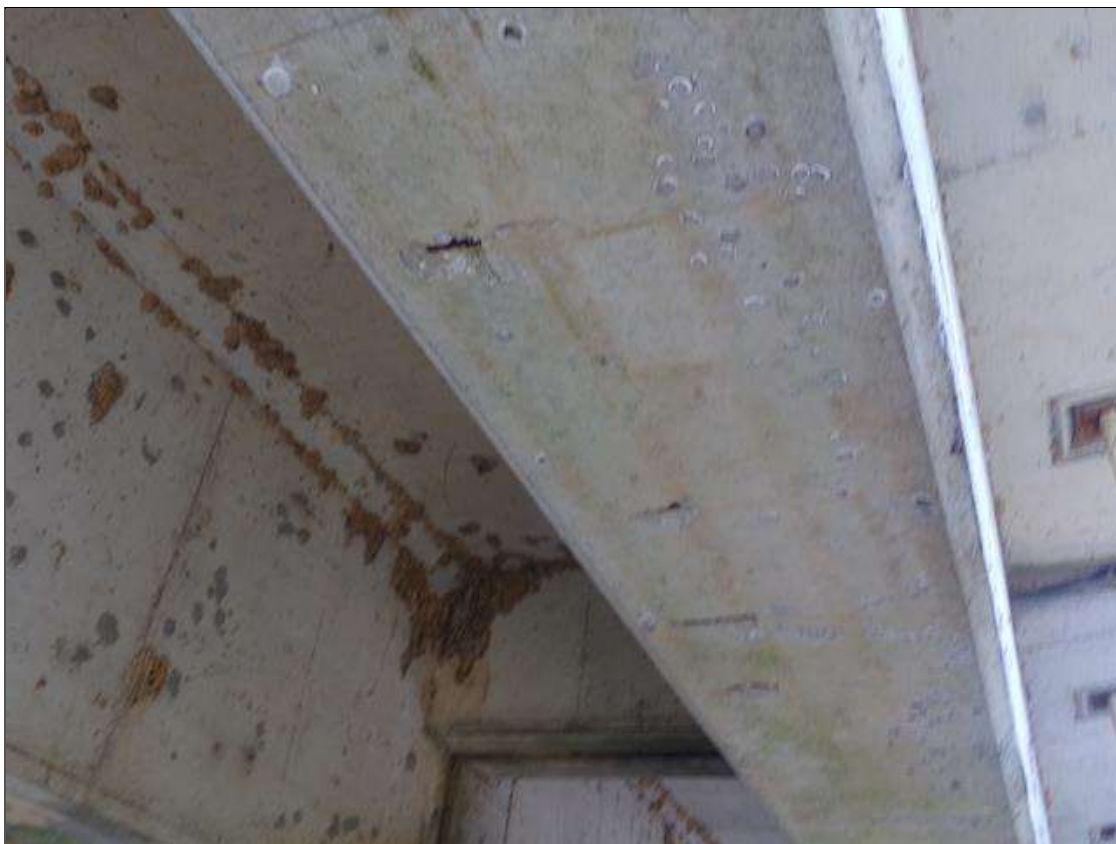
Span 9 Beam 1: 4 spalls spaced approximately 1' apart up to 3" long x 2" wide x 1/2" deep with exposed rebar with no measurable section loss on bottom of beam 7' from pier 8.

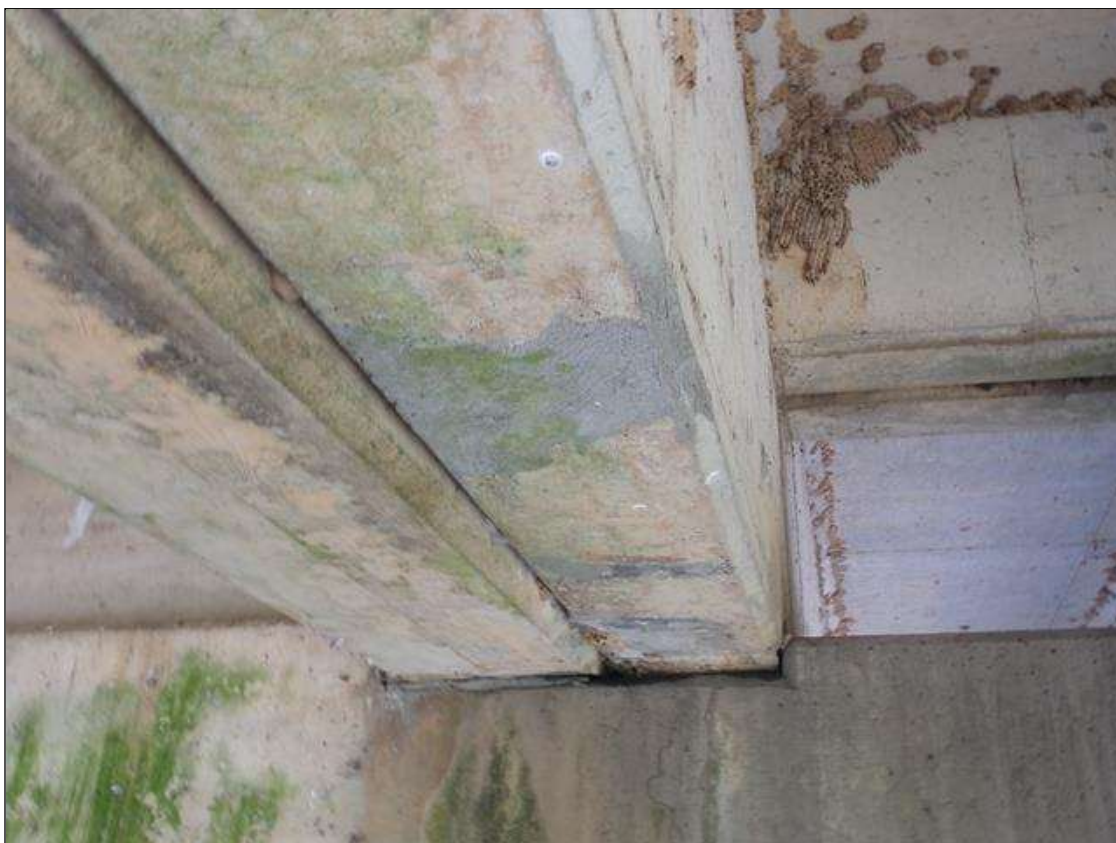
Span 9 Beam 2: Three sound patched area on bottom of beam up to 1' wide x 10" long starting at pier 8 out 4'.

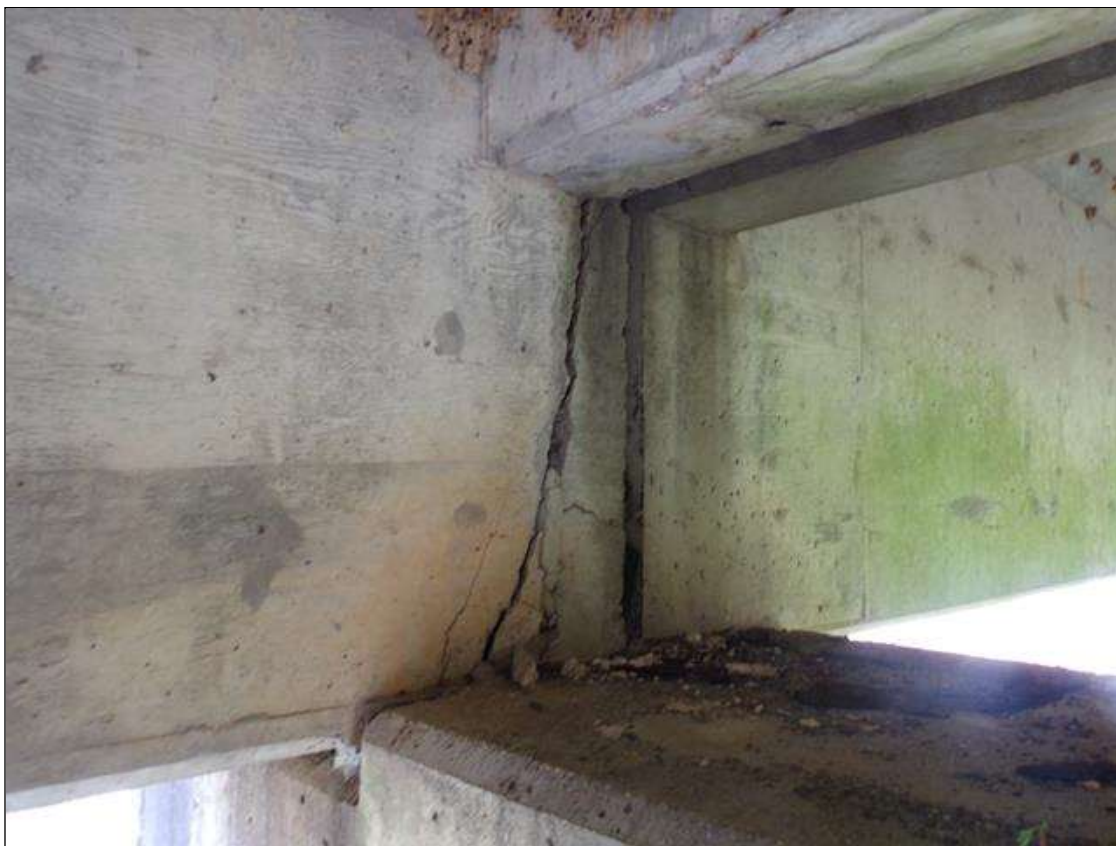
Span 9 Beam 1: Spall at beam end 1' wide x 26" high x full width over pier 9

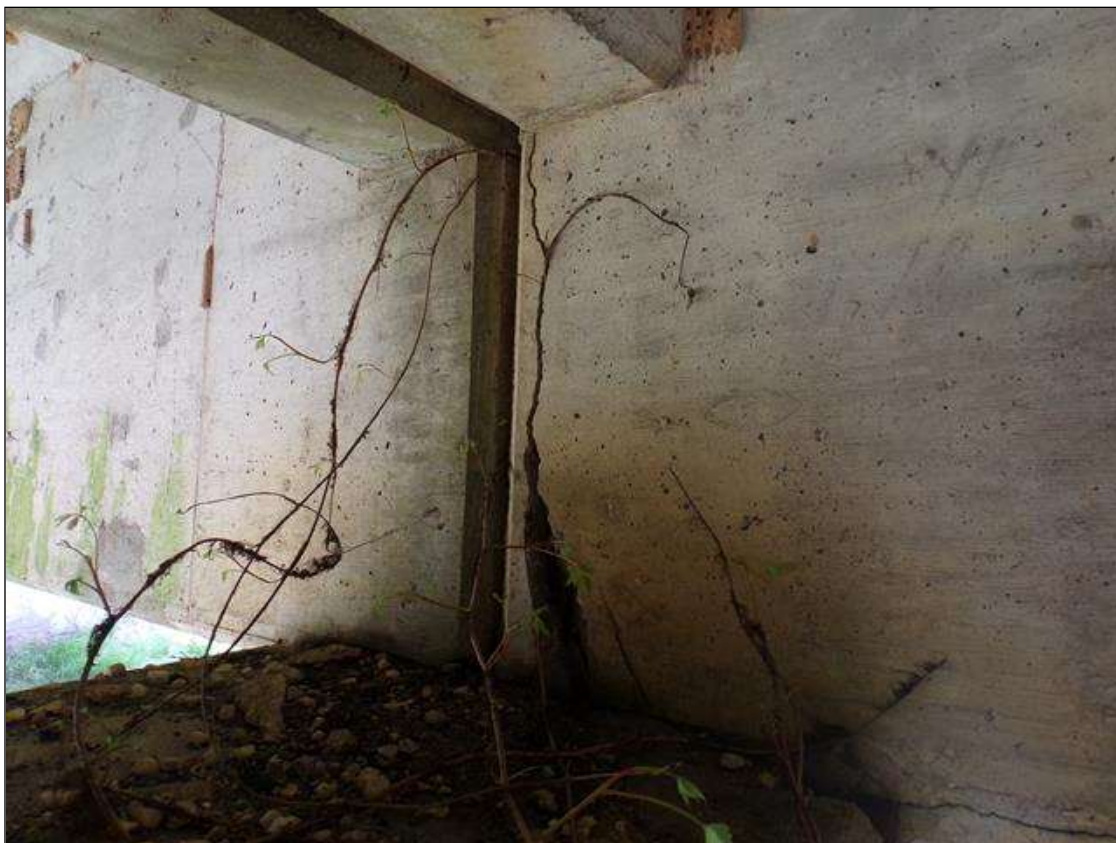
Span 9 Beam 2: Spall at beam end west face 3" wide x 10" high x 1 1/2" deep with a 16" long vertical crack 1/4" wide over pier 9

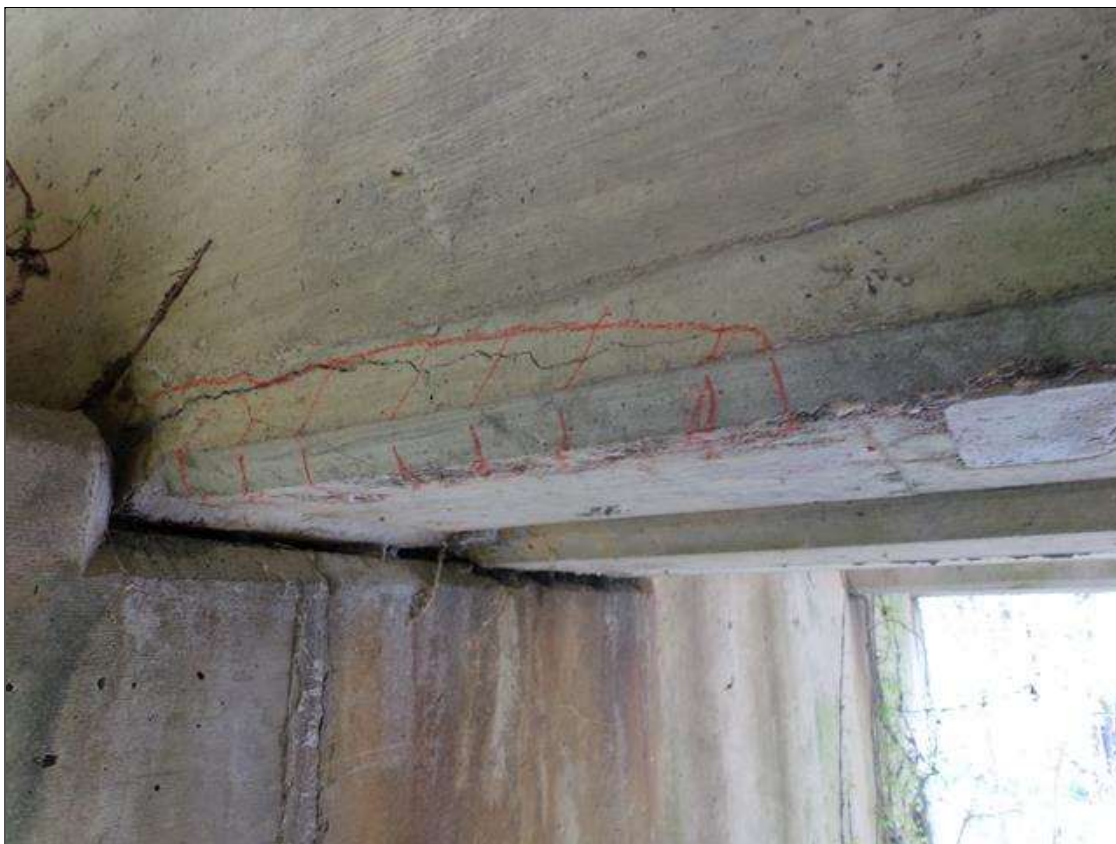
Span 9 Beam 2: Delamination 16" long x 3" high on west face x 4" wide on bottom of beam starting at pier 9.

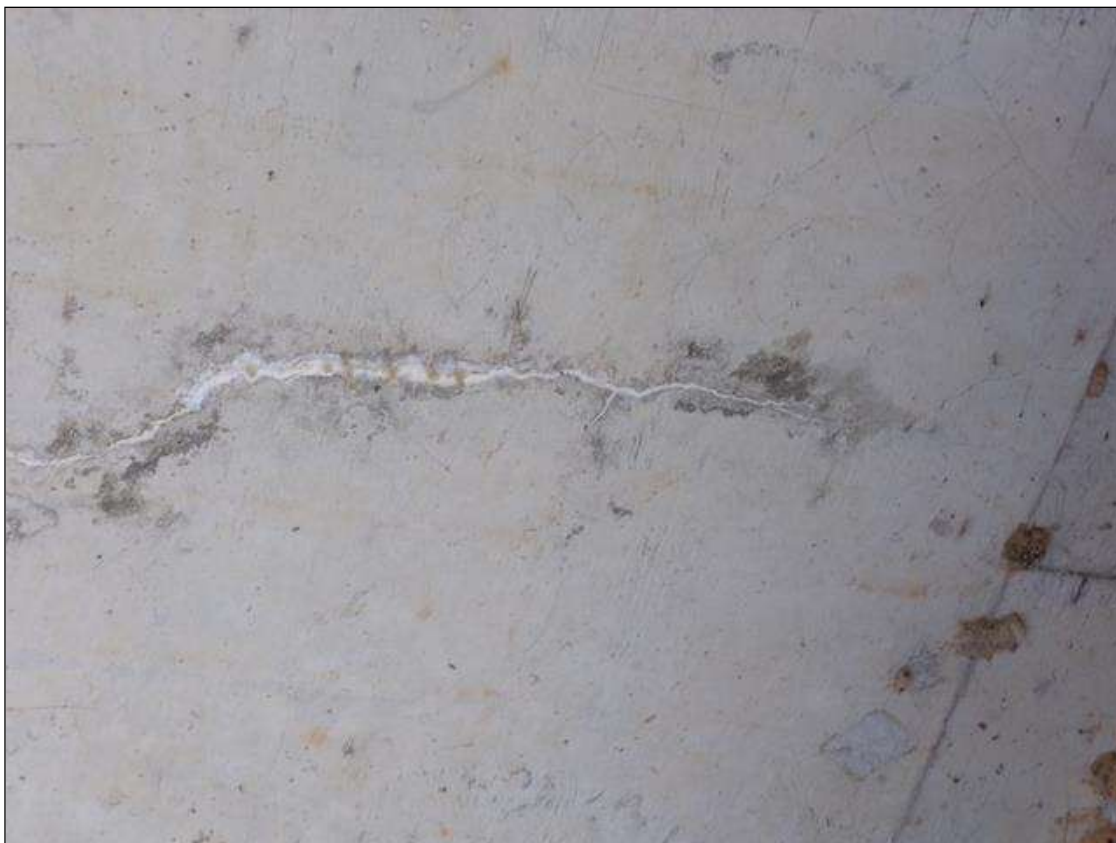
Span 9 Deck: Full width hairline transverse crack with efflorescence and stalactites on underside of deck 5' from pier 9 in bay 1.

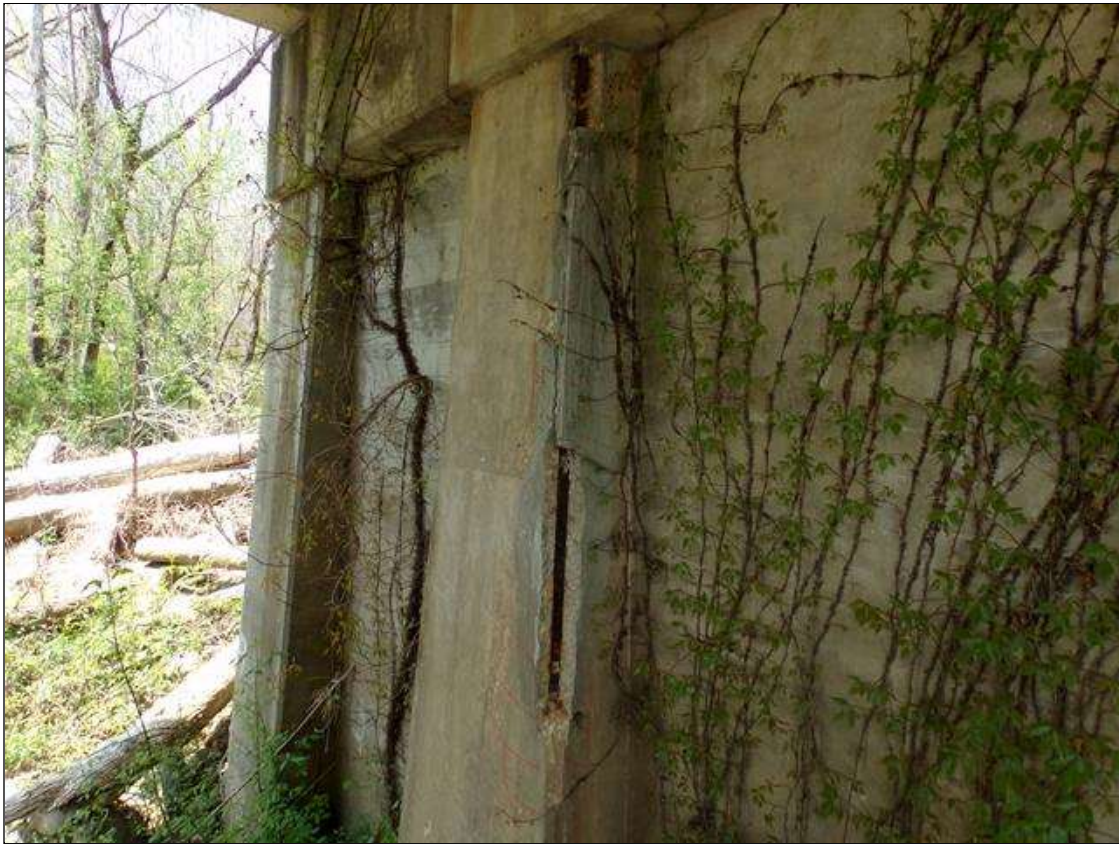
Bent 9 Pile 2: 9' high x up to 1' wide on south face x up to 5" wide on east face delaminated area with 2 spalls up to 3' high x 5" wide x 2" deep with exposed rebar with no measurable section loss starting at bottom of cap.

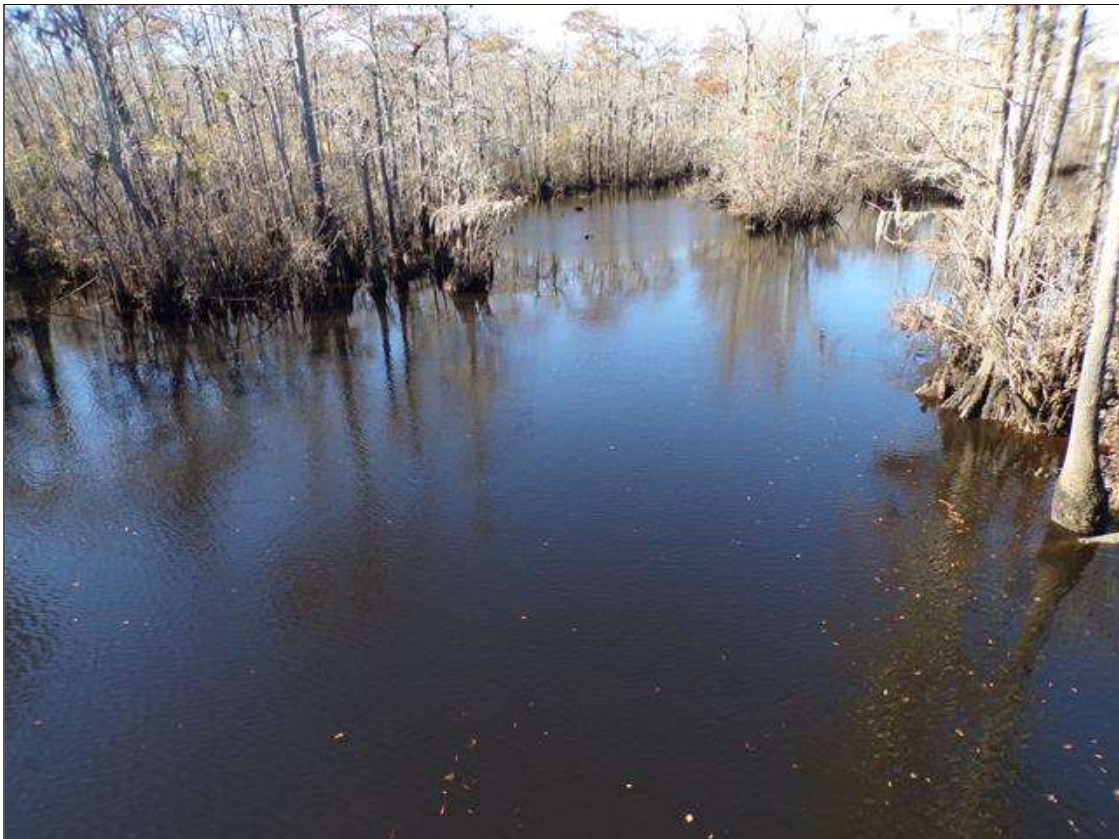
Bent 9 Pile 2: 1' high x 6" wide on south face x 6" wide on west face sound patched area 4' from ground line.

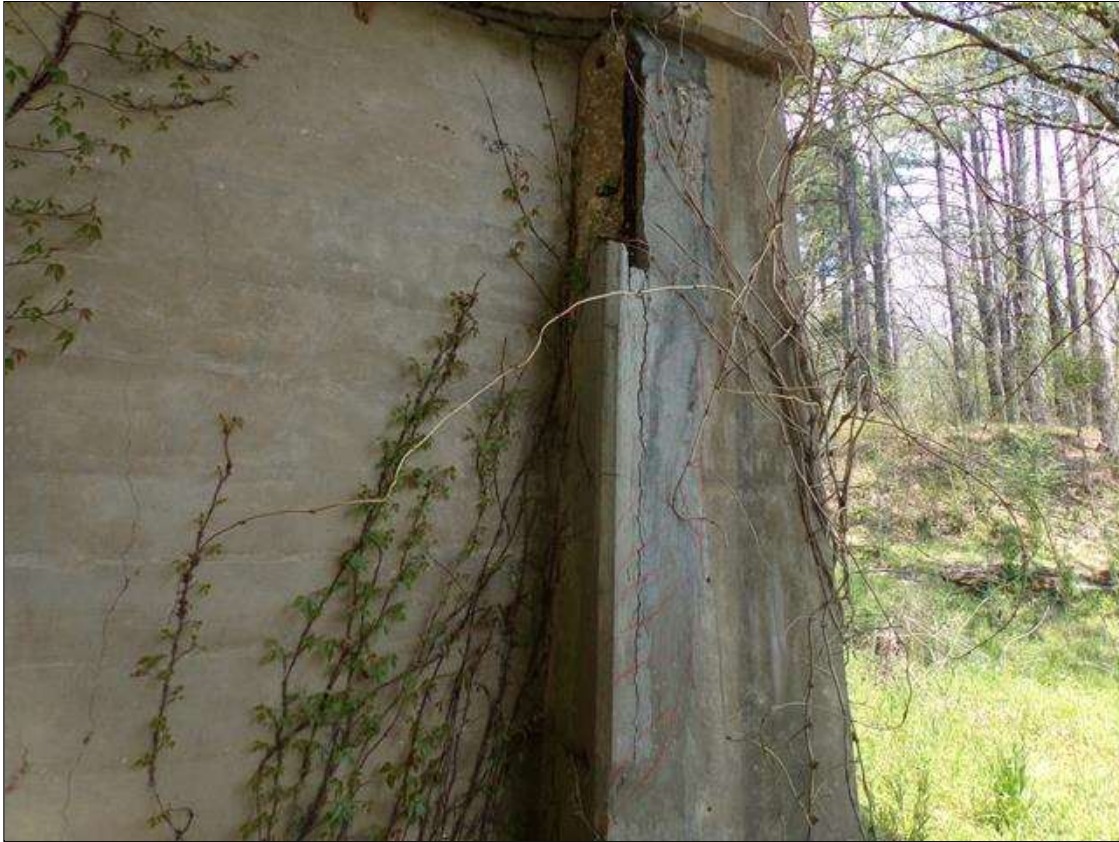
Bent 9 Pile 3: 8' high x up to 1' wide on south face x up to 10" wide on west face delaminated area with spall 3' high x 1' wide x 3" deep with exposed rebar with no measurable section loss starting at bottom of cap.

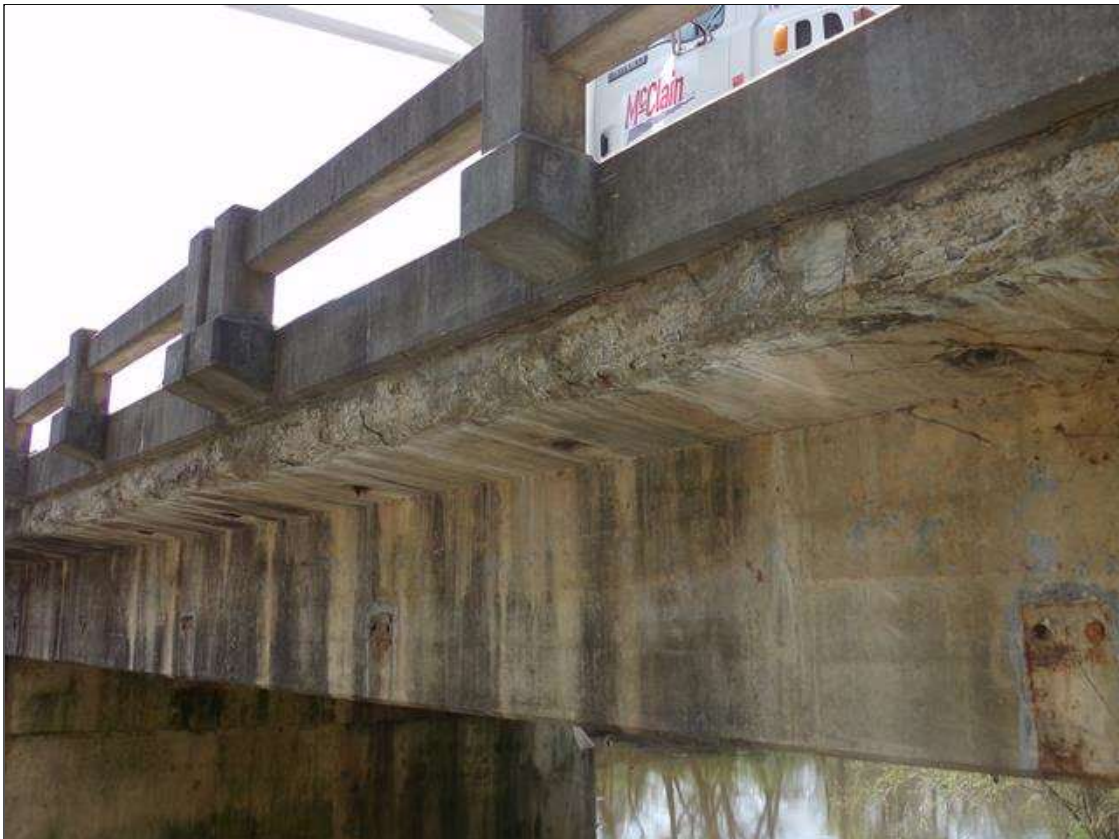
Span 9 Deck: 40' long x full height of front face east overhang area of concrete deterioration with a spalling up to 3" deep throughout starting at pier 9.

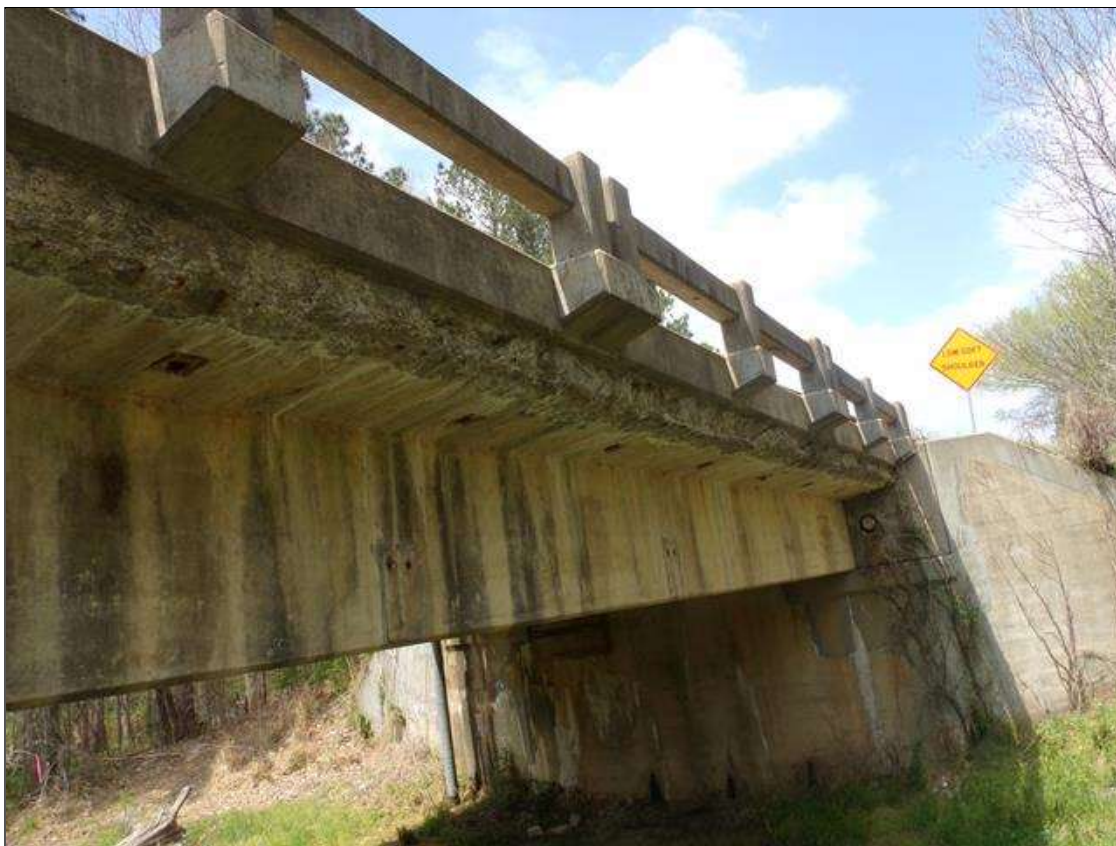
Span 10 Deck: Full length x full height of front face east overhang area of concrete deterioration with a spalling up to 3" deep throughout starting at pier 9.

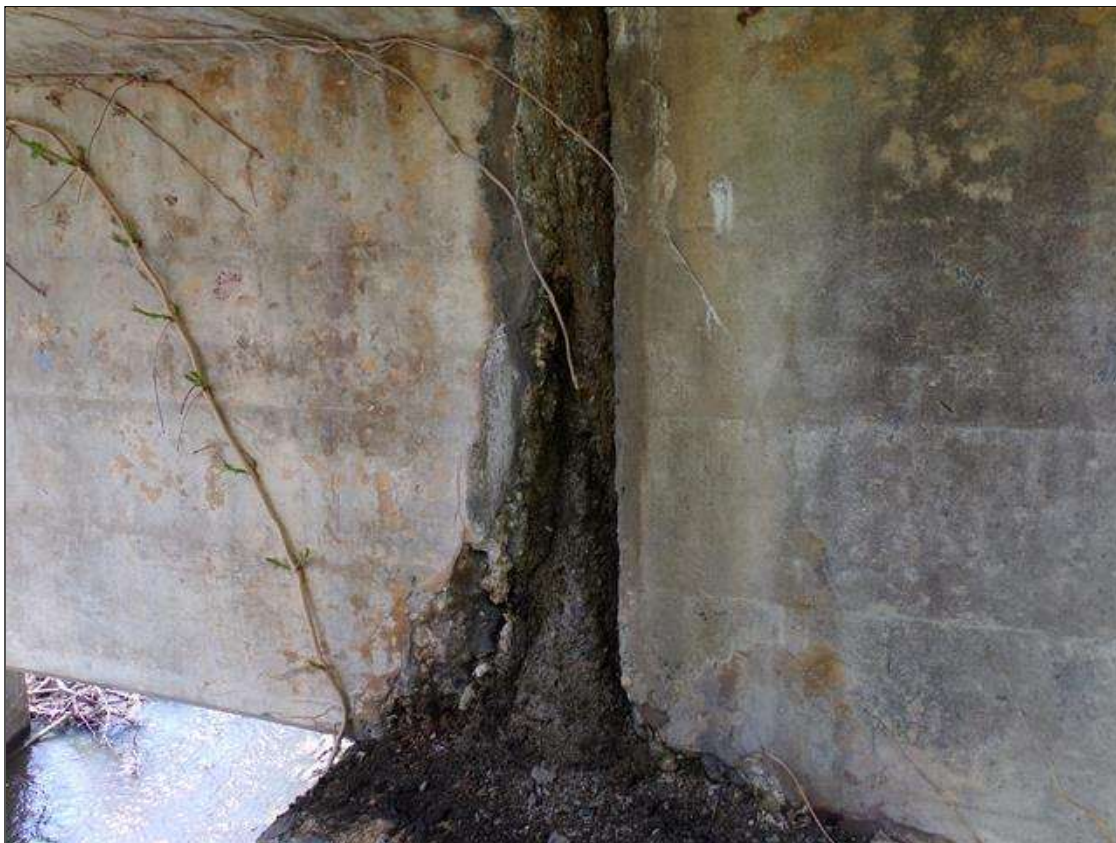
Span 9 Beam 5: Up to 1' long x full height at end of beam area of concrete deterioration with spalling up to 3" deep starting at pier 9.

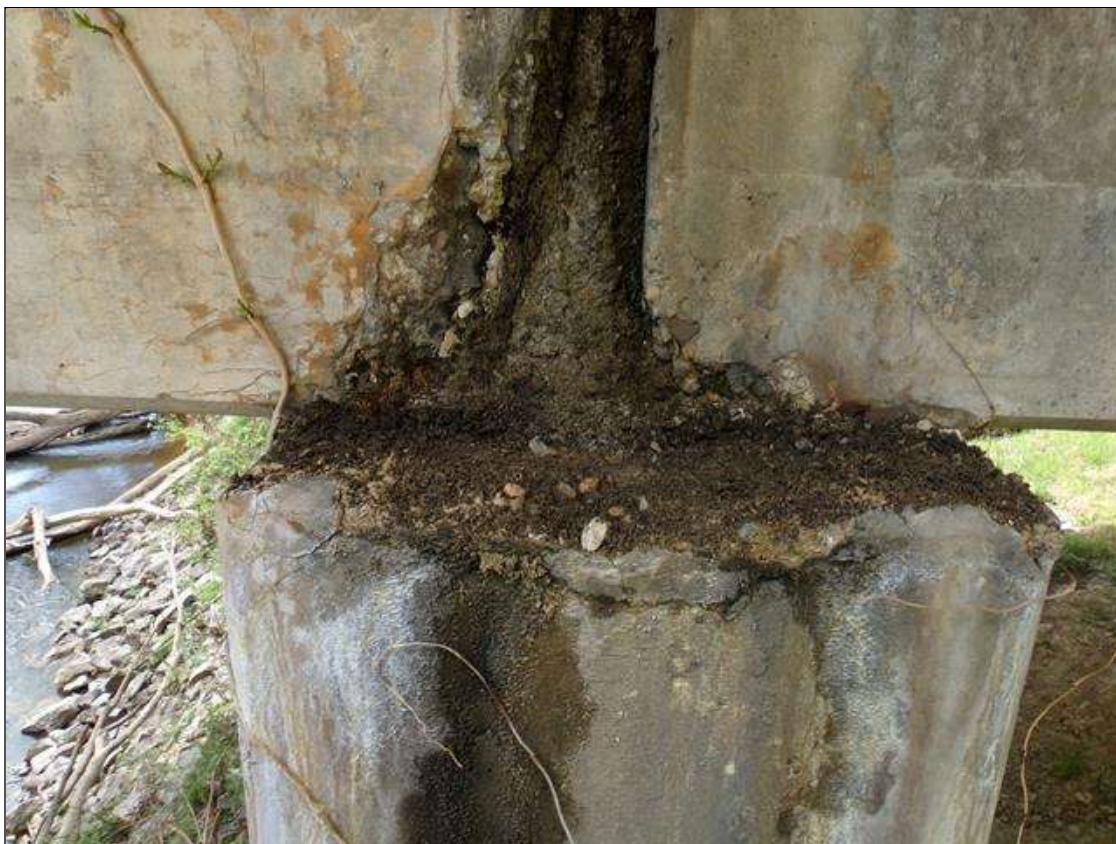
Bent 9 Cap 1: Up to 10" long x full width of top of cap east end area of concrete deterioration with spalling up to 2" deep.

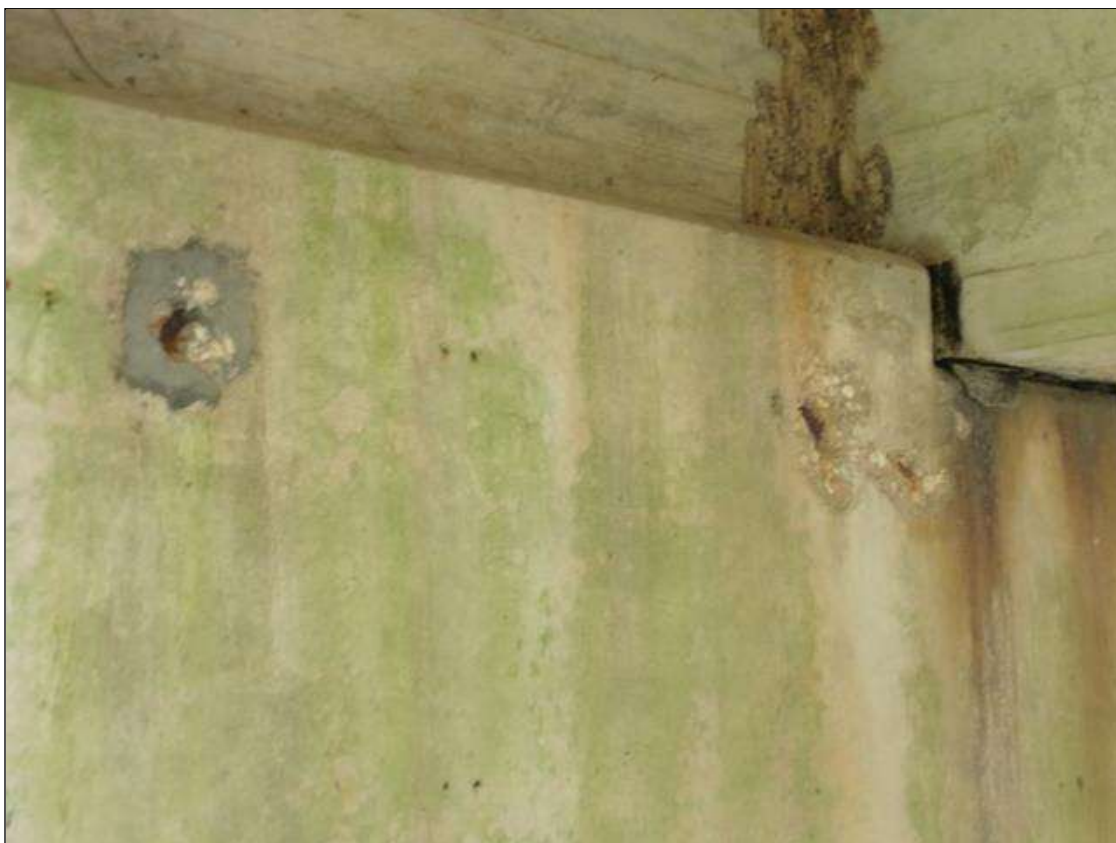
Bent 9 Cap 1: Three spalls up to 8" diameter x 3/4" deep with exposed rebar with no measurable section loss on north face of cap under bay 3

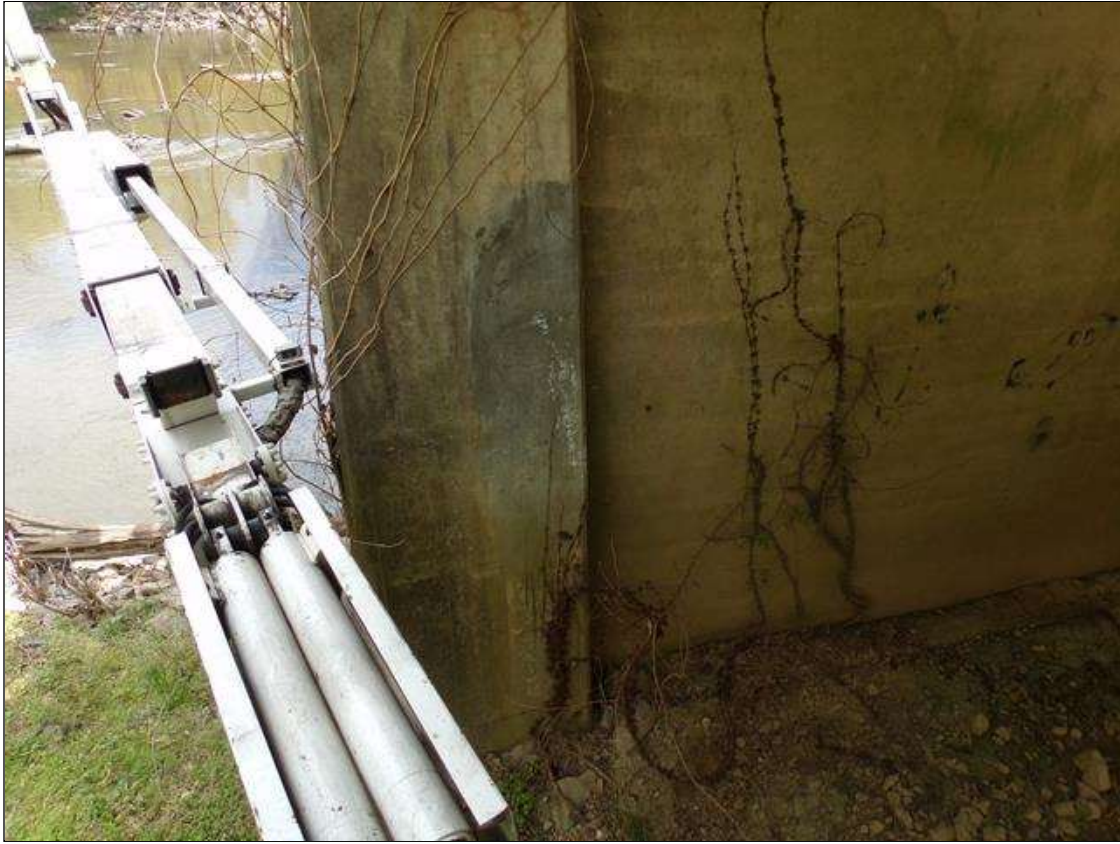
Bent 9 Pile 3: 5' high x 1' wide sound patched area on north face of column starting 3' from ground line.

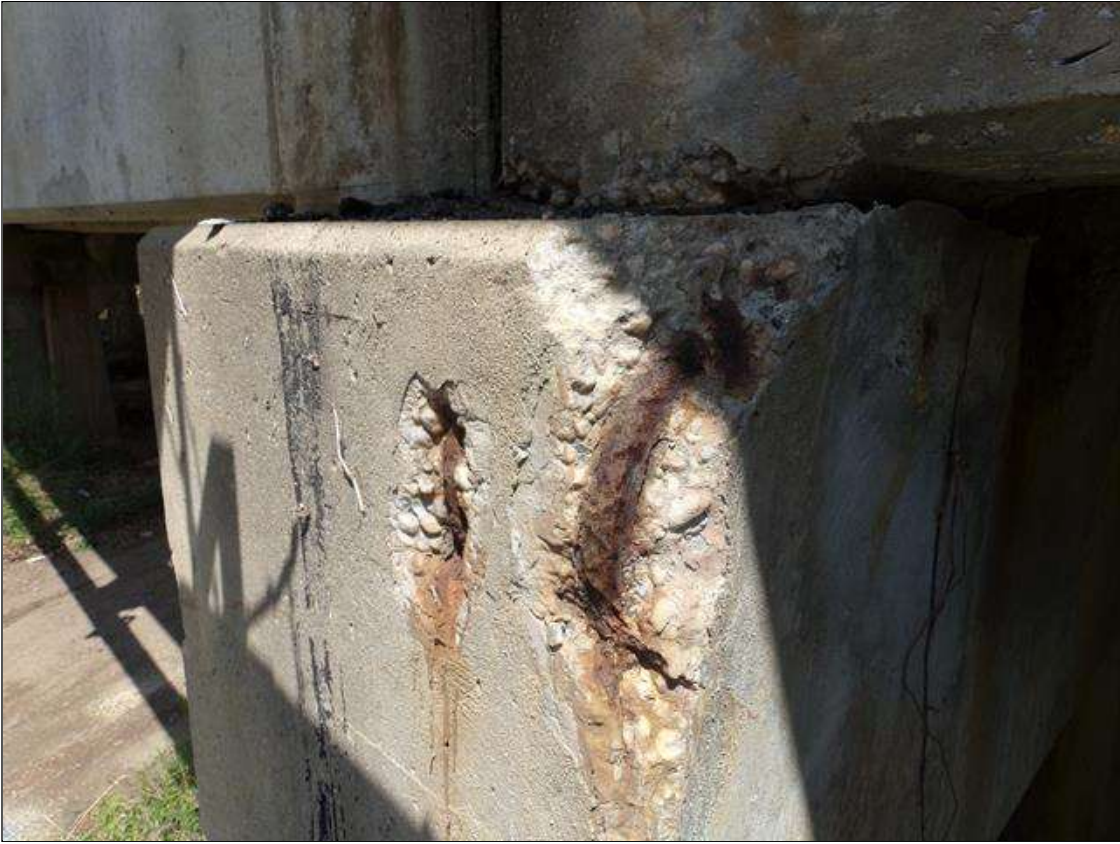
Bent 1 Cap 1: 2 spalls at west end of cap up to 13" high x 8" wide x 2" deep with exposed rebar with no measurable section loss

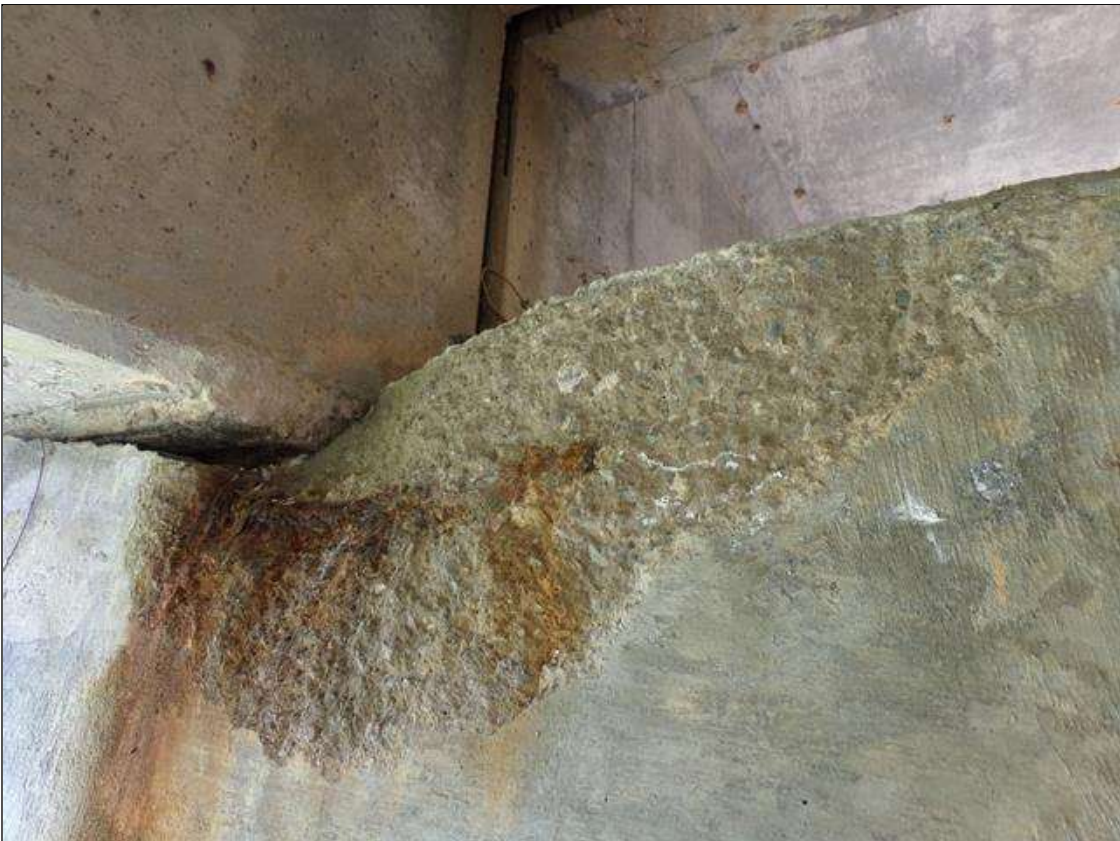
Bent 1 Cap 1: 2' long x 1' wide x 4" deep spall with exposed rebar with no measurable section loss on south face of cap under bay 1.

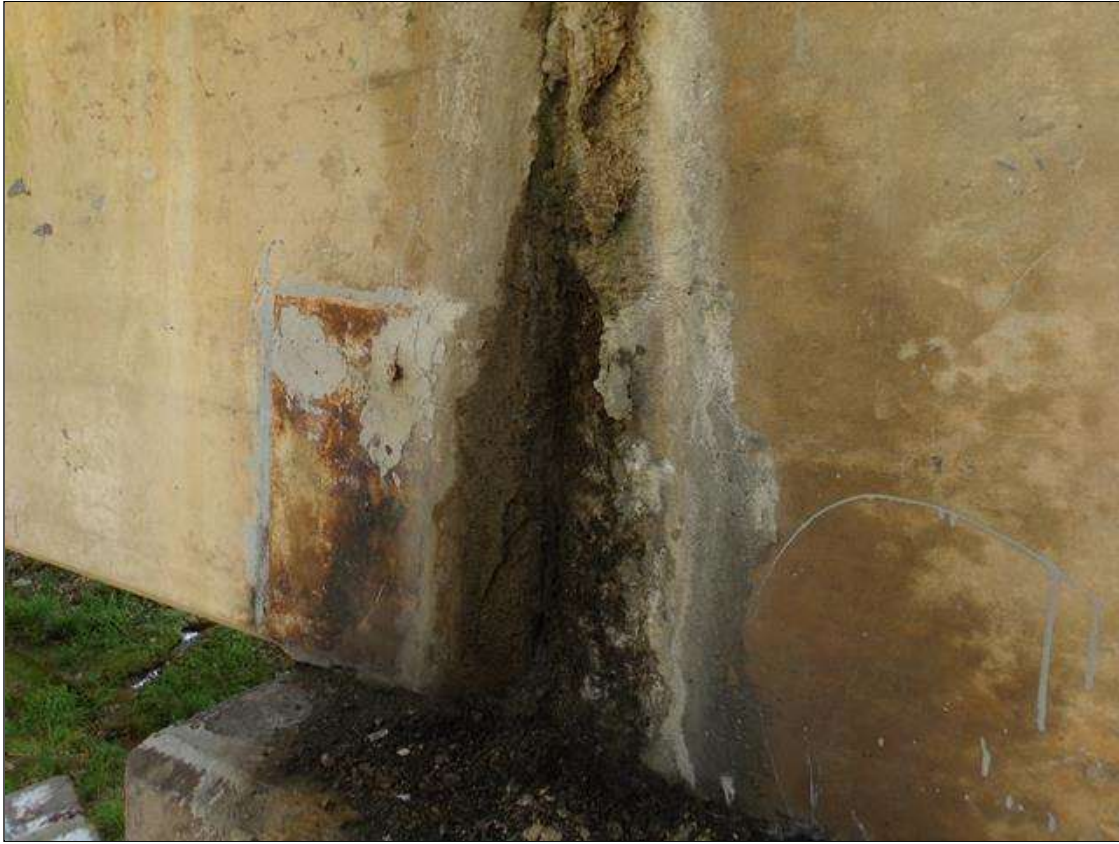
Span 2 Beam 5: 18" high x 4" wide x 1" deep spall on east face of beam over pier 1

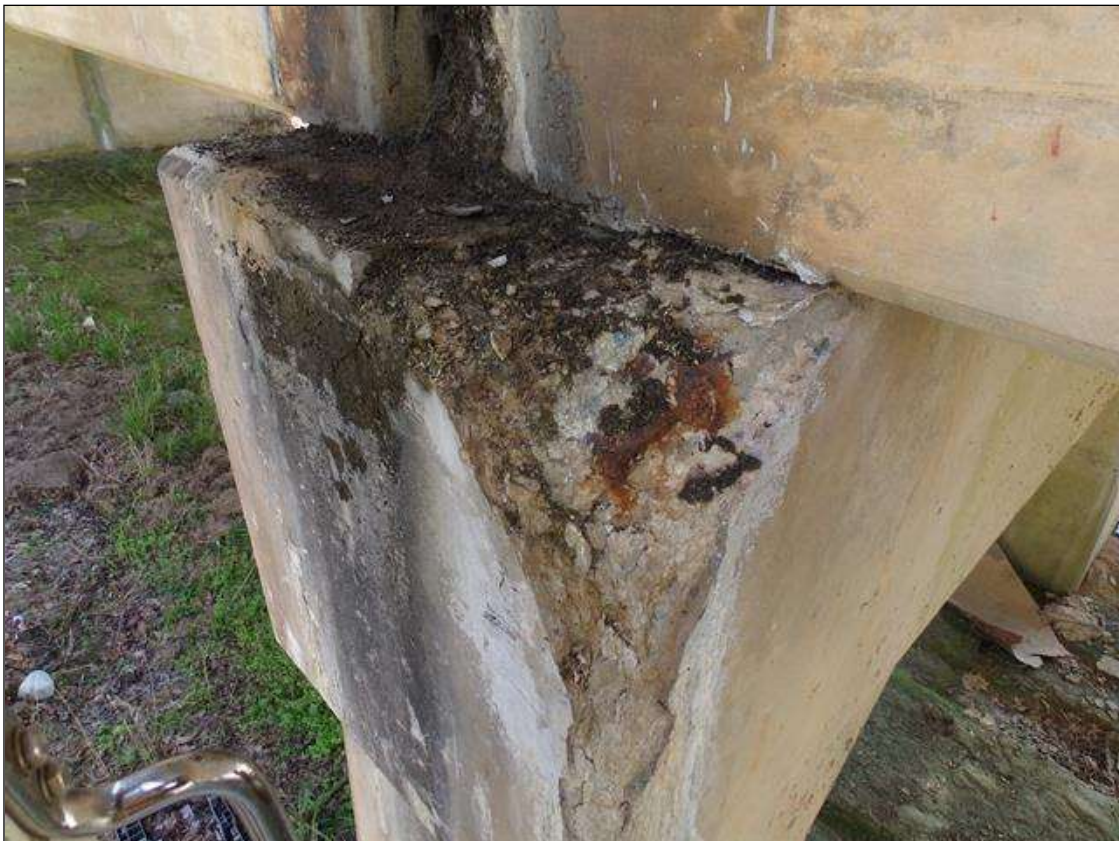
Bent 1 Cap 1: East end is spalled full height on northeast corner 4" wide x 1/4" deep with top corner spalled 16" wide x 12" wide x 2" deep and bottom corner spalled 8" wide x 8" high x 2" deep.

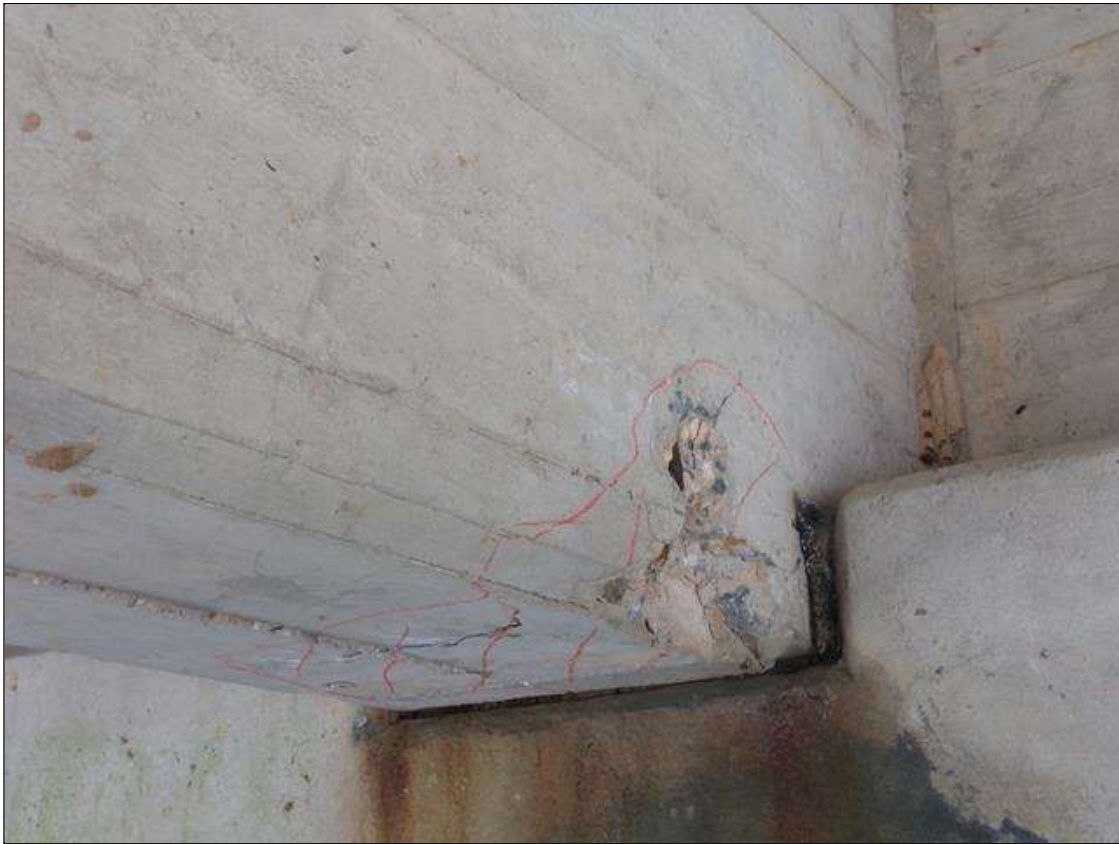
Span 2 Beam 4: Area of delamination 1' square on bottom of beam x 1' high on west face with a spall 6" high x 6" with x 1" deep with exposed rebar with no measurable section loss at pier 1.

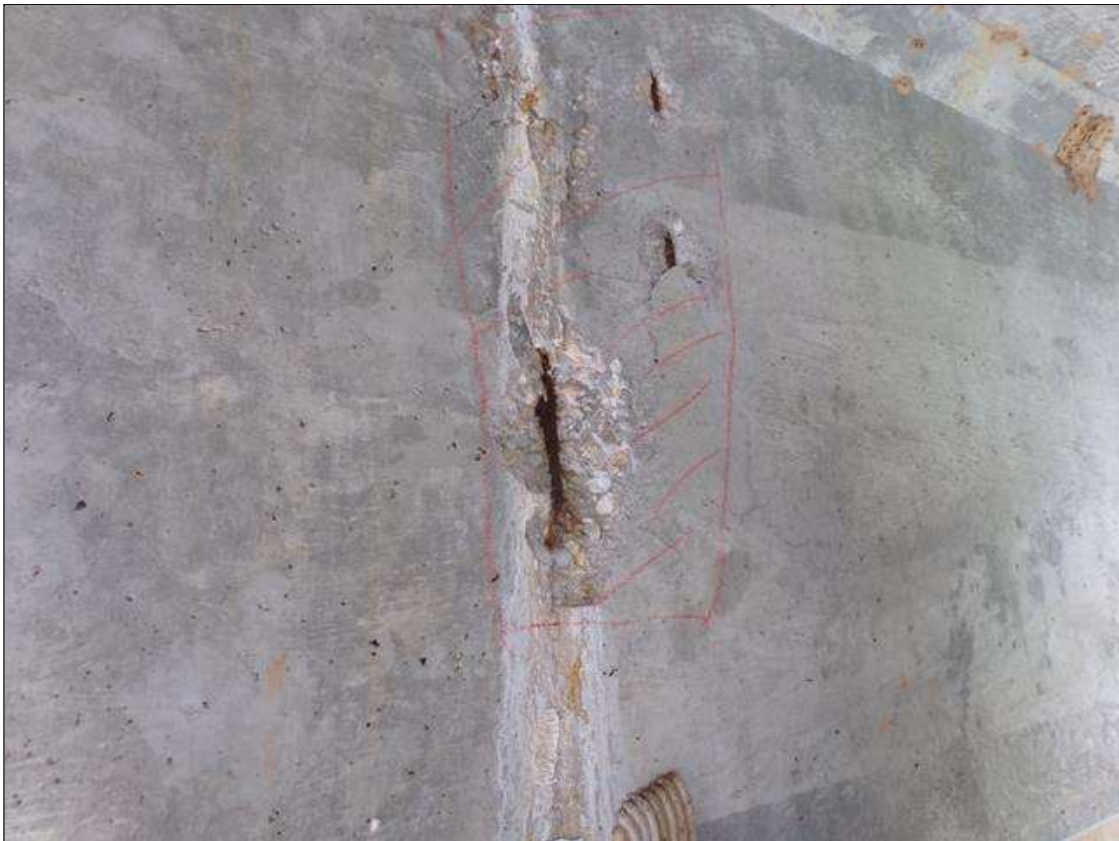
Span 2 Beam 2: 3' high x 16" wide area of delamination on west face of cap 7' from pier 1 with spalls up to 8" long x 6" wide x 1" deep .

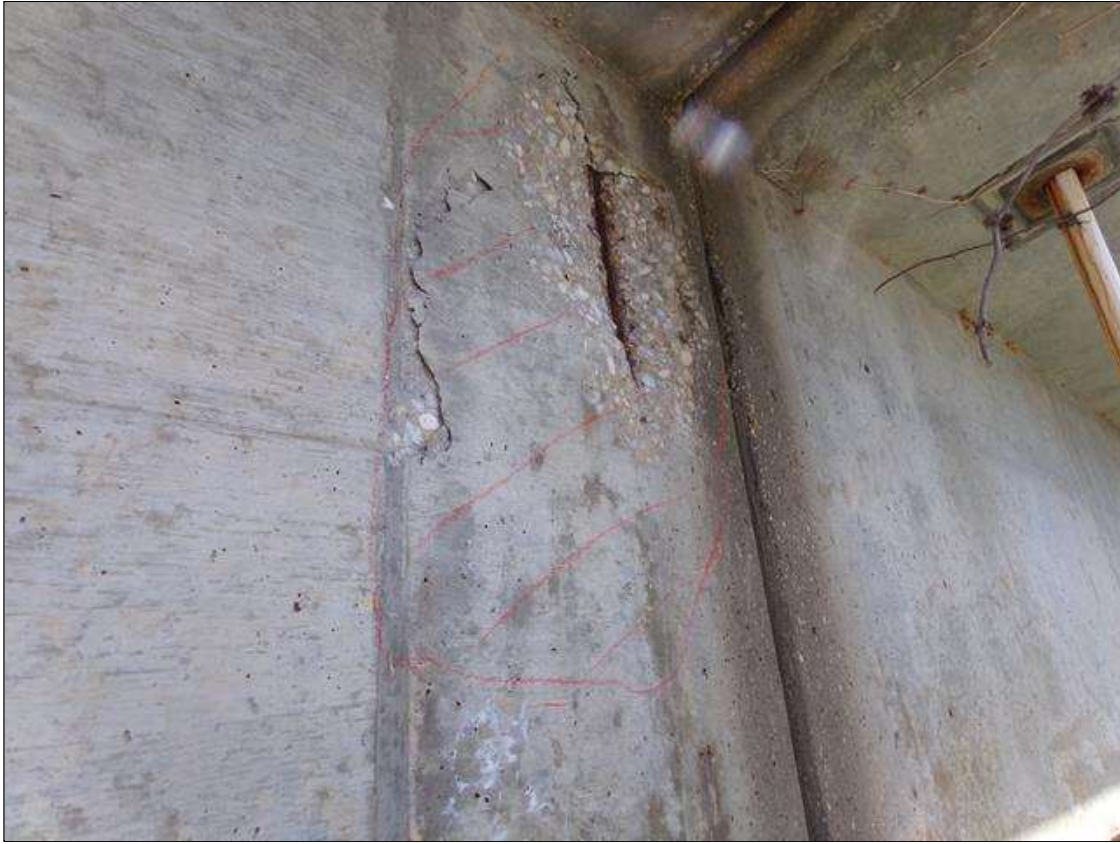
Span 2 Beam 1: 3' high x 2' wide area of delamination on west face of beam with a 16" square x 1" deep spall with exposed rebar with no measurable section loss over pier 1.
