NC DEPARTMENT OF TRANSPORTATION
 DIVISION OF HIGHWAYS
 STRUCTURE MANAGEMENT UNIT

ATTENTION: **PRIORITY MAINTENANCE ISSUED; SNOOPER USED**

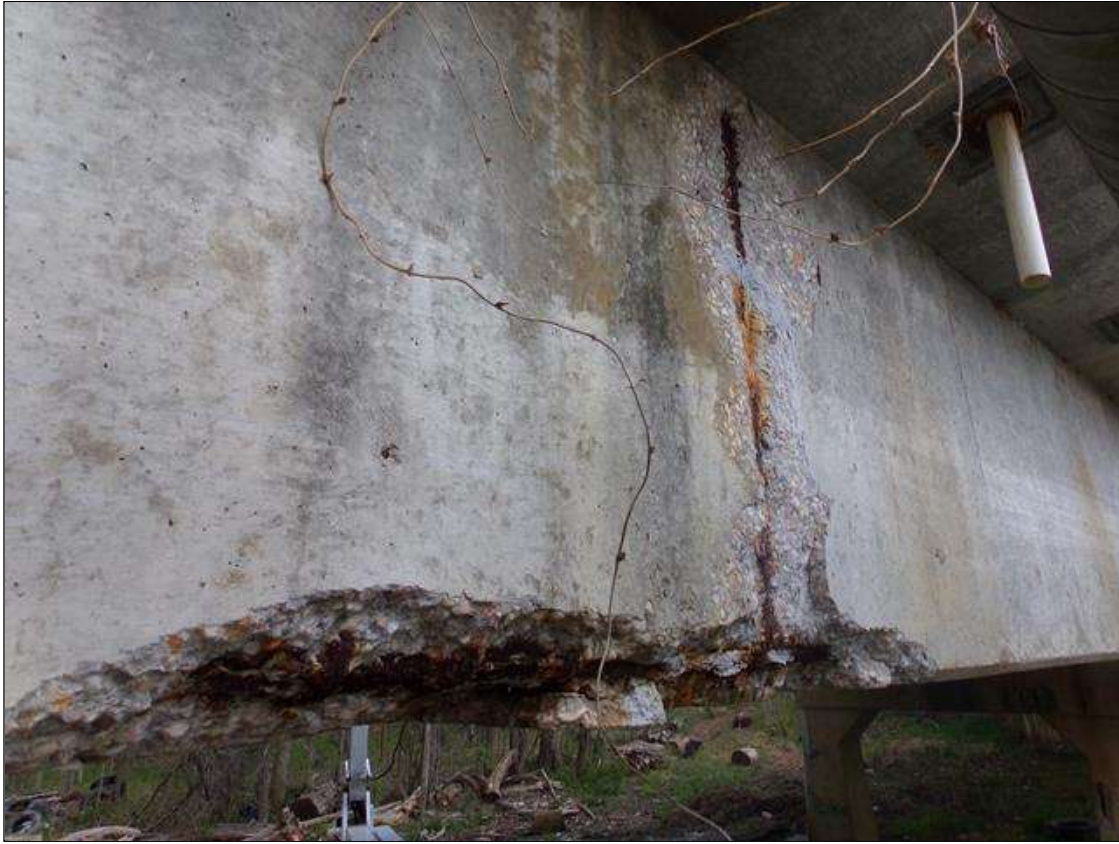
Span 2 Beam 1: Full height spall up to 2' wide x 2" deep with exposed rebar with section loss that extends down to bottom corner spall that is 5' long x up to 1' wide by up to 3" deep with exposed rebar with section loss on west face of beam 3' from pier 2.

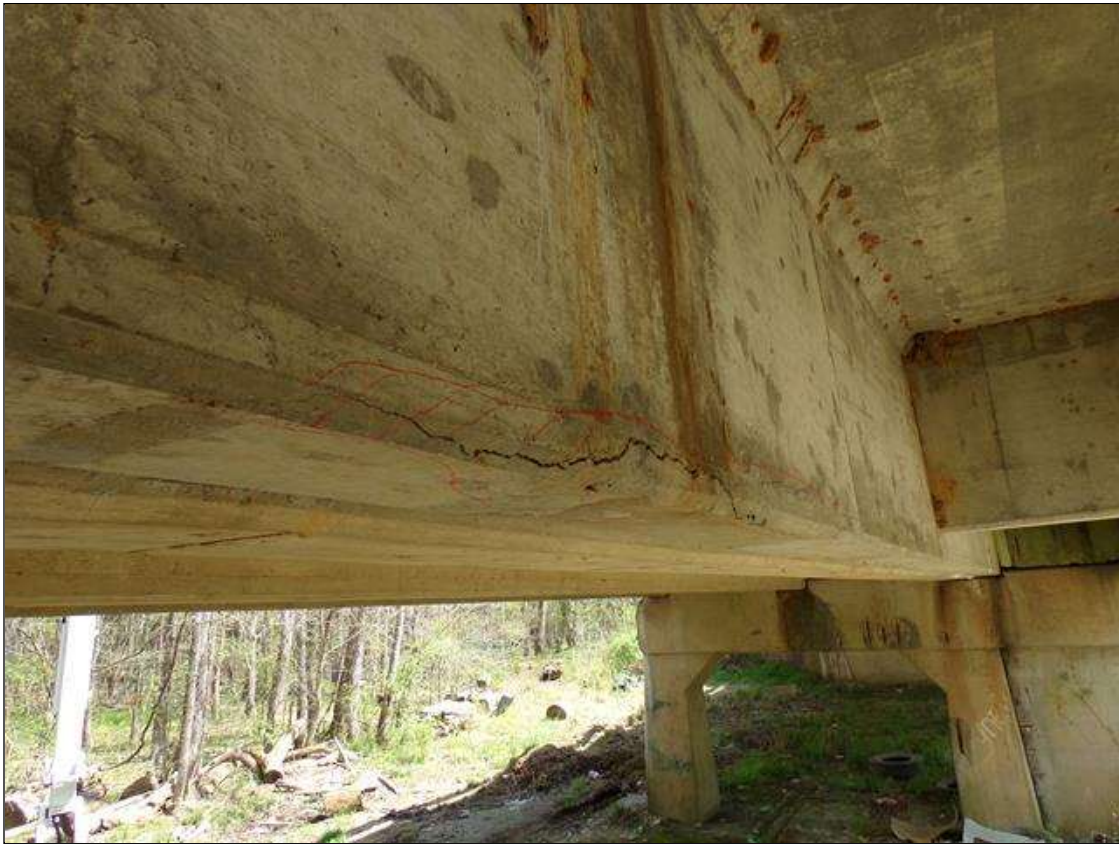
Span 2 Beam 2: Delamination 6' long x 8" wide on bottom of beam x 5" high on west face 9' from pier 2.

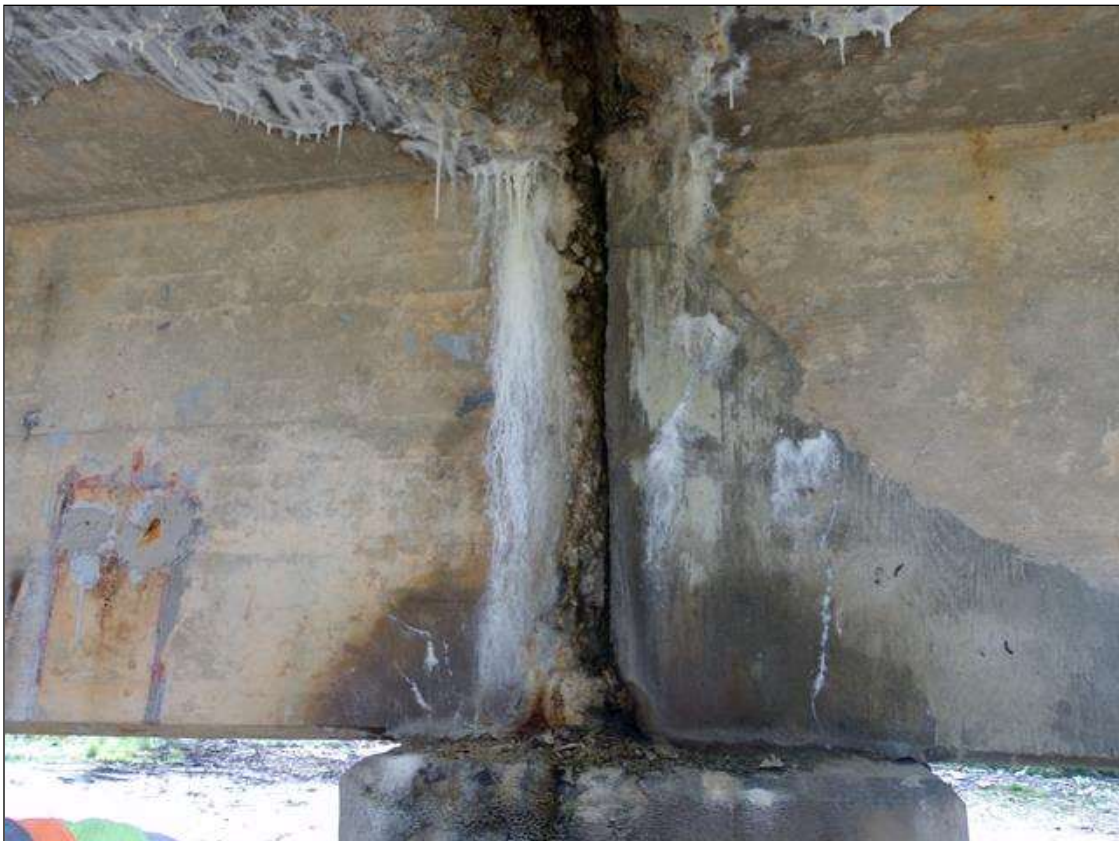
Span 2 Beam 5: Full height x 3" wide x up to 1" deep spall at end of beam over pier 2 east face.

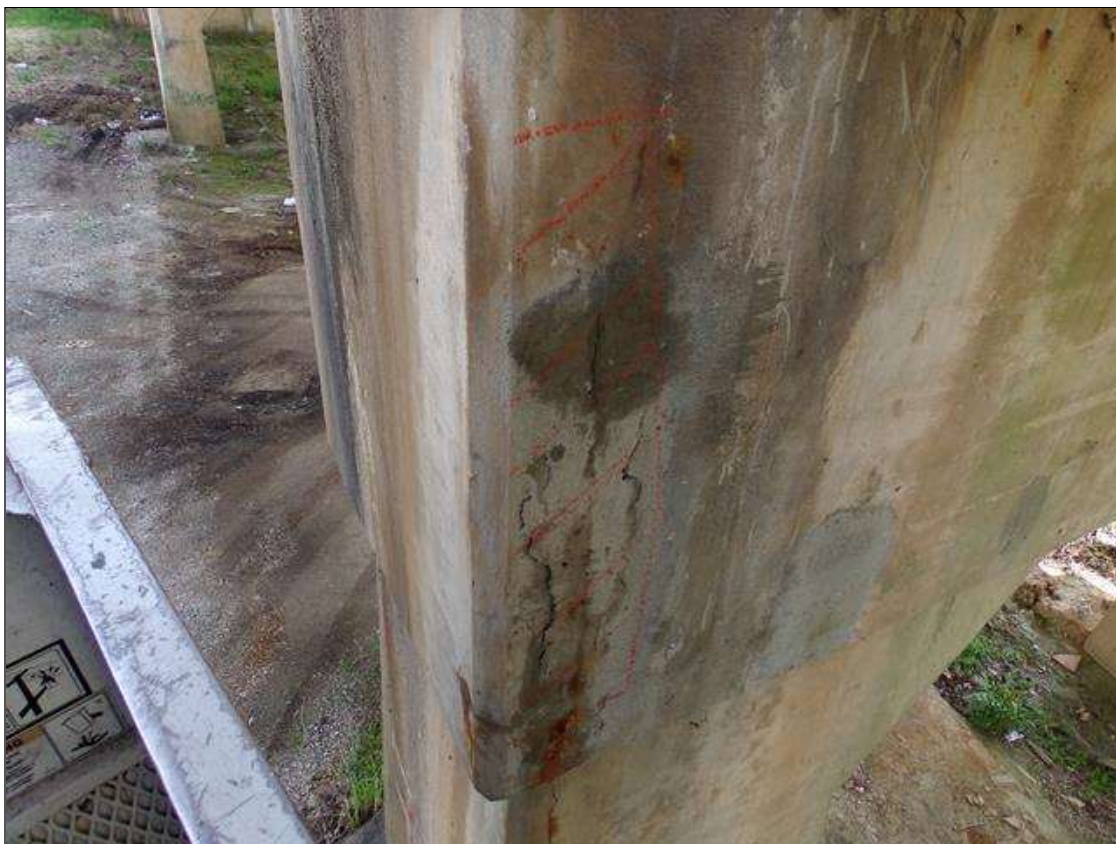
Bent 2 Cap 1: 6" wide x 30" high area of delamination at east end of cap under beam 5

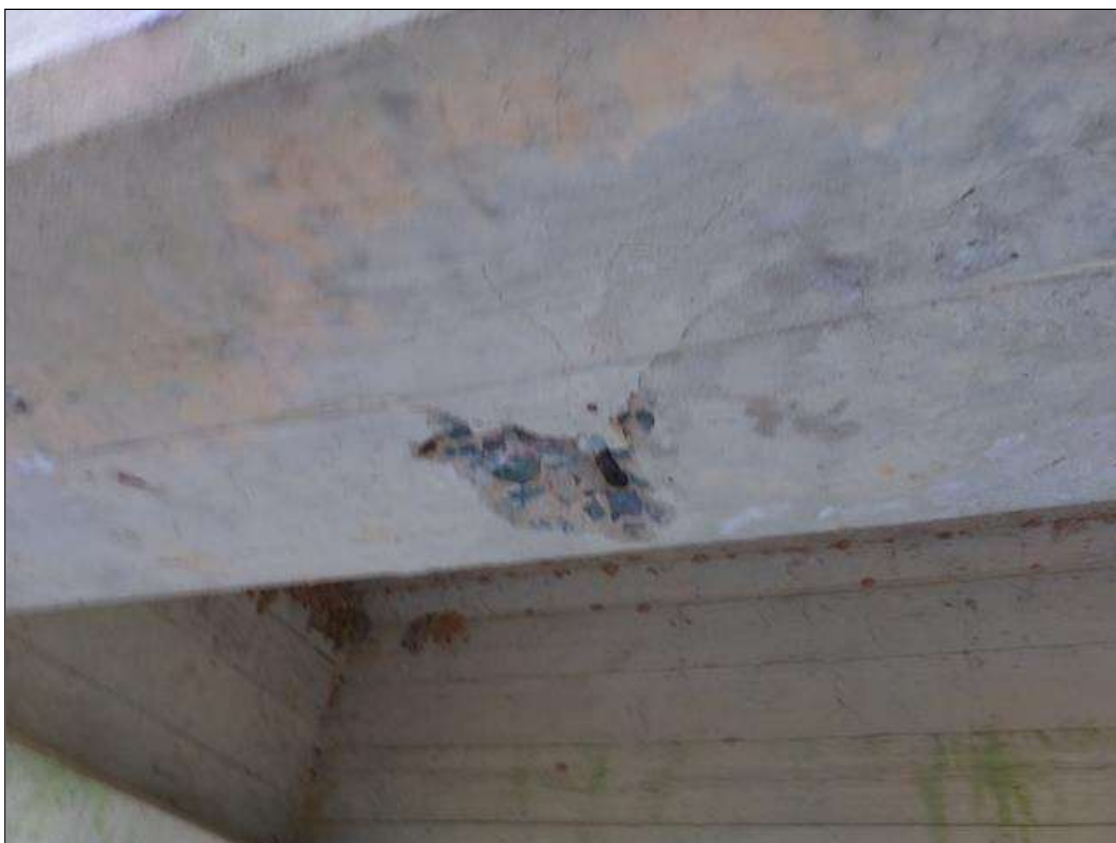
Span 3 Beam 5: 5" diameter spall 1" deep on bottom of beam with exposed rebar with no measurable section loss 5' from pier 2.

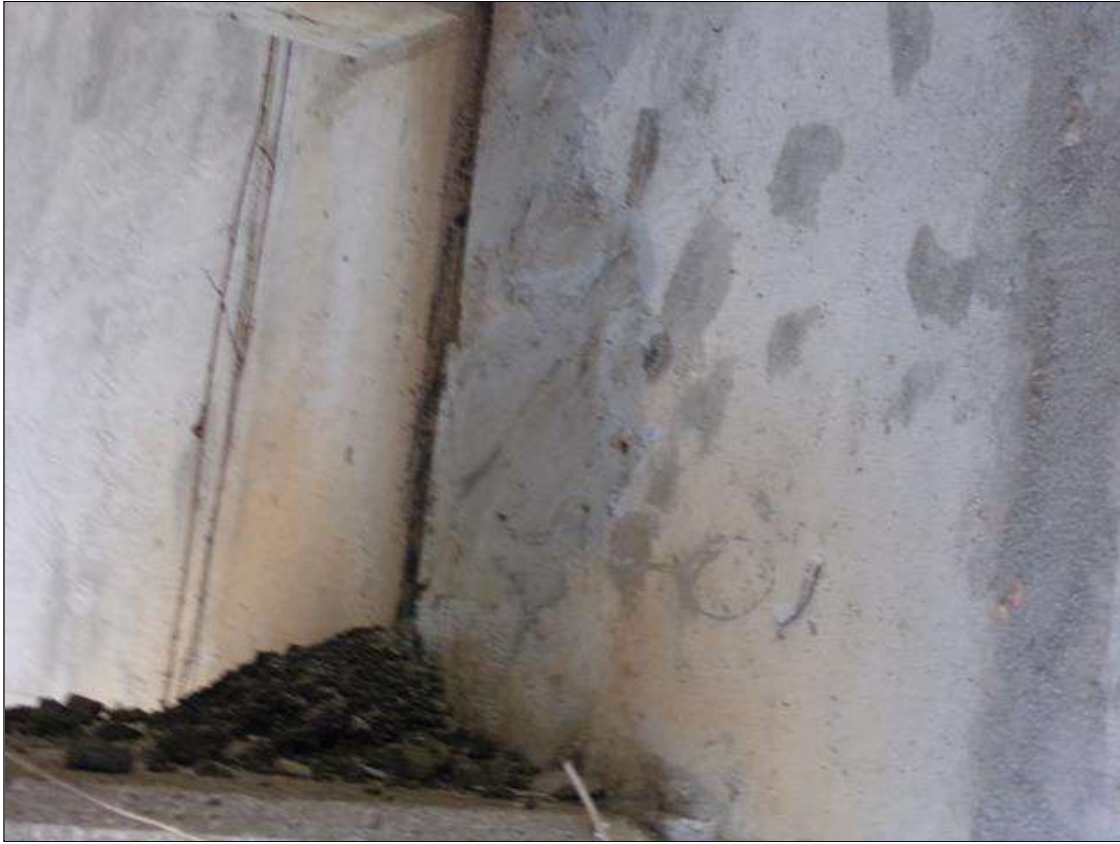
Span 3 Beam 1: 1' wide x 20" high sound patched area on east face of beam over pier 2.

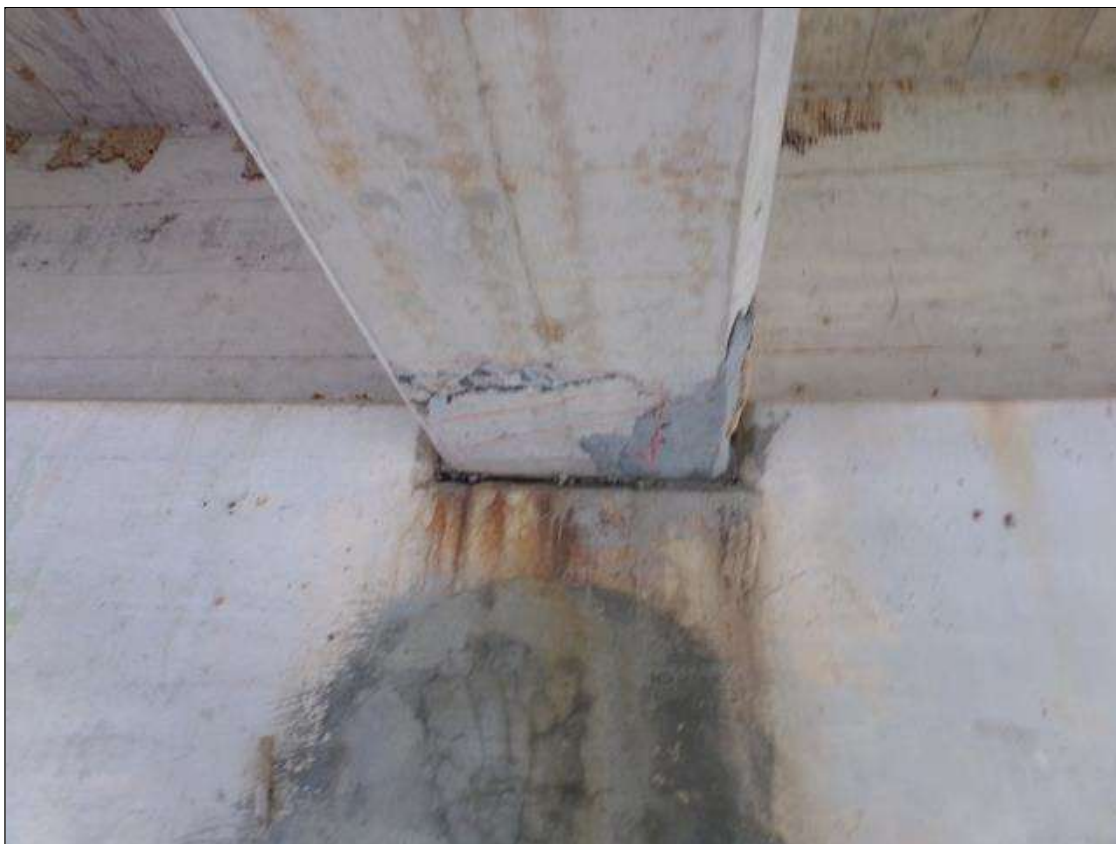
Span 3 Beam 4: 1' square area of delamination with a 10" long x 3" wide x 1/2" deep spall on bottom of beam at pier 2.

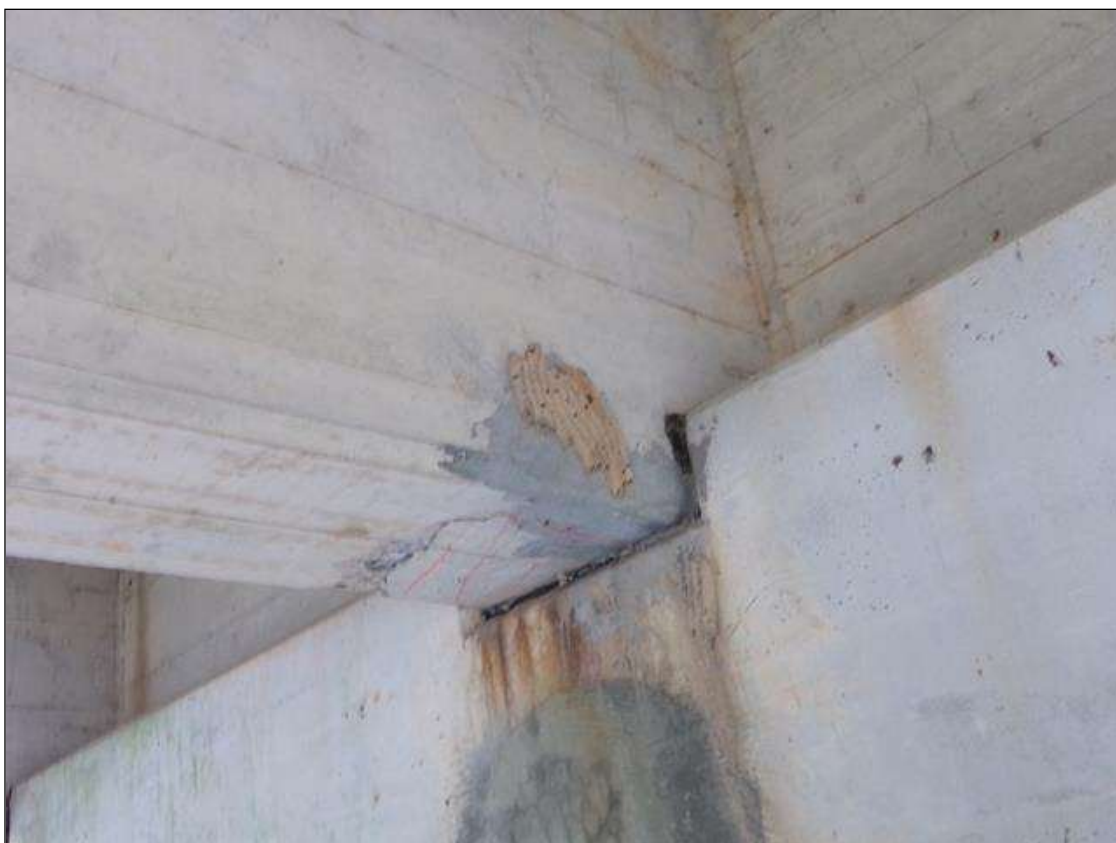
Span 3 Beam 4: Sound patched area 1' long x 3" high on west face x 6" wide on bottom of beam at pier 2.

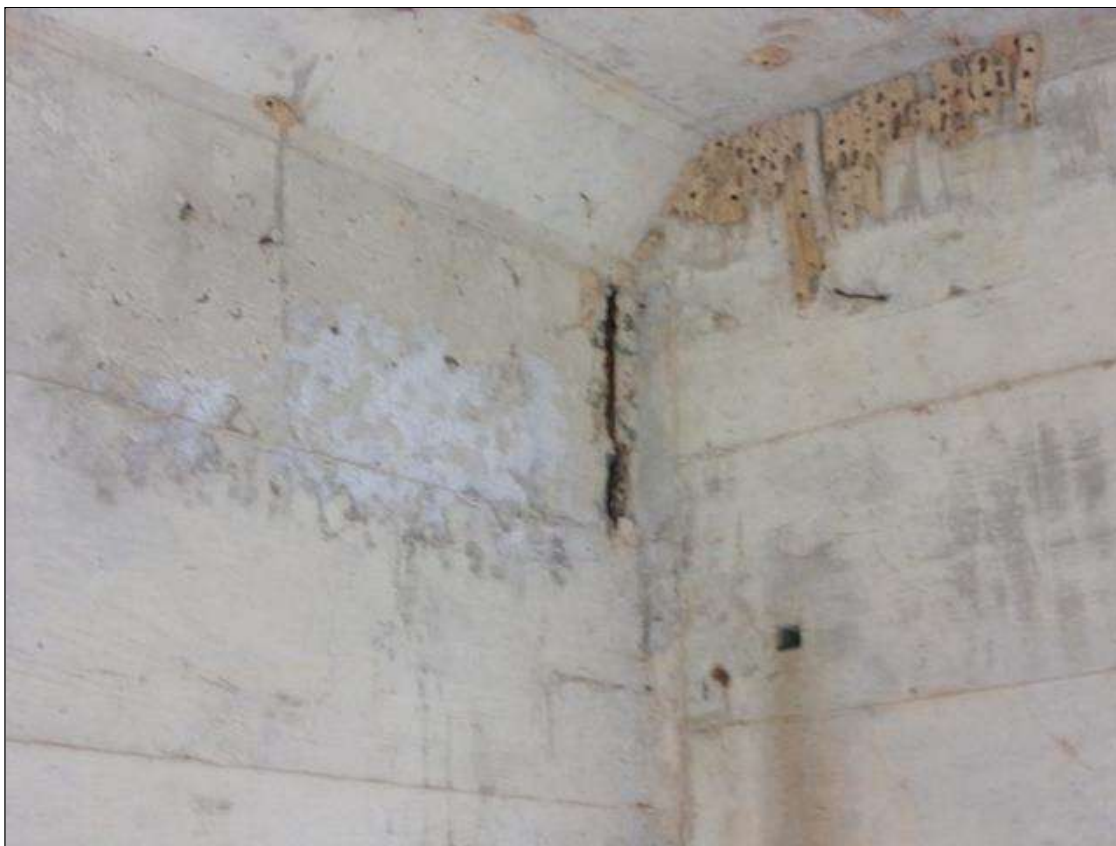
Span 3 Beam 5: 1' high x 3" wide x 1" deep spall with exposed rebar with no measurable section loss on west face of beam over pier 2.

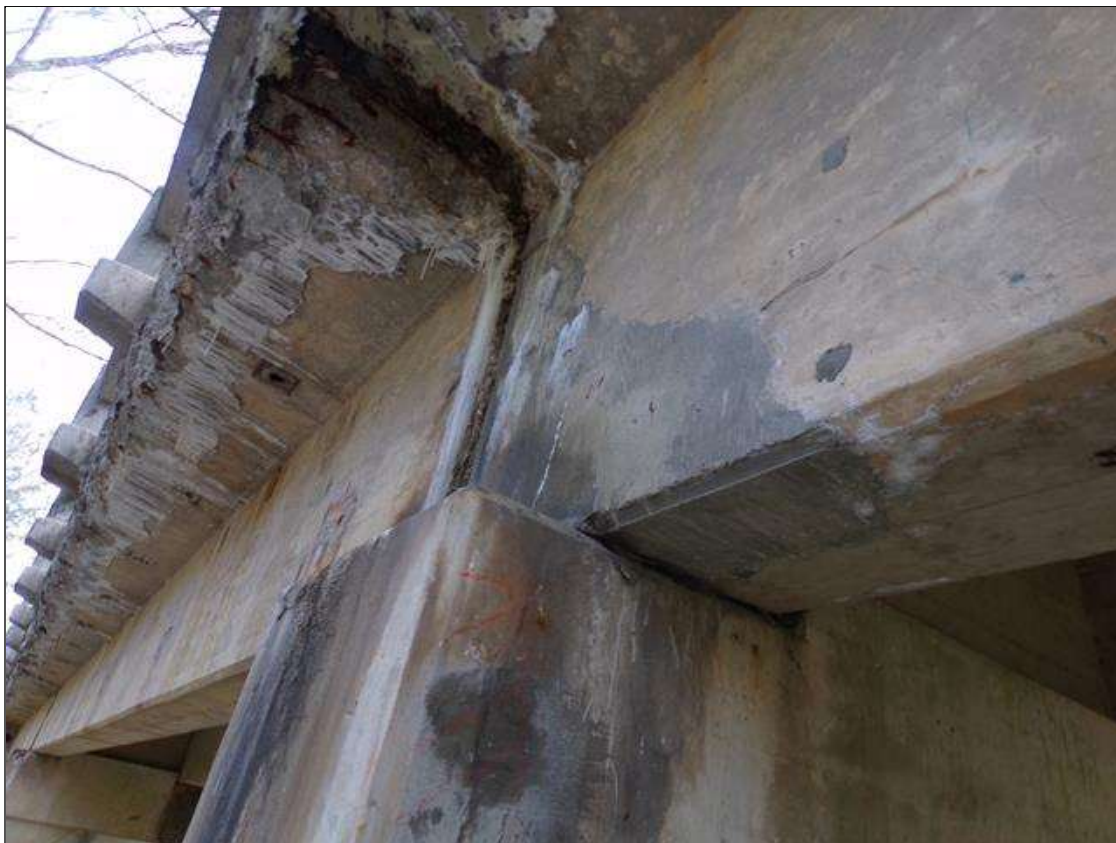
Span 3 Beam 5: Sound patched area full height at end of beam x 3' long at bottom of beam that extends 8" on bottom of beam at pier 2.

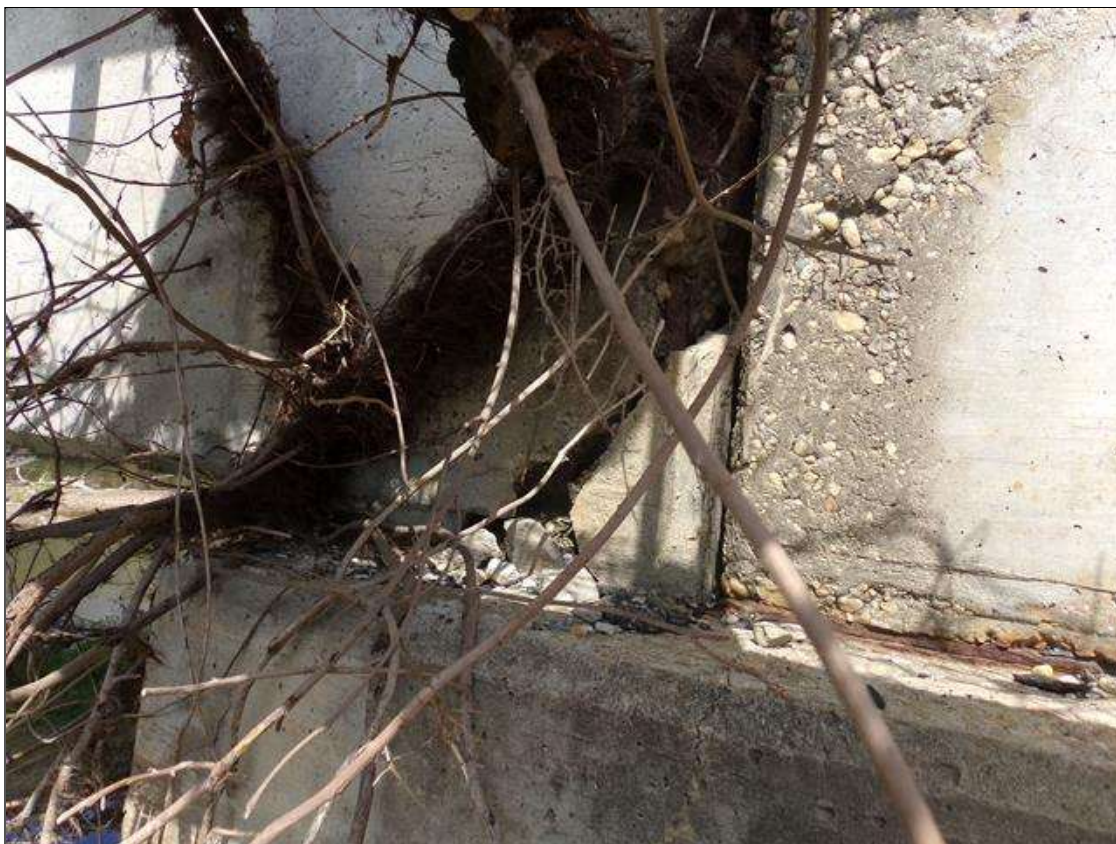
Span 4 Beam 1: 1' high x 7" wide x full width bottom corner spall at end of beam with exposed rebar with no measurable section loss over pier 3.

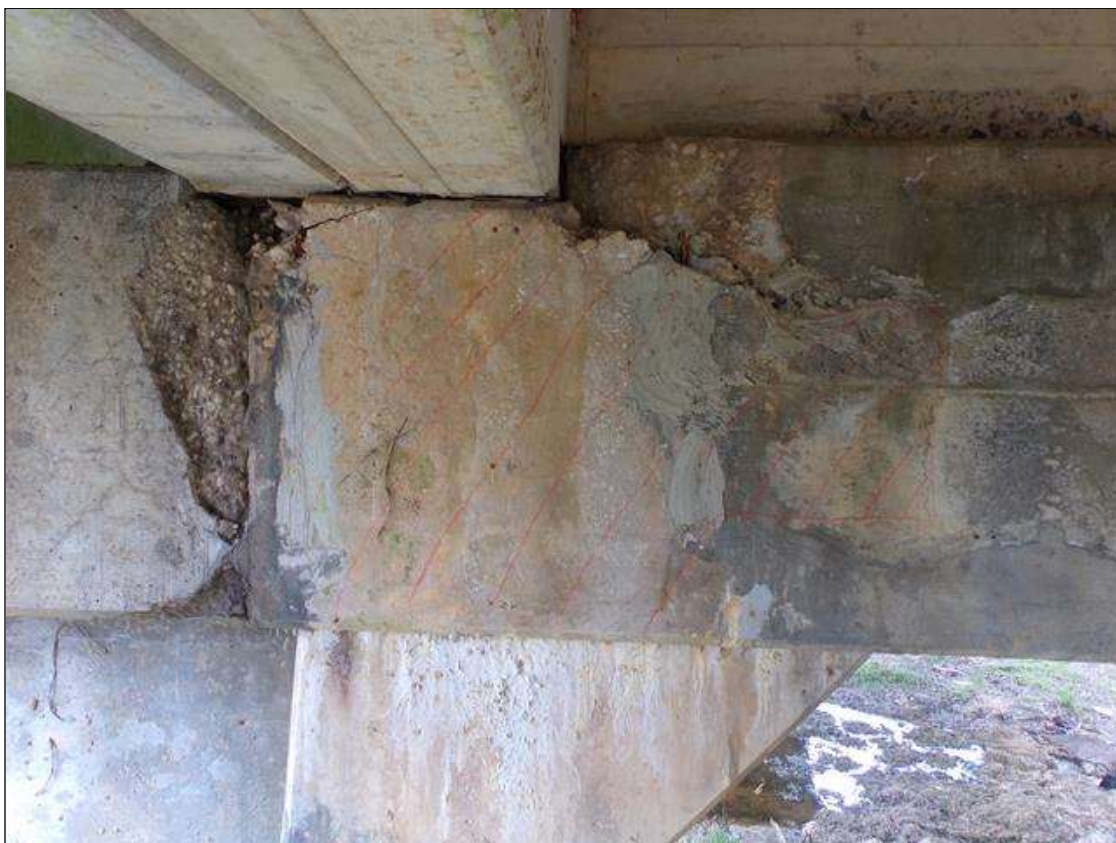
Bent 3 Cap 1: 6' long x up to full height area of delamination on south face of cap under beam 3 in to bay 2.

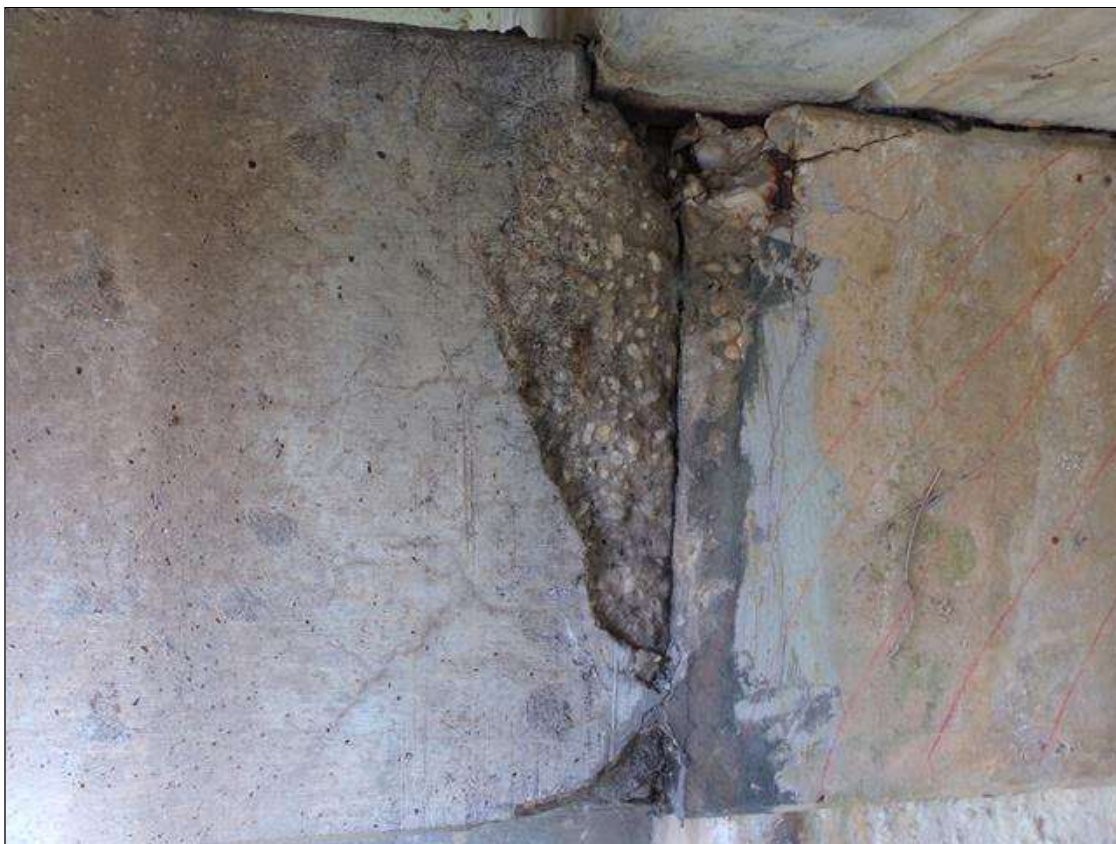
Bent 3 Cap 1: 3' high x up to 16" wide x up to 4" deep spall with exposed rebar with no measurable section loss on south face of cap under beam 2.

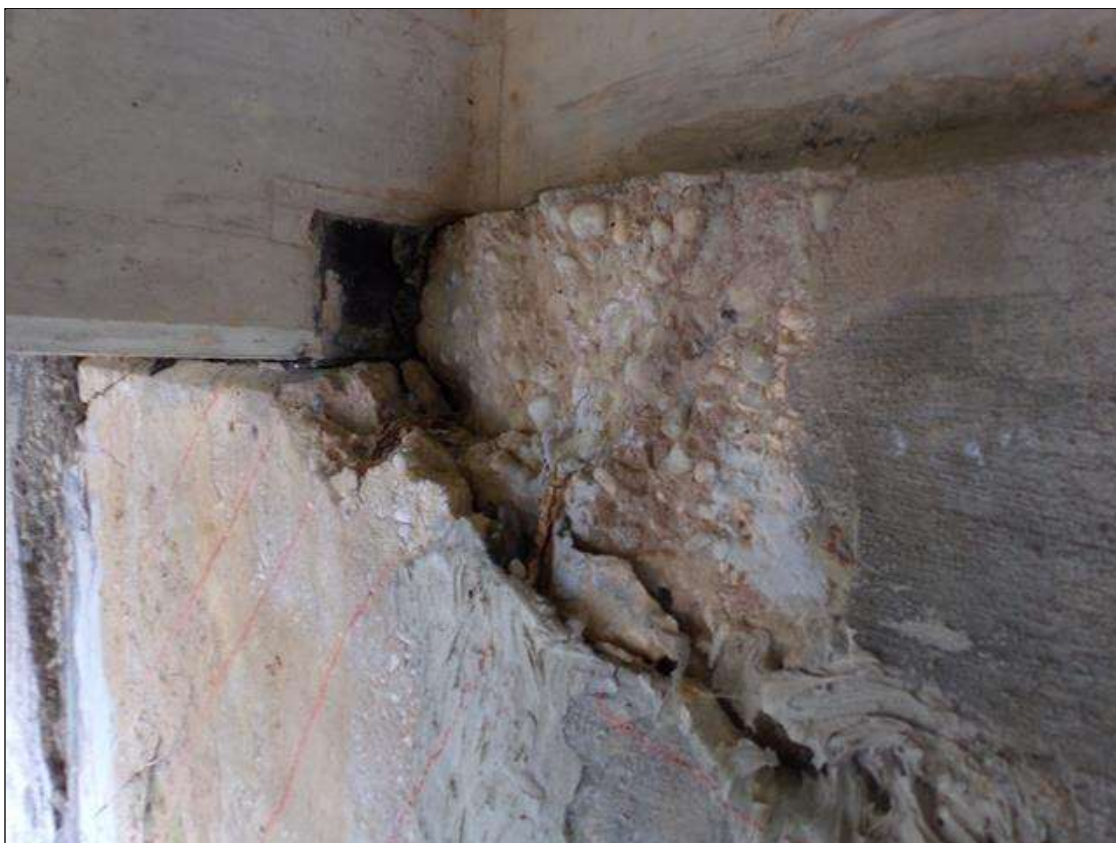
Bent 3 Cap 1: 1' high x up to 19" wide x up to 5" deep spall on south face of cap under bay 2

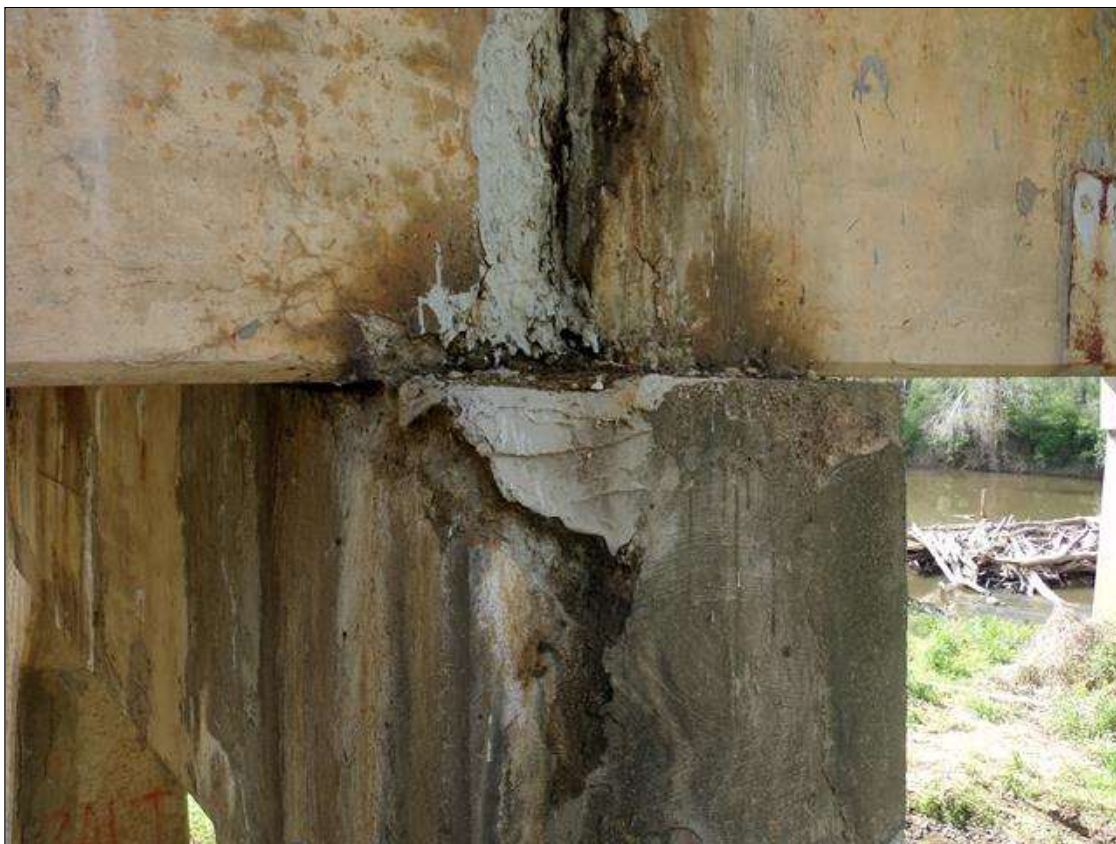
Bent 3 Cap 1: Unsound patched area on top of cap east end with 4" wide x 1/2" deep spalling around patch that extends down east face and south face.

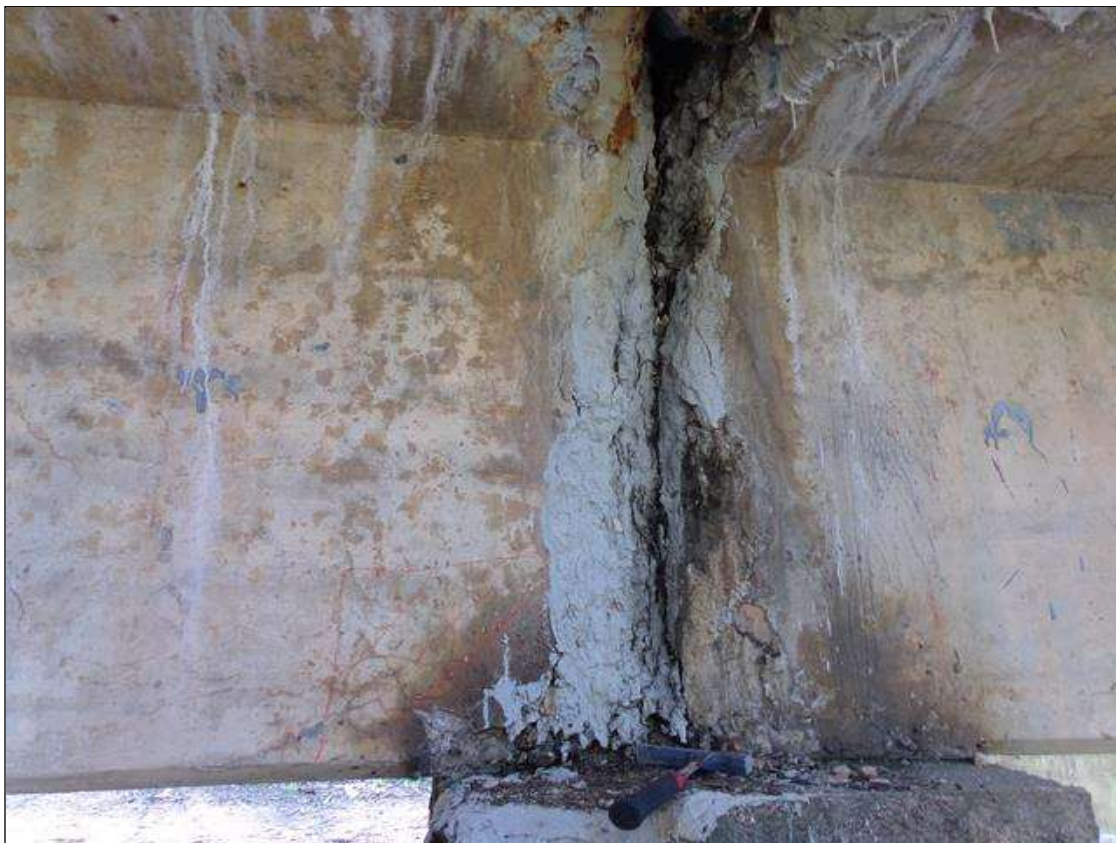
Span 3 Beam 5: 1' square area of delamination on east face of beam at pier 3.

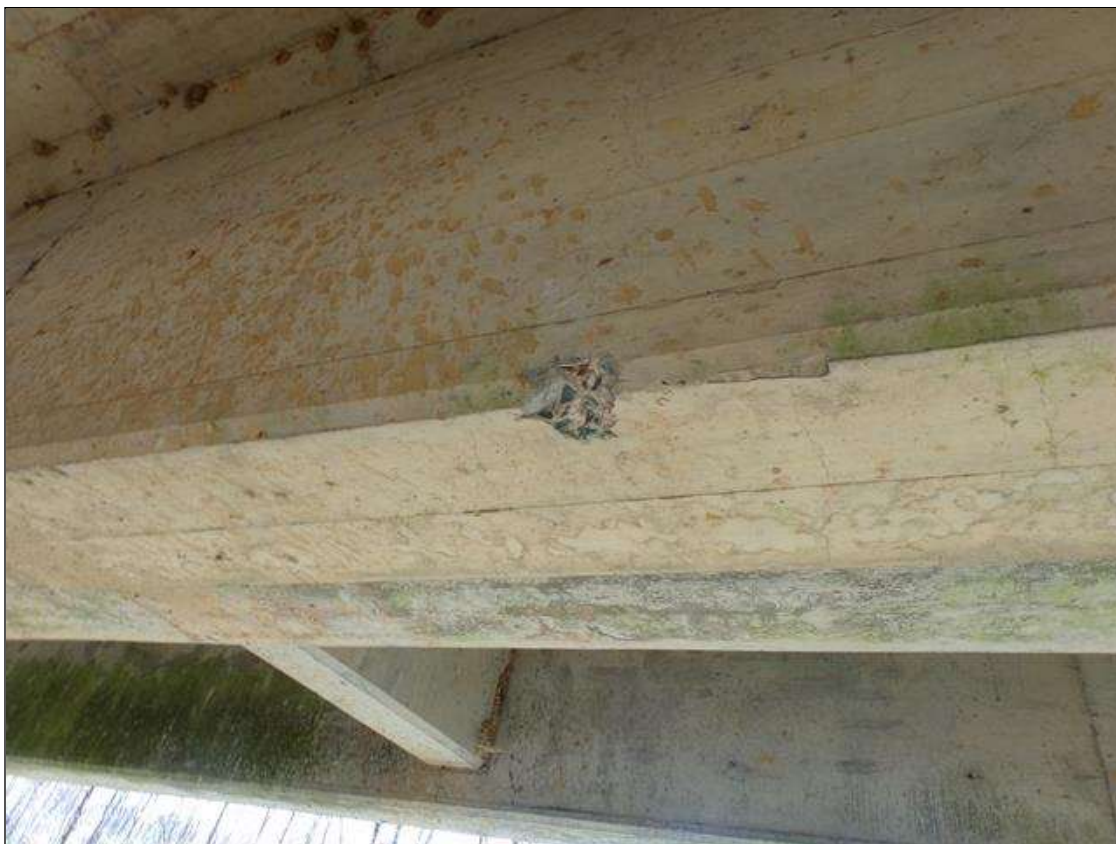
Span 4 Beam 3: 4" diameter corner spall on bottom and east faces 1/2" deep 20' from pier 4.

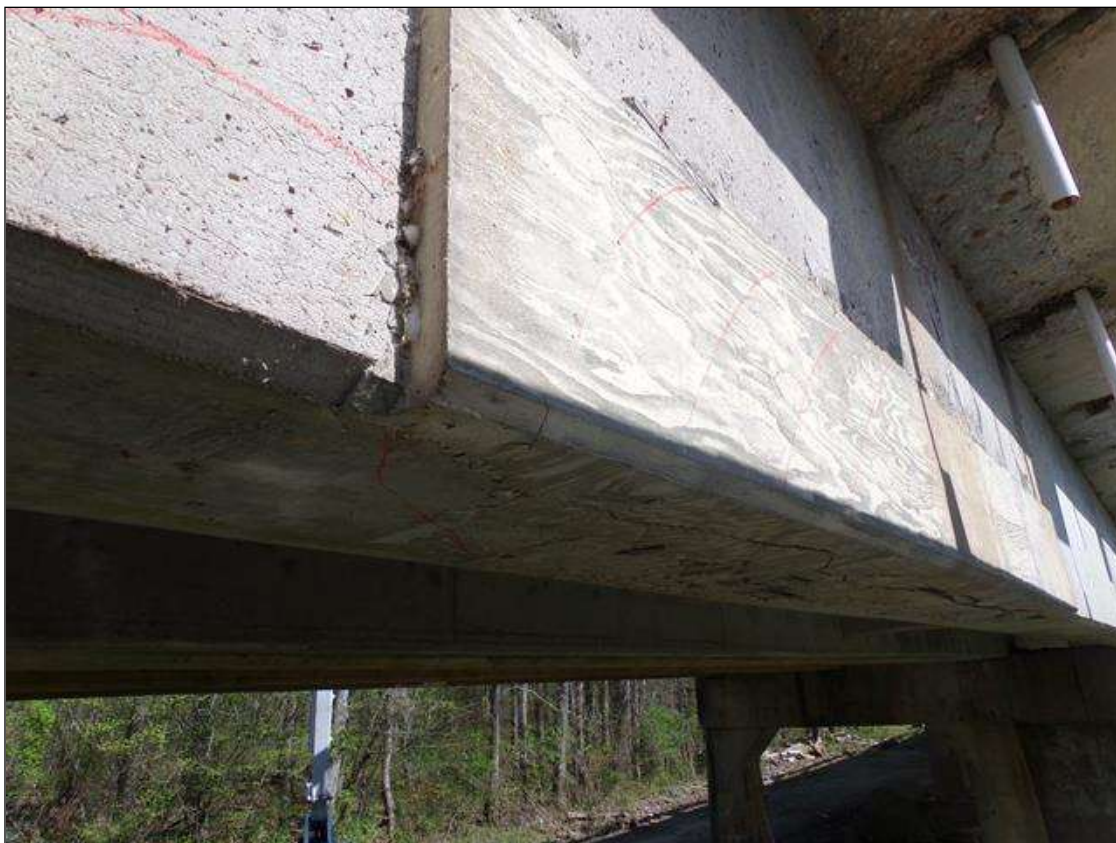
Span 4 Beam 1: Area of delamination 13' long x 15" high on west face x full width of bottom of beam with a 10' long unsound patch starting at pier 4.

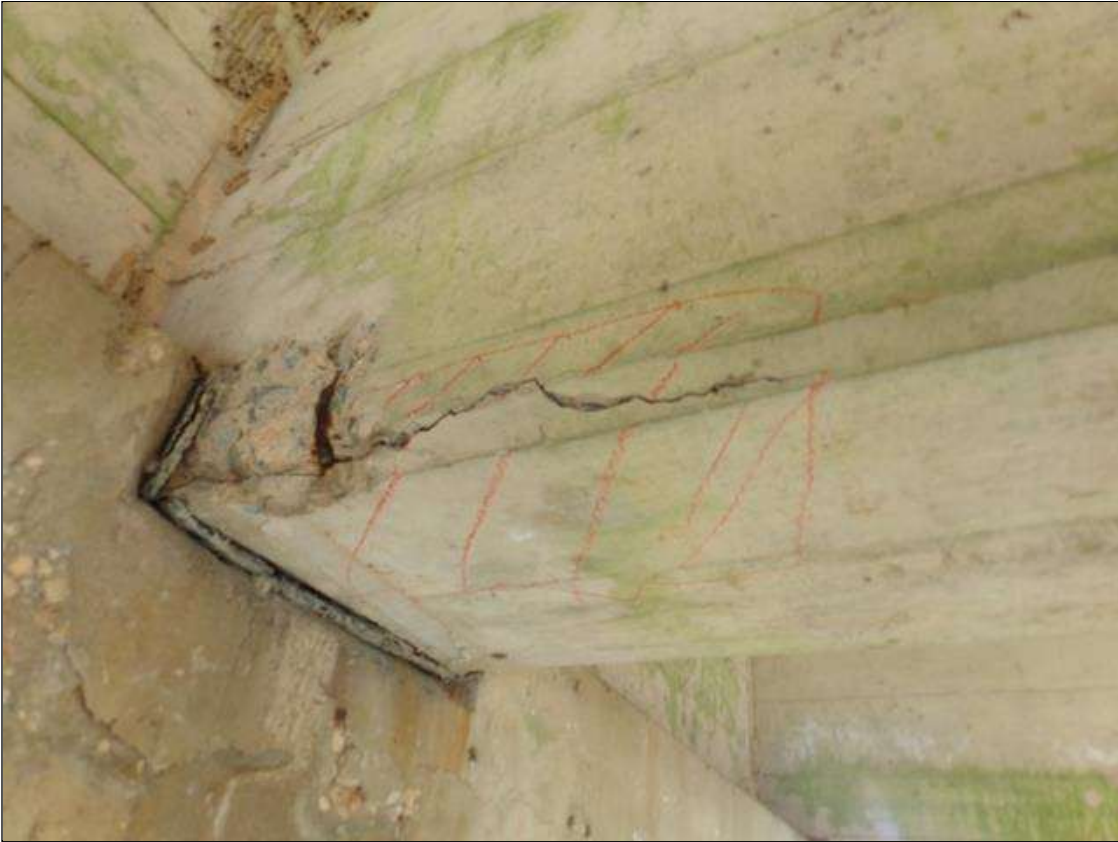
Span 4 Beam 4: Area of delamination 21" long x 3" high on west face x 10" wide on bottom of beam with a 10" wide x 8" high x 2" deep spall with exposed rebar with no measurable section loss at pier 4.

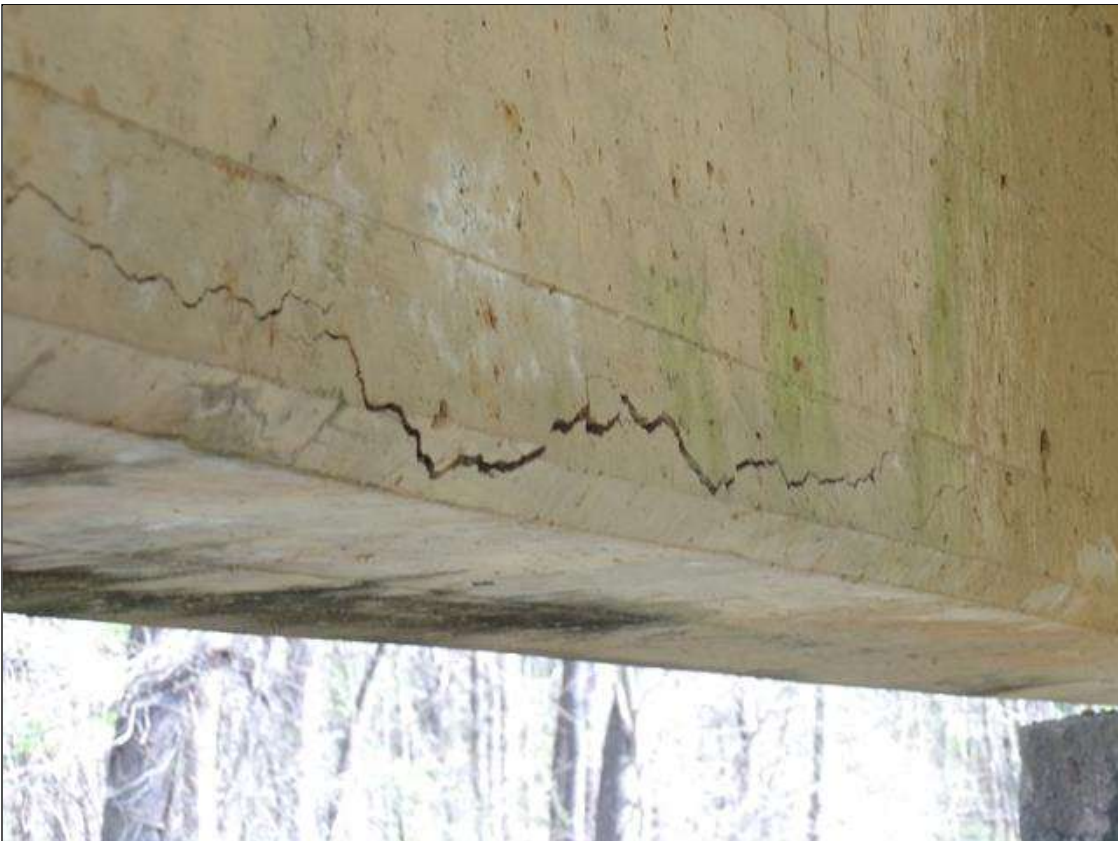
Span 4 Beam 5: 15' long x up to 1/4" deep horizontal crack in west face 1" up from bottom of beam at mid span.

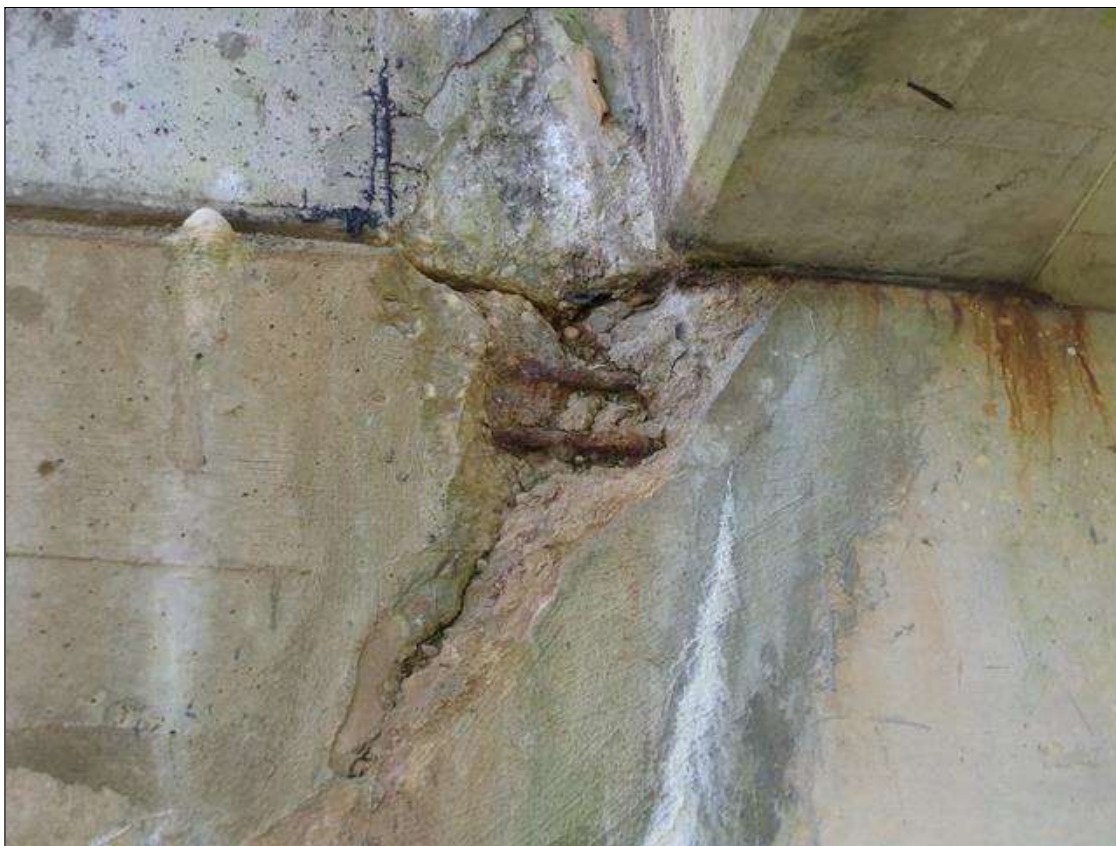
End Bent 1 Abutment/Backwall : 1.5' wide x 2.5' long x 3" deep spall with exposed rebar with no measurable section loss at beam 5.

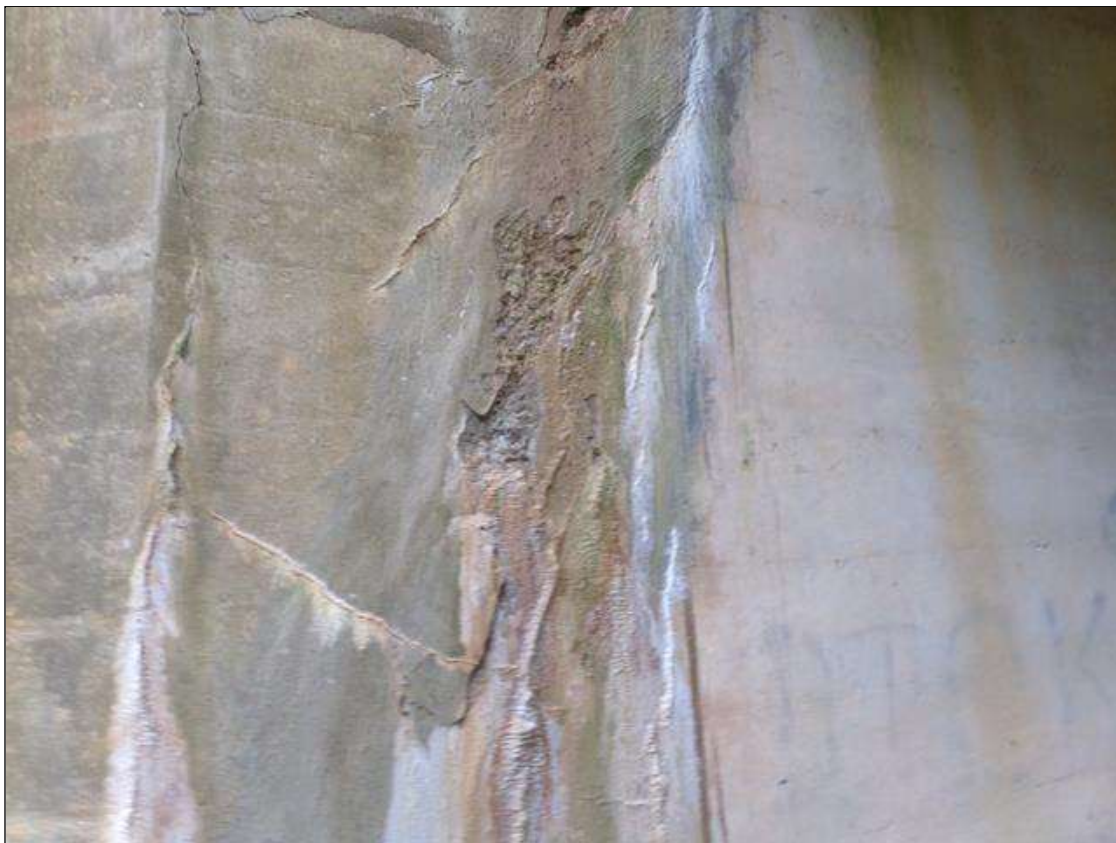
End Bent 1 Abutment/Backwall : Patched area that is unsound 16" wide x 5' high on front face under beam 5.

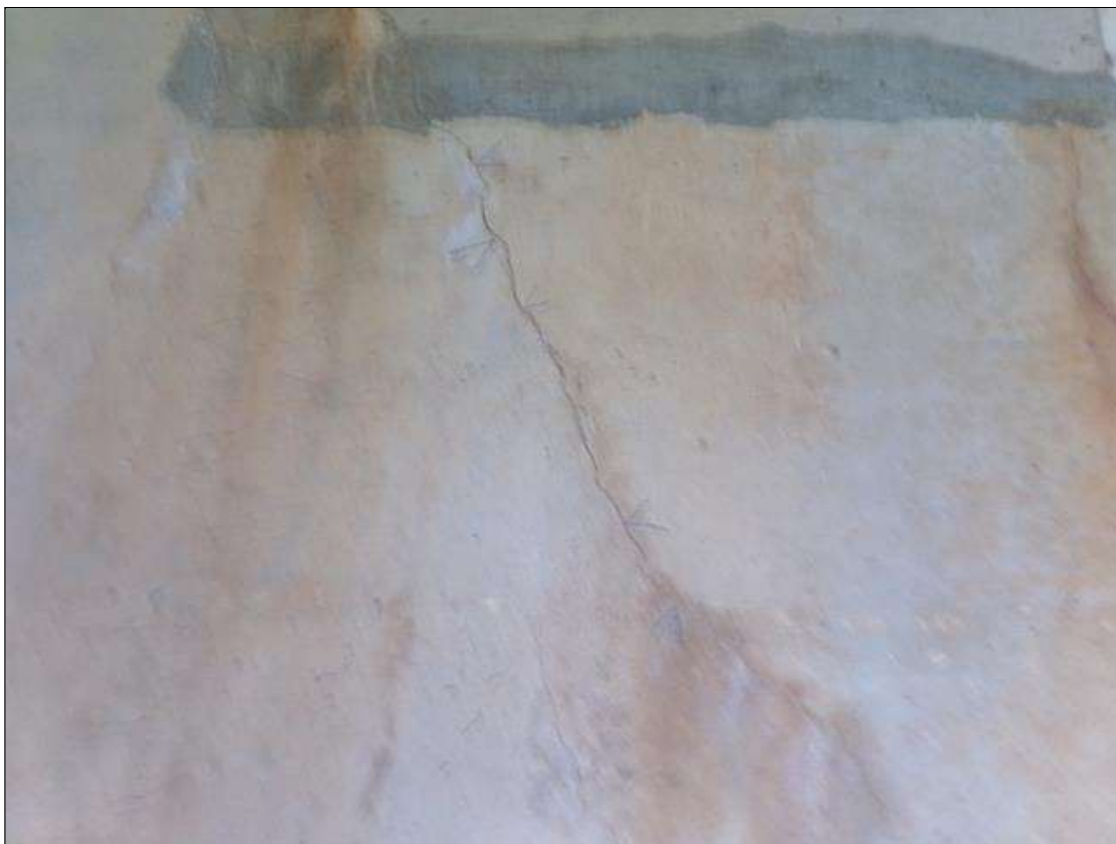
End Bent 1 Abutment/Backwall : 7' long diagonal 1/32" to 1/16" wide crack in front face under beam 2 starting at top of abutment..
