NC DEPARTMENT OF TRANSPORTATION
 DIVISION OF HIGHWAYS
 STRUCTURE MANAGEMENT UNIT

ATTENTION: **PRIORITY MAINTENANCE ISSUED; SNOOPER USED**

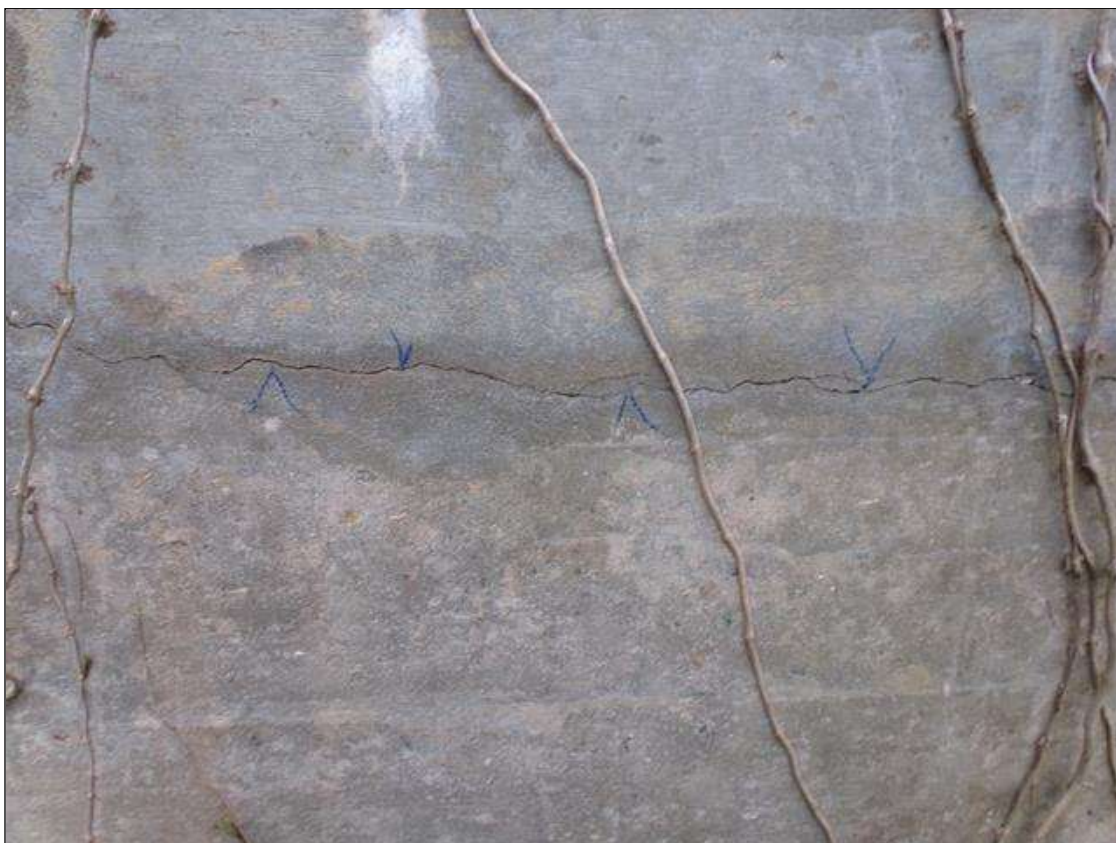
End Bent 1 Abutment/Backwall : 25' long horizontal crack up to 1/8" wide at west end of abutment that extends 3' on front face starting under bay 1.

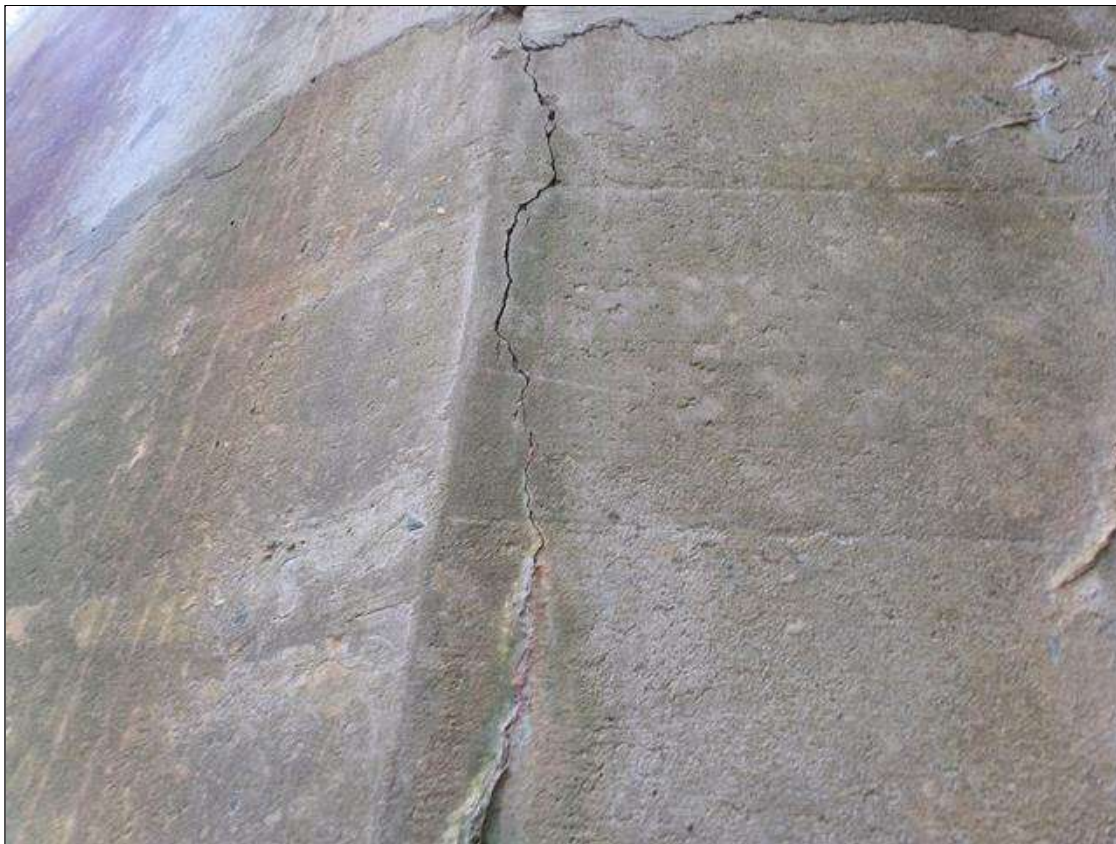
End Bent 1 Abutment/Backwall : Full height vertical/diagonal crack up to 1/16" wide with efflorescence starting at top of abutment 4' from beam 5 east side.

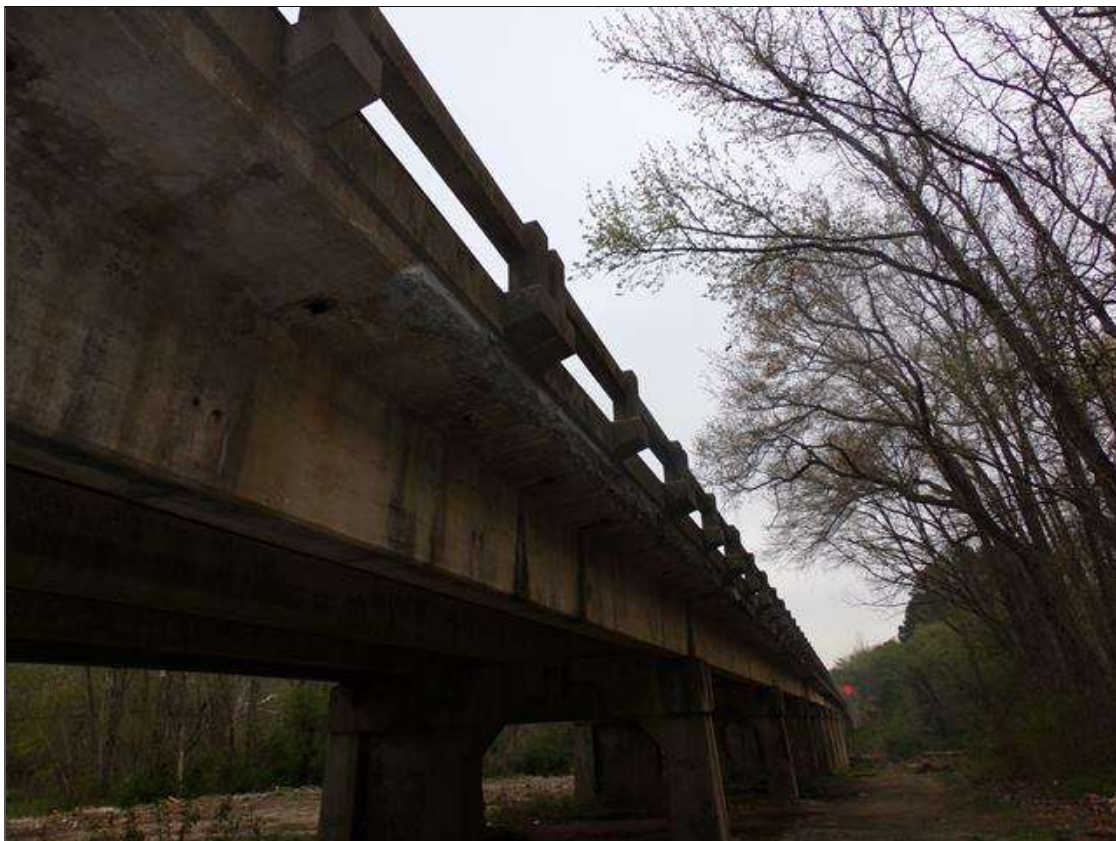
Span 1 Deck: Patched area 1' high x full length of east overhang that is distressed with efflorescence/stalactites/staining and cracking throughout .

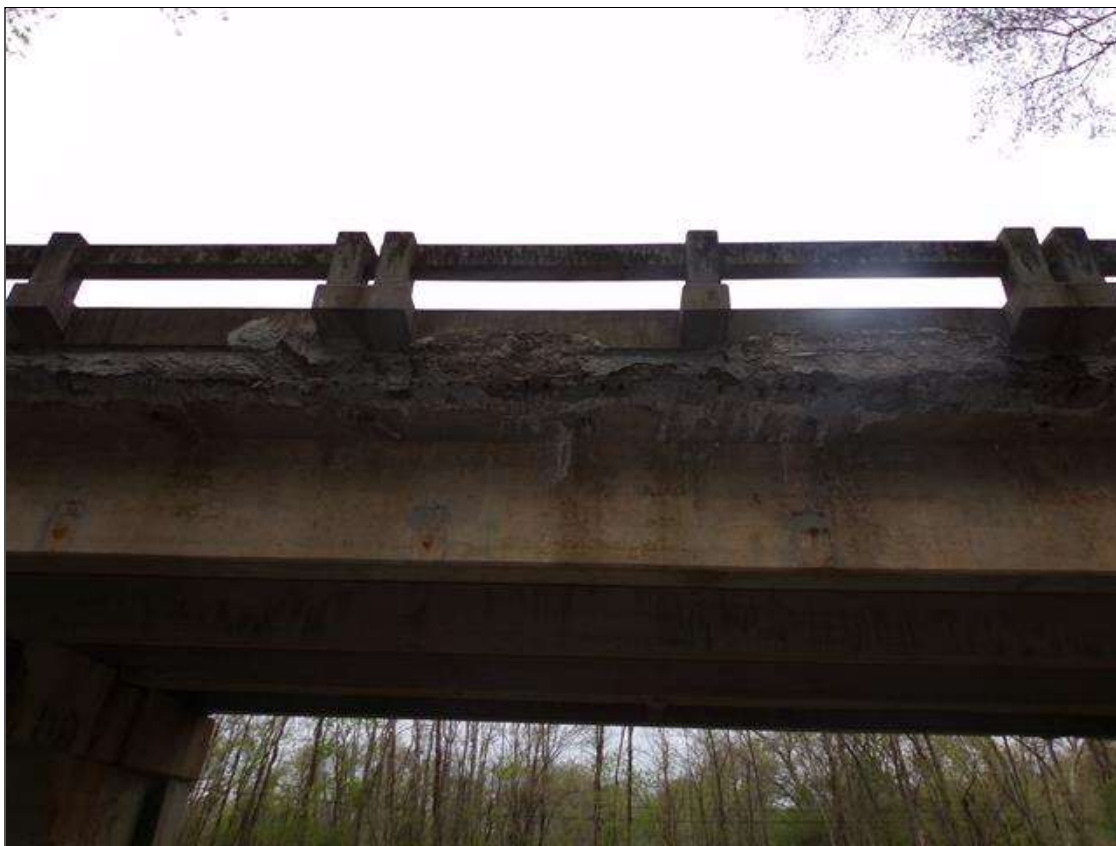
Span 2 Deck: Patched area 1' high x full length of east overhang that is distressed with efflorescence/stalactites/staining and cracking throughout

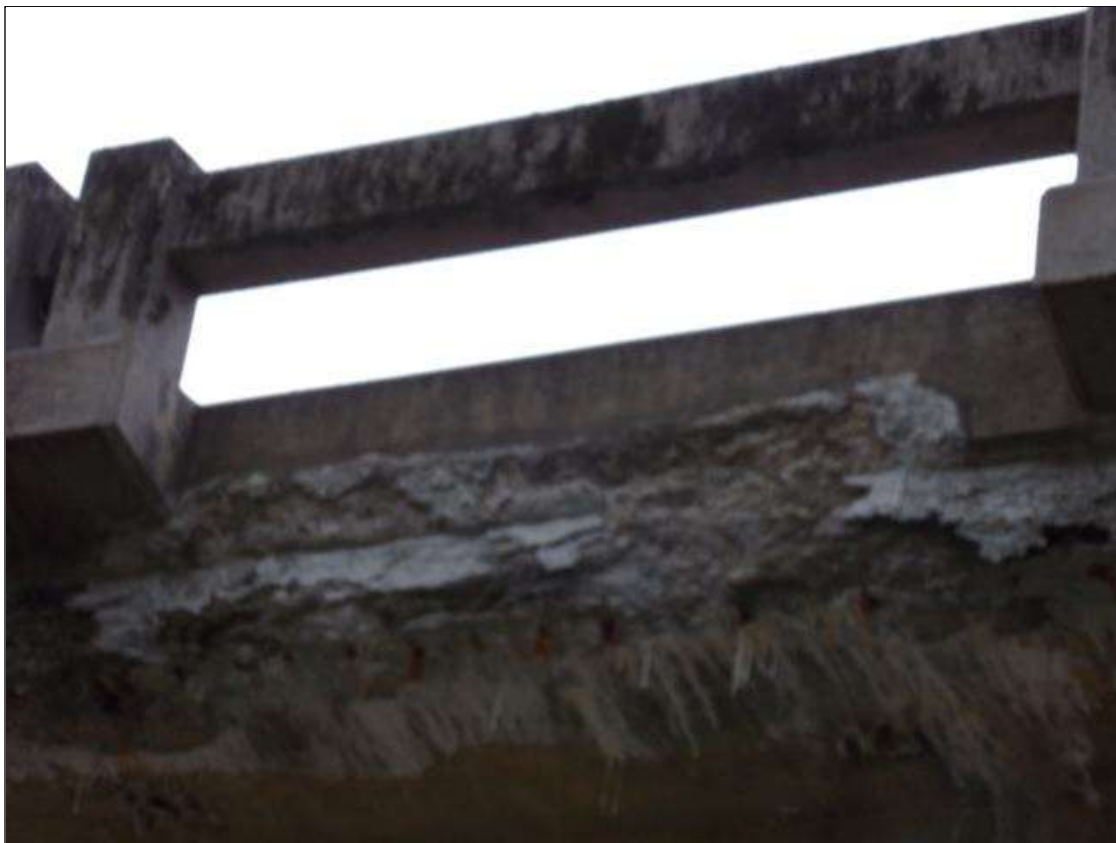
Span 2 Right Bridge Rail: East face of curb has several failed patched areas that have spalled out up to 5' long x 8" high x 2" deep at various locations.

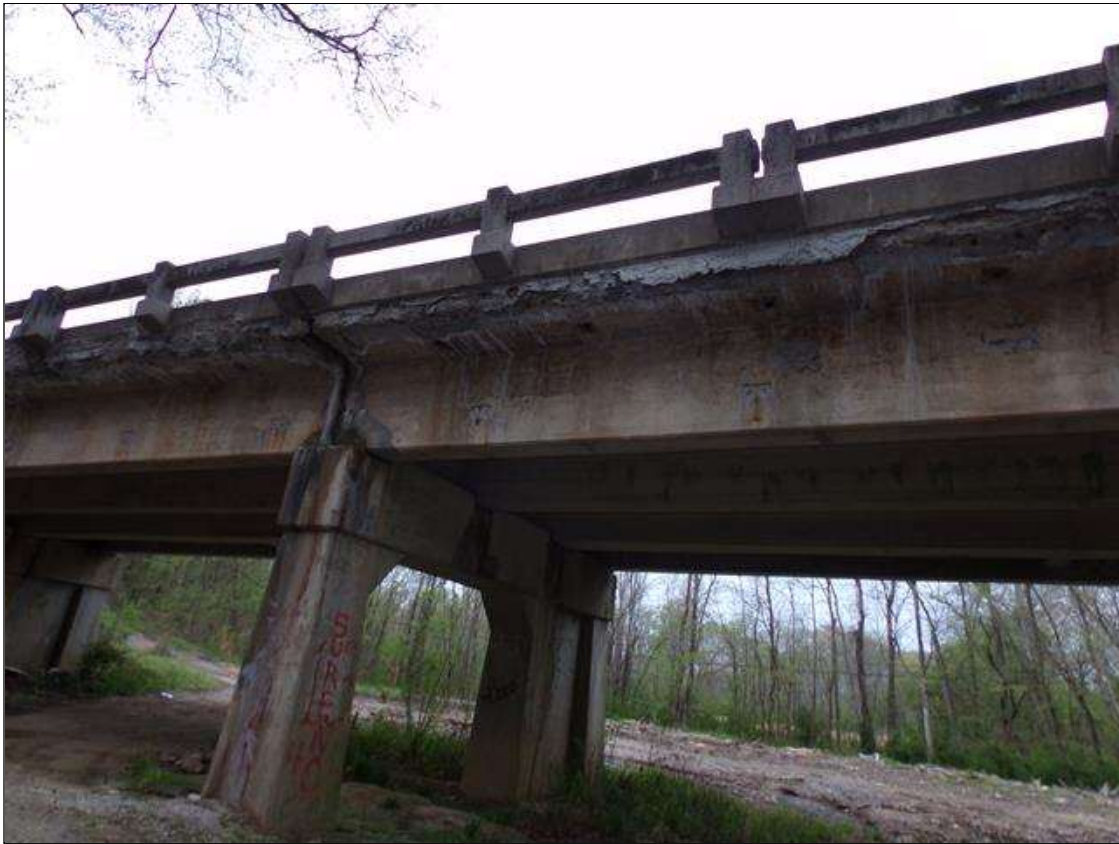
Span 3 Deck: Patched area 1' high x full length of east overhang that is distressed with efflorescence/stalactites/staining and cracking throughout

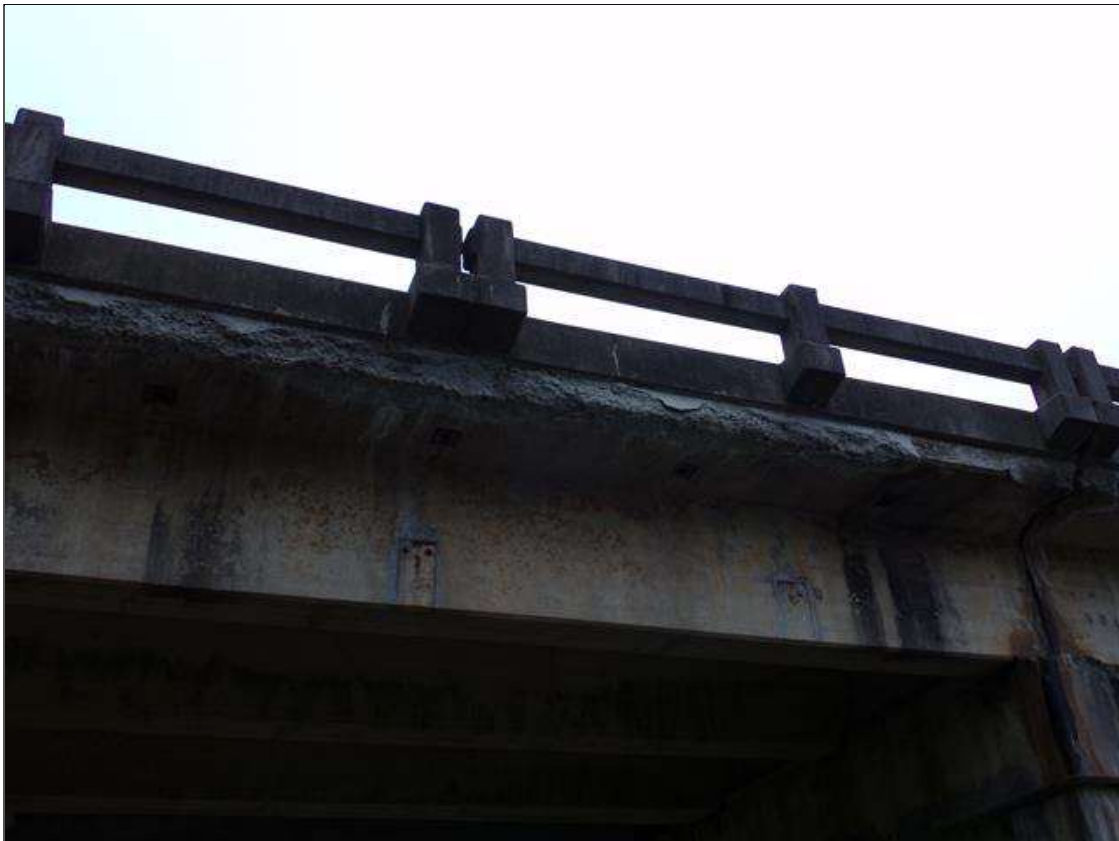
Span 4 Deck: Patched area 1' high x 6' long starting at pier 3 and 1' high x 25' long starting at pier 4 of east overhang that is distressed with efflorescence/stalactites/staining and cracking throughout.

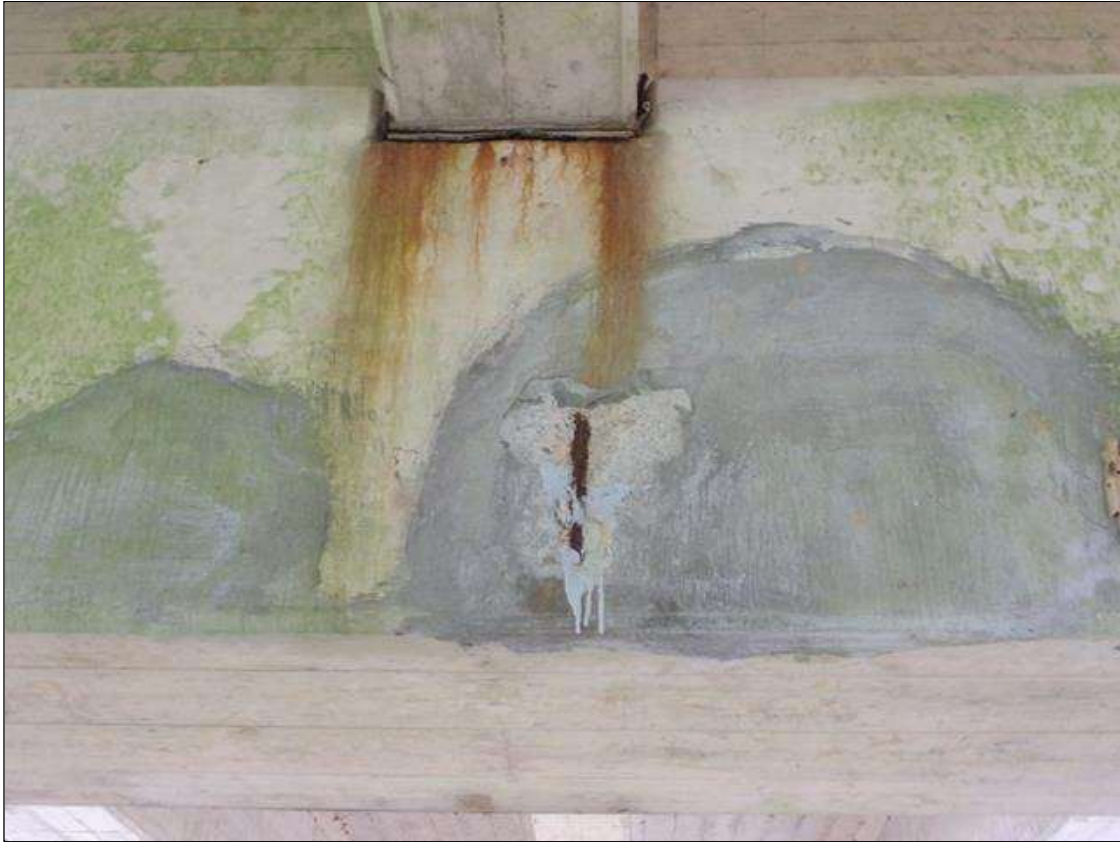
Bent 1 Cap 1: 1' high x 10" wide x 3/4" deep spall with exposed rebar with no measurable section loss on south face of cap under beam 3.

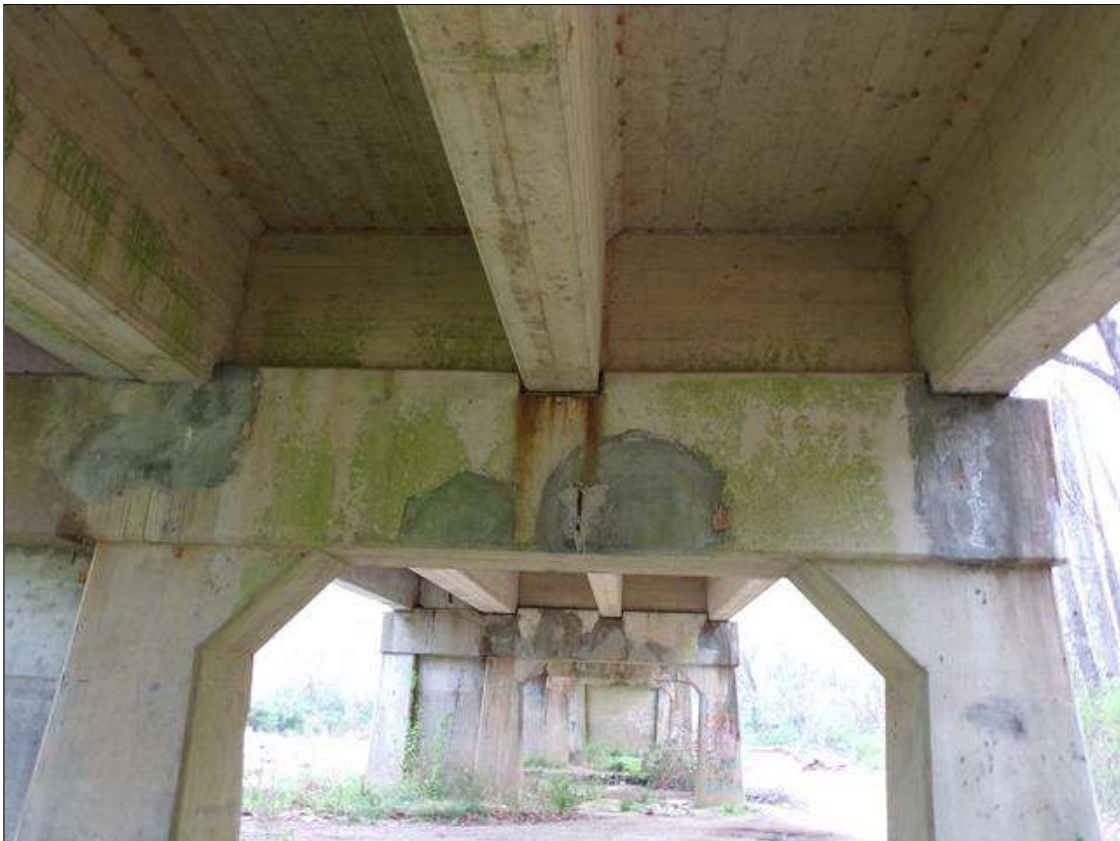
Bent 1 Cap 1: Several sound patched area on south face of cap up to 4' square starting under beam 2.

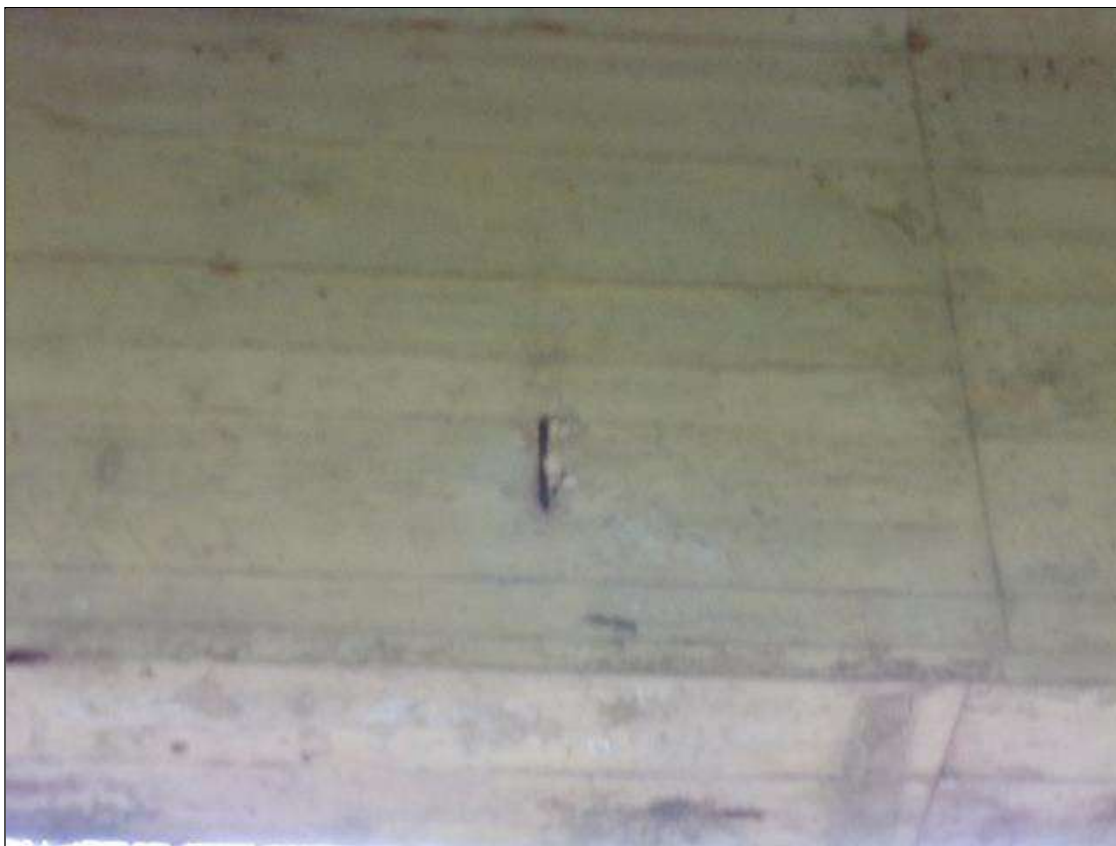
Span 1 Beam 5: 6" high x 2" wide x 1/4" deep spall with exposed rebar with no measurable section loss on west face of beam near mid span.

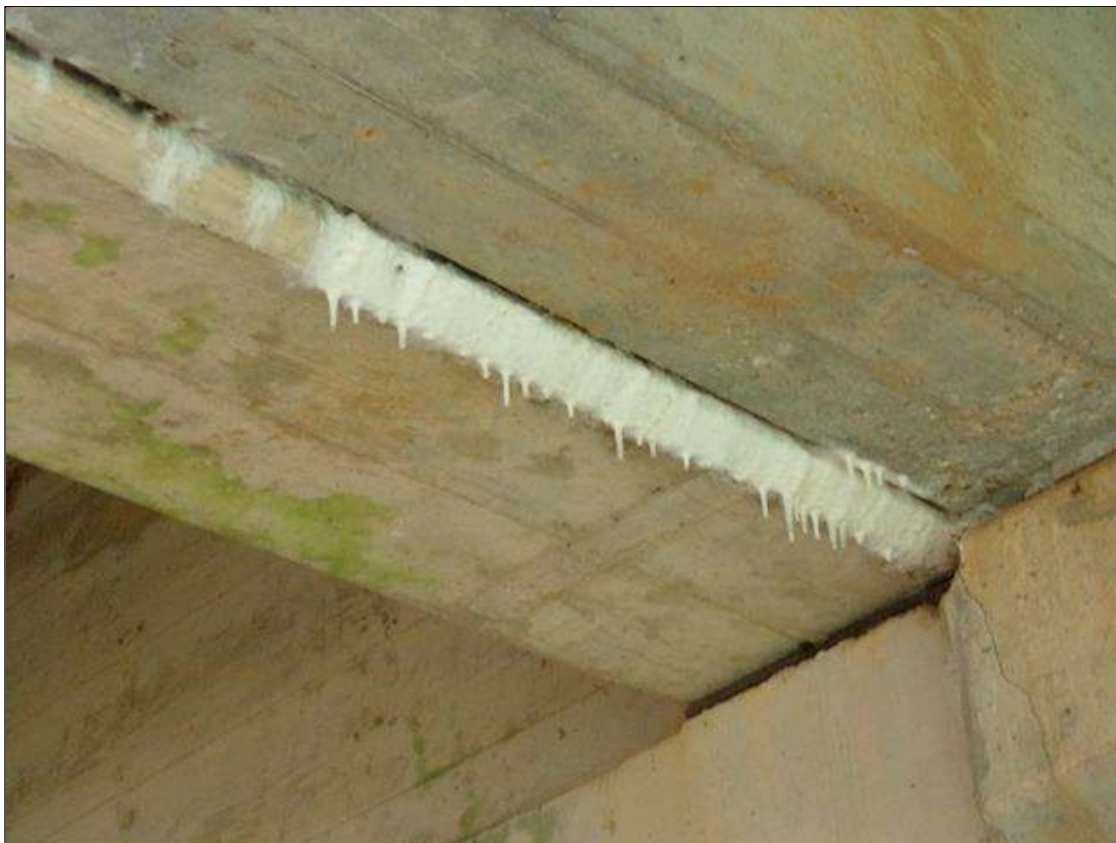
Span 1 Beam 3: 4' of efflorescence on bottom of beam between beams 2 and 3 starting at abutment 1.

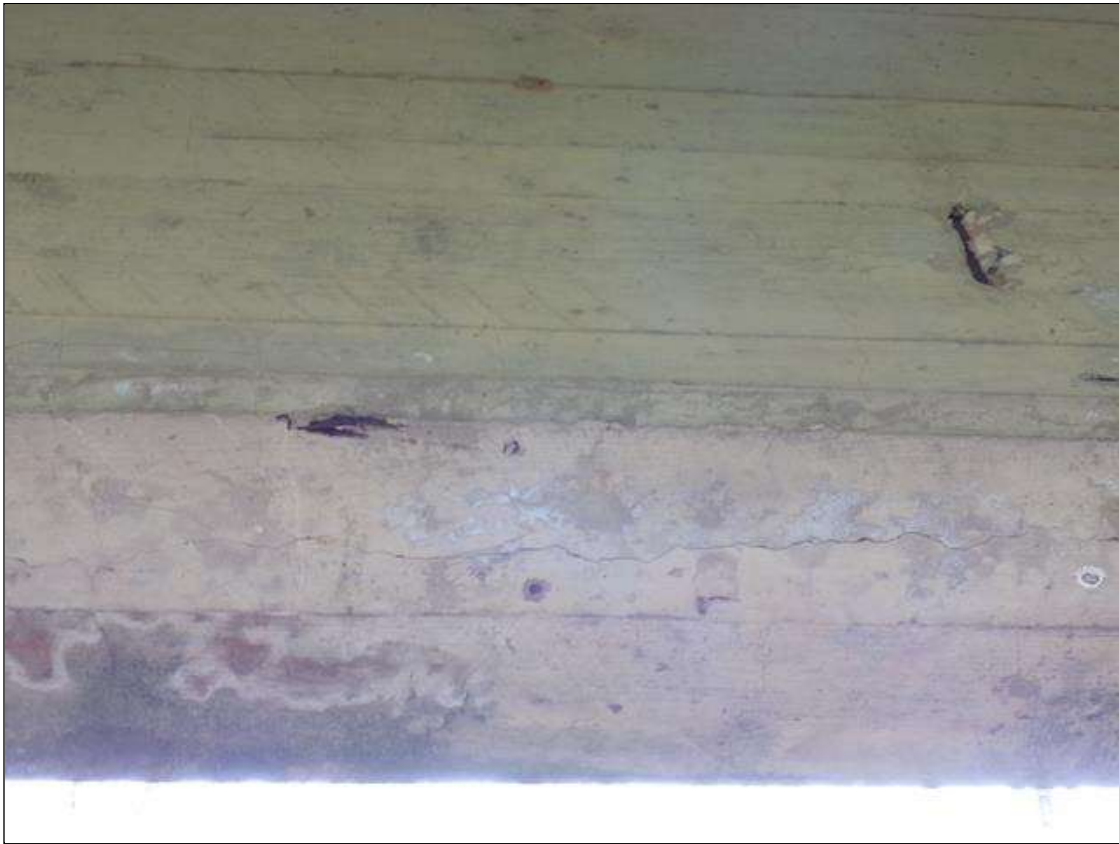
Span 1 Beam 5: 3' long longitudinal crack up to 1/16" wide on bottom of beam at mid span.

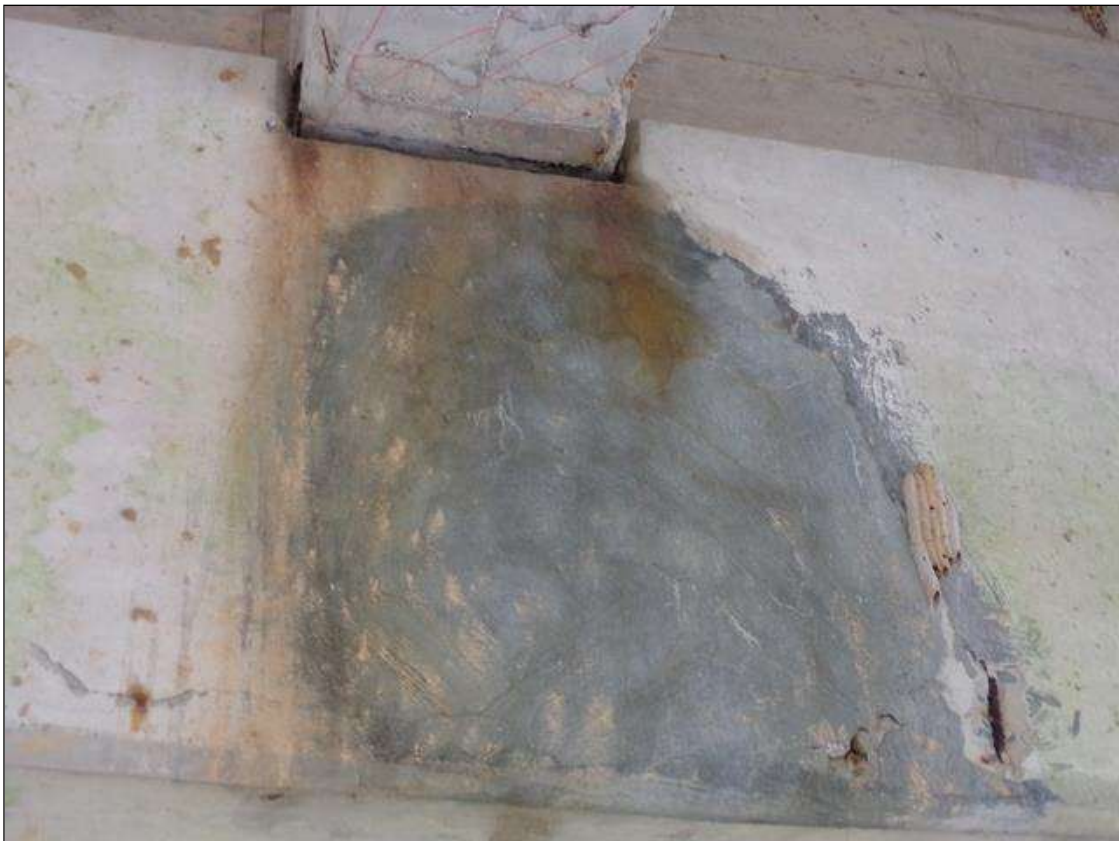
Bent 1 Cap 1: 3' high x 2' wide unsound patched area with on north face of cap with 2 spalls up to 4" diameter 1/2" deep with exposed rebar with no measurable section loss under beam 4.

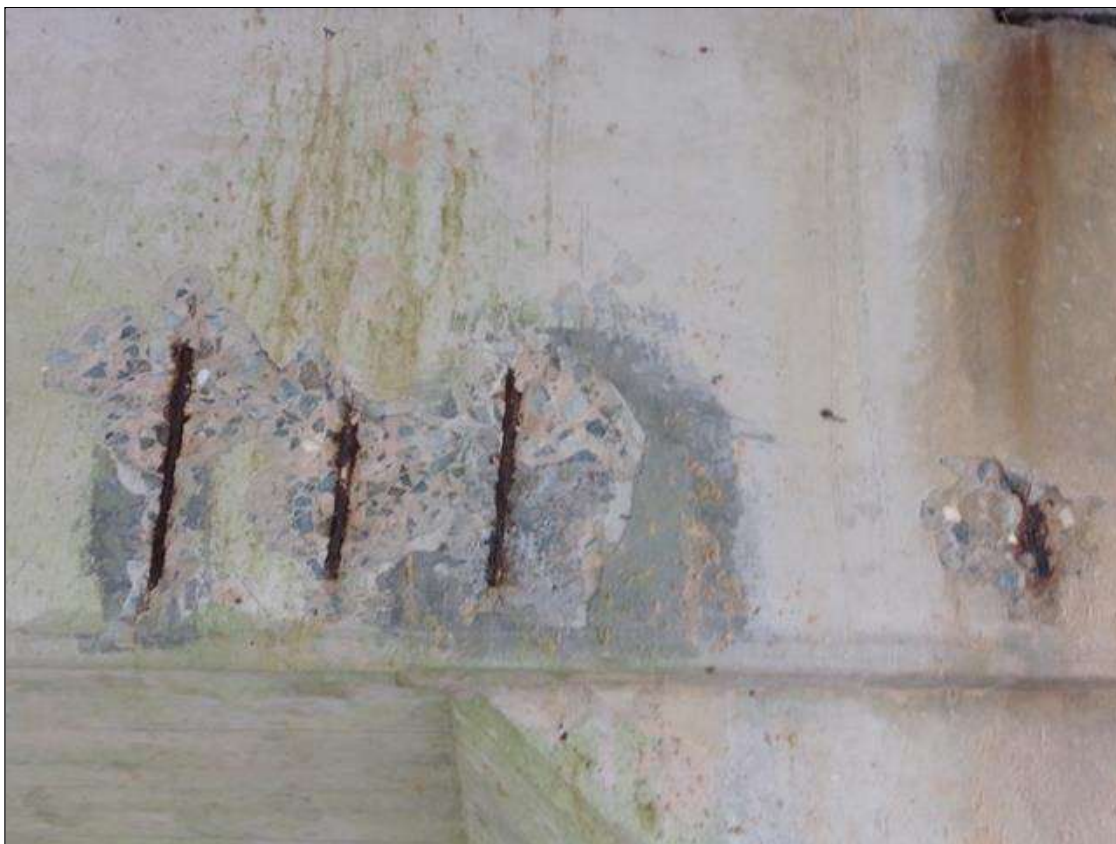
Bent 1 Cap 1: Two spalls up to 21" high x 2' wide x 1" deep with exposed rebar with no measurable section loss on north face of cap under bay 2.

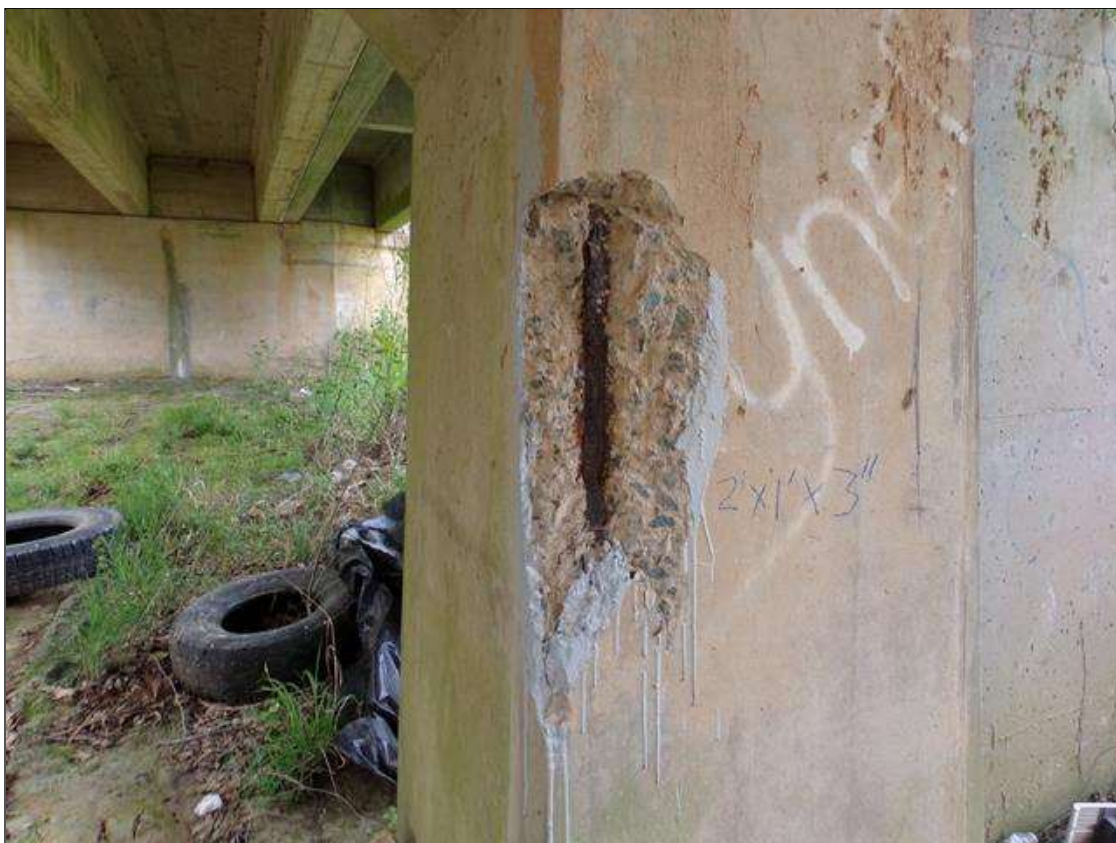
Bent 1 Pile 2: PM--2' high x 1' wide x 3" deep spall with exposed rebar with section loss on north face starting 3' from ground line.

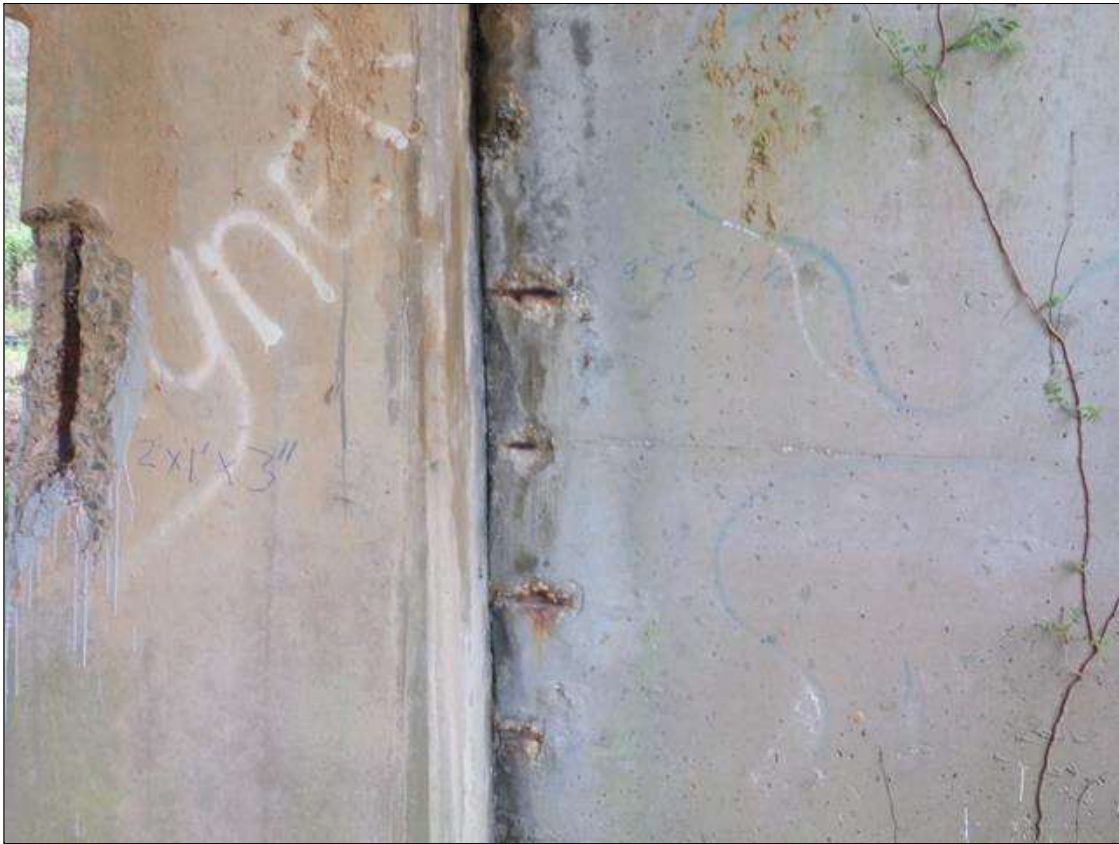
Several spalls up to 8" wide x 6" long x 1/2" deep with exposed rebar with no measurable section loss on web wall next to column 2 north face.

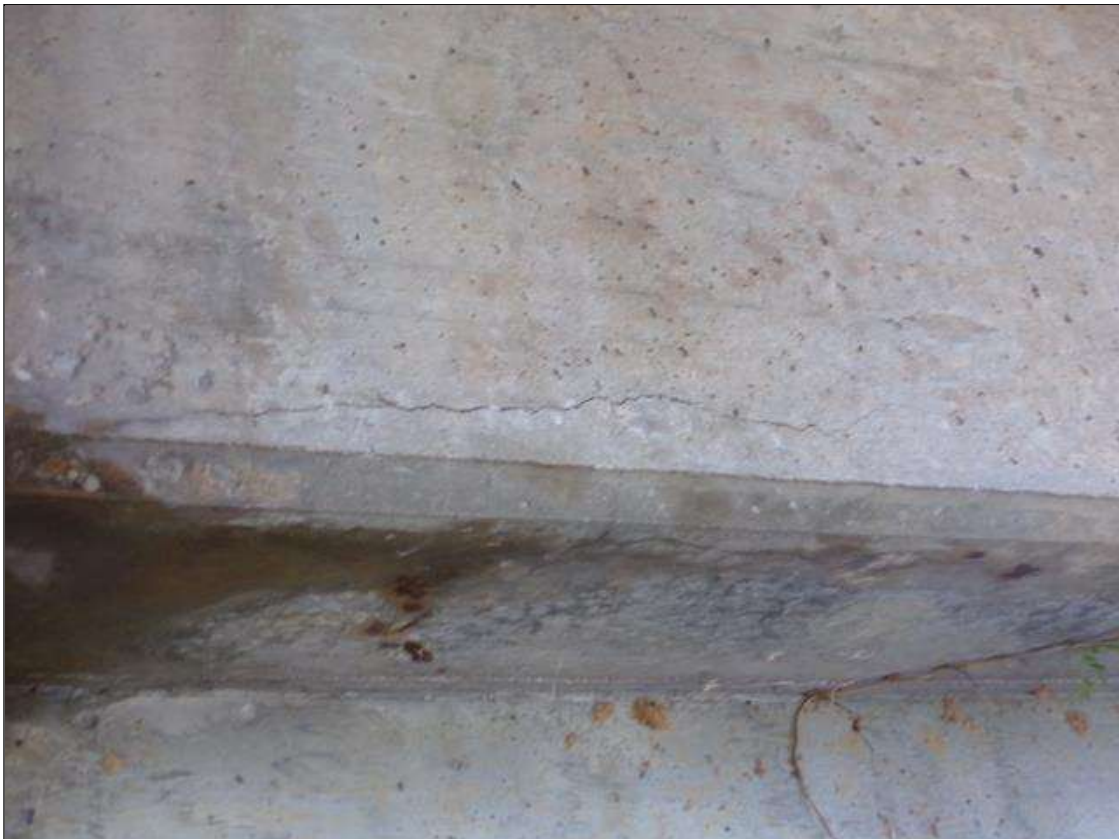
Bent 1 Cap 1: 2' long horizontal/transverse crack up to 1/16" wide on north face and bottom of cap starting at construction joint.

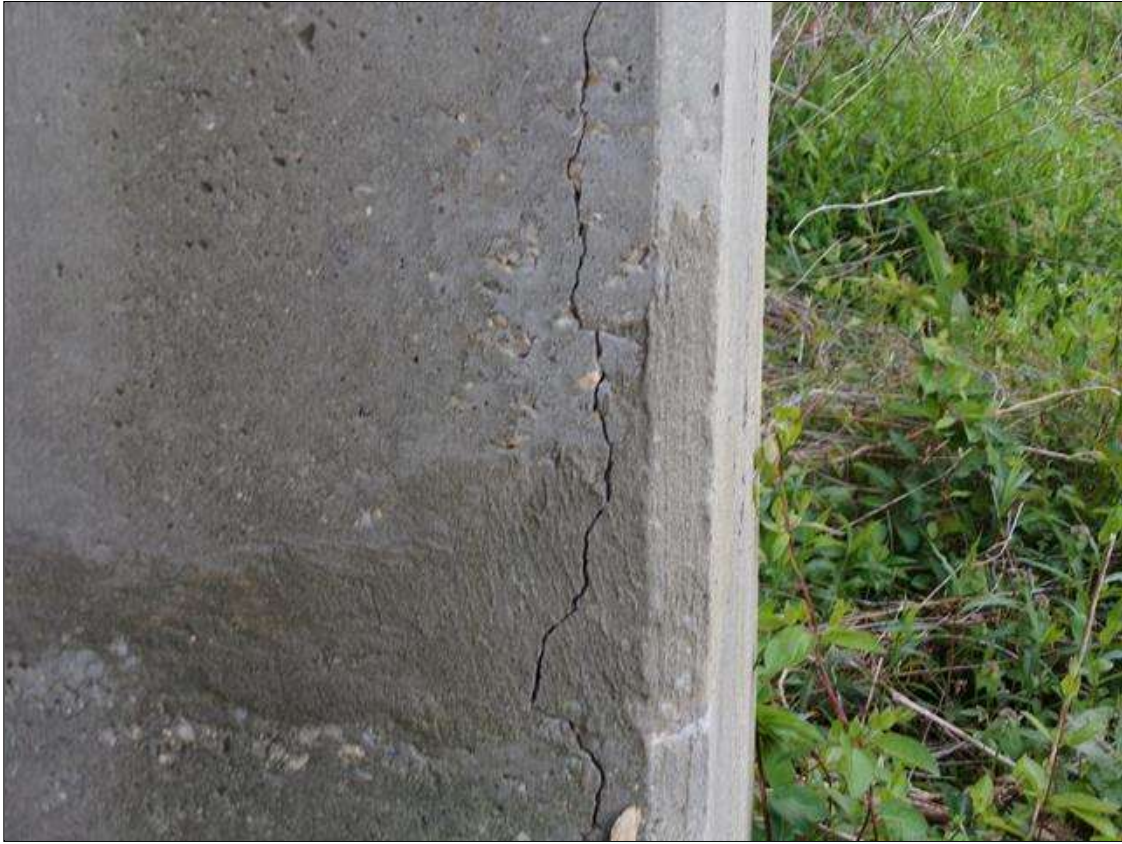
Bent 1 Pile 1: 3' high vertical crack up to 1/8" wide on north face of column starting 2' from ground line.

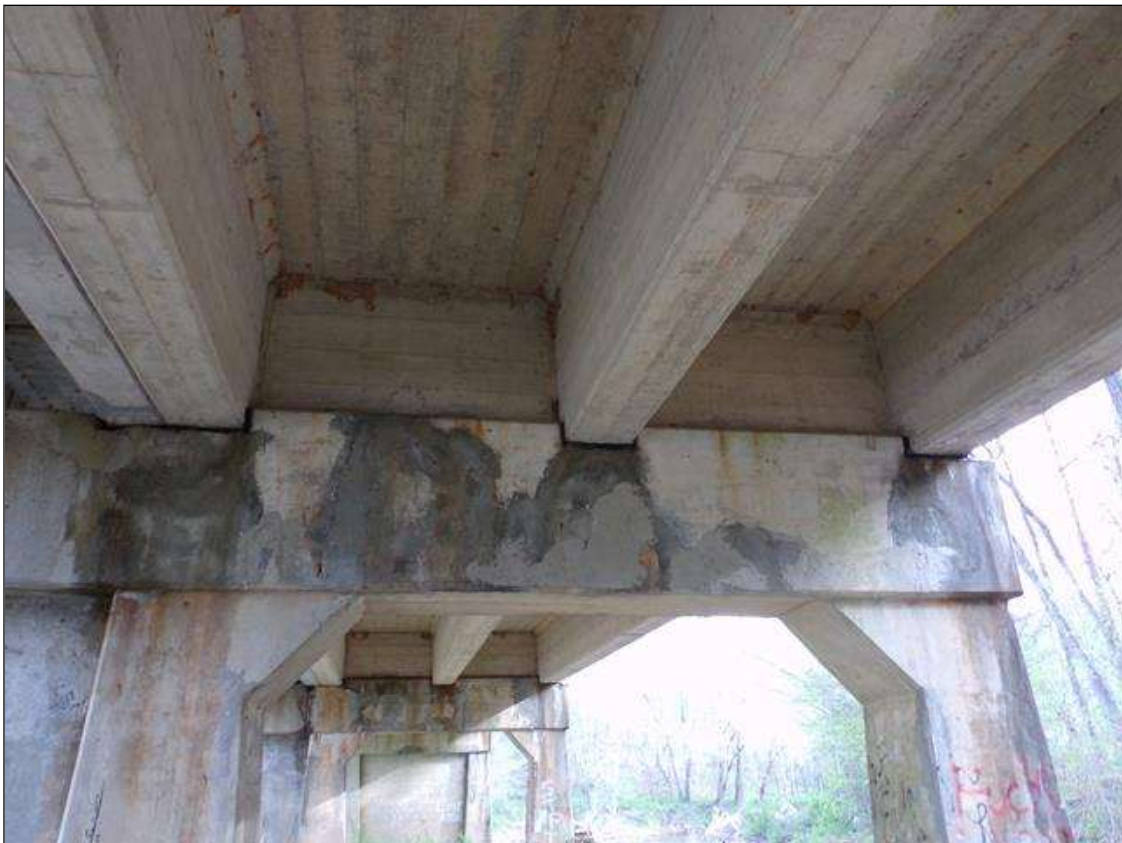
Bent 2 Cap 1: Several sound patched areas on south face of cap between beams 2 thru 5.

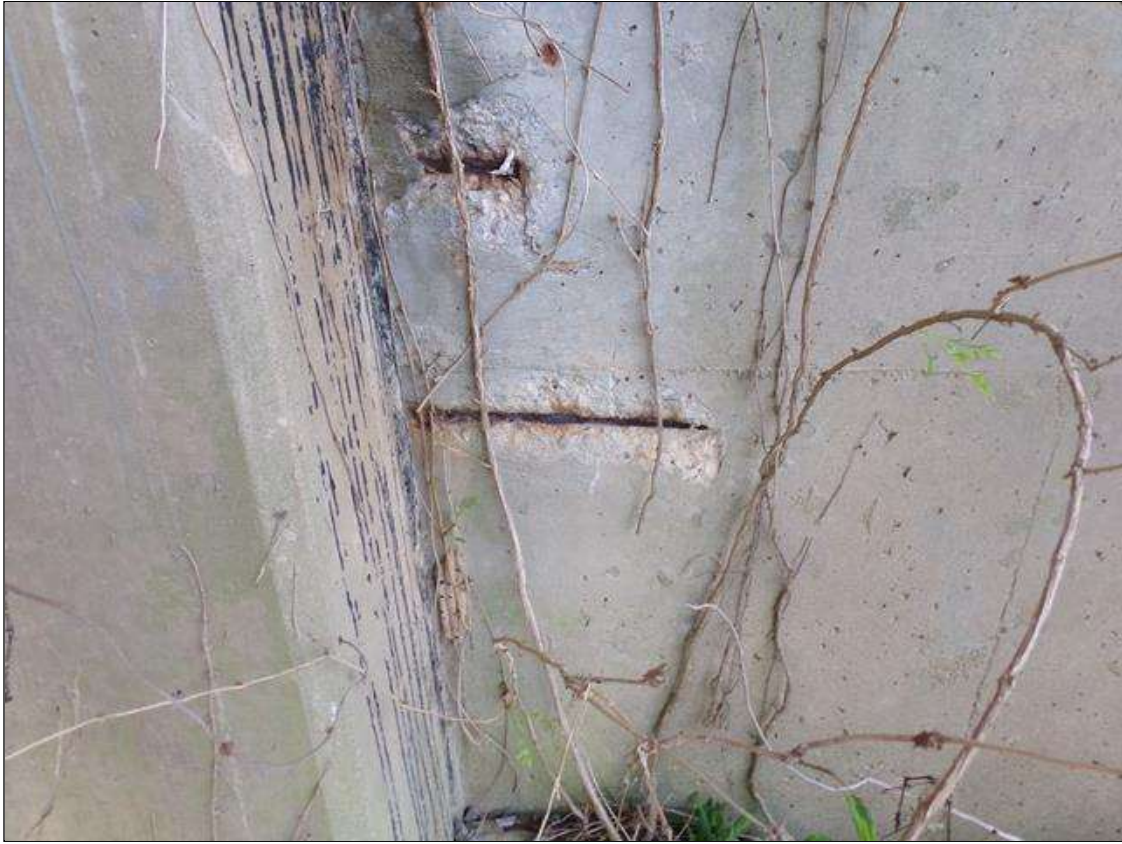
Two spalls up to 16" long x 4" wide x 1/2" deep with exposed rebar with no measurable section loss on north face of web wall next to column 2

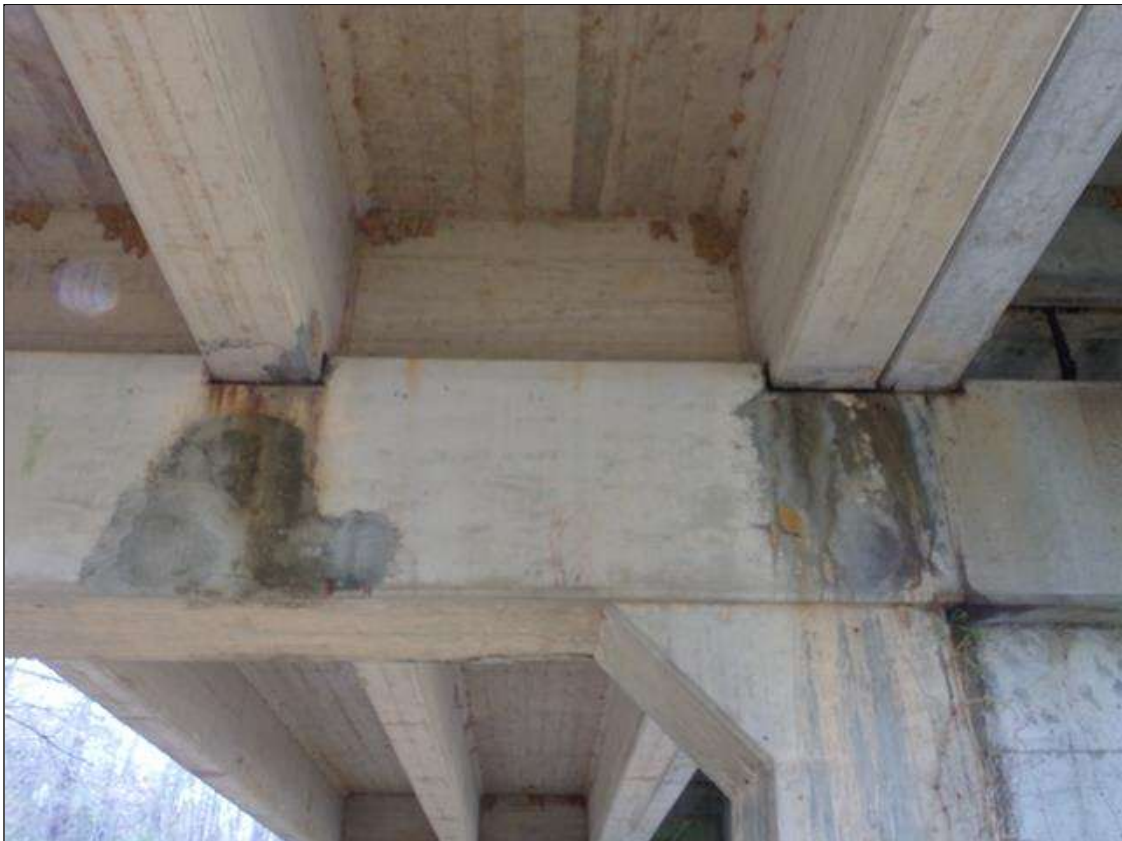
Bent 2 Cap 1: 2 sound patched area on north face of cap under beams 3 and 4.

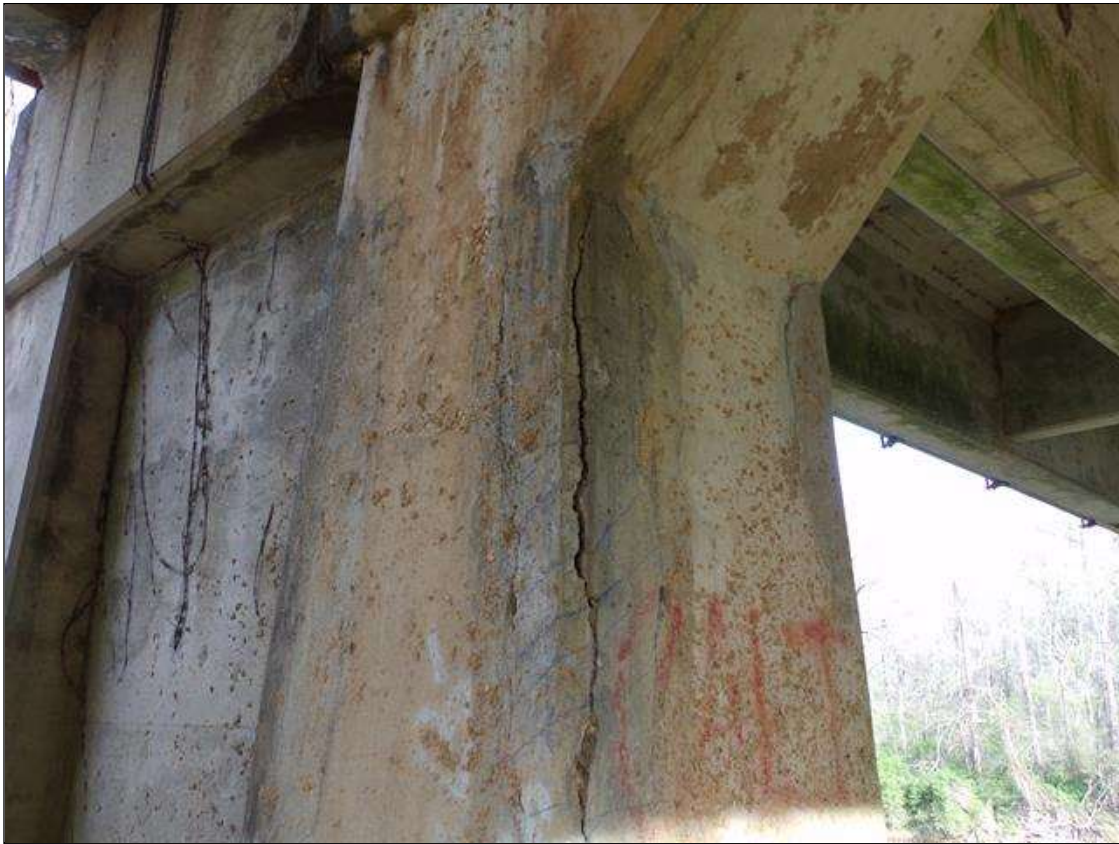
Bent 3 Pile 2: 5' high x 8" wide corner patch on southeast corner that is unsound with a crack up to 1/8" wide that extends down to ground starting 2' from bottom of cap.

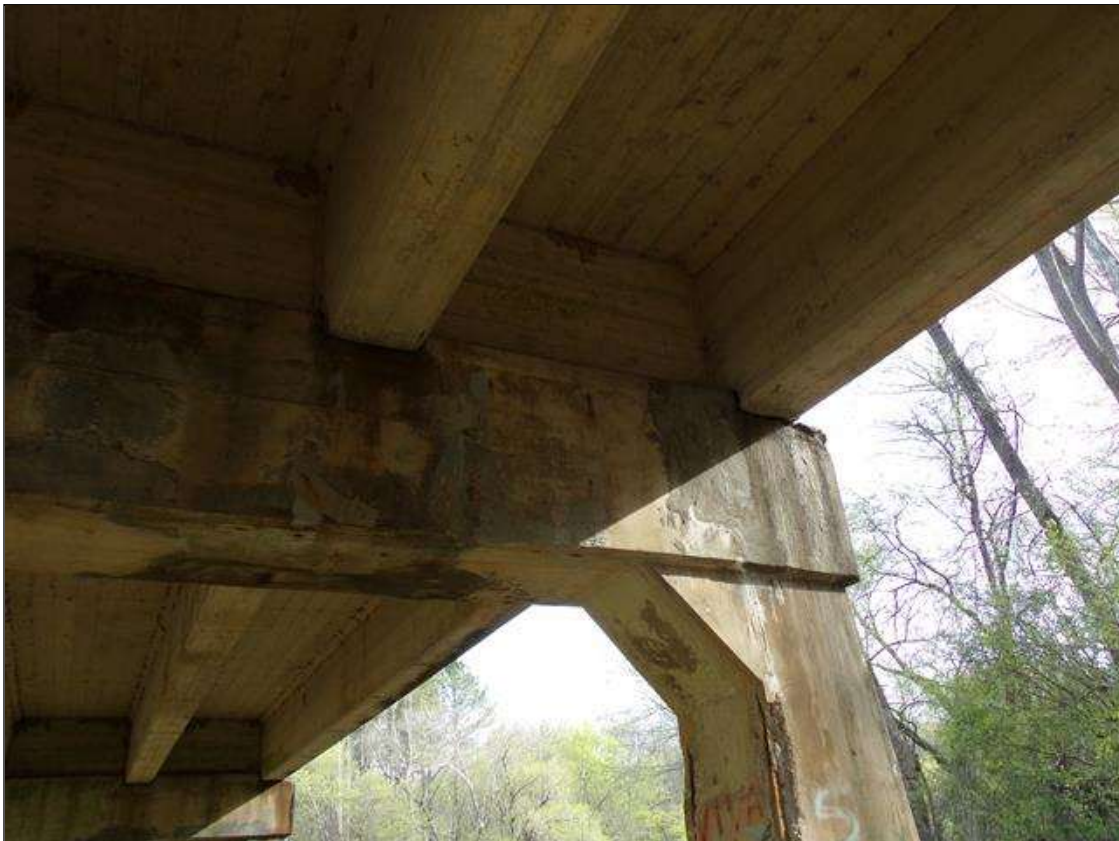
Bent 3 Cap 1: Several sound patched areas on south face of cap starting under bay 2 out to east end.
