NC DEPARTMENT OF TRANSPORTATION
 DIVISION OF HIGHWAYS
 STRUCTURE MANAGEMENT UNIT

ATTENTION: **PRIORITY MAINTENANCE ISSUED; SNOOPER USED**

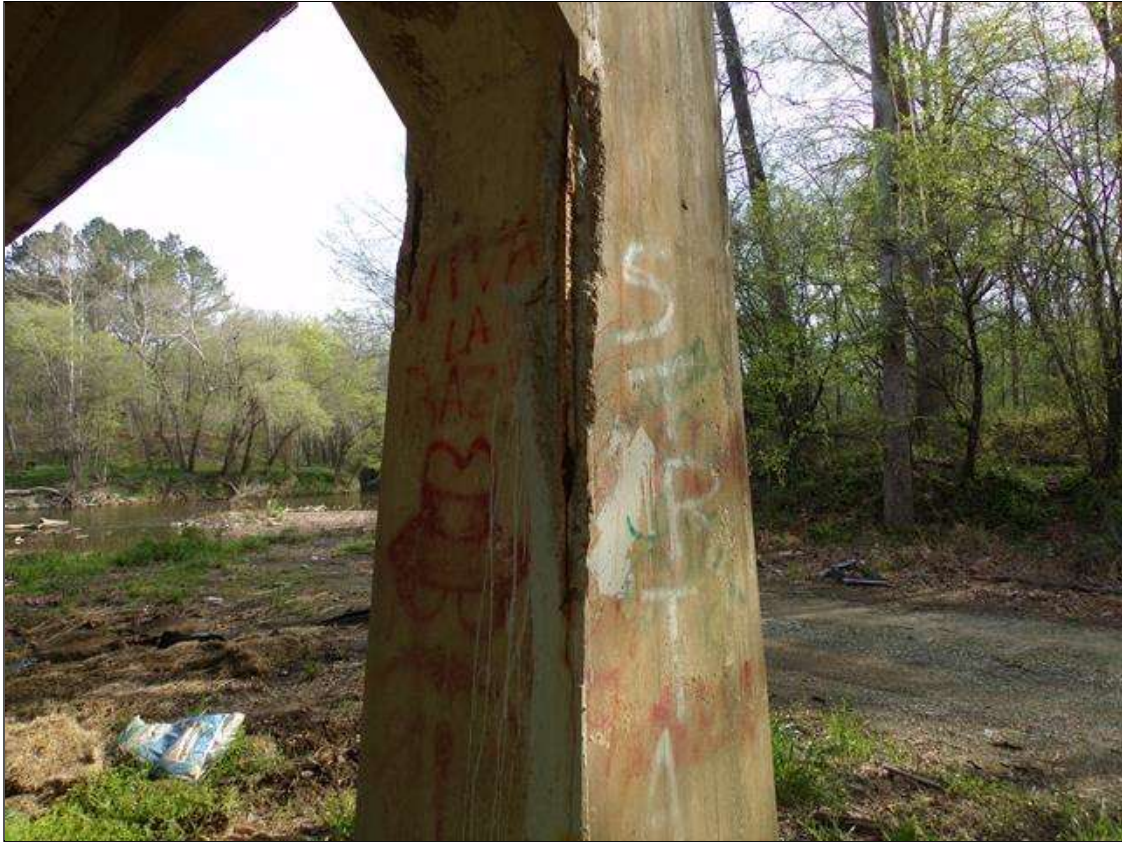
Bent 3 Pile 3: 5' high x 8" wide corner spall with exposed rebar with no measurable section loss on southwest corner with areas of delamination on both sides of spall with a crack up to 1/8" wide that extends down to ground starting 2' from bottom of cap.

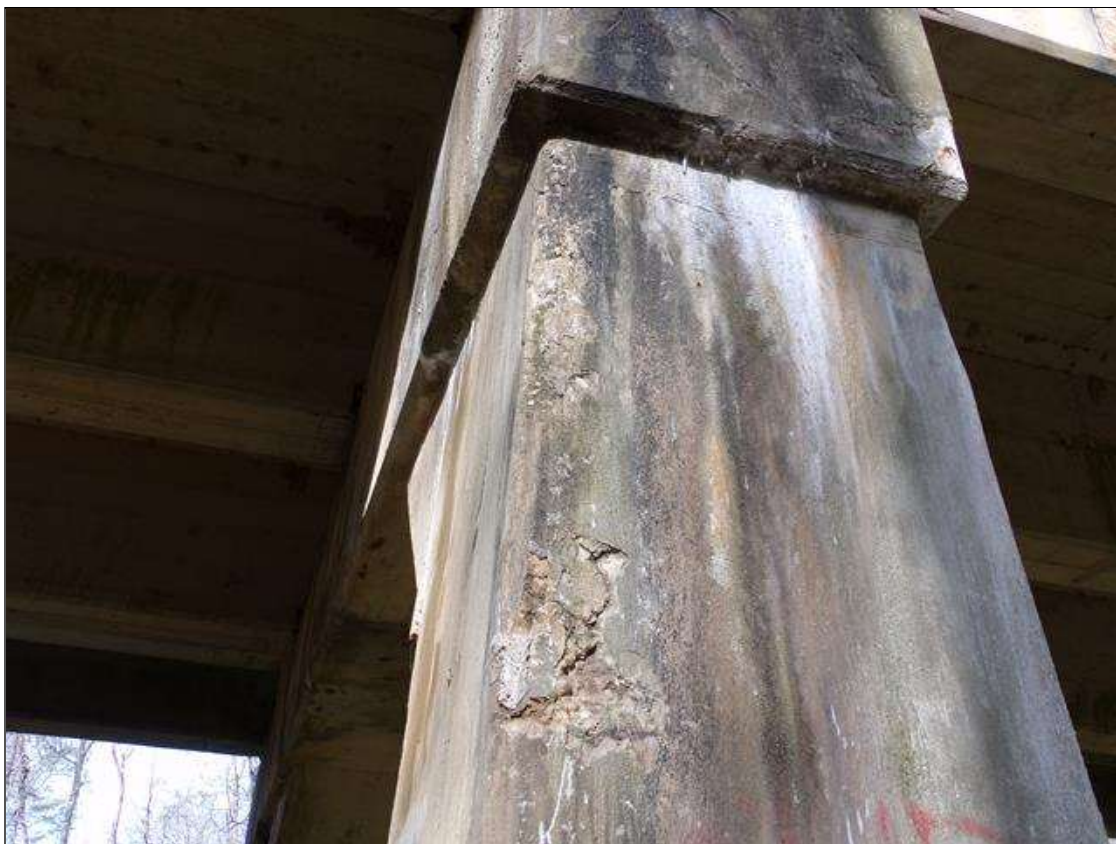
Bent 3 Pile 3: 1' square area of concrete deterioration with spalling up to 1/2" deep 7' from ground line on east face.

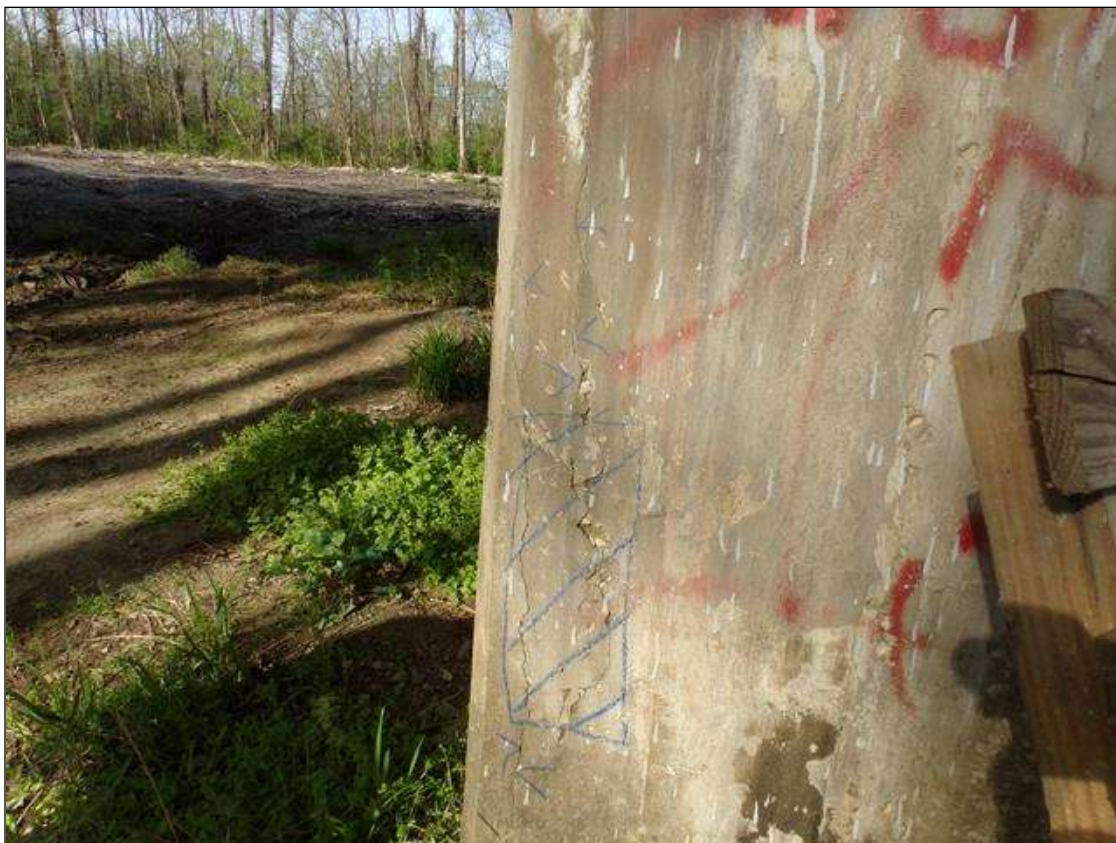
Bent 3 Pile 3: 1.5' high x 6" wide area of delamination with 1/32" cracks that extend 2' up and down from delamination.

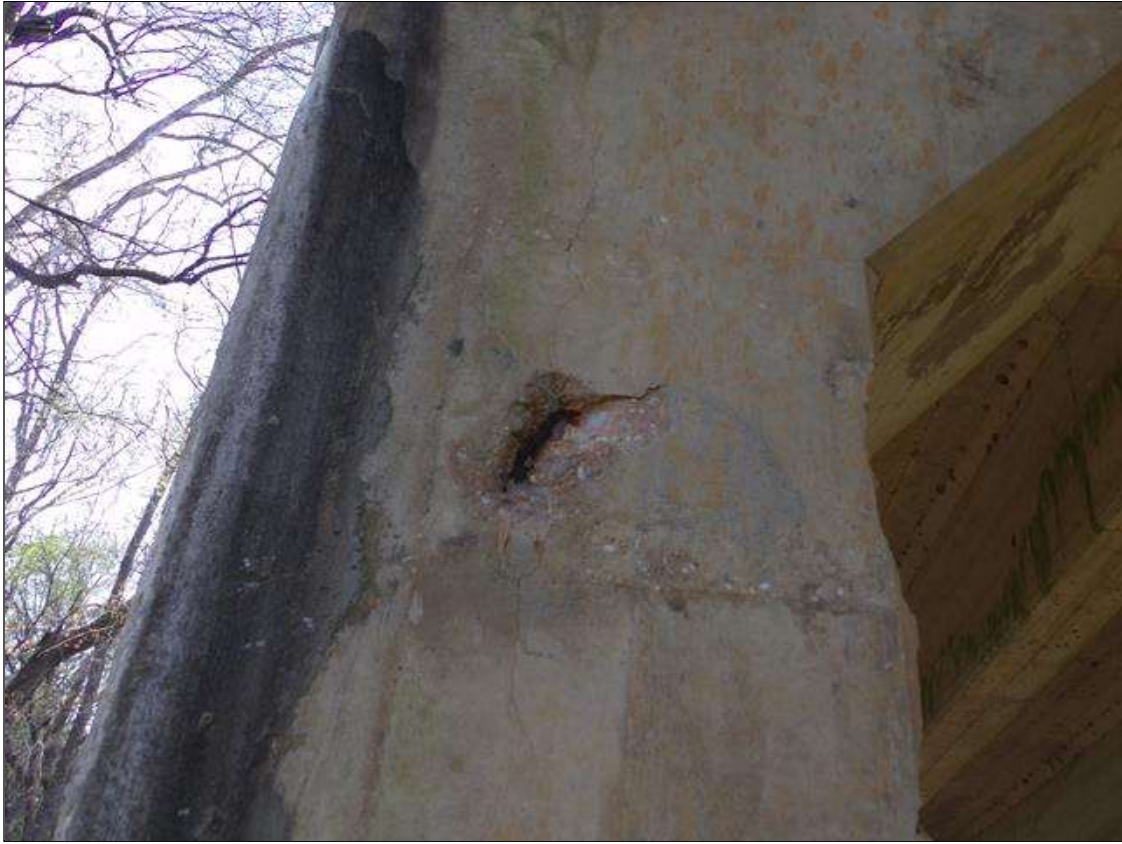
Bent 3 Pile 3: 6" diameter spall 1" deep with exposed rebar with no measurable section loss on north face of column 7' from ground.

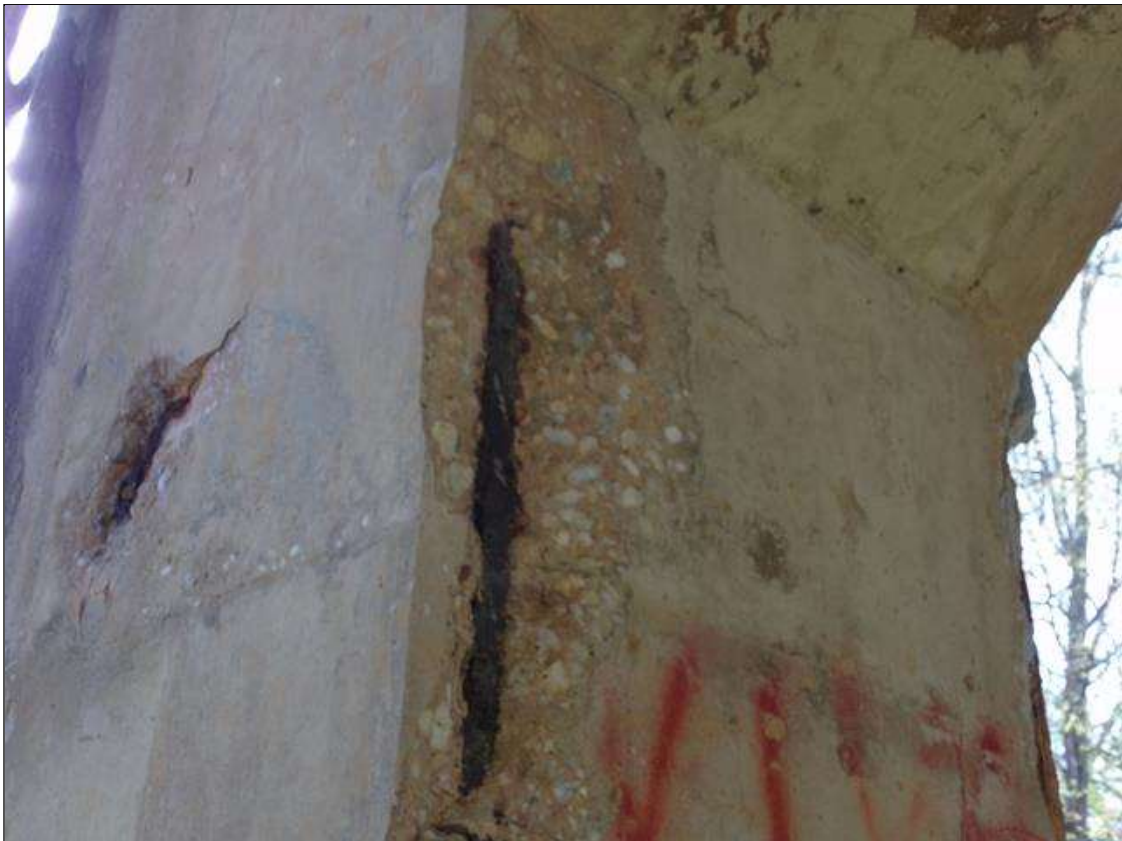
Bent 3 Pile 3: 27" high x 9" wide x 1 1/2" deep spall with exposed rebar with no measurable section loss on west face of column starting 6' from ground.

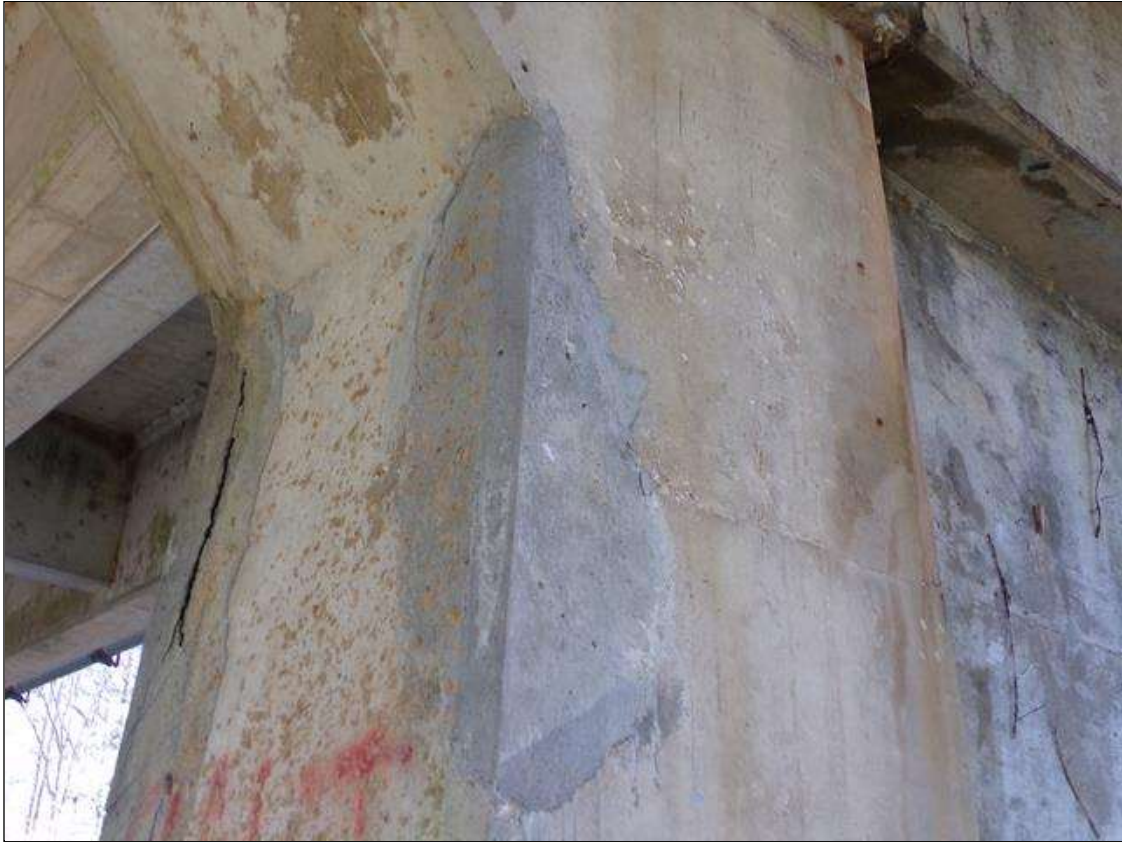
Bent 3 Pile 2: 3' high x 8" wide corner patch on northeast corner that is sound starting 2' from bottom of cap.

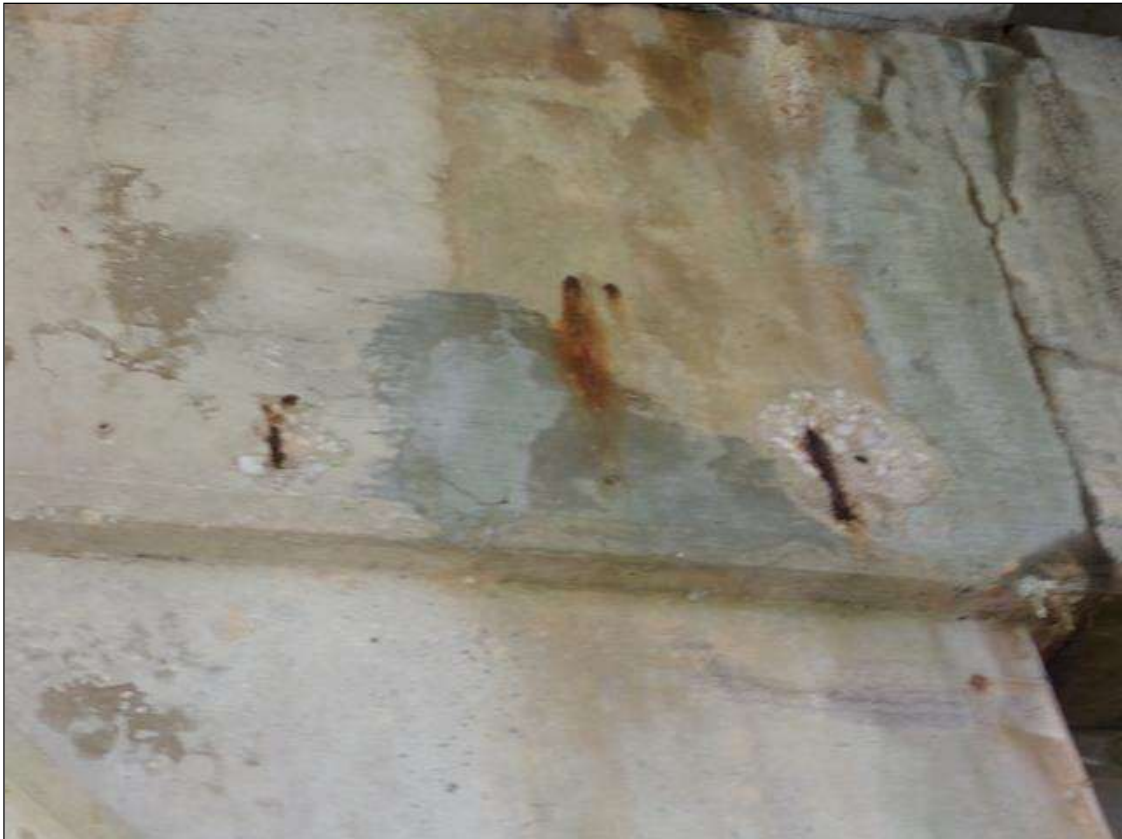
Bent 3 Cap 1: Two spalls up to 6" diameter x 1/2" deep with exposed rebar with no measurable section loss on north face of cap under beam 3.

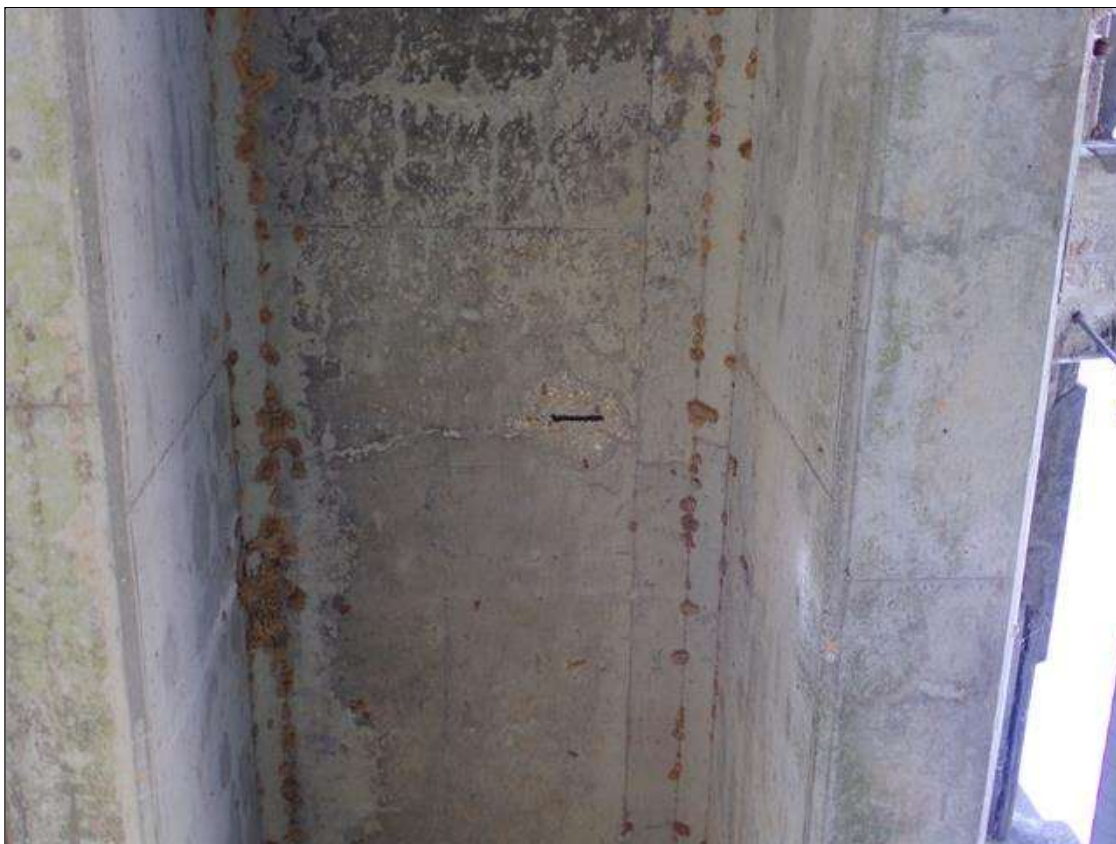
Span 3 Deck: 1' diameter spall 3/4" deep with exposed rebar with no measurable section loss on underside of deck in bay 1, 16' from middle diaphragm

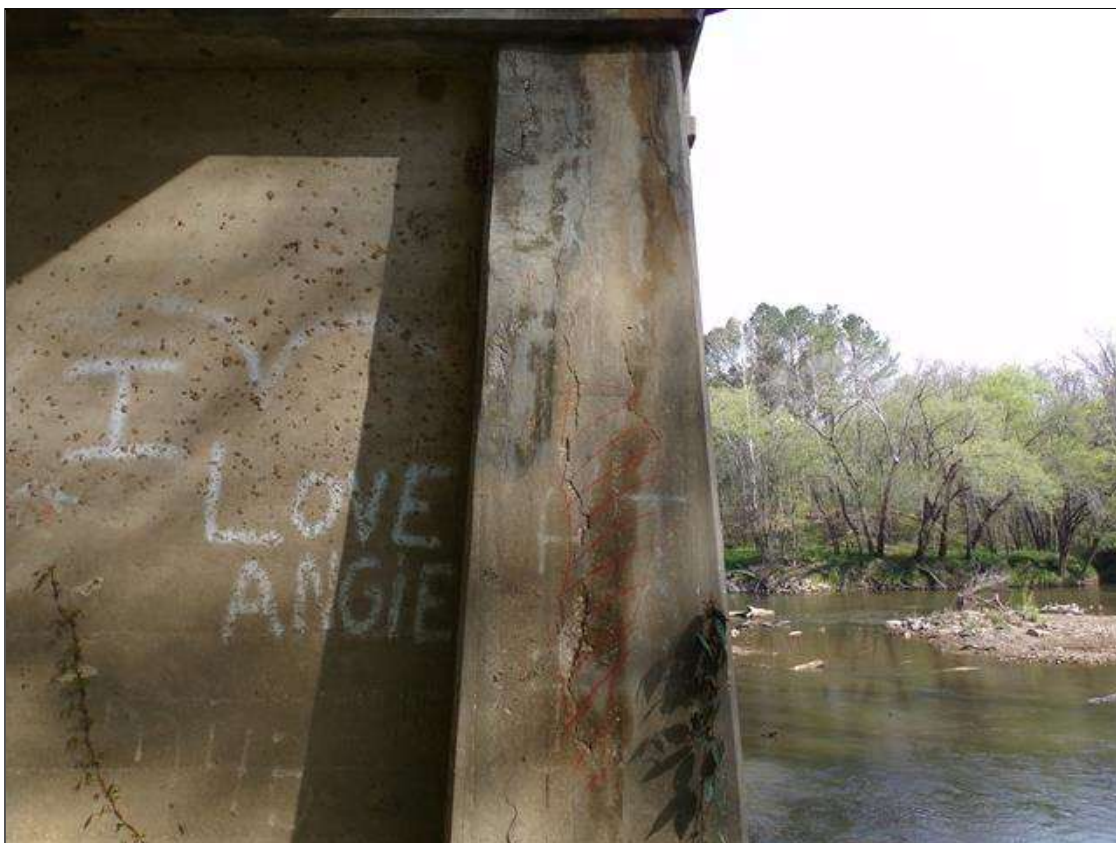
Bent 4 Pile 3: 9' high x 16" wide area of delamination on south face of column starting 3' from ground.

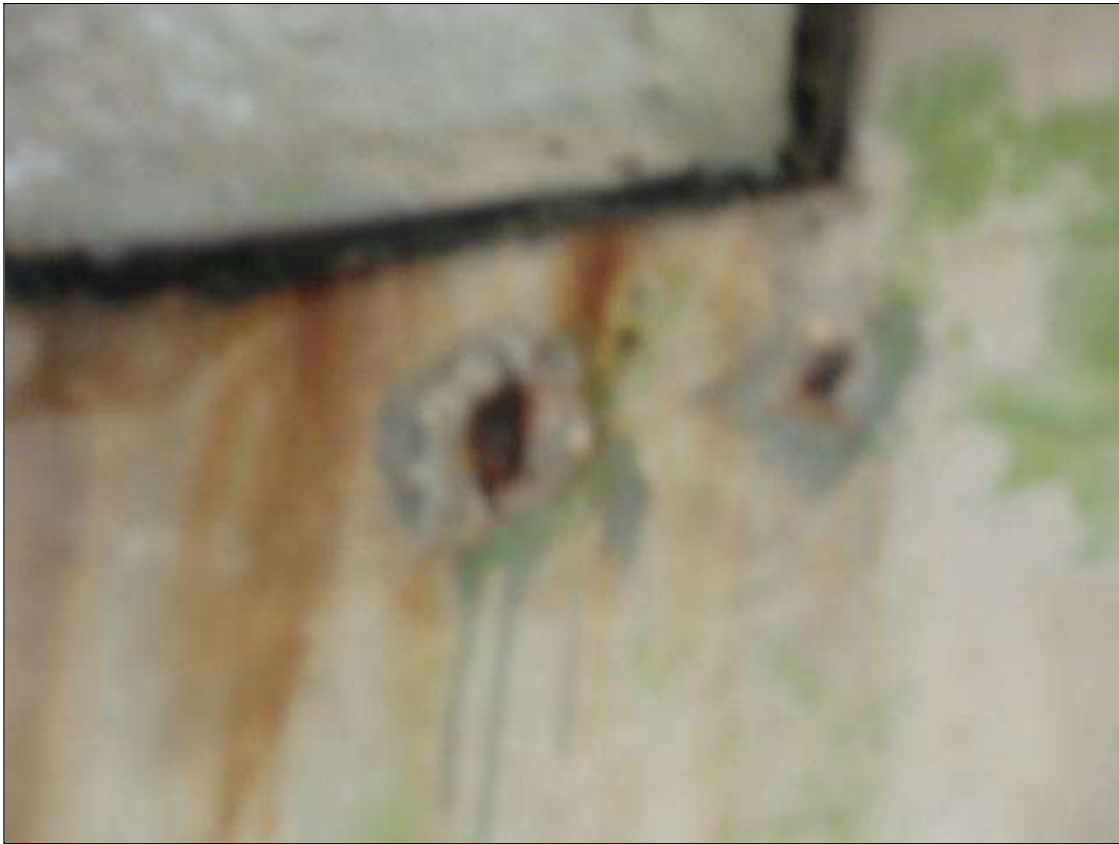
Bent 4 Cap 1: Numerous spalls up to 6" diameter x 1/2" deep with exposed rebar with no measurable section loss on south face of cap starting under beam 3 out to beam 5.

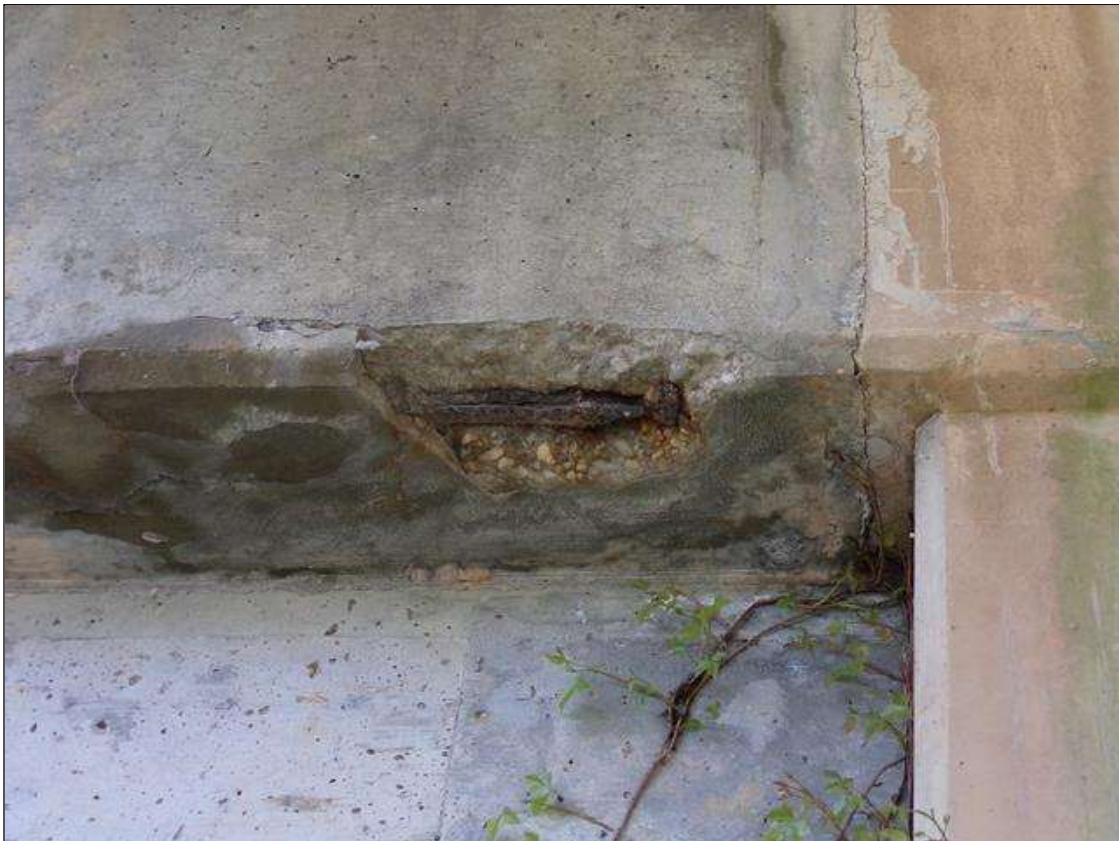
Bent 4 Cap 1: 1' long x 8" wide spall with exposed rebar with no measurable section loss with an area of delamination 1' long x 8" wide next to spall on bottom corner of cap south face between columns 1 and 2.

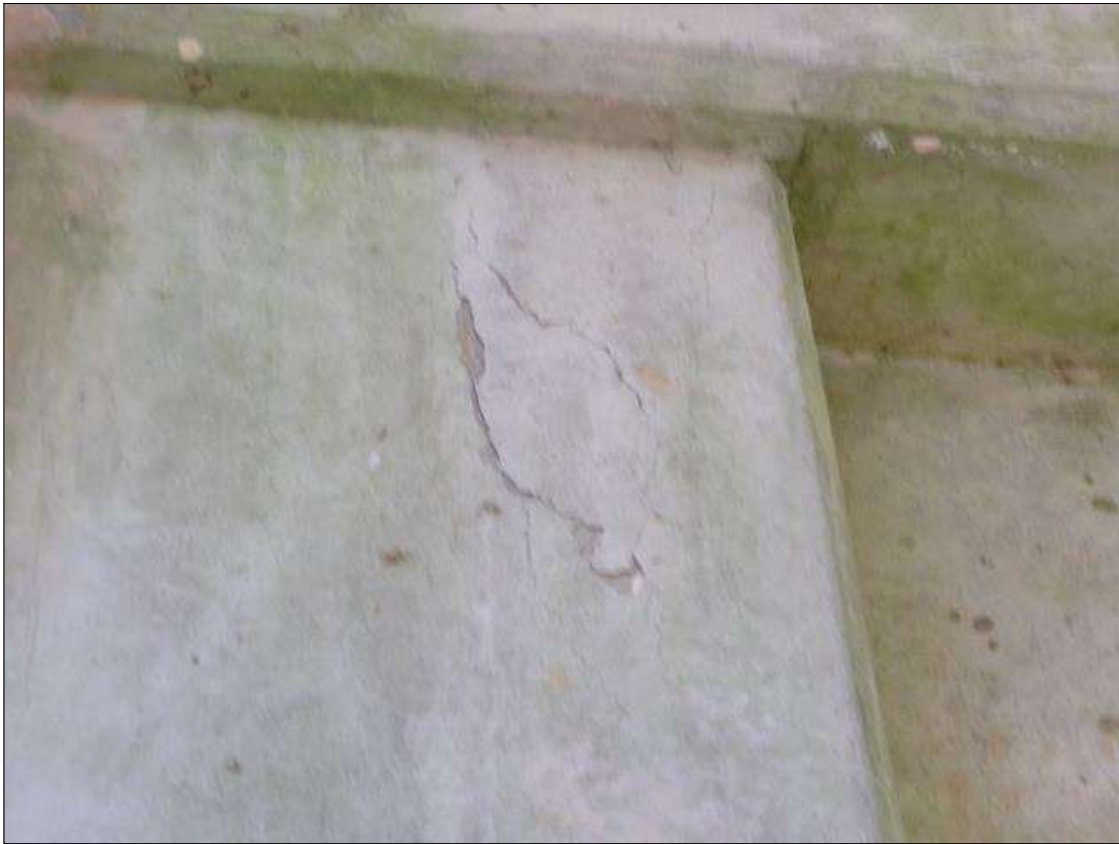
Bent 4 Pile 2: 18" wide x 1' high area of delamination on south face of column starting at bottom of cap.

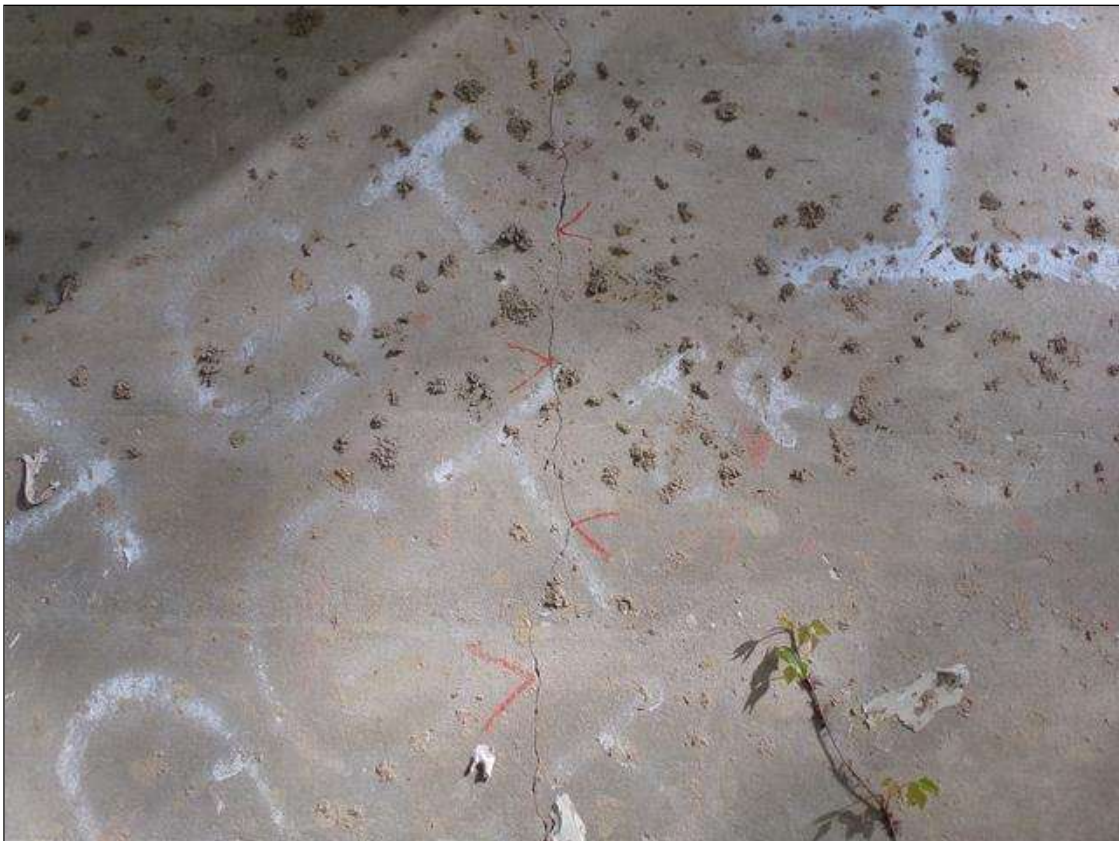
Full height vertical crack in web wall up to 1/8" wide between columns 2 and 3 south face.

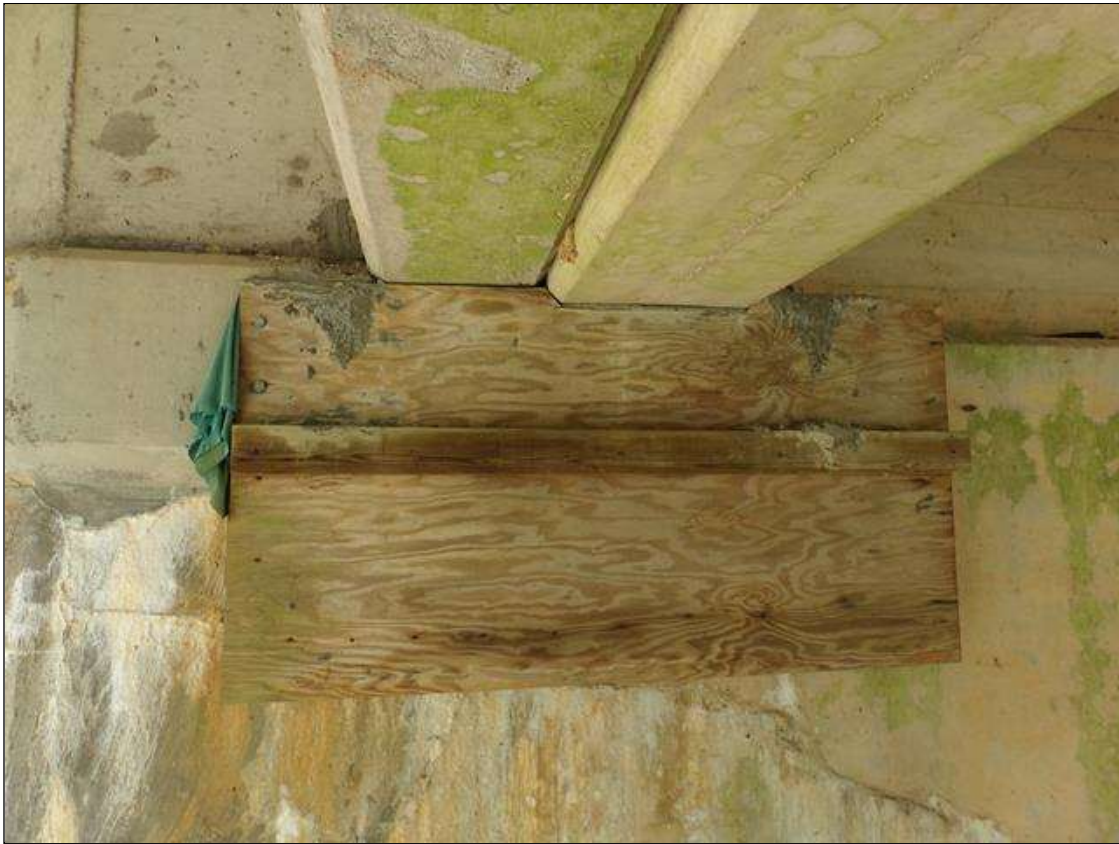
Form work left in place 4' long x 3' high under beams 2 and 3.

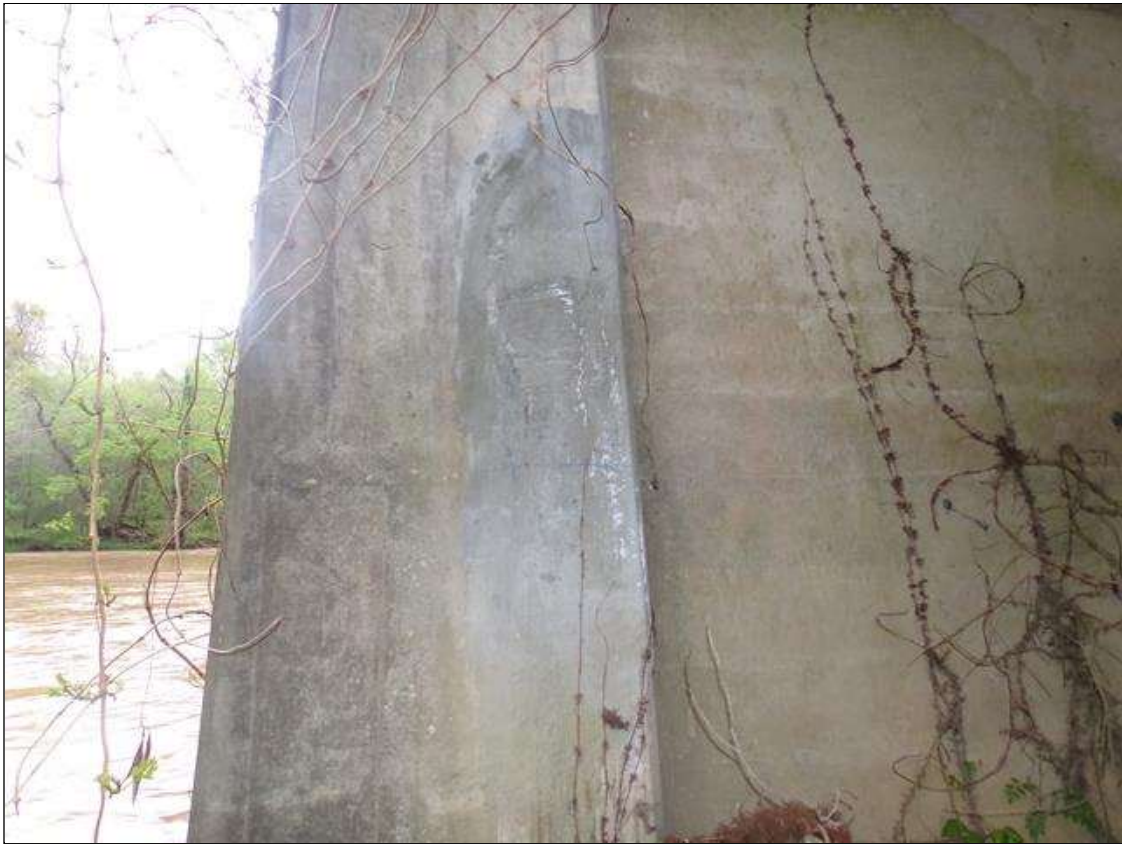
Bent 9 Pile 3: Unsound patched area on north face of column 5' high x 1.5' wide with a 1/32" x 2' long crack at top of patch starting at bottom of cap.

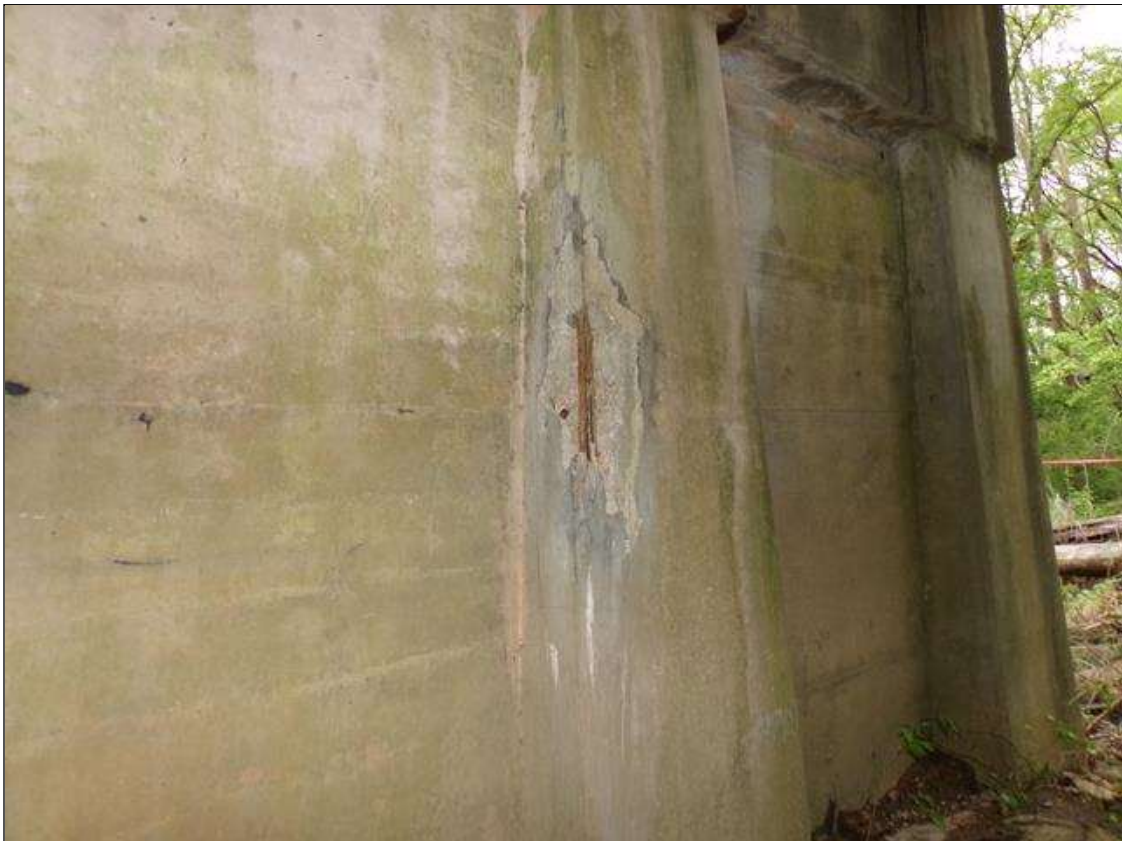
Bent 9 Pile 2: Spall 2' high x 1' wide x 2" deep with exposed rebar with no measurable section loss on north face of column starting 5' from ground line.

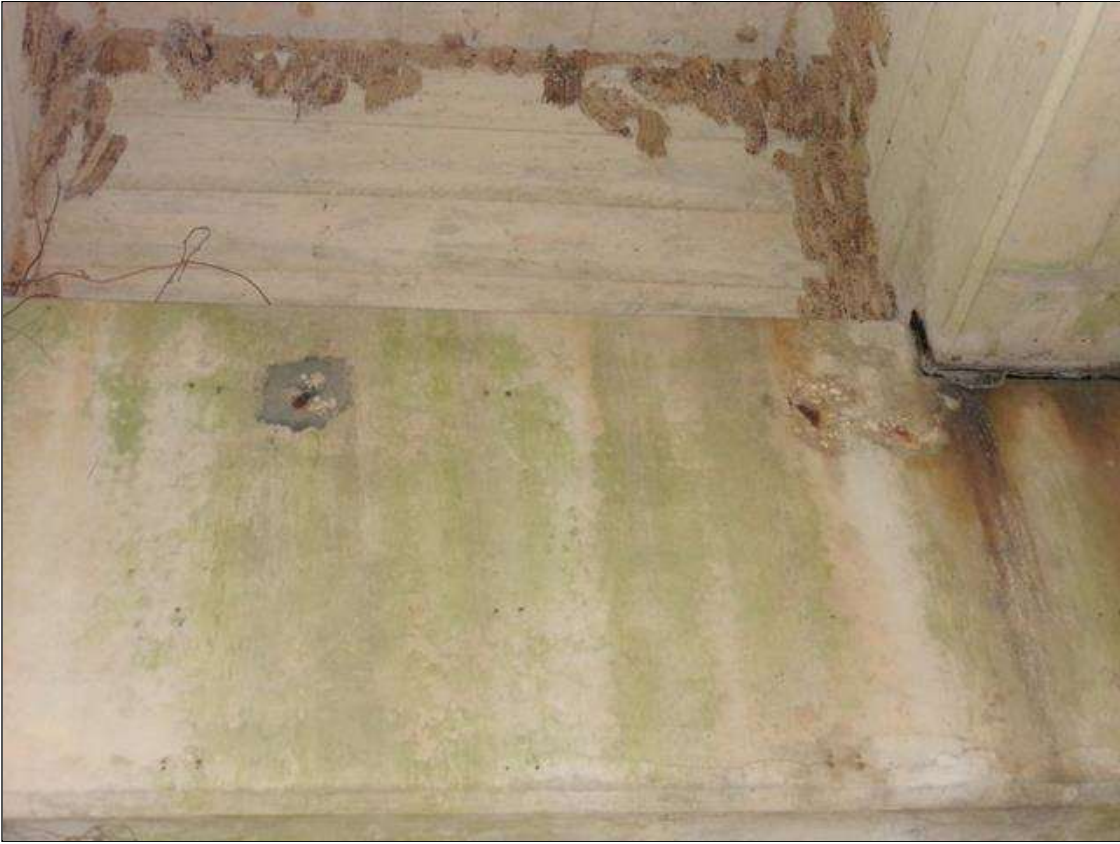
Bent 9 Cap 1: Two spalls up to 6" diameter x 1" deep with exposed rebar with no measurable section loss on north face of cap under bay 3.

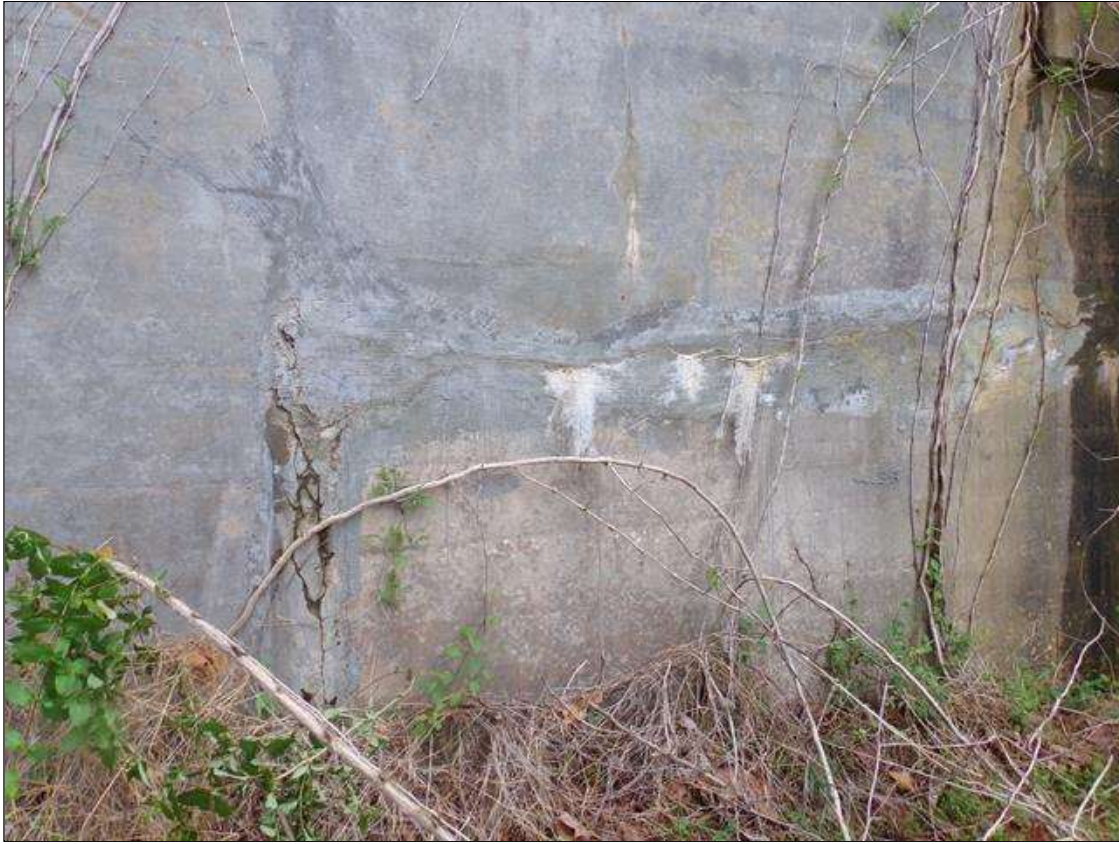
End Bent 2 Abutment/Backwall : Patched area 24' long x up to 6' high starting 12' from west end that is unsound with full width horizontal crack up to 3/16" wide with efflorescence and an area of map cracking at west end of patch up to 1/8" wide.

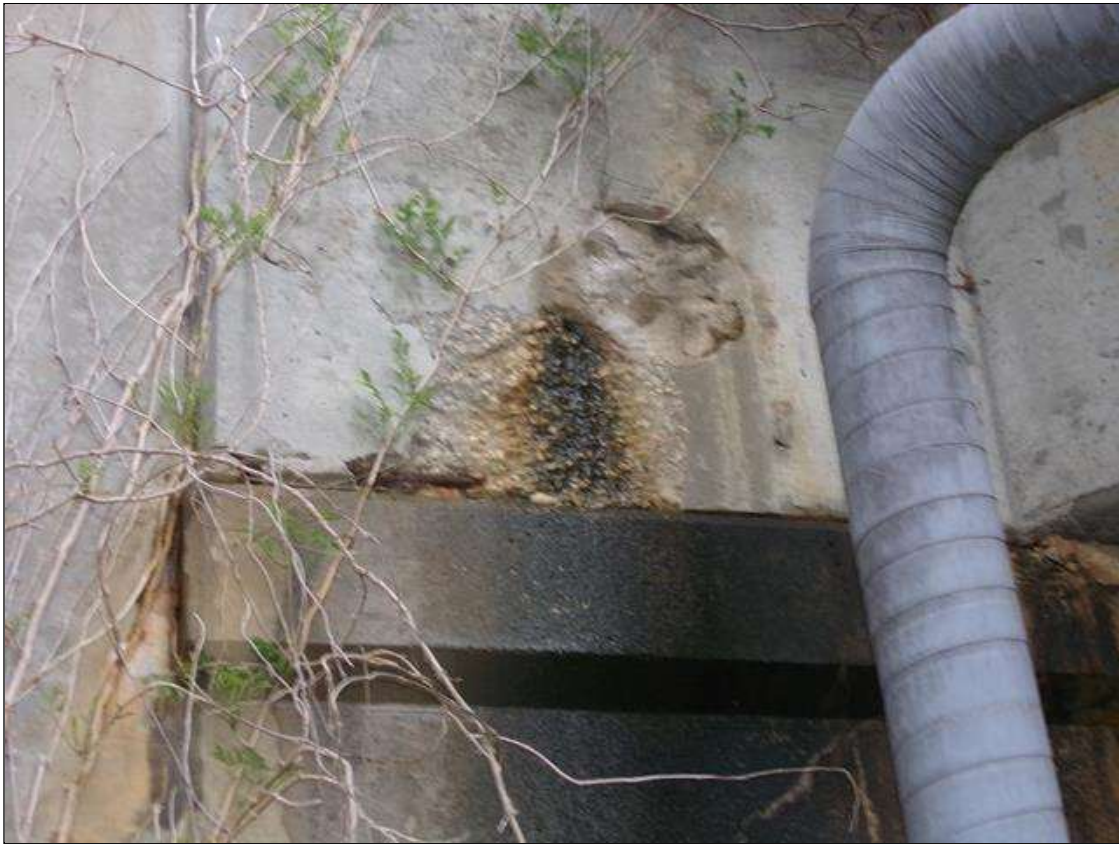
End Bent 2 Abutment/Backwall : 1.5' square area of delamination with a 1.5' square spall x up to 2" deep to the right of delamination with exposed rebar with no measurable section loss starting 3' west of beam 1.

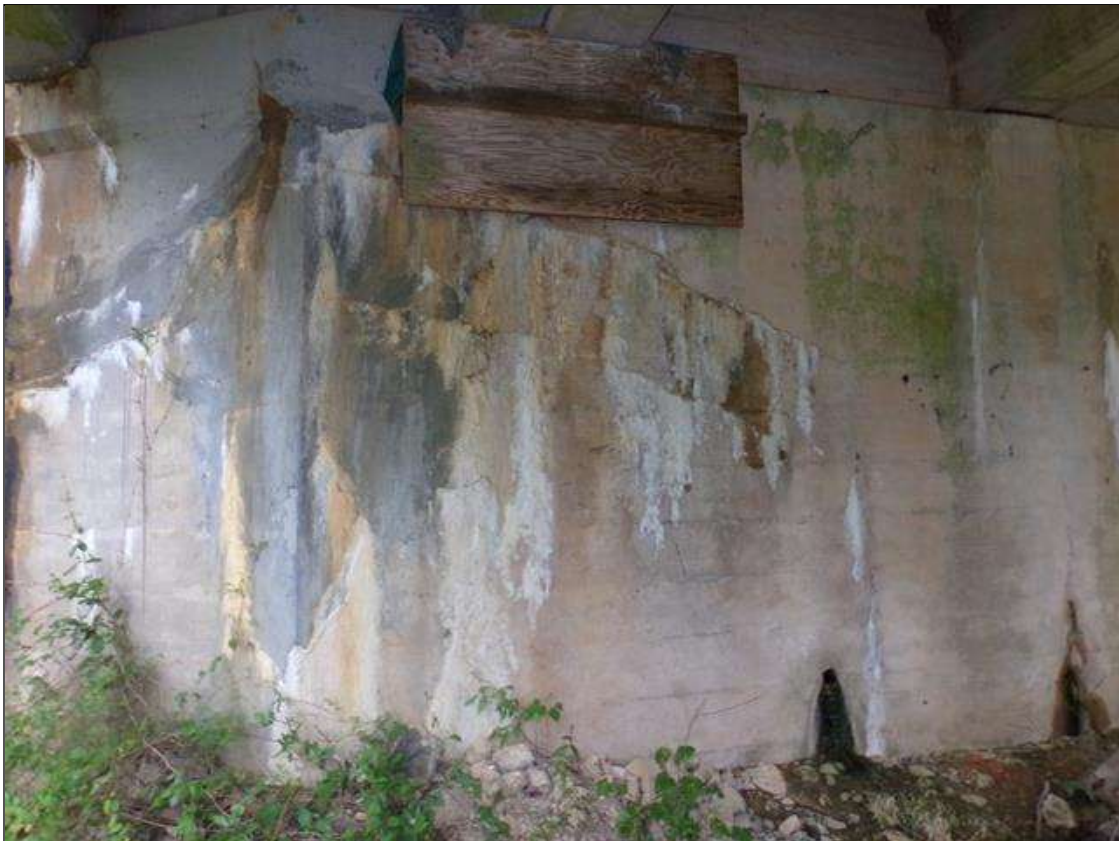
End Bent 2 Abutment/Backwall : Two 6' long x up to 1/32" wide horizontal cracks with efflorescence and a 6' high x 4' wide sound patched area under beams 2 and 3.

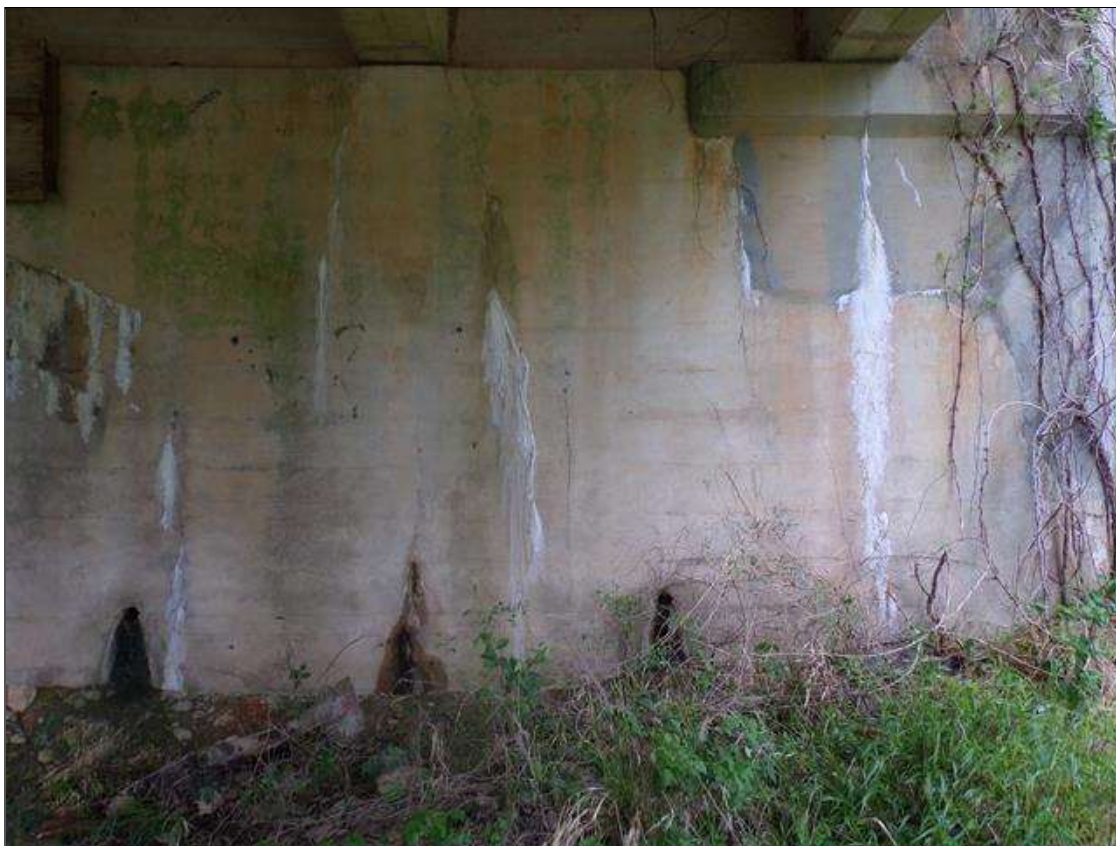
End Bent 2 Abutment/Backwall : Several full/partial height vertical cracks up to 1/16" wide with efflorescence under bay 2 out to beam 5.

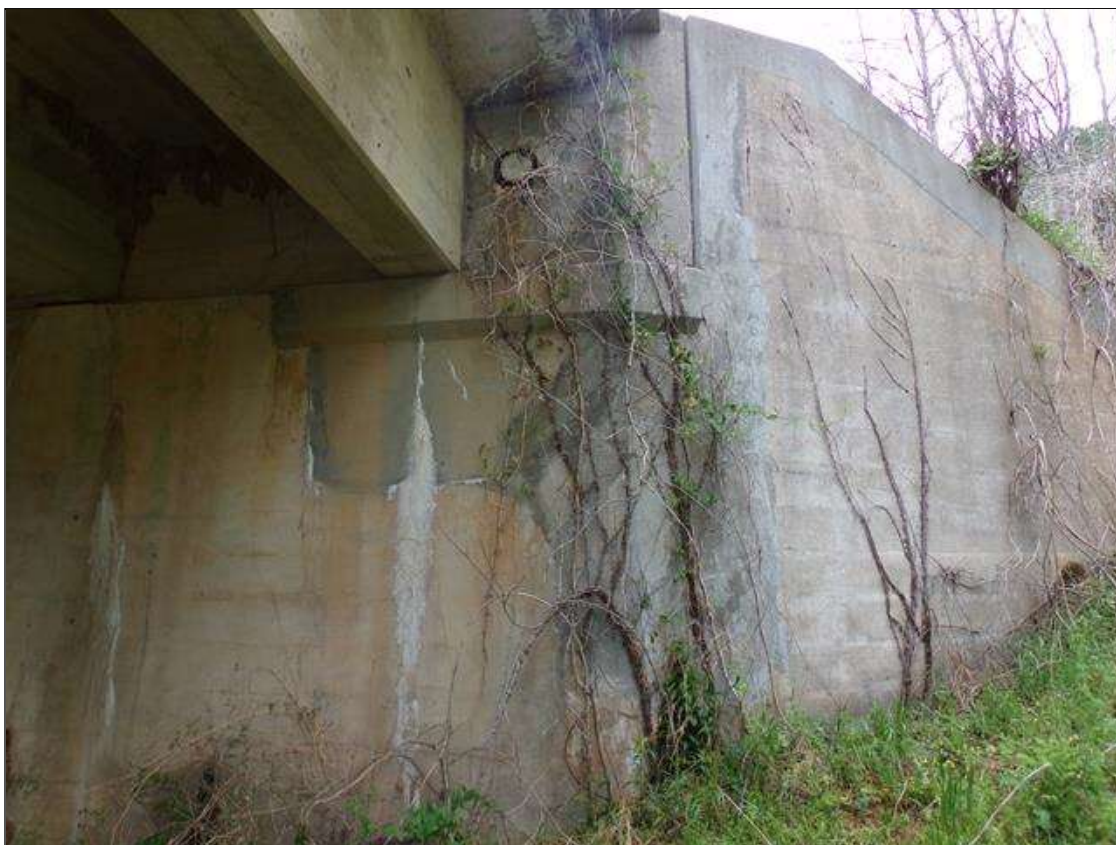
End Bent 2 Abutment/Backwall : 4' high x up to full height sound patched area starting under beam 5 that extends out to east side of beam 5.

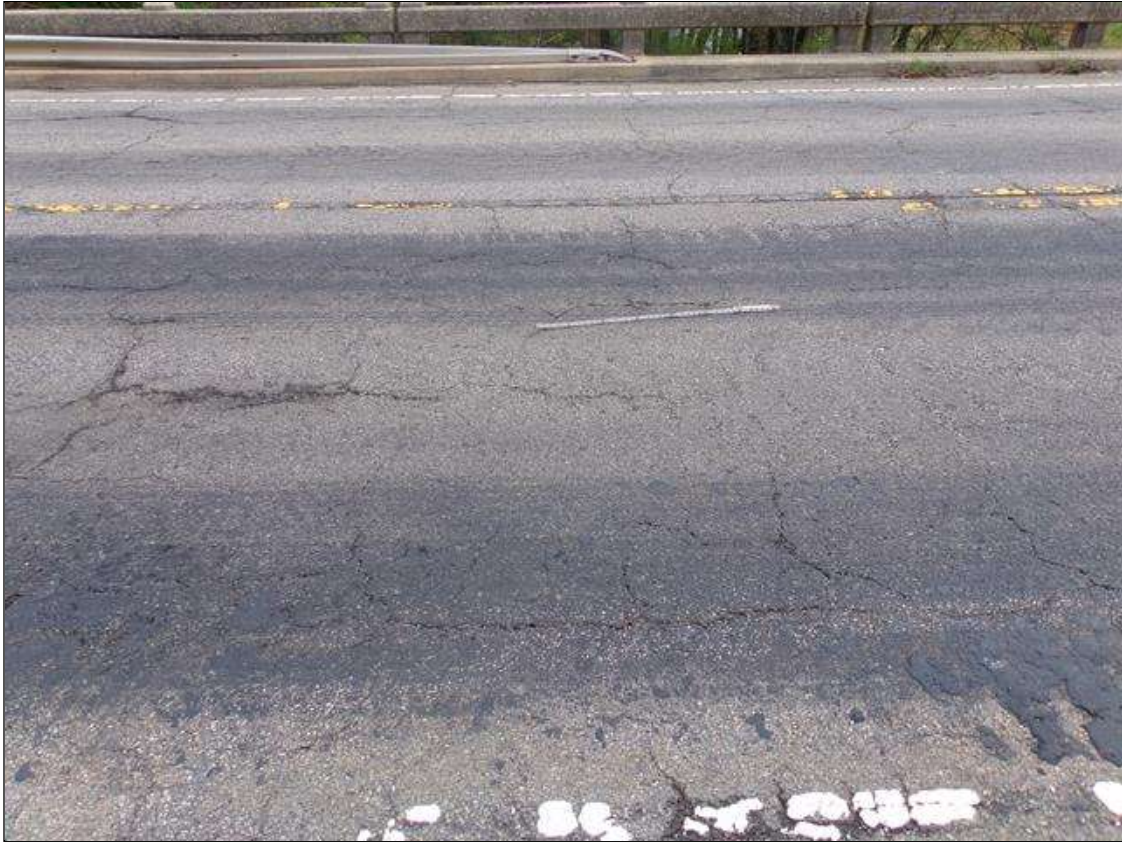
Span 10 Wearing Surface: Transverse/longitudinal/map cracking in AWS up to 1/2" wide throughout span both travel lanes.
