NC DEPARTMENT OF TRANSPORTATION
 DIVISION OF HIGHWAYS
 STRUCTURE MANAGEMENT UNIT

ATTENTION: **PRIORITY MAINTENANCE ISSUED; SNOOPER USED**

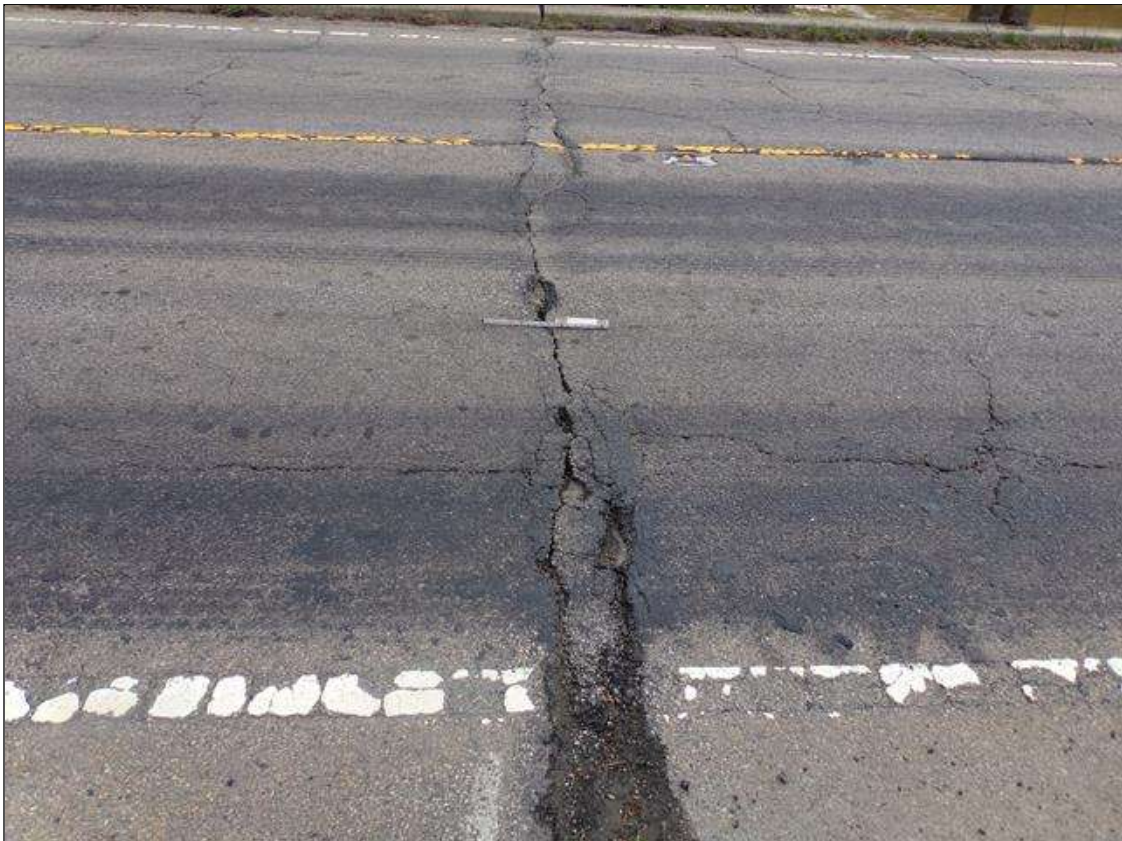
Span 10 Deck: Full width transverse cracks up to 1" wide with areas of potholes up to 6" long x 3" wide over pier 9.

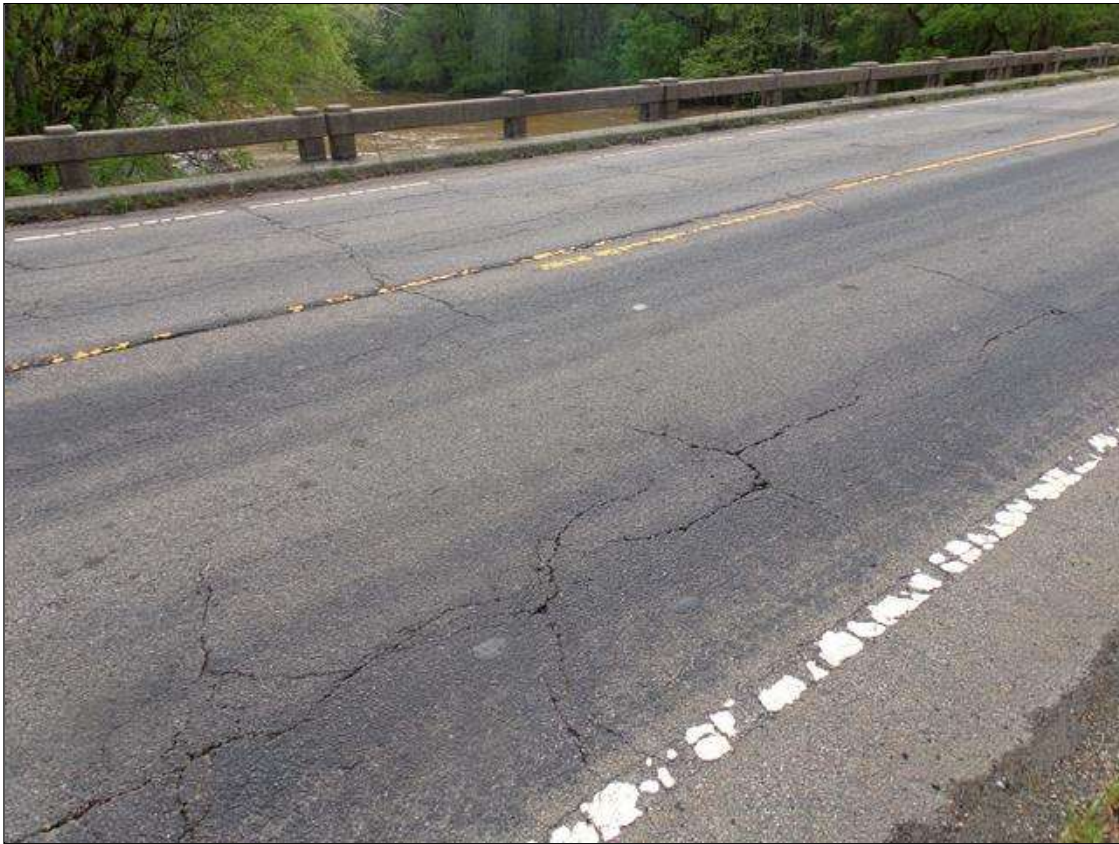
Typical transverse/longitudinal/map cracking in AWS up to 1/2" wide throughout span both travel lanes, span 9 shown

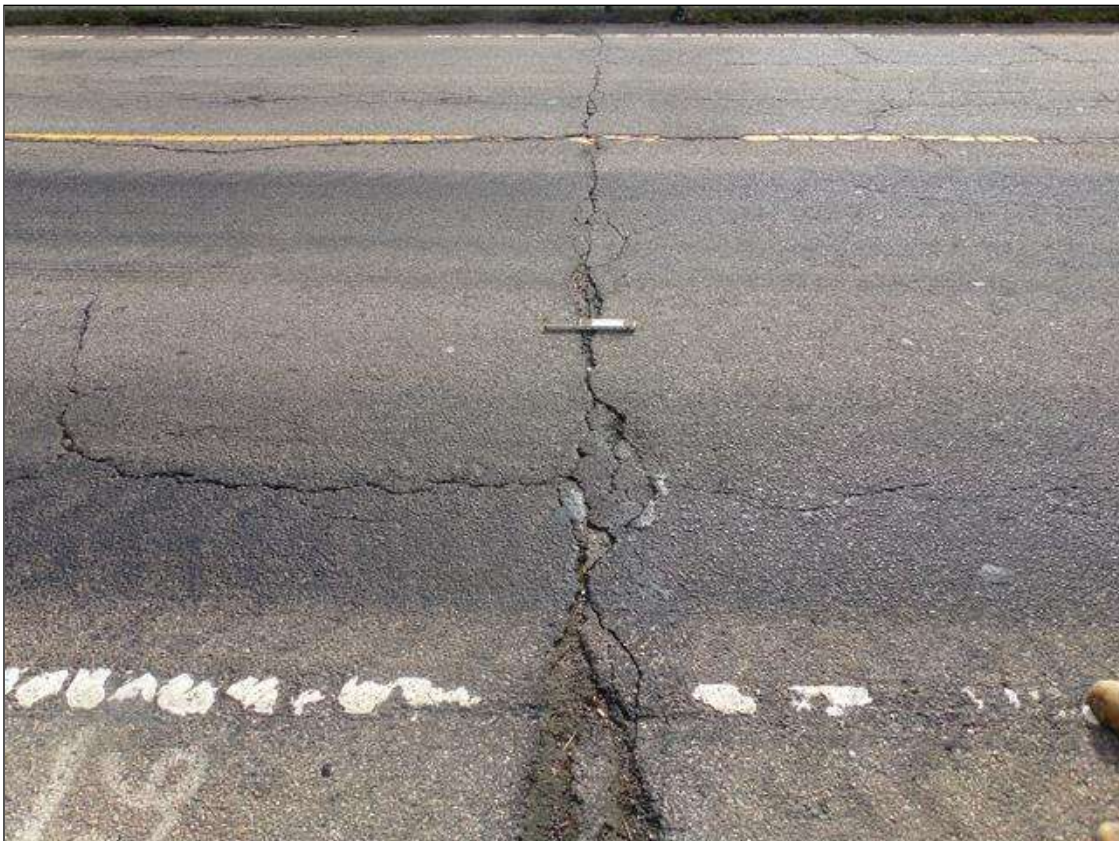
Span 9 Deck: Full width transverse cracks up to 1" wide with areas of potholes up to 1" long x 3" wide x 1/4" deep over pier 8.

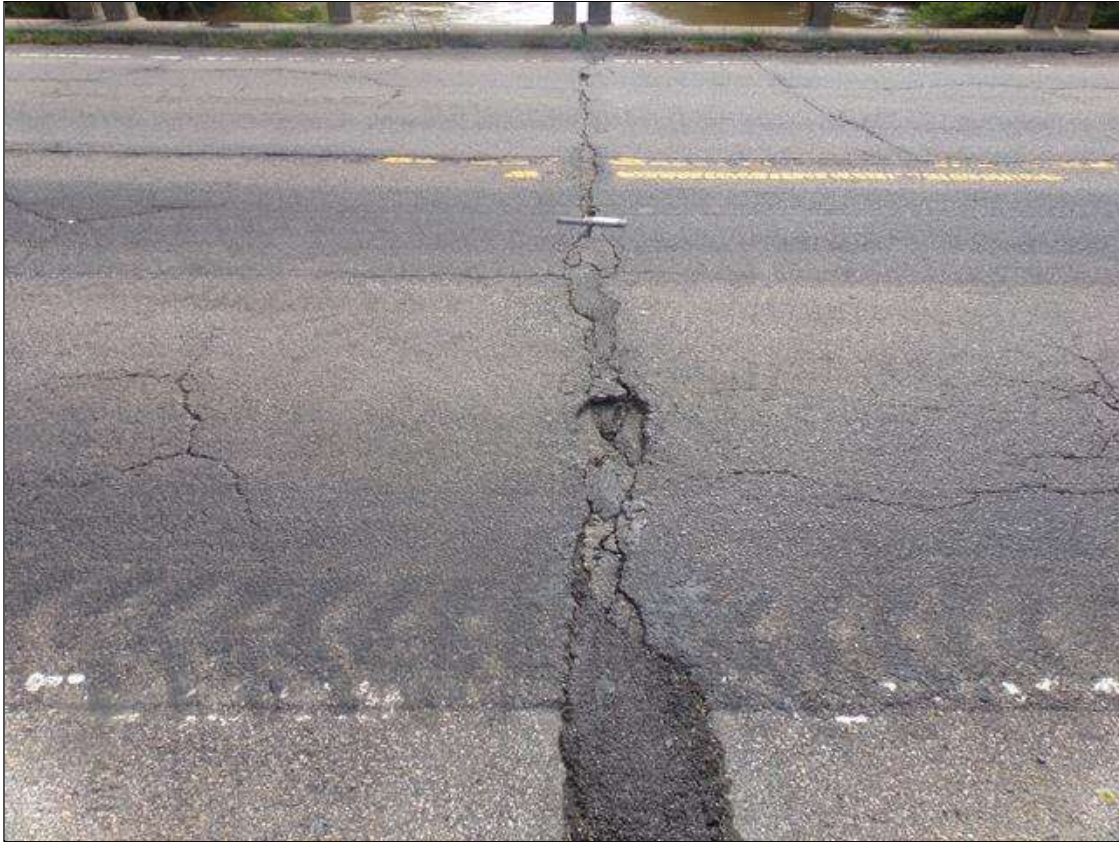
Span 8 Deck: Full width transverse cracks up to 2" wide with areas of potholes up to 3" long x 5" wide x 1" deep over pier 7.

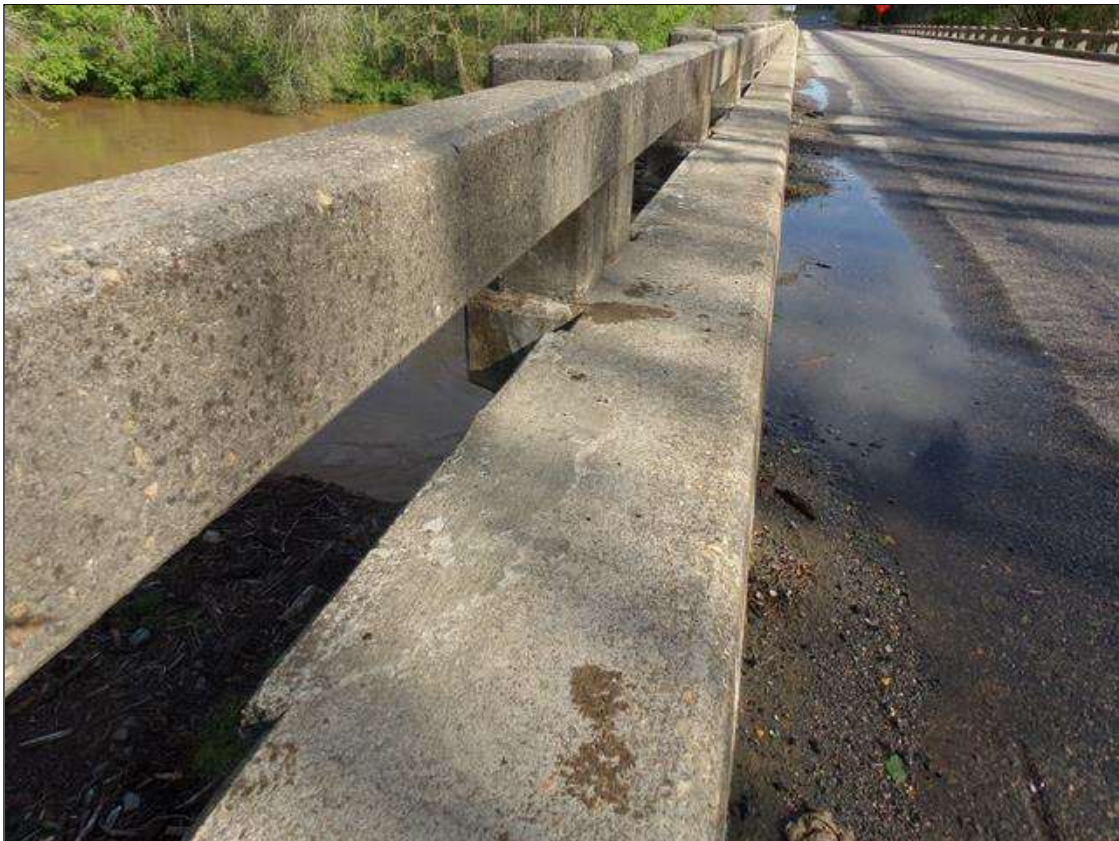
Span 4 Left Bridge Rail: Sound patched area on west face of curb between rail posts 5 and 6 and rail posts 7 and 8.

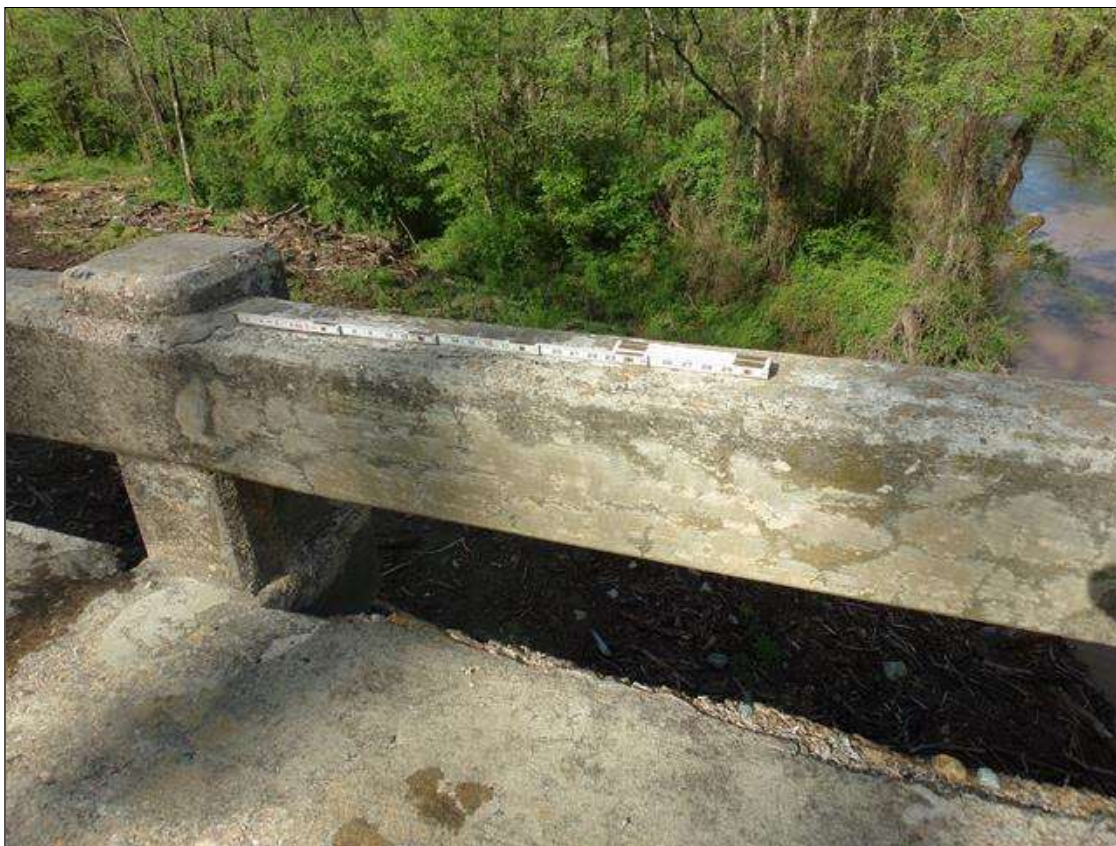
Span 4 Left Bridge Rail: 2' long x 1/8" wide crack in top of top rail at rail post 8.

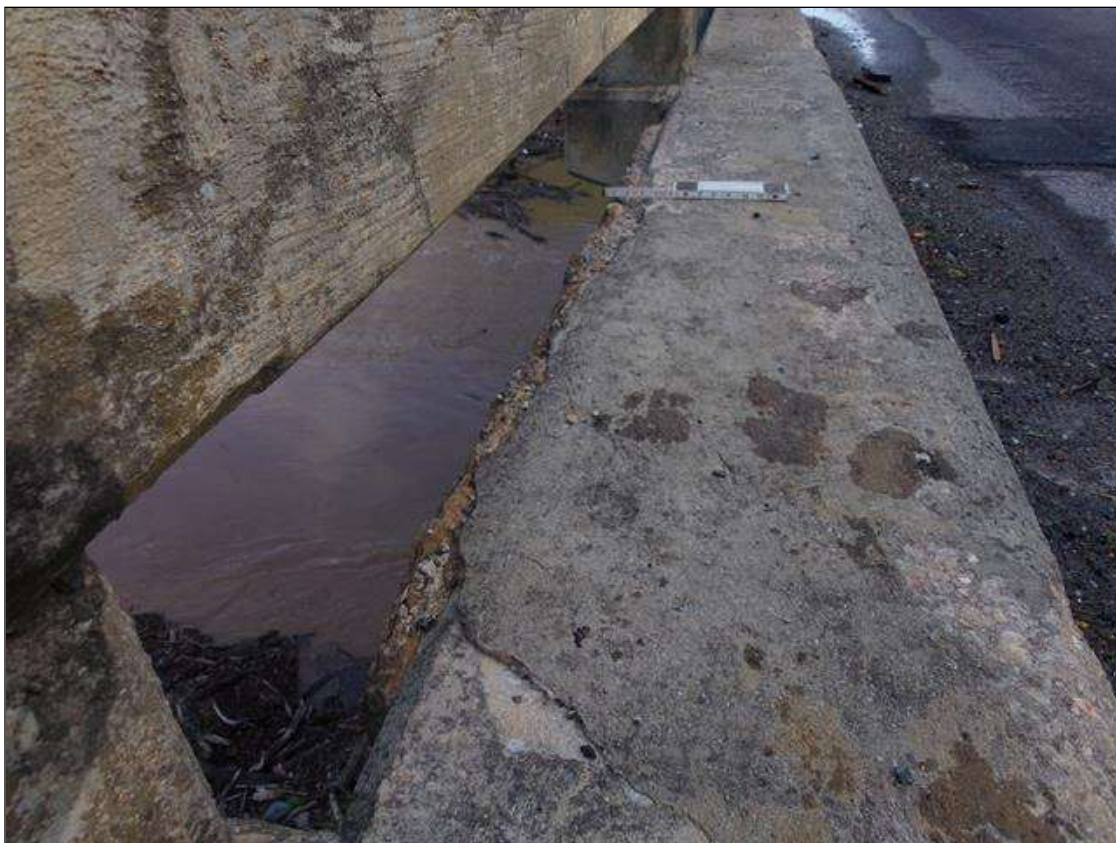
Span 4 Left Bridge Rail: unsound patched area on west face of curb between rail posts 8 and 9.

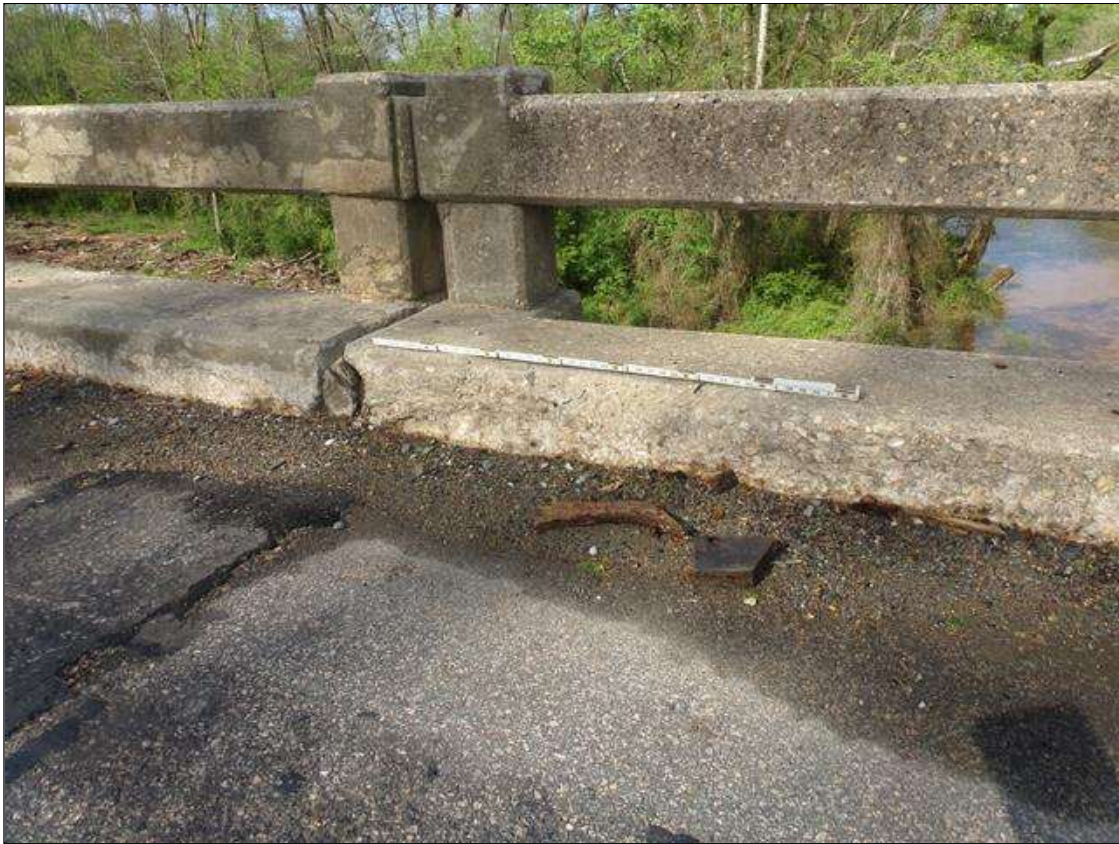
Span 5 Left Bridge Rail: 4' long x up to full height x up to 1" deep spalled area on front face of curb starting at pier 4

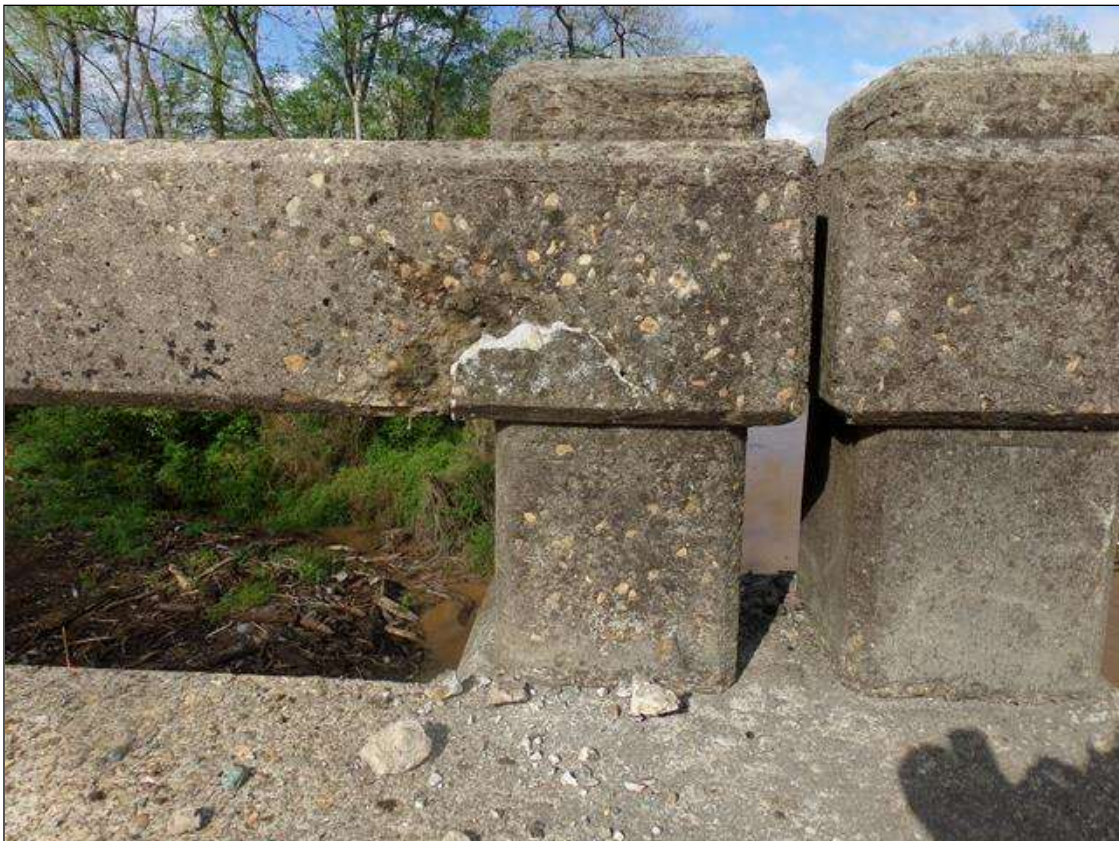
Span 5 Left Bridge Rail: Full height up to 1/16" crack with a 8" long x 4" high area of delamination/spall up to 3/4" deep in front face of post.

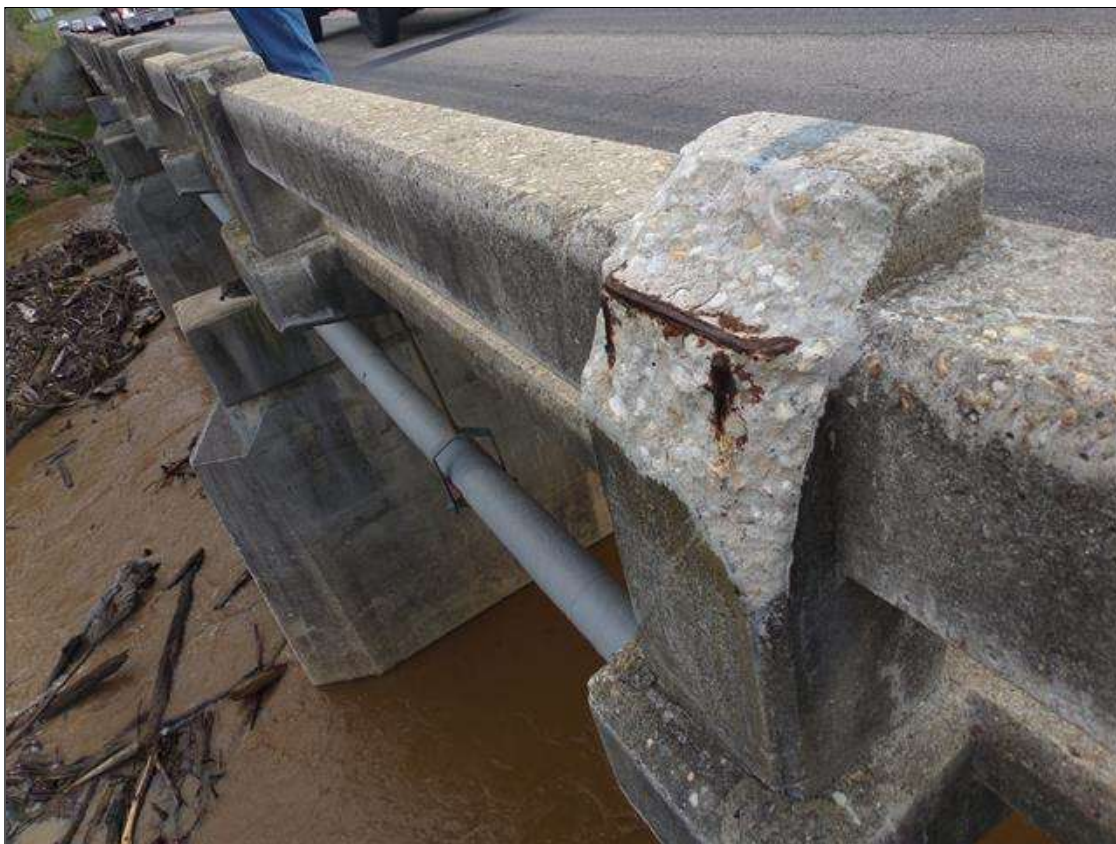
Span 6 Left Bridge Rail: 1' high x full width x 2" deep spall with exposed rebar with no measurable section loss in top of rail post 5 west face

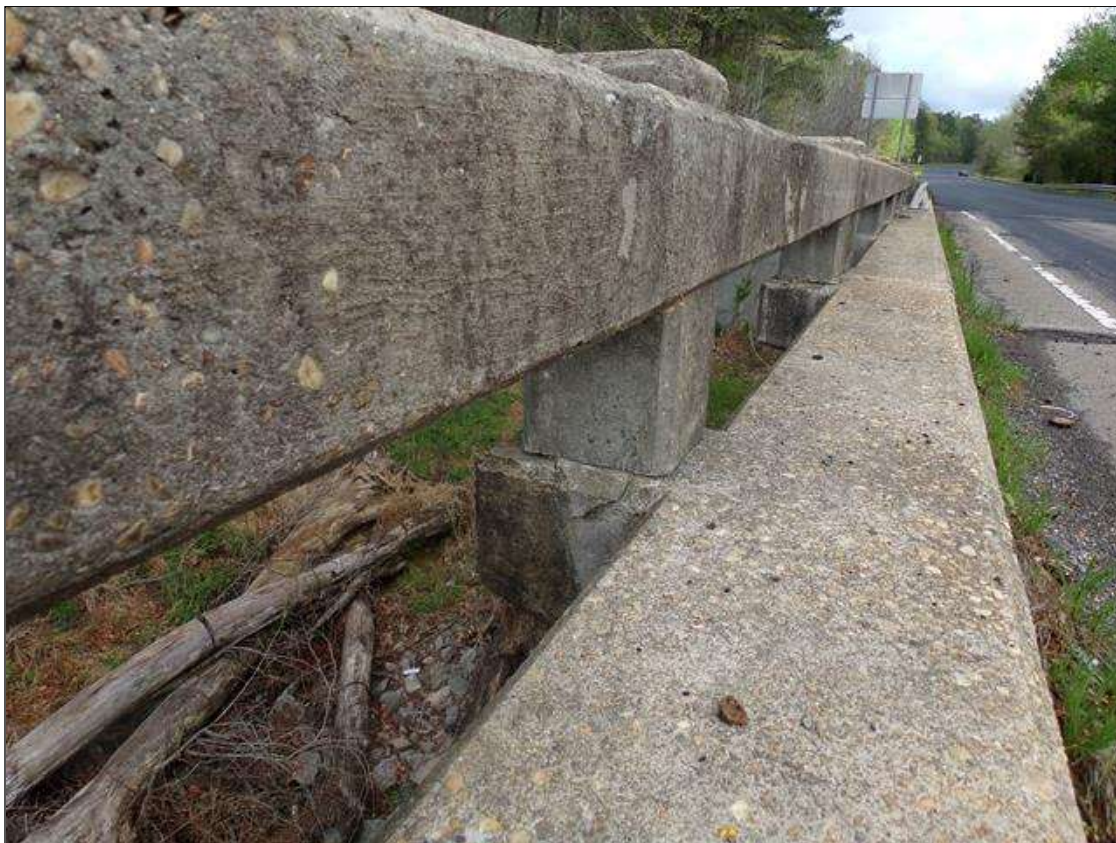
Span 9 Left Bridge Rail: Sound patched area on bottom west face of rail posts 8 and 9.

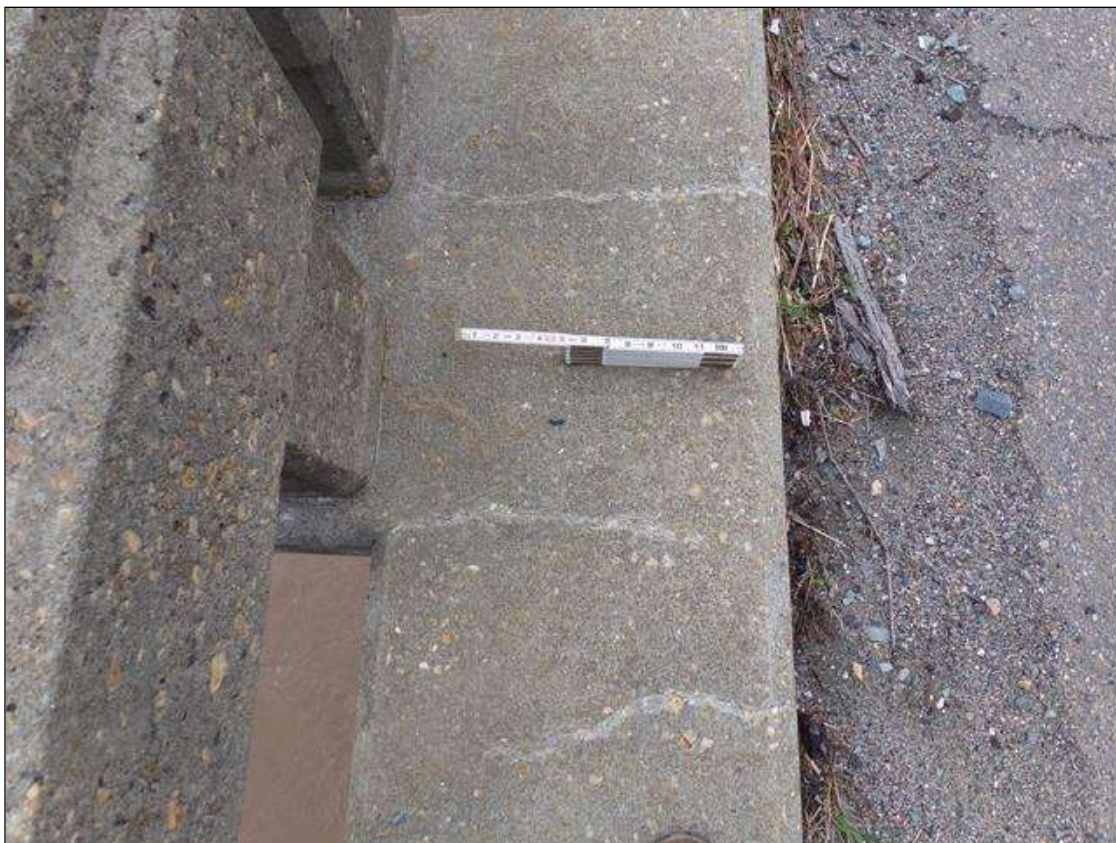
Typical full/partial width transverse cracks in top of curb at various locations right rail only all spans, span 8 shown.

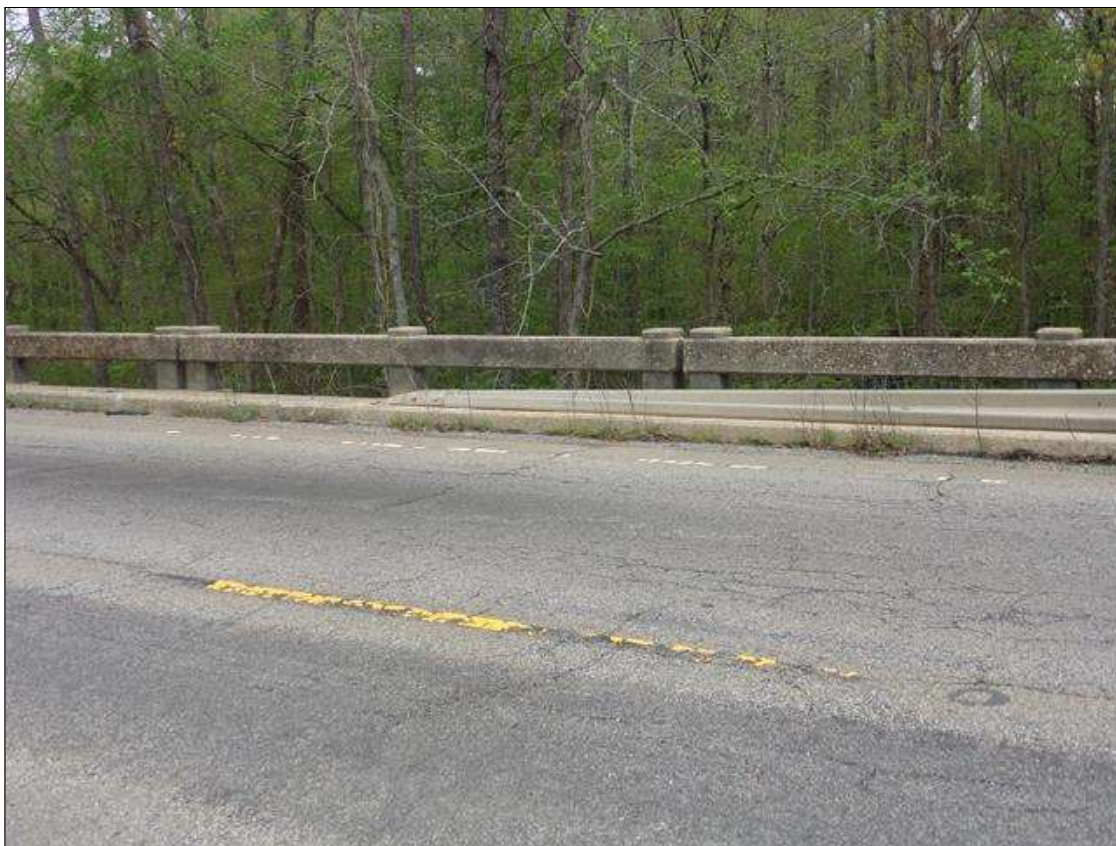
Sand and vegetation accumulation along both curbs blocking drain holes, right curb span 1 shown.

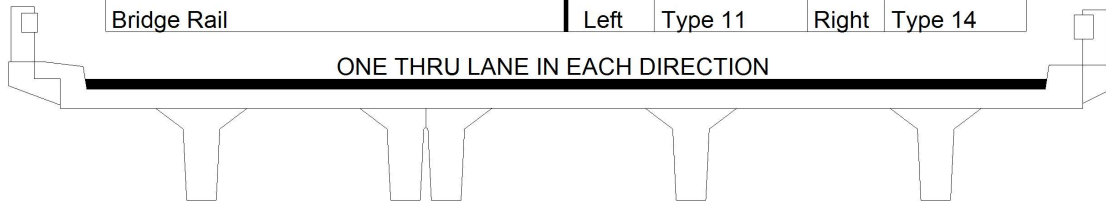
Measurements for Spans	1 thru 10		
Deck Thickness	0.563	Left Overhang	3.75
Top of Rail to Bottom of Beam	7.833	Right Overhang	3.75

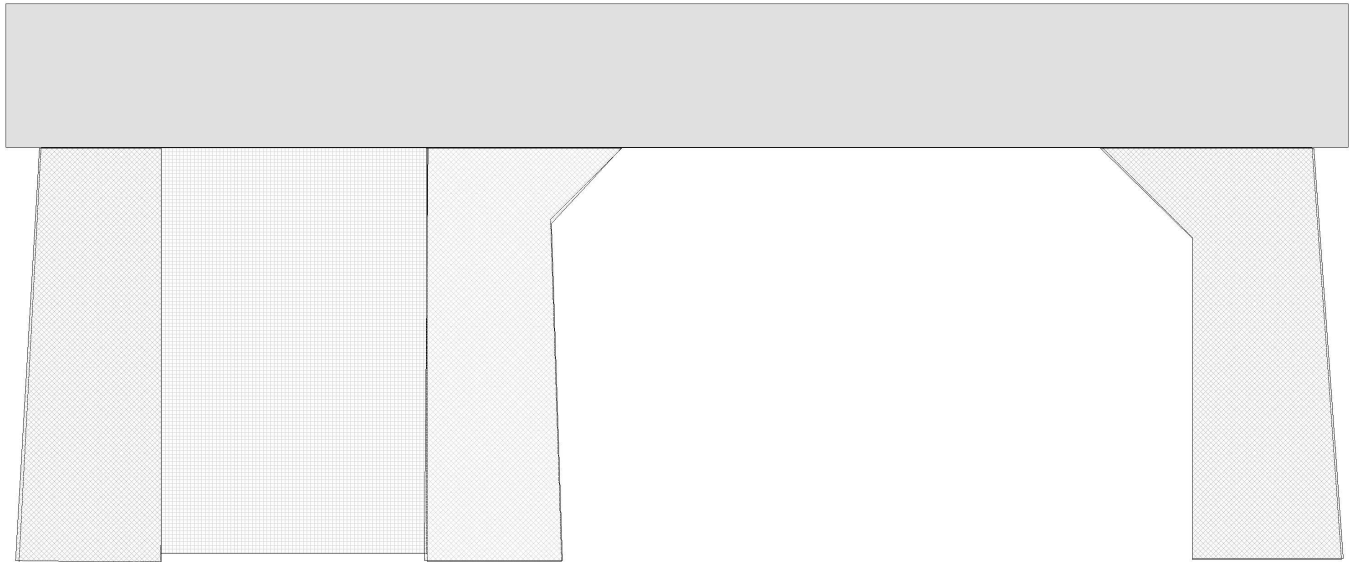
Cap Information			Material Cast-in-Place Concrete							
Length	Width	Height	Left Overhang	Right Overhang	Left Beam to End of Cap.	Right Beam to End of Cap.				
27.0 ft.	3.0 ft.	3.25 ft.	1.5 ft.	1.5 ft.	1.5 ft.	1.5 ft.				
Subcap Information			Material							
Length	Width	Height	Left Overhang	Right Overhang	Left Pile to Splice.					
Sill Information			Material							
Length	Width	Height								
Pile #	Material	Spacing	Width/Dia.	Height	Length	Orientation	Driven?	Replacement?	Removed?	Collar?
1	Concrete	8 ft.	2.5 ft.	2.5 ft.		Vertical	No	No	No	No
2	Concrete	16 ft.	2.5 ft.	2.5 ft.		Vertical	No	No	No	No
3	Concrete		2.5 ft.	2.5 ft.		Vertical	No	No	No	No
Bent: 1			Similar Bents: 2 and 3

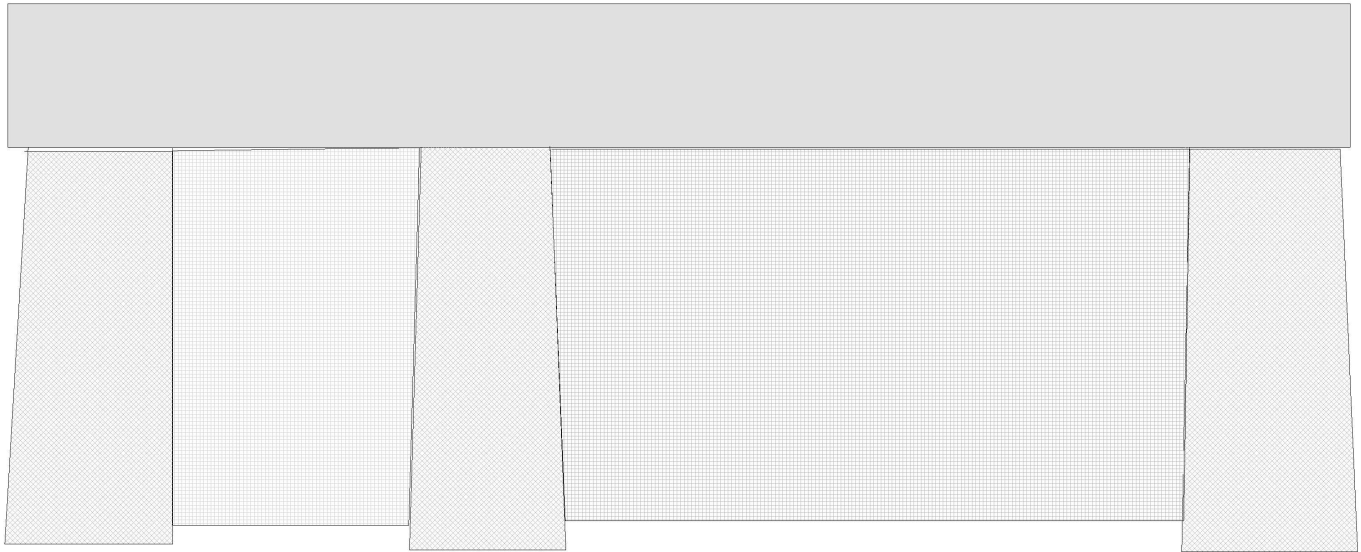
Cap Information			Material Cast-in-Place Concrete							
Length	Width	Height	Left Overhang	Right Overhang	Left Beam to End of Cap.	Right Beam to End of Cap.				
27.0 ft.	3.0 ft.	3.25 ft.	1.5 ft.	1.5 ft.	1.5 ft.	1.5 ft.				
Subcap Information			Material							
Length	Width	Height	Left Overhang	Right Overhang	Left Pile to Splice.					
Sill Information			Material							
Length	Width	Height								
Pile #	Material	Spacing	Width/Dia.	Height	Length	Orientation	Driven?	Replacement?	Removed?	Collar?
1	Concrete	8 ft.	2.5 ft.	2.5 ft.		Vertical	No	No	No	No
2	Concrete	16 ft.	2.5 ft.	2.5 ft.		Vertical	No	No	No	No
3	Concrete		2.5 ft.	2.5 ft.		Vertical	No	No	No	No
Bent: 4			Similar Bent: 9

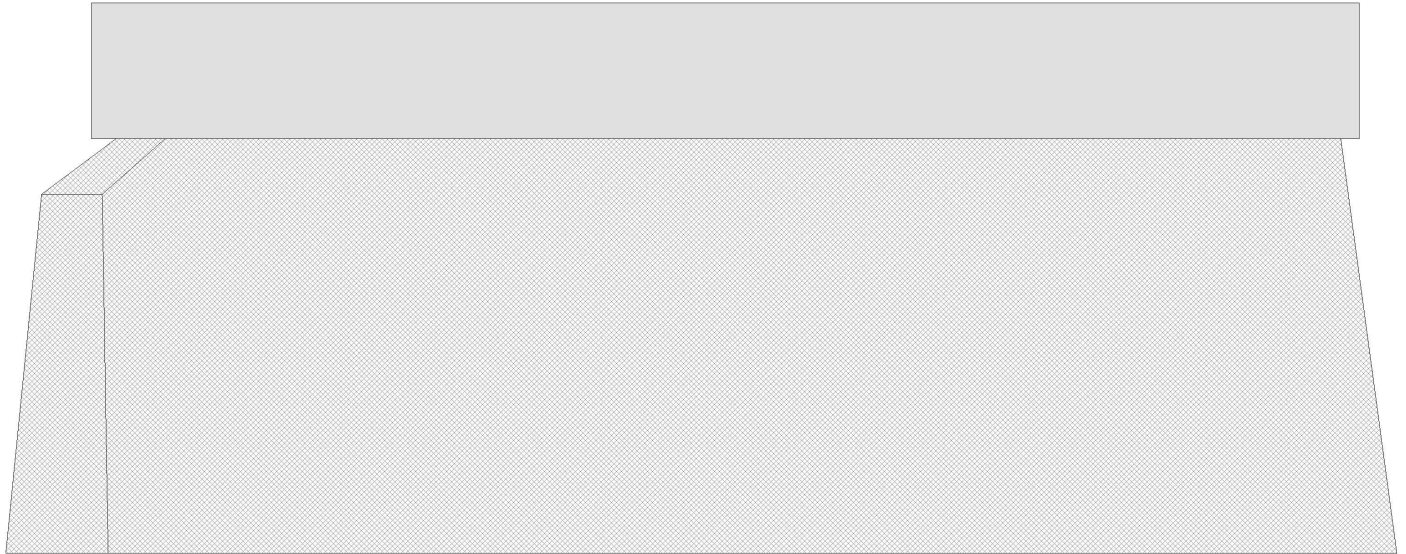
Cap Information			Material Cast-in-Place Concrete							
Length	Width	Height	Left Overhang	Right Overhang	Left Beam to End of Cap.	Right Beam to End of Cap.				
31.67 ft.	3.0 ft.	3.0 ft.	N/A	N/A	6.25 ft.	1.5 ft.				
Subcap Information			Material							
Length	Width	Height	Left Overhang	Right Overhang	Left Pile to Splice.					
Sill Information			Material							
Length	Width	Height								
Pile #	Material	Spacing	Width/Dia.	Height	Length	Orientation	Driven?	Replacement?	Removed?	Collar?
1	Concrete		33.67 ft.	3 ft.		Vertical	No	No	No	No
Bent: 5			Similar Bents: 6 thru 8
