NC DEPARTMENT OF TRANSPORTATION
 DIVISION OF HIGHWAYS
 STRUCTURE MANAGEMENT UNIT

ATTENTION:

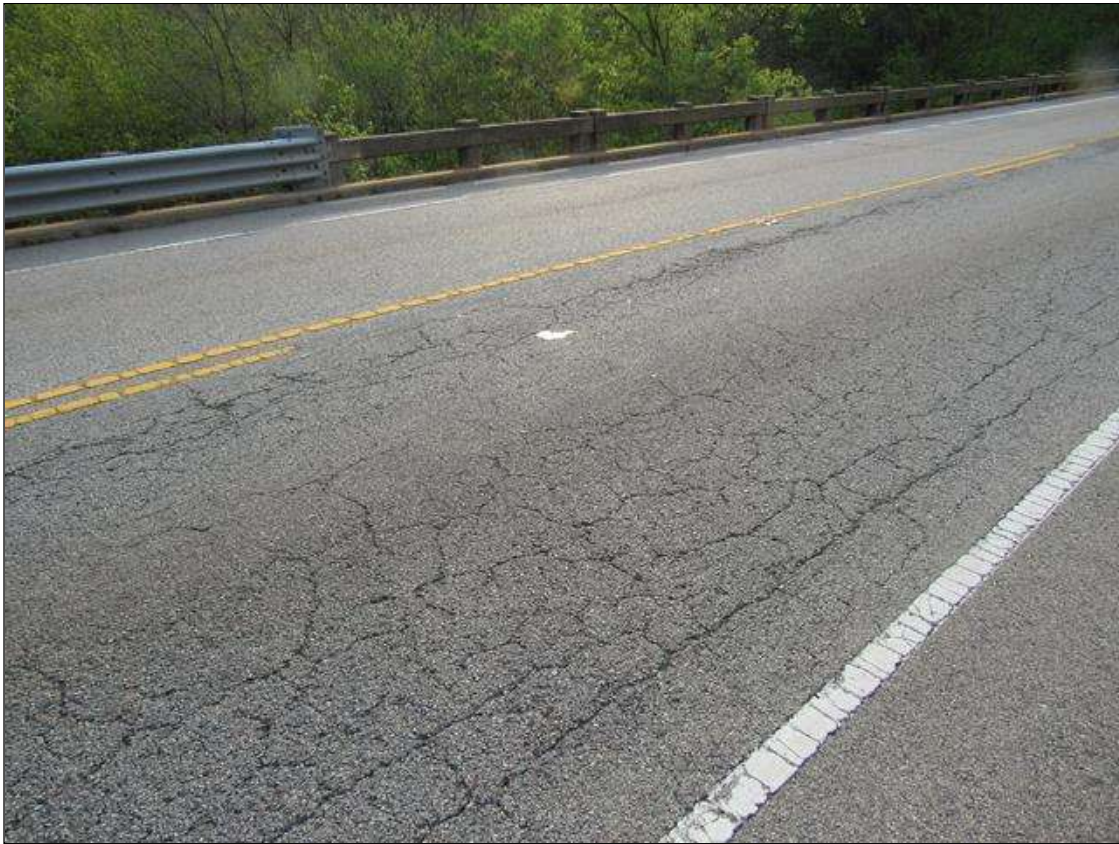
Span 1 Wearing Surface: 1615 Square Feet of Crack (Wearing Surface): Width 0.012-0.05 in. or spacing of 1.0-3.0 ft.
SPAN 1 WEARING SURFACE IS HEAVILY MAP CRACKED.

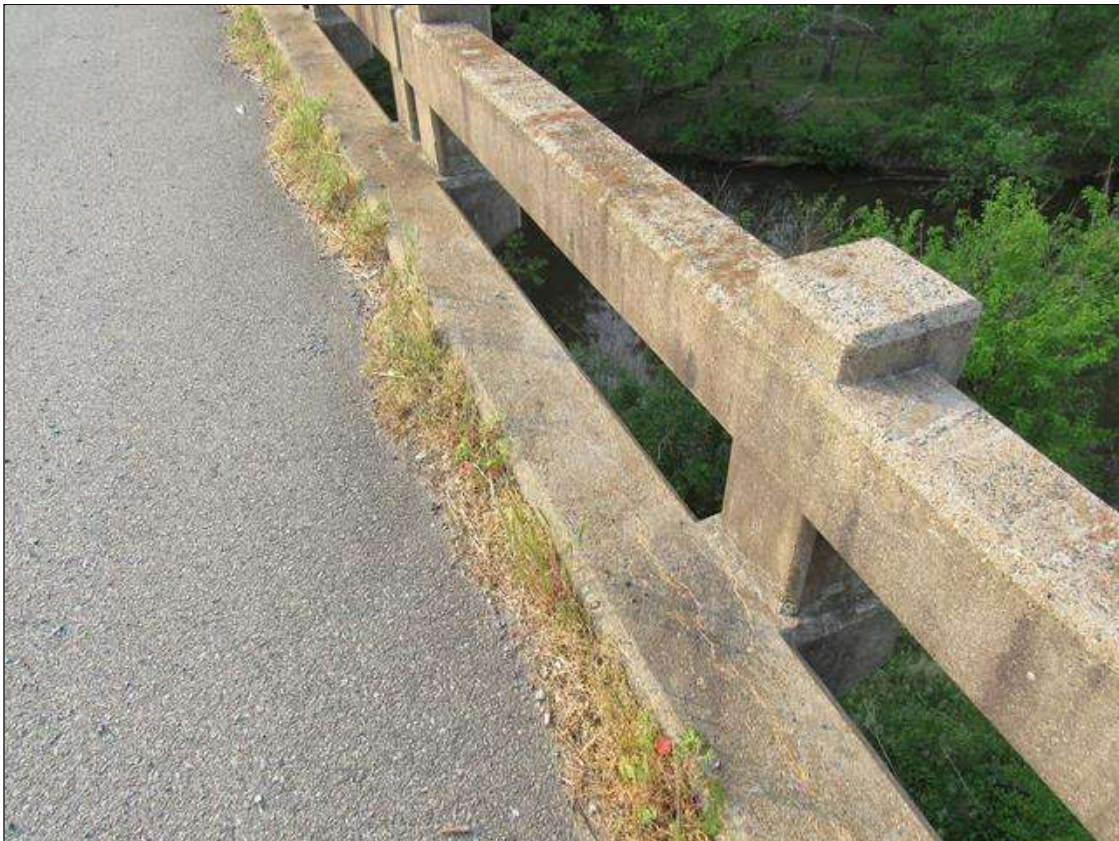
Span 1 Right Bridge Rail: 15 Feet of Cracking (RC and Other): Width 0.012-0.05 in. or spacing of 1.0-3.0 ft.
SPAN 1 RIGHT RAIL AND CURB CRACKING WITH SURFACE SCALE.

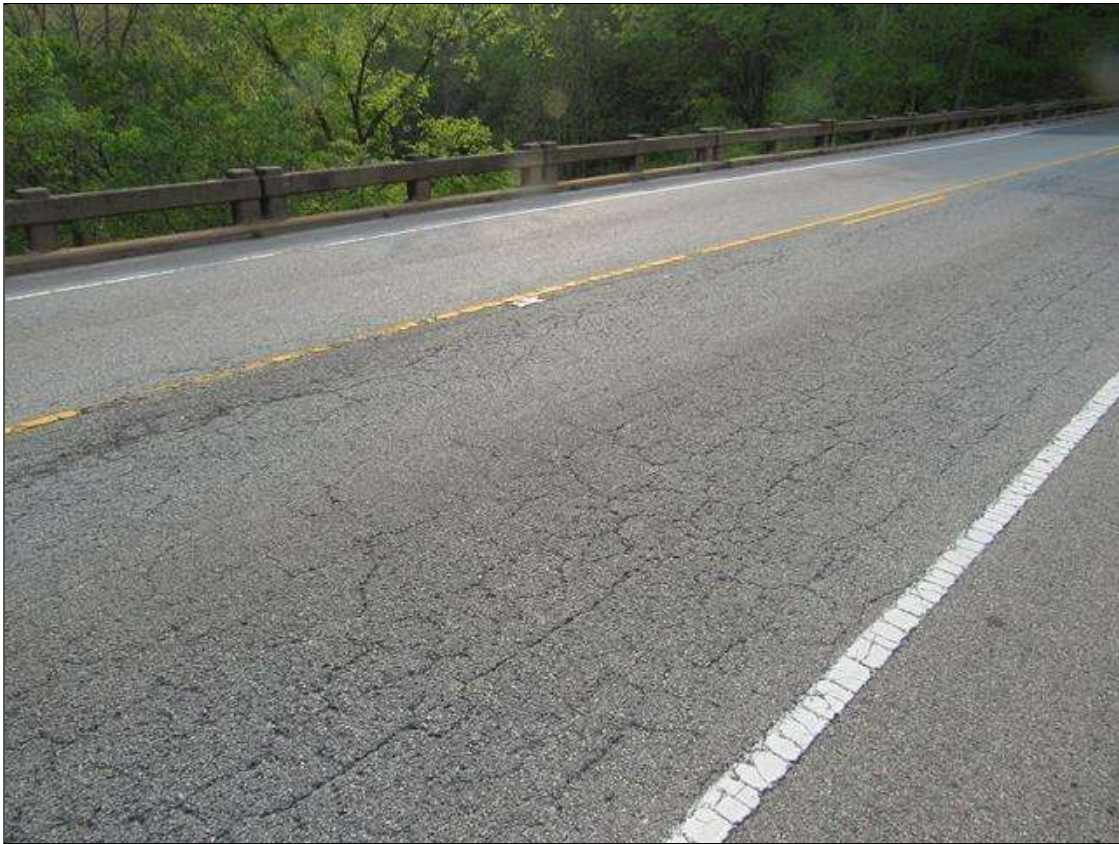
Span 2 Wearing Surface: 1615 Square Feet of Crack (Wearing Surface): Width 0.012-0.05 in. or spacing of 1.0-3.0 ft.
SPAN 2 WEARING SURFACE HEAVILY MAP CRACKED BOTH LEFT AND RIGHT LANES.

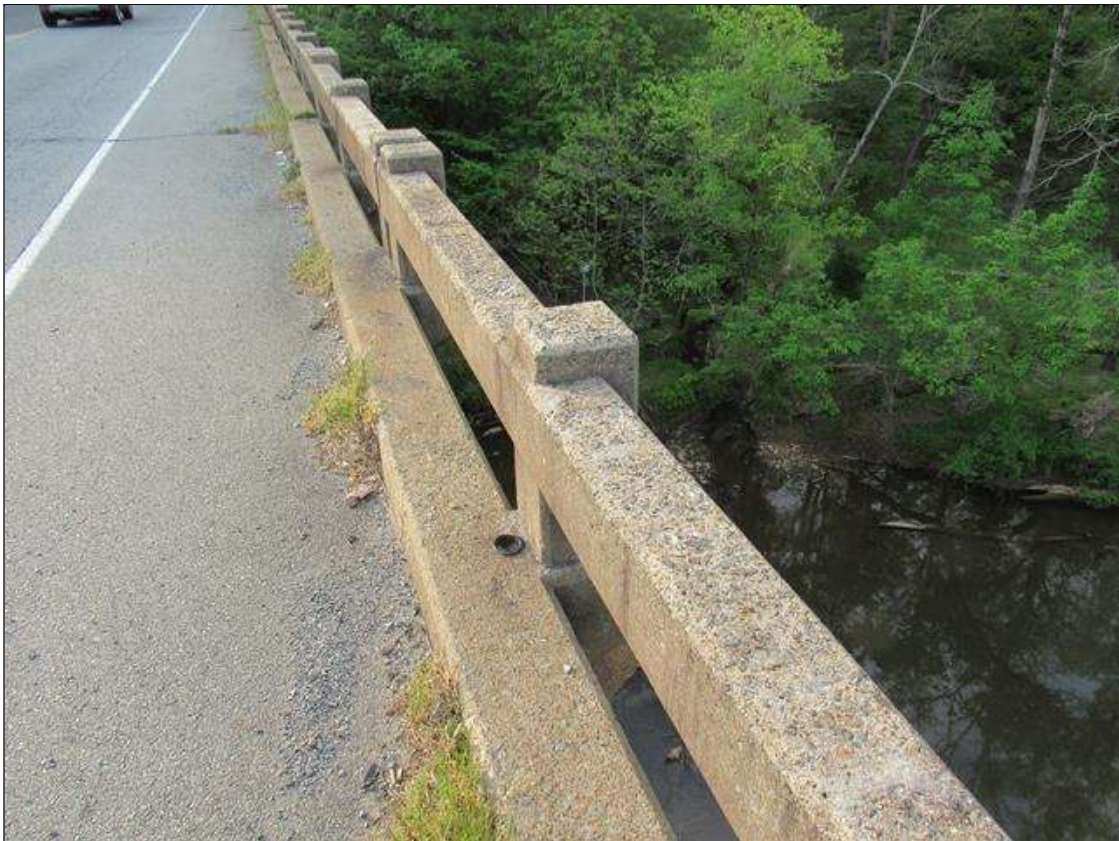
Span 2 Right Bridge Rail: 30 Feet of Cracking (RC and Other): Width 0.012-0.05 in. or spacing of 1.0-3.0 ft.
SPAN 2 RIGHT RAIL HAS MAP CRACKING AND SURFACE SCALE TOP OF RAIL AND CURB.

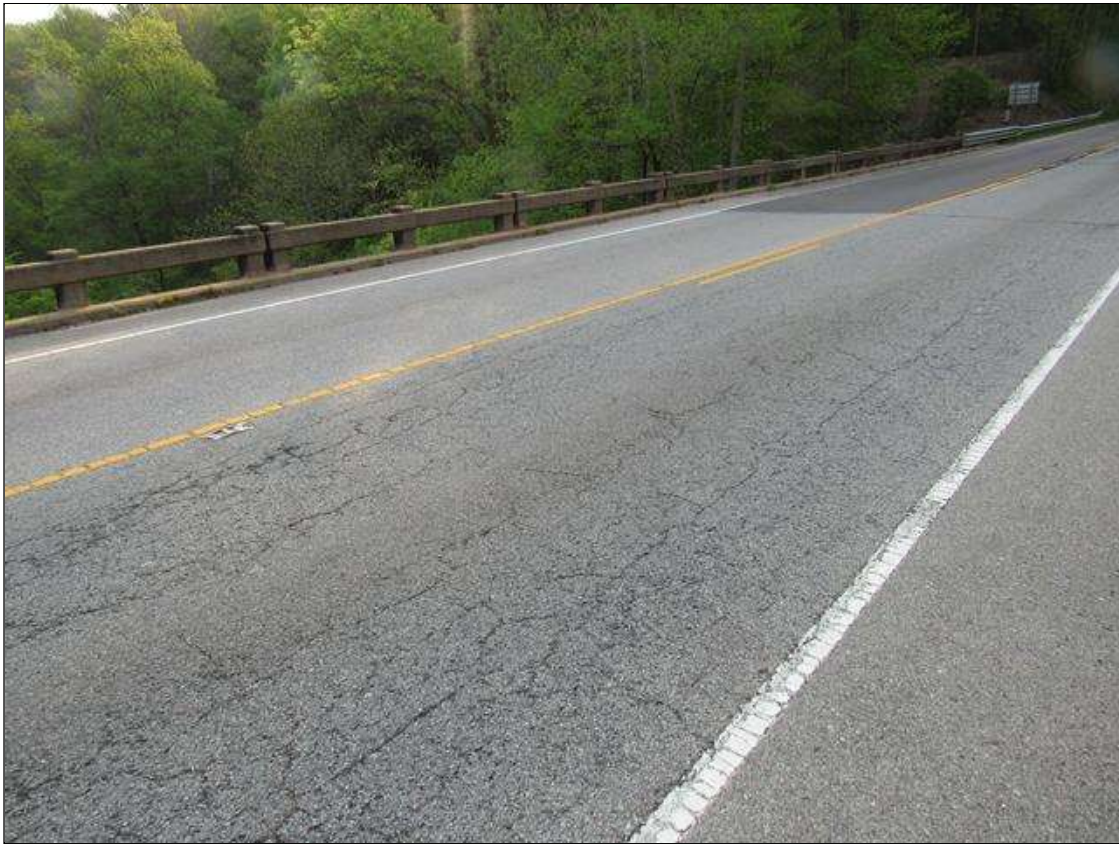
Span 3 Wearing Surface: 1615 Square Feet of Crack (Wearing Surface): Width 0.012-0.05 in. or spacing of 1.0-3.0 ft.
SPAN 3 WEARING SURFACE IS HEAVILY MAP CRACKED IN BOTH LEFT AND RIGHT LANES.

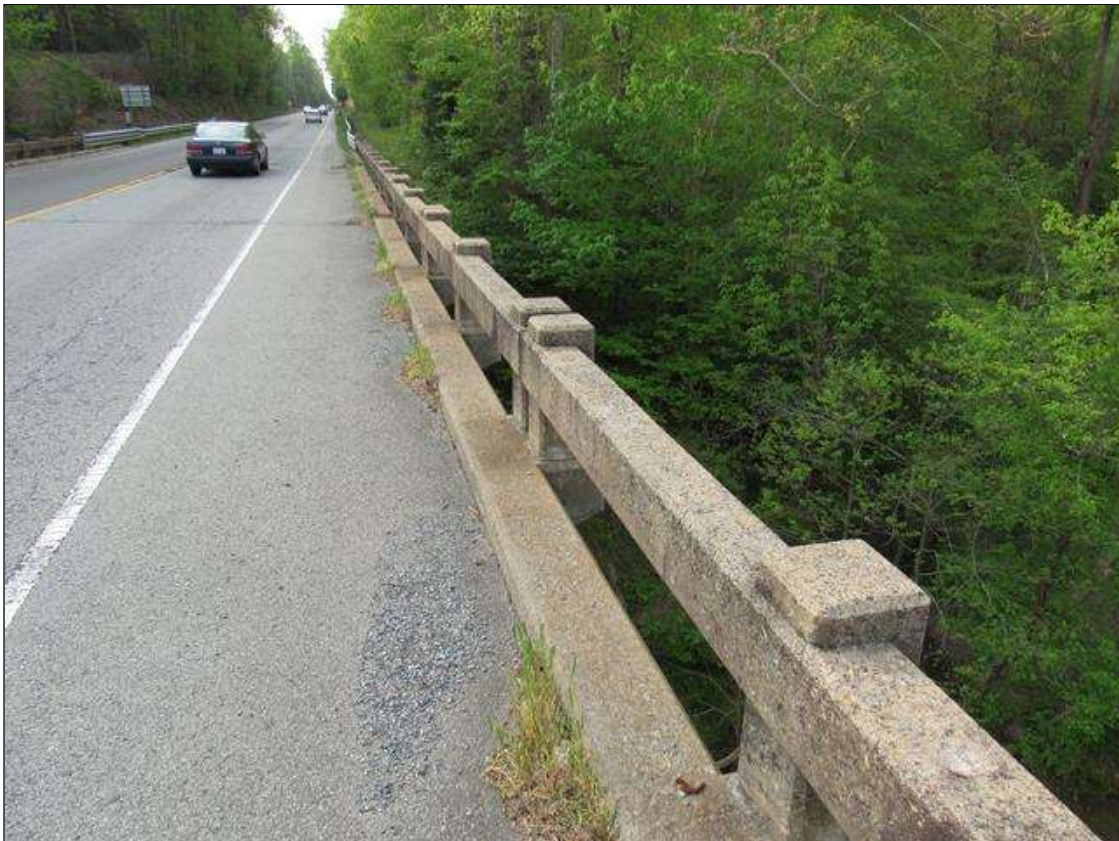
Span 3 Right Bridge Rail: 25 Feet of Cracking (RC and Other): Width 0.012-0.05 in. or spacing of 1.0-3.0 ft.
SPAN 3 RIGHT RAIL TOP AND CURB SURFACE SCALING AND MAP CRACKING.

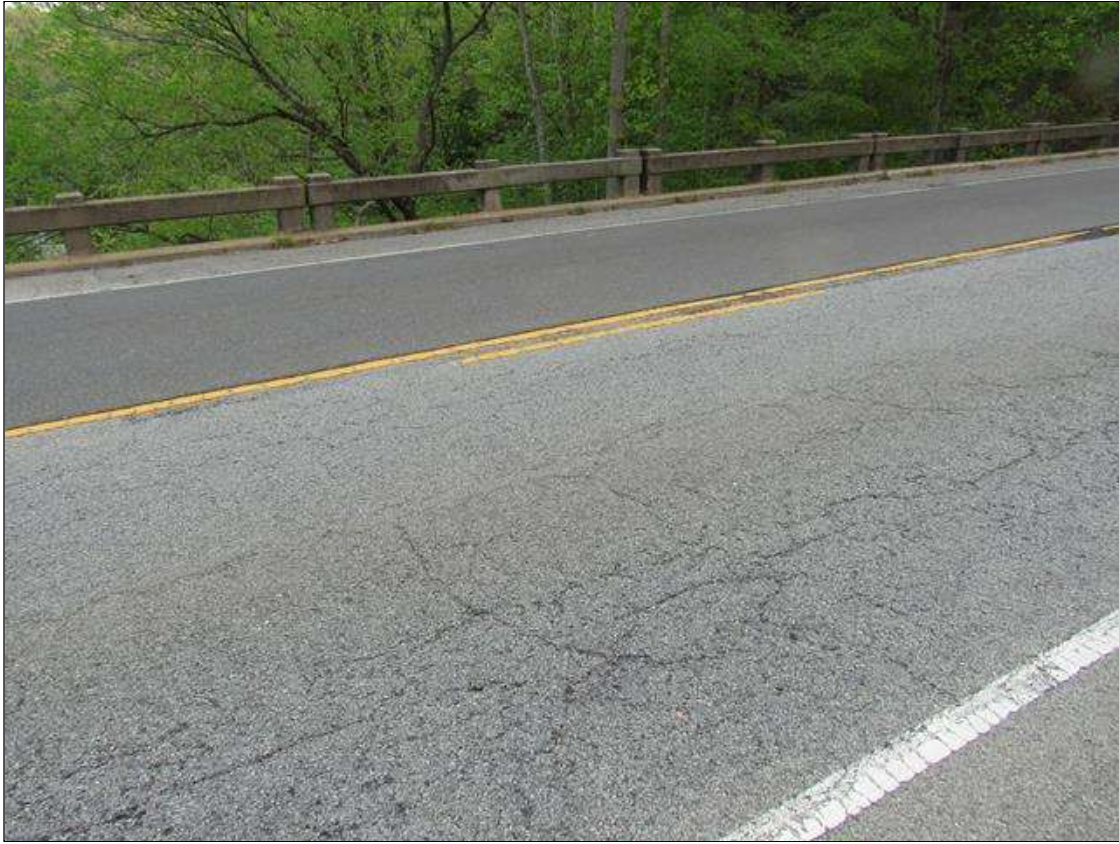
Span 4 Wearing Surface: 1615 Square Feet of Crack (Wearing Surface): Width 0.012-0.05 in. or spacing of 1.0-3.0 ft.
SPAN 4 WEARING SURFACE IS HEAVILY MAP CRACKED LEFT AND RIGHT LANE.

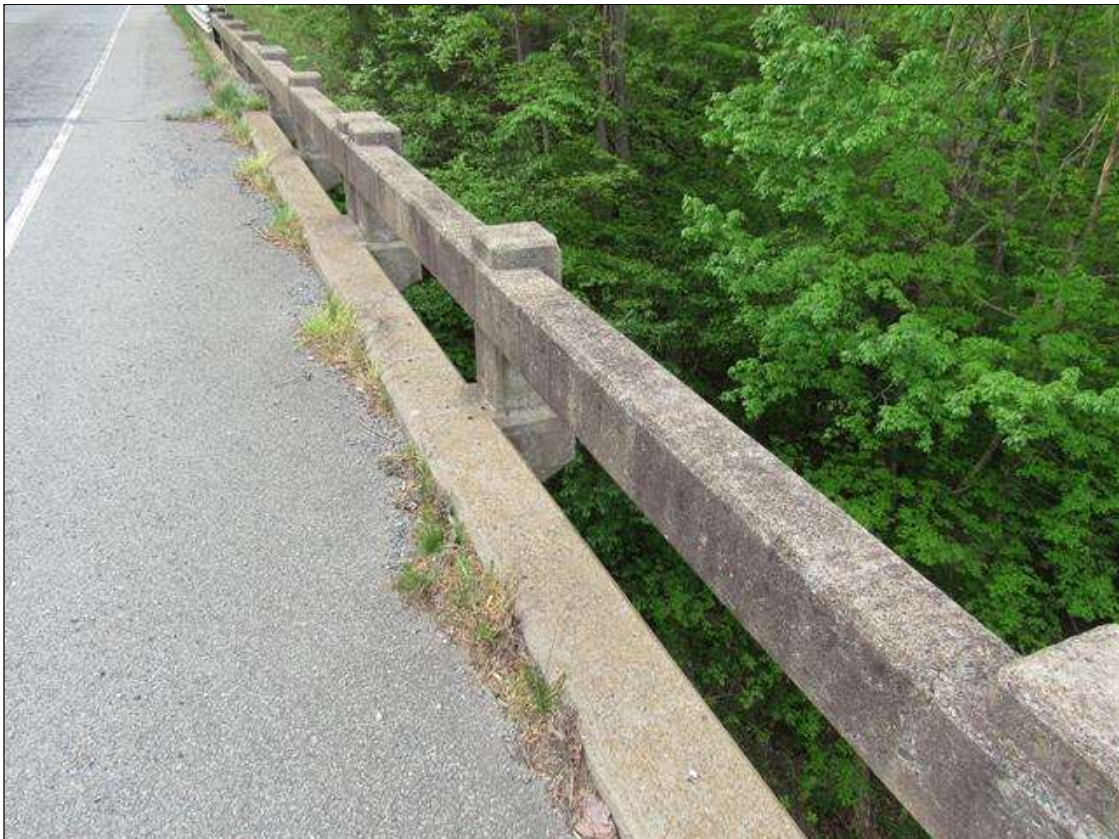
Span 4 Right Bridge Rail: 25 Feet of Cracking (RC and Other): Width 0.012-0.05 in. or spacing of 1.0-3.0 ft.
SPAN 4 RIGHT RAIL FINE MAP CRACKING AND SURFACE SCALE ON TOP OF RAIL.

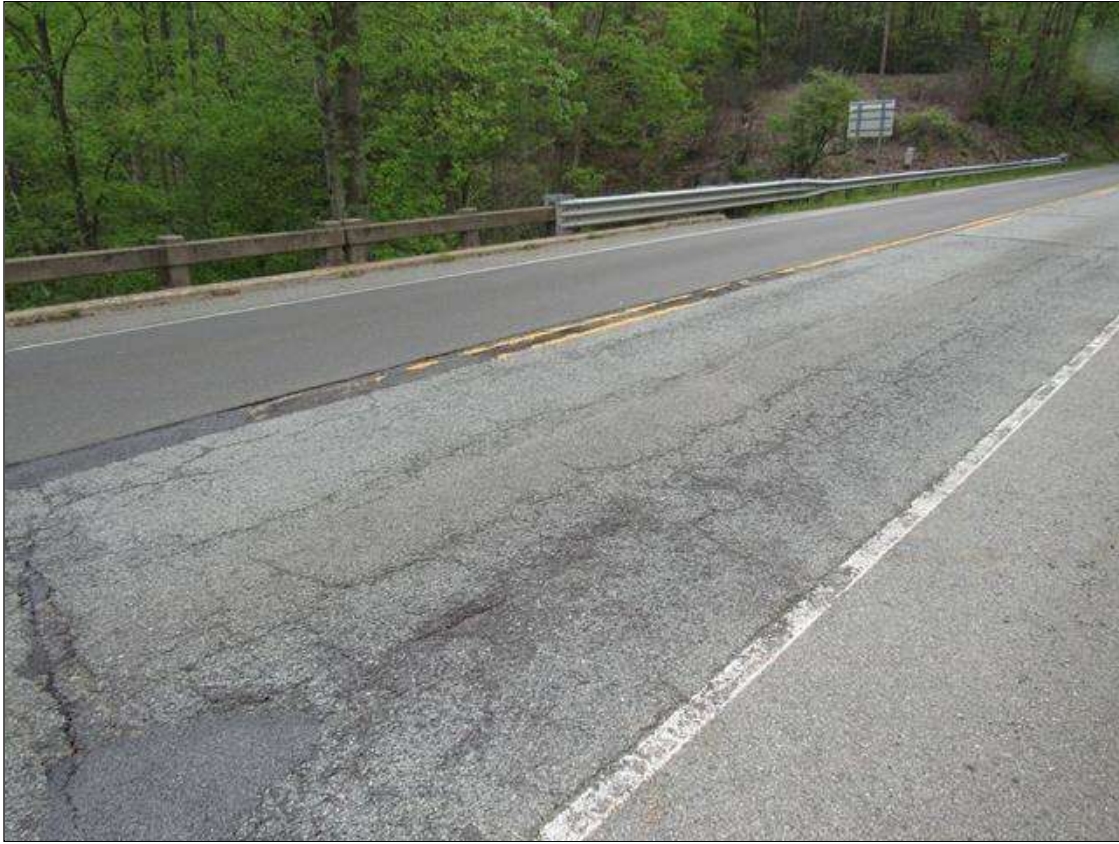
Span 5 Wearing Surface: 1615 Square Feet of Crack (Wearing Surface): Width 0.012-0.05 in. or spacing of 1.0-3.0 ft.
SPAN 5 WEARING SURFACE HEAVILY MAP CRACKED ON TOP.

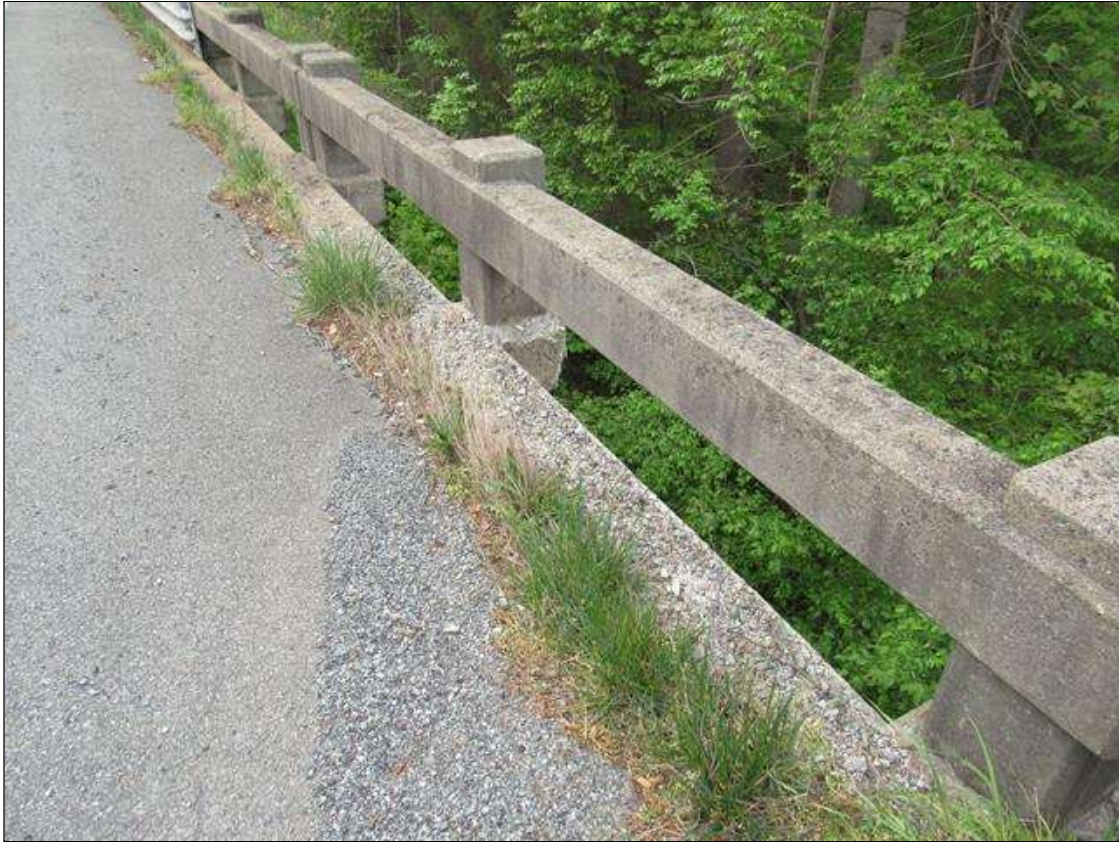
Span 5 Right Bridge Rail: 12 Feet of Delamination/Spall/Patched Area: Spall greater than 1 in. deep or greater than 6 in. diameter. Patched area that is unsound or showing distress. Does not warrant structural review.
SPAN 5 RIGHT RAIL POST 2 IS SPALL AND DETERIORATING AND RIGHT CURB CONCRETE IS DETERIORATING FORM JOINT AT BENT 4 OUT TO RAIL POST 3.

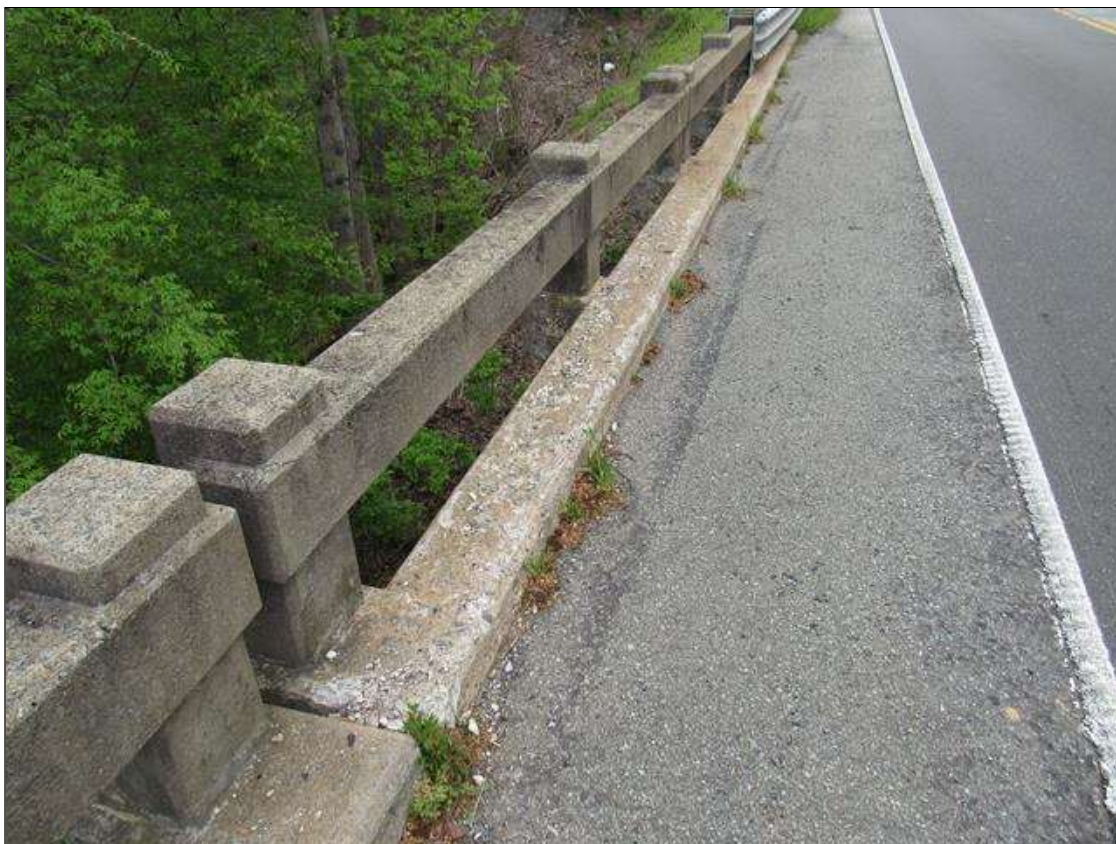
Span 5 Left Bridge Rail: 48 Feet of Cracking (RC and Other): Width greater than 0.05 in. or spacing of less than 1 ft.
SPAN 5 LEFT RAIL MAP CRACKING AND SURFACE DETERIORATION FROM BENT 4 TO END OF BRIDGE.

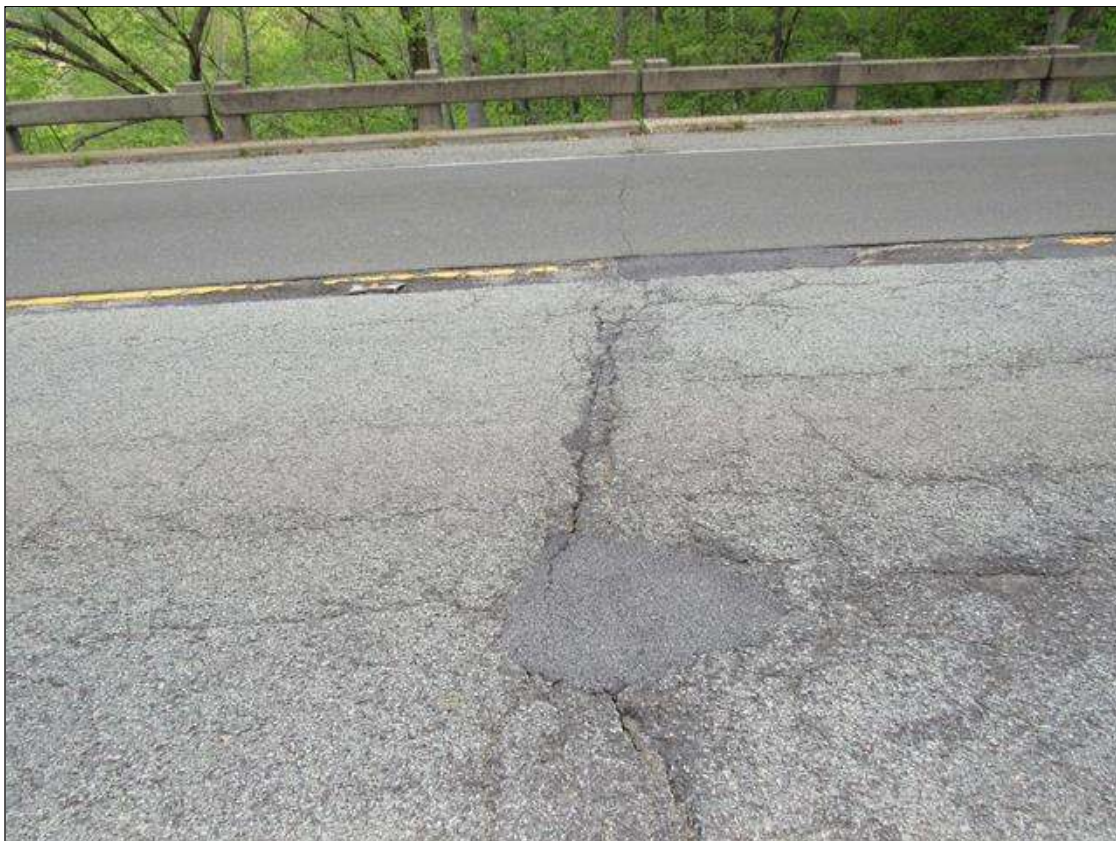
ASPHALT WEARING SURFACE IS CRACKED OVER TOP OF BENT 4. BENG 1, 2, AND 3 ARE SIMILAR.

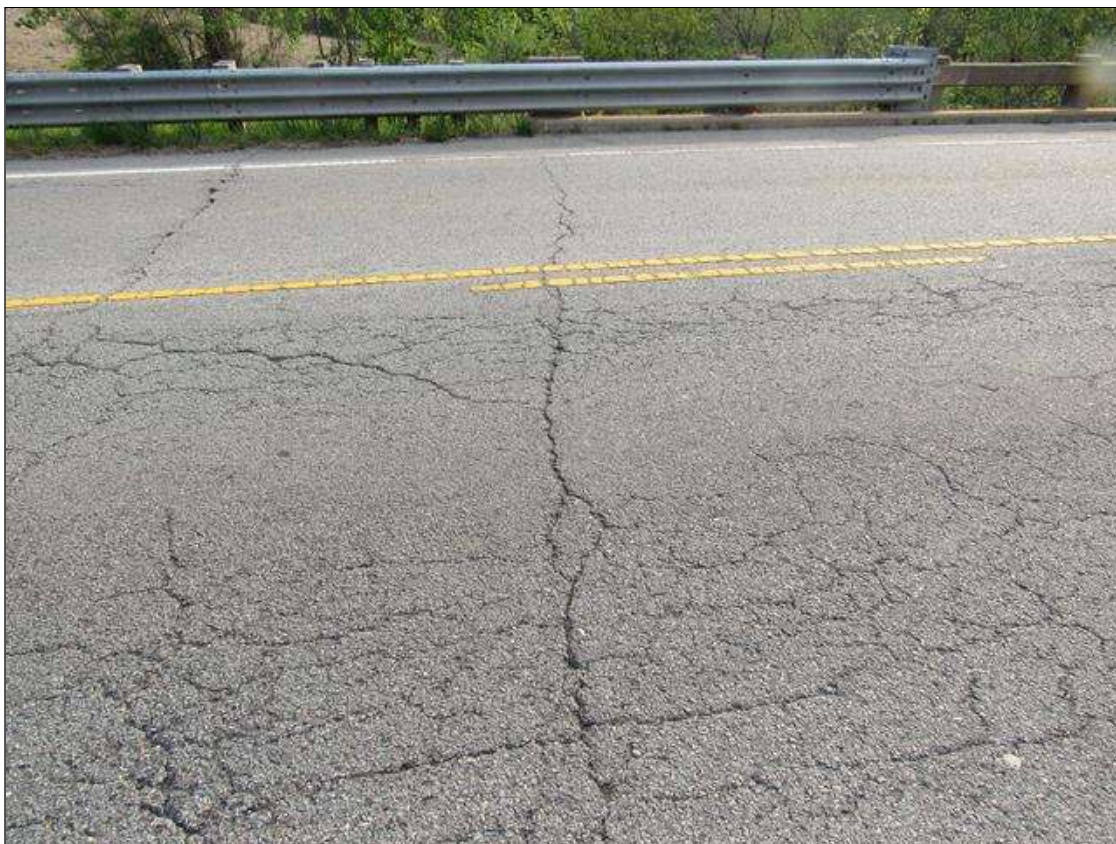
ASPHALT WEARING SURFACE OVER END BENT 1 CRACKED WITH END BENT 2 SIMILAR.

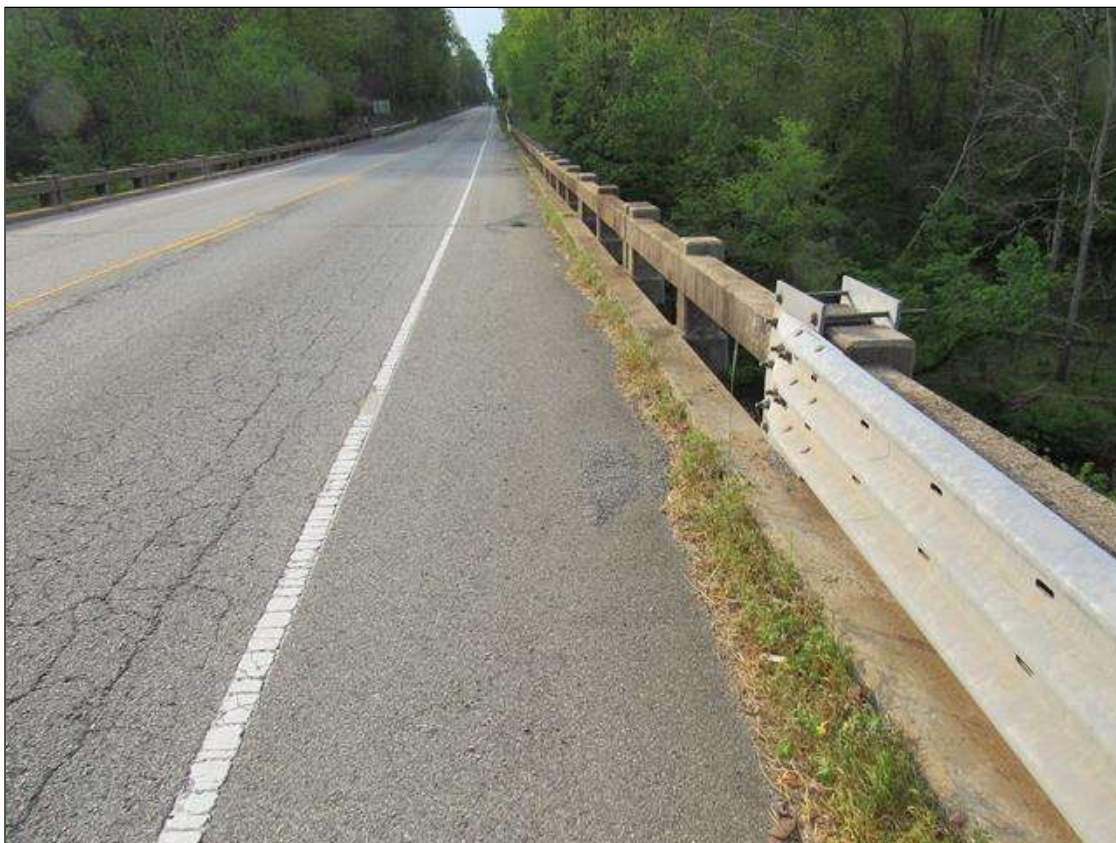
VEGETATION AND DEBRIS IN RIGHT CURB LINE WITH RIGHT CURB LINE SIMILAR.

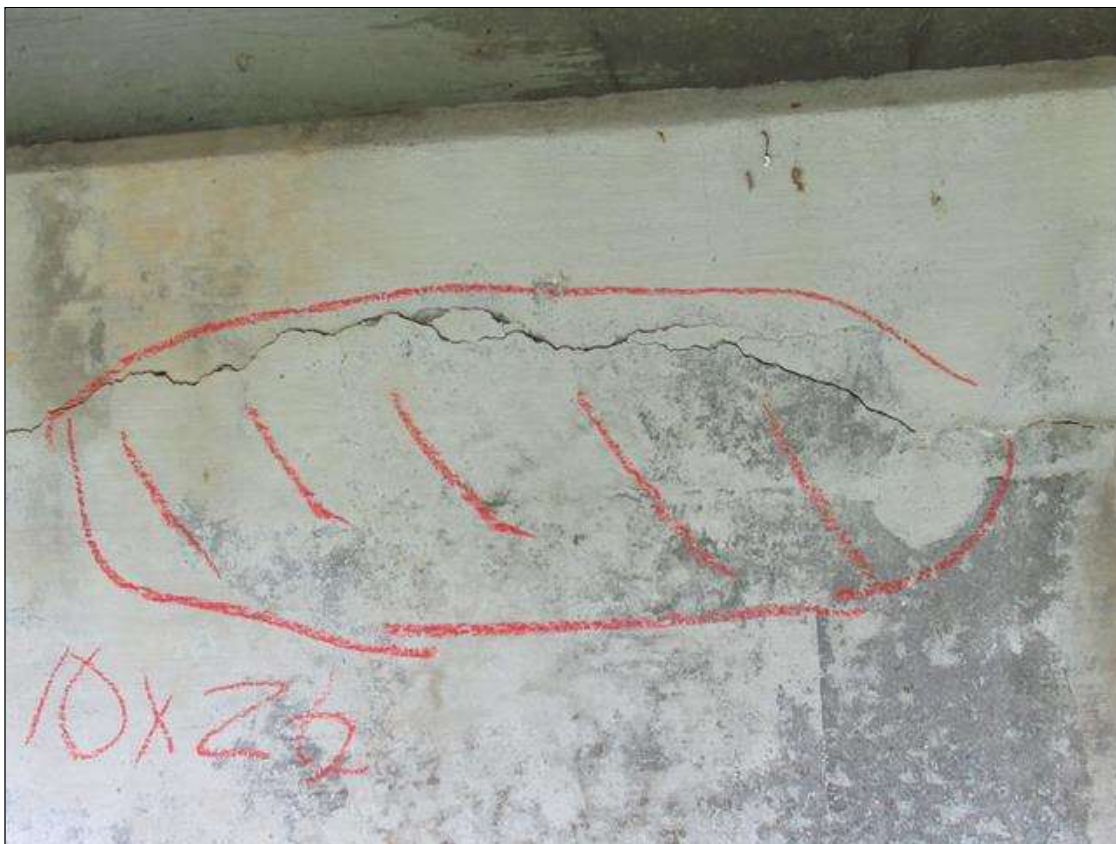
Bent 1 Cap : 2 Feet of Delamination/Spall/Patched Area: Delaminated. Spall 1 inch or less deep or 6 inches or less in diameter. Patched area that is sound.
BENT 1 WEST FACE OF CAP HAS A HORZ CRACKED DELAMINATED AREA RIGHT SIDE OF GIRDER 1 THAT IS 10" X 24".

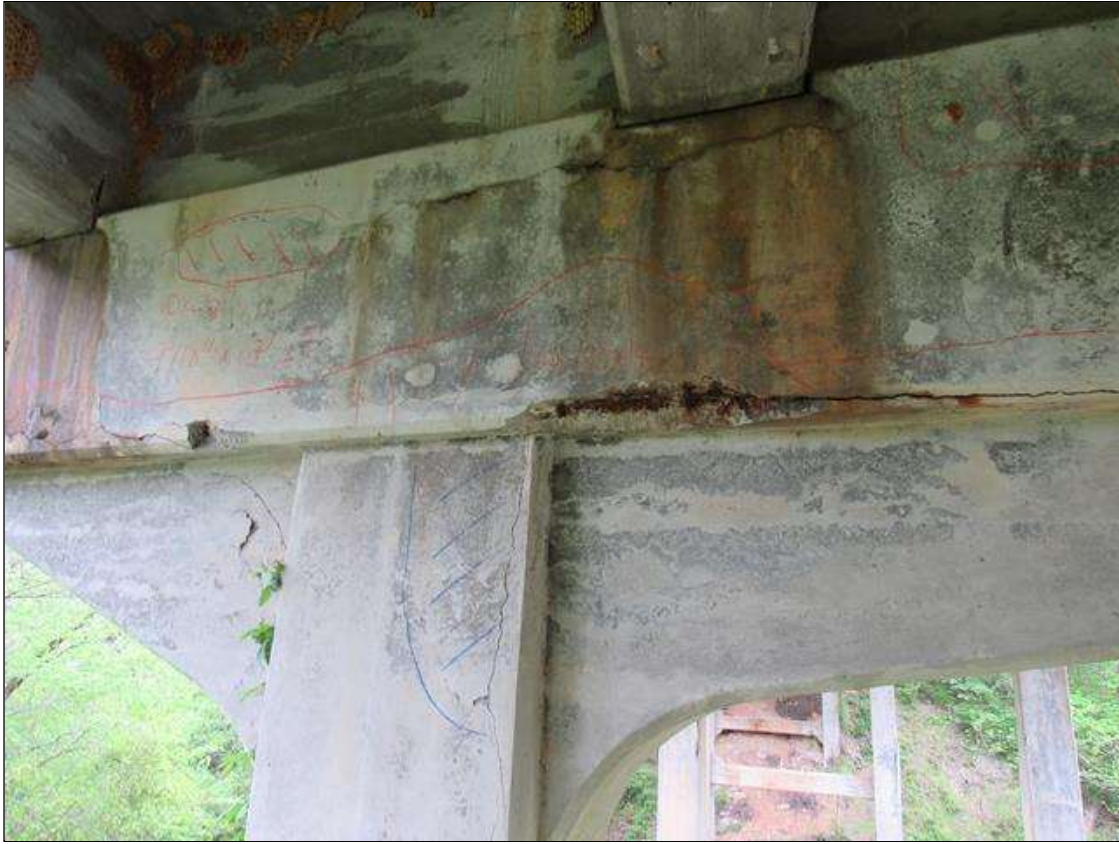
Bent 1 Cap : 13 Feet of Delamination/Spall/Patched Area: Delaminated. Spall 1 inch or less deep or 6 inches or less in diameter. Patched area that is sound
BENT 1 WEST FACE OF CAP HAS A CRACKED SPALL DELAMINATED AREA ALONG THE BOTTOM EDGE FM LEFT END TO RIGHT SIDE OF GIRDER 2. 9" TO 18" UP FACE 13' LONG 7" UNDER BOTTOM. SPALL AREA IS 4" X 30" X 4" WITH REBAR EXPOSED.

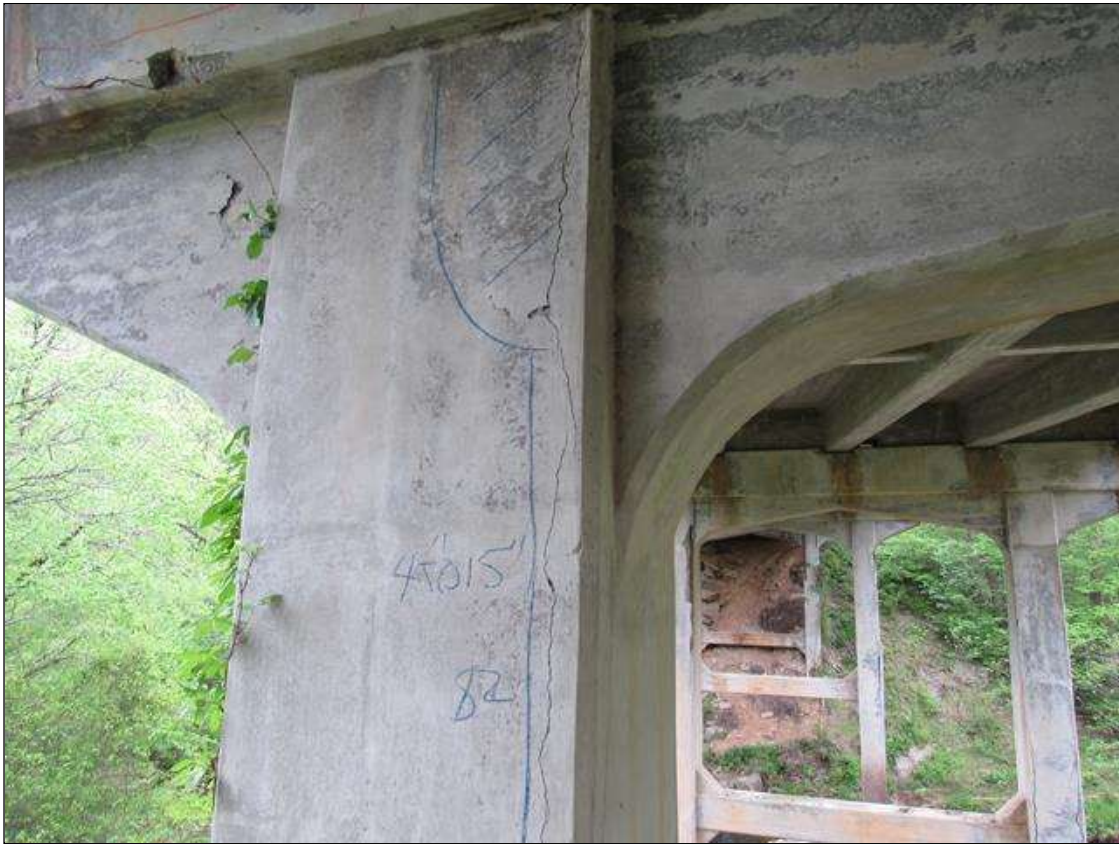
Bent 1 Pile 1: 1 Each of Delamination/Spall/Patched Area: Delaminated. Spall 1 in. or less deep or 6 in. or less in diameter. Patched area that is sound.
BENT 1 PILE 1 SOUTH WEST CORNER OF PILE HAS CRACKED DELAMINATED AREA FROM TOP DOWN 82". 4 TO 15" ON WEST FACE AN 4" ON SOUTH FACE.

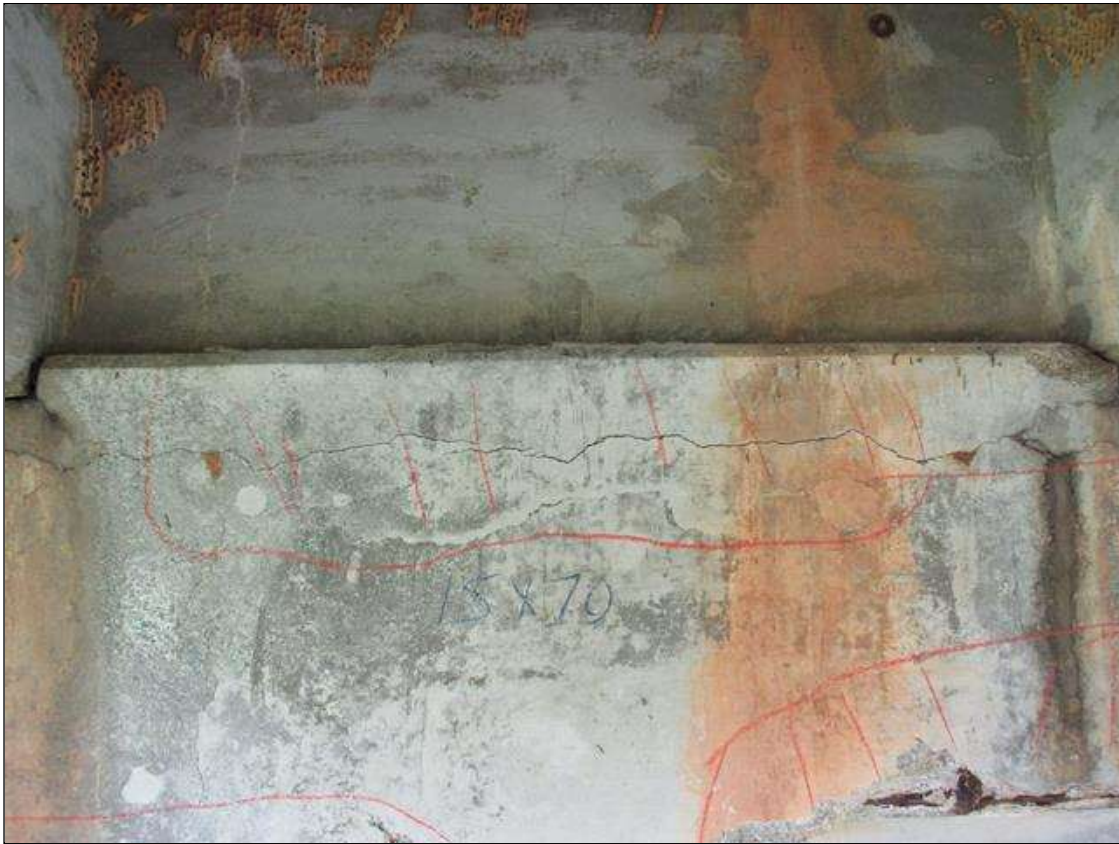
Bent 1 Cap : 6 Feet of Delamination/Spall/Patched Area: Delaminated. Spall 1 inch or less deep or 6 inches or less in diameter. Patched area that is sound
BENT 1 WEST FACE OF CAP HAS A HORZ CRACKED DELAMINATED AREA BETWEEN GIRDERS 2 AND 3
ALONG TOP OF CAP. 15" DOWN FACE AND 7" LONG.

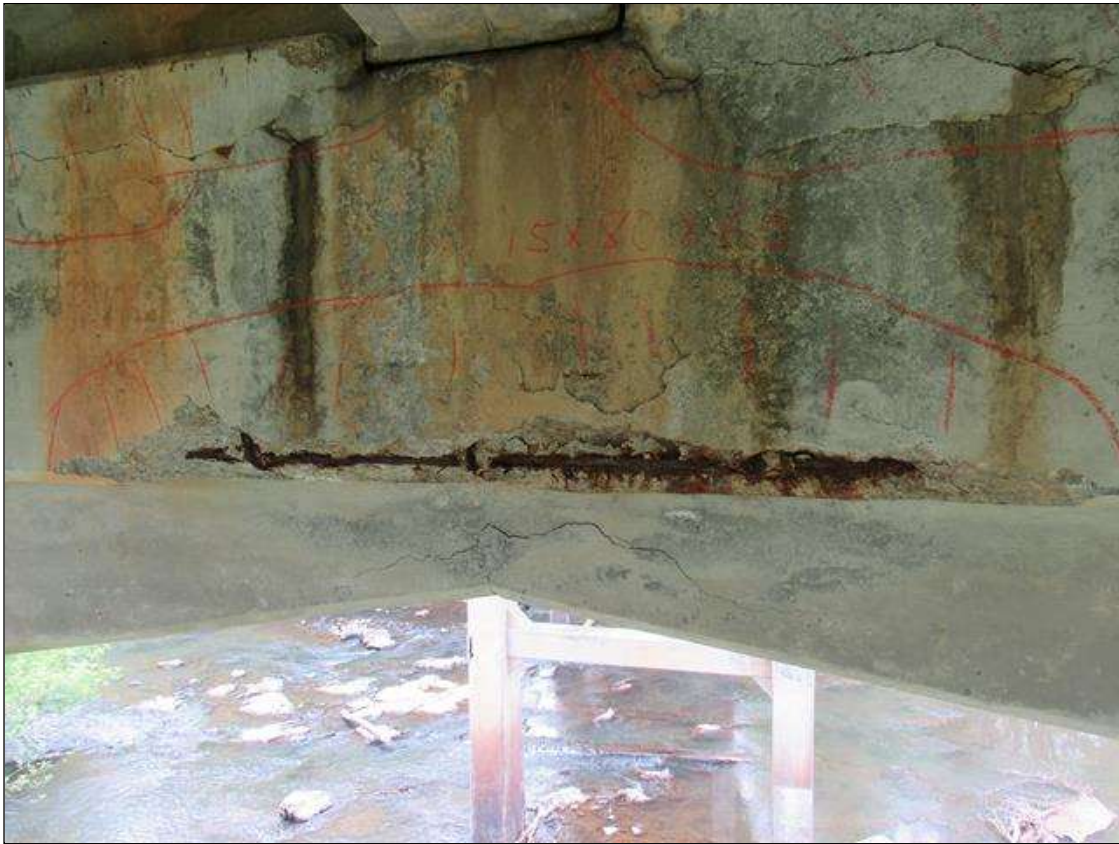
Bent 1 Cap : 7 Feet of Delamination/Spall/Patched Area: Delaminated. Spall 1 inch or less deep or 6 inches or less in diameter. Patched area that is sound
BENT 1 WEST FACE OF CAP HAS A HAS CRACKED DELAMINATED SPALL AREA UNDER G3 15" UP BASE 80" LONG AND 6" UNDER BOTTOM. LARGE REBAR AND STIRRUPS EXPOSED.

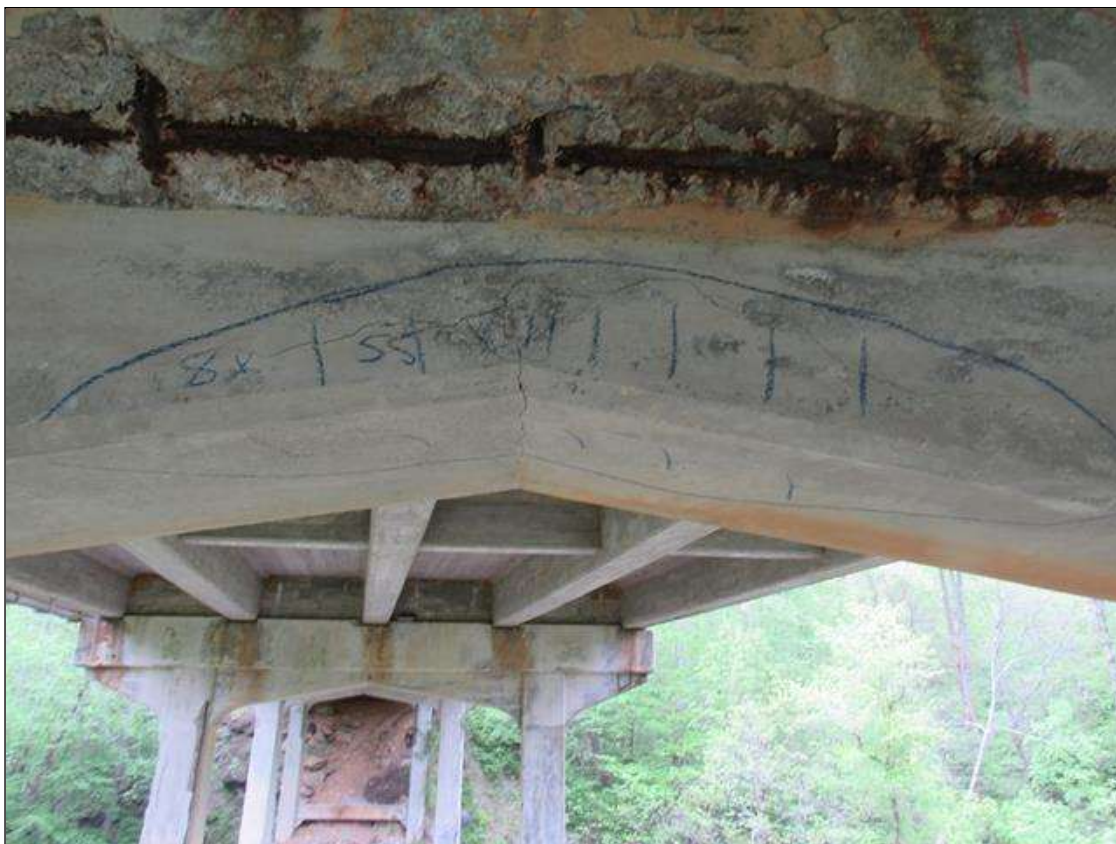
HAUNCH AREA BETWEEN PILES 1 AND 2 IN THE MIDDLE OF CAP IS CRACKED AND DELAMINATED. 8" UP FACE AND 55" LONG 11" UNDER BOTTOM.

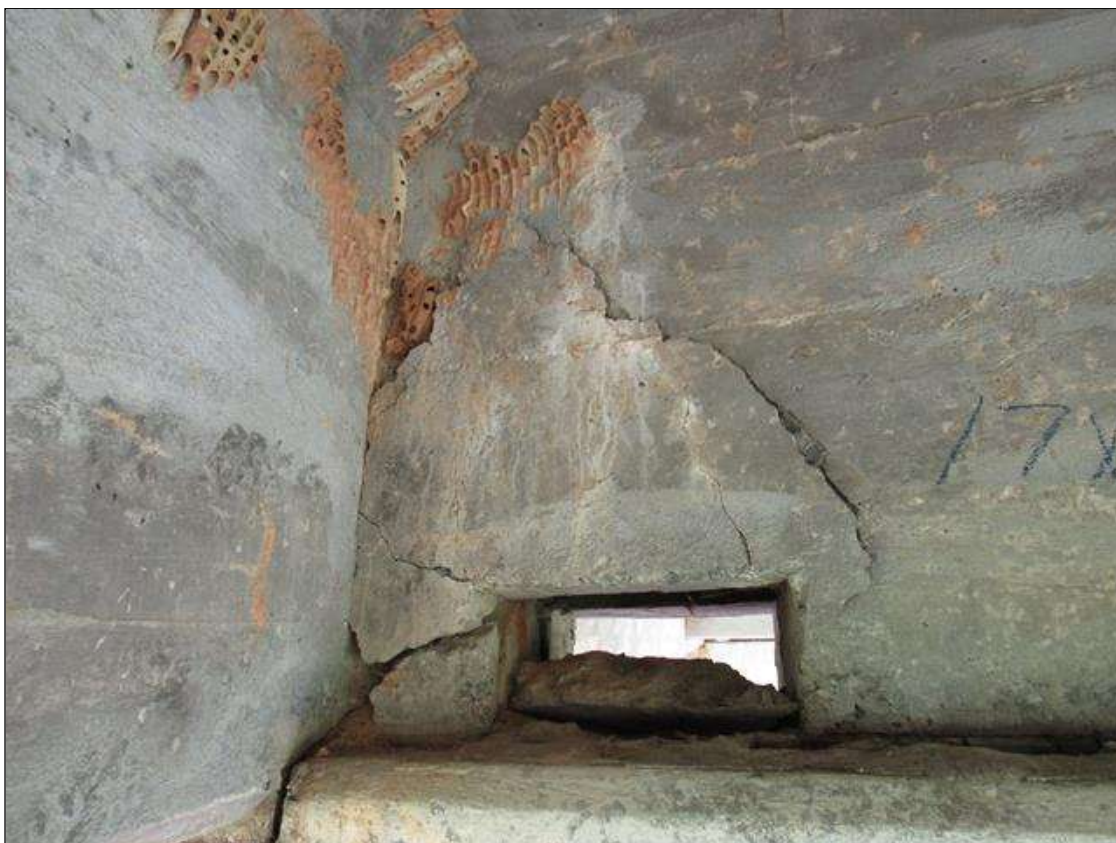
END DIAPHRAGM IN BAY 3 IS CRACKED AND DELAMINATED RIGHT SIDE OF GIRDER 3. 17" X 20".

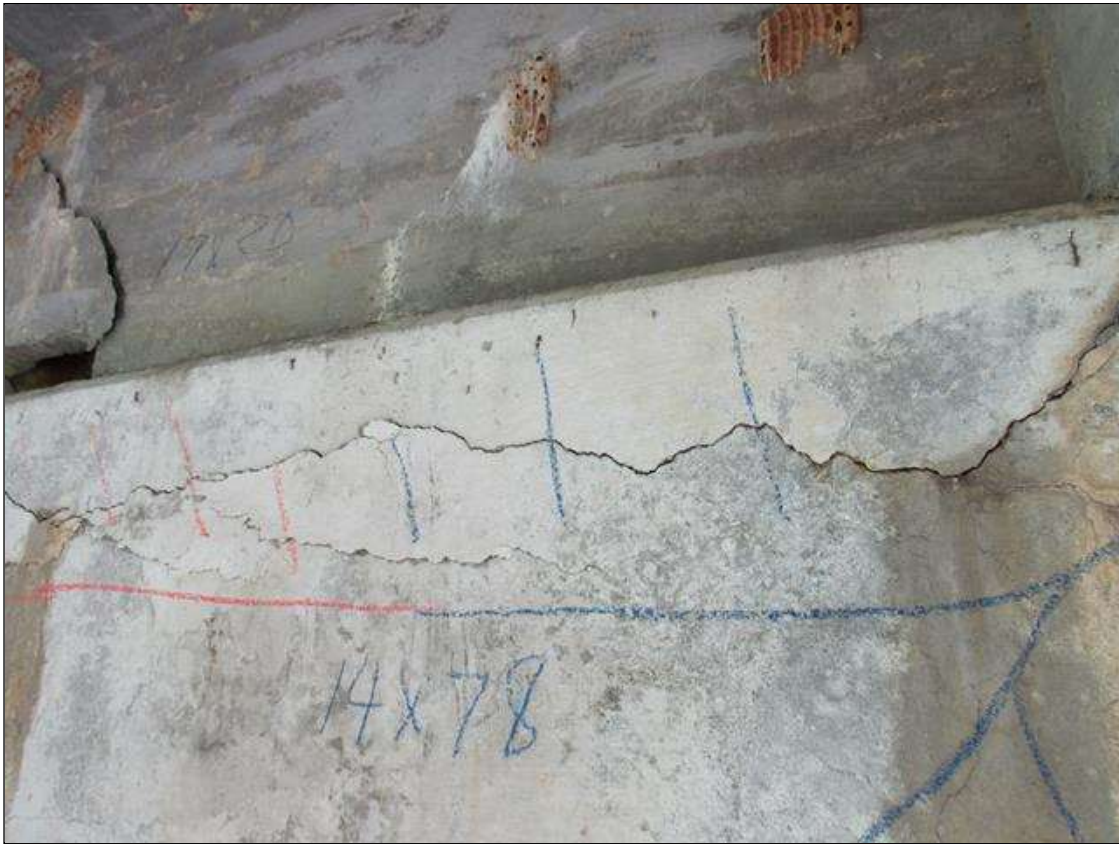
Bent 1 Cap : 6 Feet of Delamination/Spall/Patched Area: Delaminated. Spall 1 inch or less deep or 6 inches or less in diameter. Patched area that is sound
BENT 1 WEST FACE OF CAP HAS A CRACKED AND DELAMINATED AREA ALONG TOP EDGE BETWEEN GIRDERS 3 AND 4. 14" DOWN FACE AND 78" LONG.

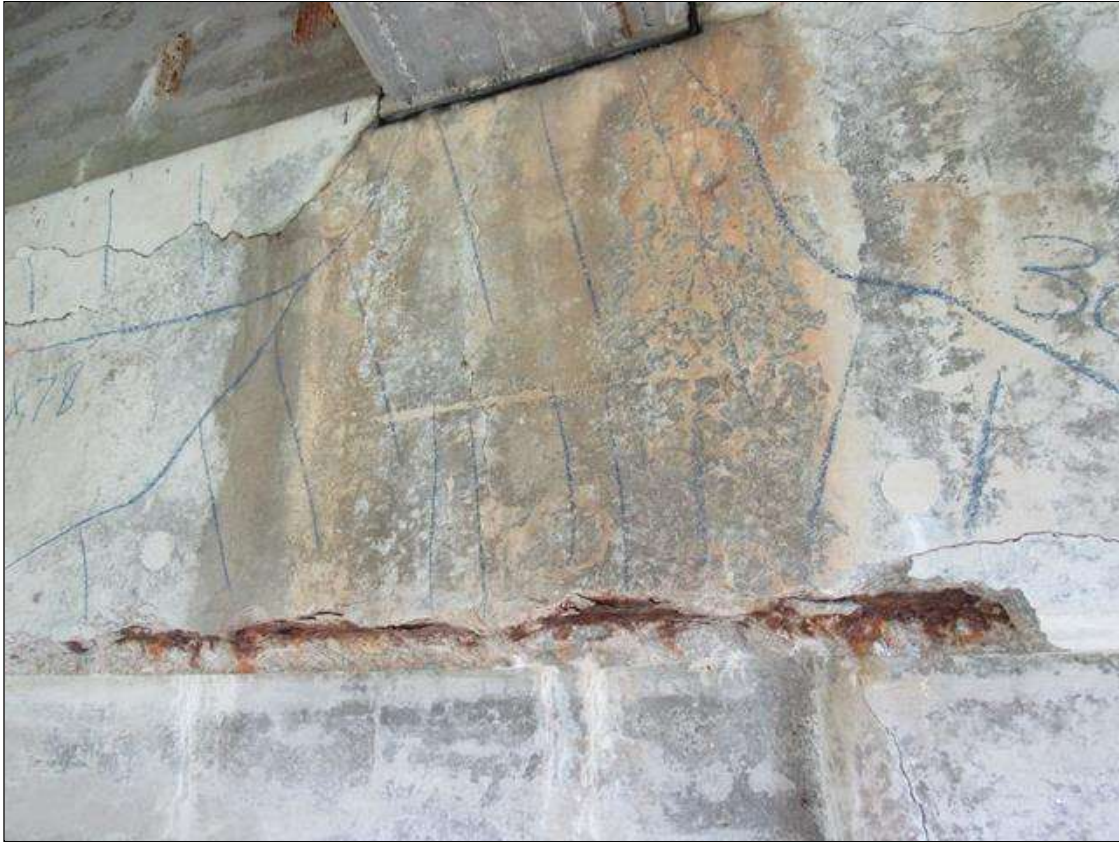
Bent 1 Cap : 0 Feet of Delamination/Spall/Patched Area: Spall greater than 1 inch deep or greater than 6 inches in diameter. Patched area that is unsound or showing distress. Condition does not warrant structural Review
BENT 1 WEST FACE OF CAP CRACKED SPALL AND DELAMINATED AREA UNDER G4 TOP DOWN 30" & 78" WIDE 6" UNDER BOTTOM REBAR AND STIRRUPS EXPOSED.
