NC DEPARTMENT OF TRANSPORTATION
 DIVISION OF HIGHWAYS
 STRUCTURE MANAGEMENT UNIT

ATTENTION:

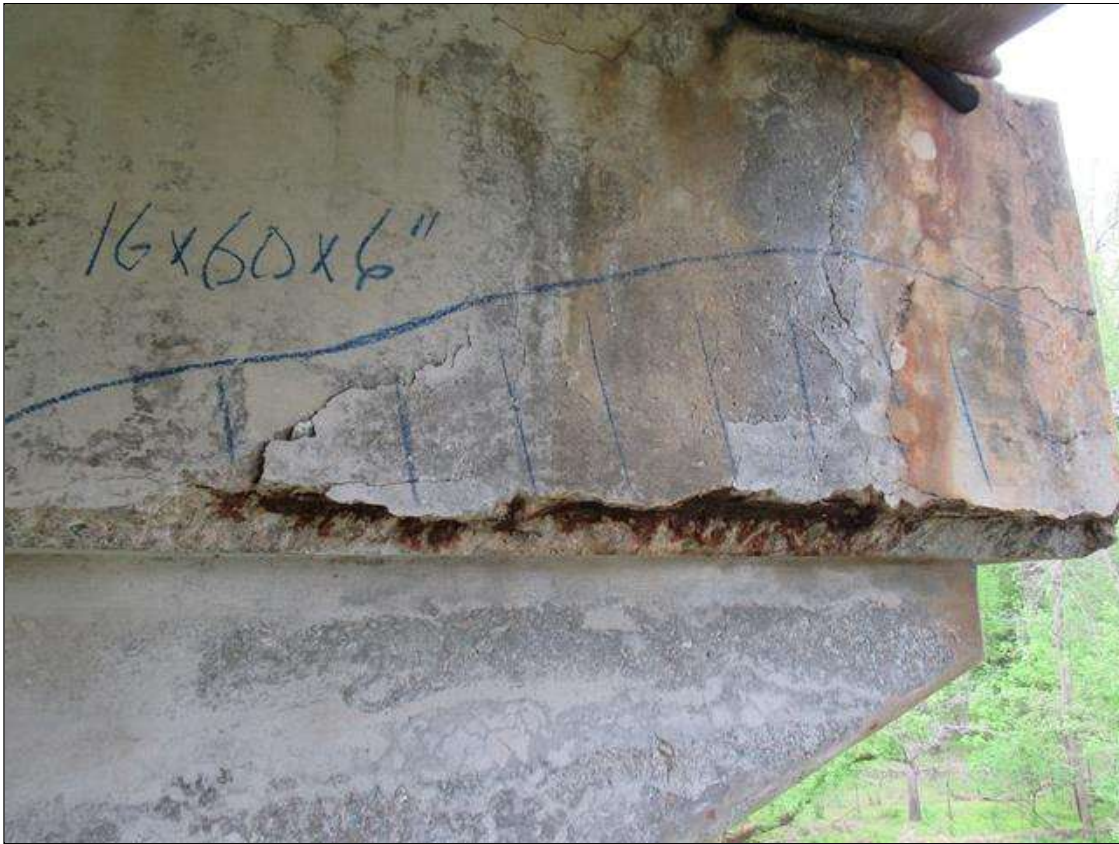
Bent 1 Cap : 0 Feet of Delamination/Spall/Patched Area: Spall greater than 1 inch deep or greater than 6 inches in diameter. Patched area that is unsound or showing distress. Condition does not warrant structural Review
BENT 1 WEST FACE OF CAP CRACKED SPALL DELAMINATED AREA FM RIGHT END BACK 60" 16" UP FACE 6" UNDER BOTTOM WITH REBAR AND STIRRUPS EXPOSED.

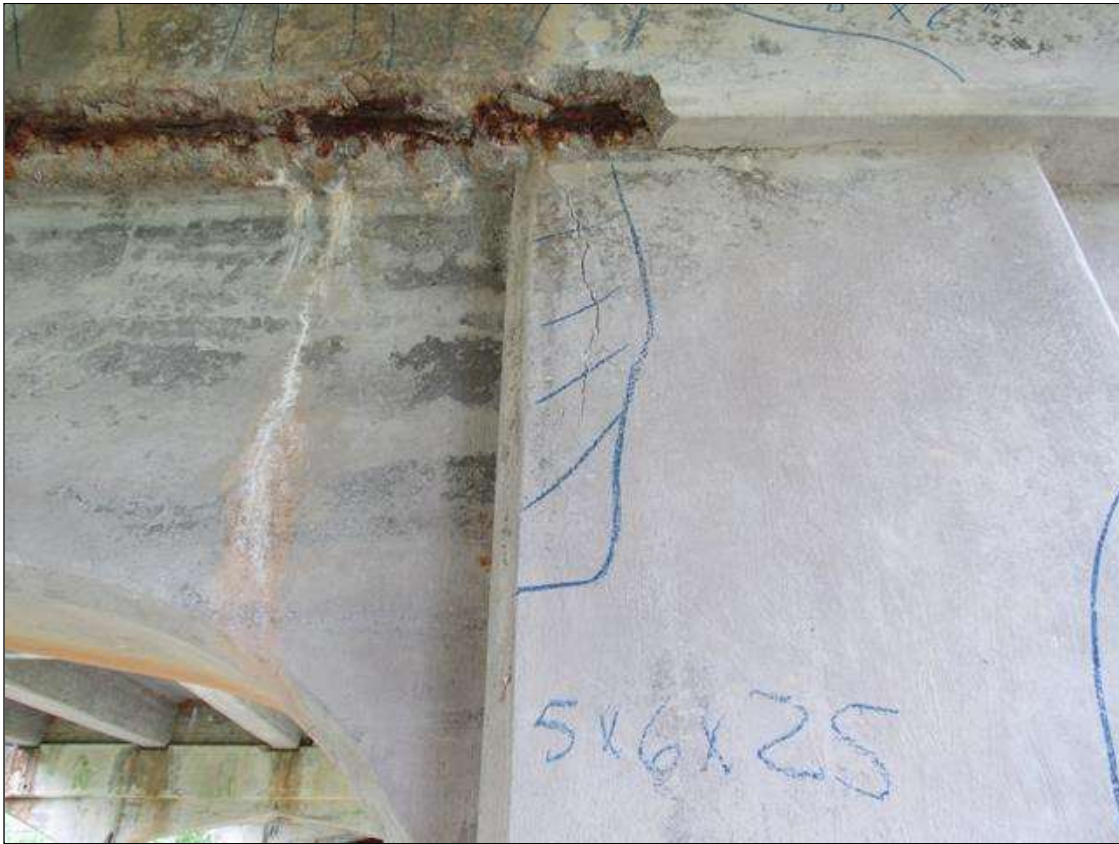
Bent 1 Pile 2: 1 Each of Delamination/Spall/Patched Area: Delaminated. Spall 1 in. or less deep or 6 in. or less in diameter. Patched area that is sound.

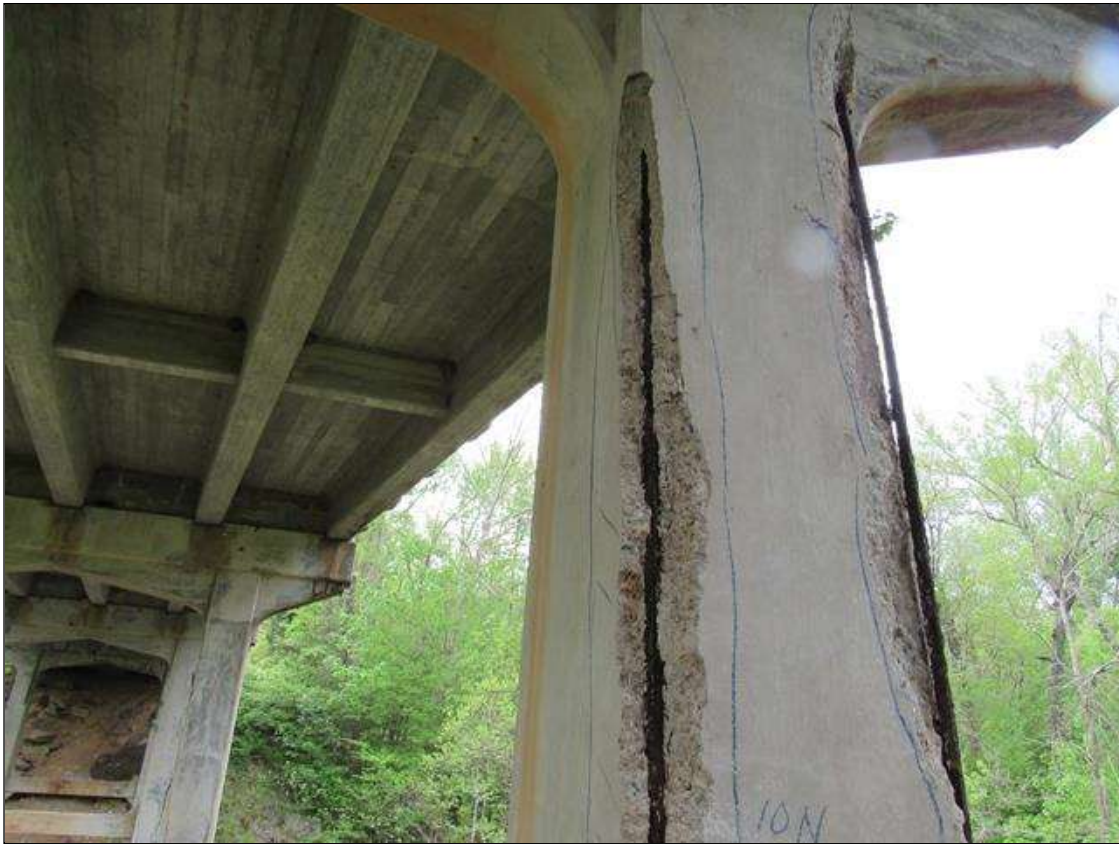
Bent 1 Pile 2: 0 Each of Delamination/Spall/Patched Area: Spall greater than 1 in. deep or greater than 6 in. diameter.
Patched area that is unsound or showing distress. Does not warrant structural review.
BENT 1 PILE 2 CRACKED DELAMINATED SPALL AREA ON NW CORNER OF PILE STARTS 35" BELOW CAP
EXTENDS DOWN 8' 10" ON NORTH FACE 8" ON WEST.

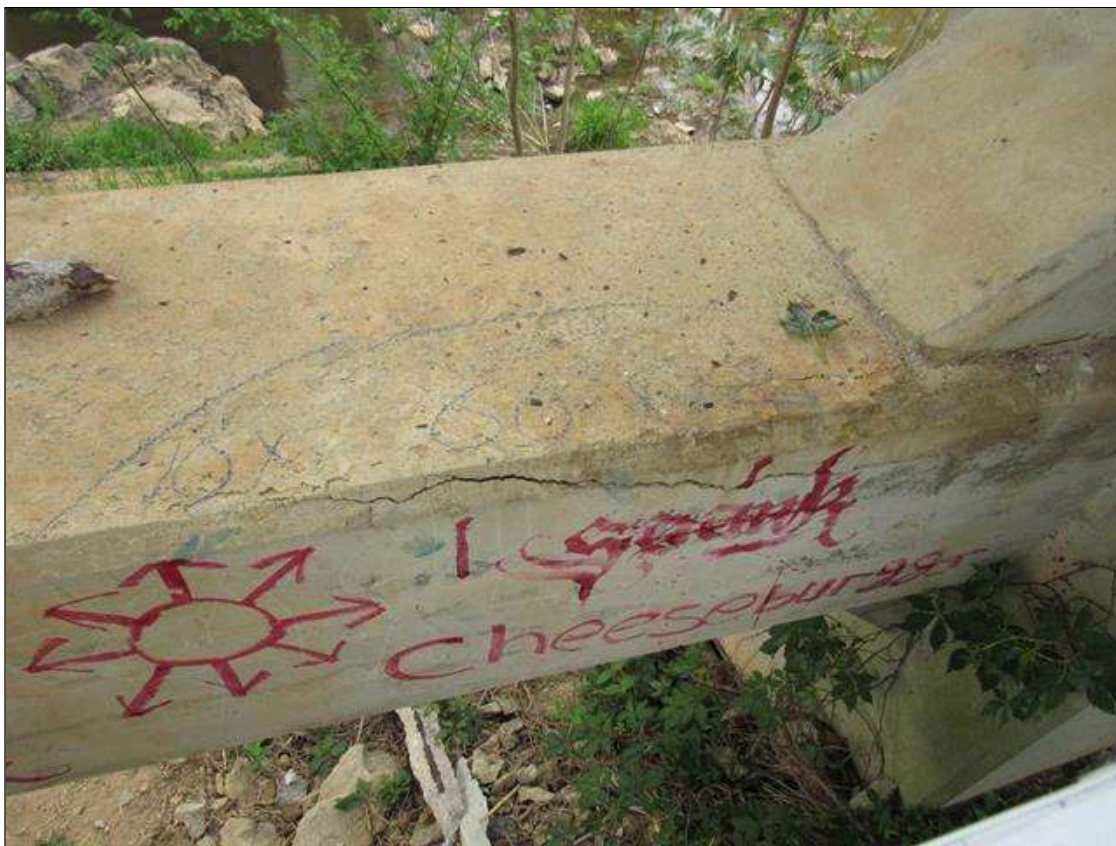
HORZ STRUT BEWTEEN PILE 1 AND 2 HAS A CRACKED AND DELAMINATED AREA ON TOP AND WEST FACE LEFT SIDE OF PILE 2 10" ON TOP 60" LONG AND 12" ON WEST FACE.

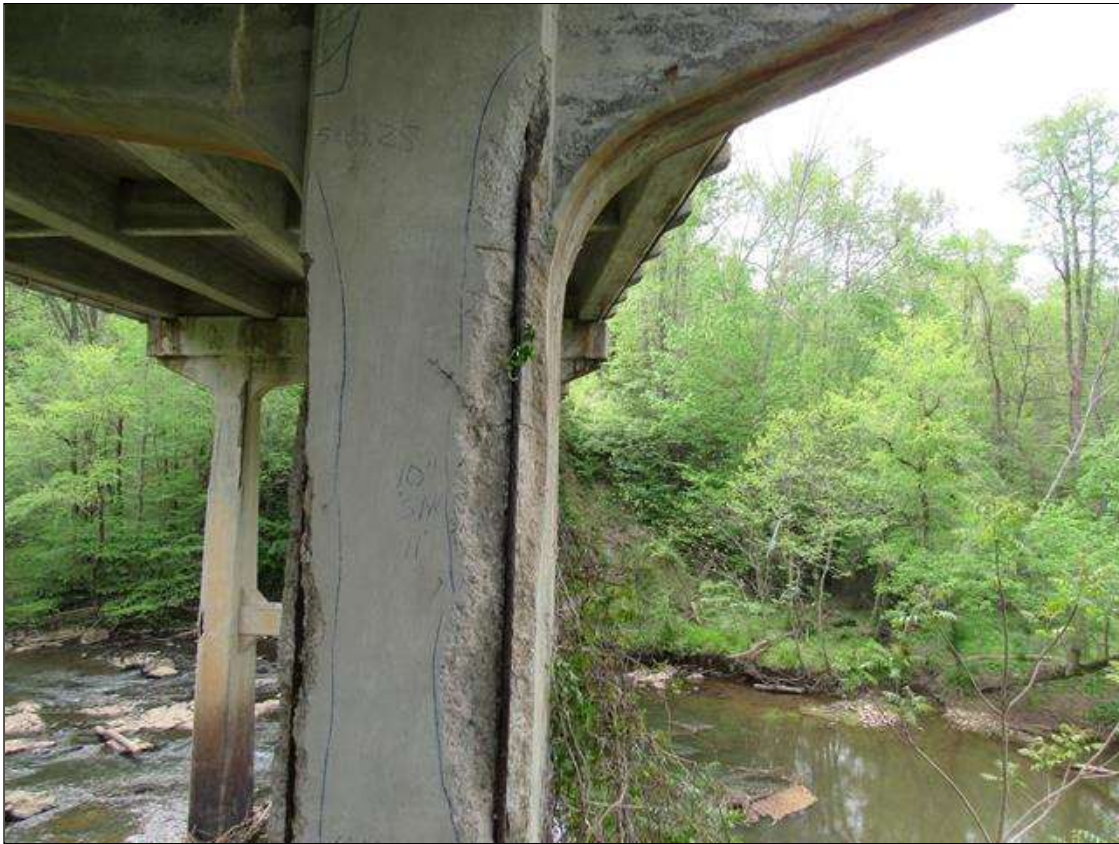
Bent 1 Pile 2: 0 Each of Delamination/Spall/Patched Area: Spall greater than 1 in. deep or greater than 6 in. diameter. Patched area that is unsound or showing distress. Does not warrant structural review.

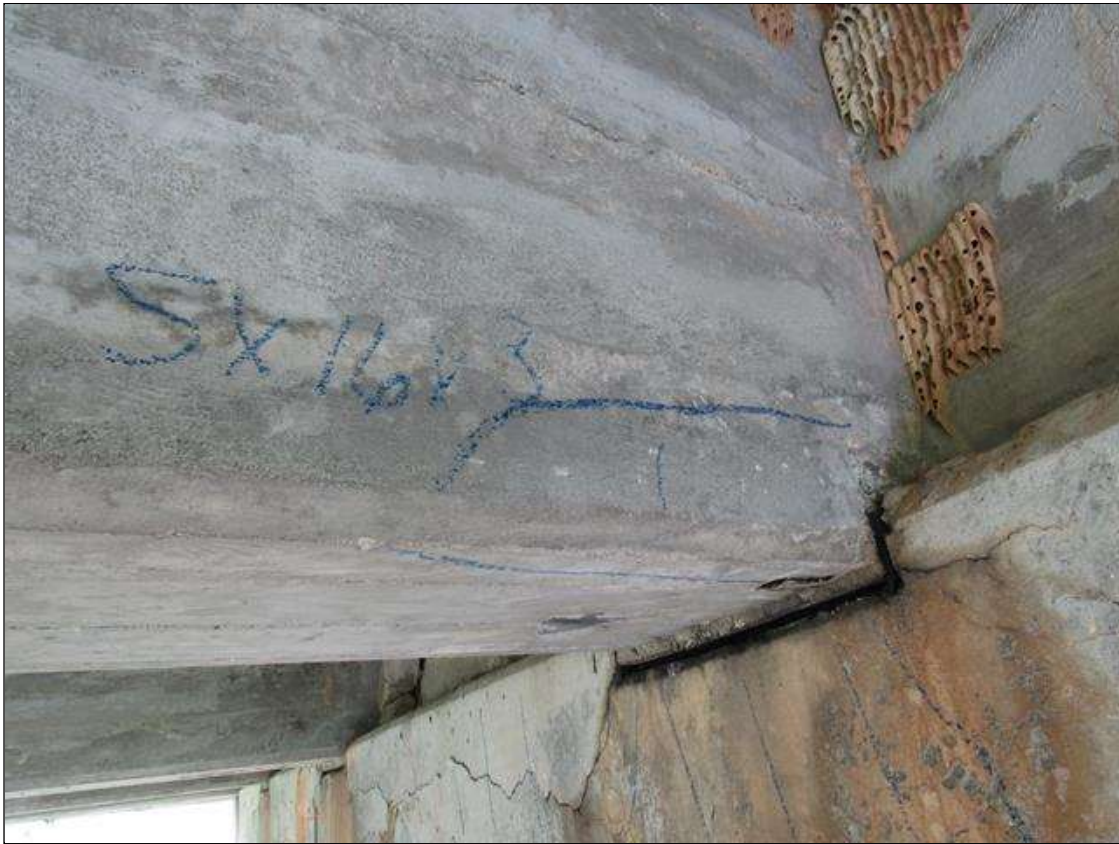
Span 1 Beam 1: 2 Feet of Delamination/Spall/Patched Area: Delaminated. Spall 1 in. or less deep or 6 in. or less in diameter. Patched area that is sound.

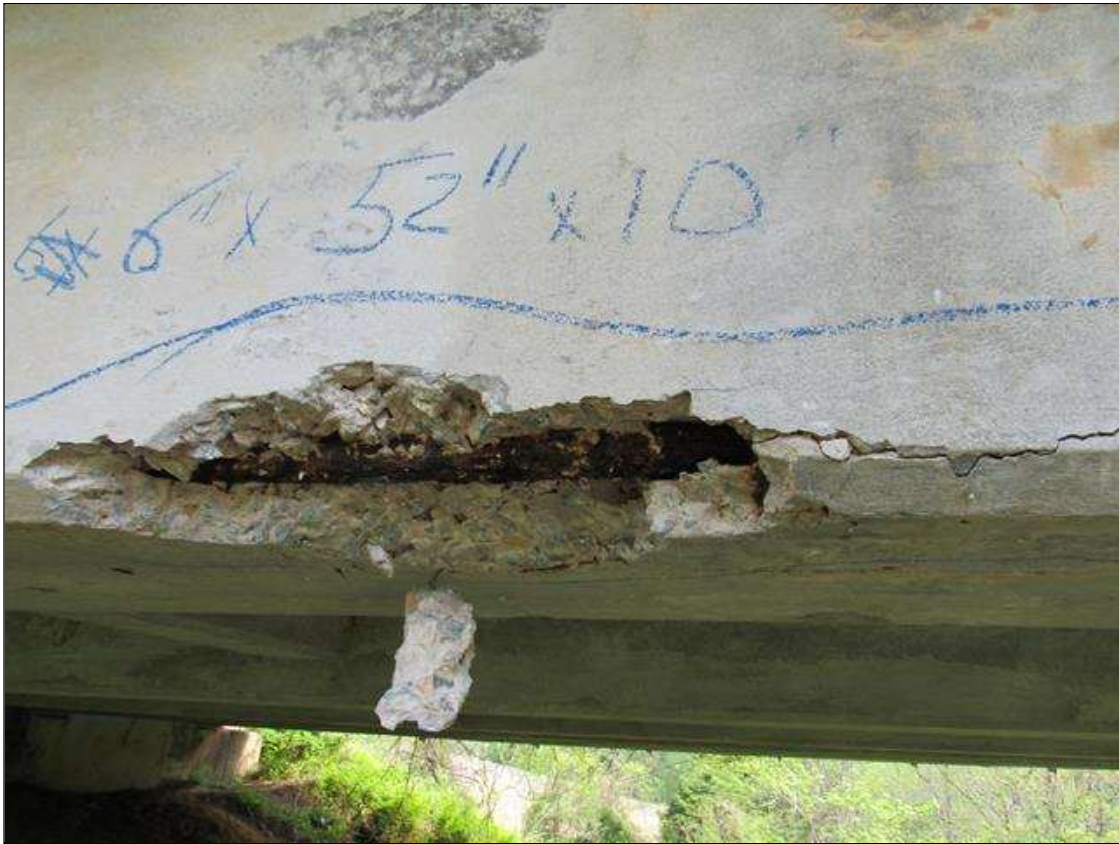
Span 1 Beam 5: 5 Feet of Delamination/Spall/Patched Area: Spall greater than 1 in. deep or greater than 6 in. diameter. Patched area that is unsound or showing distress. Does not warrant structural review.
SPAN 1 GIRDER 5 HAS A CRACKED SPALL DELAMINATED AREA LOCATED AT 15' FM BENT 1. 6" UP FACE 52" LONG 10" UNDER BOTTOM WITH LARGE REBAR EXPOSED.

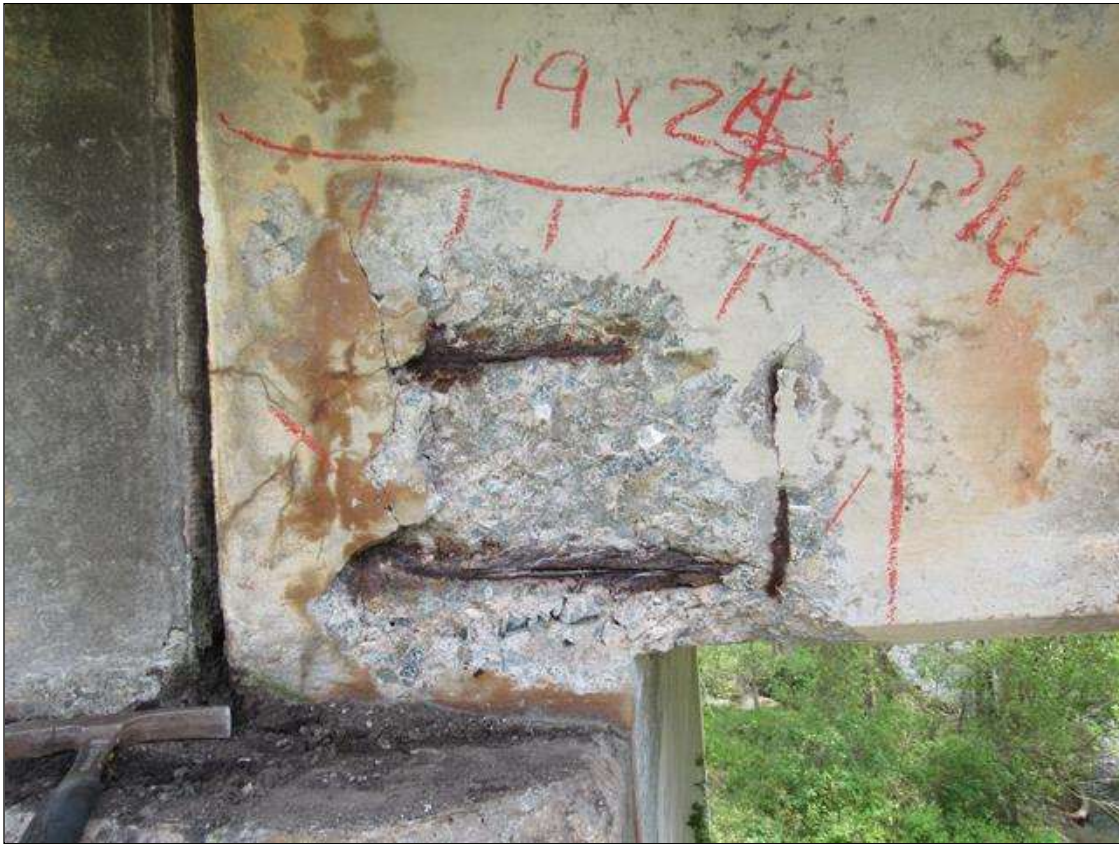
Span 2 Beam 5: 2 Feet of Delamination/Spall/Patched Area: Spall greater than 1 in. deep or greater than 6 in. diameter. Patched area that is unsound or showing distress. Does not warrant structural review.
SPAN 2 RIGHT SIDE OF GIRDER 5 HAS A CRACKED SPALL DELAMINATED AREA OVER BENT 1 19" HIGH FM
END OUT 24" 1 3/4" DEEP WITH REBAR AND STIRRUPS EXPOSED.

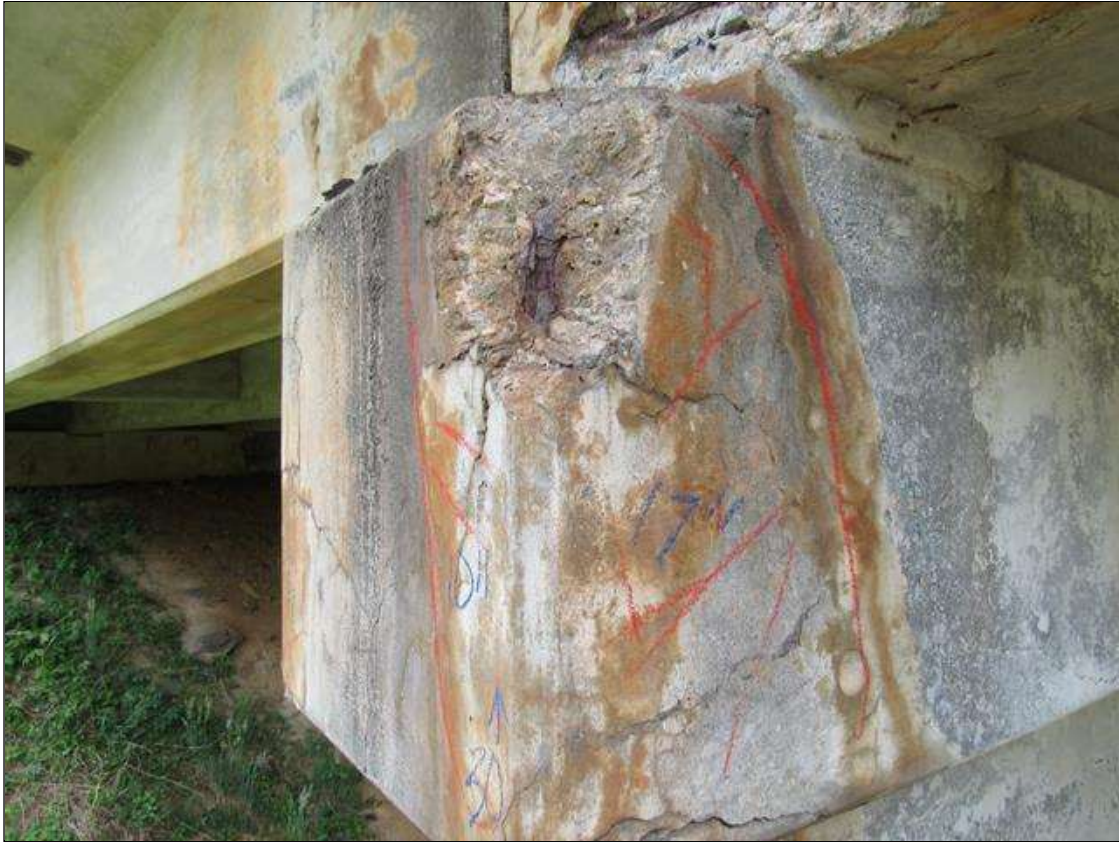
Bent 1 Cap : 0 Feet of Delamination/Spall/Patched Area: Spall greater than 1 inch deep or greater than 6 inches in diameter. Patched area that is unsound or showing distress. Condition does not warrant structural Review
BENT 1 RIGHT END AND EAST FACE OF CAP UNDER GIRDER 5 CRACKED SPALL DELAMINATED 10" ON RIGHT END 17" ON EAST FACE TOP DOWN 30".

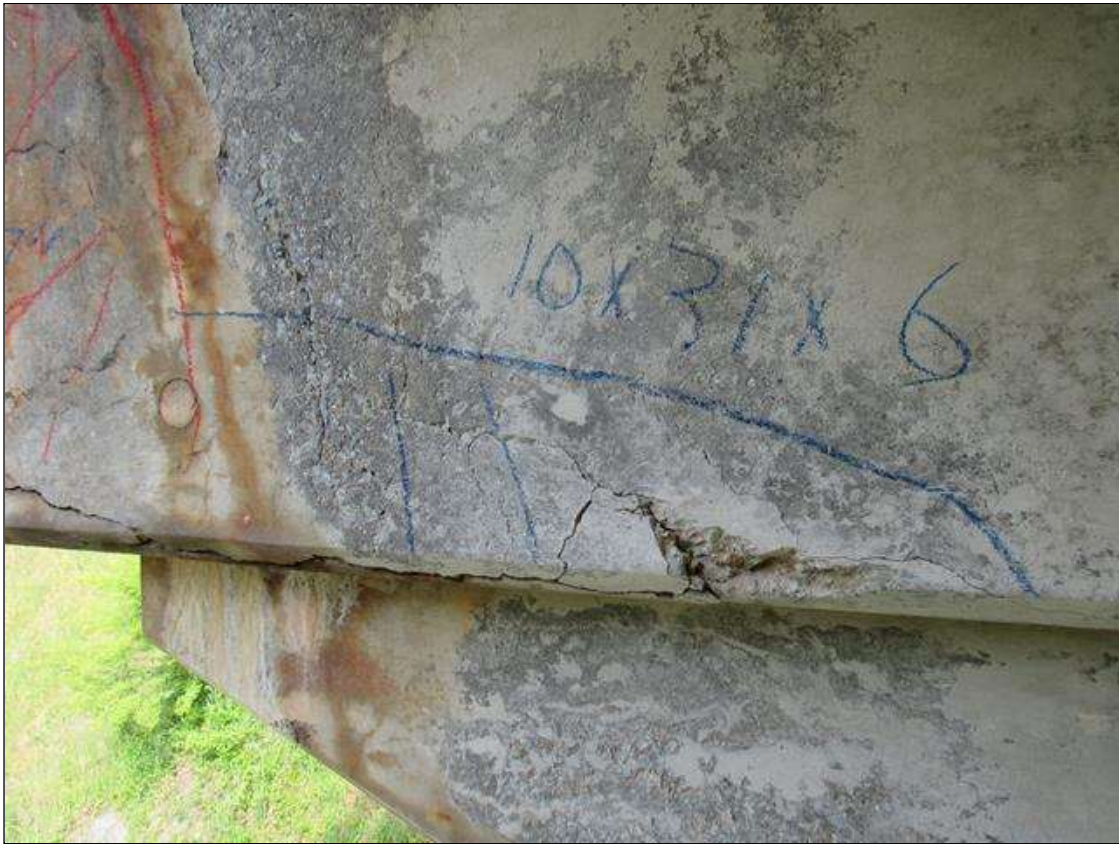
Bent 1 Cap : 0 Feet of Delamination/Spall/Patched Area: Delaminated. Spall 1 inch or less deep or 6 inches or less in diameter. Patched area that is sound
BENT 1 EAST FACE OF CAP UNDER GIRDER 5 HAS A CRACKED SPALL DELAMINATED AREA ALONG BOTTOM EDGE 10" UP FACE 31" LONG AND 6" UNDER BOTTOM.

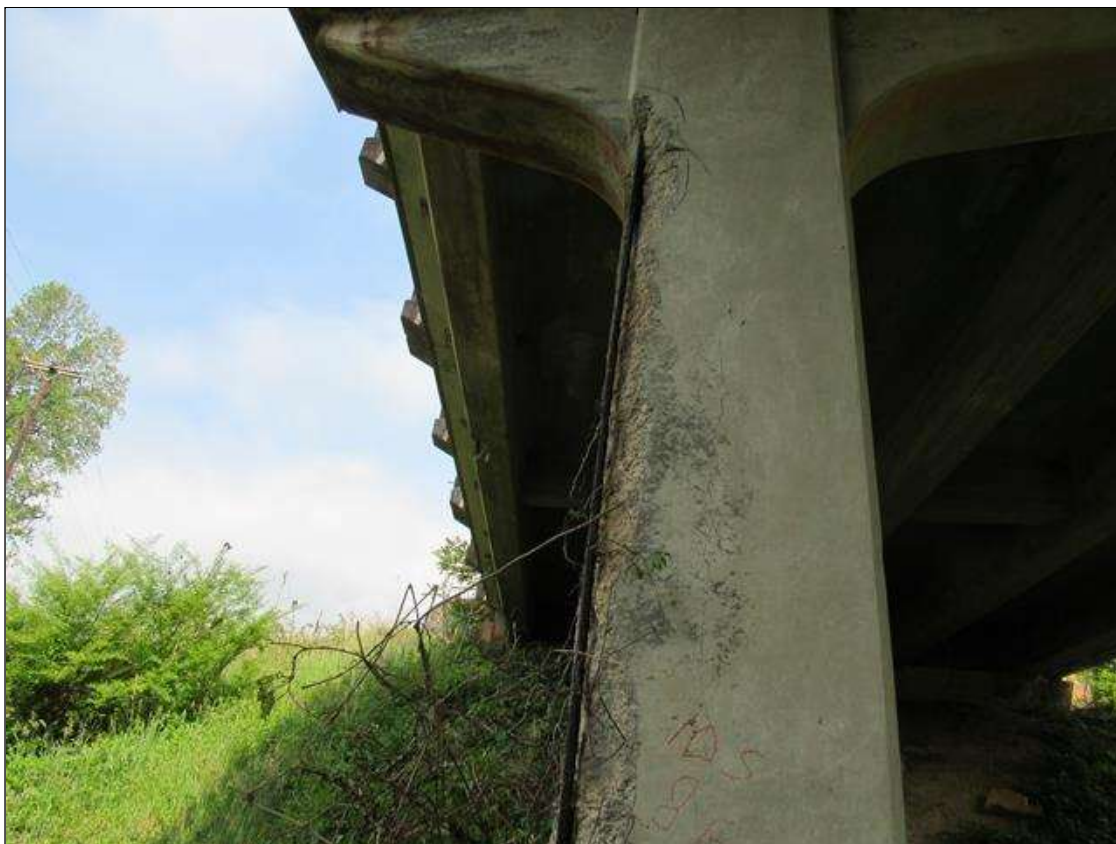
Bent 1 Pile 2: 0 Each of Delamination/Spall/Patched Area: Spall greater than 1 in. deep or greater than 6 in. diameter.
Patched area that is unsound or showing distress. Does not warrant structural review.
BENT 1 PILE 2 CRACKED SPALL DELAMINATED ON SE CORNER OF PILE 10" ON SOUTH FACE 8" ON EAST 11"
DOWN FACE START 32" BELOW THE CAP.

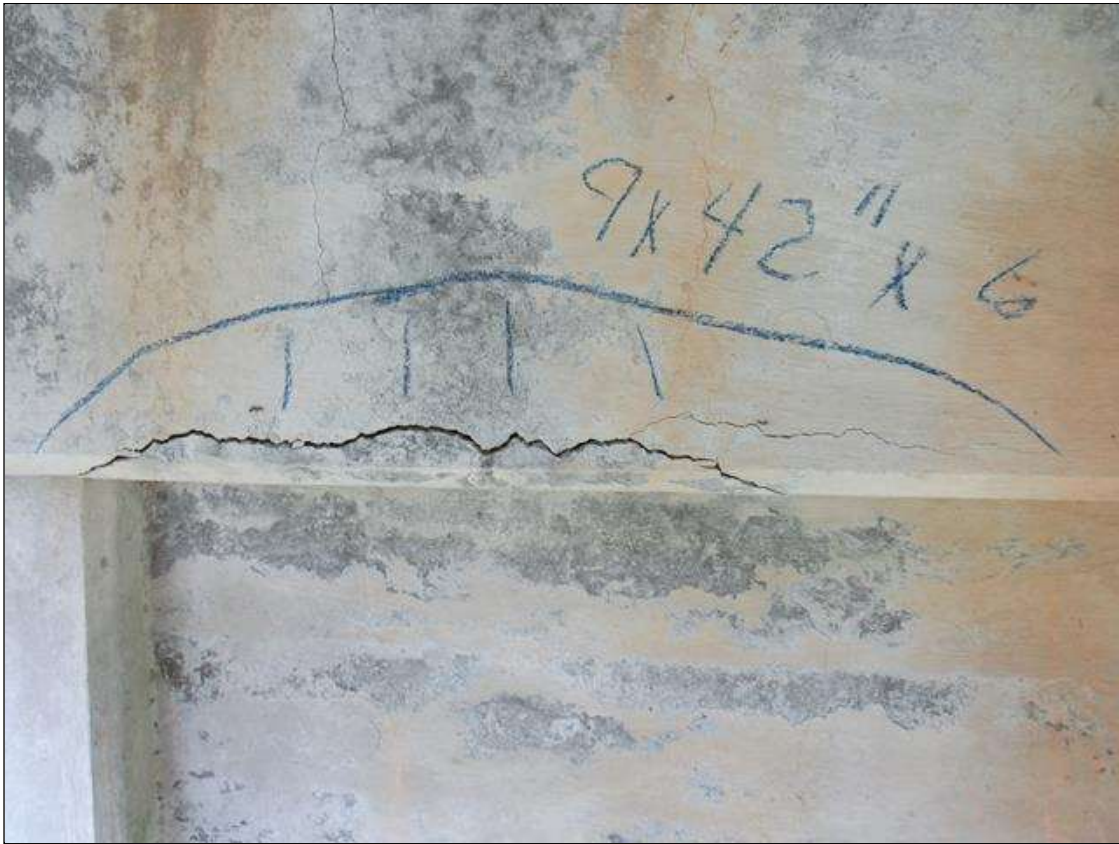
Bent 1 Cap : 0 Feet of Delamination/Spall/Patched Area: Delaminated. Spall 1 inch or less deep or 6 inches or less in diameter. Patched area that is sound
BENT EAST FACE OF CAP HAS A CRACKED AND DELAMINATED AREA UNDER GIRDER 4 UNDER BOTTOM EDGE OF CAP.

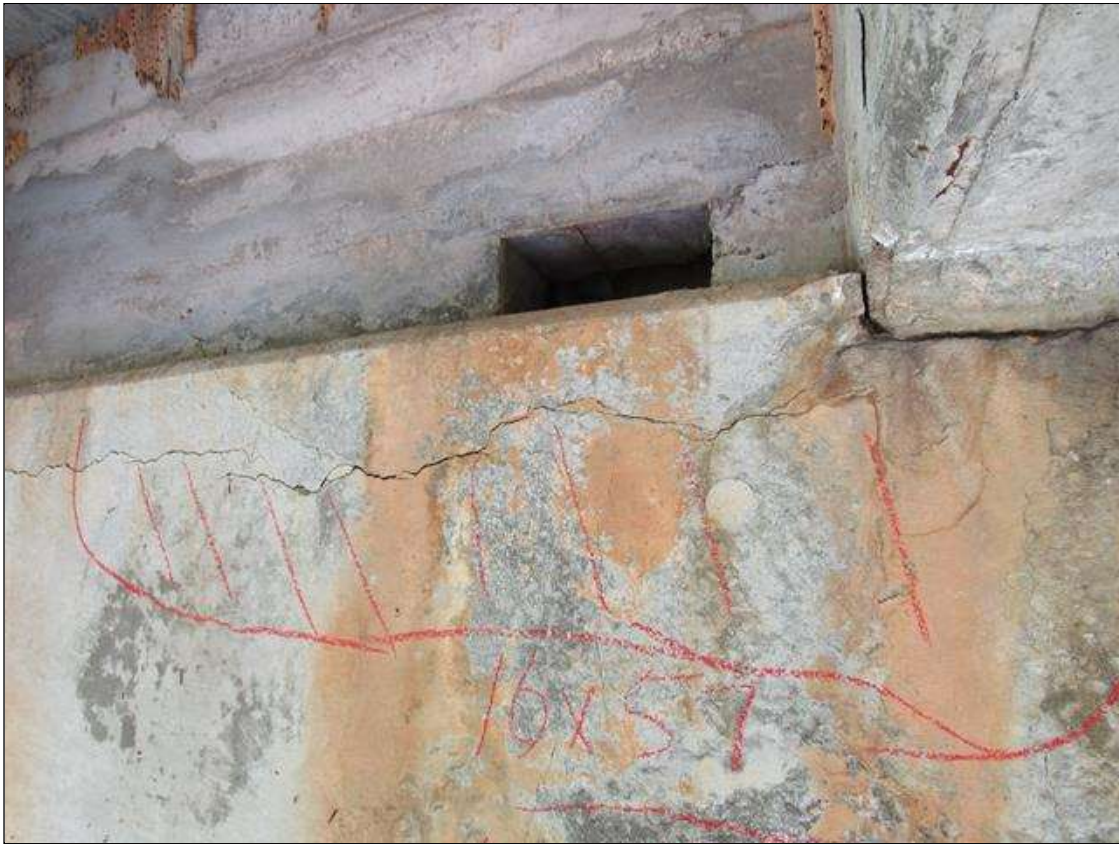
Bent 1 Cap : 0 Feet of Delamination/Spall/Patched Area: Delaminated. Spall 1 inch or less deep or 6 inches or less in diameter. Patched area that is sound
BENT 1 EAST FACE OF CAP HAS A CRACKED DELAMINATED AREA ALONG THE TOP RIGHT SIDE OF GIRDER
3. 16" DOWN FACE 57" LONG.

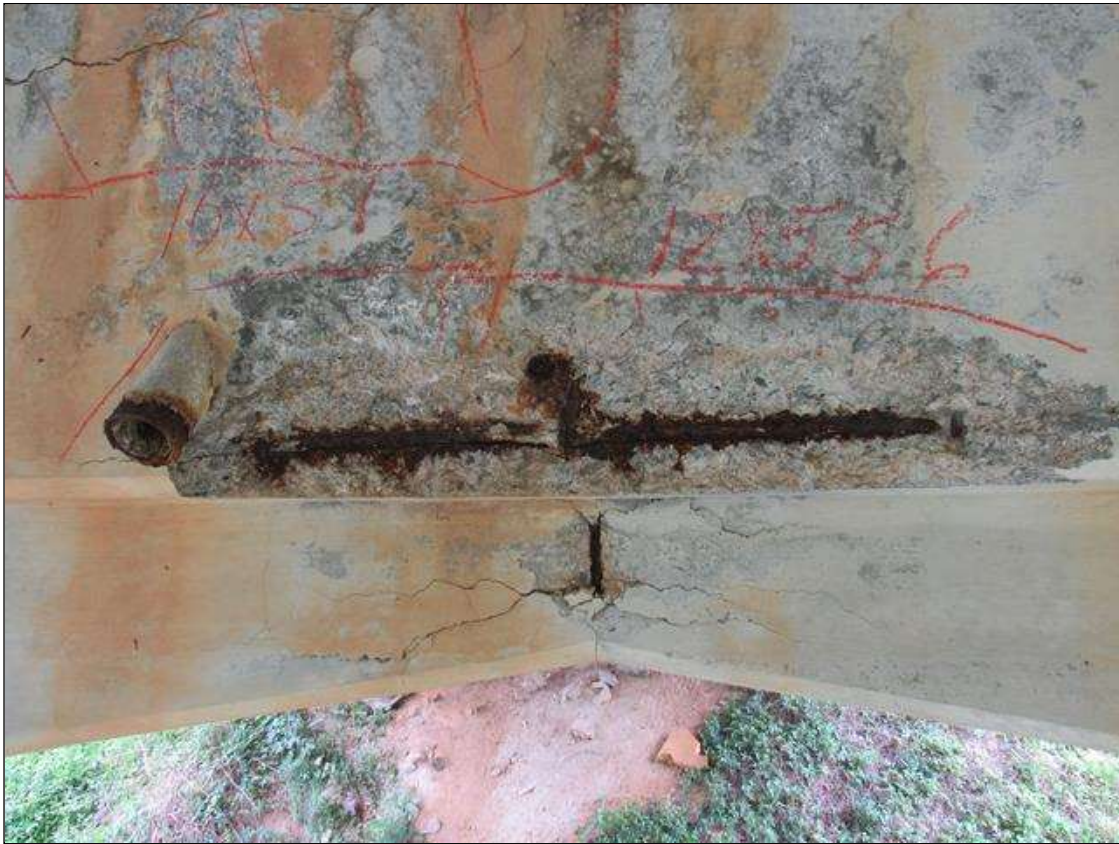
Bent 1 Cap : 0 Feet of Delamination/Spall/Patched Area: Spall greater than 1 inch deep or greater than 6 inches in diameter. Patched area that is unsound or showing distress. Condition does not warrant structural Review
BENT 1 EAST OF CAP HAS CRACKED SPALL DELAMINATED AREA ALONG BOTTOM EDGE OF CAP UNDER GIRDER 3. 12" UP FACE 15" LONG 6" UNDER BOTTOM REBAR AND STIRRUPS EXPOSED.

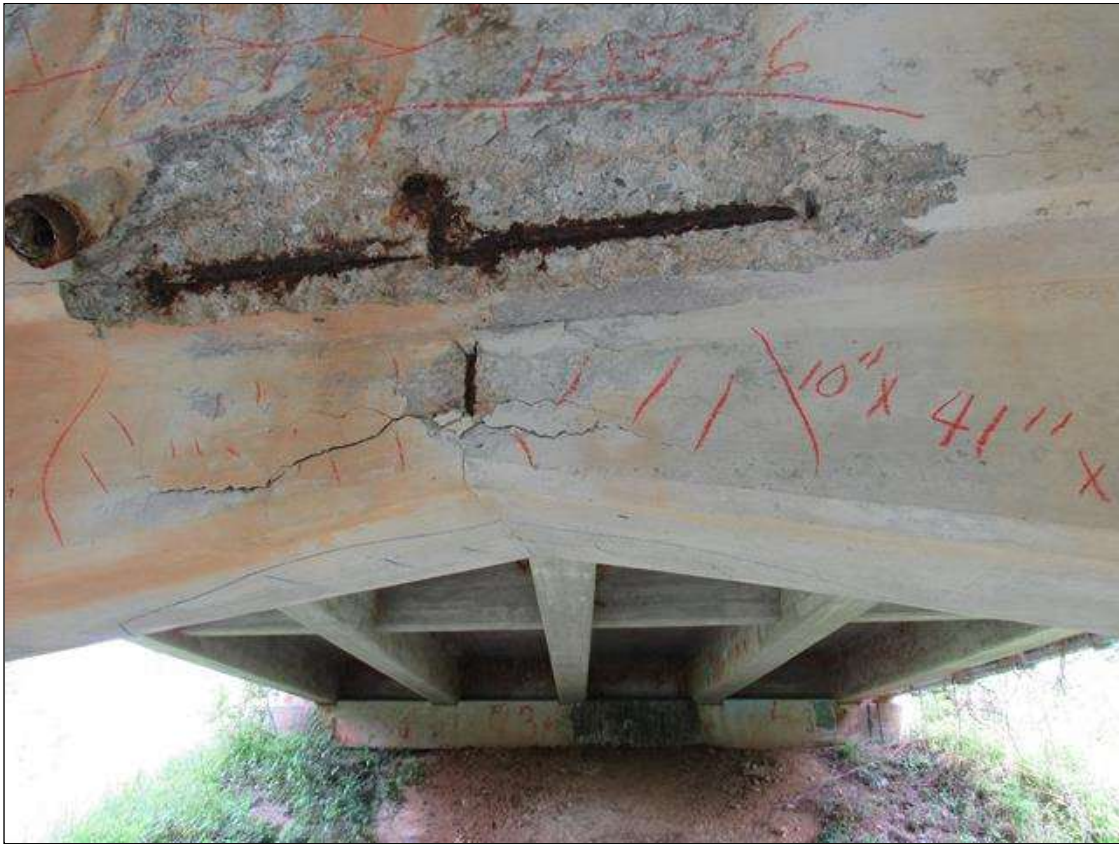
HAUNCH AREA UNDER BENT 1 CAP UNDER GIRDER 3 CRACKED AND DELAMINATED WITH A 6" X 6" X 3/4" SPALL AREA.

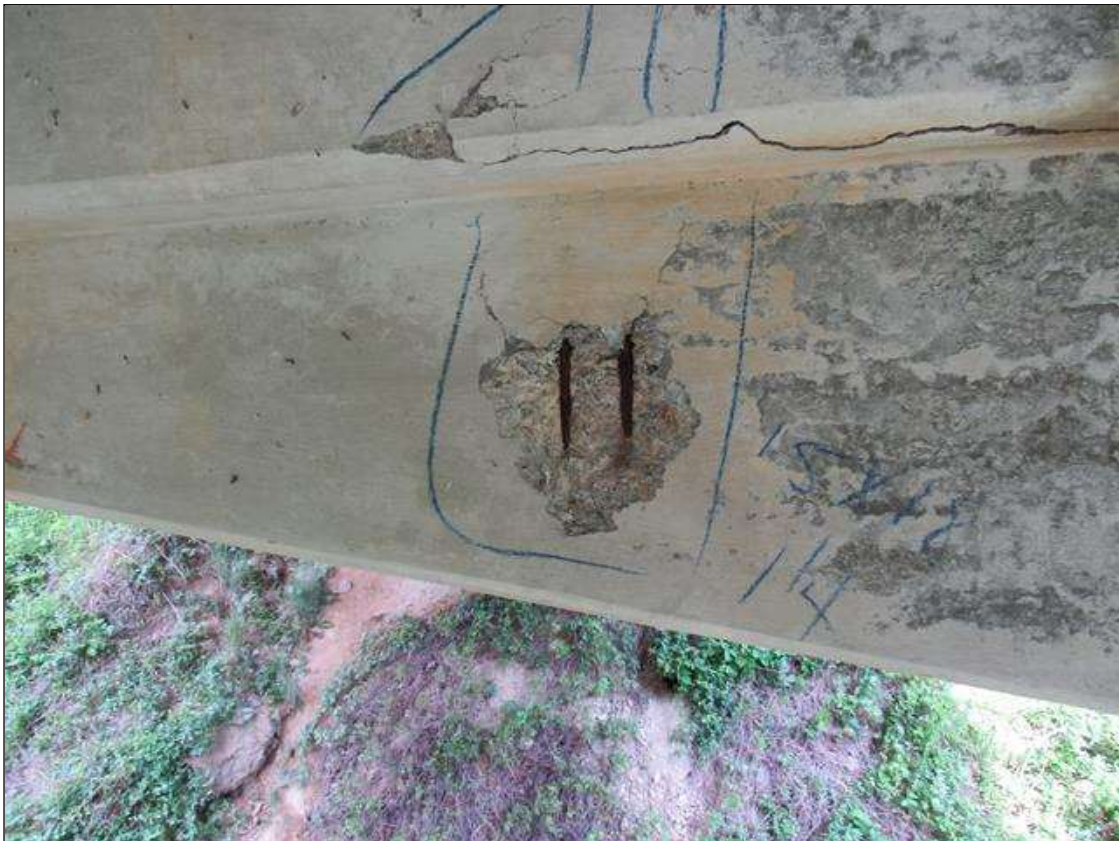
HAUNCH AREA UNDER BENT 1 CAP HAS A CRACKED SPALL DELAMINATED AREA 3' TO RIGHT OF PILE 1 15" X 18" X 1 1/4" DEEP WITH VERTICAL REBAR EXPOSED.

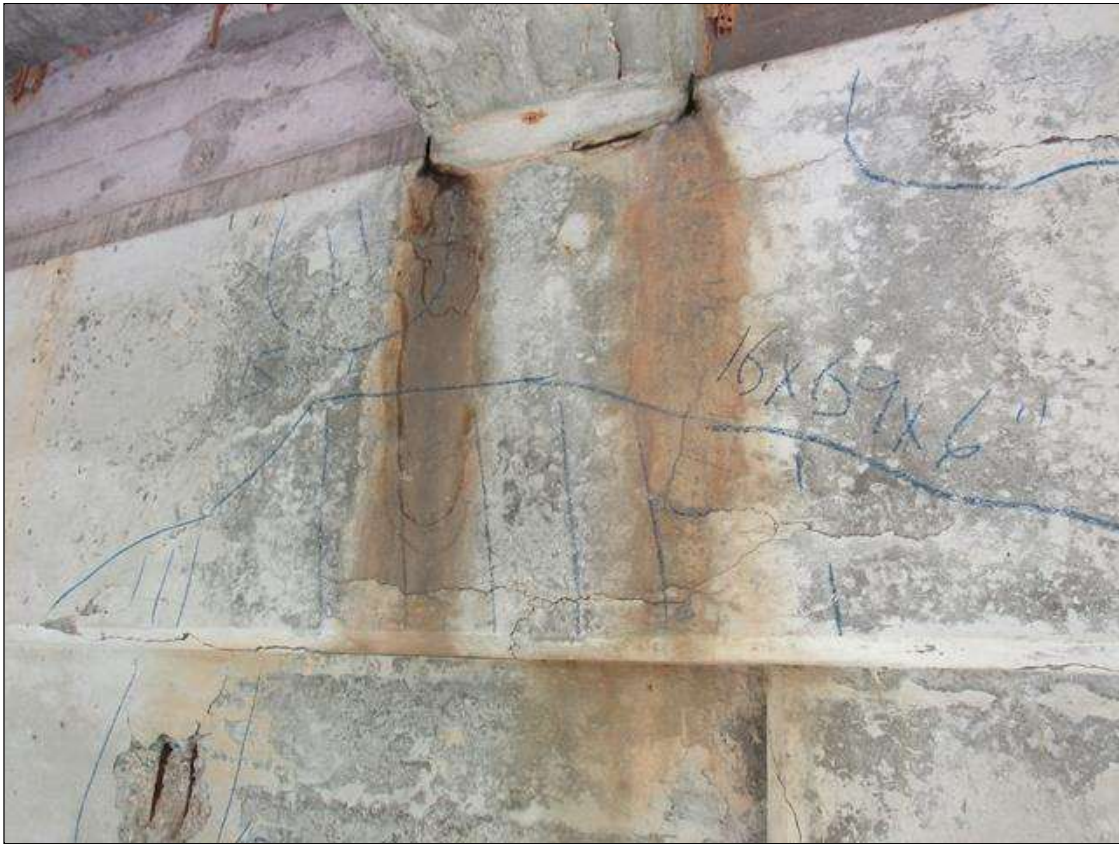
Bent 1 Cap : 0 Feet of Delamination/Spall/Patched Area: Delaminated. Spall 1 inch or less deep or 6 inches or less in diameter. Patched area that is sound
BENT 1 EAST FACE OF CAP HAS 2 SPALL AREAS UNDER GIRDER 2 15' X 16" AND FM BOTTOM UP 16" 69" LONG AND 6" UNDER BOTTOM.

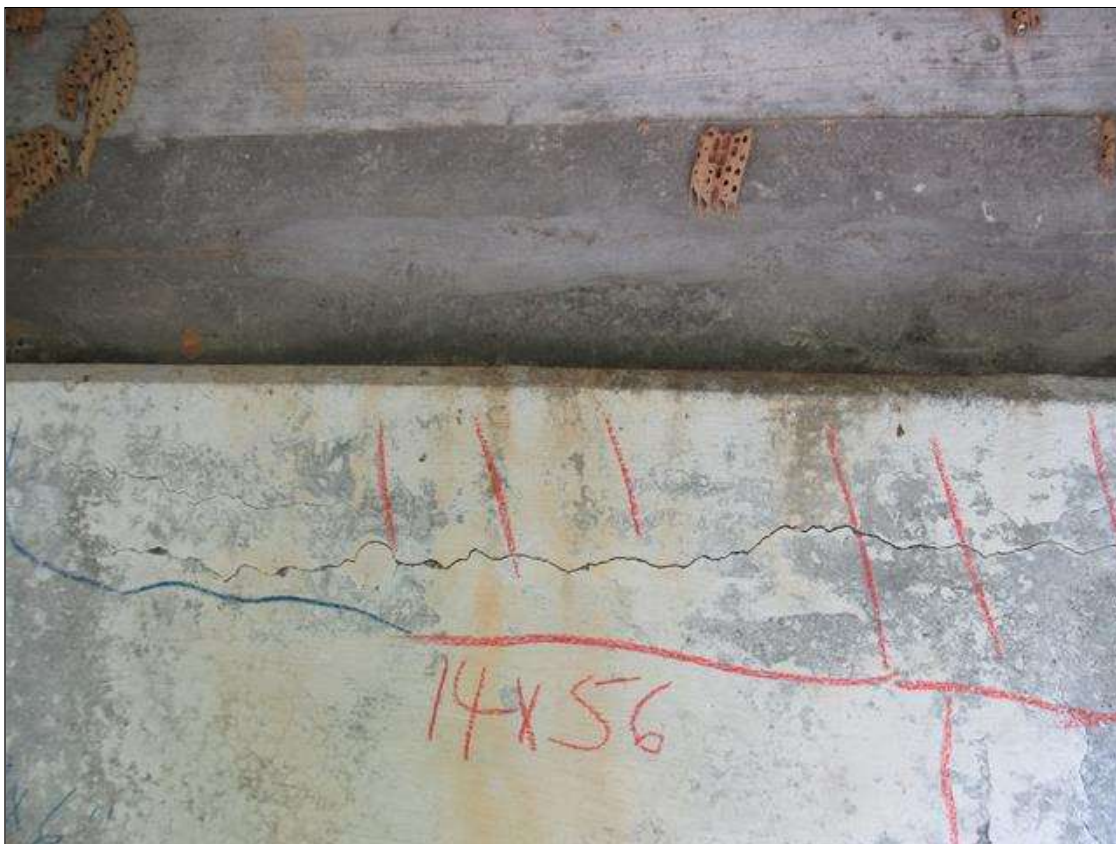
Bent 1 Cap : 0 Feet of Delamination/Spall/Patched Area: Delaminated. Spall 1 inch or less deep or 6 inches or less in diameter. Patched area that is sound
BENT 1 EAST OF CAP HAS A HORZ CRACKED AND DELAMINATED AREA BETWEEN G1 AND G2. 14" DOWN FACE AND 56" LONG.

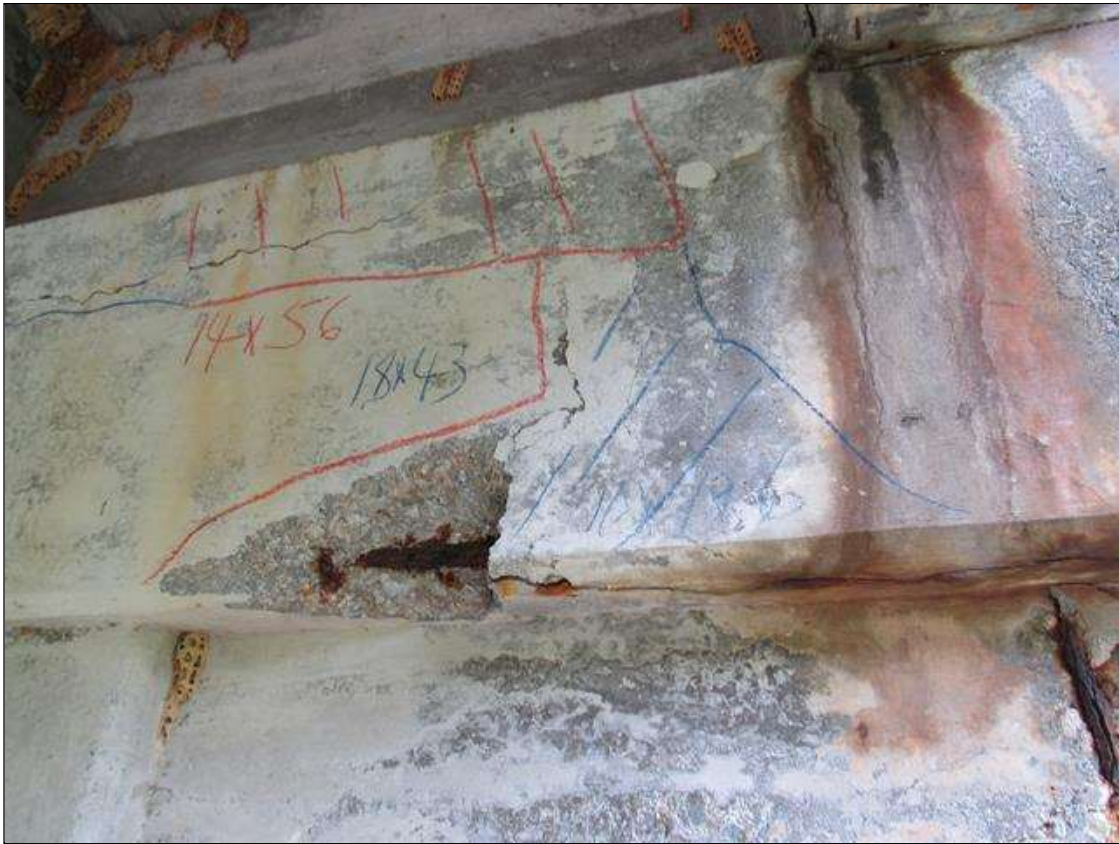
Bent 1 Cap : 0 Feet of Delamination/Spall/Patched Area: Spall greater than 1 inch deep or greater than 6 inches in diameter. Patched area that is unsound or showing distress. Condition does not warrant structural Review
BENT 1 EAST OF CAP HAS CRACKED SPALL DELAMINATED AREA ALONG BOTTOM OF CAP RIGHT SIDE OF G1 18" UP FACE 43" LONG SPALL IS 10" X 19" X 6" WITH LARGE REBAR EXPOSED.

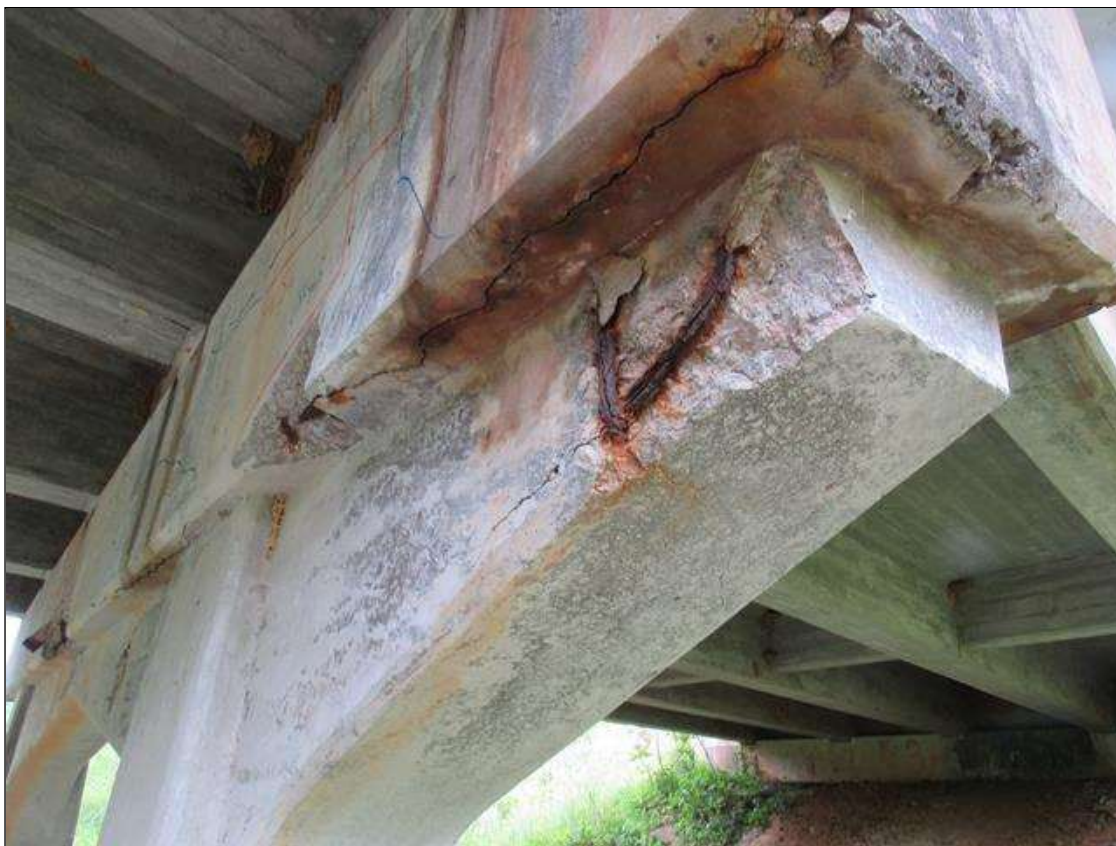
HAUNCH AREA BELOW BOTTOM OF CAP UNDER GIRDER 1 CRCKED SPALL DELAMINATED FM 8" UP FACE
32" LONG AND 12" UNDER BOTTOM.

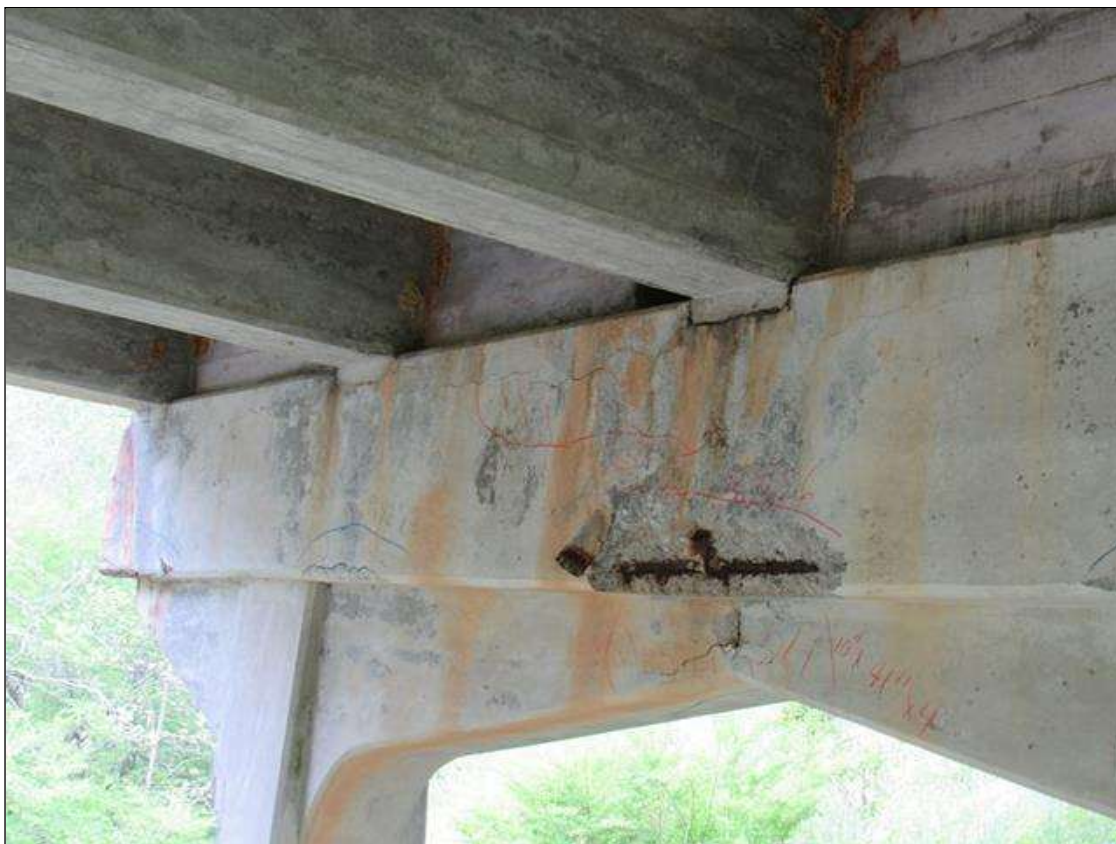
Bent 1 Cap : 0 Feet of Delamination/Spall/Patched Area: Delaminated. Spall 1 inch or less deep or 6 inches or less in diameter. Patched area that is sound
BENT 1 EAST FACE OF CAP HAS HORZ CRACKS FROM LEFT TO RIGHT END ALONG THE FACE OF CAP.

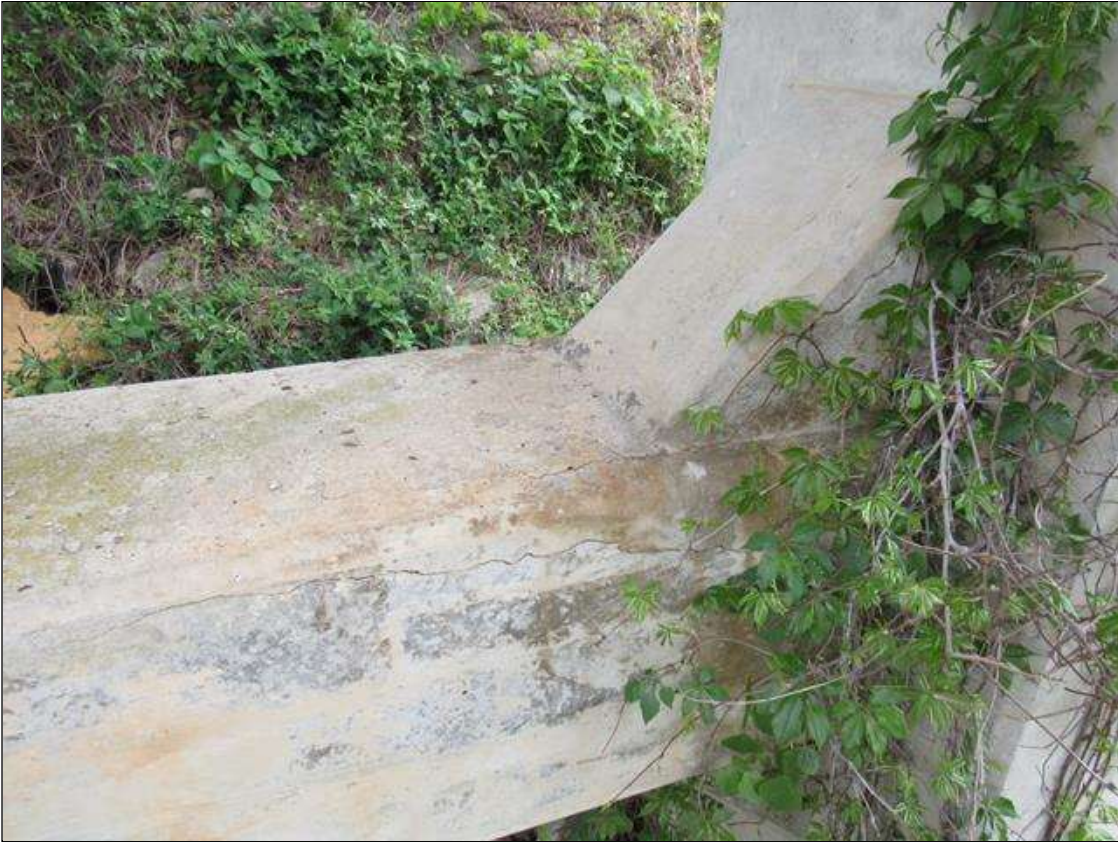
VERTICAL STRUT AT BENT 1 RIGHT SIDE OF PILE 1 CRACKED AND DELAMINATED. 15" ON TOP 5' LONG AND 10" DOWN FACE.
