NC DEPARTMENT OF TRANSPORTATION
 DIVISION OF HIGHWAYS
 STRUCTURE MANAGEMENT UNIT

ATTENTION:

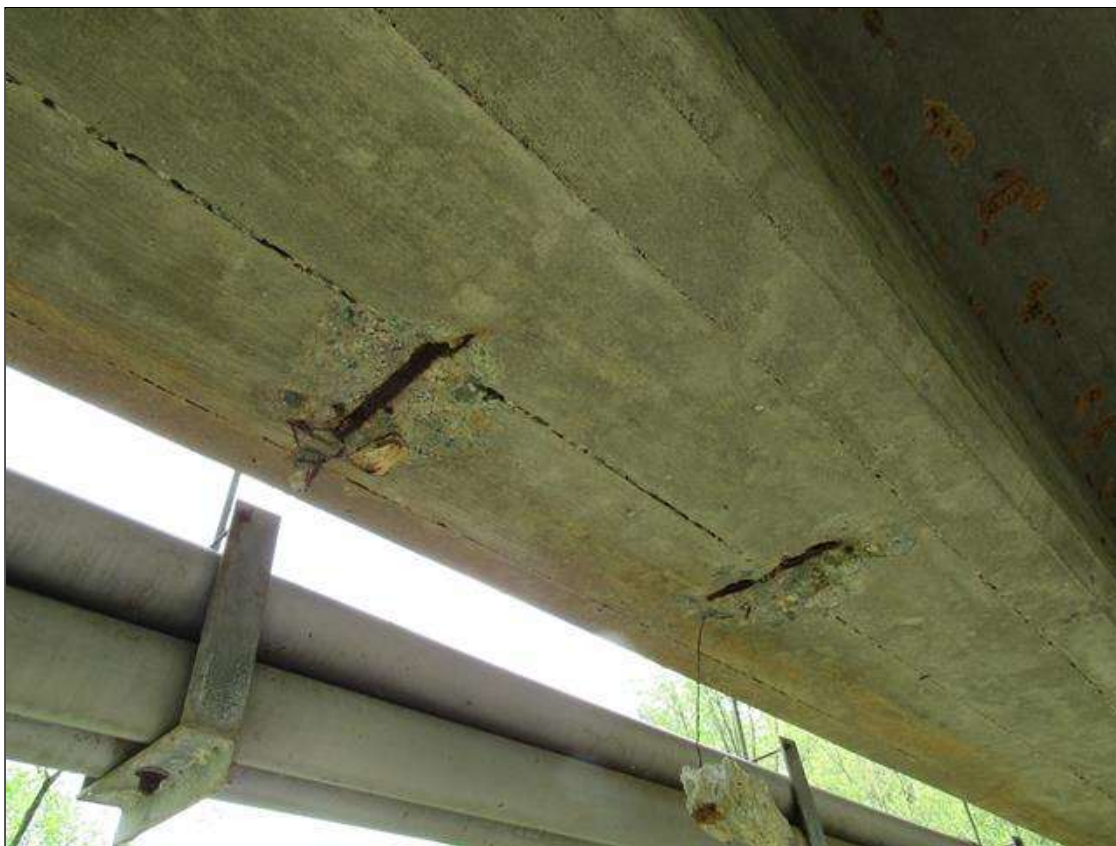
Span 2 Beam 1: 1 Feet of Delamination/Spall/Patched Area: Delaminated. Spall 1 in. or less deep or 6 in. or less in diameter. Patched area that is sound.
SPAN 2 GIRDER 1 HAS 2 SURFACE SPALL AREAS IN BOTTOM OF GIRDER 6" X 6" X 9" BOTH ARE 3/4" DEEP WITH REBAR EXPOSED 8' FROM BENT 2 CAP.

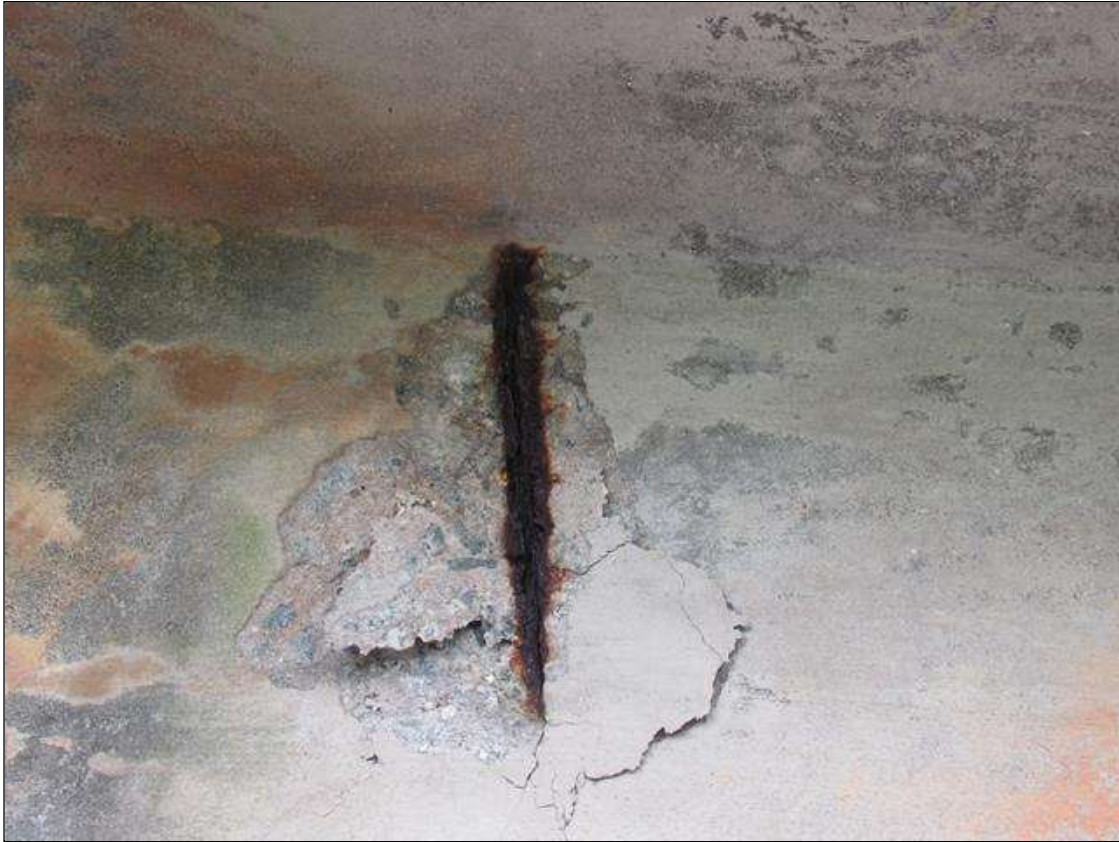
Span 2 Beam 1: 1 Feet of Delamination/Spall/Patched Area: Delaminated. Spall 1 in. or less deep or 6 in. or less in diameter. Patched area that is sound.
SPAN 2 GIRDER 1 LEFT SIDE OVER BENT 2 HAS A 9" X 10" SURFACE SPALL AREA 3/4" DEEP WITH REBAR EXPOSED.

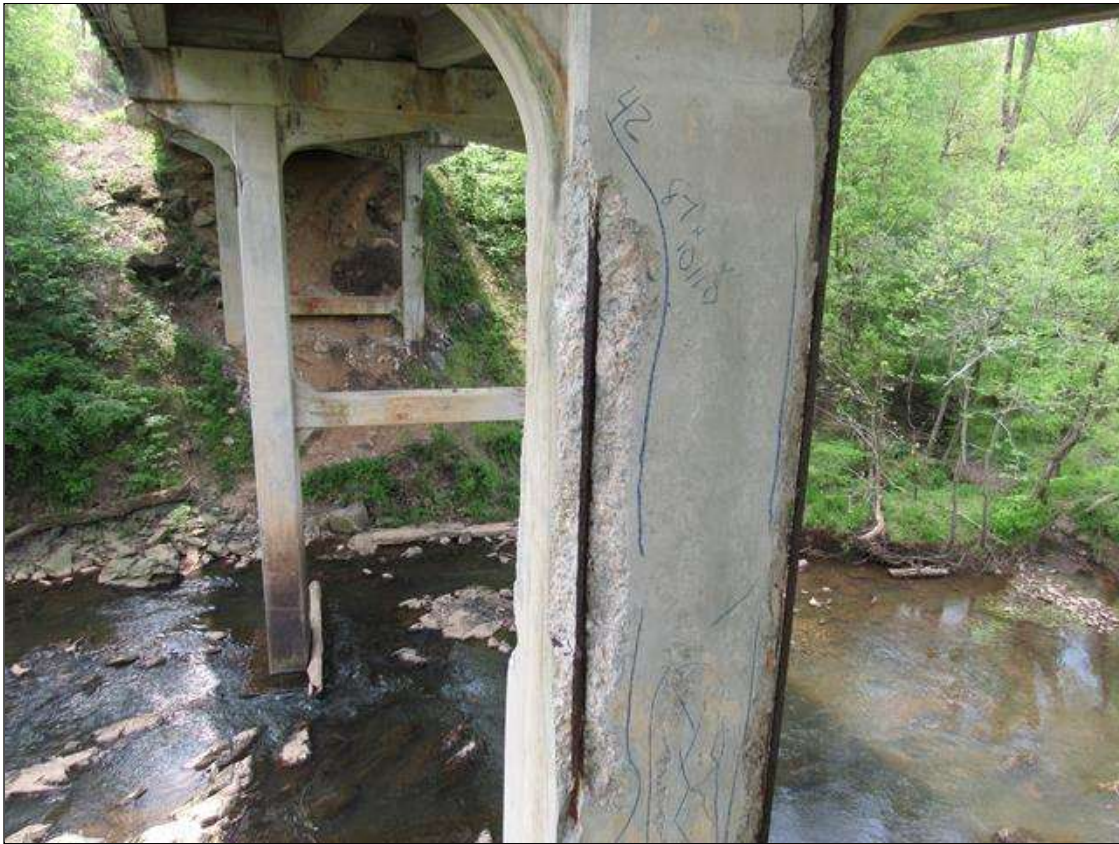
Bent 2 Pile 1: 1 Each of Delamination/Spall/Patched Area: Spall greater than 1 in. deep or greater than 6 in. diameter.
Patched area that is unsound or showing distress. Does not warrant structural review.
BENT 2 PILE 1 CRACKED SPALL DELAMINATED AREA NW CORNER OF PILE STARTS 42" BELOW CAP
EXTENDS DOWN 87" AND 10" ON EACH FACE.

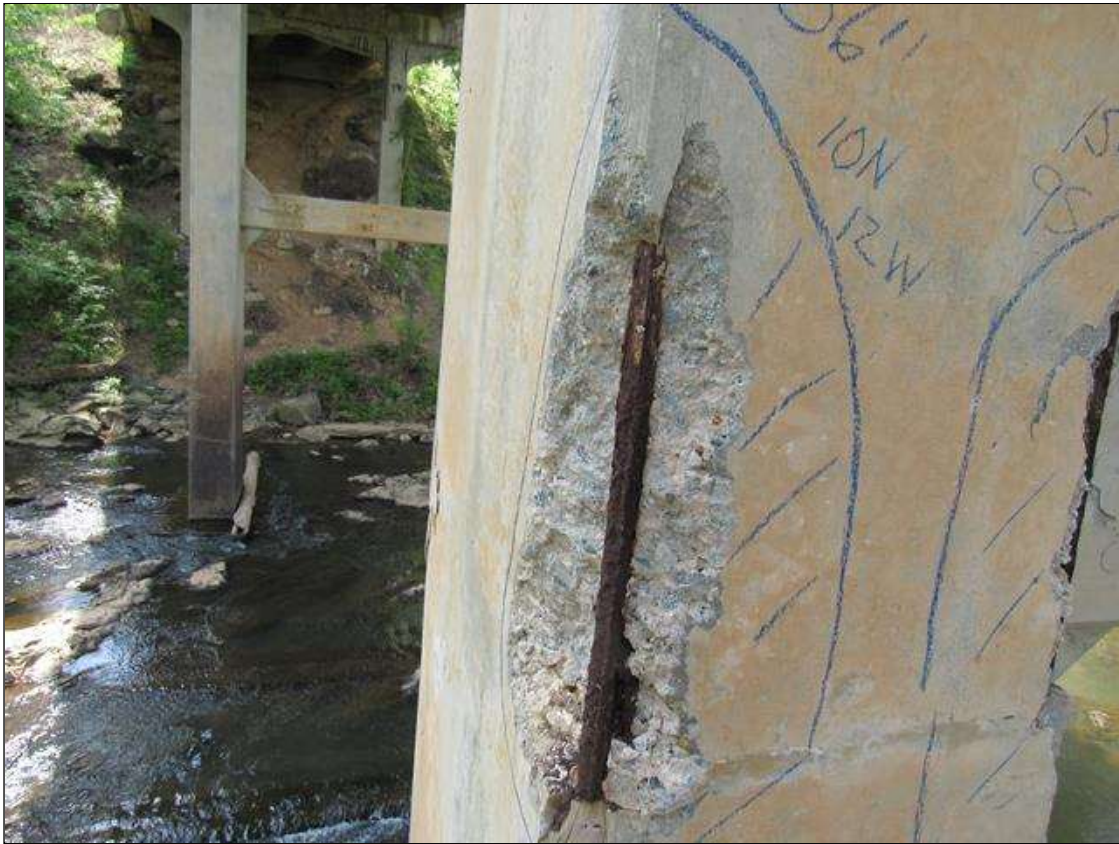
Bent 2 Pile 1: 0 Each of Delamination/Spall/Patched Area: Spall greater than 1 in. deep or greater than 6 in. diameter.
Patched area that is unsound or showing distress. Does not warrant structural review.
BENT 2 PILE 1 NW CORNER HAS CRACKED SPALL DELAMINATED AREA START 15' ABOVE FOOTING
EXTENDS UP 36" & 10" ON NORTH FACE 12" ON WEST FACE WITH 2 LARGE REBAR EXPOSED.

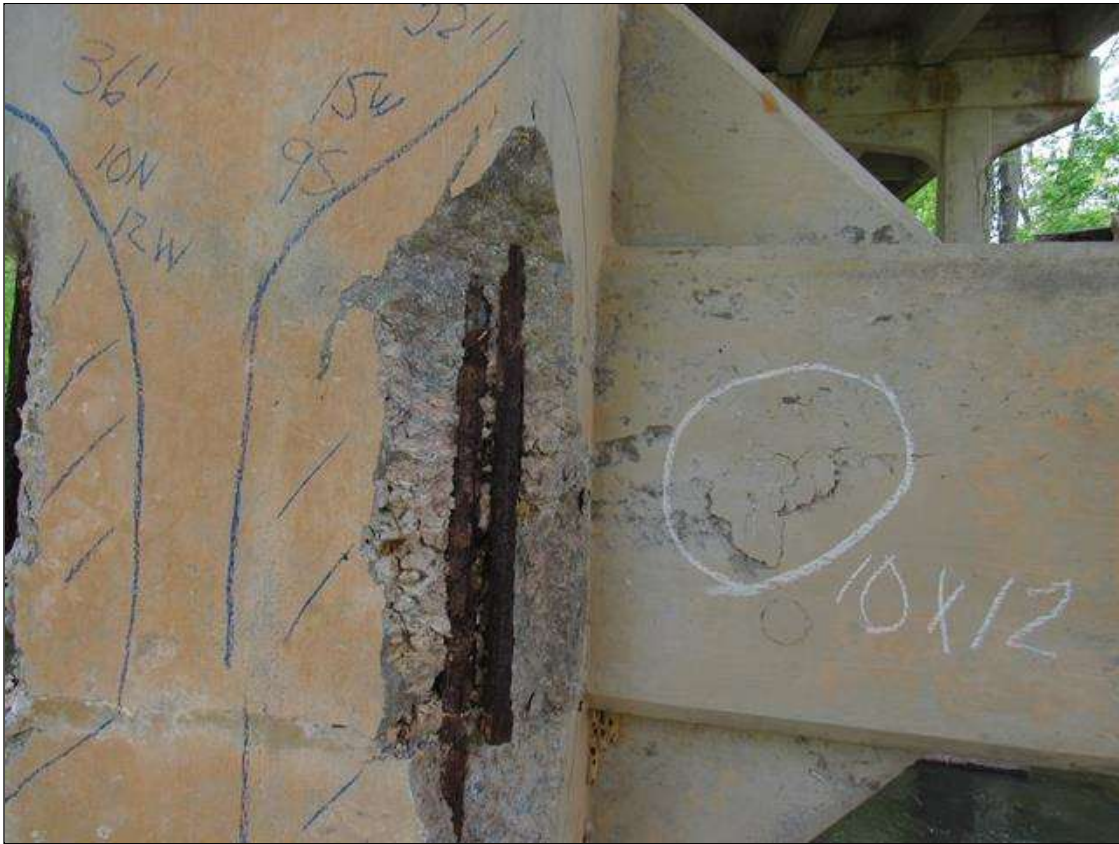
Bent 2 Pile 1: 0 Each of Delamination/Spall/Patched Area: Spall greater than 1 in. deep or greater than 6 in. diameter.
Patched area that is unsound or showing distress. Does not warrant structural review.

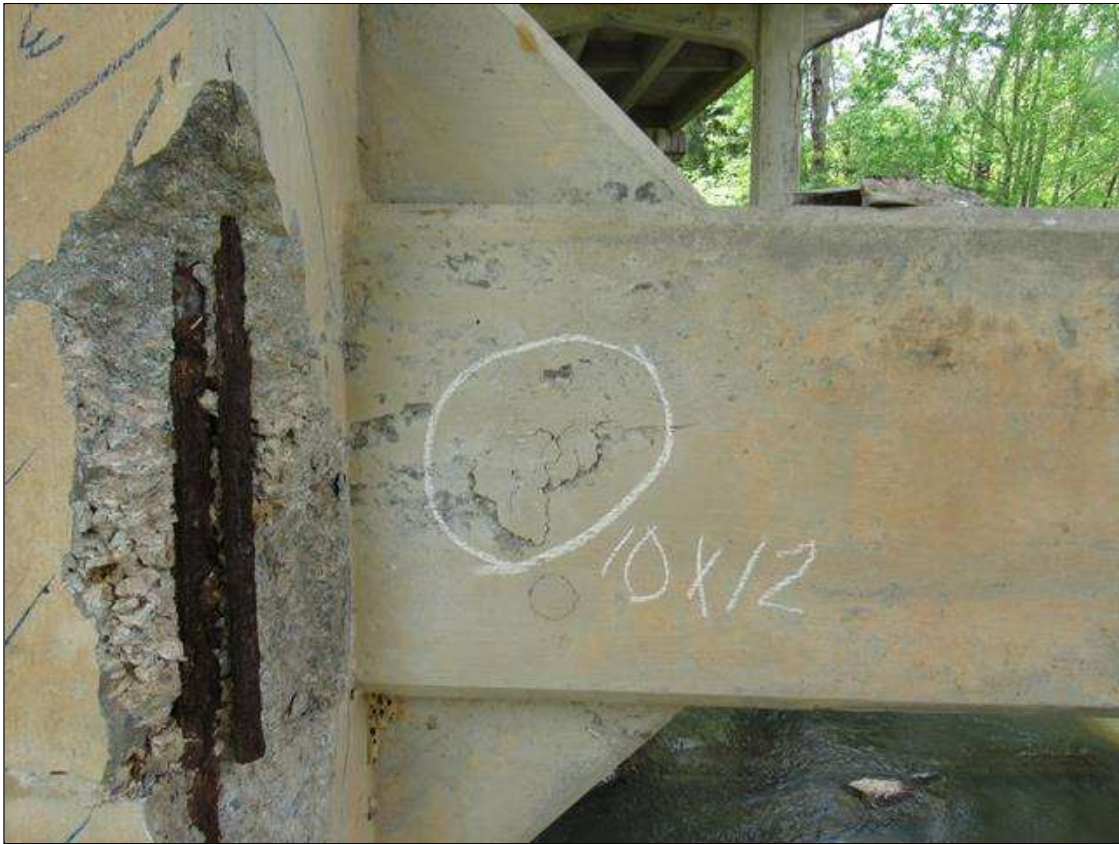
BENT 2 CRACKED DELAMINATED AREA 10" BY 12" ON VERTICAL STRUT RIGHT SIDE OF PILE 1.

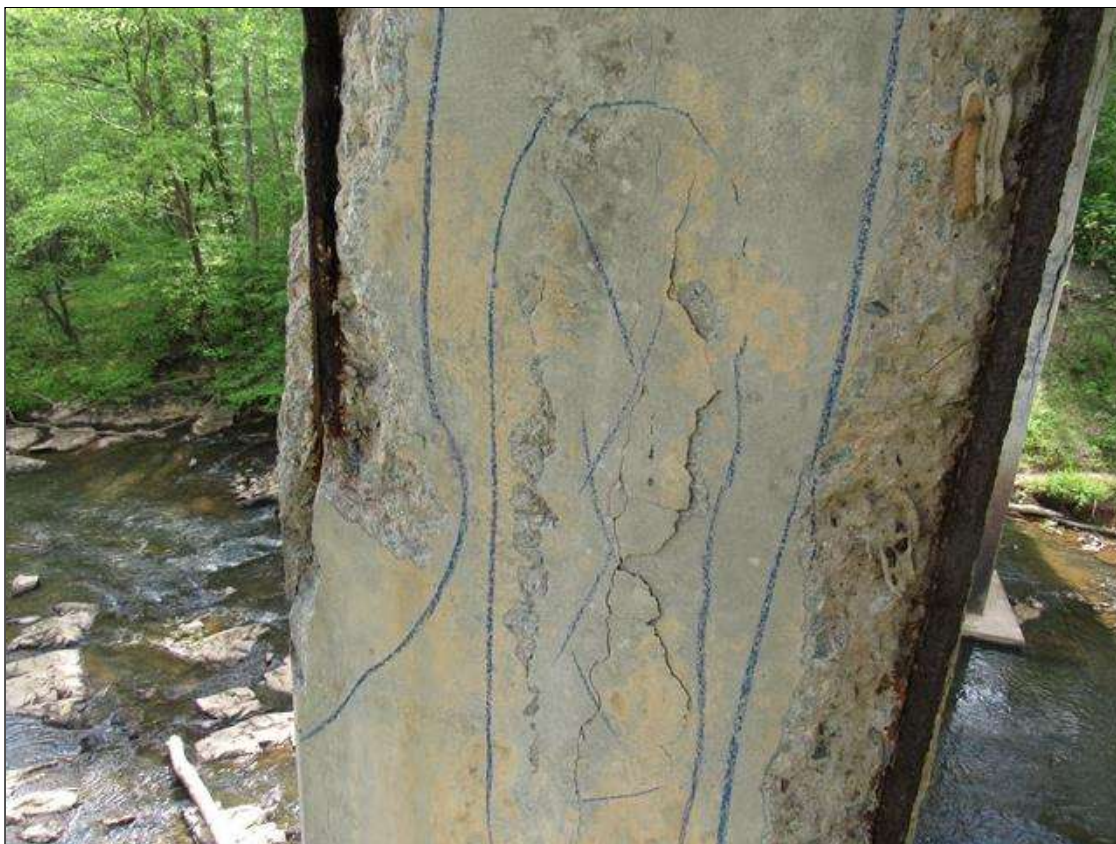
Bent 2 Pile 1: 0 Each of Delamination/Spall/Patched Area: Delaminated. Spall 1 in. or less deep or 6 in. or less in diameter. Patched area that is sound.
BENT 2 PILE 1 HAS A CRACKED DELAMINATED AREA ON WEST FACE 100" BELOW BOTTOM OF CAP 9" X 36".

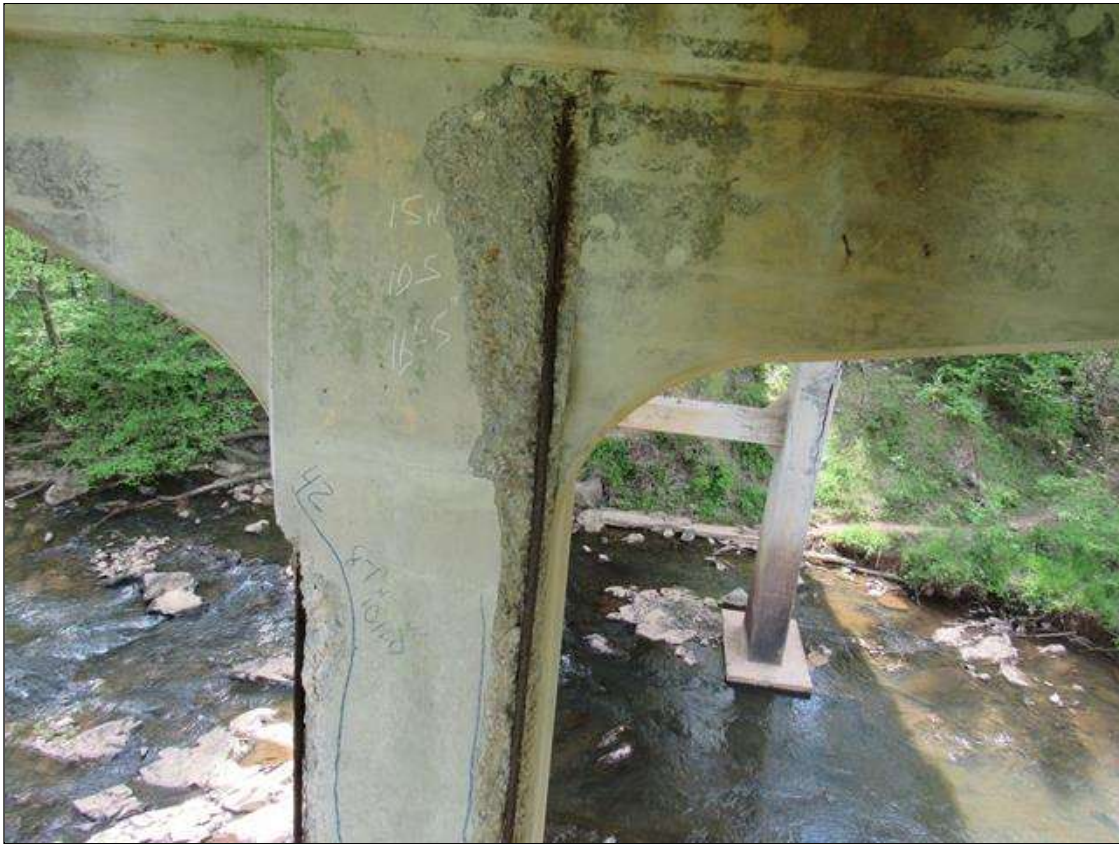
Bent 2 Pile 1: 0 Each of Delamination/Spall/Patched Area: Spall greater than 1 in. deep or greater than 6 in. diameter.
Patched area that is unsound or showing distress. Does not warrant structural review.
BENT 2 PILE 1 HAS A CRACKED SPALL DELAMINATED AREA ON SW CORNER FM BOTTOM OF CAP DOWN 16'
5" FROM 8 TO 15 ON WEST FACE AND 10" ON SOUTH. LARGE REBAR EXPOSED.

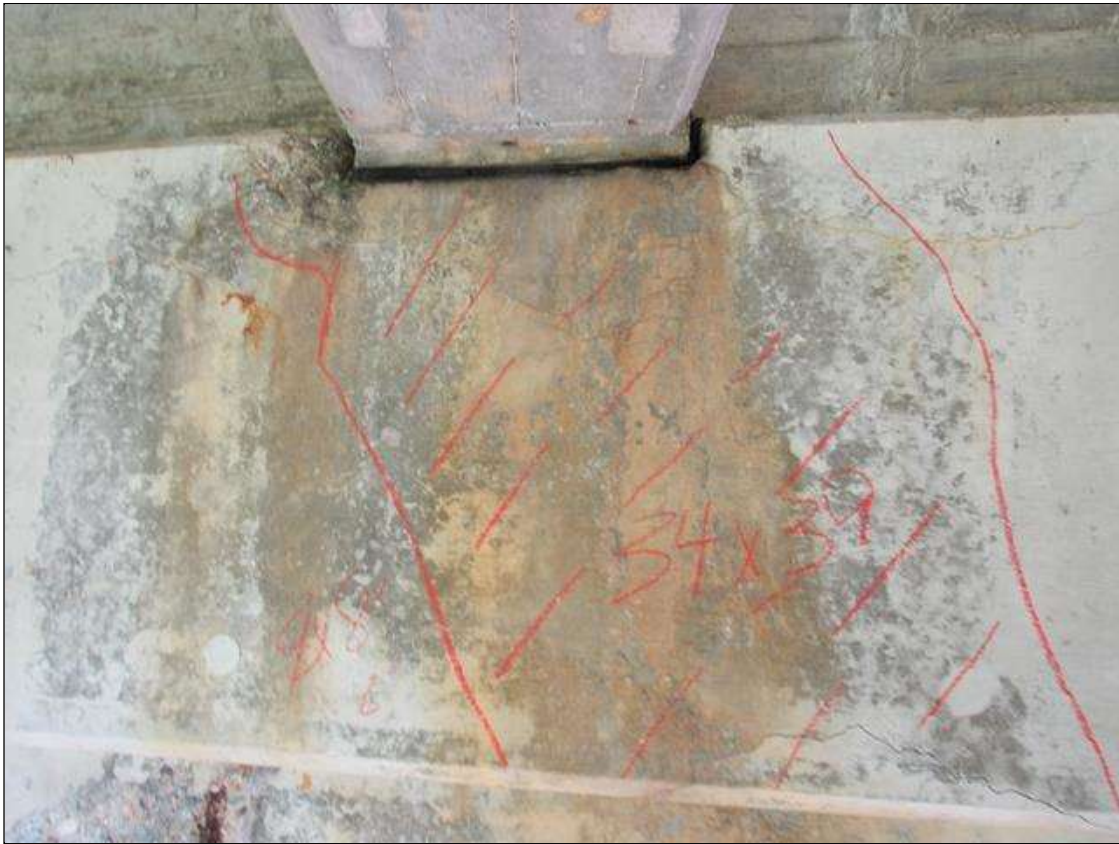
Bent 2 Cap : 3 Feet of Delamination/Spall/Patched Area: Delaminated. Spall 1 inch or less deep or 6 inches or less in diameter. Patched area that is sound

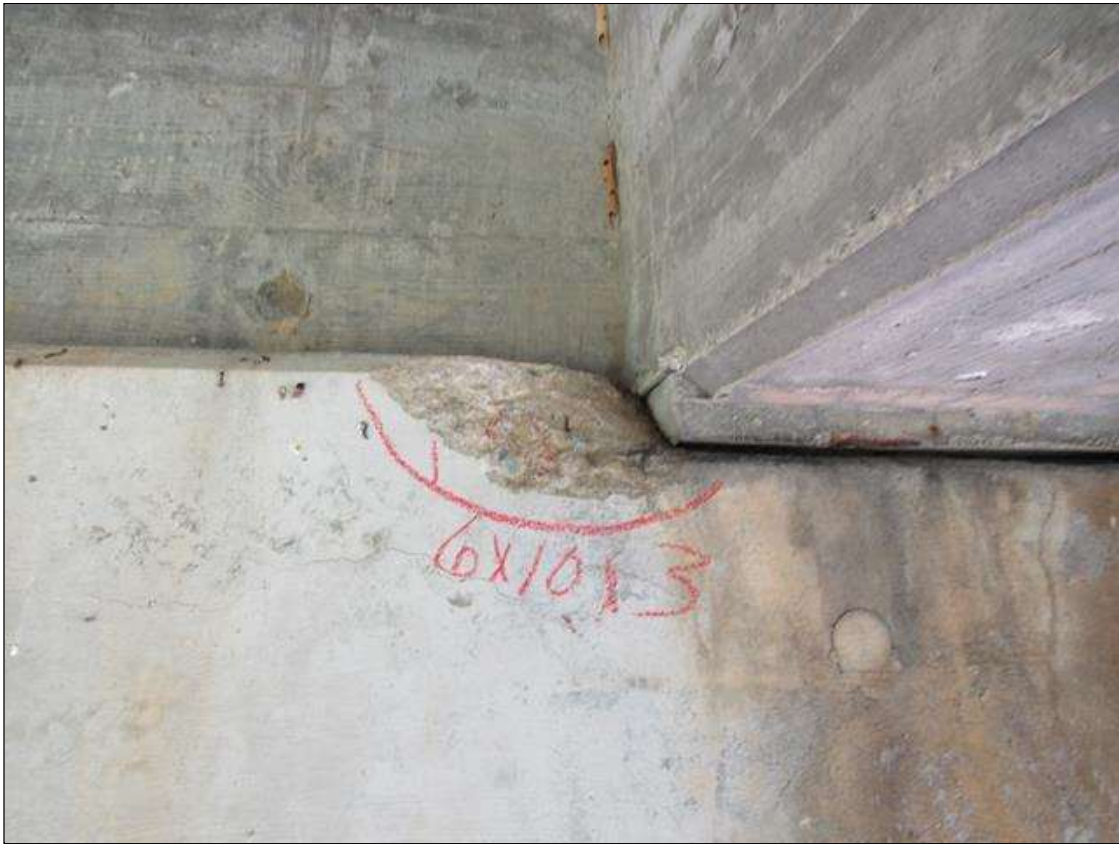
Bent 2 Cap : 1 Feet of Delamination/Spall/Patched Area: Delaminated. Spall 1 inch or less deep or 6 inches or less in diameter. Patched area that is sound
BENT 2 CAP WEST FACE HAS A SPALL AREA ALONG LEFT SIDE OF GIRDER 3. 6" X 10" X 3" DEEP.

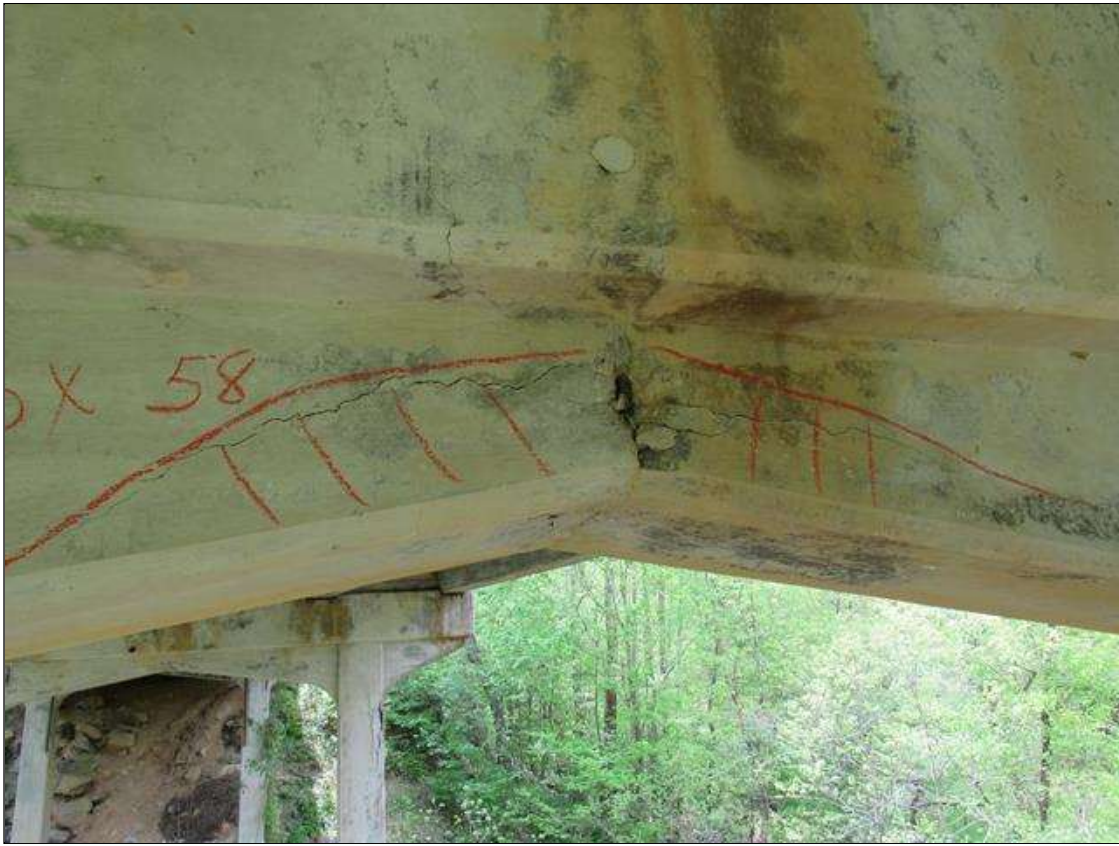
HAUNCH AREA UNDER BOTTOM OF BENT 2 CAP WEST FACE HAS A CRACKED DELAMINATED SPALL AREA.
8" X 58". SPALL AREA IS 8" X 8" X 3/4" DEEP.

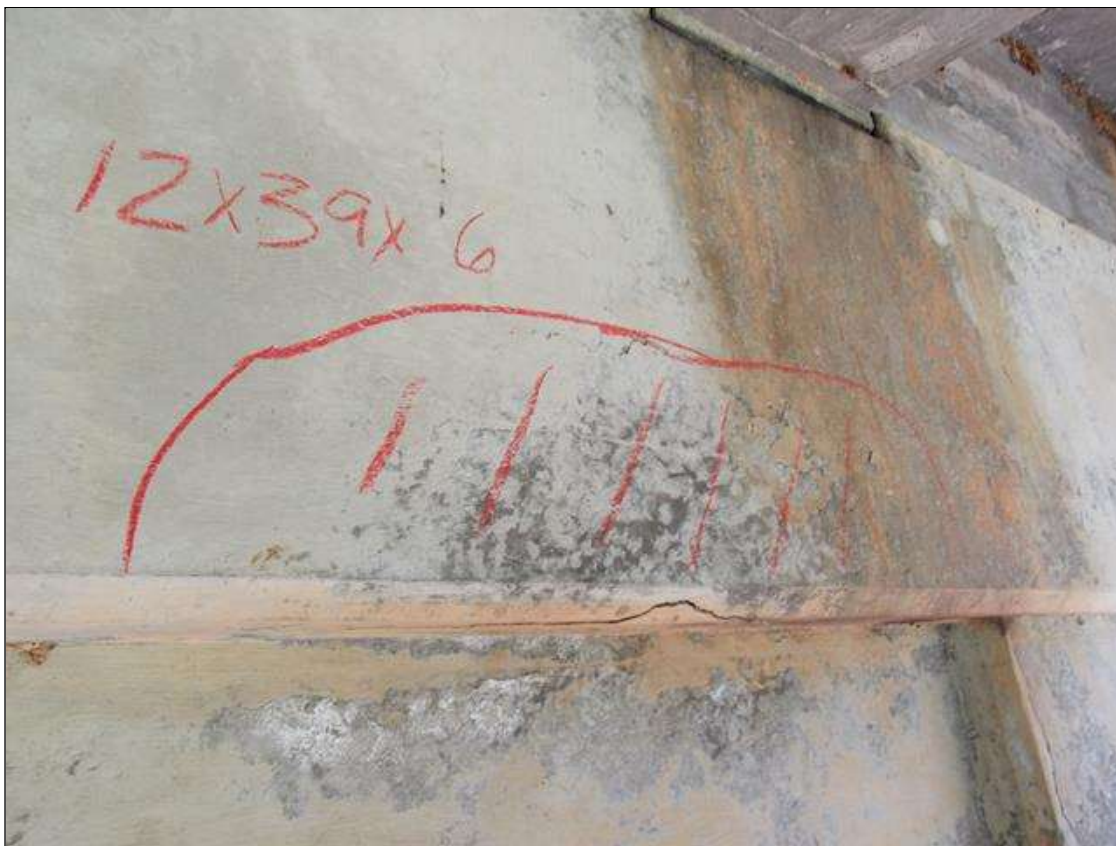
Bent 2 Cap : 4 Feet of Delamination/Spall/Patched Area: Delaminated. Spall 1 inch or less deep or 6 inches or less in diameter. Patched area that is sound
BENT 2 WEST FACE OF CAP CRACKED AND DELAMINATED AREA UNDER BOTTOM EDGE 12" UP FACE 39" LONG 6" UNDER BOTTOM.

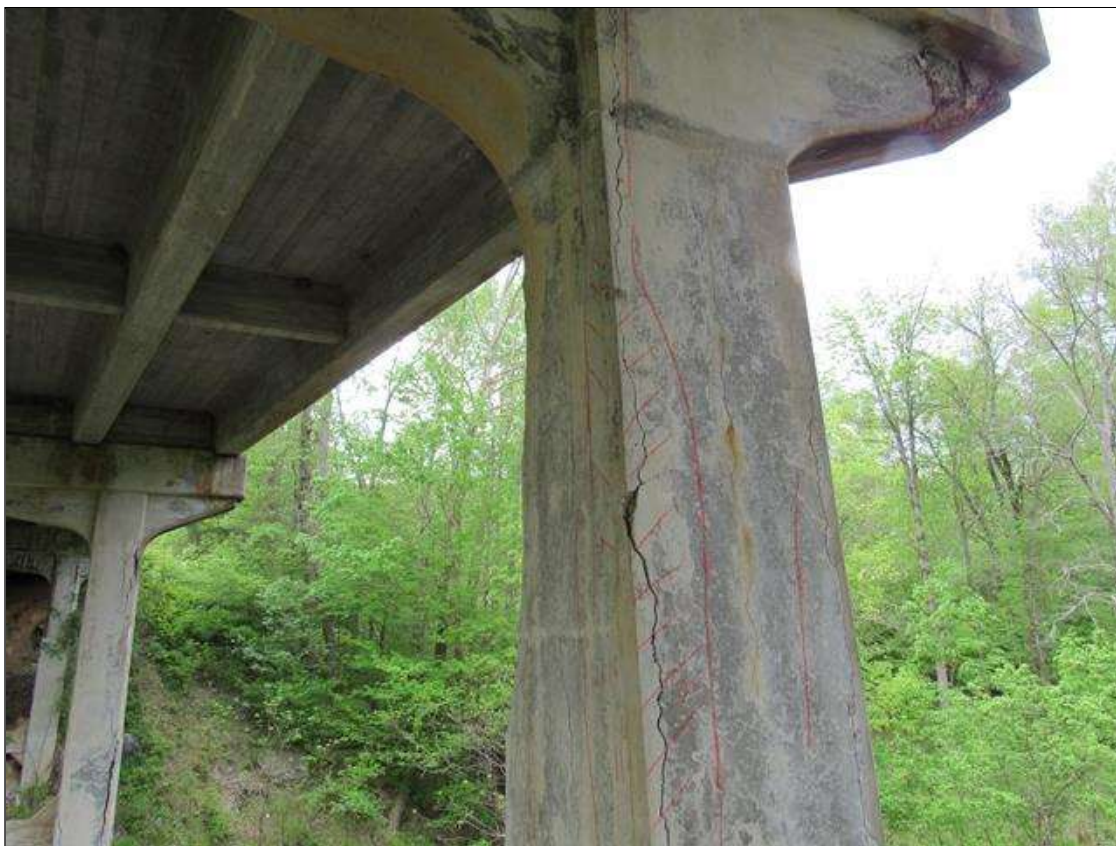
Bent 2 Pile 2: 1 Each of Delamination/Spall/Patched Area: Delaminated. Spall 1 in. or less deep or 6 in. or less in diameter. Patched area that is sound.
BENT 2 PILE 2 CRACKED DELAMINATED AREA ON NW FACE OF PILE FM TOP DOWN 11' AND 11" ON NORTH AND 9" ON WEST.

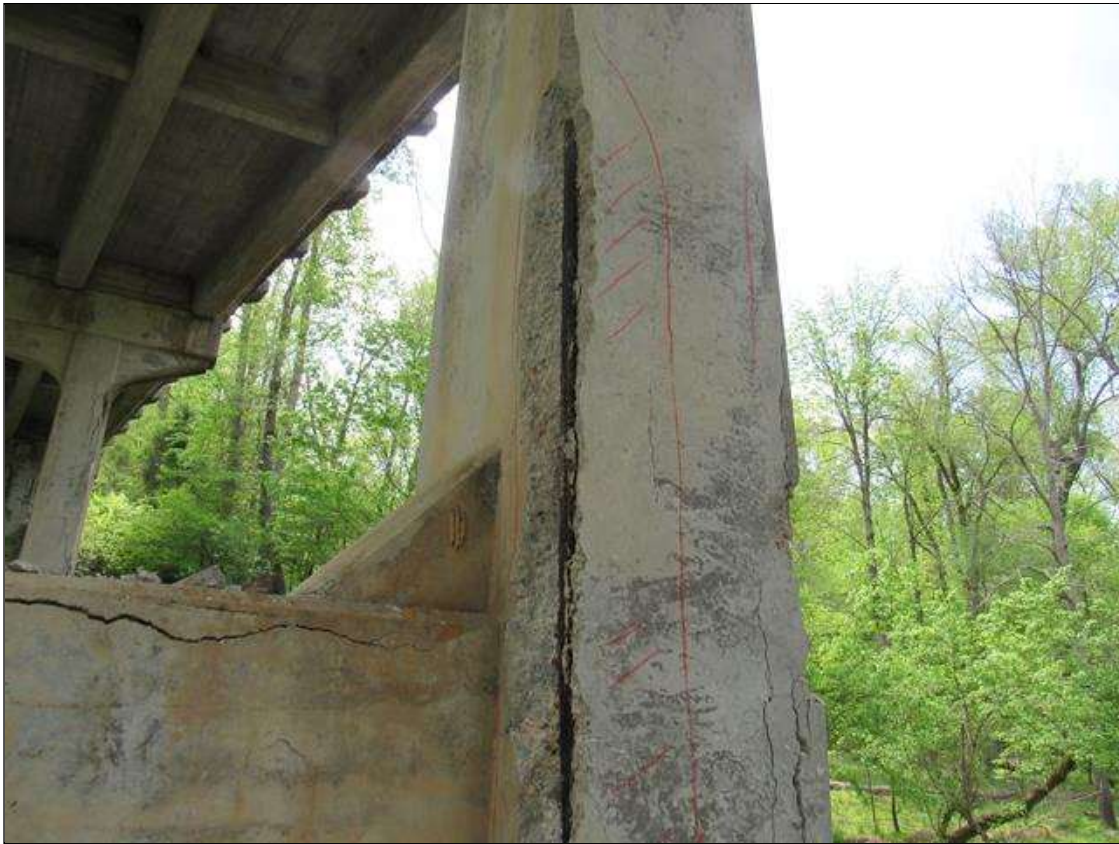
Bent 2 Pile 2: 0 Each of Delamination/Spall/Patched Area: Spall greater than 1 in. deep or greater than 6 in. diameter.
Patched area that is unsound or showing distress. Does not warrant structural review.
BENT 2 PILE 2 HAS A CRACKED SPALL DELAMINATED AREA NW CORNER 10" ON NORTH 12 ON WEST,
START 14' ABOVE FOOTING EXTENDS UP 9' HIGH WITH LARGE REBAR EXPOSED.

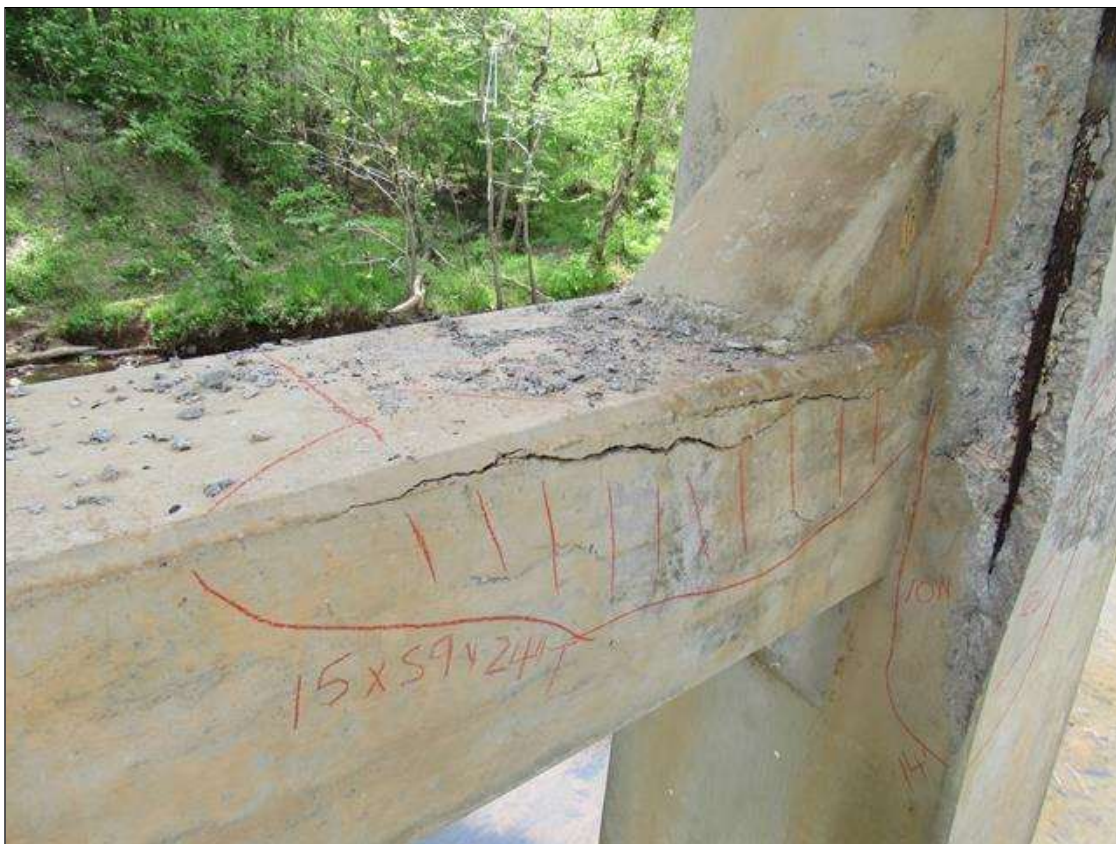
HORZ STRUT BETWEEN PILES 1 AND 2 AT BENT 2 CRACKED AND DELAMINATED AREA LEFT SIDE OF PILE 2
15" DOWN FACE 59" LONG 24" ON TOP.

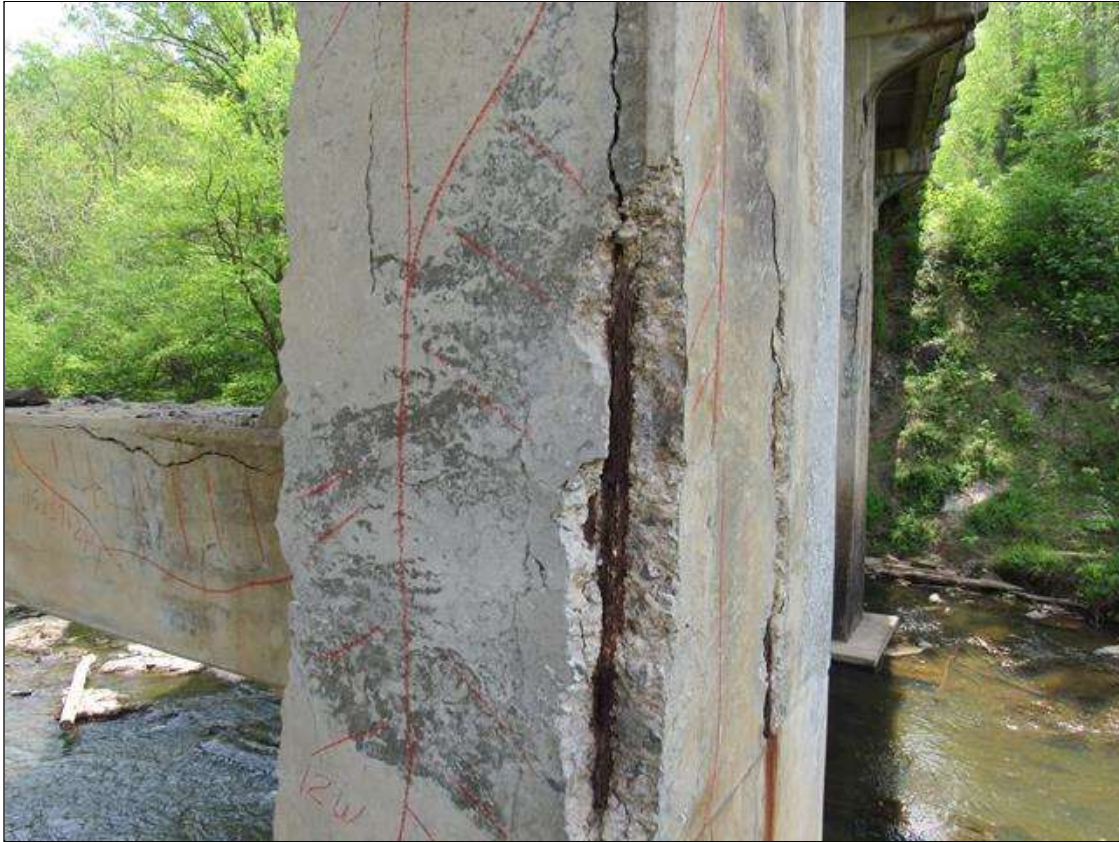
Bent 2 Pile 2: 0 Each of Delamination/Spall/Patched Area: Spall greater than 1 in. deep or greater than 6 in. diameter. Patched area that is unsound or showing distress. Does not warrant structural review.
BENT 2 PILE 2 CRACKED SPALL DELAMINATED AREA SW CORNER STARTS 14' ABOVE FOOTING EXTENDS UP 8' 4" FM 6" TO 16' ON WEST FACE AND 10" ON SOUTH. REBAR EXPOSED.

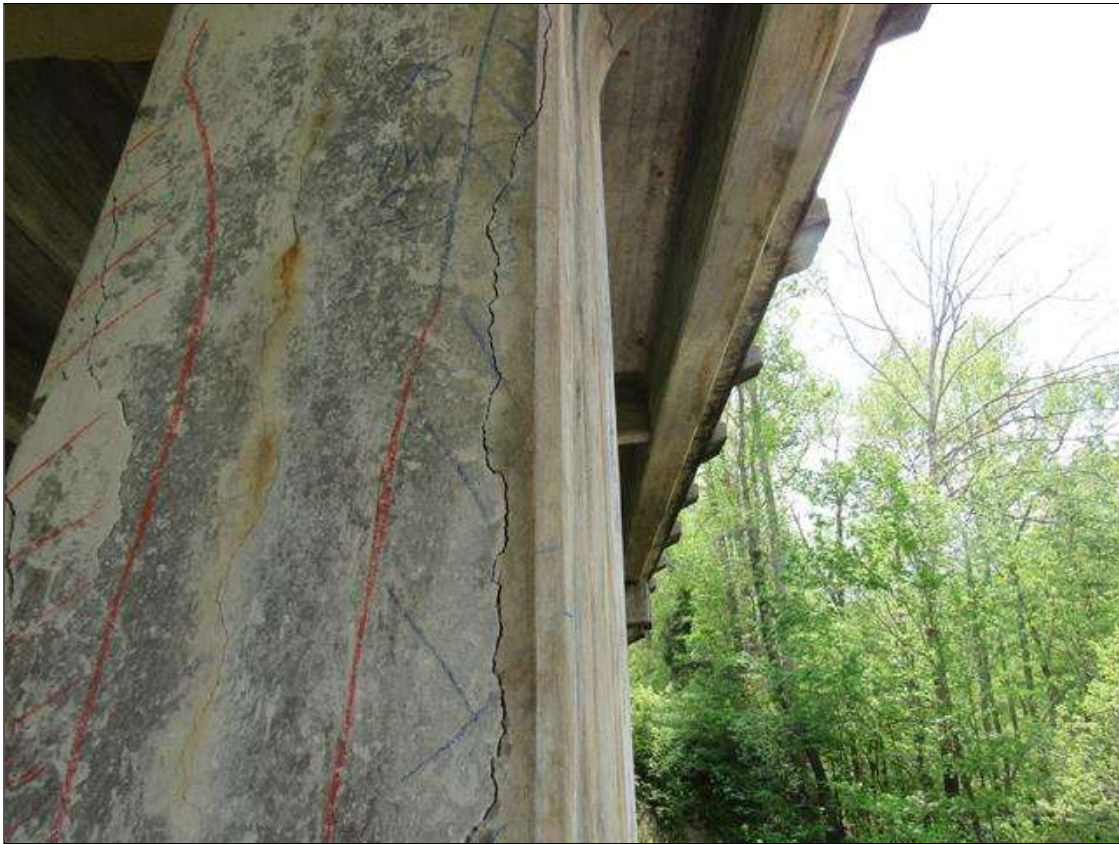
Bent 2 Pile 2: 0 Each of Delamination/Spall/Patched Area: Delaminated. Spall 1 in. or less deep or 6 in. or less in diameter. Patched area that is sound.
BENT 2 PILE 2 HAS CRACKED DELAMINATED AREA SW CORNER OF PILE STARTS 53" BELOW CAP EXTENDS DOWN 75". 9" ON WEST FACE AND 5" ON SOUTH.

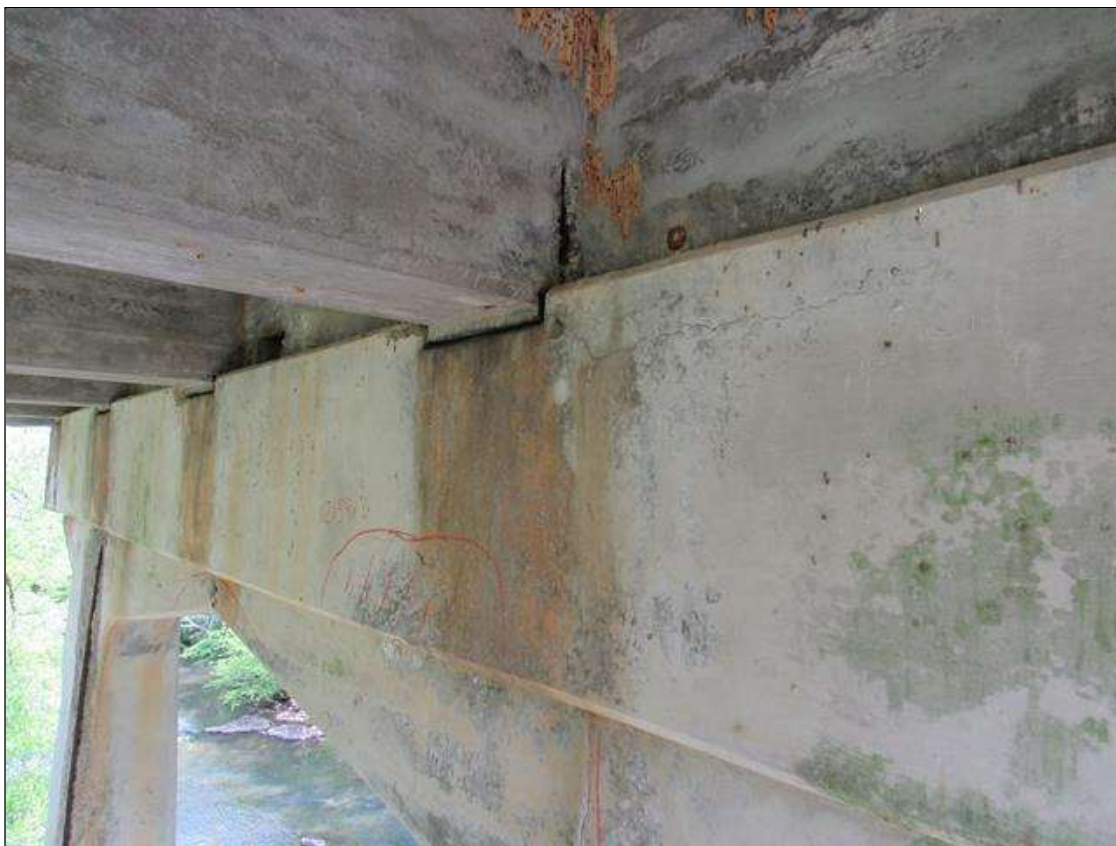
Bent 2 Cap : 15 Feet of Delamination/Spall/Patched Area: Delaminated. Spall 1 inch or less deep or 6 inches or less in diameter. Patched area that is sound
BENT 2 WEST FACE OF CAP HAS HORZ CRACKS ALONG THE TOP AND MAP CRACKING ON THE ENDS.

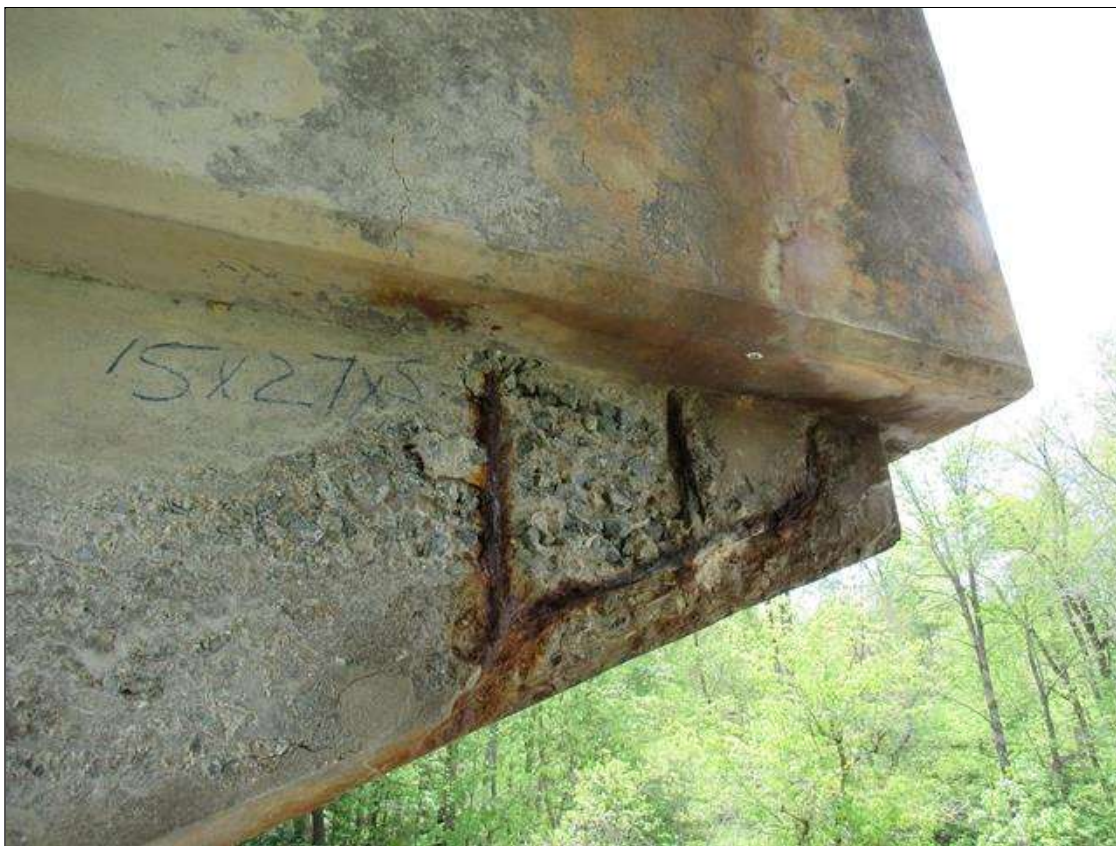
BENT 2 WEST FACE OF HAUNCH AREA UNDER GIRDER 5 CRACKED SPALL AND DELAMINATED. 15" DOWN THE FACE 27" LONG AND 5" UNDER BOTTOM WITH REBAR AND STIRRUPS EXPOSED.

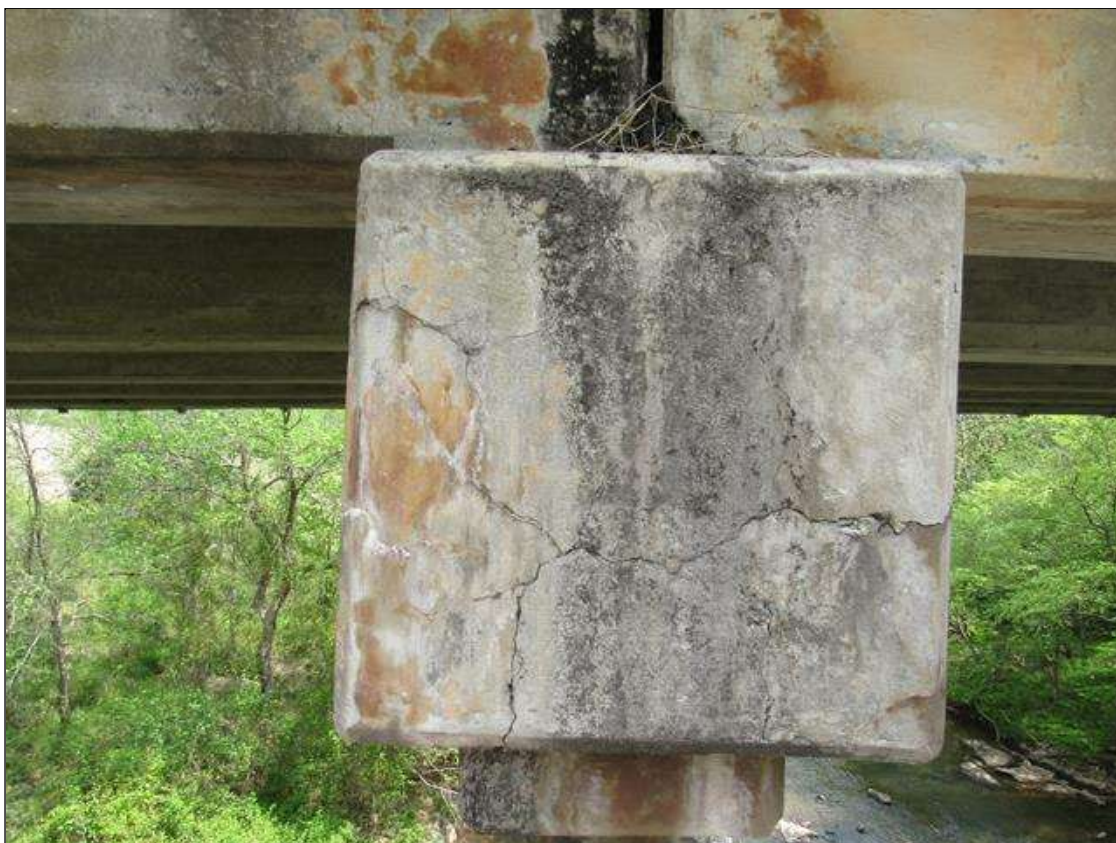
Bent 2 Cap : 0 Feet of Cracking (RC and Other): Width greater than 0.05 in. or spacing of less than 1 ft.
BENT 2 CAP RIGHT END OF CAP HEAVILY MAP CRACKED.

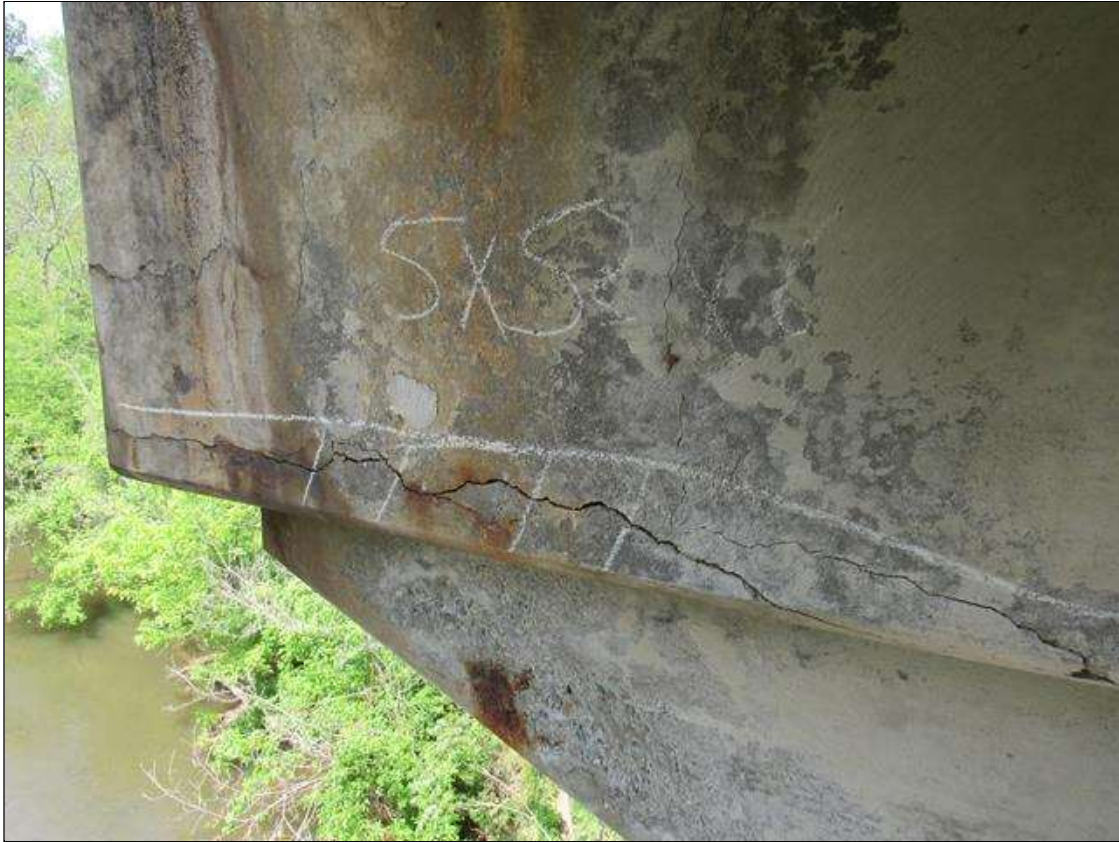
Bent 2 Cap : 5 Feet of Delamination/Spall/Patched Area: Delaminated. Spall 1 inch or less deep or 6 inches or less in diameter. Patched area that is sound
BENT 2 EAST FACE OF CAP HAS A CRACKED DELAMINATED AREA ALONG THE BOTTOM EDGE 5" UP FACE
52" LONG 6" UNDER BOTTOM.

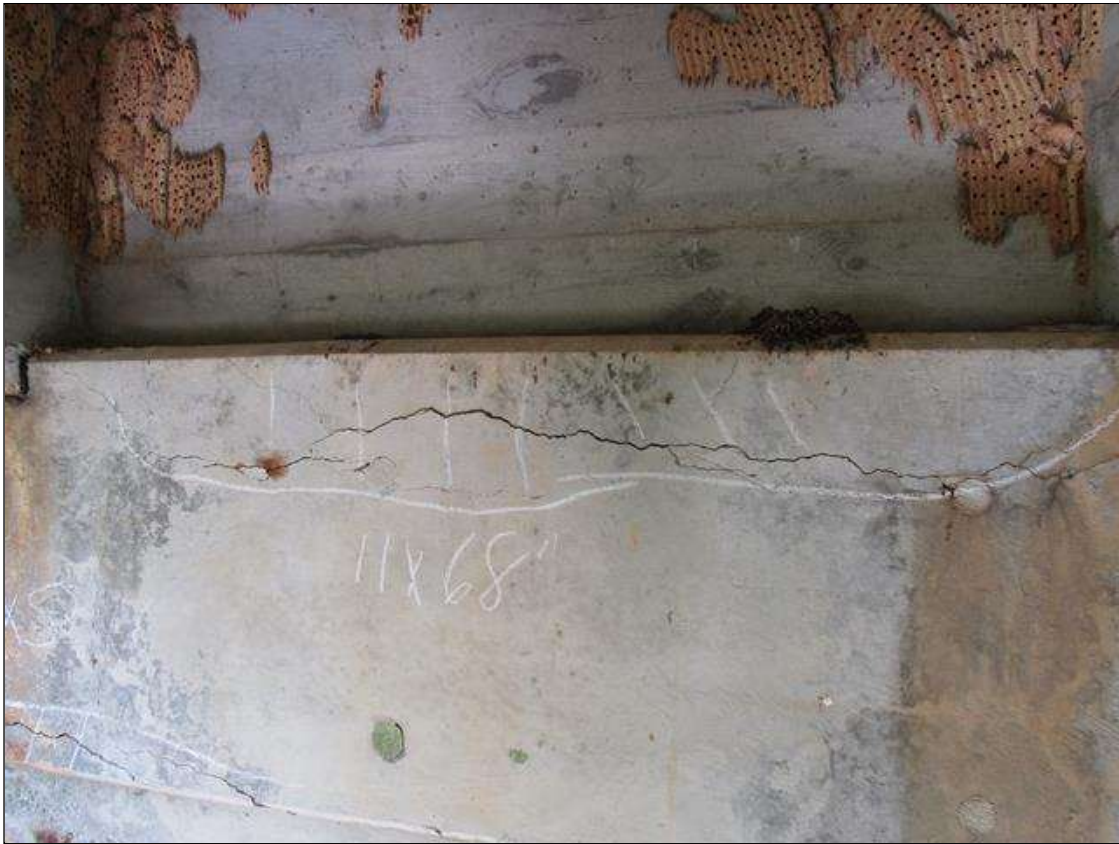
Bent 2 Cap : 6 Feet of Delamination/Spall/Patched Area: Delaminated. Spall 1 inch or less deep or 6 inches or less in diameter. Patched area that is sound
BENT 2 EAST FACE OF CAP HAS A CRACKED DELAMINATED AREA BETWEEN G1 AND G5 11" DOWN FACE AND 60" LONG.
