NC DEPARTMENT OF TRANSPORTATION
 DIVISION OF HIGHWAYS
 STRUCTURE MANAGEMENT UNIT

ATTENTION:

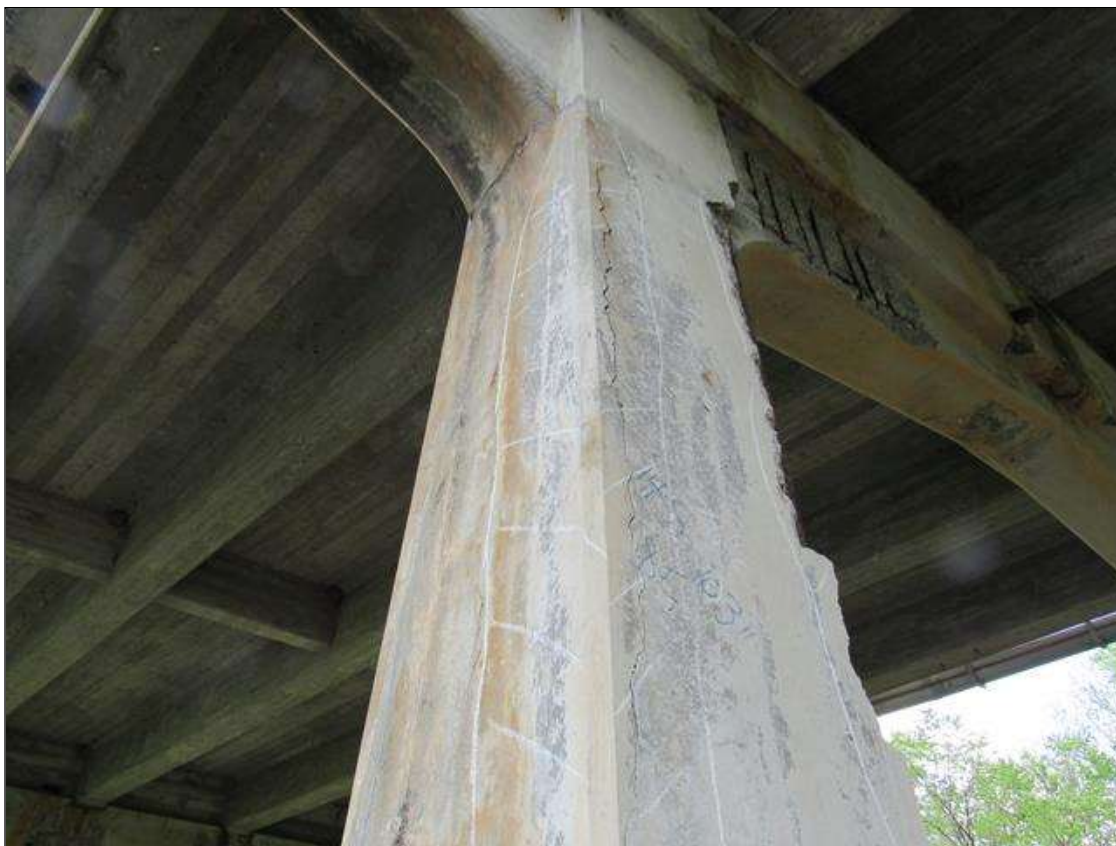
Bent 2 Pile 2: 0 Each of Delamination/Spall/Patched Area: Delaminated. Spall 1 in. or less deep or 6 in. or less in diameter. Patched area that is sound.
BENT 2 PILE 2 CRACKED AND DELAMINATED AREA ON SE CORNER OF PILE STARTS 28" BELOW CAP EXTENDS DOWN 103" 14" ON SOUTH FACE AND 8" ON THE EAST.

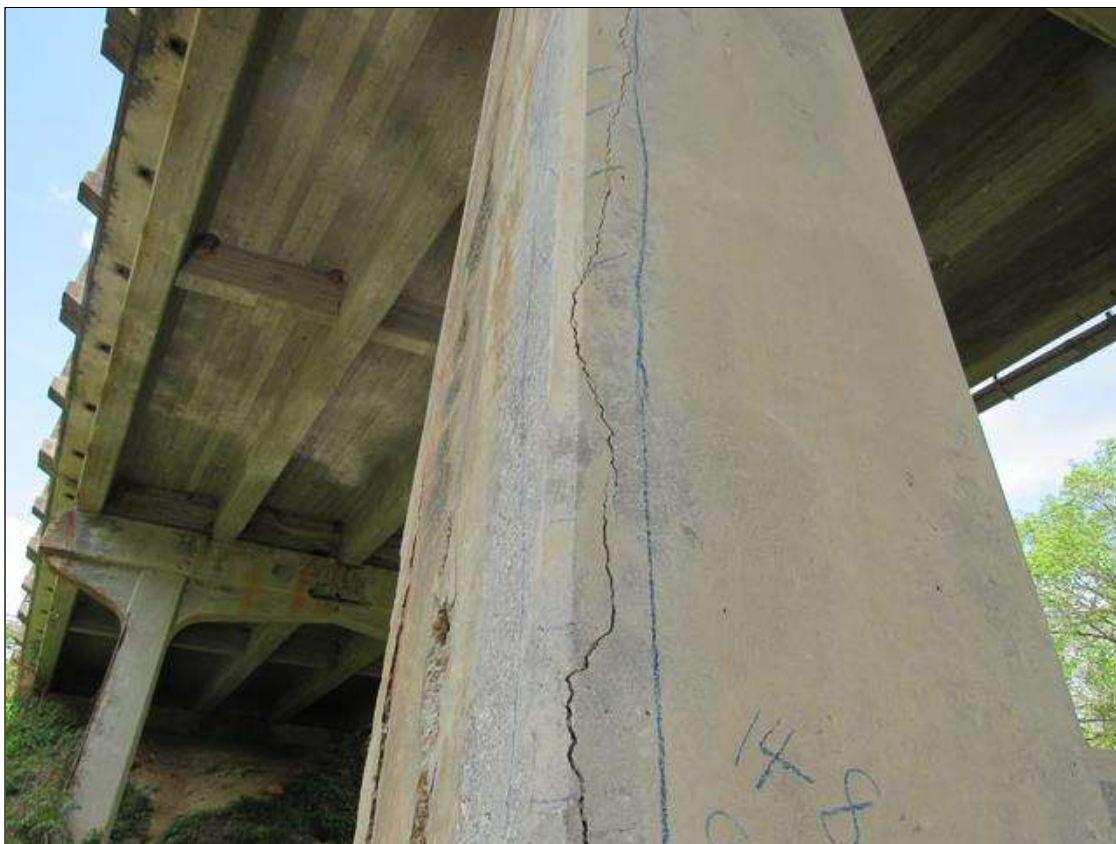
Bent 2 Pile 2: 0 Each of Delamination/Spall/Patched Area: Delaminated. Spall 1 in. or less deep or 6 in. or less in diameter. Patched area that is sound.
BENT 2 PILE 2 IS CRACKED AND DELAMINATED ON SE CORNER OF PILE STARTS 14' 8" ABOVE FOOTING EXTENDS UP 94" . 5" ON SOUTH AND EAST FACE.

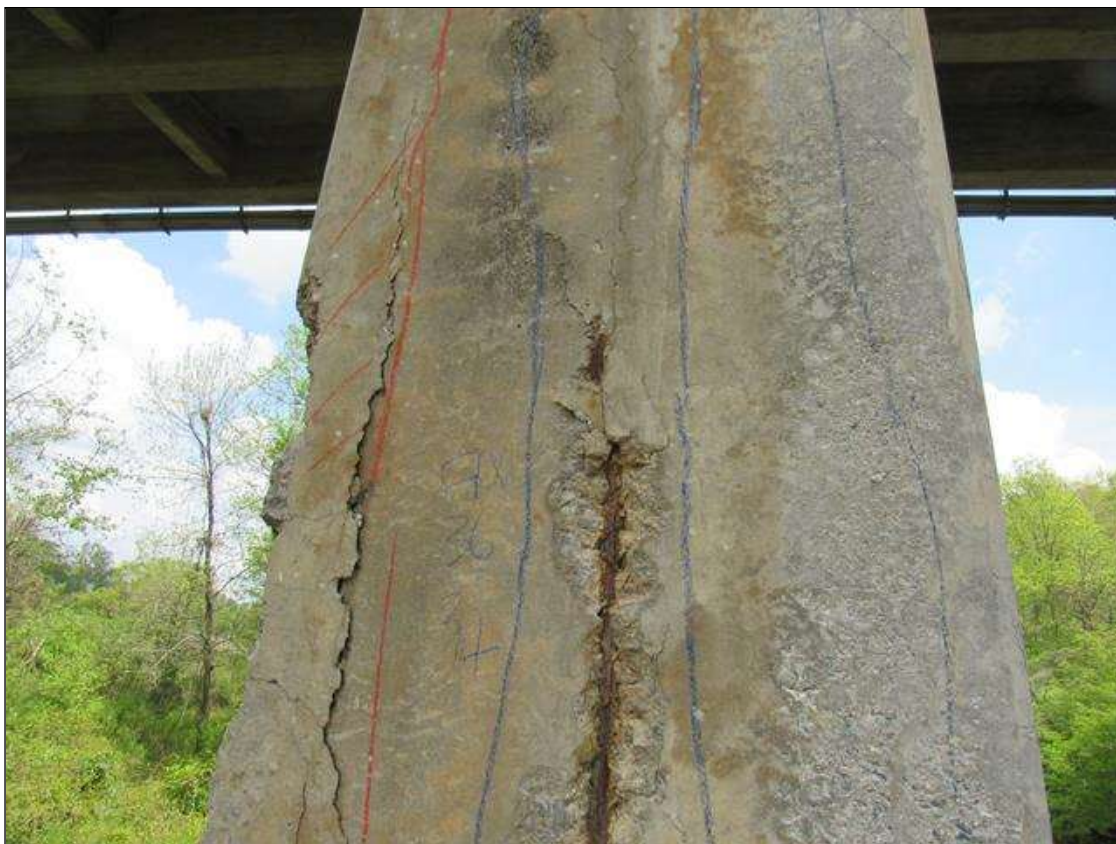
Bent 2 Pile 2: 0 Each of Delamination/Spall/Patched Area: Delaminated. Spall 1 in. or less deep or 6 in. or less in diameter. Patched area that is sound.

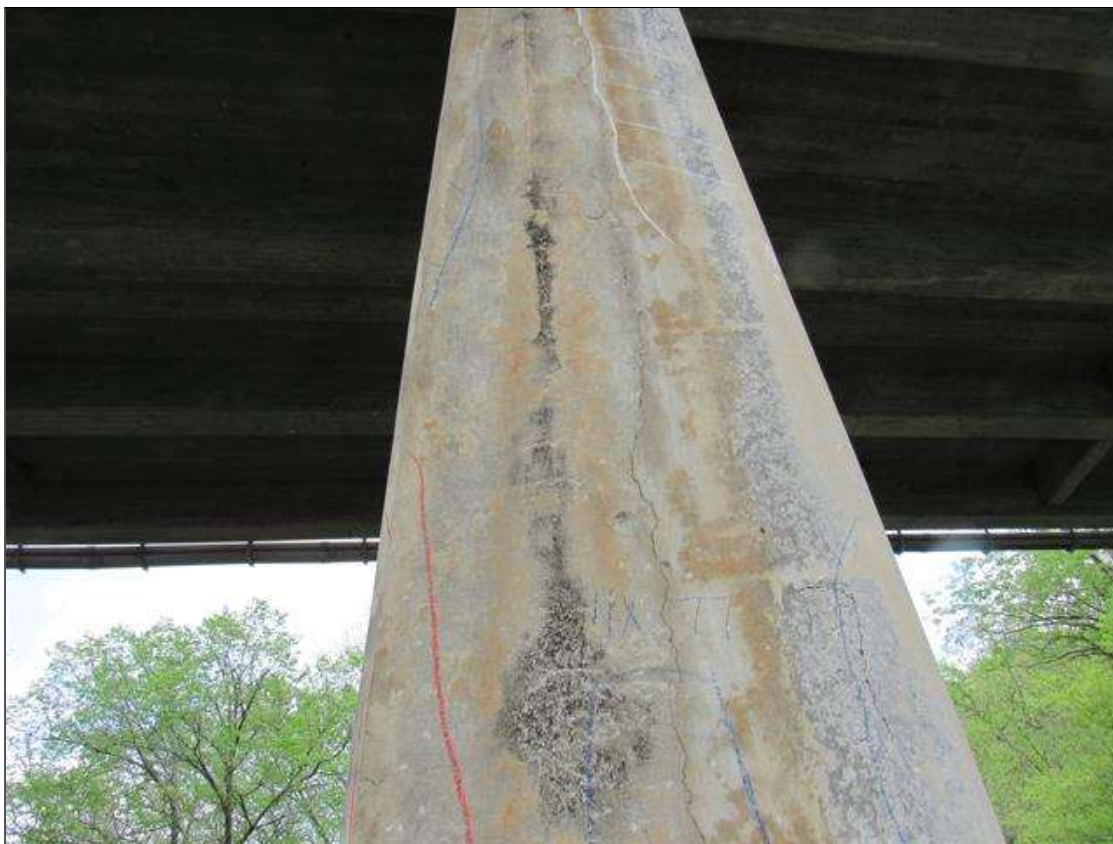
Bent 2 Pile 2: 0 Each of Cracking (RC and Other): Width 0.012-0.05 in. or spacing or 1.0-3.0 ft.
BENT 2 PILE 2 HAS VERTICAL CRACKS ON THE FACE OF THE PILE.

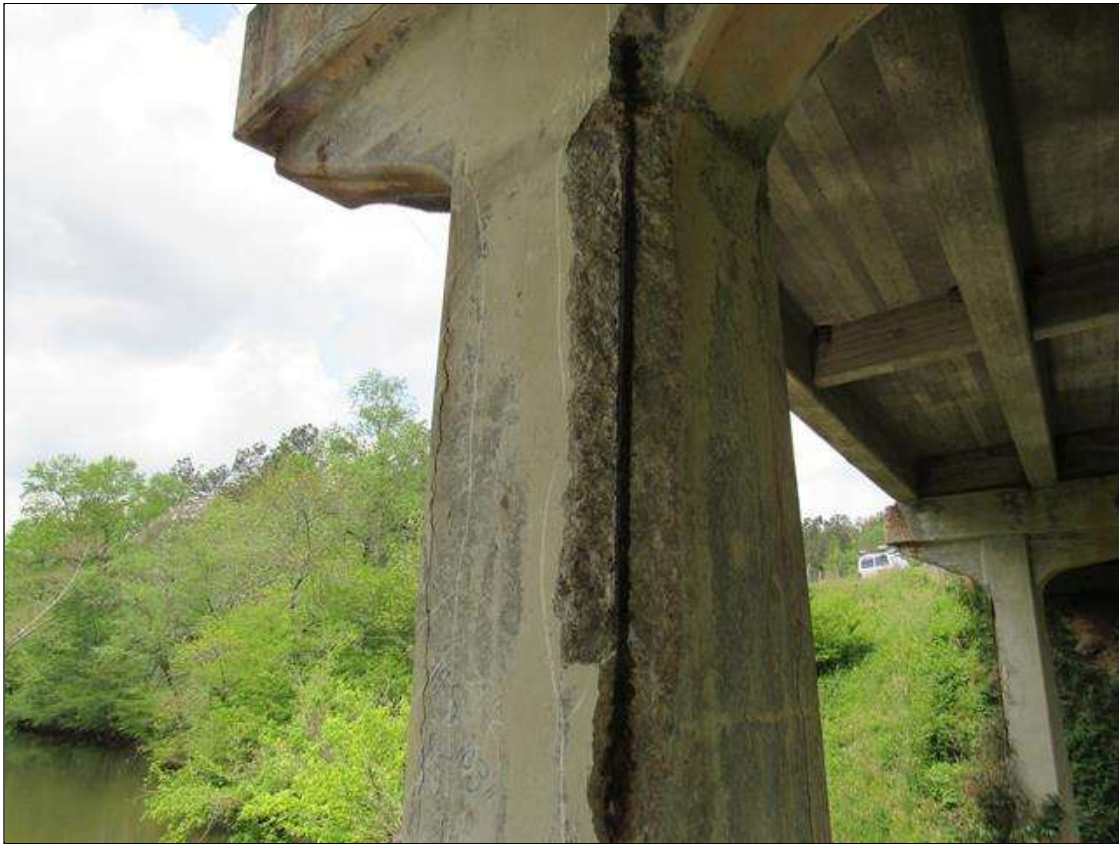
Bent 2 Pile 2: 0 Each of Delamination/Spall/Patched Area: Spall greater than 1 in. deep or greater than 6 in. diameter. Patched area that is unsound or showing distress. Does not warrant structural review.

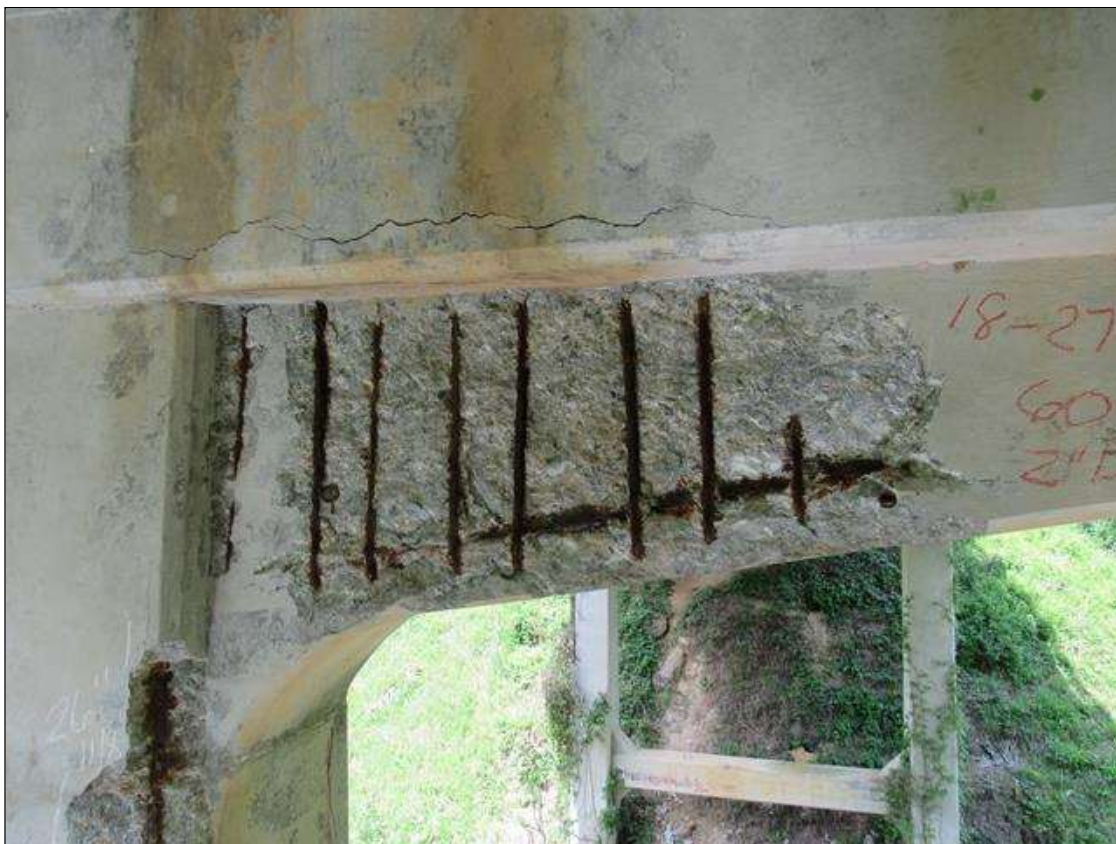
BENT 2 EAST FACE OF HAUNCH UNDER BOTTOM OF CAP LEFT OF PILE 2 CRACKED SPALL AND DELAMINATED. 18" TO 27" DOWN FACE 60" LONG 2" DEEP WITH STIRRUPS AND REBAR EXPOSED.

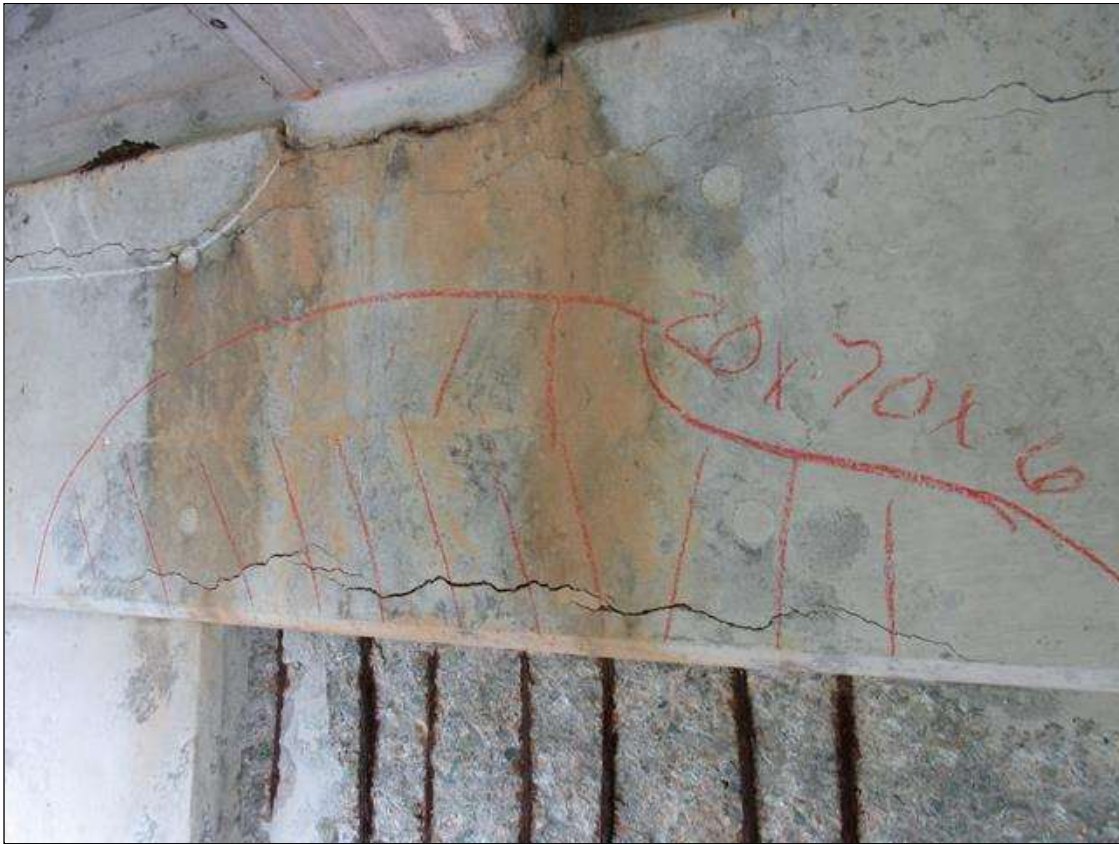
Bent 2 Cap : 0 Feet of Delamination/Spall/Patched Area: Delaminated. Spall 1 inch or less deep or 6 inches or less in diameter. Patched area that is sound
BENT 2 EAST FACE OF CAP HAS A CRACKED DELAMINATED AREA ALONG BOTTOM OF CAP UNDER GIRDER
4. 20" UP THE FACE 7" LONG 6" UNDER BOTTOM.

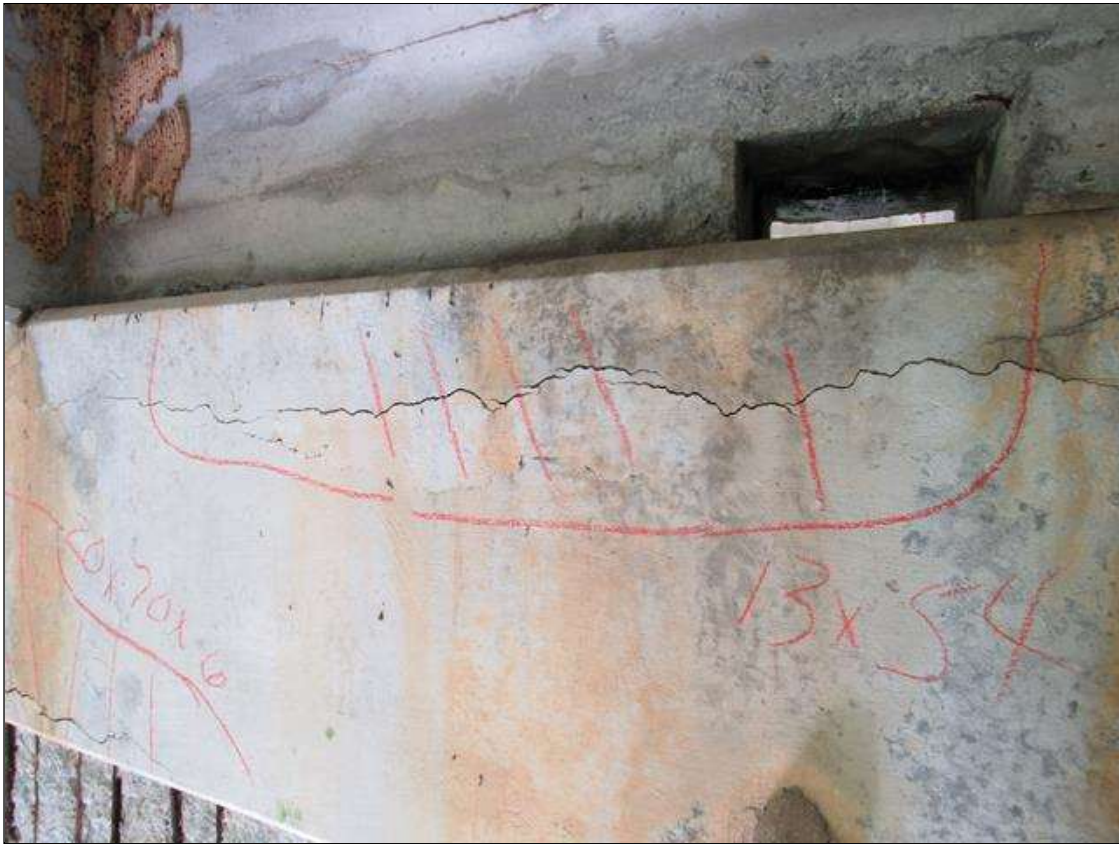
Bent 2 Cap : 0 Feet of Delamination/Spall/Patched Area: Delaminated. Spall 1 inch or less deep or 6 inches or less in diameter. Patched area that is sound
BENT 2 EAST FACE OF CAP CRACKED AND DELAMINATED AREA ALONG TOP OF CAP BETWEEN GIRDERS 3 AND 4. 13" X 54".

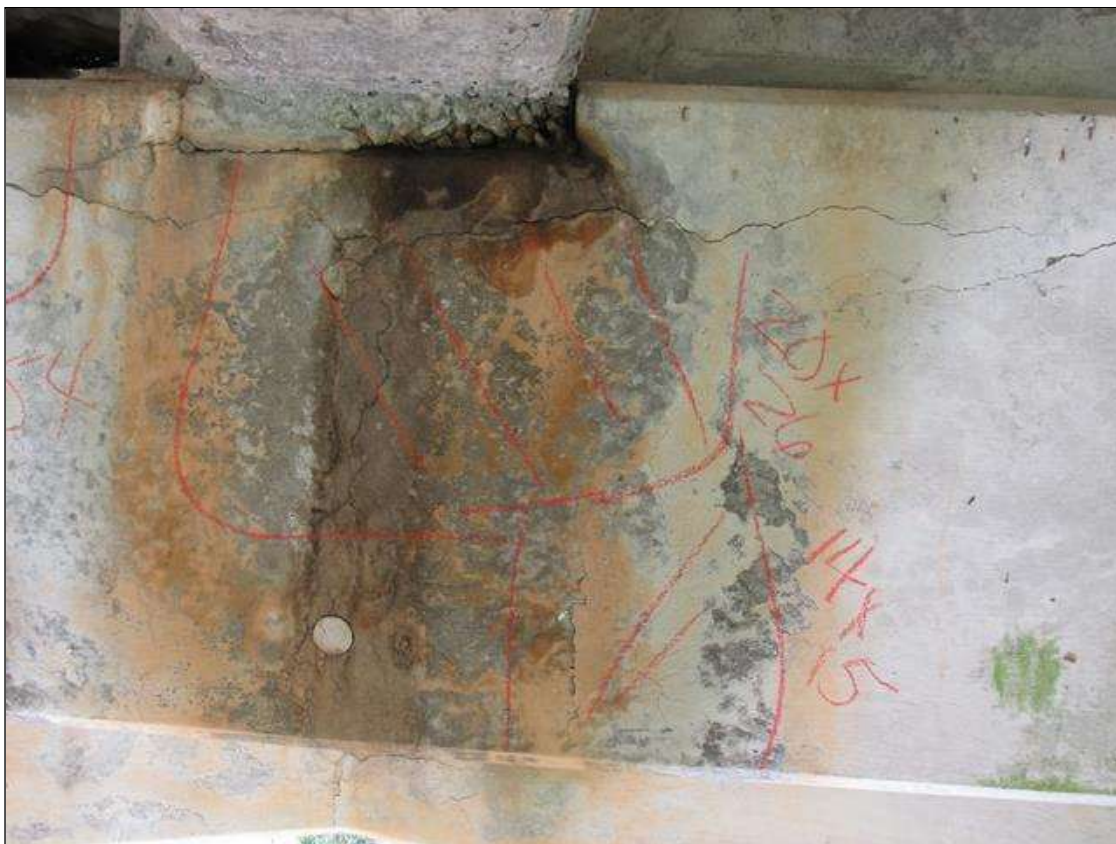
Bent 2 Cap : 0 Feet of Delamination/Spall/Patched Area: Delaminated. Spall 1 inch or less deep or 6 inches or less in diameter. Patched area that is sound
BENT 2 EAST FACE OF CAP HAS 2 CRACKED DELAMINATED AREAS UNDER GIRDER 3 14" X 15" AND 20" X 26".

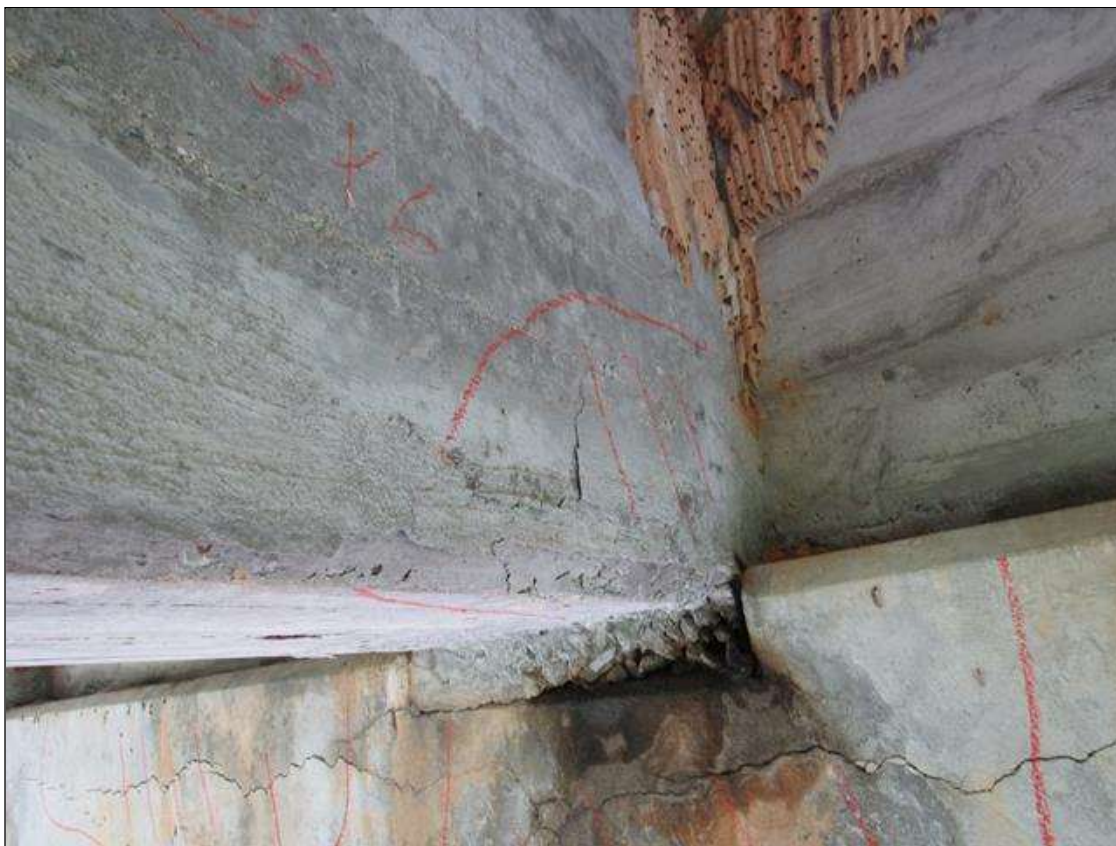
Span 3 Beam 3: 2 Feet of Delamination/Spall/Patched Area: Delaminated. Spall 1 in. or less deep or 6 in. or less in diameter. Patched area that is sound.
SPAN 3 GIRDER 3 LEFT SIDE HAS CRACKED DELAMINATED AREA FM BENT 2 CAP OUT 23".

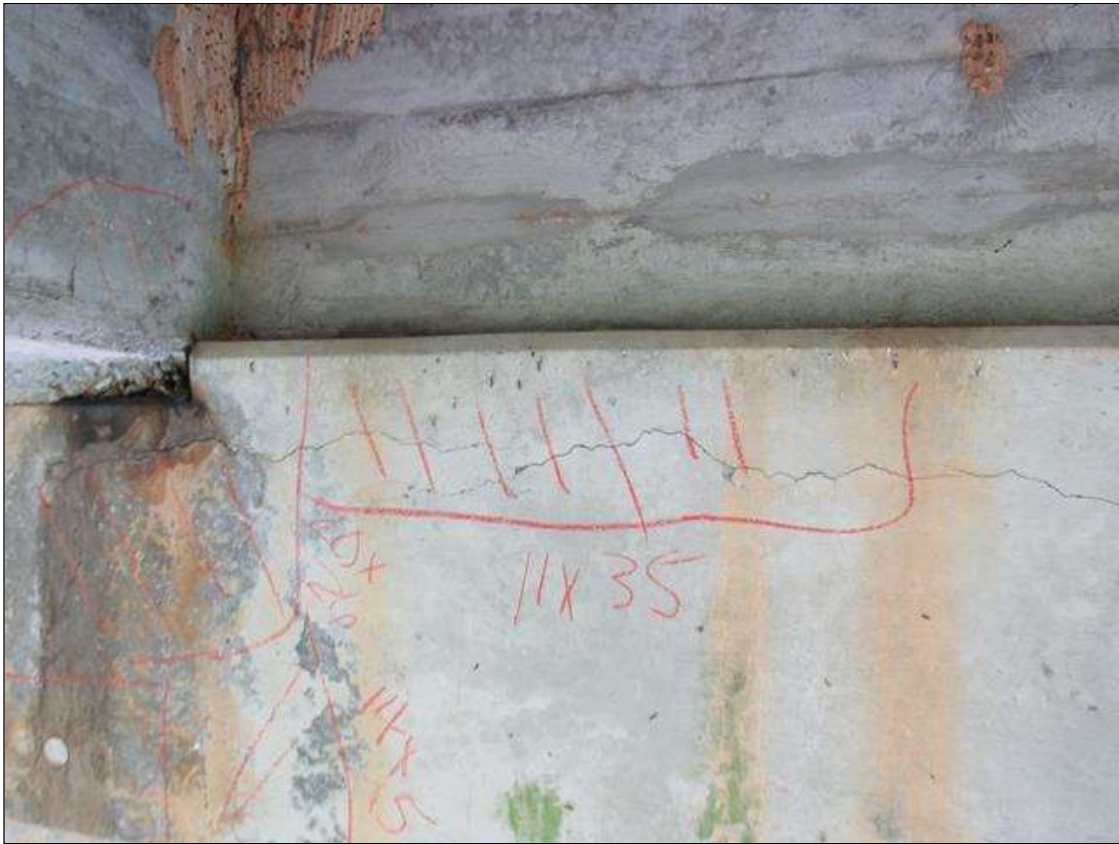
Bent 2 Cap : 0 Feet of Delamination/Spall/Patched Area: Delaminated. Spall 1 inch or less deep or 6 inches or less in diameter. Patched area that is sound

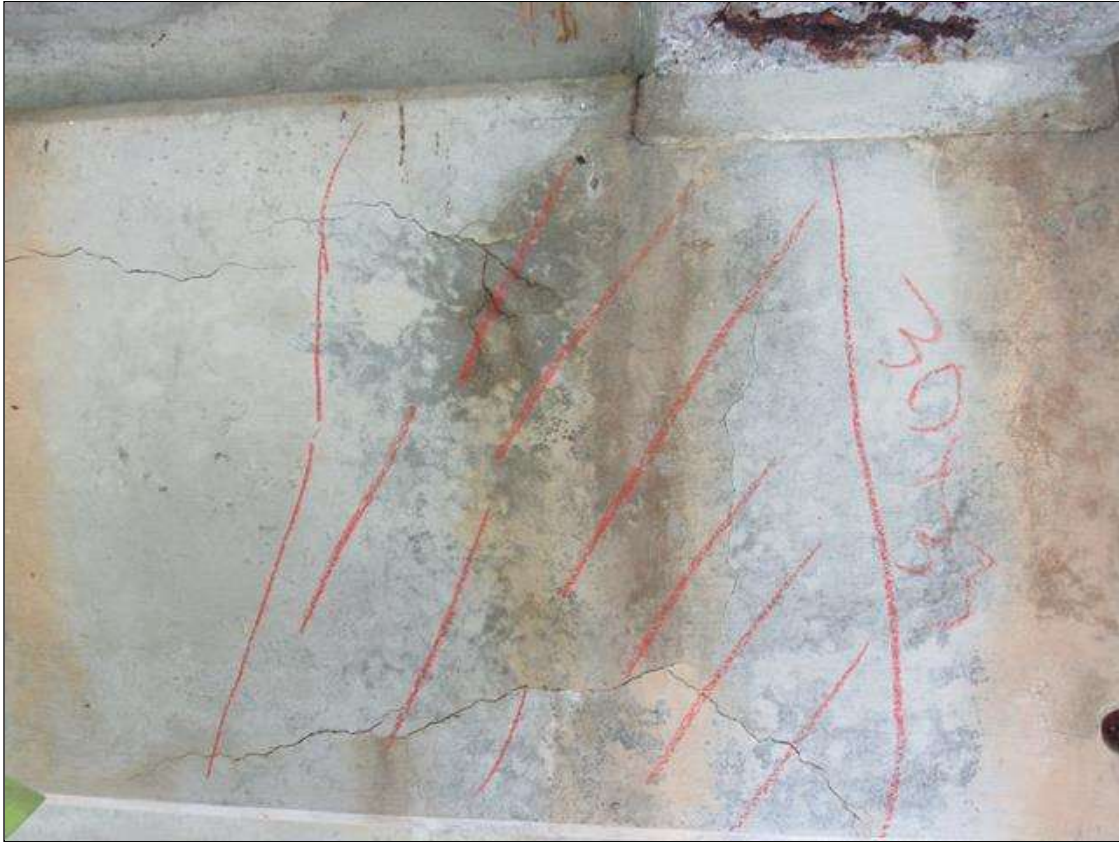
Bent 2 Cap : 0 Feet of Delamination/Spall/Patched Area: Delaminated. Spall 1 inch or less deep or 6 inches or less in diameter. Patched area that is sound
BENT 2 EAST FACE OF CAP HAS A CRACKED DELAMINATED AREA AT GIRDER 2 30" X 33".

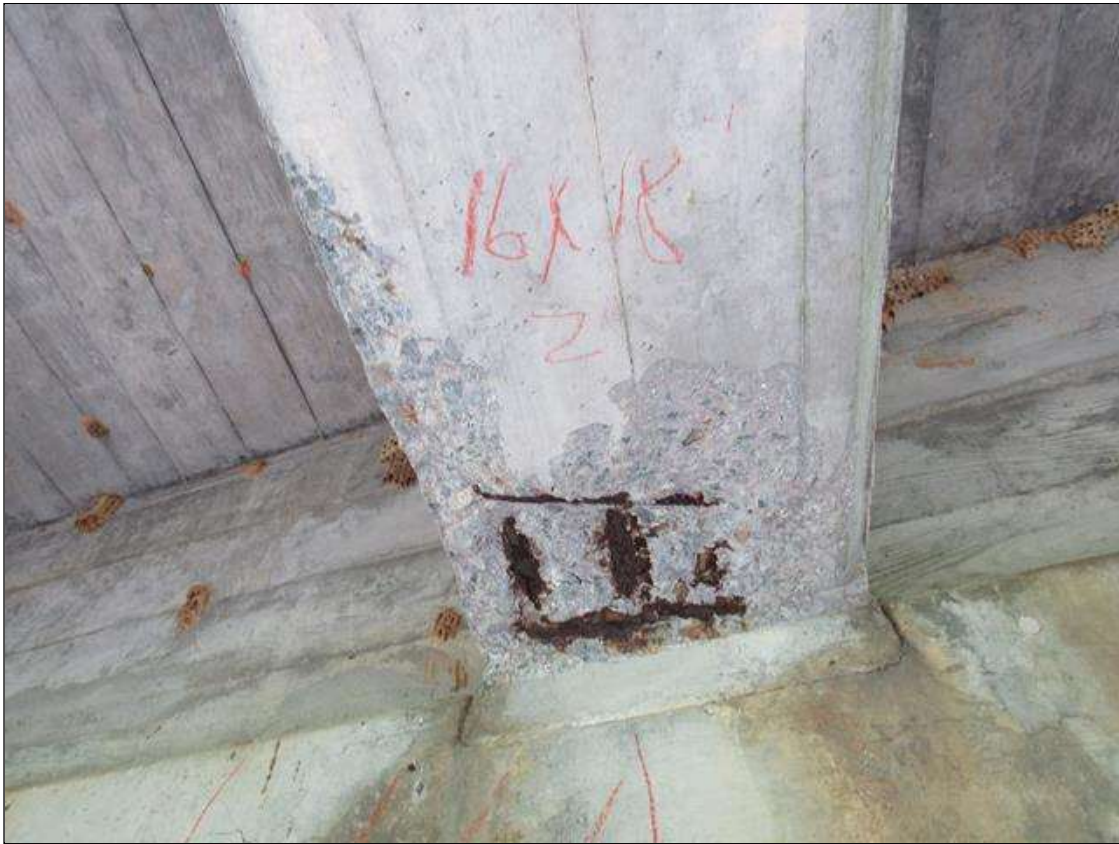
Span 3 Beam 2: 2 Feet of Delamination/Spall/Patched Area: Spall greater than 1 in. deep or greater than 6 in. diameter. Patched area that is unsound or showing distress. Does not warrant structural review.
SPAN 3 BEAM 2 AT BENT 2 BOTTOM OF GIRDER HAS A SPALL AREA 16" W FROM CAP OUT 18" AND 2" DEEP REBAR AND STIRRUPS EXPOSED.

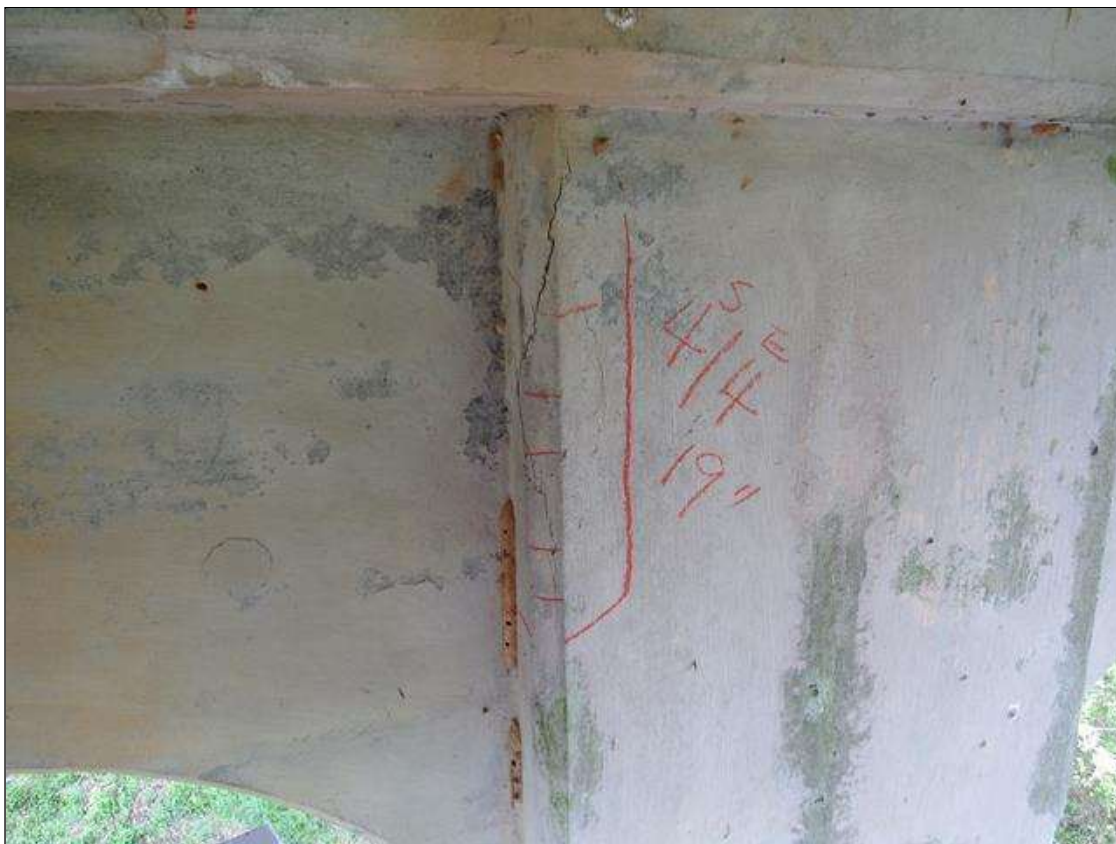
Bent 2 Pile 1: 0 Each of Delamination/Spall/Patched Area: Delaminated. Spall 1 in. or less deep or 6 in. or less in diameter. Patched area that is sound.

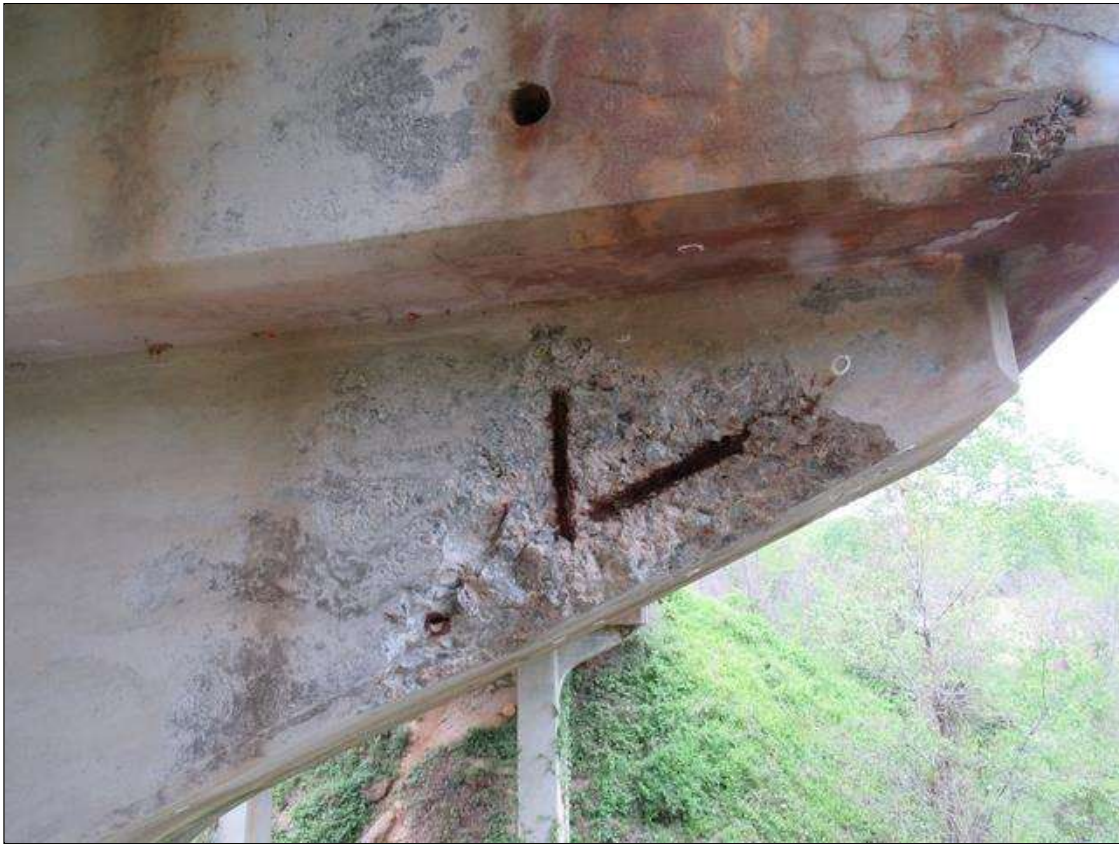
HAUNCH AREA ON EAST FACE OF BENT 2 UNDER GIRDER 1 IS SPALL WITH REBAR EXPOSED. 13" X 28" X 2" DEEP.

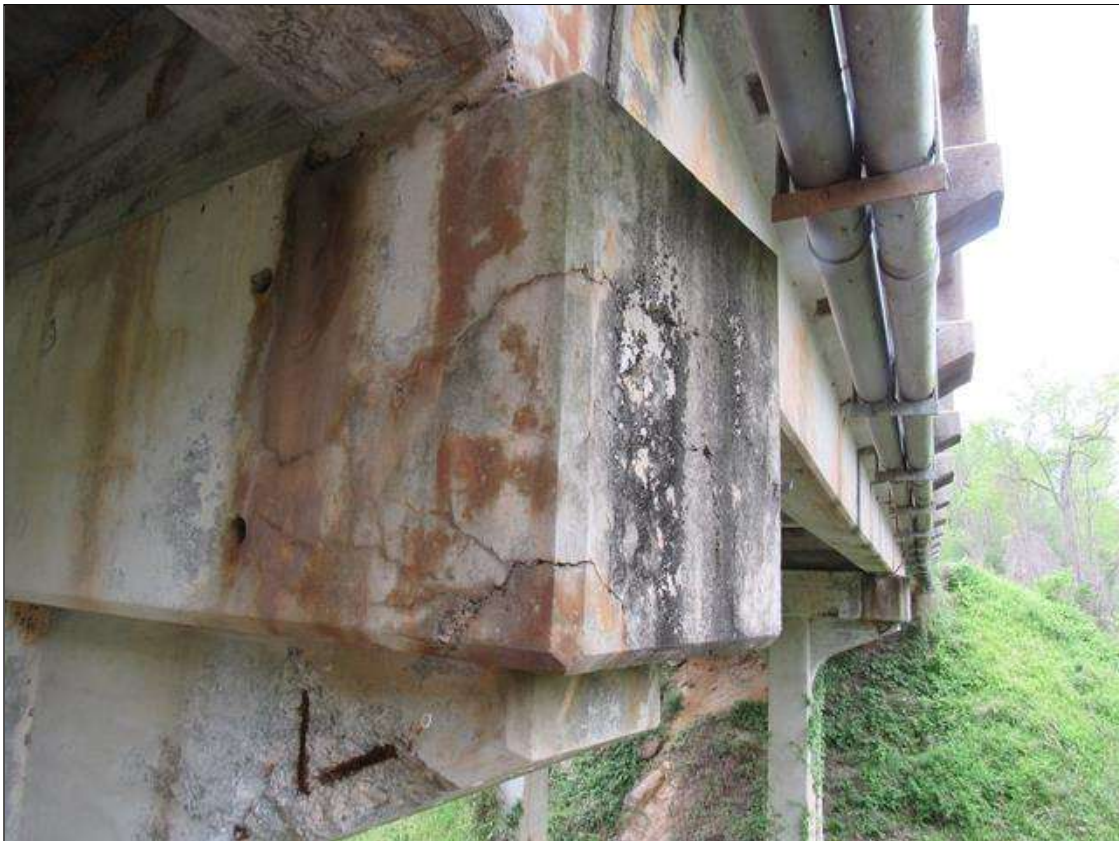
Bent 2 Cap : 0 Feet of Cracking (RC and Other); Width 0.012-0.05 in. or spacing of 1.0-3.0 ft.
BENT 2 LEFT END OF CAP MAP CRACKING AND ALONG THE BOTTOM EAST FACE UNDER GIRDER 1.

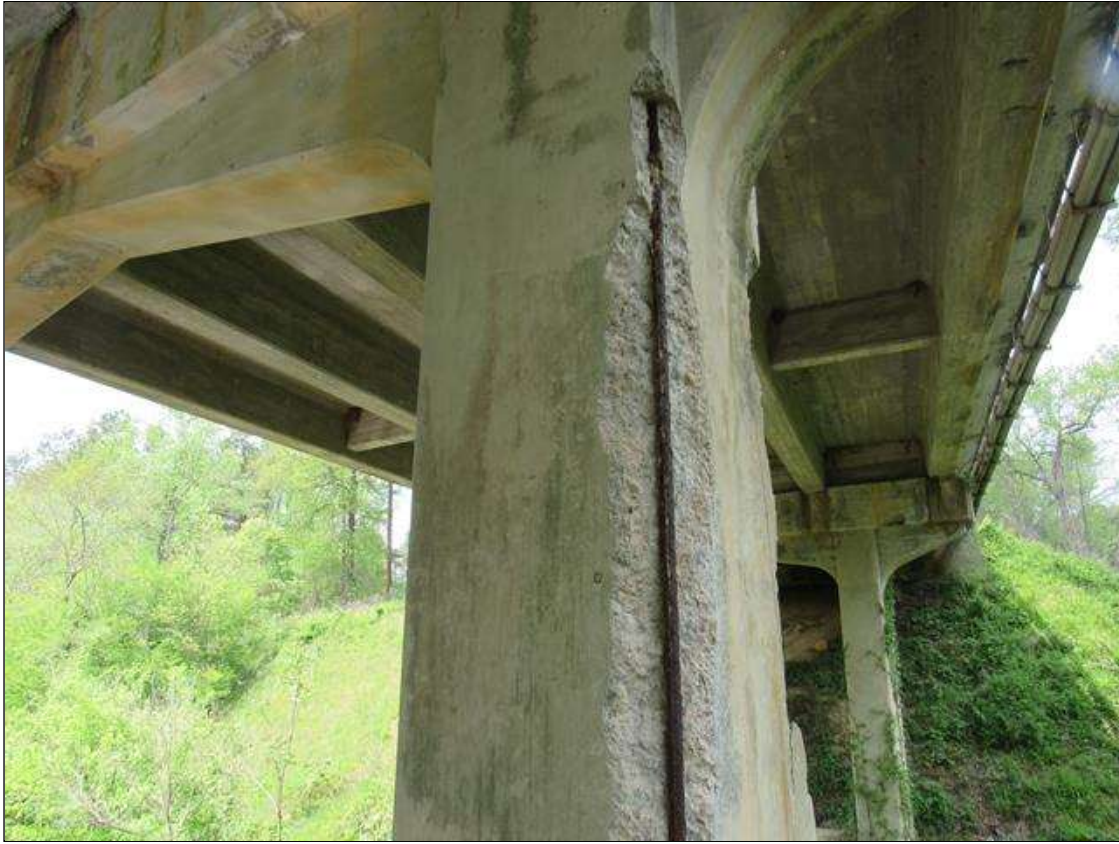
Bent 1 Pile 1: 0 Each of Delamination/Spall/Patched Area: Spall greater than 1 in. deep or greater than 6 in. diameter.
Patched area that is unsound or showing distress. Does not warrant structural review.
BENT 2 PILE 1 NE CORNER CRACKED SPALL DELAMINATED STARTS 3' BELOW CAP EXTENDS DOWN 7' 9"
ON EACH FACE. LARGE REBAR EXPOSED.

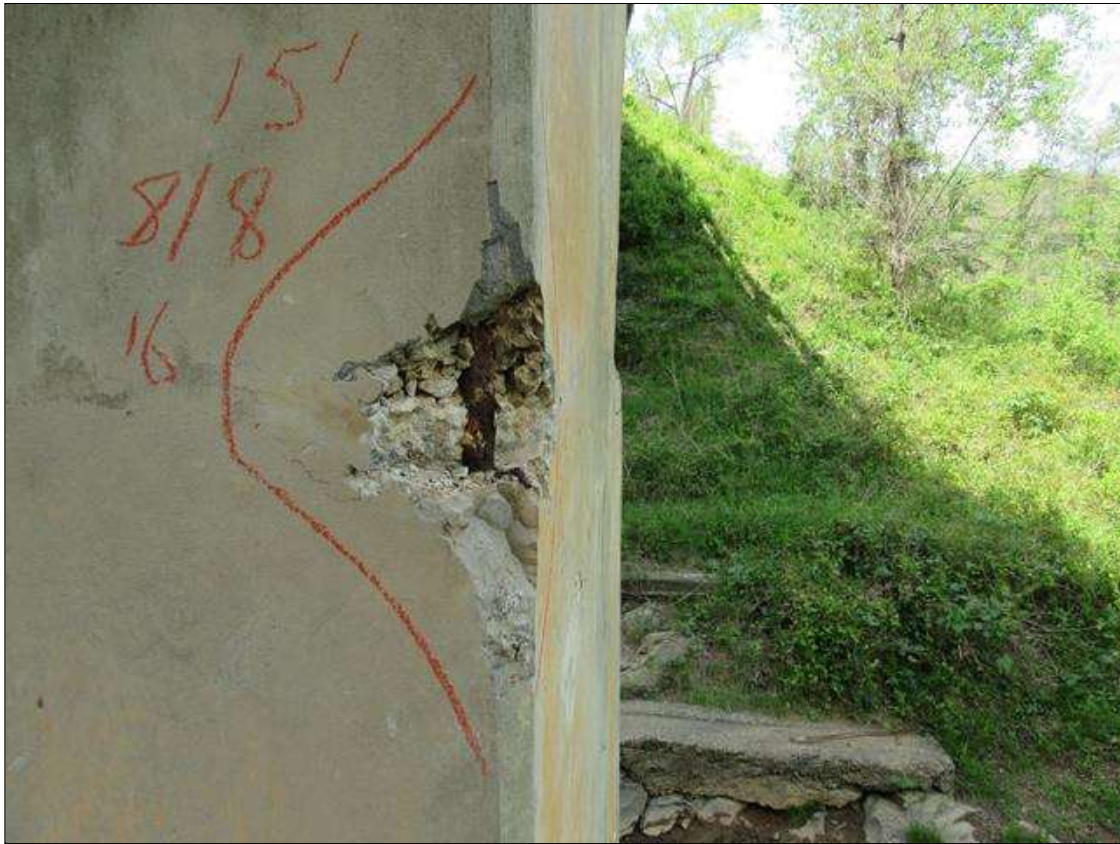
Bent 1 Pile 1: 0 Each of Delamination/Spall/Patched Area: Spall greater than 1 in. deep or greater than 6 in. diameter. Patched area that is unsound or showing distress. Does not warrant structural review.

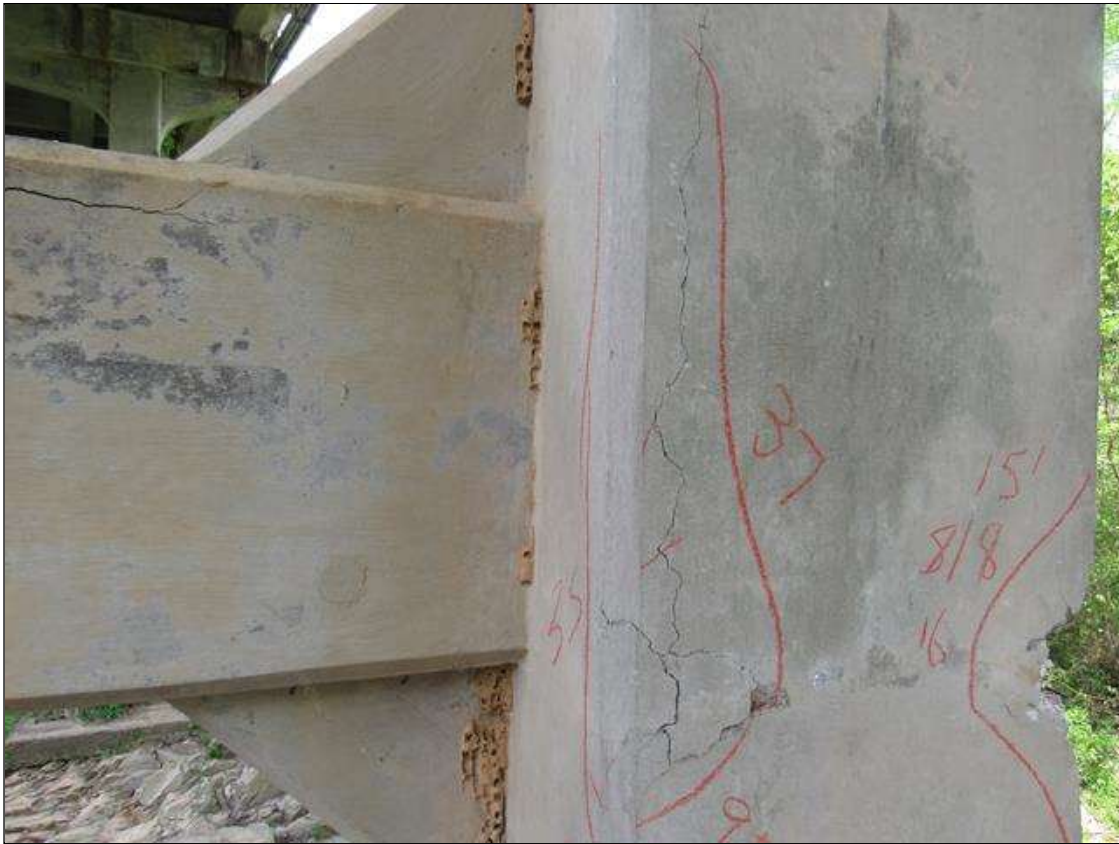
Bent 2 Pile 1: 0 Each of Delamination/Spall/Patched Area: Delaminated. Spall 1 in. or less deep or 6 in. or less in diameter. Patched area that is sound.
BENT 2 PILE 1 CRACKED DELAMINATED AREA ON SE CORNER OF PILE AT THE STRUT 3" ON SOUTH FACE 9" ON EAST FACE AND 37" HIGH.

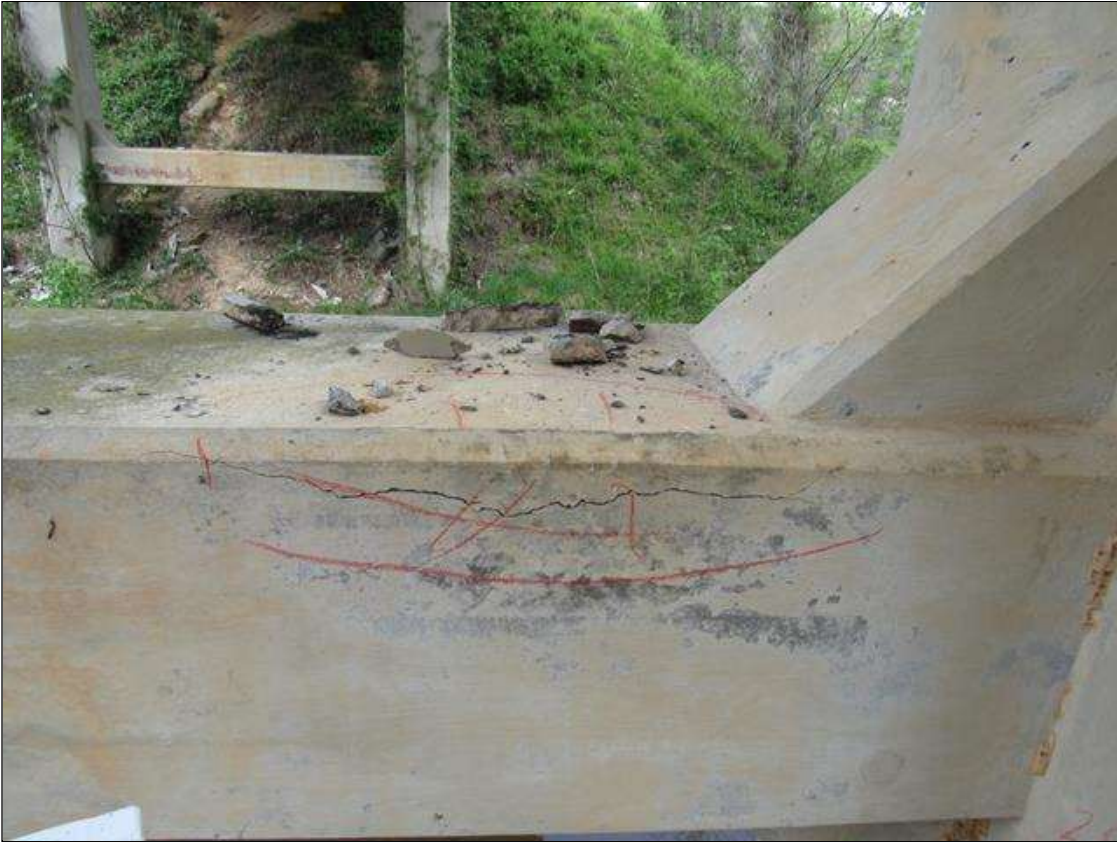
BENT 2 STRUT CRACKED DELAMINATED AREA RIGHT SIDE OF PILE 1 7" DOWN FACE 10" ON TOP 24" LONG. LEFT SIDE OF PILE 2 SIMILAR AREA.

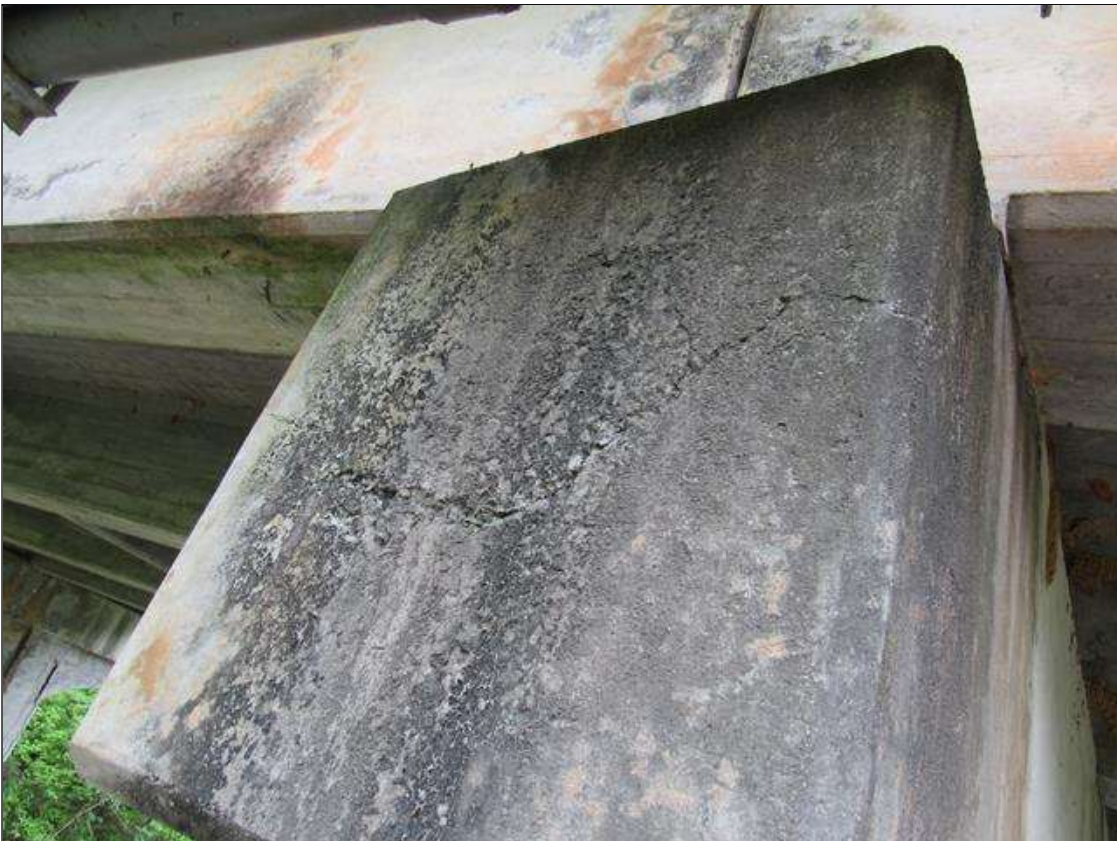
Bent 3 Cap : 0 Feet of Cracking (RC and Other): Width 0.012-0.05 in. or spacing of 1.0-3.0 ft. BENT 3 LEFT END OF CAP IS MAP CRACKED.

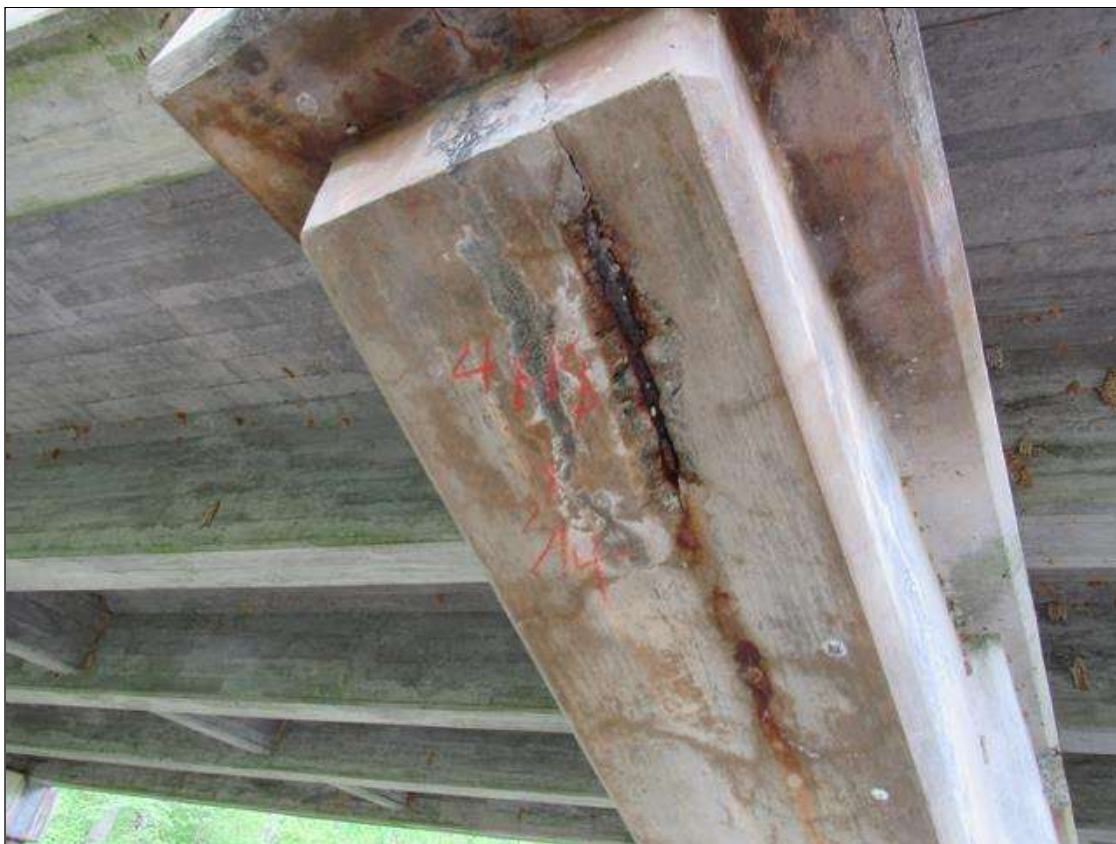
BENT 3 HUANCH AREA UNDER GIRDER 1 HAS A CRACKED AND SPALL AREA WITH REBAR EXPOSED UNDER BOTTOM OF HUANCH. 4" X 18" X 34".

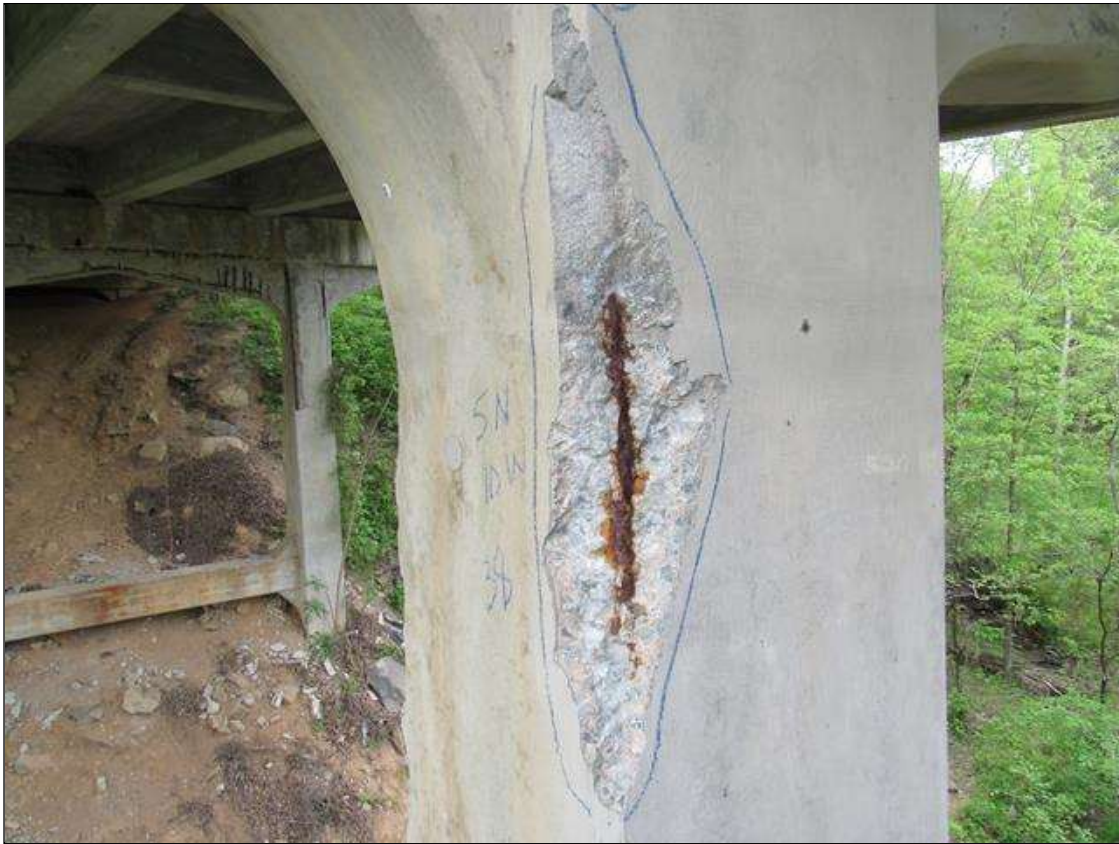
Bent 3 Pile 1: 1 Each of Delamination/Spall/Patched Area: Spall greater than 1 in. deep or greater than 6 in. diameter. Patched area that is unsound or showing distress. Does not warrant structural review.
BENT 3 NW CORNER OF PILE 1 SPALL AREA 33" BELOW CAP EXTENDS DOWN 38". 5" ON NORTH 10" ON WEST WITH LARGE REBAR EXPOSED.
