NC DEPARTMENT OF TRANSPORTATION
 DIVISION OF HIGHWAYS
 STRUCTURE MANAGEMENT UNIT

ATTENTION:

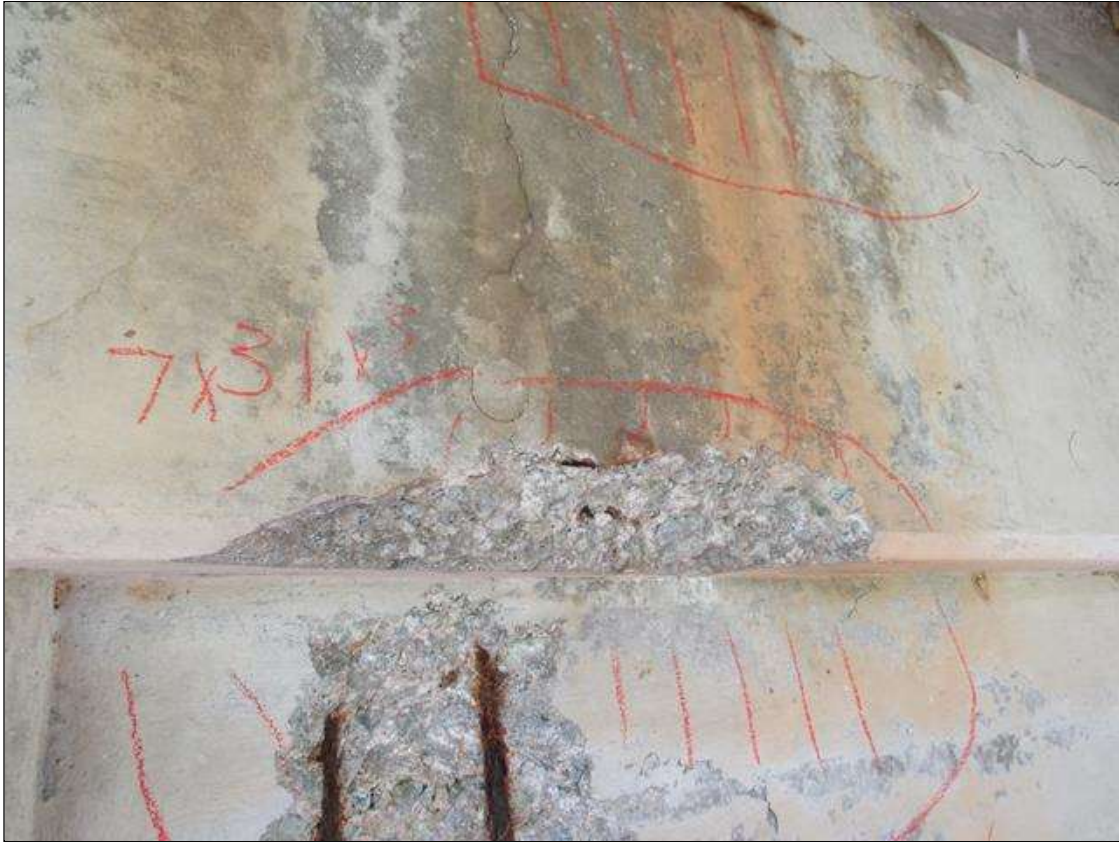
Bent 3 Cap : 3 Feet of Delamination/Spall/Patched Area: Delaminated. Spall 1 inch or less deep or 6 inches or less in diameter. Patched area that is sound
BENT 3 WEST FACE OF CAP HAS A SPALL AREA ALONG BOTTOM EDGE UNDER GIRDER 2 7" UP FACE 31" LONG 3" DEEP 6" UNDER BOTTOM.

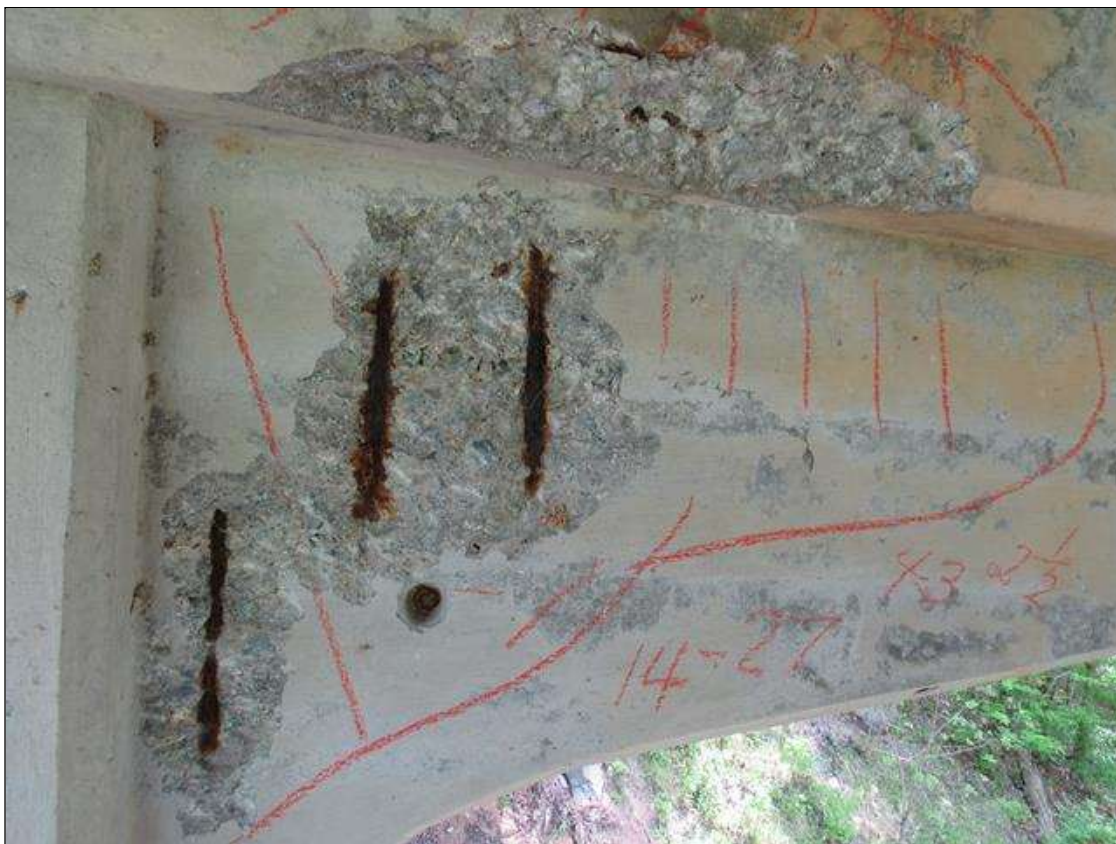
BENT 3 WEST FACE OF HAUNCH RIGHT SIDE OF PILE 1 CRACKED SPALL DELAMINATED. 14" TO 27" DOWN FACE 43" LONG 2 1/2" DEEP REBAR EXPOSED.

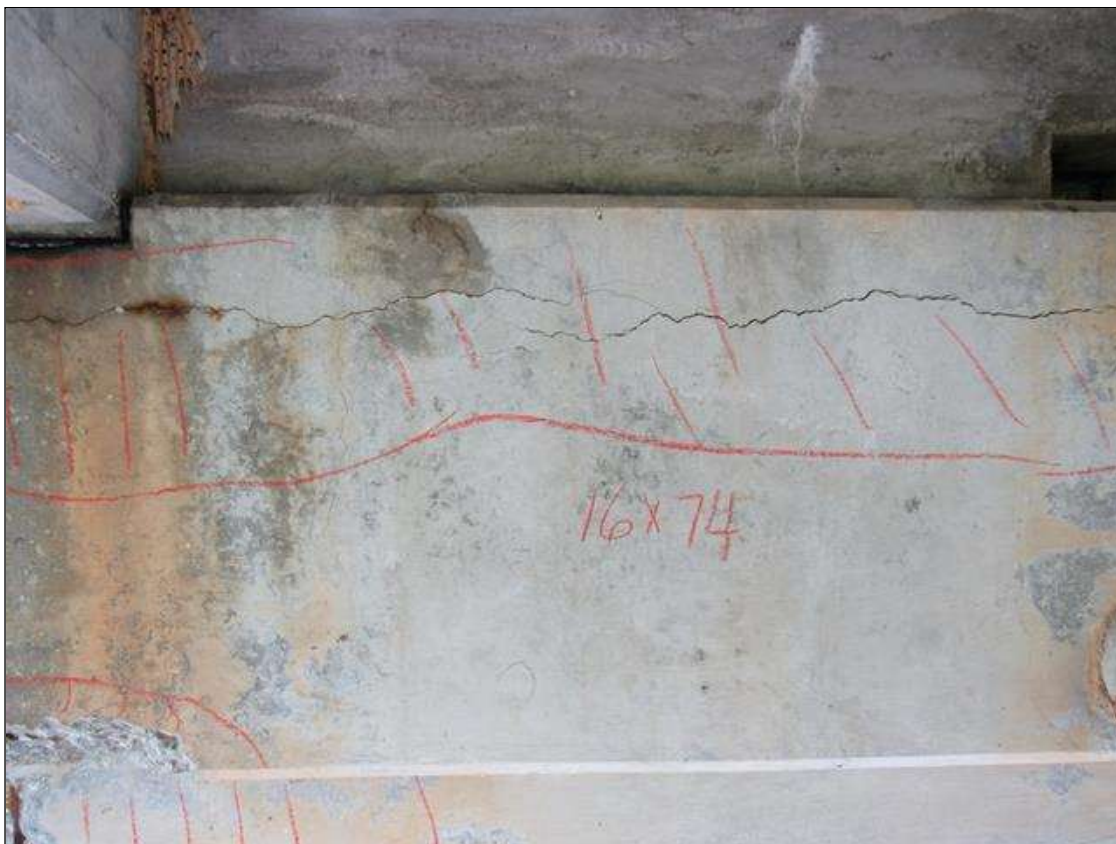
Bent 3 Cap : 7 Feet of Delamination/Spall/Patched Area: Delaminated. Spall 1 inch or less deep or 6 inches or less in diameter. Patched area that is sound
BENT 3 EAST FACE OF CAP HORZ CRACK AND DELAMINATED AREA ALONG TOP EDGE OF CAP FROM TOP DOWN 16" AND 74" LONG.

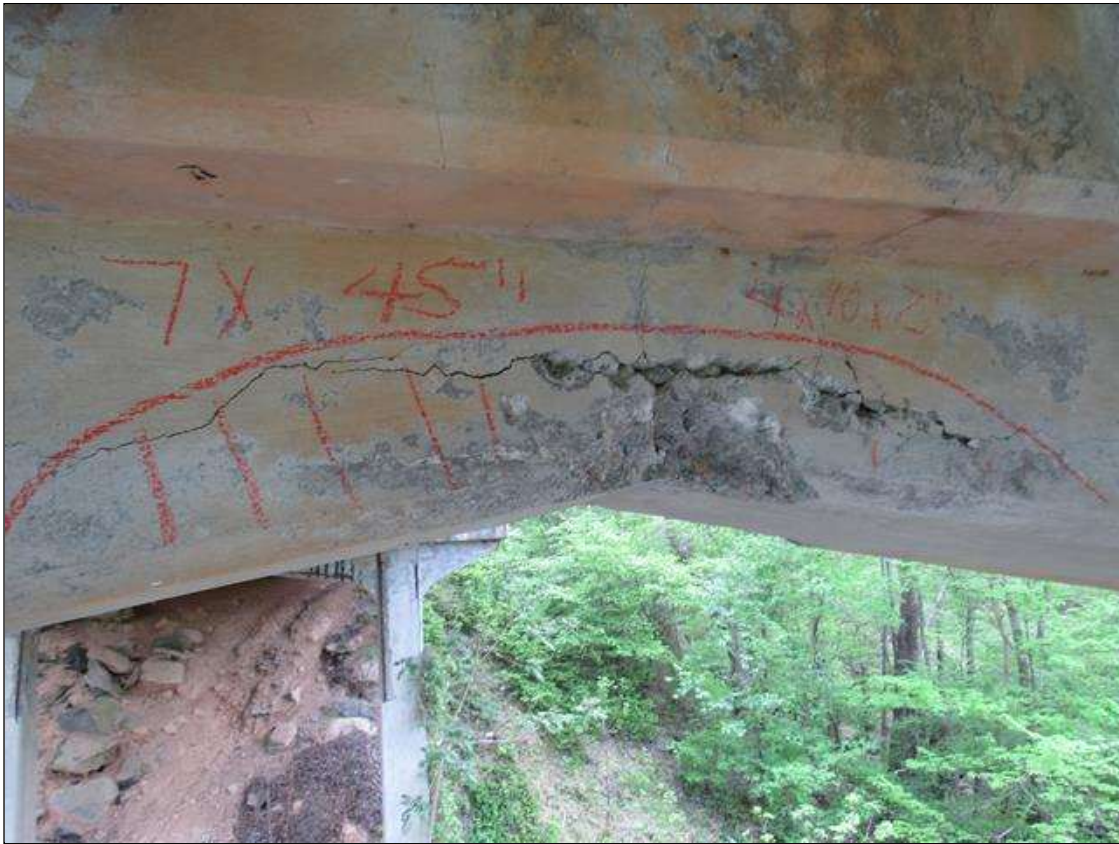
BENT 3 EAST FACE OF THE HAUNCH UNDER GIRDER 3 CRACKED SPALL AND DELAMINATED. 7" X 45" AND SPALL AREA IS 7" X 10" X 2" DEEP.

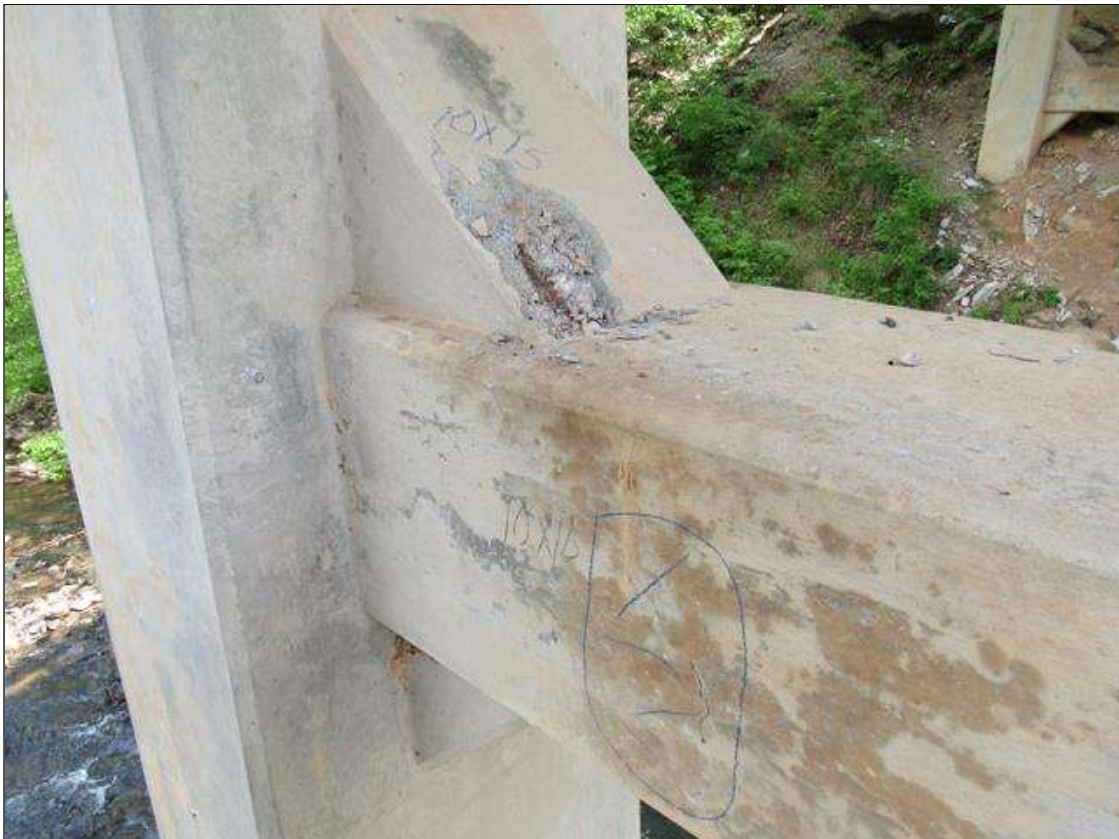
BENT 3 STRUT AREA RIGHT SIDE OF PILE 1 ON TOP AND EAST FACE HAS A 10" X 15" SPALL AREA 1 1/4" DEEP REBAR EXPOSED AND A 10" X 16" CRACKED AND DELAMINATED AREA.

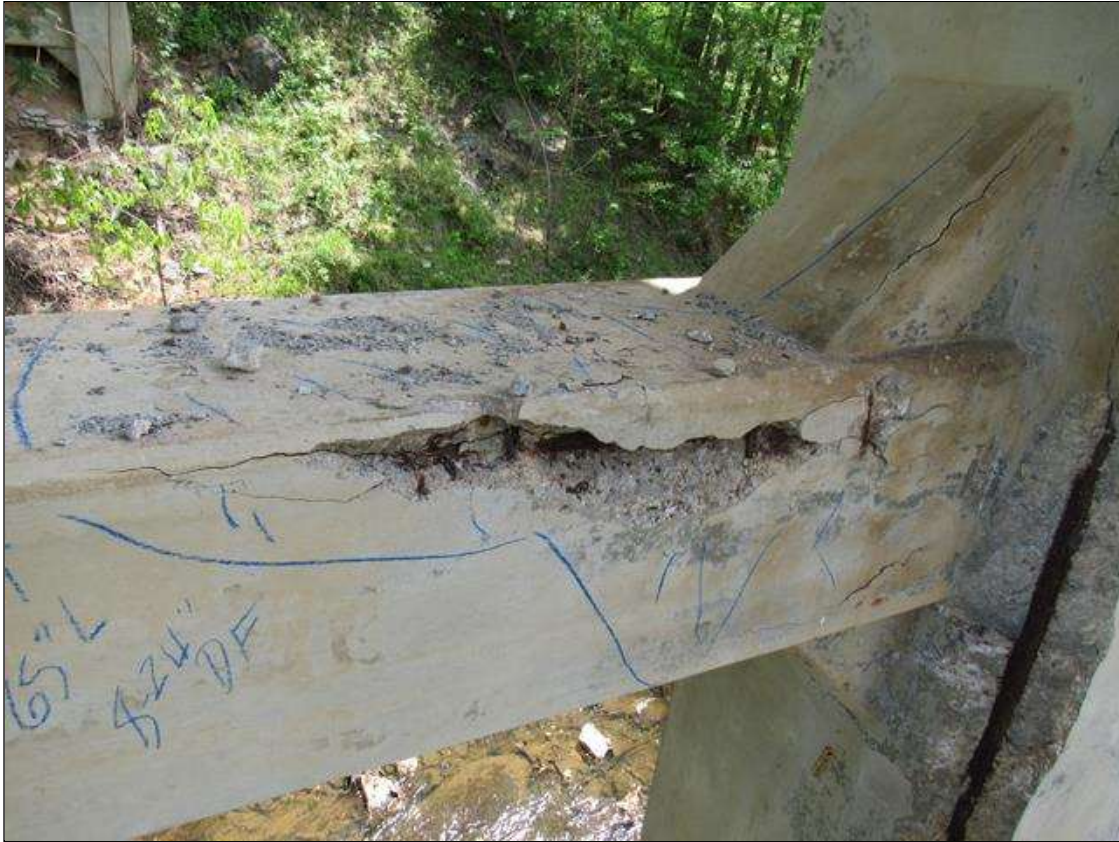
BENT 3 HORZ STRUT AREA LEFT SIDE OF PILE 2 IS CRACKED SPALL DELAMINATED 24" ON TOP 65" LONG AND FROM 8" TO 24" DOWN FACE REBAR AND STIRRUPS EXPOSED.

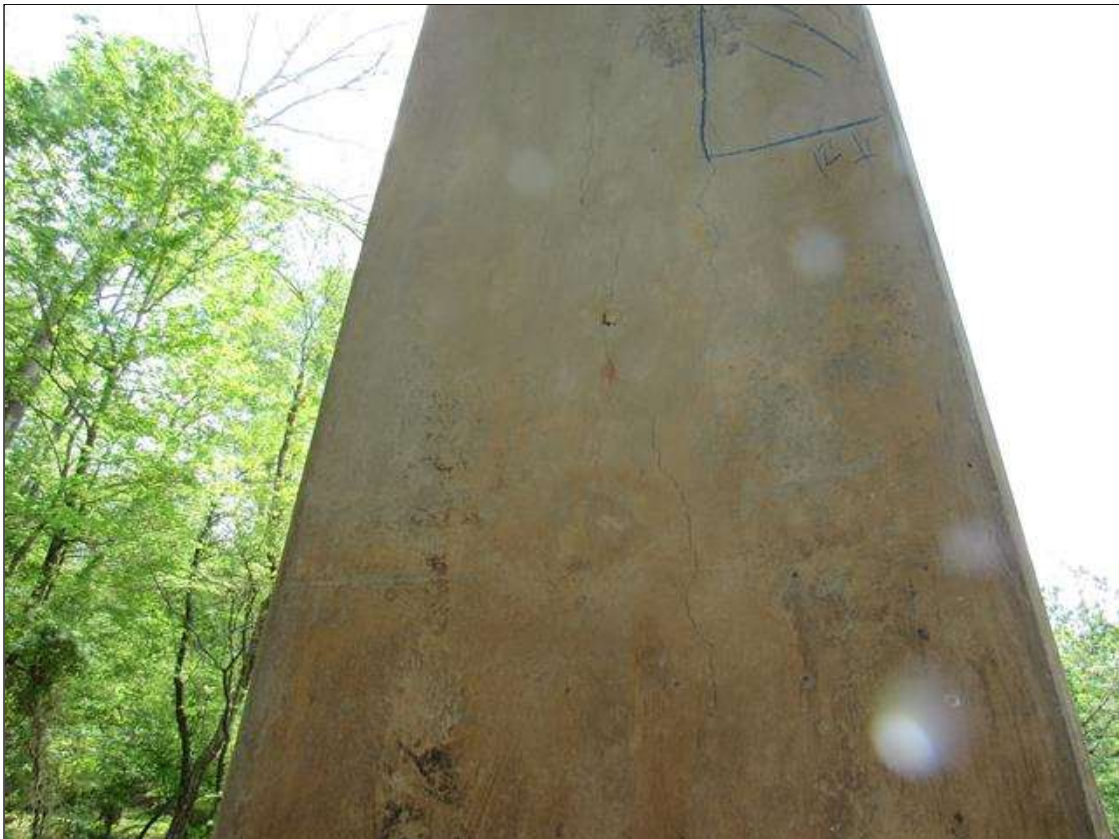
Bent 3 Pile 2: 1 Each of Cracking (RC and Other): Width 0.012-0.05 in. or spacing or 1.0-3.0 ft.
BENT 3 PILE 2 HAS SCATTERED VERTICAL CRACKS IN FACE OF PILE.

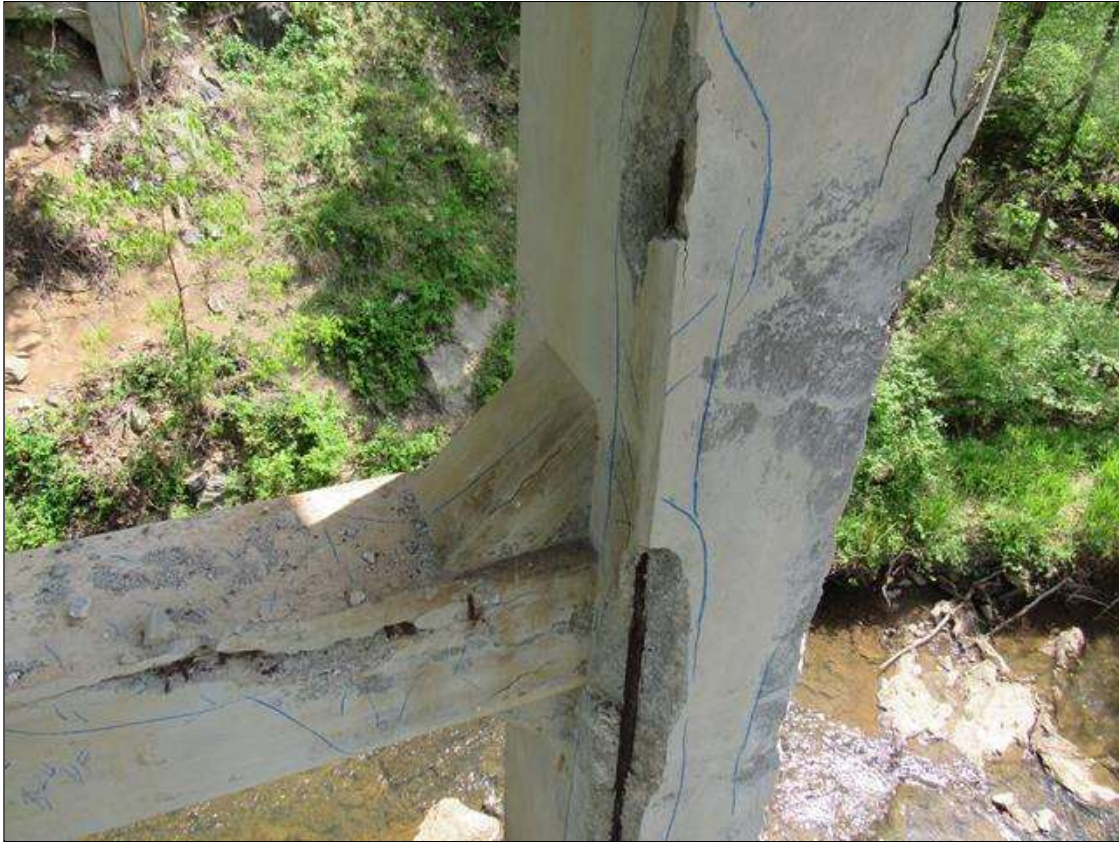
Bent 3 Pile 2: 0 Each of Delamination/Spall/Patched Area: Spall greater than 1 in. deep or greater than 6 in. diameter. Patched area that is unsound or showing distress. Does not warrant structural review.
BENT 3 PILE 2 CRACKED SPALL DELAMINATED AREA NW CORNER STARTS 12' ABOVE FOOTING EXTENDS UP 11' 6". 16" ON NORTH AND 11" ON WEST.

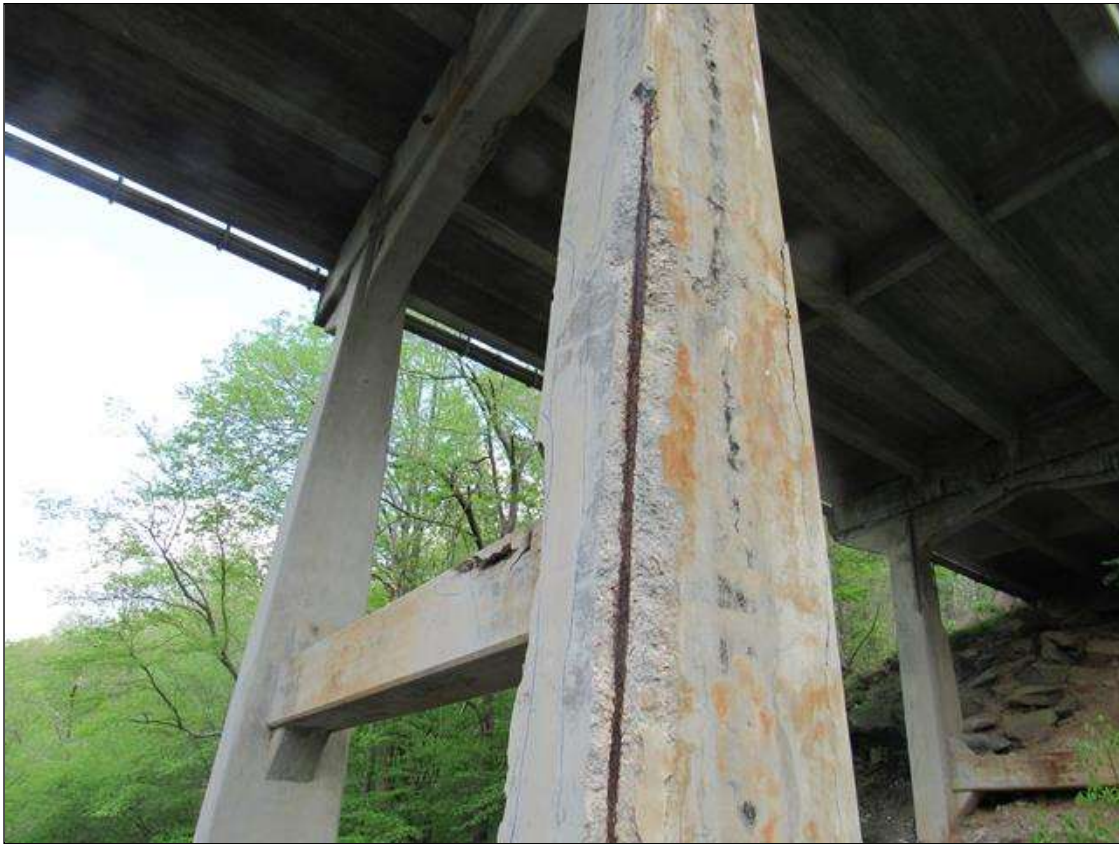
Bent 3 Pile 2: 0 Each of Delamination/Spall/Patched Area: Spall greater than 1 in. deep or greater than 6 in. diameter. Patched area that is unsound or showing distress. Does not warrant structural review.
BENT 3 PILE 2 CRACKED SPALL DELAMINATED AREA SW CORNER OF PILE STARTS 32" FM BOTTOM OF CAP EXTENDS DOWN 24' 16" ON WEST FACE 13" ON SOUTH FACE WITH LARGE REAR EXPOSED.

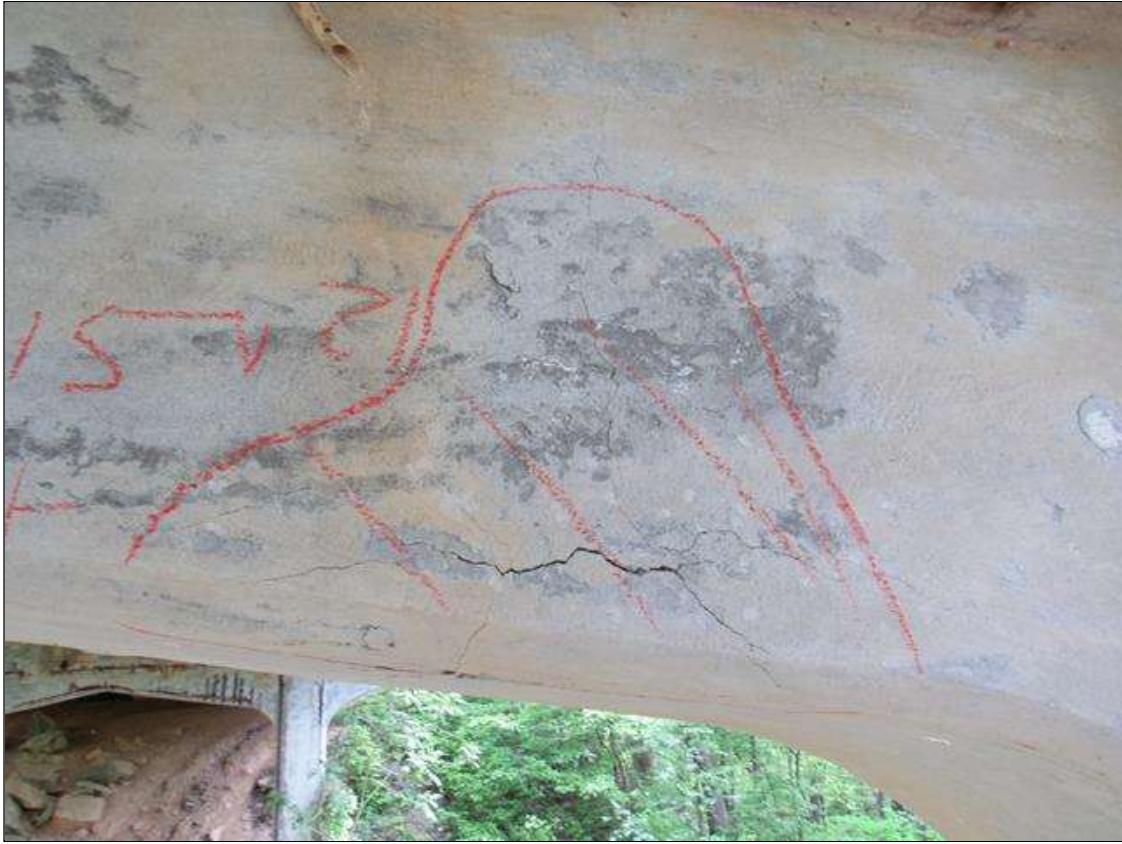
BENT 3 EAST FACE OF HAUNCH AREA LEFT SIDE OF PILE 2 CRACKED AND DELAMINATED 15" UP FACE 21" LONG AND 4" UNDER BOTTOM.

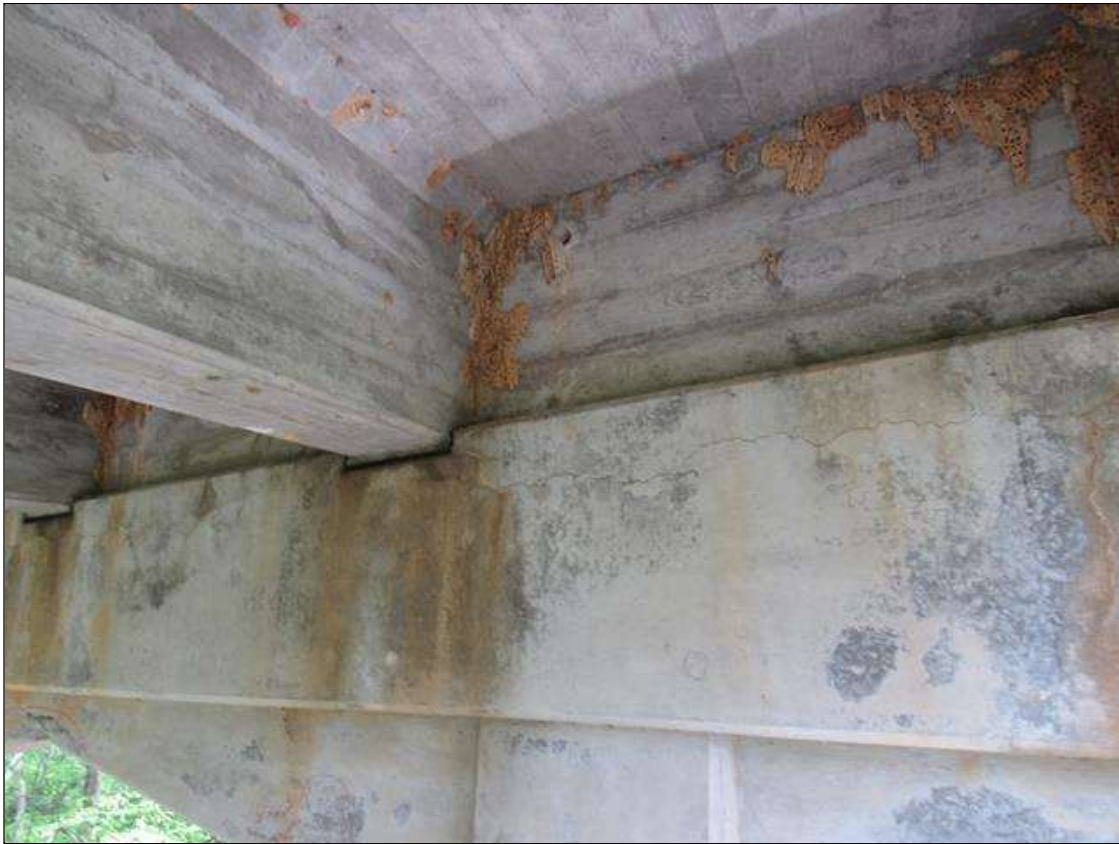
Bent 3 Cap : 24 Feet of Cracking (RC and Other): Width 0.012-0.05 in. or spacing of 1.0-3.0 ft.
BENT 3 CAP WEST FACE HAS HORZ CRACKS ALONG TOP EDGE FROM G1 TO G5 AND APPROX 10" TO 12"
DOWN FACE.

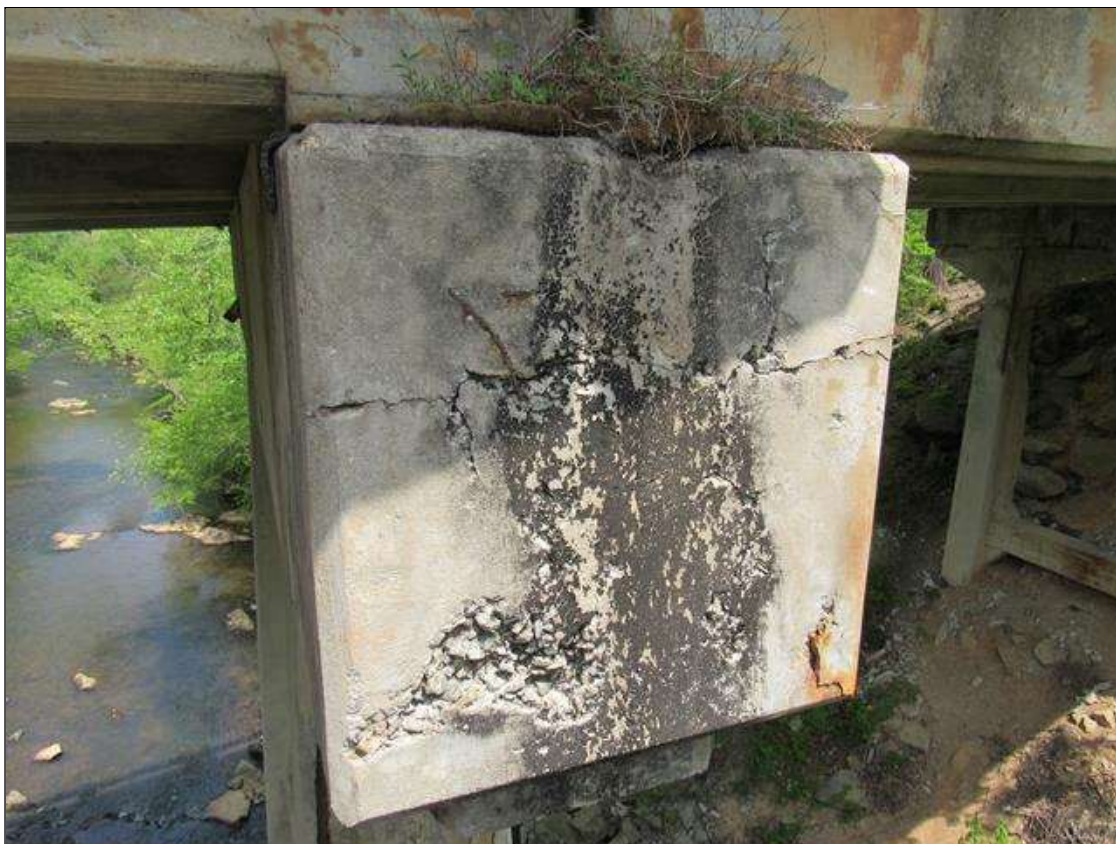
Bent 3 Cap : 0 Feet of Cracking (RC and Other): Width 0.012-0.05 in. or spacing of 1.0-3.0 ft.
BENT 3 RIGHT END OF CAP MAP CRACKING AND HAS A 7" X 12" SPALL 1" DEEP.

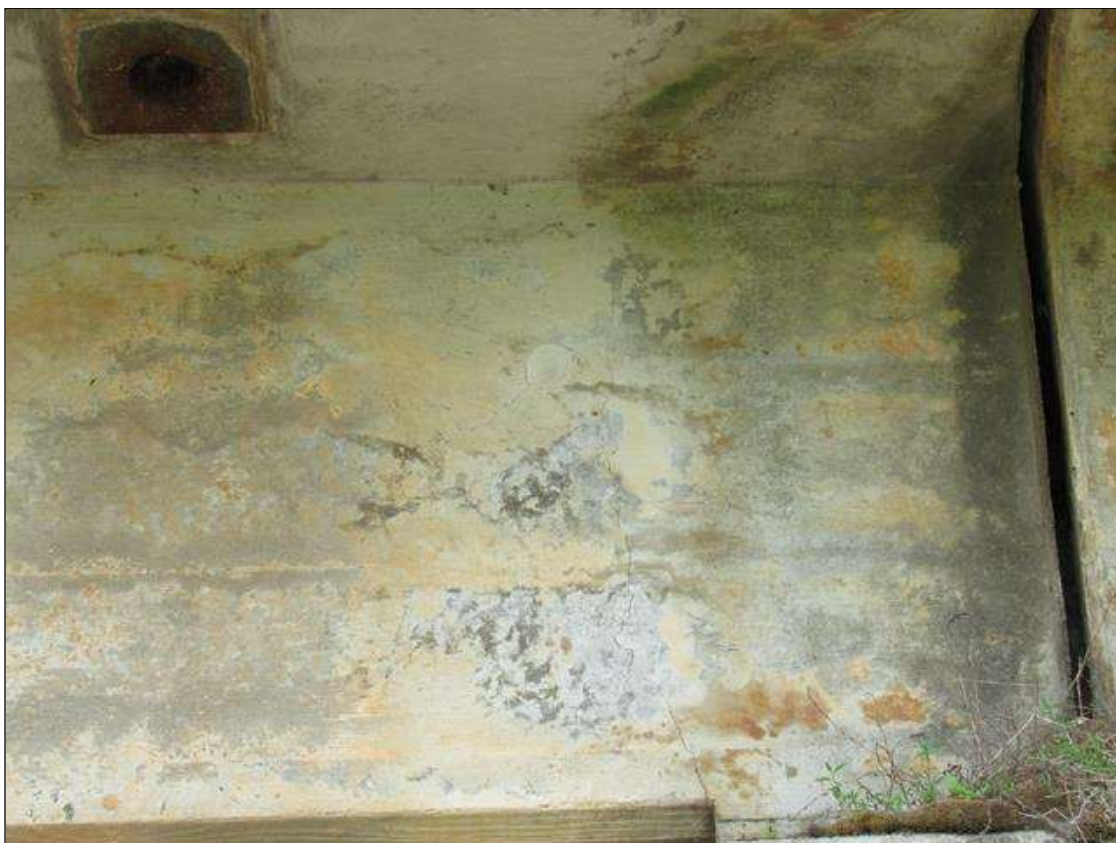
Span 3 Beam 5: 3 Feet of Cracking (RC and Other): Width 0.012-0.05 in. or spacing of 1.0-3.0 ft.
SPAN 3 RIGHT SIDE OF GIRDER 5 MAP CRACKING OVER BENT 3 CAP.

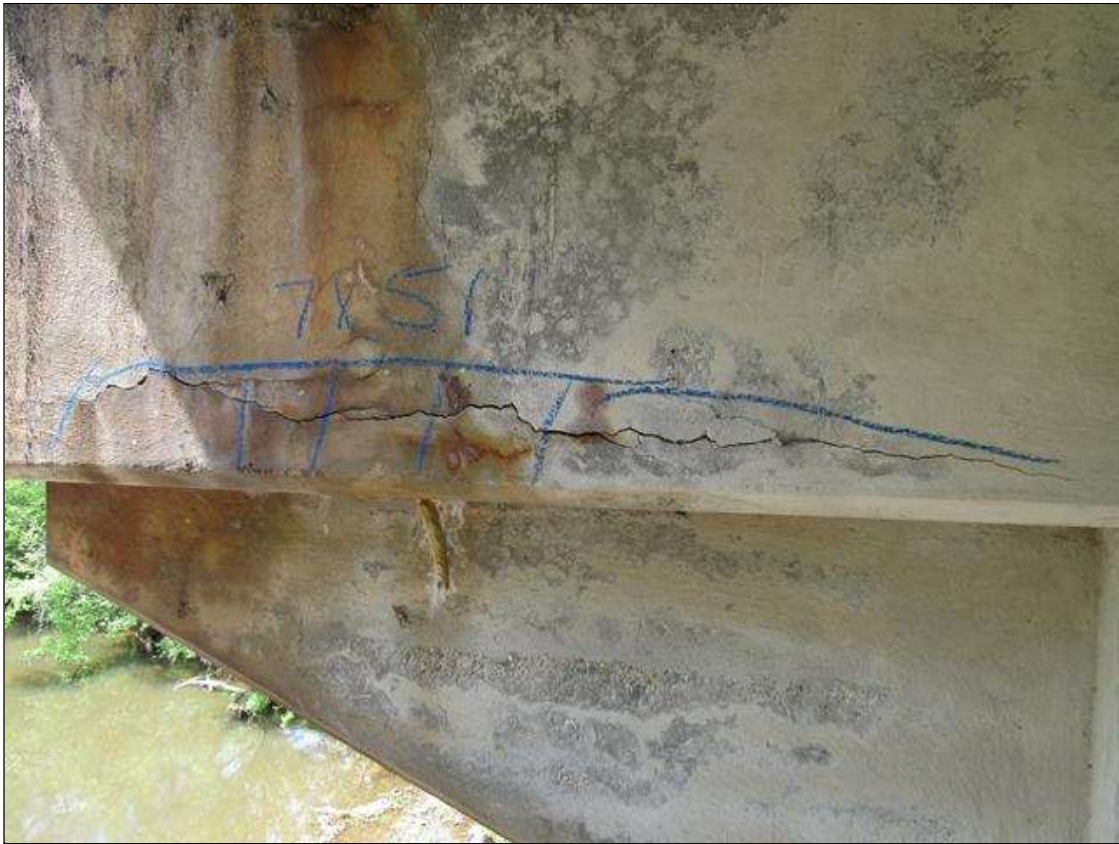
Bent 3 Cap : 0 Feet of Delamination/Spall/Patched Area: Delaminated. Spall 1 inch or less deep or 6 inches or less in diameter. Patched area that is sound
BENT 3 EAST FACE OF CAP HAS A CRACKED AND DELAMINATED AREA UNDER GIRDER 5 ALONG THE BOTTOM EDGE. 7" UP FACE AND 51" LONG.

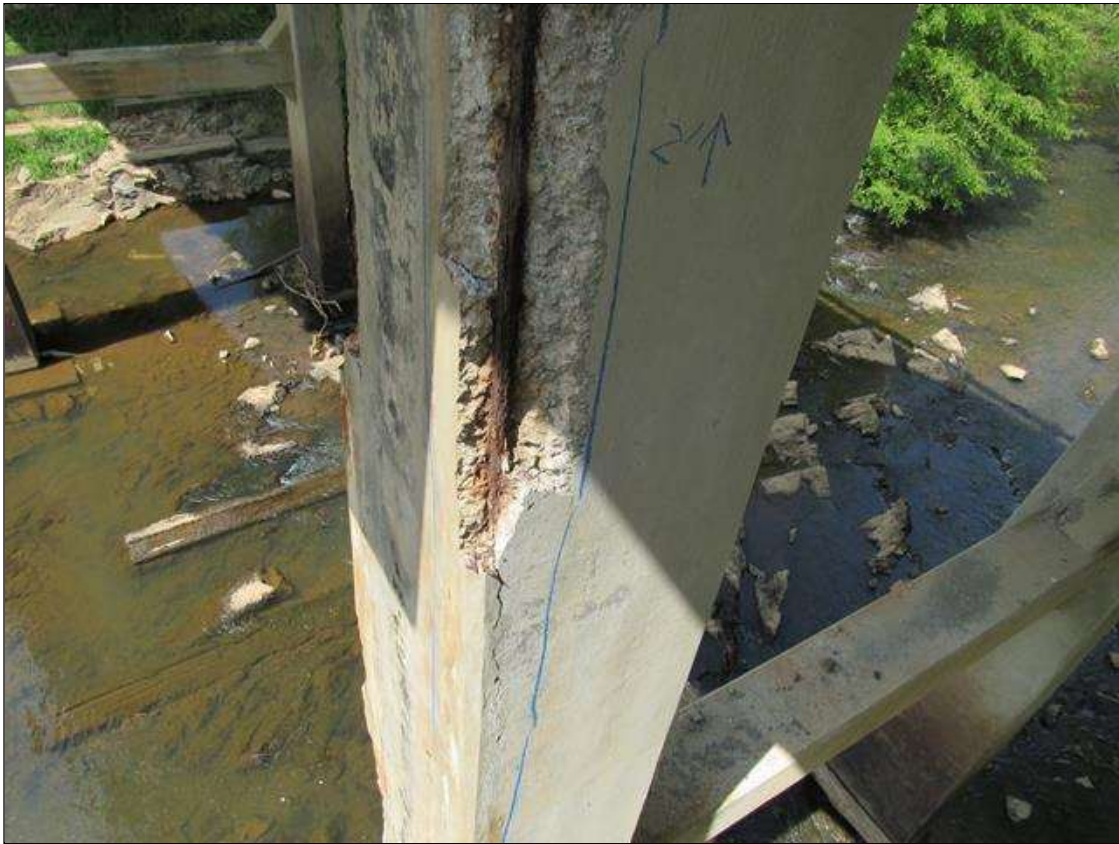
Bent 3 Pile 2: 0 Each of Delamination/Spall/Patched Area: Spall greater than 1 in. deep or greater than 6 in. diameter.
Patched area that is unsound or showing distress. Does not warrant structural review.
BENT 3 PILE 2 CRACKED SPALL DELAMINATED AREA SE CORNER OF PILE STARTS 24" BELOW CAP
EXTENDS DOWN 24' 14" ON SOUTH FACE AND 16" ON EAST LARGE REBAR EXPOSED.

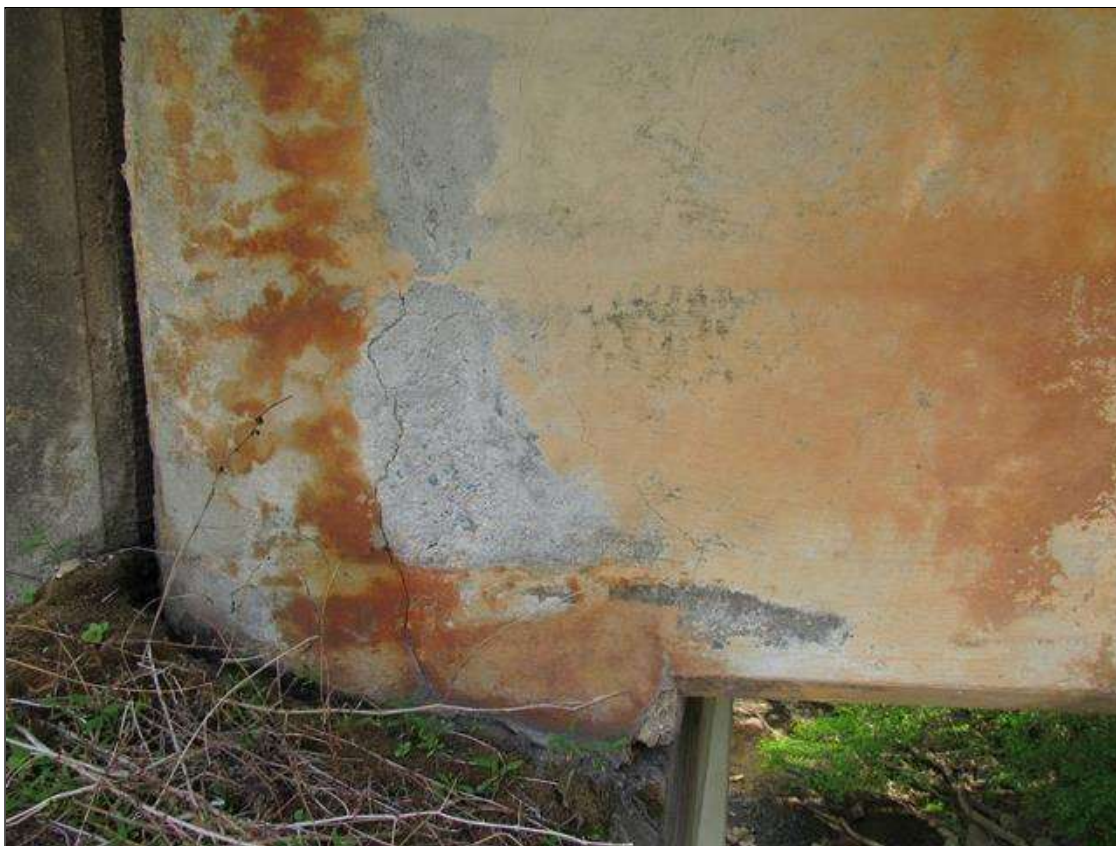
Span 4 Beam 5: 2 Feet of Cracking (RC and Other): Width 0.012-0.05 in. or spacing of 1.0-3.0 ft.
SPAN 4 GIRDER 5 CRACKED.

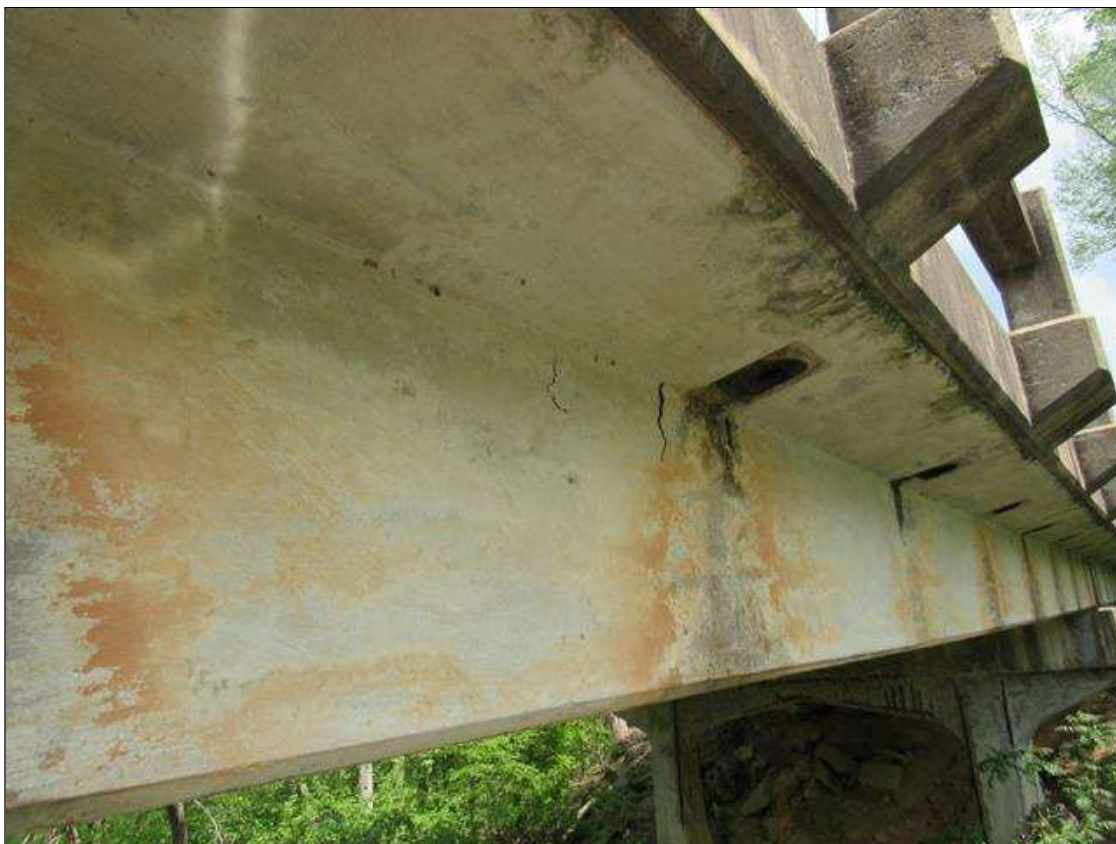
Span 4 Beam 5: 2 Feet of Delamination/Spall/Patched Area: Delaminated. Spall 1 in. or less deep or 6 in. or less in diameter. Patched area that is sound.
SPAN 4 GIRDER 5 RIGHT SIDE HAS 3 SURFACE SPALL AREAS NEAR BENT 3 WITH EFFLO STAINS.

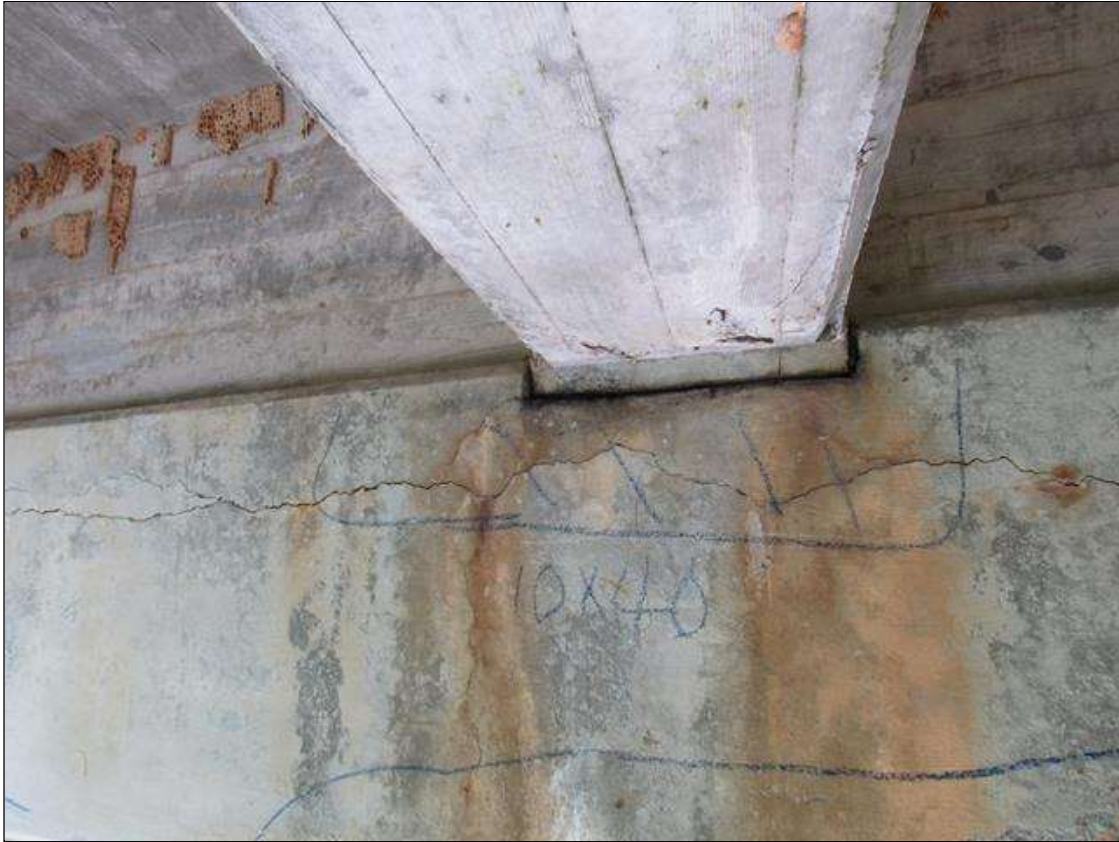
Bent 3 Cap : 0 Feet of Delamination/Spall/Patched Area: Delaminated. Spall 1 inch or less deep or 6 inches or less in diameter. Patched area that is sound
BENT 3 EAST FACE OF CAP HAS A HORZ CRACK AND DELAMINATED AREA UNDER GIRDER 4 FROM TOP DOWN 10" AND 40" LONG.

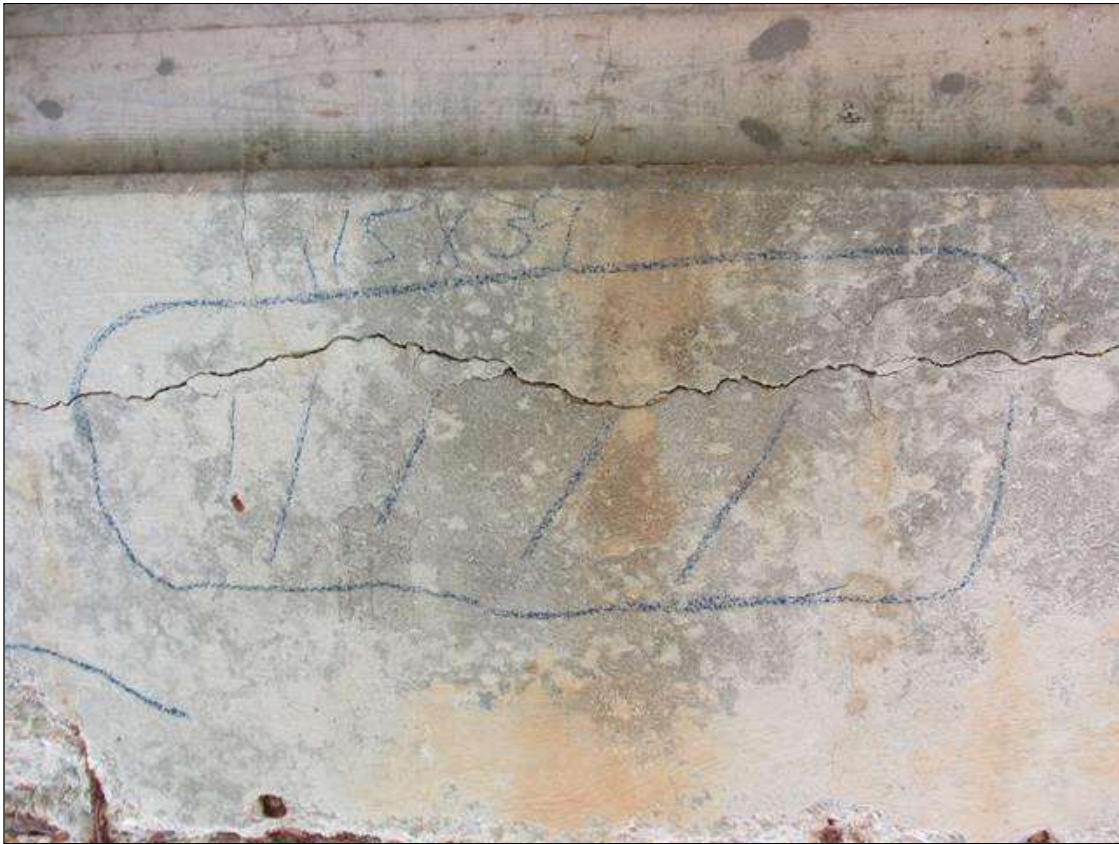
Bent 3 Cap : 0 Feet of Delamination/Spall/Patched Area: Delaminated. Spall 1 inch or less deep or 6 inches or less in diameter. Patched area that is sound
BENT 3 EAST OF CAP HAS A CRACKED AND DELAMINATED AREA BETWEEN GIRDERS 3 AND 4. 15" X 39".

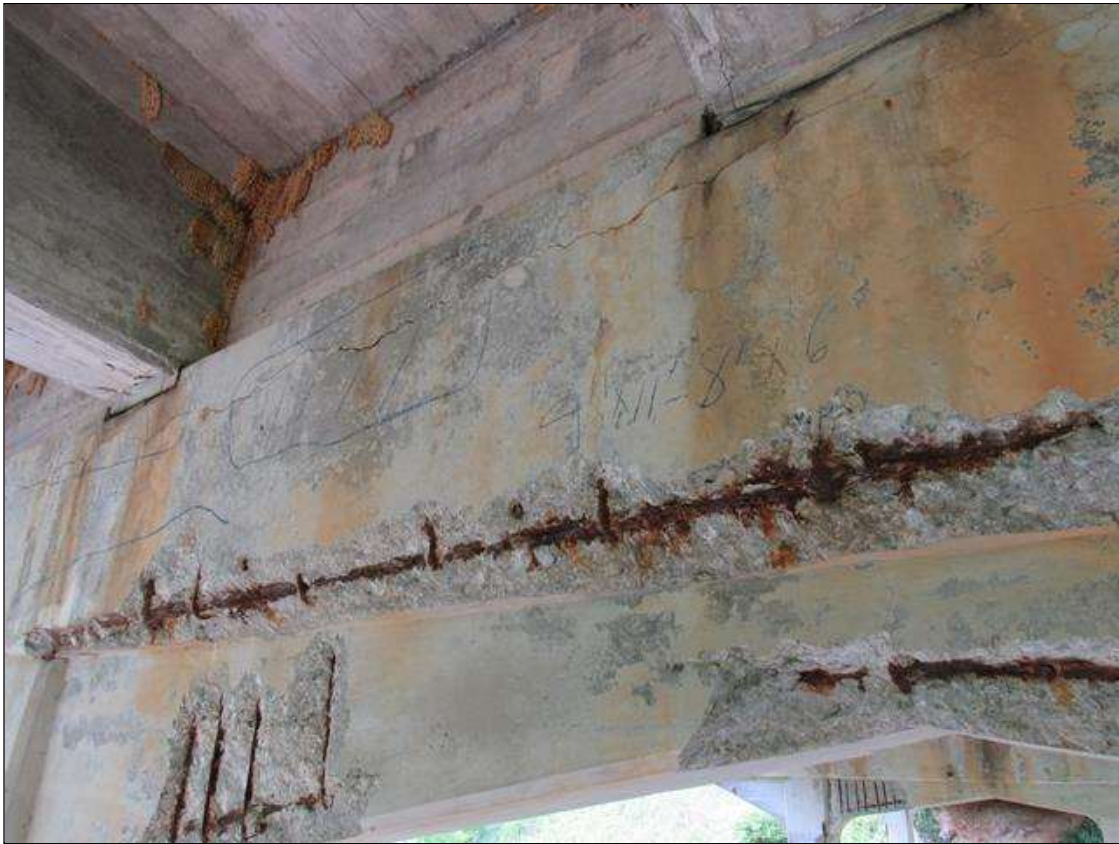
Bent 3 Cap : 0 Feet of Delamination/Spall/Patched Area: Spall greater than 1 inch deep or greater than 6 inches in diameter. Patched area that is unsound or showing distress. Condition does not warrant structural Review
BENT 3 EAST FACE OF CAP HAS A DELAMINATED AND SPALL AREA ALONG BOTTOM EDGE OF CAP FM G3 TO RT OF G4. 9" UP FACE 11' 8" LONG 6" UNDER BOTTOM REBAR STIRRUPS EXPOSED.

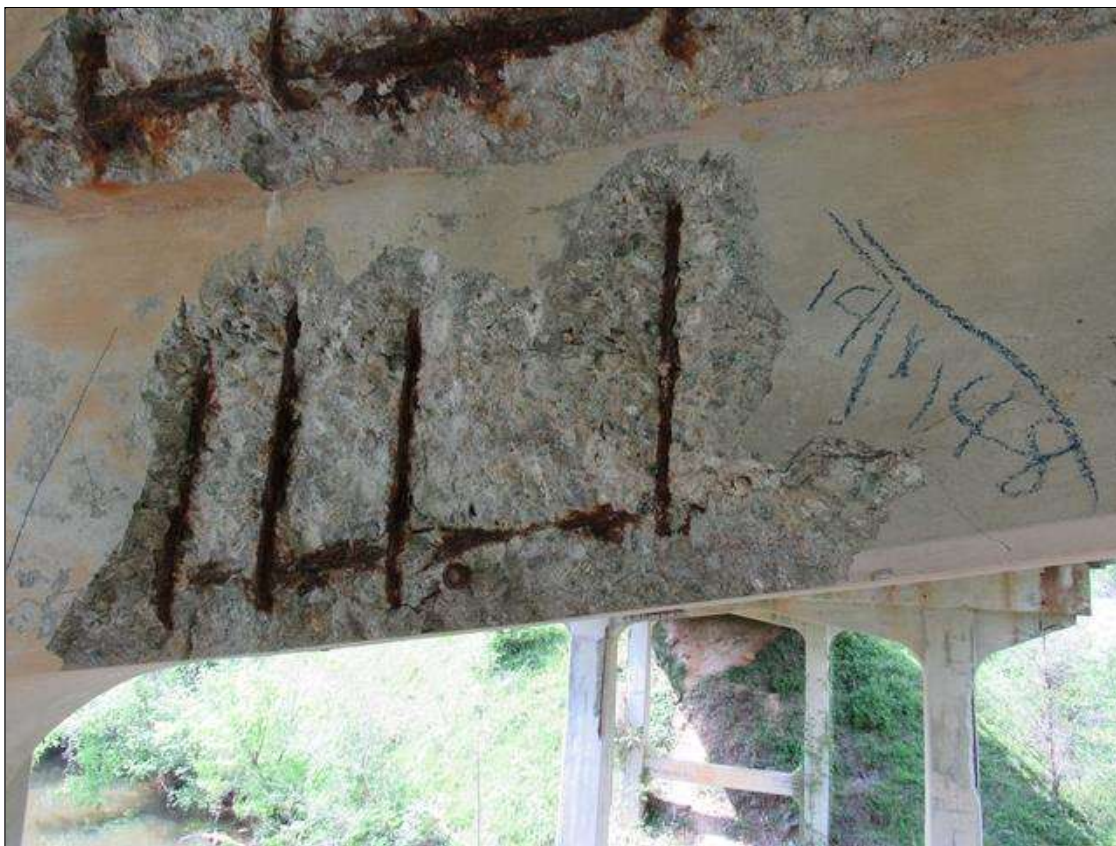
BENT 3 EAST FACE OF HAUNCH UNDER BOTTOM OF CAP SPALL DELAMINATED 19" HIGH 48" LONG 2" DEEP WITH REBAR AND STIRRUPS EXPOSED.

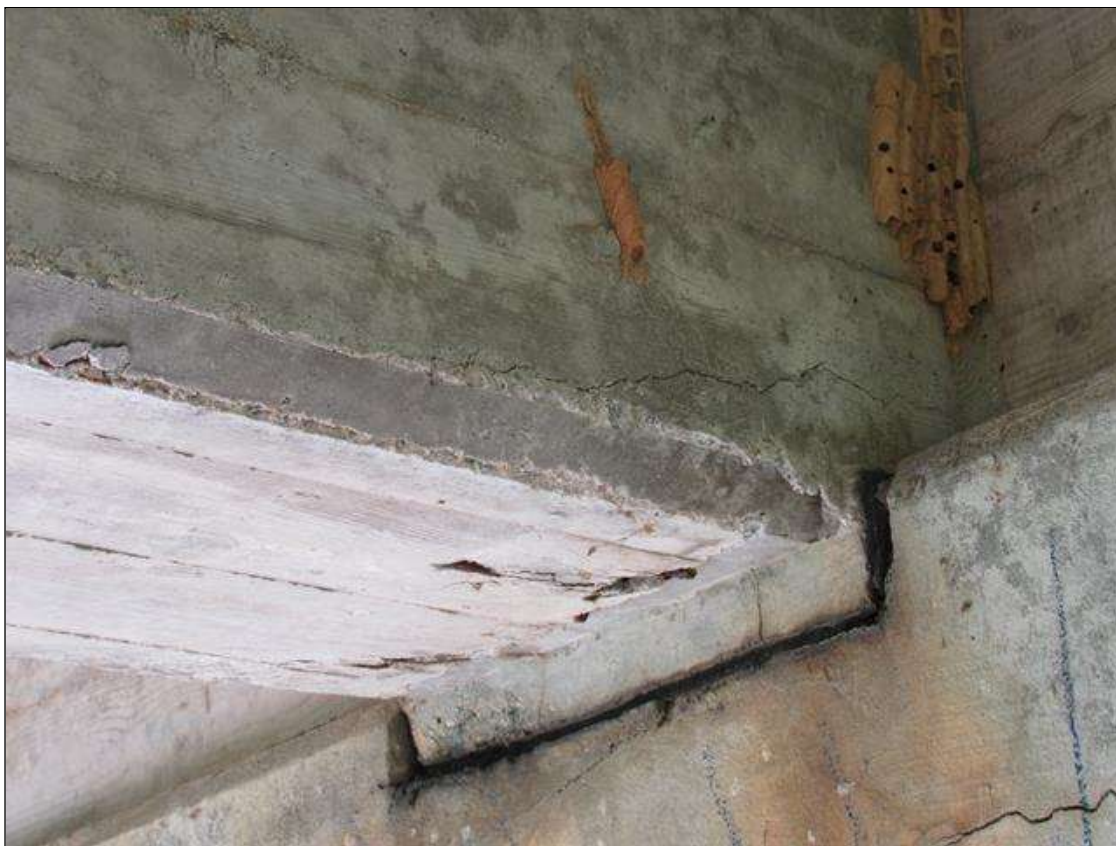
Span 4 Beam 4: 2 Feet of Cracking (RC and Other): Width 0.012-0.05 in. or spacing of 1.0-3.0 ft.
SPAN 4 LEFT SIDE OF G4 AT BENT 3 CRACKED AND DELAMINATED AREA ALONG BOTTOM OF GIRDER. 3" UP
FACE FROM END OF GIRDER OUT 17" AND 2" UNDER BOTTOM.

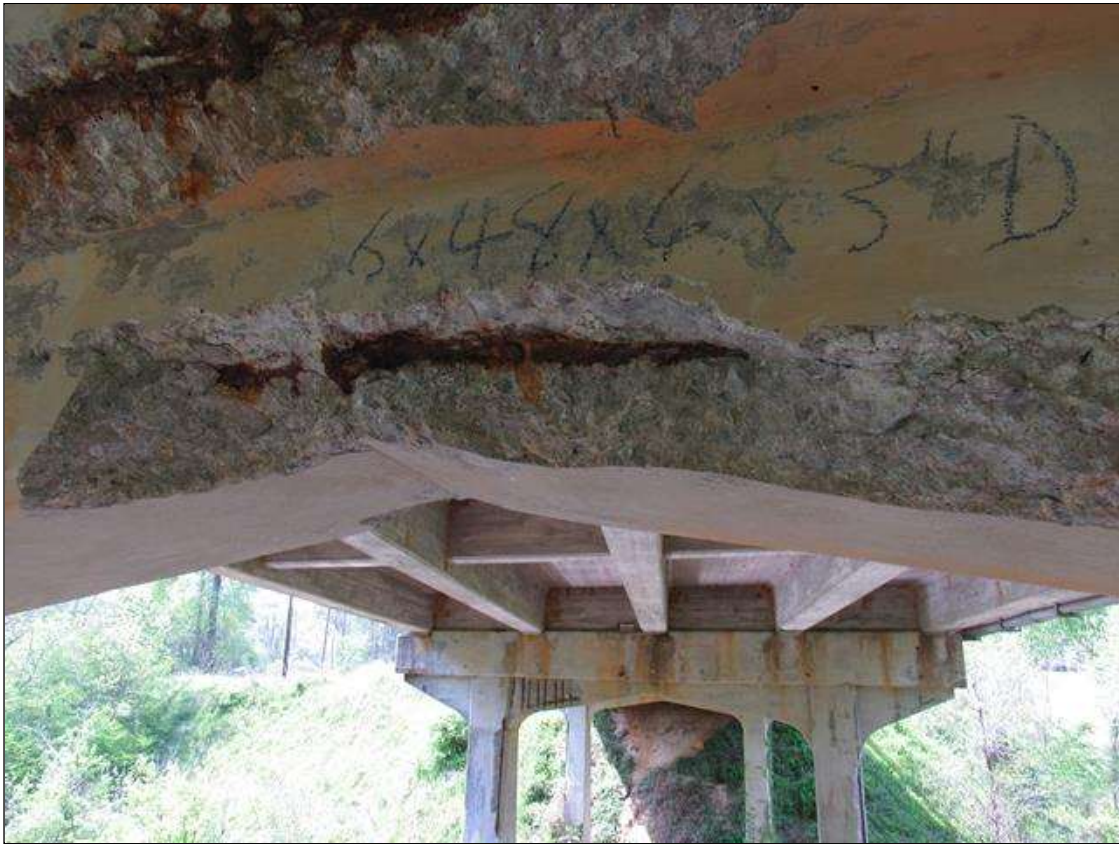
BENT 3 EAST FACE OF HAUNCH UNDER G3 SPALL AND DELAMINATED 6" HIGH 48" LONG 6" UNDER BOTTOM REBAR AND STIRRUPS EXPOSED.
