NC DEPARTMENT OF TRANSPORTATION
 DIVISION OF HIGHWAYS
 STRUCTURE MANAGEMENT UNIT

ATTENTION:

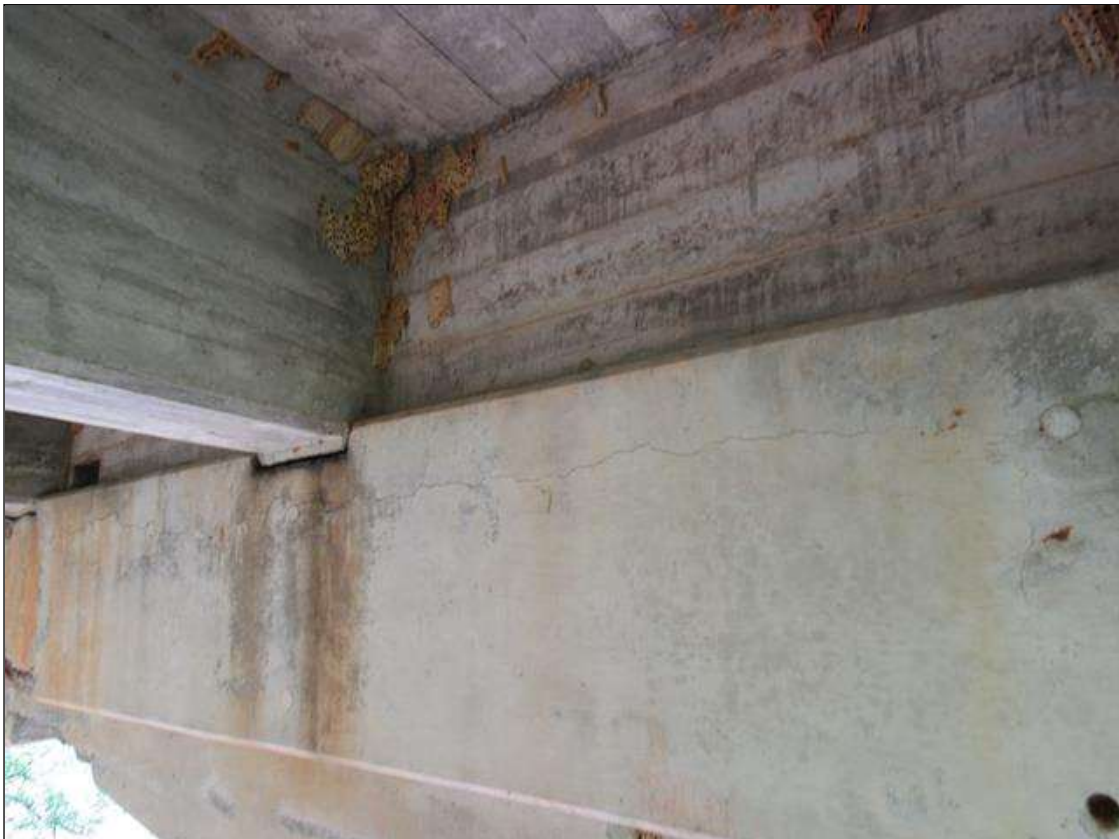
Bent 3 Cap : 0 Feet of Cracking (RC and Other); Width 0.012-0.05 in. or spacing of 1.0-3.0 ft.
BENT 3 EAST FACE OF CAP HAS A HORZ CRACK FROM G1 TO G5 10" TO 12" DOWN FACE.

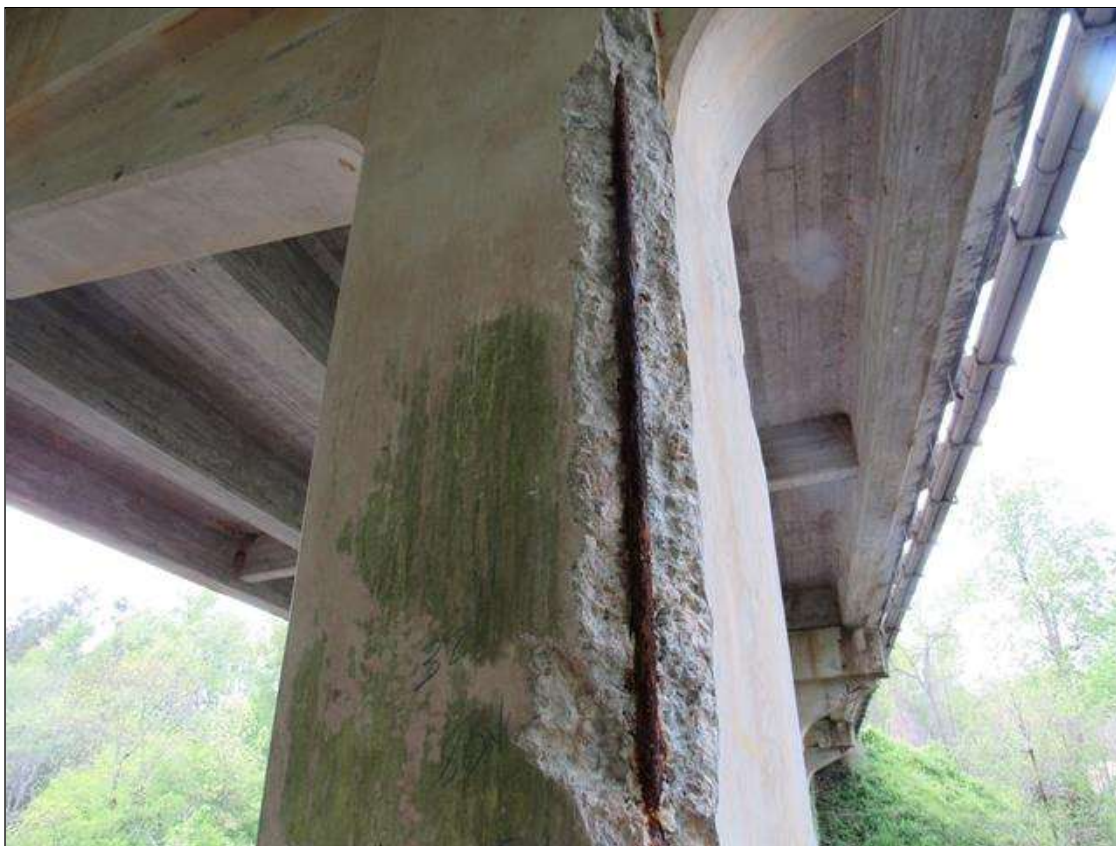
Bent 3 Pile 1: 0 Each of Delamination/Spall/Patched Area: Spall greater than 1 in. deep or greater than 6 in. diameter. Patched area that is unsound or showing distress. Does not warrant structural review.
BENT 3 PILE 1 CRACKED SPALL DELAMINATED AREA NE CORNER OF PILE STARTS 32" BELOW CAP EXTENDS DOWN 80" 11" ON EAST AND 6" NORTH.

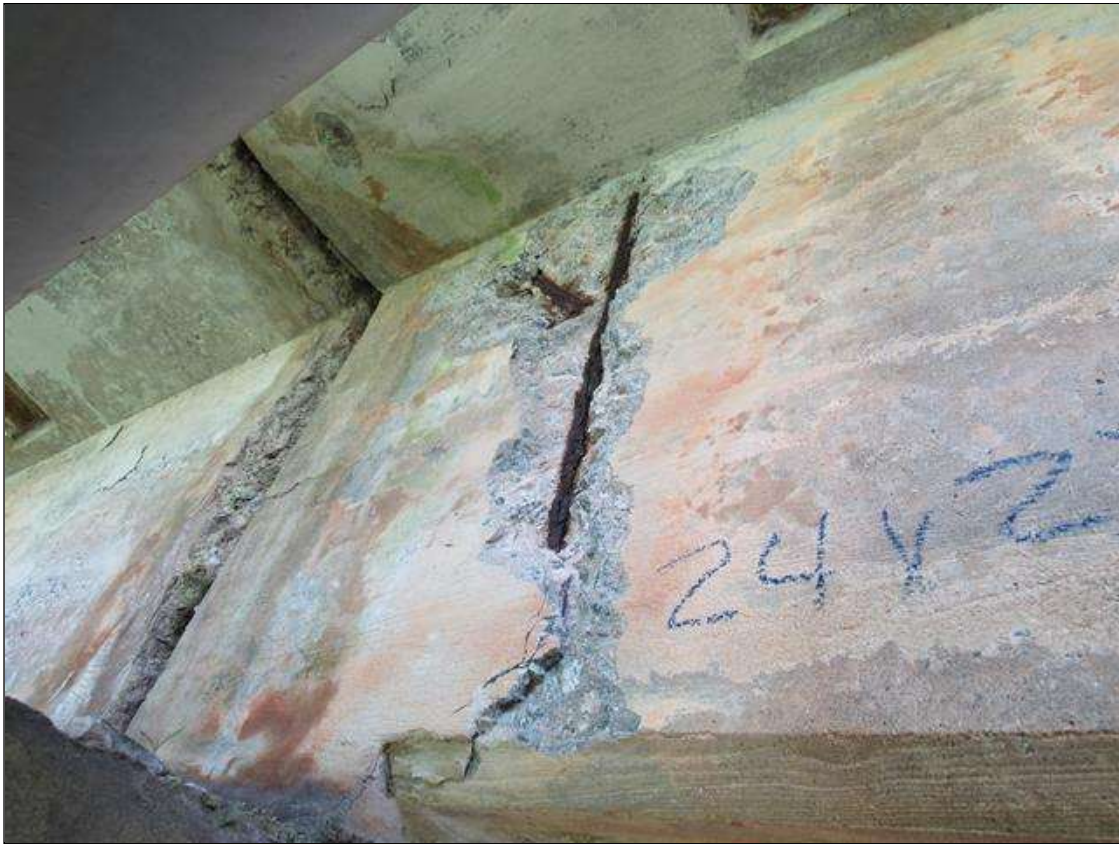
Span 4 Beam 1: 2 Feet of Delamination/Spall/Patched Area: Spall greater than 1 in. deep or greater than 6 in. diameter. Patched area that is unsound or showing distress. Does not warrant structural review.
SPAN 4 LEFT SIDE OF G1 OVER BENT 4 CRACKED SPALL DELAMINATED AREA FM END OF GIRDER BACK 24" BOTTOM UP 27" & 1 1/2" DEEP. VERT REBAR EXPOSED.

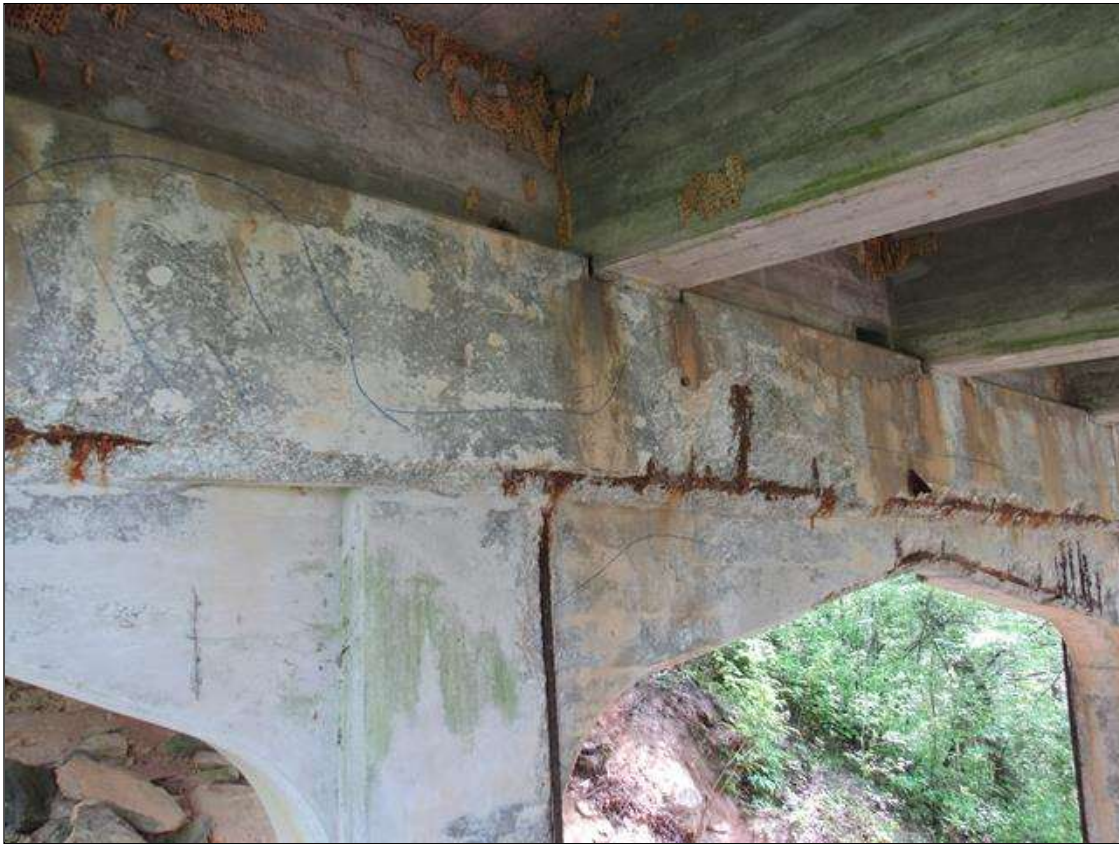
Bent 4 Cap : 27 Feet of Delamination/Spall/Patched Area: Spall greater than 1 inch deep or greater than 6 inches in diameter. Patched area that is unsound or showing distress. Condition does not warrant structural Review
BENT 4 WEST FACE OF CAP FM LT END OVER TO PILE 2 CRACKED SPALL DELAMINATED 27' LONG FM 12' TO 30" FM BOTTOM OF CAP UP WITH REBAR AND STIRRUPS EXPOSED.

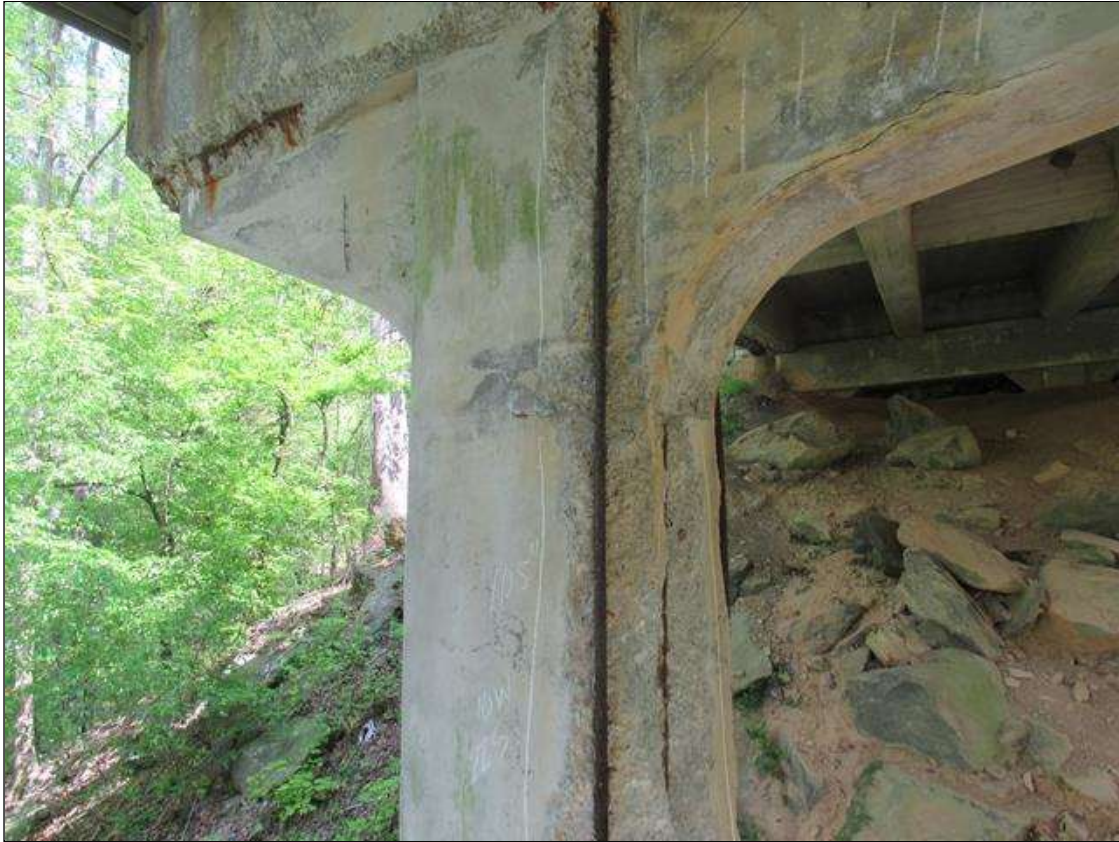
Bent 4 Pile 1: 1 Each of Delamination/Spall/Patched Area: Spall greater than 1 in. deep or greater than 6 in. diameter.
Patched area that is unsound or showing distress. Does not warrant structural review.

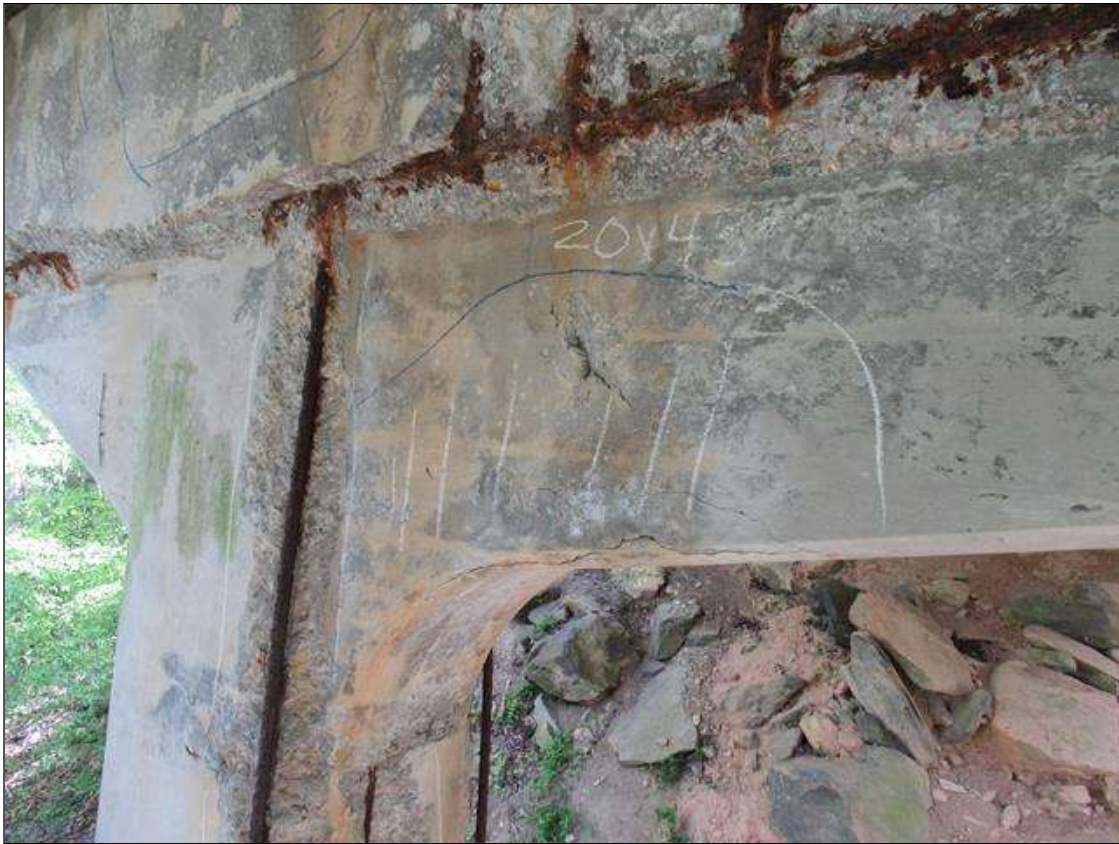
BENT 4 WEST FACE OF HAUNCH RIGHT SIDE OF PILE 1 CRACKED DELAMINATED 20" X 43" AND 10" UNDER BOTTOM.

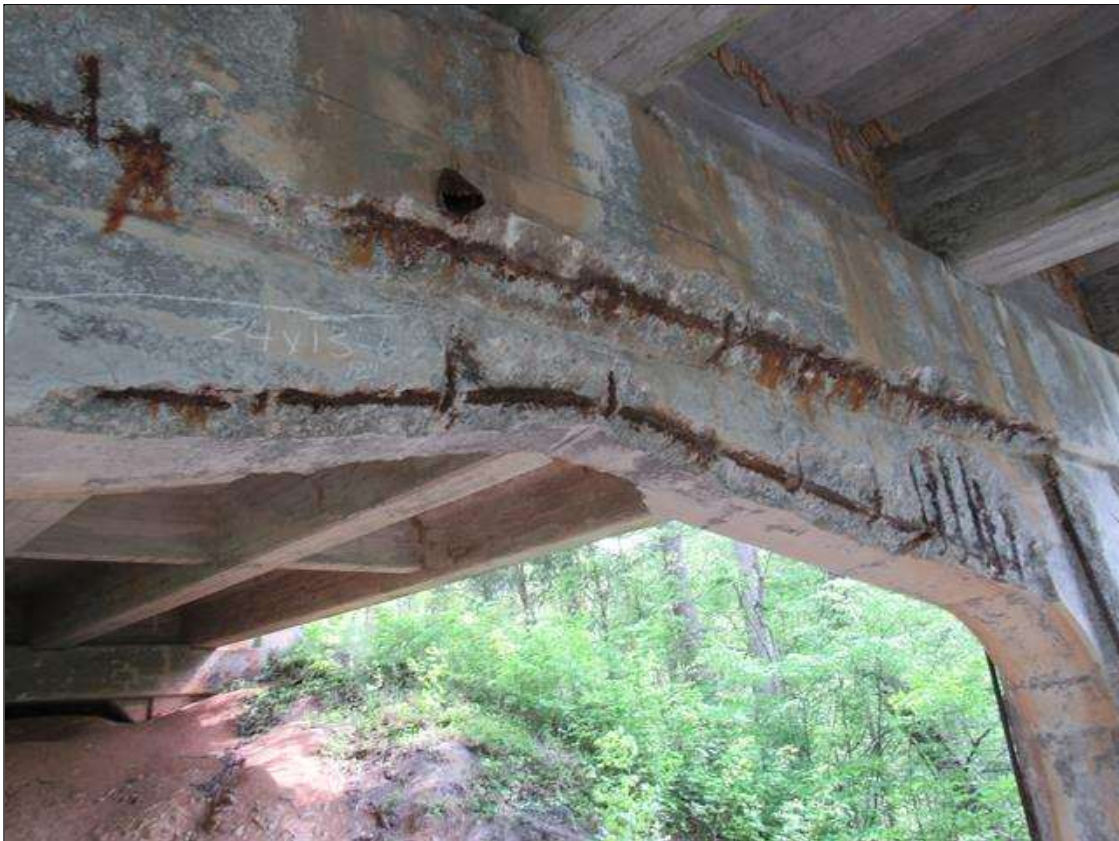
BENT 4 WEST FACE OF HAUNCH CRACKED SPALL DELAMINATED FM 15" TO 24" HIGH 13' 6" LONG 12" UNDER BOTTOM REBAR AND STIRRUPS EXPOSED.

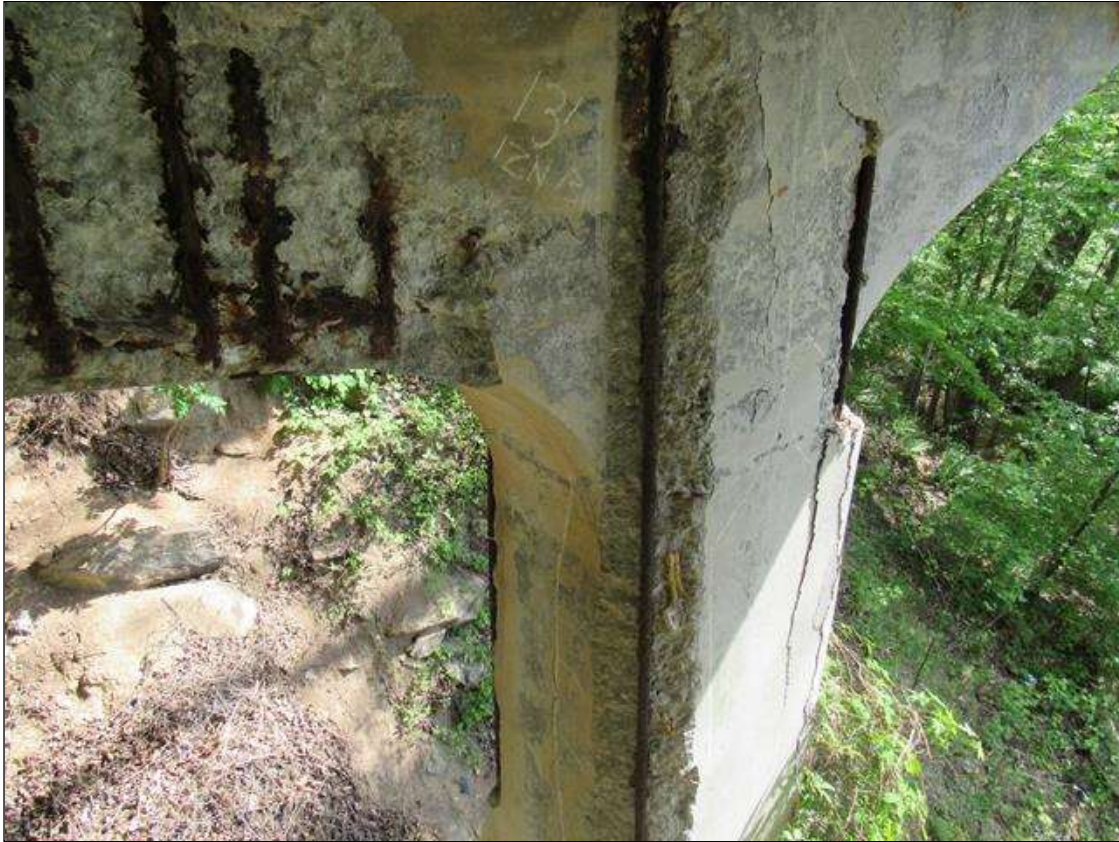
Bent 4 Pile 2: 1 Each of Delamination/Spall/Patched Area: Spall greater than 1 in. deep or greater than 6 in. diameter. Patched area that is unsound or showing distress. Does not warrant structural review.
BENT 4 PILE 2 CRACKED SPALL DELAMINATED NW CORNER FM CAP DOWN 13' & 12" ON NORTH FACE 13" ON WEST. REBAR EXPOSED.

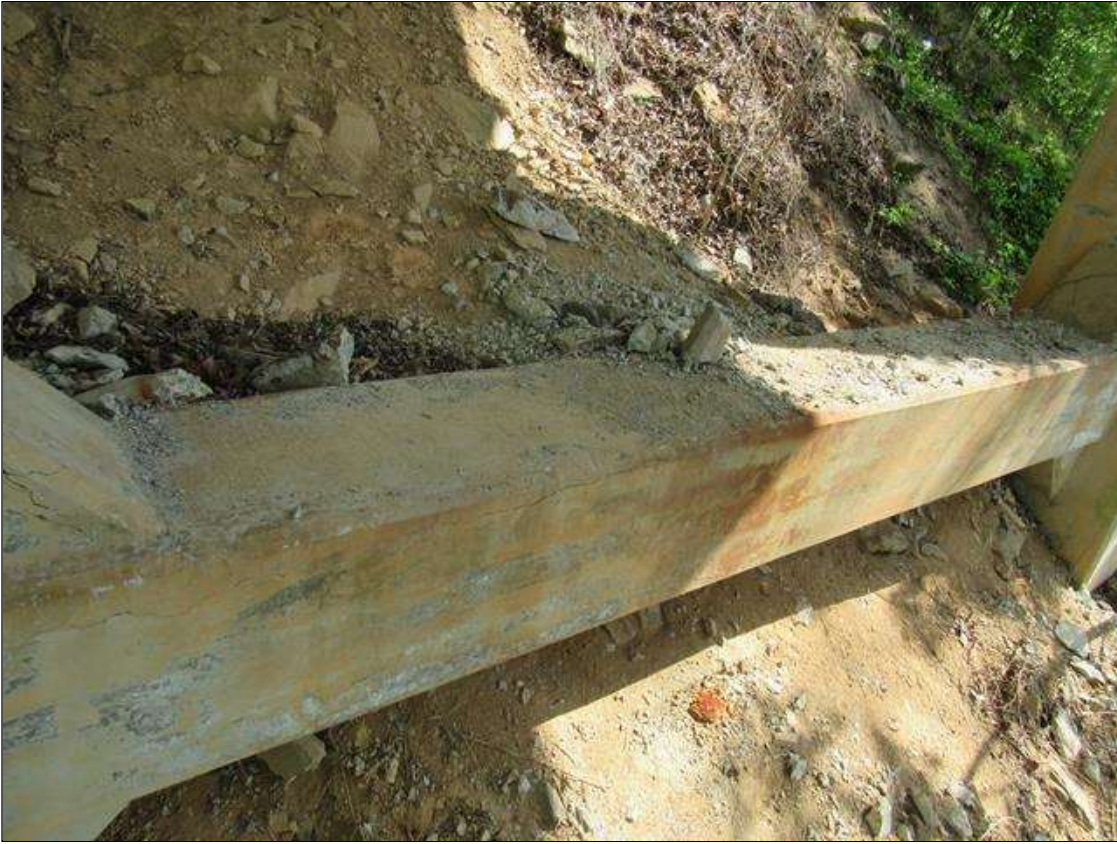
BENT 4 HORZ STRUT BETWEEN PILES 1 AND 2 IS CRACKED AND DELAMINATED 24" ON TOP 8" DOWN FACE ALL THE WAY ACROSS.

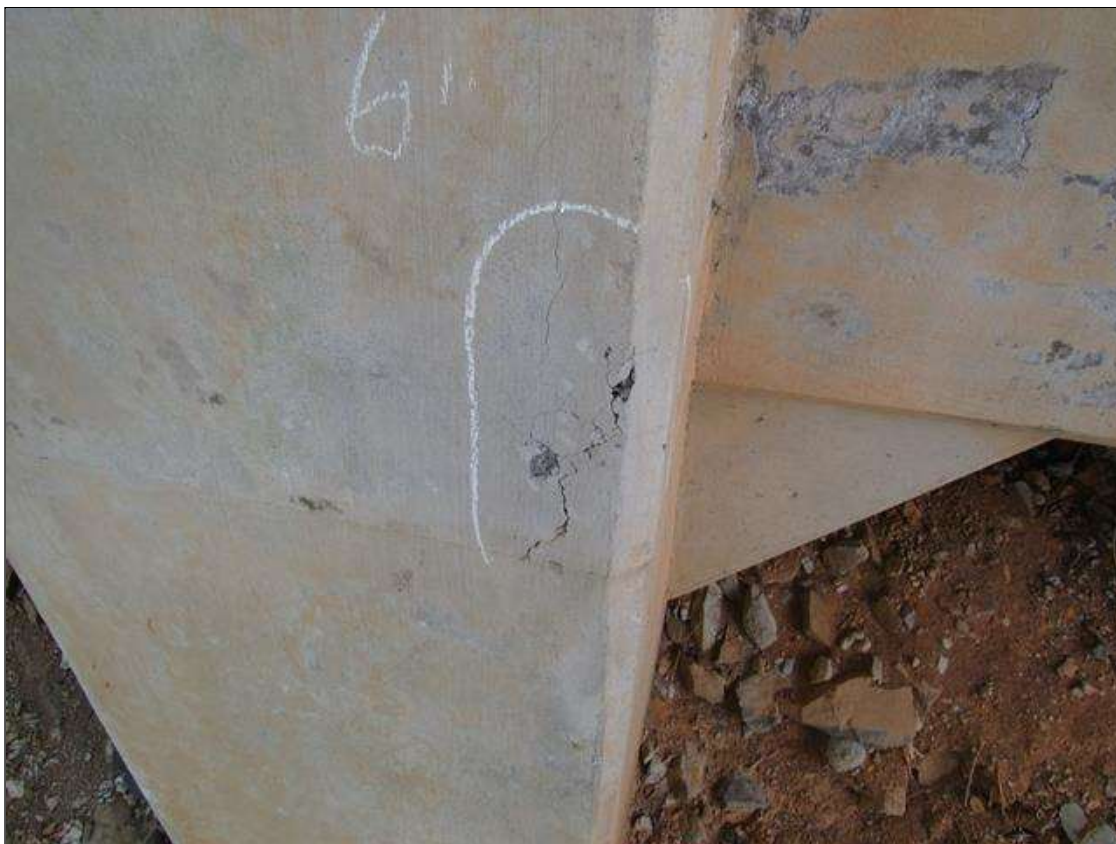
Bent 4 Pile 1: 0 Each of Delamination/Spall/Patched Area: Delaminated. Spall 1 in. or less deep or 6 in. or less in diameter. Patched area that is sound.
BENT 4 PILE 1 CRACKED DELAMINATED ON SW CORNER STARTS 3' ABOVE GROUND LINE 12 HIGH AND 6" ON EACH FACE.

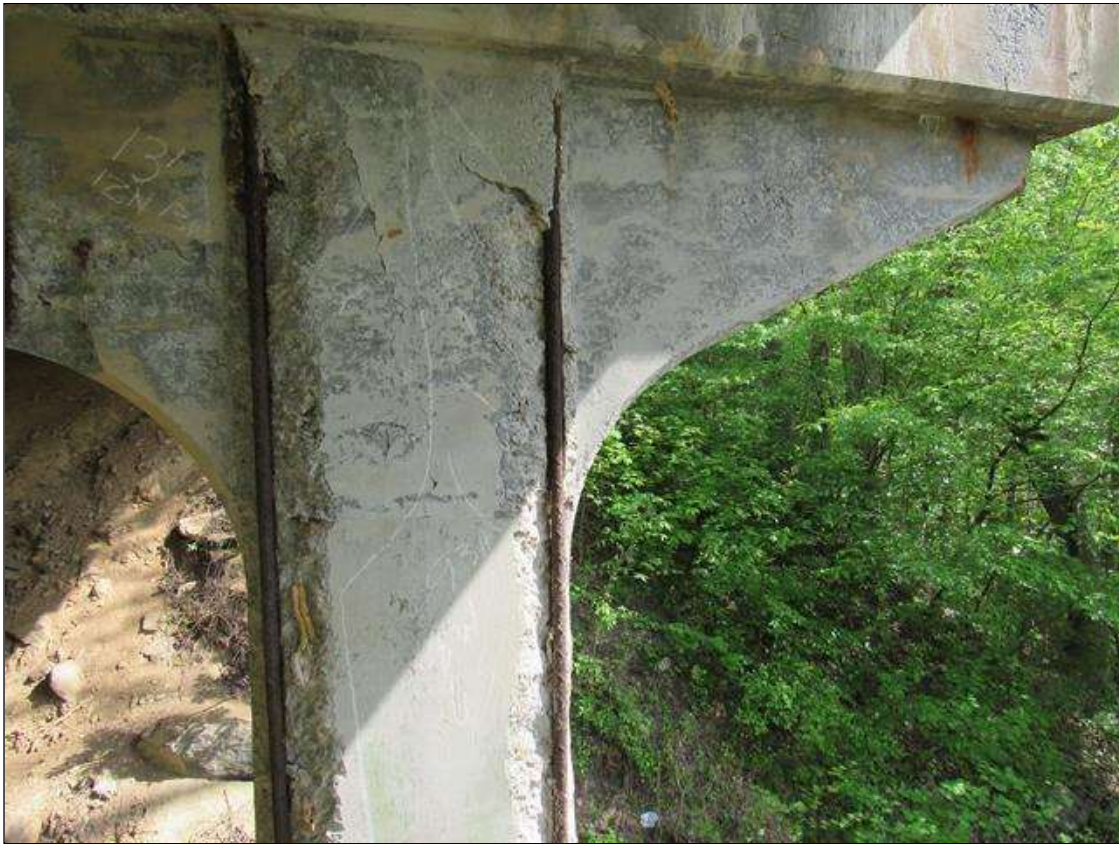
Bent 4 Pile 2: 0 Each of Delamination/Spall/Patched Area: Spall greater than 1 in. deep or greater than 6 in. diameter.
Patched area that is unsound or showing distress. Does not warrant structural review.
BENT 4 PILE 2 CRACKED DELAMINATED SPALL AREA SW CORNER OF PILE FM BOTTOM OF CAP DOWN 93".
8" ON WEST FACE AND 6" ON SOUTH.

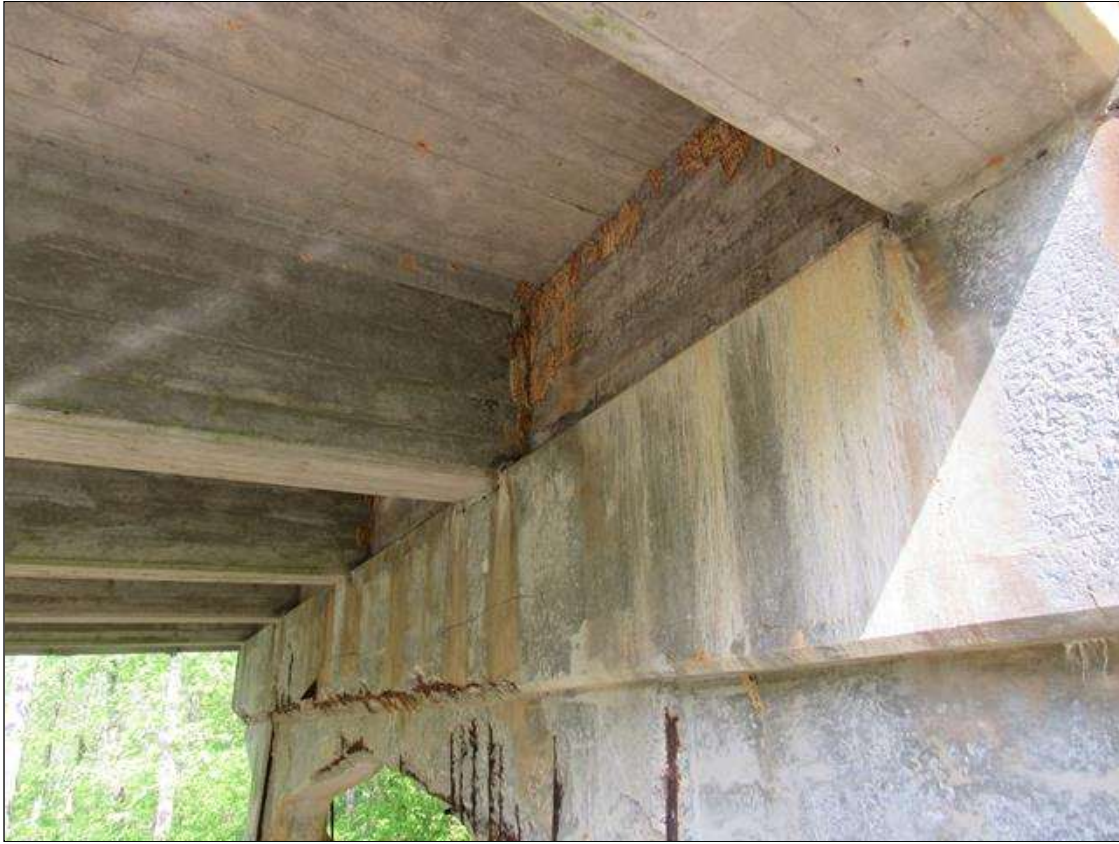
Bent 4 Cap : 7 Feet of Cracking (RC and Other): Width 0.012-0.05 in. or spacing of 1.0-3.0 ft.
BENT 4 WEST FACE OF CAP HORZ CRACK ALONG TOP EDGE FM G1 TO G4 WITH EFFLO ON FACE OF CAP
LEFT SIDE OF G5.

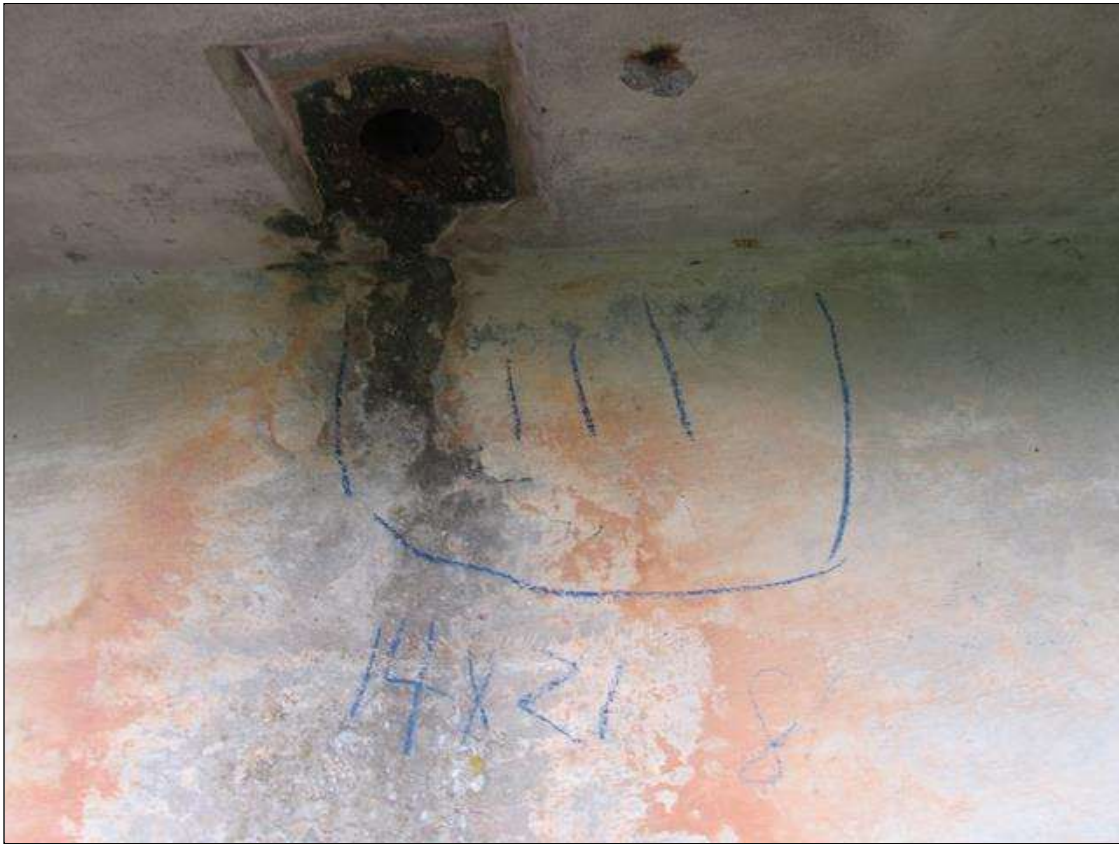
Span 4 Beam 5: 2 Feet of Delamination/Spall/Patched Area: Delaminated. Spall 1 in. or less deep or 6 in. or less in diameter. Patched area that is sound.
SPAN 4 RIGHT SIDE OF G5 HAS A CRACKED DELAMINATED AREA IN FACE OF GIRDER 8' FROM BENT 4 CAP 14" X 21".

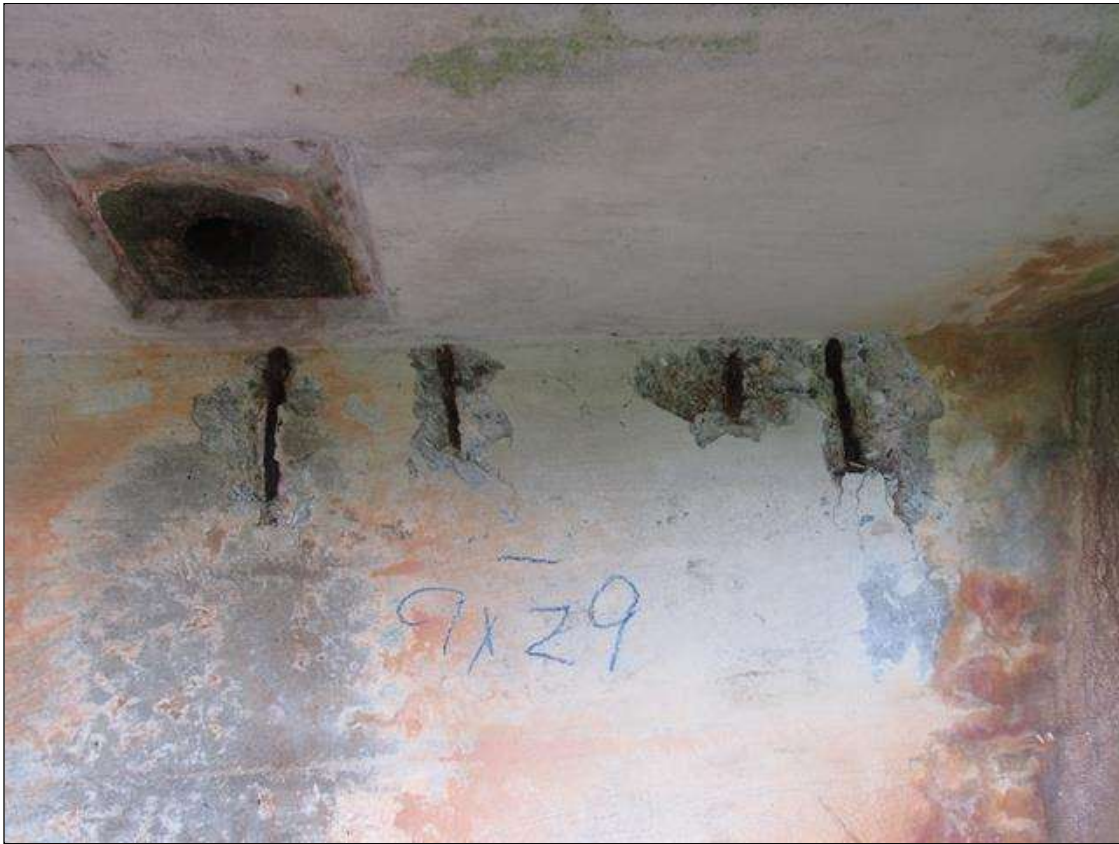
Span 4 Beam 5: 3 Feet of Delamination/Spall/Patched Area: Delaminated. Spall 1 in. or less deep or 6 in. or less in diameter. Patched area that is sound.

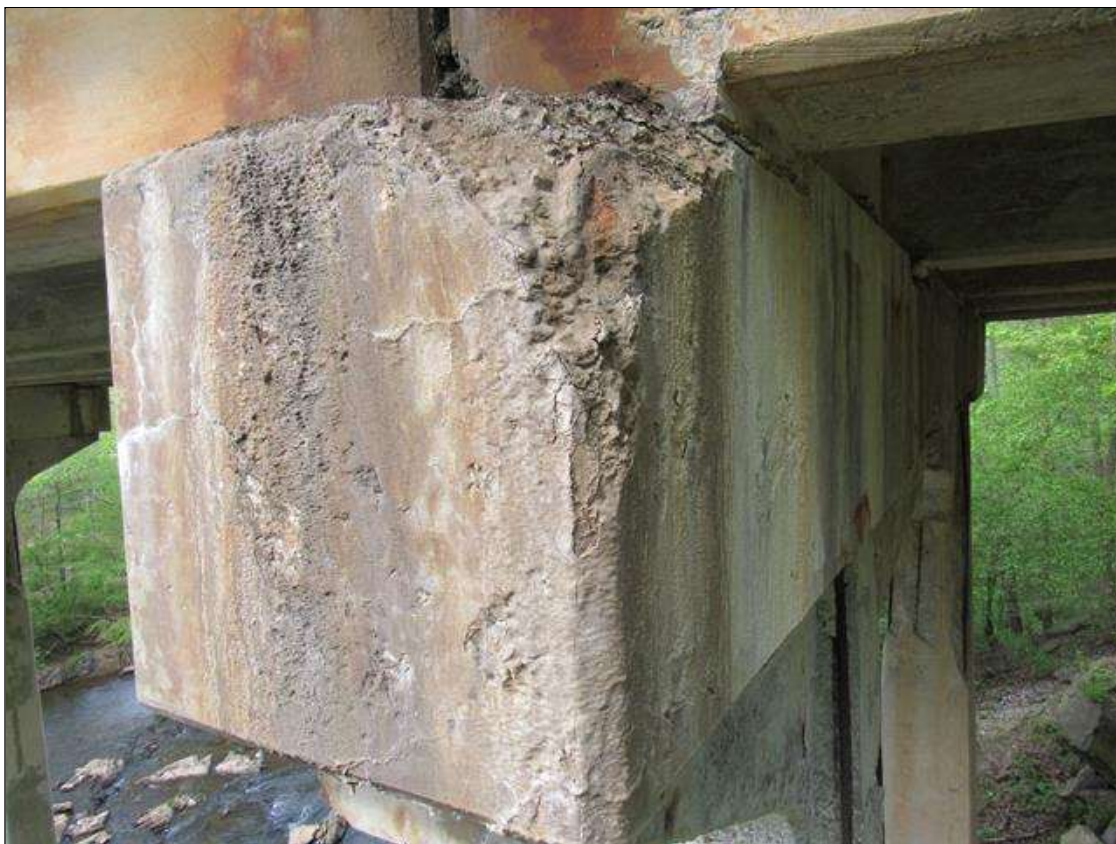
Bent 4 Cap : 0 Feet of Delamination/Spall/Patched Area: Delaminated. Spall 1 inch or less deep or 6 inches or less in diameter. Patched area that is sound
BENT 4 RIGHT END OF CAP HEAVILY CRACKED WITH EFFLO WITH SPALL AREA IN TOP RIGHT CORNER 12" X 15" X 13" DOWN FACE.

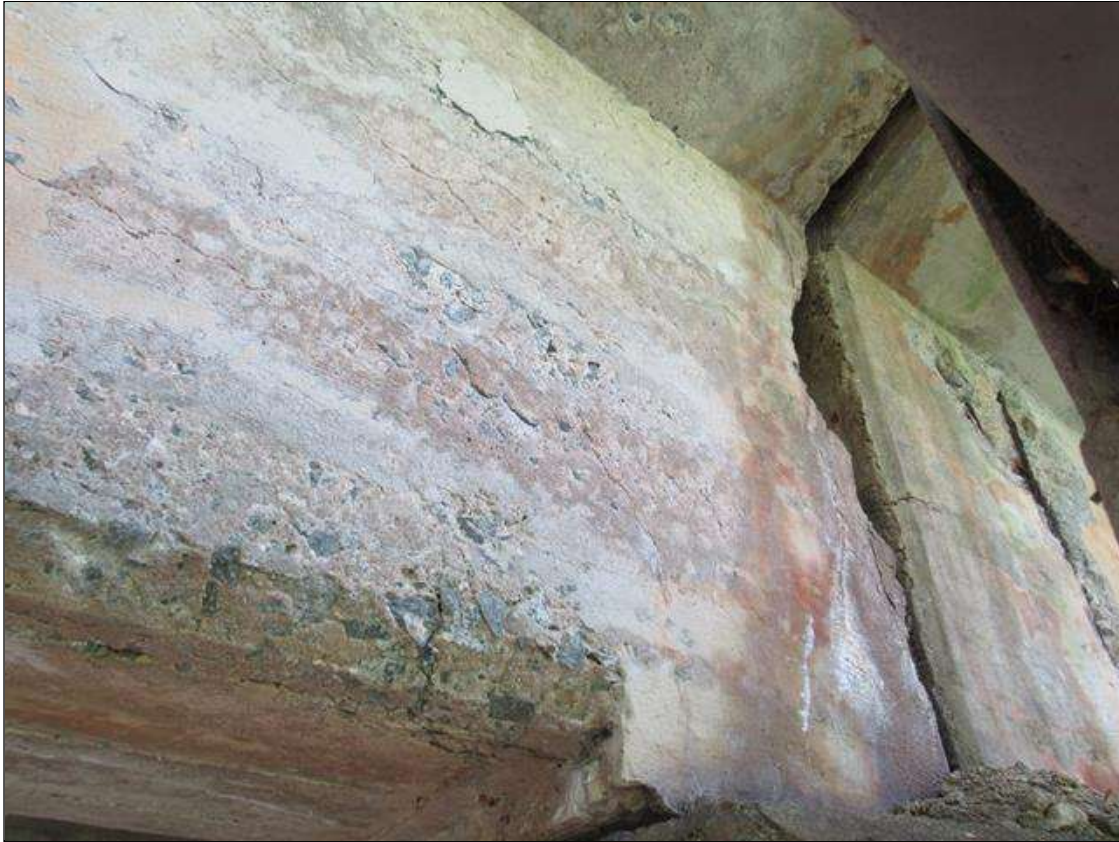
Span 5 Beam 1: 3 Feet of Delamination/Spall/Patched Area: Delaminated. Spall 1 in. or less deep or 6 in. or less in diameter. Patched area that is sound.
SPAN 5 LEFT SIDE OF G1 MAP CRACKED AND SPALL AREA ALONG END OF GIRDER OVER BENT 4. SPALL IS 21" DOWN GIRDER 5" WIDE AND 5" DEEP.

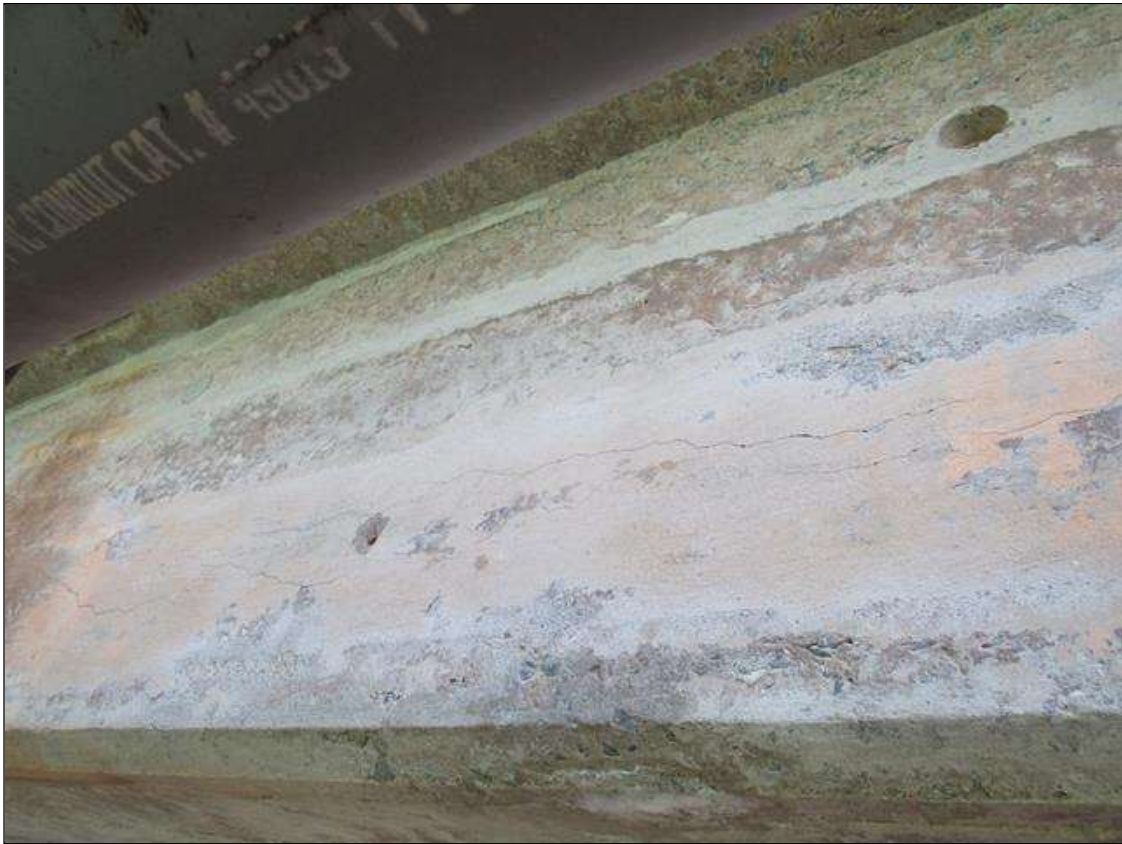
Span 5 Beam 1: 15 Feet of Cracking (RC and Other): Width 0.012-0.05 in. or spacing of 1.0-3.0 ft.
SPAN 5 G1 SCATTERED LONGITUDINAL CRACK AND MAP CRACKS.

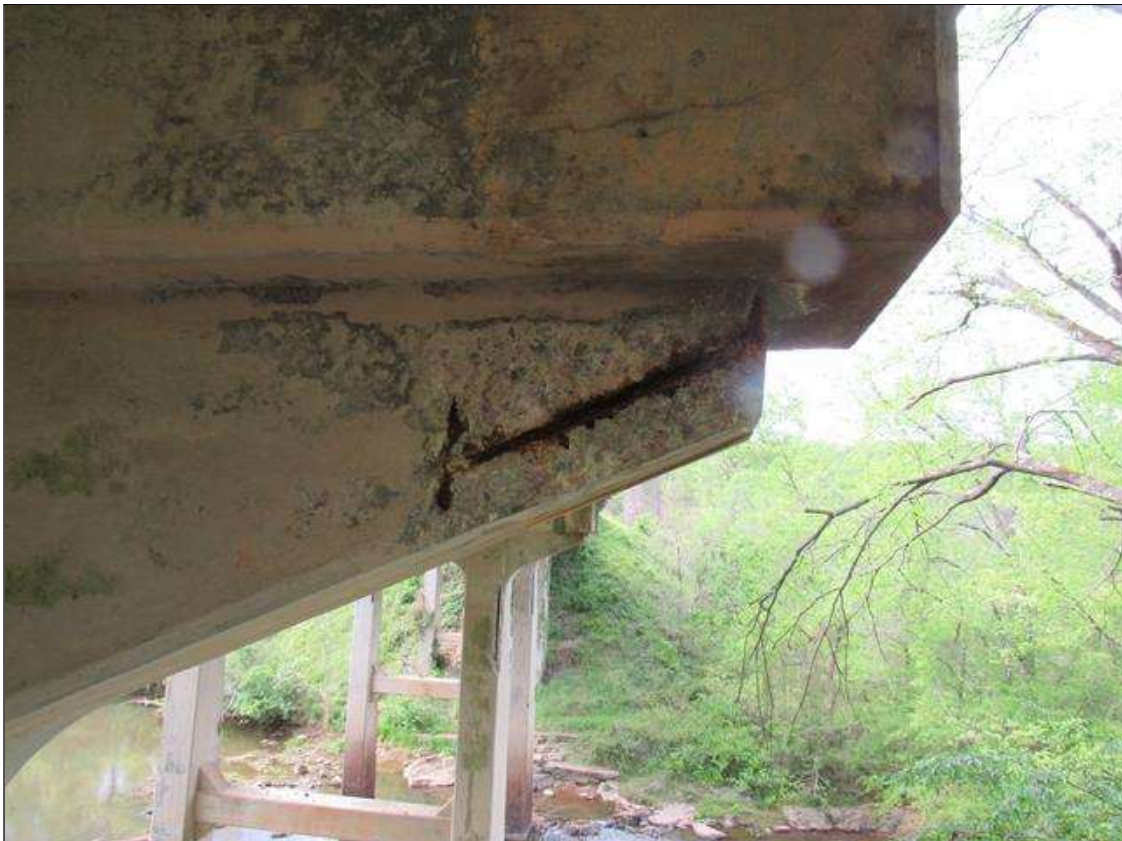
BENT 5 EAST FACE OF HUANCH UNDER LEFT END OF CAP SPALL AREA 9" X 18" X 4" UNDER BOTTOM
REBAR AND STIRRUPS EXPOSED.

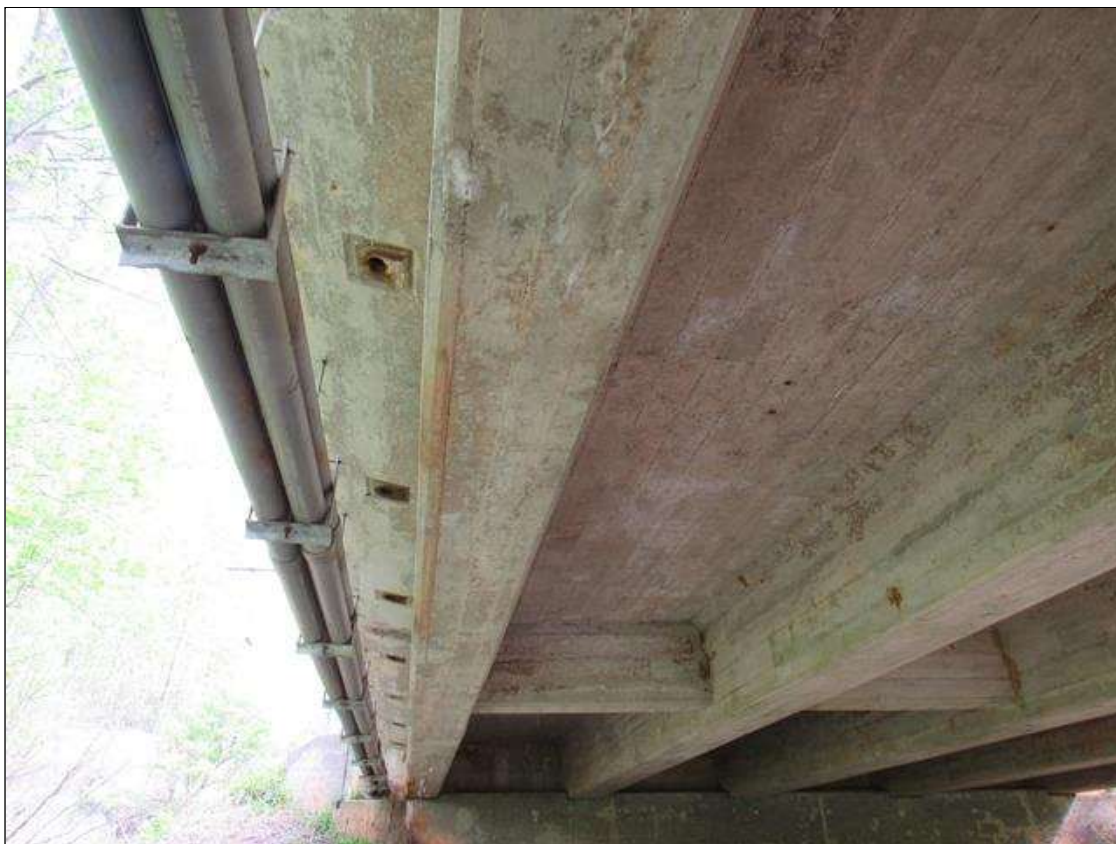
Span 5 Beam 1: 30 Feet of Cracking (RC and Other): Width 0.012-0.05 in. or spacing of 1.0-3.0 ft.
SPAN 5 BOTTOM OF G1 FROM BENT 4 TO END BENT 2 SCATTERED LONGITUDINAL CRACKS WITH EFFLO
STAINS.

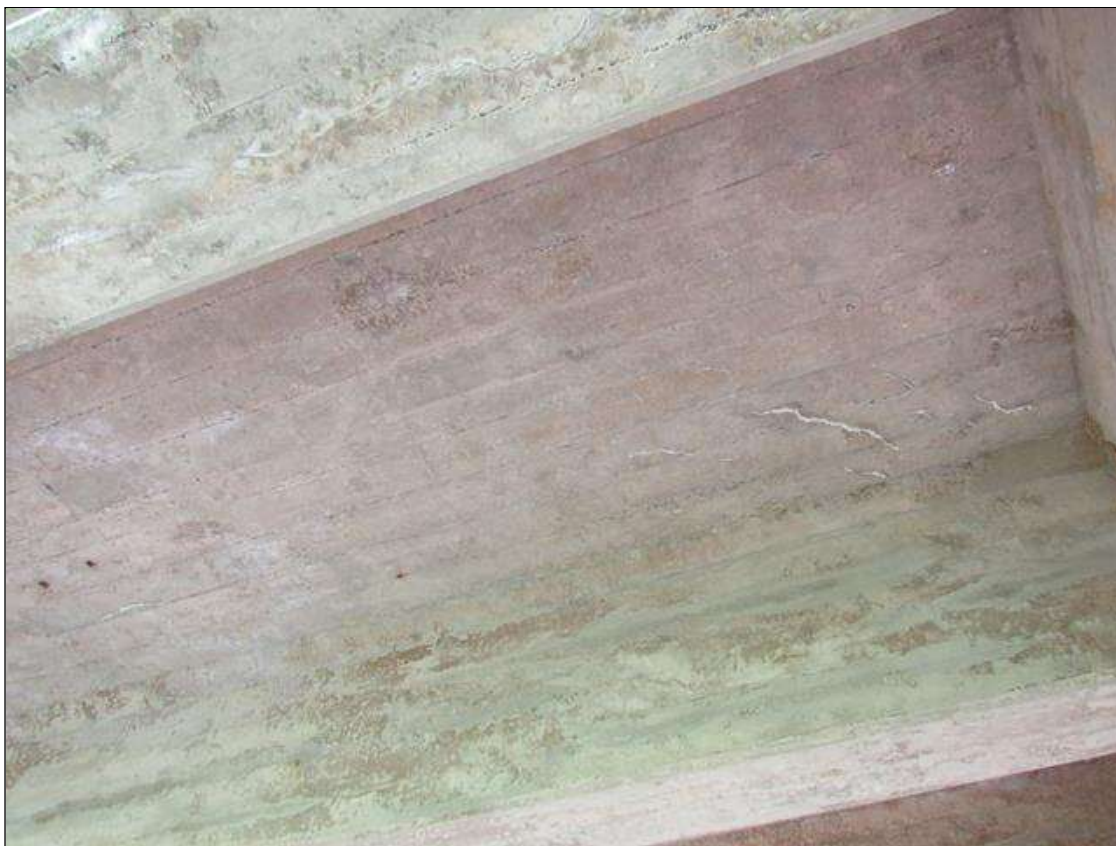
Span 5 Deck: 350 Square Feet of Cracking (RC and Other): Width 0.012-0.05 in. or spacing of 1.0-3.0 ft. SPAN 5 BOTTOM OF DECK HAS SCATTERED MAP CRACKING WITH EFFLO THROUGH OUT BAY 1.

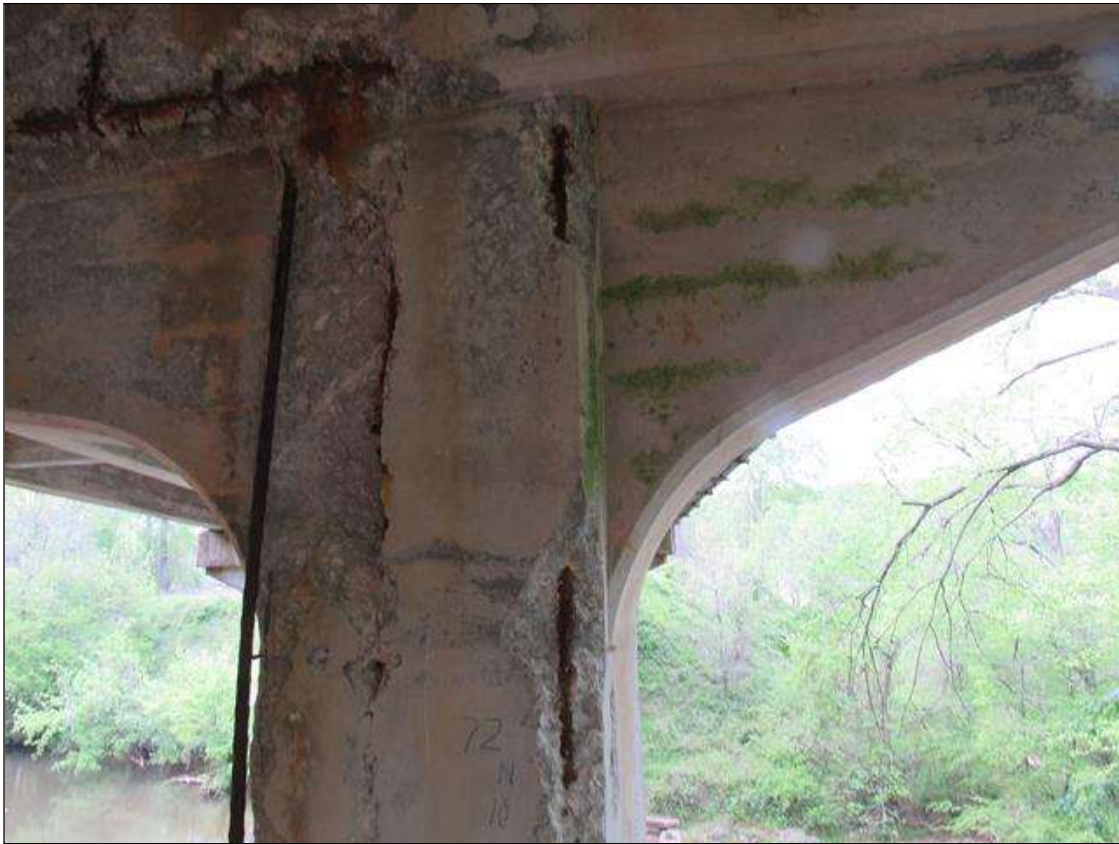
Bent 4 Pile 1: 0 Each of Delamination/Spall/Patched Area: Spall greater than 1 in. deep or greater than 6 in. diameter.
Patched area that is unsound or showing distress. Does not warrant structural review.
BENT 4 PILE 1 CRACKED SPALL AREA NE CORNER CAP DOWN 72" & 10" ON NORTH FACE & 12" ON EAST
WITH REBAR EXPOSED.

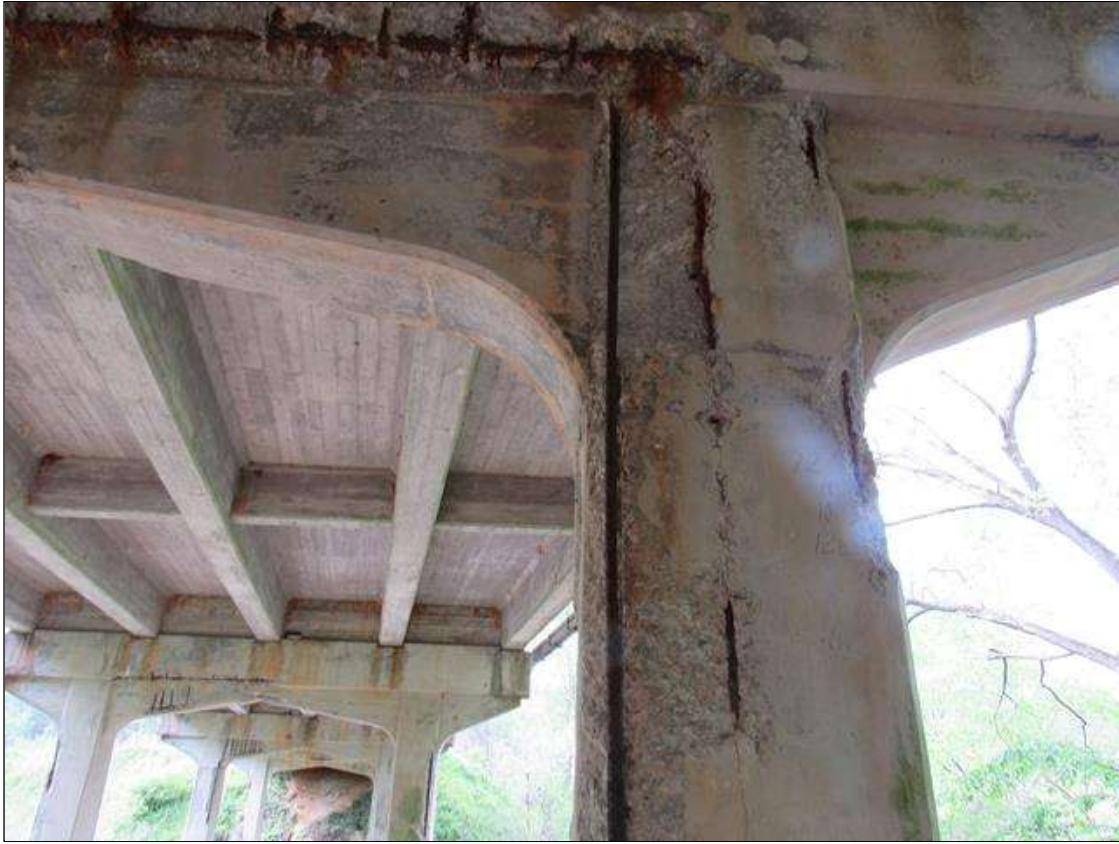
Bent 4 Pile 1: 0 Each of Delamination/Spall/Patched Area: Spall greater than 1 in. deep or greater than 6 in. diameter. Patched area that is unsound or showing distress. Does not warrant structural review.
BENT 4 PILE 1 CRACKED SPALL DELAMINATED AREA ON SE CORNER OF PILE FM CAP DOWN 9' 4" AND 10" ON SOUTH 15" ON EAST REBAR EXPOSED.

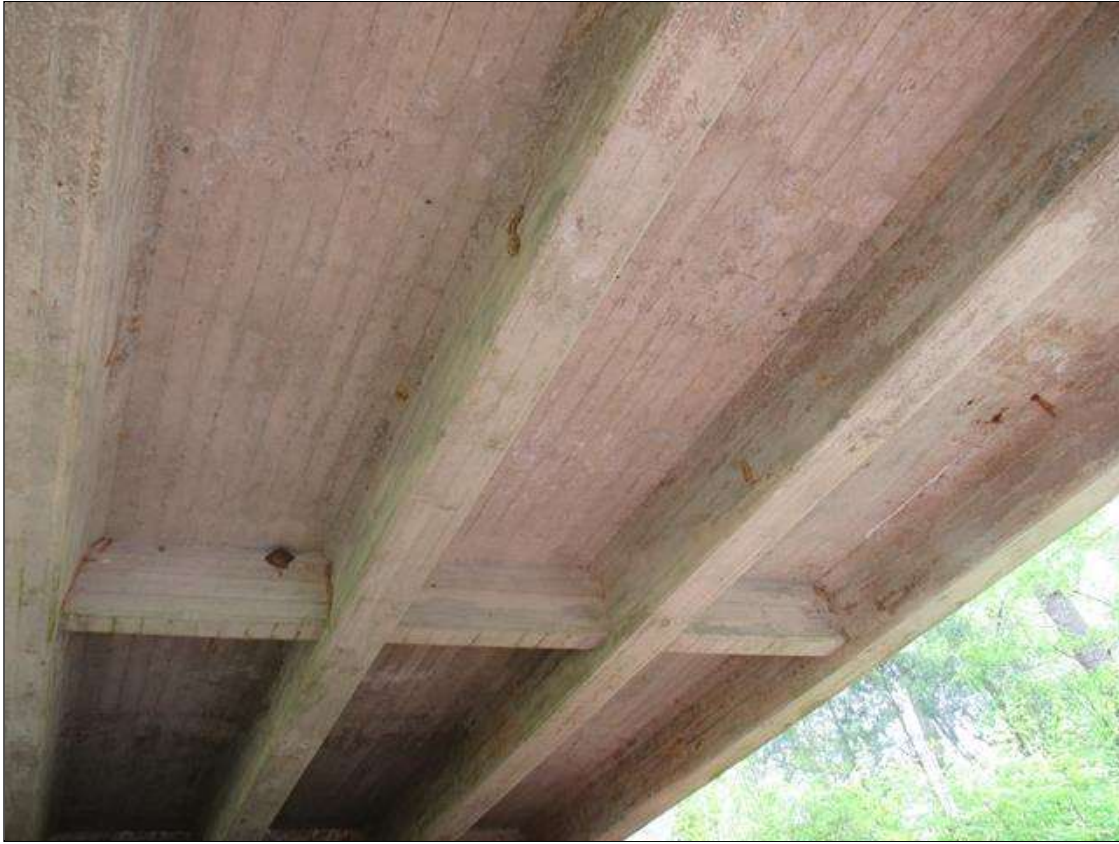
Span 5 Deck: 1400 Square Feet of Cracking (RC and Other): Width 0.012-0.05 in. or spacing of 1.0-3.0 ft.
SPAN 5 BOTTOM OF DECK HAS SCATTERED MAP CRACKING WITH EFFLO STAINS.
