NC DEPARTMENT OF TRANSPORTATION
 DIVISION OF HIGHWAYS
 STRUCTURE MANAGEMENT UNIT

ATTENTION:

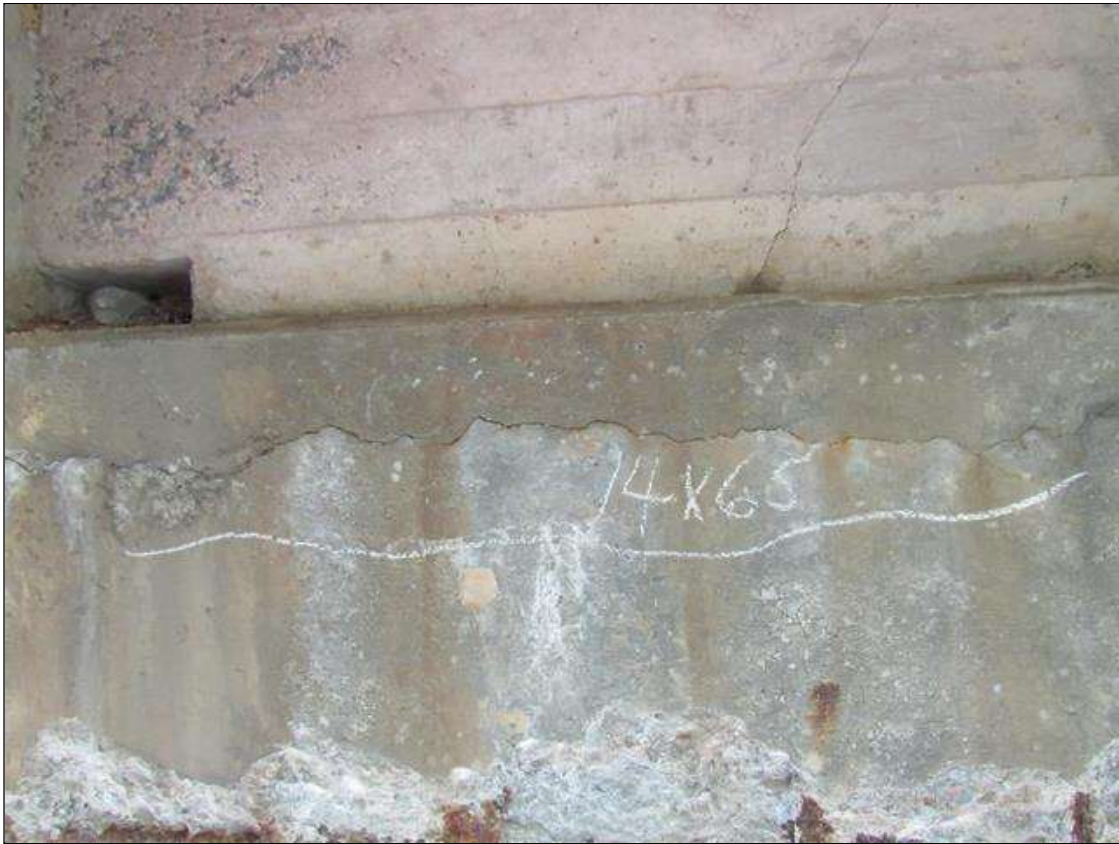
Bent 4 Cap : 0 Feet of Delamination/Spall/Patched Area: Delaminated. Spall 1 inch or less deep or 6 inches or less in diameter. Patched area that is sound
BENT 5 EAST FACE OF CAP CRACKED AND DELAMINATED AREAS BETWEEN G2 AND G3 ALONG TOP EDGE.
14" DOWN FACE AND 65" LONG.

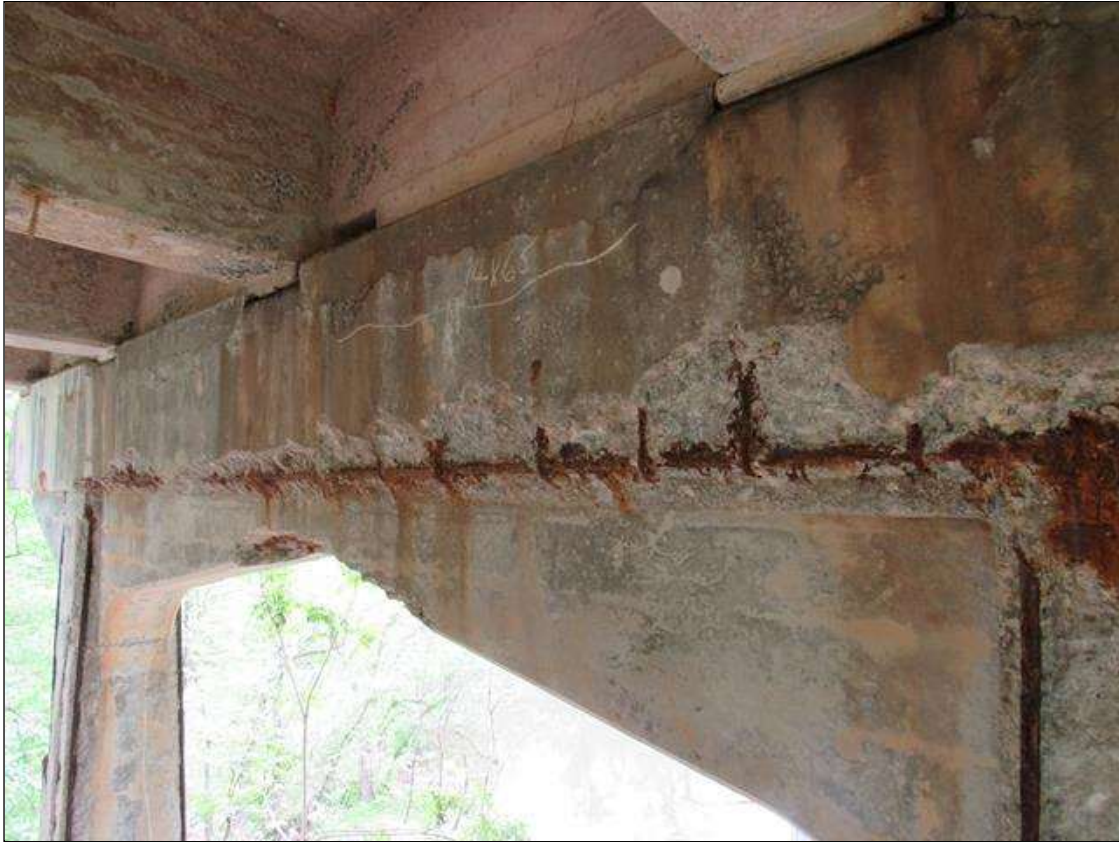
Bent 4 Cap : 0 Feet of Delamination/Spall/Patched Area: Spall greater than 1 inch deep or greater than 6 inches in diameter. PAtched area that is unsound or showing distress. Condition does not warrant structural Review
BENT 4 CAP EAST FACE OF CAP CRACKED SPALL DELAMINATED FM LEFT SIDE OF G2 TO RIGHT OF G4. 17" UP FACE 21' LONG 6" UNDER BOTTOM REBAR AND STIRRUPS EXPOSED.

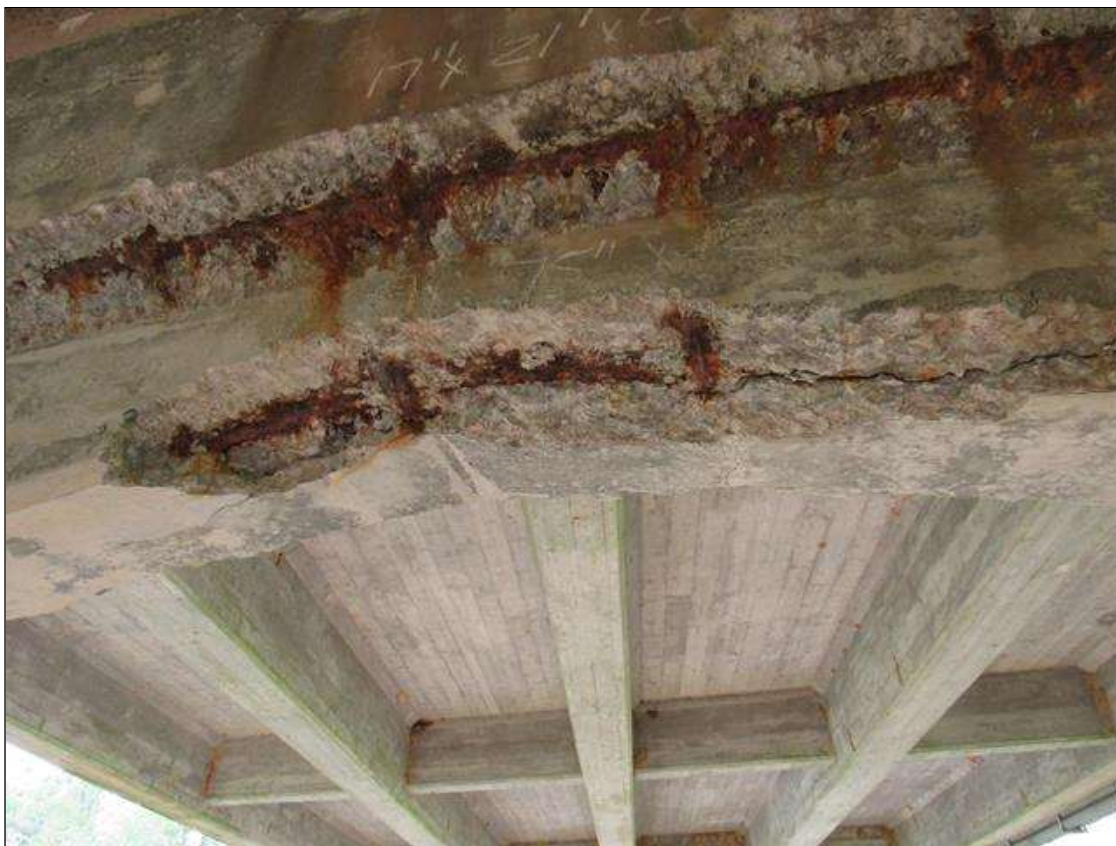
BENT 4 EAST FACE AND BOTTOM OF HUANCH UNDER G3 CRACKED SPALL AND DELAMINATED 9" WIDE 75" LONG 6" UNDER BOTTOM WITH REBAR AND STIRRUPS EXPOSED.

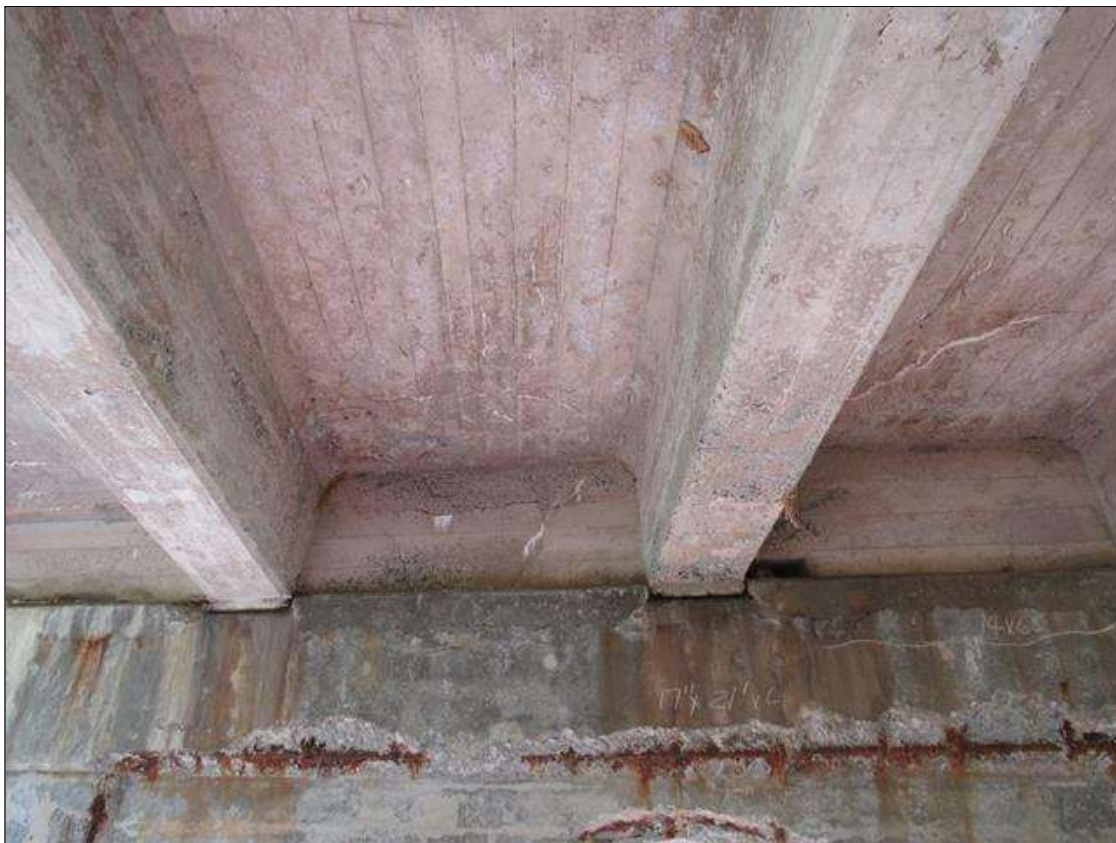
END DIAPHRAGM OVER BENT 4 IN BAYS 2, 3 AND 4 ON EAST FACE ARE CRACKED WITH EFFLO STAINS.

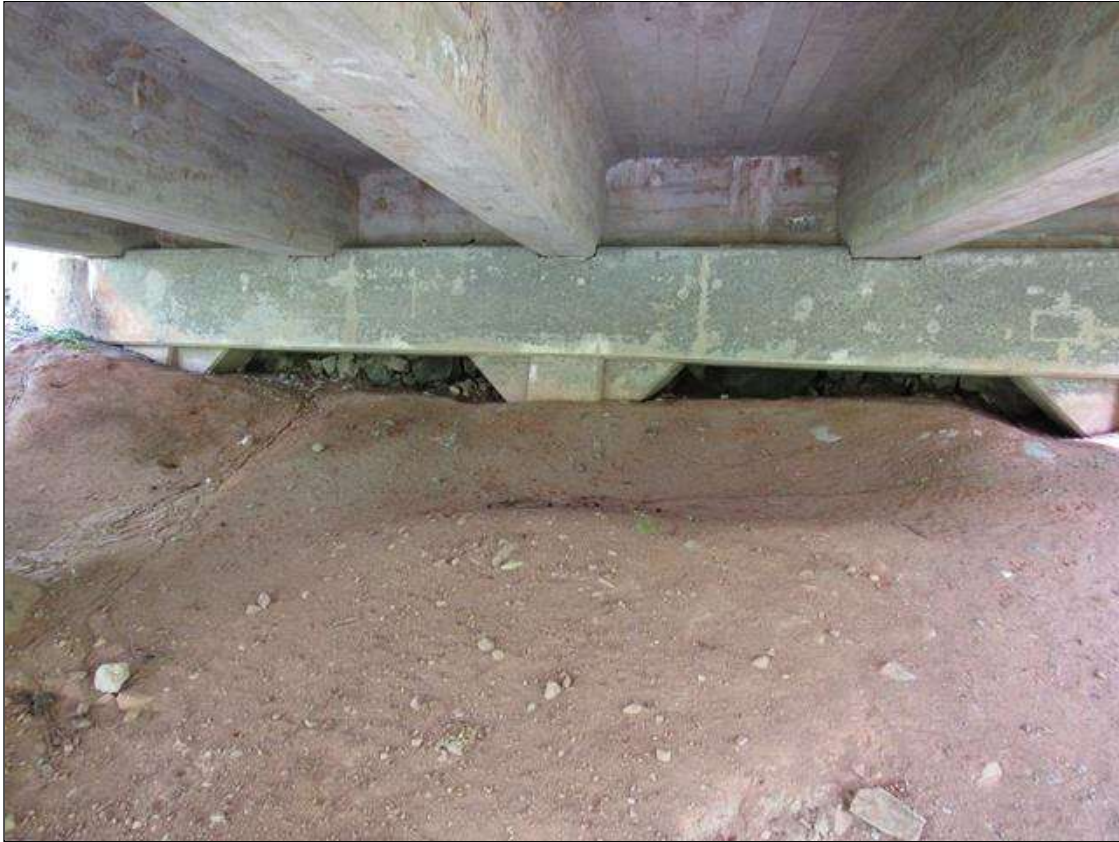
END BENT 2 ERROSION AREA UNDER BOTTOM OF CAP FROM PILE 1 TO PILE 3 12" TO 15" UNDER BOTTOM AND 36" BACK.

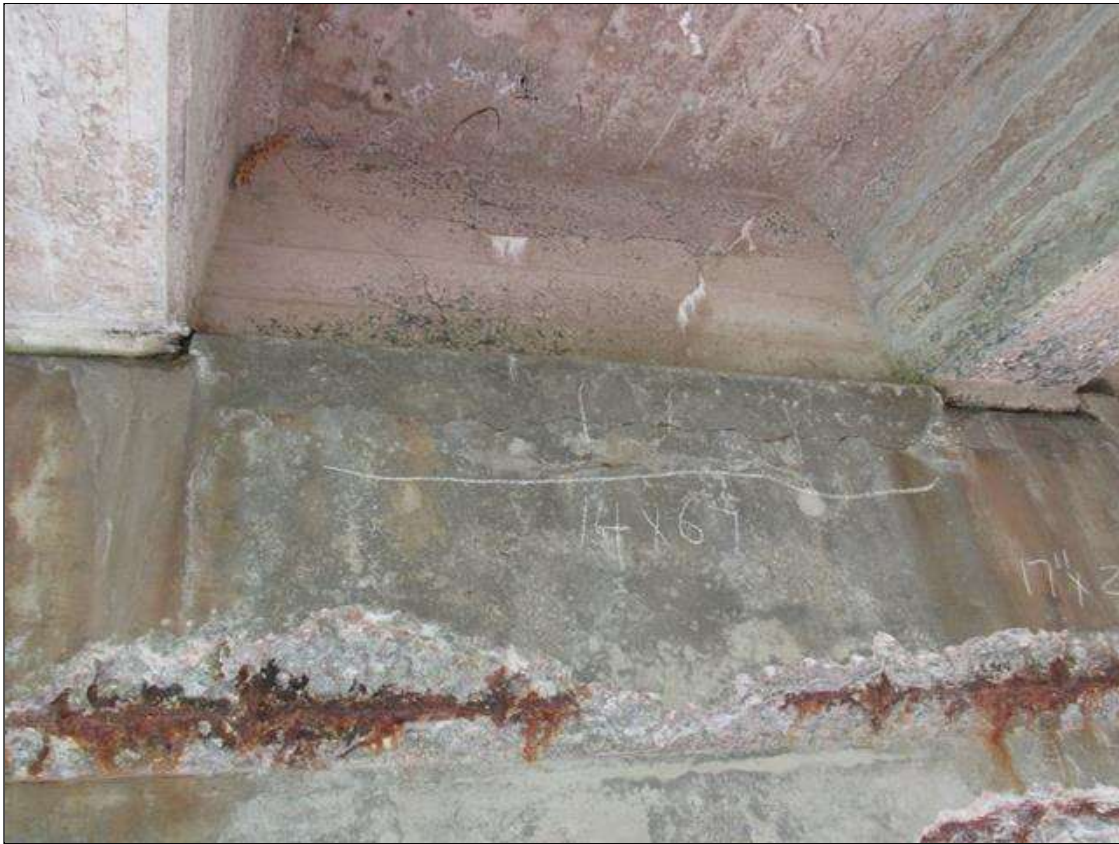
Bent 4 Cap : 0 Feet of Delamination/Spall/Patched Area: Delaminated. Spall 1 inch or less deep or 6 inches or less in diameter. Patched area that is sound
BENT 4 EAST FACE OF CAP BETWEEN G3 AND G4 IS CRACKED AND DELAMINATED AREA 14" DOWN FACE AND 67" LONG.

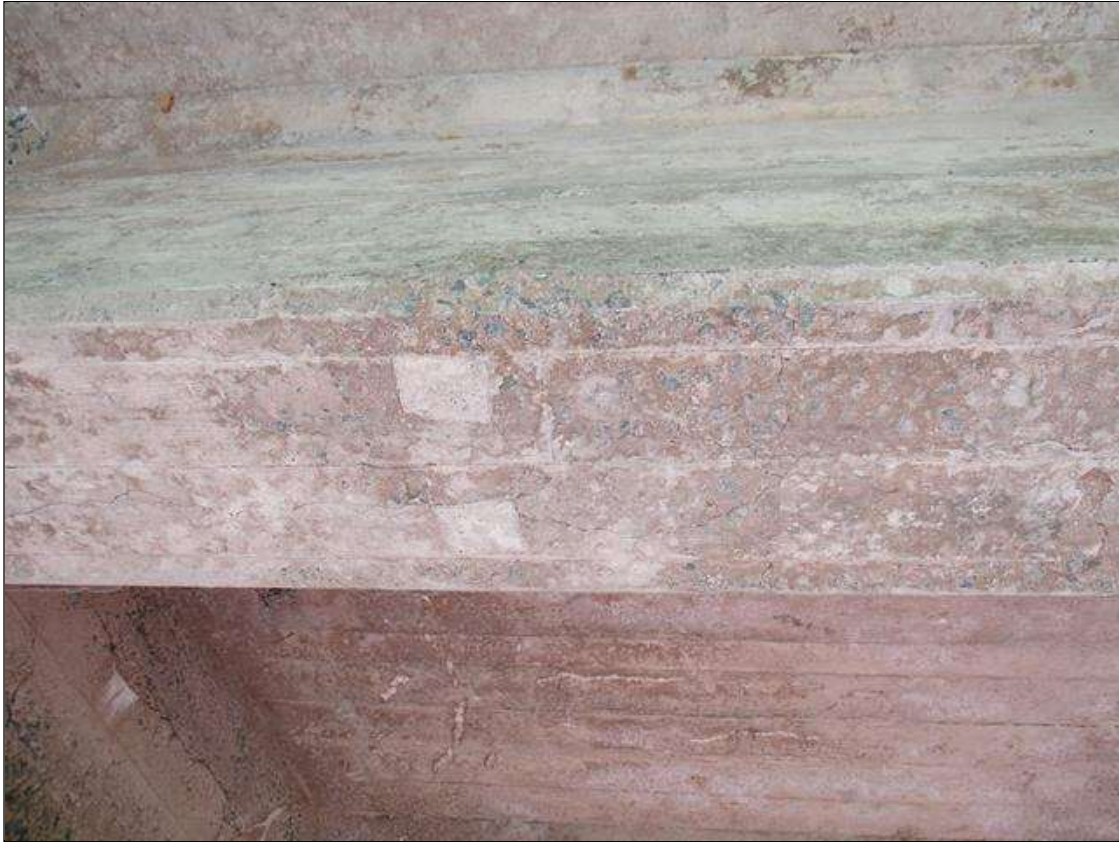
Span 5 Beam 4: 15 Feet of Cracking (RC and Other): Width 0.012-0.05 in. or spacing of 1.0-3.0 ft.
SPAN 5 BOTTOM OF BEAM 5 HAS SCATTERED MAP CRACKS AND LONGITUDINAL CRACKS ALONG THE
BOTTOM FROM BENT 4 OUT.

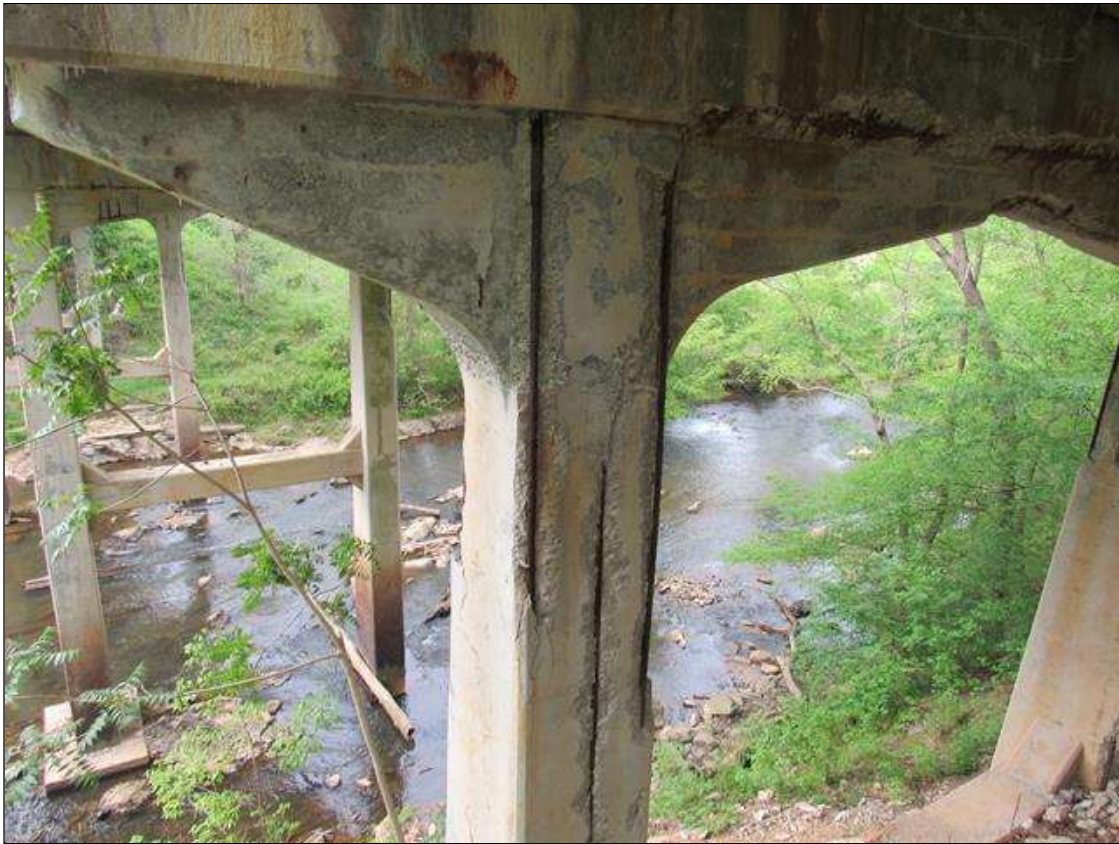
Bent 4 Pile 2: 0 Each of Delamination/Spall/Patched Area: Spall greater than 1 in. deep or greater than 6 in. diameter.
Patched area that is unsound or showing distress. Does not warrant structural review.
BENT 4 PILE 2 CRACKED SPALL DELAMINATED SE AND NORTH FACE FM CAP DOWN 13' & 32" WIDE ON
EAST FACE & 6" ON SOUTH AND NORTH.

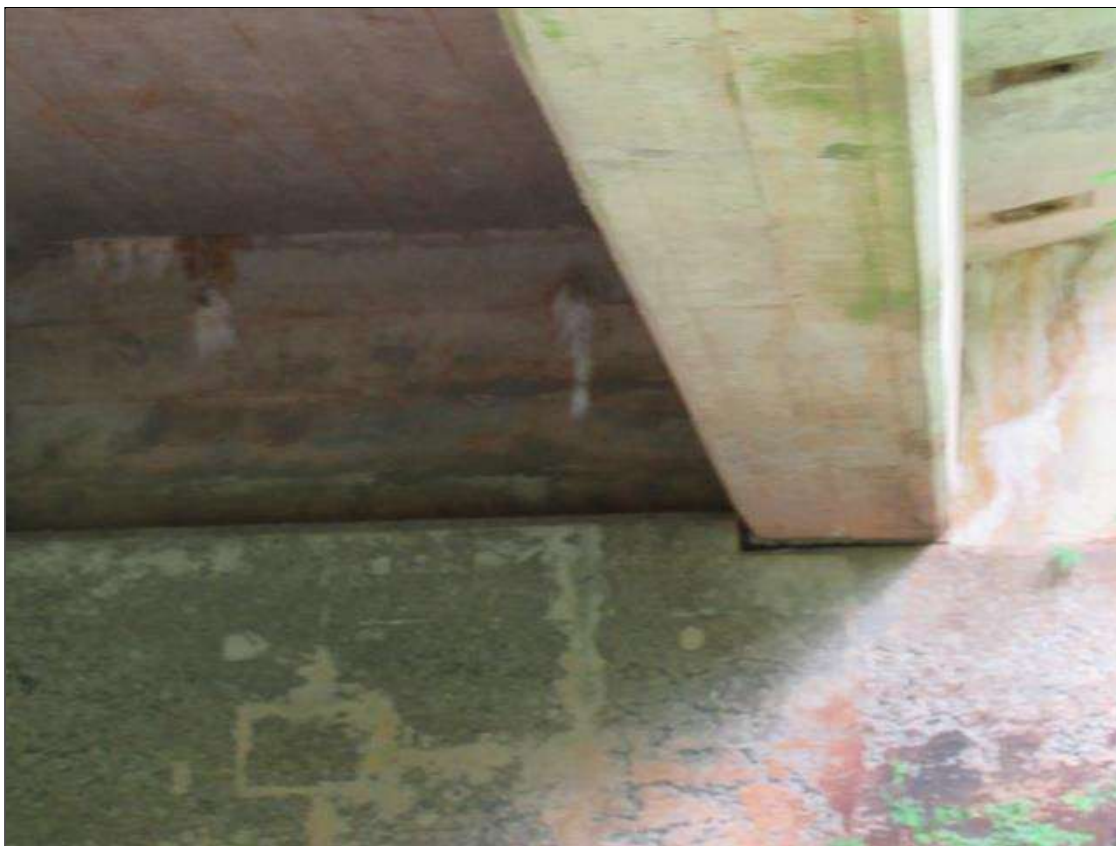
END BENT 2 BACK WALL HAS CRACKS WITH EFFLO IN BAY 4 AND RIGHT SIDE OF G5.

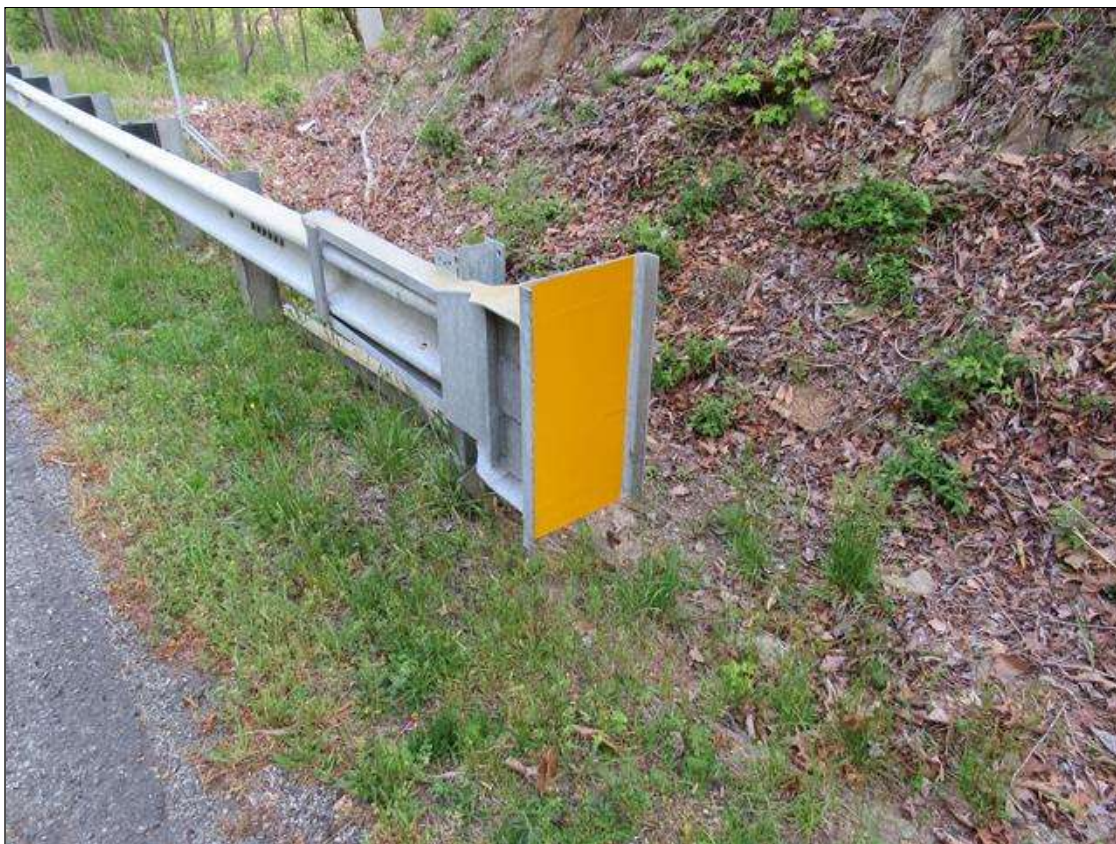
GUARD RAIL TERMINAL END

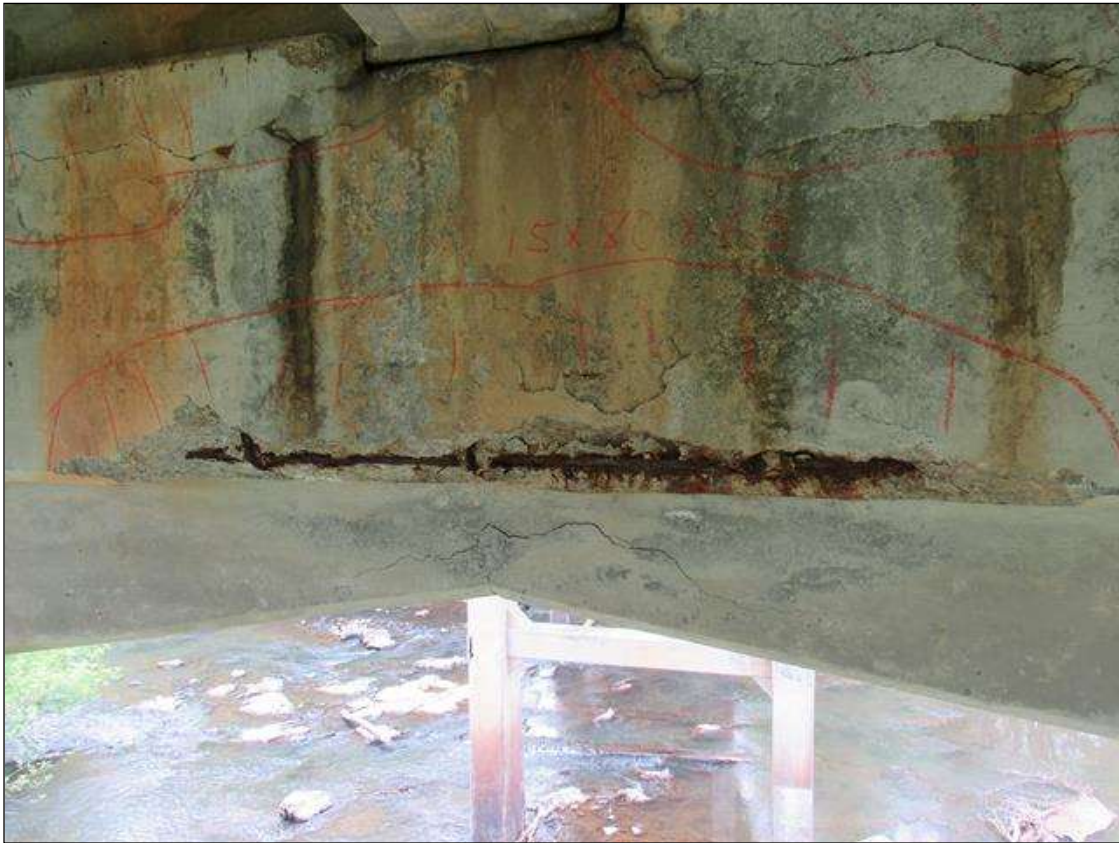
BENT 1 WEST FACE OF CAP HAS A HAS CRACKED DELAMINATED SPALL AREA UNDER G3 15" UP BASE 80" LONG AND 6" UNDER BOTTOM. LARGE REBAR AND STIRRUPS EXPOSE

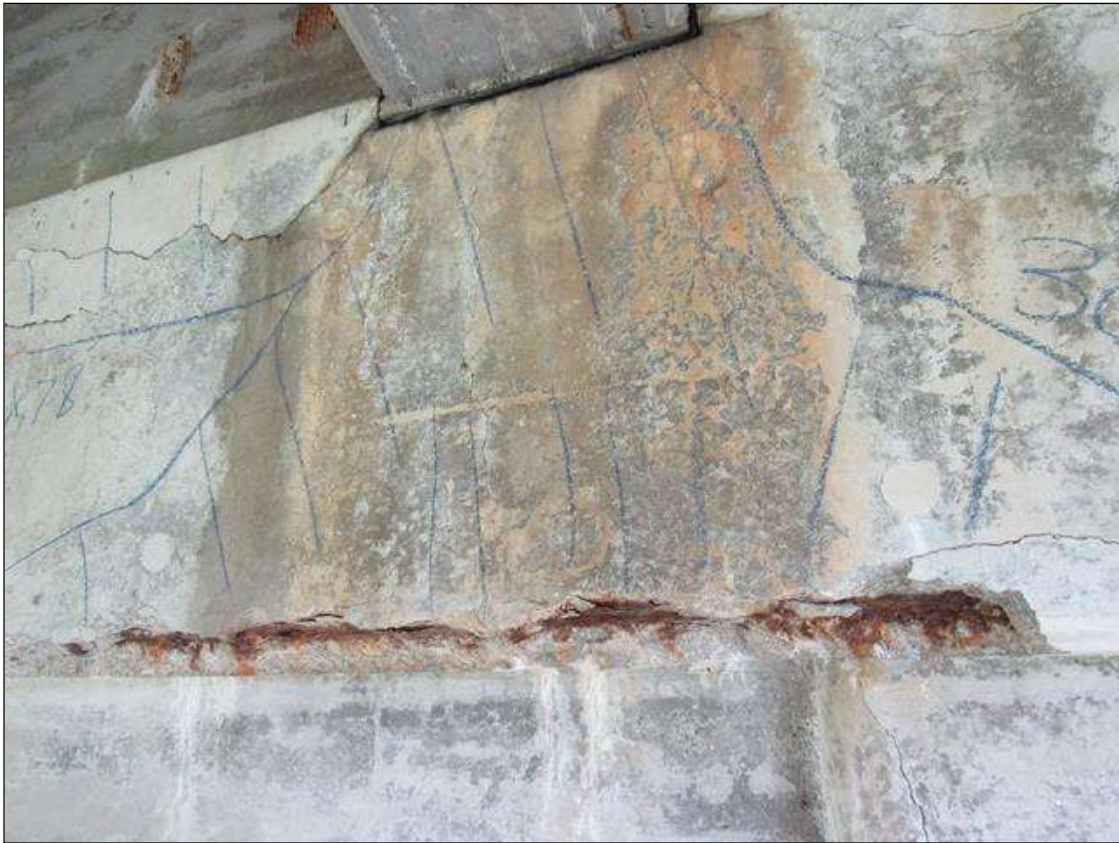
BENT 1 WEST FACE OF CAP CRACKED SPALL AND DELAMINATED AREA UNDER G4 TOP DOWN 30" & 78" WIDE 6" UNDER BOTTOM REBAR AND STIRRUPS EXPOSED.

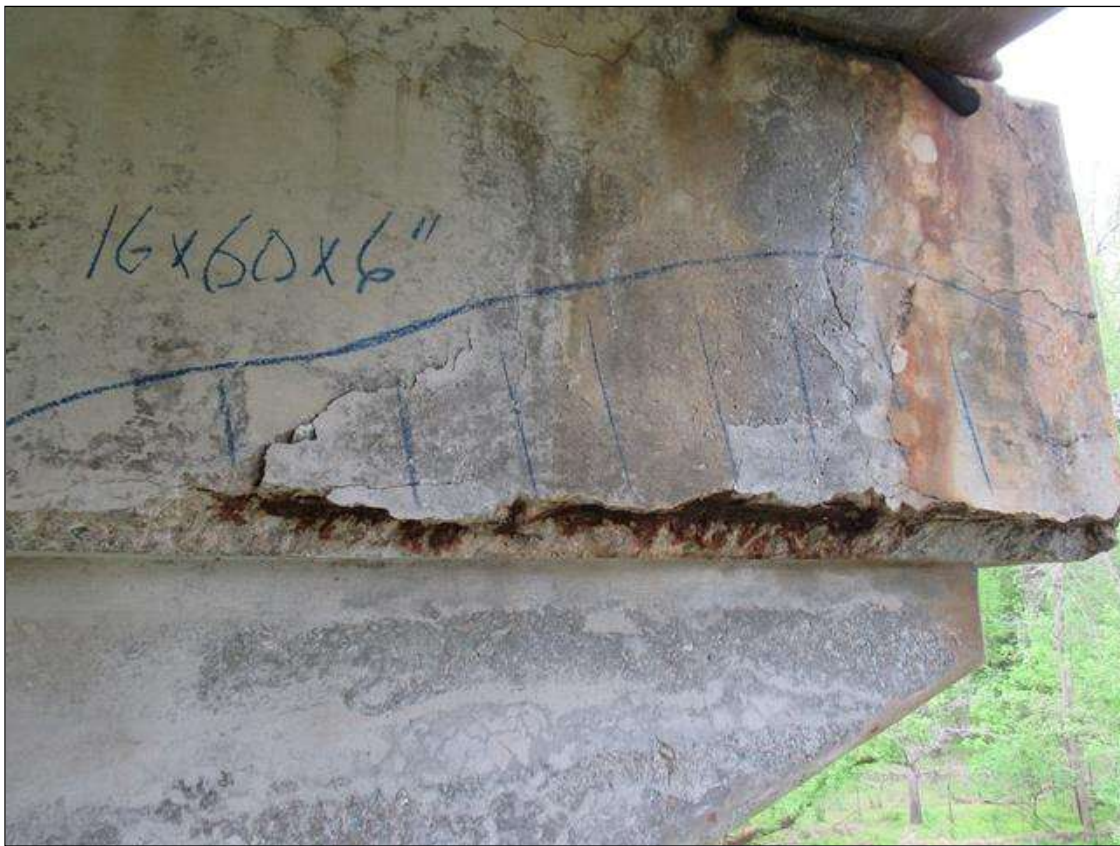
BENT 1 WEST FACE OF CAP CRACKED SPALL DELAMINATED AREA FM RIGHT END BACK 60" 16" UP FACE 6" UNDER BOTTOM WITH REBAR AND STIRRUPS EXPOSED.

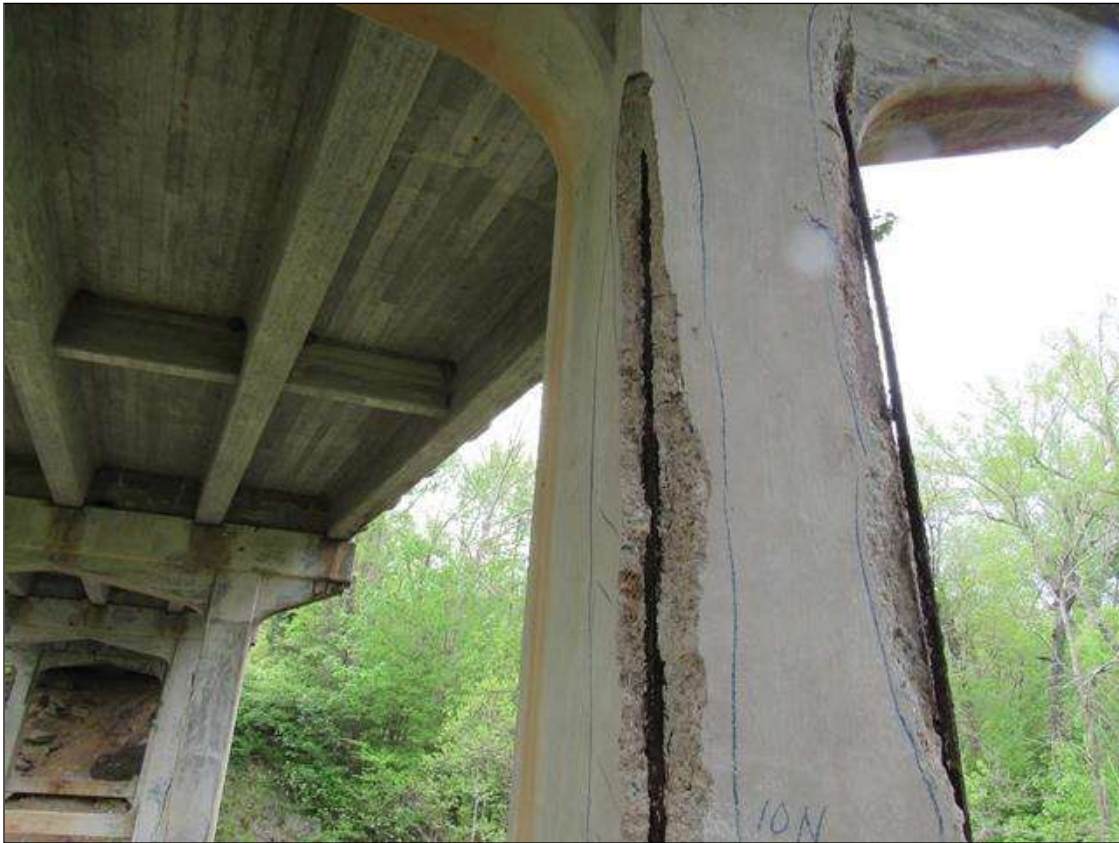
BENT 1 PILE 2 CRACKED DELAMINATED SPALL AREA ON NW CORNER OF PILE STARTS 35" BELOW CAP EXTENDS DOWN 8' 10" ON NORTH FACE 8" ON WEST.

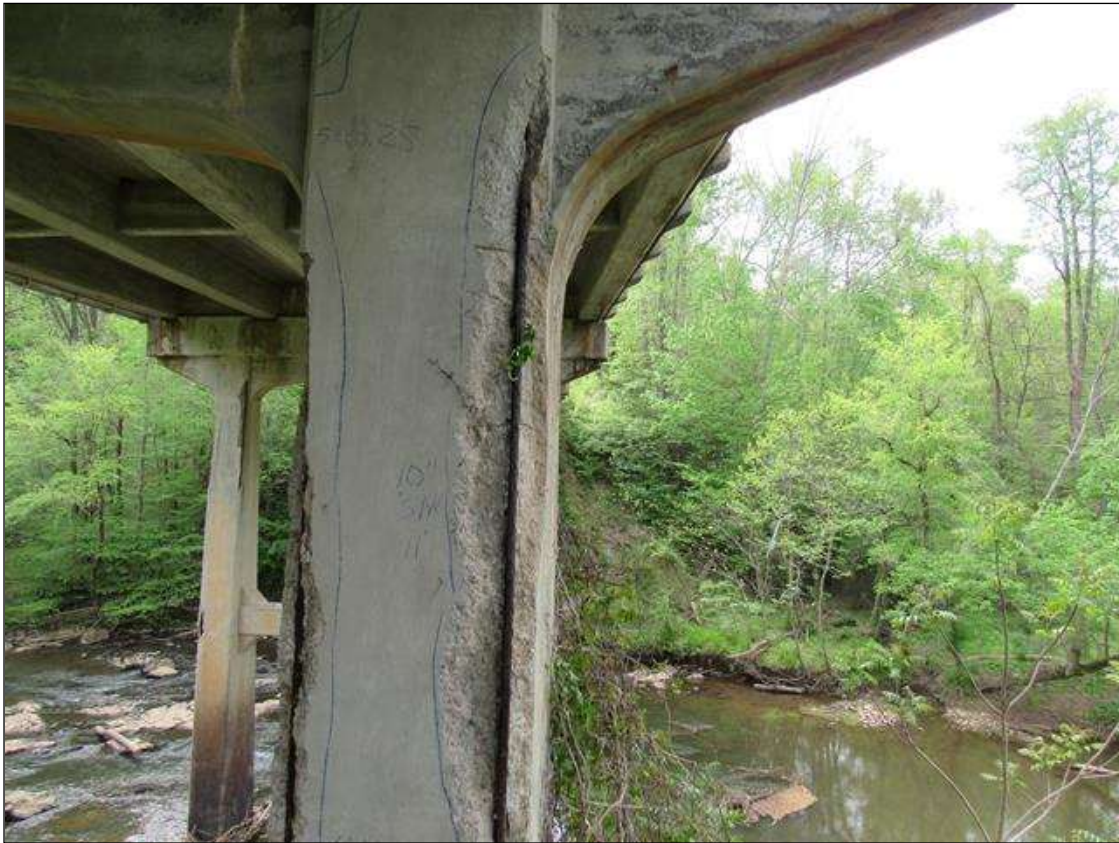
BENT 1 PILE 2 CRCKED DELAM SPALL AREA ON SW CRNER STARTS 20" BELOW BOTTOM OF CAP & EXTENDS DWN 11' & 10" ON SOUTH AND WEST FACE WITH LRGE REBAR EXPOSE

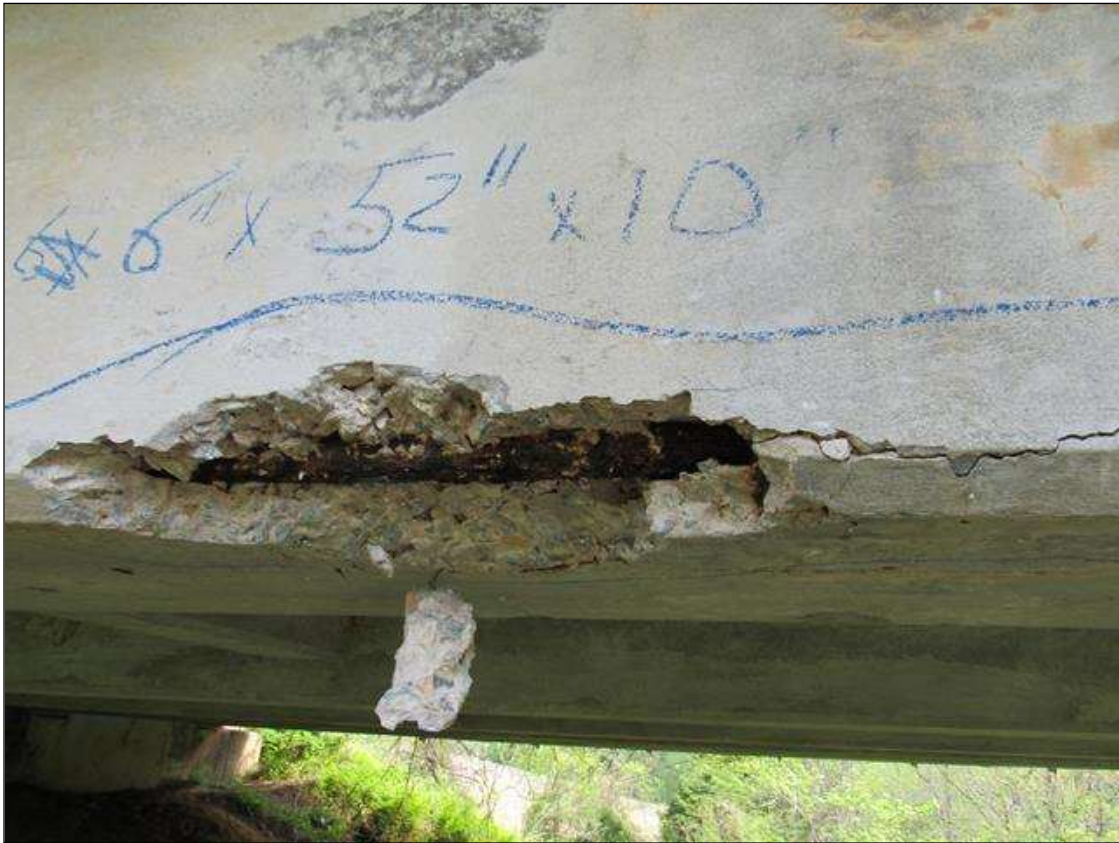
SPAN 1 GIRDER 5 HAS A CRACKED SPALL DELAMINATED AREA LOCATED AT 15' FM BENT 1. 6" UP FACE 52" LONG 10" UNDER BOTTOM WITH LARGE REBAR EXPOSED.

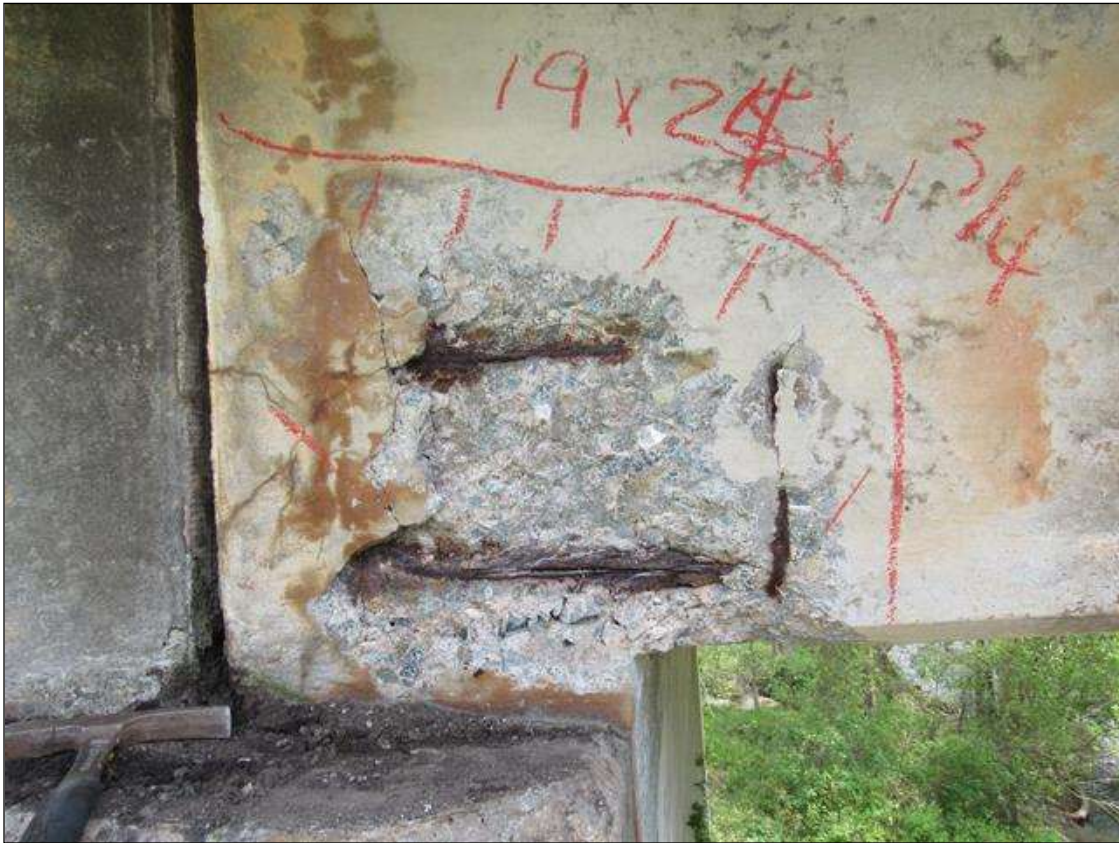
SPAN 2 RIGHT SIDE OF GIRDER 5 HAS A CRACKED SPALL DELAMINATED AREA OVER BENT 1 19" HIGH FM
END OUT 24" 1 3/4" DEEP WITH REBAR AND STIRRUPS EXPOSED.

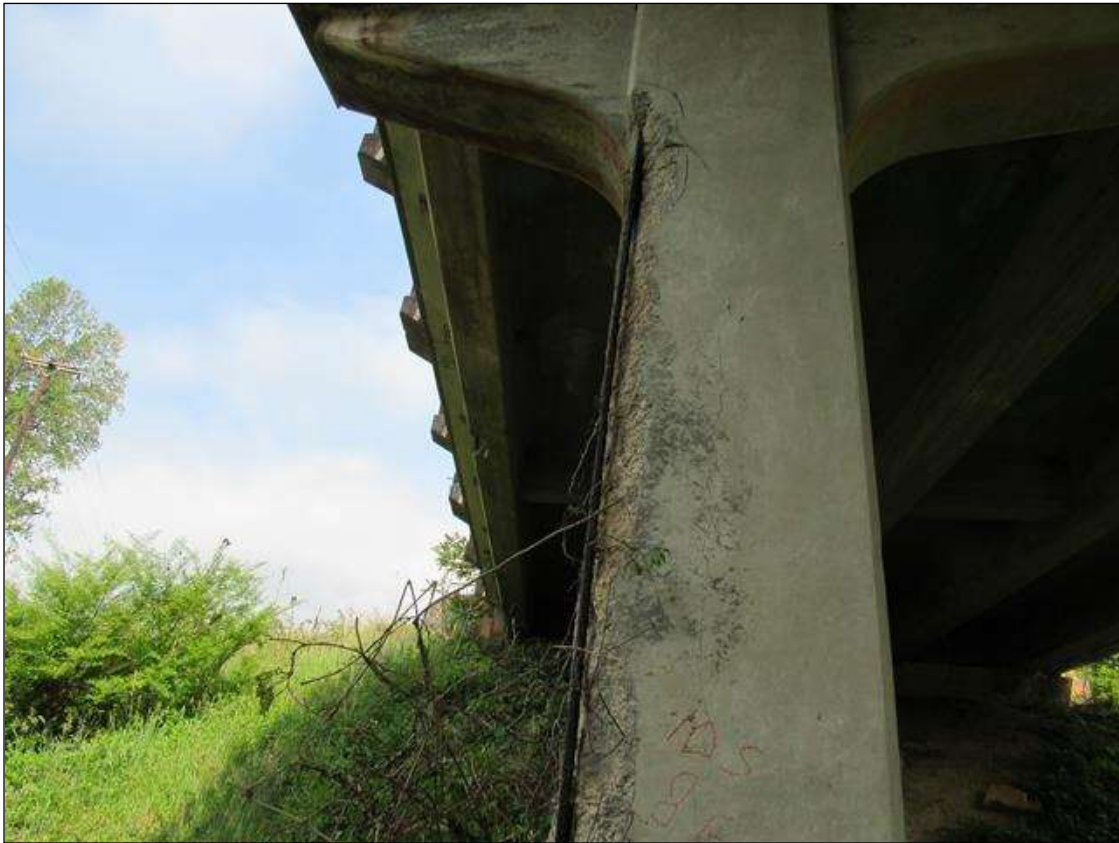
BENT 1 PILE 2 CRACKED SPALL DELAMINATED ON SE CORNER OF PILE 10" ON SOUTH FACE 8" ON EAST 11" DOWN FACE START 32" BELOW THE CAP.

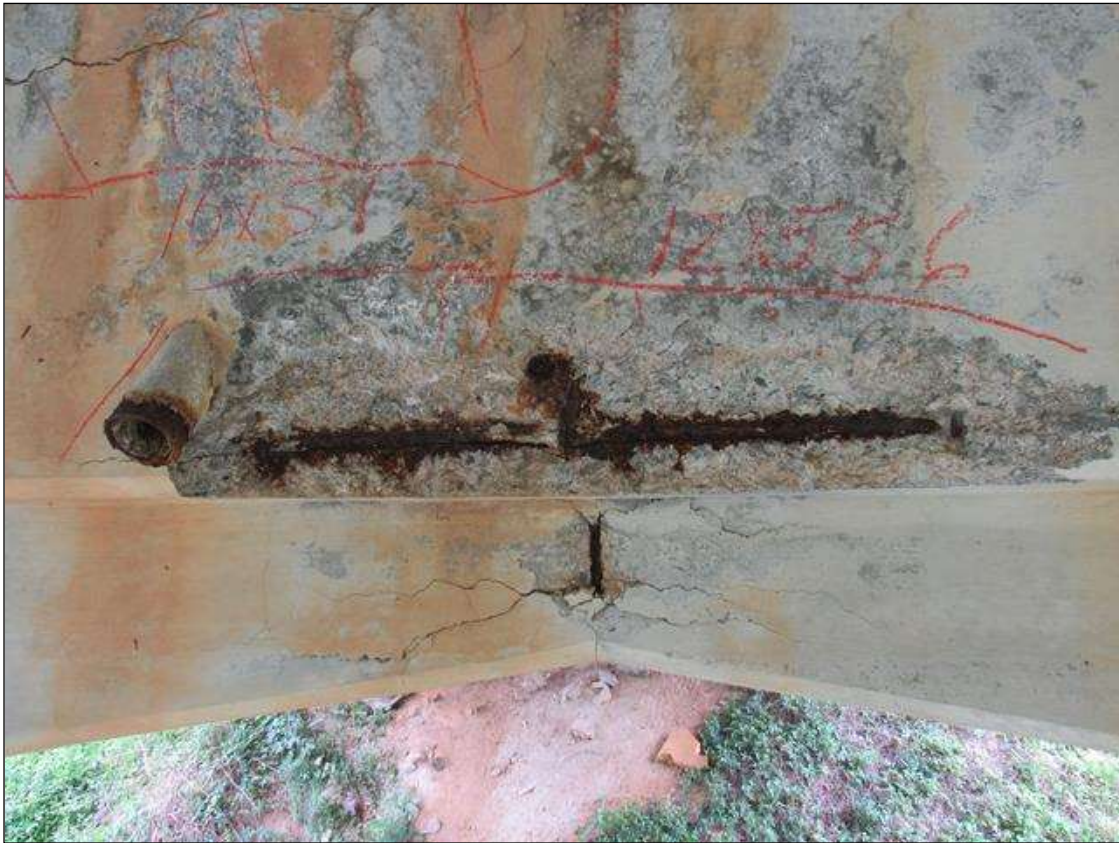
BENT 1 EAST OF CAP HAS CRACKED SPALL DELAM AREA ALONG BOTOM EDGE OF CAP UNDER G 3. 12" UP FACE 15" LONG 6" UNDER BOTTOM REBAR AND STIRRUPS EXPOSED.

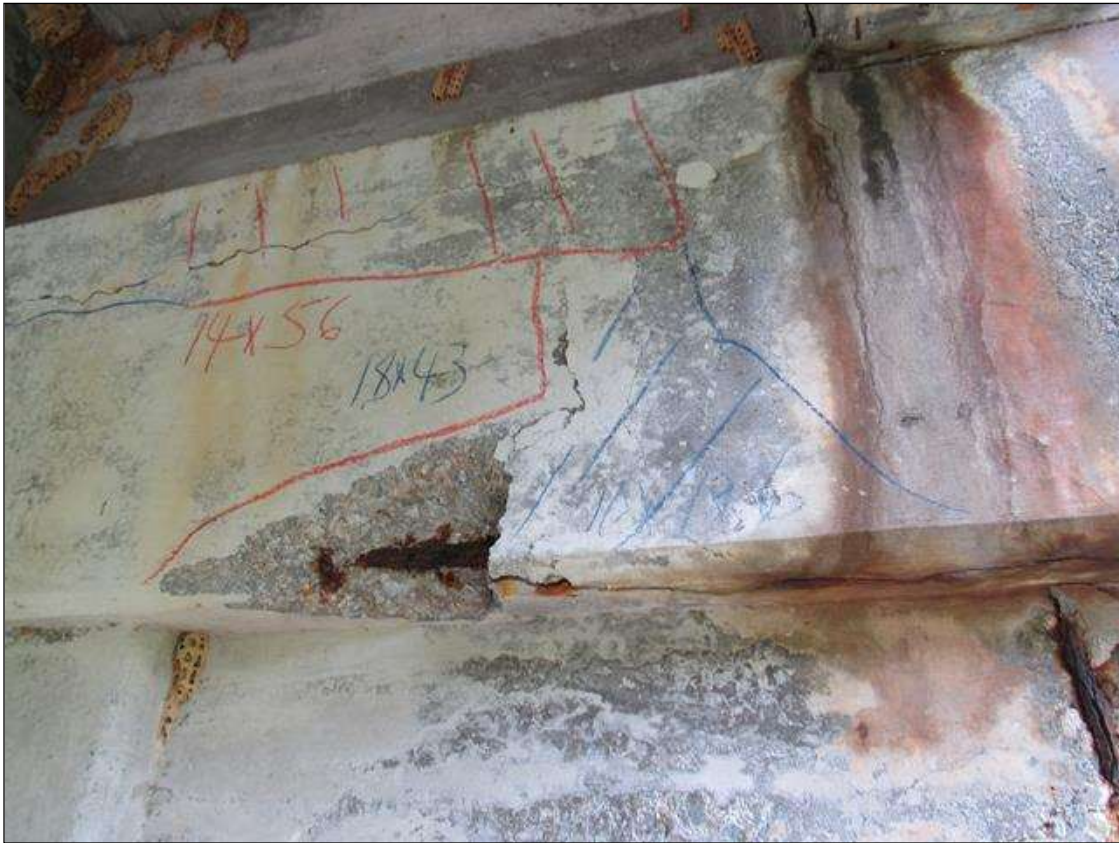
BENT 1 EAST OF CAP HAS CRACKED SPALL DELAM AREA ALONG BOTTOM OF CAP RIGHT SIDE OF G1 18"
UP FACE 43" LONG SPALL IS 10" X 19" X 6" WITH LARGE REBAR EXP

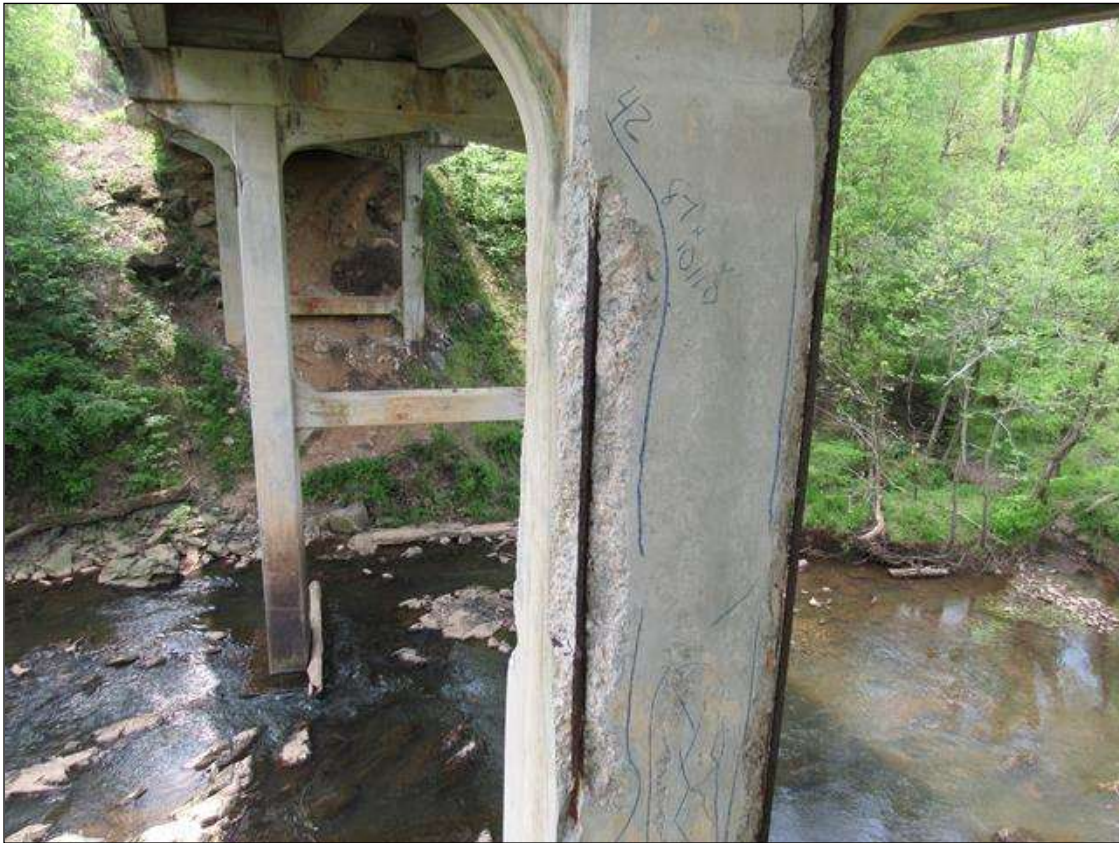
BENT 2 PILE 1 CRACKED SPALL DELAMINATED AREA NW CORNER OF PILE STARTS 42" BELOW CAP EXTENDS DOWN 87" AND 10" ON EACH FACE.

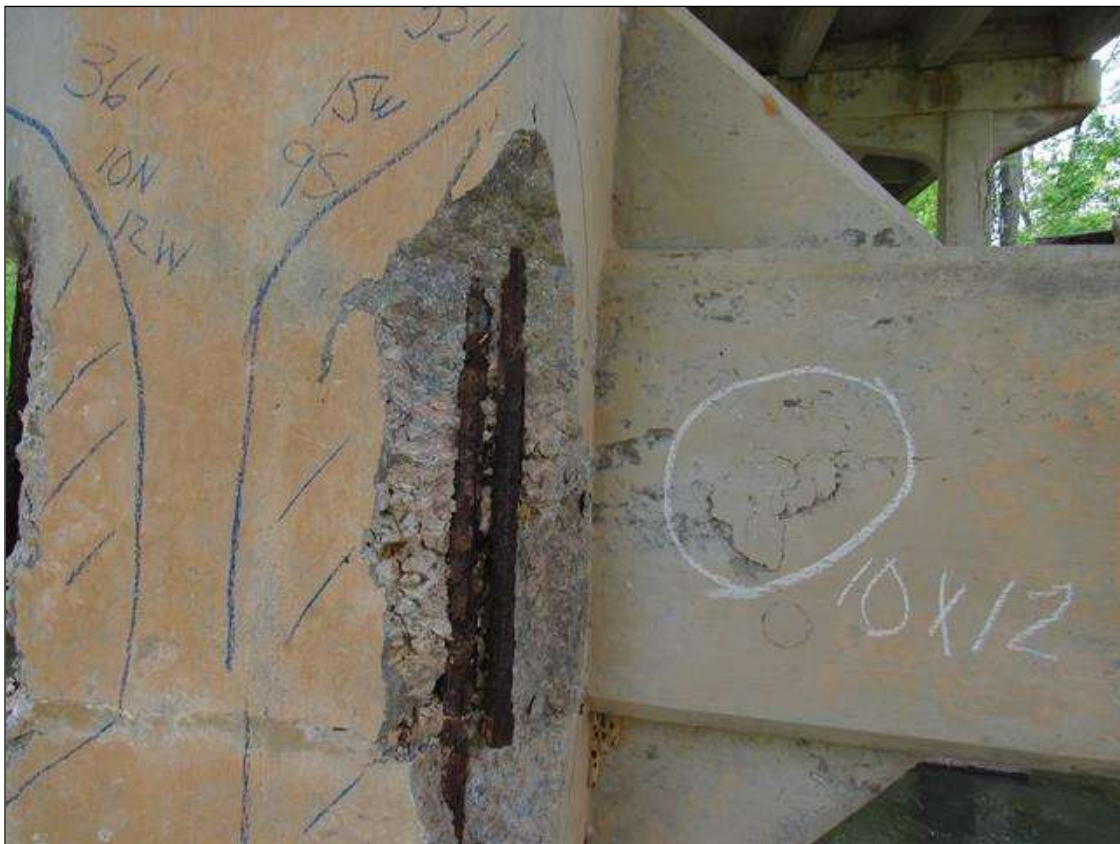
BENT 2 PILE 1 CRCKED SPALL DELAM AREA ON SW CORNER OF PILE STARTS 14' ABOVE FOTING EXTEND UP 52" 15" ON WEST FACE AND 9" ON SOUTH WITH 2 LRGE REBAR EX

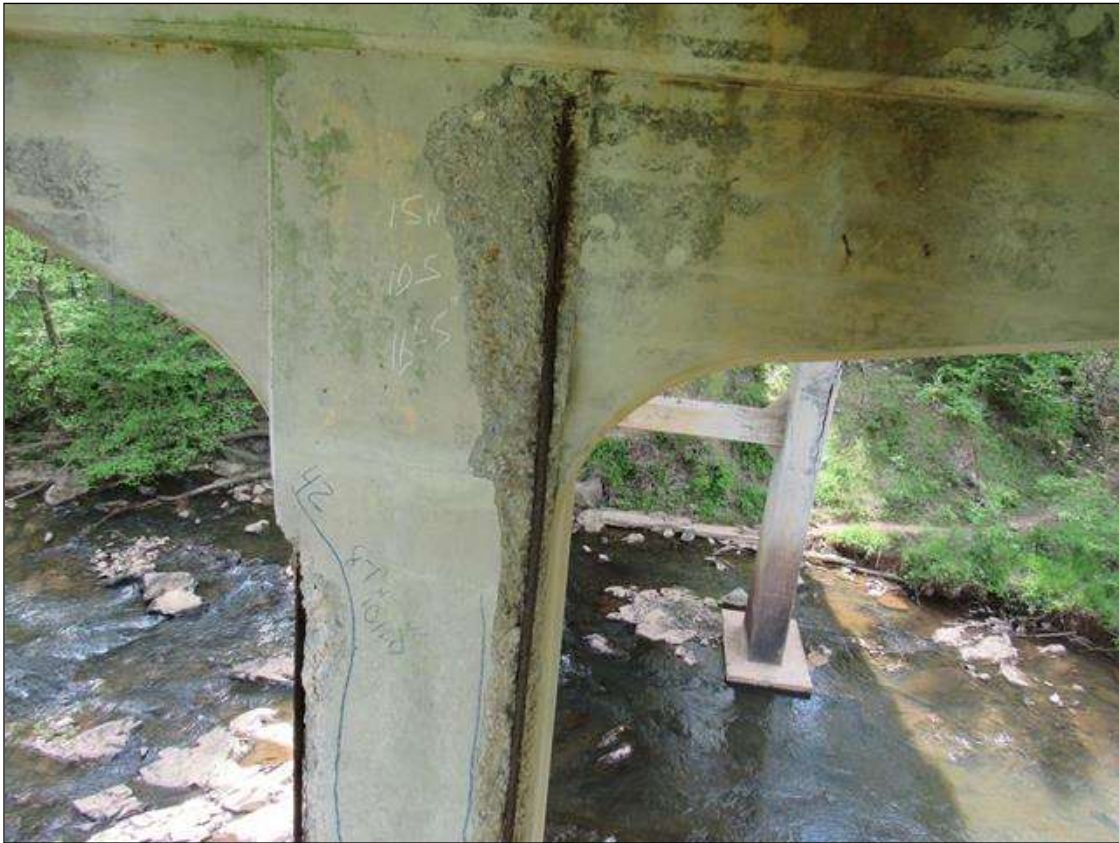
BENT 2 PILE 1 HAS A CRACKED SPALL DELAM AREA ON SW CORNER FM BOTTOM OF CAP DOWN 16' 5" FROM 8 TO 15 ON WEST FACE AND 10" ON SOUTH. LARGE REBAR EXPOSED
