NC DEPARTMENT OF TRANSPORTATION
 DIVISION OF HIGHWAYS
 STRUCTURE MANAGEMENT UNIT

ATTENTION:

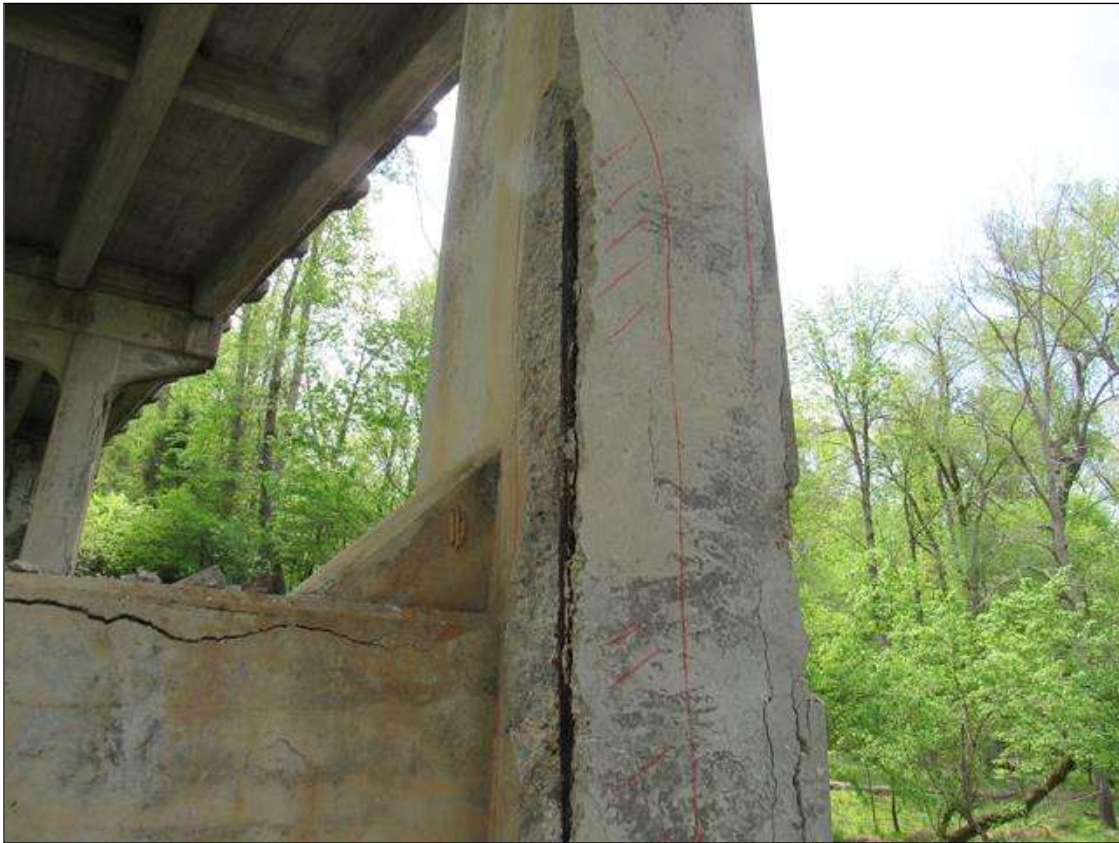
DELAMINATED AREA NW CORNER 10" ON NORTH 12 ON WEST, START 14' ABOVE FOOTING EXTENDS UP 9' HIGH WITH LARGE REBAR EXPOSED.

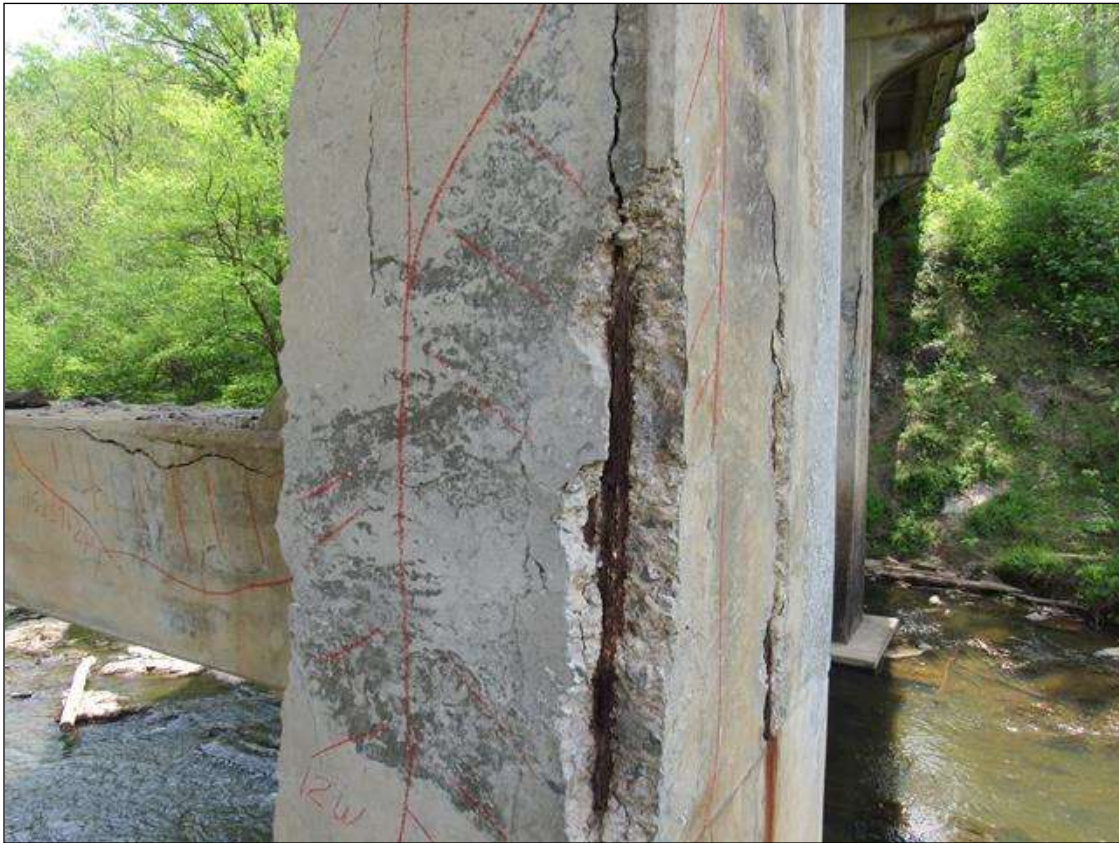
BNT 2 PILE 2 CRACKED SPALL DELAM AREA SW CORNER STARTS 14' ABOVE FOOTING EXTEND UP 8' 4" FM 6" TO 16' ON WEST FACE AND 10" ON SOUTH WITH REBAR EXPOSED

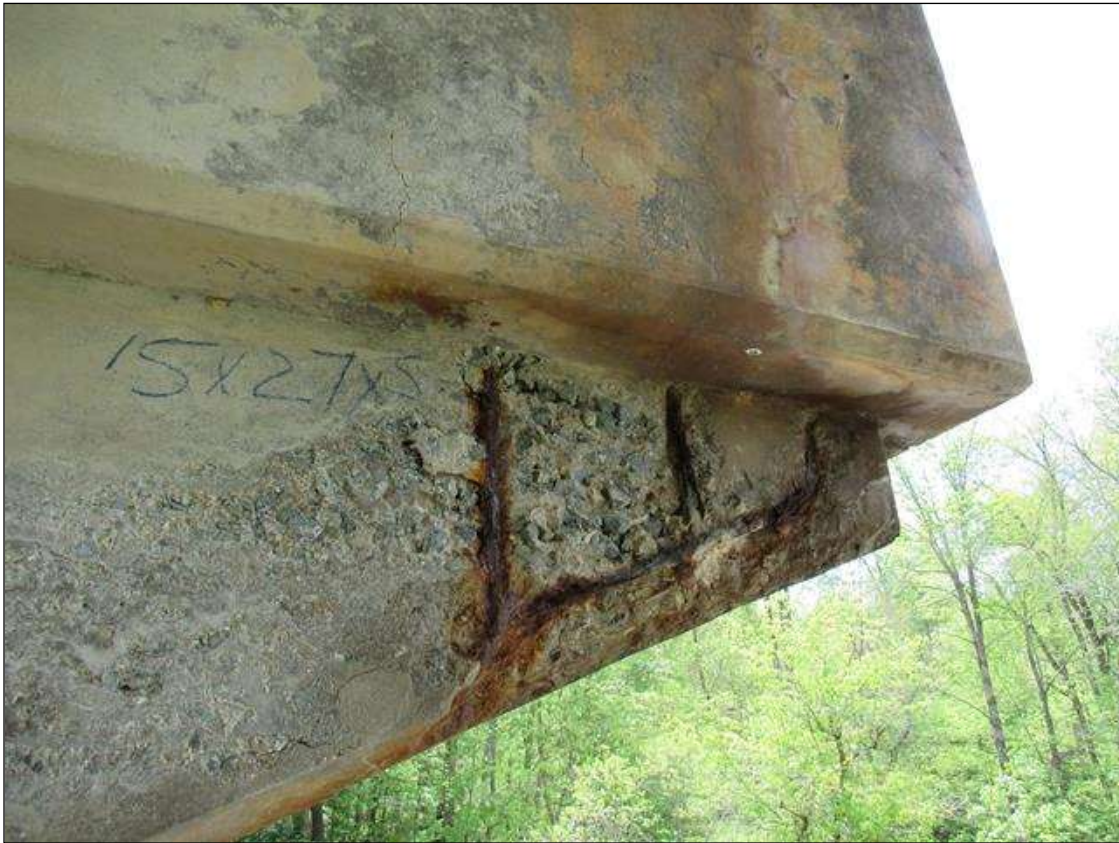
BENT 2 WEST FACE OF HAUNCH AREA UNDER G 5 CRACKED SPALL AND DELAMIN. 15" DOWN THE FACE 27" LONG AND 5" UNDER BOTTOM WITH REBAR AND STIRRUPS EXPOSED.

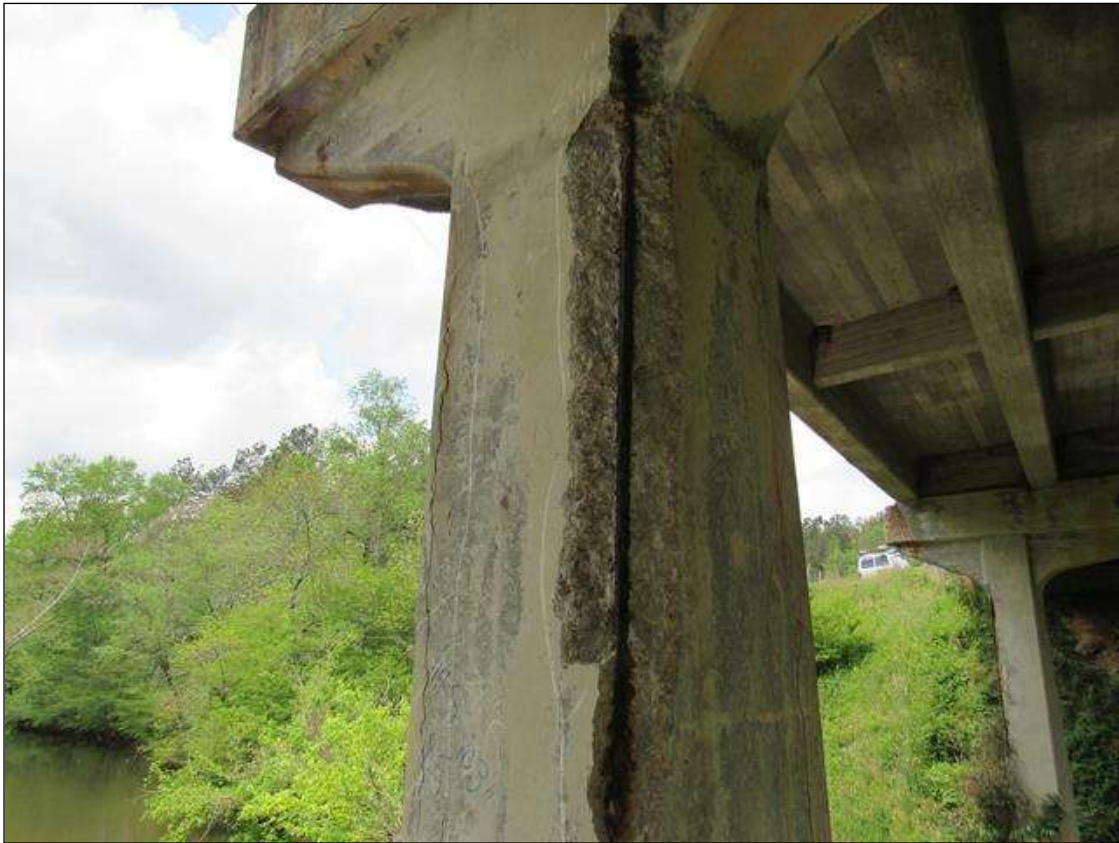
BENT 2 PILE 2 CRACKED DELAMINATED AND SPALL AREA ON NE CORNER OF PILE STARTS 26" BELOW THE CAP EXTENDS DOWN 90" 11" ON EAST FACE AND 8" ON NORTH.

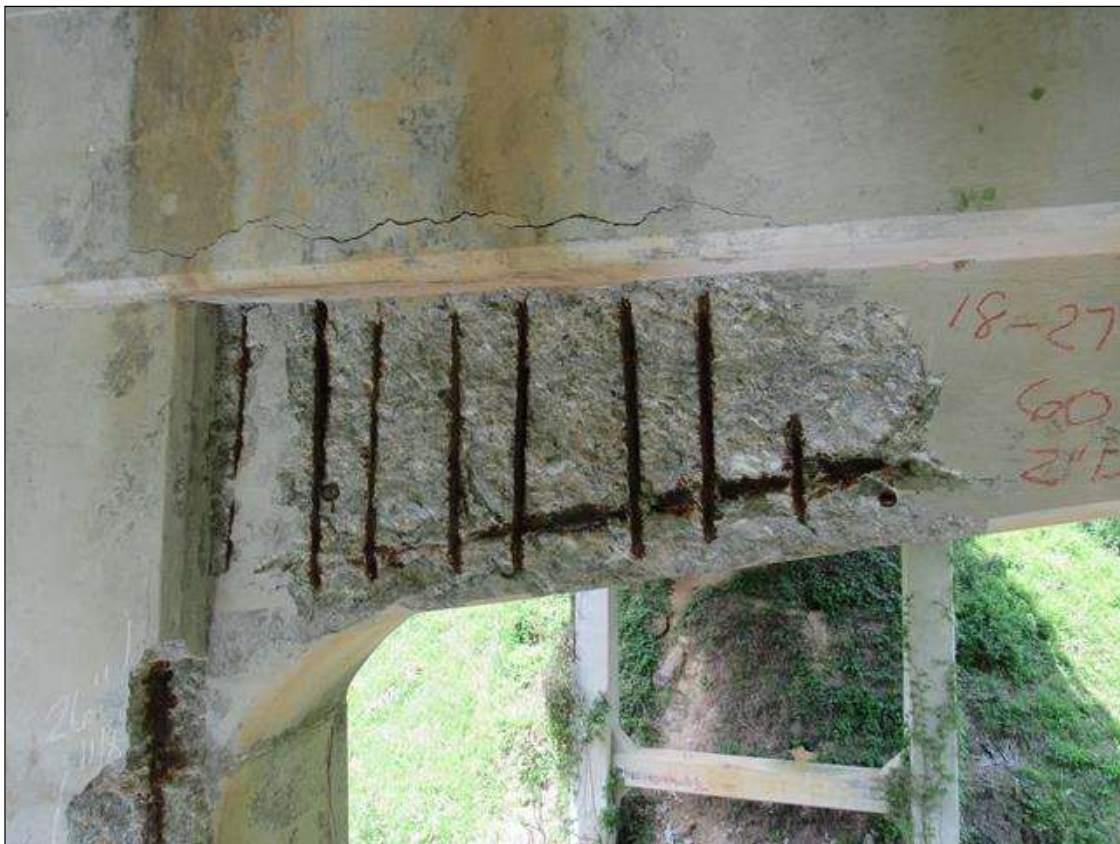
BENT 2 EAST FACE OF HAUNCH UNDER BOTTOM OF CAP LEFT OF PILE 2 CRACKED SPALL AND DELAMINATED. 18" TO 27" DWN FACE 60" LONG 2" D REBAR AND STIRUPS EXPOS

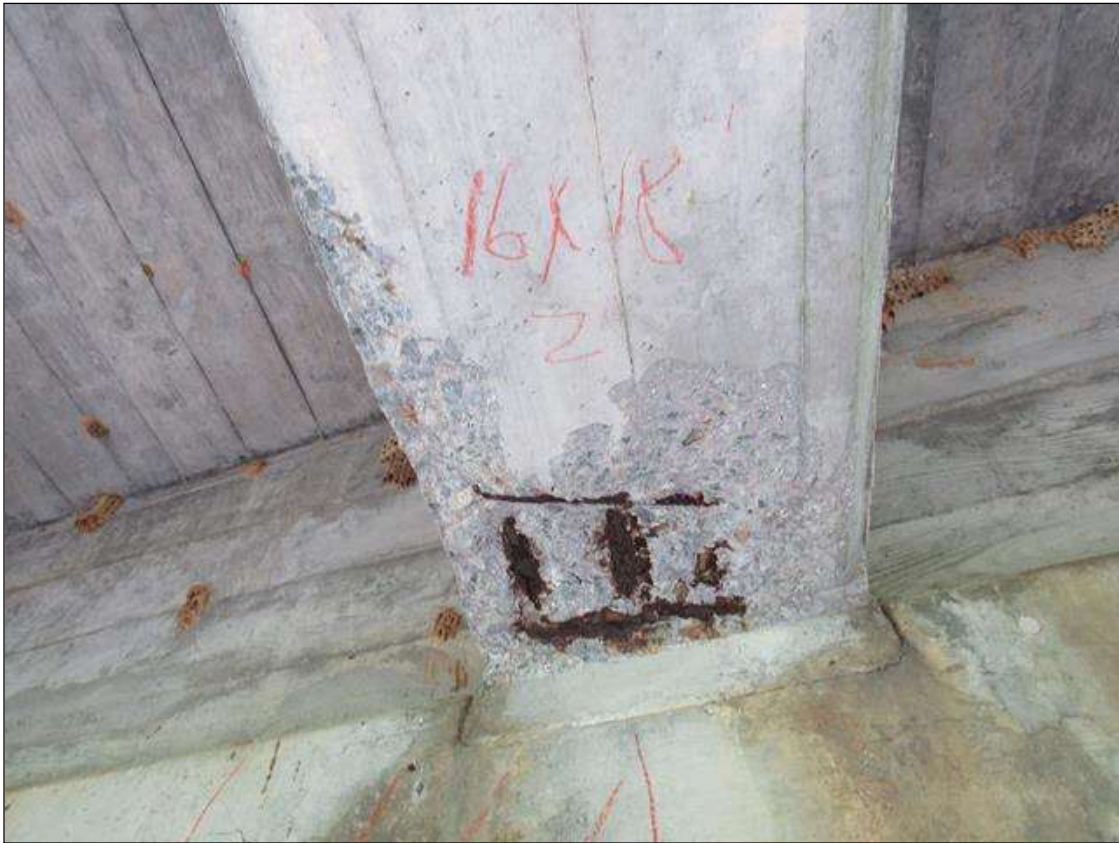
SPAN 3 BEAM 2 AT BENT 2 BOTTOM OF GIRDER HAS A SPALL AREA 16" W FROM CAP OUT 18" AND 2" DEEP REBAR AND STIRRUPS EXPOSED.

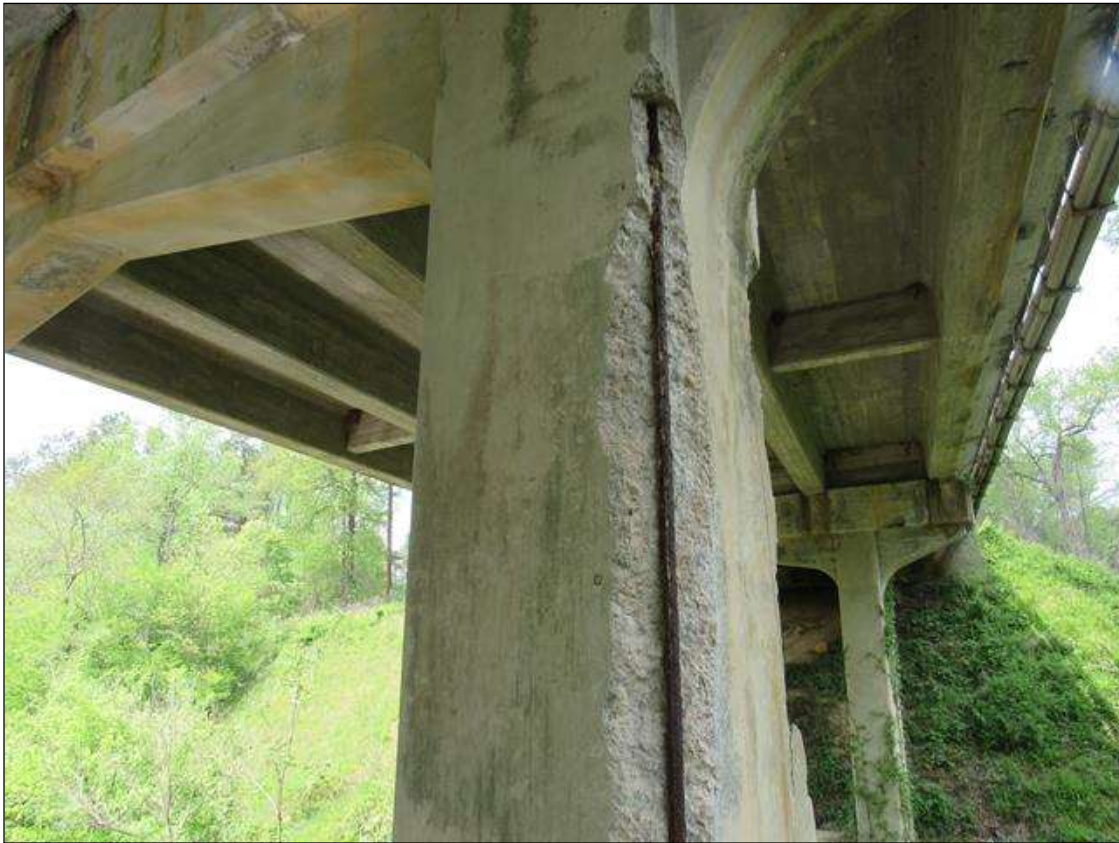
BENT 2 PILE 1 NE CORNER CRACKED SPALL DELAMINATED STARTS 3' BELOW CAP EXTENDS DOWN 7' 9" ON EACH FACE. LARGE REBAR EXPOSED.

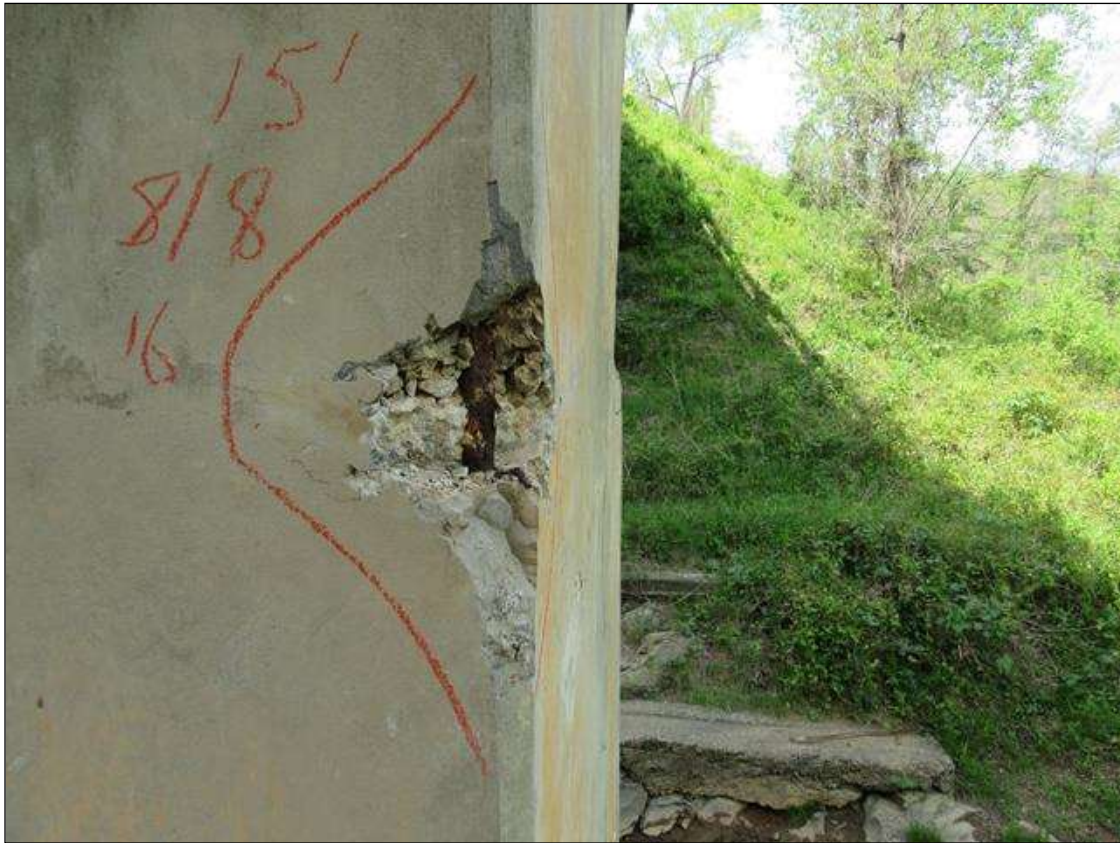
BENT 2 PILE 1 CRACKED SPALL DELAMINATED ON NE CORNER OF PILE 15' ABOVE FOOTING EXTENDS UP 16" & 8" ON EACH FACE.

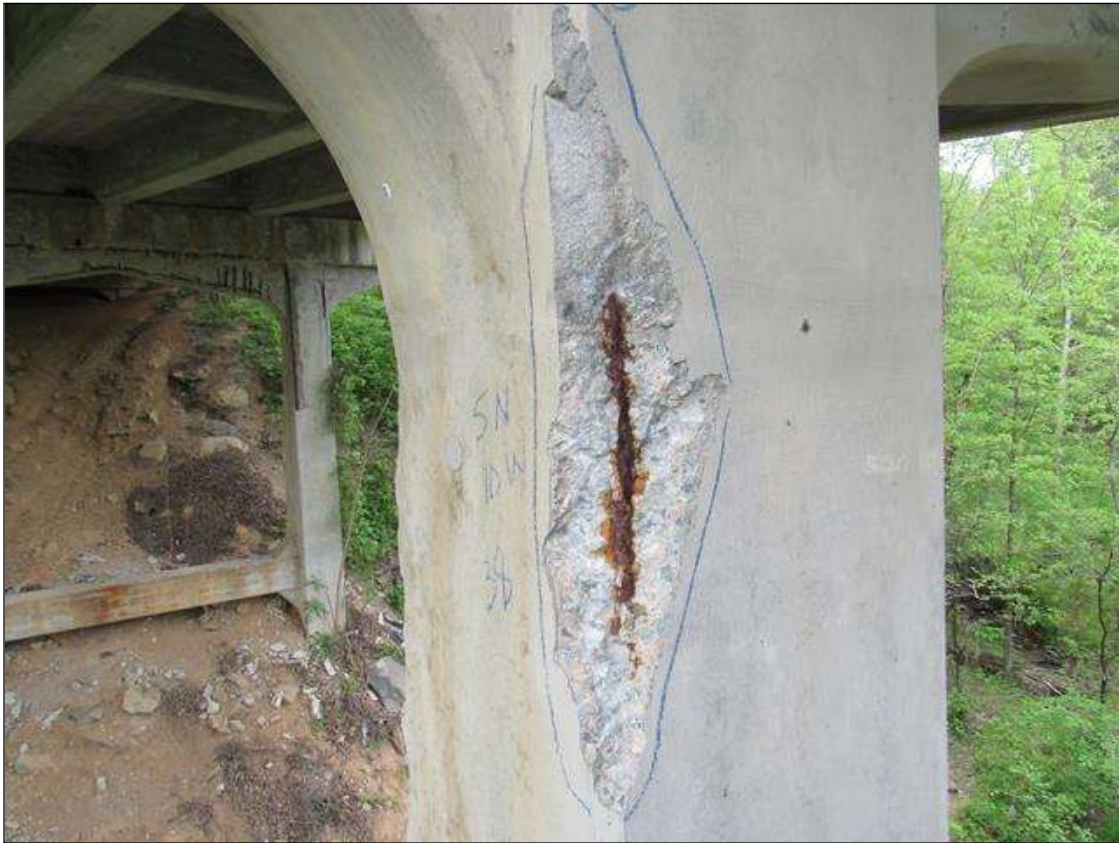
BENT 3 NW CORNER OF PILE 1 SPALL AREA 33" BELOW CAP EXTENDS DOWN 38". 5" ON NORTH 10" ON WEST WITH LARGE REBAR EXPOSED.

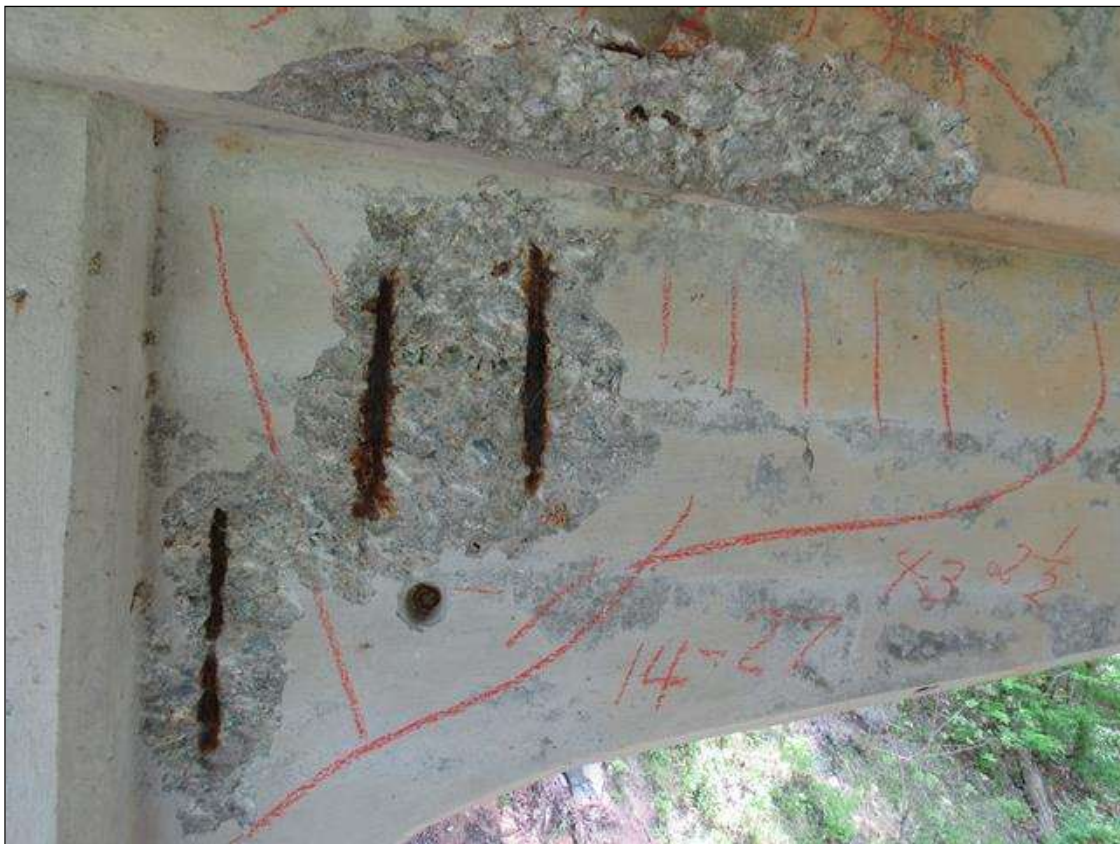
BENT 3 WEST FACE OF HAUNCH RIGHT SIDE OF PILE 1 CRACKED SPALL DELAMINATED. 14" TO 27" DOWN FACE 43" LONG 2 1/2" DEEP REBAR EXPOSED.

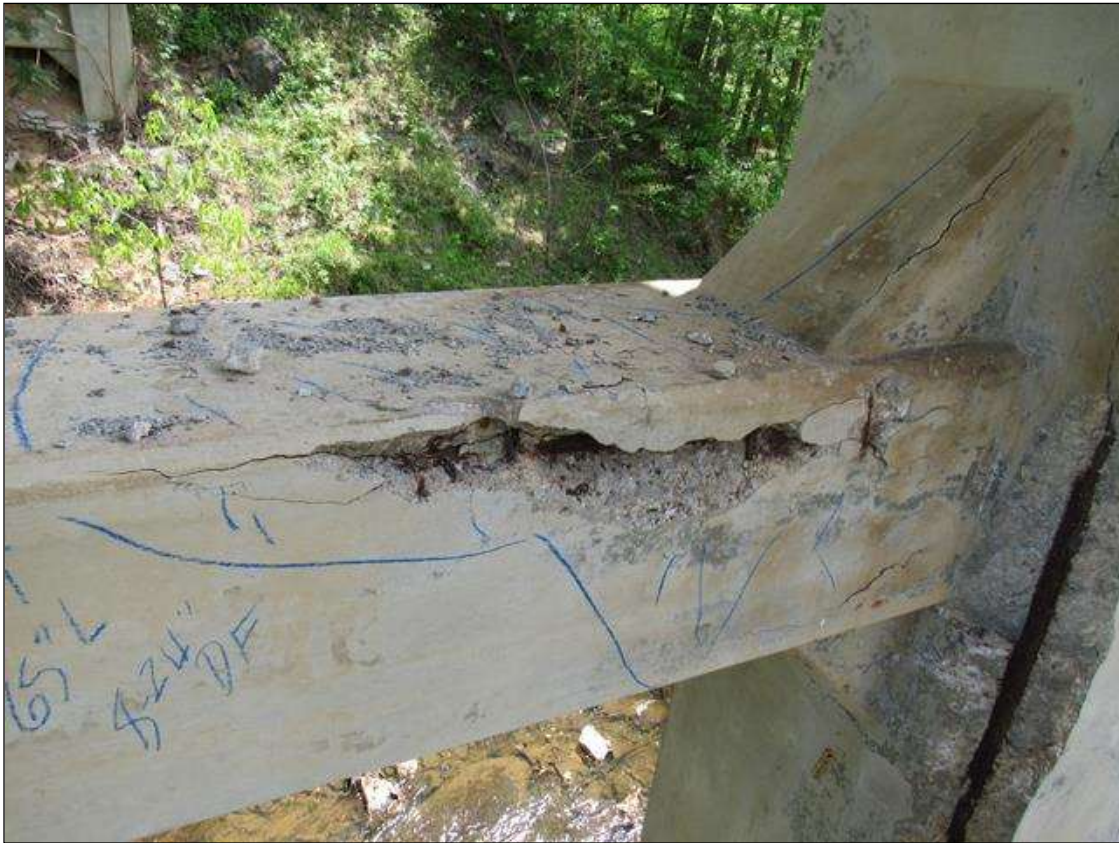
BENT 3 HORZ STRUT AREA LEFT SIDE OF PILE 2 IS CRACKED SPALL DELAMINATED 24" ON TOP 65" LONG AND FROM 8" TO 24" DOWN FACE REBAR AND STIRRUPS EXPOSED.

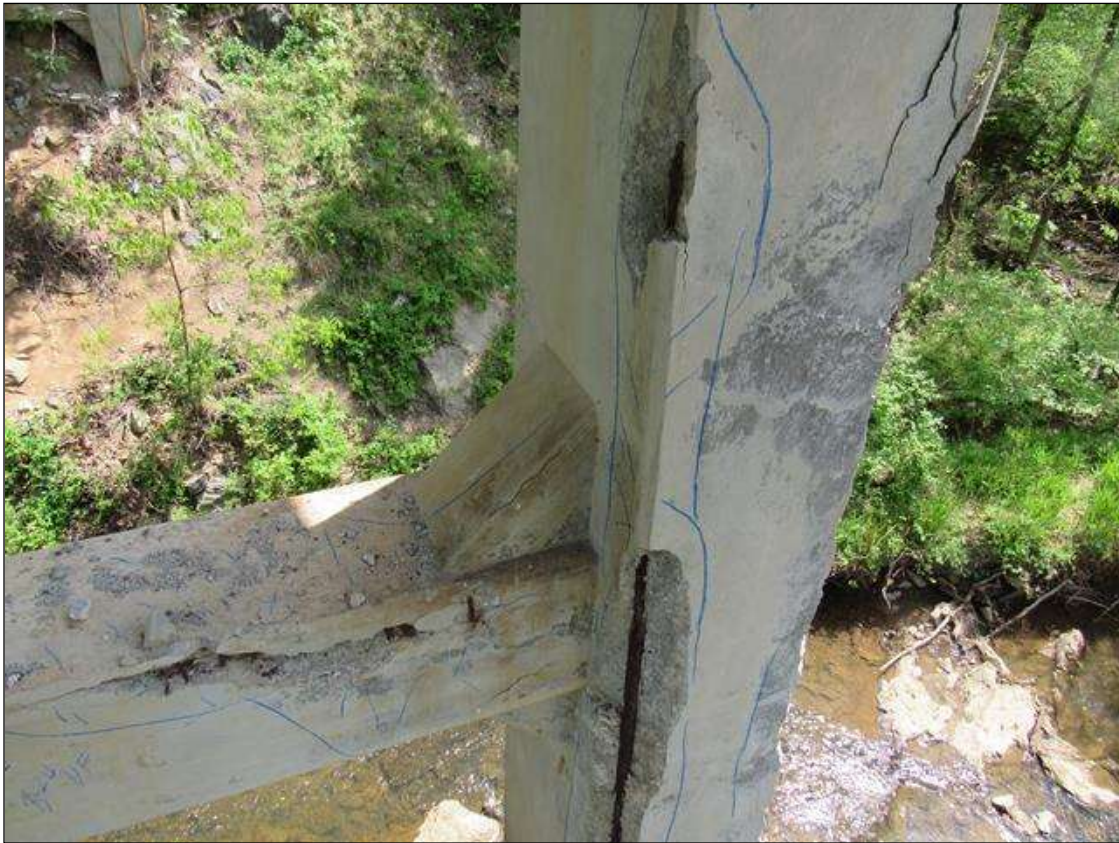
BENT 3 PILE 2 CRACKED SPALL DELAMINATED AREA NW CORNER STARTS 12' ABOVE FOOTING EXTENDS UP 11' 6". 16" ON NORTH AND 11" ON WEST.

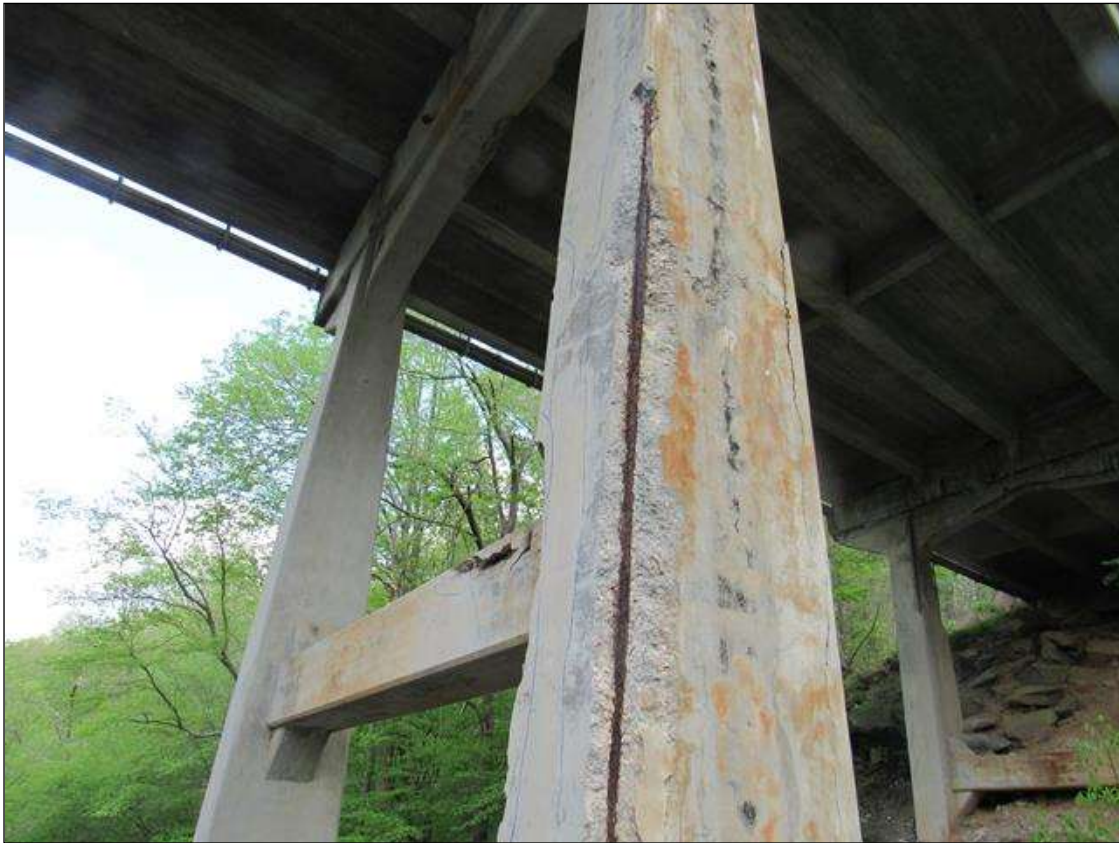
BENT 3 PILE 2 CRCKED SPALL DELAM AREA SW CORNR OF PILE STARTS 32" FM BOTM OF CAP EXTENDS DOWN 24' 16" ON WST FACE 13" ON SOUTH FACE WITH LRG REBAR EXP

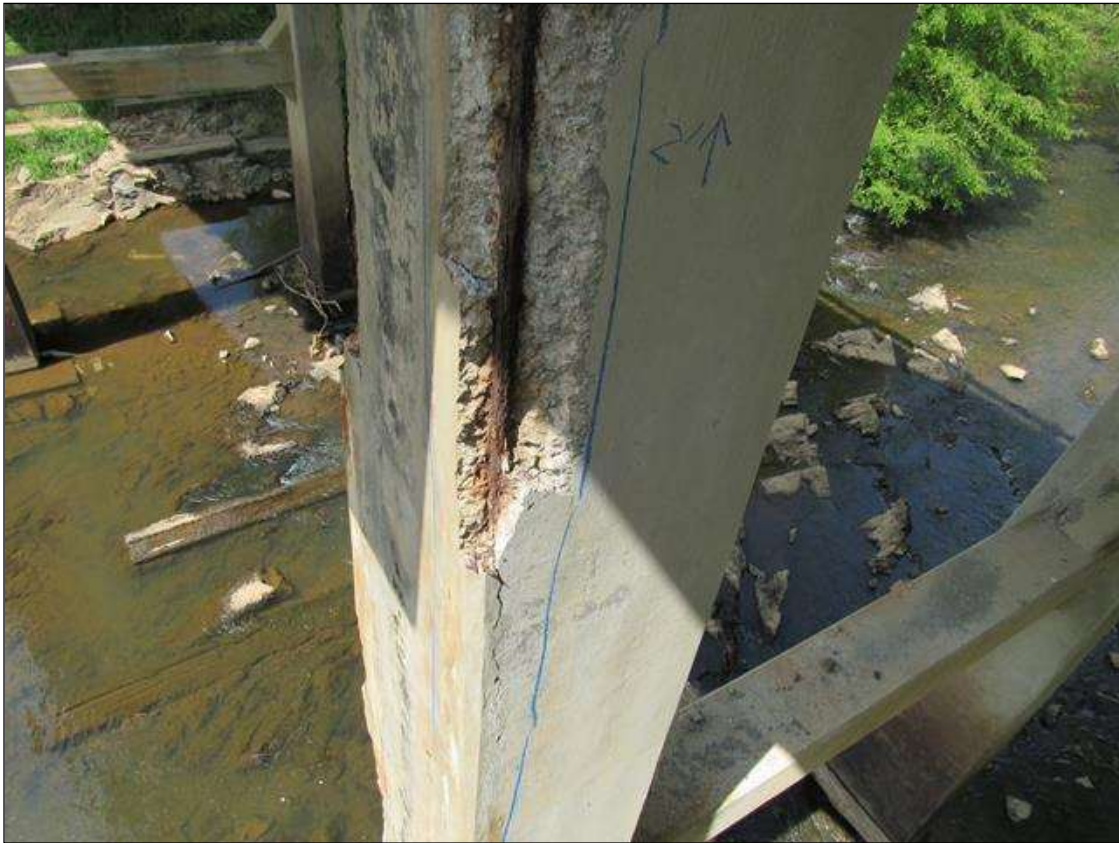
BENT 3 PILE 2 CRACKED SPALL DELAMINATED AREA SE CORNER OF PILE STARTS 24" BELOW CAP EXTENDS DOWN 24' 14" ON SOUTH FACE AND 16" ON EAST LARGE REBAR EXP

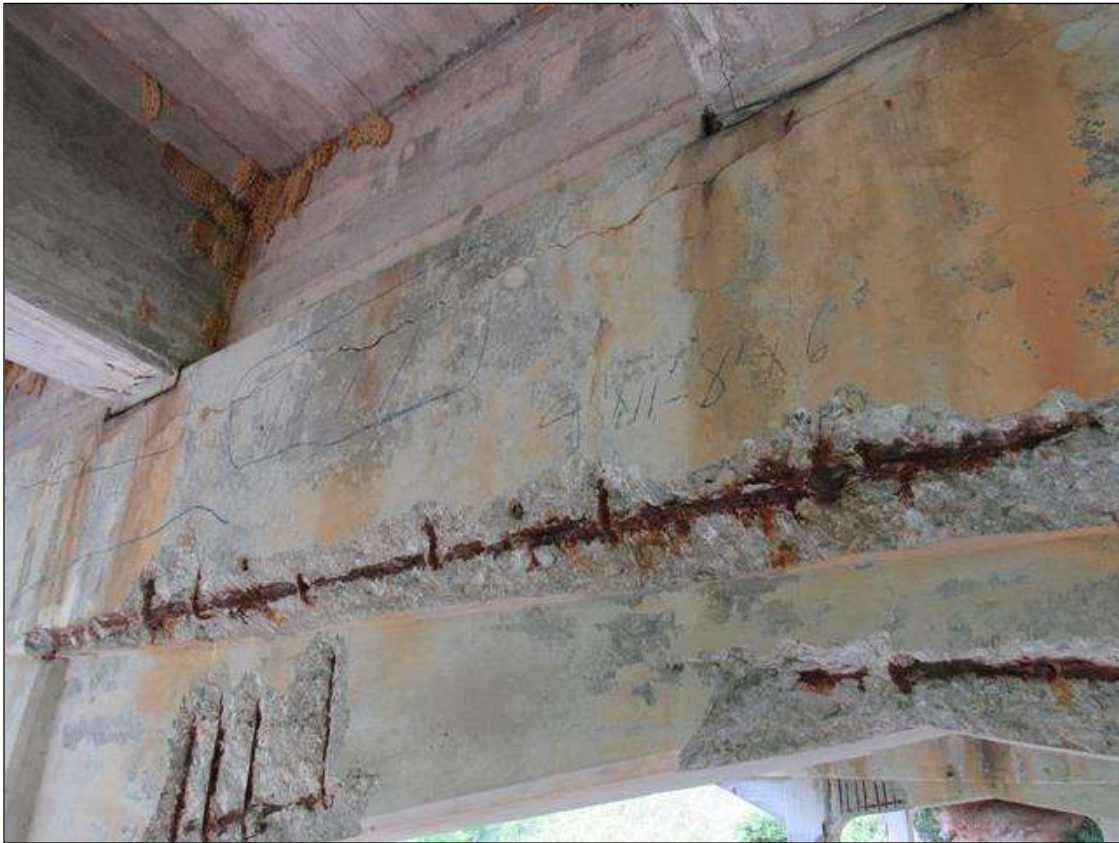
BNT 3 EAST FACE OF CAP HAS A DELAM AND SPALL AREA ALONG BOTM EDGE OF CAP FM G3 TO RT OF G4.
9" UP FACE 11' 8" LONG 6" UNDR BOTM REBAR STIRRUPS EXPOSED

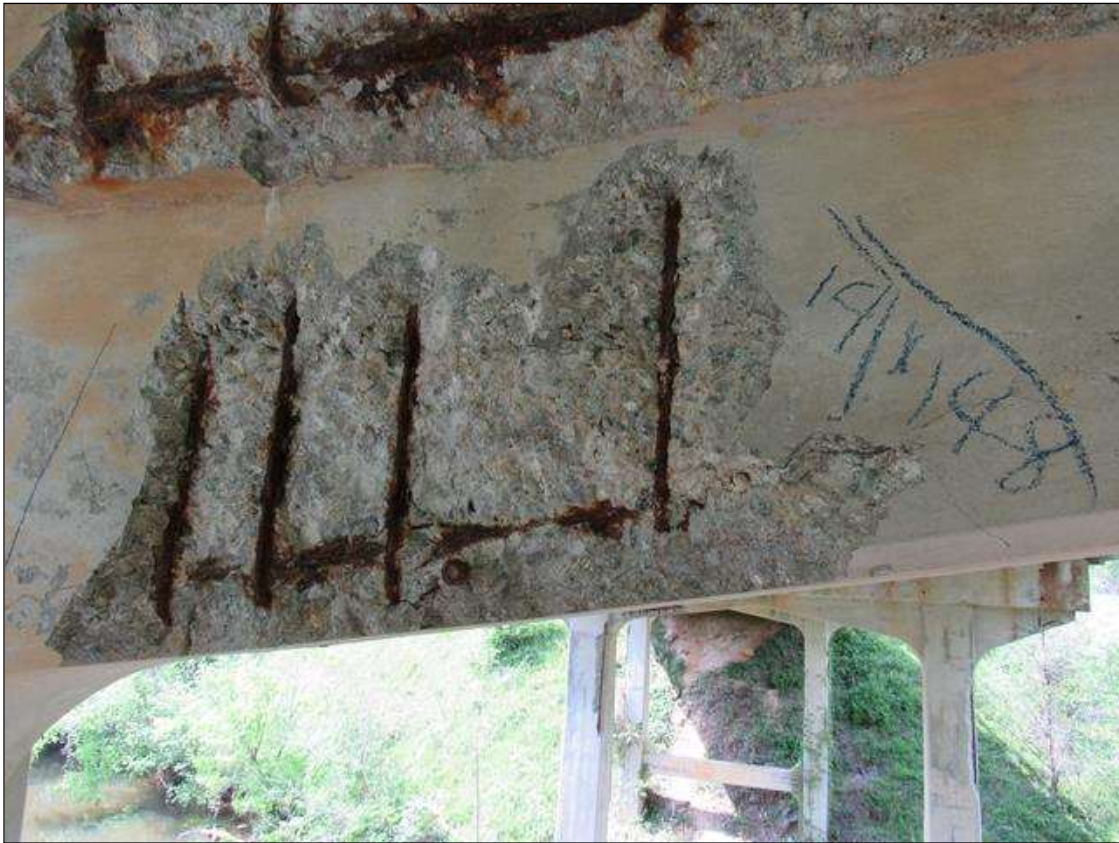
BENT 3 EAST FACE OF HAUNCH UNDER BOTTOM OF CAP SPALL DELAMINATED 19" HIGH 48" LONG 2" DEEP WITH REBAR AND STIRRUPS EXPOSED.

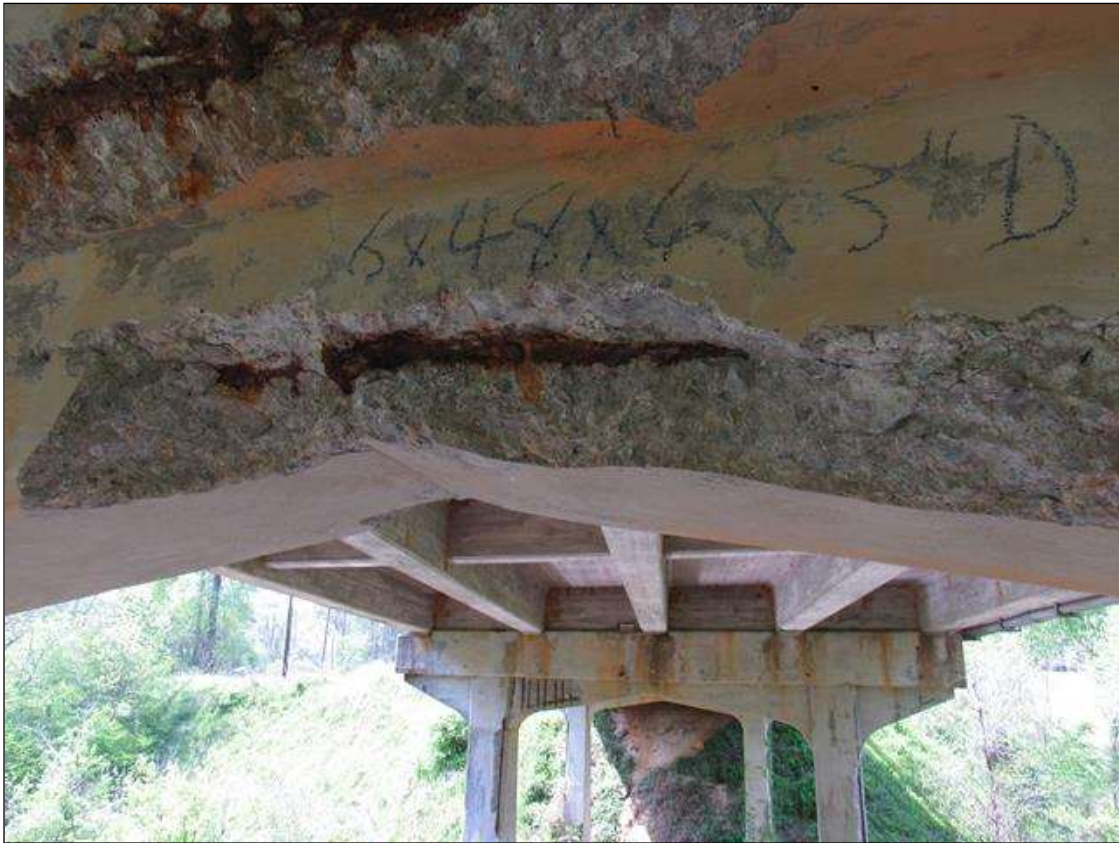
BENT 3 EAST FACE OF HAUNCH UNDER G3 SPALL AND DELAMINATED 6" HIGH 48" LONG 6" UNDER BOTTOM REBAR AND STIRRUPS EXPOSED.

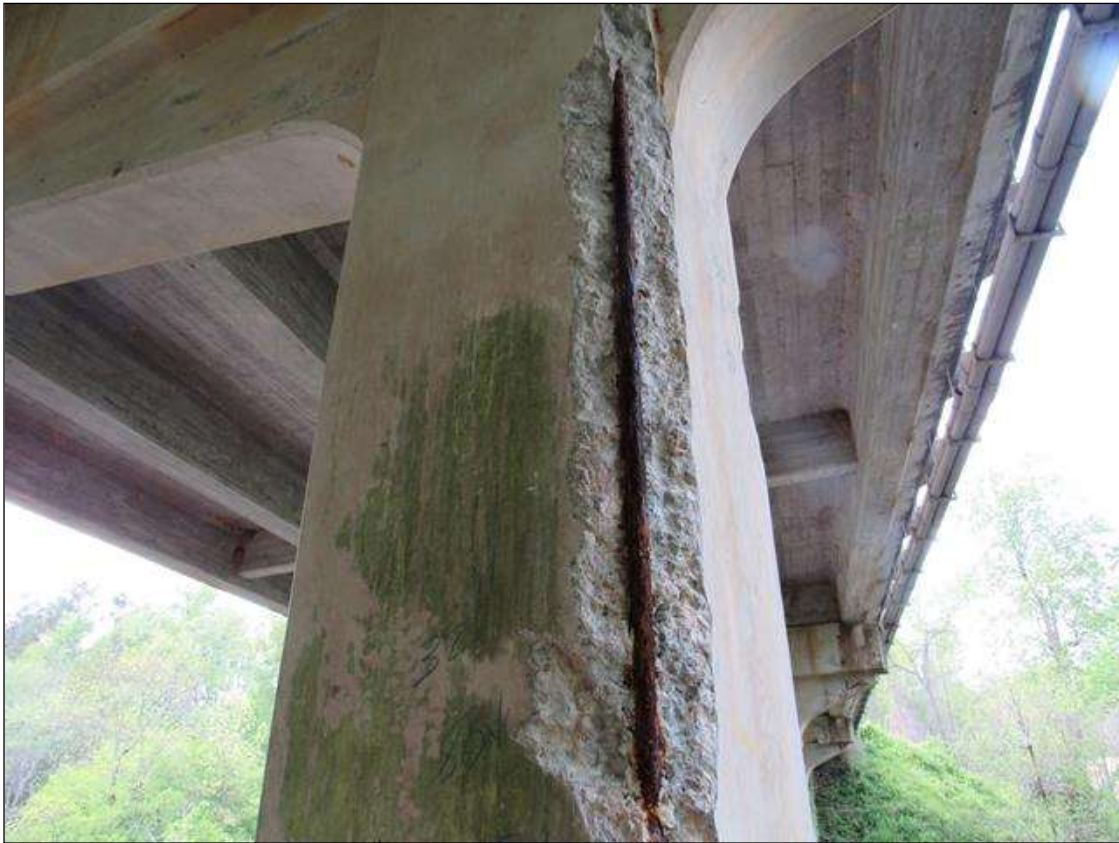
BENT 3 PILE 1 CRACKED SPALL DELAMINATED AREA NE CORNER OF PILE STARTS 32" BELOW CAP EXTENDS DOWN 80" 11" ON EAST AND 6" NORTH.

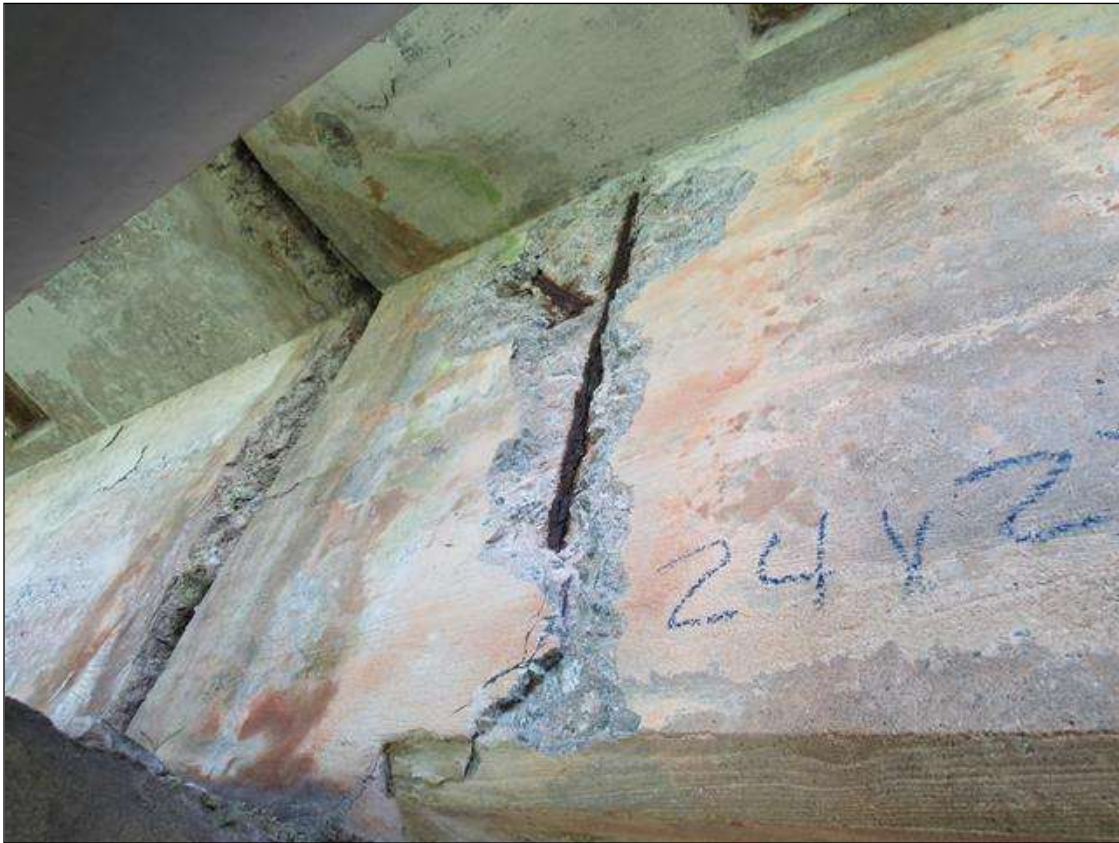
SPAN 4 LEFT SIDE OF G1 OVER BENT 4 CRACKED SPALL DELAMINATED AREA FM END OF GIRDER BACK 24"
BOTTOM UP 27" & 1 1/2" DEEP. VERT REBAR EXPOSED.

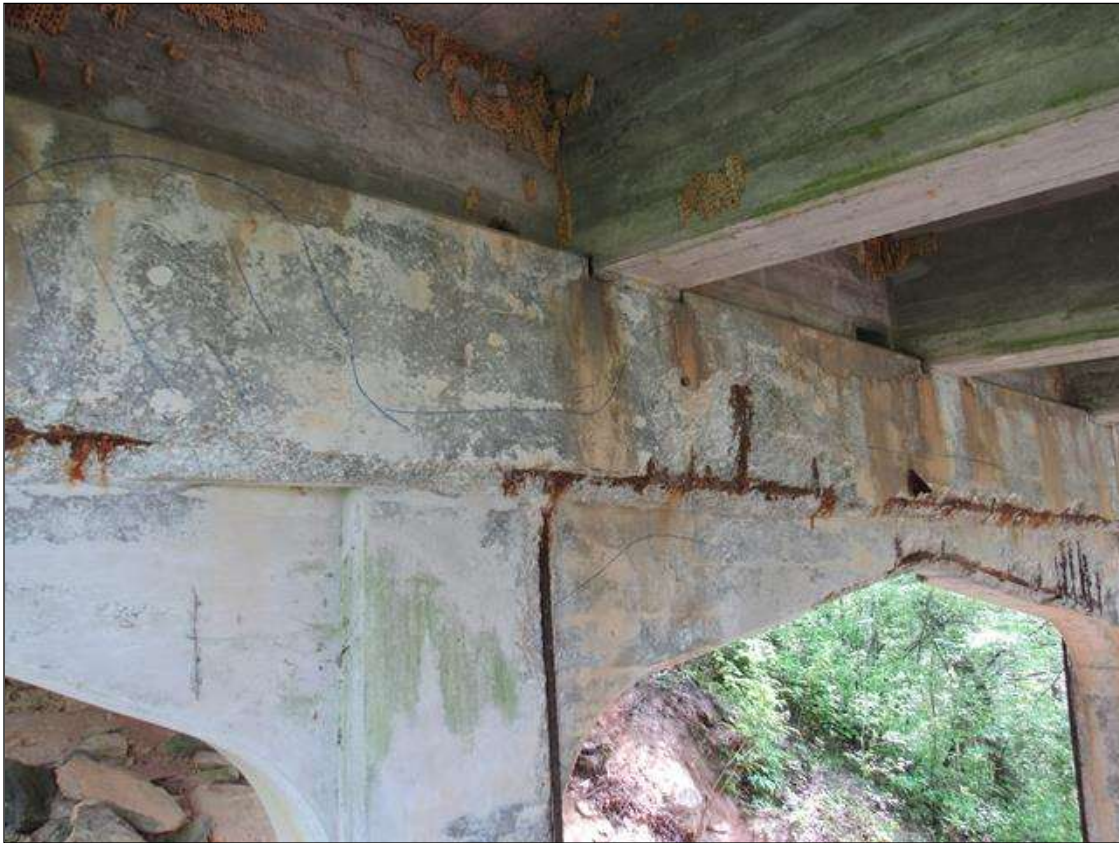
BENT 4 WEST FACE OF CAP FM LT END OVER TO PILE 2 CRACKED SPALL DELAMINATED 27' LONG FM 12' TO 30" FM BOTTOM OF CAP UP WITH REBAR AND STIRRUPS EXPOSED.

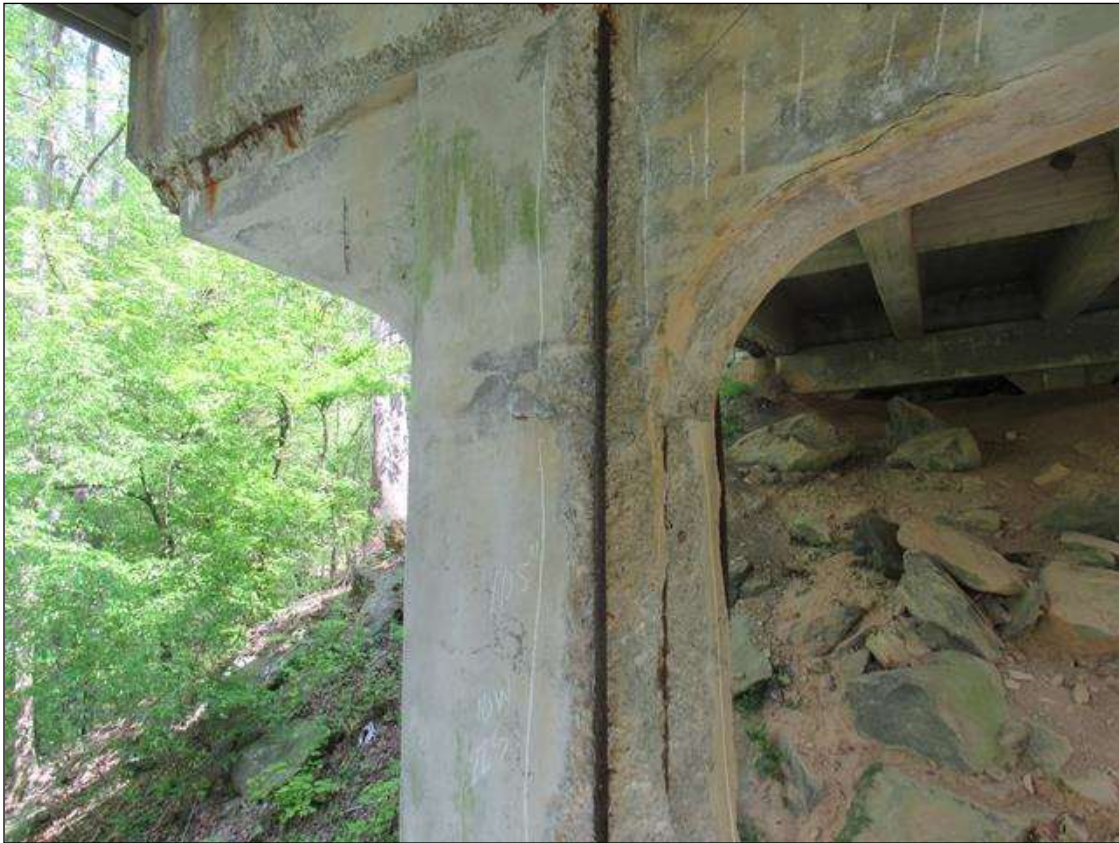
BENT 4 PILE 1 CRACKED SPALL DELAMINATED AREA ON SW CORNER OF PILE BOTTOM CAP DOWN 105" 22" ON SOUTH FACE AND 10" ON WEST REBAR EXPOSED.

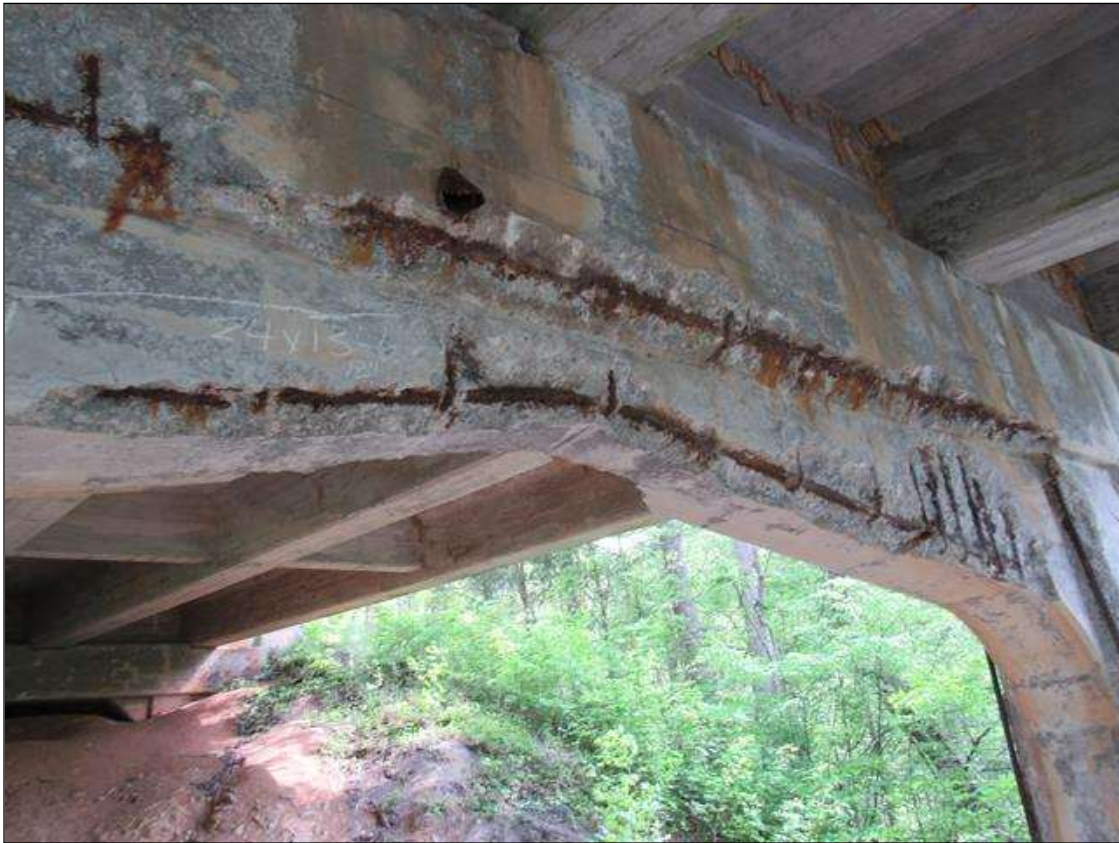
BENT 4 WEST FACE OF HAUNCH CRACKED SPALL DELAMINATED FM 15" TO 24" HIGH 13' 6" LONG 12" UNDER BOTTOM REBAR AND STIRRUPS EXPOSED.

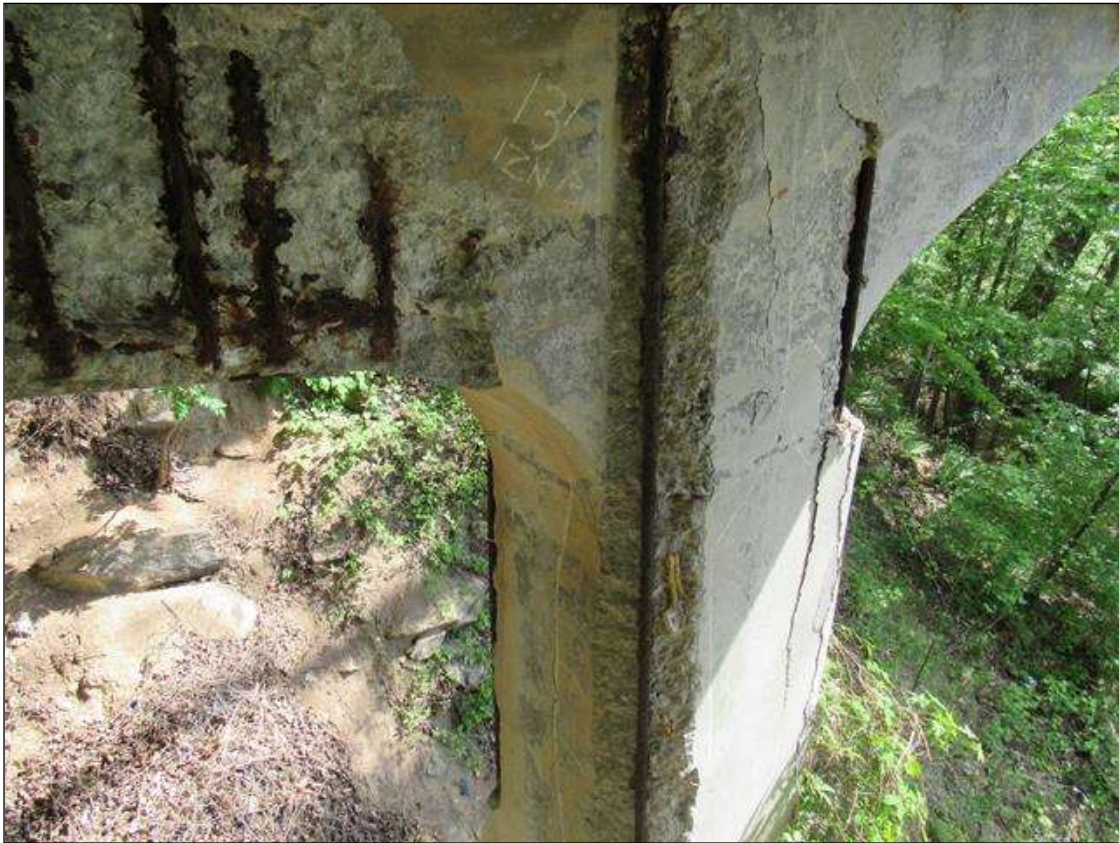
BENT 4 PILE 2 CRACKED SPALL DELAMINATED NW CORNER FM CAP DOWN 13' & 12" ON NORTH FACE 13" ON WEST. REBAR EXPOSED.
