NC DEPARTMENT OF TRANSPORTATION
 DIVISION OF HIGHWAYS
 STRUCTURE MANAGEMENT UNIT

ATTENTION:

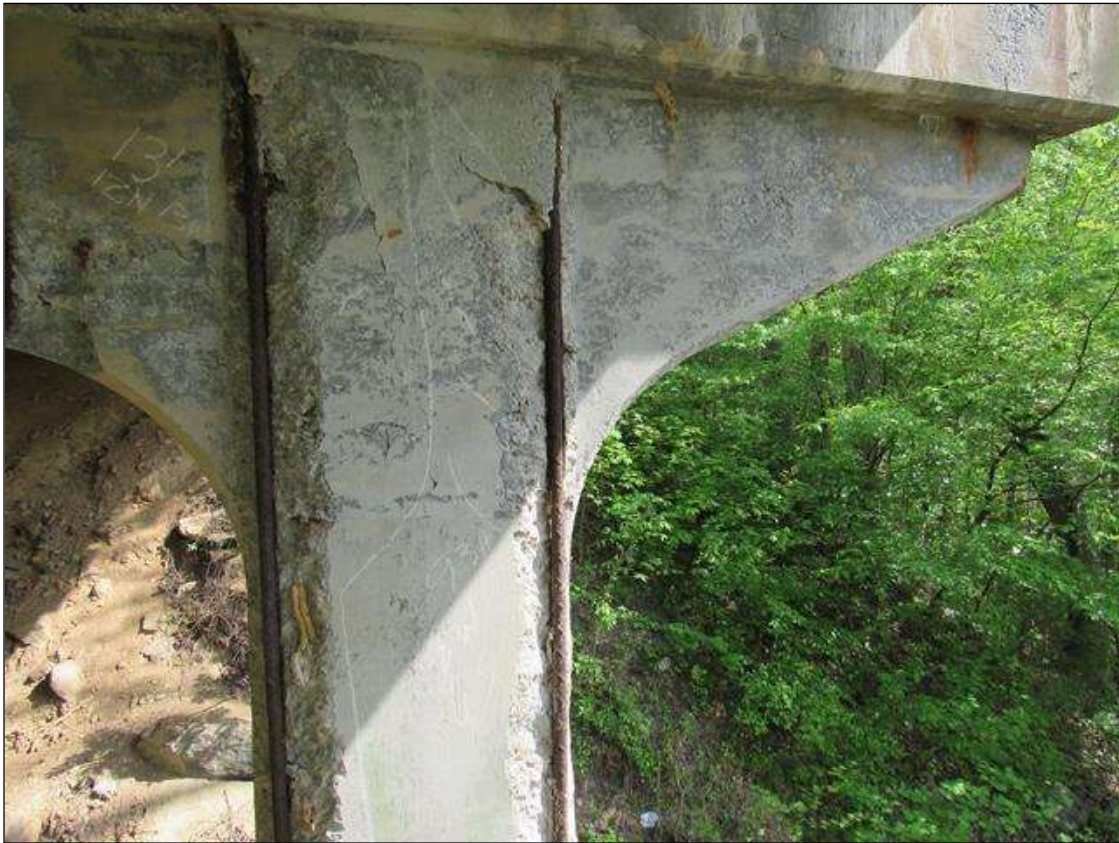
BENT 4 PILE 2 CRACKED DELAMINATED SPALL AREA SW CORNER OF PILE FM BOTTOM OF CAP DOWN 93".
8" ON WEST FACE AND 6" ON SOUTH.

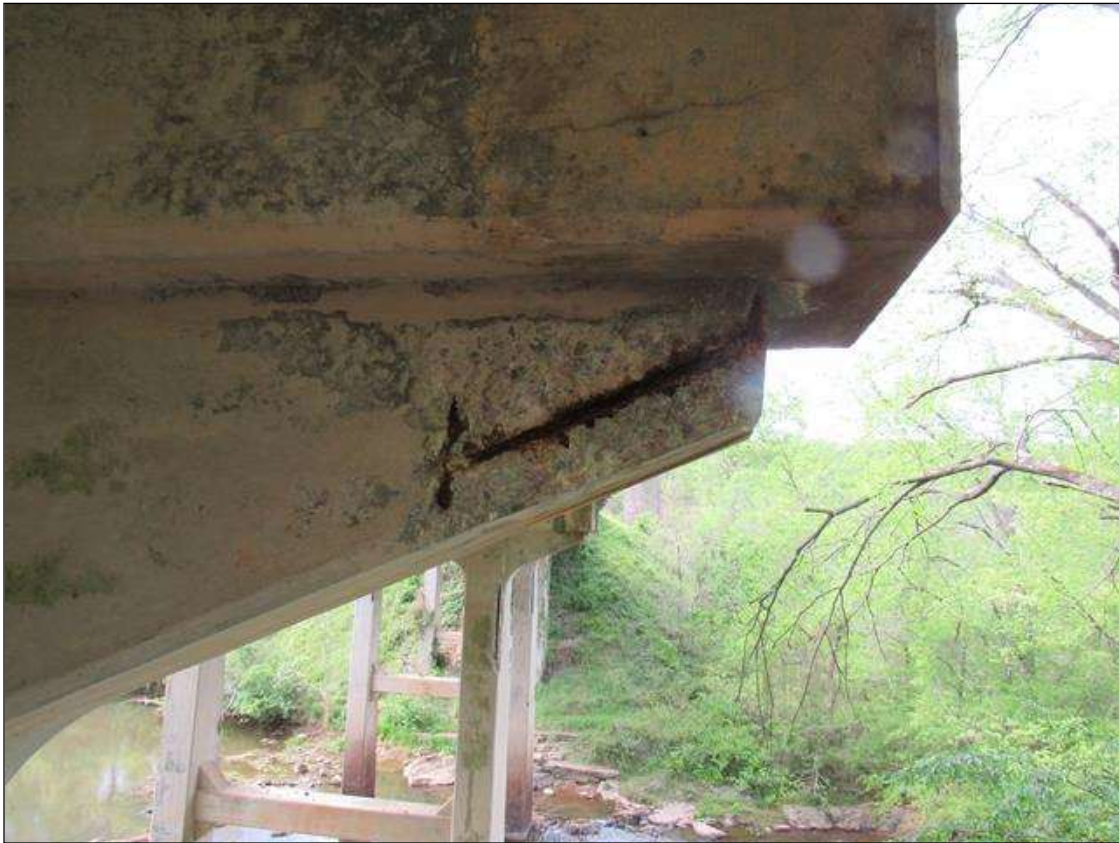
BENT 5 EAST FACE OF HUANCH UNDER LEFT END OF CAP SPALL AREA 9" X 18" X 4" UNDER BOTTOM REBAR AND STIRRUPS EXPOSED.

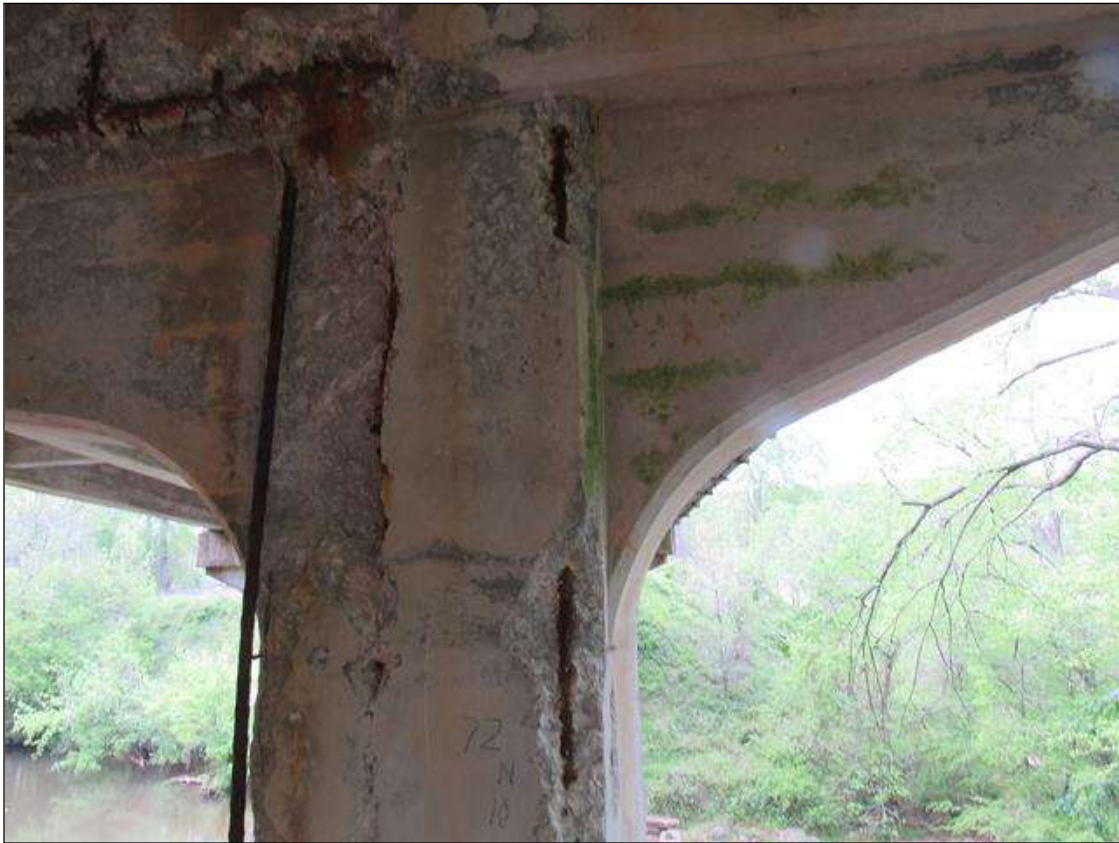
BENT 4 PILE 1 CRACKED SPALL AREA NE CORNER CAP DOWN 72" & 10" ON NORTH FACE & 12" ON EAST WITH REBAR EXPOSED.

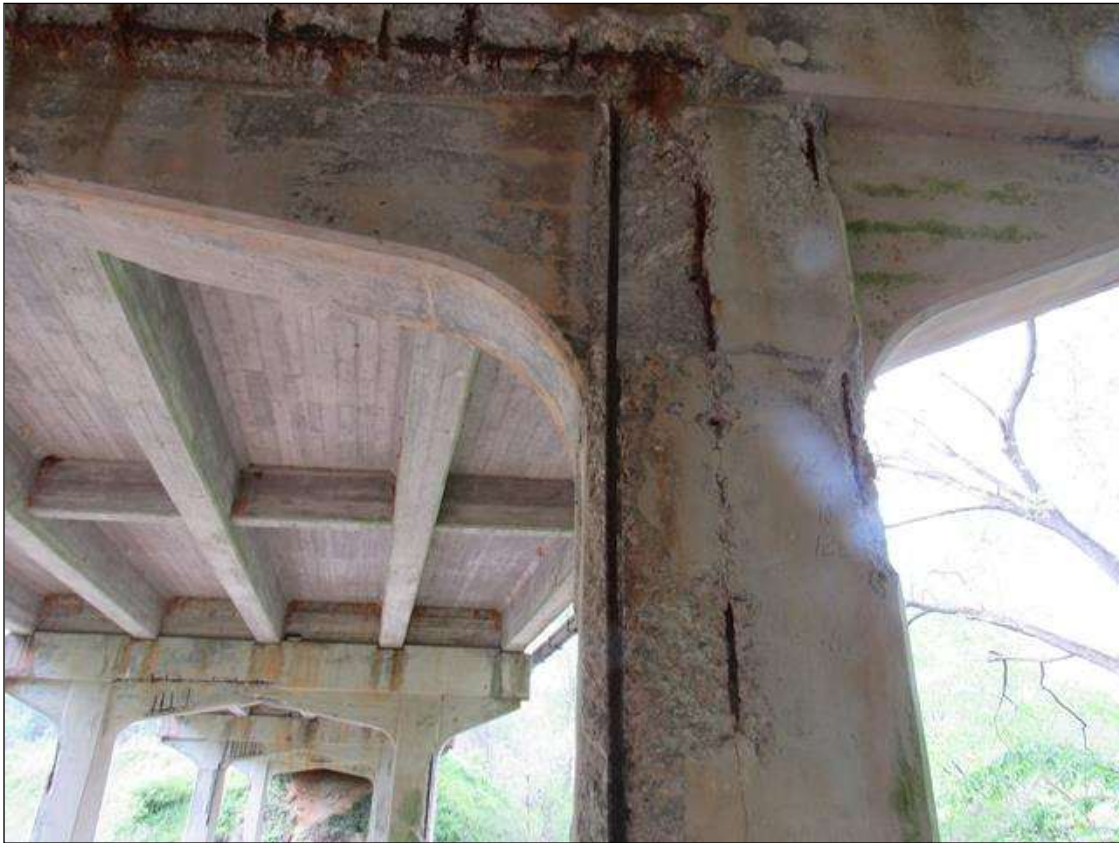
BENT 4 PILE 1 CRACKED SPALL DELAMINATED AREA ON SE CORNER OF PILE FM CAP DOWN 9' 4" AND 10" ON SOUTH 15" ON EAST REBAR EXPOSED.

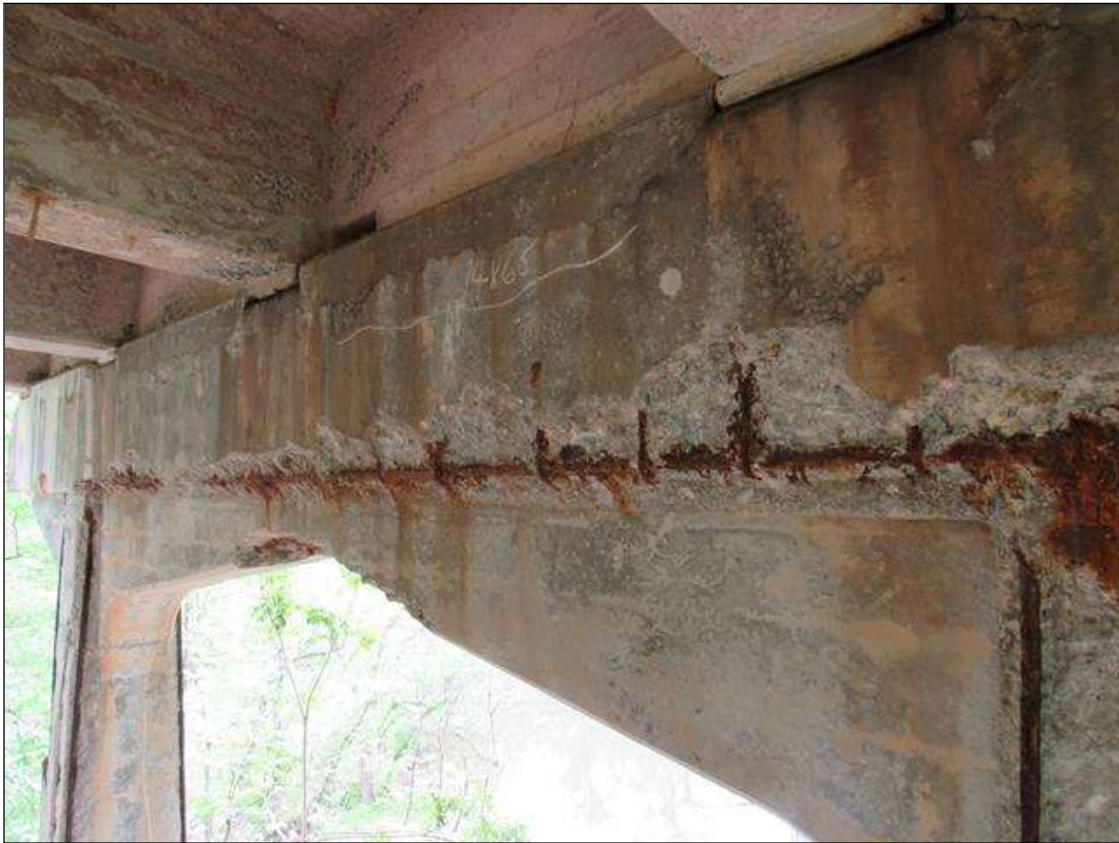
BENT 4 CAP EAST FACE OF CAP CRACKED SPALL DELAM FM LEFT SIDE OF G2 TO RIGHT OF G4. 17" UP FACE 21' LONG 6" UNDER BOTTOM REBAR AND STIRRUPS EXPOSED.

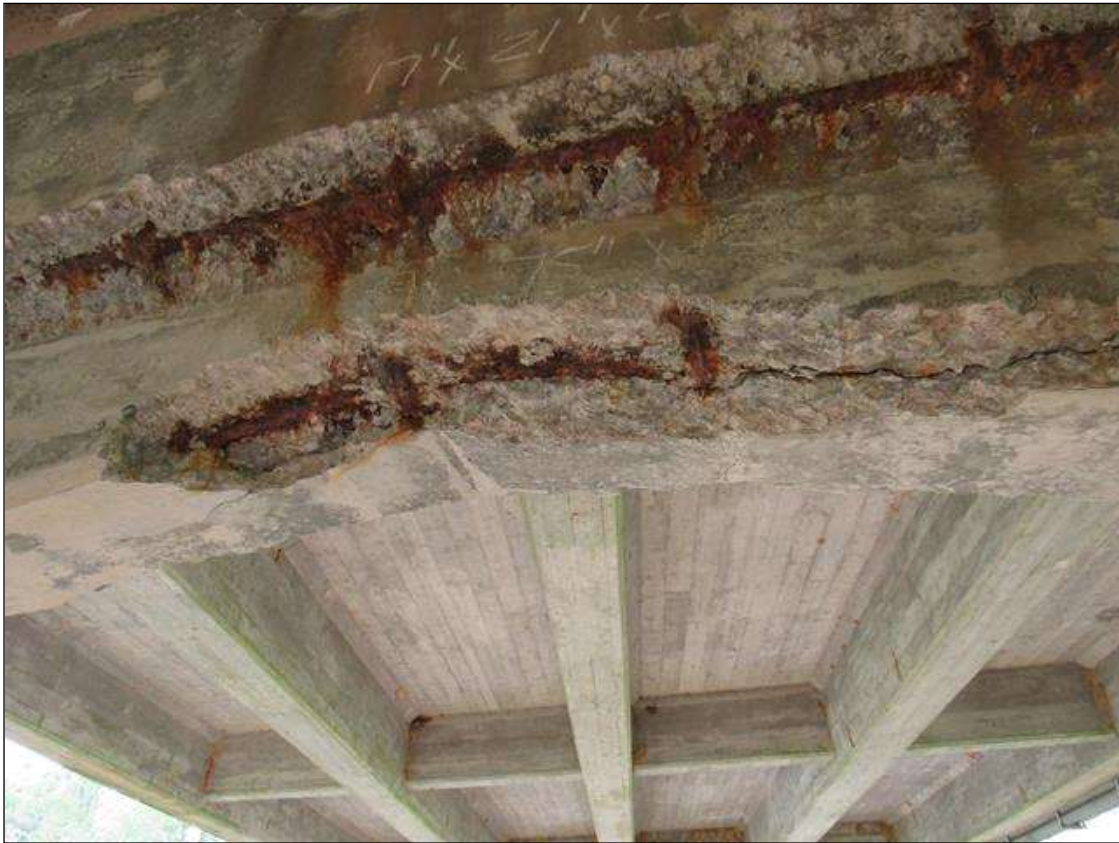
BENT 4 EAST FACE AND BOTTOM OF HUANCH UNDER G3 CRACKED SPALL AND DELAMINATED 9" WIDE 75" LONG 6" UNDER BOTTOM WITH REBAR AND STIRRUPS EXPOSED.

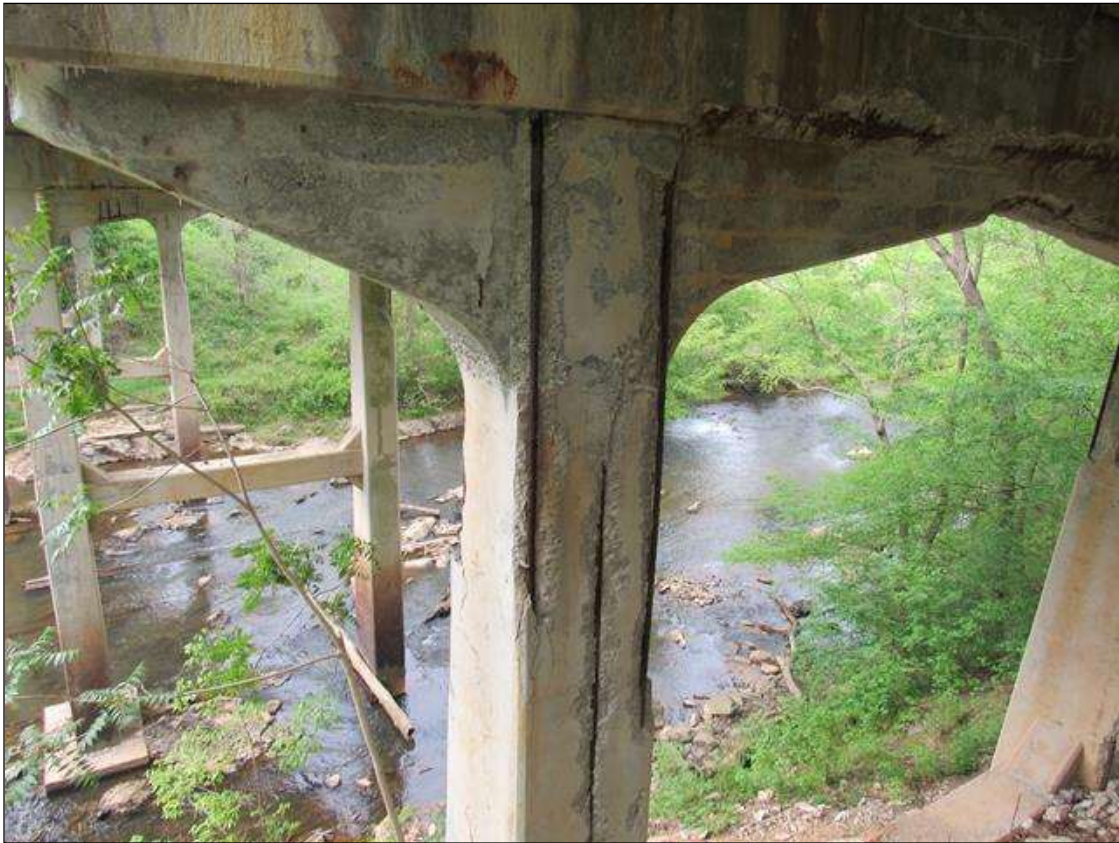
BENT 4 PILE 2 CRACKED SPALL DELAMINATED SE AND NORTH FACE FM CAP DOWN 13' & 32" WIDE ON EAST FACE & 6" ON SOUTH AND NORTH.

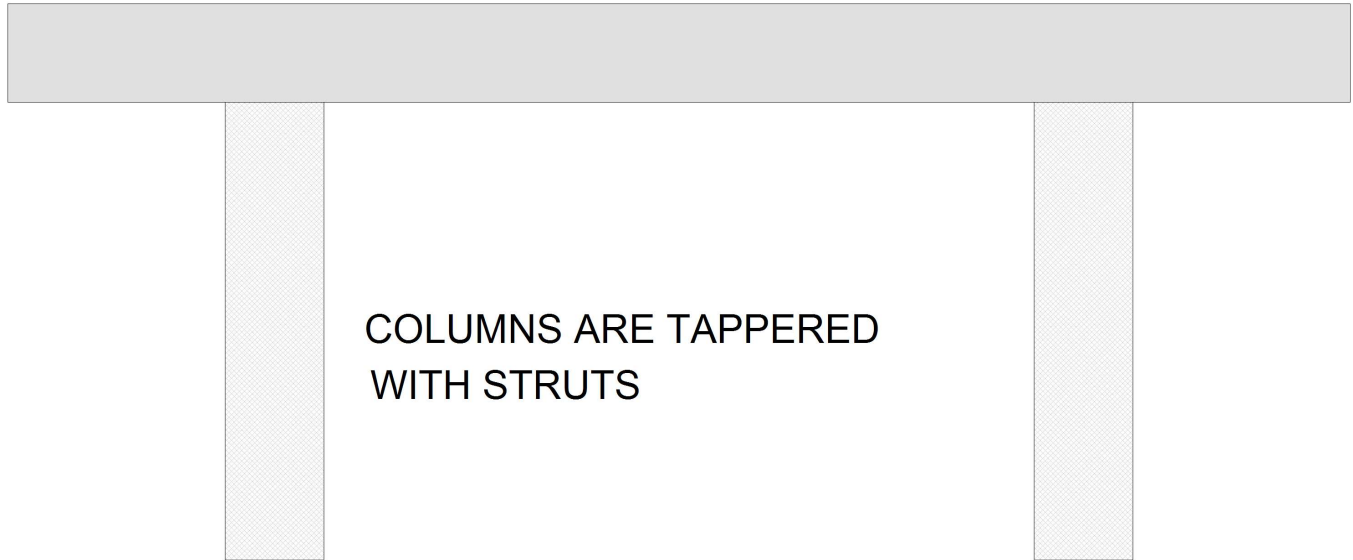
COLUMNS ARE TAPPED
WITH STRUTS
