NC DEPARTMENT OF TRANSPORTATION  
 DIVISION OF HIGHWAYS  
 STRUCTURE MANAGEMENT UNIT

ATTENTION: **PRIORITY MAINTENANCE, REVISED  
 SUPERSTRUCTURE SKETCHES**

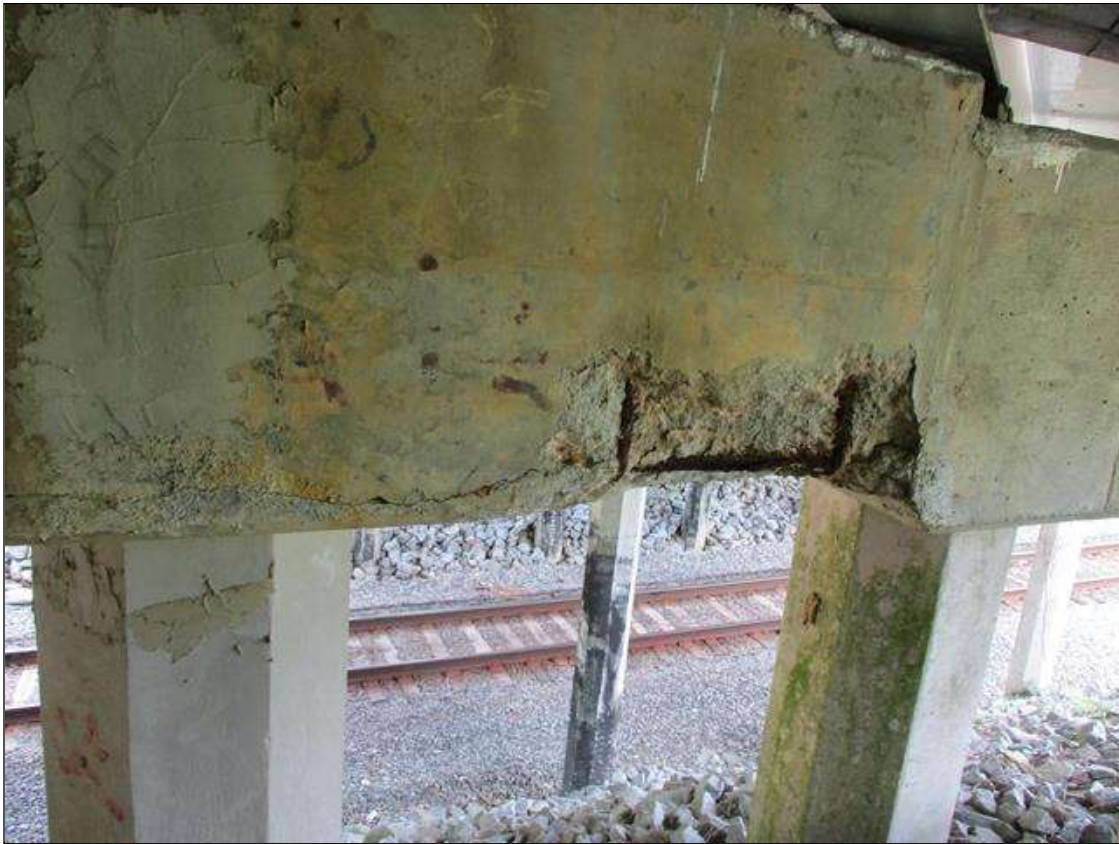
Bent 4 Cap 1: SPALL 28" WIDE X 18" HIGH X 4" DEEP WITH 10% LOSS OF SECTION AT EXPOSED REBAR BETWEEN PILES 3 AND 4 ON NORTH FACE. HORIZONTAL CRACK .04" OPEN EXTENDING FROM SPALL 3' LONG. (PRIORITY MAINTENANCE)

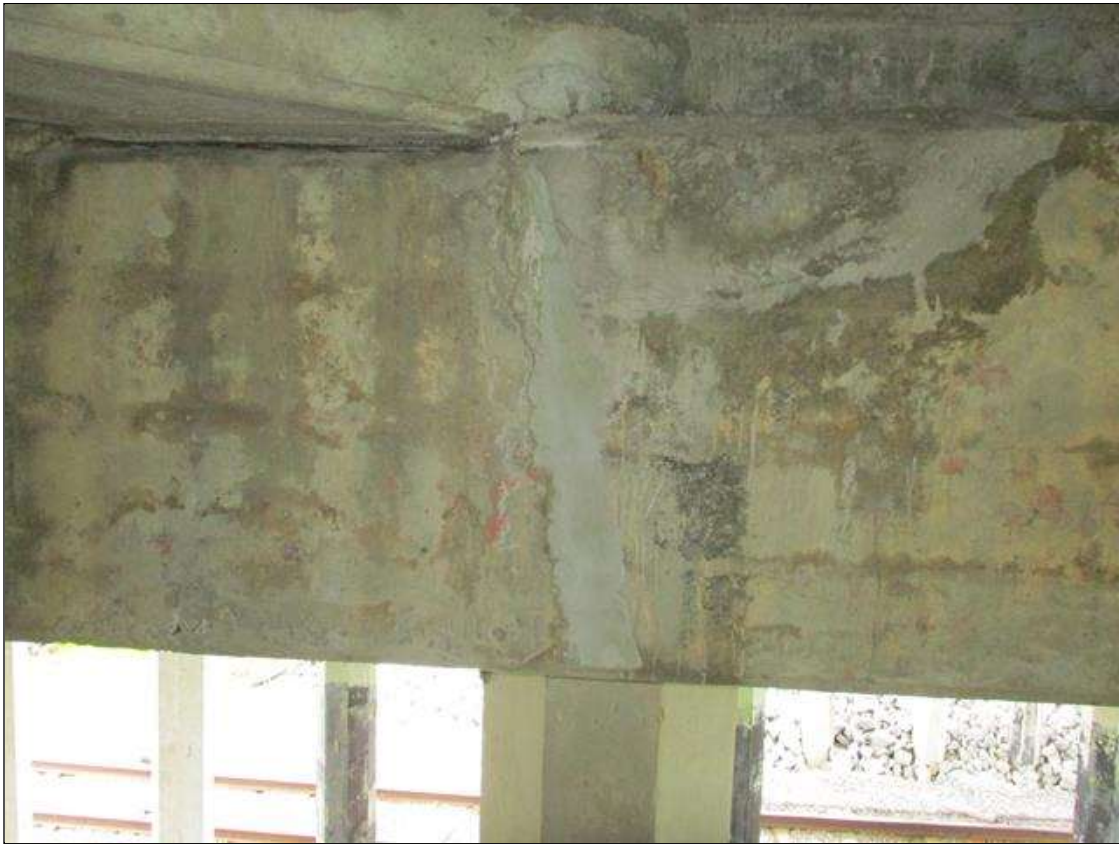
Bent 4 Cap 1: PATCHED AREA 30" WIDE X 14" HIGH AT BEAM 5 ON NORTH FACE.

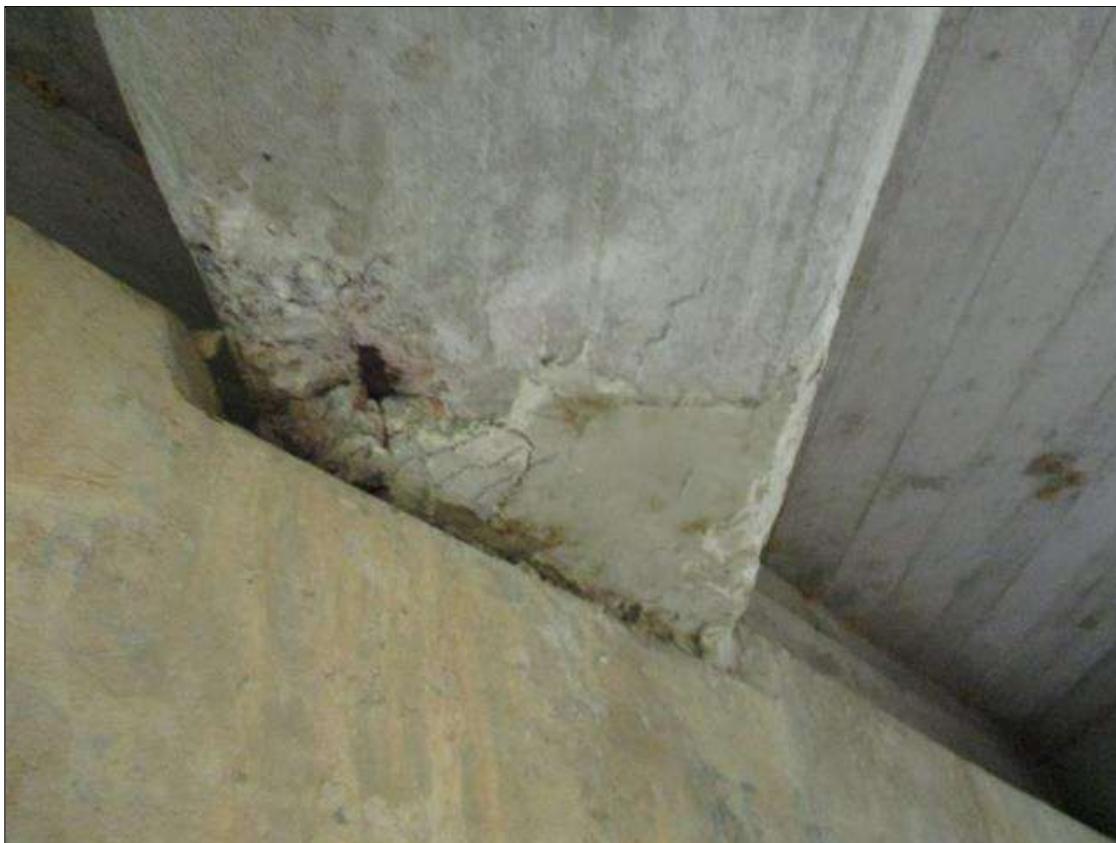
Span 5 Beam 7: SPALL 9" X 9" X 2" DEEP WITH REBAR EXPOSED, AT GIRDER 7 BENT 4 END.

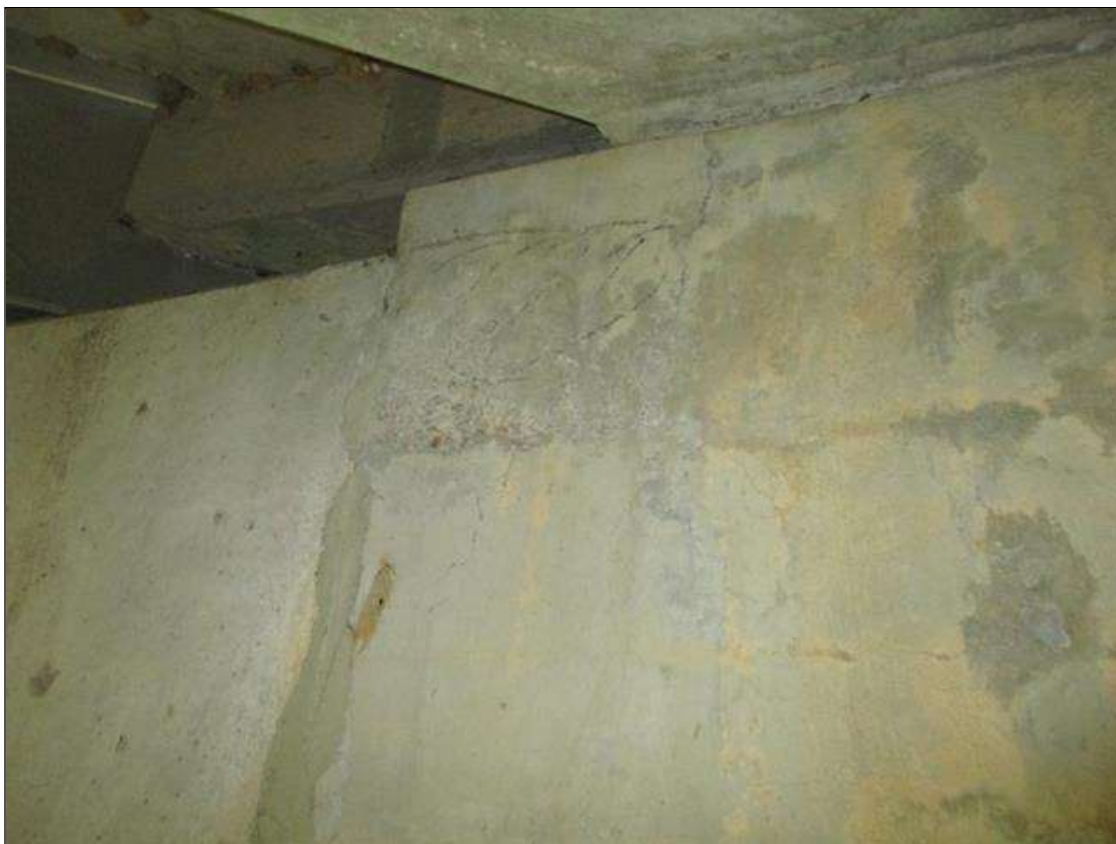
Bent 4 Cap 1: DELAMINATED AREA 11" WIDE X 24" HIGH WITH .125" SEPARATION UNDER BEAM 8 ON NORTH FACE.

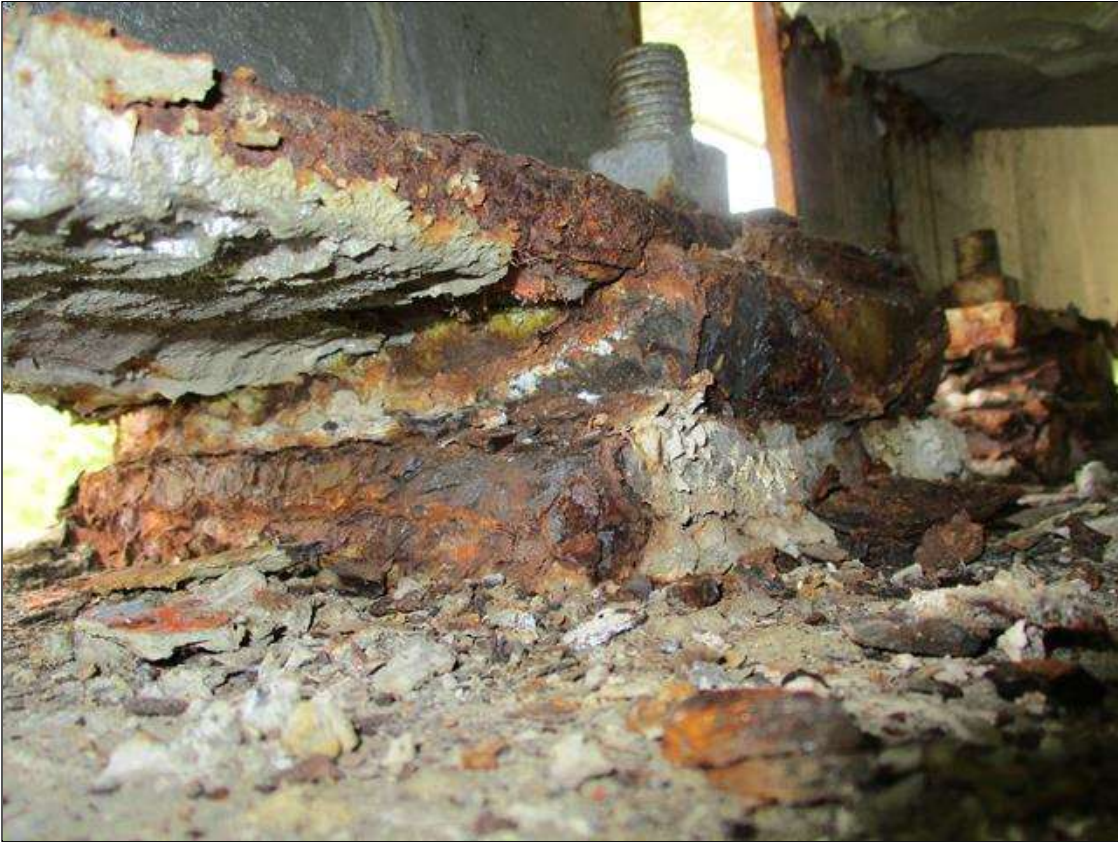
Span 5 Beam 11 Near Bearing: SPAN 5 BEAM. 11 N/B: LOSS OF SECTION .063" ALONG PLATE EDGES WITH PACK RUST BETWEEN PLATES.

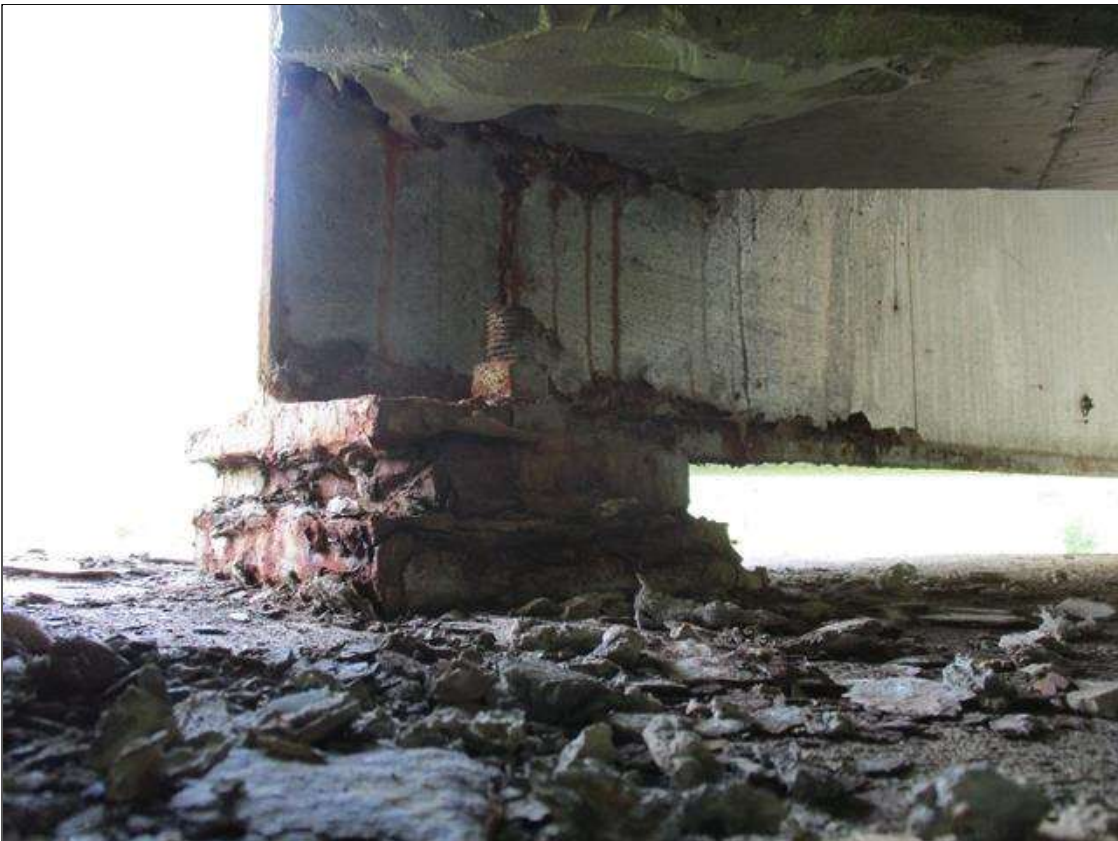
Span 4 Beam 11 Near Bearing: SPAN 4 BEAM. 11 F/B: LOSS OF SECTION .063" ALONG PLATE EDGES WITH PACK RUST BETWEEN PLATES.

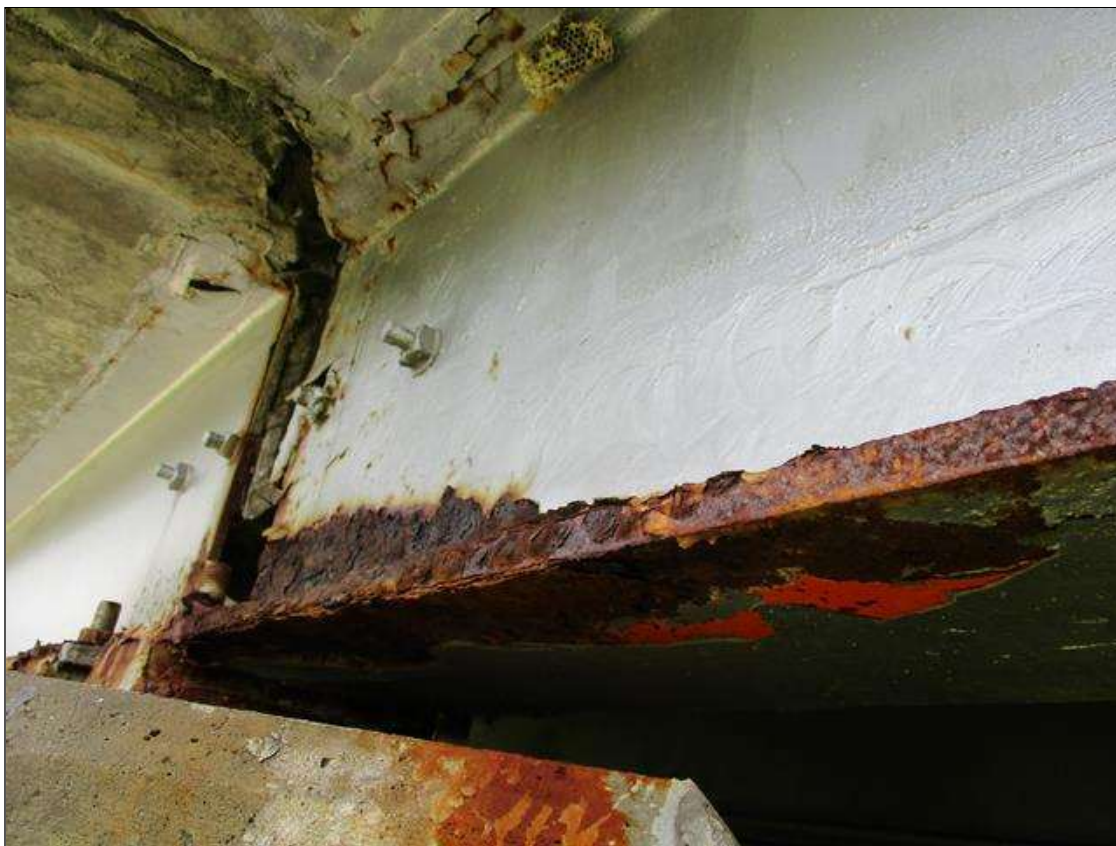
Span 5 Beam 11: LOSS OF SECTION .03" WITH .72" REMAINING BOTTOM FLANGE 9" WIDE X 3' LONG AT BENT 4 END.

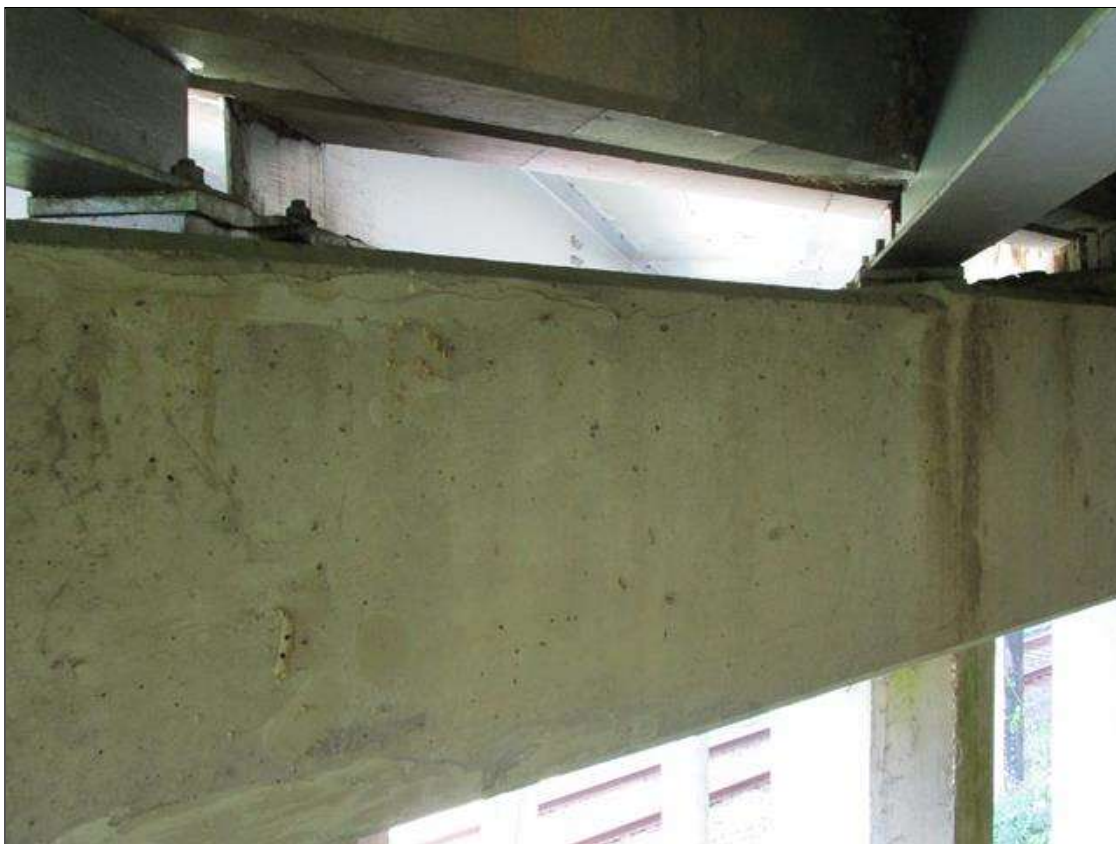
Bent 4 Cap 1: HORIZONTAL CRACKING UP TO .063" OPEN 3' LONG BETWEEN BEAMS 9 AND 10 ON NORTH FACE.

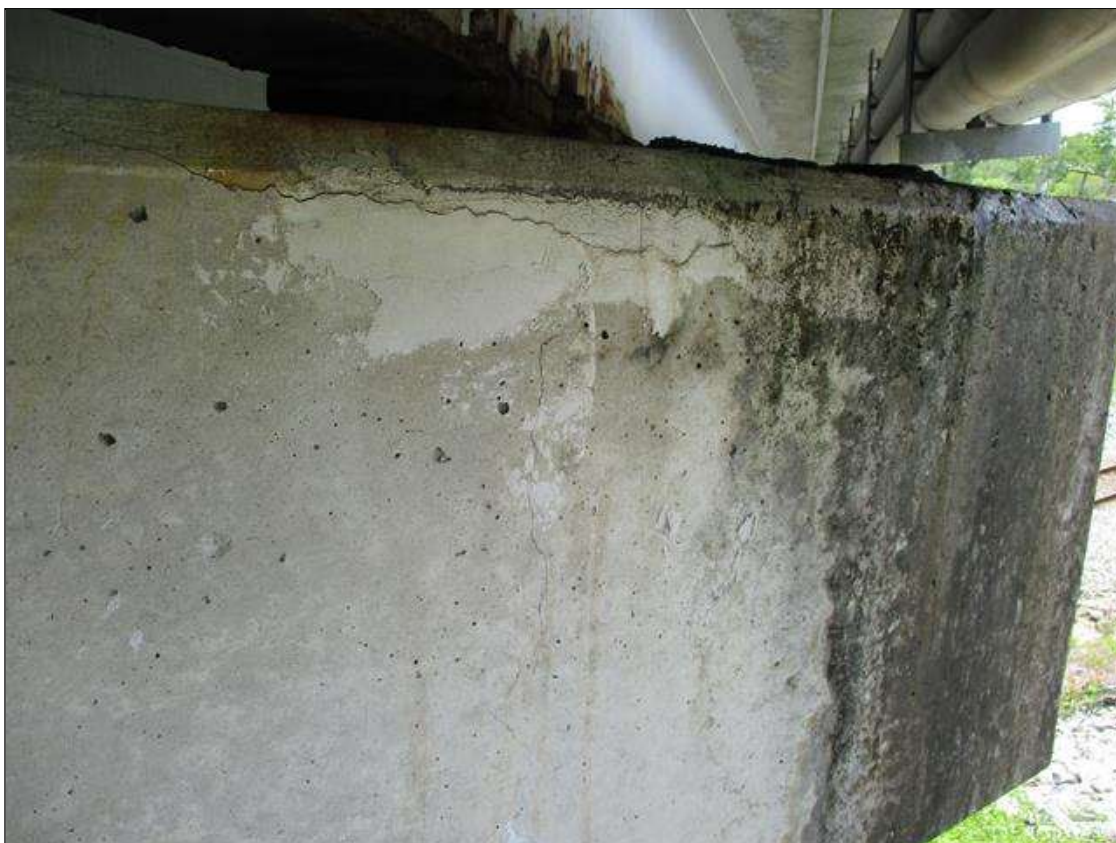
Bent 4 Cap 1: HORIZONTAL CRACKING .03" OPEN 2' LONG UNDER BEAM 1 ON NORTH FACE.

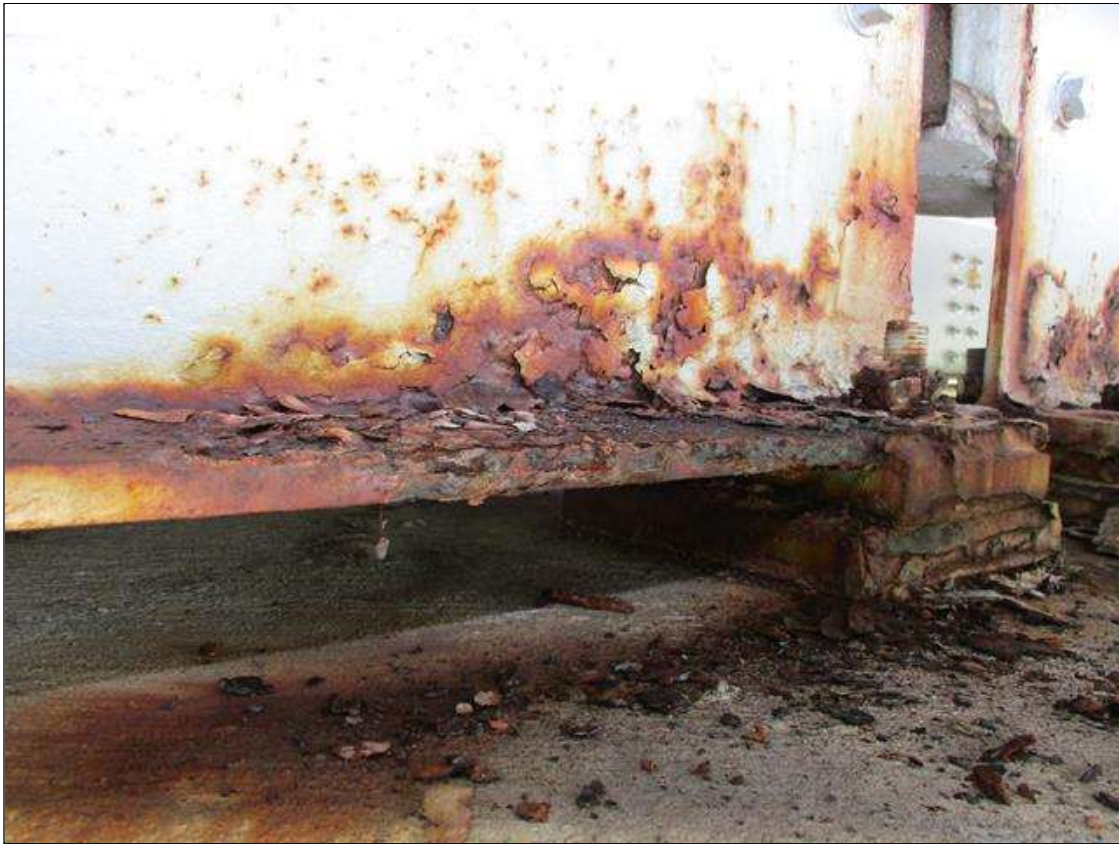
Span 4 Beam 1: FRECKLE SURFACE RUST WITH NO MEASURABLE LOSS OF SECTION ON BOTTOM FLANGE 9" WIDE X 3' LONG AND BOTTOM 3" HIGH OF WEB AT BENT 4 END.

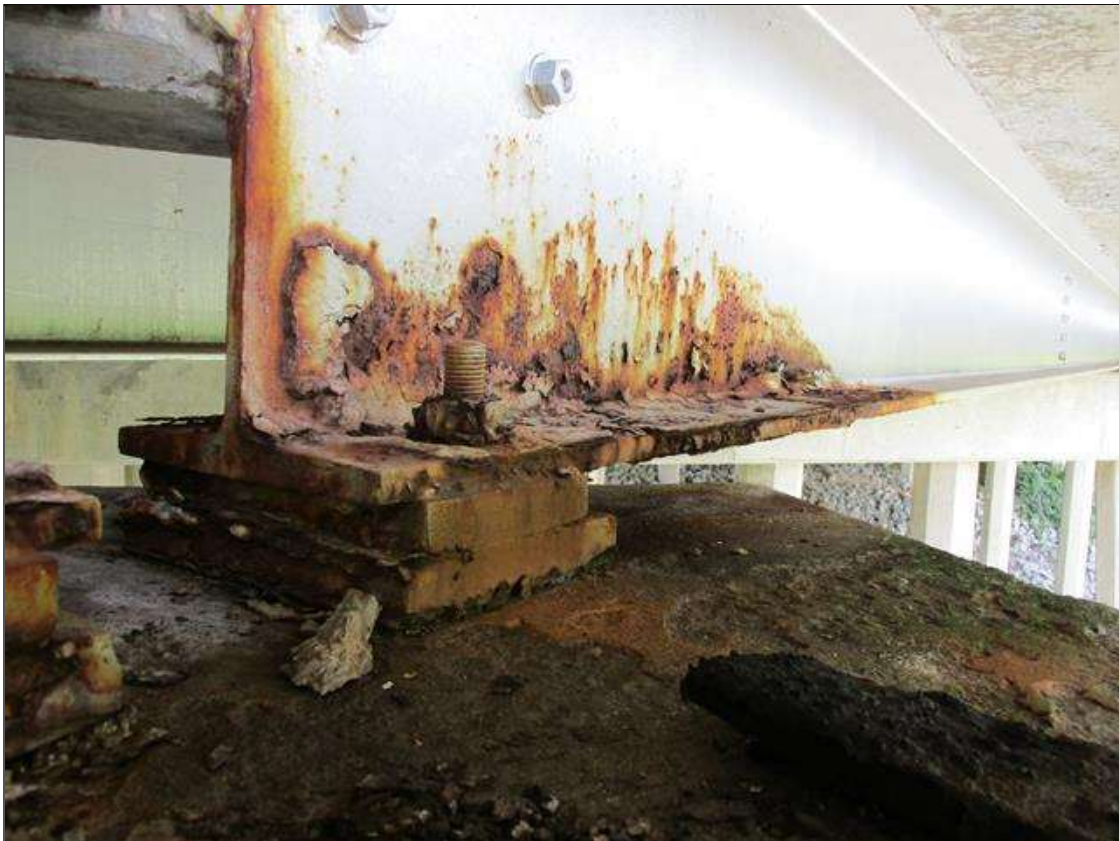
Span 5 Beam 1: FRECKLE SURFACE RUST WITH NO MEASURABLE LOSS OF SECTION ON BOTTOM FLANGE 9" WIDE X 3' LONG AND BOTTOM 3" HIGH OF WEB AT BENT 4 END.

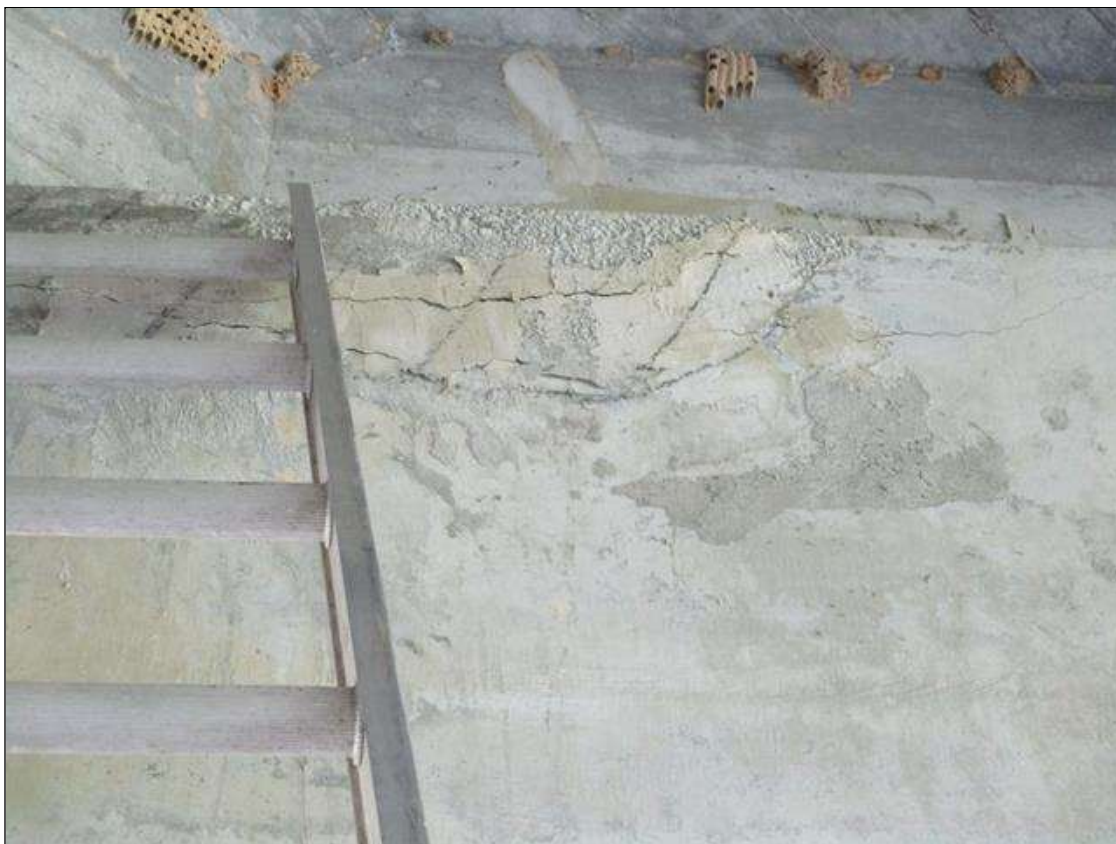
Bent 3 Cap 1: DELAMINATED AREA 33" WIDE X 13" HIGH WITH .125" SEPARATION UNDER BEAM 6 ON NORTH FACE.

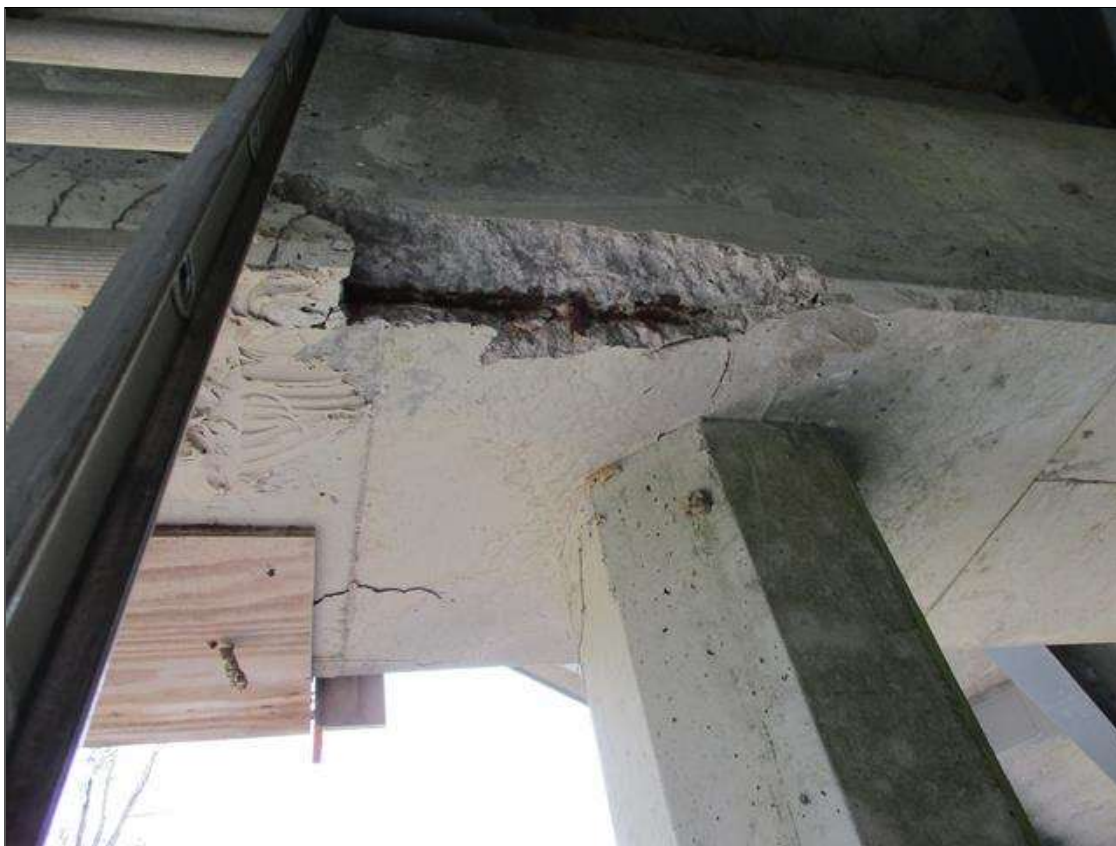
Bent 3 Cap 1: SPALL 30" WIDE X 10" HIGH X 3-1/2" DEEP BETWEEN PILES 10 AND 11 ON NORTH FACE.  
(PRIORITY MAINTENANCE)

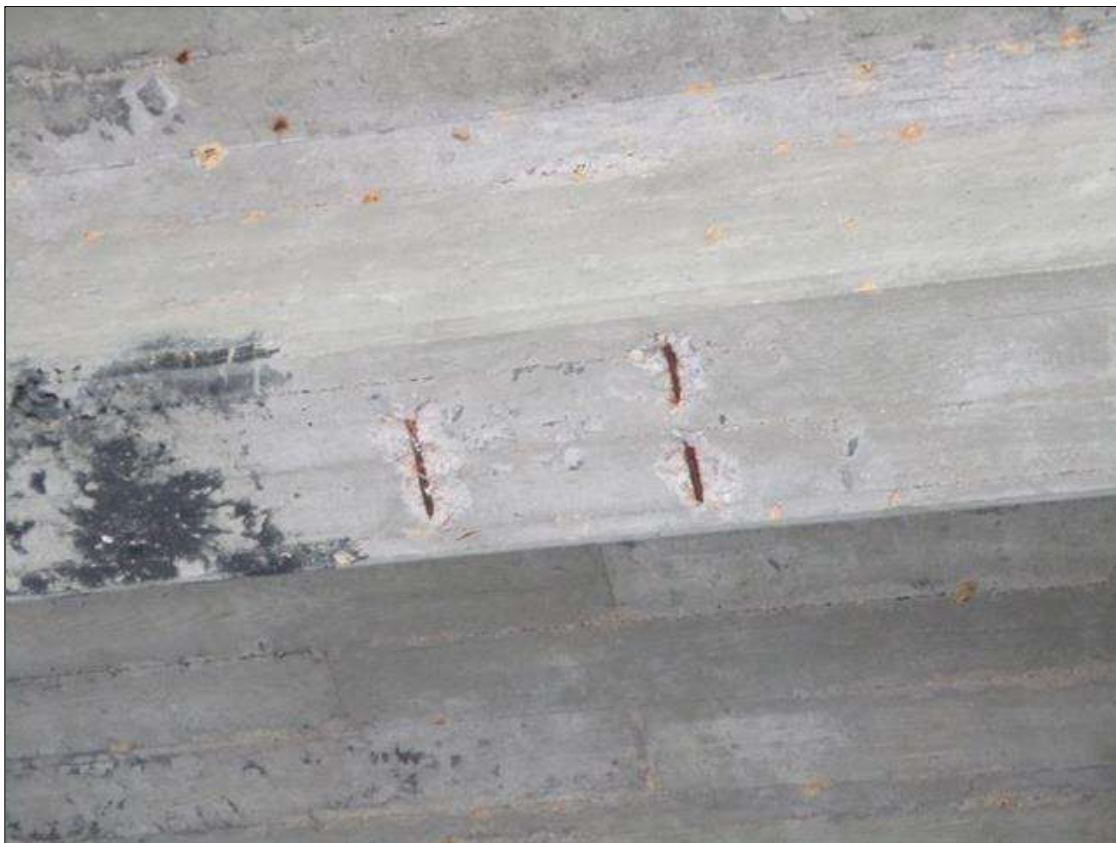
Span 3 Beam 6: SPALLS (3) UP TO 10" WIDE X 4" LONG X 1" DEEP WITH REBAR EXPOSED 8' FROM BENT 2

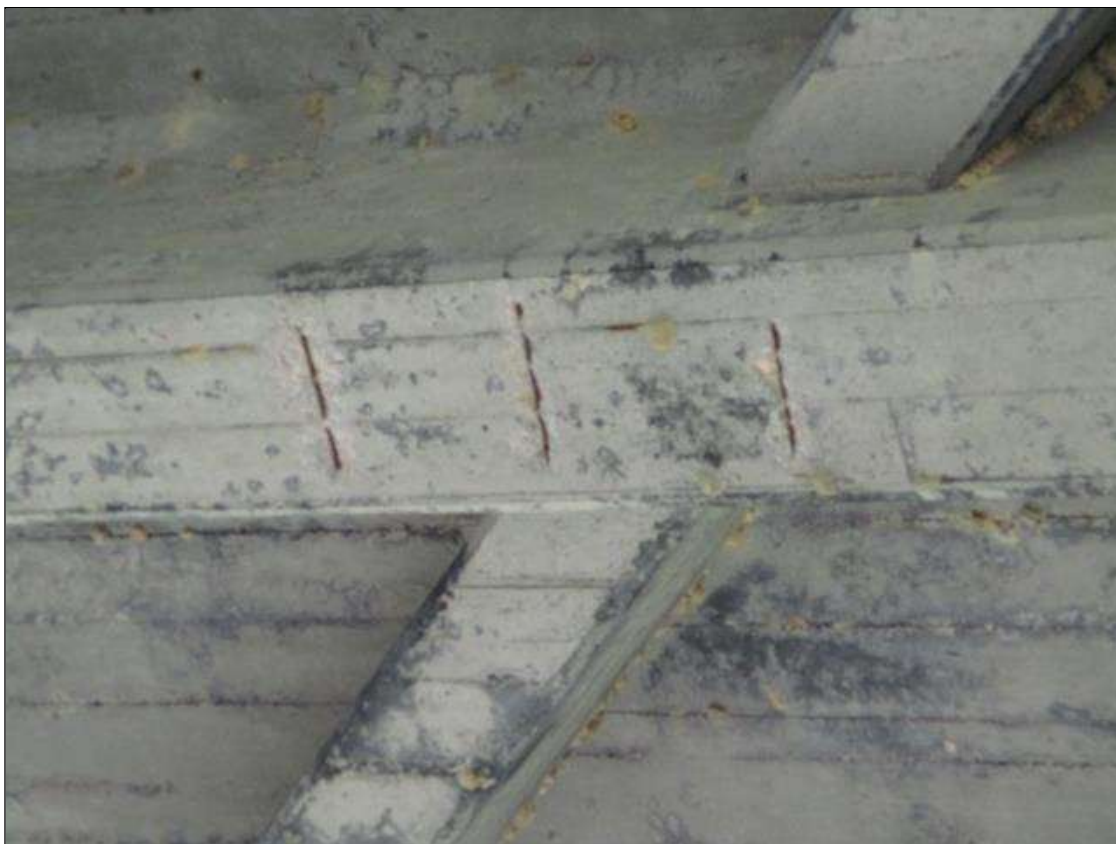
Span 3 Beam 7: SPALLS (3) UP TO 10" WIDE X 4" LONG X 1/2" DEEP WITH REBAR EXPOSED AT MID-SPAN.

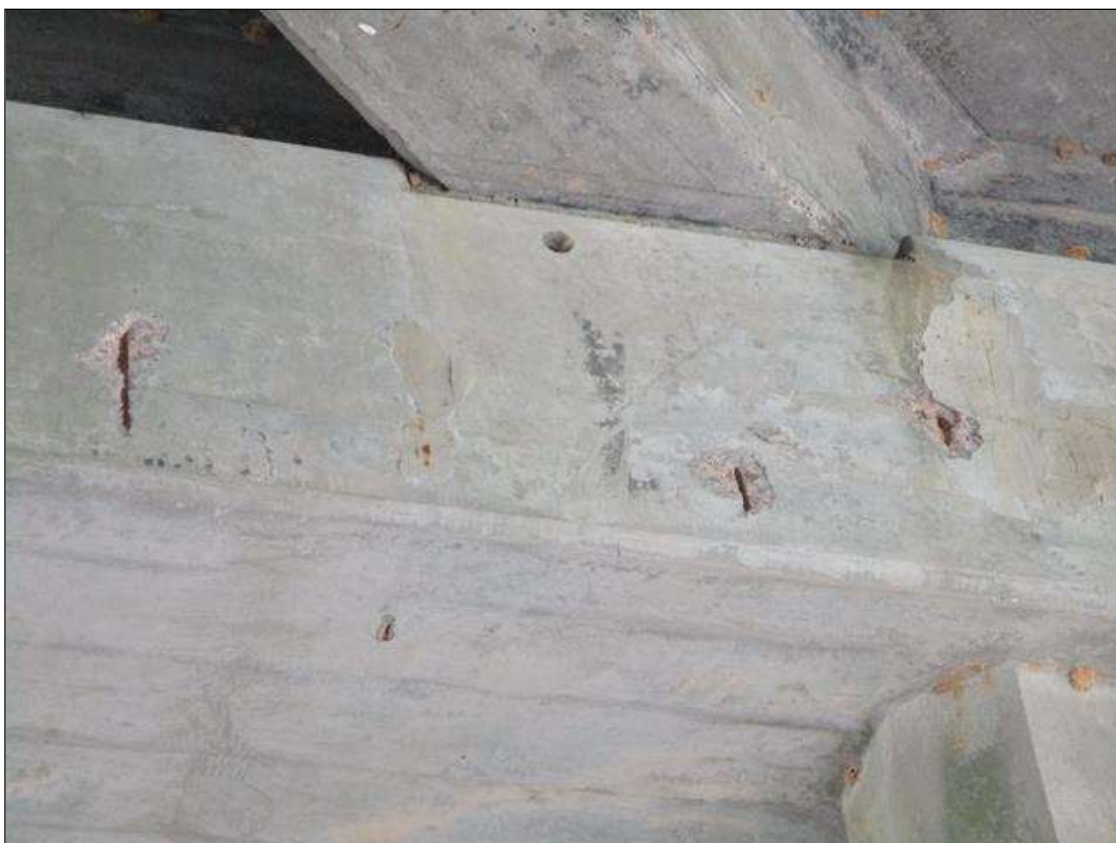
Bent 2 Cap 1: SPALLS (3) (2) 6" X 6" X 1/2" DEEP AND 11" WIDE X 5" LONG X 3/4" DEEP WITH REBAR EXPOSED OVER PILE 6.

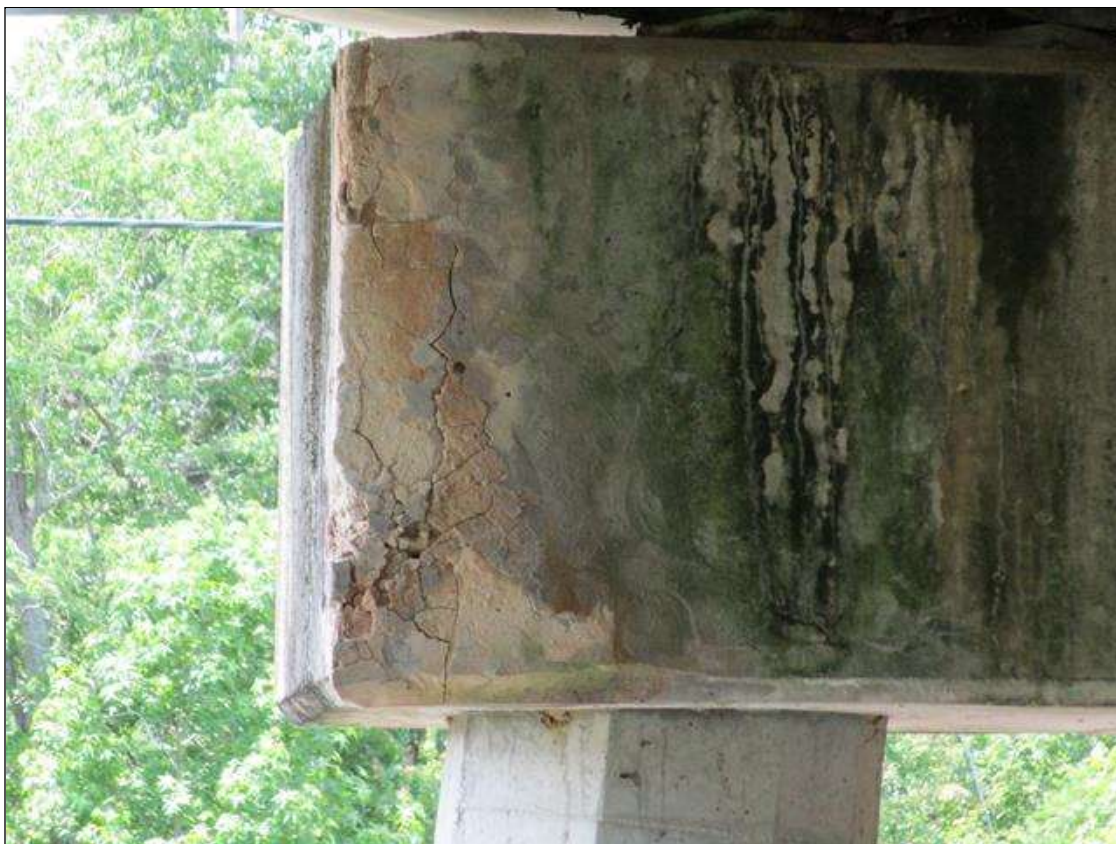
Bent 2 Cap 1: PATCHWORK ON LEFT END HAS MAP CRACKING 063" OPEN AND DELAMINATED 10" WIDE X 24" HIGH.

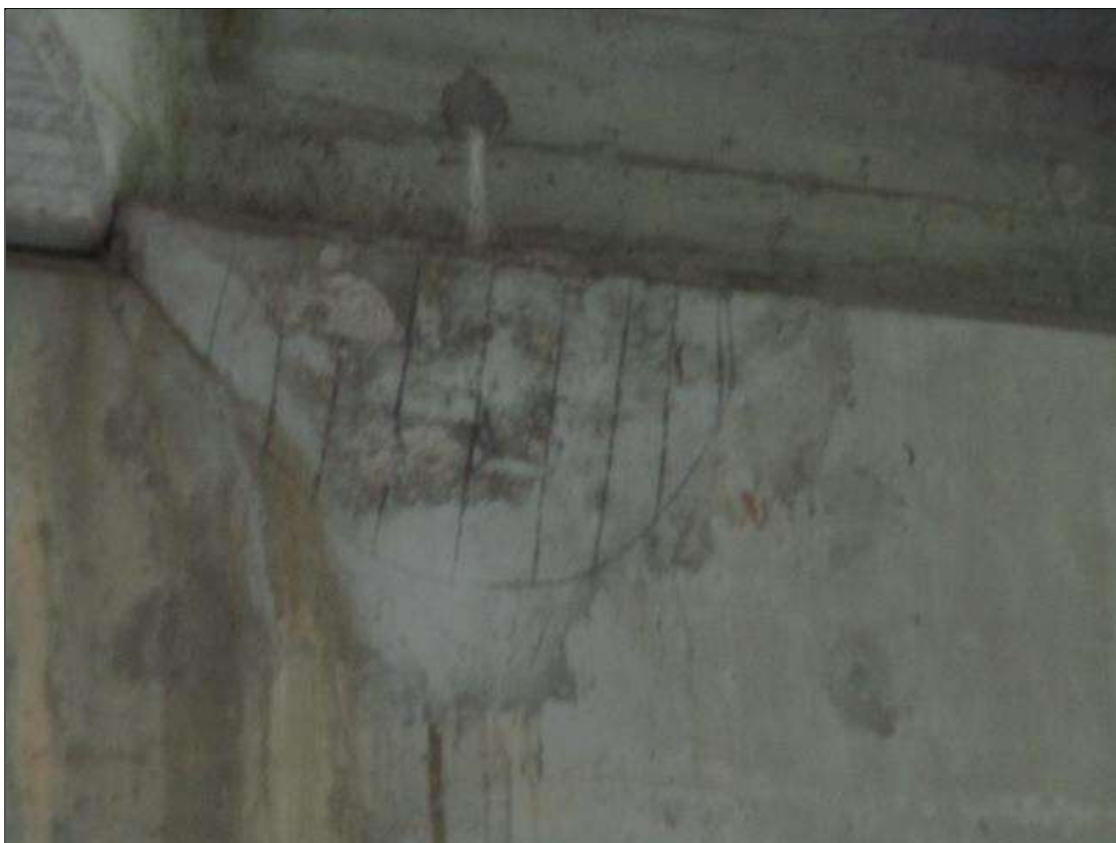
Bent 2 Cap 1: DELAMINATED PATCH 33" WIDE X 20" HIGH UNDER BEAM 6 ON SOUTH FACE.

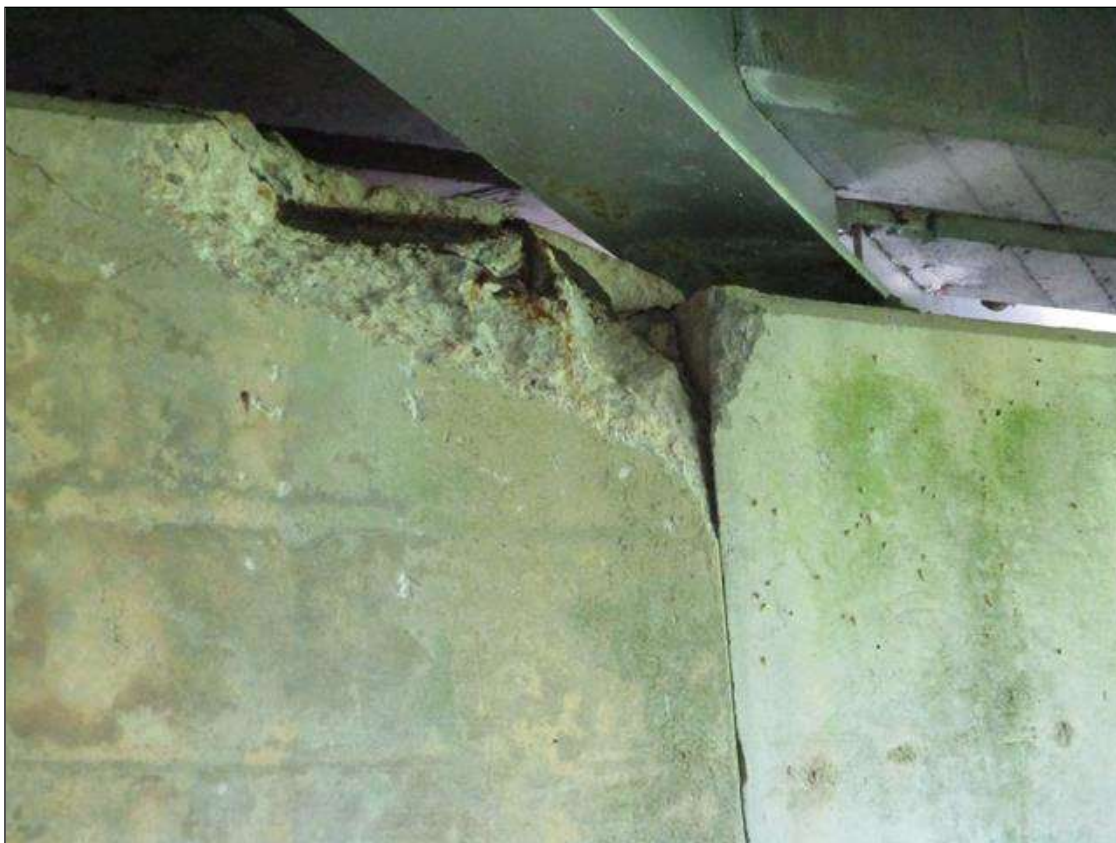
Bent 1 Cap 1: SPALL 24" WIDE X 12" HIGH X 4" DEEP WITH 10% LOSS OF SECTION AT EXPOSED REBAR UNDER BEAM 9 SOUTH FACE. (PRIORITY MAINTENANCE)

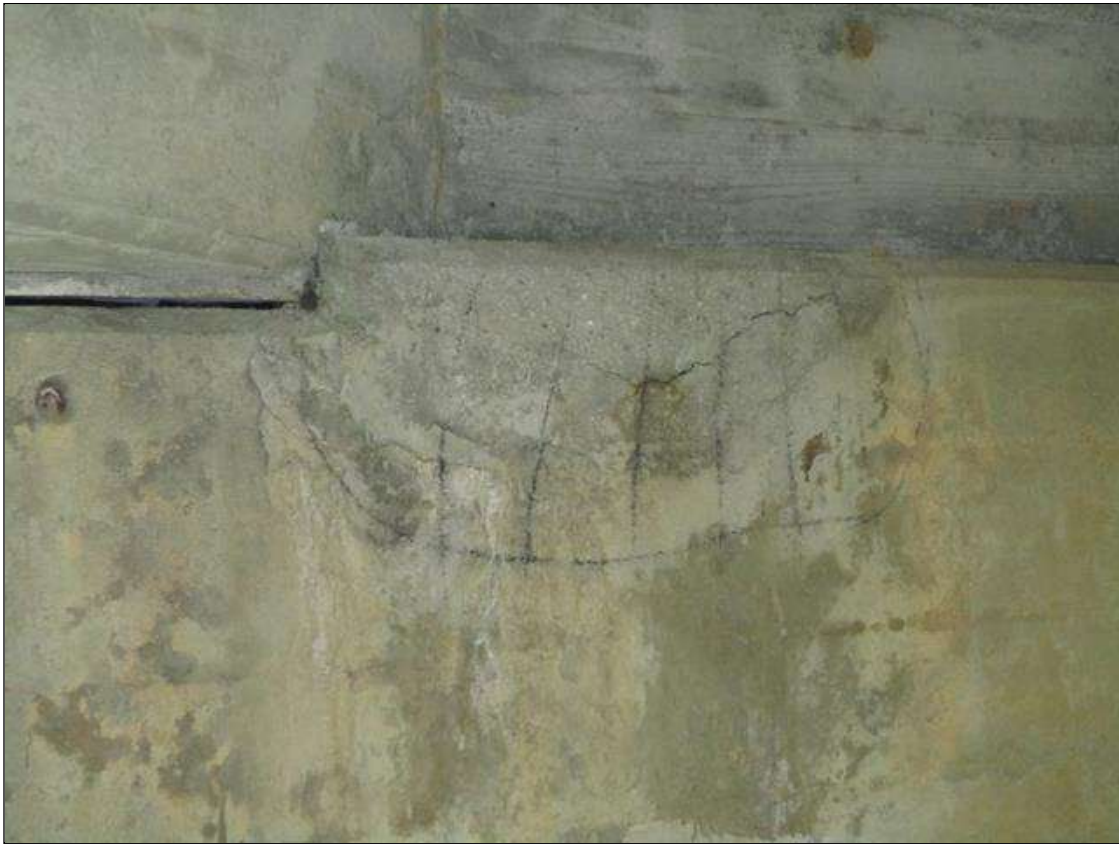
Bent 1 Cap 1: DELAMINATED AREA 36" WIDE X 19" HIGH WITH .125" SEPARATION UNDER BEAM 5 ON SOUTH FACE.

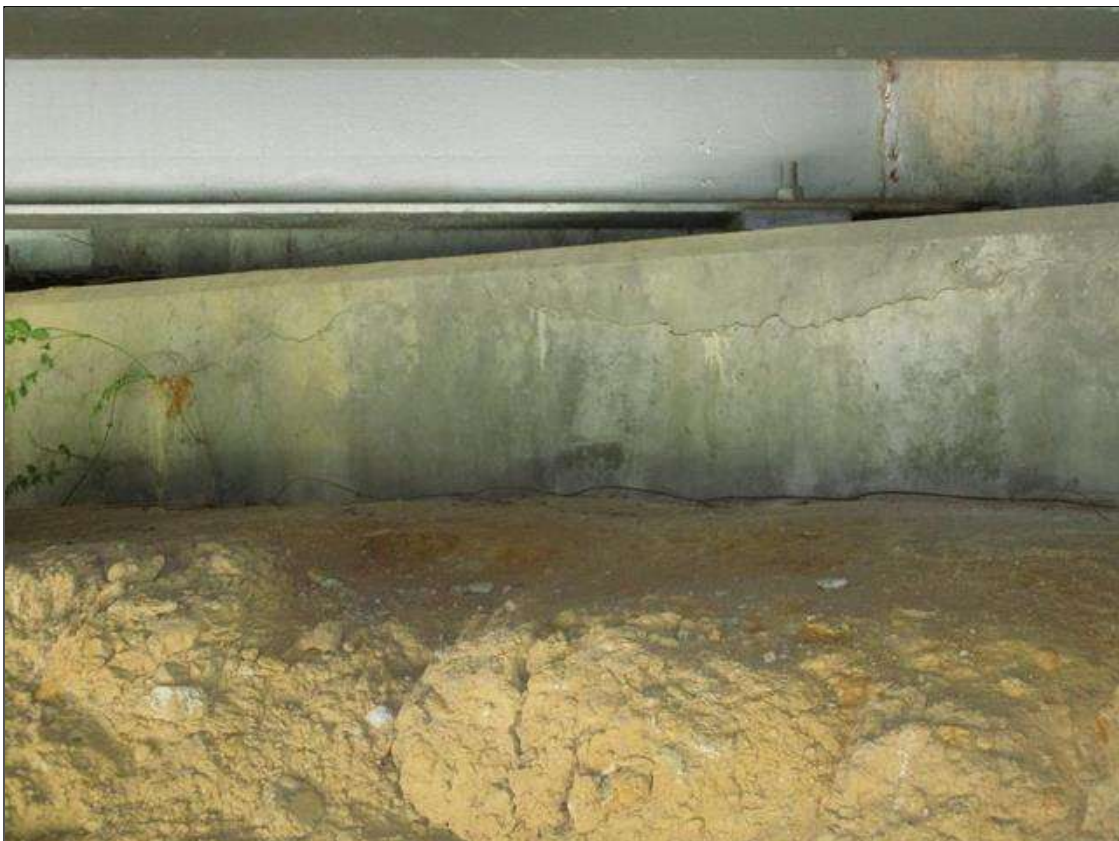
Bent 1 Cap 1: HORIZONTAL CRACKING .063" OPEN UNDER BEAMS 9 AND 10.

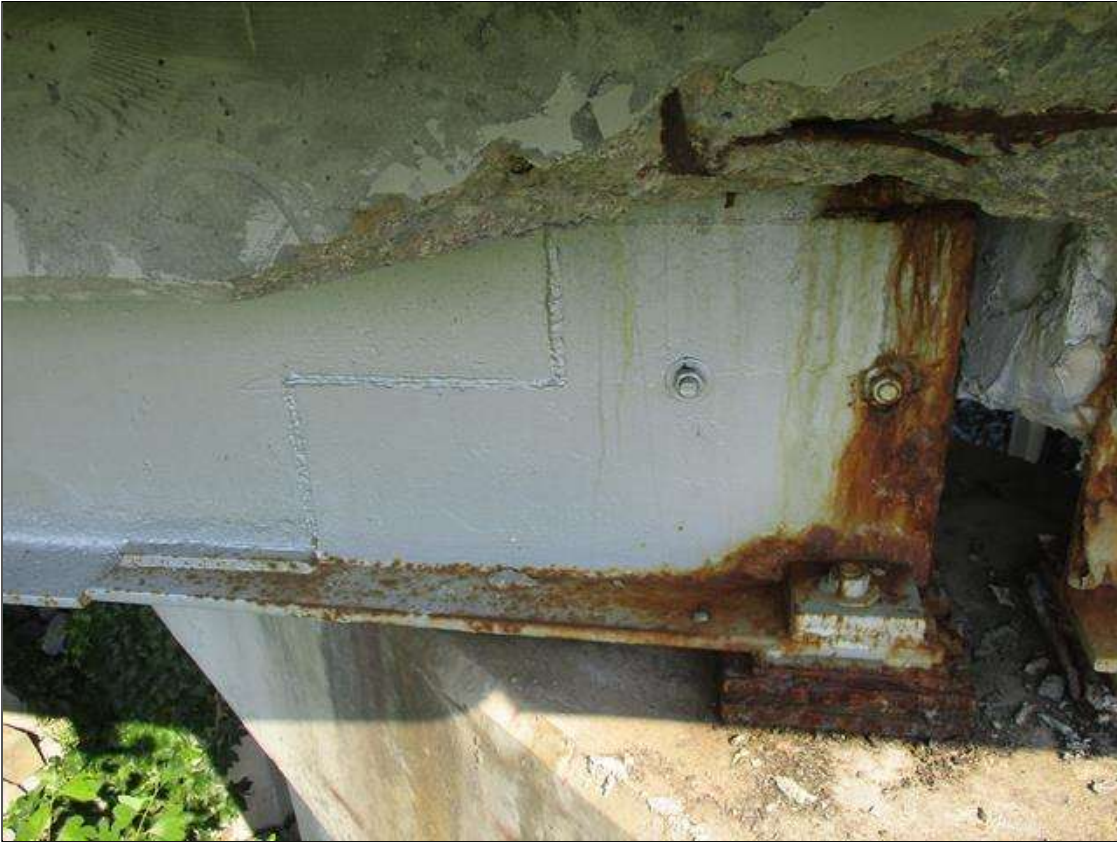
Span 1 Beam 11: FRECKLE SURFACE RUST WITH NO MEASURABLE LOSS OF SECTION ALONG LAST 3' AT BENT 1 END. REPAIR SECTION 30" LONG X 18" HIGH IN WEB AT BENT 1 END.

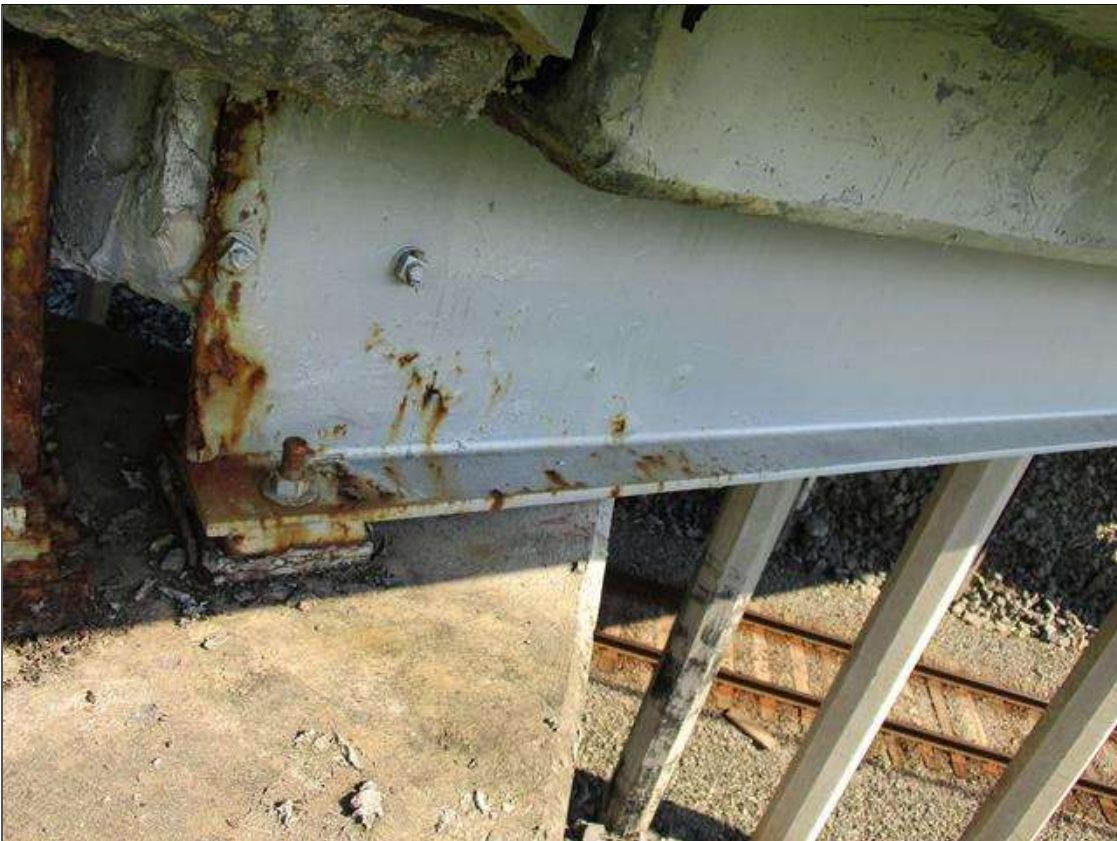
Span 2 Beam 11: FRECKLE SURFACE RUST WITH NO MEASURABLE LOSS OF SECTION ALONG LAST 3' ON WEB AND FLANGES, AT BENT 1 END.

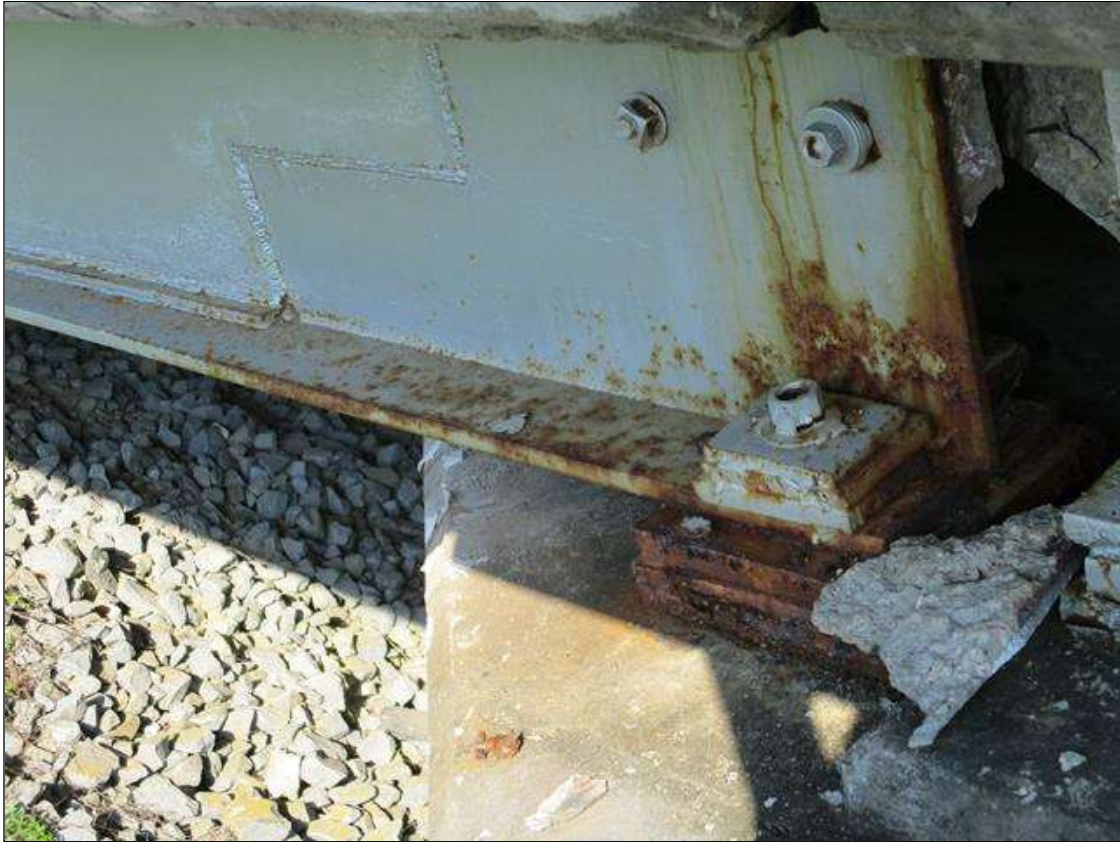
Span 2 Beam 11: FRECKLE SURFACE RUST WITH NO MEASURABLE LOSS OF SECTION ALONG LAST 3' AT BENT 2 END. REPAIR SECTION 24" LONG X 6" IN WEB.
