NC DEPARTMENT OF TRANSPORTATION  
 DIVISION OF HIGHWAYS  
 STRUCTURE MANAGEMENT UNIT

ATTENTION: **PRIORITY MAINTENANCE, REVISED  
 SUPERSTRUCTURE SKETCHES**

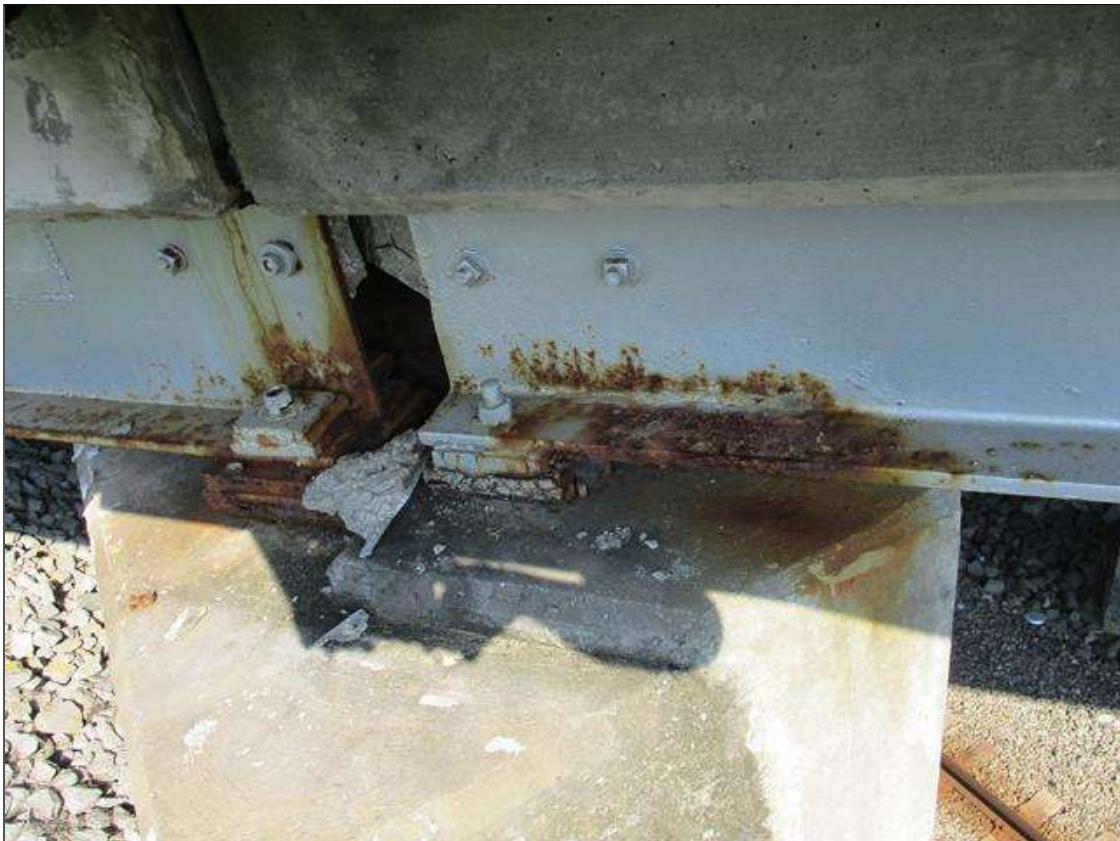
Span 3 Beam 11: FRECKLE SURFACE RUST WITH NO MEASURABLE LOSS OF SECTION ALONG BEGINNING 5' ON WEB AND FLANGES, AT BENT 2 END.

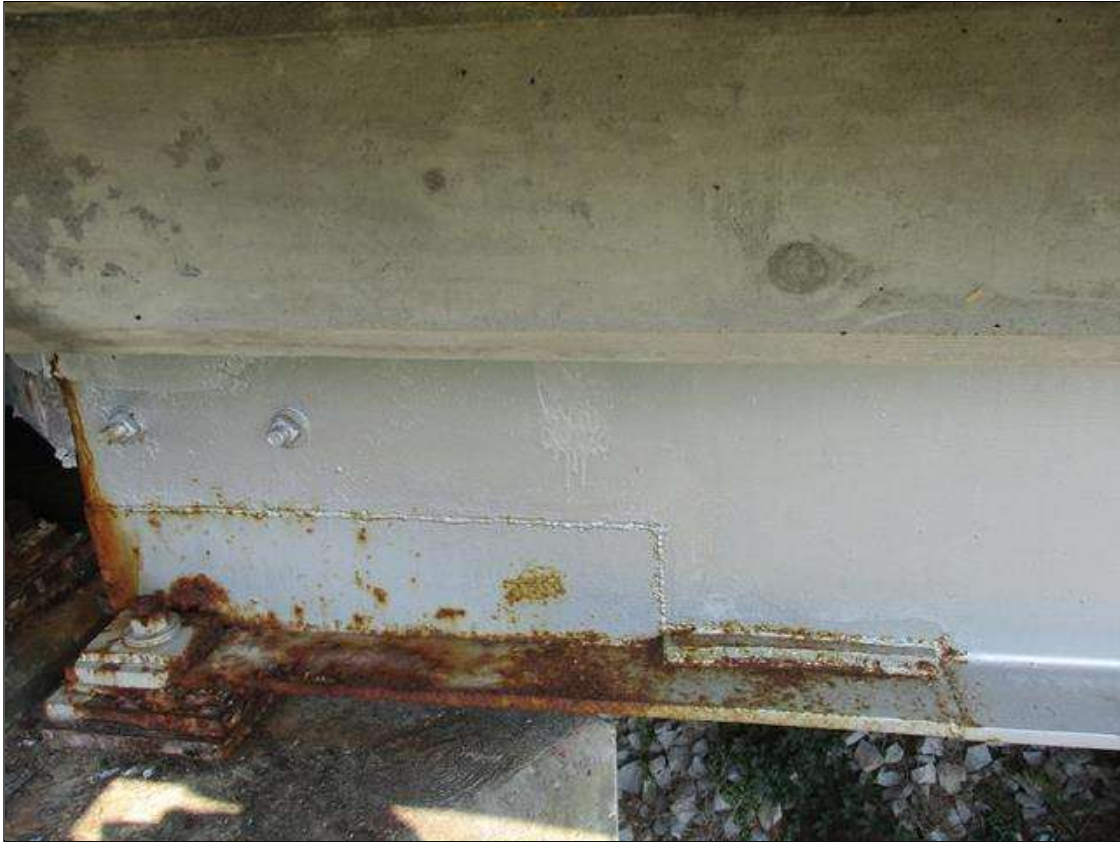
Span 4 Beam 11: FRECKLE SURFACE RUST WITH WEB REPAIR PLATE 36" LONG X 6" HIGH AT BENT 4 END.

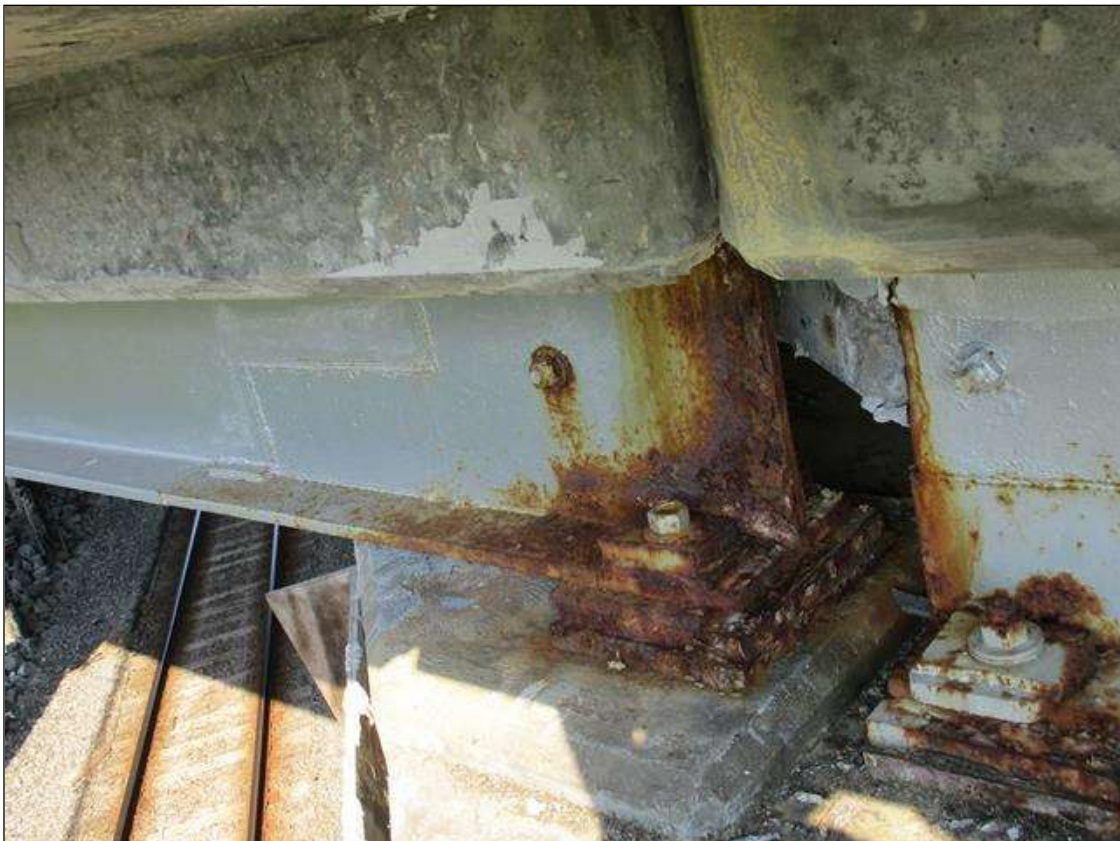
Span 3 Beam 11: FRECKLE SURFACE RUST WITH NO MEASURABLE LOSS OF SECTION ALONG LAST 5' ON WEB AND FLANGES, AT BENT 3 END. REPAIR PLATE SECTION IN WEB 36" LONG X 6" HIGH.

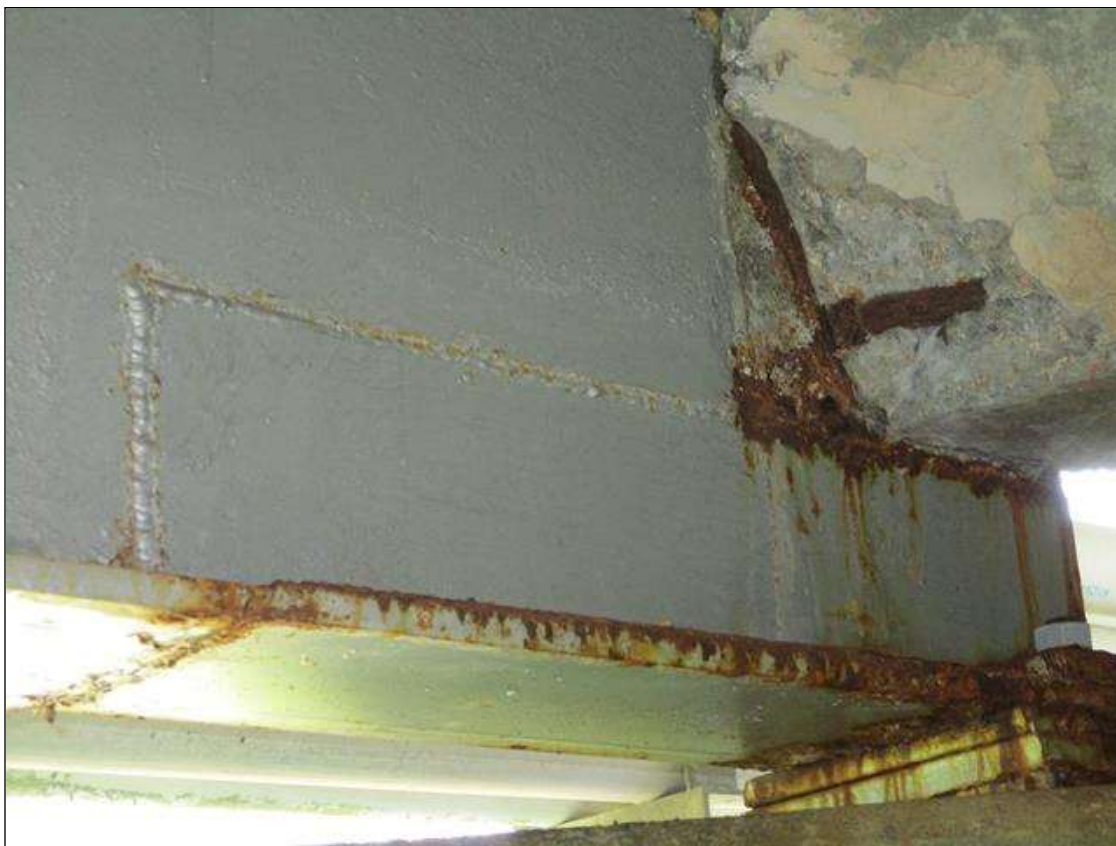
Span 1 Beam 1: FRECKLE SURFACE RUST WITH NO MEASURABLE LOSS OF SECTION ALONG LAST 3' AT BENT 1 END. REPAIR SECTION 30" LONG X 6" HIGH IN WEB AT BENT 1 END.

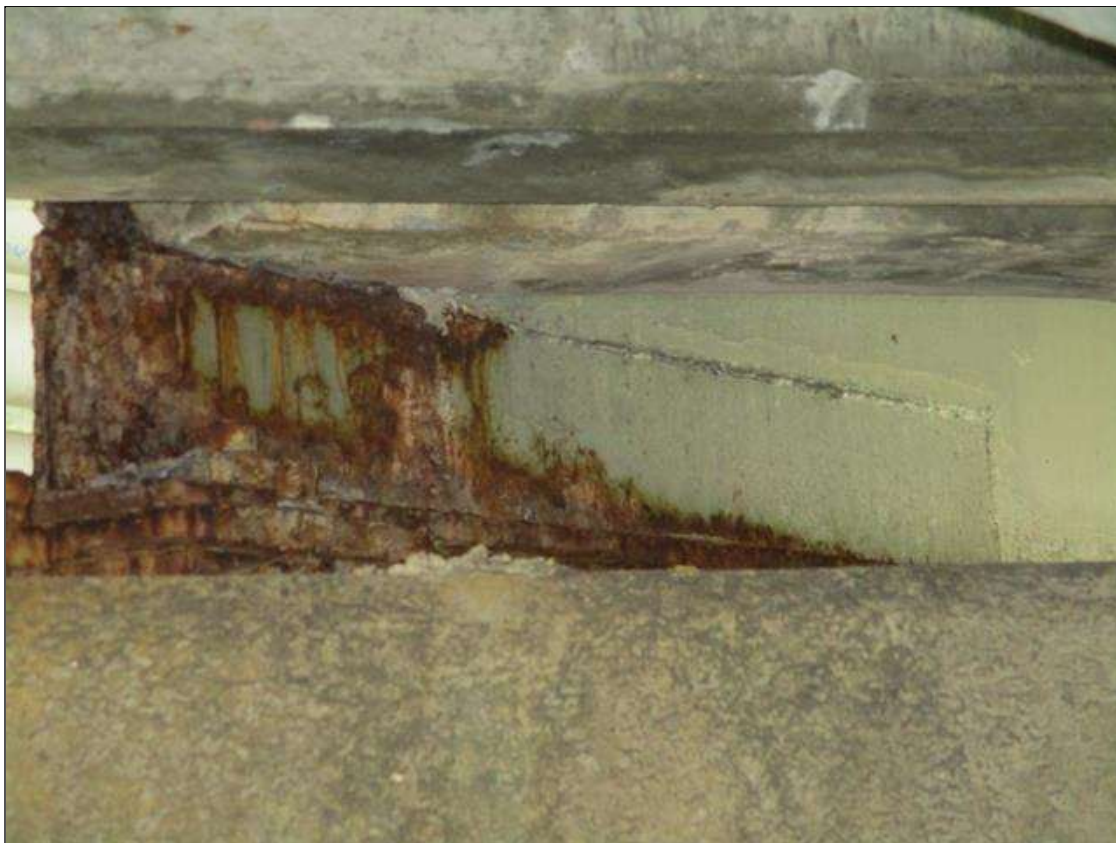
Span 2 Beam 1: FRECKLE SURFACE RUST WITH NO MEASURABLE LOSS OF SECTION ALONG LAST 3' AT BENT 1 END. REPAIR SECTION 30" LONG X 6" HIGH IN WEB AT BENTS 1 AND 2 ENDS.

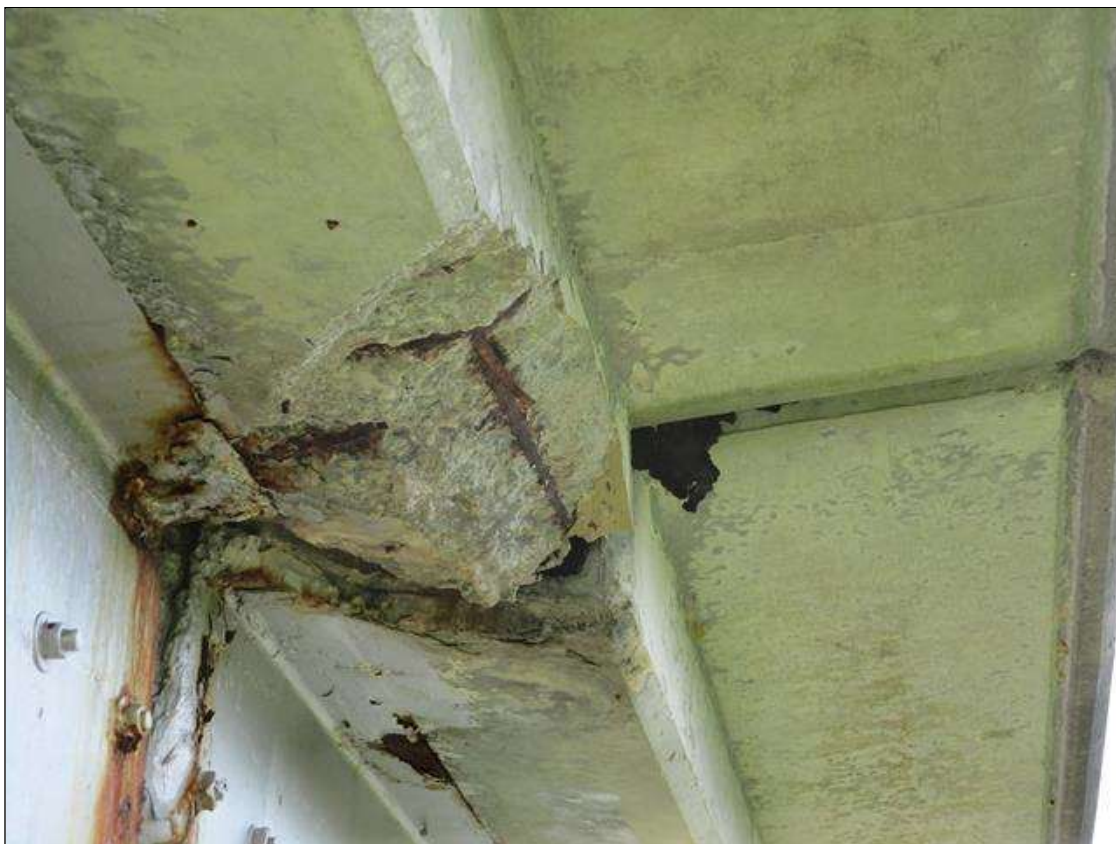
Span 1 Deck: SPALL 24" LONG X 18" WIDE X 4" DEEP WITH 10% LOSS OF SECTION ON EXPOSED REBAR AT BENT 1 END OVERHANG. (PRIORITY MAINTENANCE)

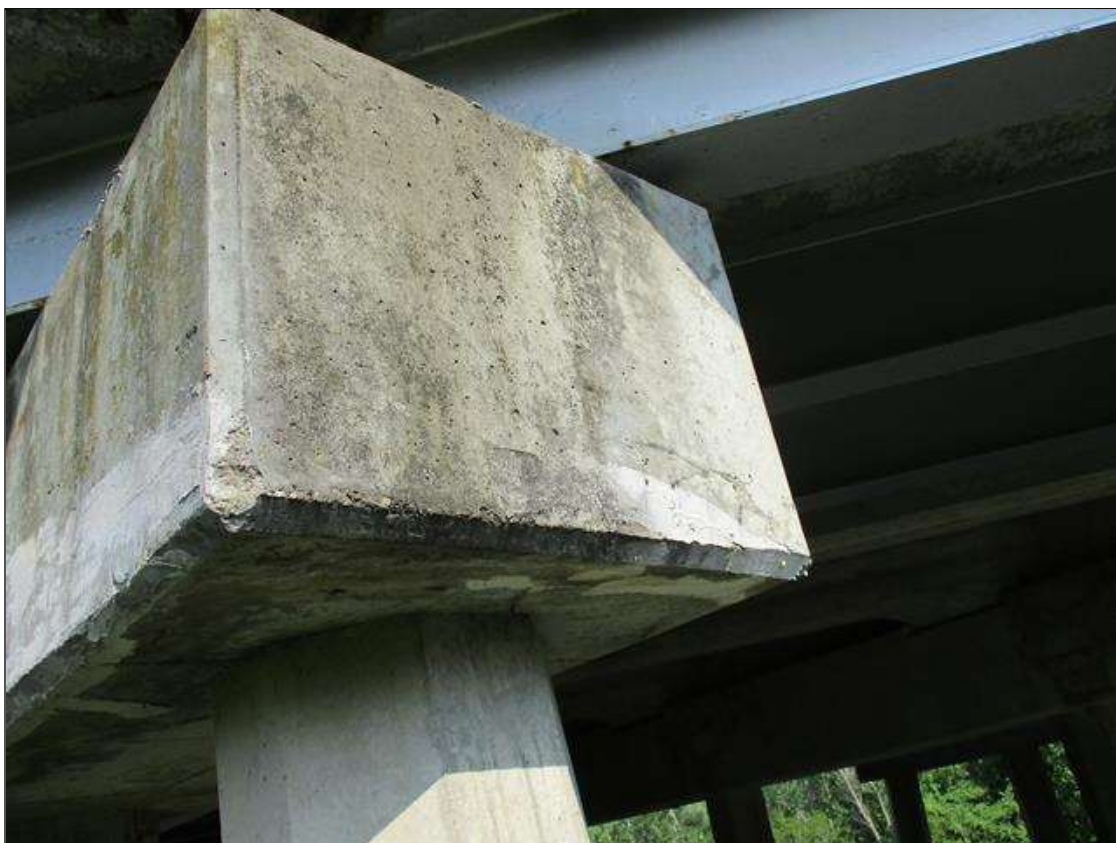
Bent 1 Cap 1: DELAMINATED AREA 24" WIDE X 7" HIGH ON RIGHT END.

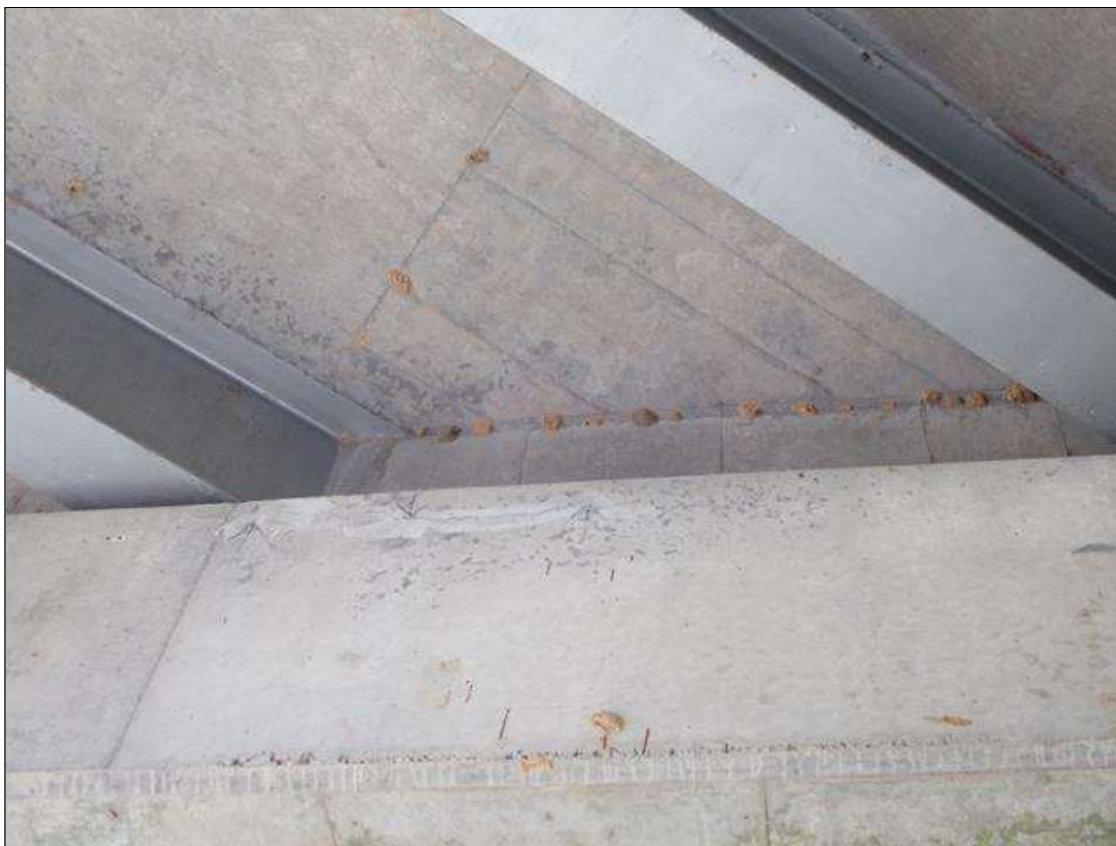
Bent 1 Cap 1: HORIZONTAL CRACKING .03" OPEN 3' LONG UNDER BEAM 10 ON NORTH FACE.

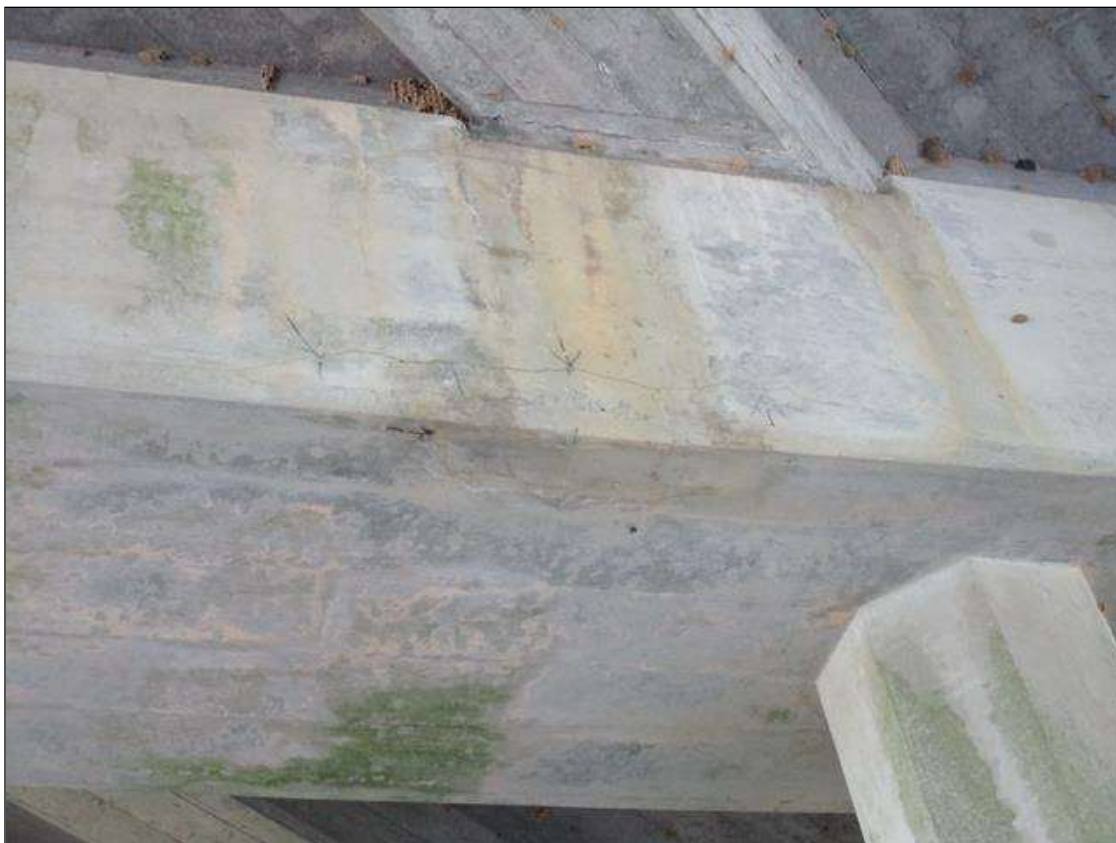
Bent 1 Cap 1: HORIZONTAL CRACK UP TO .03" OPEN 3' LONG UNDER BEAM 7 ON NORTH FACE.

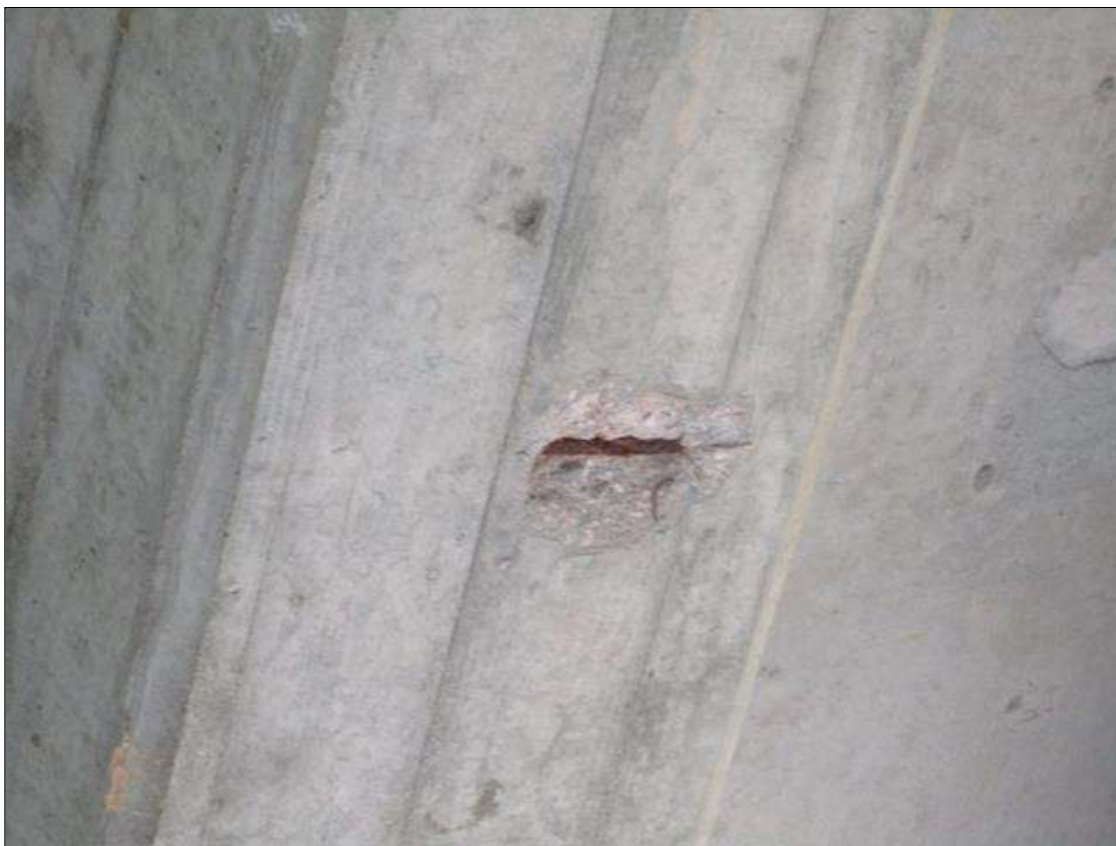
Span 2 Beam 8: SPALL 7" X 7" X 3/4" DEEP REBAR EXPOSED BOTTOM FACE, 8' FROM BENT 1 END

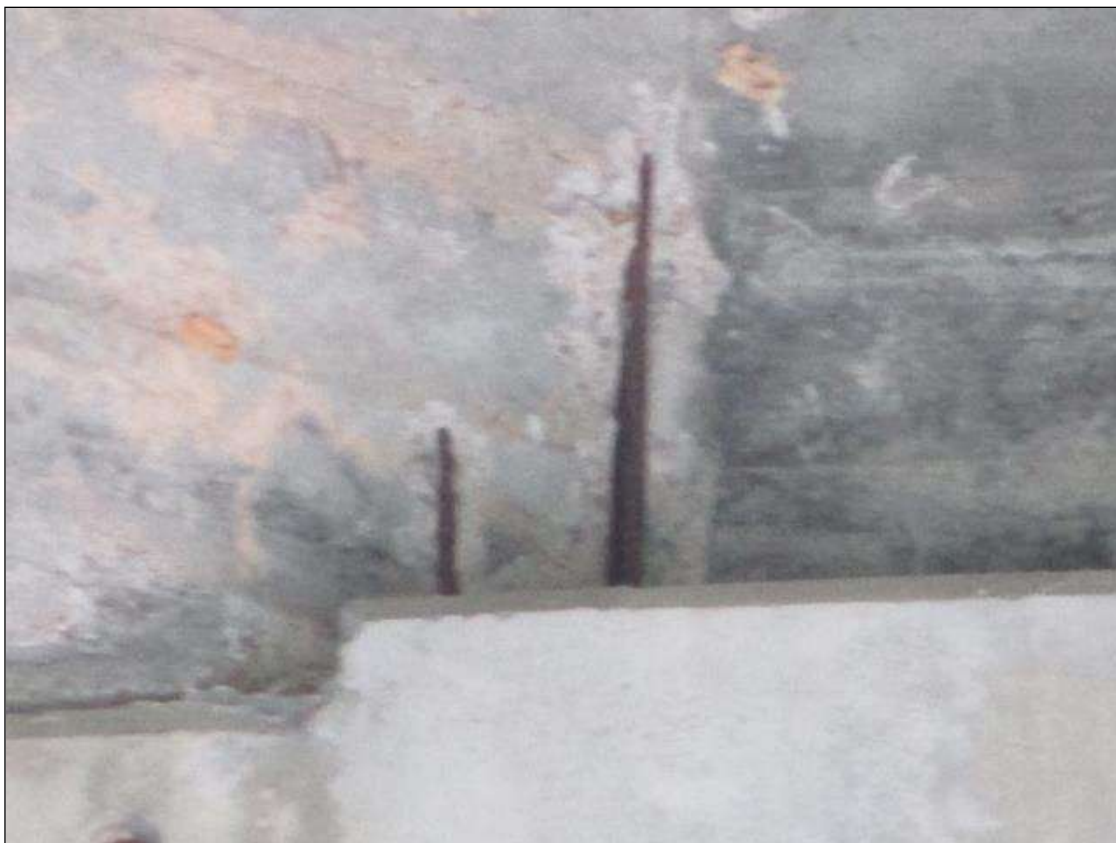
Span 3 Beam 5: SPALLS (2) 6" X 6" AND 6" WIDE X 14" HIGH BOTH 1/2" DEEP REBAR EXPOSED AT RIGHT SIDE, BENT 3 END.

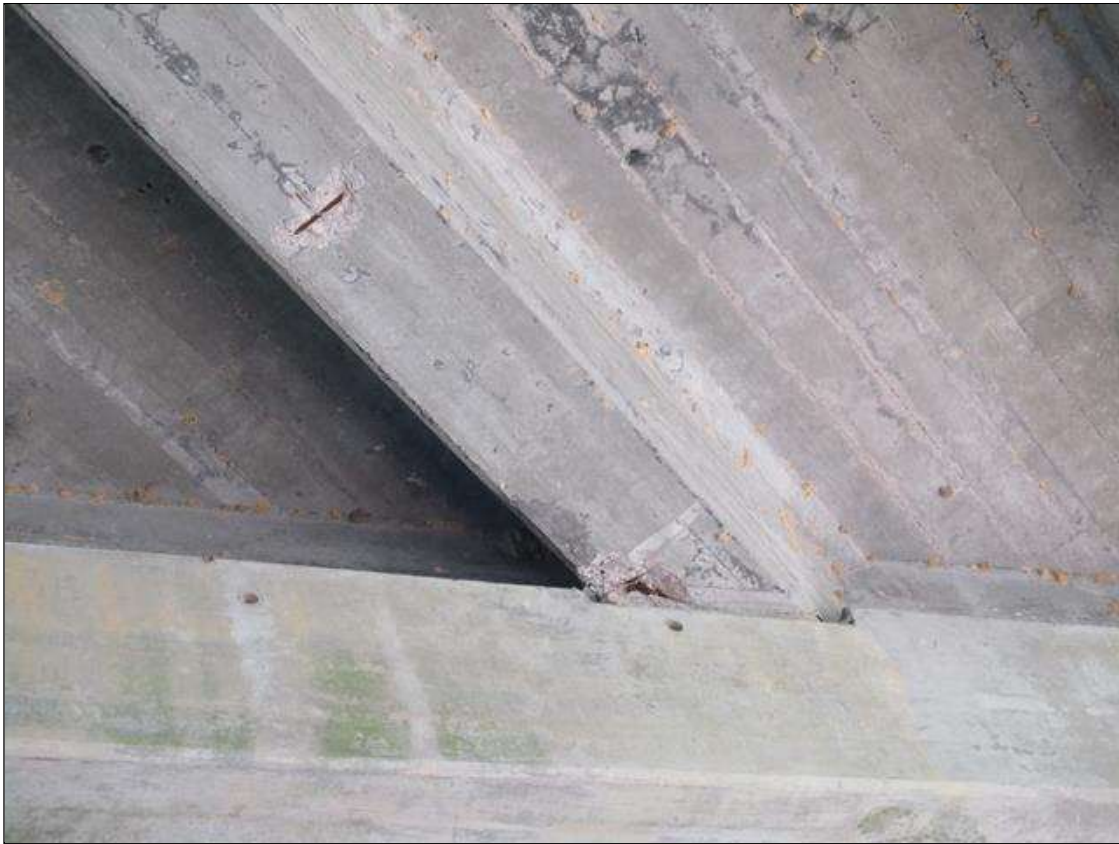
Span 3 Beam 6: SPALLS (2) 10" WIDE X 8" LONG X 3/4" DEEP REBAR EXPOSED , 6' FROM BENT 3 END AND 7" WIDE X 12" LONG X 1" DEEP AT BENT 3 END.

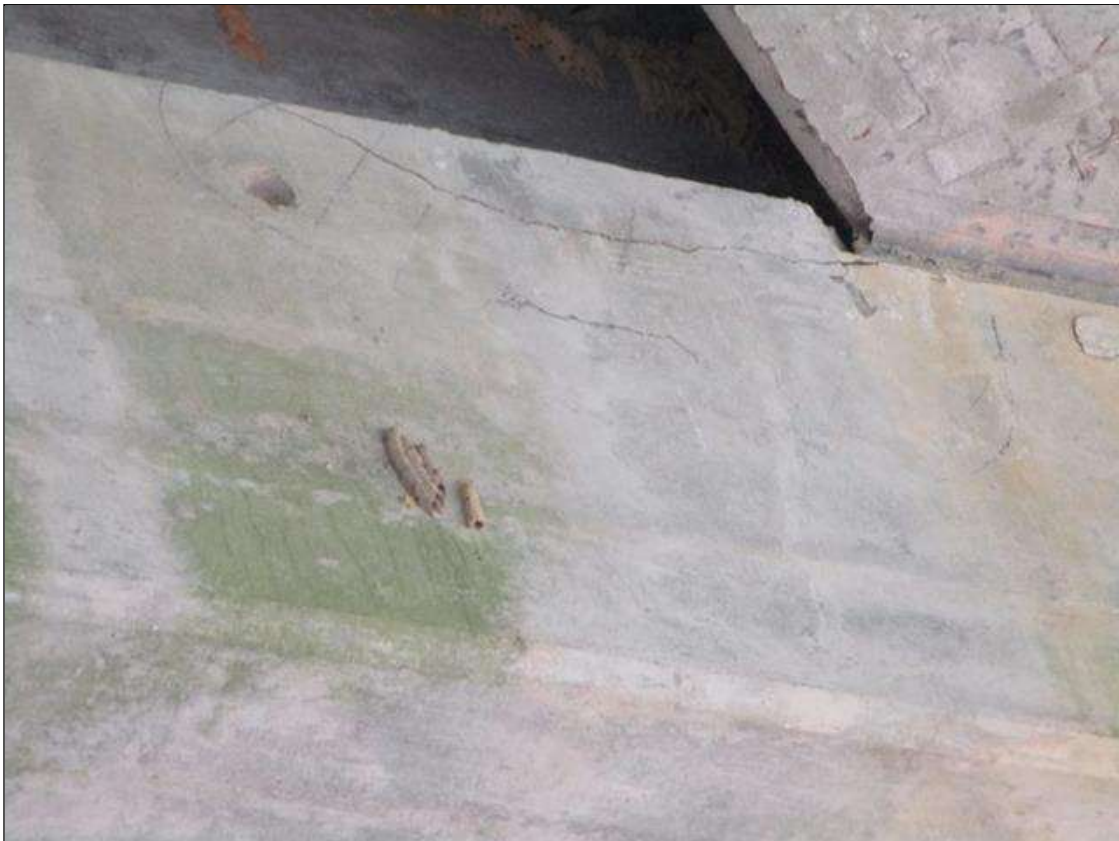
Bent 3 Cap 1: DELAMINATED AREA 36" WIDE X 16" HIGH WITH .063" SEPARATION UNDER BEAM 7 ON SOUTH FACE.

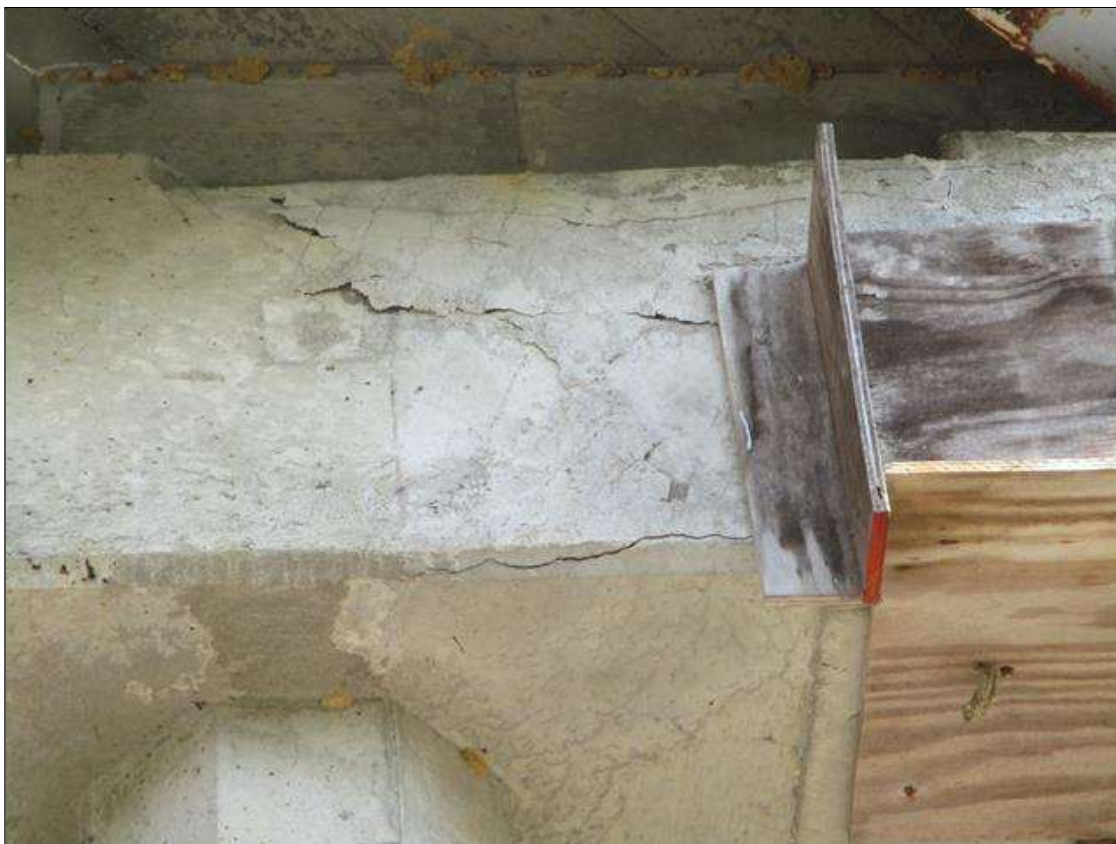
Bent 3 Cap 1: DELAMINATED AREA 4' WIDE X 30" HIGH WITH OLD REPAIR FORMWORK IN PLACE ON SOUTH FACE UNDER BAY 10.

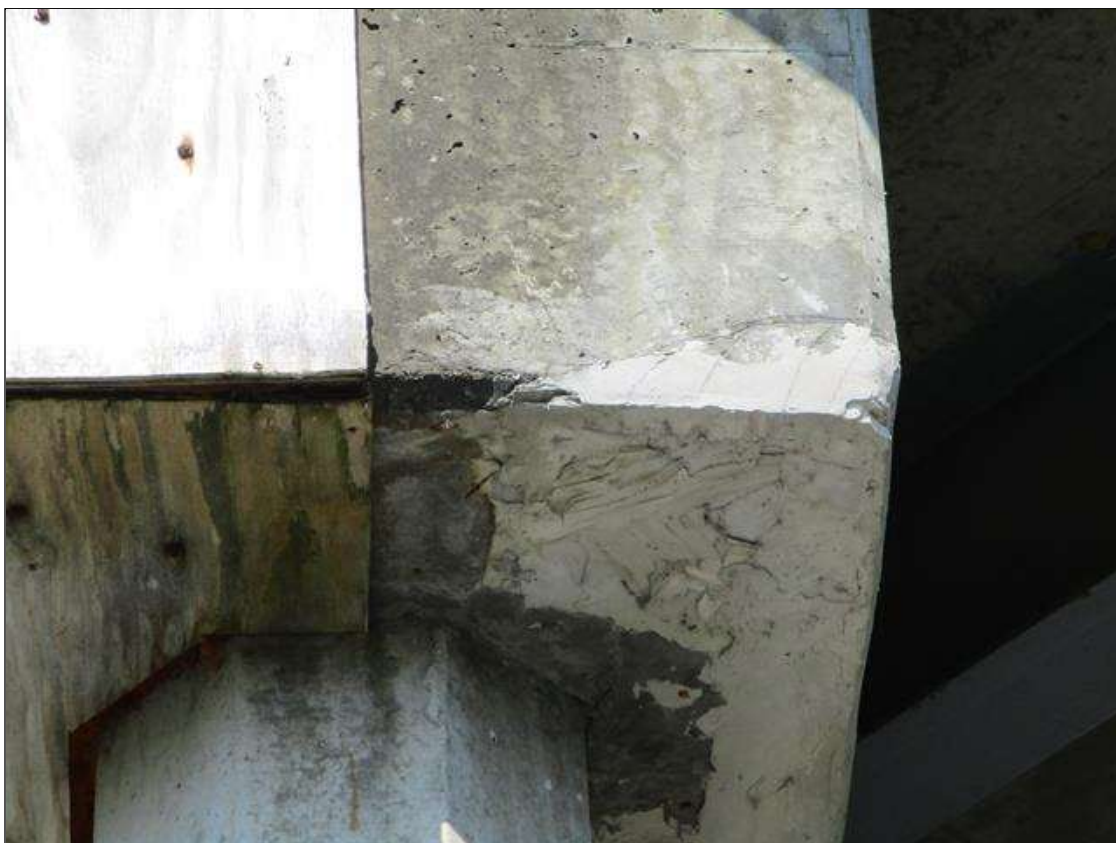
Bent 3 Cap 1: DELAMINATED AREA 12" WIDE X 6" HIGH ON RIGHT END.
