NC DEPARTMENT OF TRANSPORTATION  
 DIVISION OF HIGHWAYS  
 STRUCTURE MANAGEMENT UNIT

ATTENTION: **PRIORITY MAINTENANCE ISSUED SIGN NOTICE**

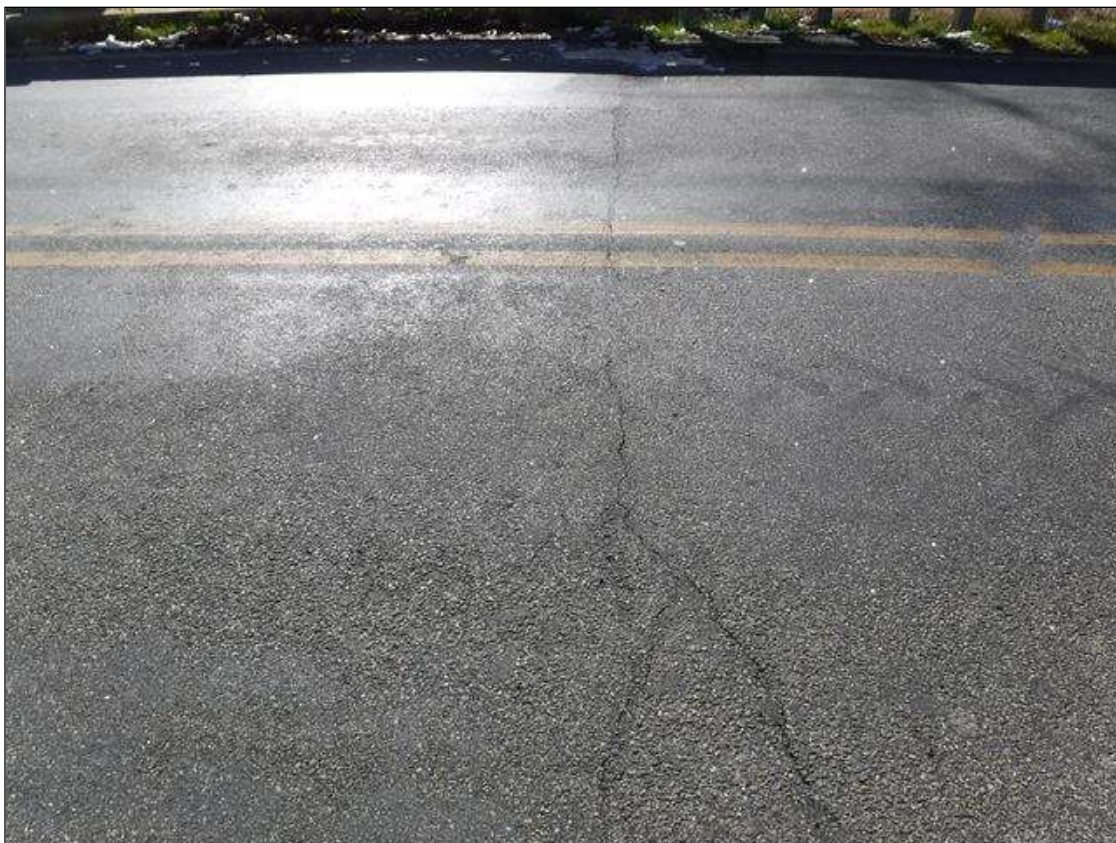
Span 1 Wearing Surface: TRANSVERSE CRACK END BENT 1

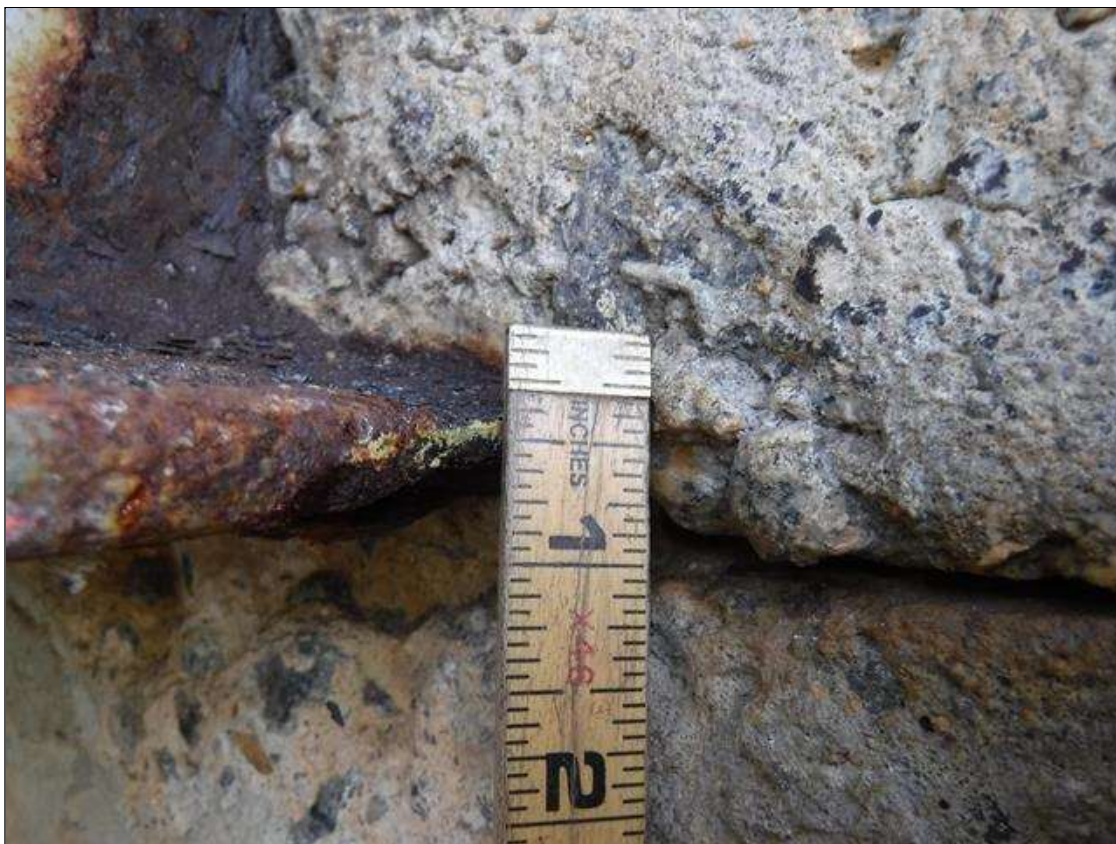
Span 1 Beam 1: SECTION LOSS BOTTOM FLANGE 1/4 IN REMAINING 2 IN LONG AT ABUTMENT 1 PRIORITY MAINTENANCE ISSUED

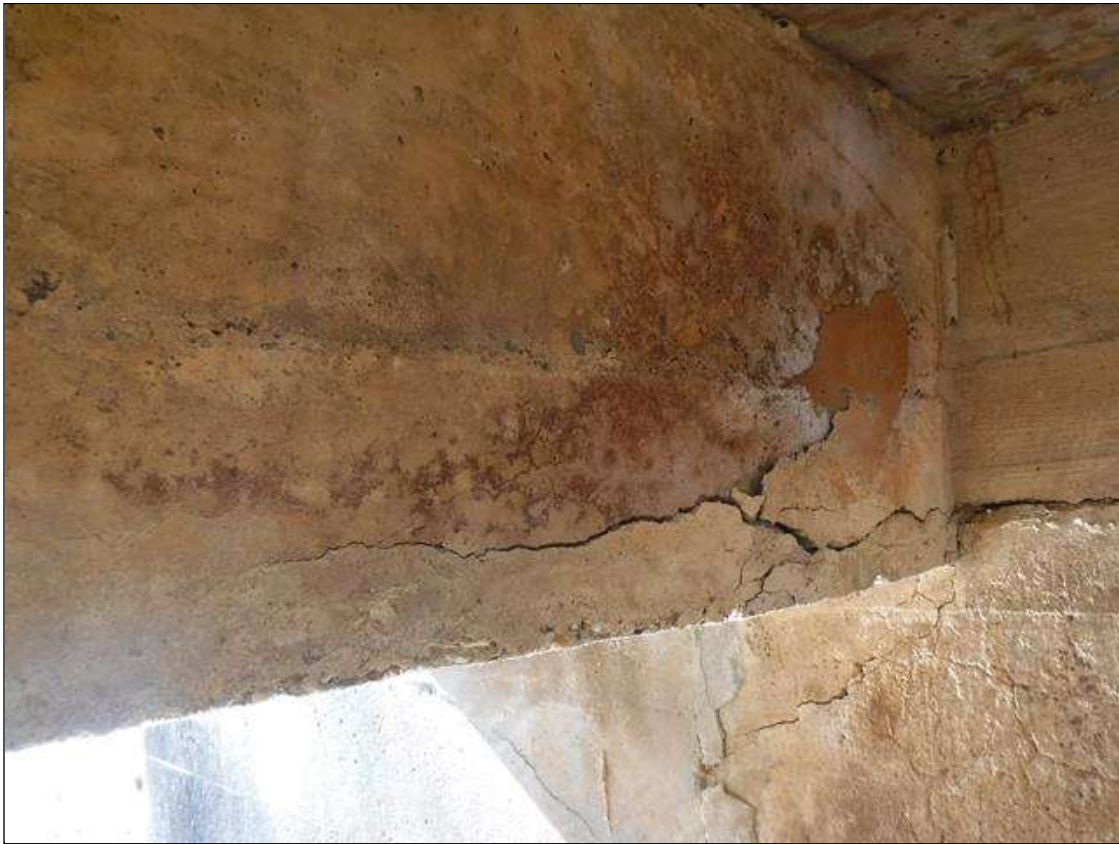
4' OF CRACKING IN CONCRETE INCASEMENT

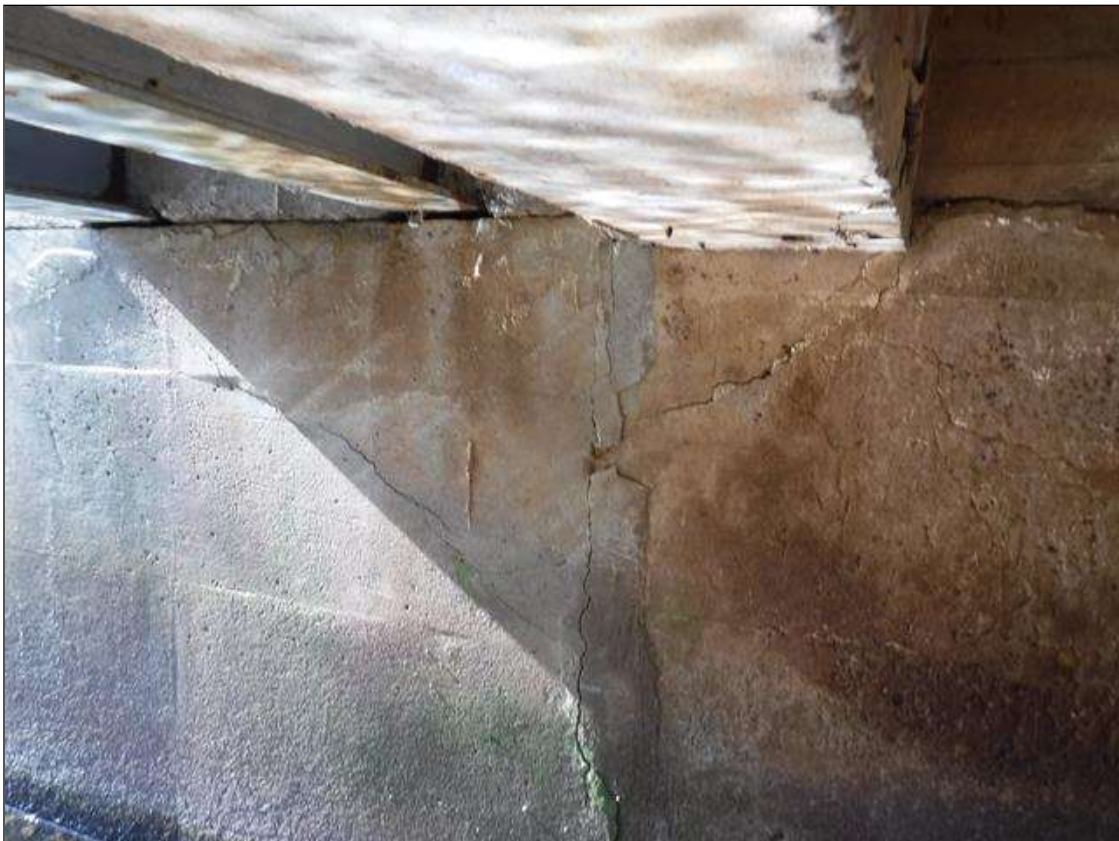
End Bent 1 Abutment/Backwall : MAP CRACKING IN FACE

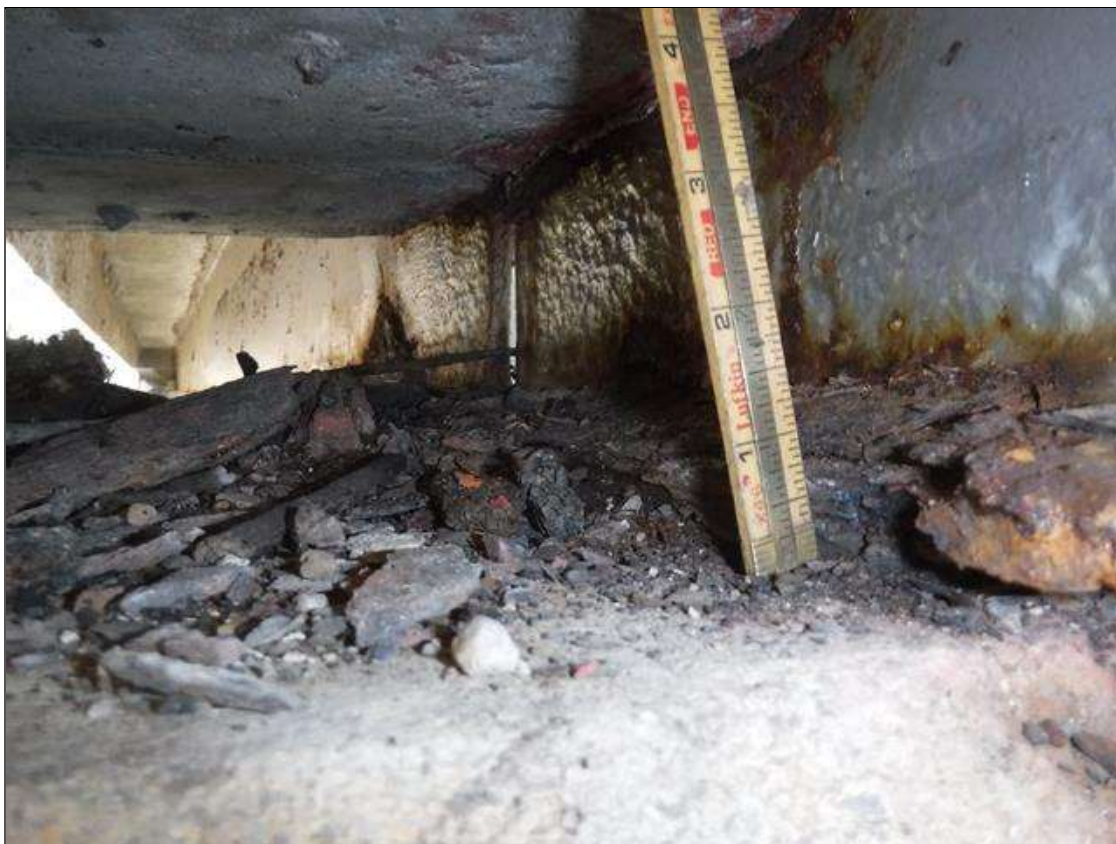
Span 1 Beam 9: SECTION LOSS 100 % BOTTOM FLANGE AT BENT 1 - 3/4 IN X 12 IN LONG , SECTION LOSS WEB 3 IN HIGH X 5/16 IN REMAINING PRIORITY MAINTENANCE ISSUED

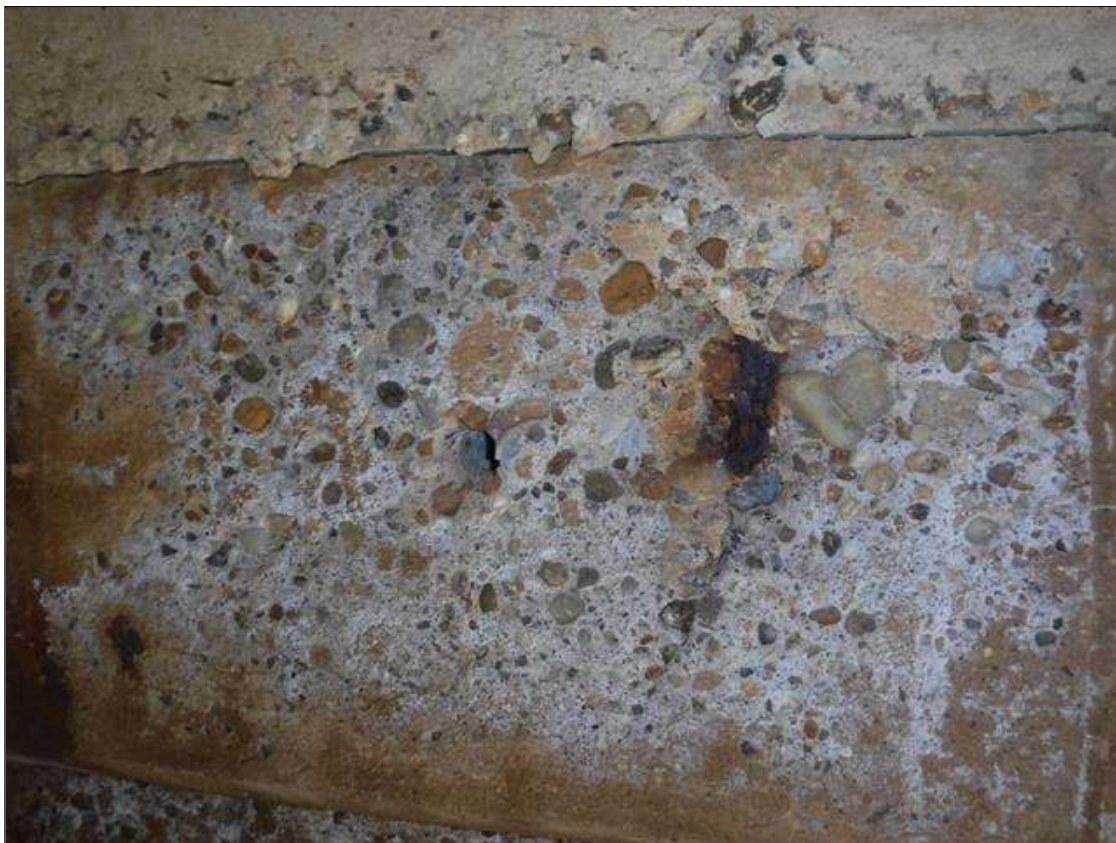
SURFACE SPALL IN BENT 1 CAP SPAN 1 SIDE WITH EXPOSED STEEL

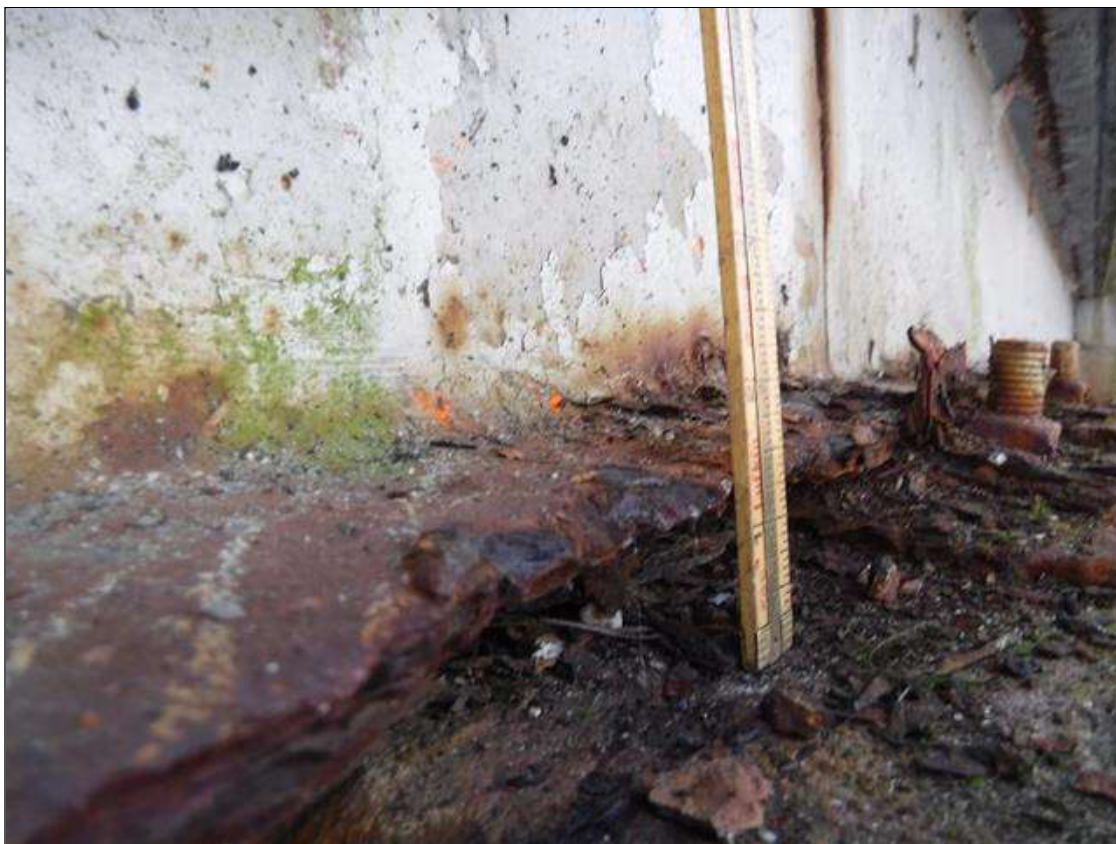
Span 2 Beam 1: 100 % SECTION LOSS BOTTOM FLANGE AT BENT 1 - 1.5 IN WIDE X 14 IN LONG , 5/16 IN REMAINING IN WEB 5 IN HIGH X 1 FOOT LONG PRIORITY MAINTENANCE ISSUED

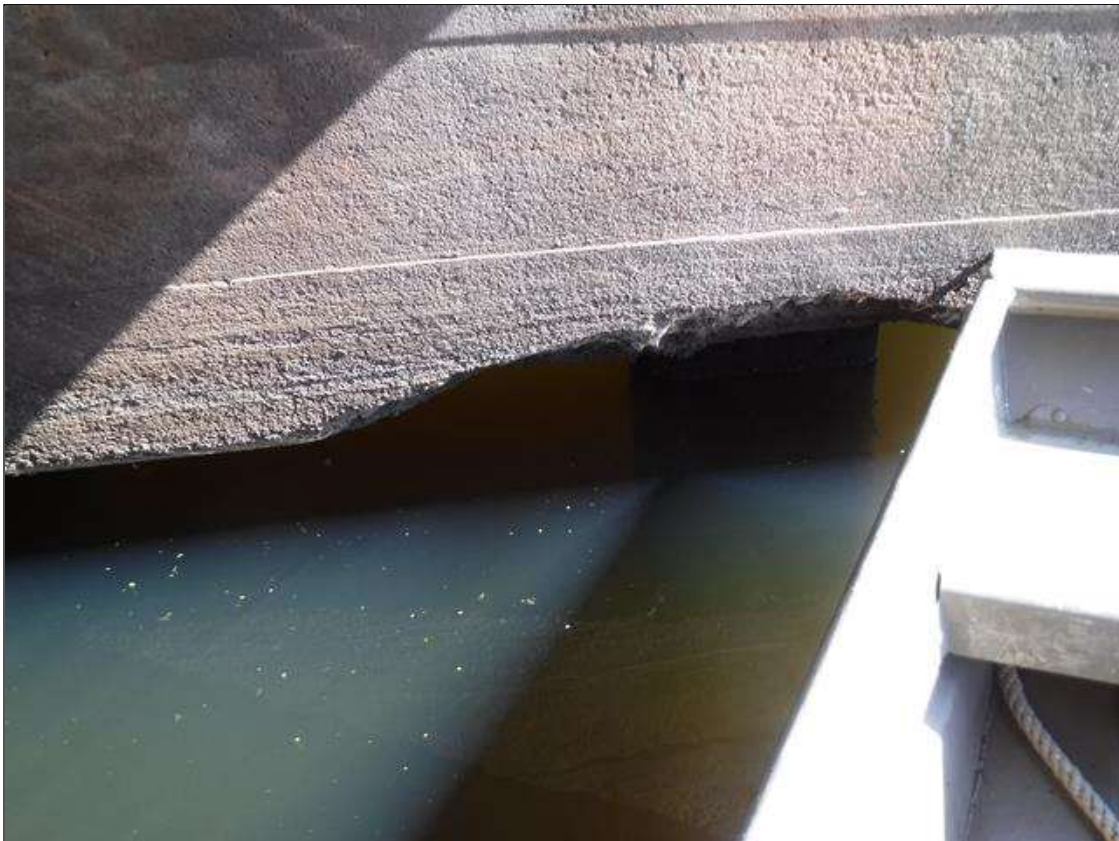
4' LONG X 6" WIDE SPALL IN BOTTOM CORNER OF BENT 2 CAP WITH EXPOSED STEEL

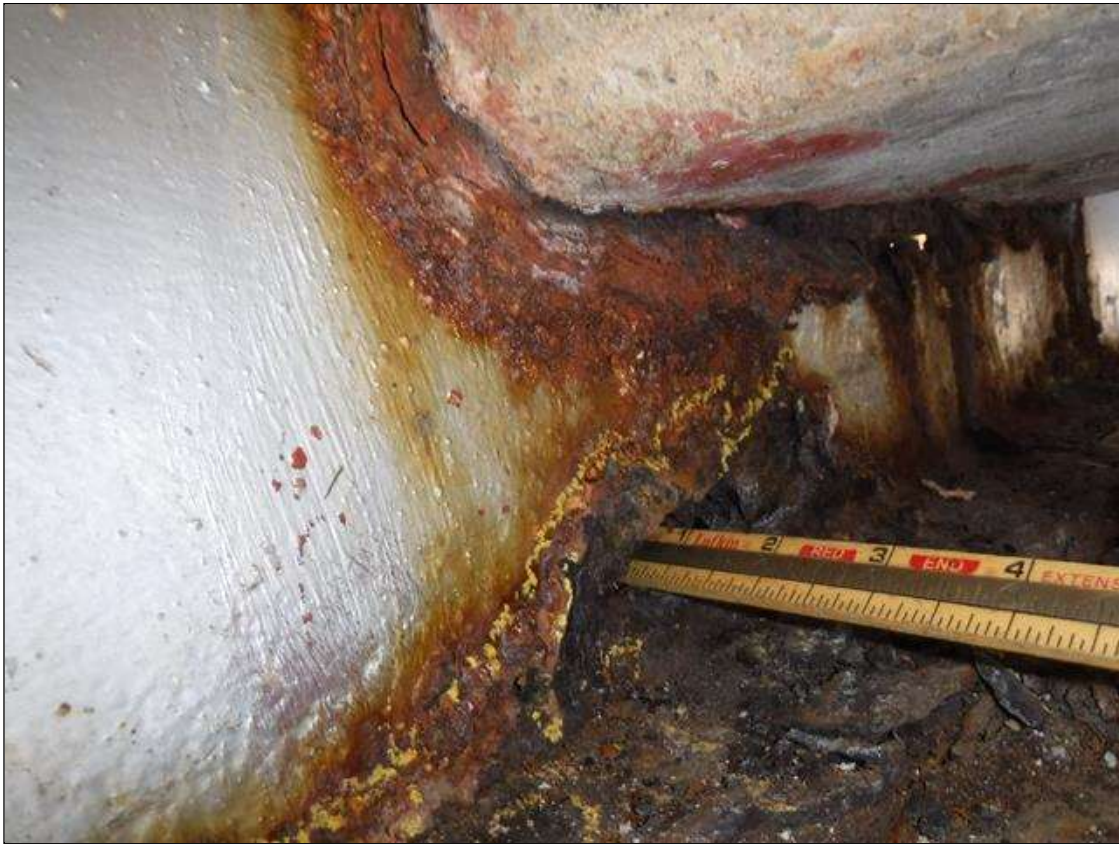
Span 2 Beam 9: SECTION LOSS BENT 2 WEB - HOLE 1 IN DIAMETER 1 IN UP FROM BOTTOM FLANGE, 100 % SECTION LOSS IN EDGE BOTTOM FLANGE 1 IN WIDE X 12 IN LONG, 1/4 IN REMAINING IN MIDDLE BOTTOM FLANGE PRIORITY MAINTENANCE ISSUED

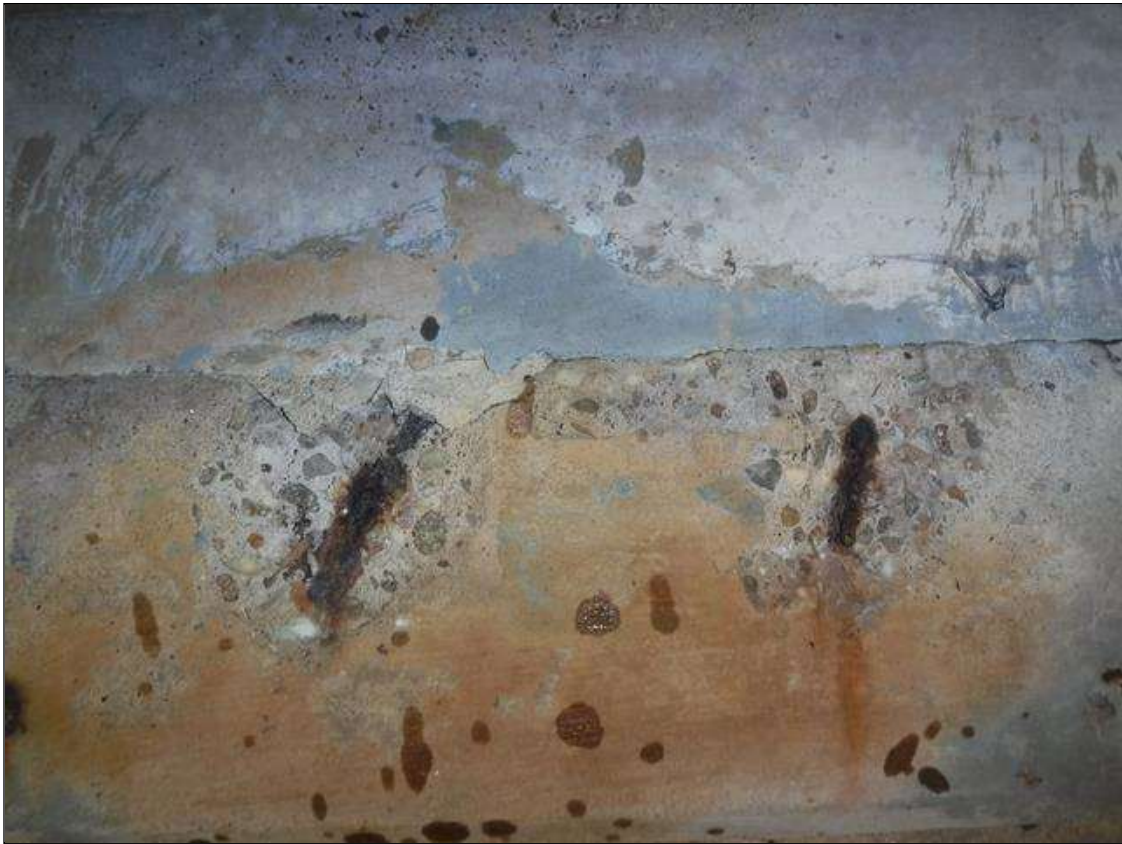
SPALL WITH EXPOSED STEEL IN BENT 4 CAP SPAN 5 SIDE

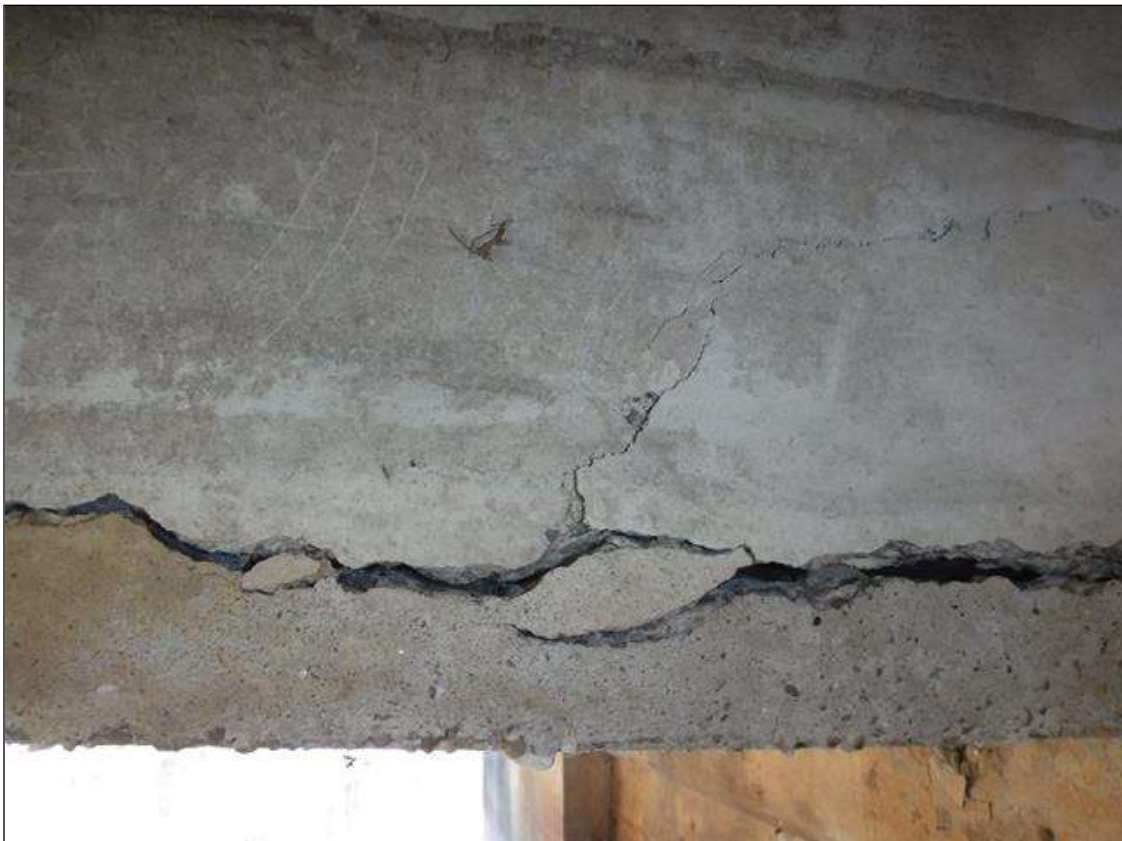
CRACKING IN CONCRETE INCASEMENT BEAM 6 SPAN 5 AT BENT 4

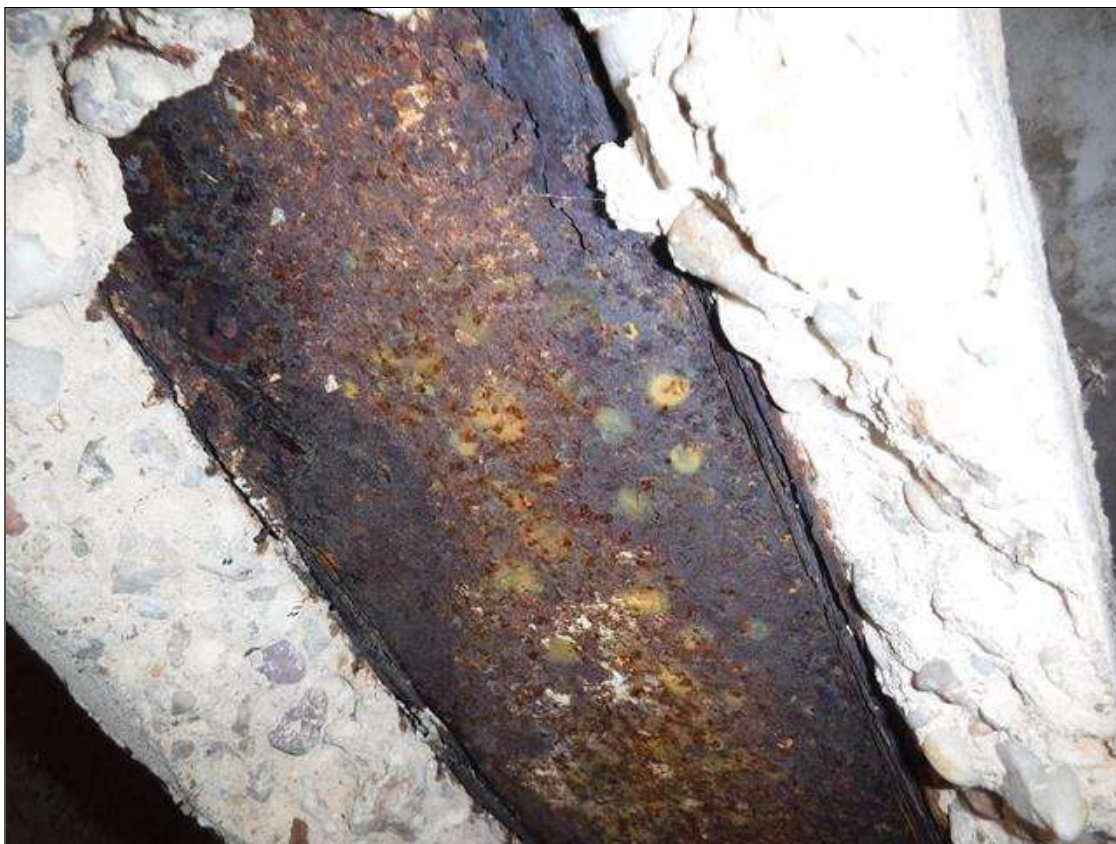
Span 5 Beam 7: RUST ON BOTTOM FLANGE

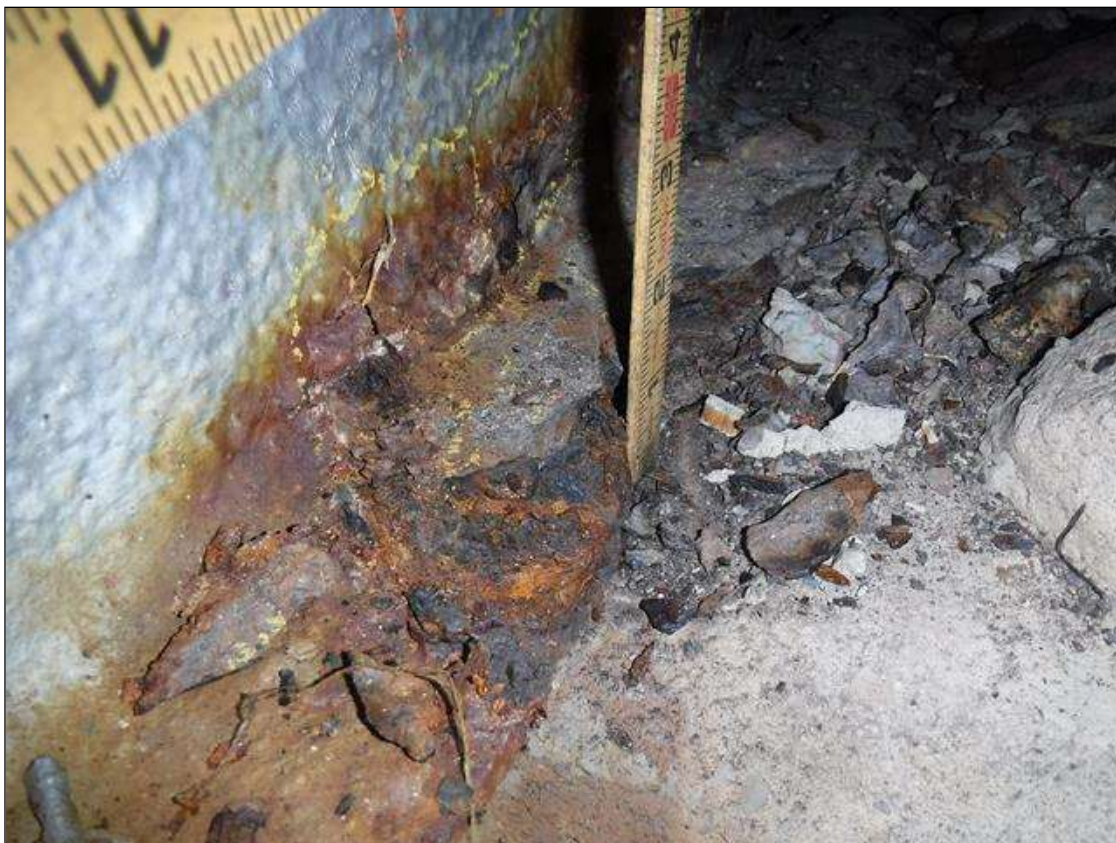
Span 5 Beam 9: SECTION LOSS WEB BENT 4 -1 IN DIAMETER OVER BEARING , SECTION LOSS BOTTOM FLANGE 100 % IN EDGE 1 IN WIDE X 6 IN LONG BEARING OUT, PRIORITY MAINTENANCE ISSUED

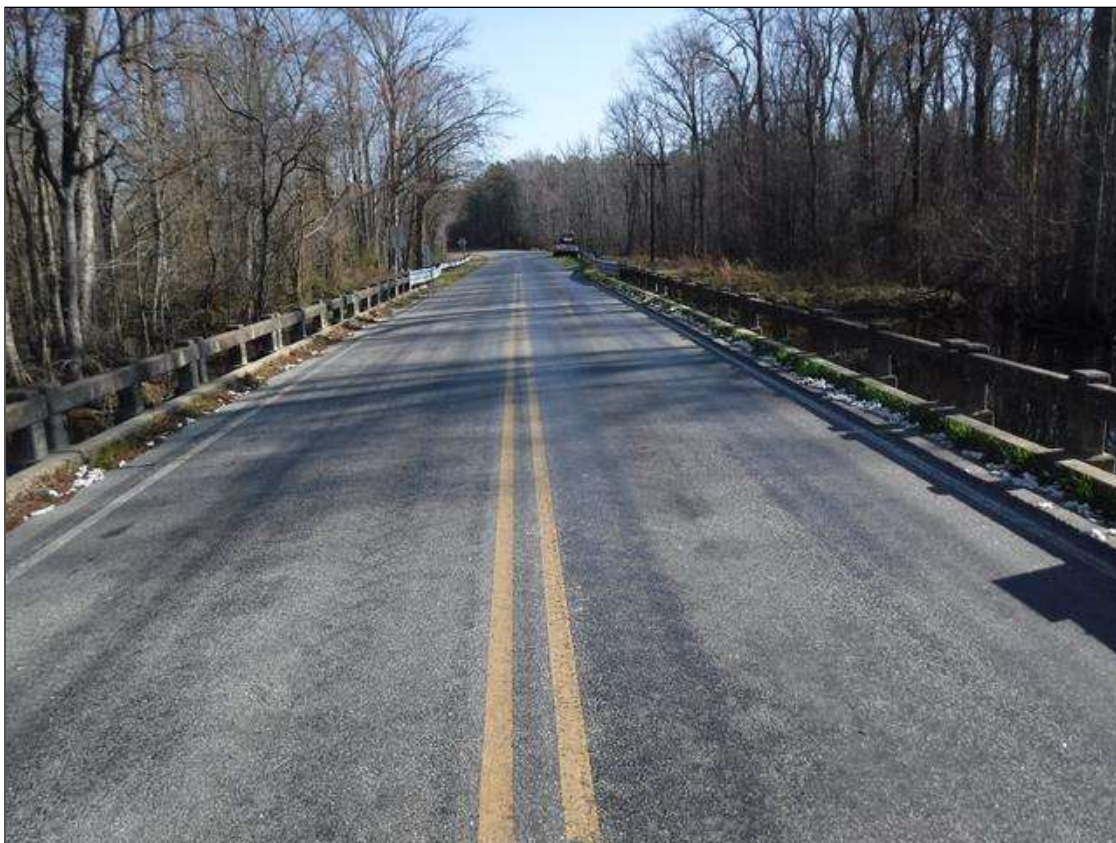
ASPHALT WEARING SURFACE

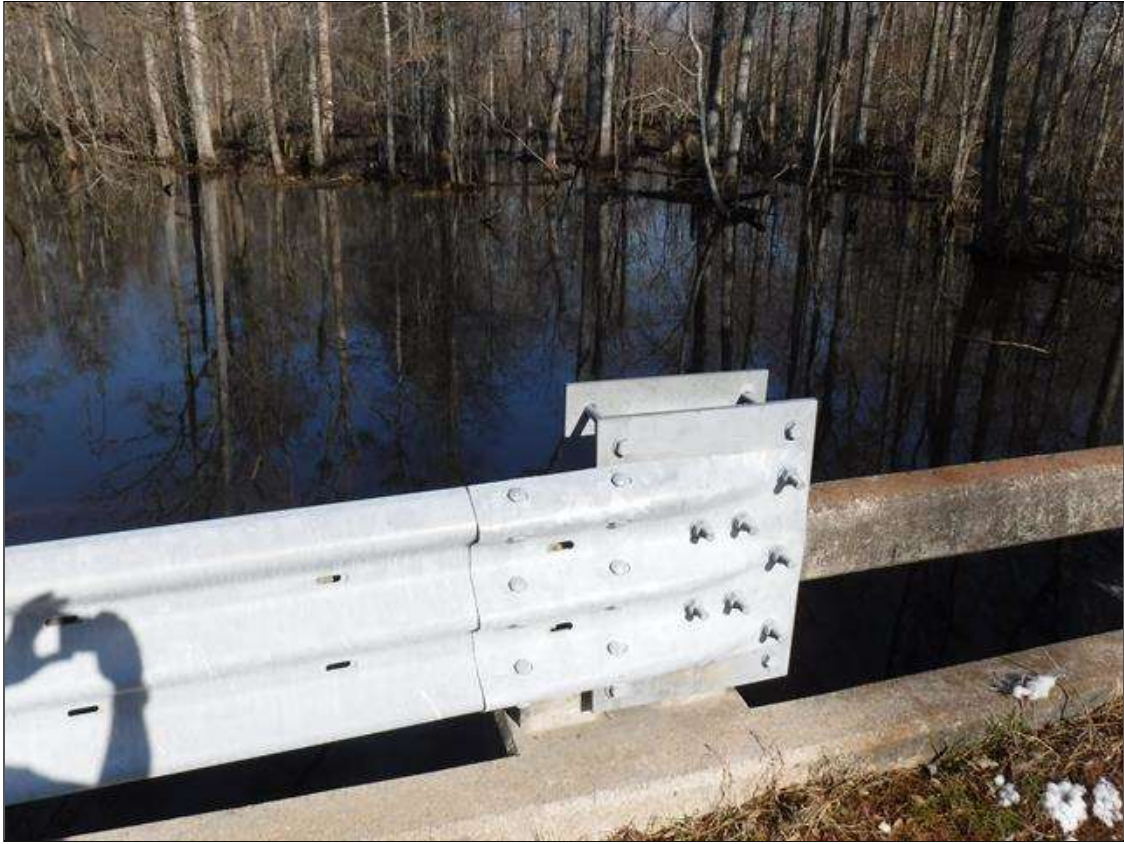
GUARDRAIL ATTACHMENT

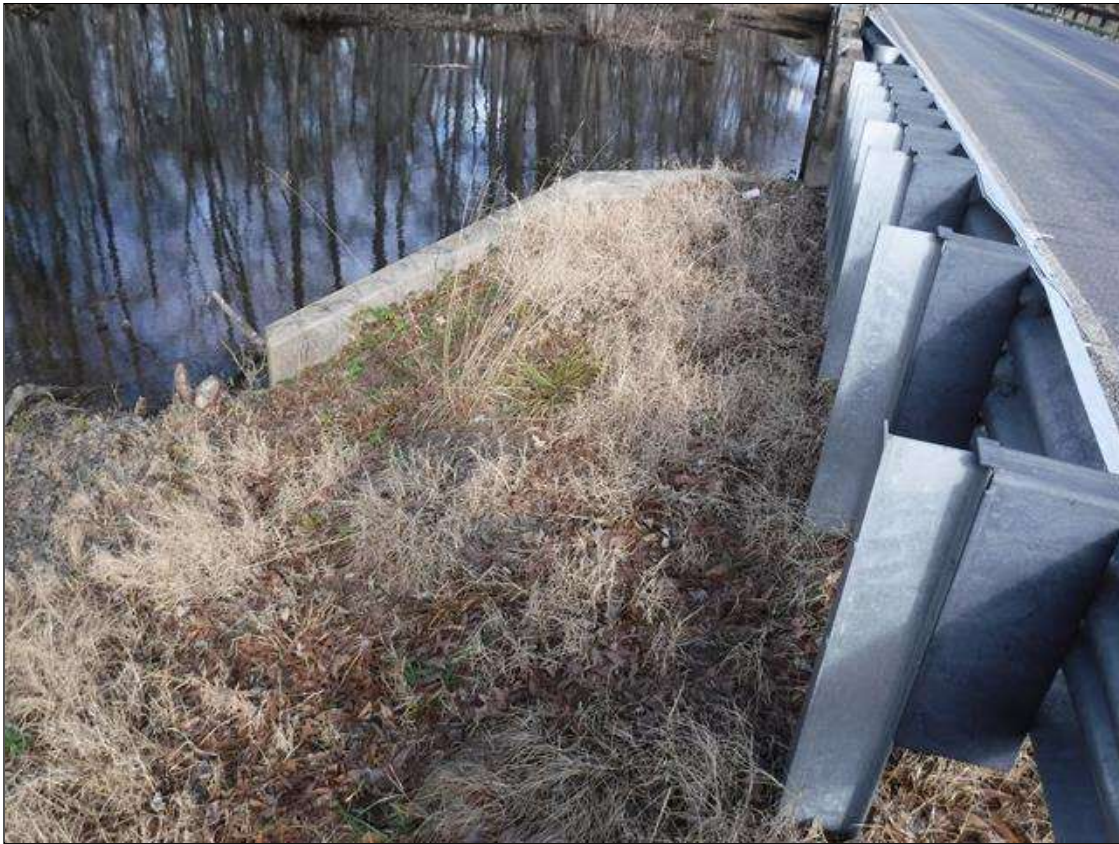
MISSING DELINEATOR SOUTH WEST CORNER SIMILAR AT NORTH EAST CORNER PRIORITY MAINTENANCE ISSUED
